Toby Creek Field Reconnaissance Observations

September 26, 2018

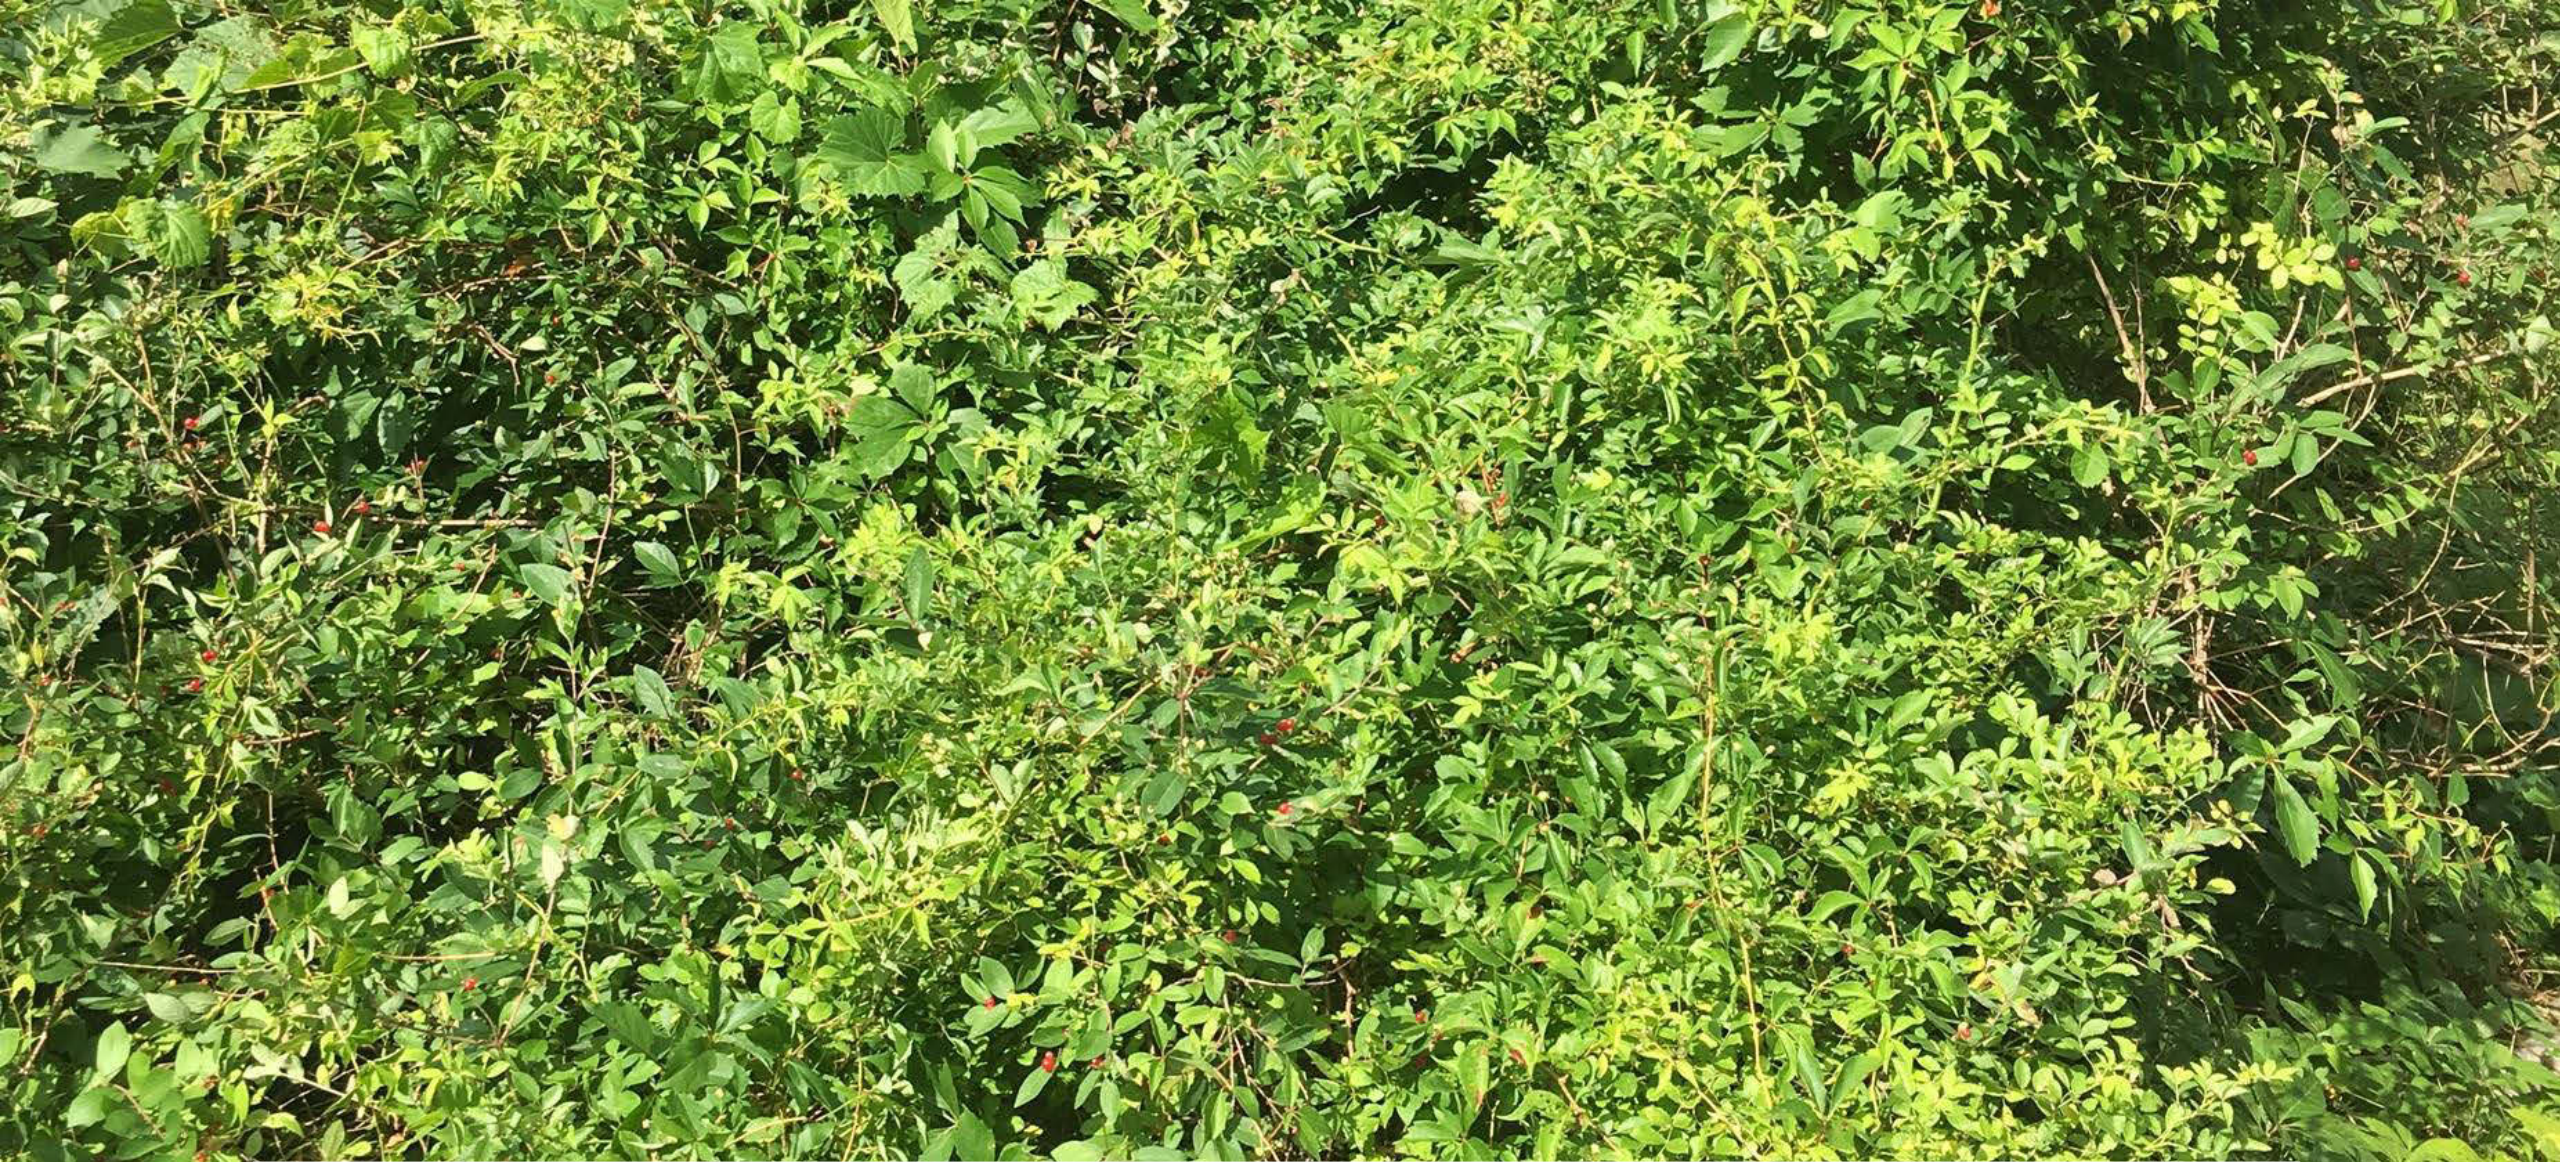
Figure 195. Downstream of culvert at the dip in Irem Road at the bottom of the hill. The herbaceous woody shrubbery has overgrown the outlet to the point it isn't even visible.

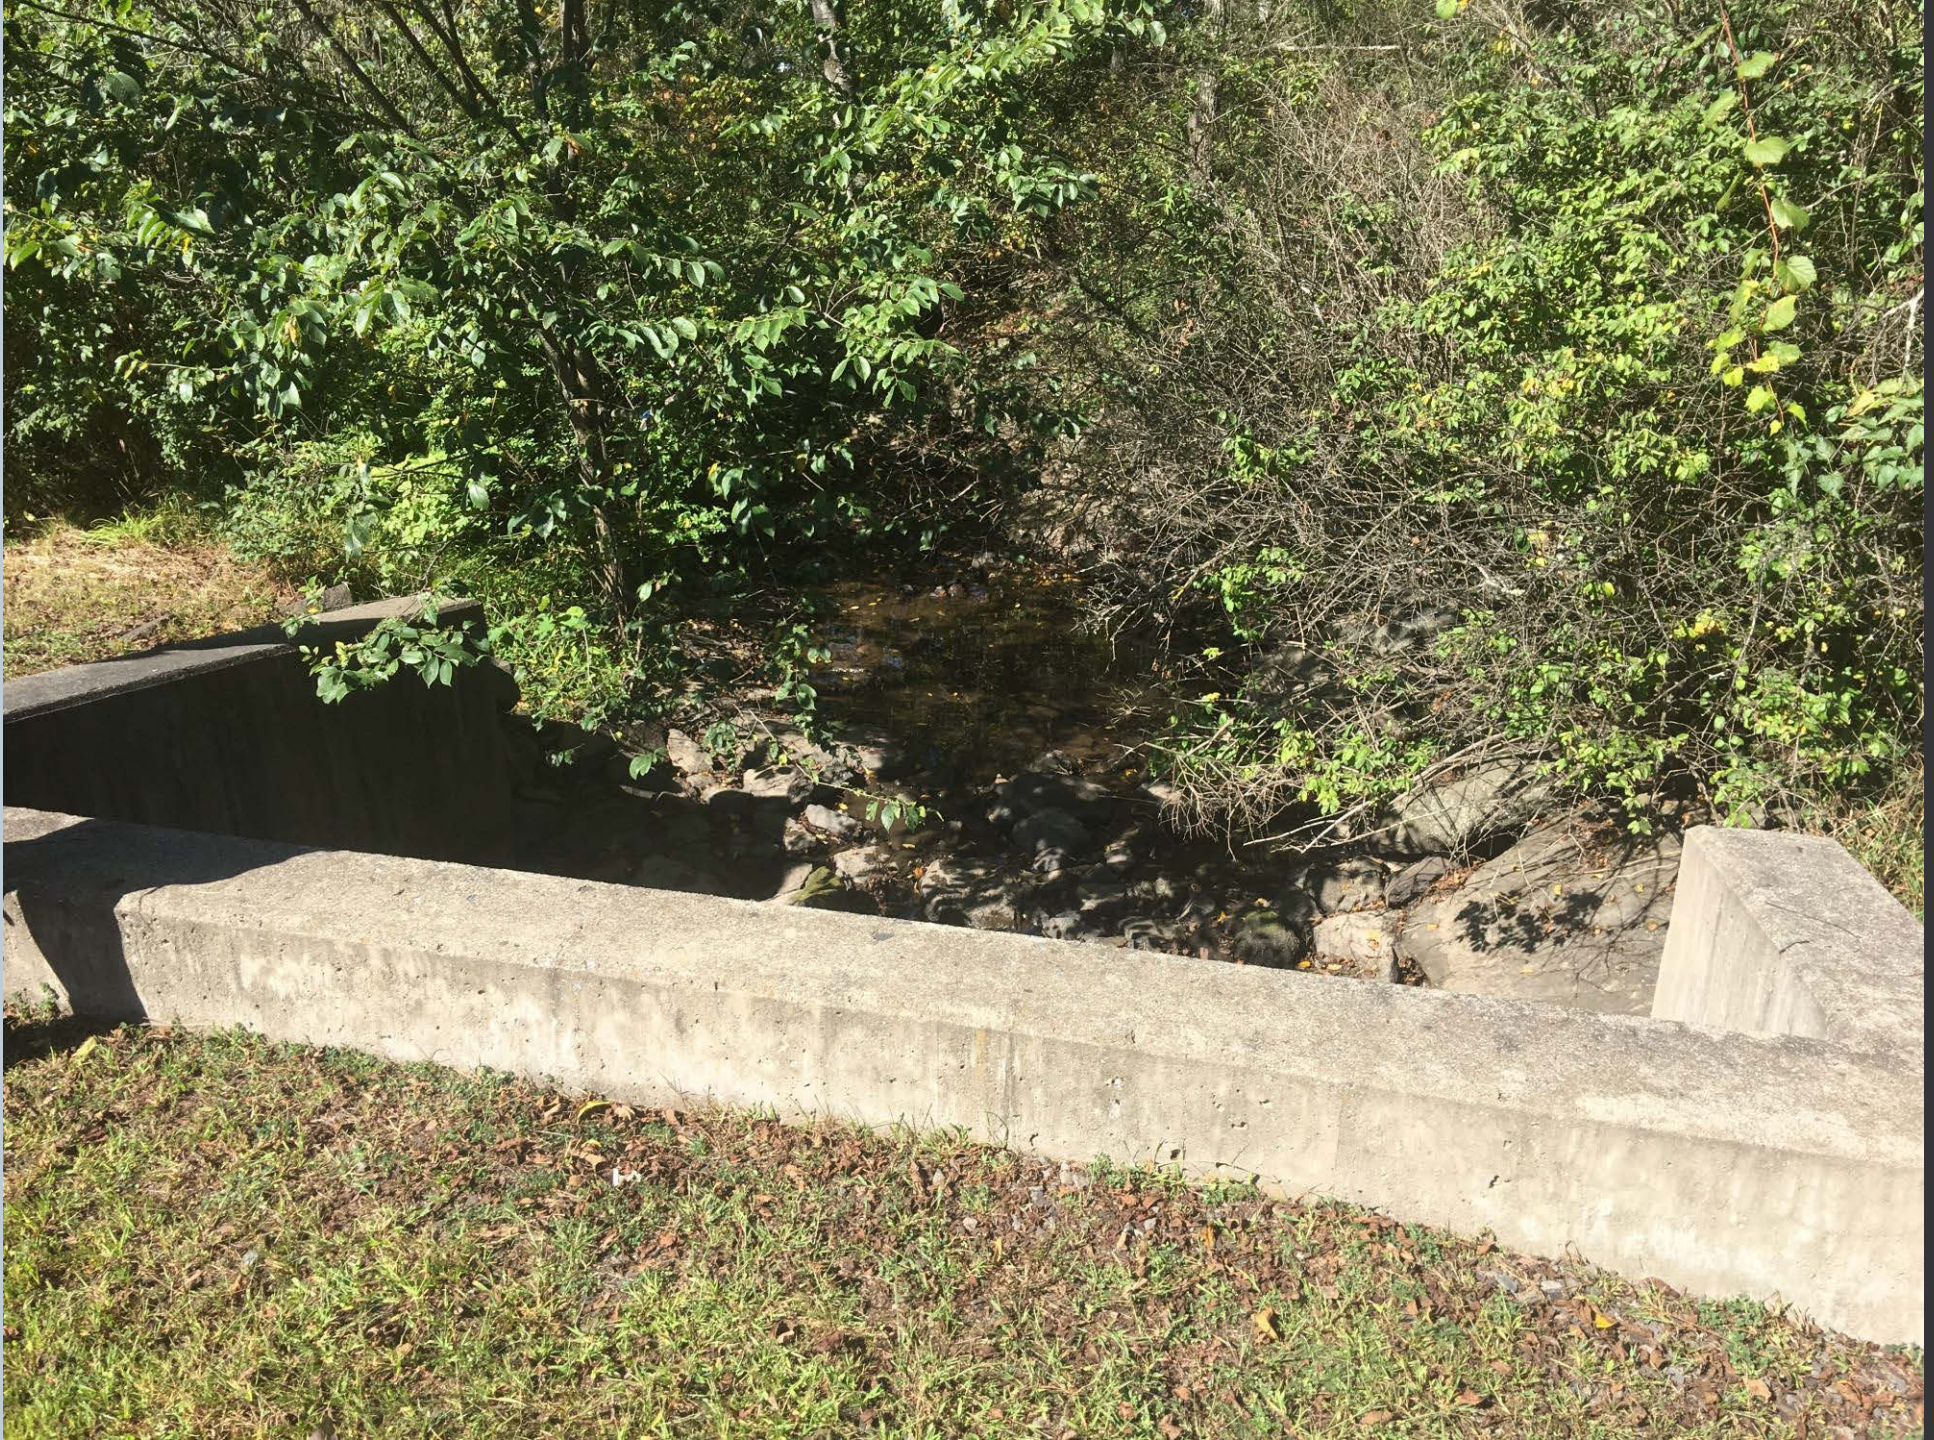
Figure 232. Looking upstream on an unnamed tributary to Toby Creek at a multiple structure culvert along the outlet culvert on McAuley Drive. Recommend Misericordia University not mow the grass along the streambank and replanting the riparian corridor on the upstream end of the culvert to create cooler water conditions and reduce sediment loads downstream caused by the eroded streambanks.

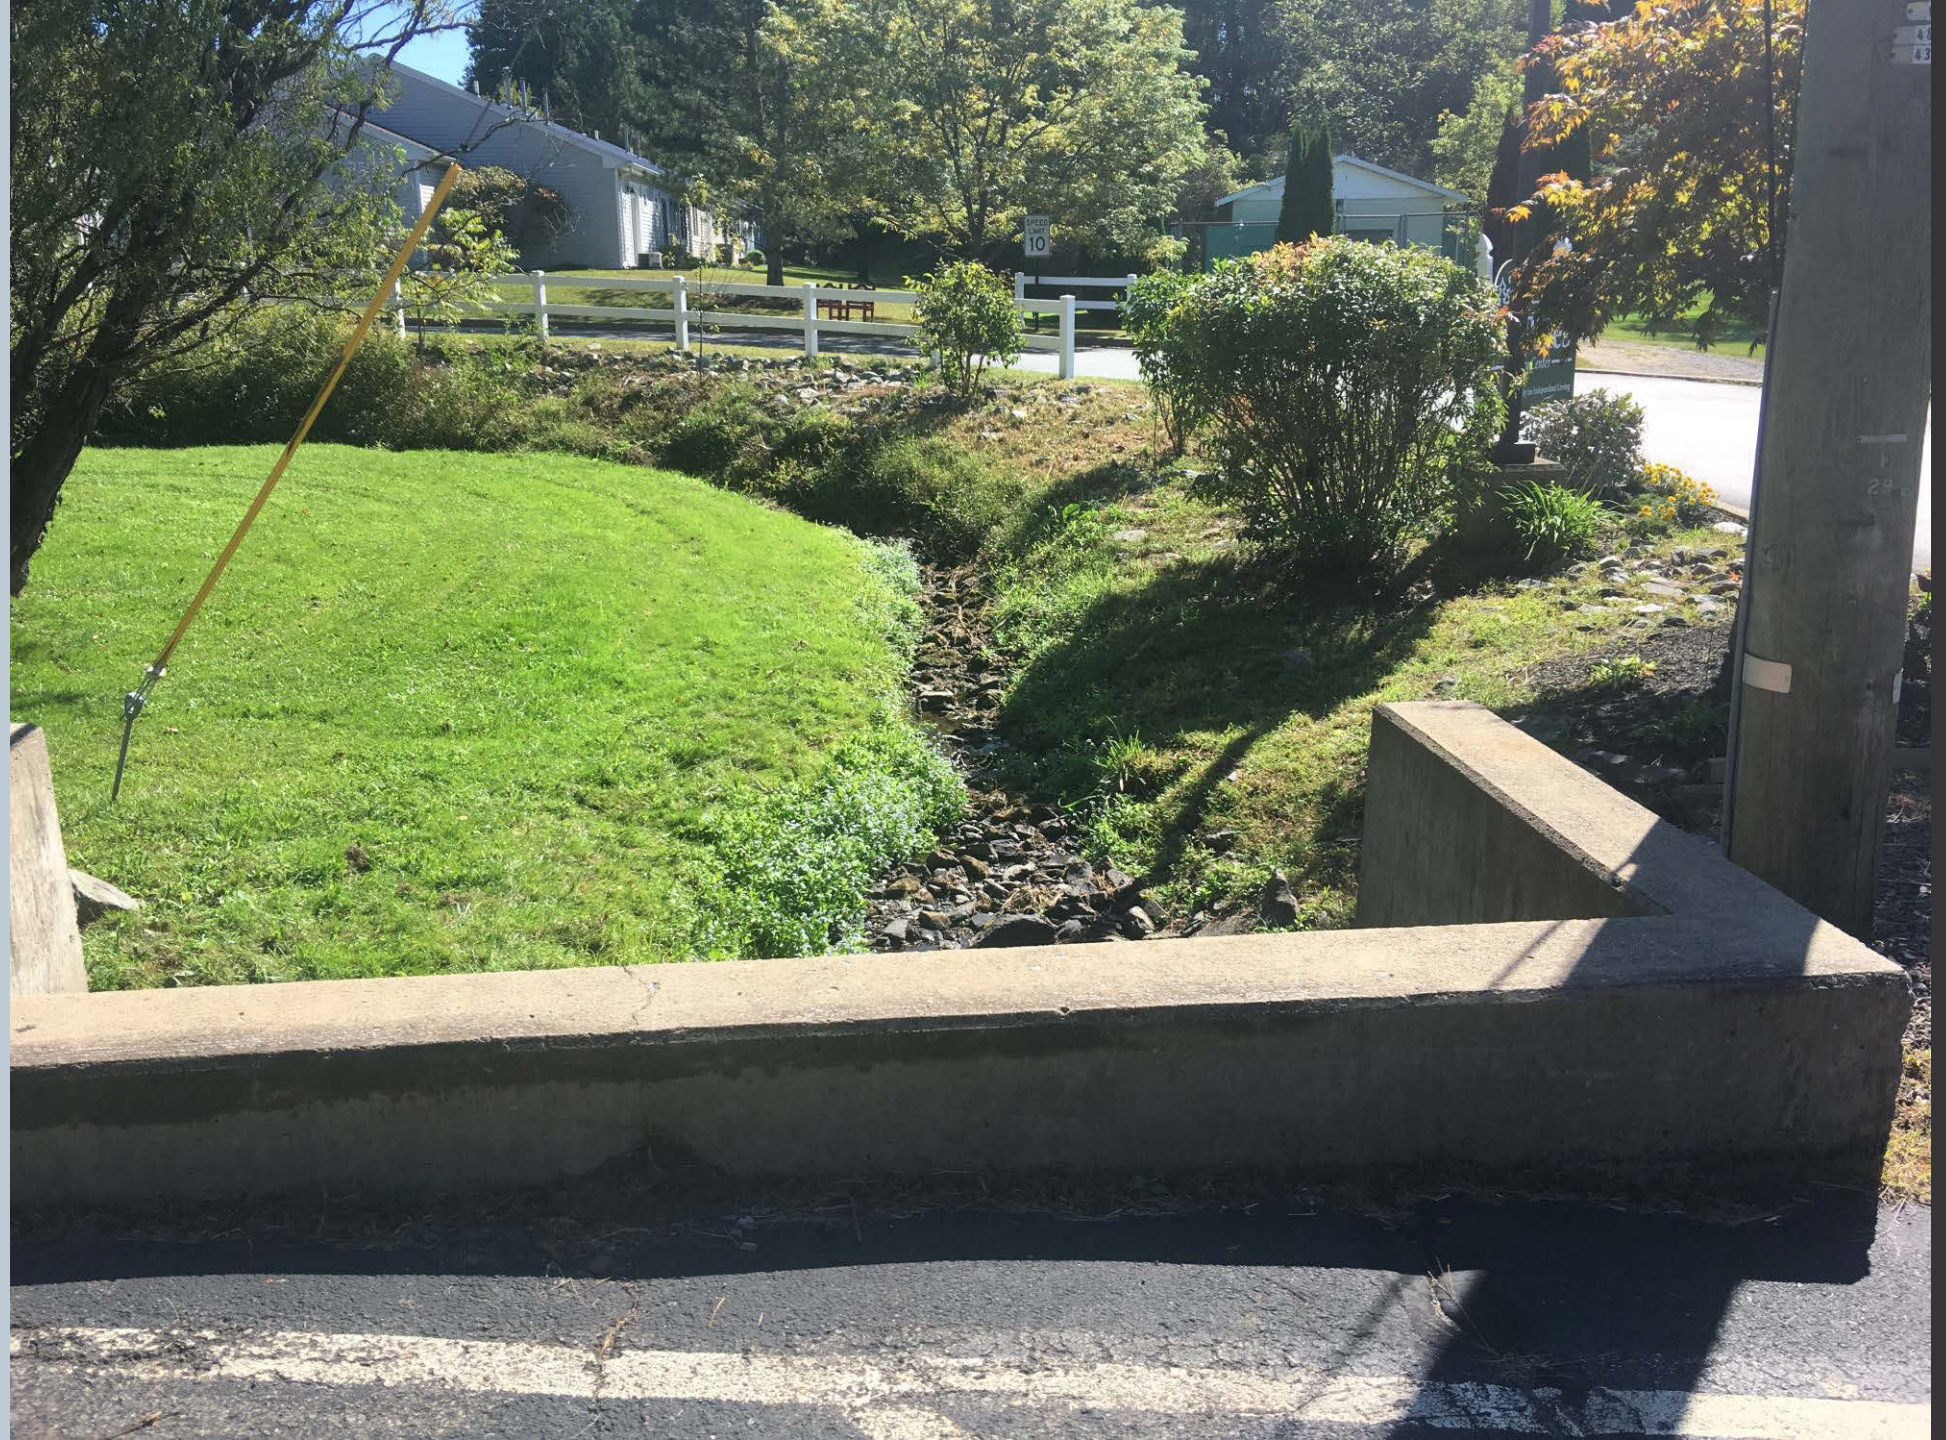
Figure 233. Looking downstream on an unnamed tributary to Toby Creek at a multiple structure culvert along the outlet culvert on McAuley Drive. Recommend Misericordia excavate the sediment bar that is blocking the flow of water from the tributary along the grassy area to the center and right culvert structures that is creating a constriction of the flow down to the one pipe on the left of the culvert.

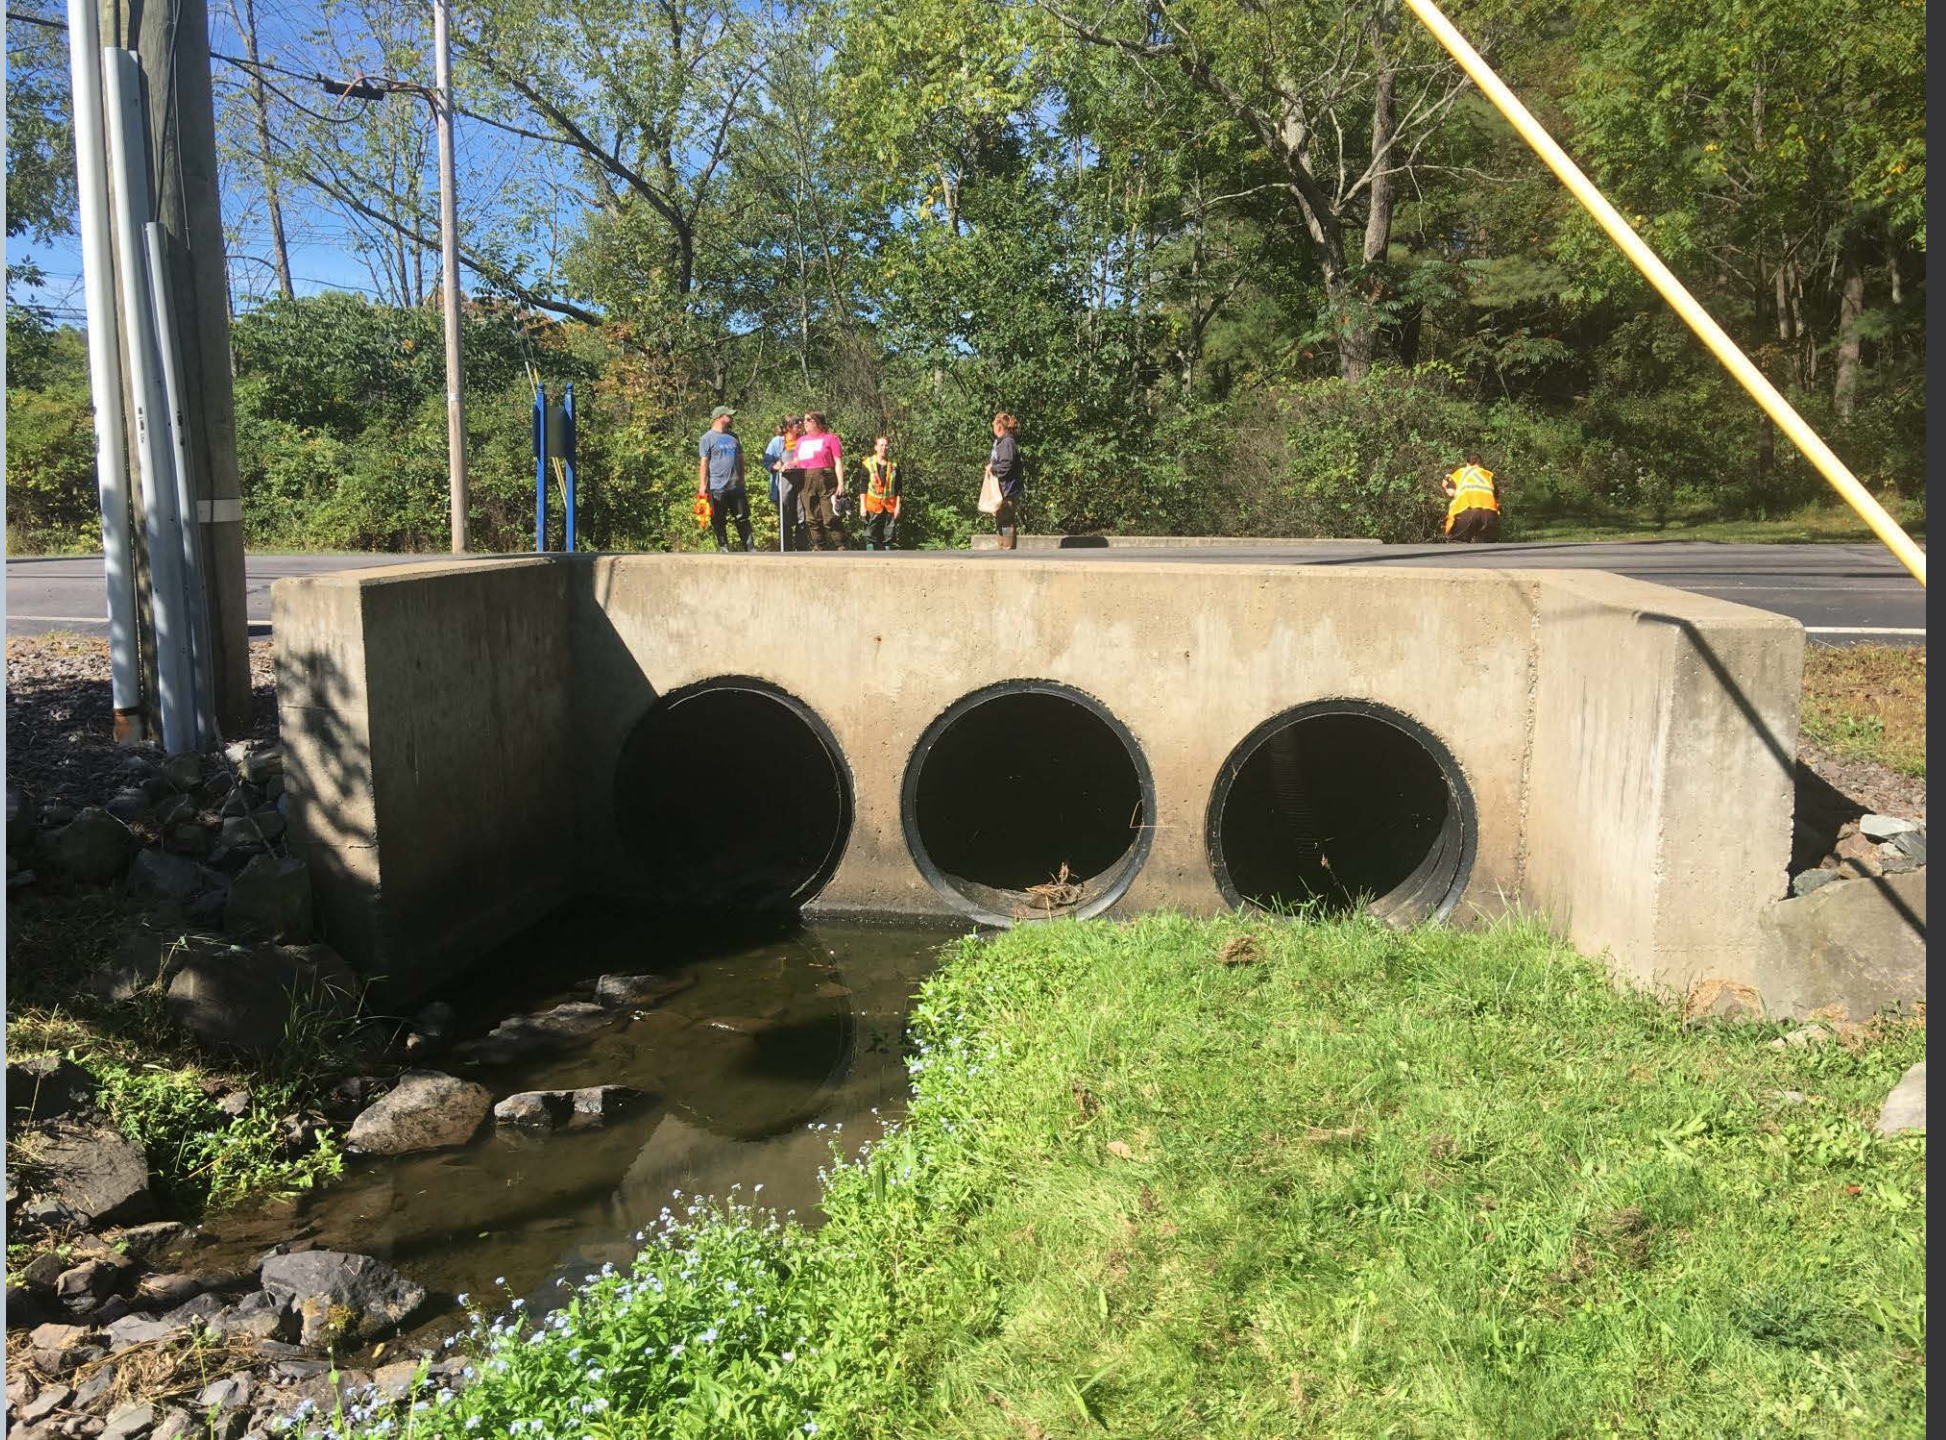
Figure 234.
Looking upstream
on an unnamed
tributary to Toby
Creek off Lake
Street on
Misericordia
University
grounds above the
pedestrian bridge
and the bridge on
Lake Street.
Freshwater snails
present in the
pooled water
beneath the
bridge.

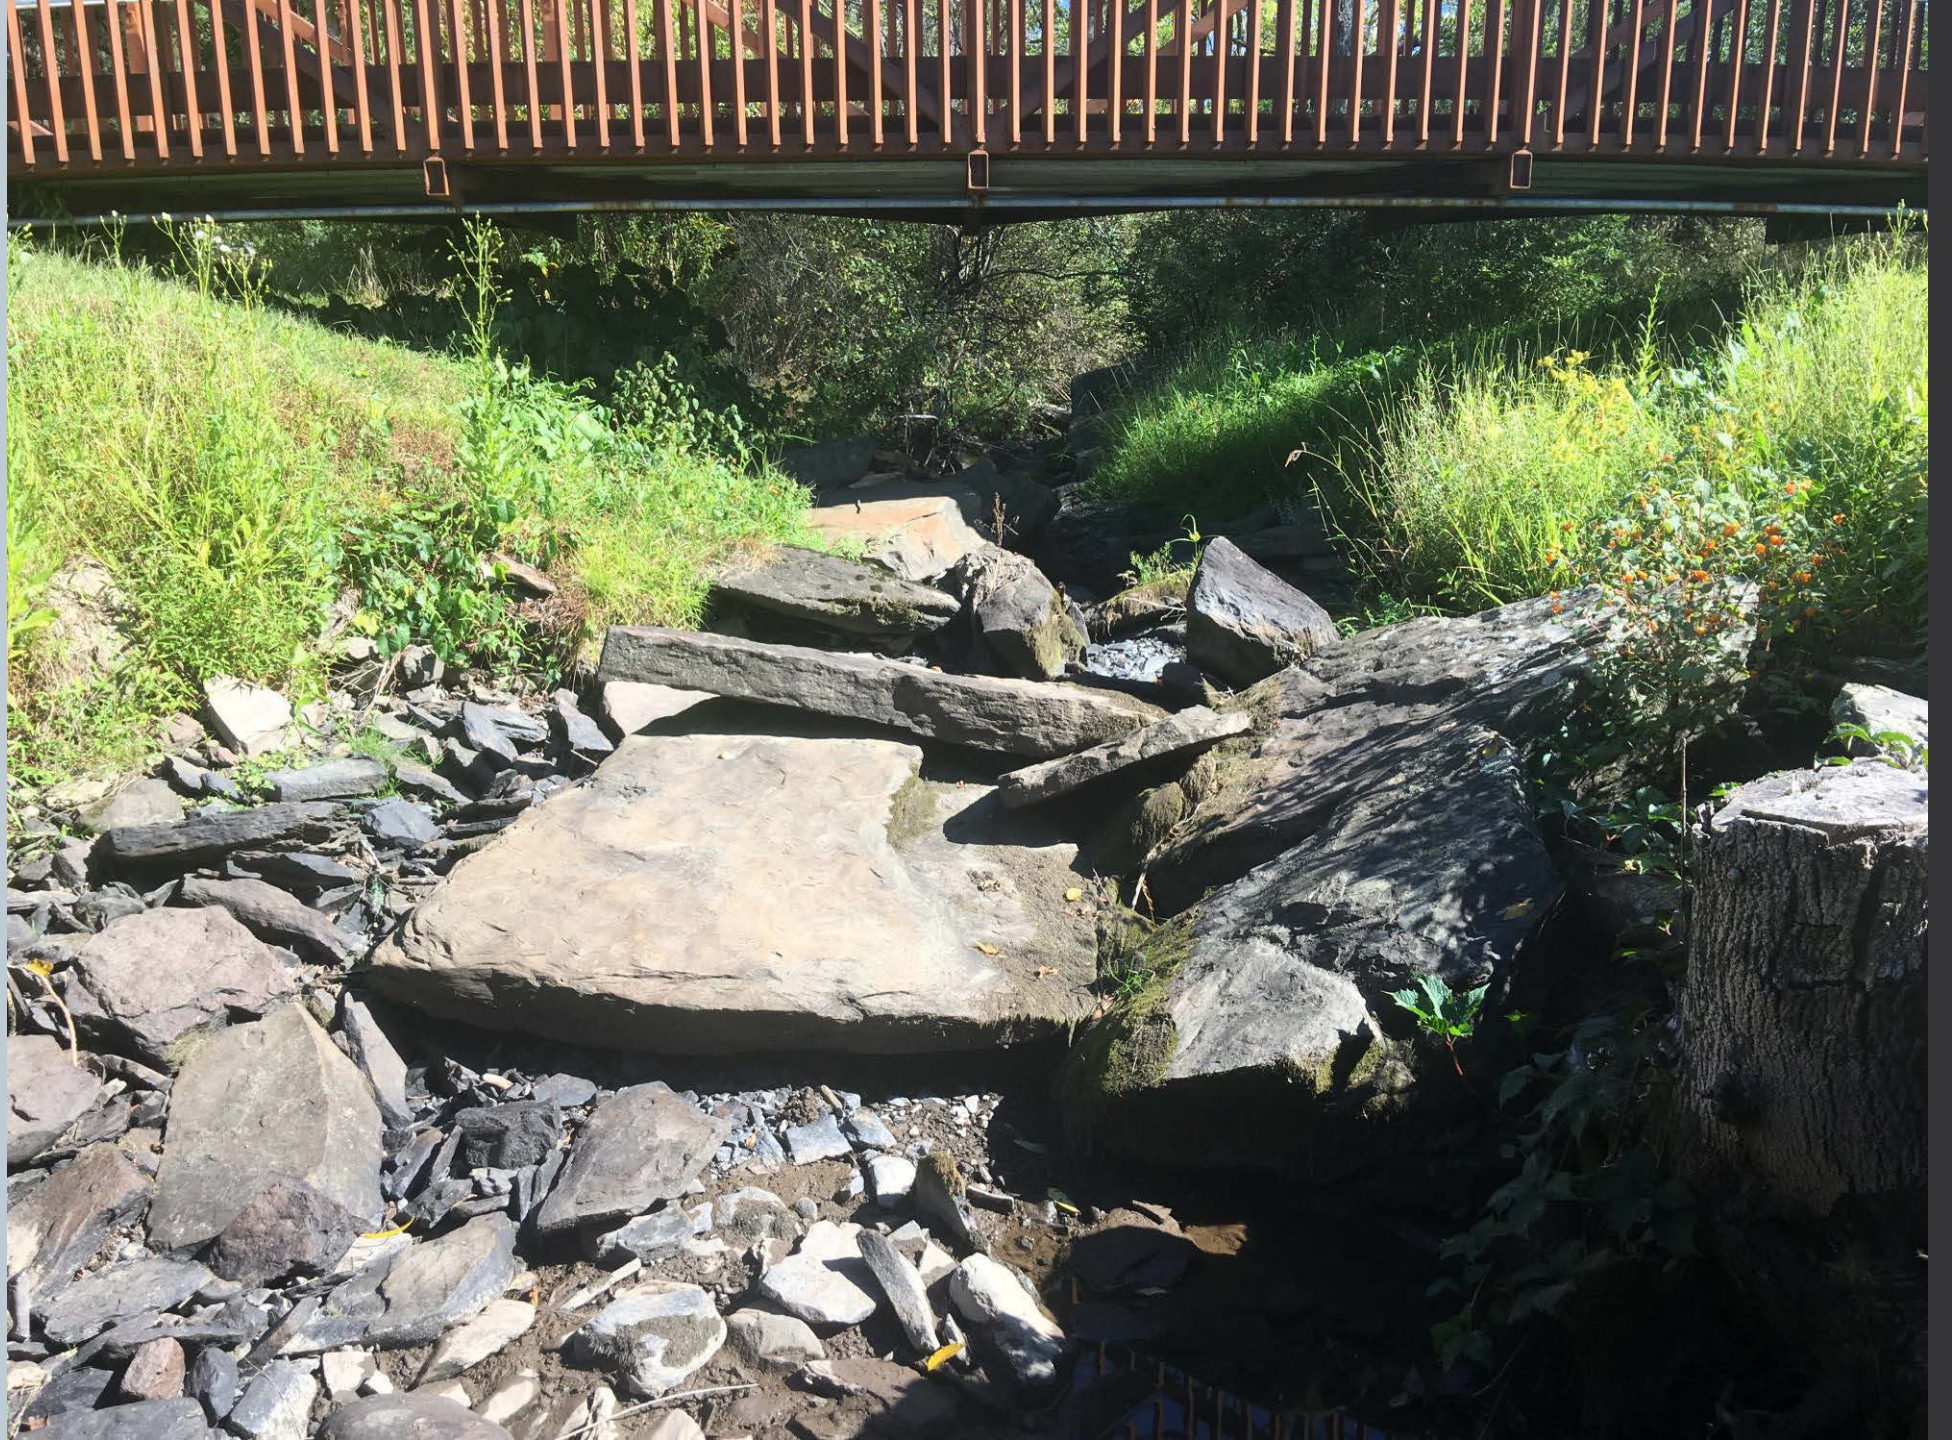
Figure 235. Looking downstream on an unnamed tributary to Toby Creek off Lake Street on Misericordia University grounds below the pedestrian bridge and the bridge on Lake Street. Heavy sediment deposition was noted all the way through the culvert. Recommend removal of the sediment.

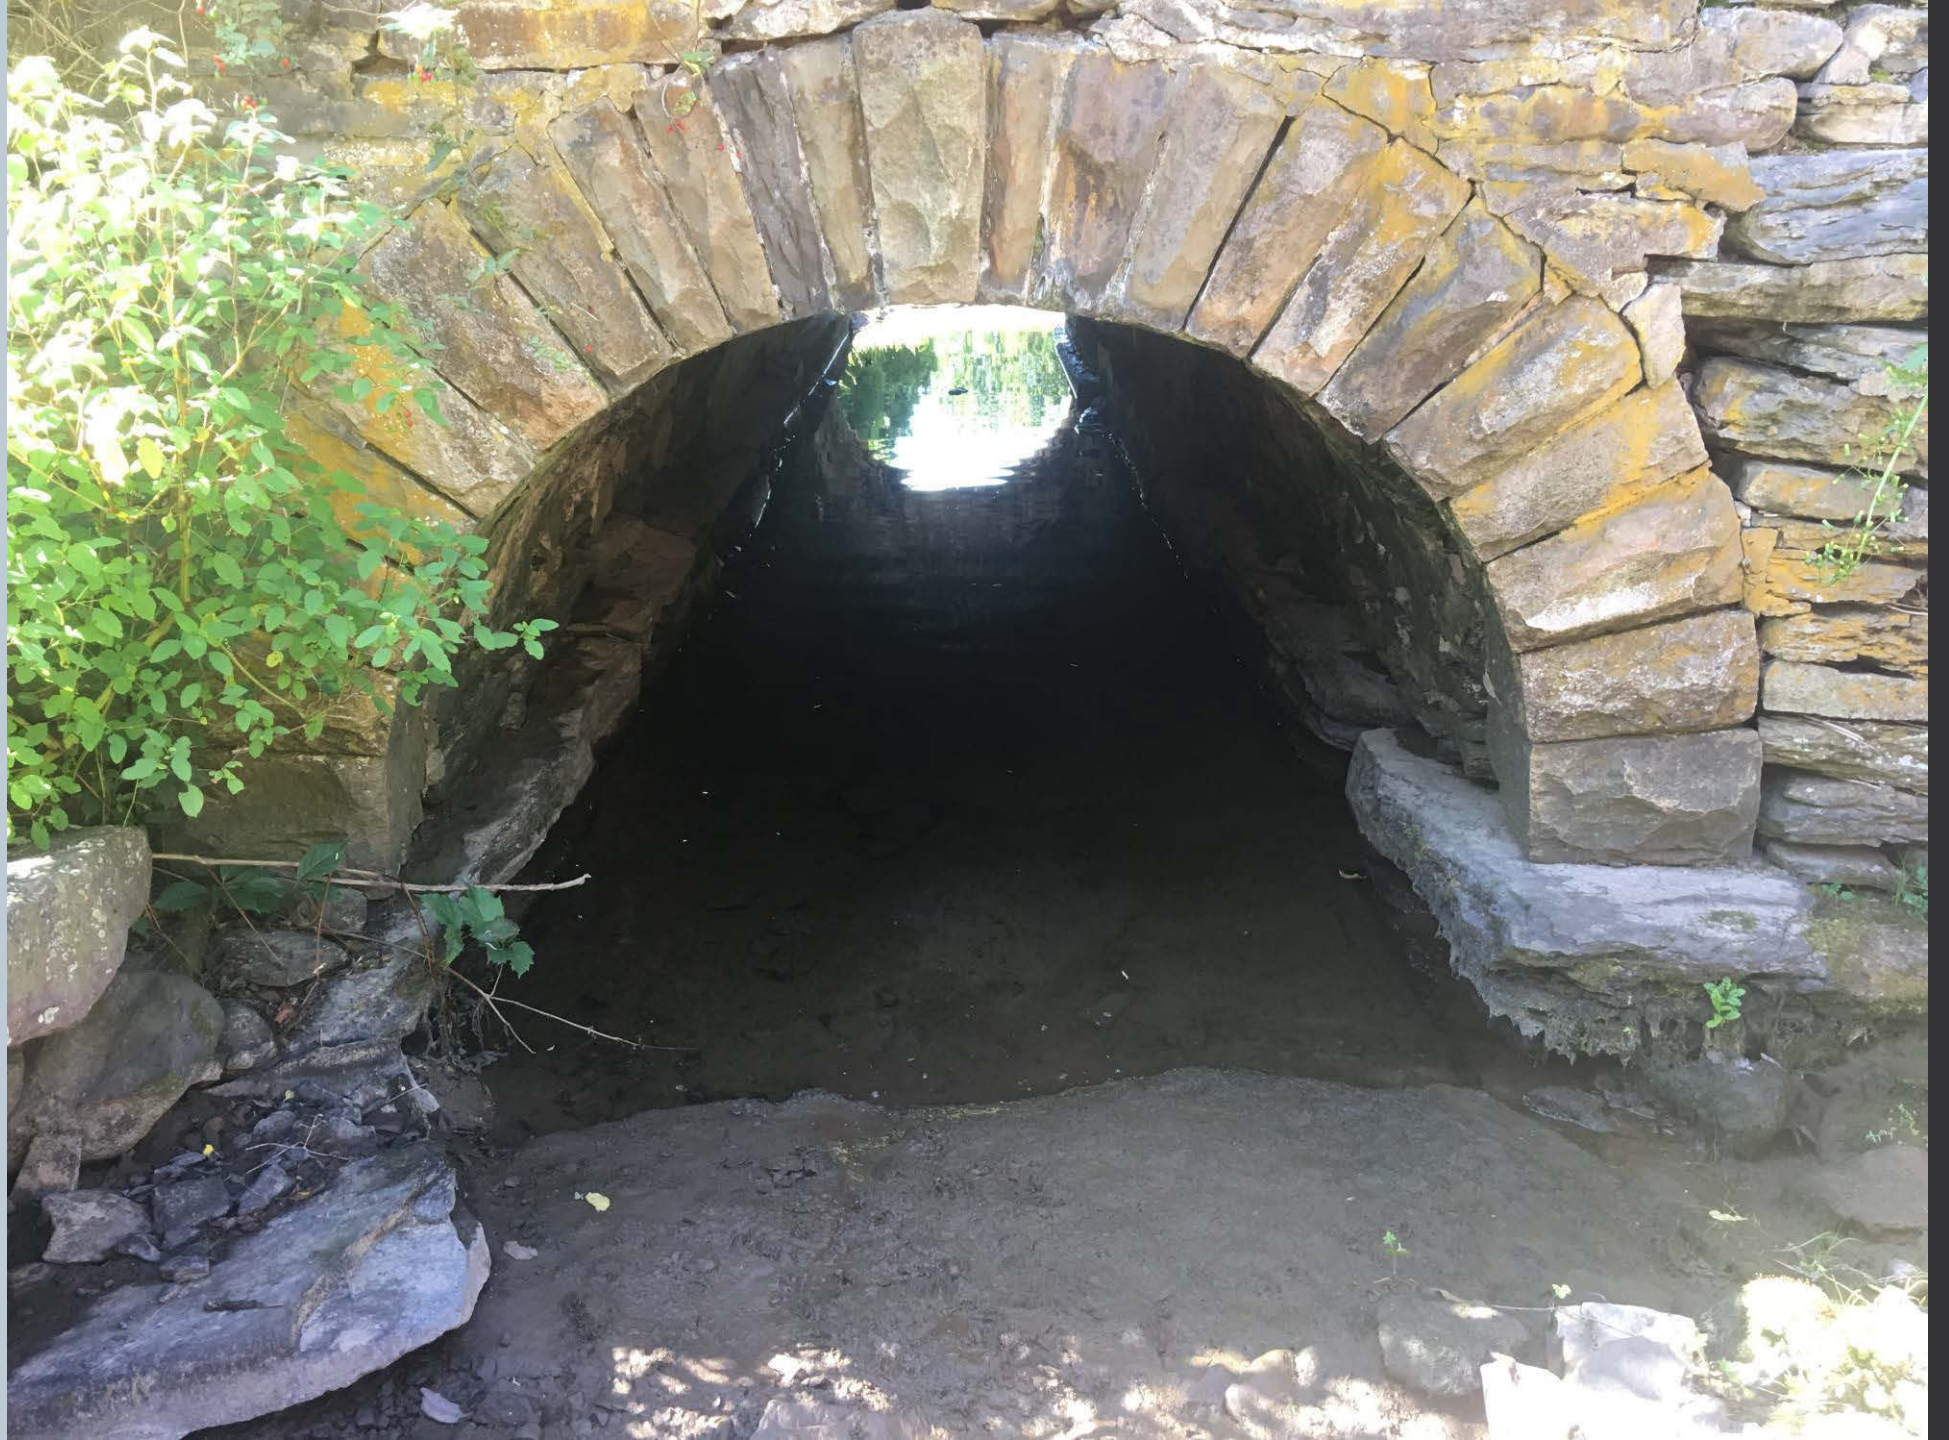
Figure 236.
Looking
downstream on
an unnamed
tributary to
Toby Creek off
Lake Street
that flows
through the
Meadows
Nursing Home
property with
DHL/EPCAMR
Volunteer.
Recommend
not mowing up
to the
streambank
and planting
additional
riparian area
plants along
the corridor.

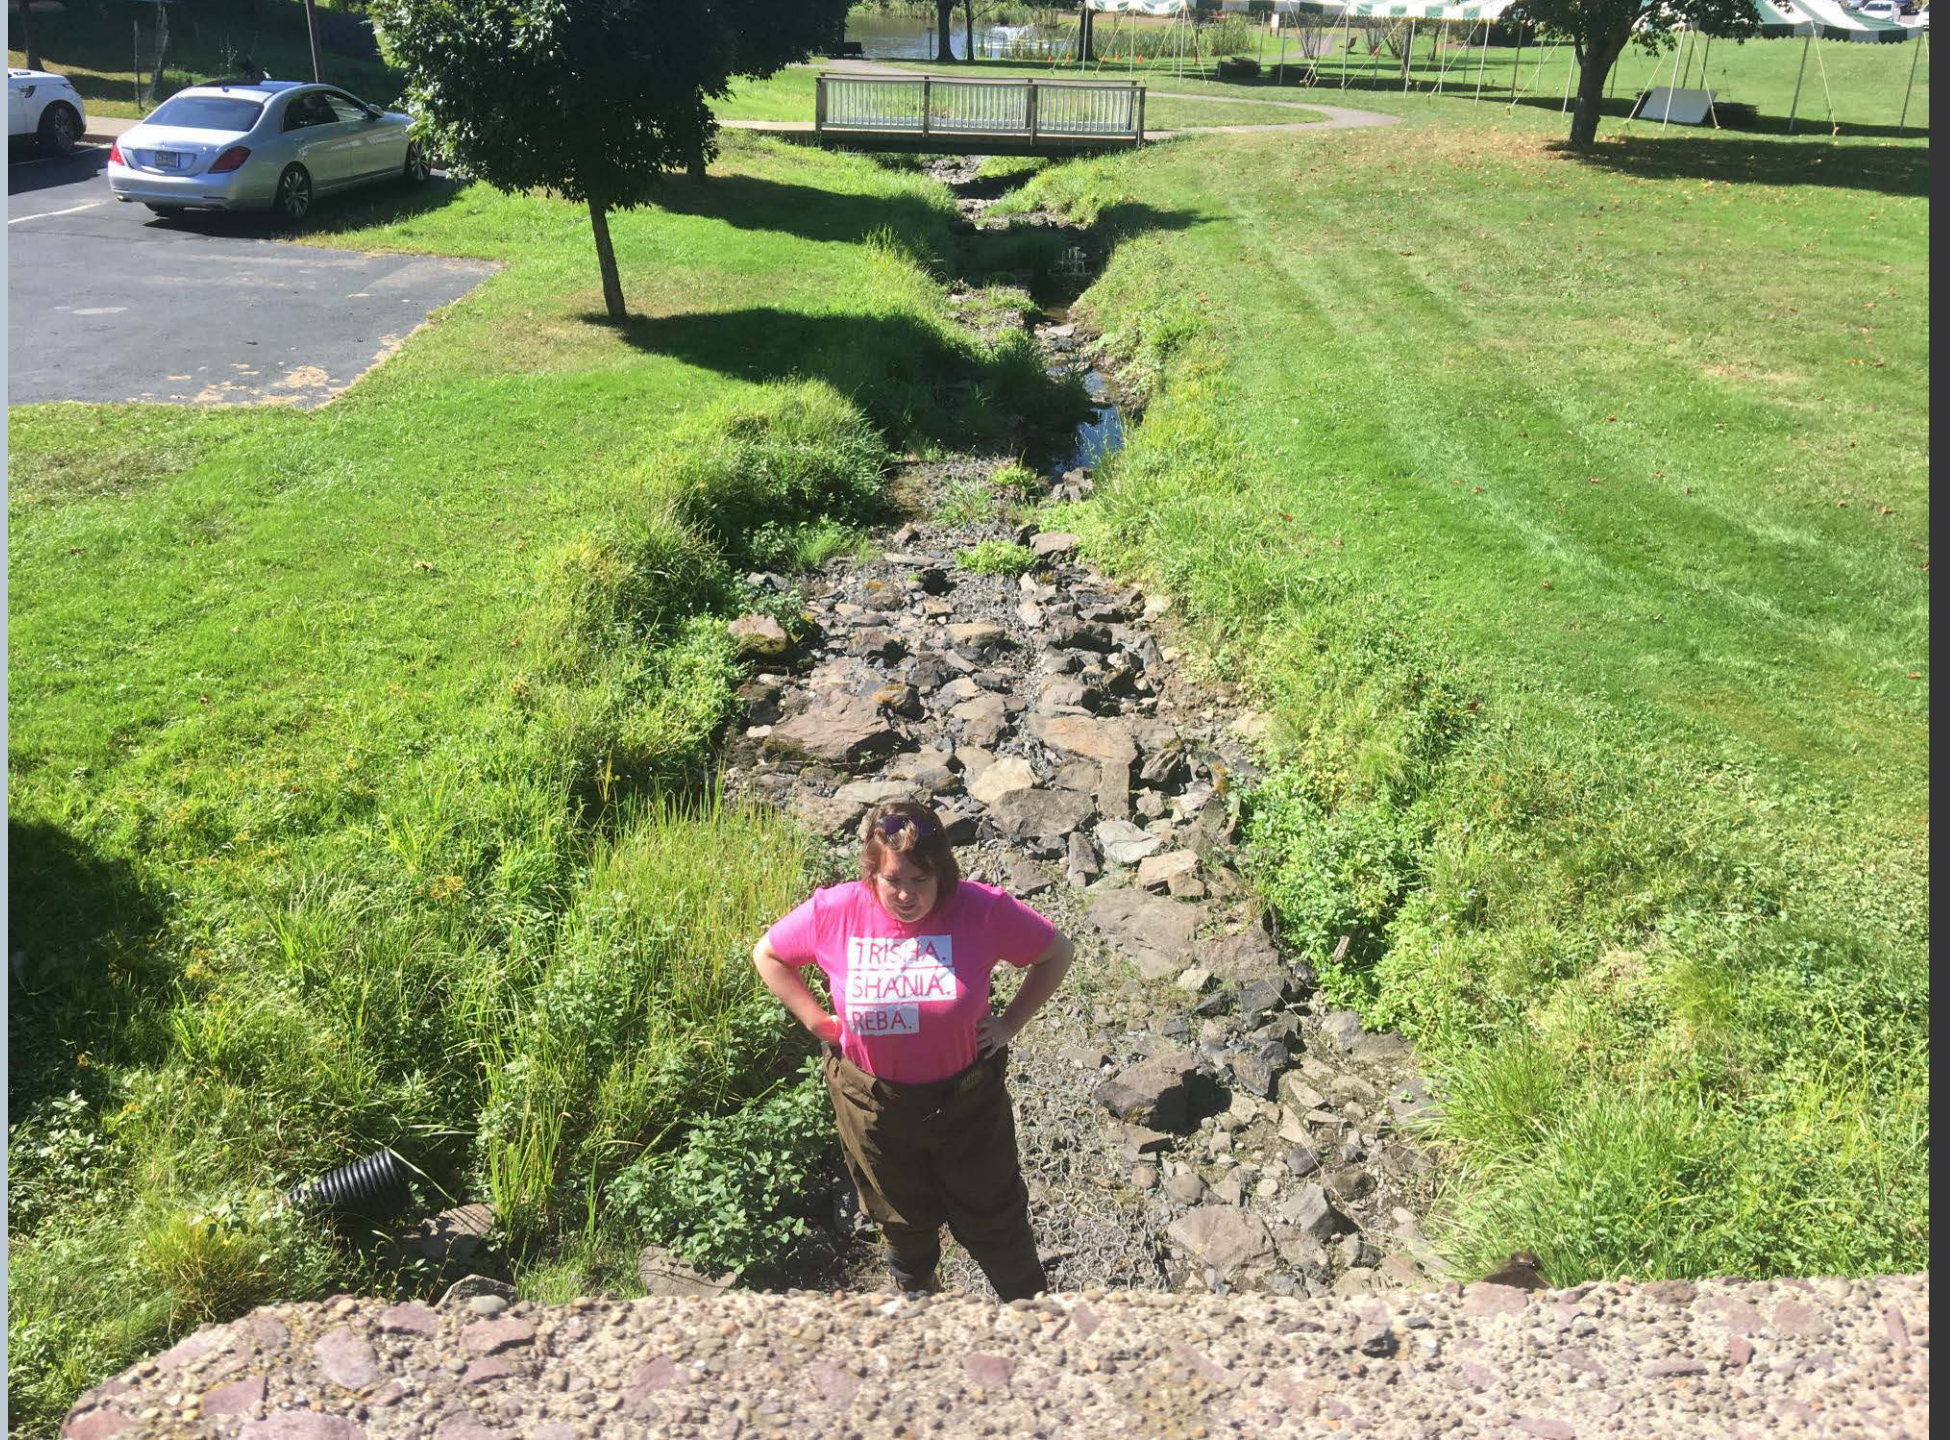
Figure 237. Looking upstream on an unnamed tributary to Toby Creek off Lake Street that flows through the Meadows Nursing Home property with DHL/EPCAMR Volunteers. Recommend not mowing up to the streambank and planting additional riparian area plants along the corridor and removal of chain link fence in the channel.

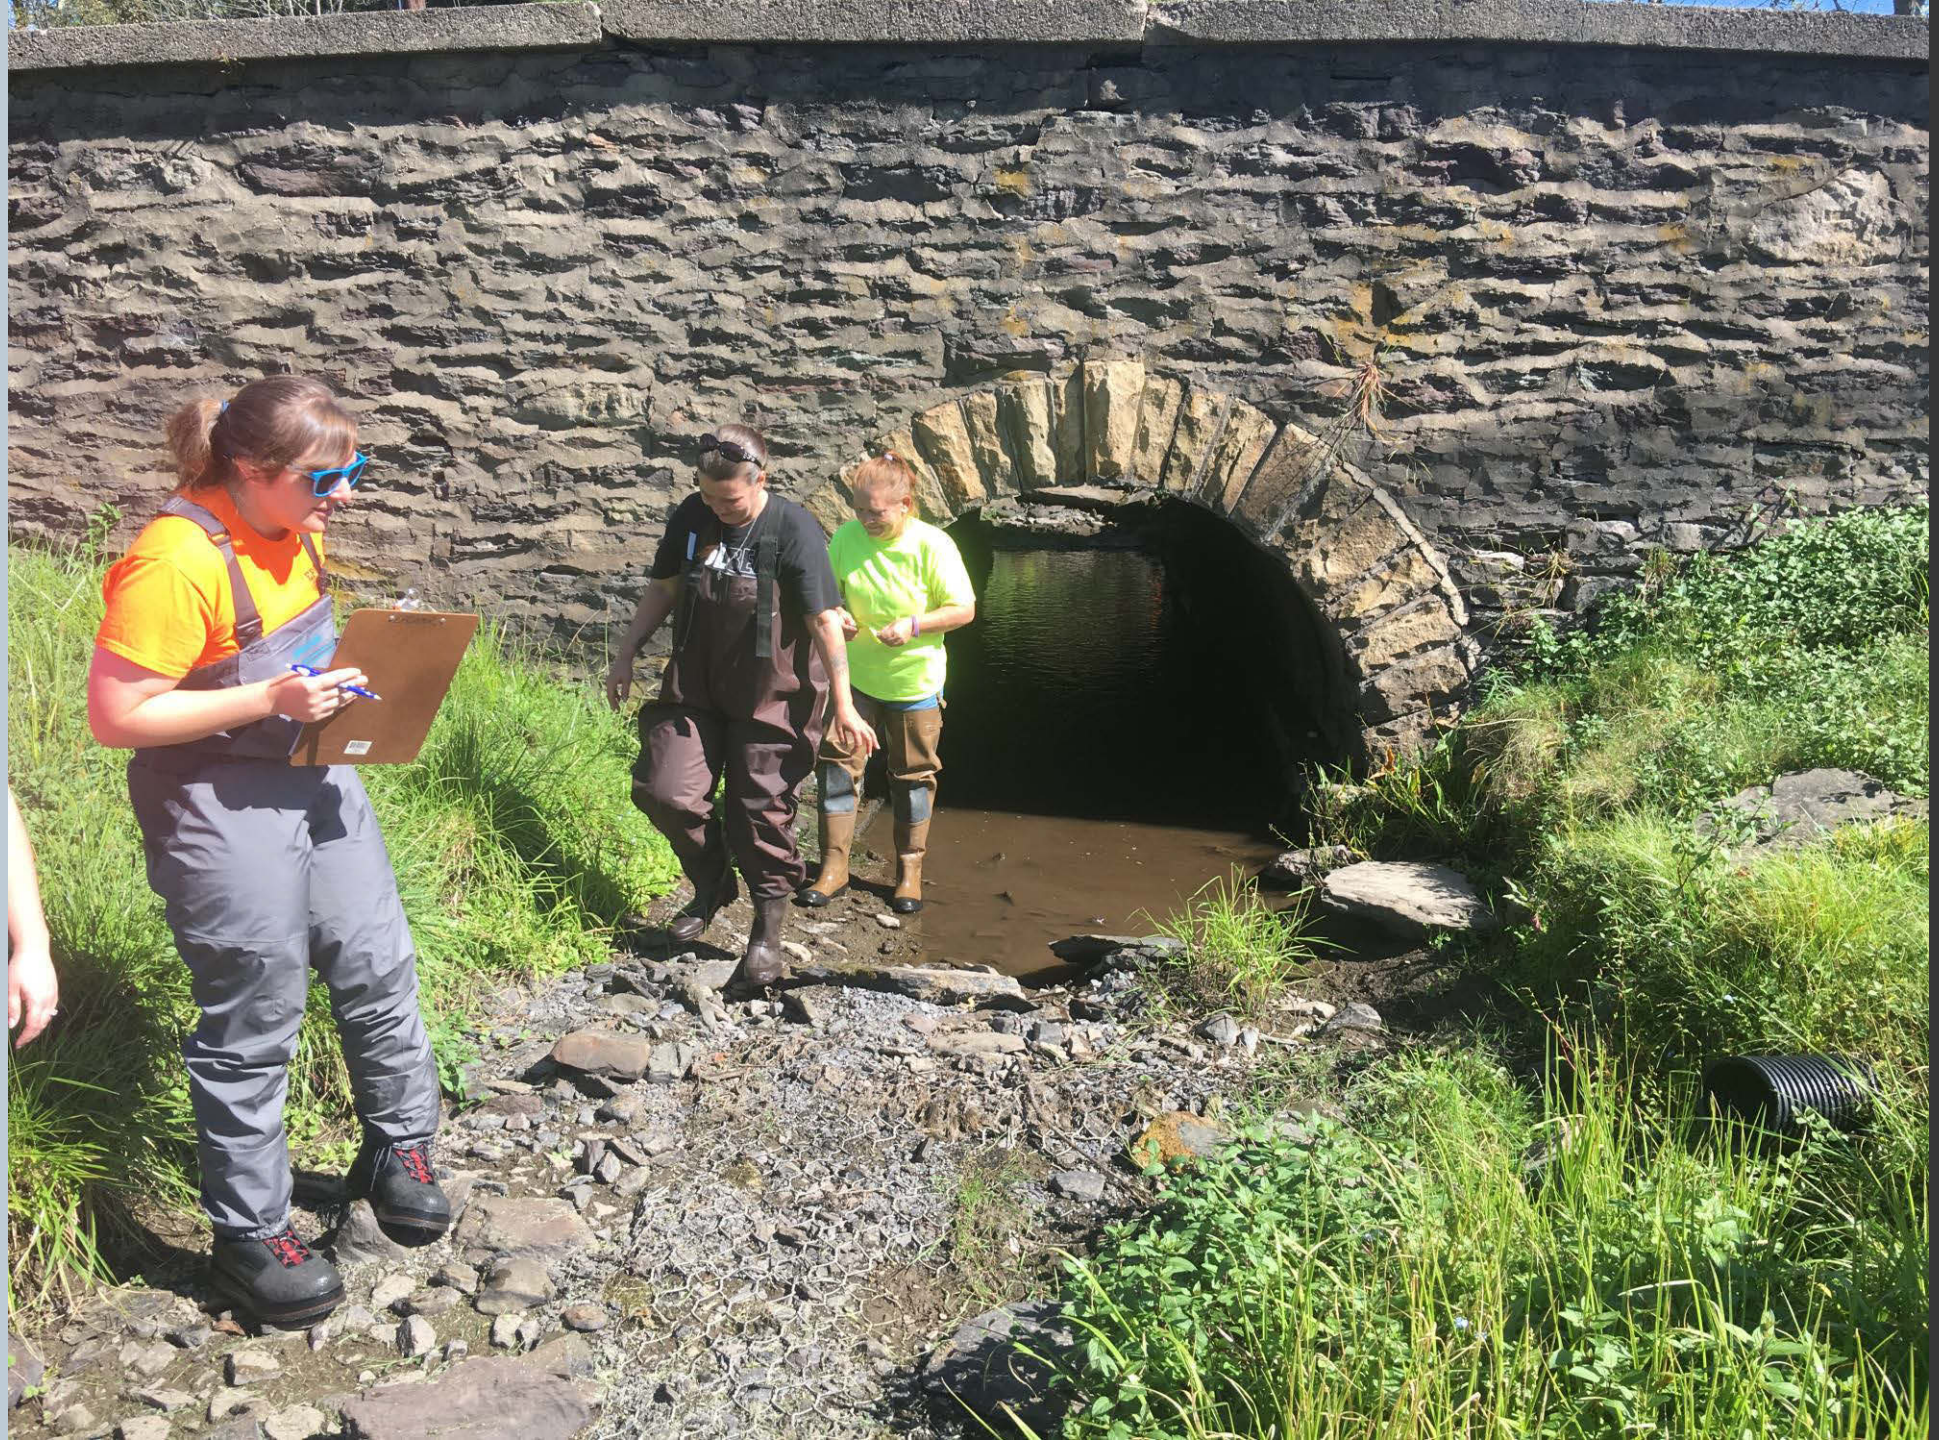
Figure 238.
Looking
downstream on an
unnamed tributary
to Toby Creek that
flows through the
Meadows Nursing
Home property
with
DHL/EPCAMR
Volunteer Gabby
Zawacki along
Center Hill Road.
Recommend not
mowing up to the
streambank and
planting additional
riparian area
plants along the
corridor and
removal of chain
link fence in the
channel.
