Toby Creek Field Reconnaissance Observations

September 26, 2018

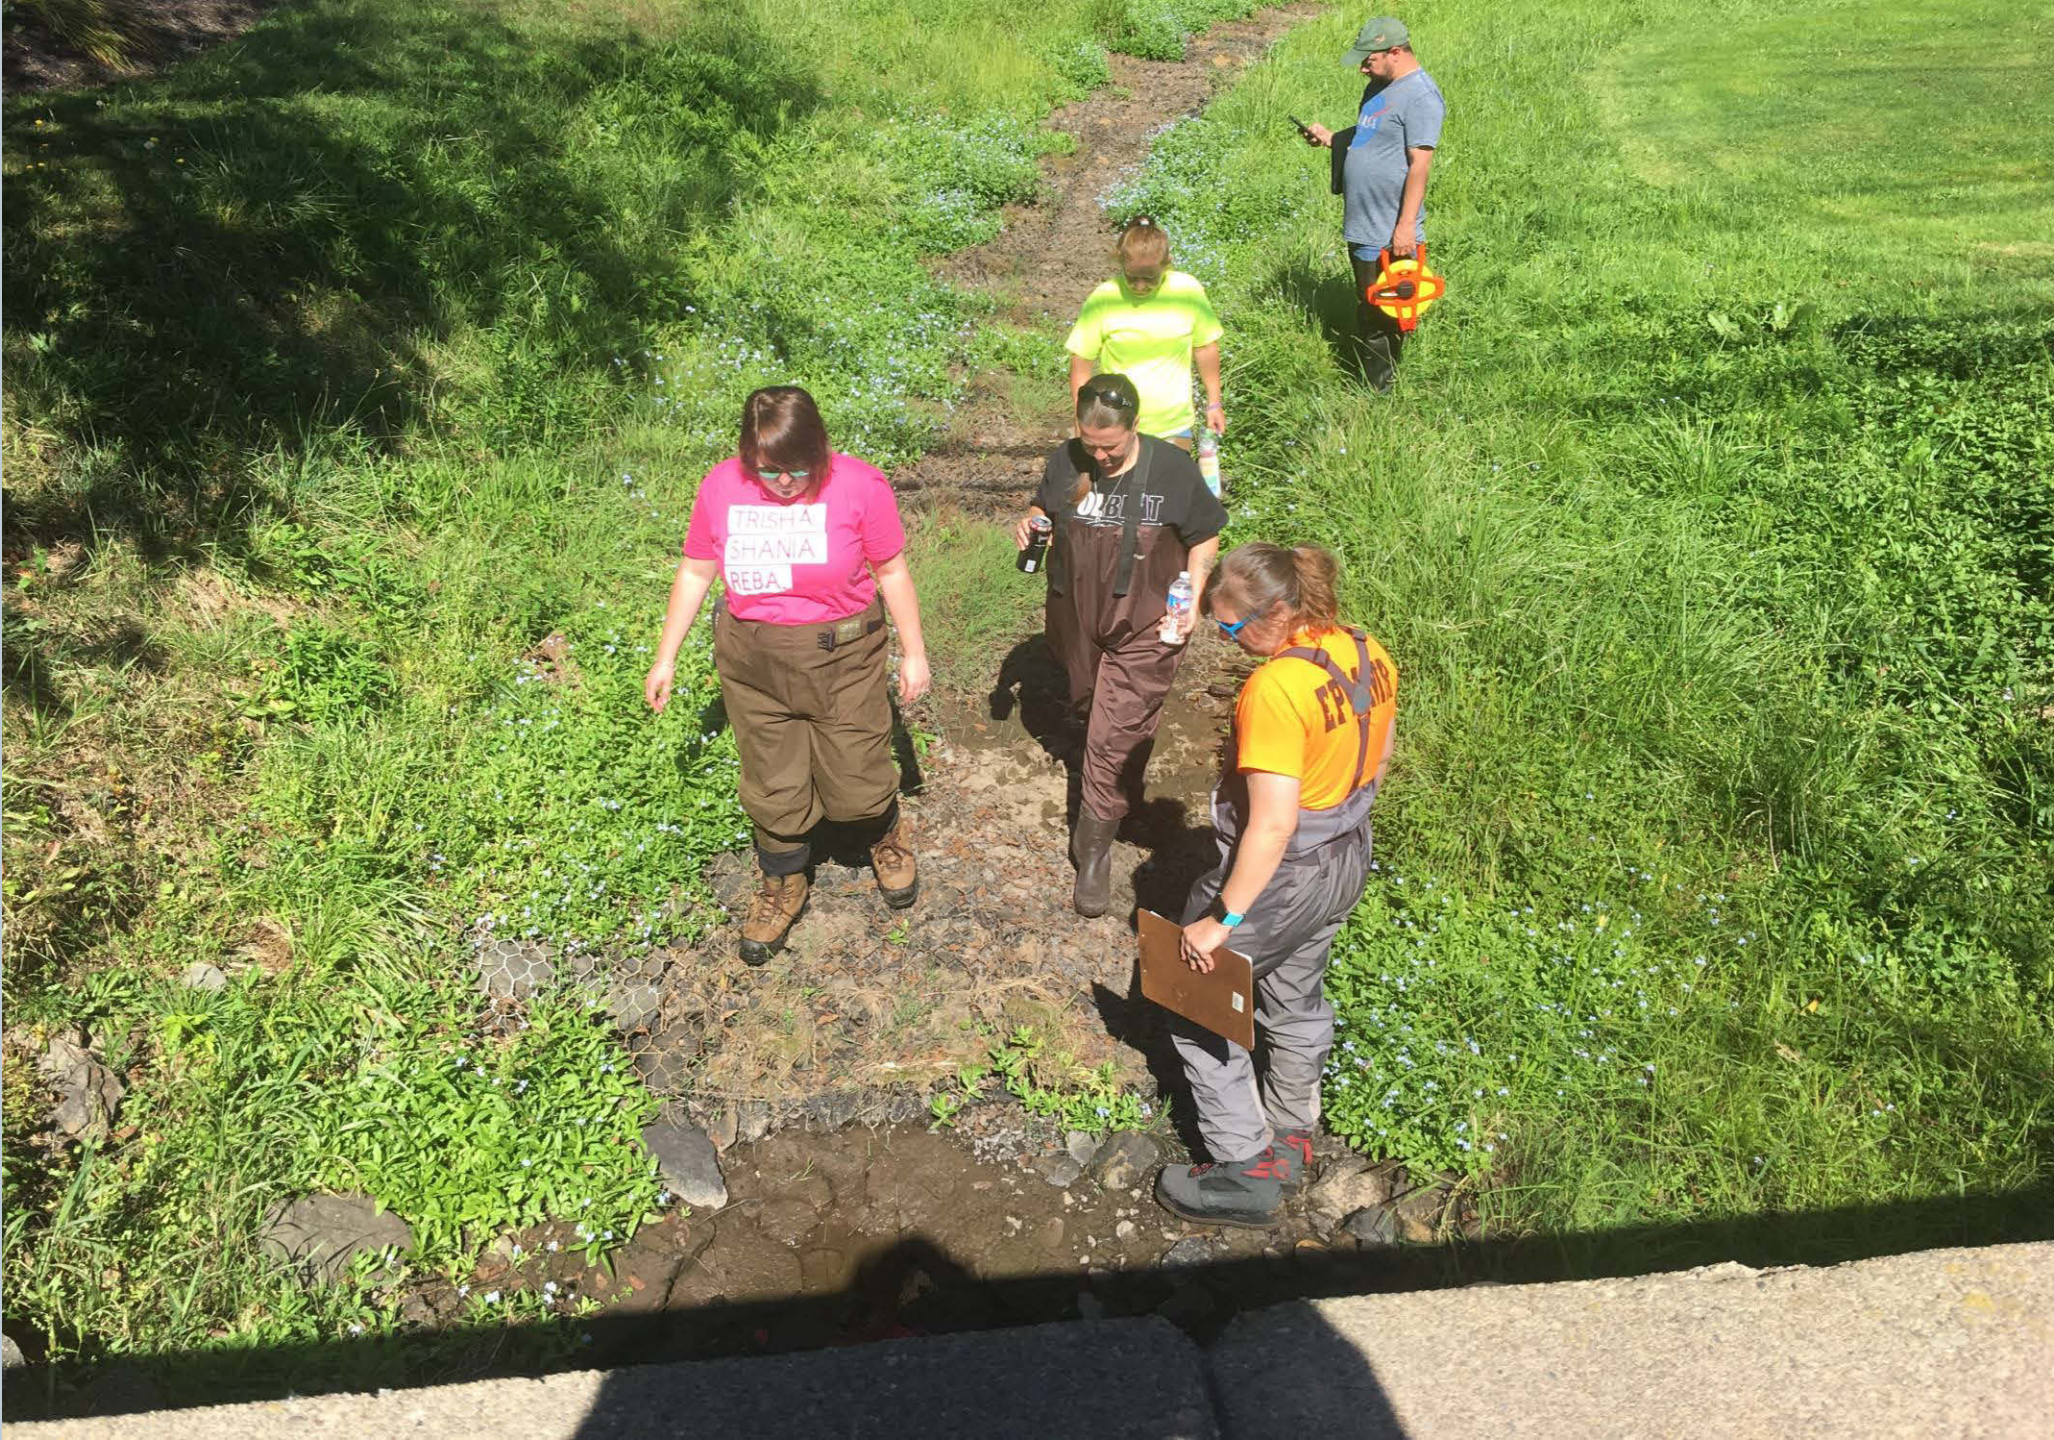
Figure 240. Looking downstream on an unnamed tributary to Toby Creek that flows through the Meadows Nursing Home property along Center Hill Road. Recommend not mowing up to the streambank and planting additional riparian area plants along the corridor and removal of sediment in ponded area of the tributary further downstream. Minnows were present under the bridge.

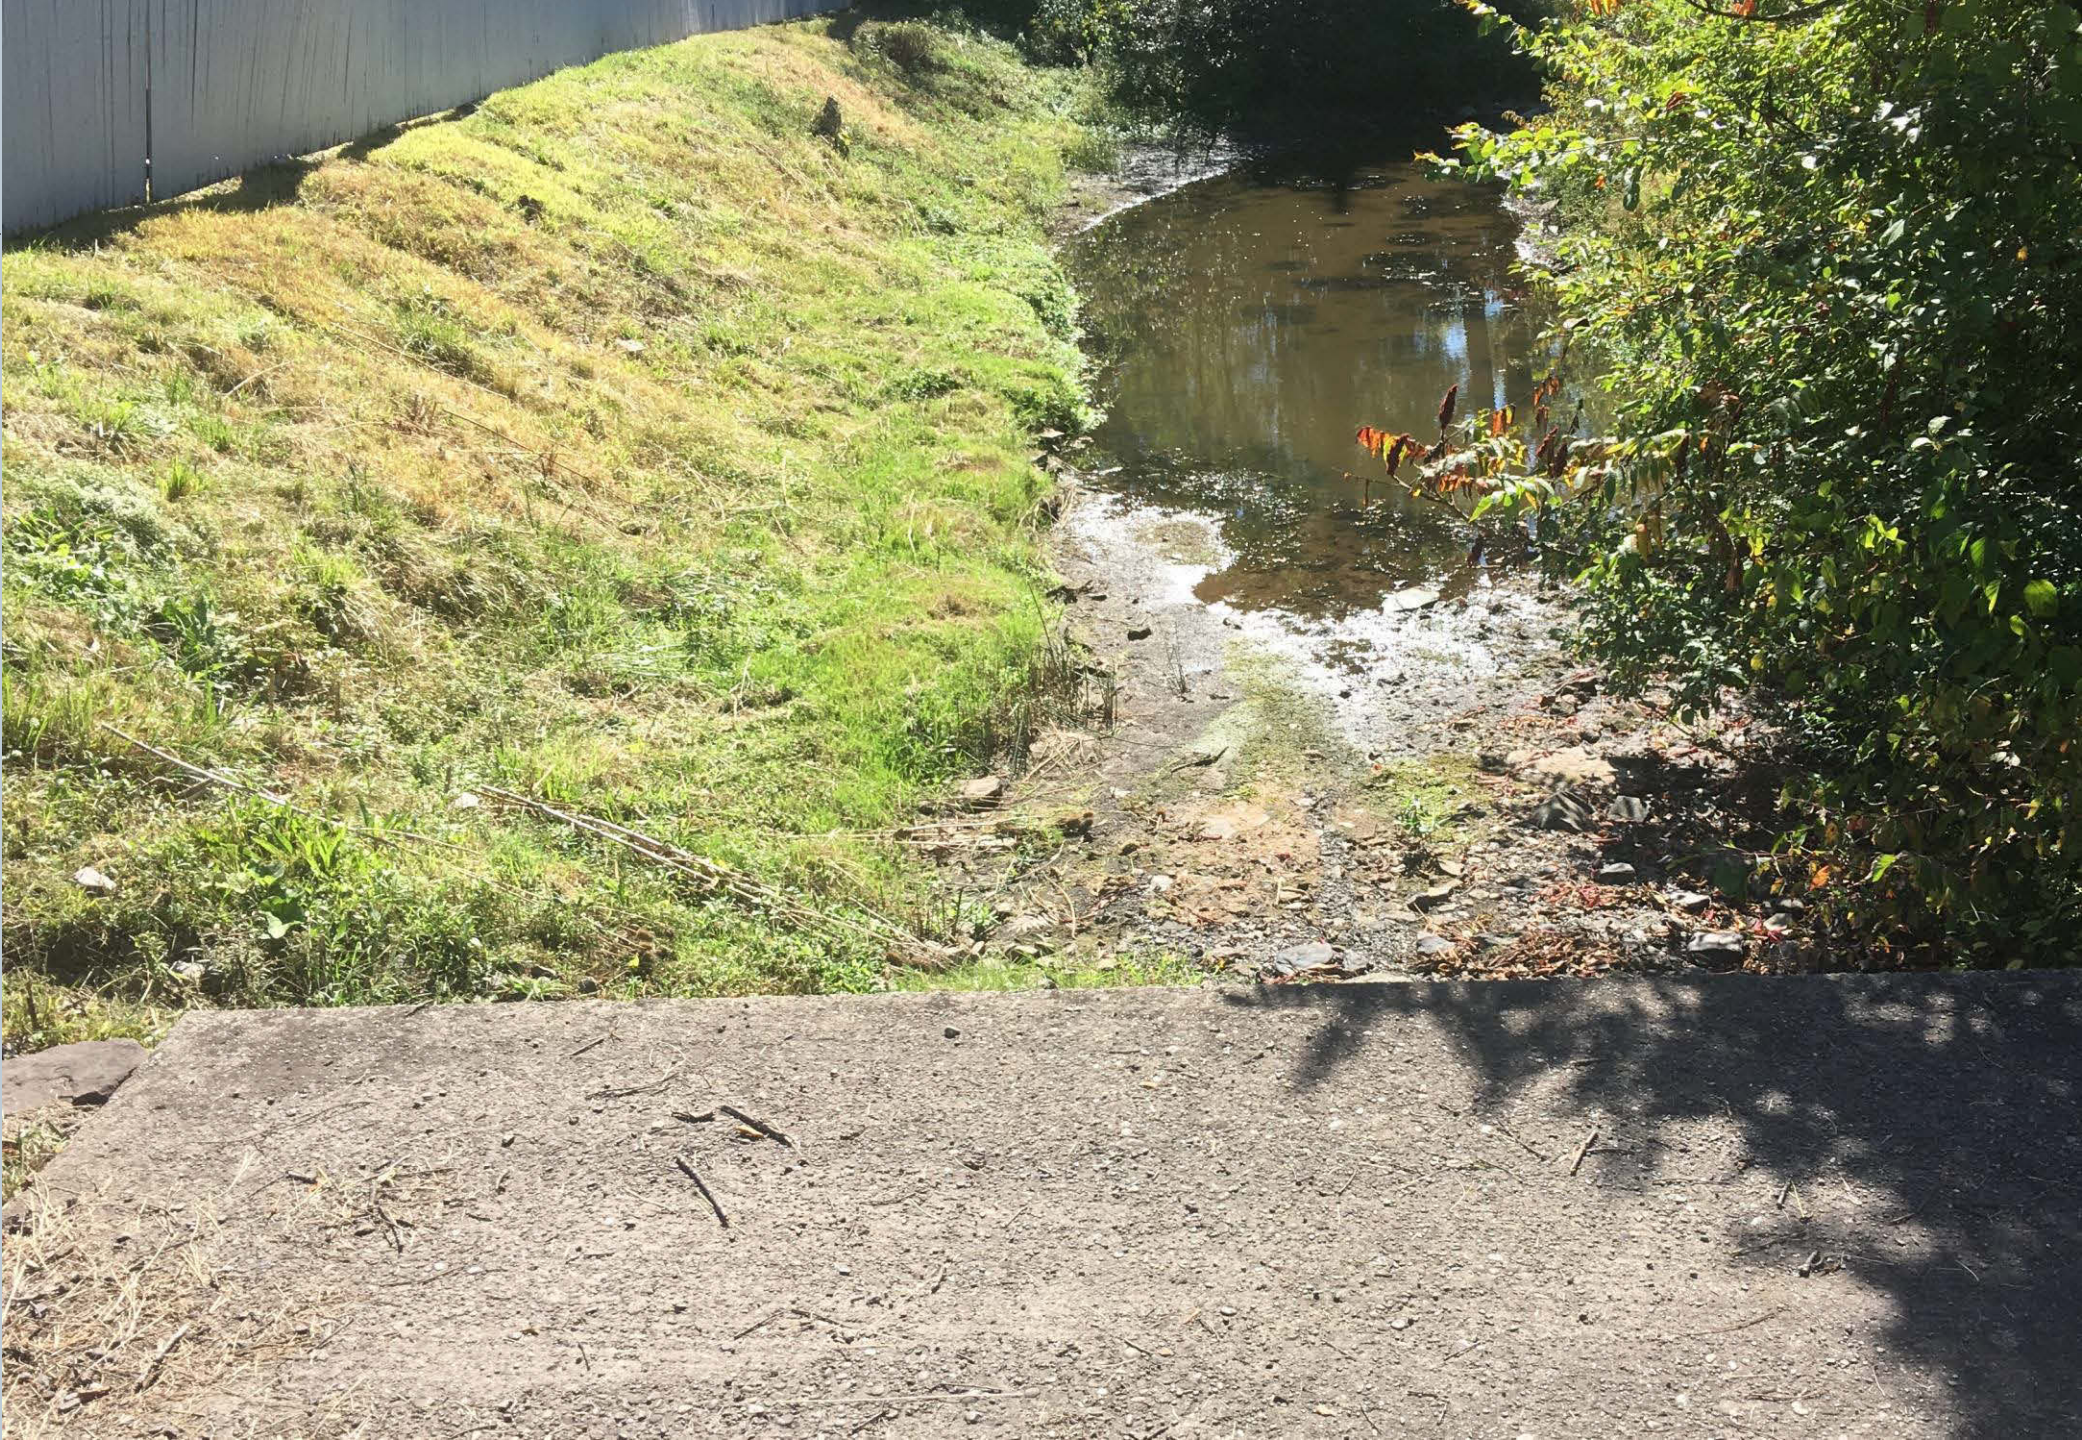
Figure 241. Looking upstream on an unnamed tributary to Toby Creek that flows through the Meadows Nursing Home property along Center Hill Road. Recommend not mowing up to the streambank and planting additional riparian area plants along the corridor and removal of sediment and anti-skid/road salt deposition inside the culvert and in ponded area of the tributary further downstream. Minnows were present under the bridge.

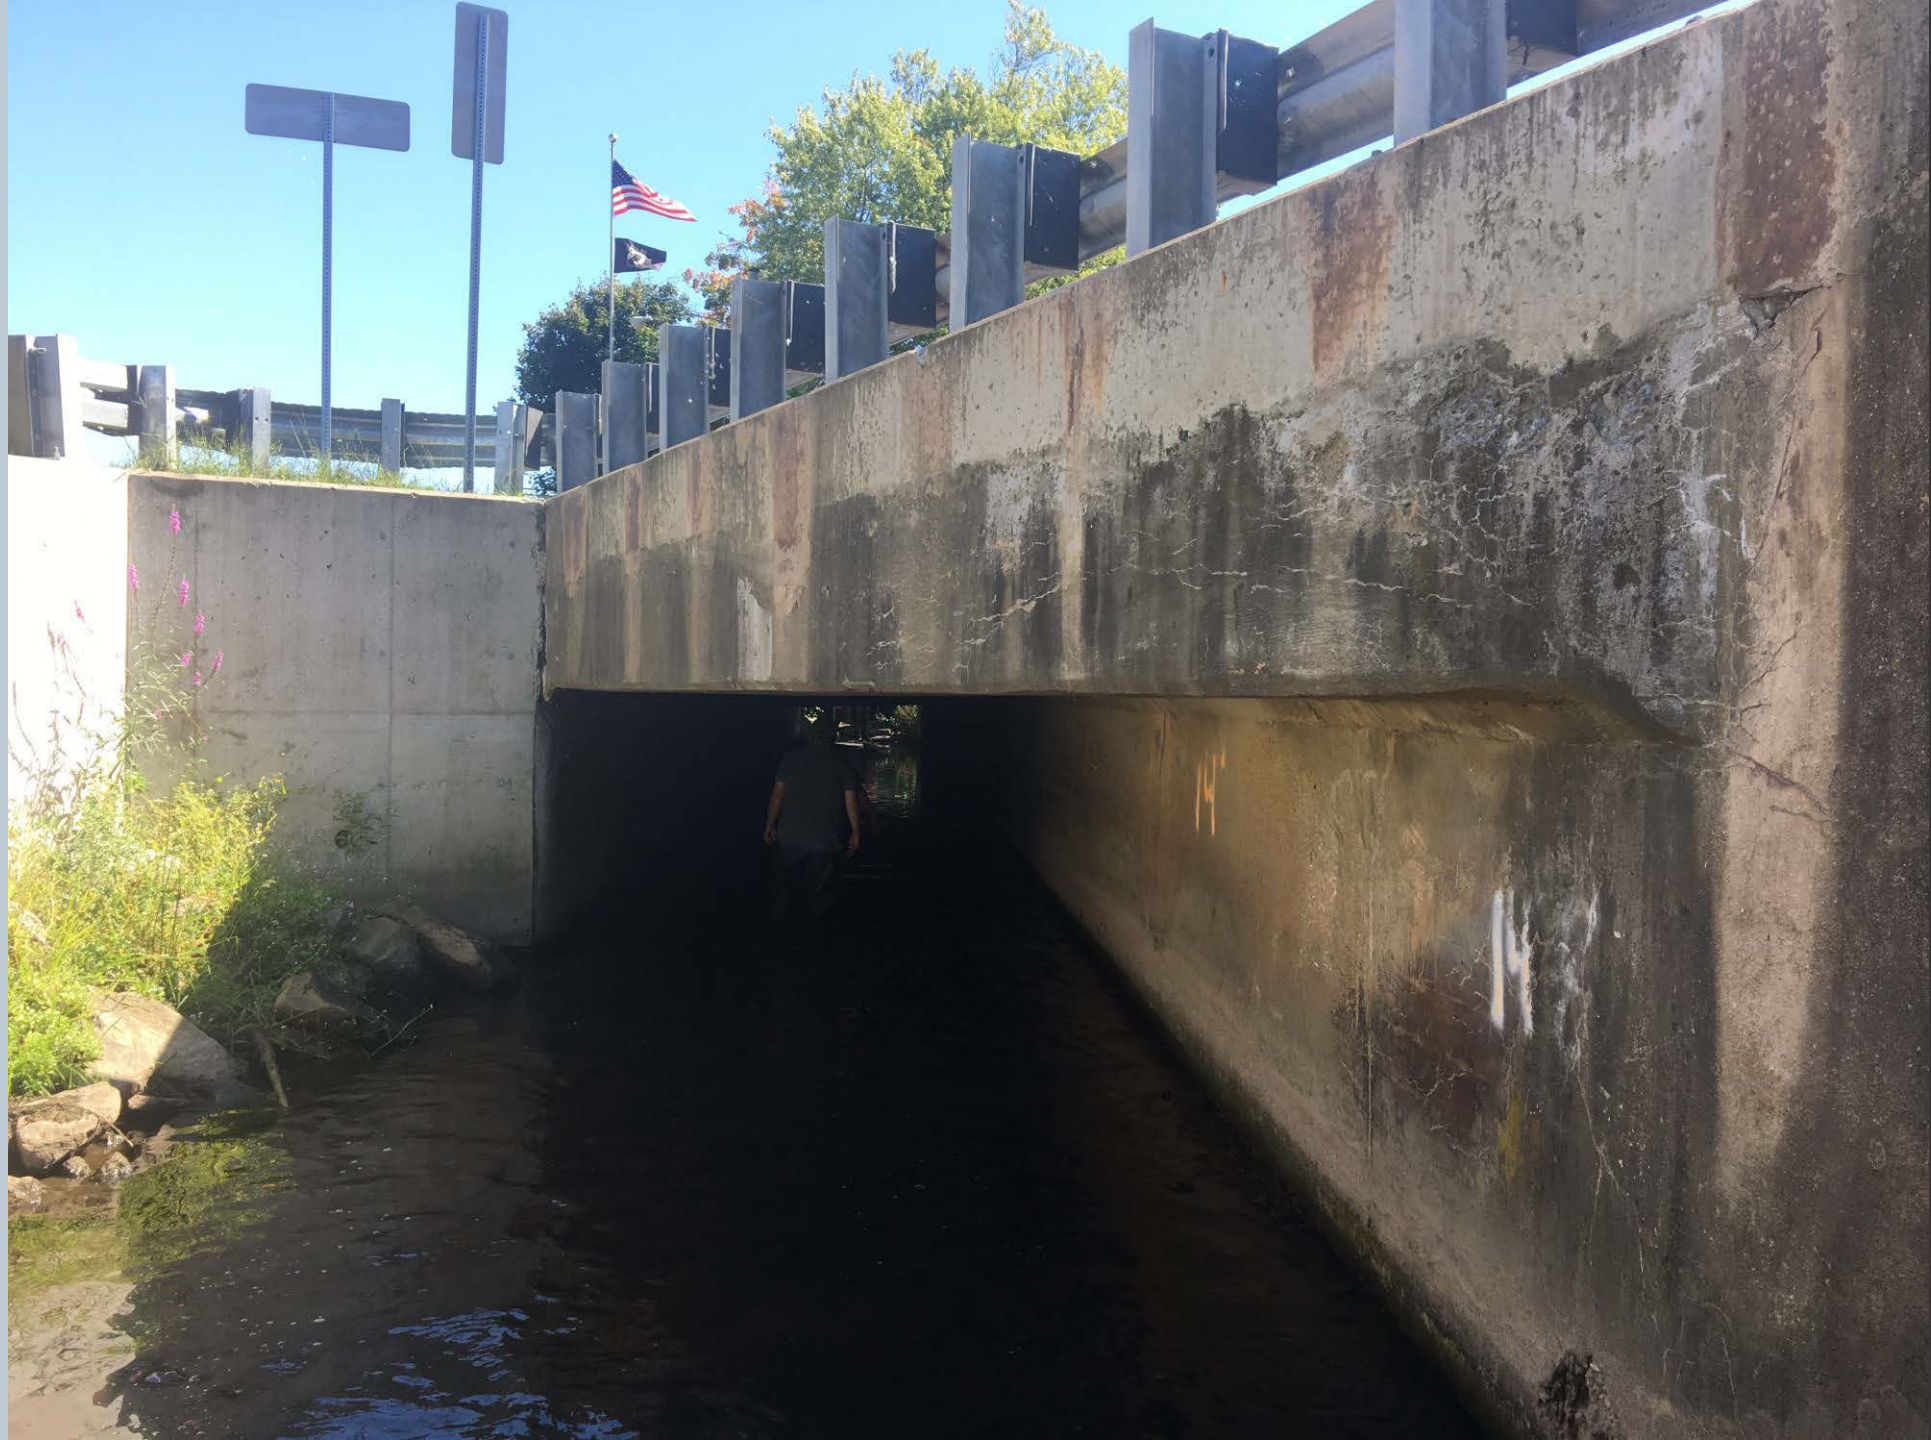
Figure 244. Piles of sediment that are being deposited following rain events from culvert pipes that drain to Toby Creek from above the somewhere near the roundabout in Dallas. This section of the main stem is heavily silted from roadside stormwater runoff. Beneath the culvert the entire stretch of Toby Creek is full of sediment. A DAMA Vac Truck is recommended to remove the sediment.

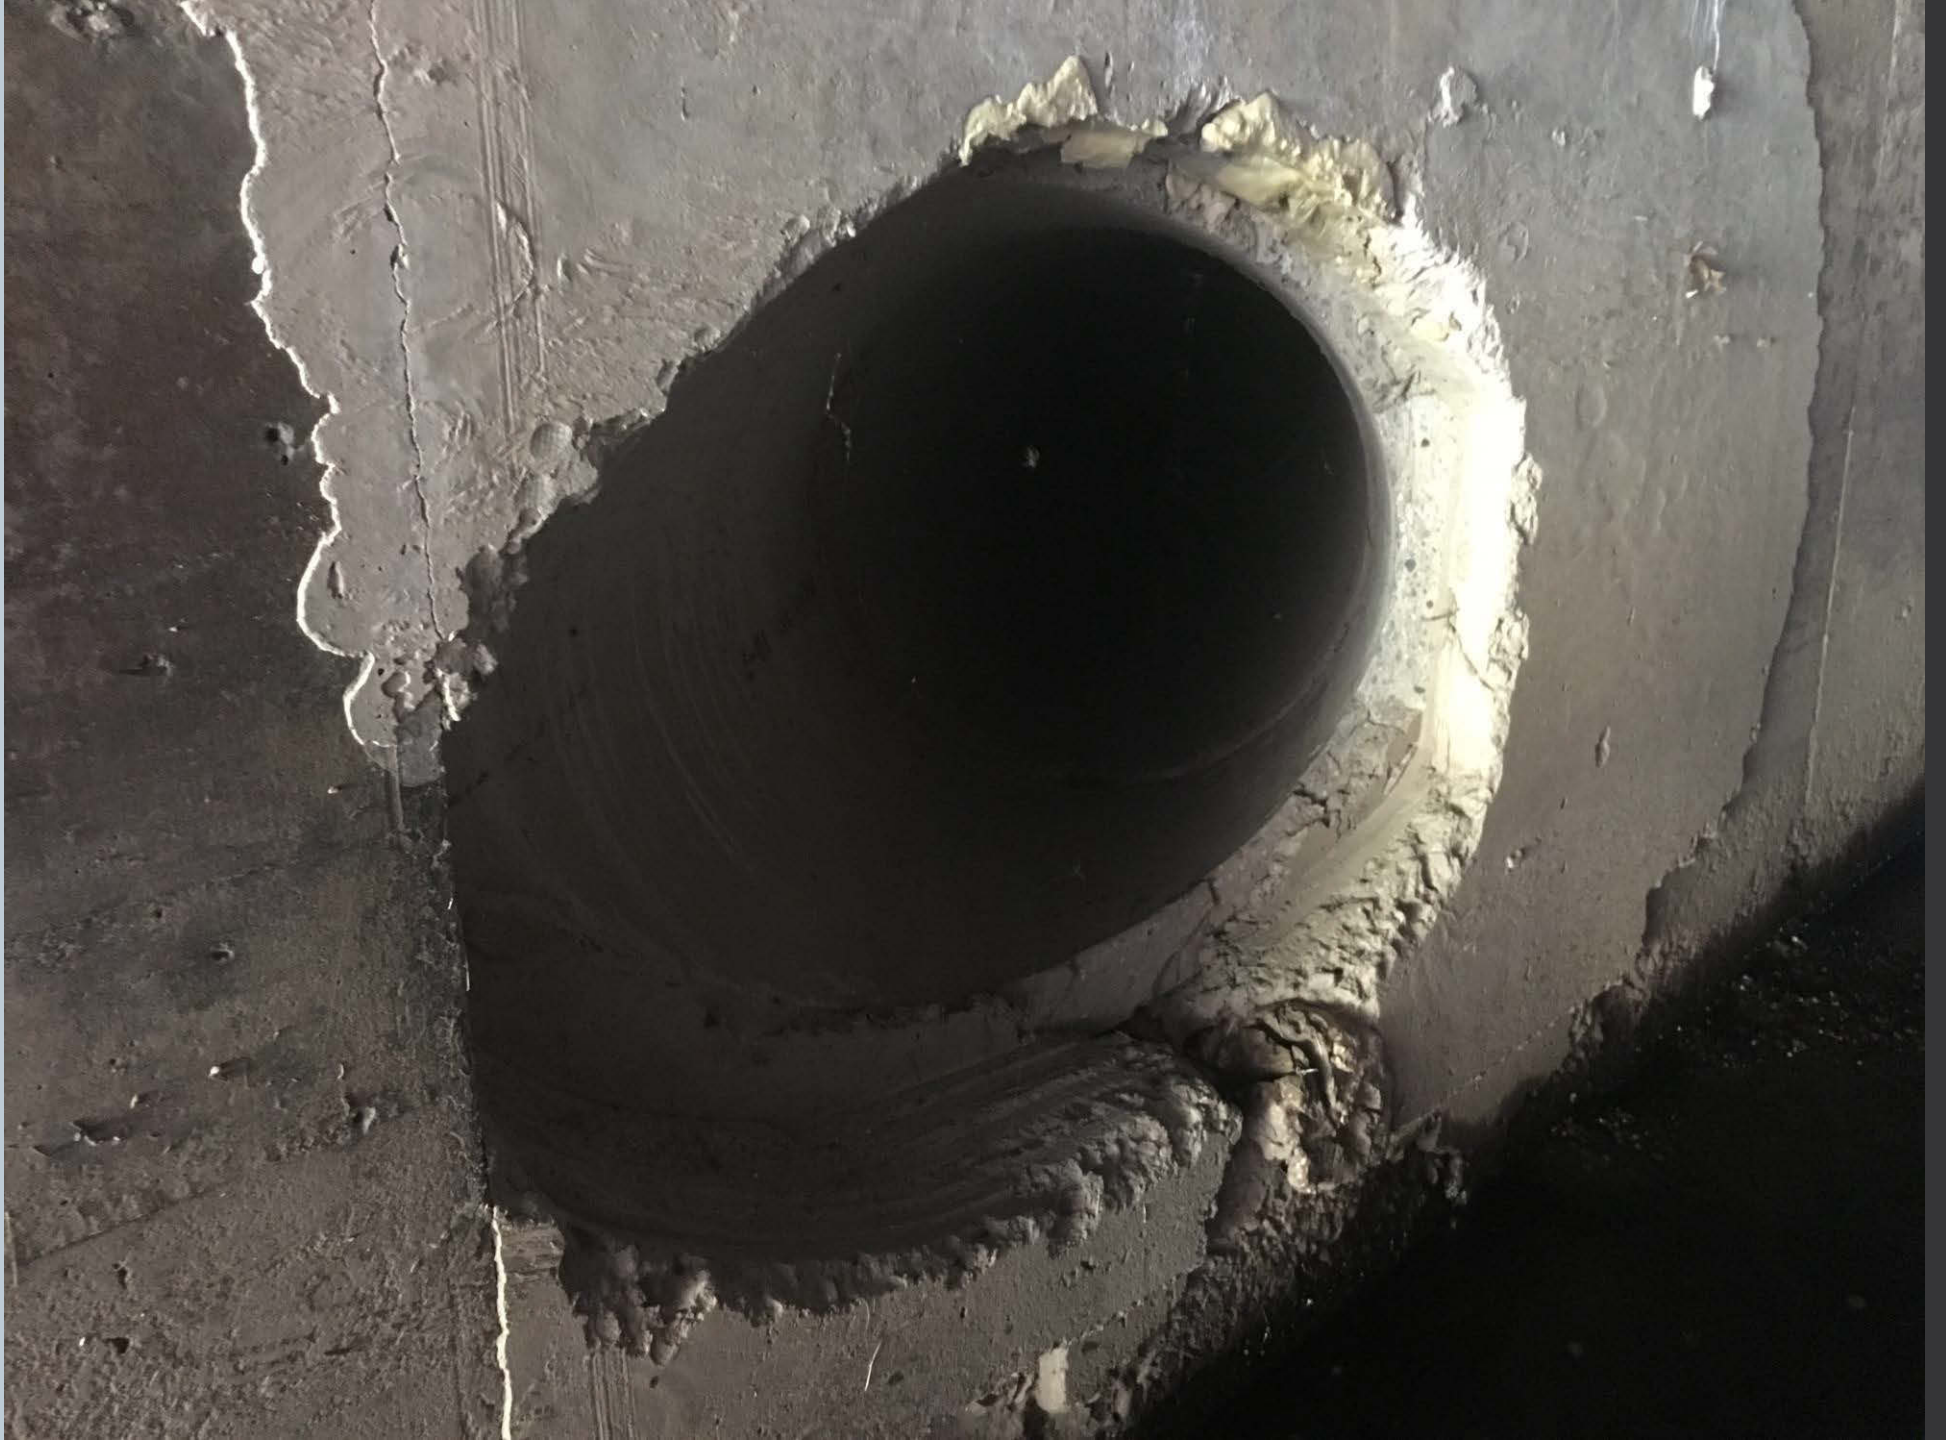
Figure 246.
Culvert pipe
draining to Toby
Creek from
somewhere above
the roundabout in
Dallas. This
section of the
main stem is
heavily silted from
roadside
stormwater
runoff. Beneath
the culvert the
entire stretch of
Toby Creek is full
of sediment. A
DAMA Vac Truck
is recommended to
remove the
sediment.

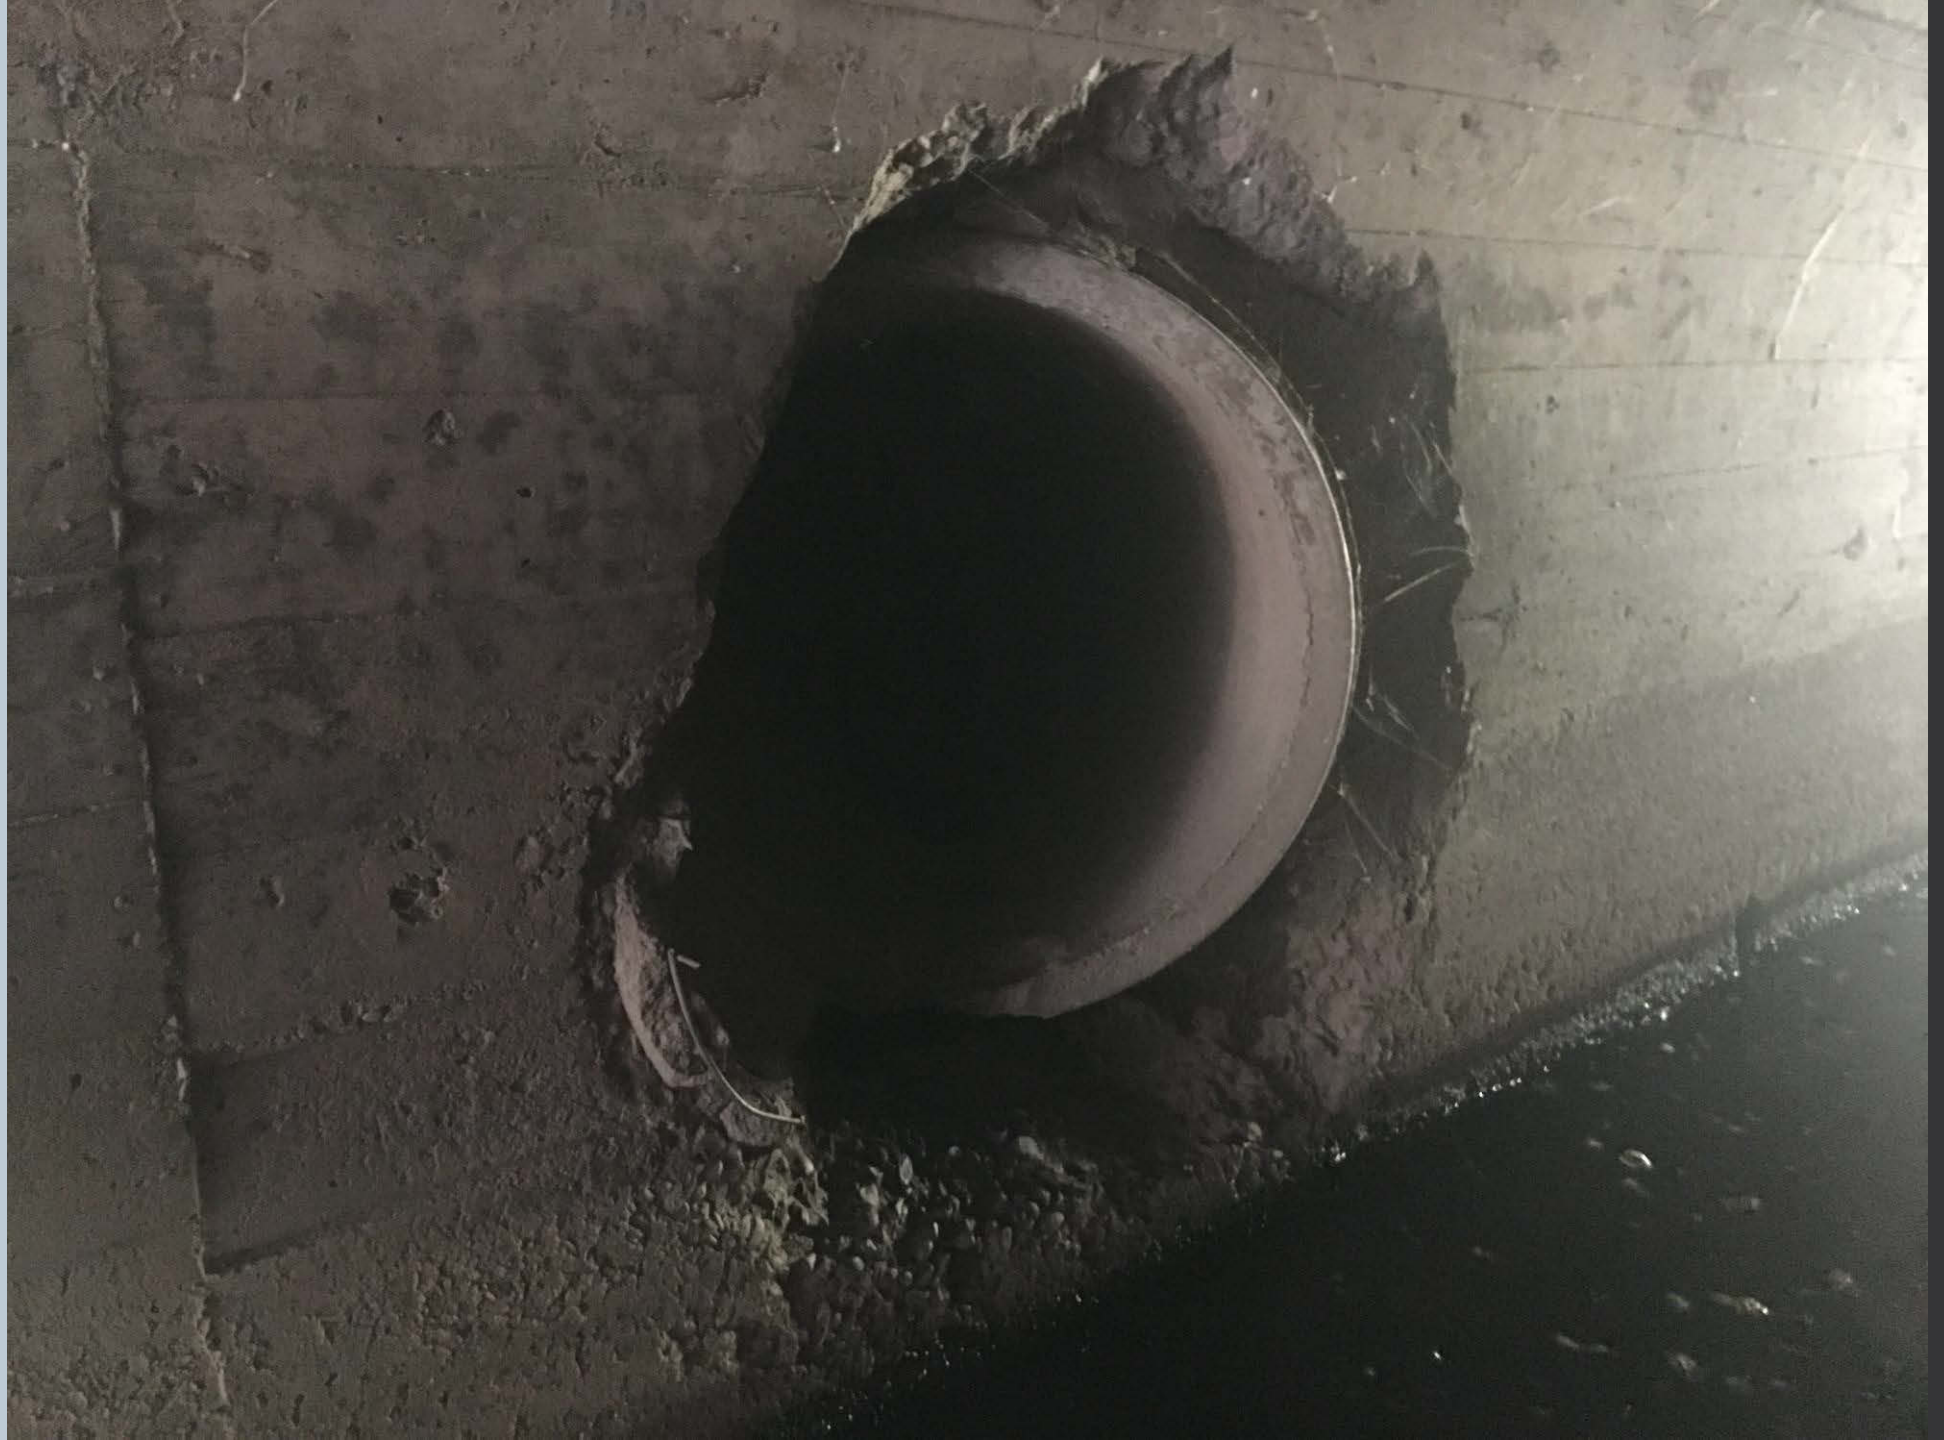
Figure 247.
Culvert that
directs Toby Creek
from beneath Main
Street, under the
commercial
district, until it
outlets along Verve
Vertu in Dallas.
This section of the
main stem is
heavily silted from
roadside
stormwater runoff.
Beneath the
culvert large
stretches of Toby
Creek are full of
sediment. A DAMA
Vac Truck is
recommended to
remove the
sediment.

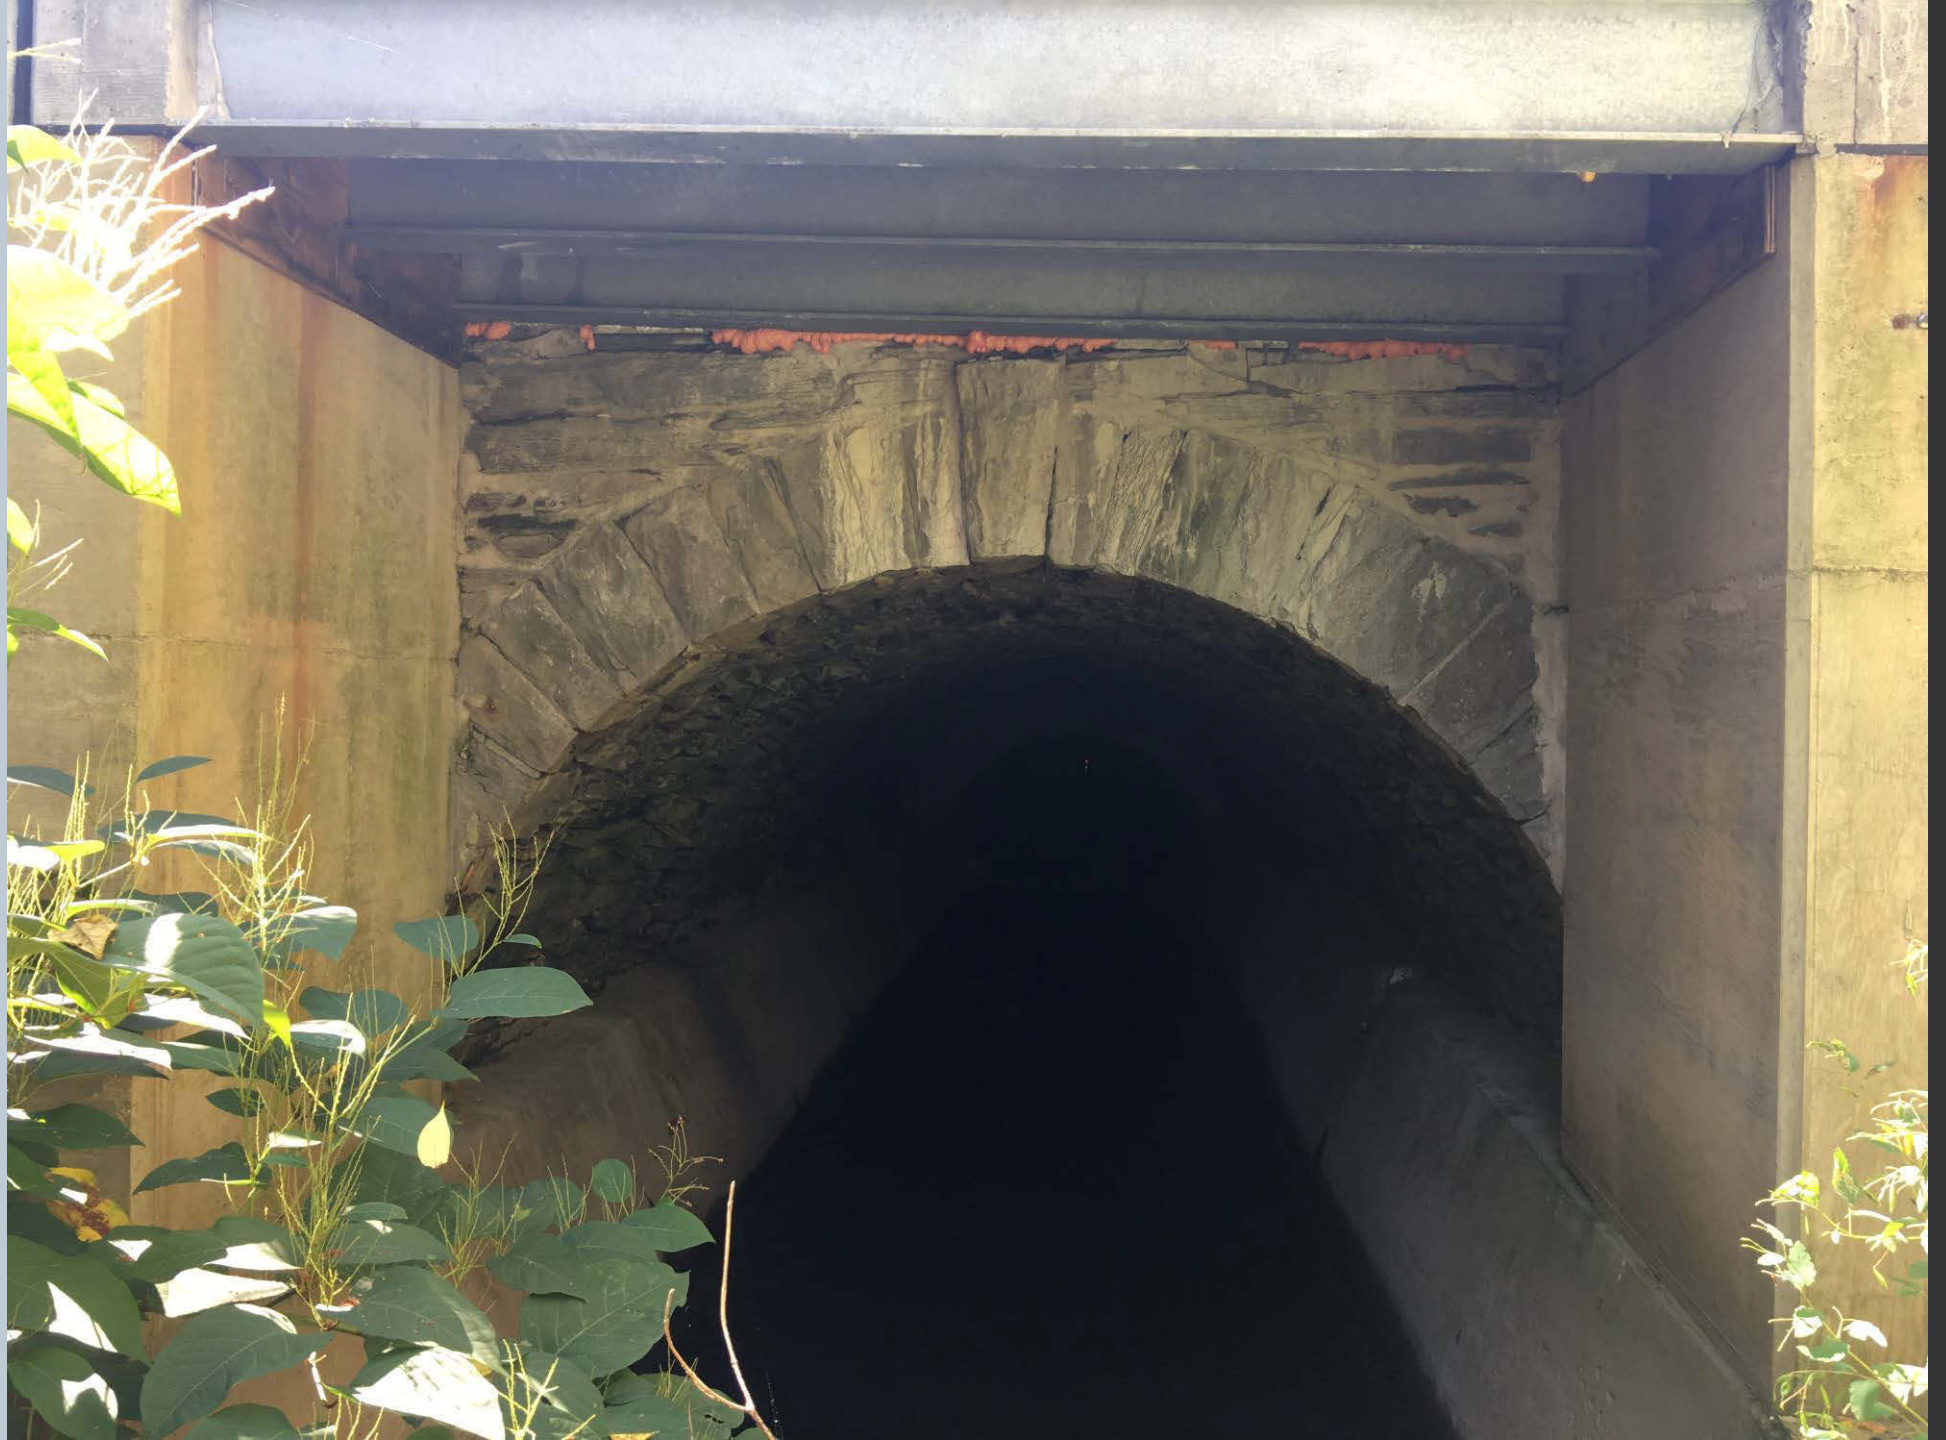
Figure 252. Looking downstream from the culvert over Main Street beneath Main Street in Dallas under the commercial district. This section of the stream is along Verve Vertu in Dallas. Invasives are present downstream in this area, including Japanese Knotweed. An Invasive Removal Project and riparian planting is recommended.

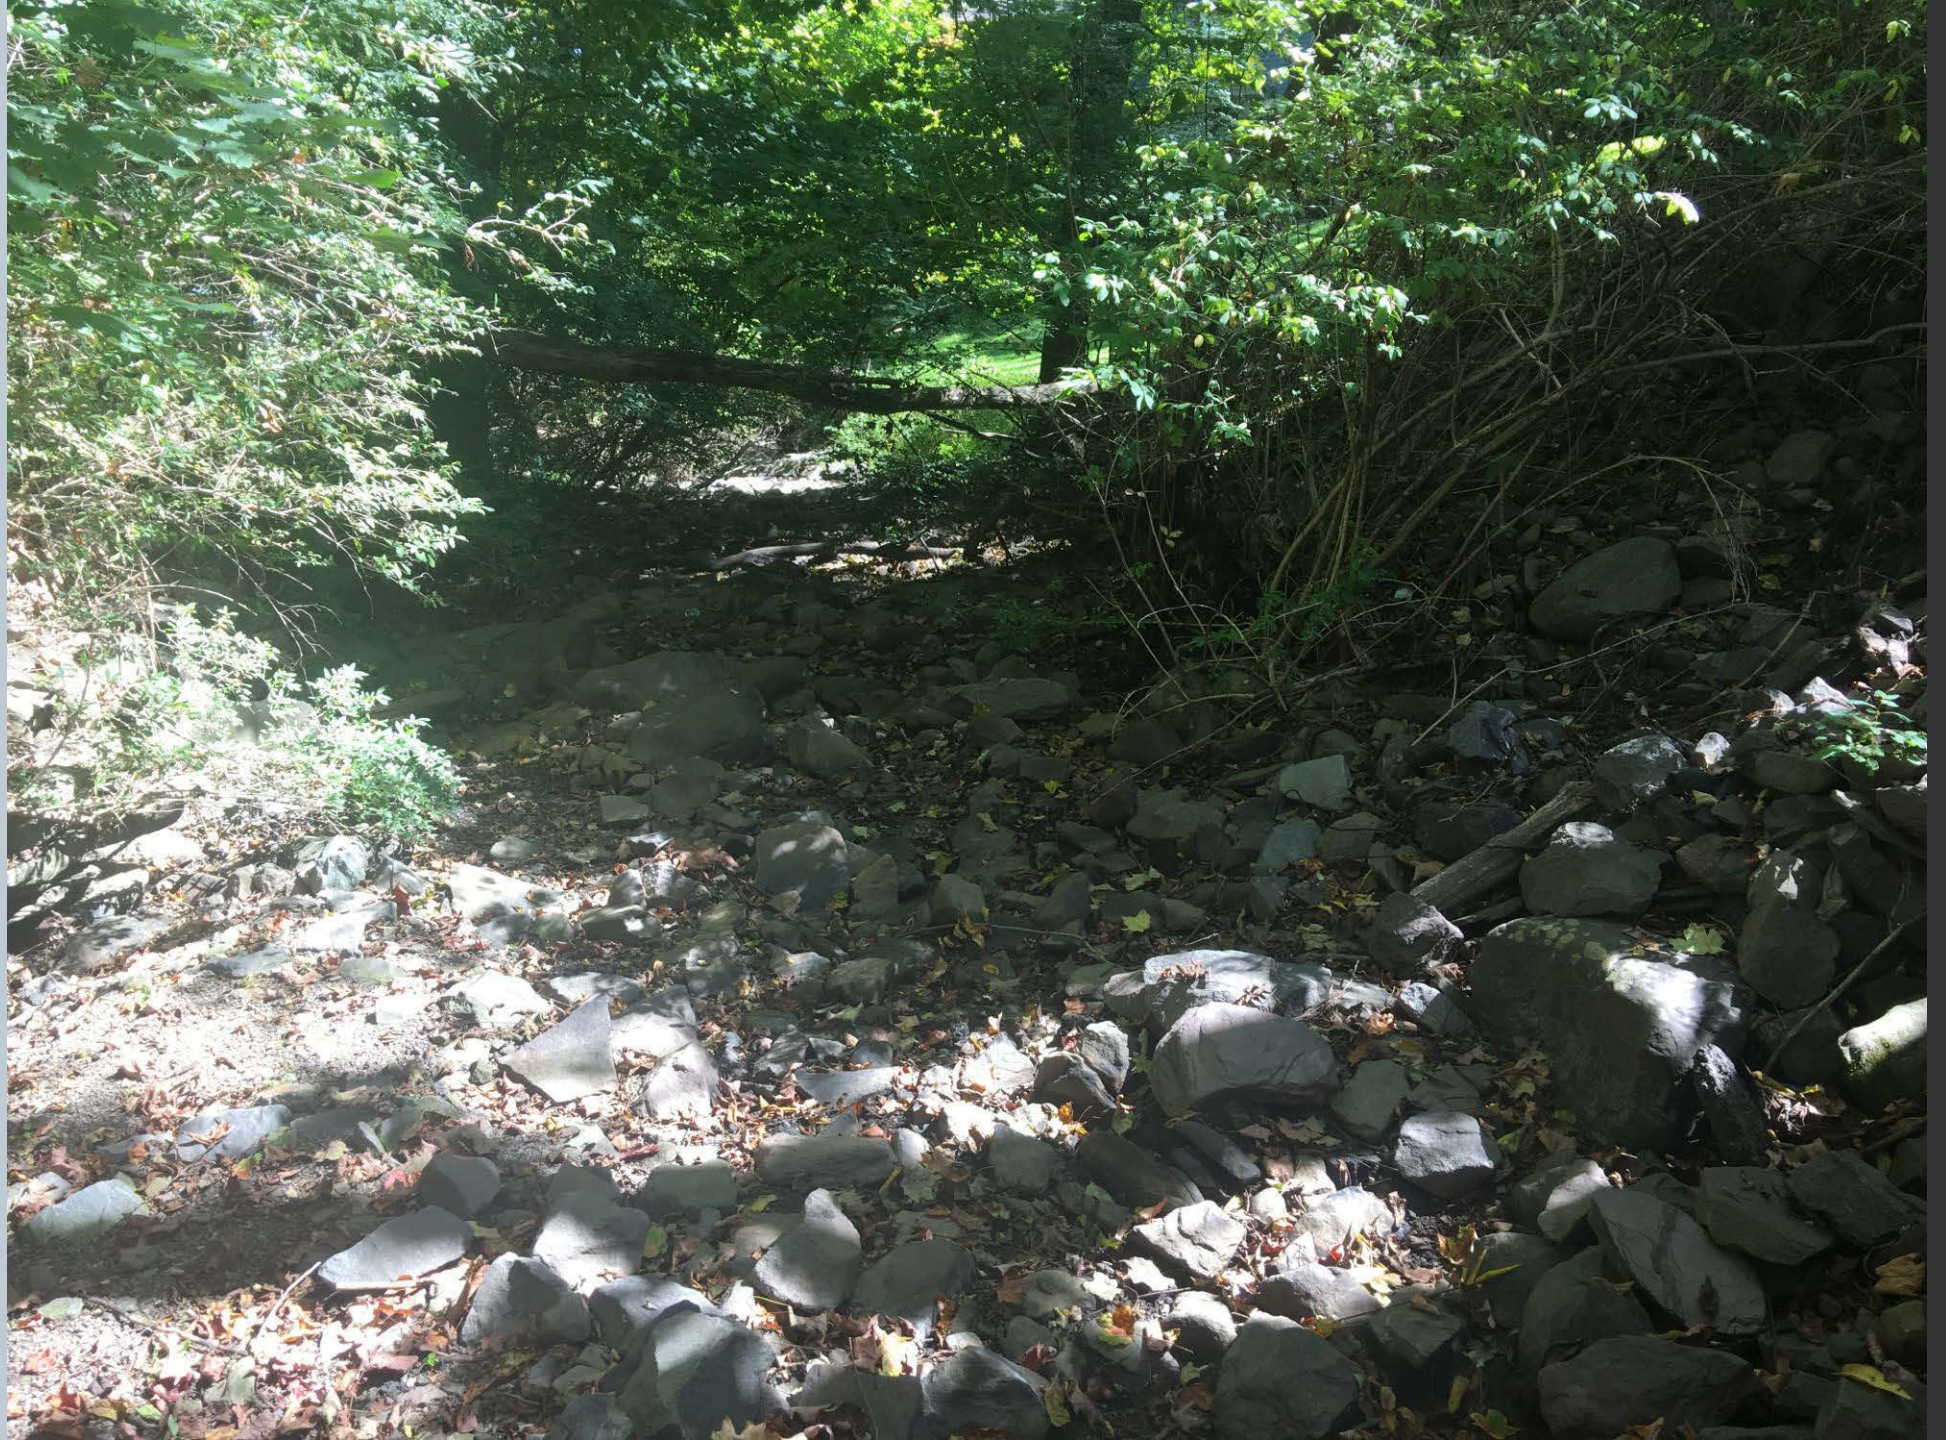
Figure 256. Inlet drop structure filled with sediment from stormwater coming down Pioneer Avenue.
