Toby Creek Field Reconnaissance Observations

September 26, 2018

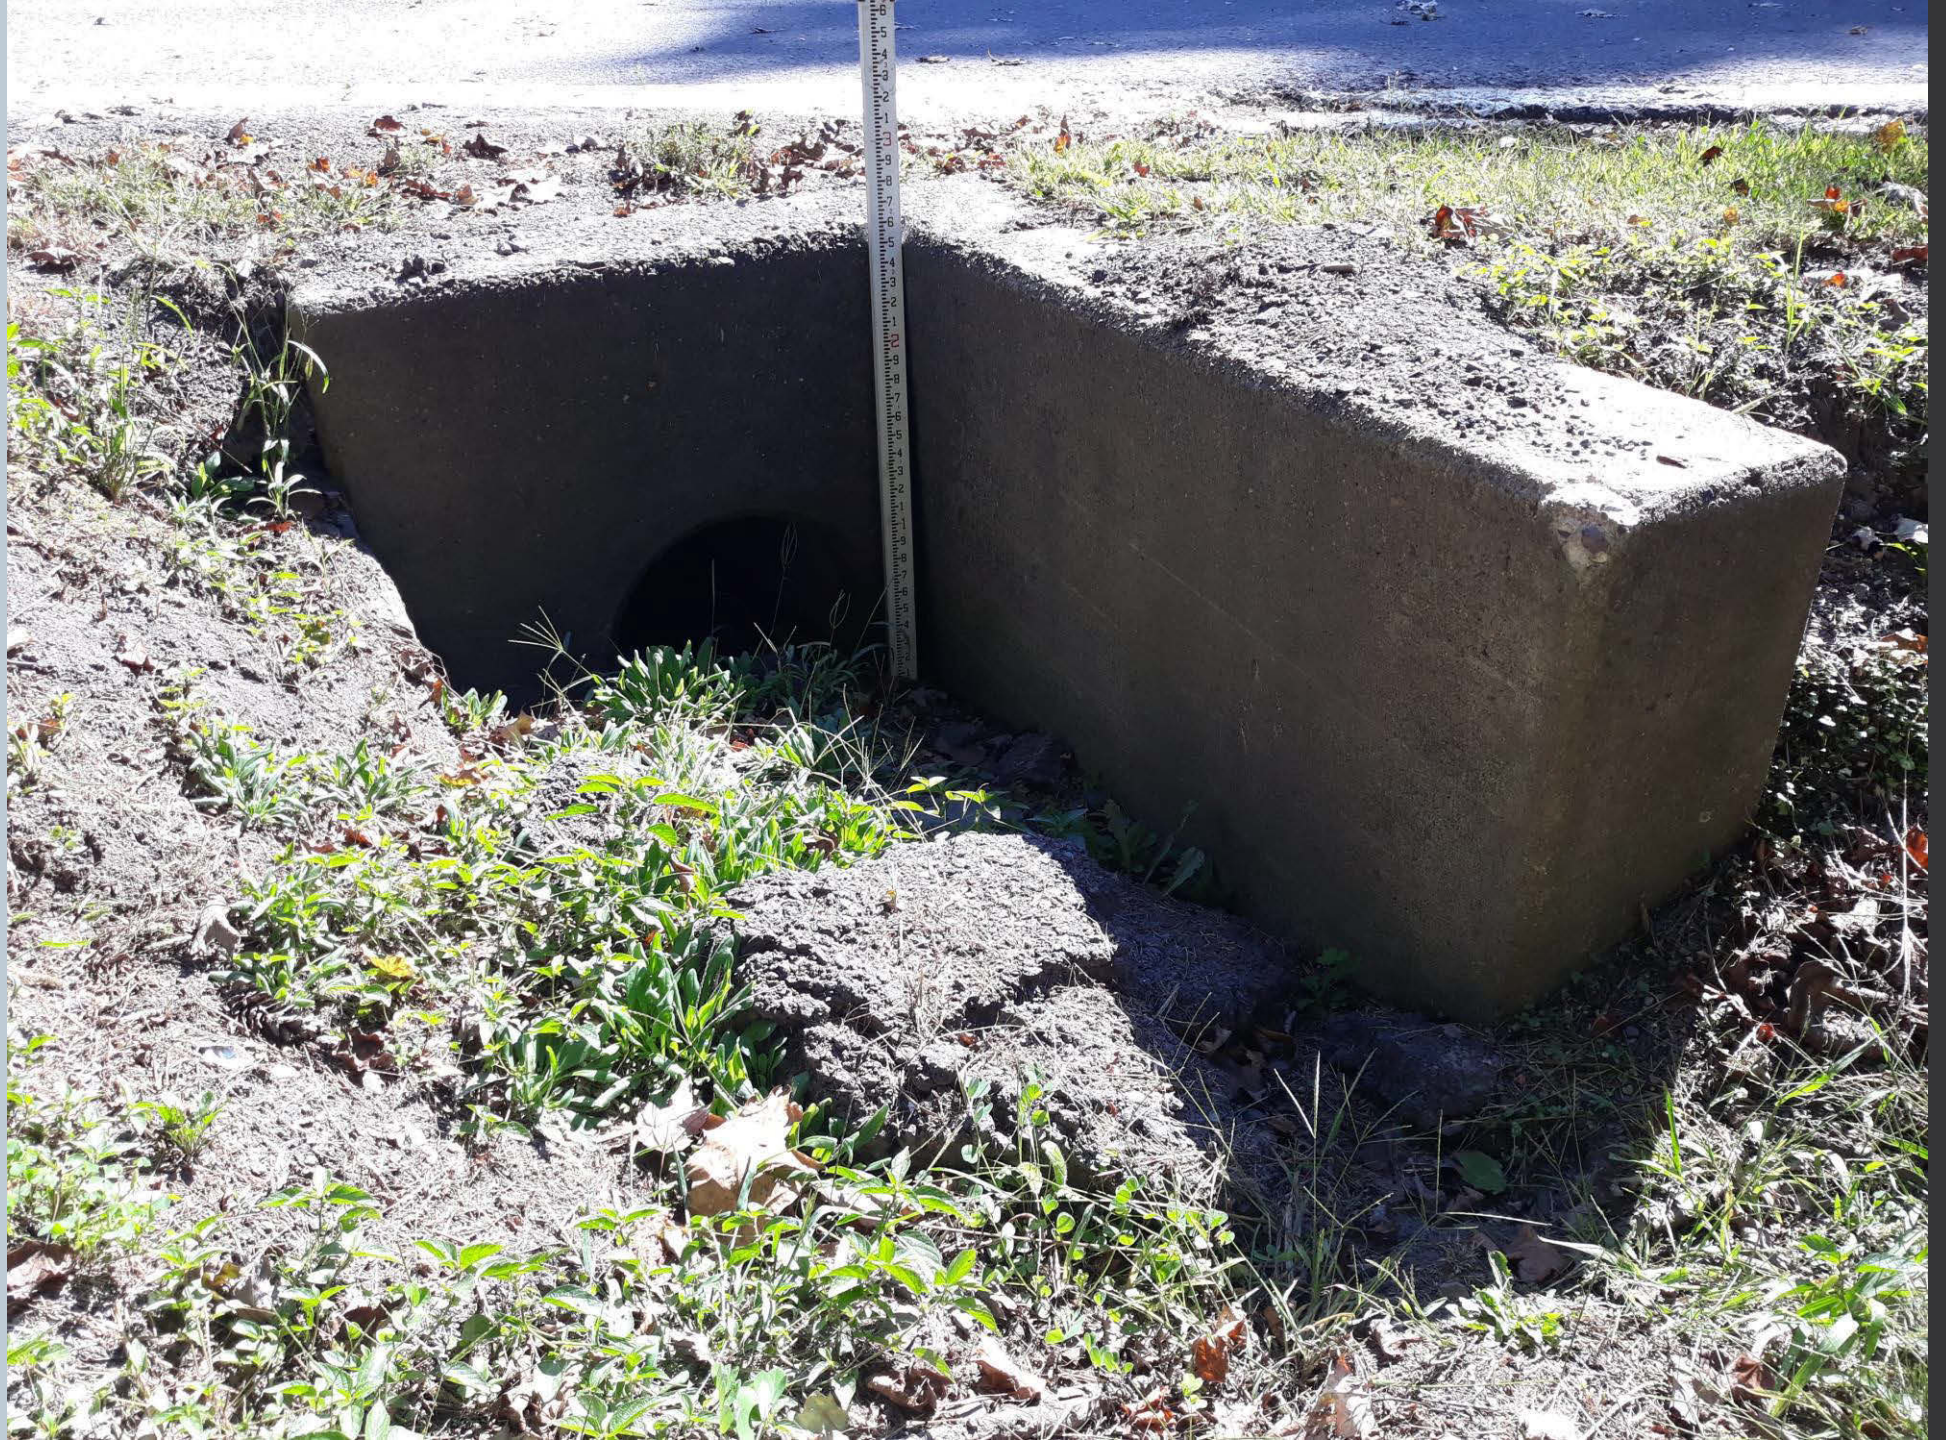
Figure 257. Multiple concrete pipe structures are collapsed and disconnected from an unnamed tributary to Toby Creek that conveys mostly stormwater through Druid Hills below Pioneer Avenue and Overbrook Road. The wingwalls of the culvert foundation are undermined with very little support beneath it. Replacement of the entire structure and foundation should be designed and constructed is recommended.

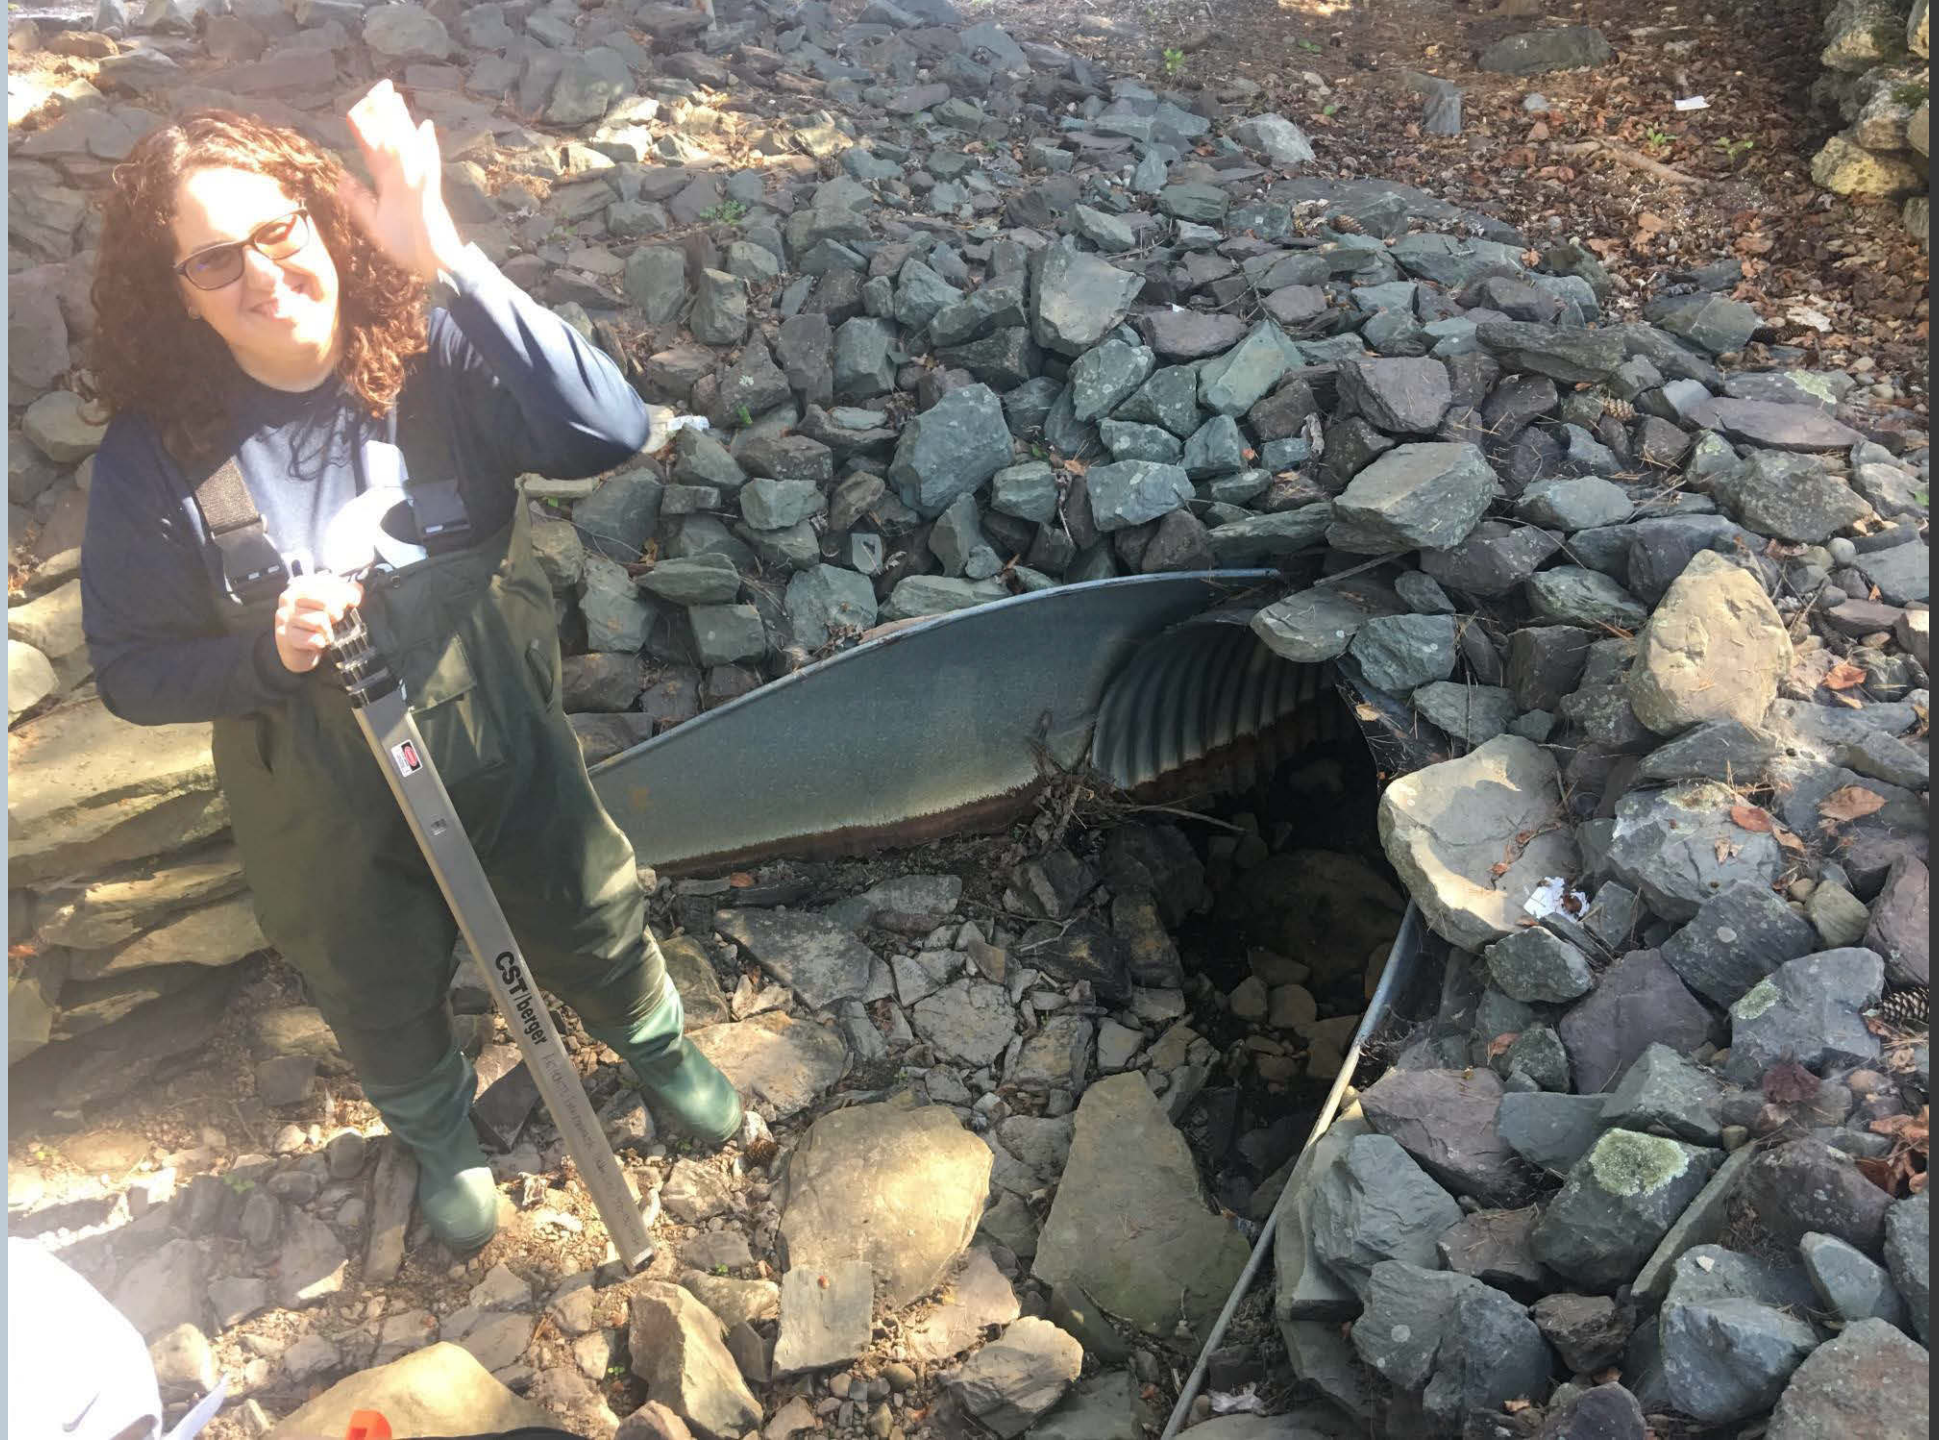
Figure 263. Dry, unnamed tributary to Toby Creek at the corner of W. Franklin and Ferguson Avenue flows through a private residence that has beautifully landscaped the conveyance with a stone rock wall. Recommend having a discussion with the landowner about considering a riparian restoration project in this area.

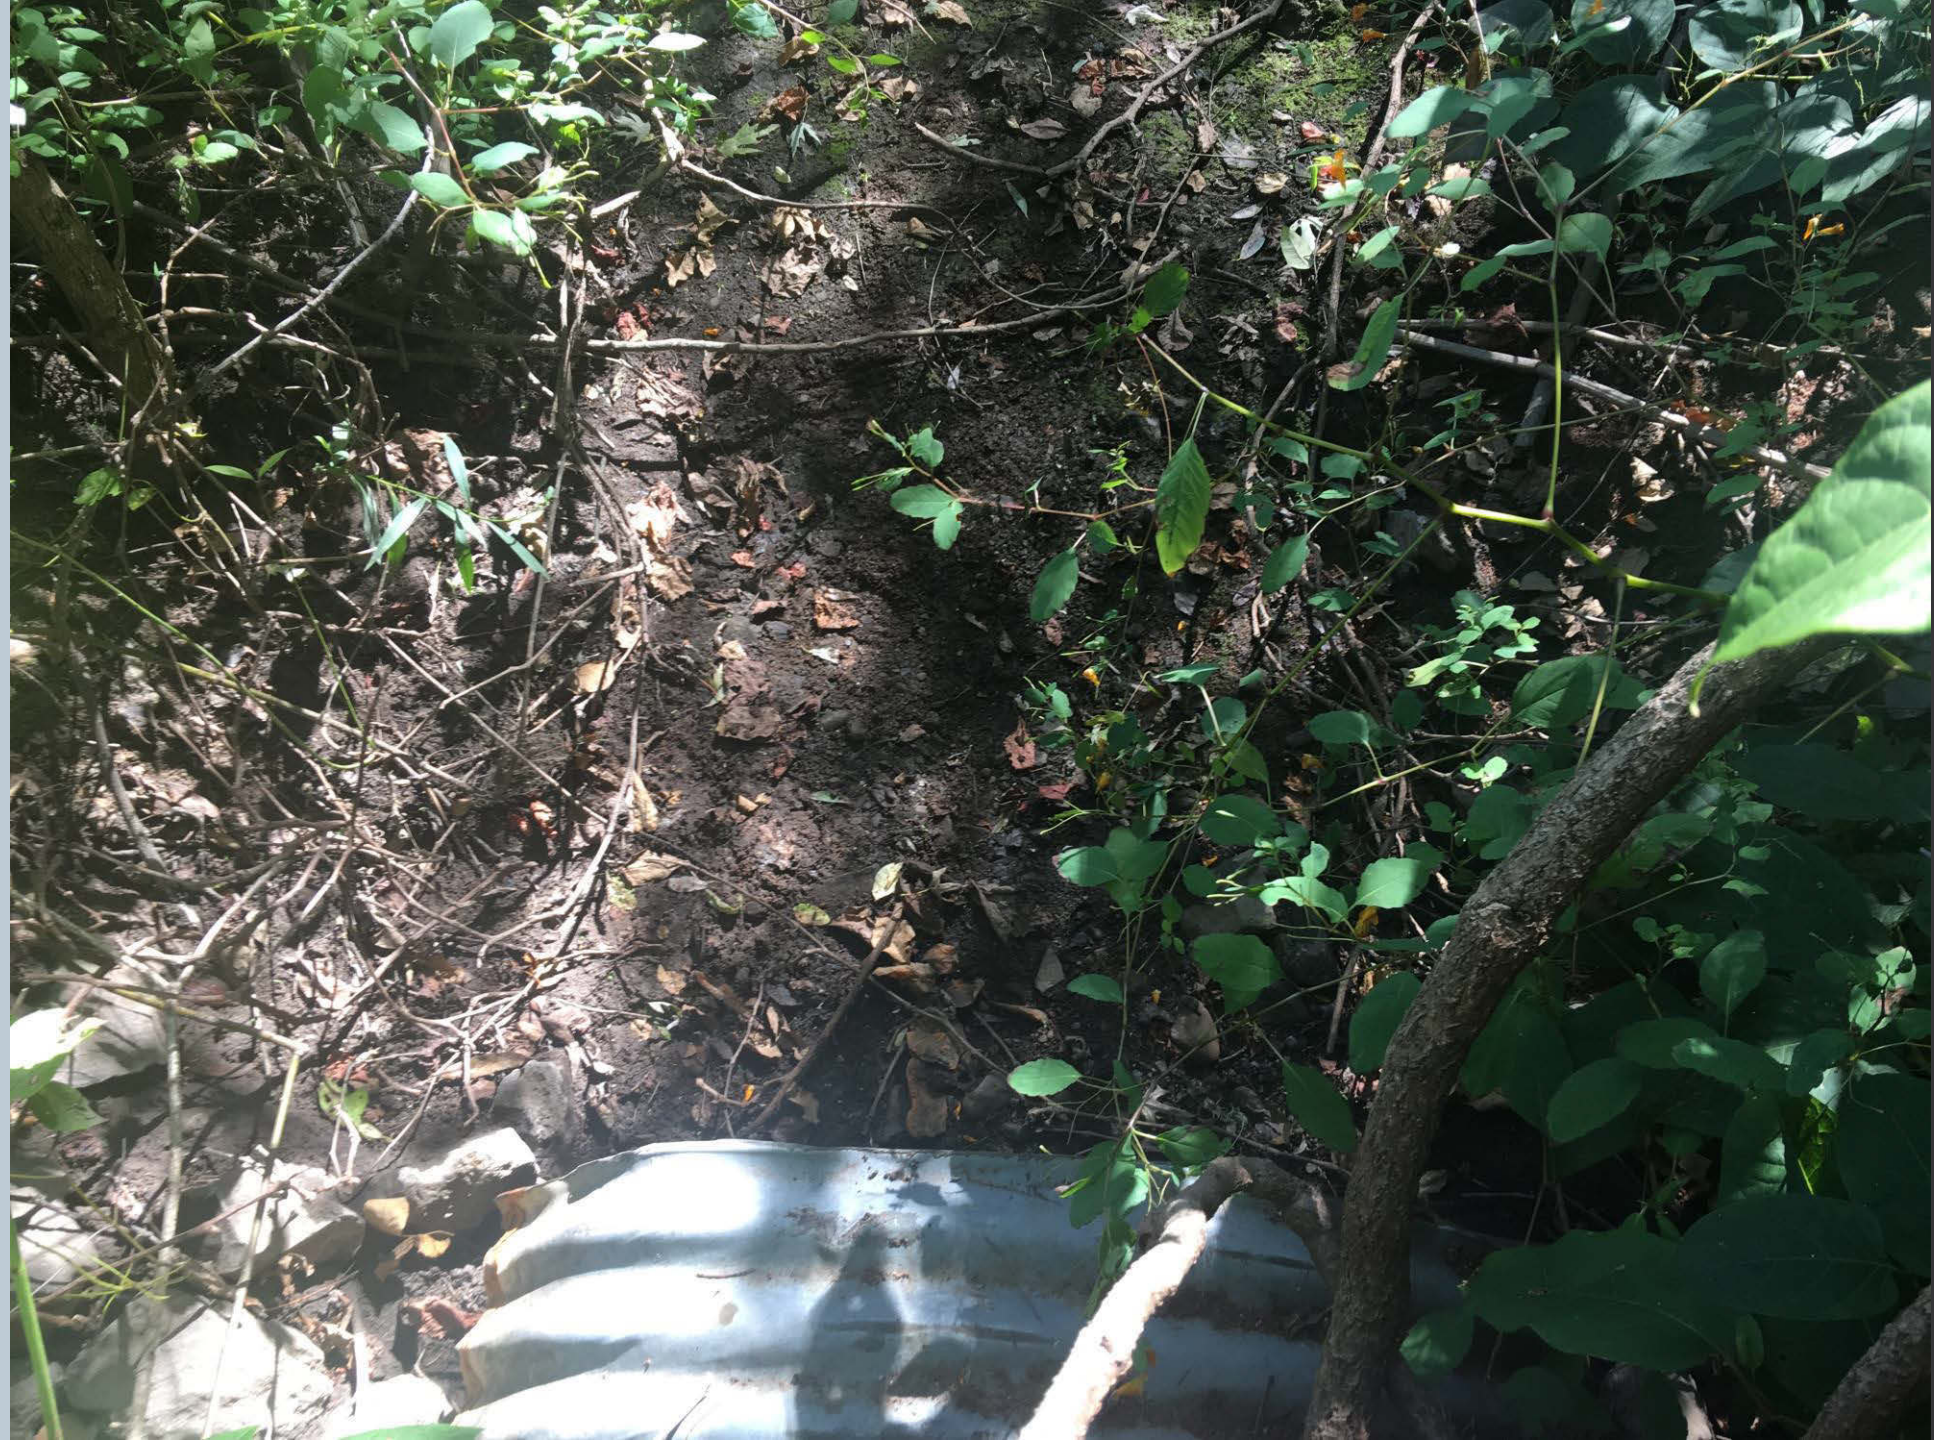
Figure 265. Dry, unnamed tributary to Toby Creek at the outlet of the metal corrugated pipe from the rear of the private residence along West Franklin and Ferguson Avenue. The pipe is half full of sediment. The DAMA Vac Truck is recommended for cleanout of this outlet pipe that is located behind the fence at the rear of the McDonald's.

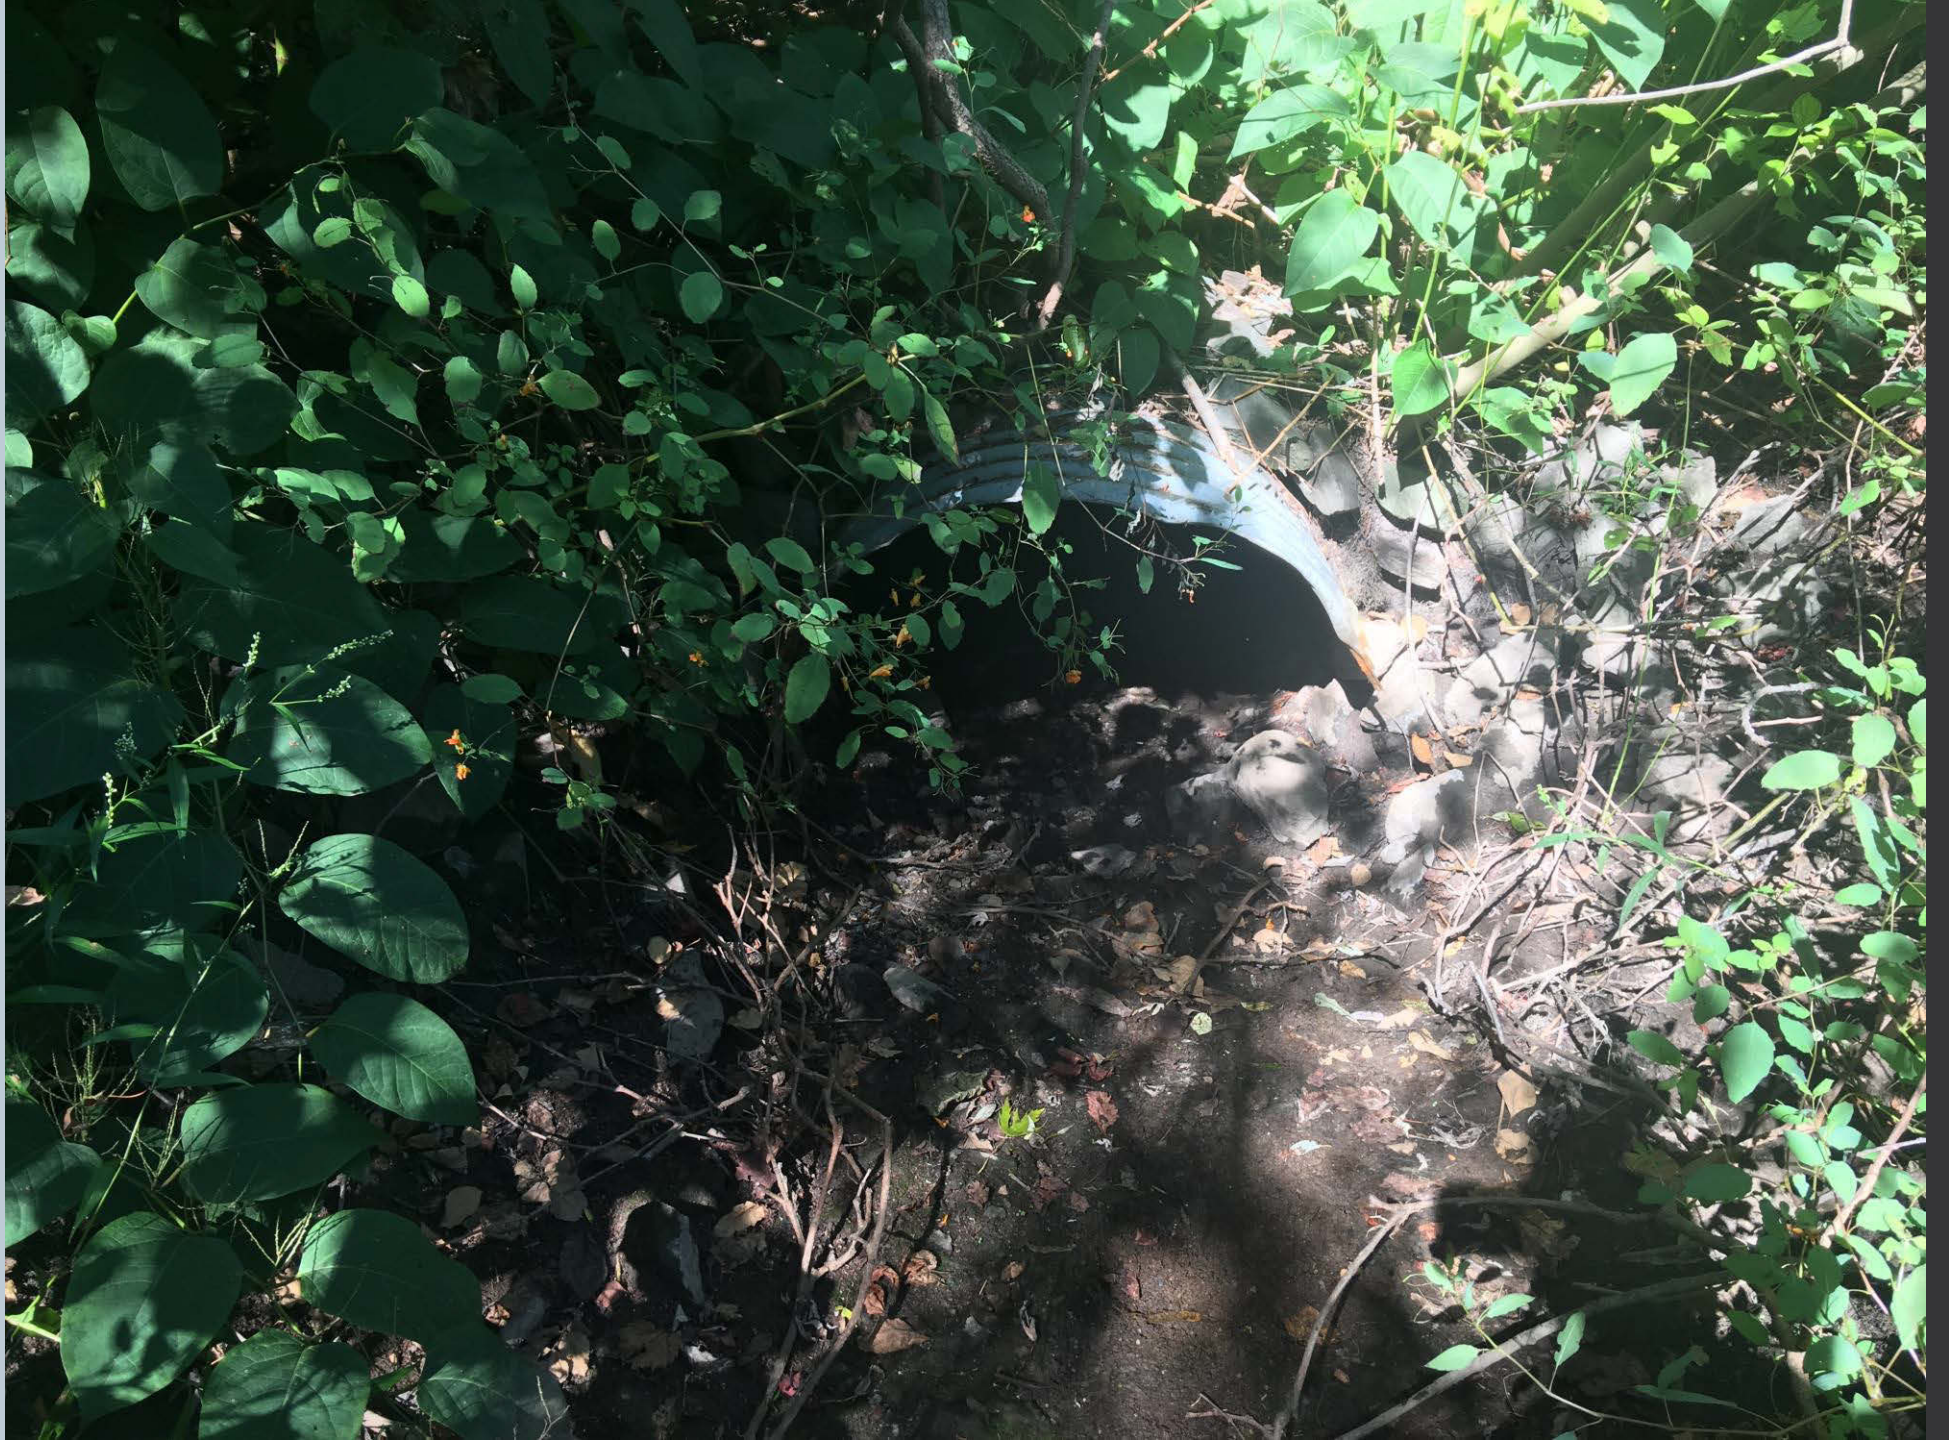
Figure 266. Dry, unnamed tributary to Toby Creek behind McDonald's conveys water into a drop inlet concrete culvert beneath the Back Mountain Shopping Center that is severely blocked with woody debris, trash, and sediment. A small litter cleanup is recommended for the area and removal of the woody debris and branches that are blocking the flow of water through the culvert. Green frogs were present.

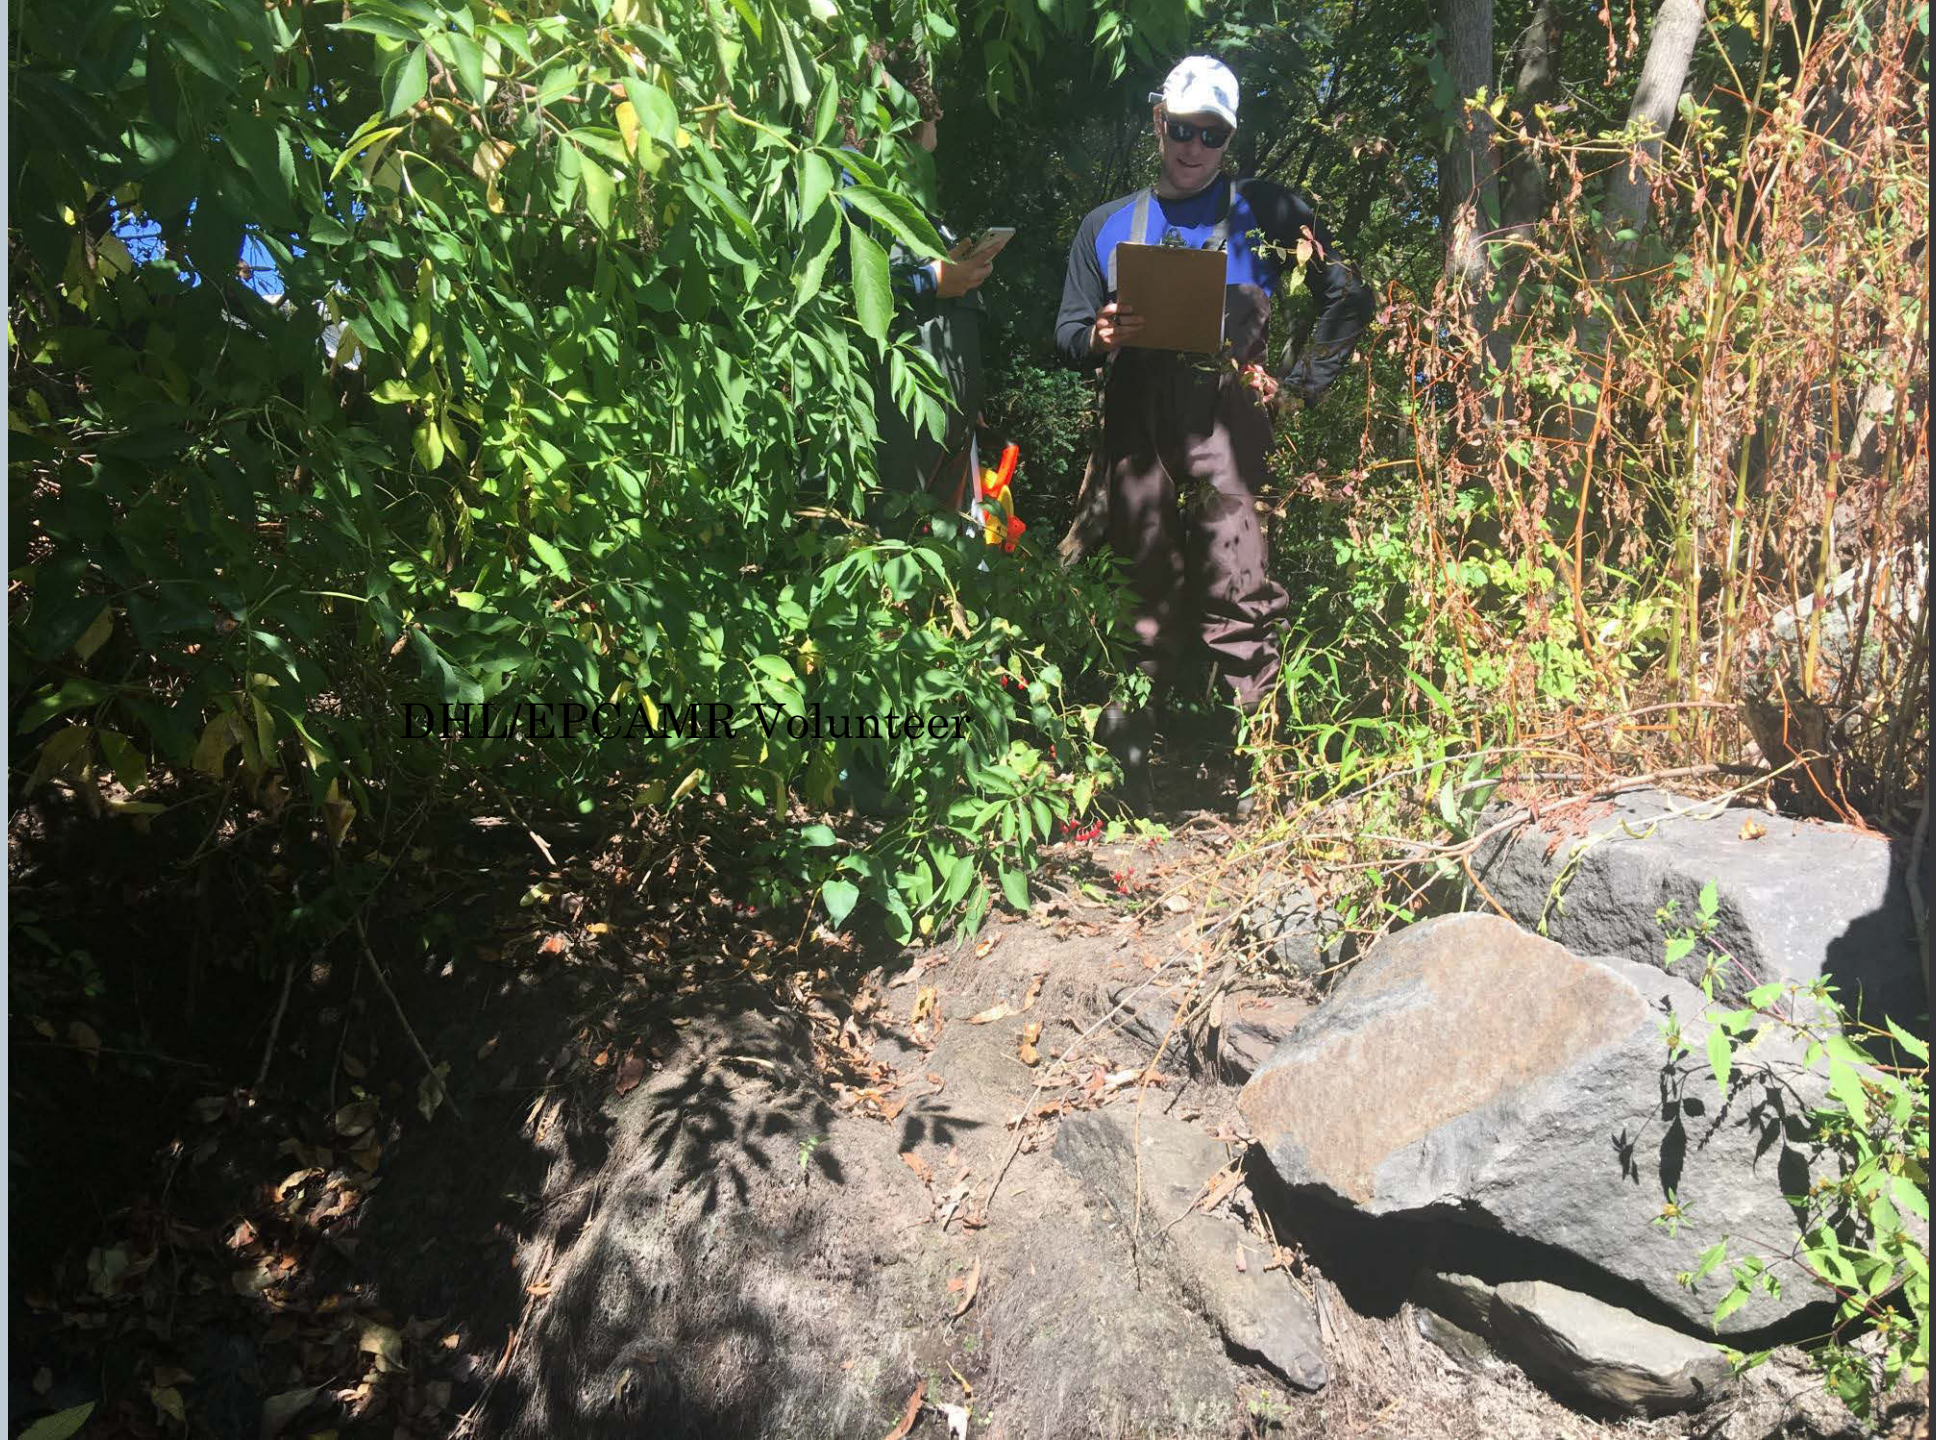
Figure 267. The first sign of some baseflow was found near the headwall of the culvert beneath all of the sediment and woody debris blockage at the inlet. This would carry flow beneath the Back Mountain Shopping Center over to where it outlets near Amelia's Diner across the Dallas Memorial Highway. DAMA Stormwater Coordinator and Gabby Zawacki, DHL/EPCAMR Volunteer look in amazement.

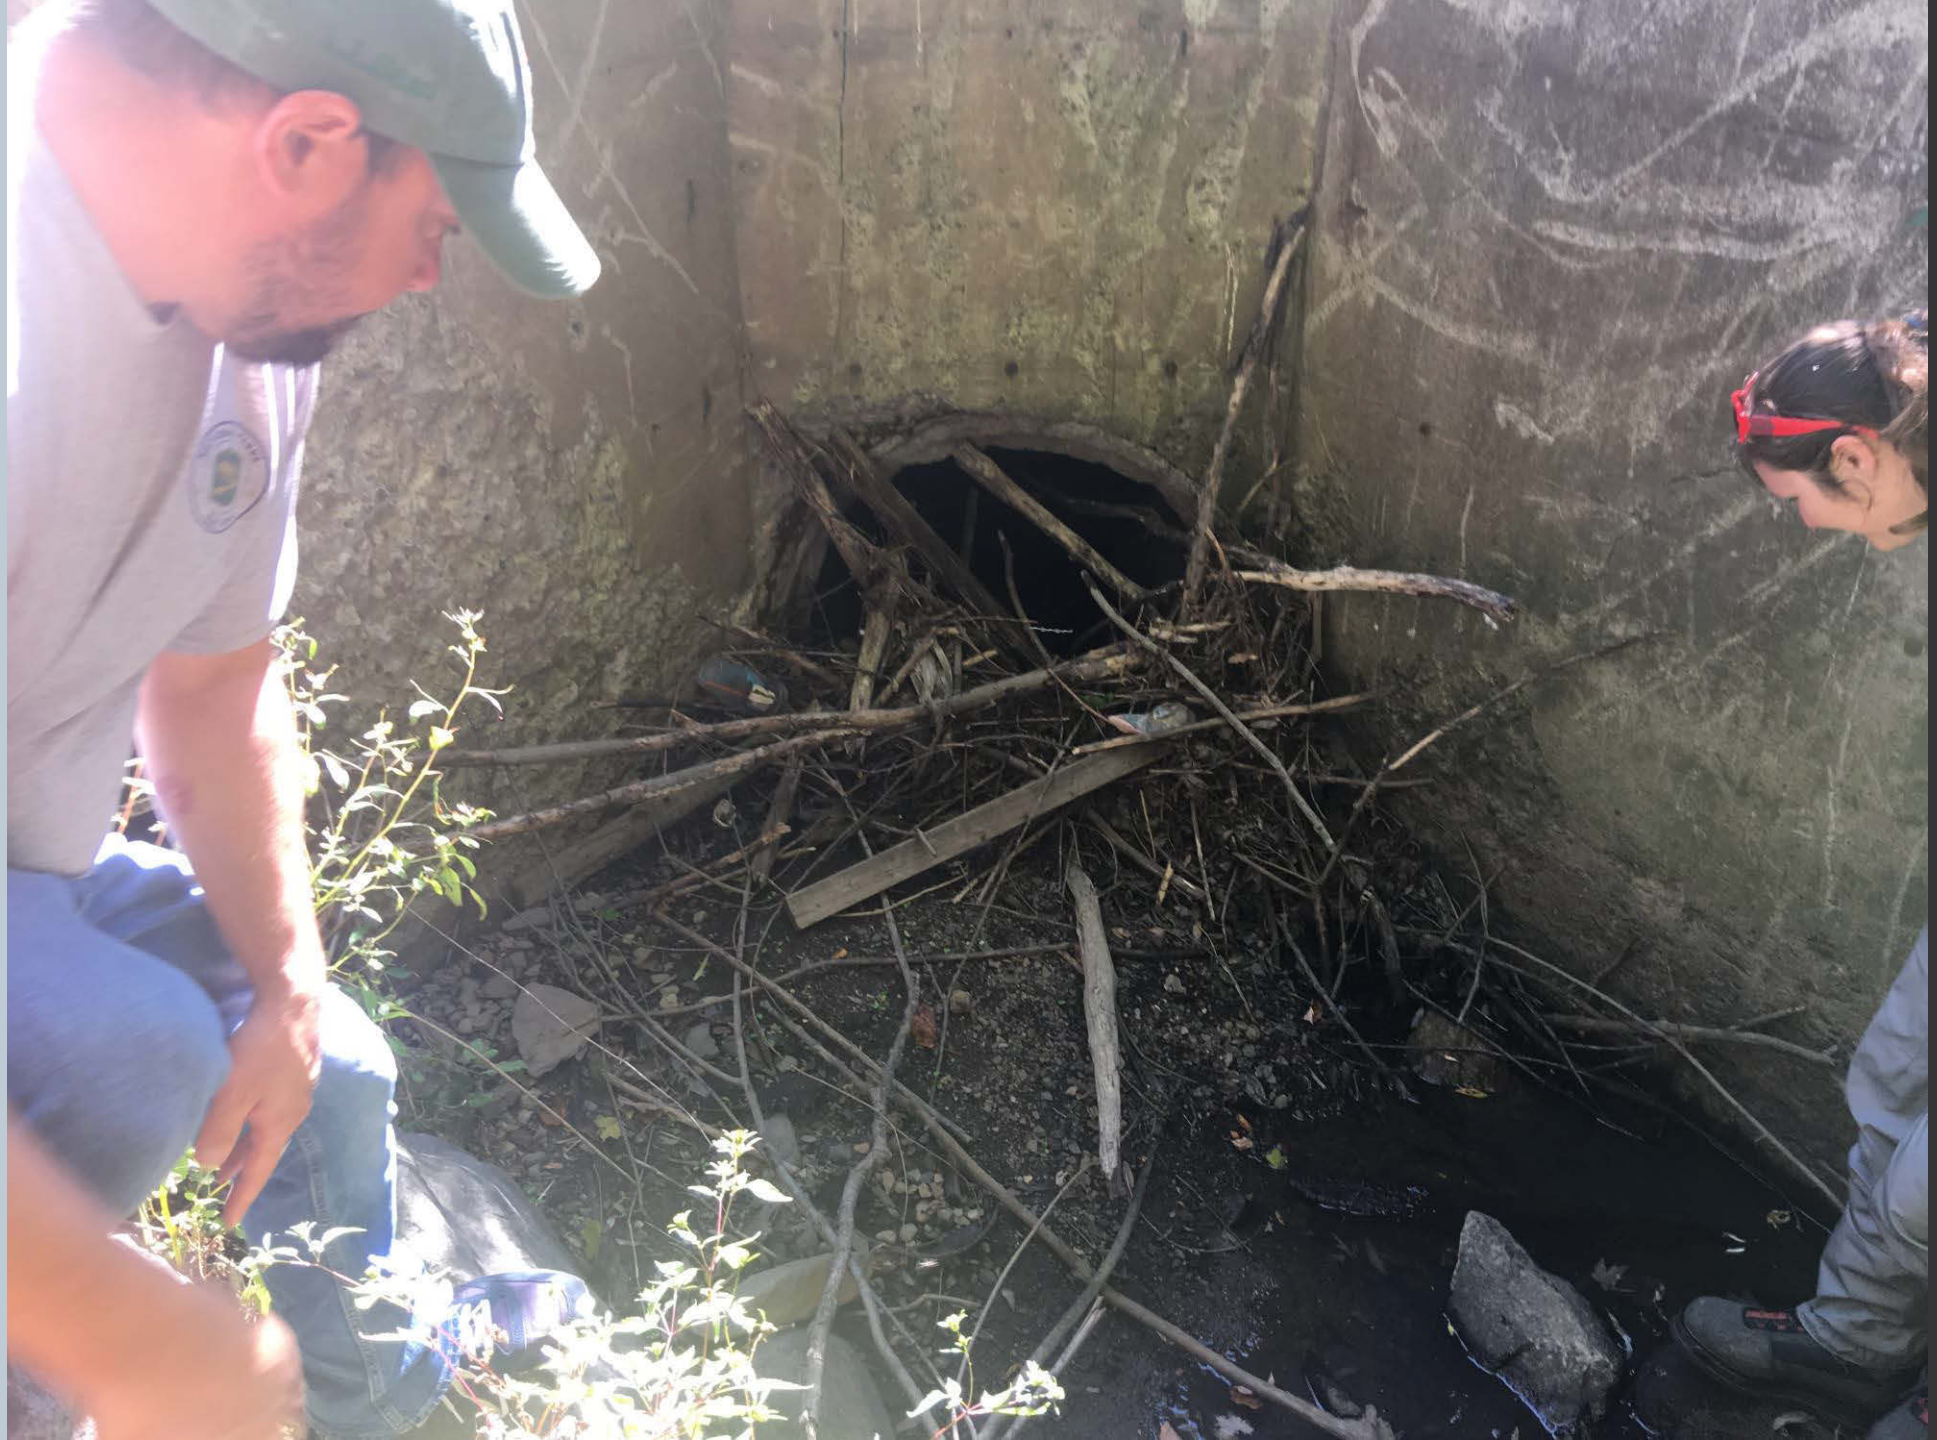
Figure 268. Looking downstream into the concrete culvert beneath the Back Mountain Shopping Center into the first 20' and woody debris and large stone are found blocking the flow of stormwater through the length of the pipe of the unnamed tributary to Toby Creek that crosses the parking lot and under the Dallas Memorial Highway before it outlets near Amelia's Diner and the Gas Station. Removal of the rocks and woody debris is recommended.

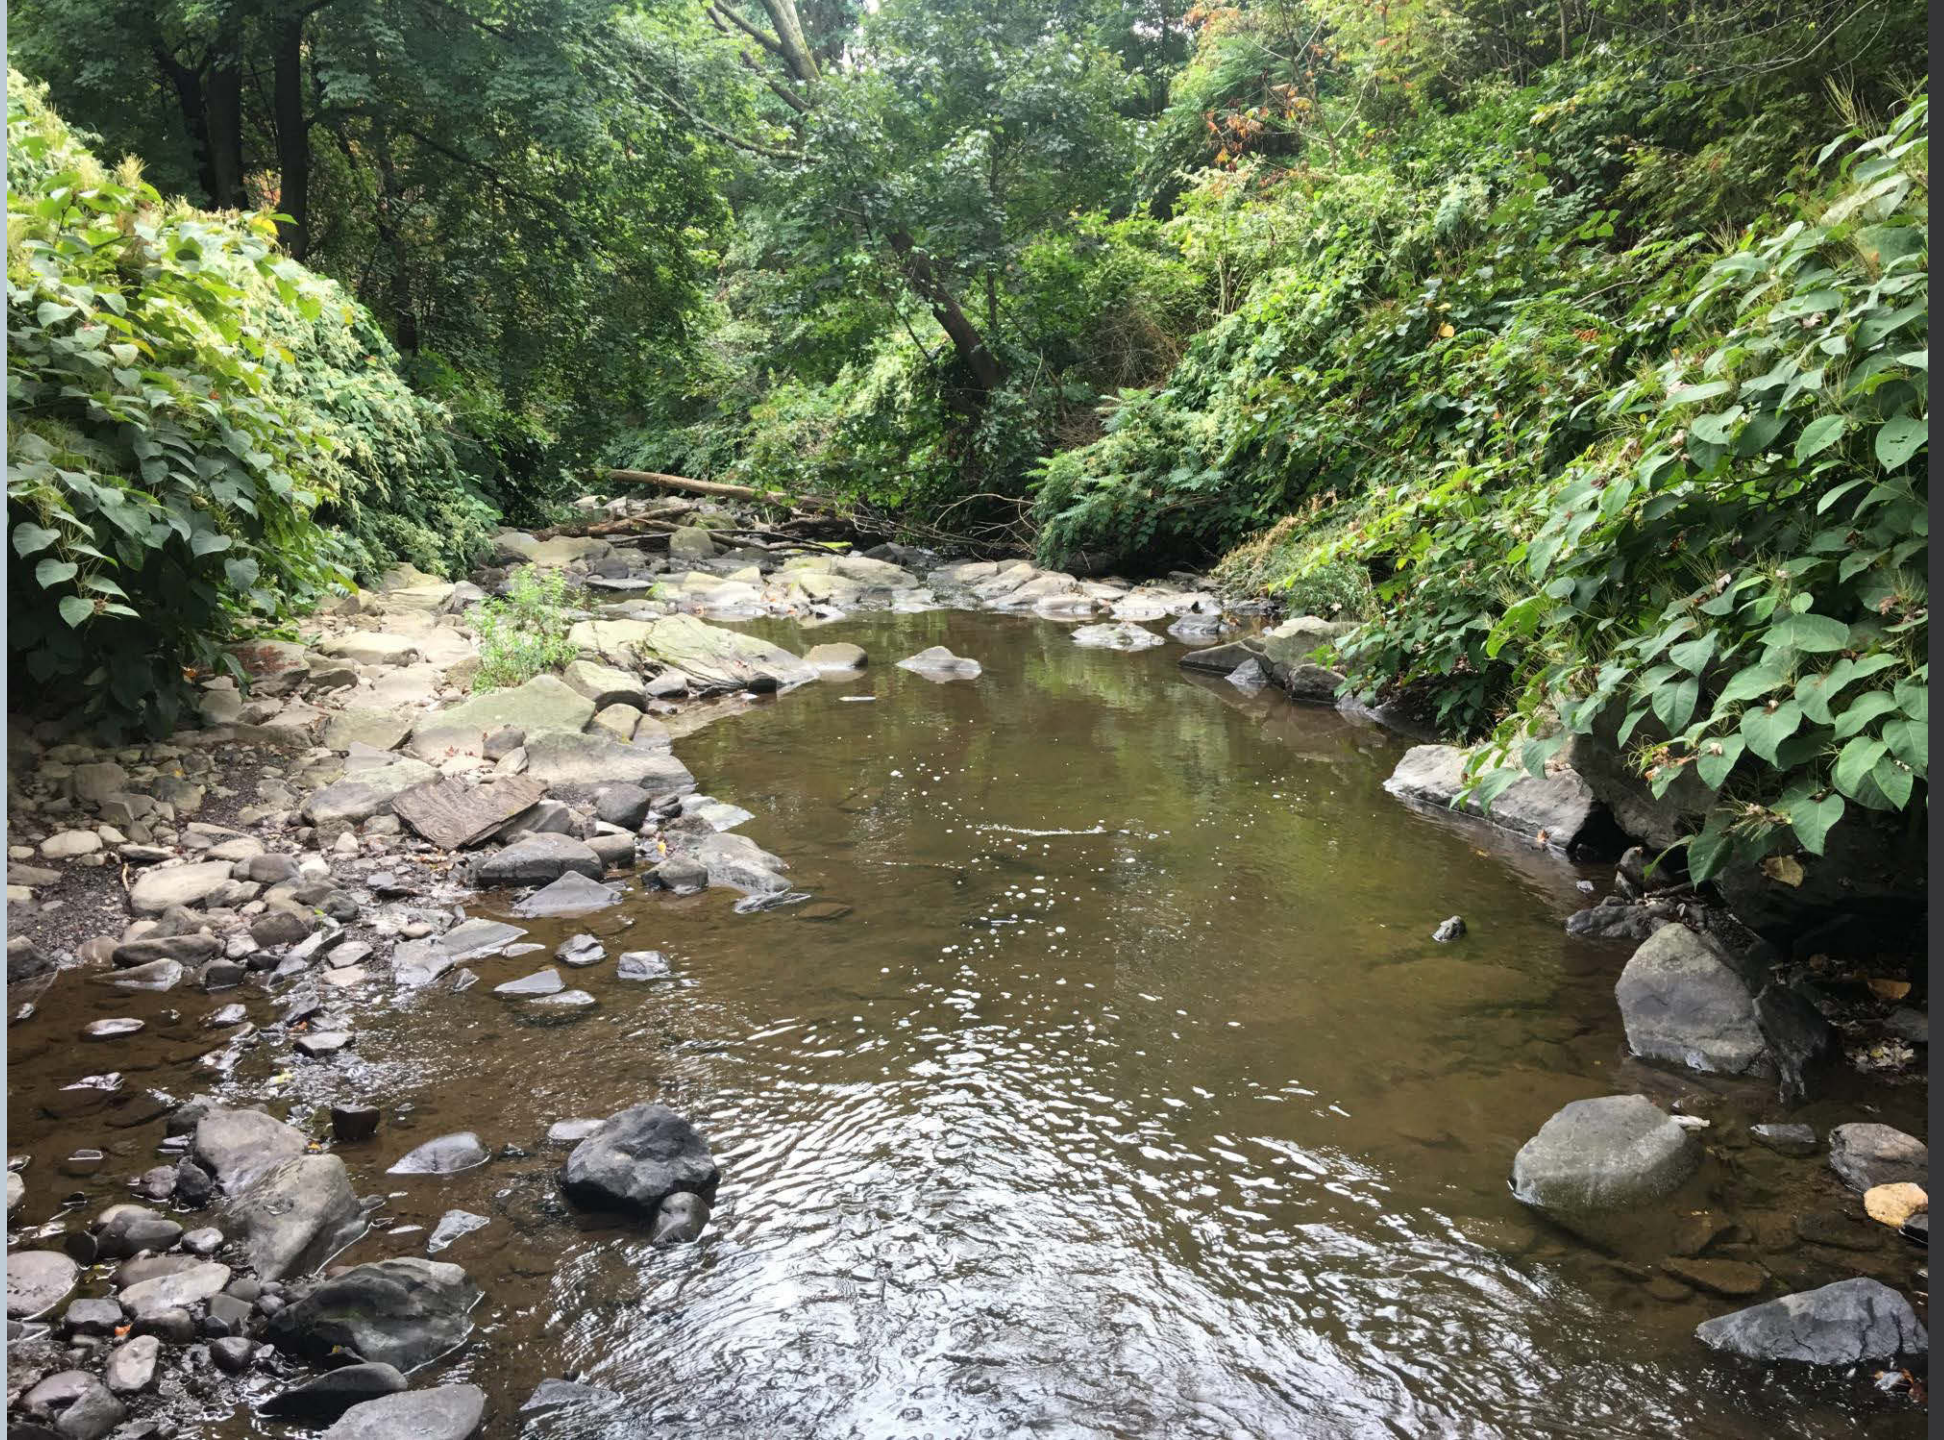
Figure 274.
Looking
downstream on
Toby Creek from
the inlet side over
the Dallas
Memorial
Highway.
DHL/EPCAMR
Volunteers and
Tom Mayka,
DAMA
Stormwater
Coordinator were
assisting with
taking culvert
measurements for
aquatic organism
passage.

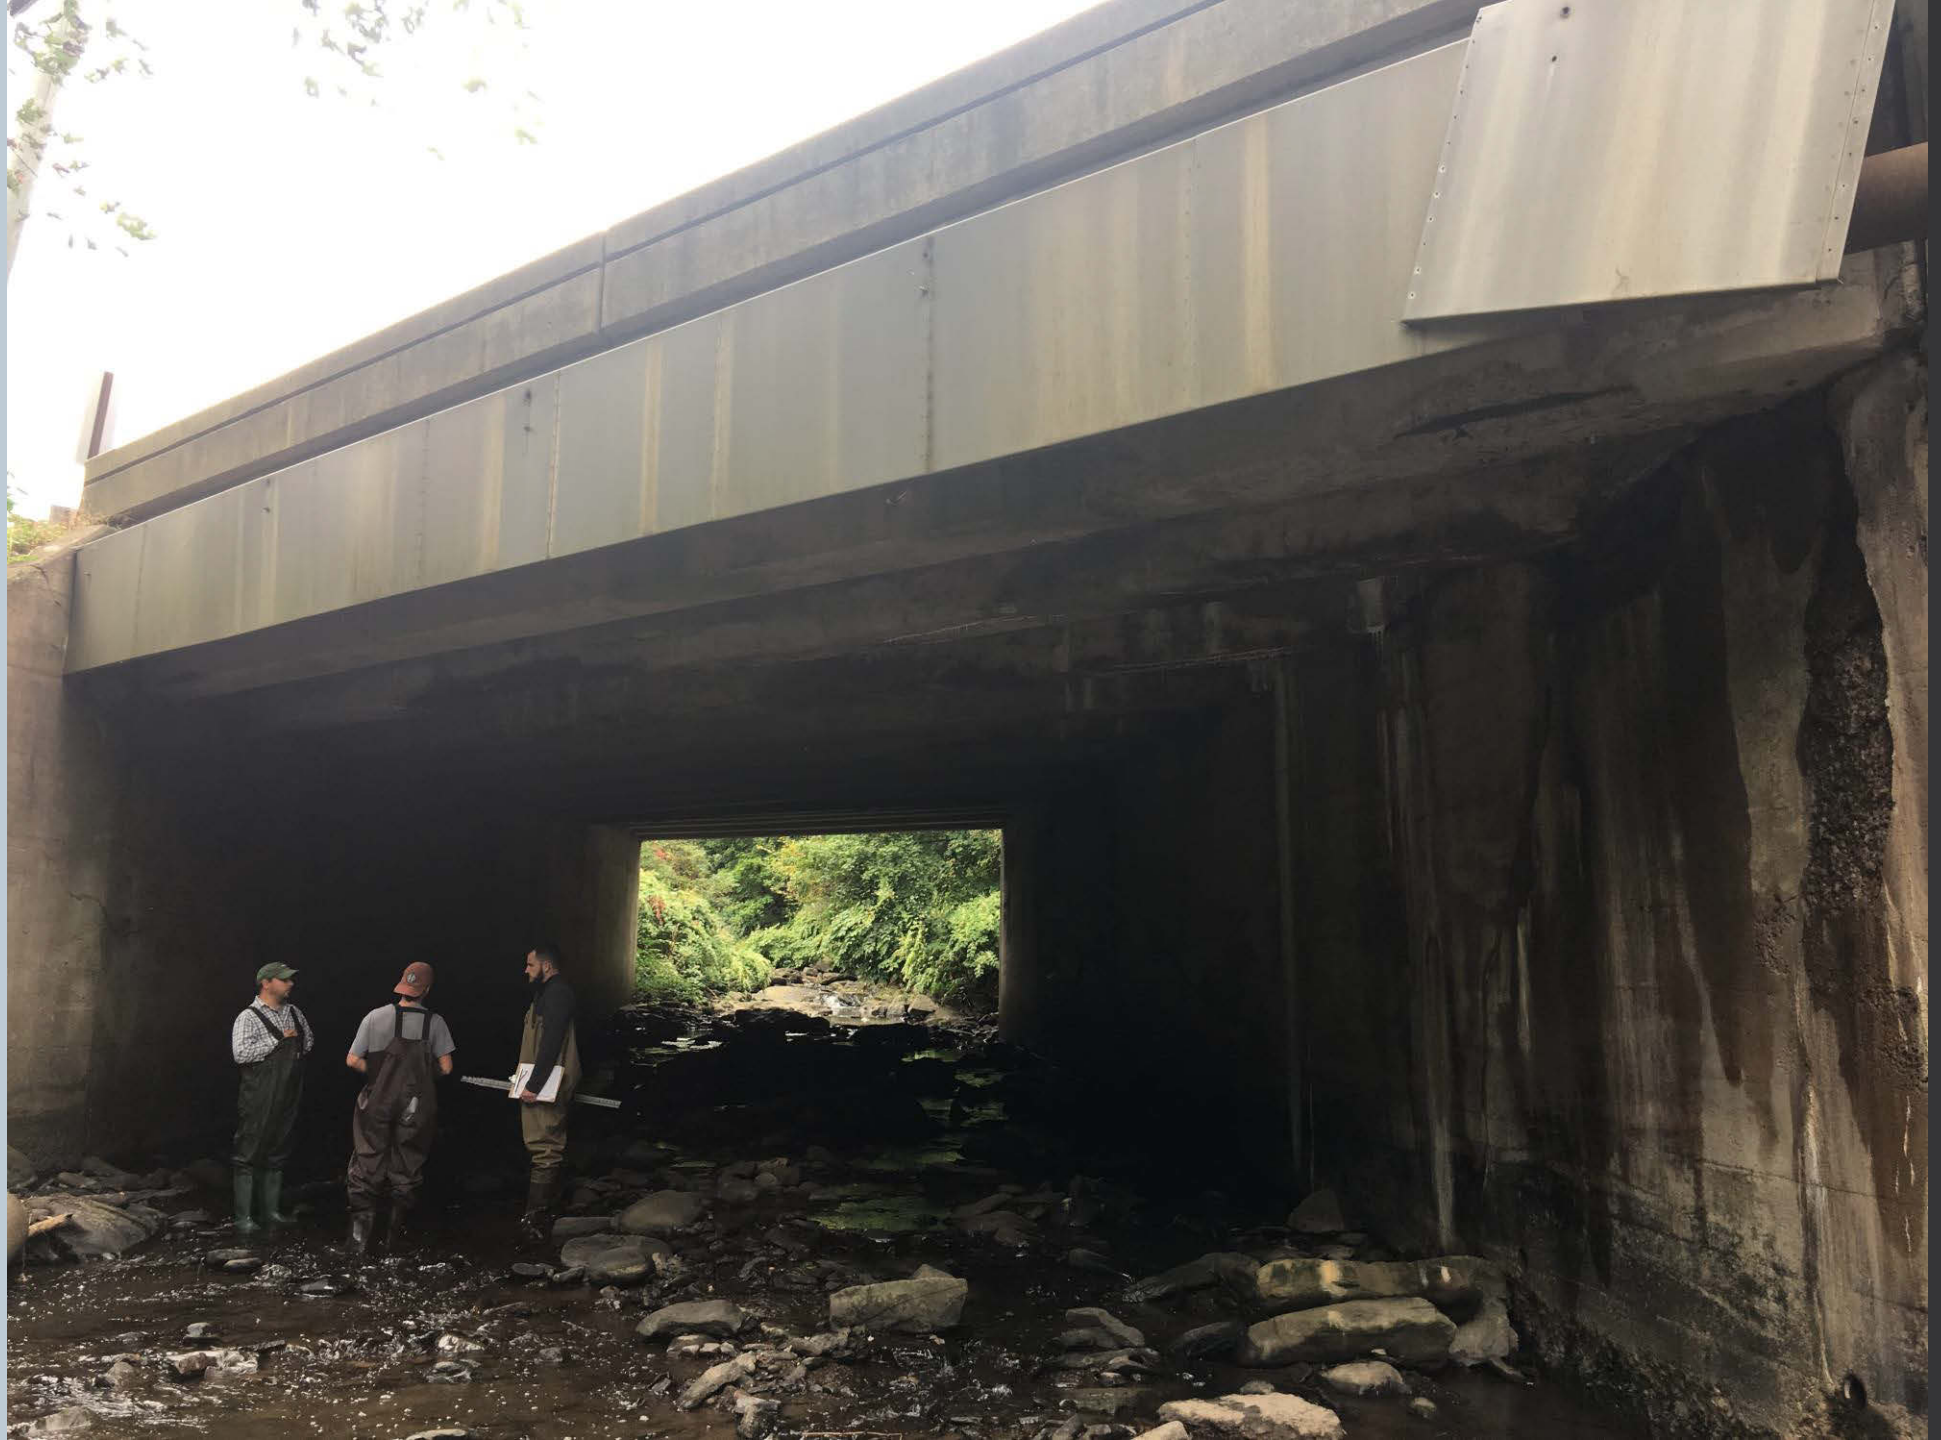
Figure 275. Looking upstream on Toby Creek standing in front of the inlet side of the of the bridge culvert over the Dallas Memorial Highway. The habitat is excellent with a nice riffle-run-pool feature shown and again Japanese Knotweed is prevalent. Recommend an invasive removal project and planting with native vegetation along this stream corridor.
