Toby Creek Field Reconnaissance Observations

September 26, 2018

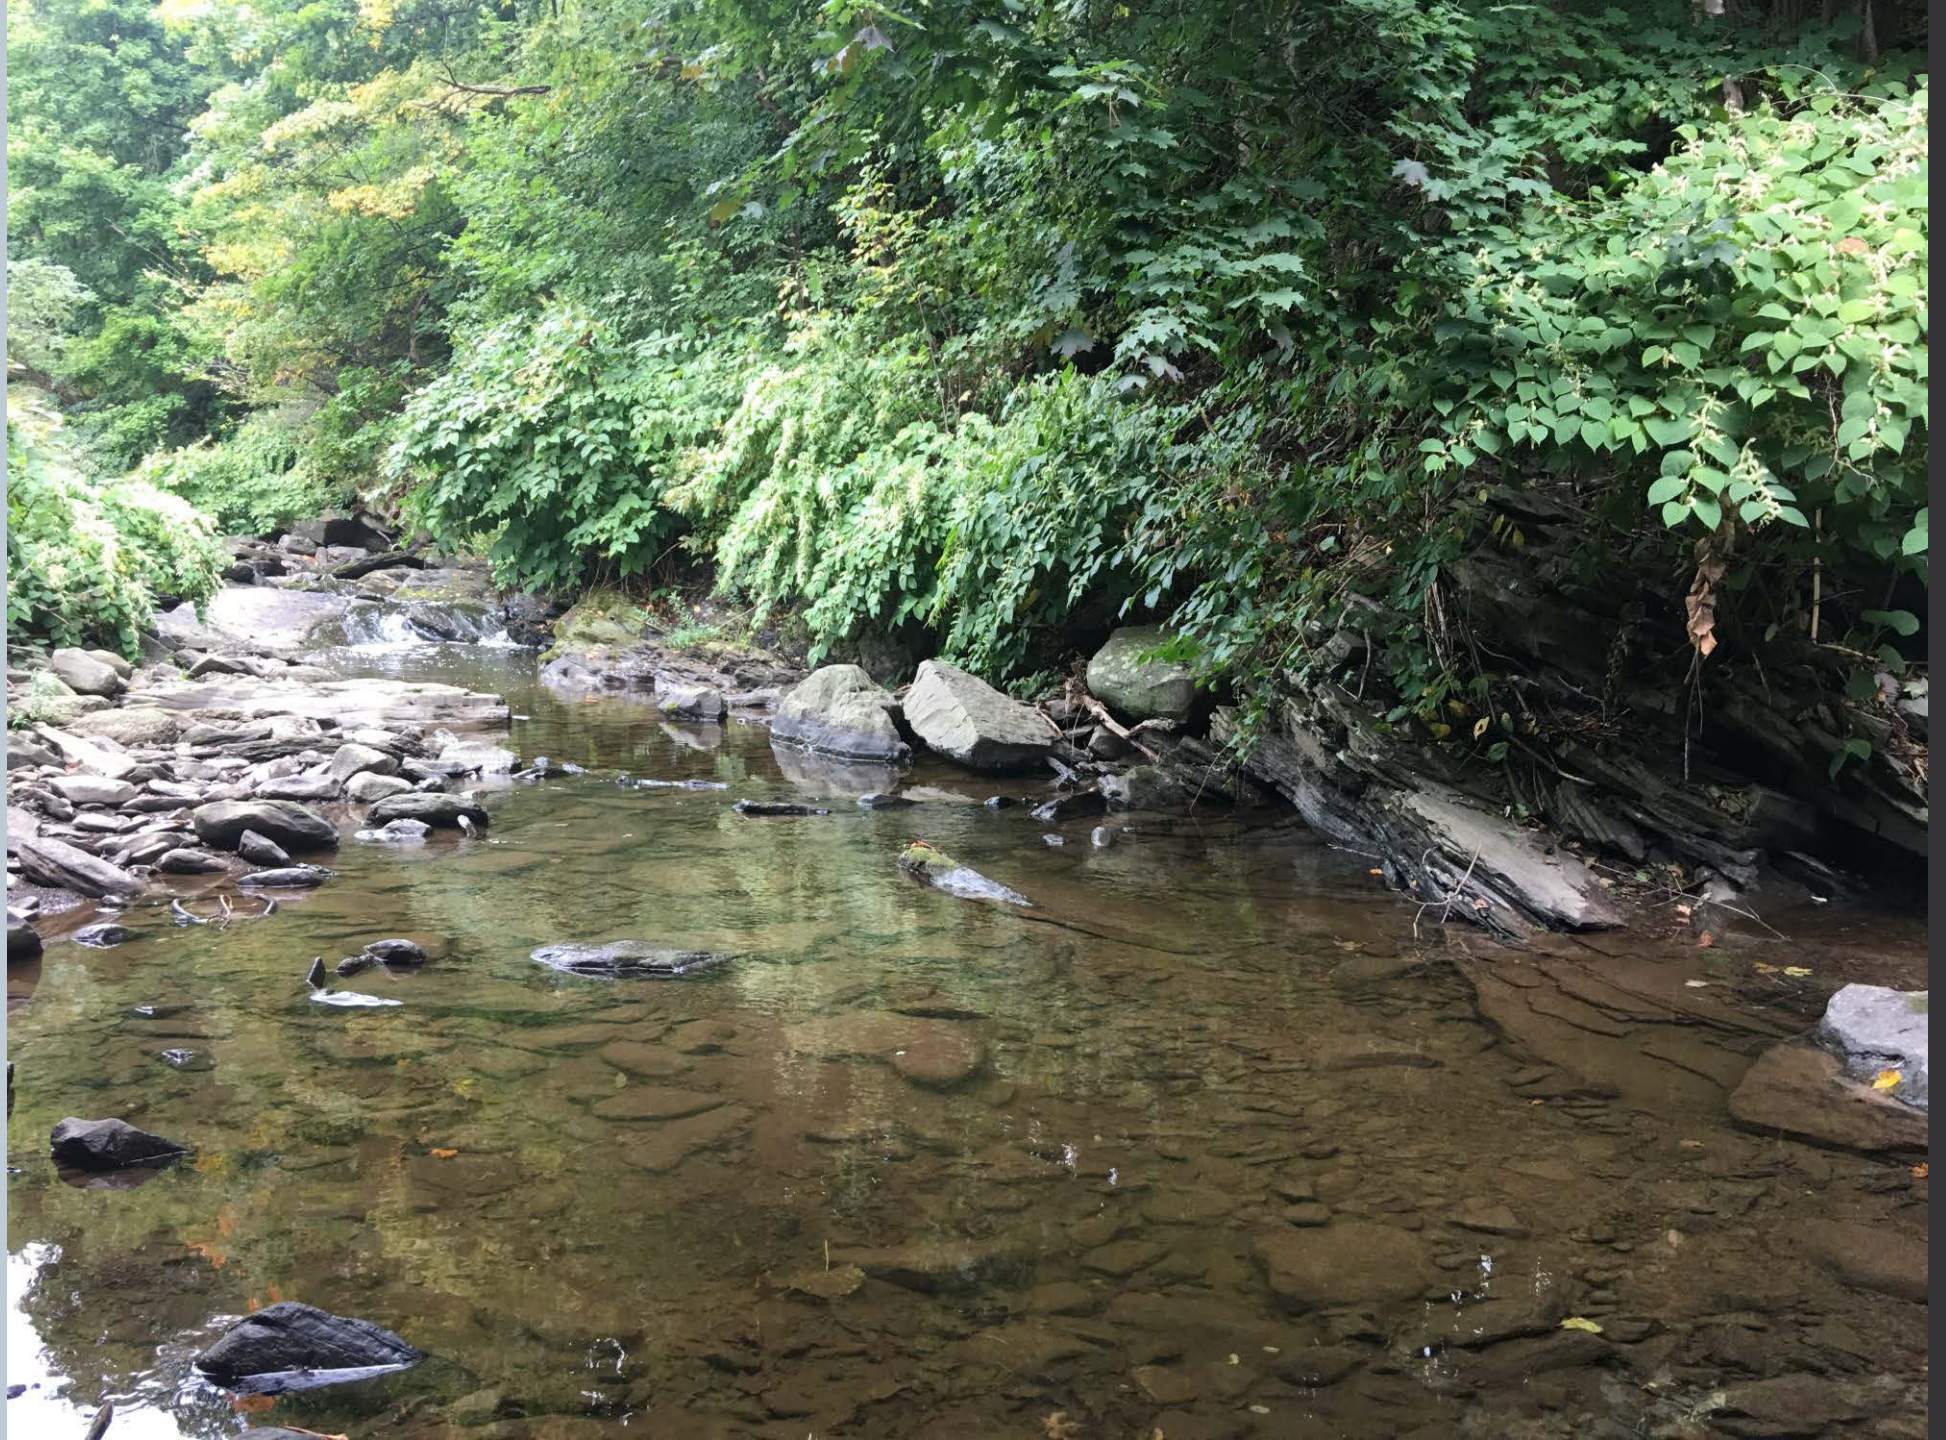
Figure 276. Looking upstream on Toby Creek standing in front of the outlet side of the of the bridge culvert over the Dallas Memorial Highway. Japanese Knotweed is prevalent. Recommend an invasive removal project and planting with native vegetation along this stream corridor. Several trees are down across Toby Creek that should be removed.

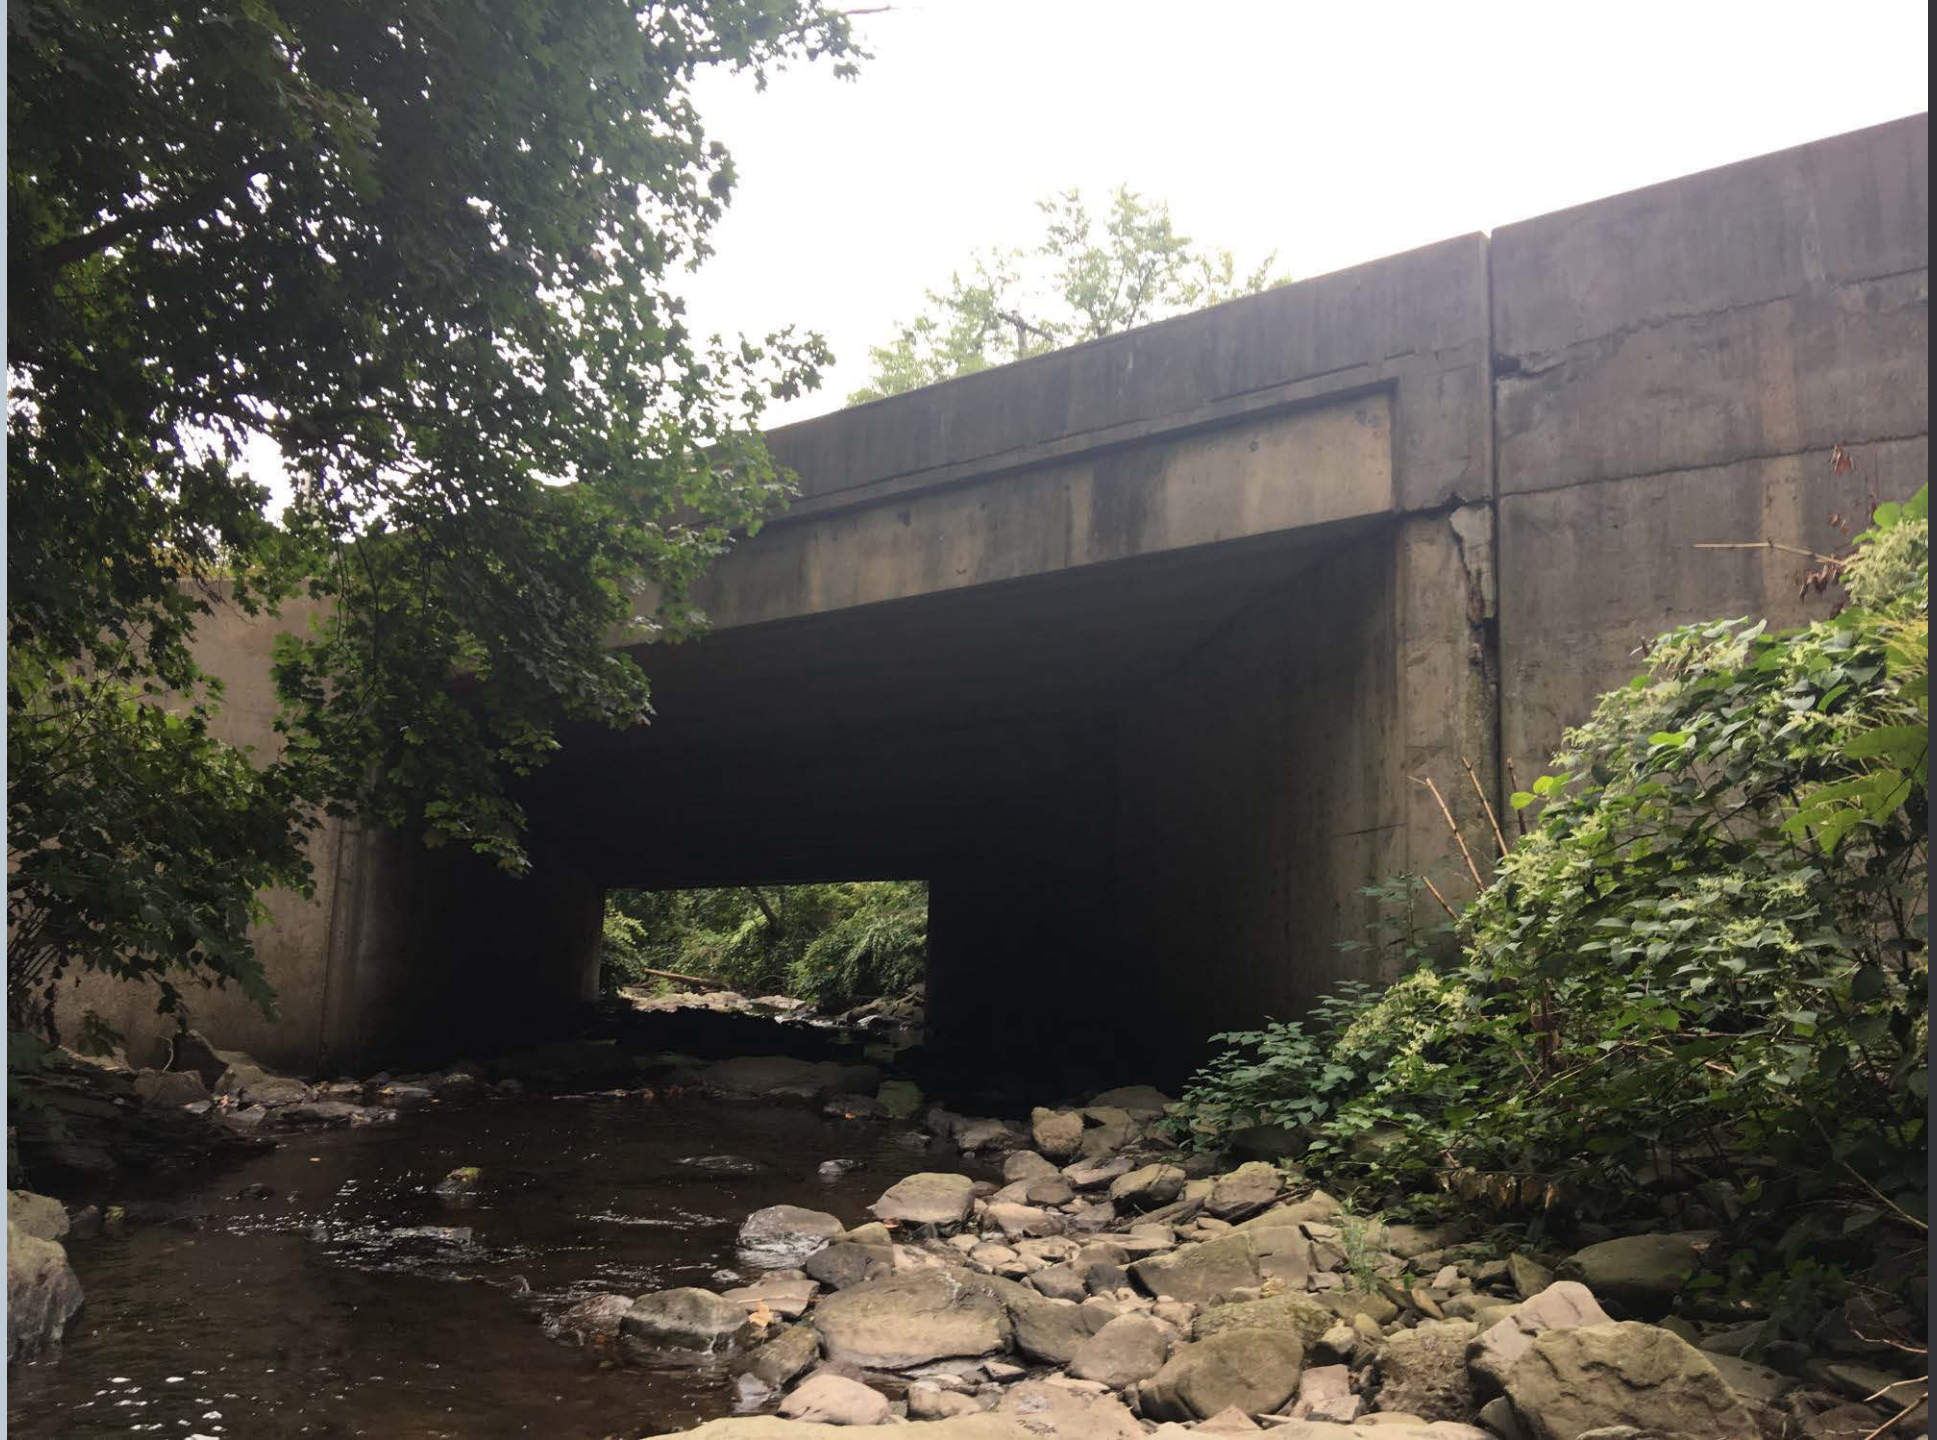
Figure 277. Looking downstream on Toby Creek standing in front of the inlet side of the of the bridge culvert over the Dallas Memorial Highway. Concrete sandbags are along the culvert for stabilization. Large sediment deposits beneath the bridge due to the skewed alignment of the bridge with Toby Creek along N. Main Street.

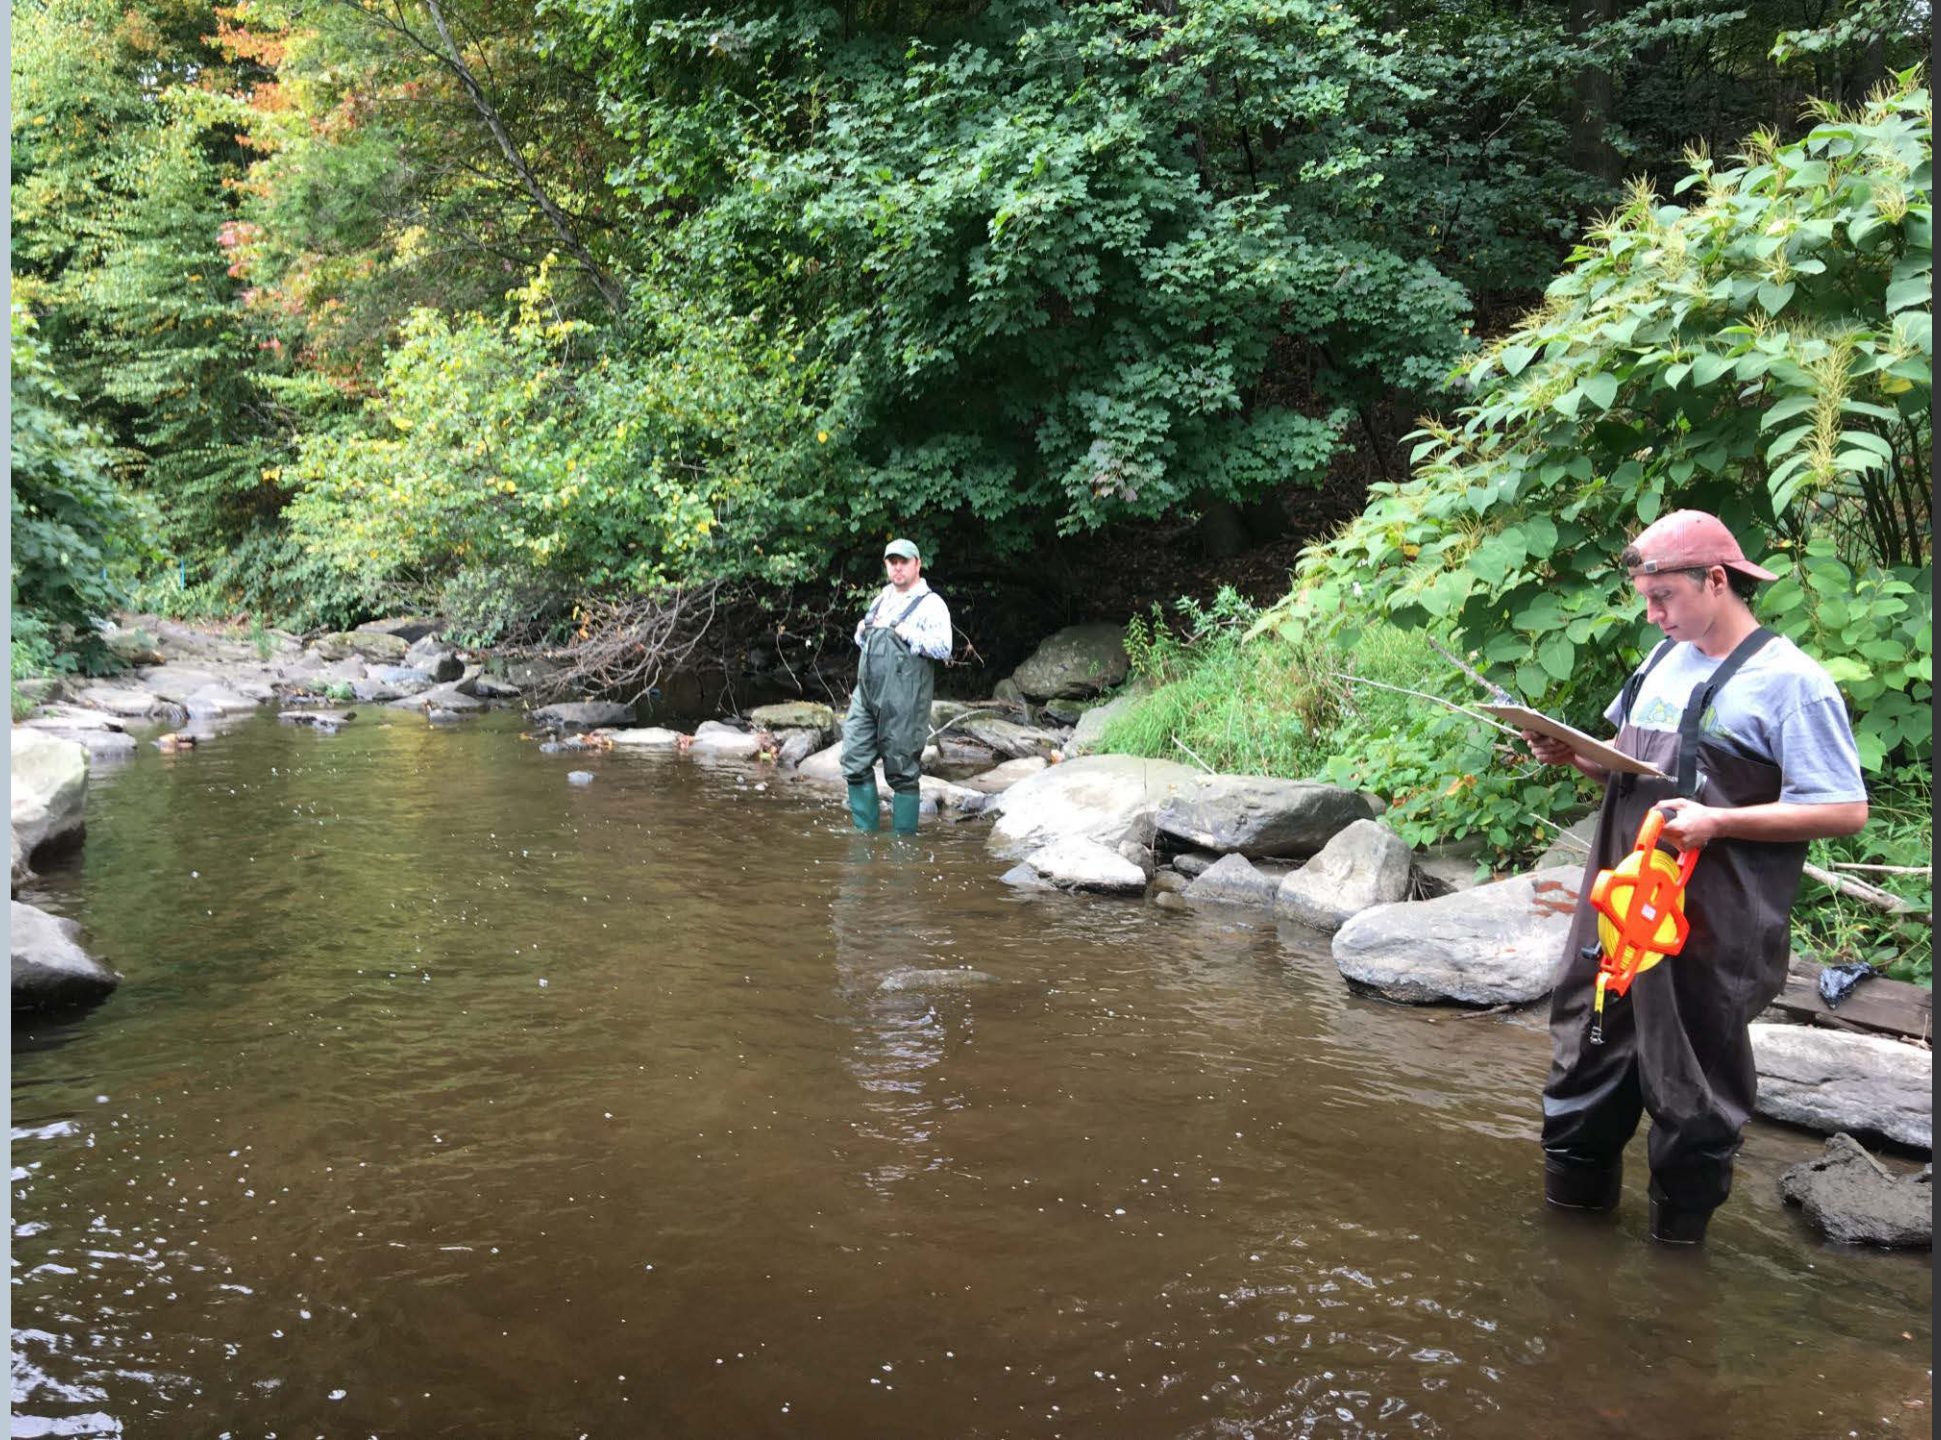
Figure 281.
Looking upstream
on Toby Creek
standing in front
of the inlet side of
the of the bridge
culvert over the
Dallas Memorial
Highway heading
towards E. Center
Street. Several
large trees have
fallen in the
channel.
Recommend
removal of them if
they are not
lodged into the
stream to avoid
blockages at the
bridge.

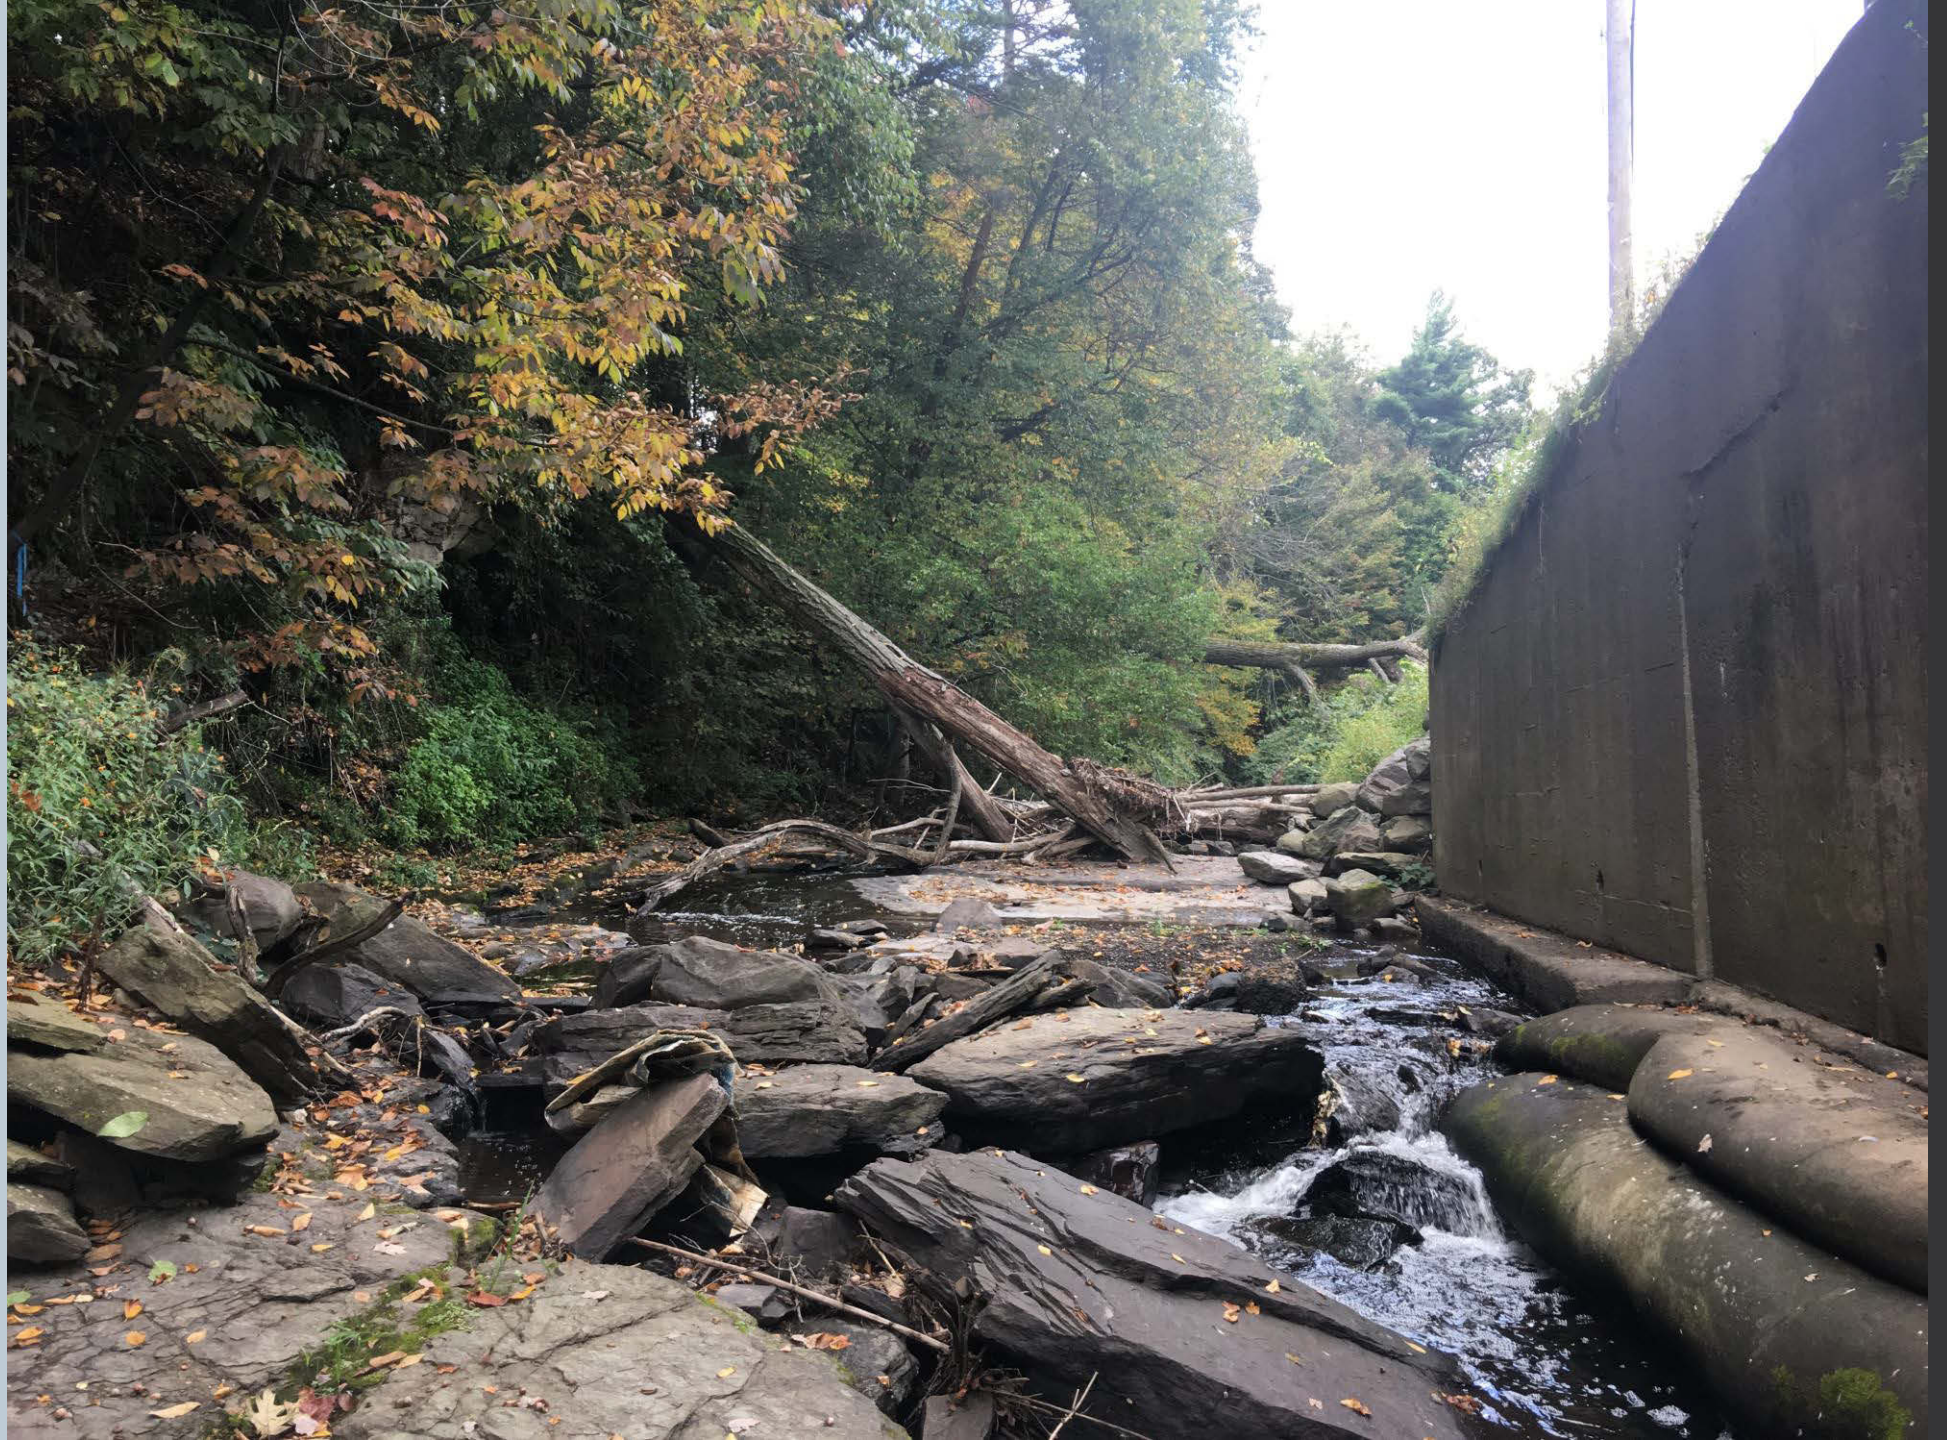
Figure 282. Looking upstream on Toby Creek standing in front of the outlet side of the of the bridge culvert over the Dallas Memorial Highway DHL/EPCAMR Volunteer and Tom Mayka-DAMA Stormwater Coordinator were taking culvert measurements for aquatic organism passage. Concrete filled sandbags for stabilization were throughout the bridge culvert and sediment was highly deposited beneath the entire length of the bridge.

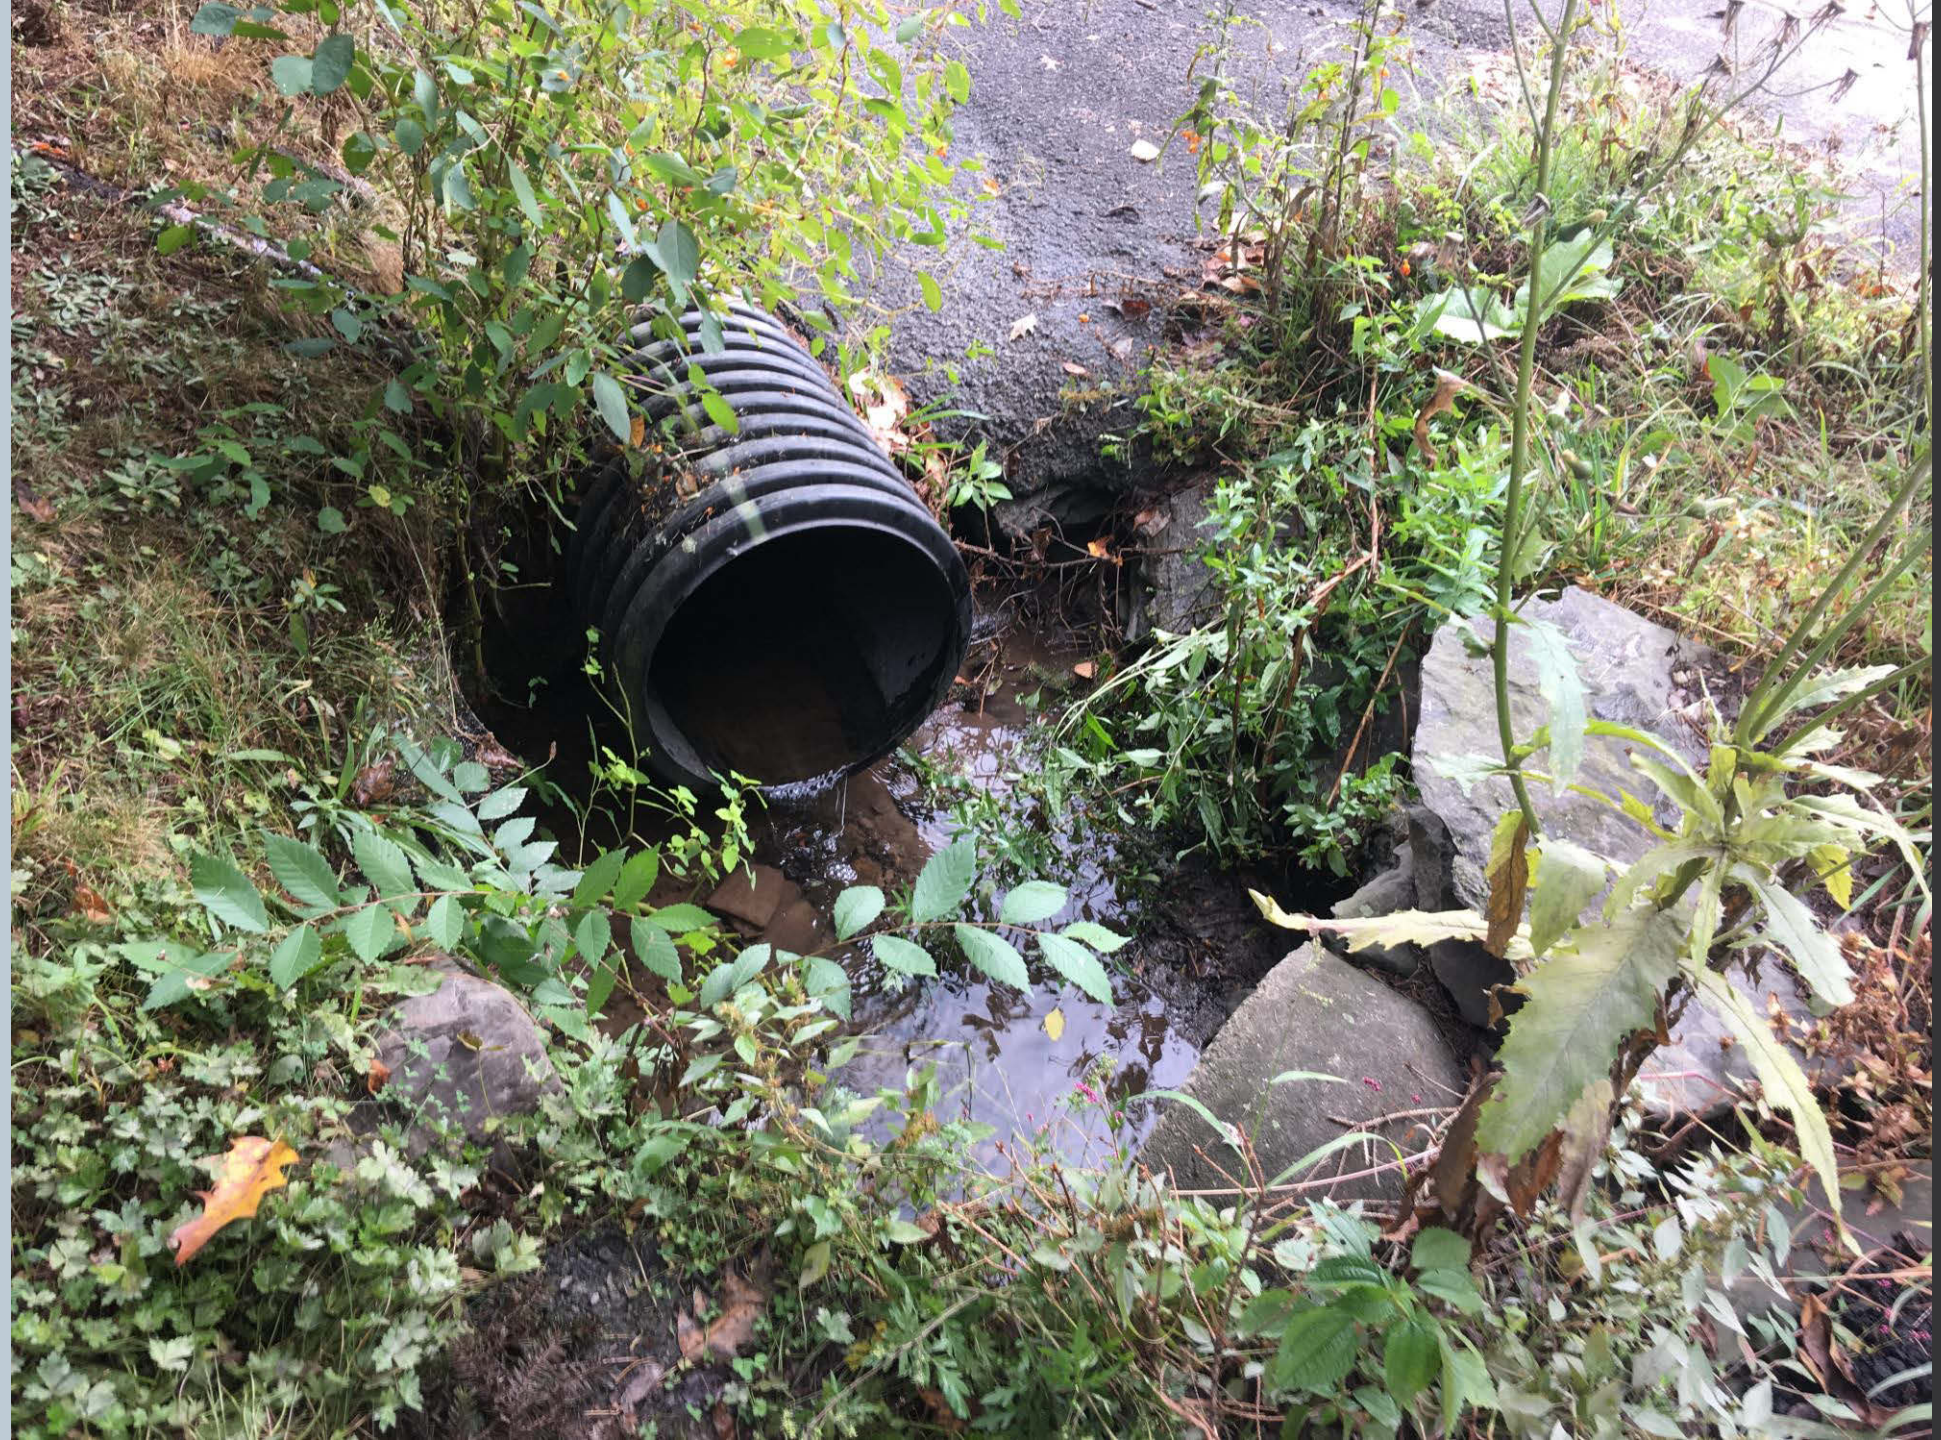
Figure 286. Looking downstream at a black HDPE Corrugated pipe carrying flow from an unnamed tributary to Toby Creek that flows along Division Street down to the intersection with N. Main Street that drops into a scour pool and then flows into the concrete pipe before crossing N. Main Street and entering Toby Creek.

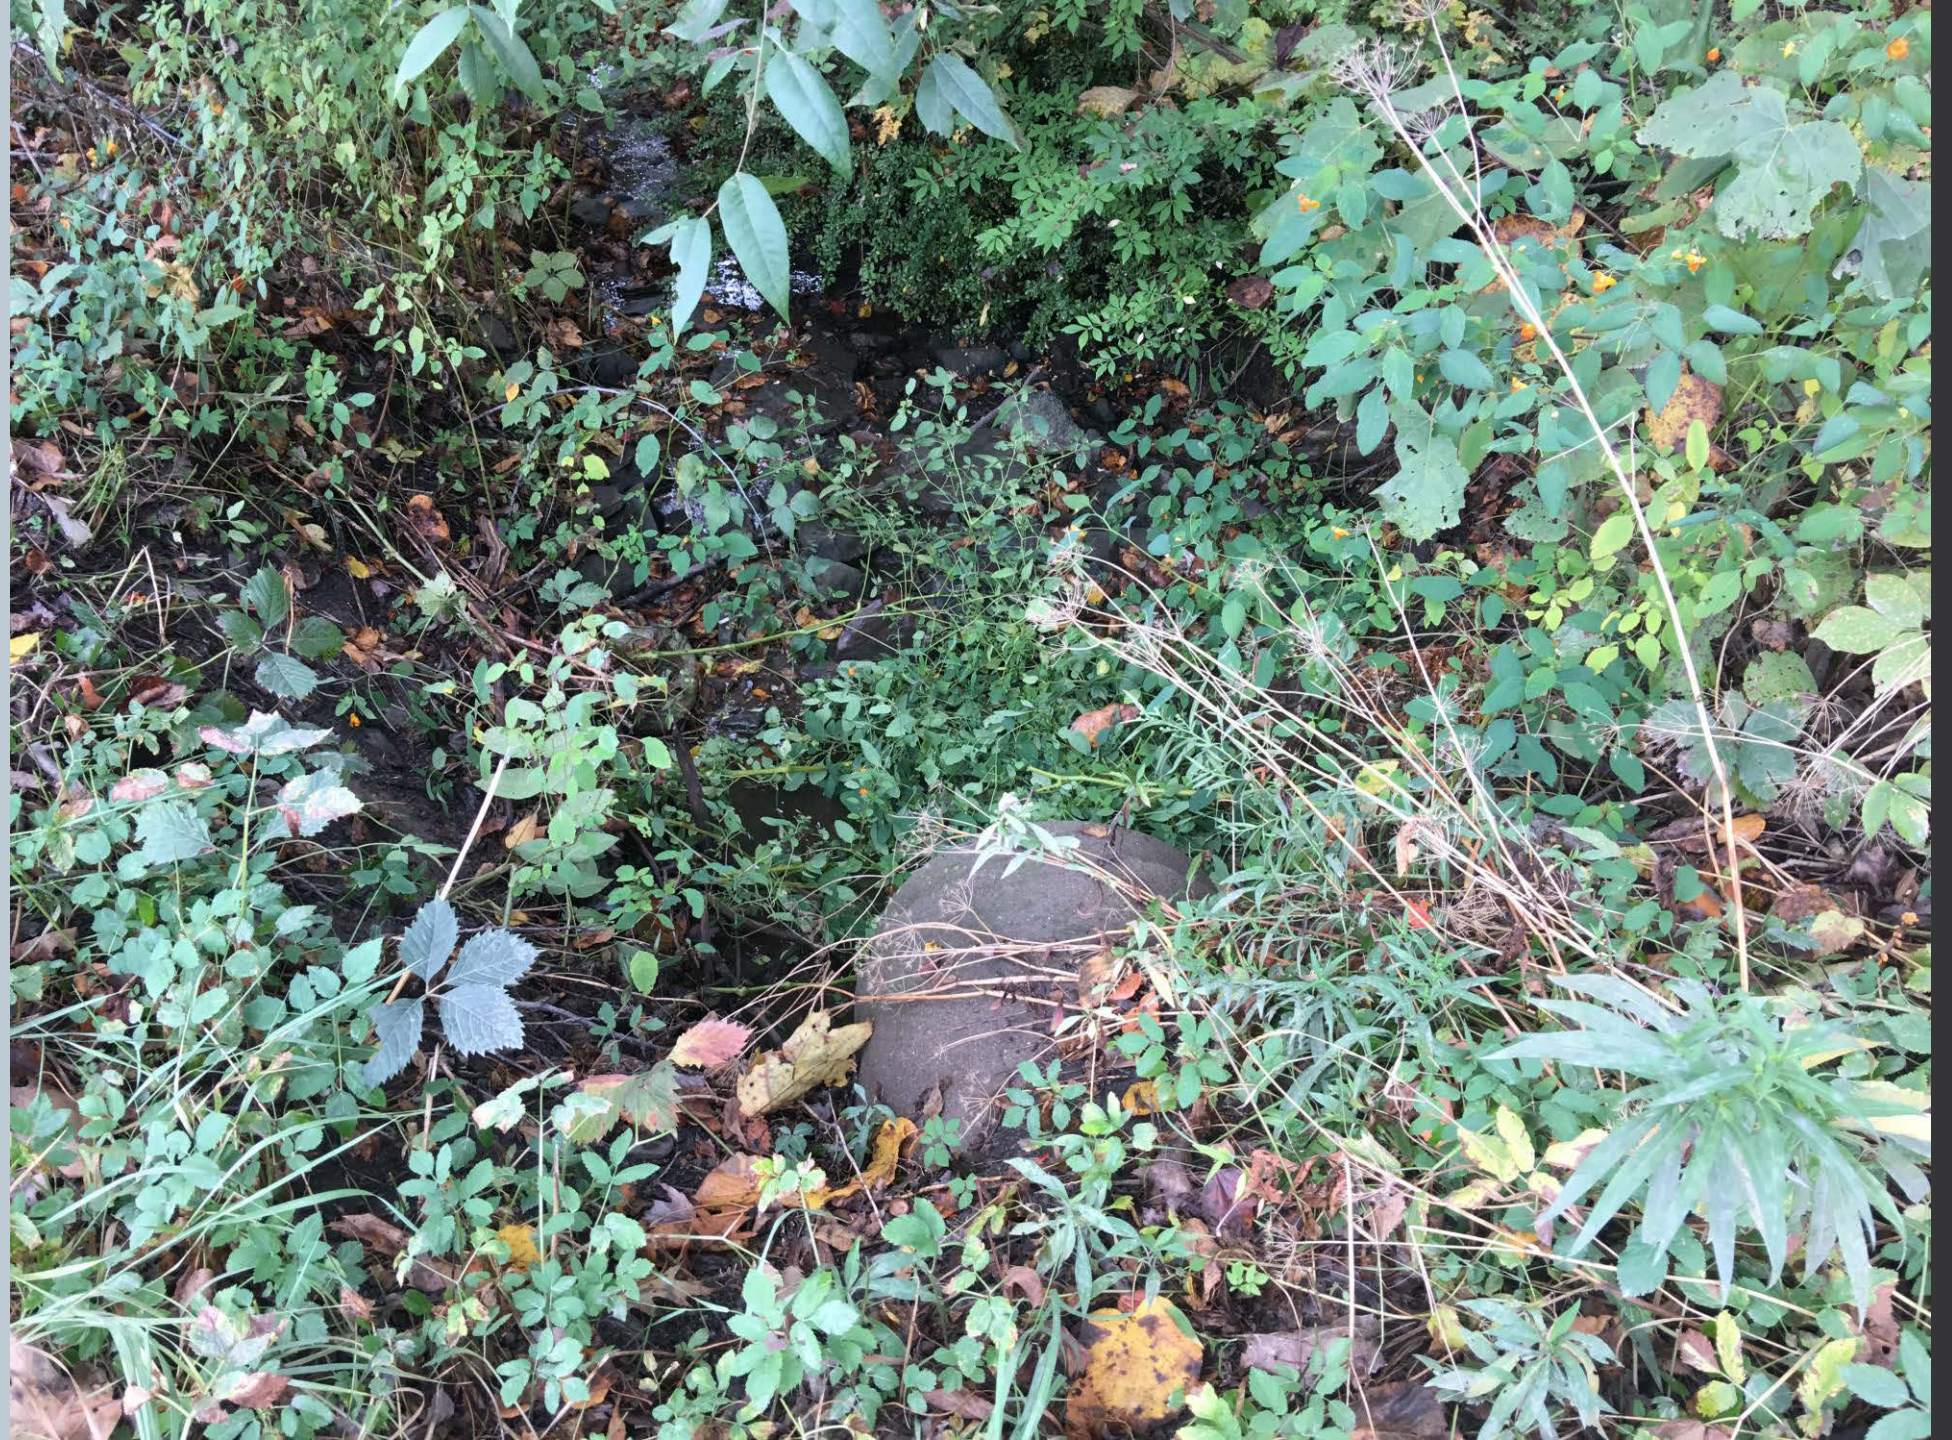
Figure 288. Looking upstream at a concrete pipe culvert that is carrying flow from an unnamed tributary to Toby Creek that flows along Division Street down to the intersection with N. Main Street that drops into a scour pool and then flows into the concrete pipe before crossing N. Main Street creating another scour pool before entering Toby Creek. Recommend a rock apron at the outlet since the outlet grade is well above the stream channel.

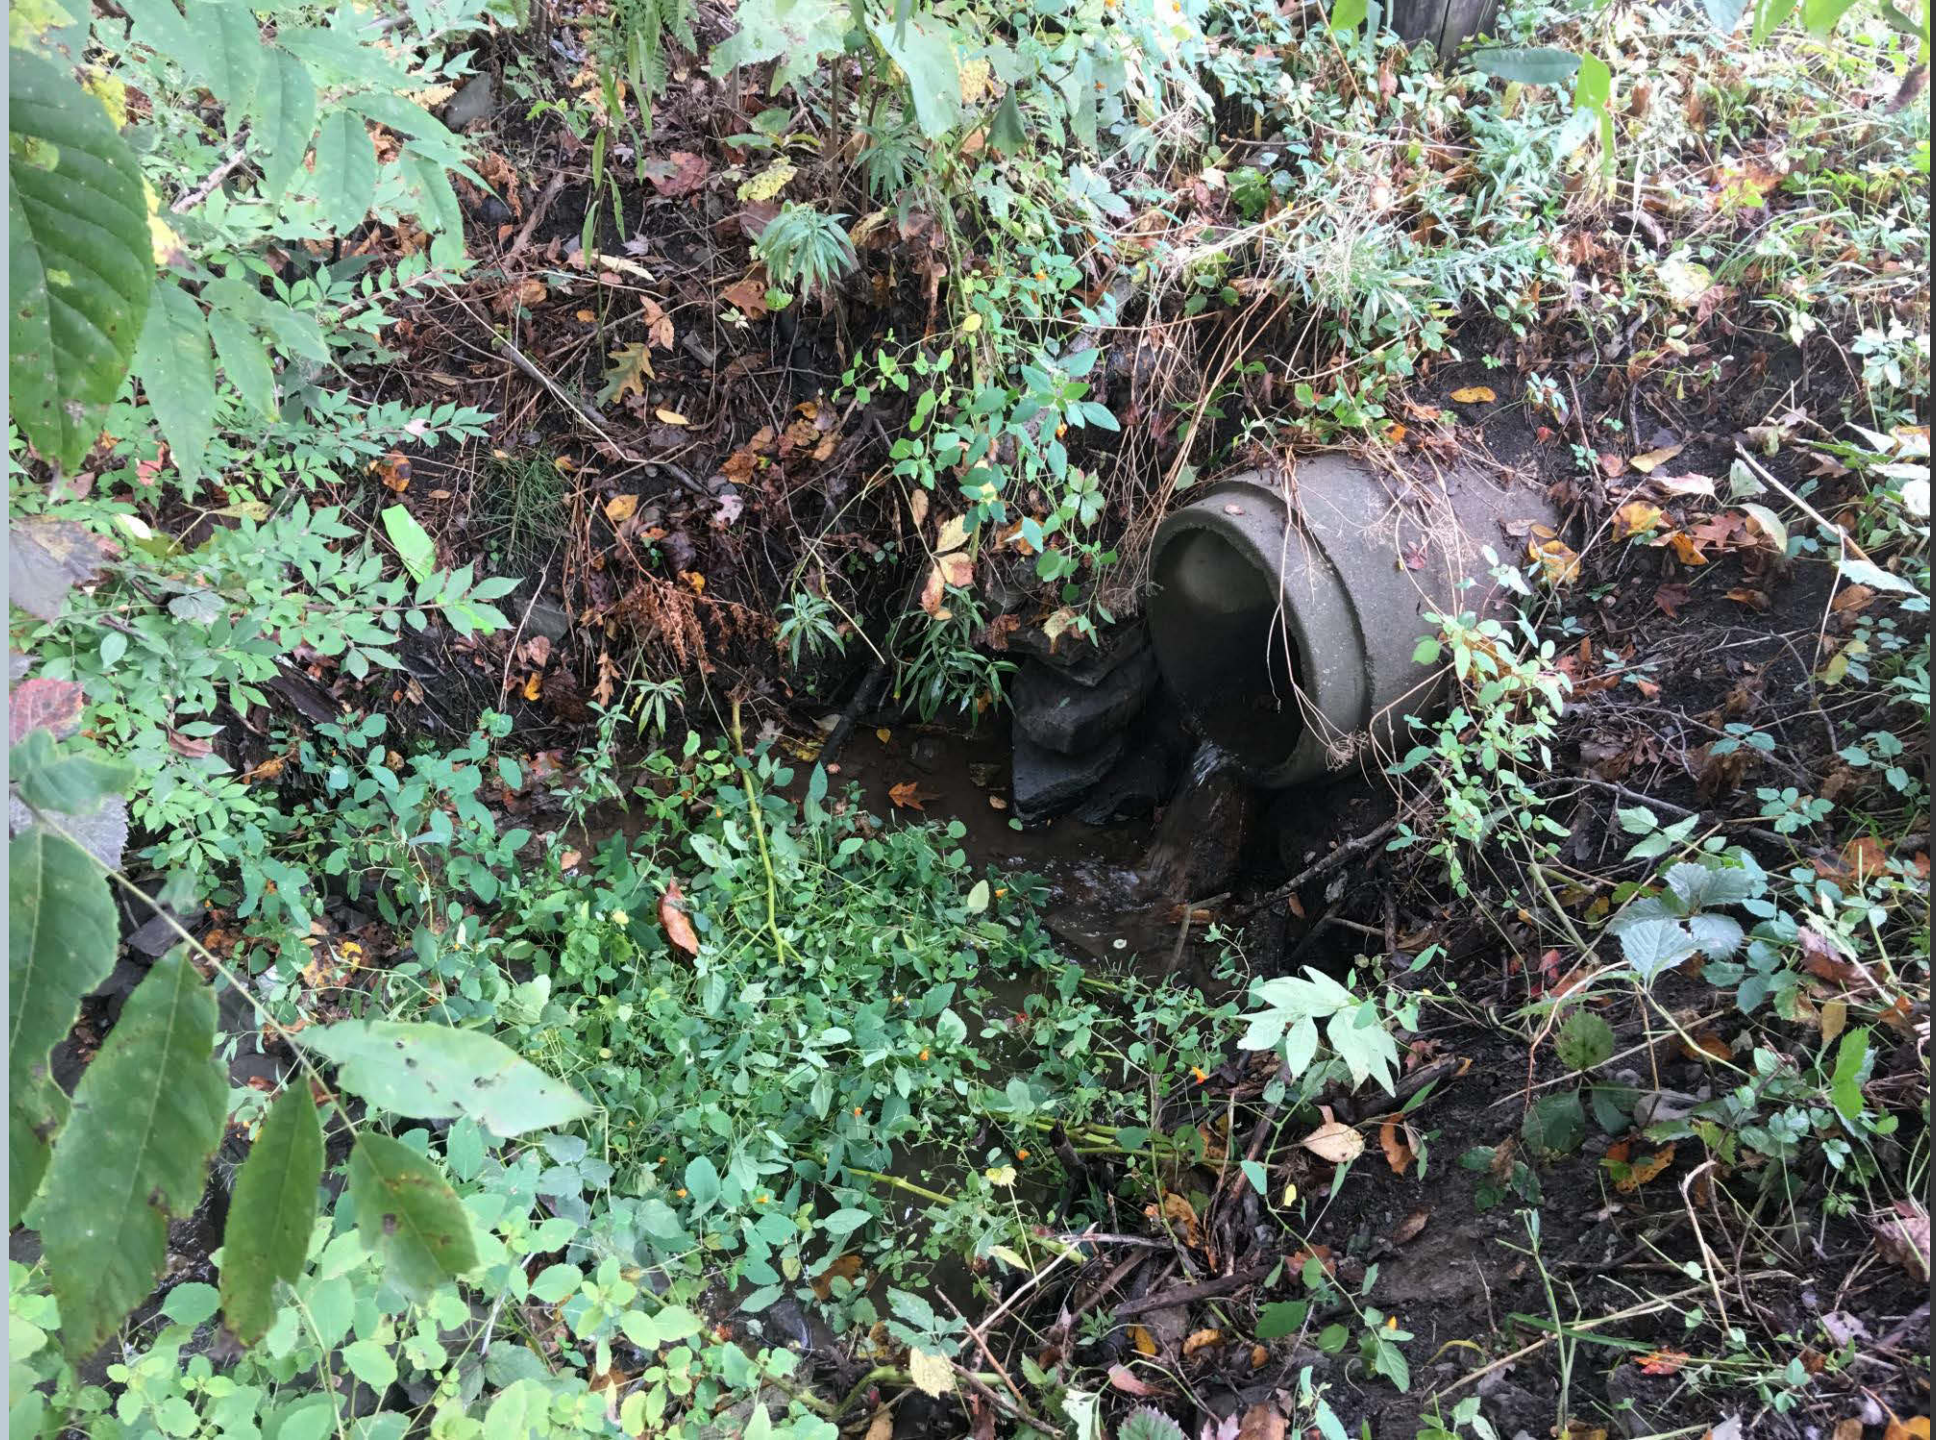
Figure 289. Looking downstream on Toby Creek along N. Main Street where the new bridge was constructed where a large gravel bar extends the entire length of the bridge from the inlet to the outlet. Recommend gravel bar removal and point bar removal at the other end of the bridge.

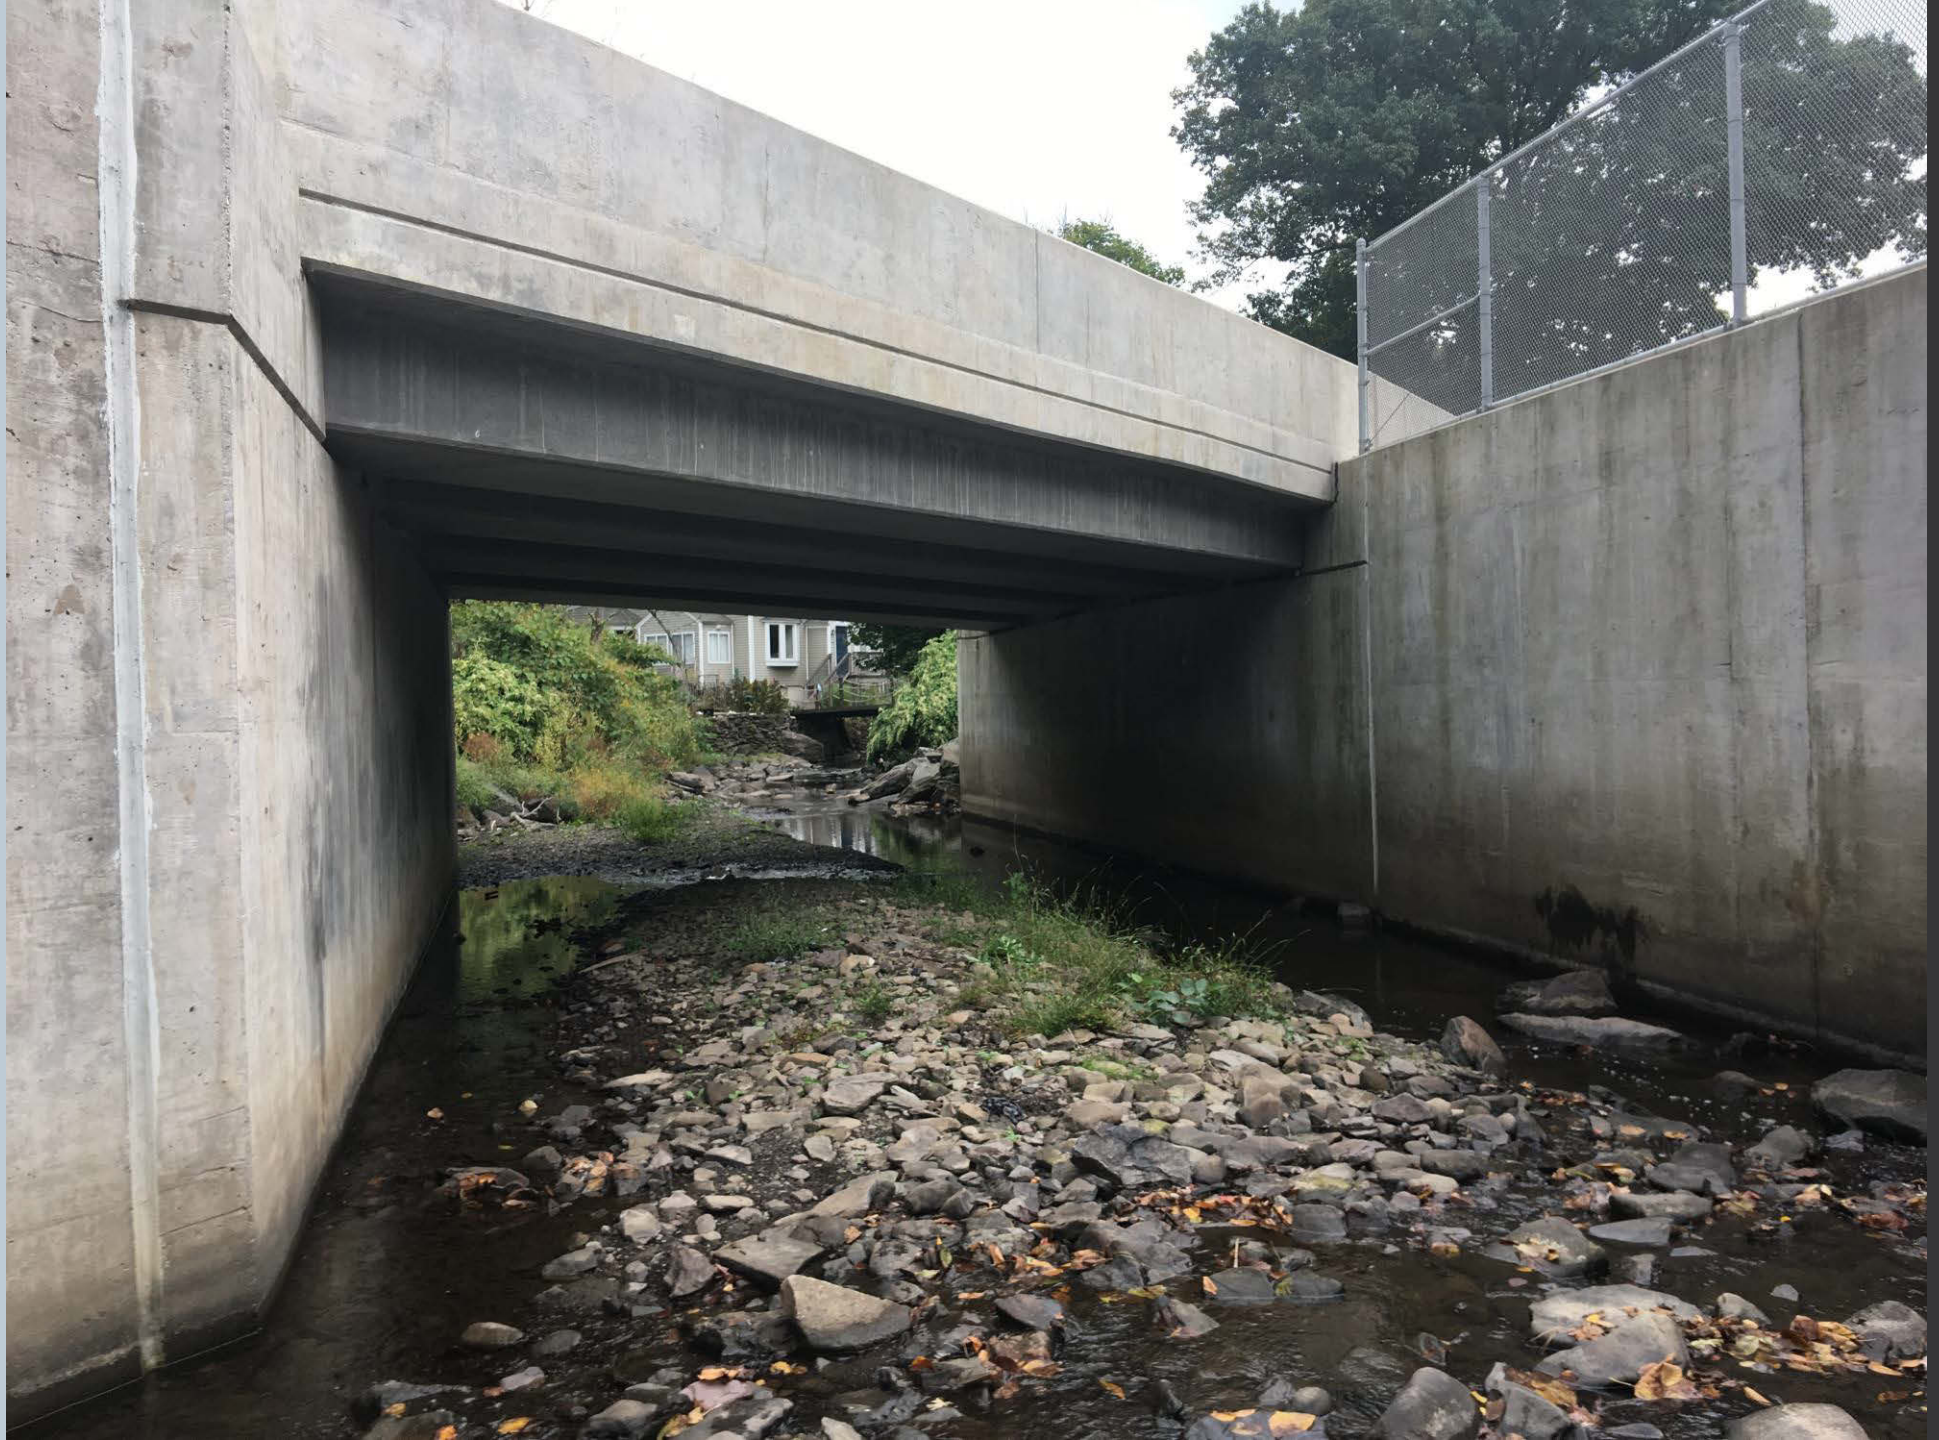
Figure 290. Looking upstream on Toby Creek along N. Main Street where the new bridge was constructed where a large gravel bar extends the entire length of the bridge from the inlet to the outlet. Recommend gravel bar removal and point bar removal at the other end of the bridge. Seepage from an unnamed tributary on the other side of the Dallas Memorial Highway near the Greenwood Cemetery is can be seen entering Toby Creek through the pipe in the concrete retaining wall.
