Toby Creek Field Reconnaissance Observations

September 26, 2018

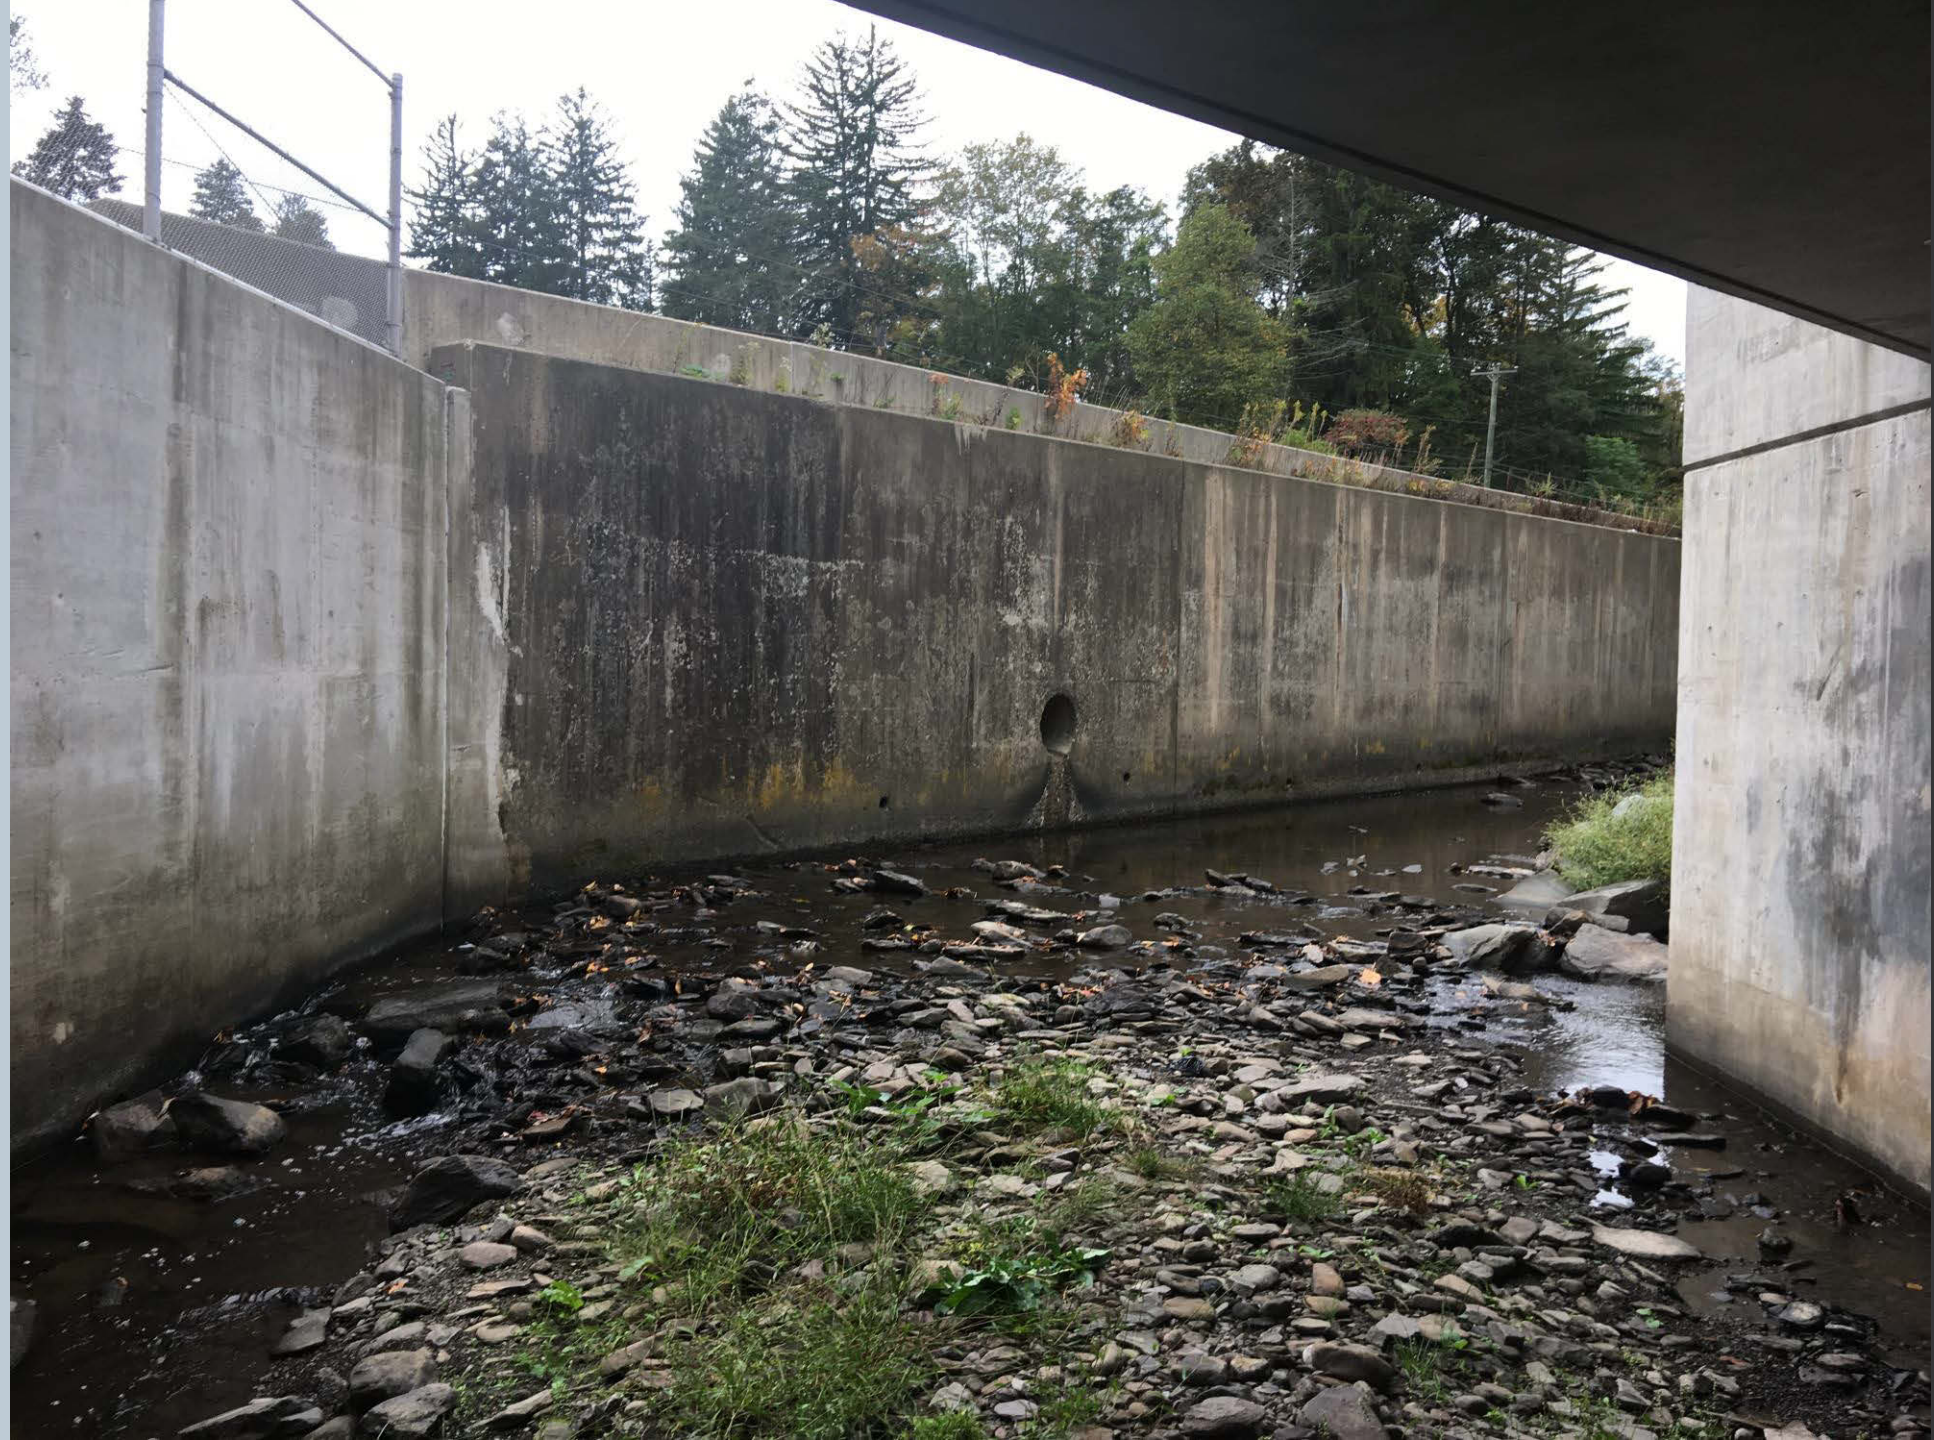
Figure 291. Looking upstream on Toby Creek along N. Main Street where the new bridge was constructed where a point bar extends from beneath the bridge from the outlet. Recommend point bar removal at the other end of the bridge.

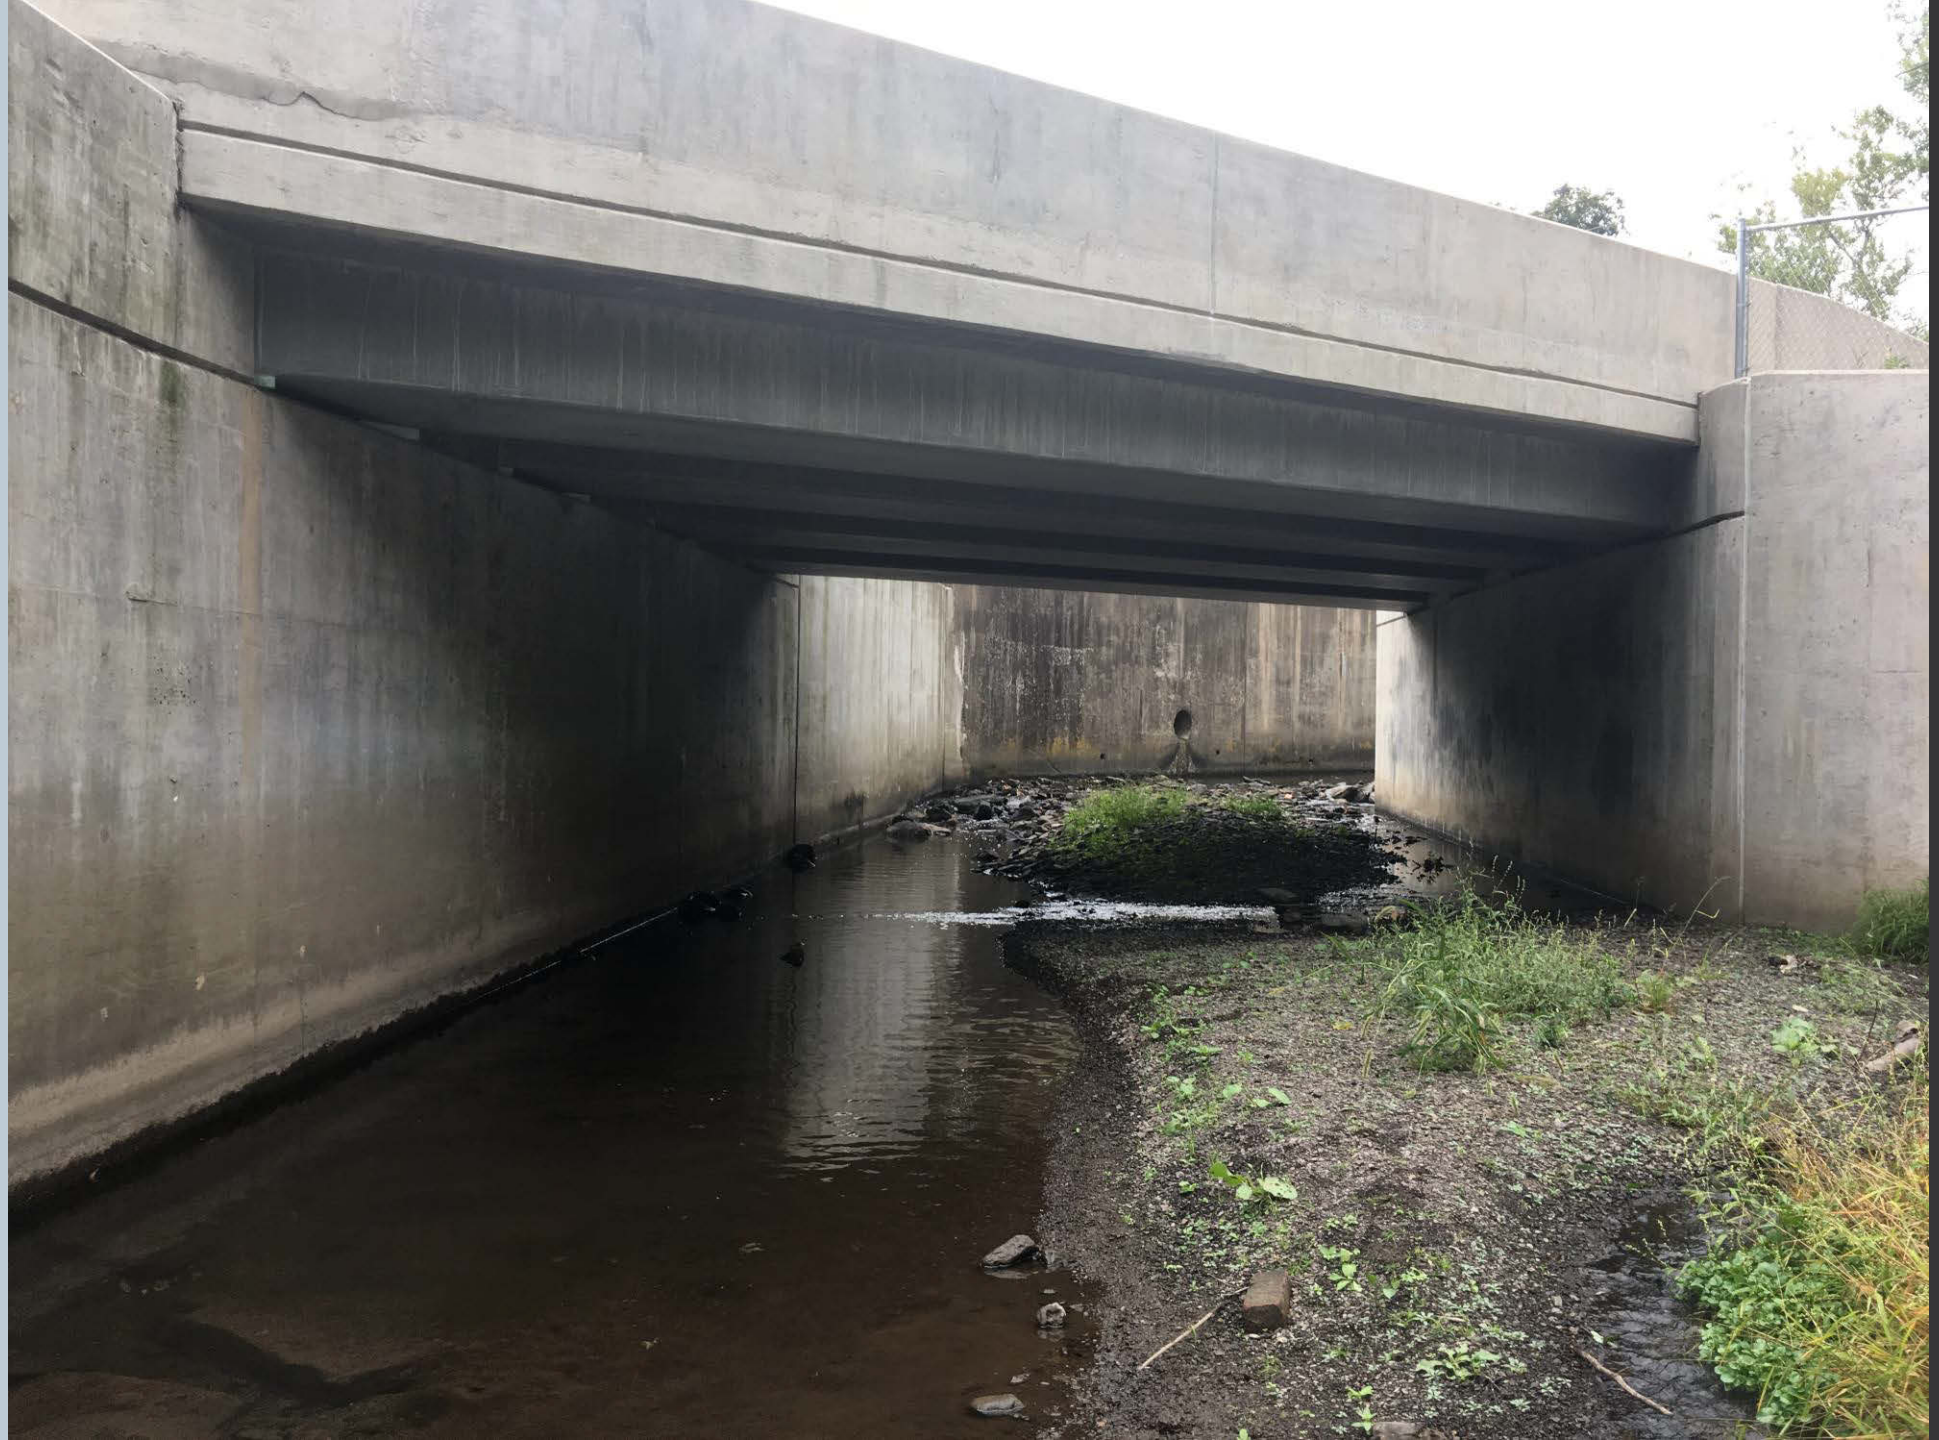
Figure 292. Looking downstream on Toby Creek along N. Main Street where the new bridge was constructed where a point bar extends from beneath the bridge from the outlet. Recommend point bar removal at the other end of the bridge. Japanese knotweed is prevalent and an invasive plant removal and native riparian restoration is recommended for this area.

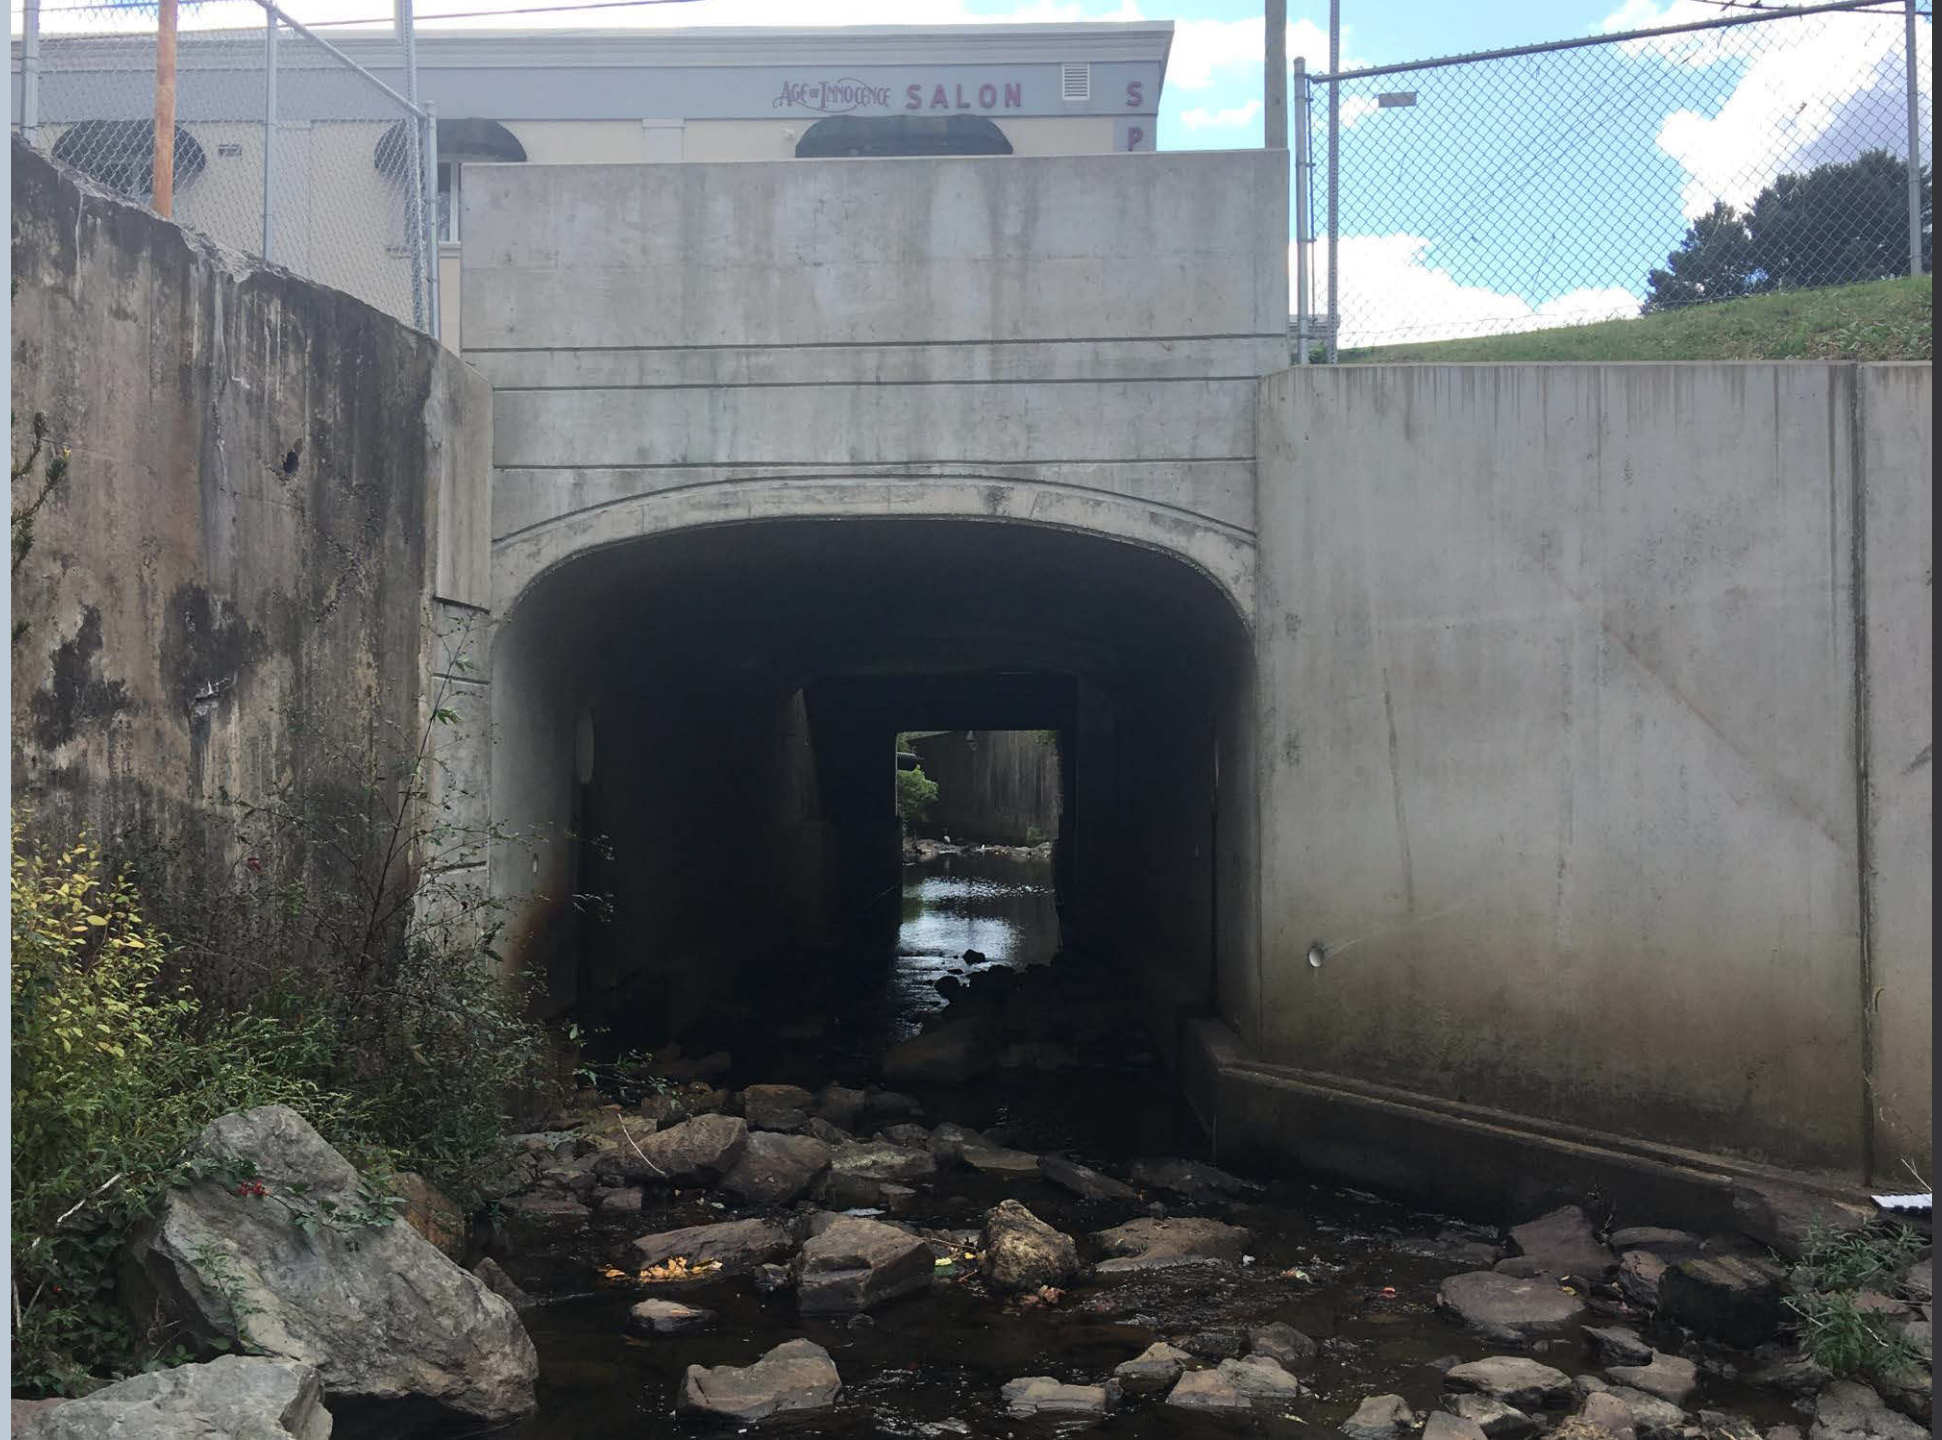
Figure 295.
Looking upstream
on Toby Creek
along W. Center
Street towards
Snowdon Funeral
Home. A riparian
restoration is
recommended in
this area along the
left bank looking
upstream and a
closer look is
needed for some of
the failing large
boulders that have
come loose from the
retaining wall
along a few
sections of the
right bank of Toby
Creek.

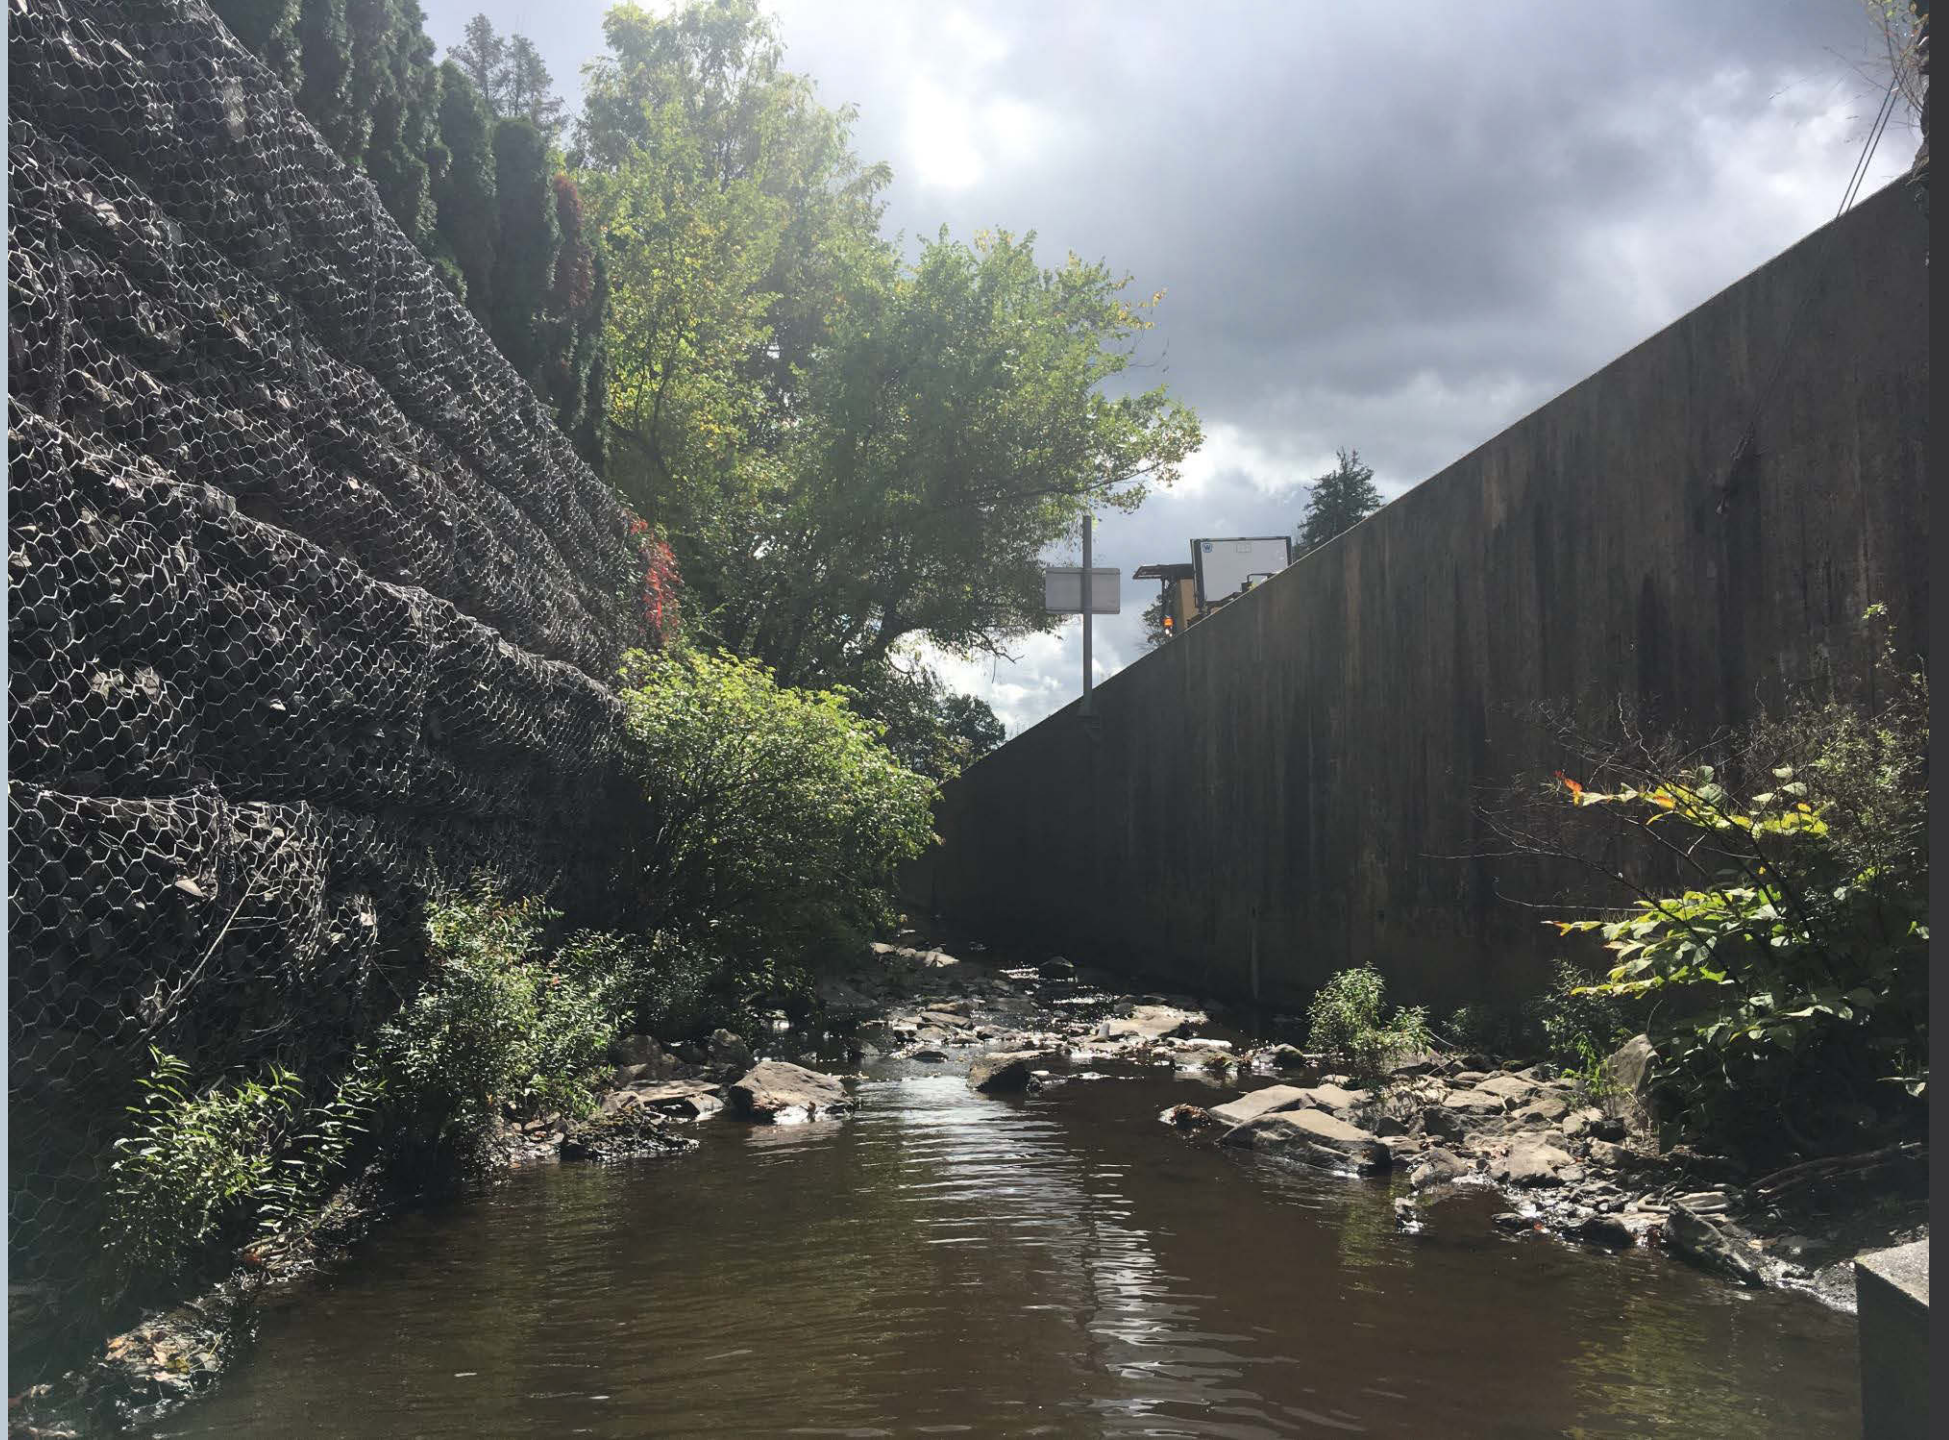
Figure 298. Looking upstream on Toby Creek below the bridge on W. Center Street at a very steep and vertical rock-filled gabion basket wall that has some areas that are undermined along the stream channel and the retaining wall along the Dallas Memorial Highway. A black HDPE pipe is protruding from the rock-filled gabion basket retaining wall nearly 10' above the stream channel that is not aligned. Recommend that the pipe be brought to grade and realigned to the flow alignment of Toby Creek.

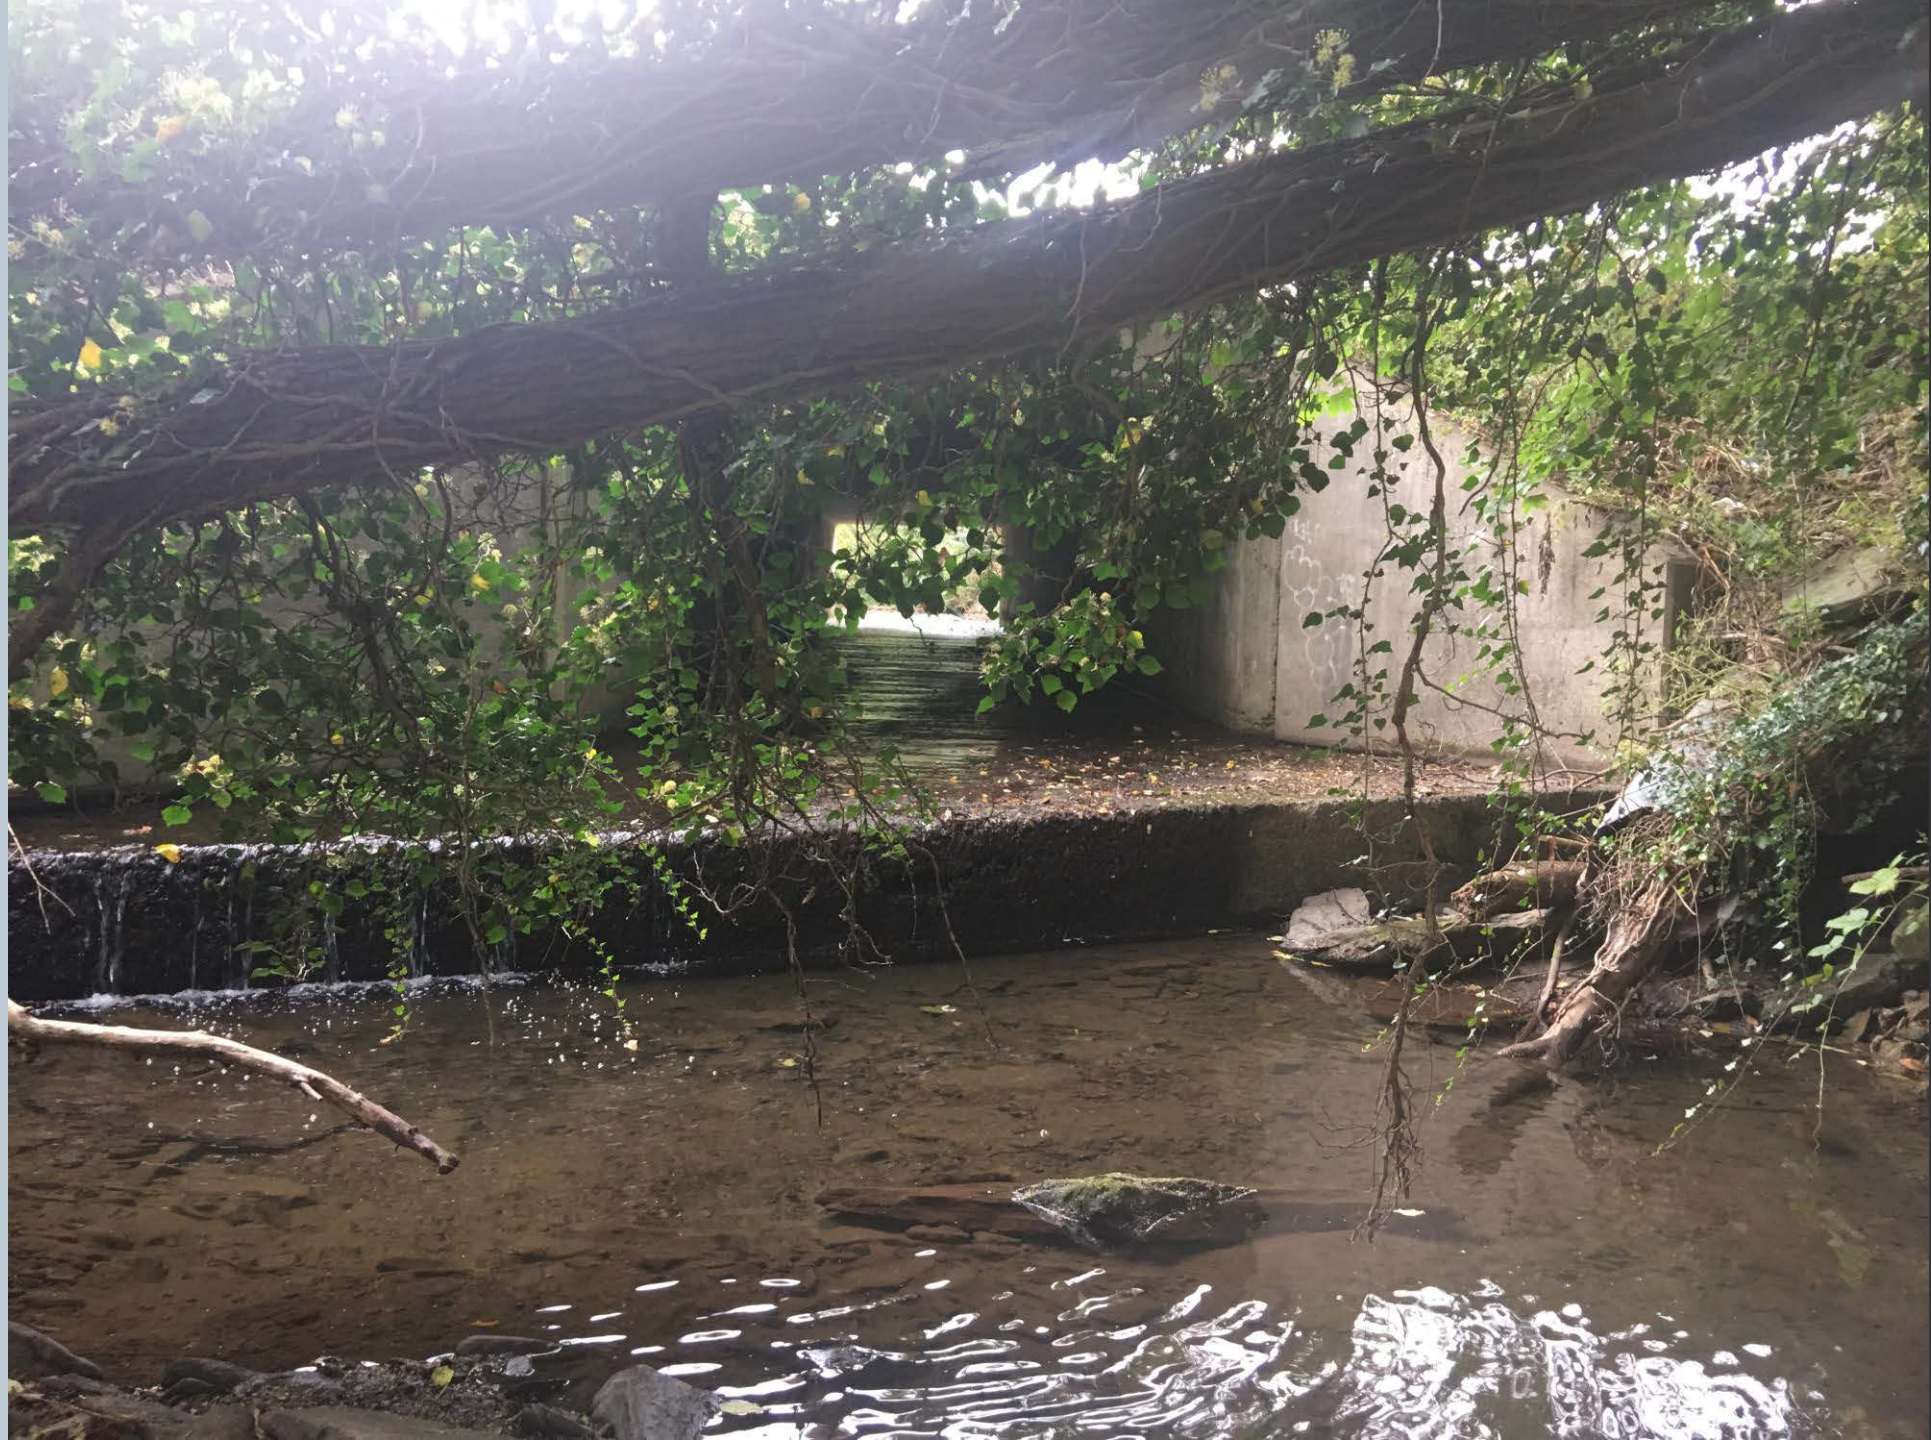
Figure 300. Bridge culvert over Carverton Road adjacent to the Trucksville Pocket Park. A stormwater corrugated metal pipe is pointed directly into the unnamed tributary looking downstream causing a scour pool formation below the concrete dam. Heavy sediment below the concrete dam. Fish present below the outlet of the culvert. This dam is impeding aquatic passage. Recommend design and construction of a step pool feature to allow for fish passage and realignment and grading of the stormwater pipe along the left bank looking downstream.

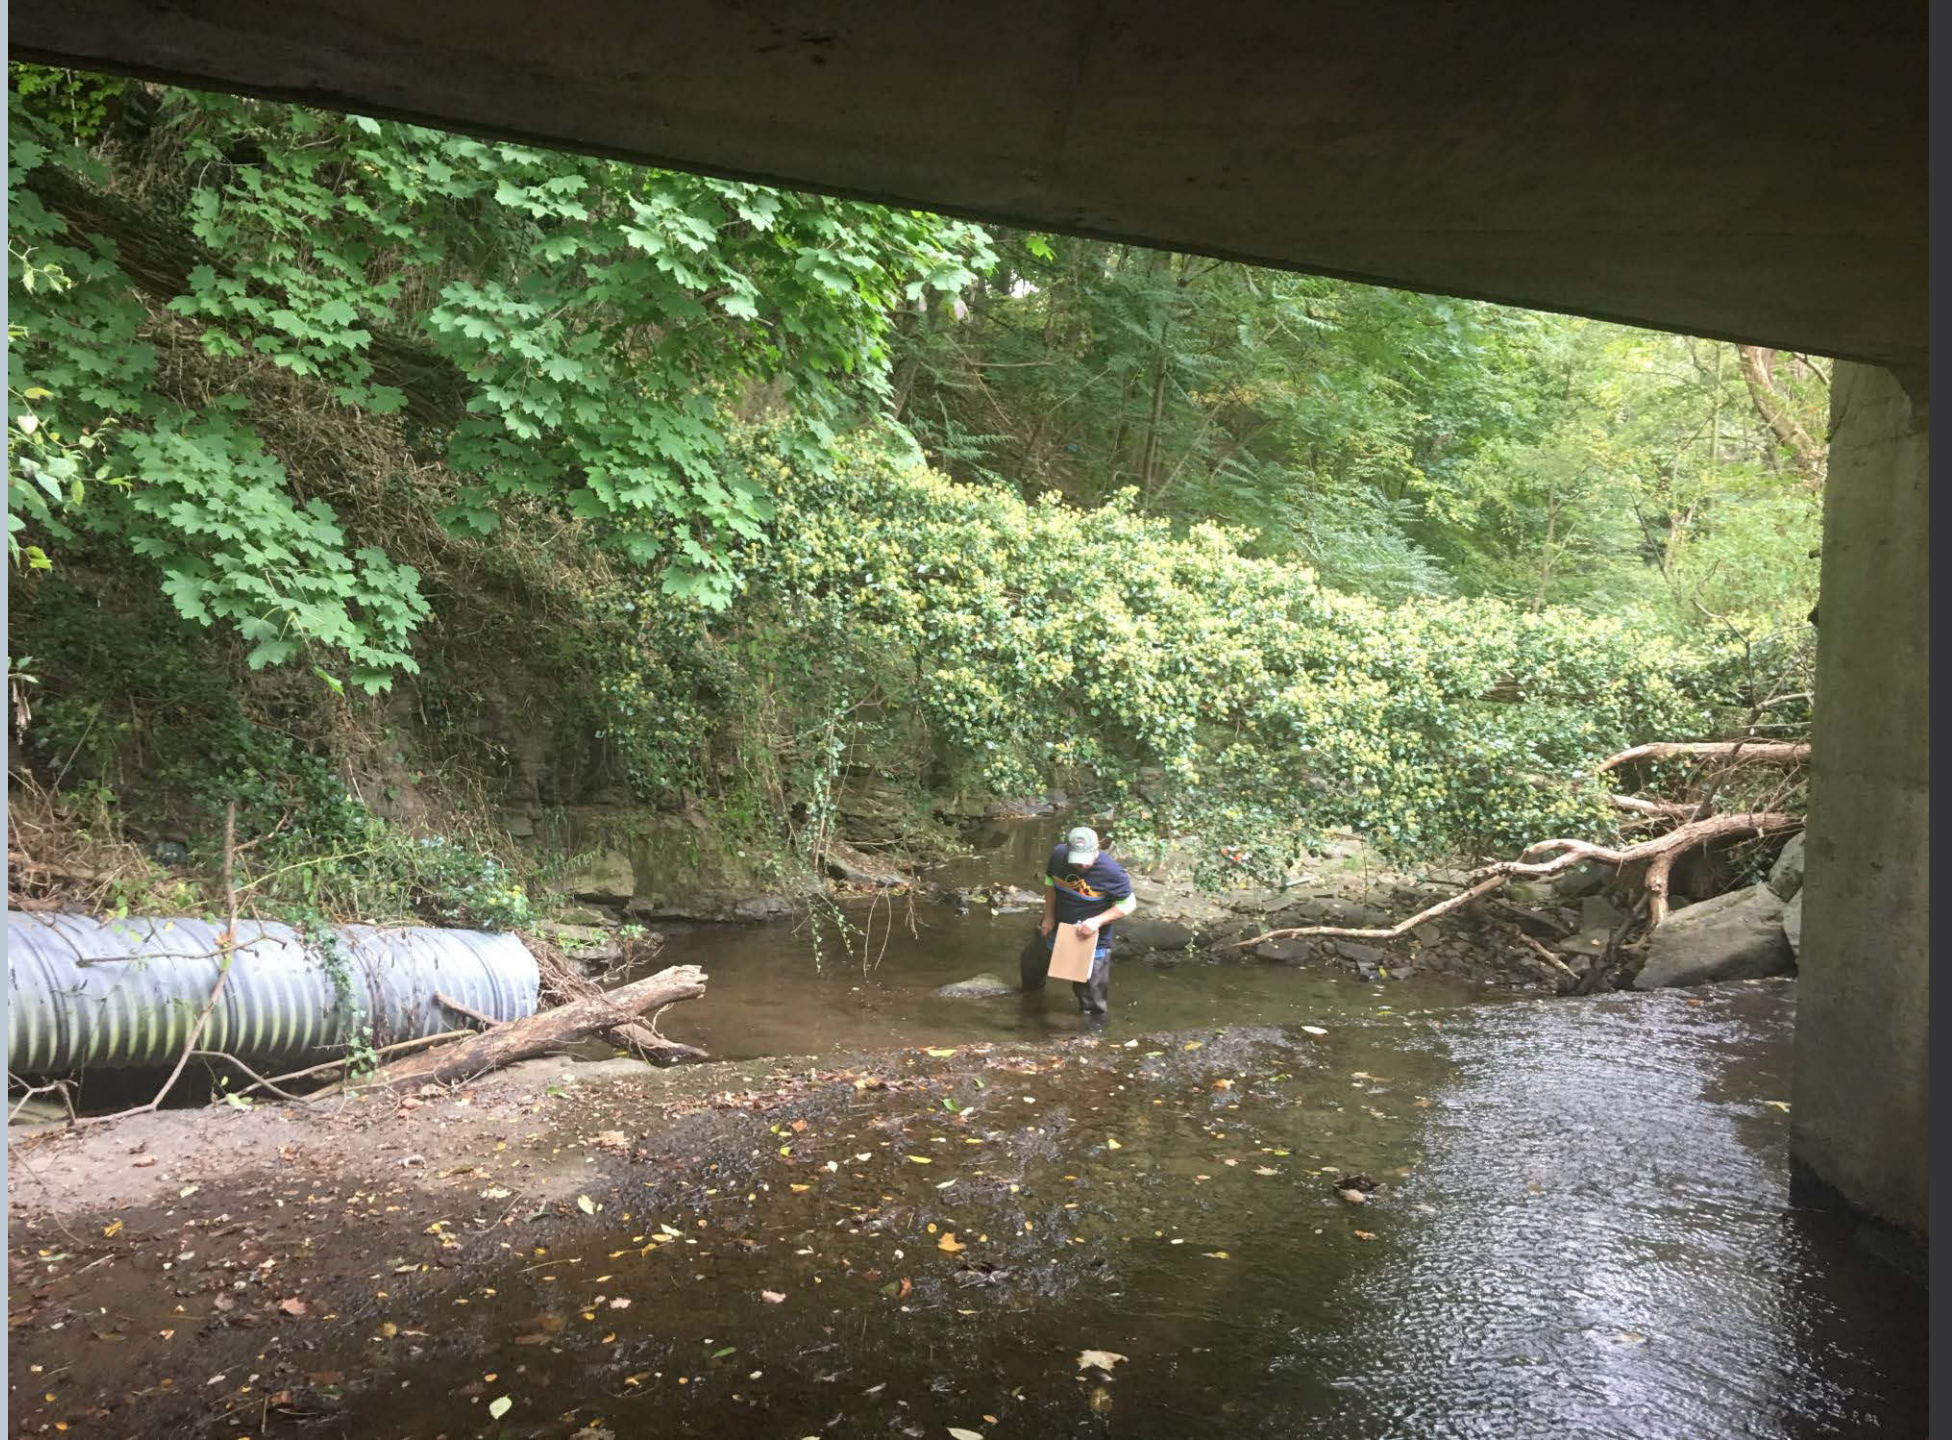
Figure 301. Bridge culvert over Carverton Road looking upstream on the unnamed tributary with Tom Mayka, DAMA Stormwater Coordinator where the concrete footer meets the unnamed tributary.

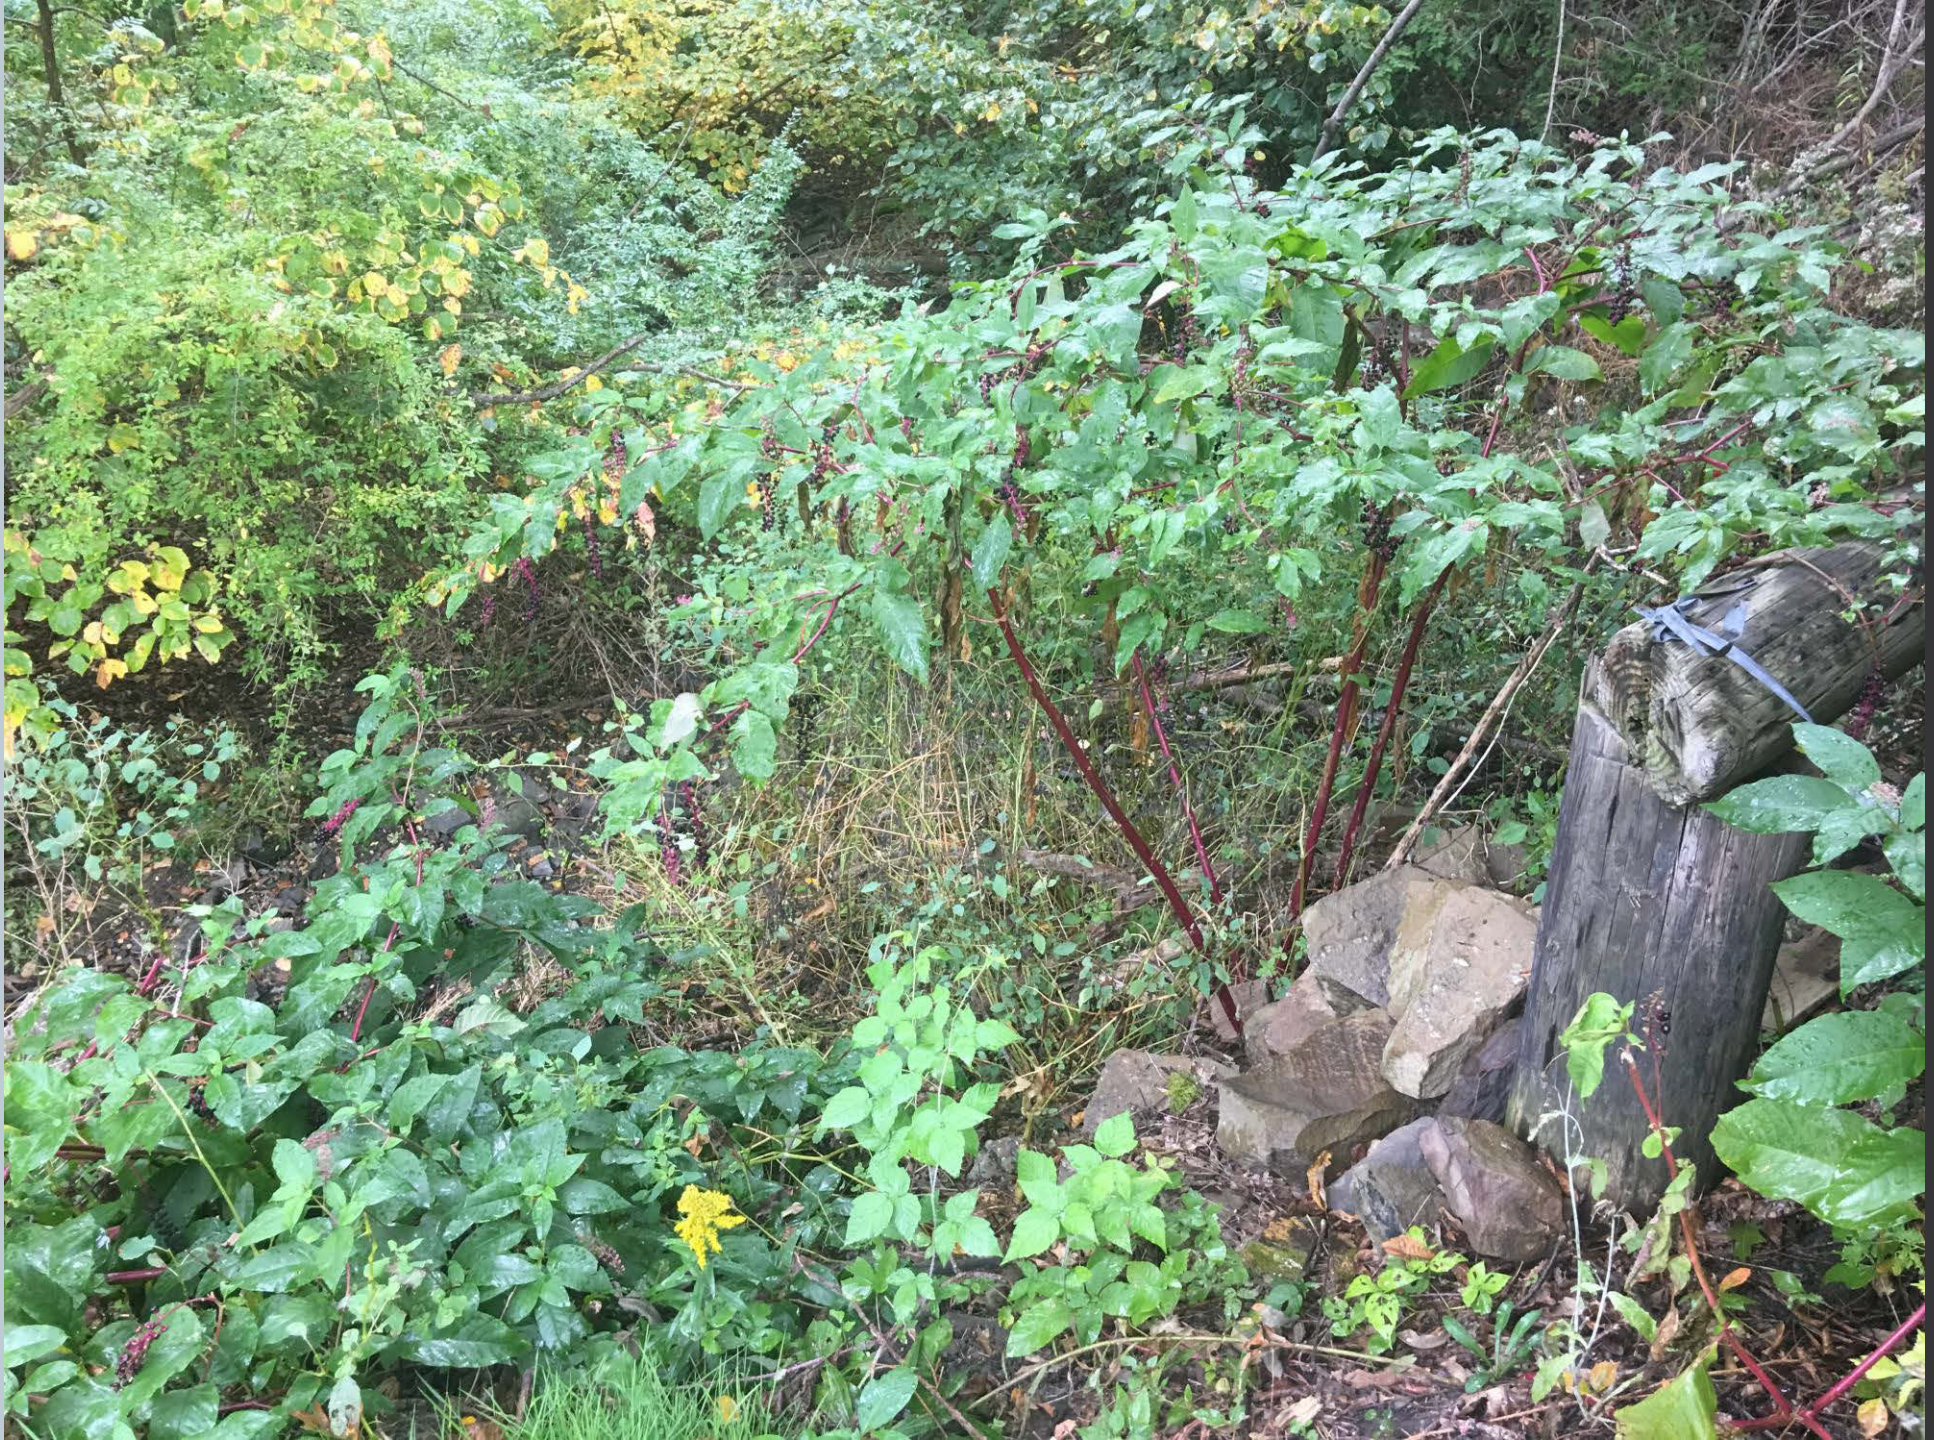
Figure 314.
Looking upstream
on the Swoga
property at the
outlet of the
culvert on the
unnamed tributary
along Manor Drive.
There is a several
foot drop to the
channel where a
recommended step
pool structure
could be designed
and constructed to
prevent further
scouring of the
area below the
bridge.

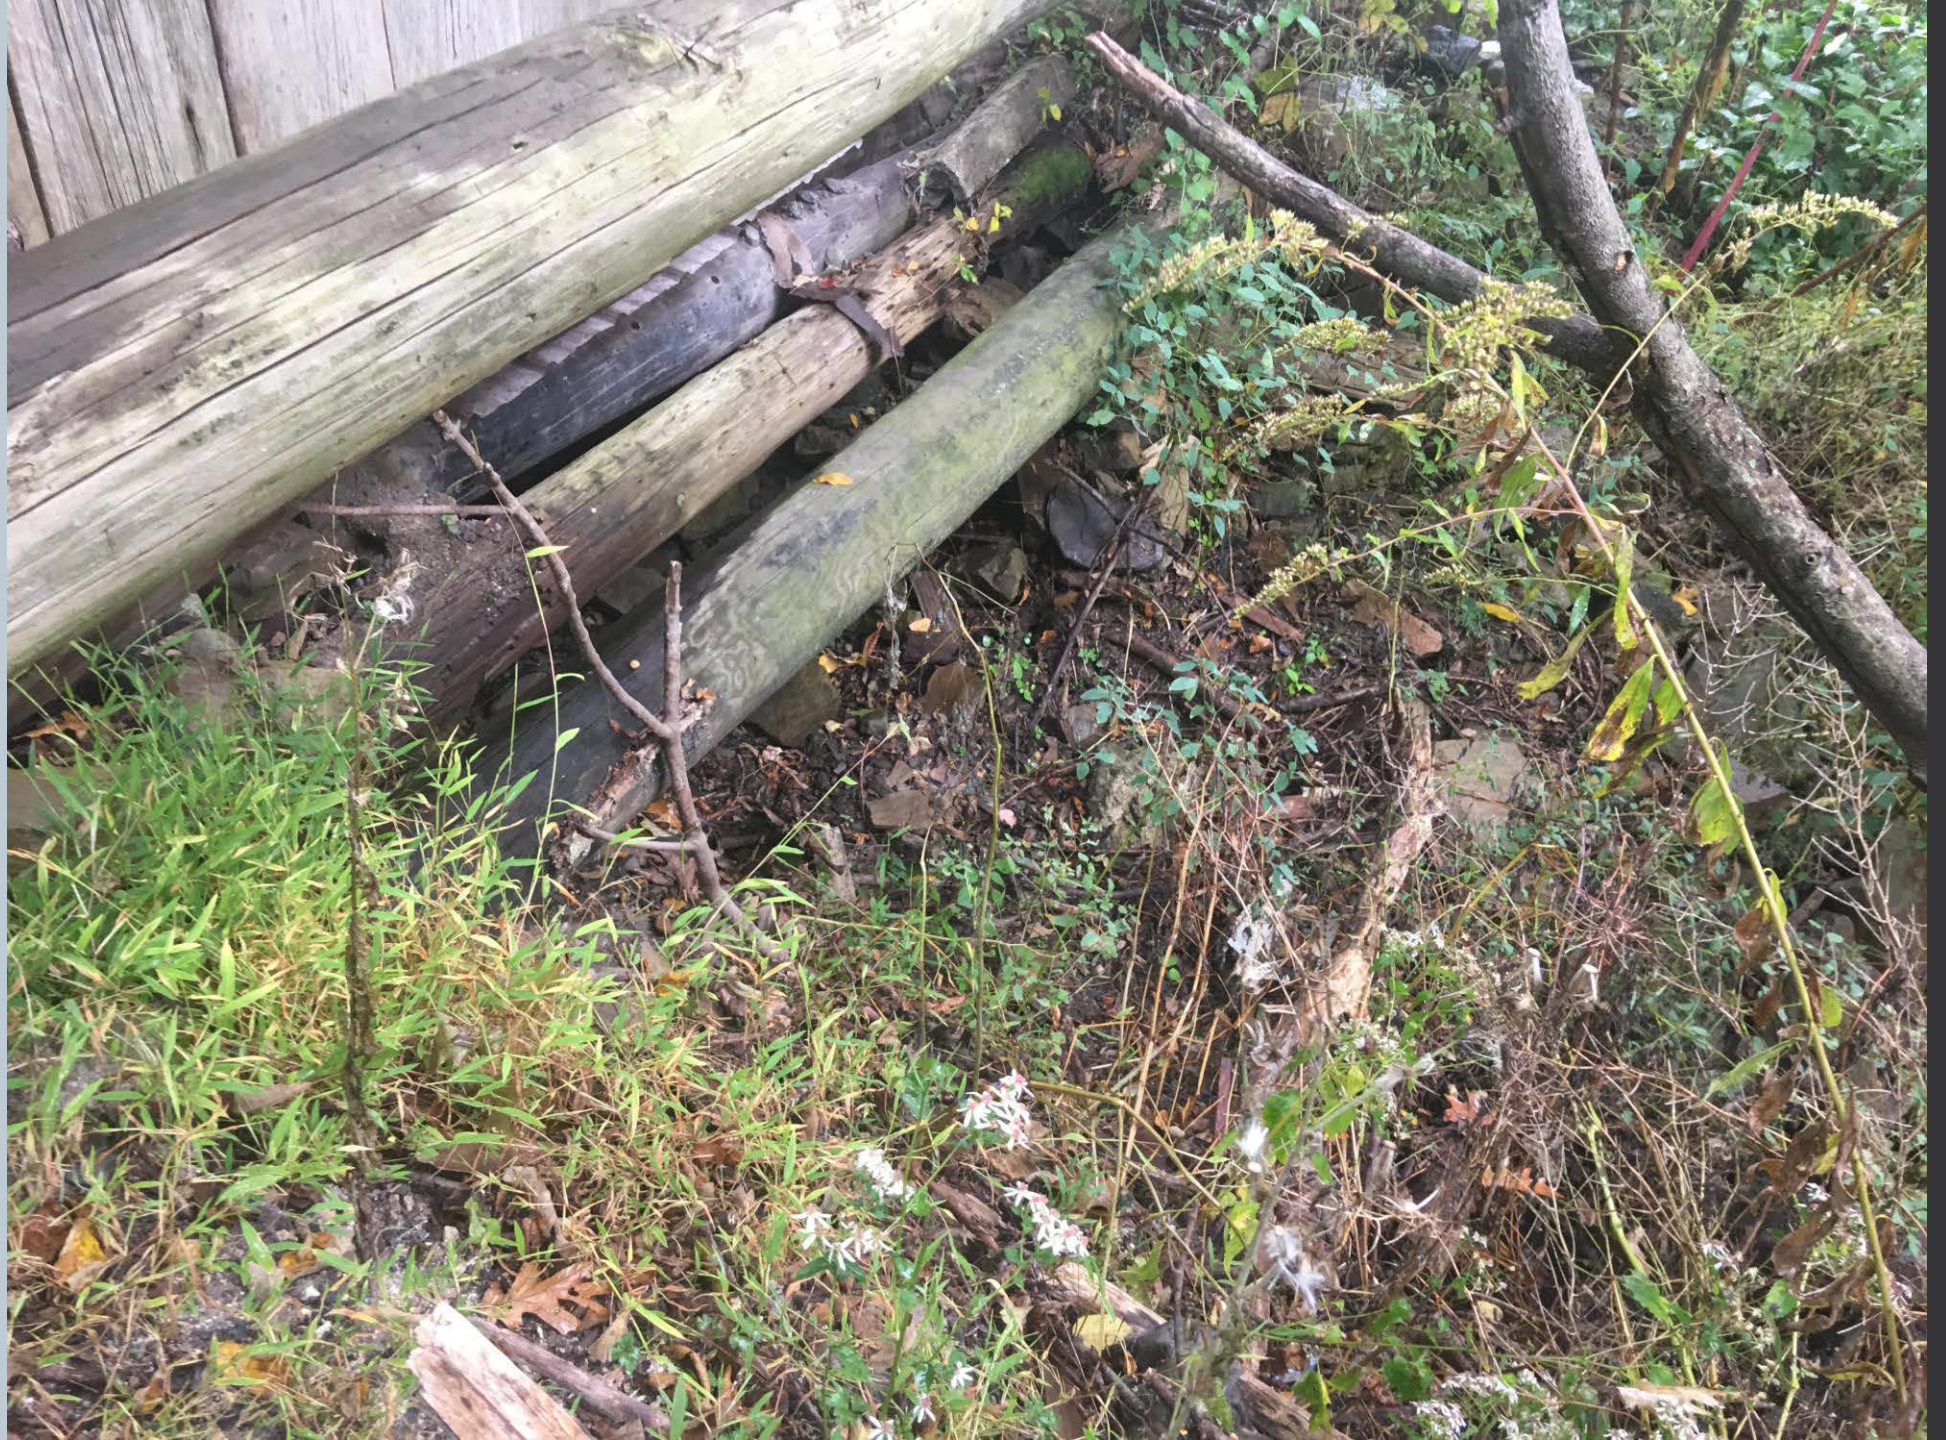
Figure 315.
Looking upstream
on unnamed
tributary to Toby
Creek along Manor
Drive at the bend
in the road across
from the Swoga
property. Sediment
and debris are
causing an inlet
drop. Recommend
removal of the
sediment and
debris with a small
cleanout by hand
and a DAMA Vac
Truck.
