Toby Creek Field Reconnaissance Observations

September 26, 2018

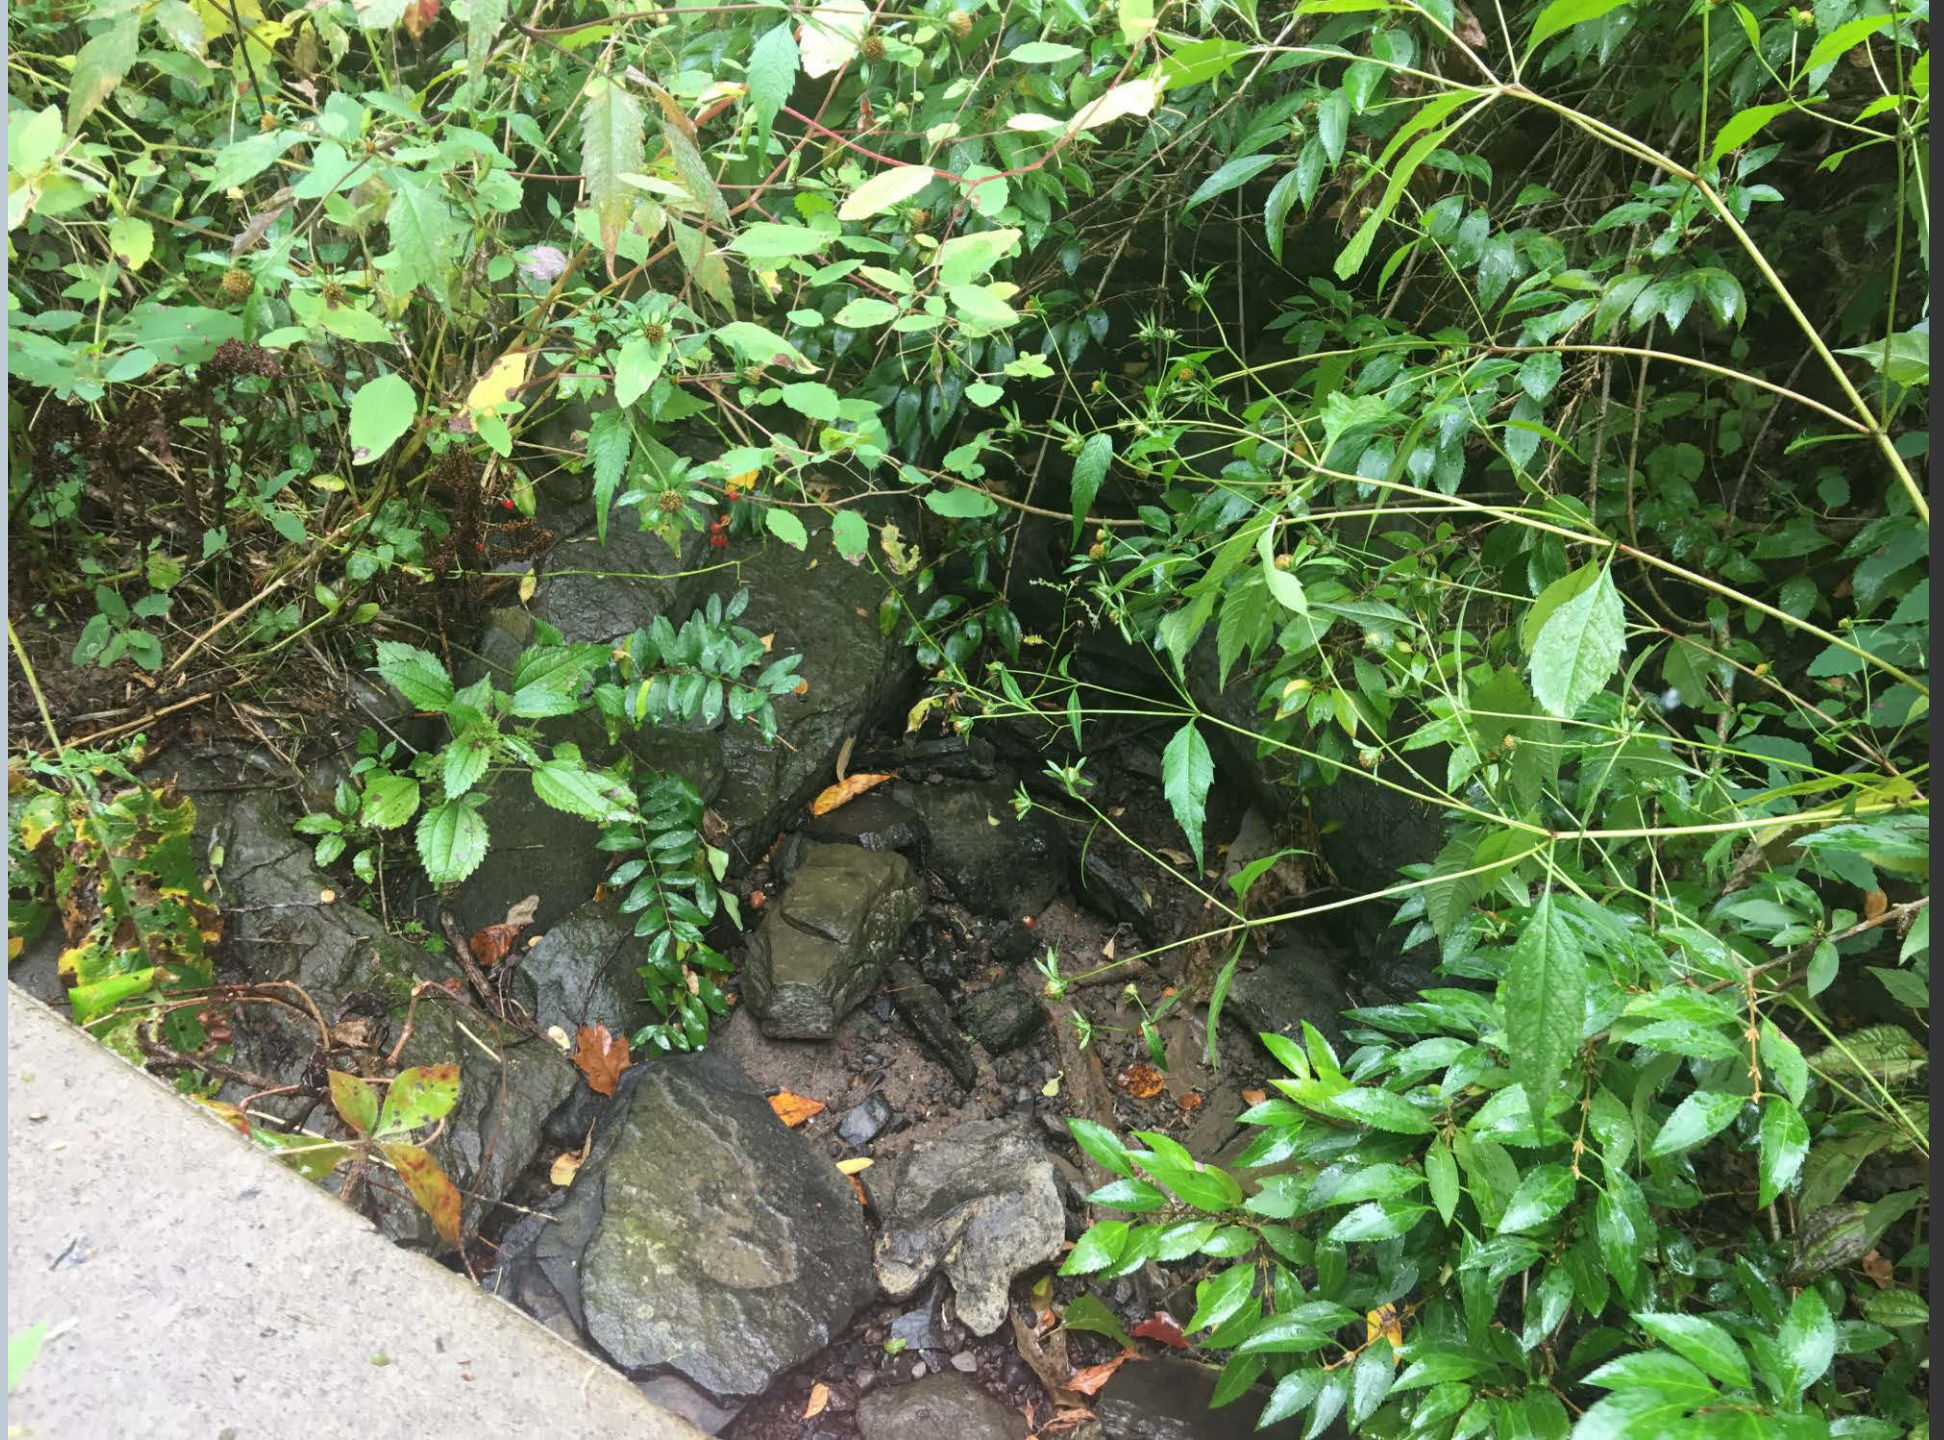
Figure 316.
Looking
downstream at the
culvert inlet on an
unnamed tributary
to Toby Creek
along Manor Drive
at the bend in the
road across from
the Swoga
property. Sediment
and debris are
causing an inlet
drop. Recommend
removal of the
sediment and
debris with a small
cleanout by hand
and a DAMA Vac
Truck.

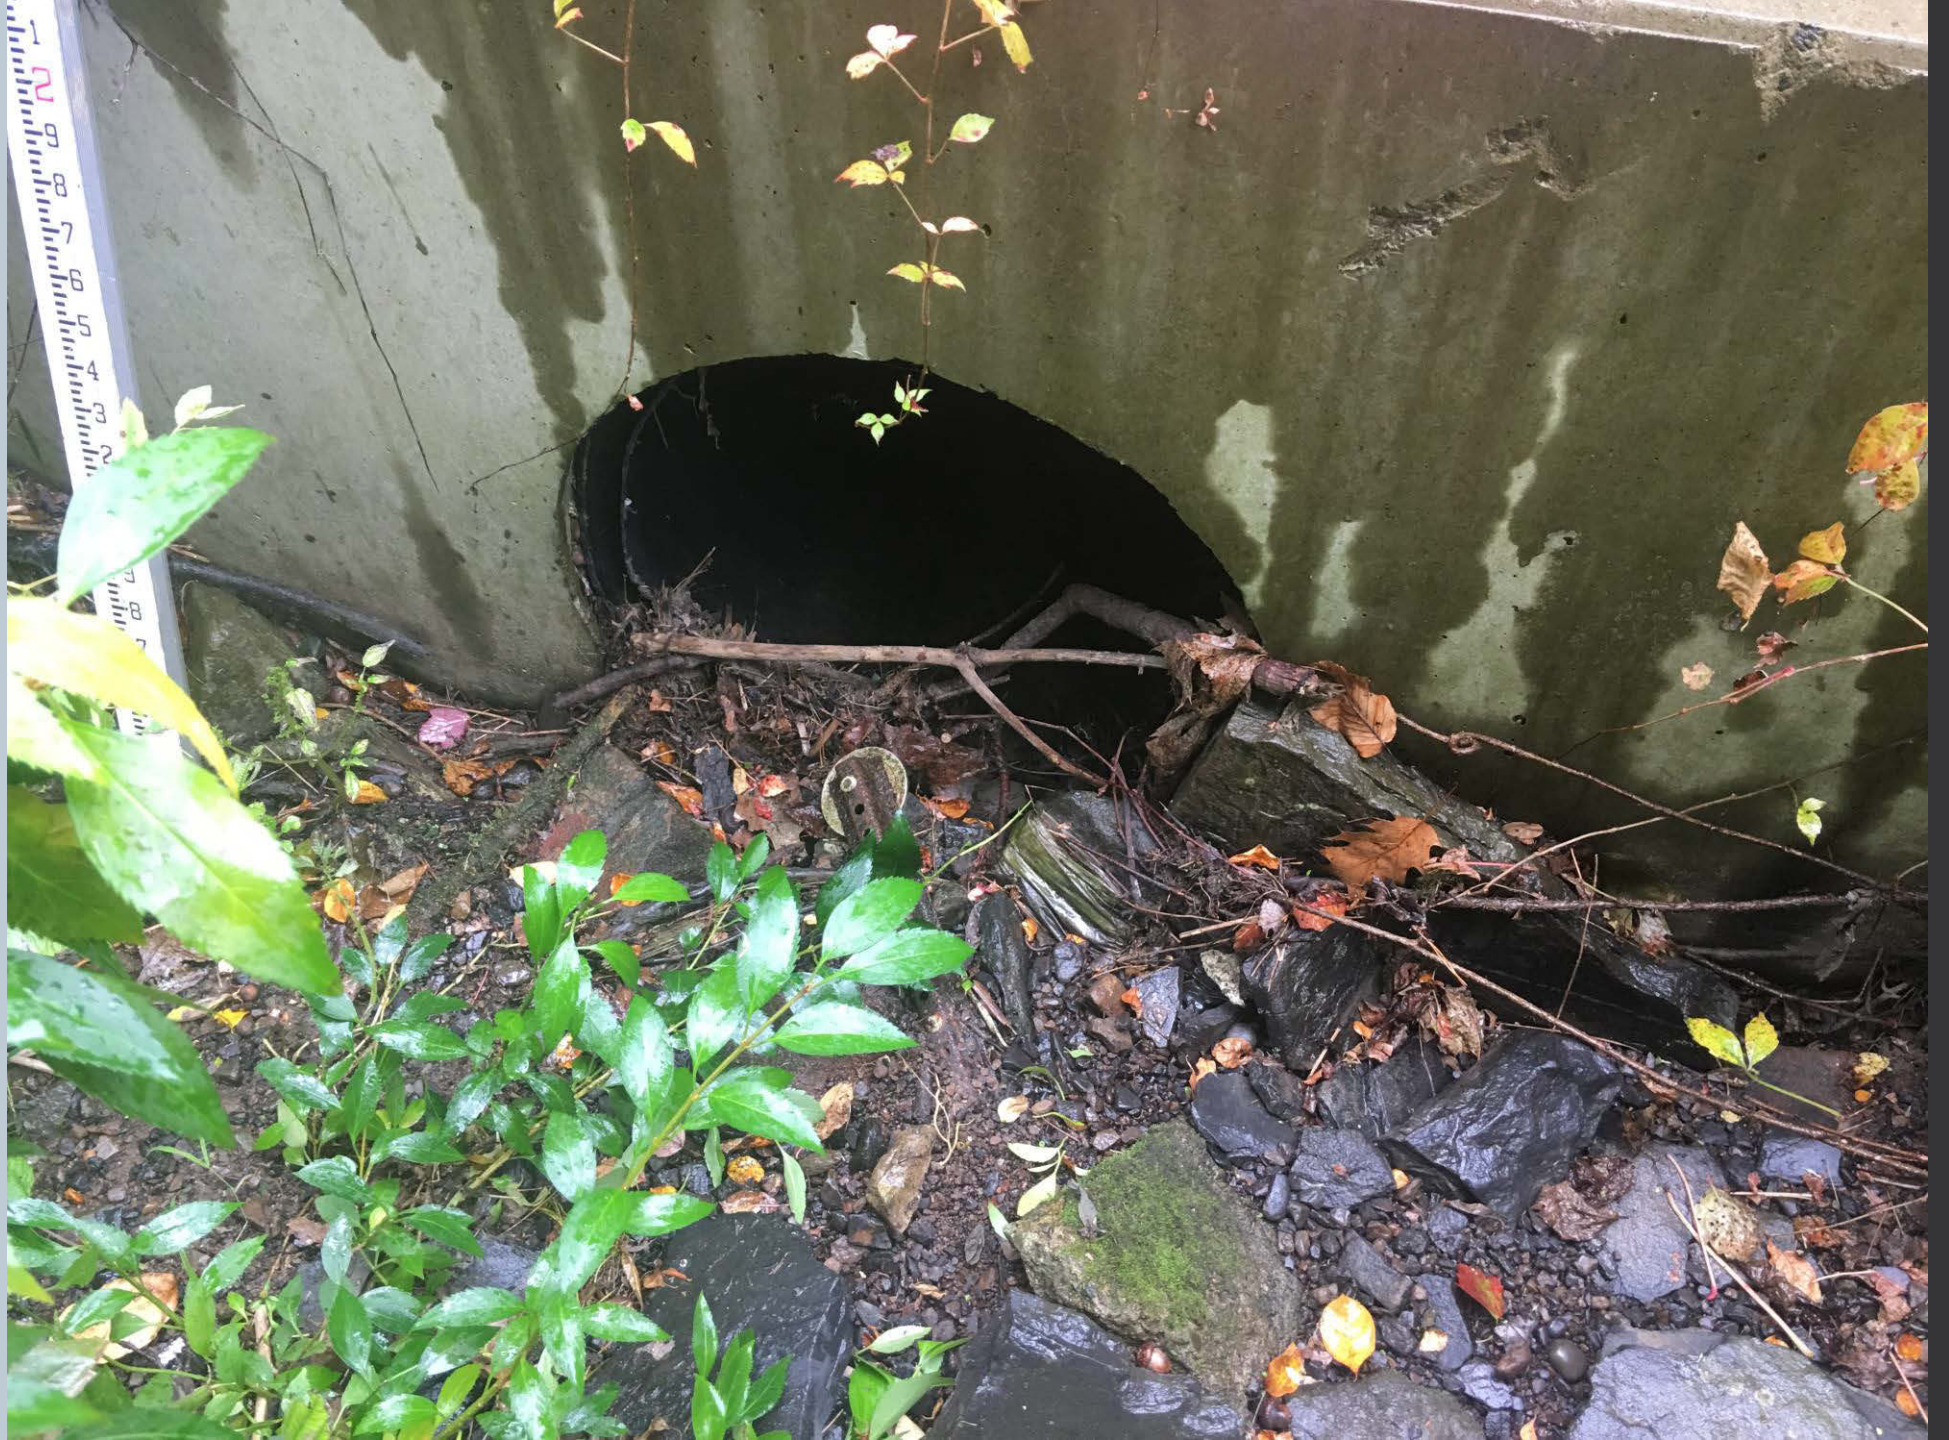
Figure 317.
Looking upstream
at the culvert
outlet on an
unnamed tributary
to Toby Creek
along Manor Drive
at the bend in the
road. A large scour
pool has developed
below this culvert
and severe erosion
of the streambank.
Several large trees
are precariously
leaning towards
Manor Drive.
Recommend a
larger rock apron
and shoring up of
the outlet and bank
stabilization in this
area.

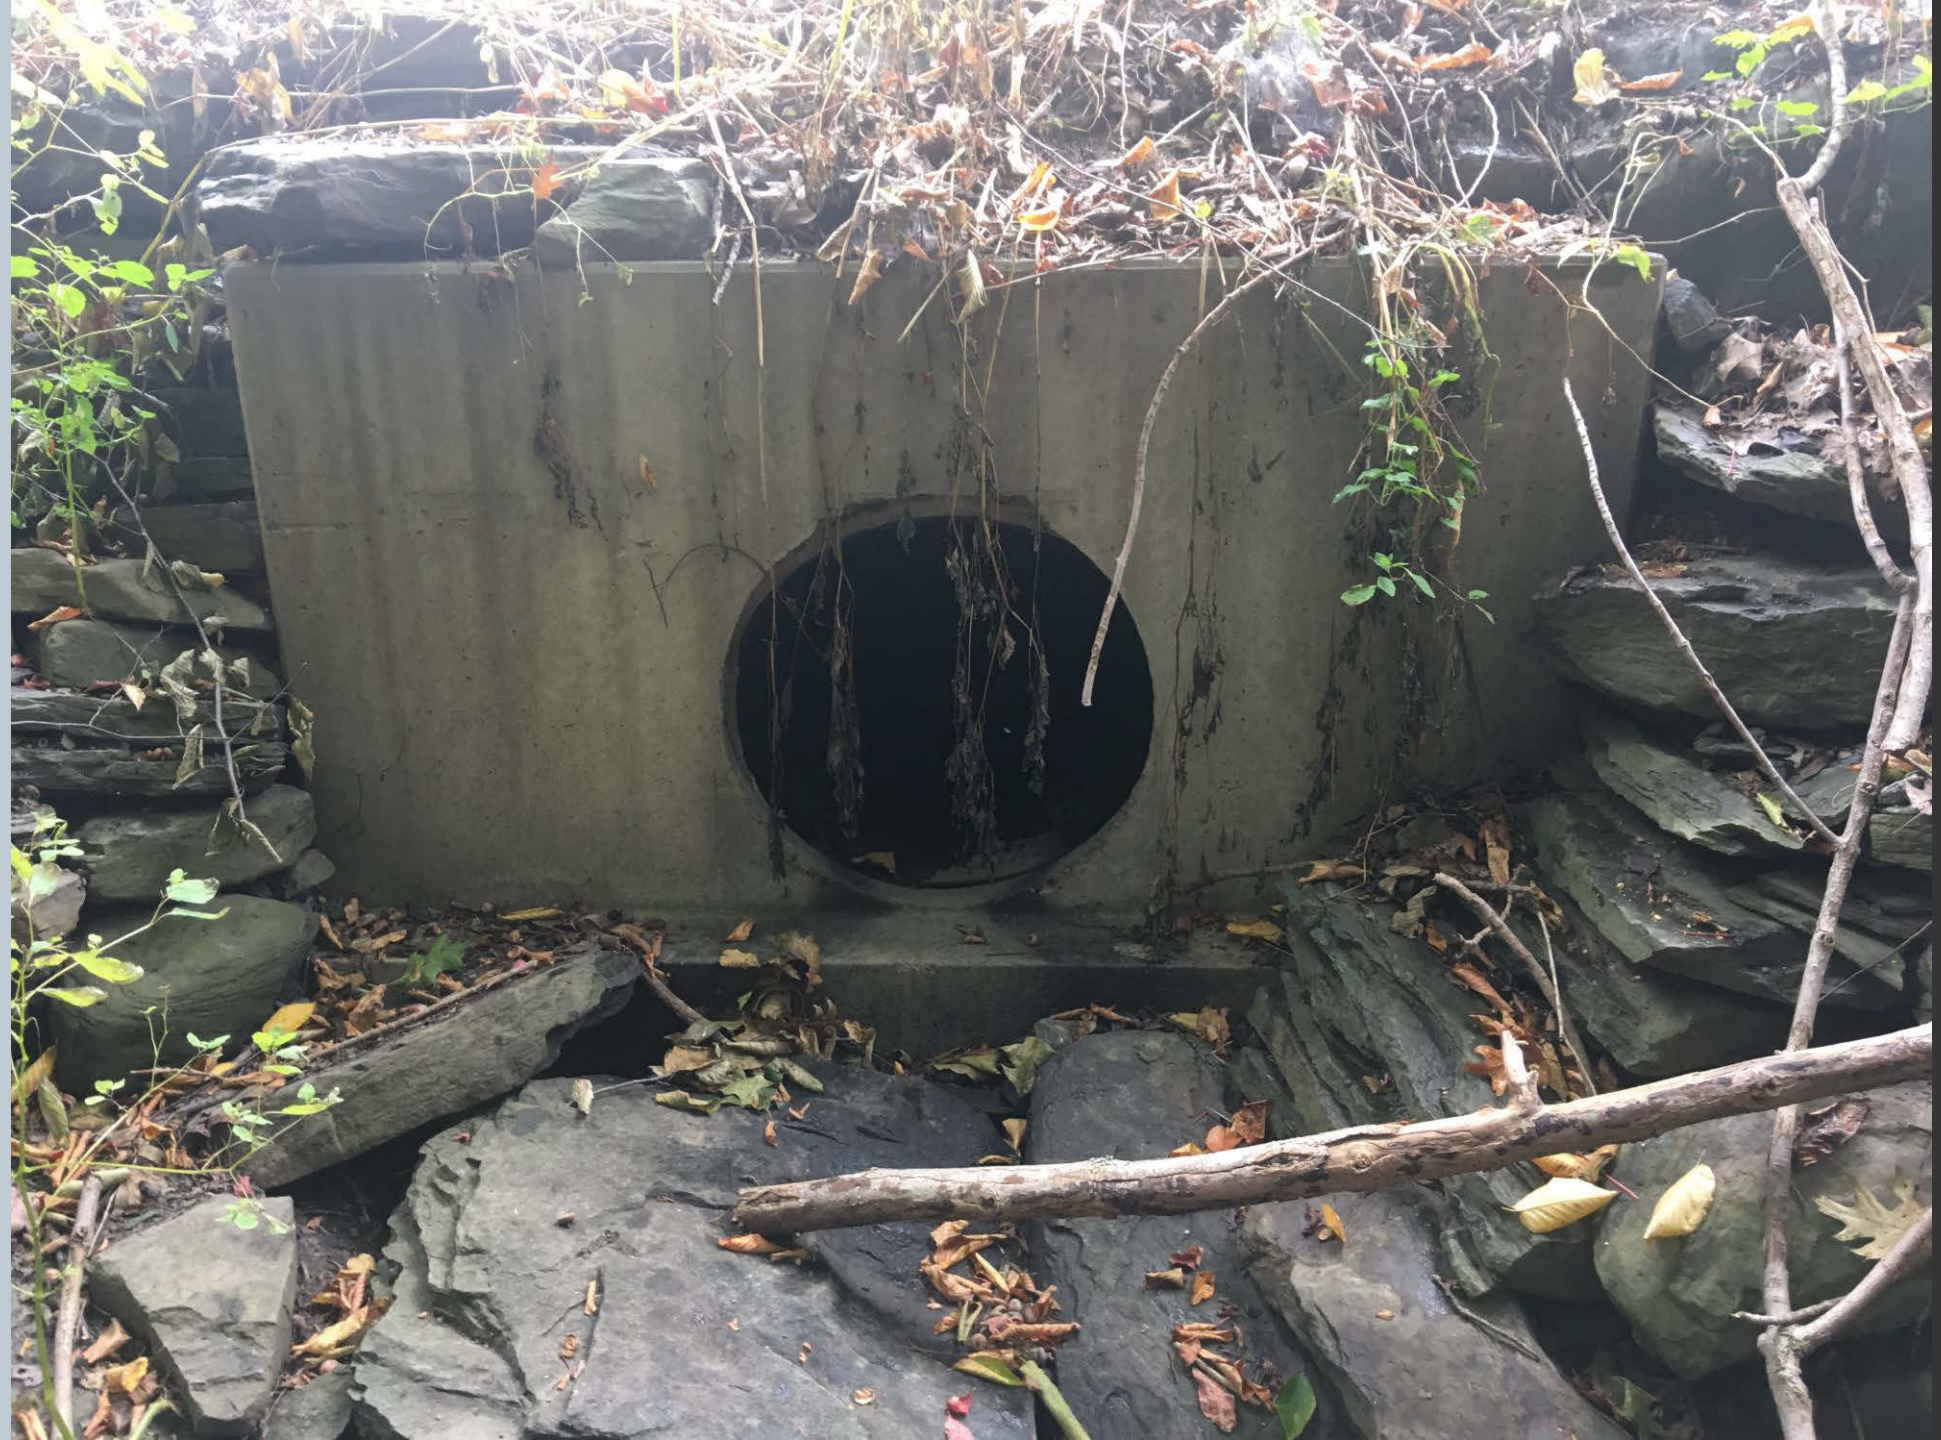
Figure 318. Looking downstream from the culvert outlet on an unnamed tributary to Toby Creek along Manor Drive at the bend in the road. A large scour pool has developed below this culvert and severe erosion of the streambank. Several large trees are precariously leaning towards Manor Drive. Recommend a larger rock apron and shoring up of the outlet and bank stabilization in this area.

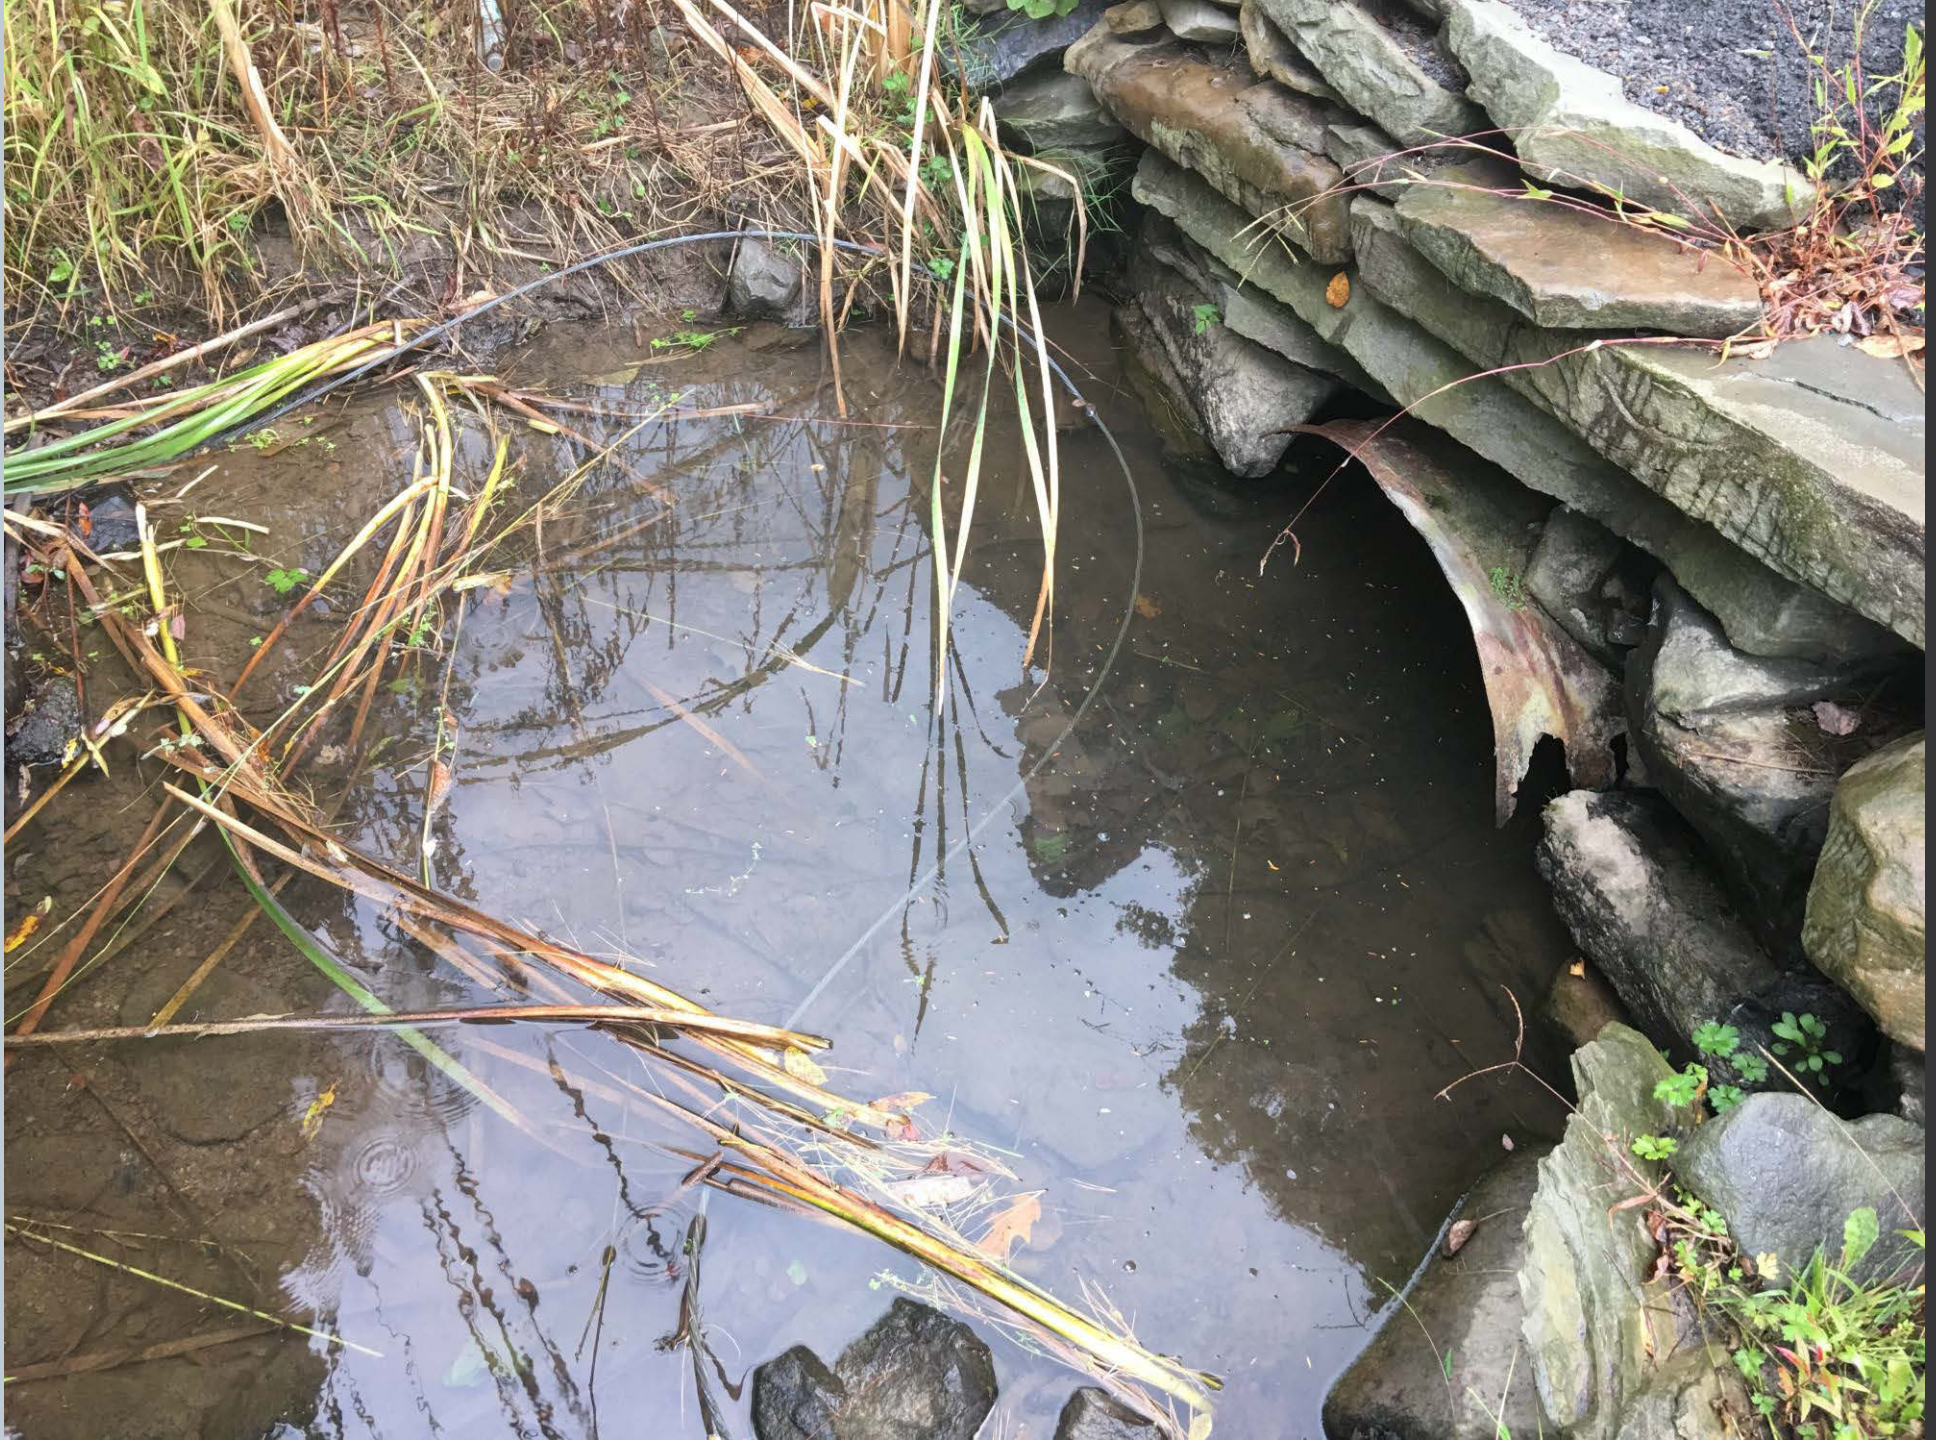
Figure 326. Looking upstream of the culvert outlet along Terrace Drive where a tire is embedded in unnamed tributary below Dug Road. Fish present.
