Initial Huntsville Creek Culvert Survey

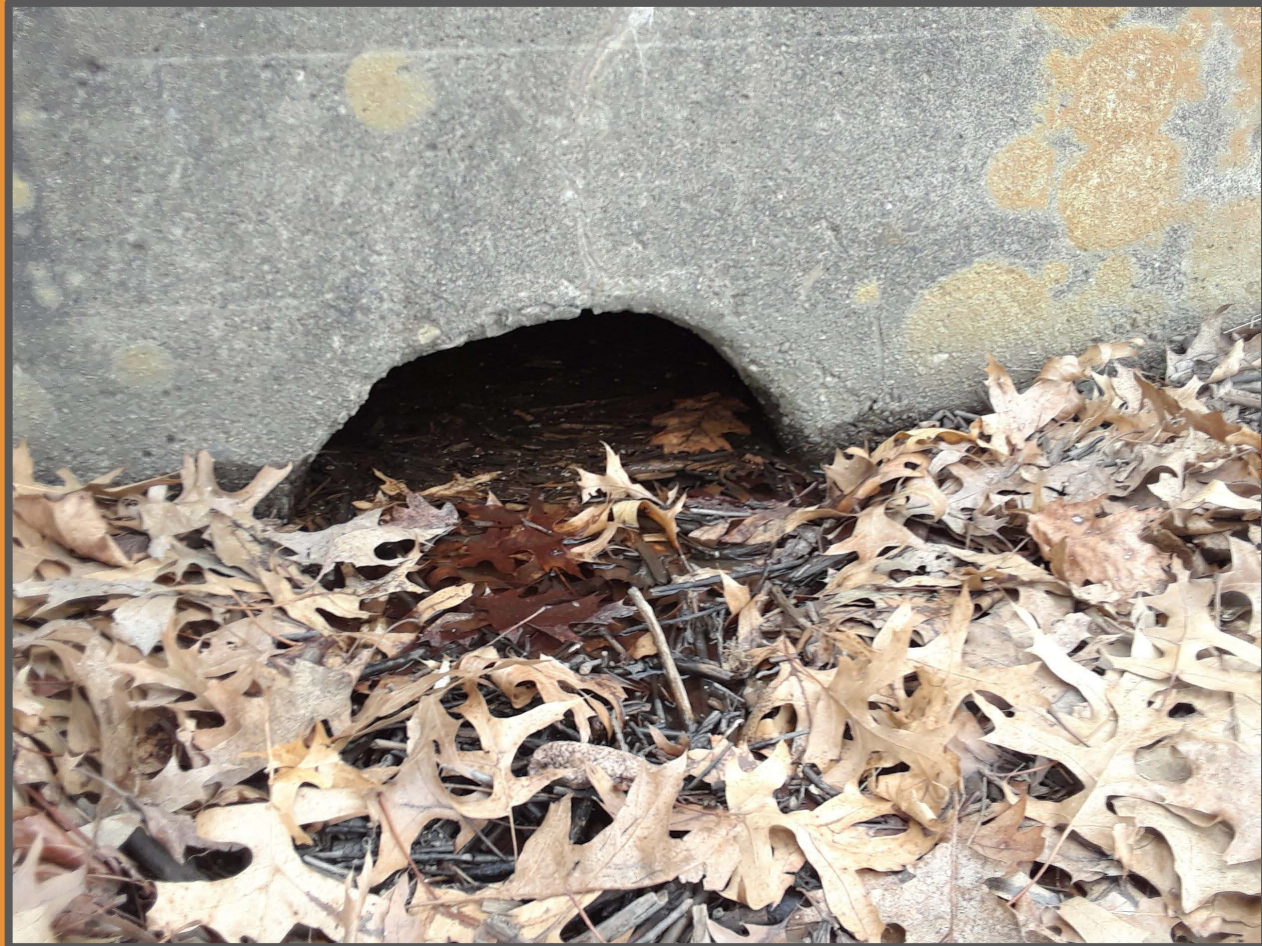
Point 1

12" concrete culvert
carrying drainage from
Fig. 19. More than half
full of debris.

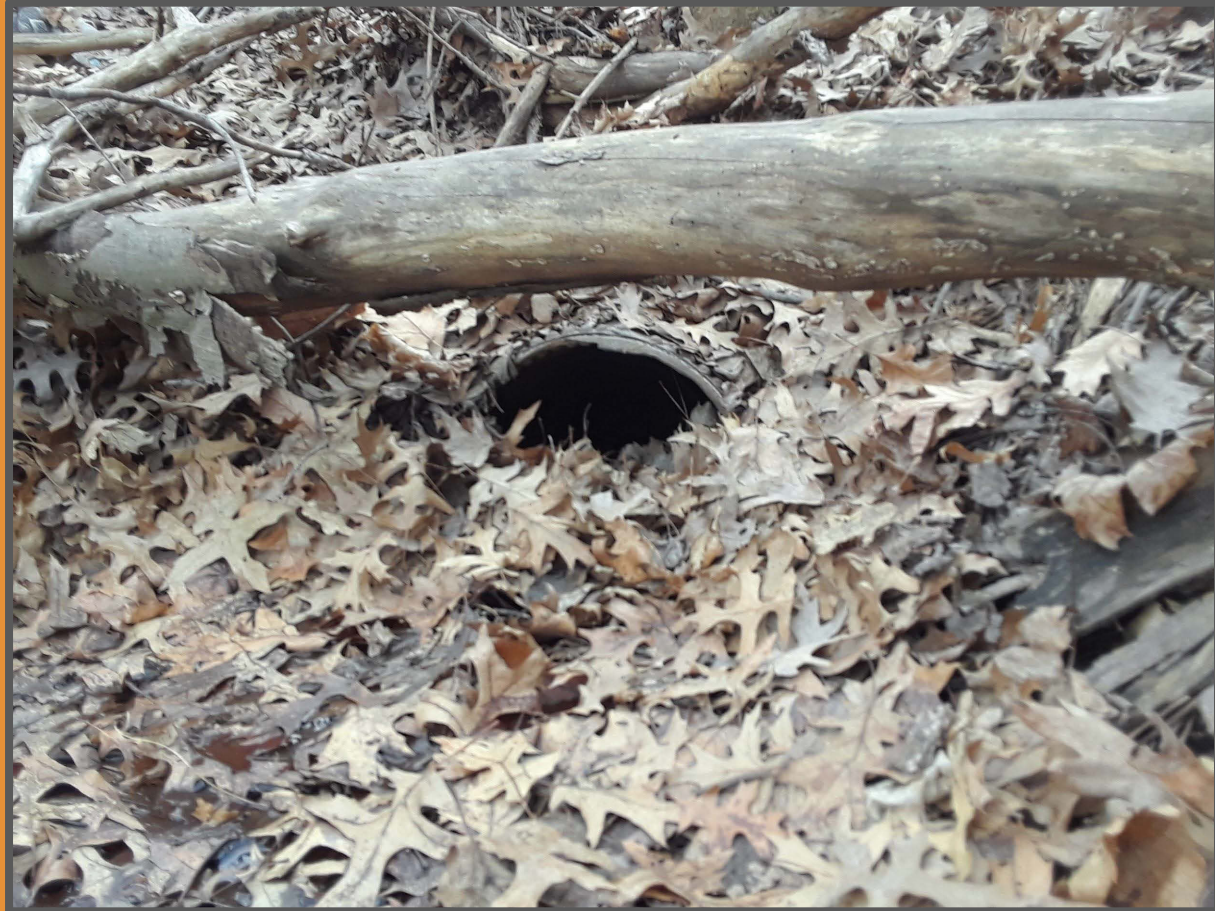
Point 1

Upstream view of flow from culvert in Fig. 20 on the other side of Old Rte. 115. Full of leaf litter that is clogging the pipe.

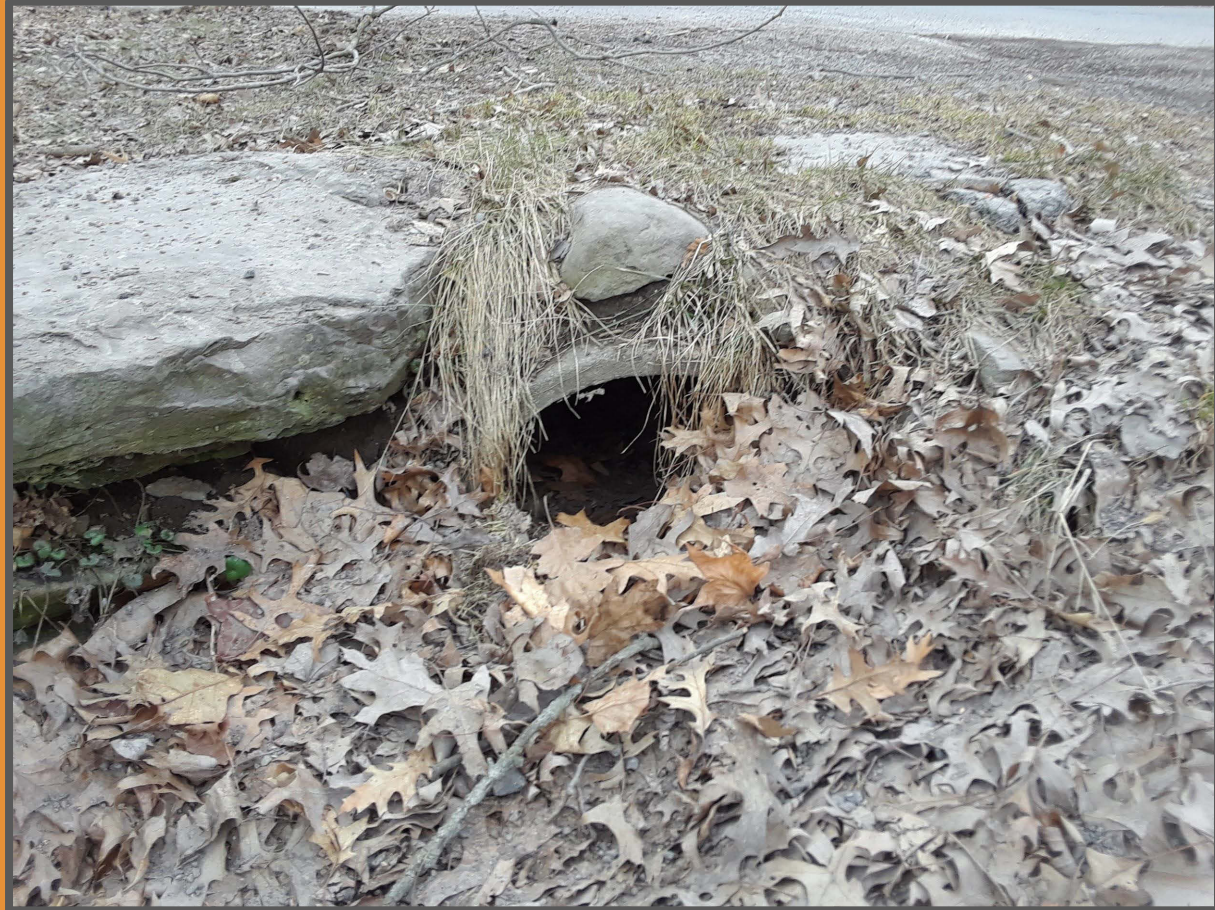
Near 1

12" concrete pipe under University Dr. at intersection with Old Rte. 115 carrying stormwater that is half full of leaf litter.

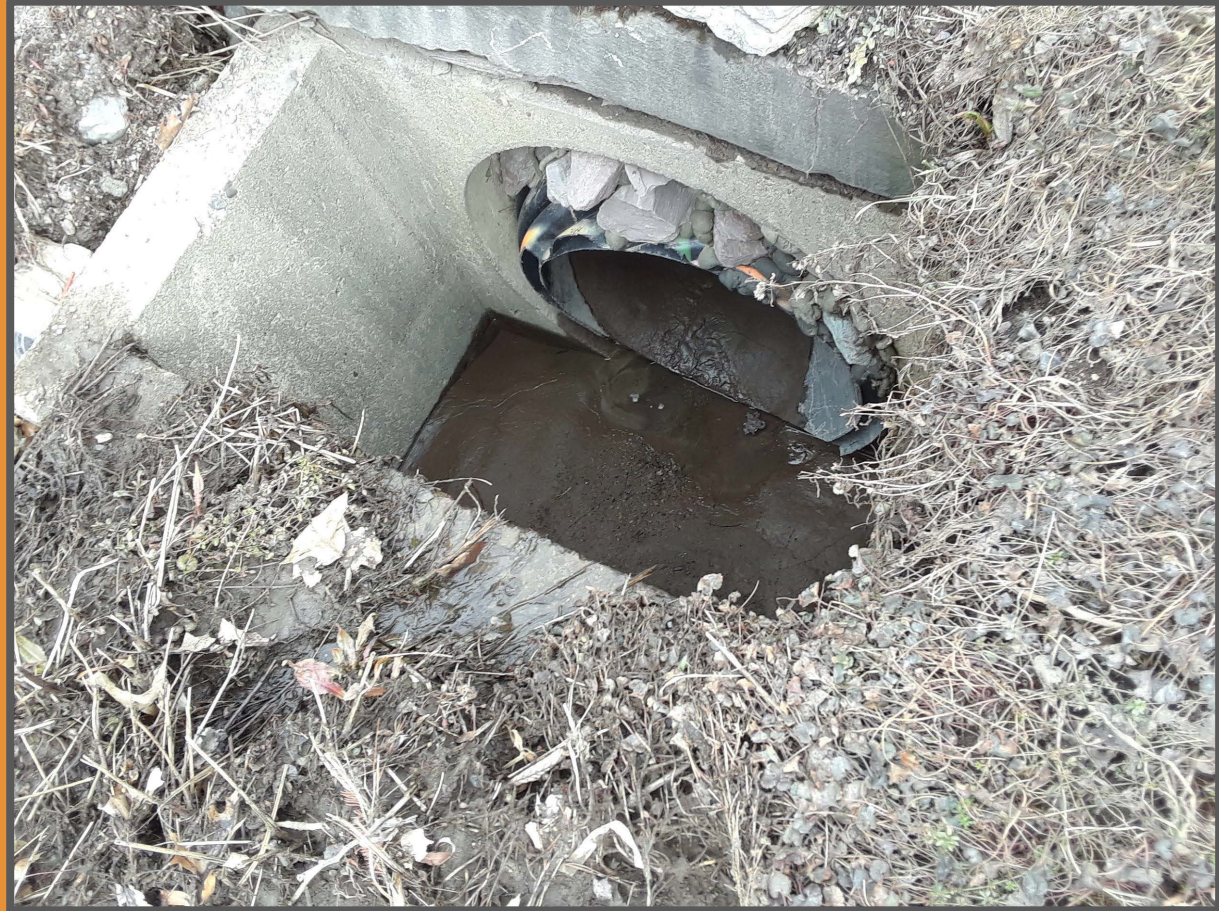
Point 2

Downstream view of rectangular culvert with 18-inch HDPE pipe, mortared into larger concrete pipe with rocks.

2-3 inches of sediment outside of pipe, 1 inch inside pipe

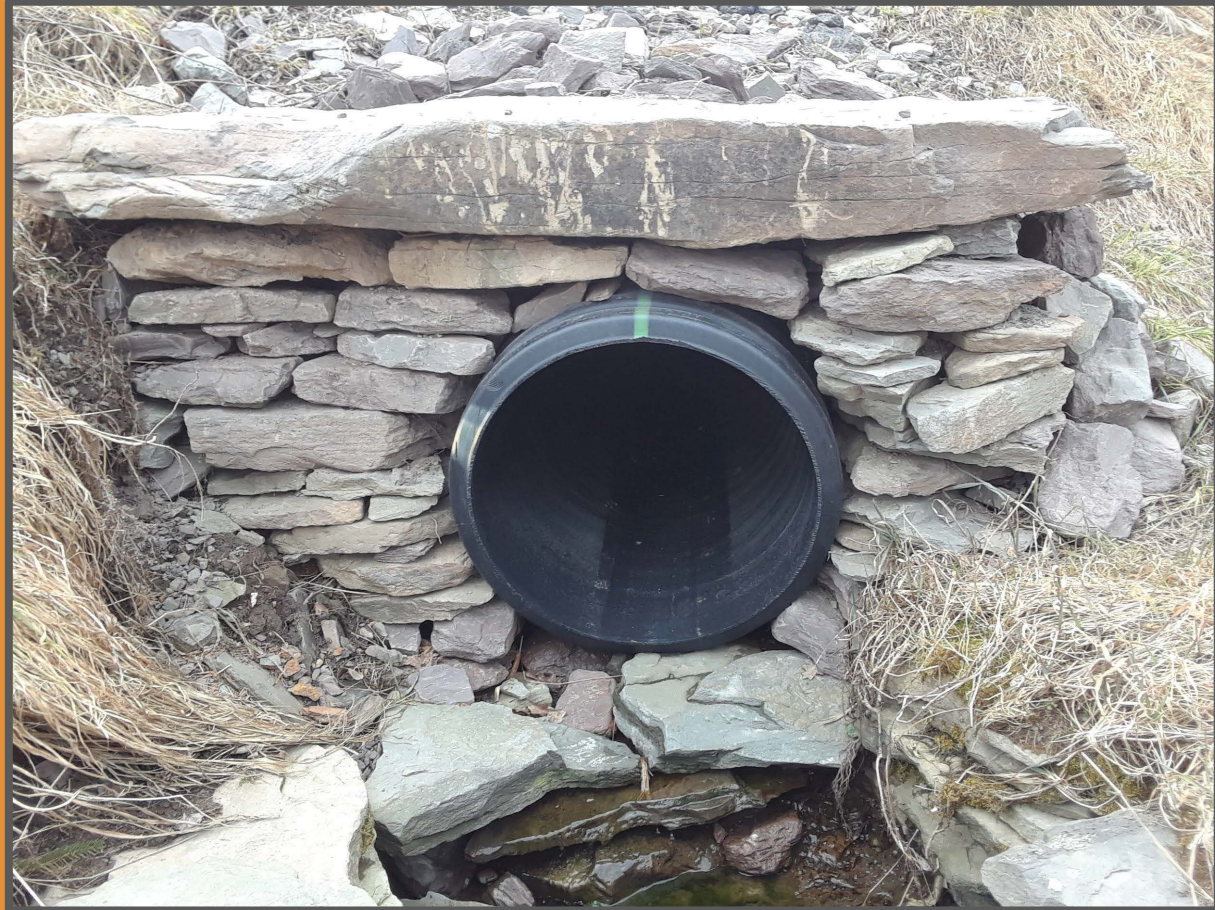
Point 3

24" HDPE pipe that carries flow from under Old Rte. 115 and Market St.

Consistent flow of groundwater under pipe that trickles down lower rocks.

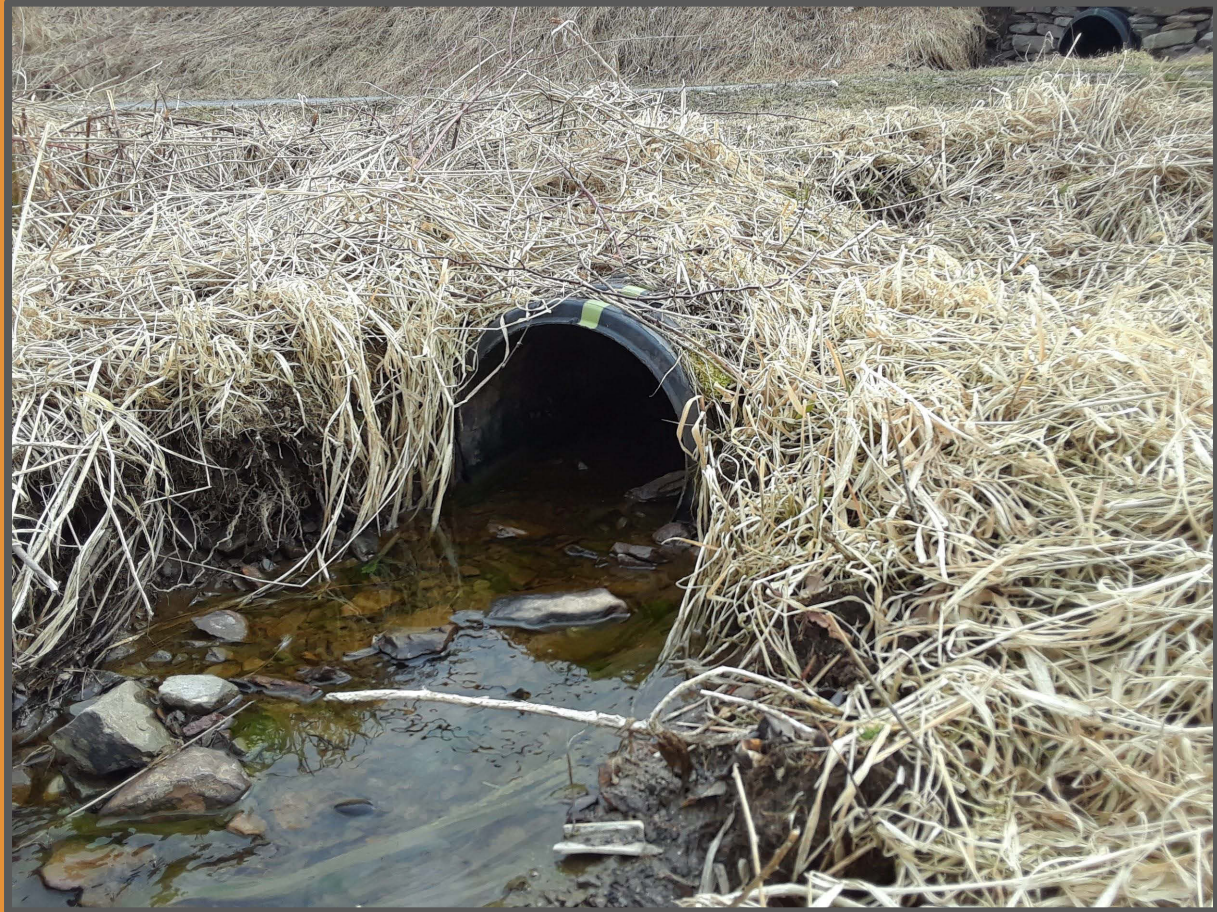
Point 3

Upstream view of HDPE pipe from Fig. 14 that crosses road in the golf course. A small amount of sediment in pipe.

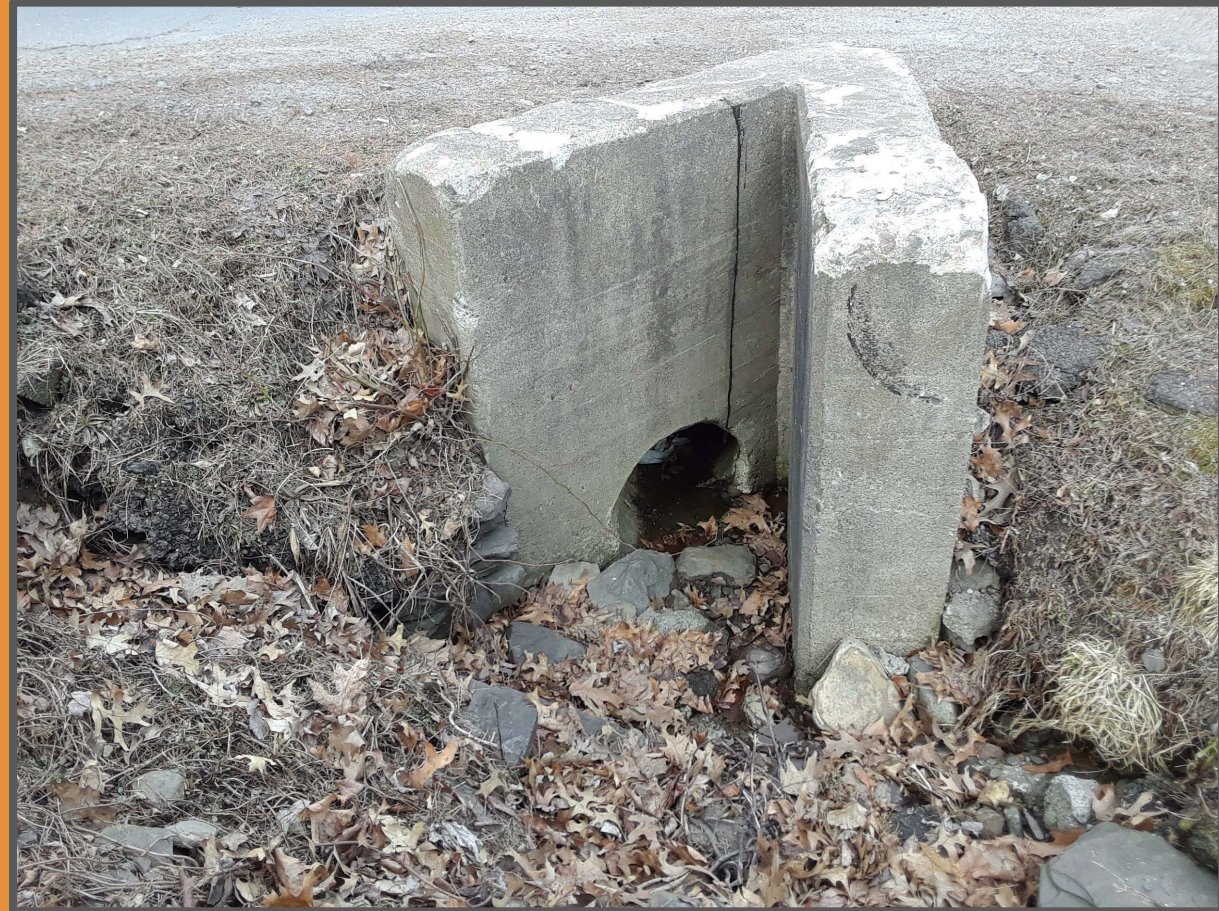
Point 6

Downstream (DS) view of
culvert from Fig.1.

18-inch with some rocks
and debris blocking
drainage

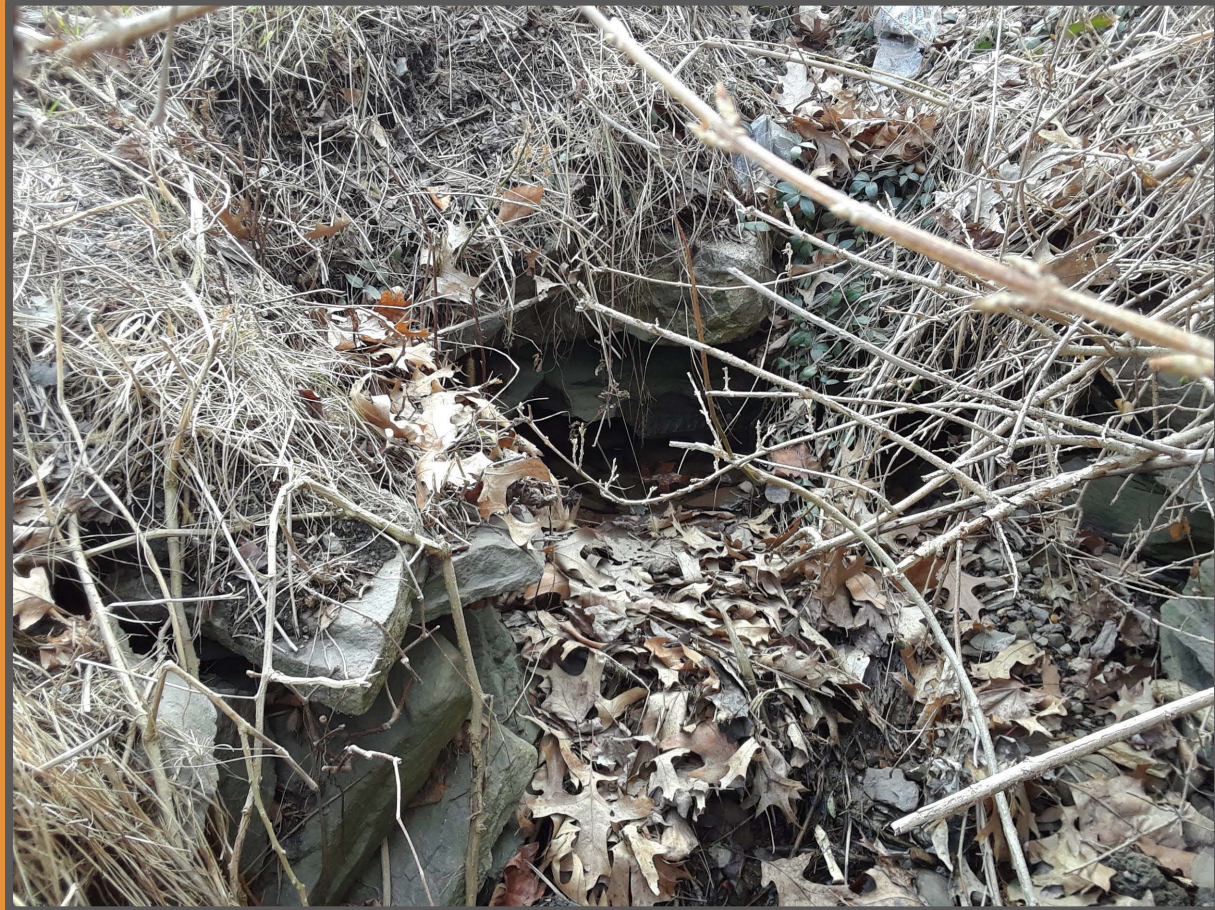
Point 8

Upstream view of
opposite side of culvert
under Old Rte. 115. -
Completely blocked with
debris and leaf litter.

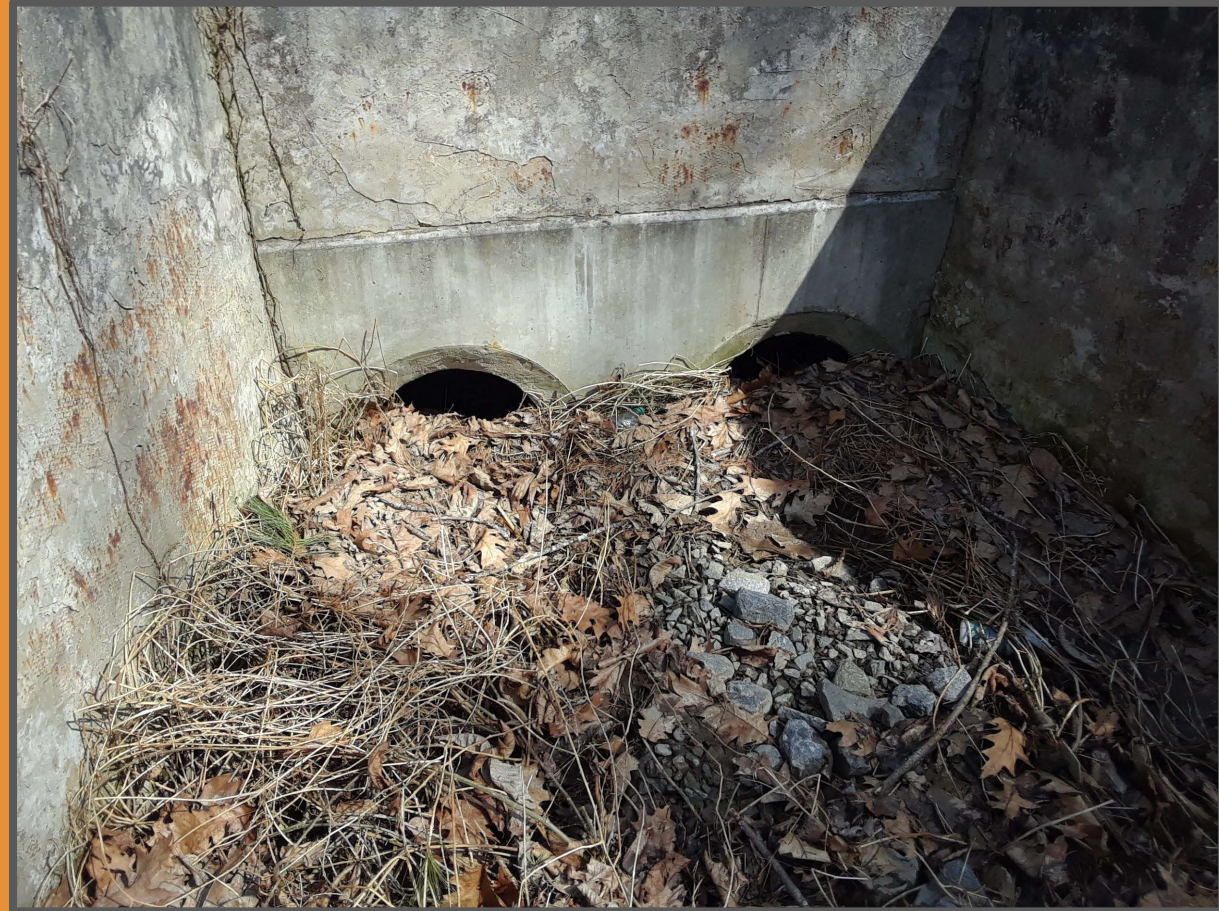
Point 10

2 12" concrete pipes in square drop-off that pass under Huntsville-Idetown Rd. - Half full of leafy debris and sediment

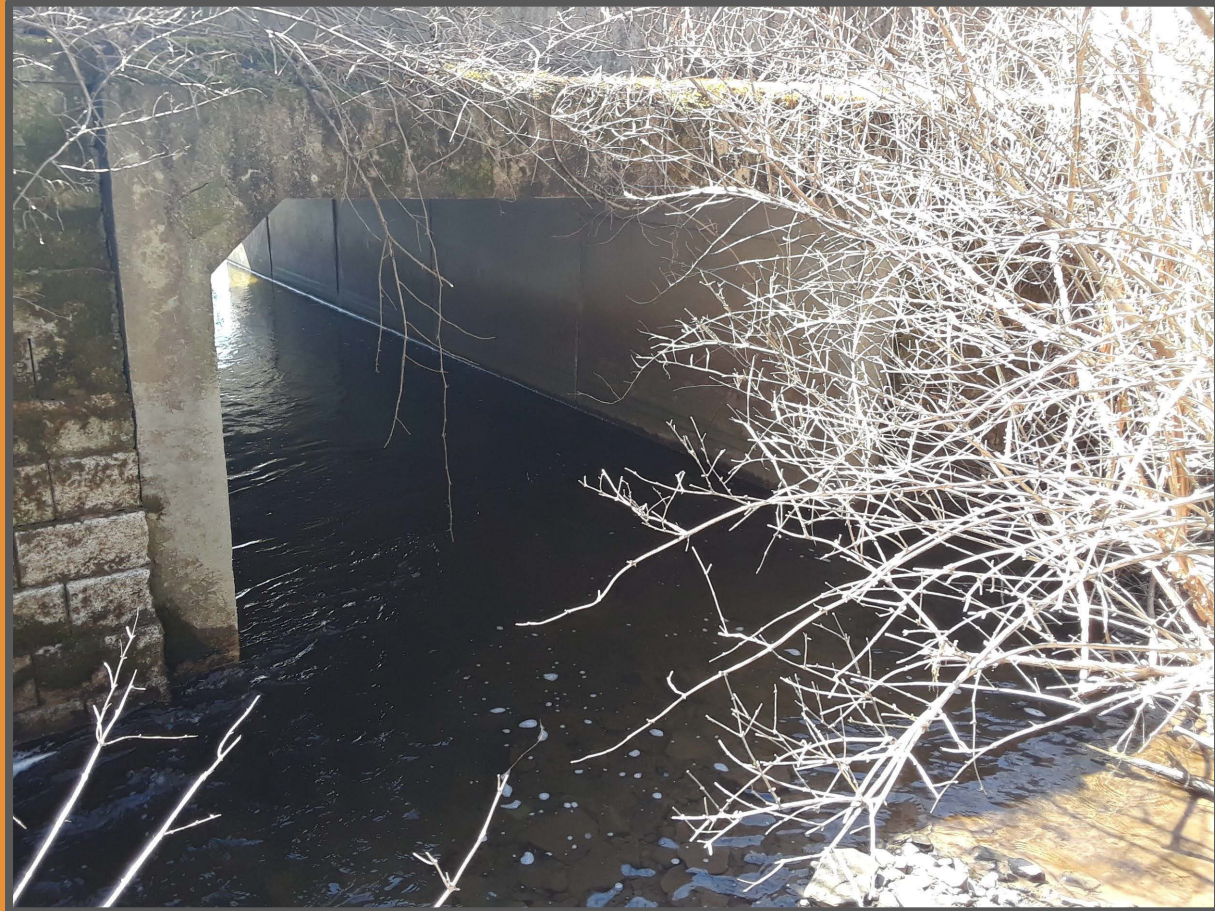
Point 16

View of UNT passing under Park Rd.

Bank repair in Fig. 74 could help direct UNT to better alignment with bridge

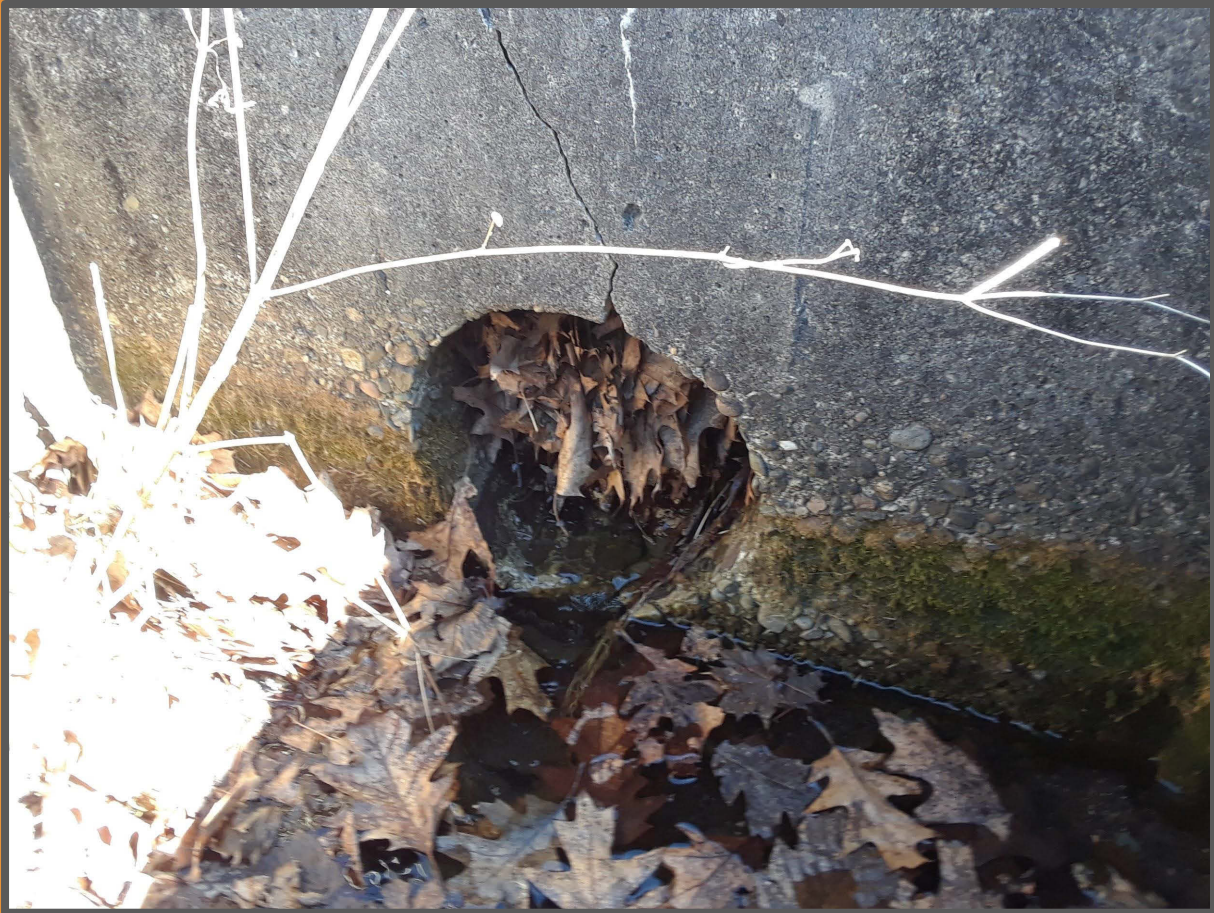
Point 22

Close-up of one pipe in Fig. 61 and leafy debris

Resident complained it regularly fills and sends flow across road.

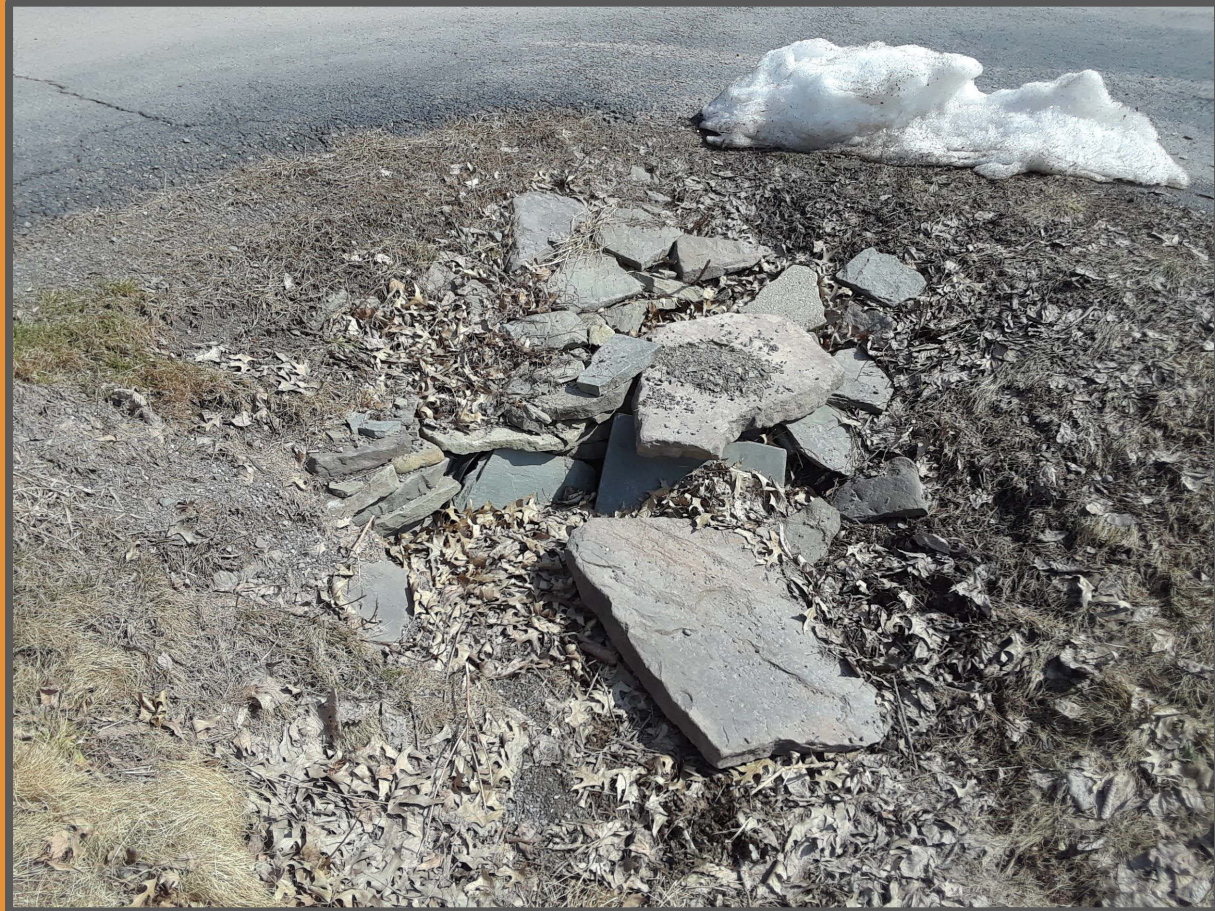
Near 20

Collapsed headwall over
drain just outside of
parking entrance to
Dance Studio.

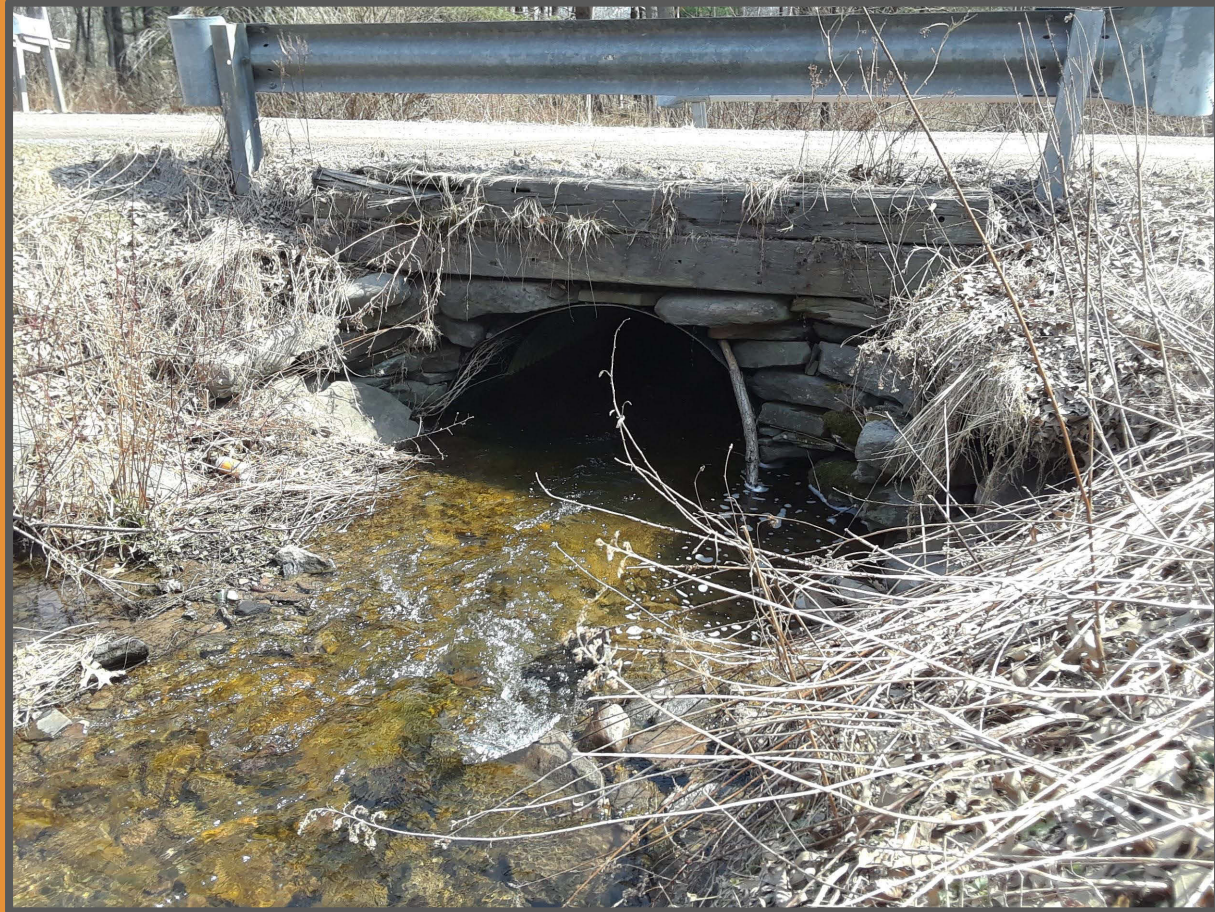
Point 21

View of 2-3' metal pipe carrying UNT under Goodman Rd. Pipe has some build up of sediment, but flow is level through the pipe relative to the UNT

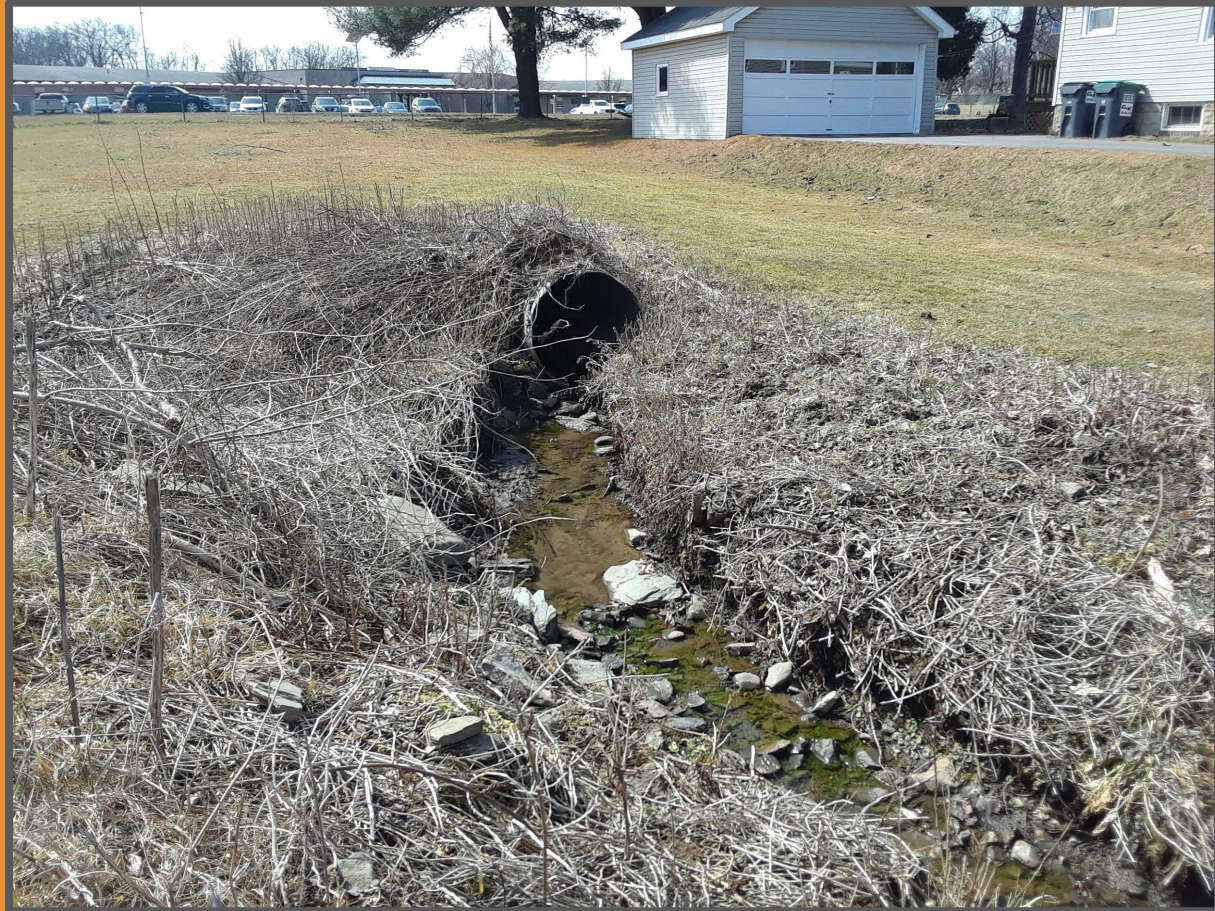
Near 9

Upstream view of 30-inch corrugated metal pipe bringing drainage from Lake Lehman Early Learning Center. Pipe is corroded along base of the structure.

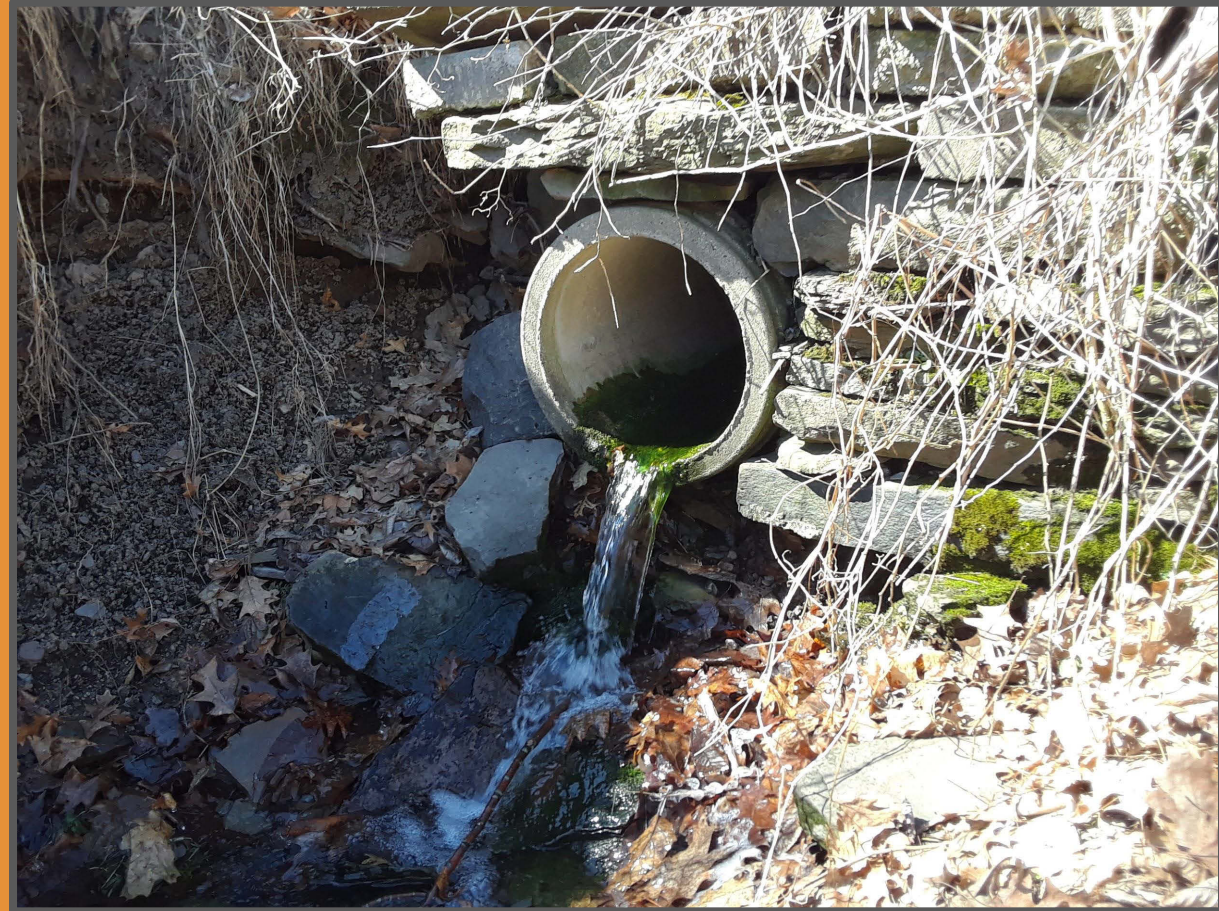
Figure 66

Upstream view of
concrete pipe from
opposite side of Idetown
Rd.

Heavy scouring and
collapsed headwall just
above top of image
