# Huntsville Creek Coldwater Heritage Plan Unnamed Tributary to Lower Toby Creek: Courtdale Borough

### Culvert Assessments 12-03-2020

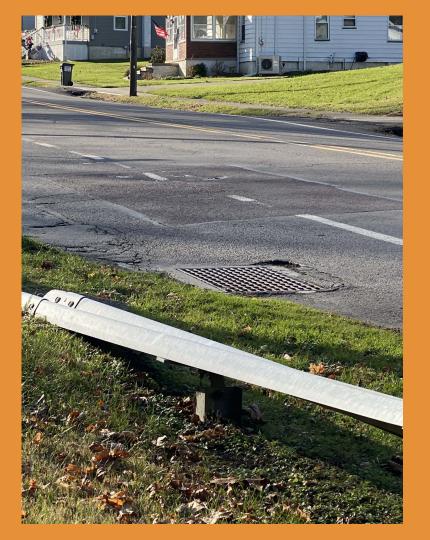
41.282051, -75.907301

Stormwater culvert drop inlet structure draining Courtdale Ave

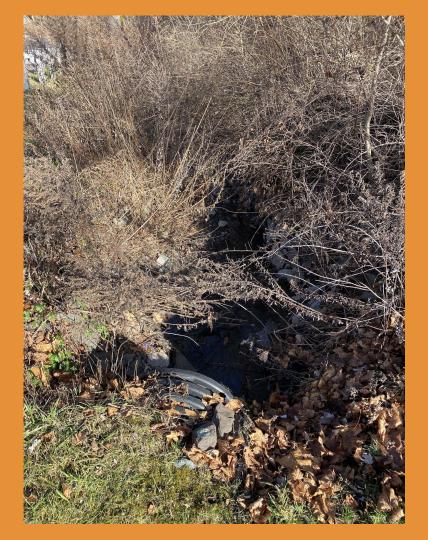
Stormwater culvert from drop inlet draining Courtdale Ave

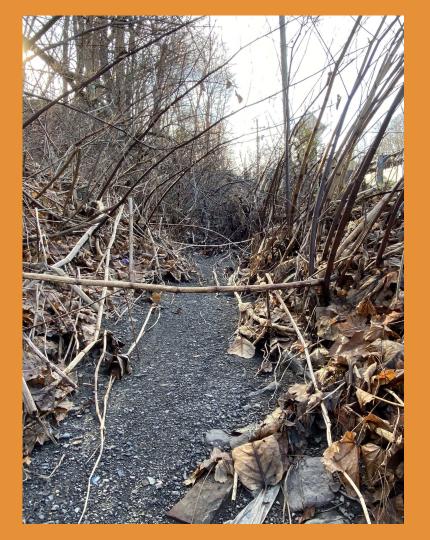
## Invasive Knotweed Sediment in conveyance channel

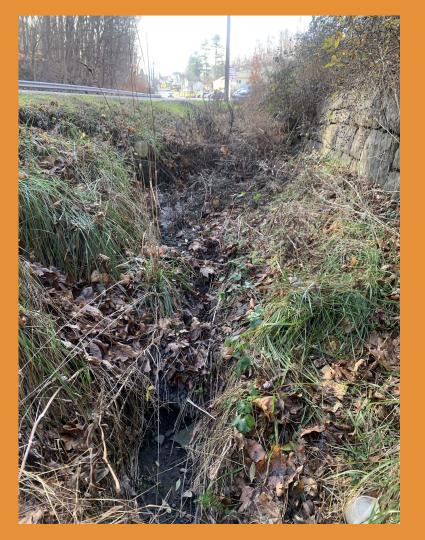
Looking upstream in conveyance channel below Hurricane Car Wash

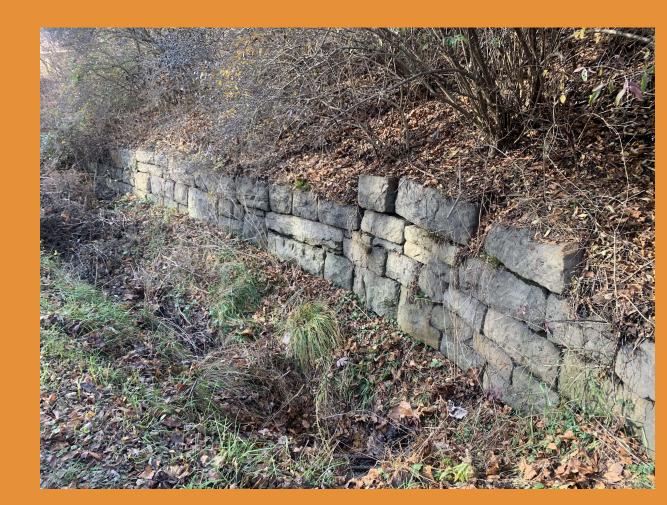
Masonry retaining wall near Hurricane Car Wash

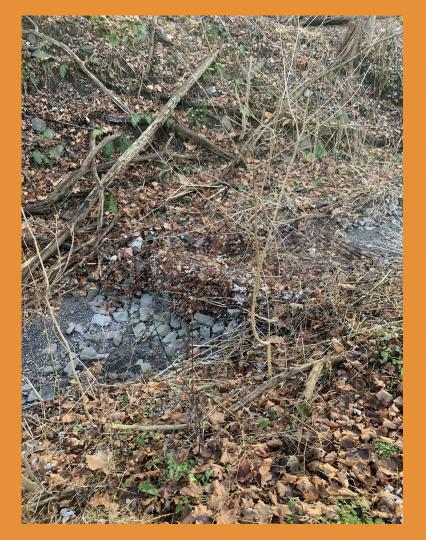
#### Woody debris blocking check dams

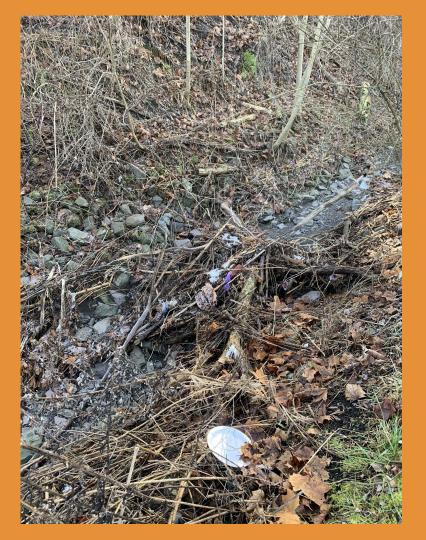
## Woody debris and trash blocking channel

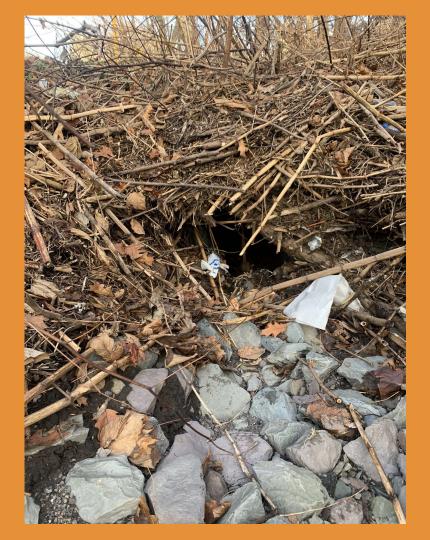
41.283732, -75.903618

Knotweed and trash covering/blocking culvert along Courtdale Ave

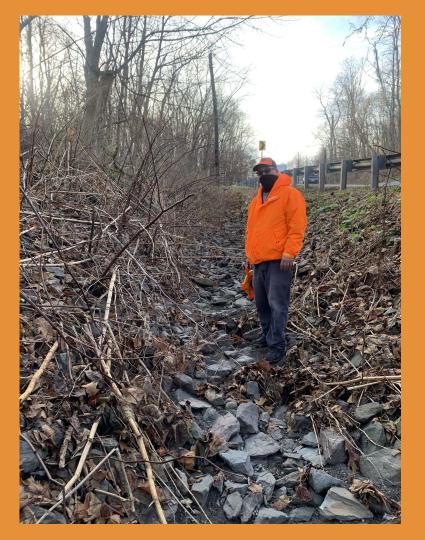
41.283732, -75.903618

Looking upstream of debris blocked culvert along Courtdale Ave

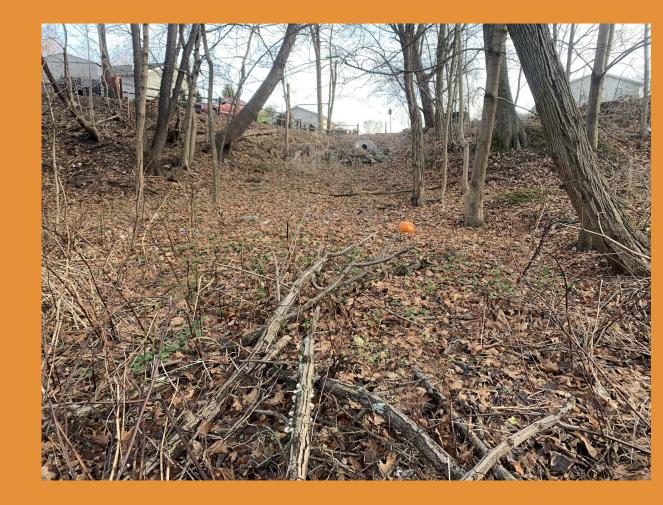
41.283156, -75.903995

Stormwater culvert outletting from Valley View Ave to Courtdale Ave

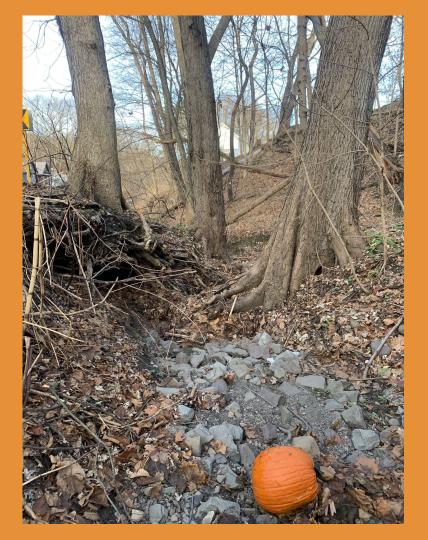
Stream channel restoration project potential below culvert along Courtdale Ave

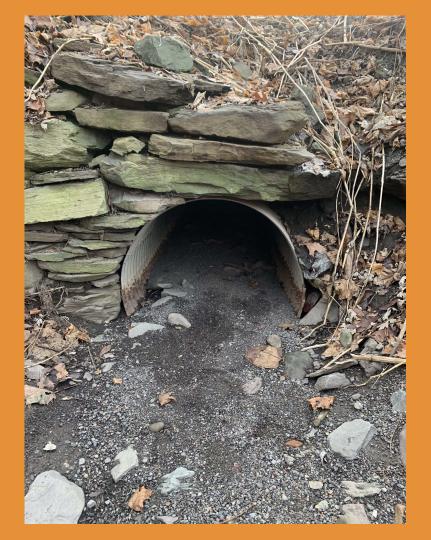
Looking upstream into sediment laden, blocked culvert along Courtdale Ave

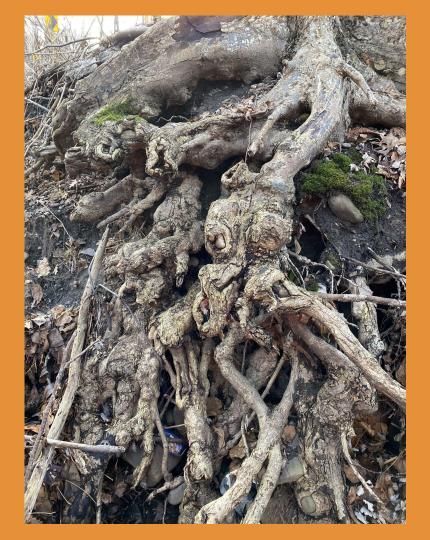
#### Burls in root system of trees

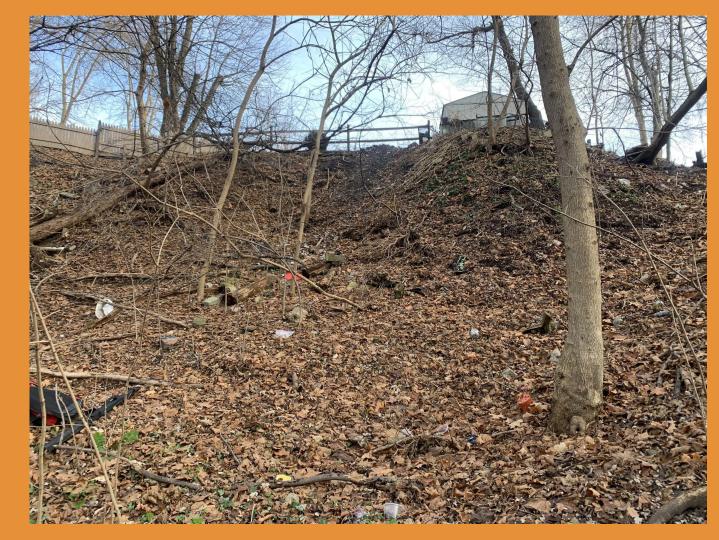
Trashed area along a steep bank near Courtdale Ave

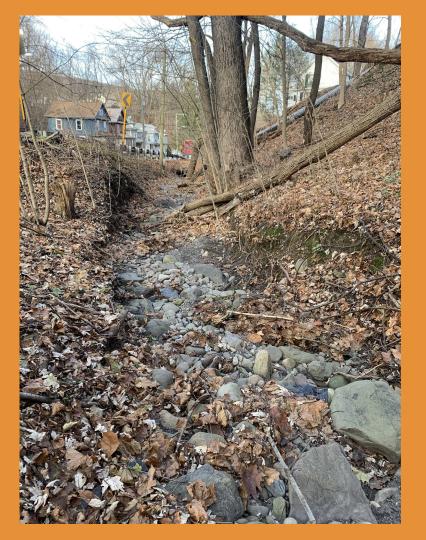
### Stream channel restoration potential along Courtdale Ave

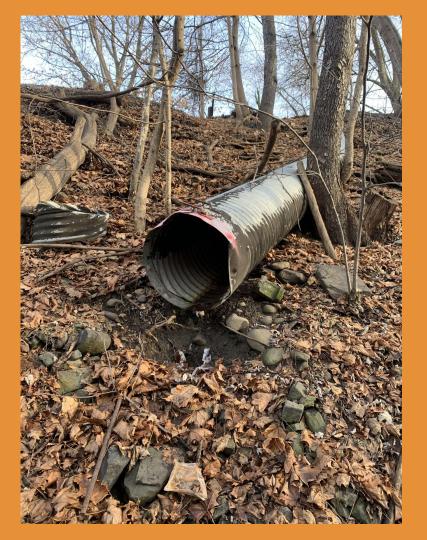
41.283156, -75.903995

Corrugated stormwater pipe from Valley View Drive

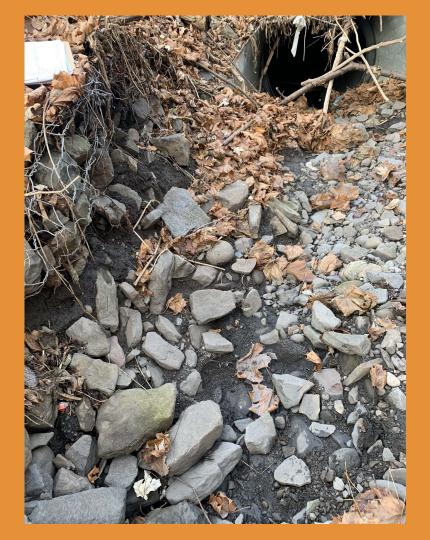
41.283149, -75.903989

#### Culvert along Courtdale Ave, above Cooper Street

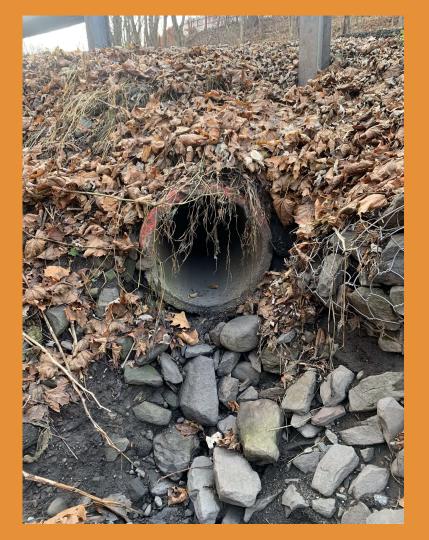
41.283509, -75.903877

#### Concrete stormwater pipe crossing Courtdale Ave

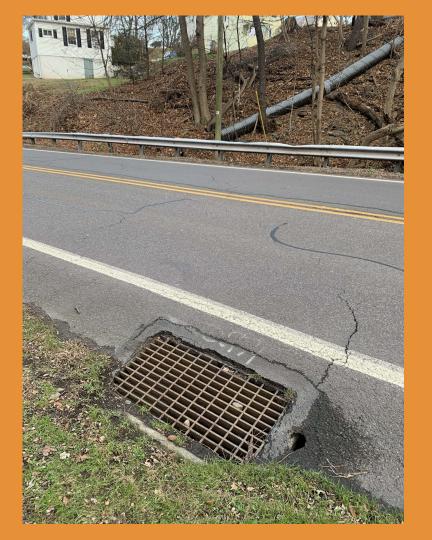
41.283509, -75.903877

Concrete stormwater pipe crossing Courtdale Ave

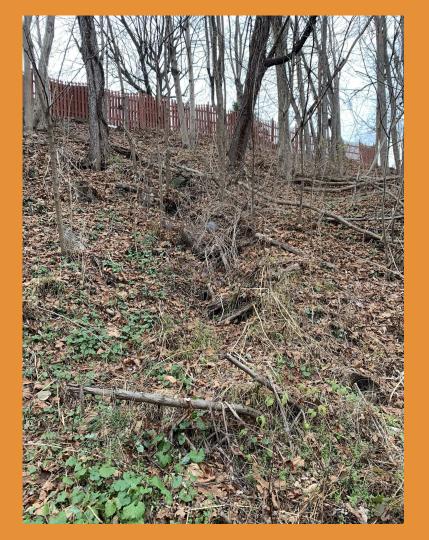
41.283527, -75.903933

Stormwater channel flowing from corner of Roy Street and Barry Street

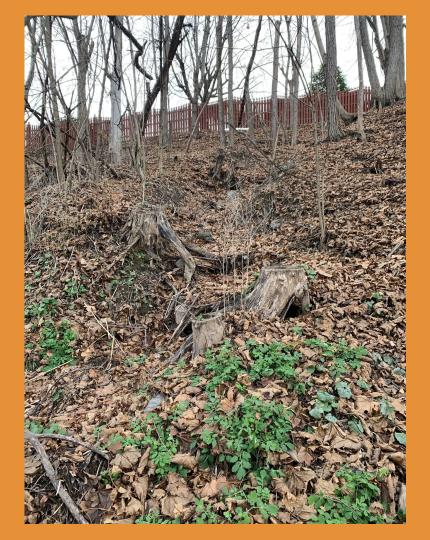
41.283527, -75.903933

Stormwater channel flowing from corner of Roy Street and Barry Street

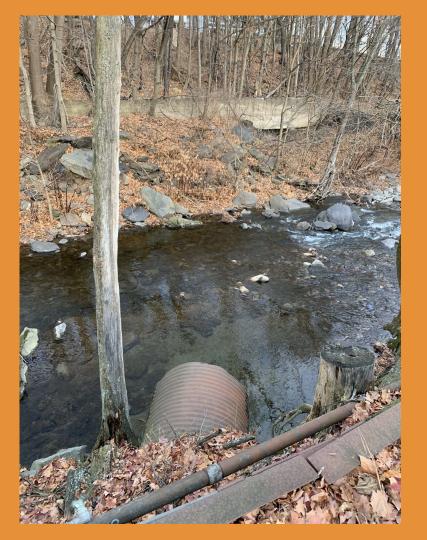
41.285760, -75.900998

Outlet pipe from Courtdale Ave to Toby Creek, beneath the Skovish Pools parking lot
