# Huntsville Golf Course Headwater Tributaries flowing into the Huntsville Creek Watershed

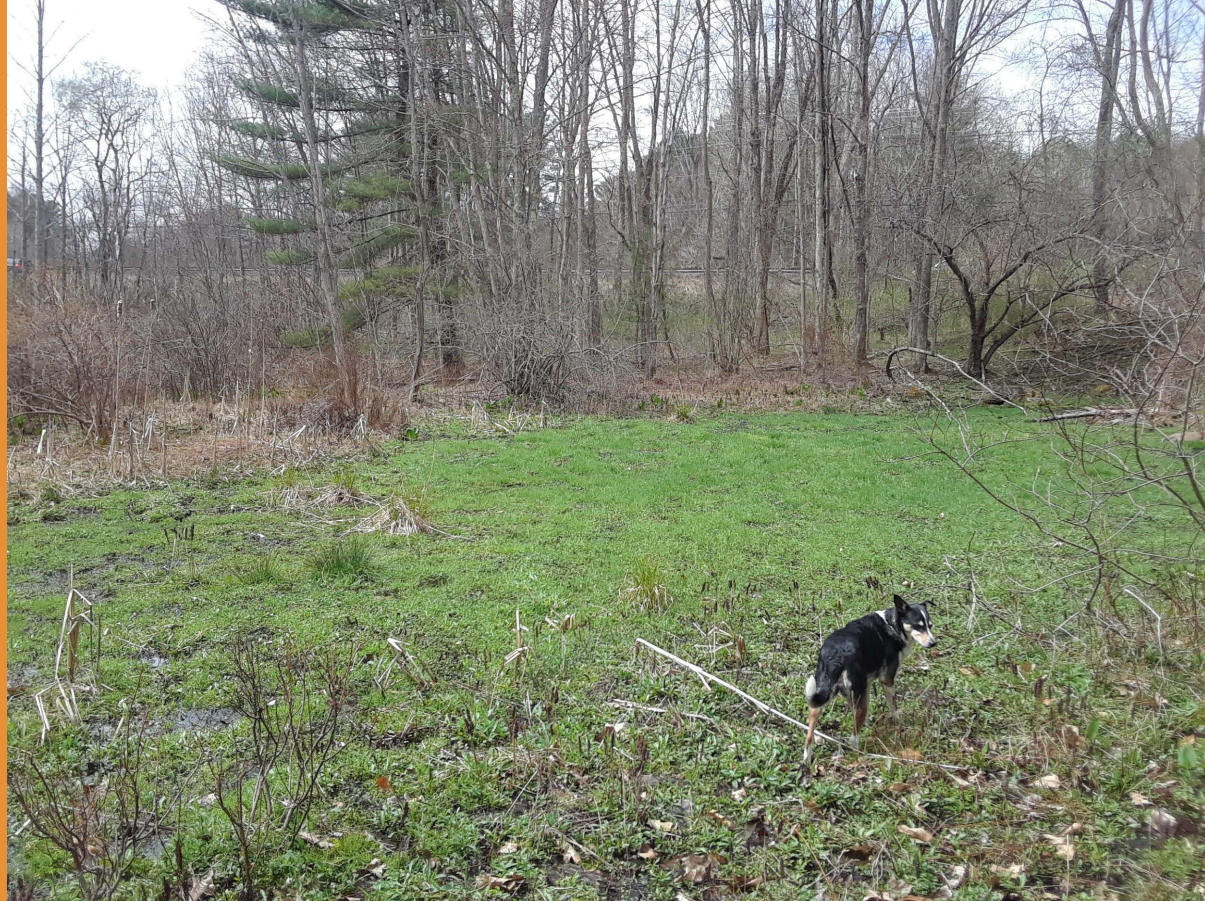
# Figure 1

Headwaters of unnamed tributary (UNT) through Huntsville Golf Club, further upstream it passes under 118

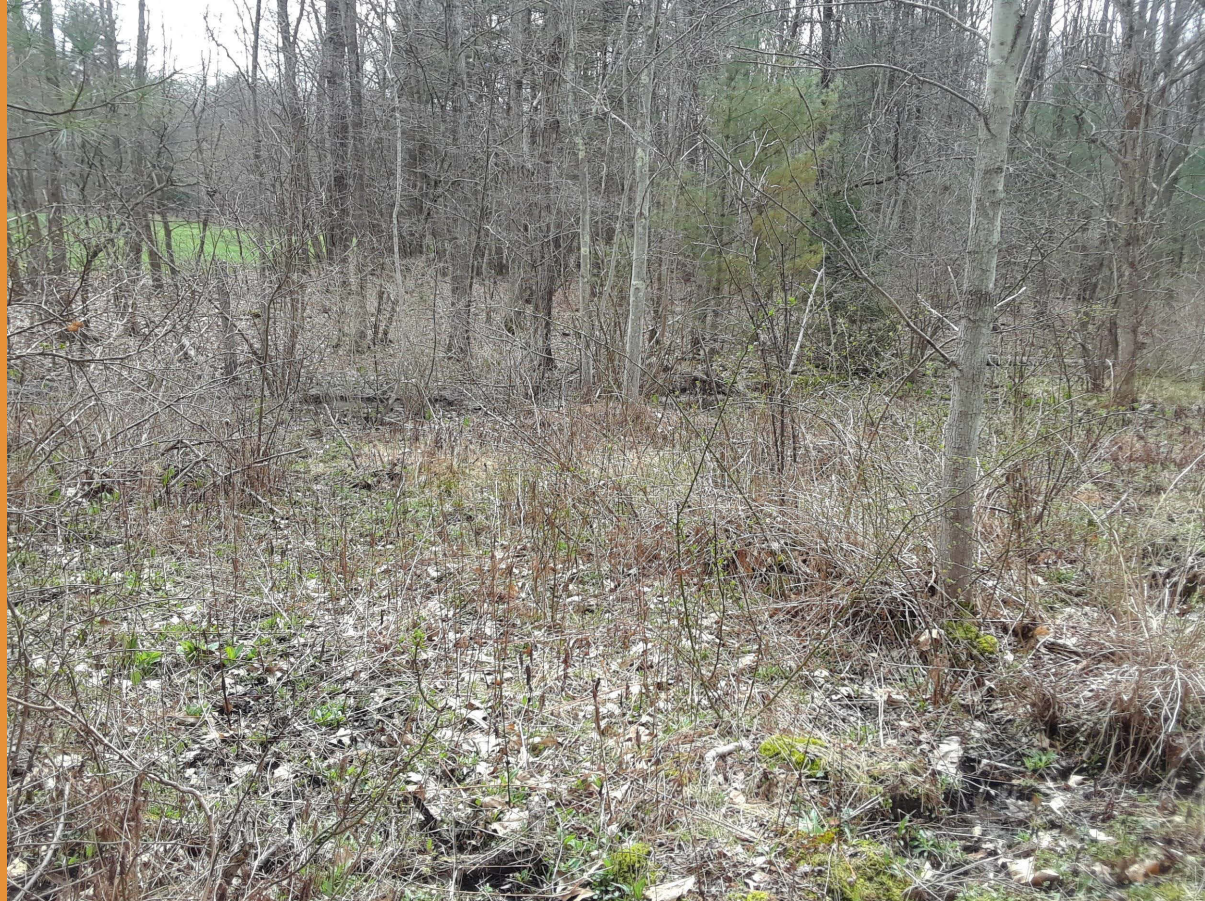
## Figure 2

More headwaters  
downstream from Fig. 1

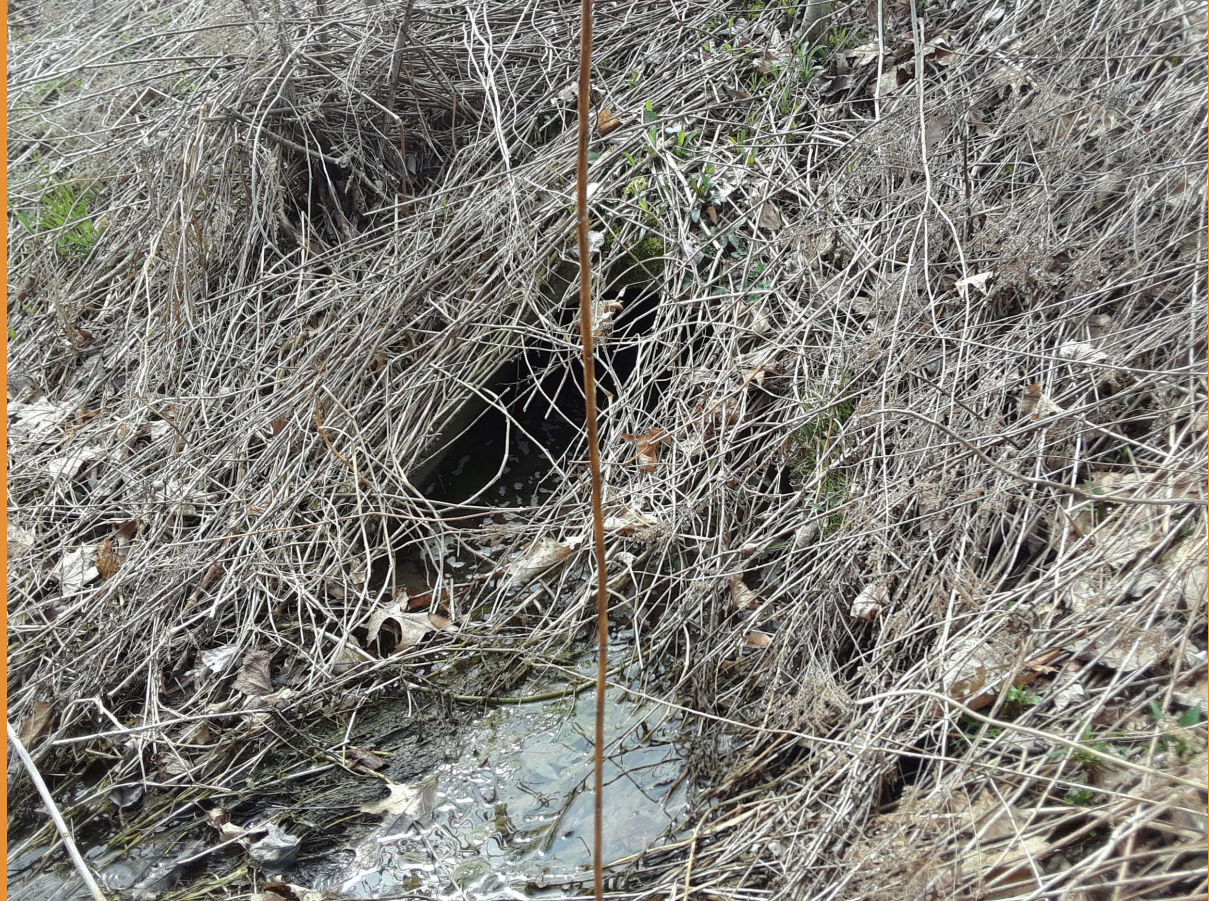
# Figure 3

Headwaters entering  
UNT on golf club near  
Route 118

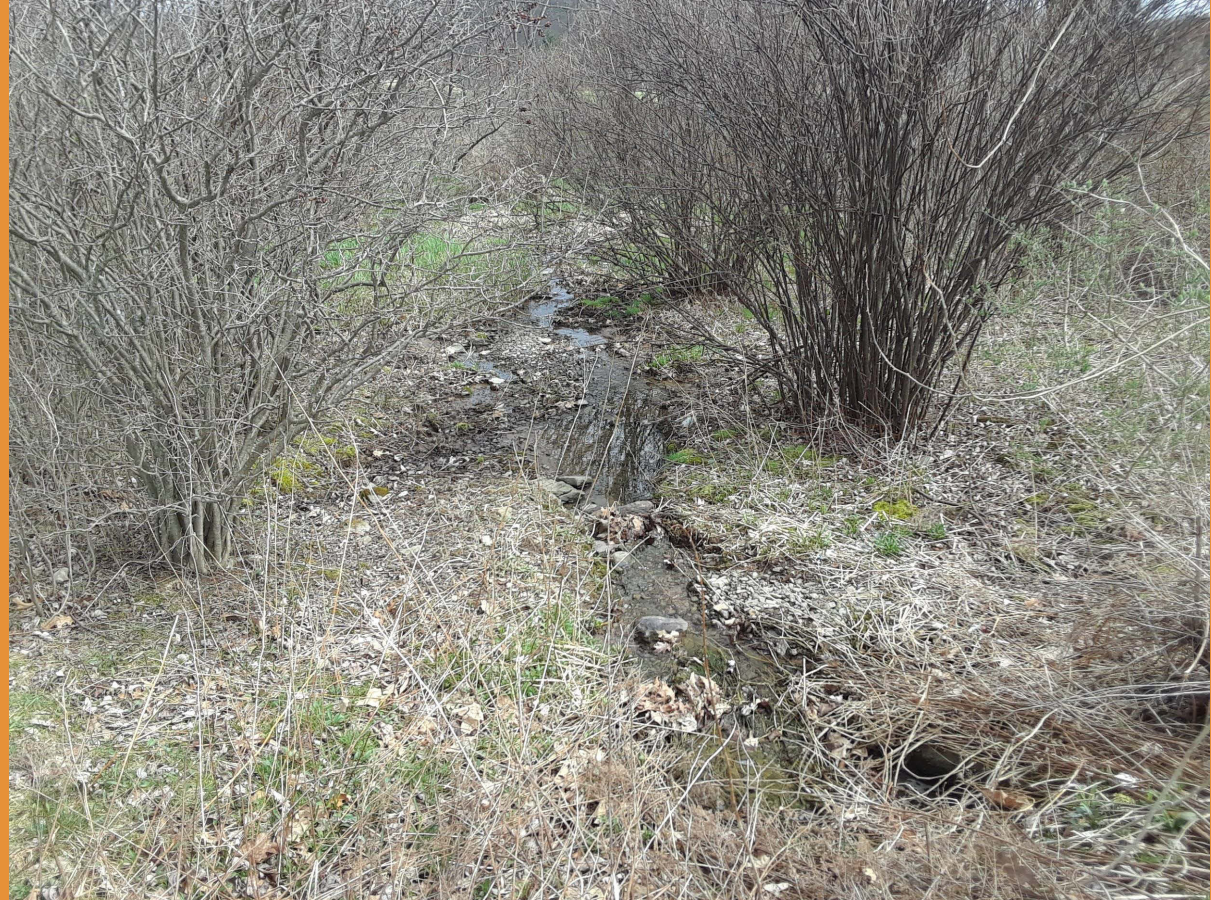
# Figure 4

Downstream view of UNT  
passing further into golf  
club.

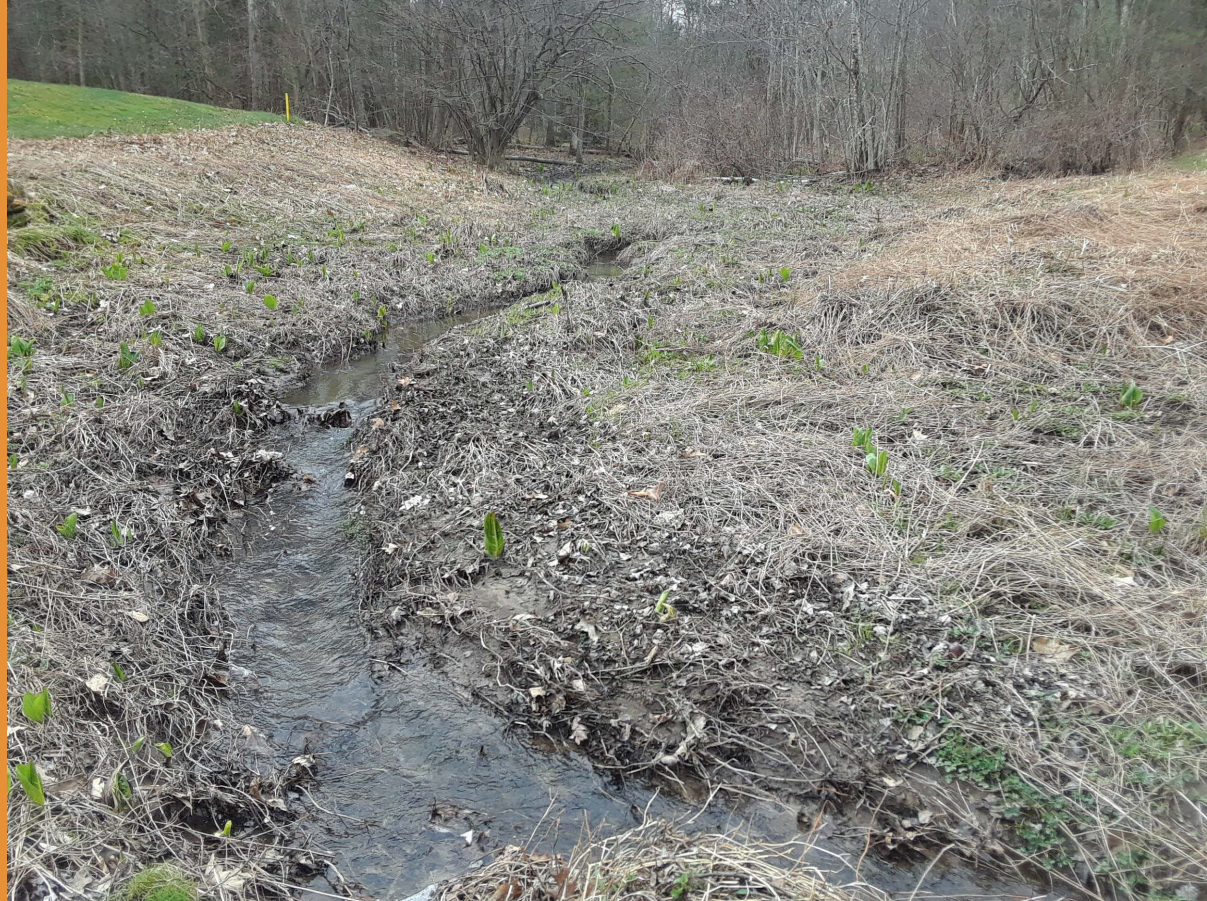
# Figure 5

Upstream view of UNT  
meandering through golf  
club.

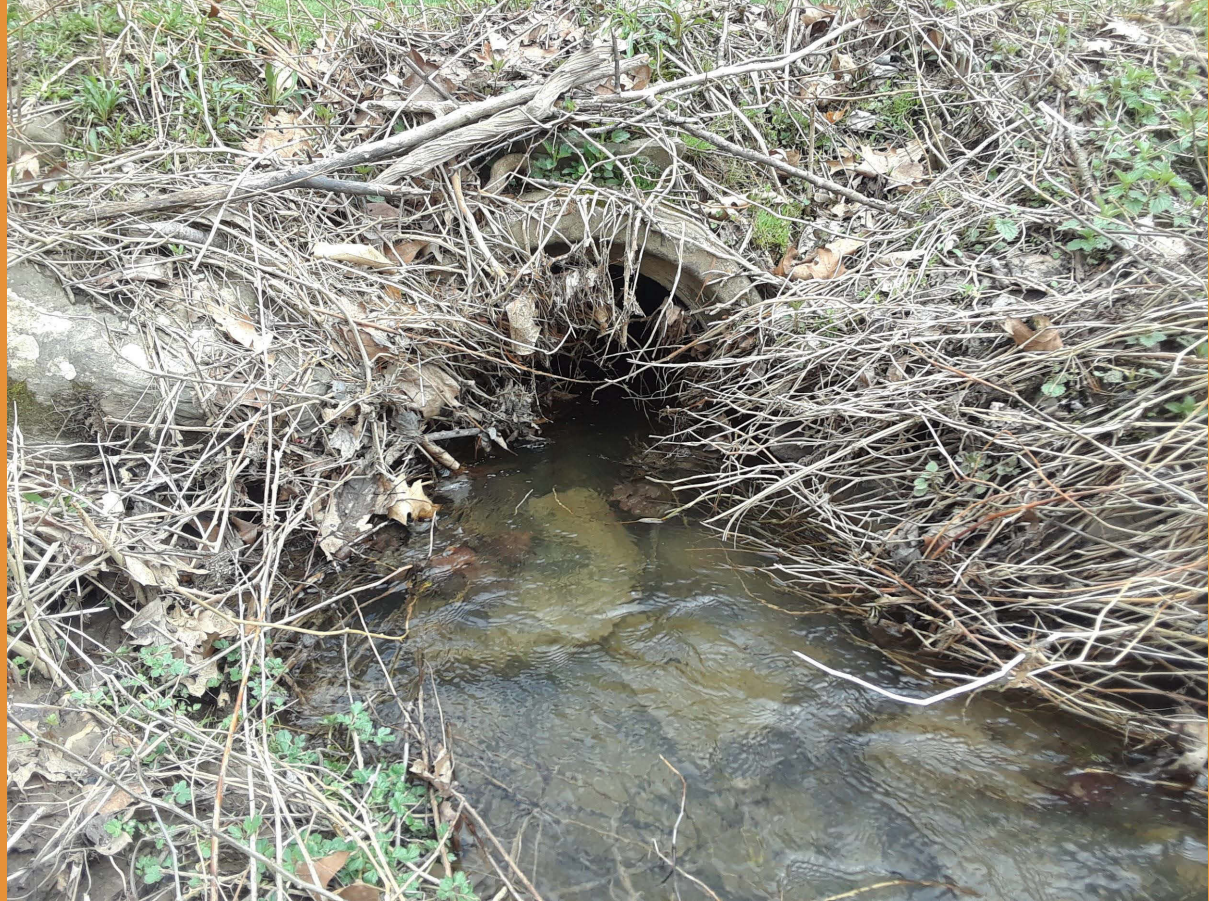
## Figure 6

Downstream view of UNT entering concrete pipe under path in golf club.

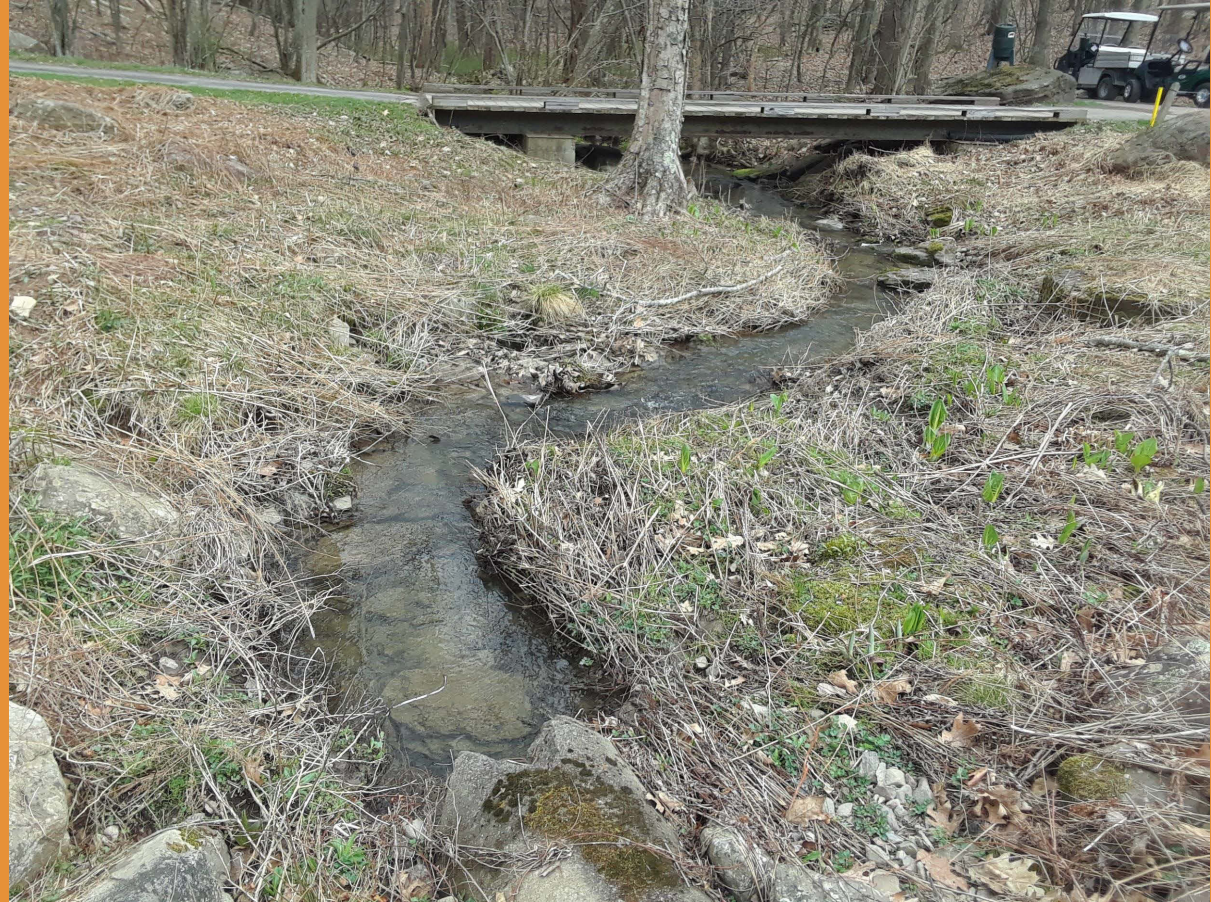
# Figure 7

Downstream view of UNT passing through concrete pipe and then under bridge

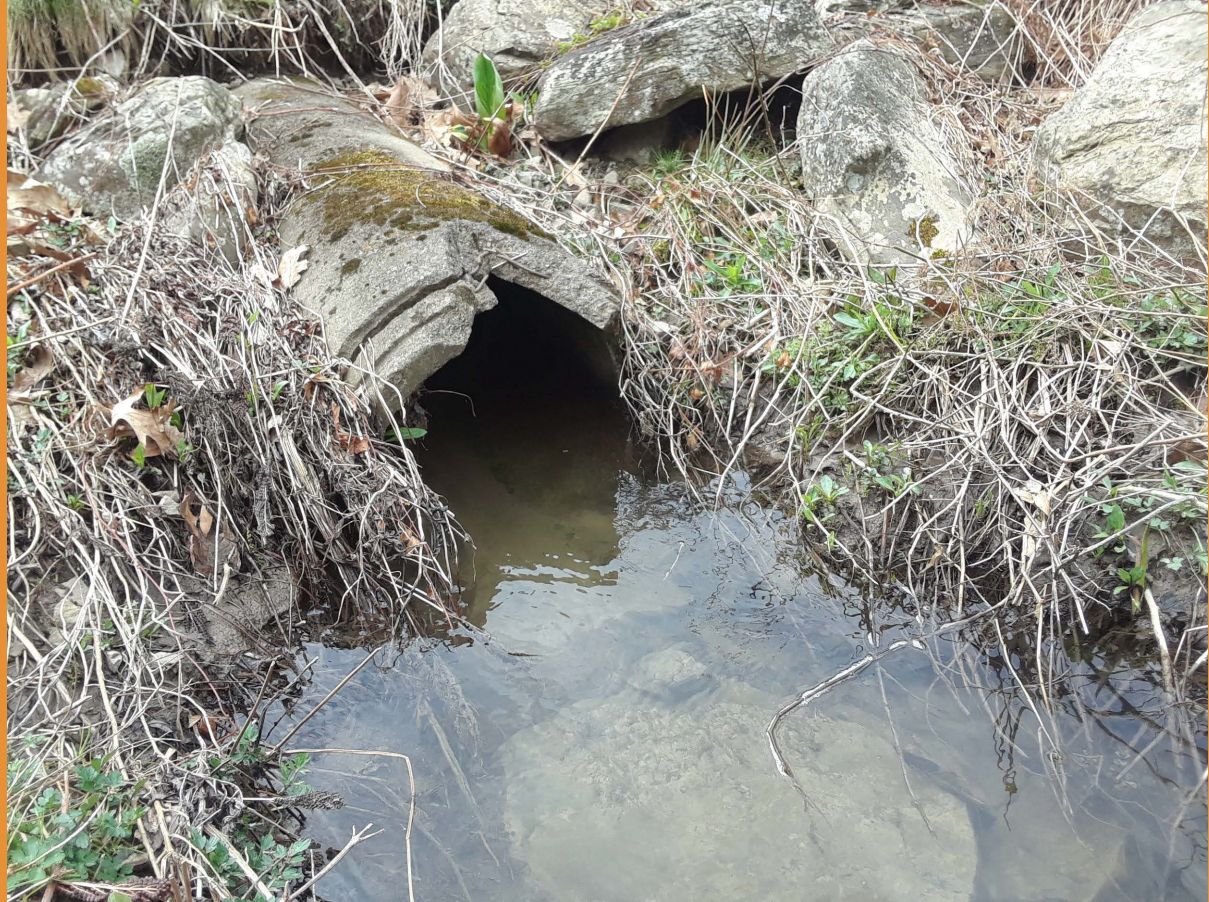
# Figure 8

Upstream view of pipe in  
Fig. 7, slightly broken and  
filled with sediment

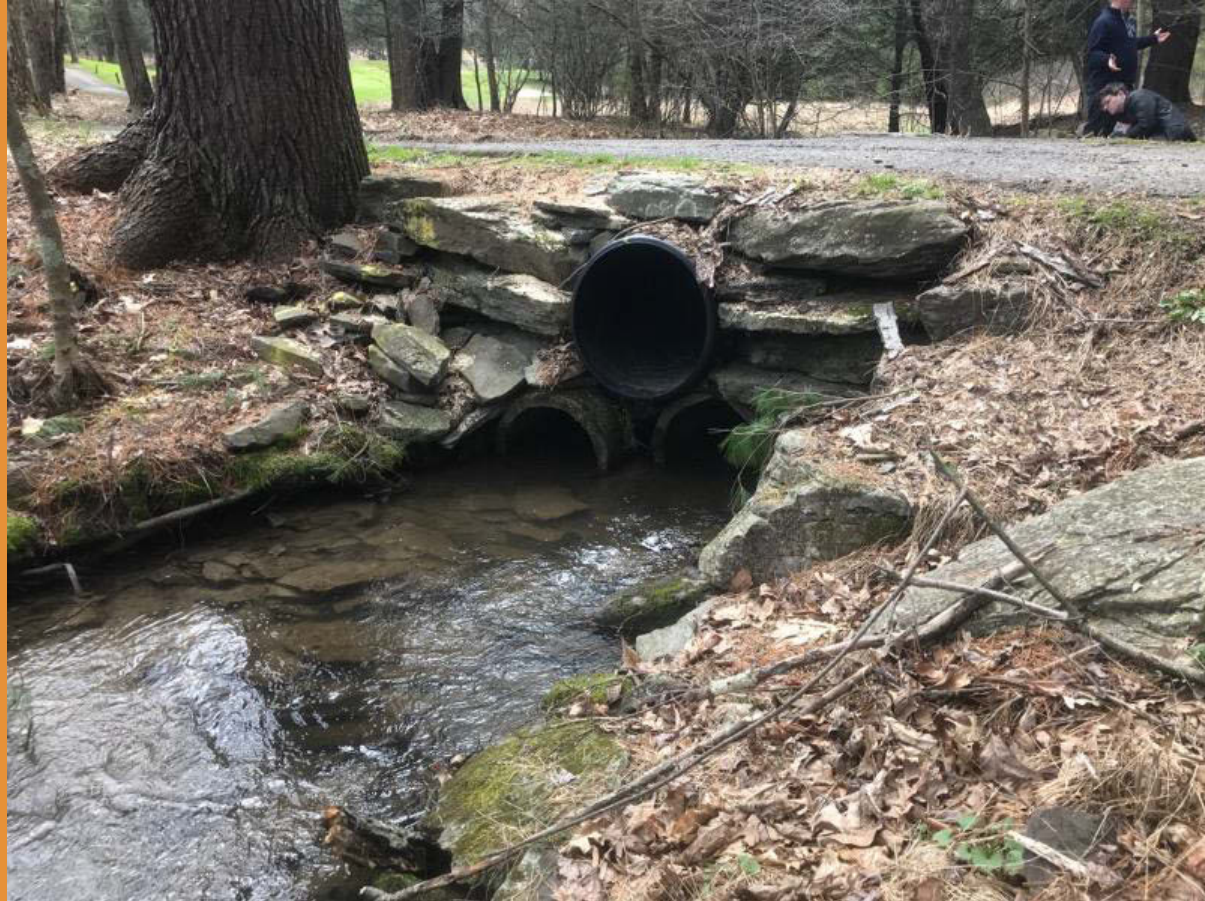
## Figure 9

Downstream view of UNT in Fig. 3-8: Further downstream, passing through two concrete pipes, with one HDPE pipe for high flow

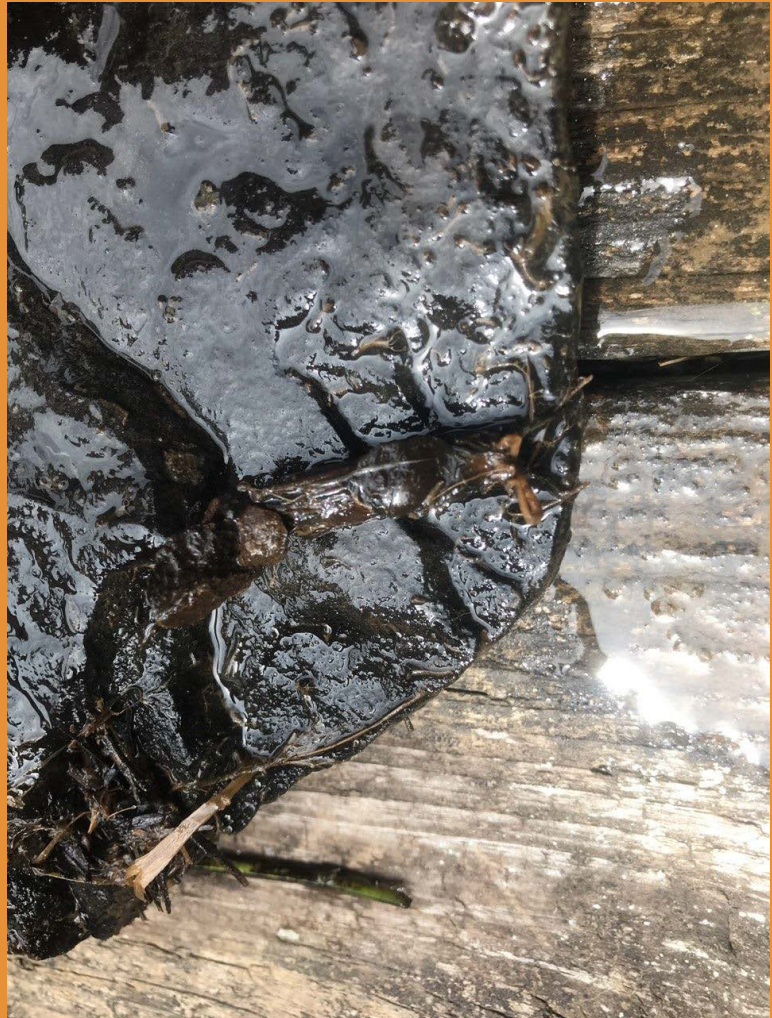
# Figure 10

Photo of stick-building  
caddisfly in UNT in Fig. 9

Further upstream from  
Fig. 9, a footpath  
obstructs flow.

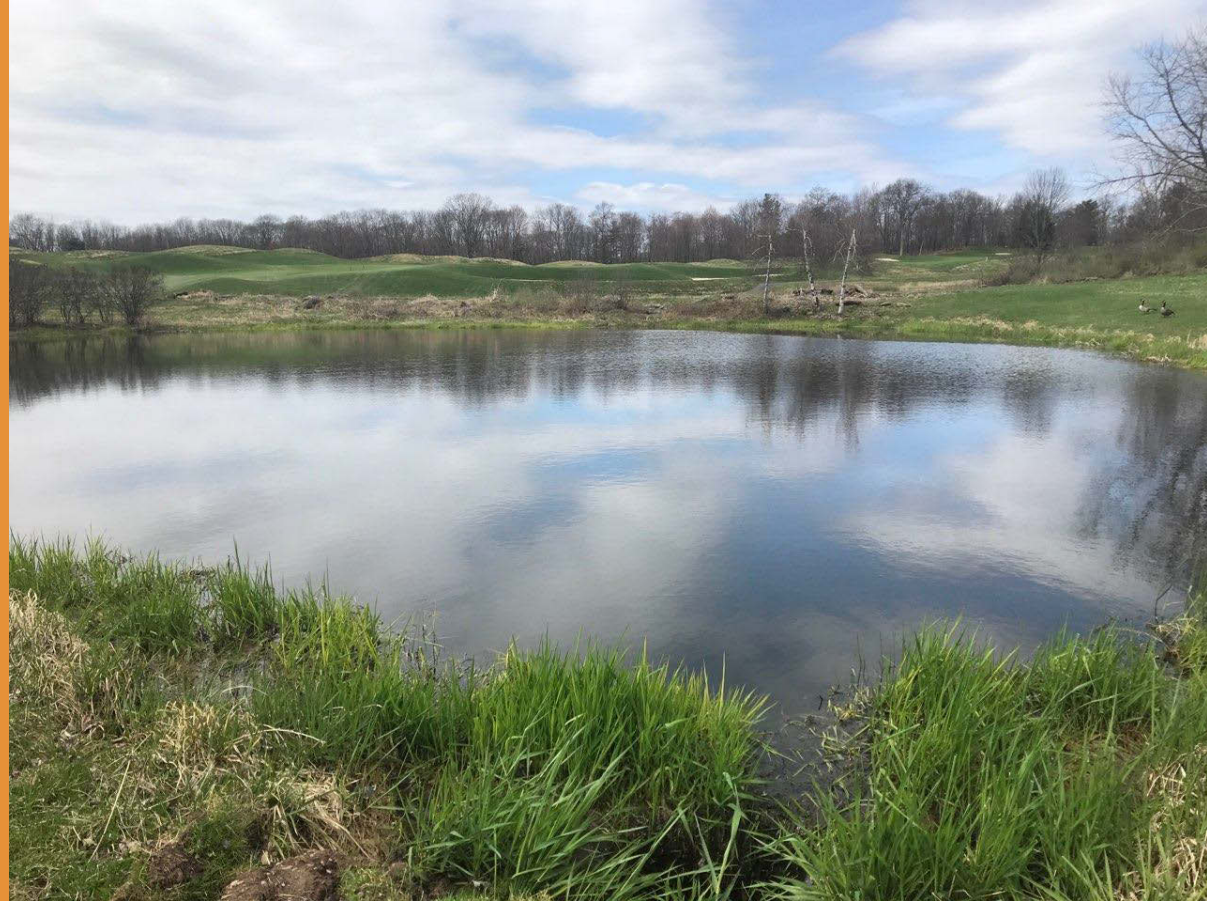
# Figure 11

Two ponds on one side of cart path, not part of golf club property, all drain toward Rte. 115

Winged culvert carries small UNT from here to second pond

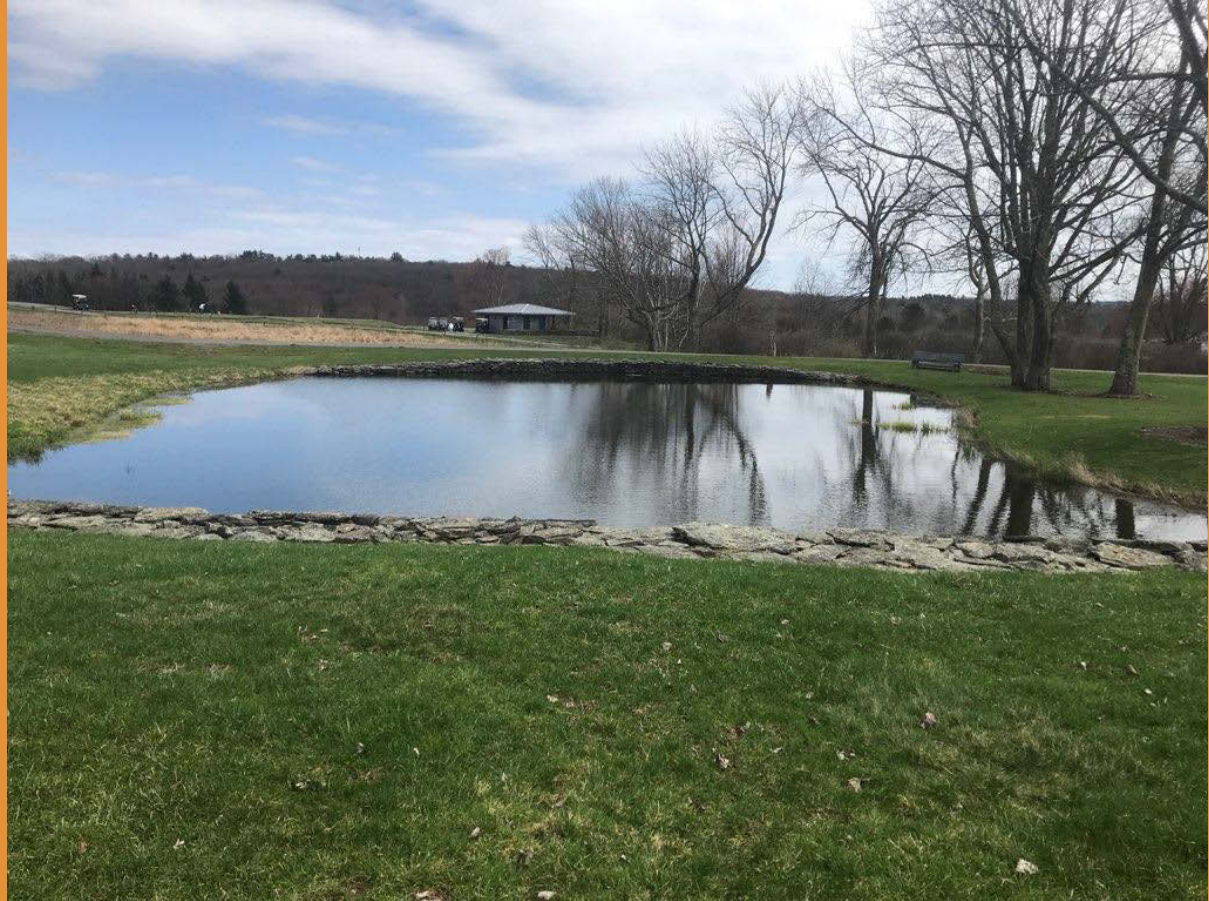
# Figure 12

Second pond near golf club, connected to first with winged culvert

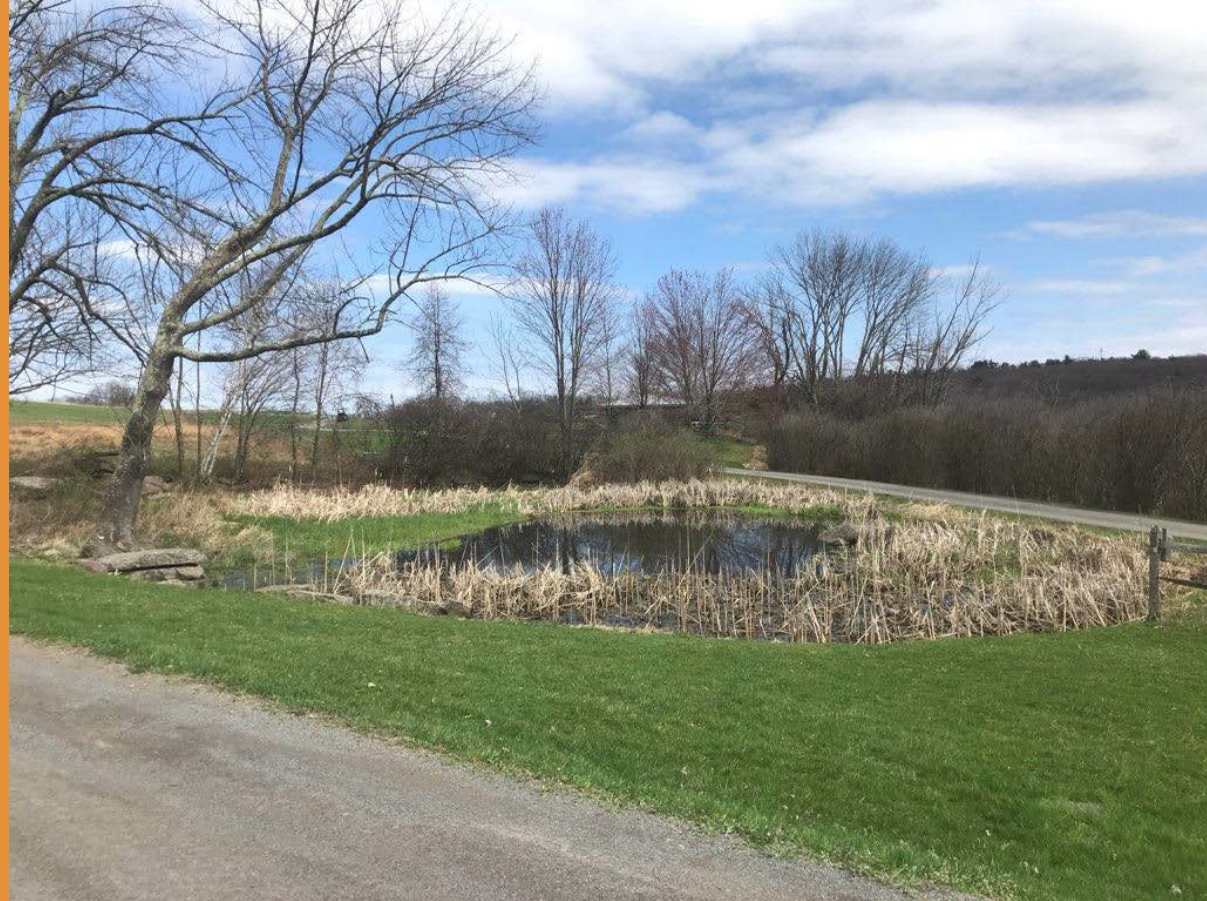
# Figure 13

Third pond on other side  
of cart path with drain  
from Fig. 13, also drains  
to Rte. 115

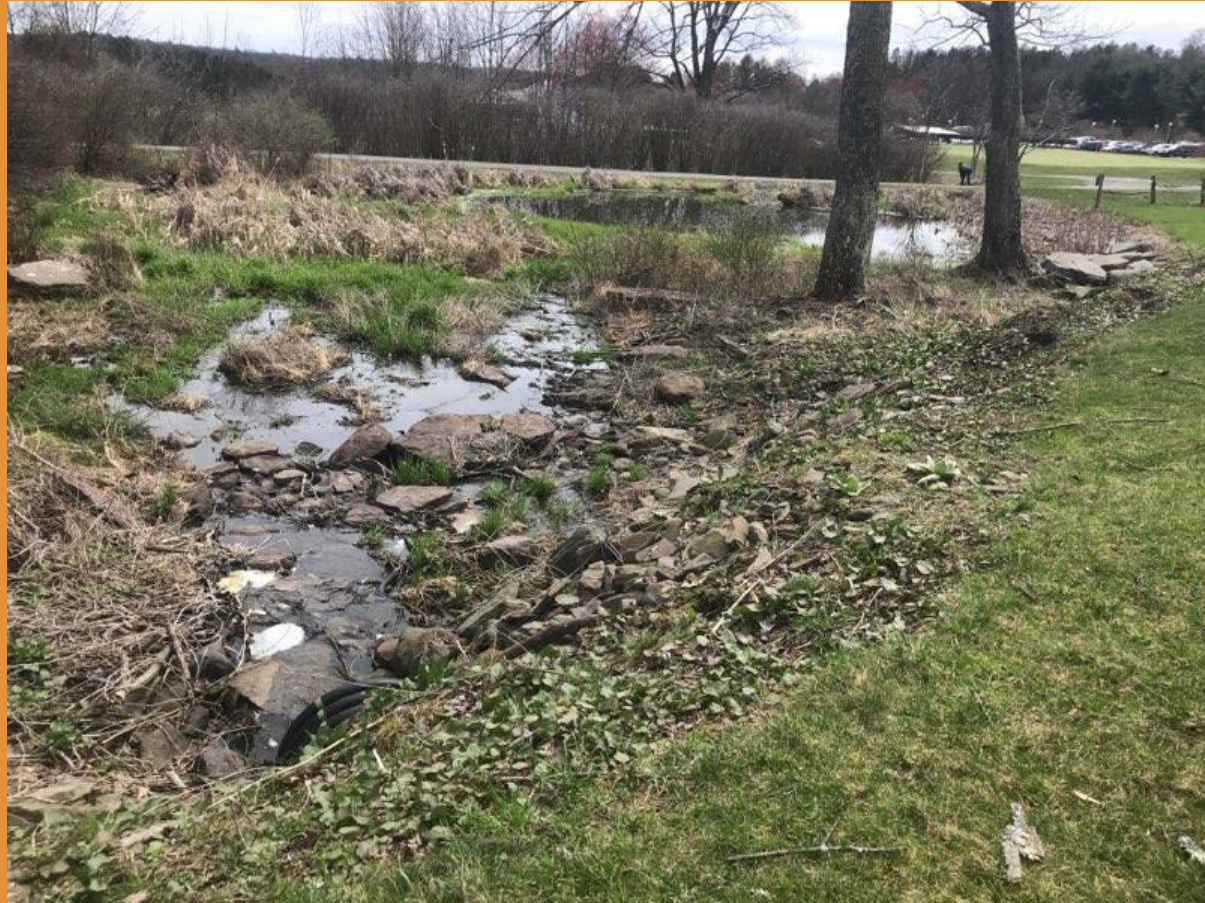
# Figure 14

Downstream view of  
drainage from pond in  
Fig. 12 to pond in Fig. 13

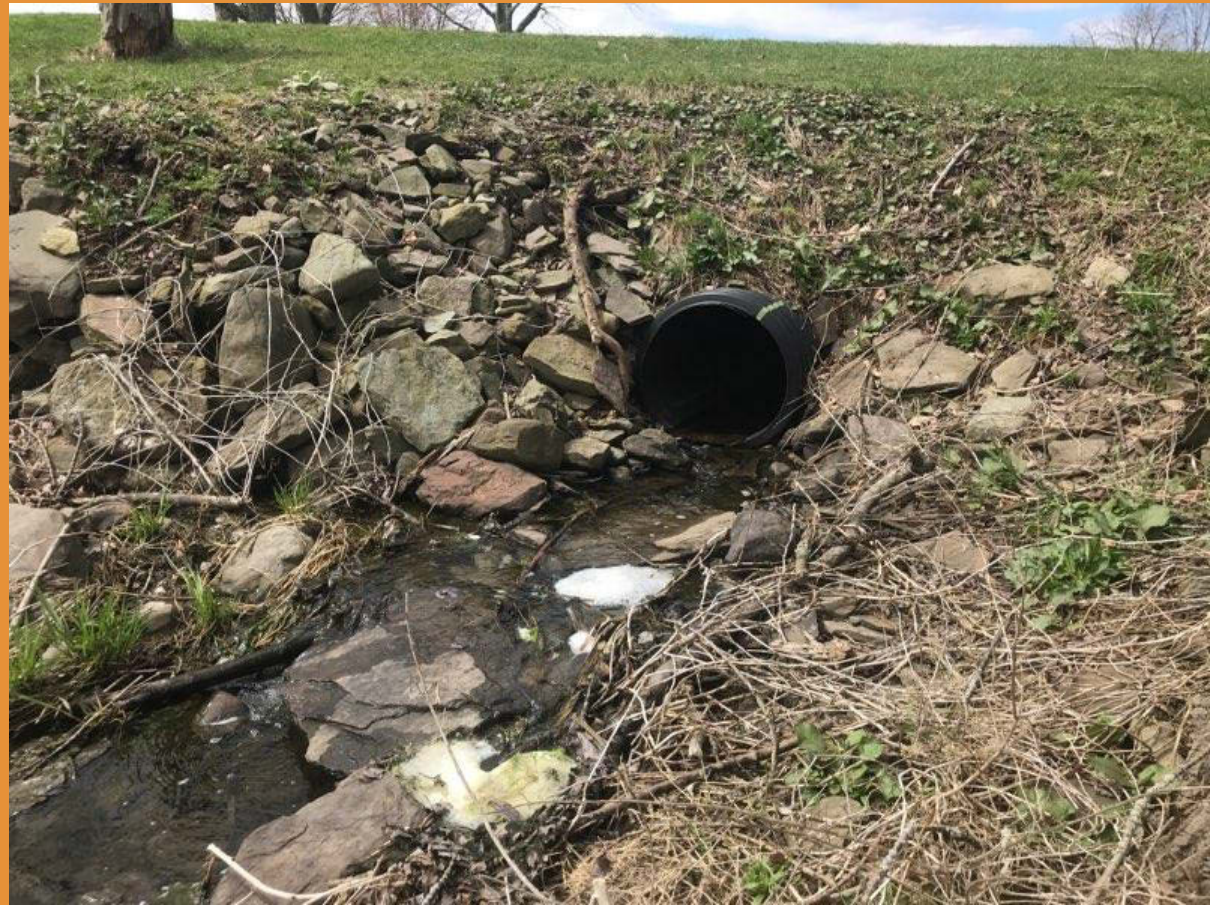
# Figure 15

Upstream view of HDPE pipe in Fig. 14

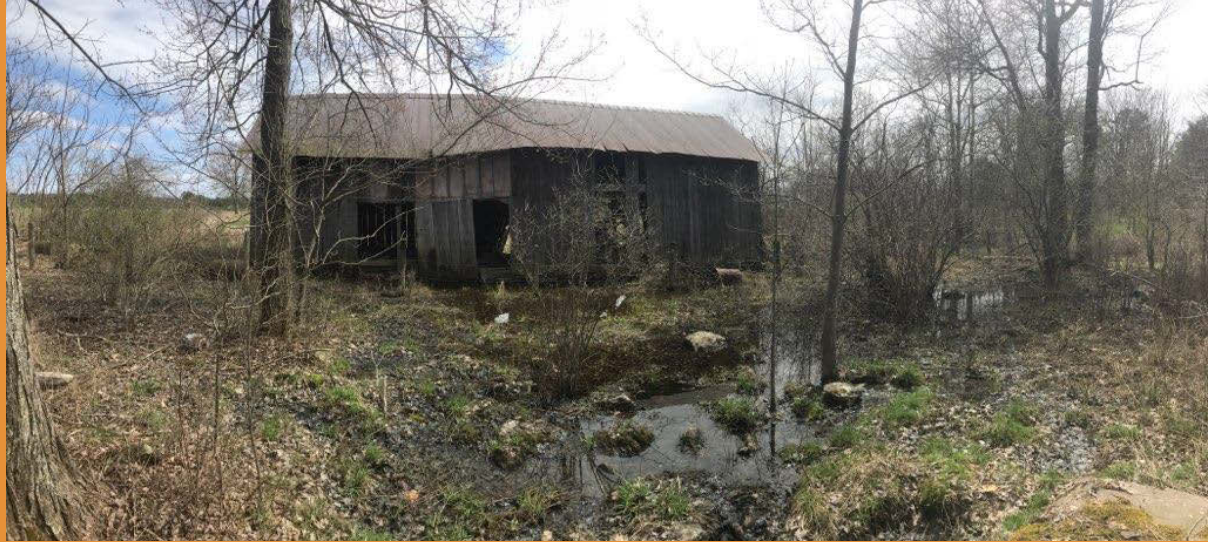
# Figure 16

Abandoned barn on golf club with UNT and headwaters that drain toward Rte. 115

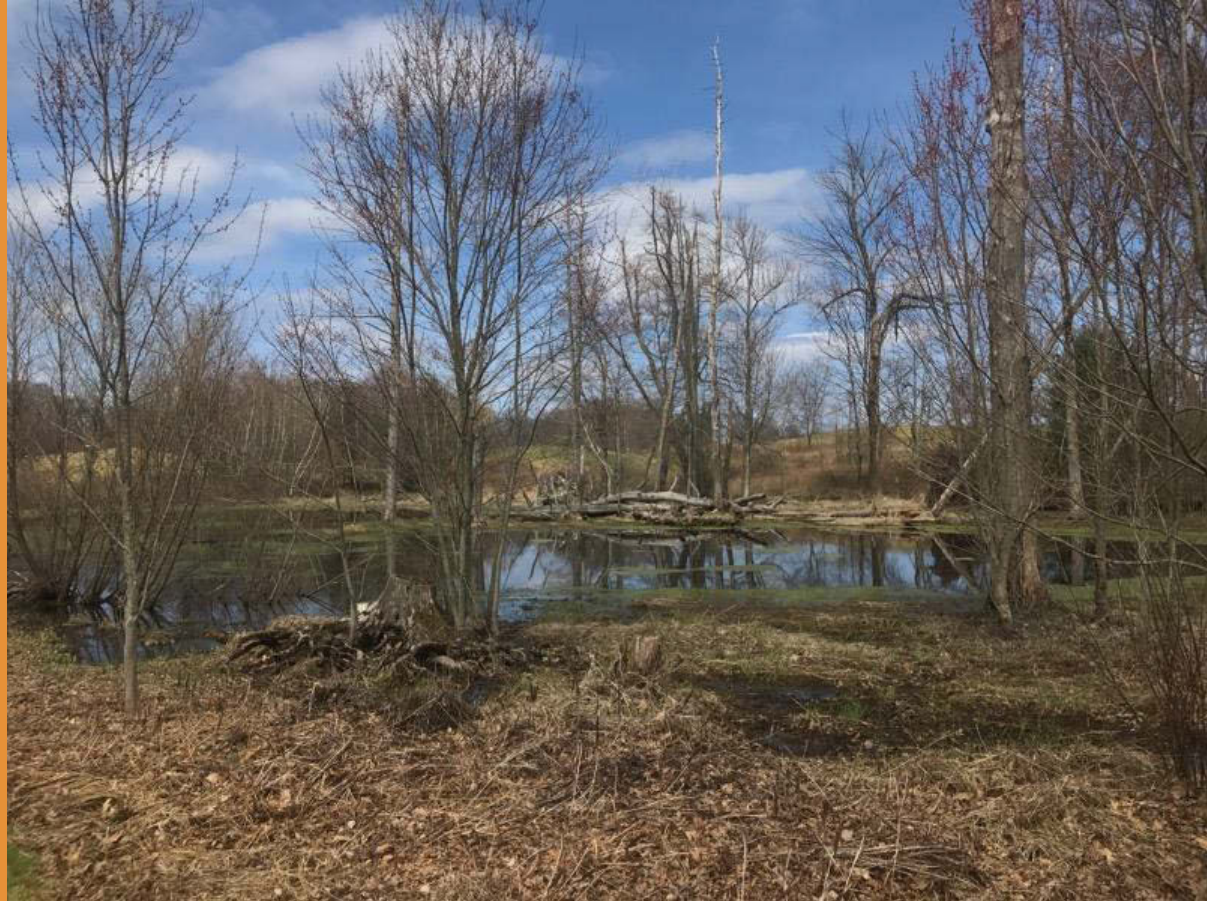
# Figure 17

Large pond near Fig. 16  
with drainage pump that  
carries excess flow to  
other wetlands closer to  
Rte. 115

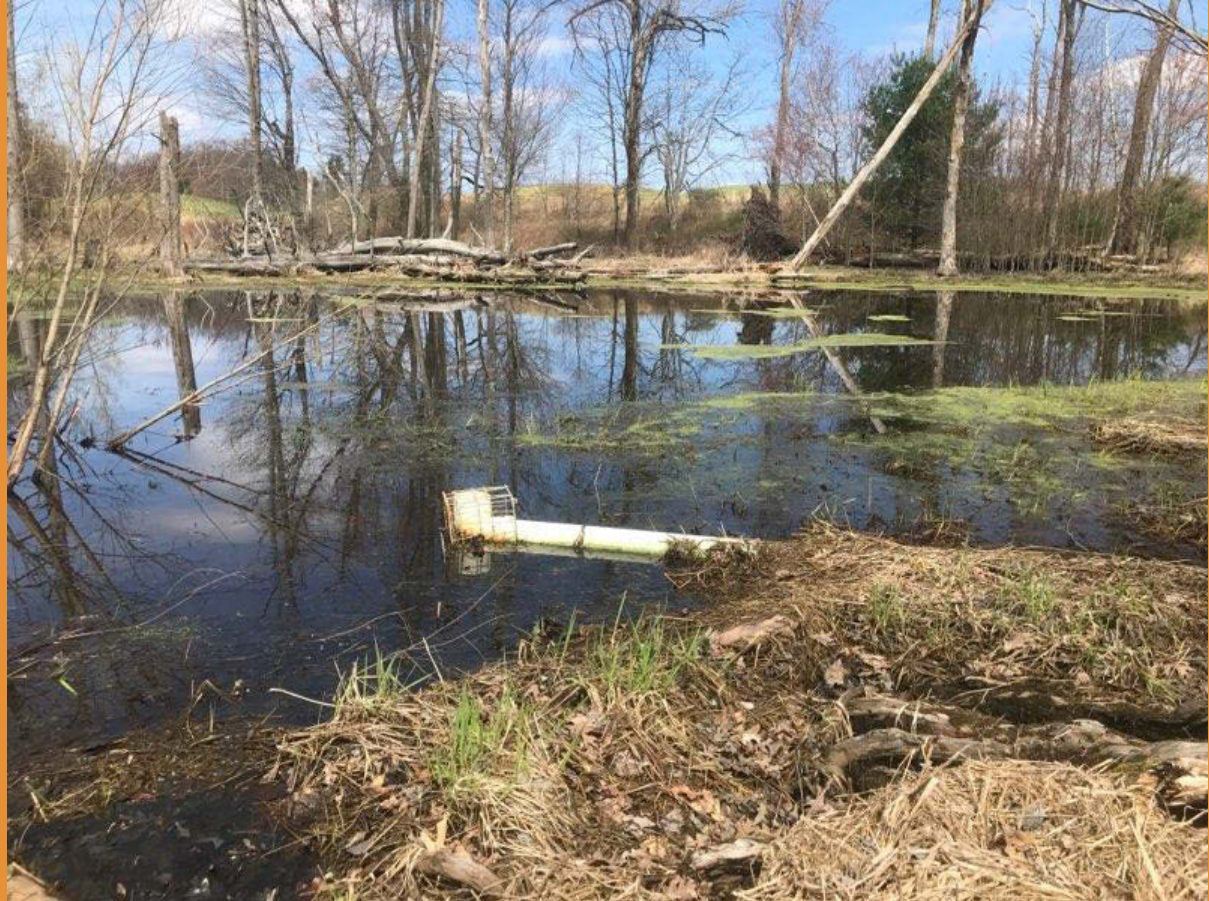
# Figure 18

View of pump in pond in  
Fig. 17 that carries  
excess flow

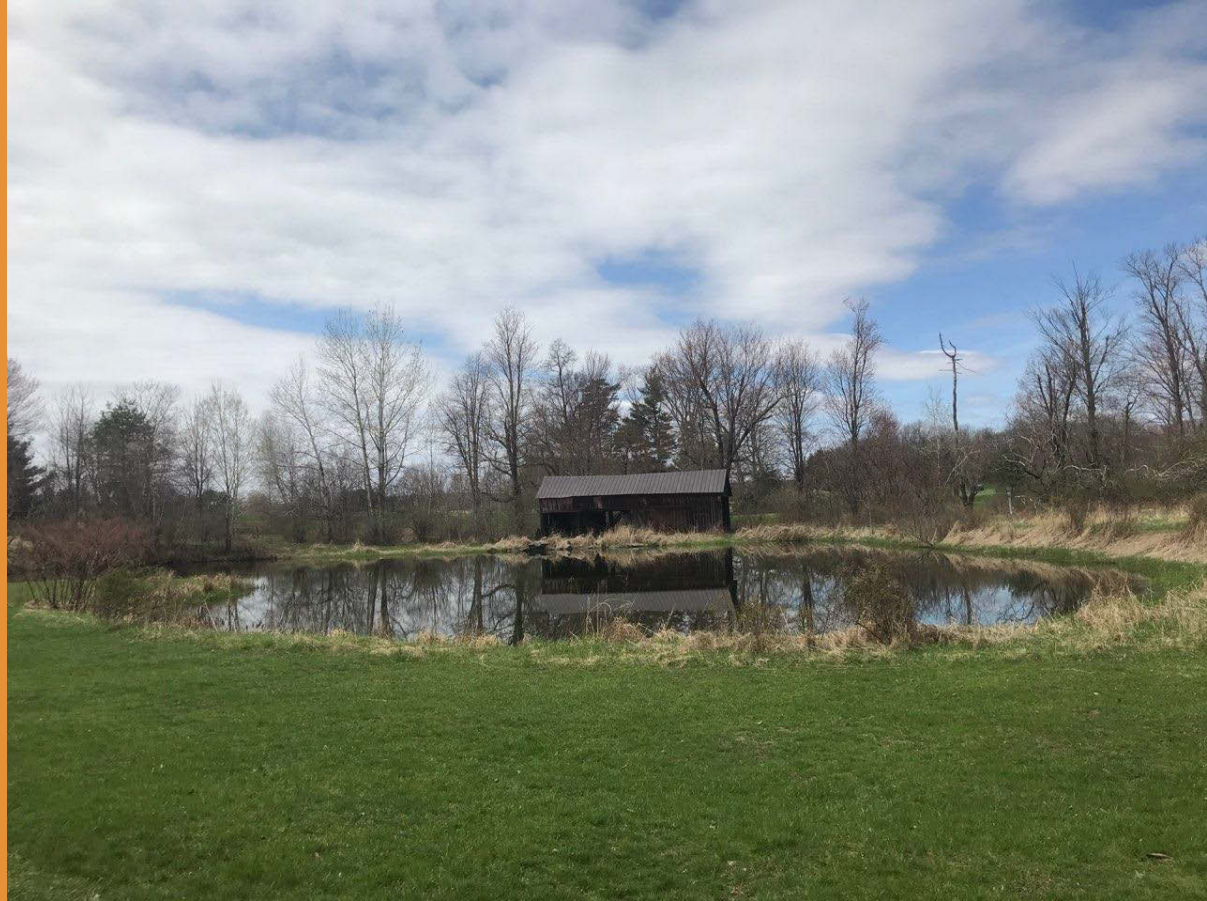
# Figure 19

Another pond near Fig.  
16-19, also drains toward  
Rte. 115

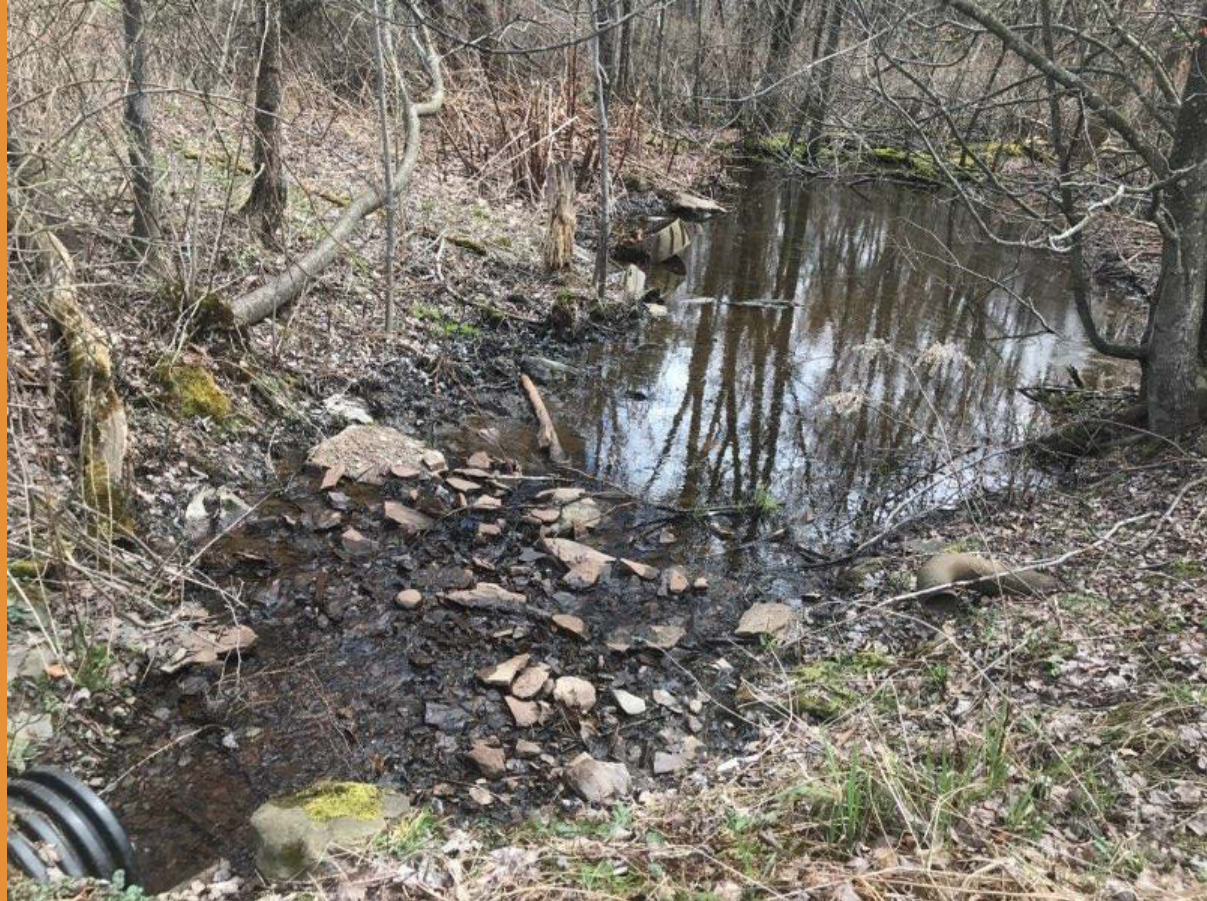
## Figure 20

Downstream view of HDPE pipe that carries excess flow from pond in Fig. 17-18 into wetlands that drain toward Rte. 115

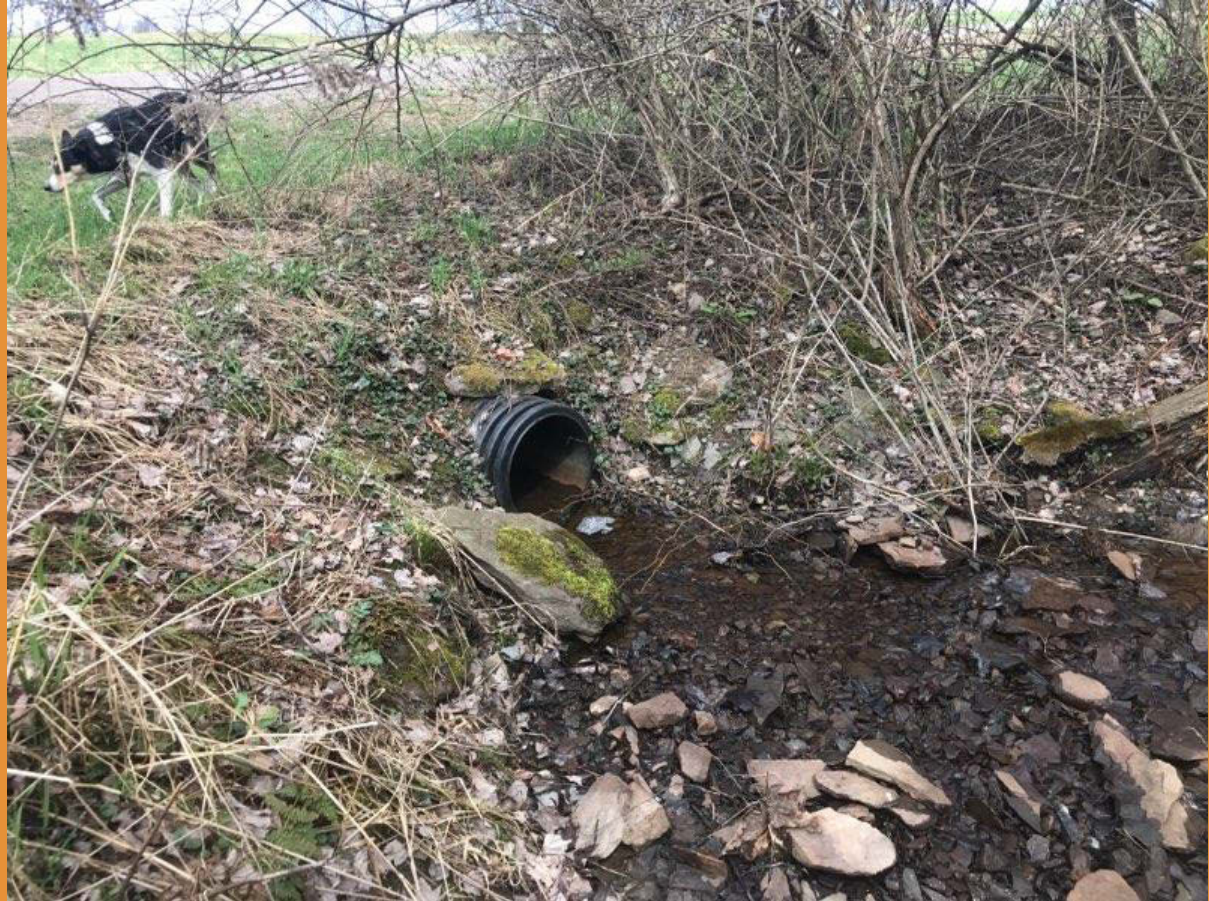
# Figure 21

Downstream view of  
HDPE pipe in Fig. 20 and  
the golf club's dog
