# Huntsville Golf Course Headwater Tributaries flowing into the Huntsville Creek Watershed

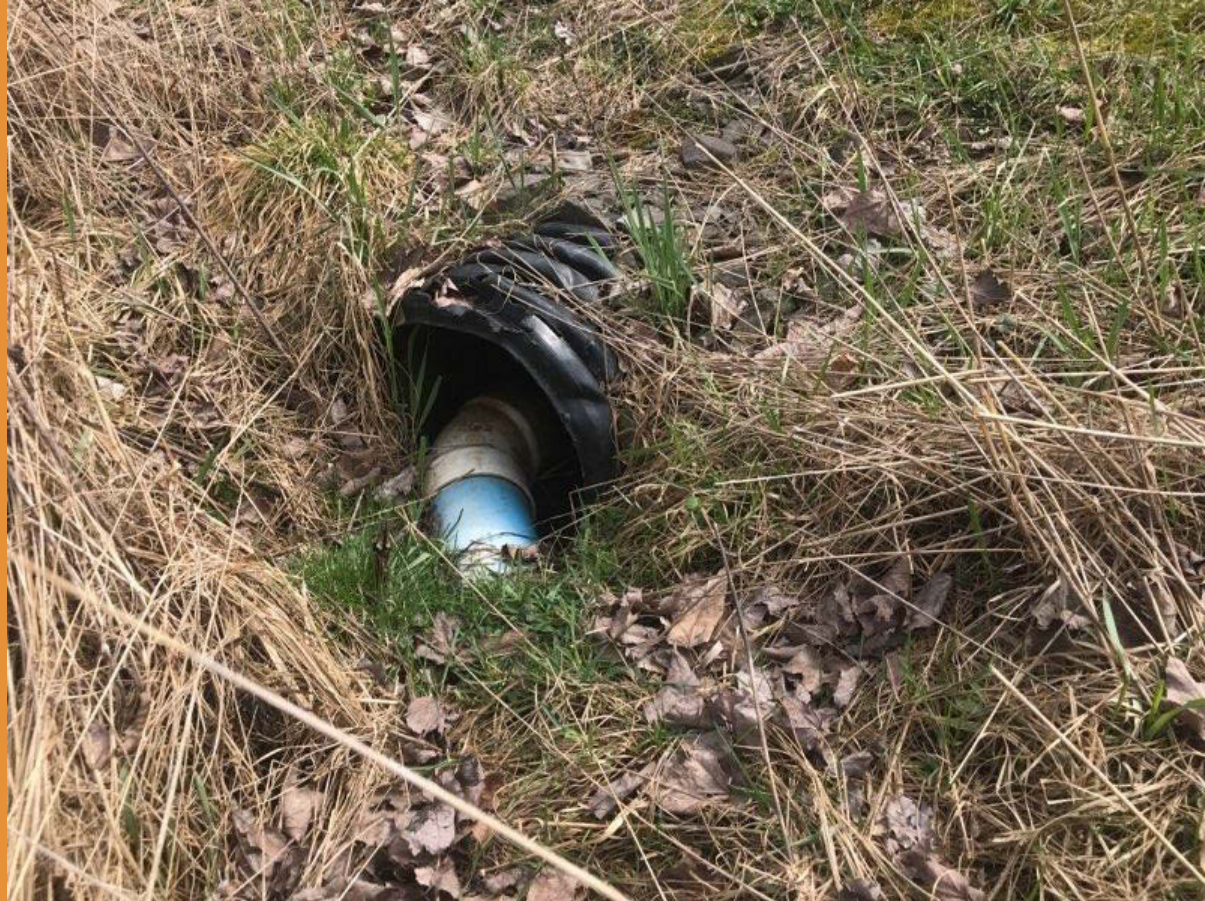
## Figure 22

View of HDPE pipe on other side of cart path that receives the pump used in the pond in Fig. 17-18

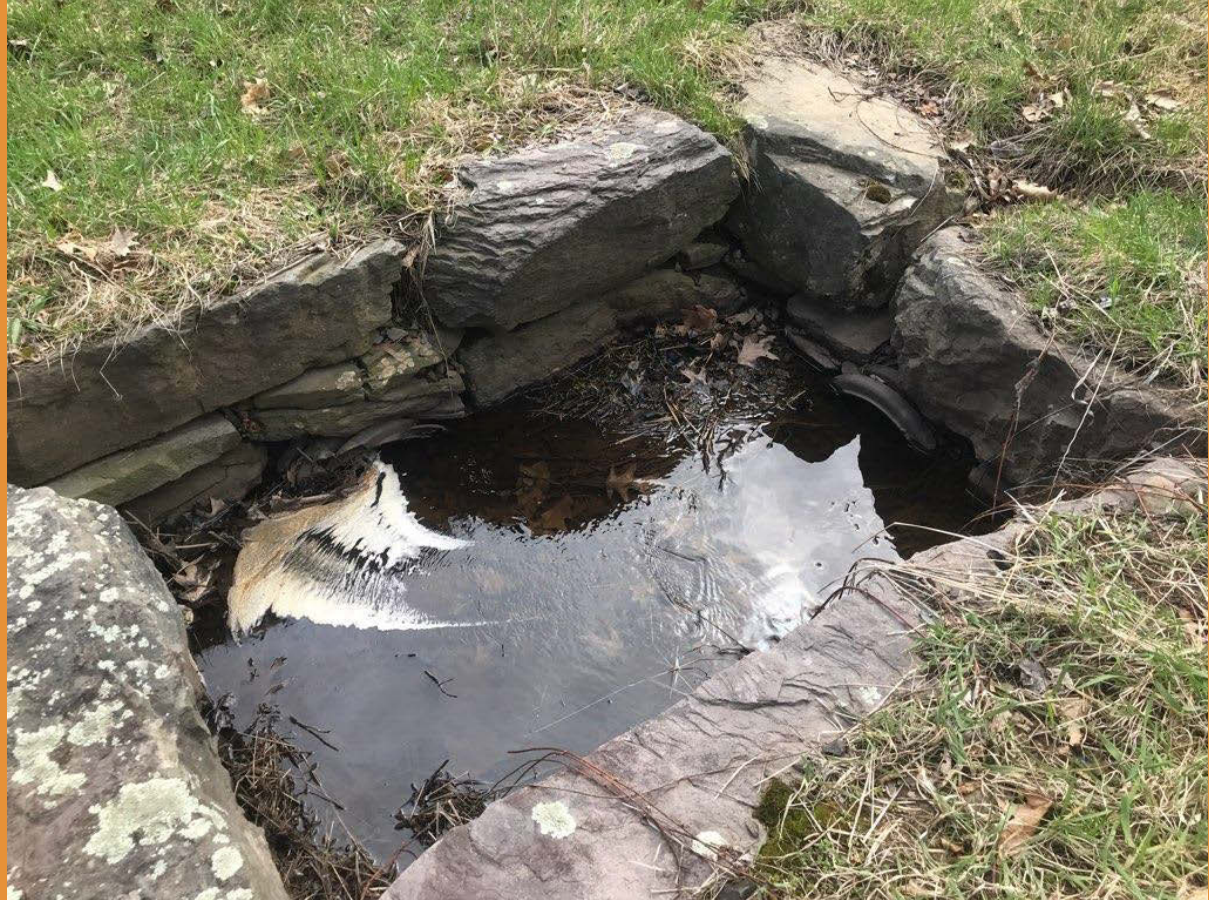
## Figure 23

View of drop-in culvert  
that carries flow from  
wetlands in Fig. 20-21  
further toward Rte. 115

Full of sediment and  
prone to flooding in high  
flow events

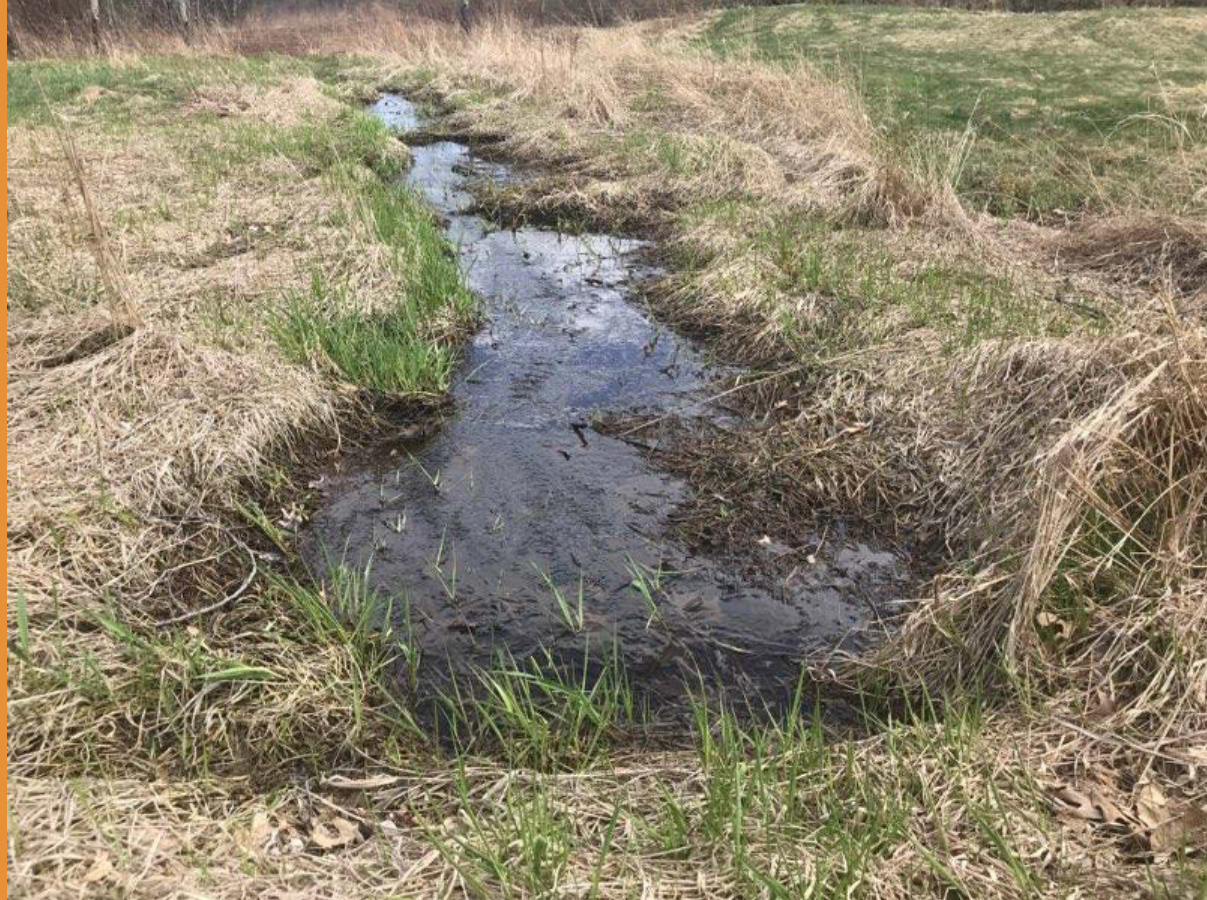
# Figure 24

Downstream view of UNT  
from Fig. 23 after it  
passes under cart path  
(very entrance of GC)

Pipe is buried under soil  
and sediment

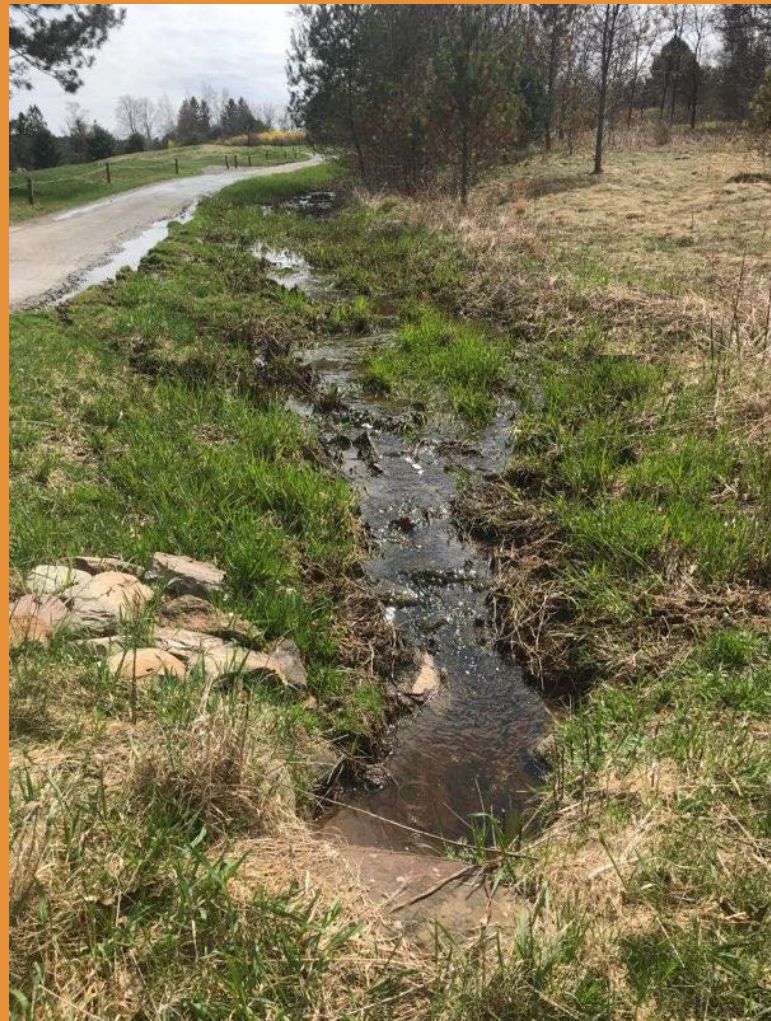
## Figure 25

Upstream view of UNT further DS from Fig. 24 after it enters the GC

Manager commented that flow often crosses cart path, wondered how to improve

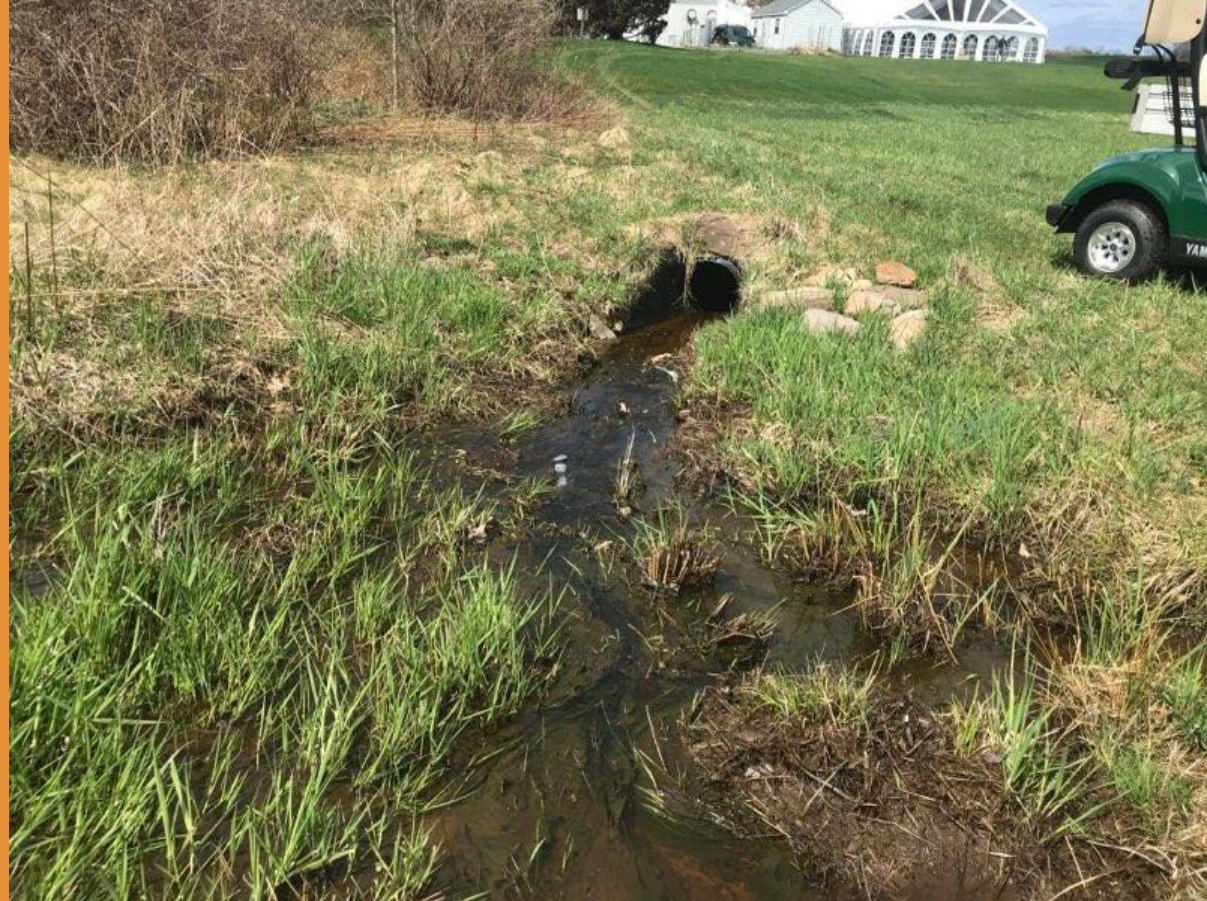
## Figure 26

Downstream view of UNT  
in Fig. 25 as it enters  
HDPE before being  
buried under golf club,  
then draining into  
wetlands closer to Rte.  
115

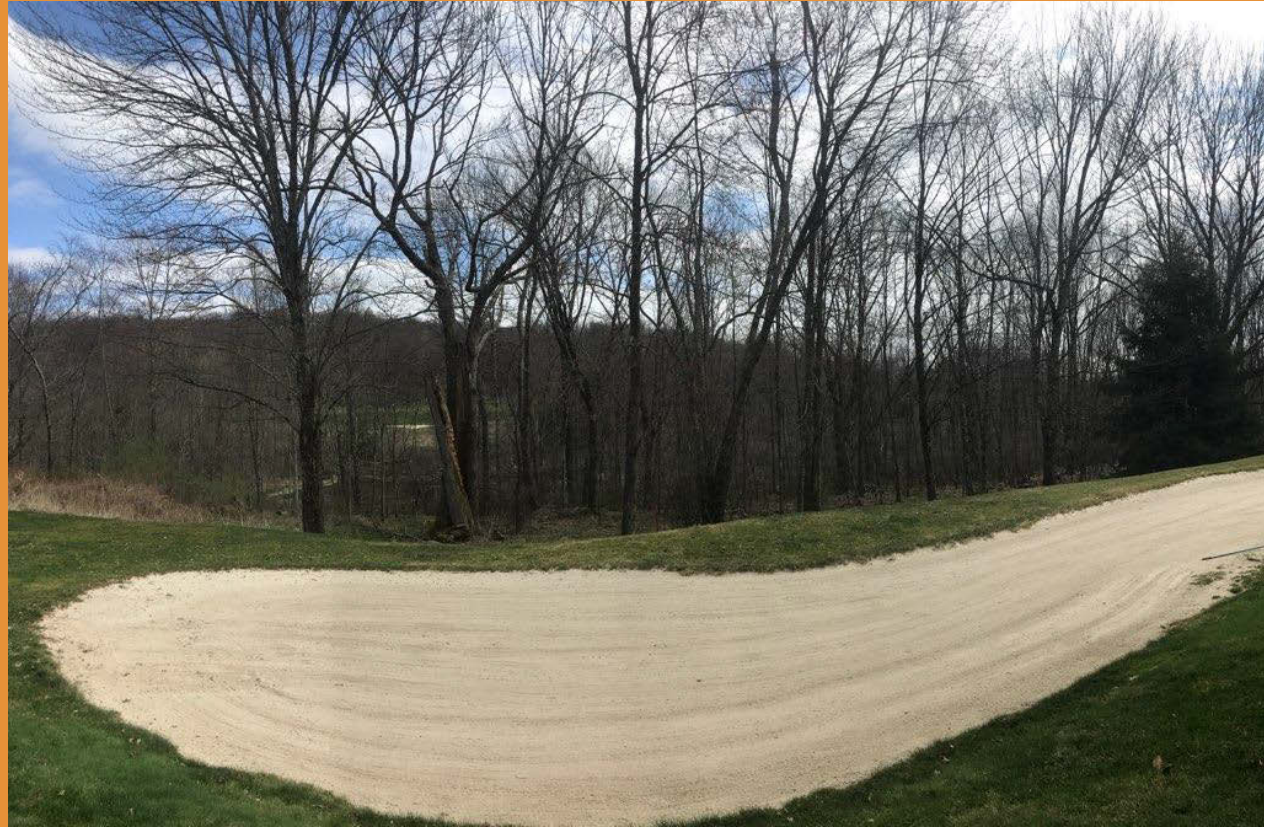
# Figure 27

Broad view of where UNT  
passes under golf club  
before entering wetlands

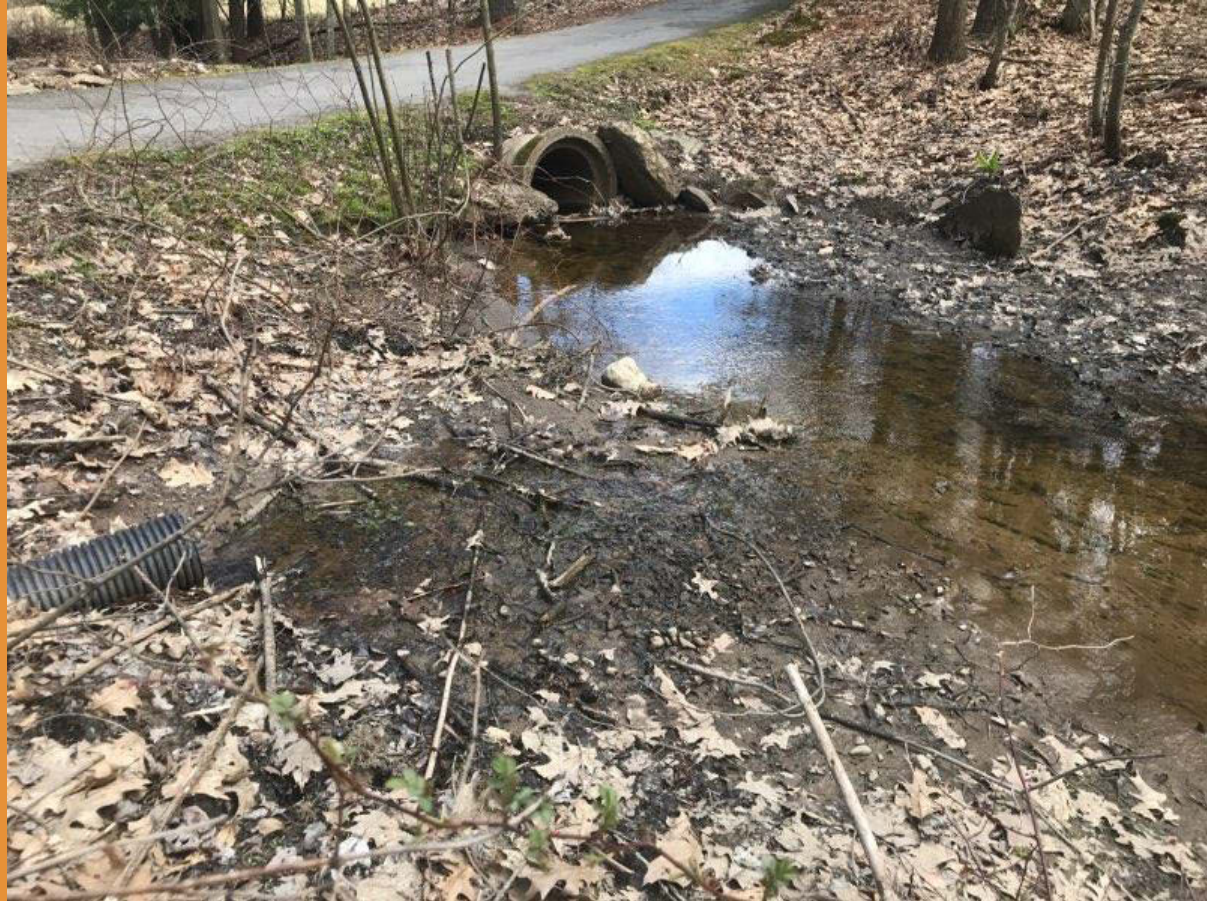
## Figure 28

Downstream view of wetlands closest to Rte. 115, where most flow drains, including that from HDPE pipe on left

Flow enters concrete pipe before UNT flows into more wetlands

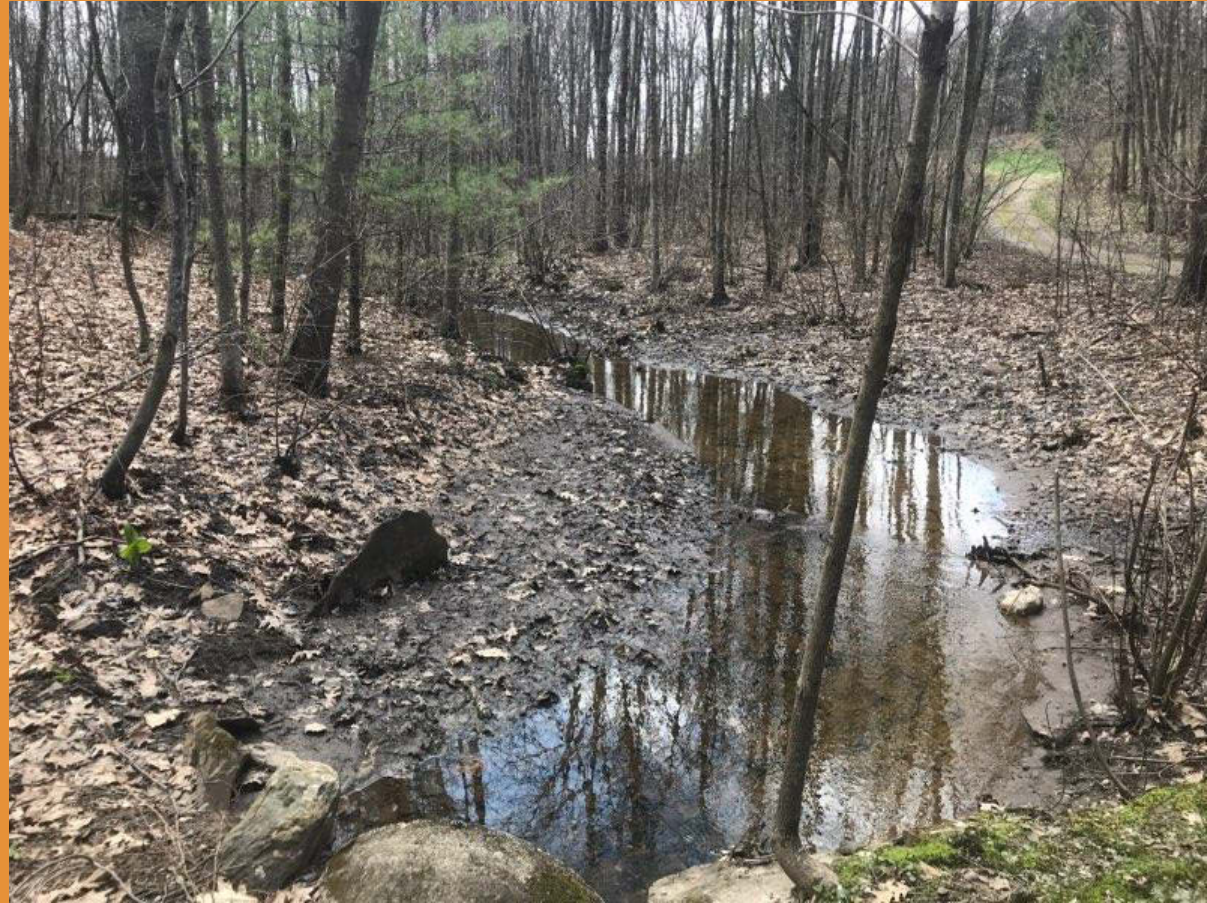
# Figure 29

Upstream of UNT in Fig. 28 as it meanders through lower golf club

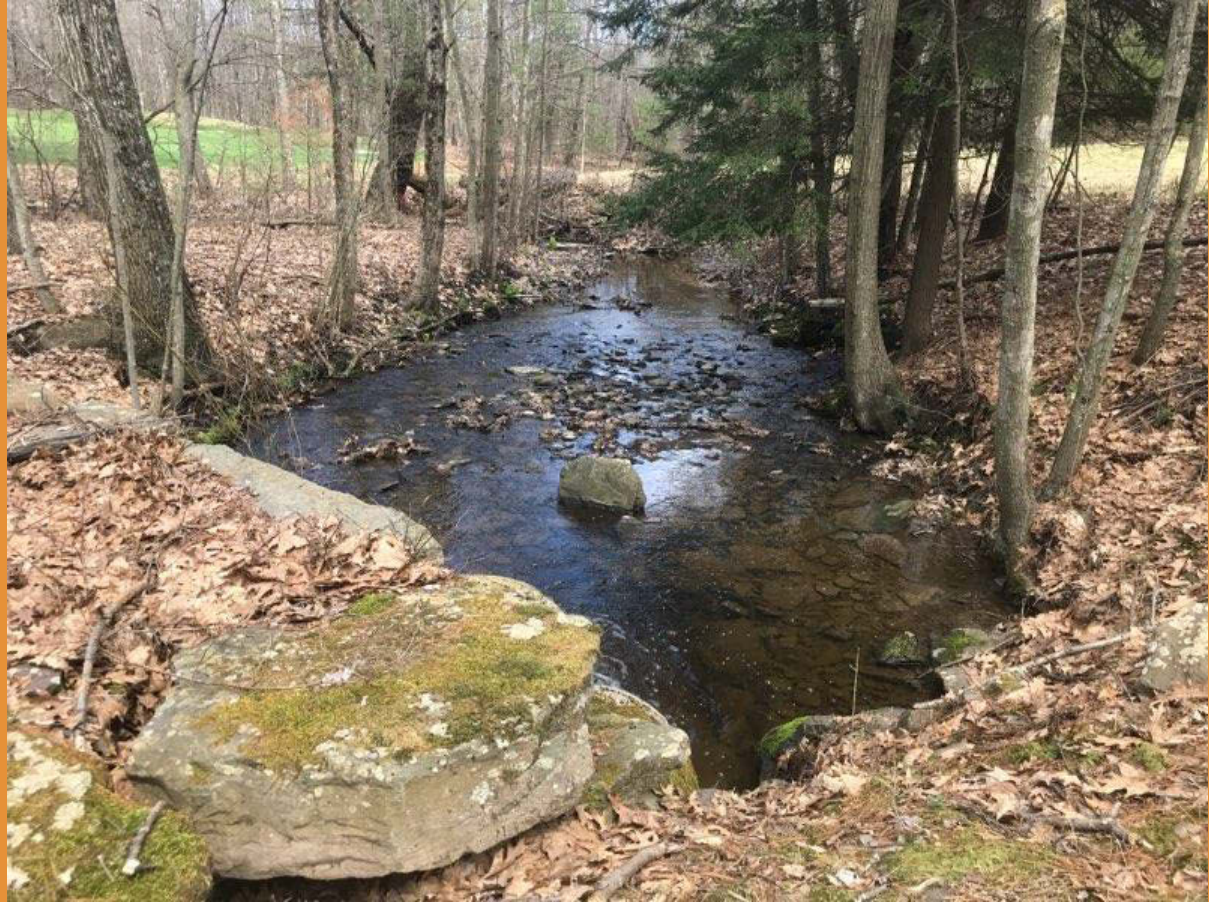
# Figure 30

Downstream view of UNT  
in Fig. 28-29 after it  
passes under cart path

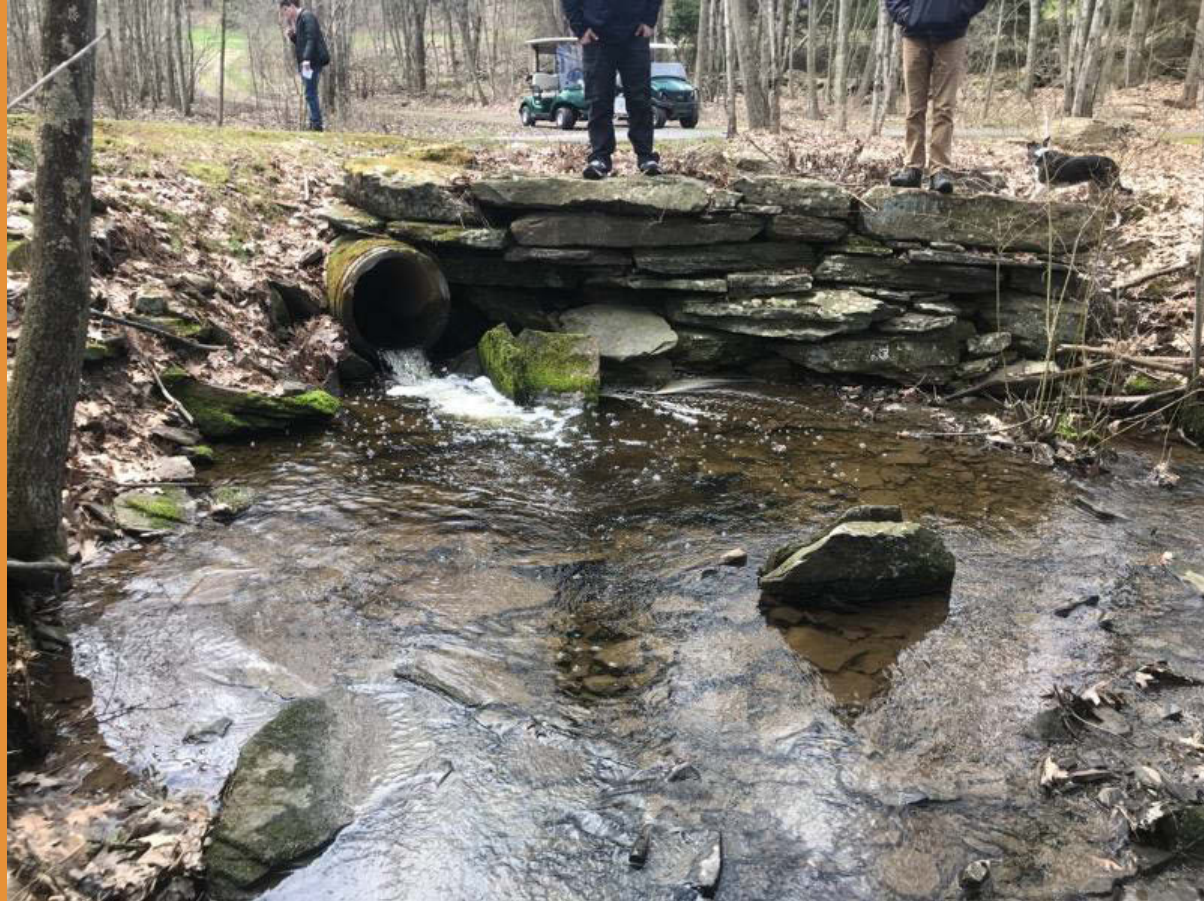
# Figure 31

Upstream view of unnamed tributary (UNT) in Fig. 30 as it passes through concrete pipe

Large scour with roughly 6" drop to UNT from pipe, does cause some bank erosion
