Sugar Notch Run sub-watershed Assessment

EPCAMR surveyed 6 stream segments in the Sugar Notch Run sub-watershed. They were labeled as **SNR 01-06** in the data tables and on the Solomon Creek Watershed Monitoring Map. The photo essay documents the entire length of the tributary and their unnamed tributaries and on occasion makes recommendations for future stream or habitat improvement projects or cleanups.

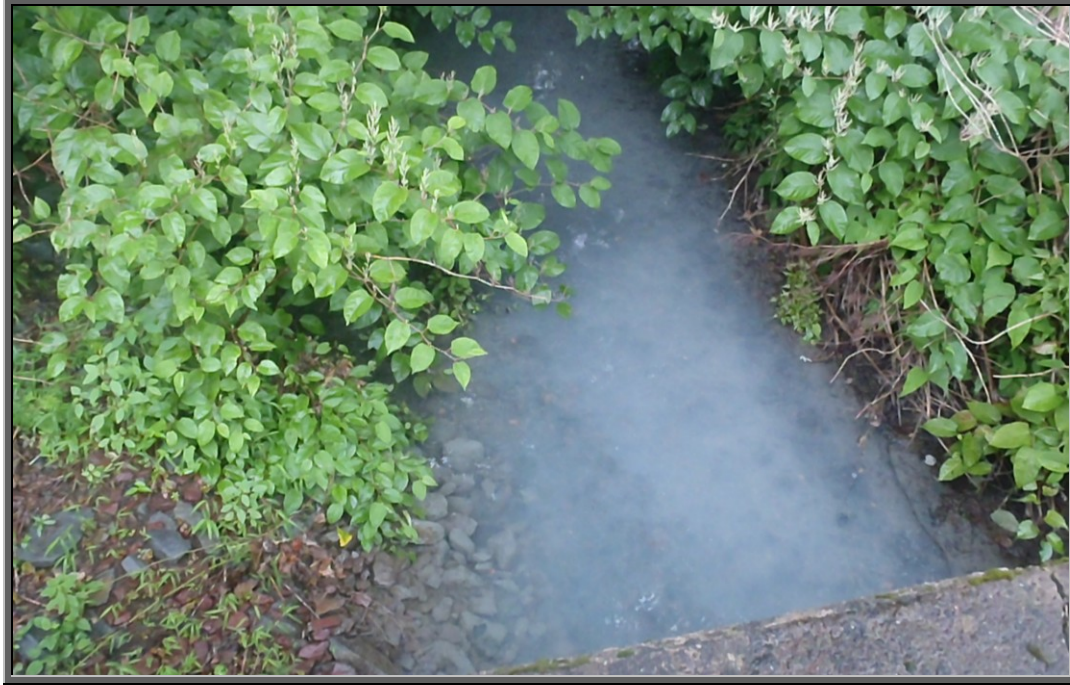
Photo : Sugar Notch Run below Carey's Patch surrounded by Japanese Knotweed and what EPCAMR believes to be an aluminum precipitate, sewage or phosphate contamination in the tributary; Further lab testing or E. Coli bacterial plating is recommended to find out what exactly what the precipitate on the stream bottom is consistent of

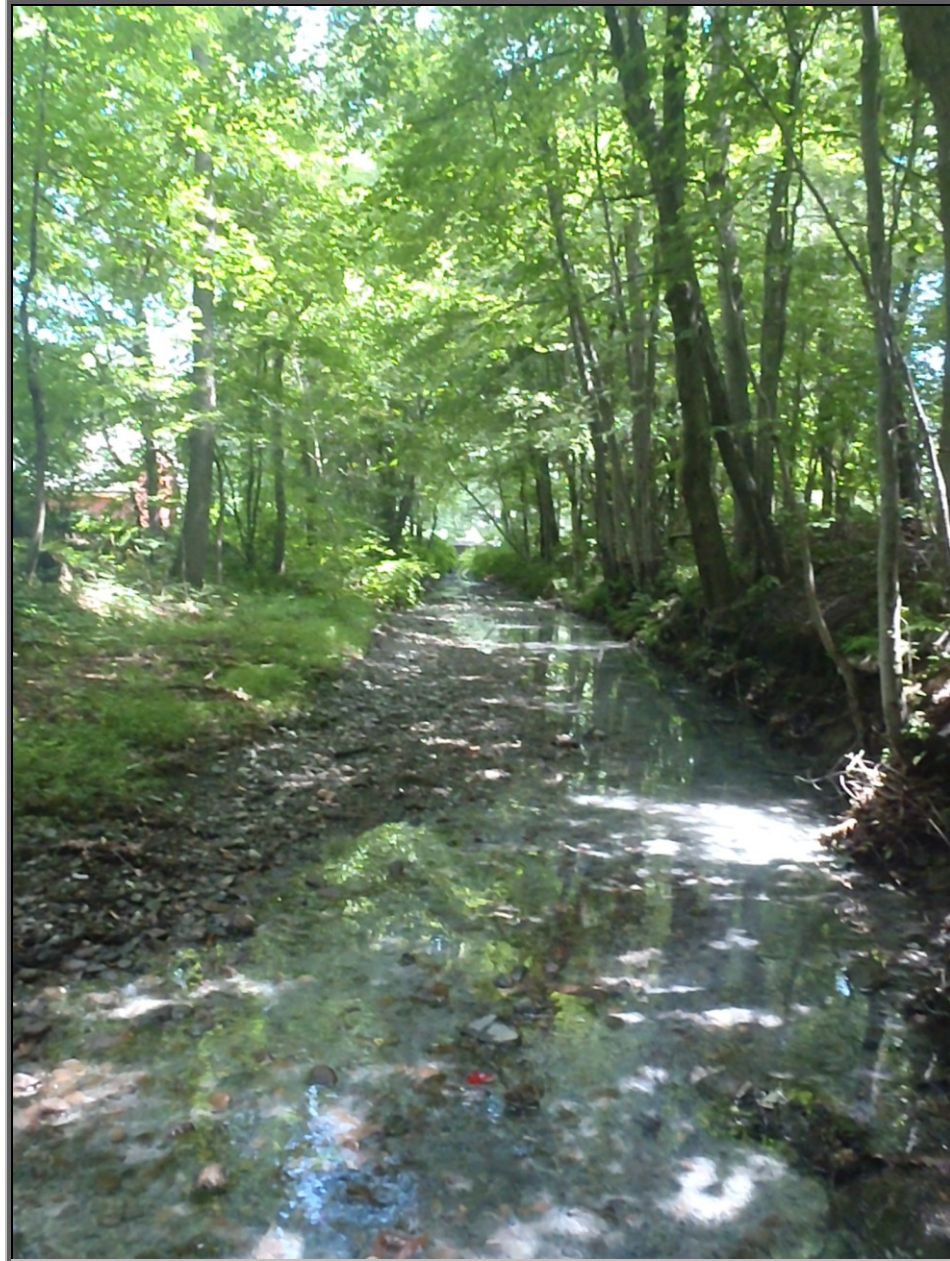
Photo : The milky white precipitate from Sugar Notch Run can be seen entering beneath the Ashley Street culvert before emptying into the Solomon Creek Main Stem

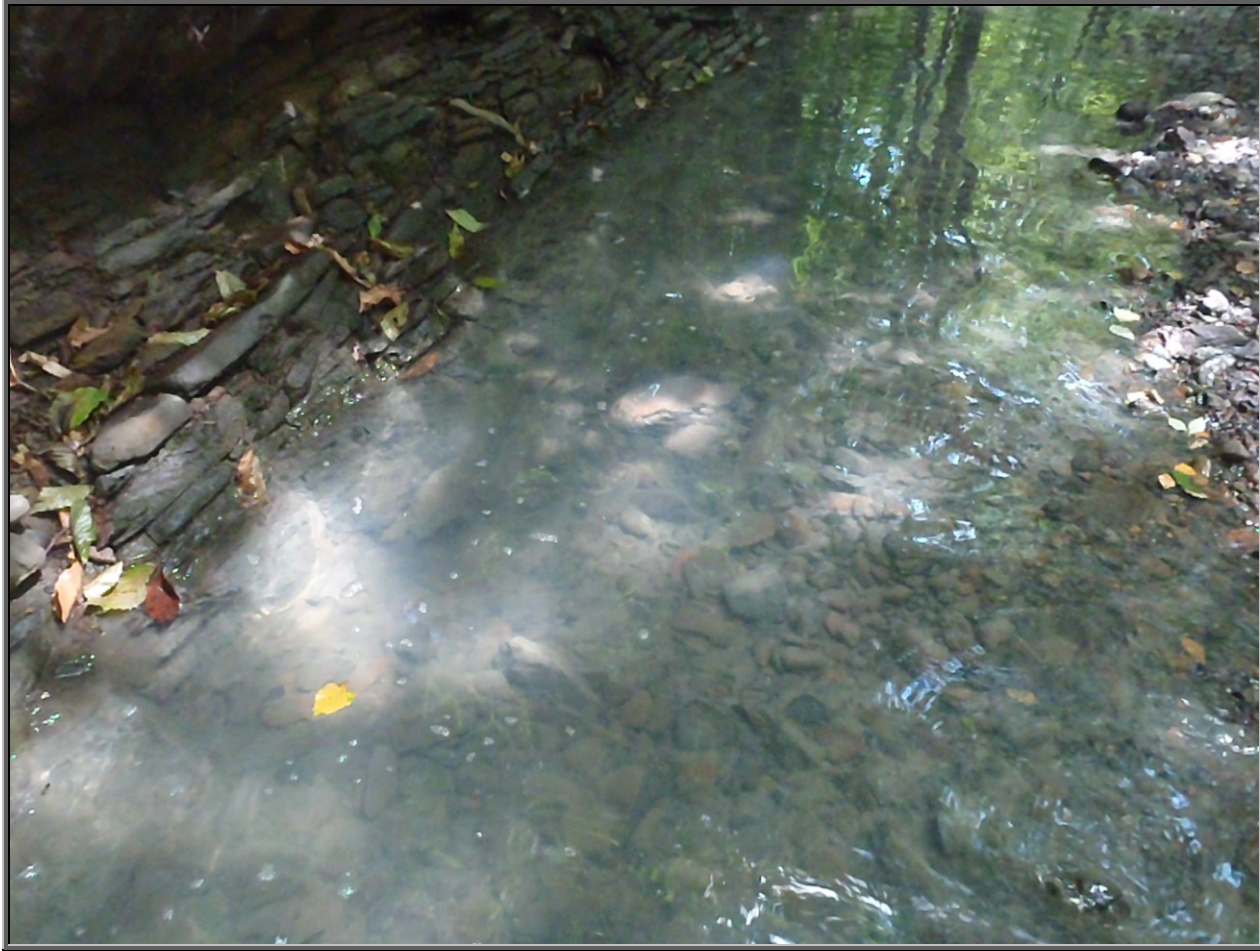
Photo : Sugar Notch Run below Carey's Patch and what EPCAMR believes to be an aluminum precipitate, sewage or phosphate contamination in the tributary; Further lab testing or E. Coli bacterial plating is recommended to find out what exactly what the precipitate on the stream bottom is consistent of; Ashley Street and the road culvert that carries Sugar Notch Run into the Main Stem of Solomon Creek can be seen in the distance

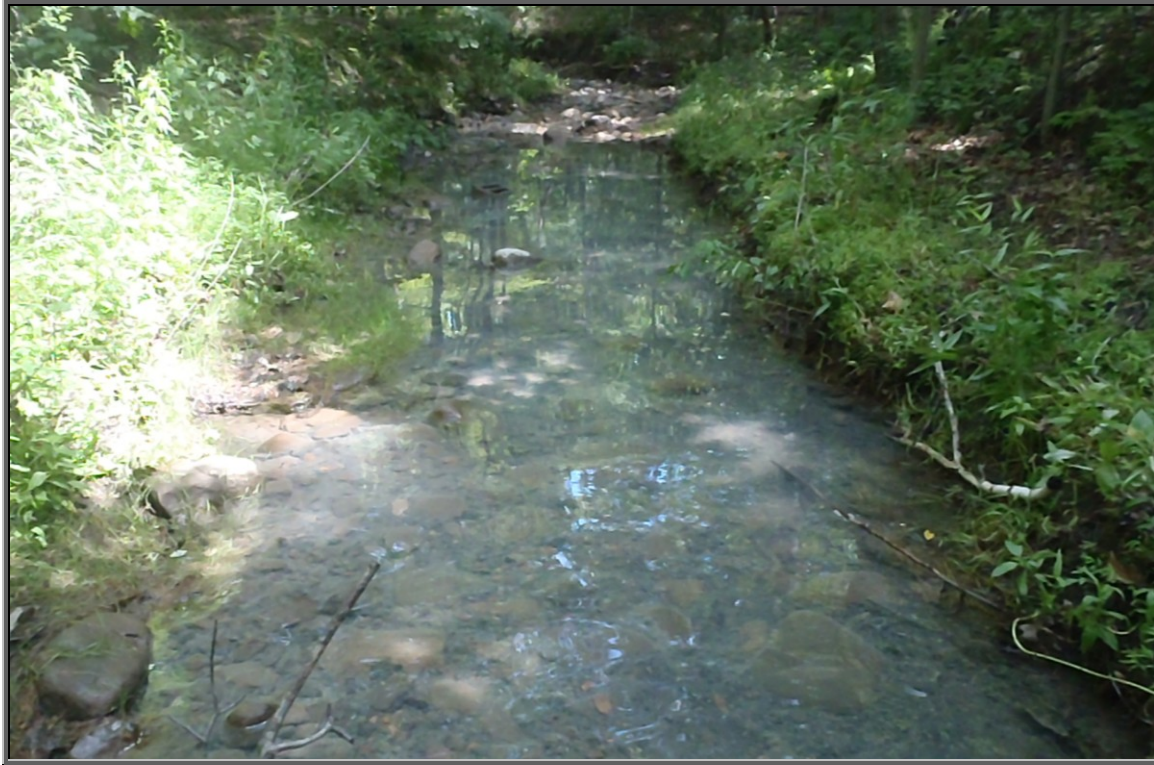
Photo : A closer look at the white precipitate and almost filamentous algal like substance that was coating the stream bottom of Sugar Notch Run below Carey's Patch

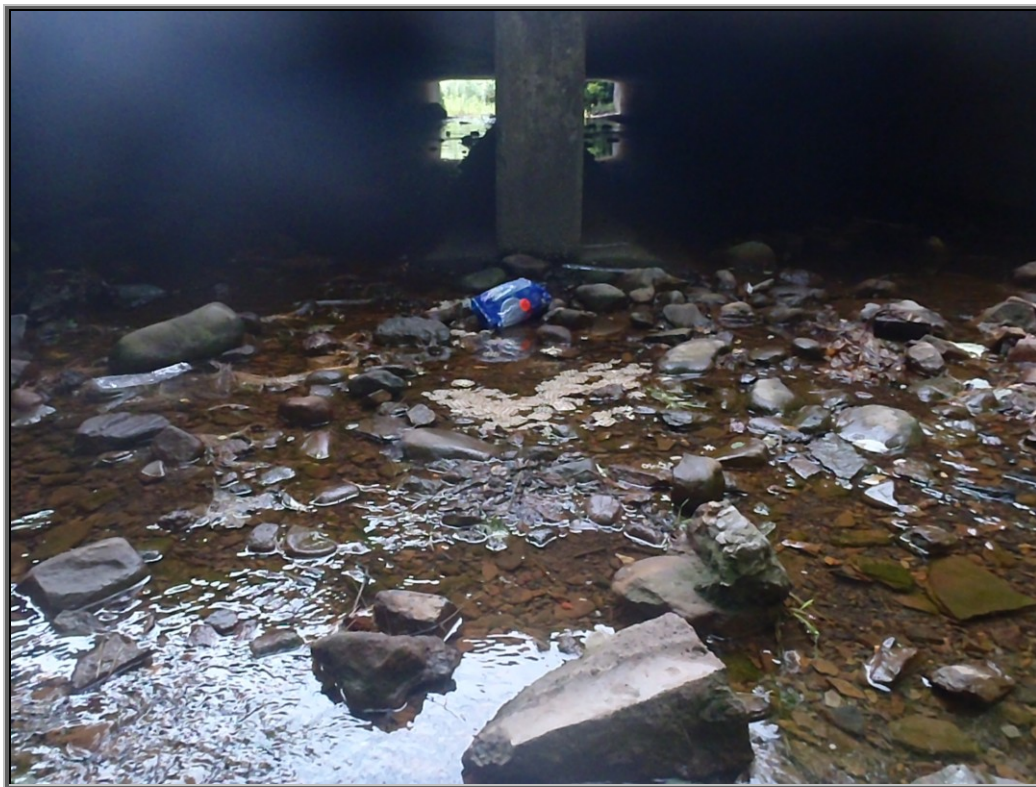
Photo : Sugar Notch Run flowing below Carey's Patch looking upstream towards Sively Street at a double-wide culvert

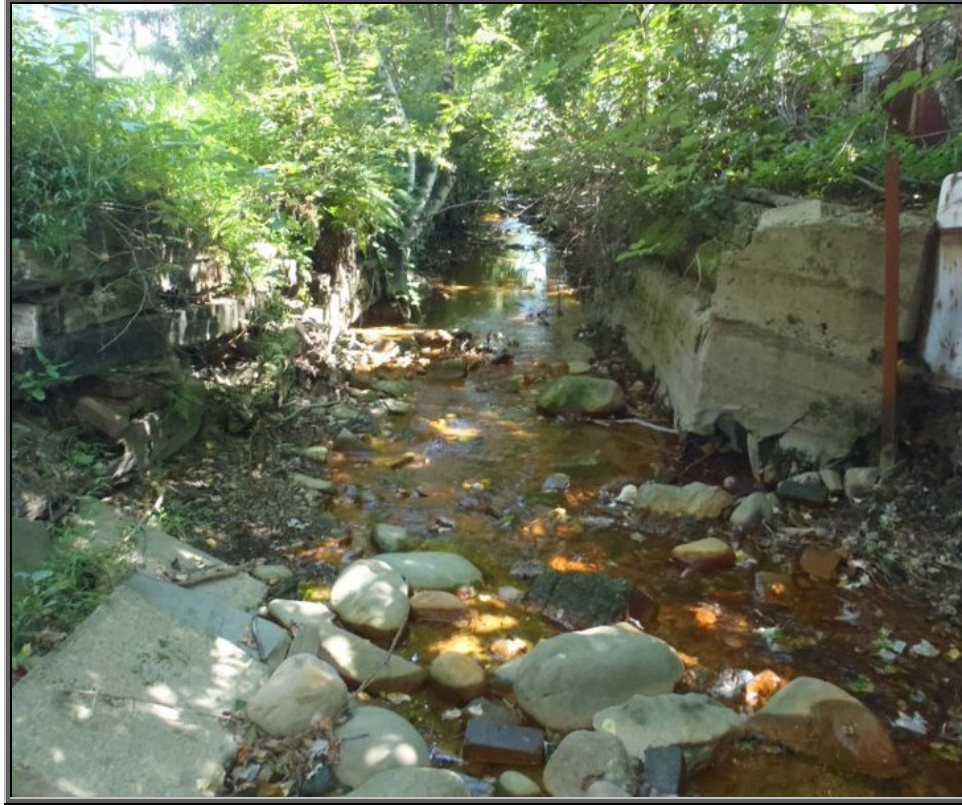
Photo : 3 holed masonry brick submerged in AMD and filamentous algae in Sugar Notch Run

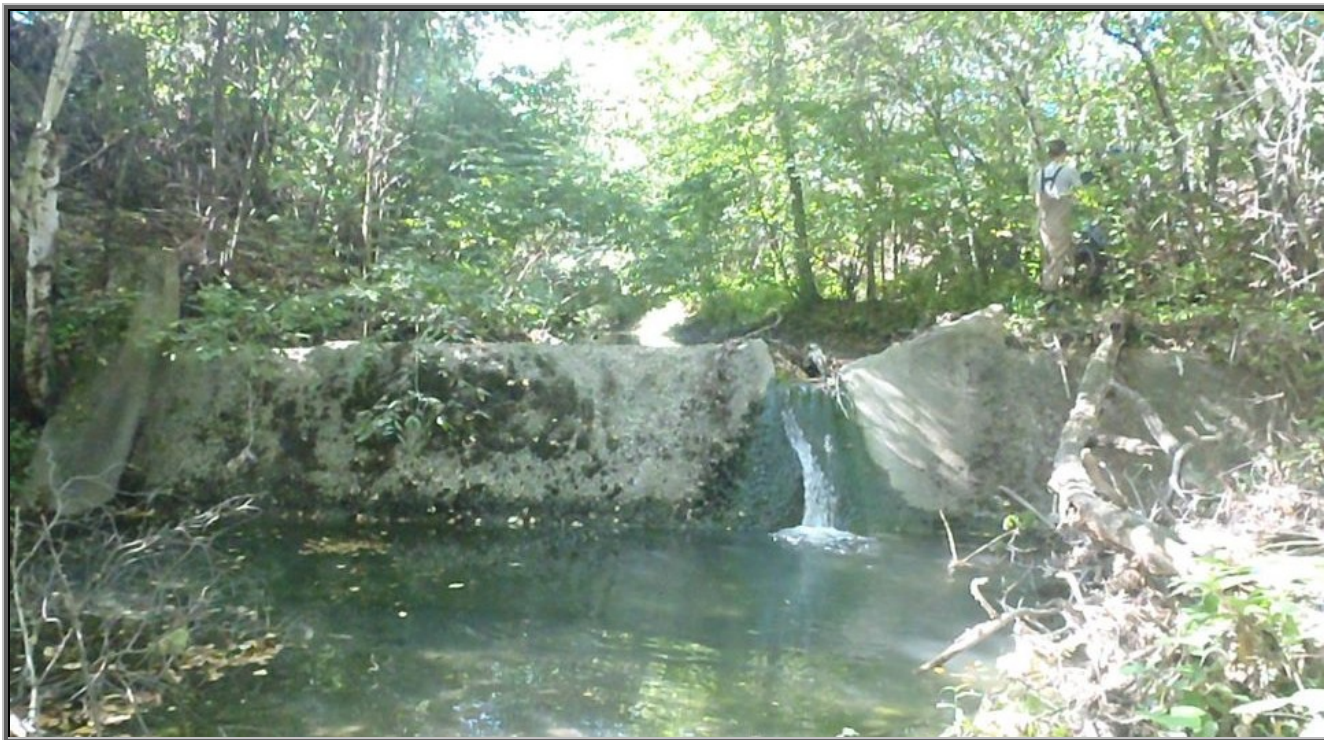
Photo : Close up of the overflow area at the concrete dam on Sugar Notch Run; This dam should be recommended to be removed to allow for potential fish passage from upstream areas down through Sugar Notch Run as a stream improvement and habitat restoration project

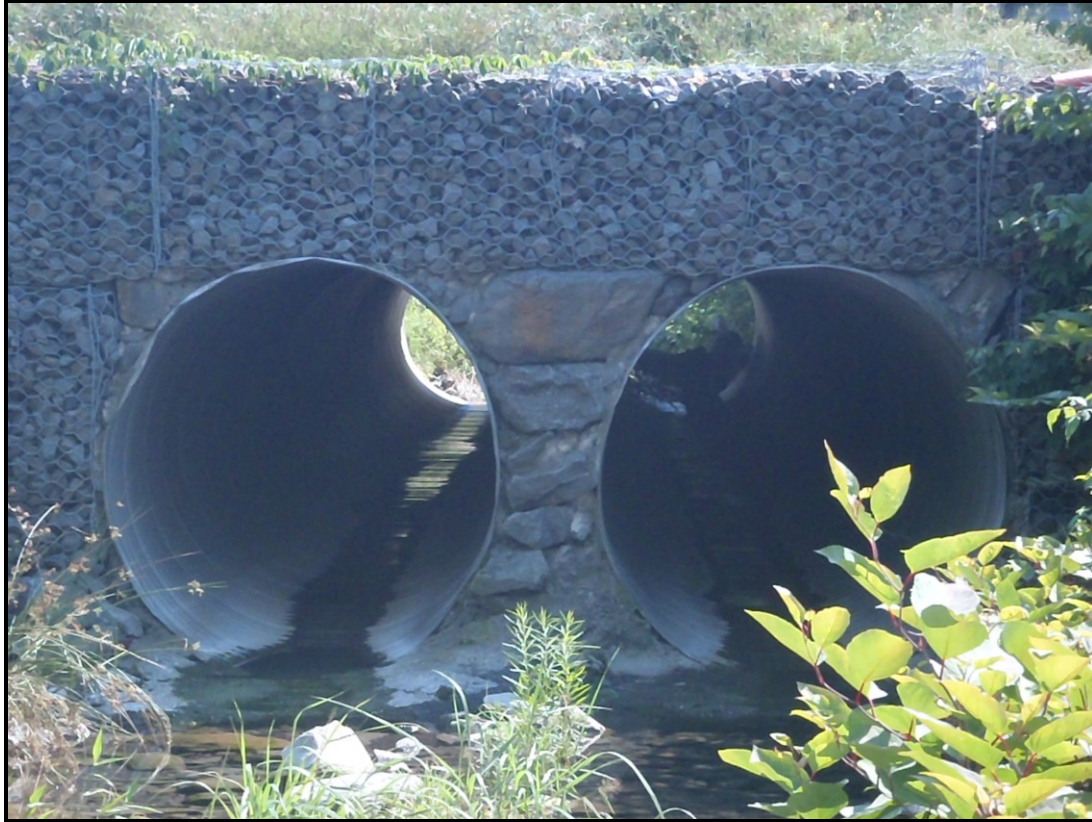
Photo : Double corrugated drainage pipes under Preston Road looking upstream on Sugar Notch Run just off S. Main Street

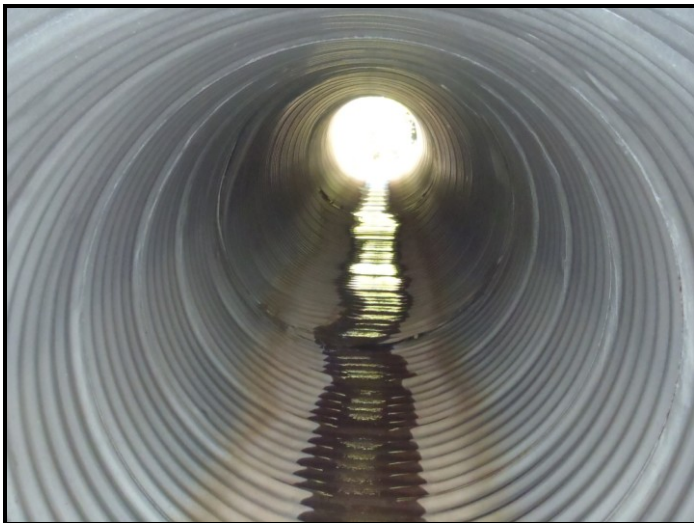
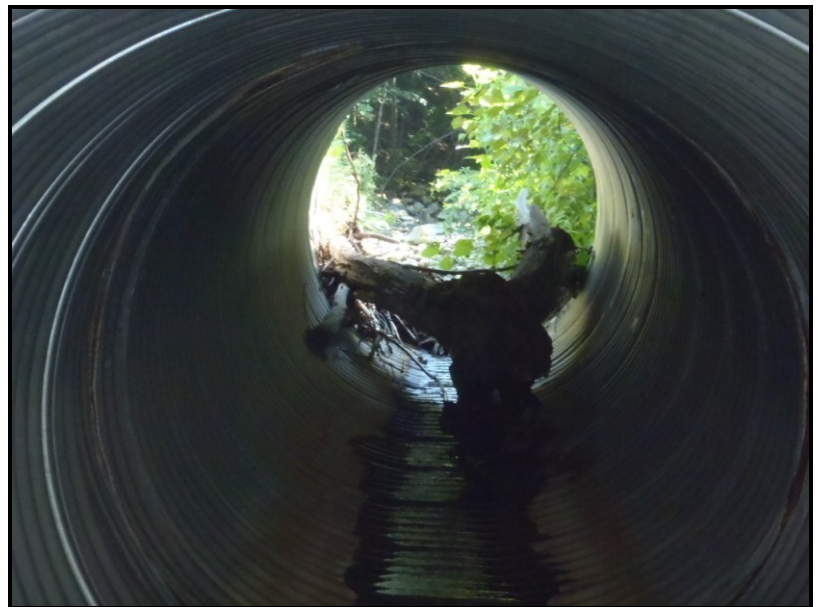
Photo : A tree that is nearly 20' long with its rootwad in lodged in the culvert on the right hand side of the split flow on Sugar Notch Run

Photo: (L & R): The culvert pipe on the left is clear of any debris looking upstream and the culvert pipe on the right is blocked with a large tree and other woody debris; This culvert on the right is in need of a small debris removal project to remove the hazard to the road crossing into the Industrial Park and Hanover Township Youth and Recreation Center

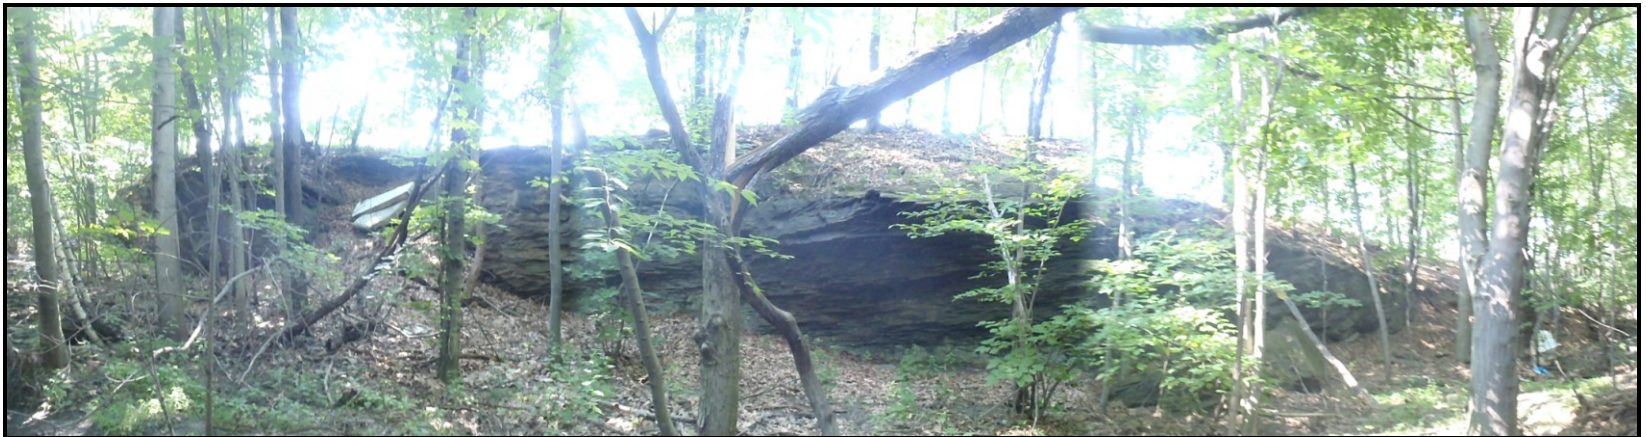
Photo: A shaley outcrop along the right bank looking upstream on Sugar Notch Run that has eroded to the point where stormwater from South Main Street has entered this section and cut down into the fracture shale and caused it to break up into the channel

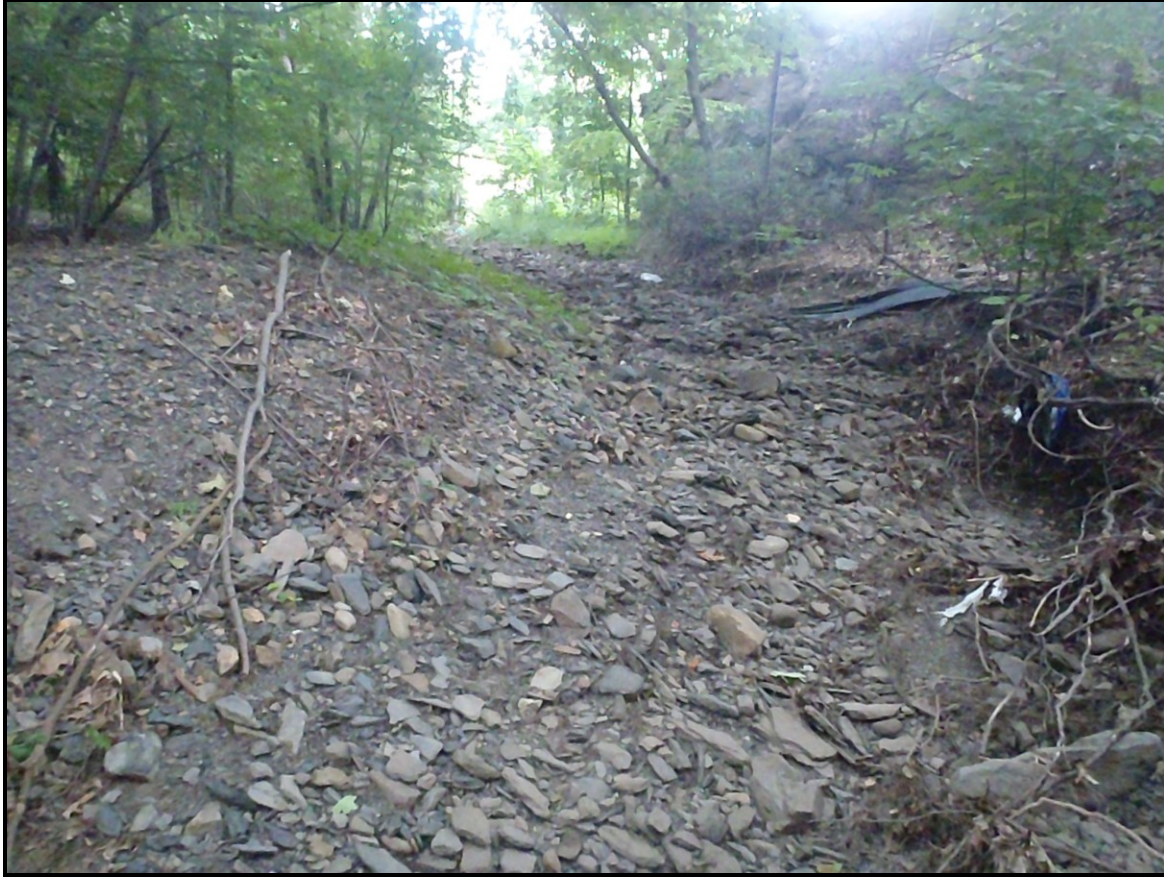
Photo : The left drainage pipe is entirely blocked on the upstream side of Sugar Notch Run which is dry and has already experienced high water and storm events that have deposited all of the smaller rock material in a gravel bar deposition just above both pipes

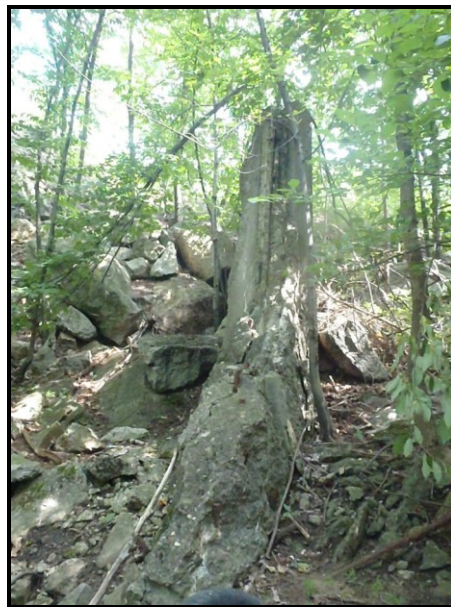
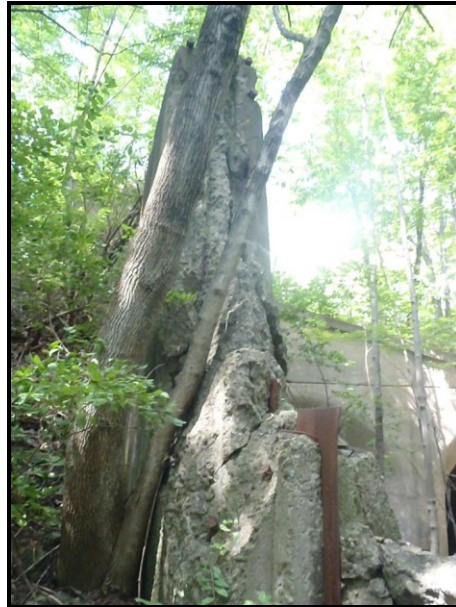
(R) Photo: Sugar Notch Run flowing through a broken section of an old concrete dam; Trout and other minnow species were shocked and present in this stretch of Sugar Notch Run that currently appears on the List of Impaired Waters that EPCAMR is seeking assisting in removing from the Impaired Waters List due to our findings with PA Trout Unlimited; Some woody debris is present and can easily be removed as a part of a stream and habitat improvement project

(L) Photo: Remnants of the old concrete dam with rebar exposed along the left stream bank looking upstream

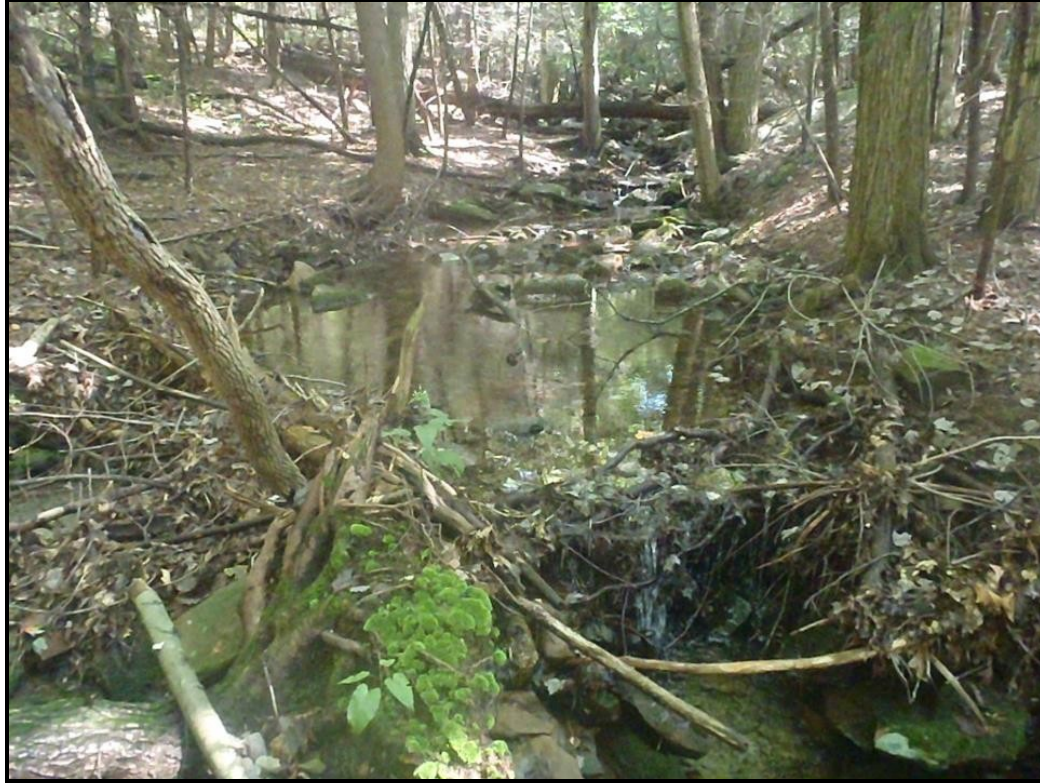
Photo: Leaf blockage and woody debris on Sugar Notch Run
