Abraham's Creek Biological Assessment

Report Provided by Trout Unlimited

March 2019

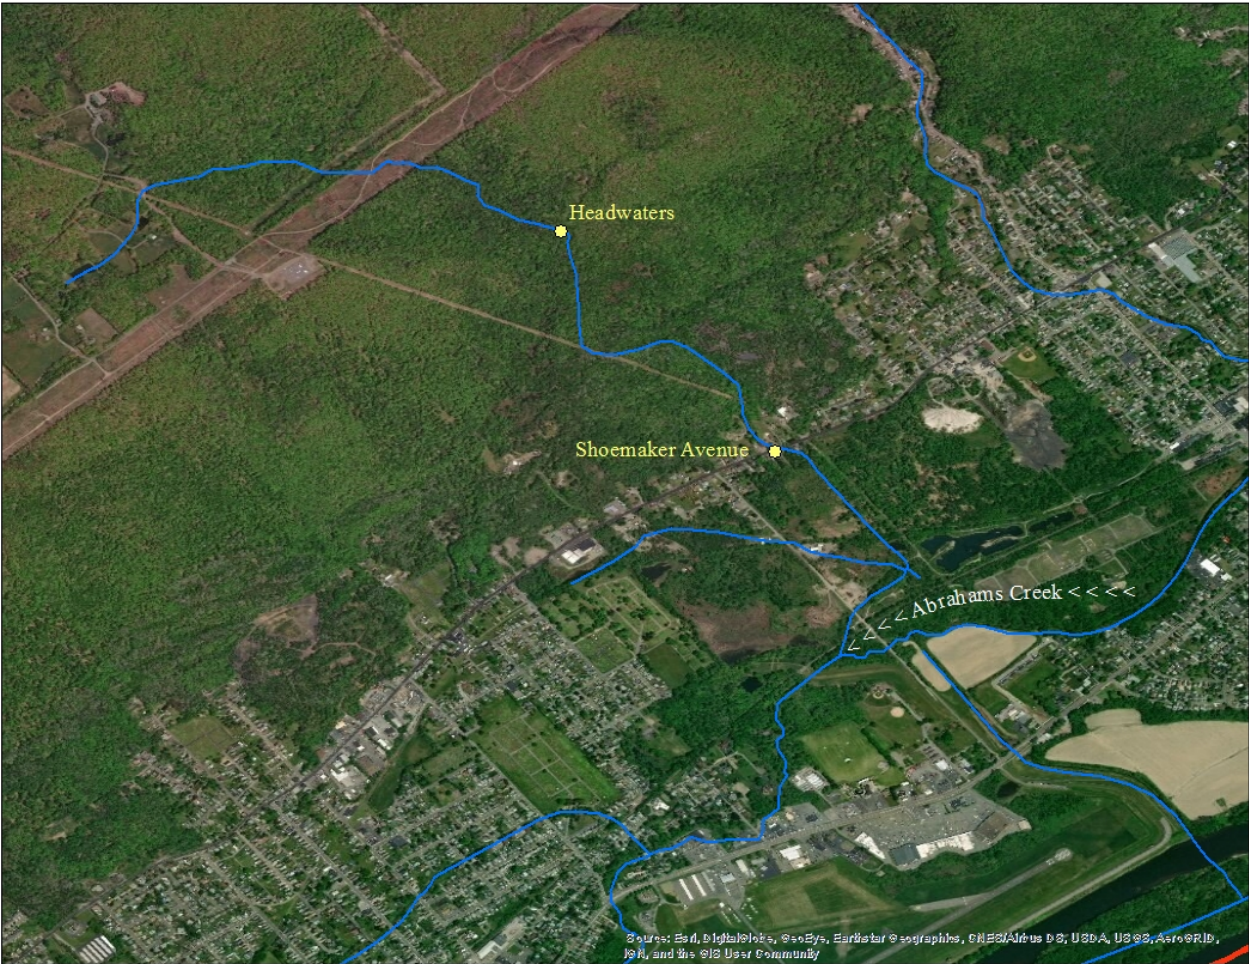
Figure 1. Sample site locations within the Abraham’s Creek watershed.

Table 1. Sample locations and descriptions in the Abraham's Creek watershed.

Site ID	Site Description	Latitude	Longitude
Headwaters	Upstream of known water loss and mined areas	41.321594	-75.86401
Shoemaker Avenue	Downstream of Shoemaker Avenue road crossing where channel is frequently dry	41.31391	-75.85656

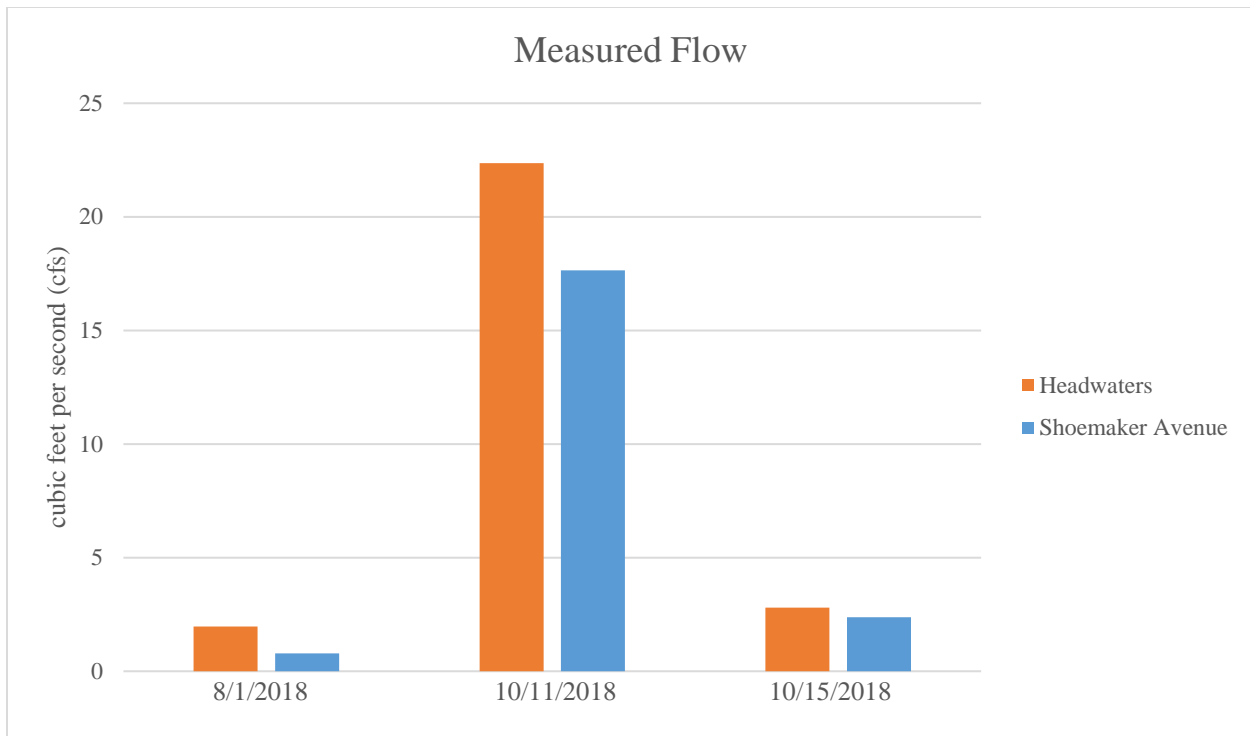
Figure 3. Flow measurements and difference between flows at the headwaters and Shoemaker Avenue sites on all sampling dates.

Table 3. Flow data from both sites and the percent of streamflow loss between sites for each sampling event.

Site	Date	Flow (cfs)	% Loss
Shoemaker Avenue	8/1/2018	0.792	60%
Headwaters	8/1/2018	1.97	
Shoemaker Avenue	10/11/2018	17.65	22.1%
Headwaters	10/11/2018	22.36	
Shoemaker Avenue	10/15/2018	2.38	15%
Headwaters	10/15/2018	2.8

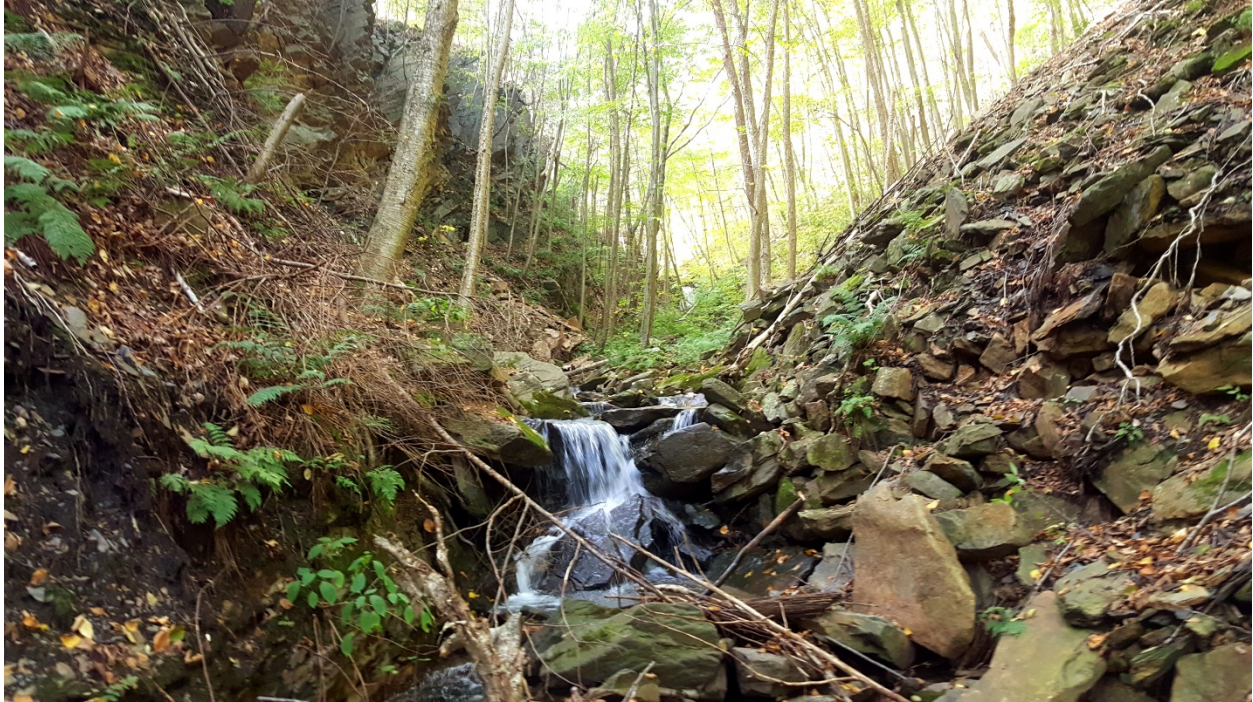
Figure 4. Steep grade with weak\unnatural banks upstream of Shoemaker Avenue and downstream of trout populations.

In the 0.5 mile reach upstream of Shoemaker Avenue, the channel becomes narrow and appears to be heavily manipulated with steep unstable banks and a steep grade (Figure 4). Landowners from this part of the watershed said that in heavy rainfall from previous storms, substrate material has washed down filling the channel up, eventually resulting in government agencies coming to dredge out the material. Topographic imagery of the watershed suggests the stream may have been relocated from its original channel. TU and ECAMR staff observed a large pile of coal refuse and related material on the left bank (left side looking down gradient) that appears to have been placed in what was the original stream channel. Historical mining records indicate there was a ‘barrel sluice’ made of wooden barrels attached end-to-end to relocate the stream water in order to wash coal. When investigators requested permission of the landowner at Shoemaker Avenue to investigate the property, the landowner confirmed there was once a barrel sluice but stated the wood had been reclaimed to construct a barn on the property decades ago.

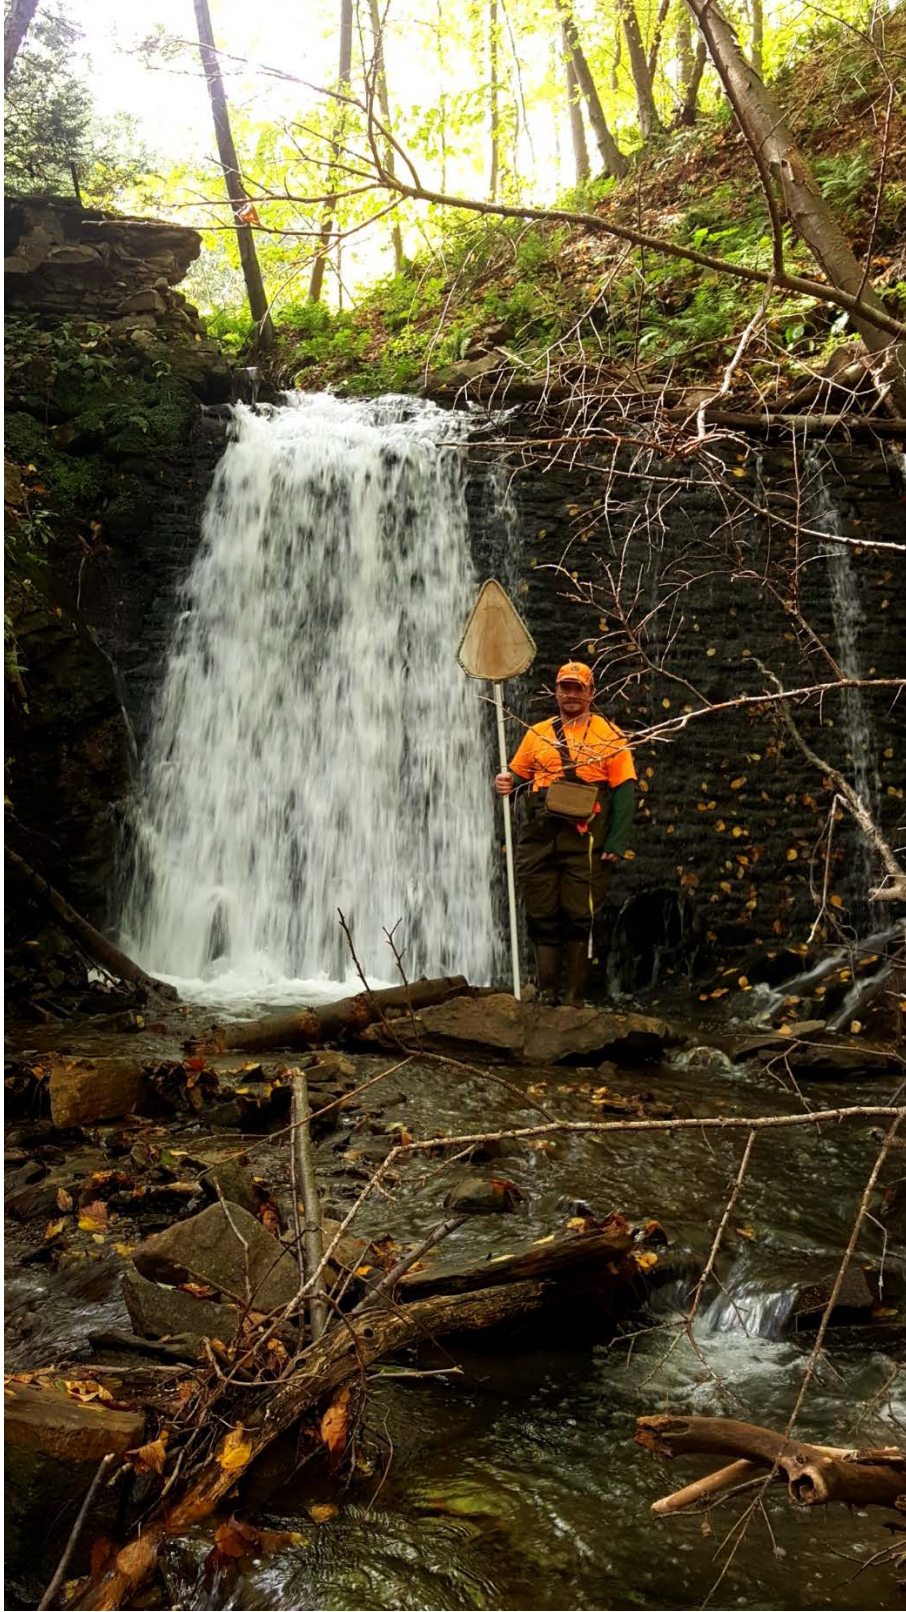
Figure 5. EPCAMR staff Michael Hewitt stands next to a structure of hand laid stone that creates a large cascade waterfall. Approximately 0.5 miles upstream from Shoemaker Avenue.

At approximately 0.5 mile upstream of the residence on Shoemaker Avenue there is a manmade structure resembling a stone wall, causing an approximately 12 foot cascade waterfall (Figure 5). The height and grade of this structure would be a barrier to aquatic organism passage upstream. The first brook trout, measuring 159mm, was documented 5m upstream of the stone structure (Figure 6). The fishery survey continued upstream to be certain there was a population of trout in the reach and not just one individual. The very next pool held three more adult brook trout, measuring 190mm, 238mm, and 245mm, affirming the downstream extent of brook trout in the watershed. When overlaying the watershed with the digitized mine areas (PASDA.psu.edu), the lowest extent of trout in the watershed is just upstream of the mined areas and the stone structure (Figure 7.)
