HUNTSVILLE CREEK COLDWATER CONSERVATION PLAN

Including the Lower Toby Creek Watershed

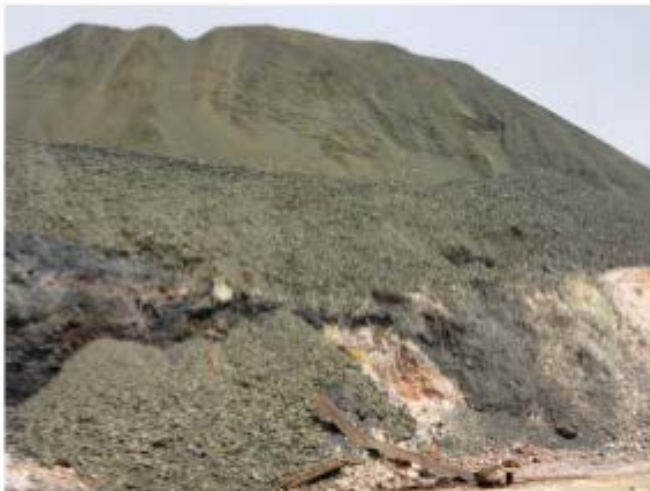
The 40-ft high Harry E. Breaker Waste Coal Pile, which was on fire, continues to be a source of pollution in Swoyersville, PA.

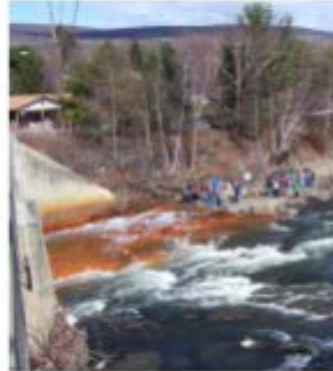
The orange pollutant in AMD known as iron-oxide pours out of the Old Forge Borehole in Lackawanna County, Pennsylvania at an estimated 40 to 100 million gallons a day. This amount of drainage per day is equivalent to the amount of water the average person uses in an entire year!

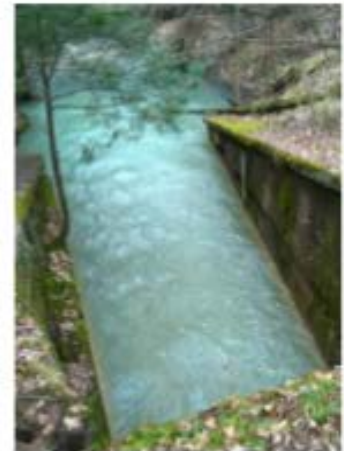
Although AMD is often thought to be orange due to iron oxide, it has many different colors and levels of toxicity dependent on the chemistry. This form of AMD is crystal blue, which gets its hue from the high amount of aluminum. The Jeddo Tunnel of Luzerne County, Pennsylvania releases an estimated 40,000 gallons of polluted mine water every minute.

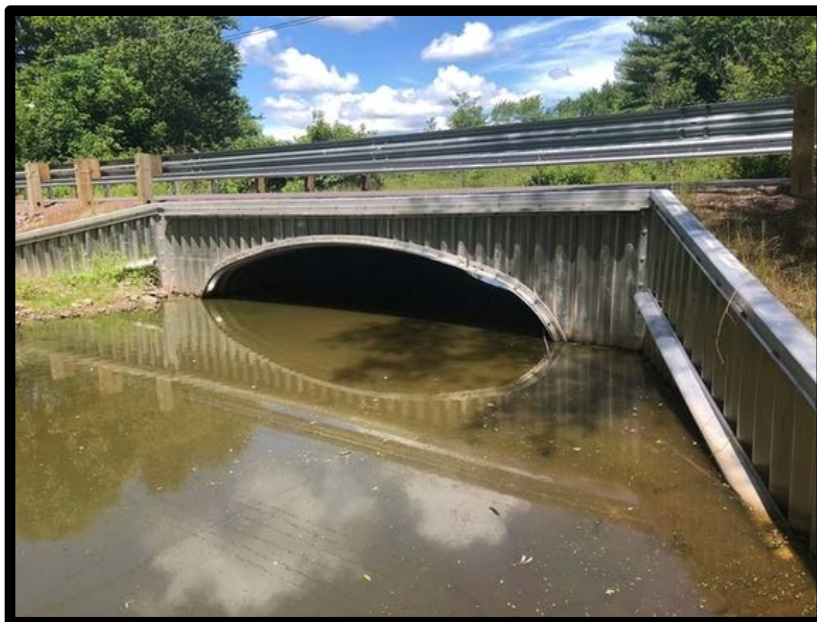
Figure 4. Newly installed bridge culvert near Yalick Farms where the headwaters of Huntsville Creek flows beneath Reservoir Road before heading towards the Luzerne County Fairgrounds

Figure 4. Newly installed bridge culvert near Yalick Farms 21

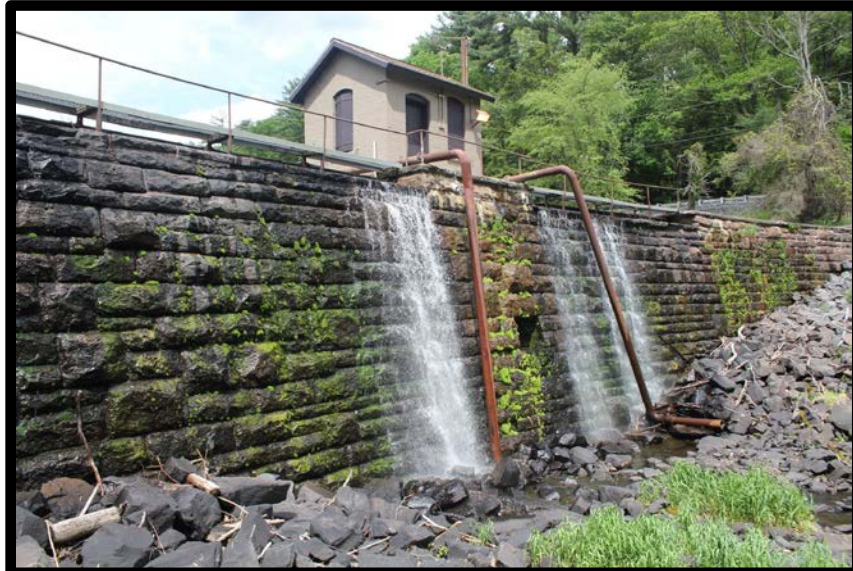
Figure 5. Present view of Huntsville Dam; Photo credit: Levi Sunday-Lefkowitz - EPCAMR

Water exiting the reservoir cascades over the Huntsville Dam and forms the downstream portion of Huntsville Creek. Leaving the reservoir, the creek passes under a large stone culvert at the five way intersection of Old State Route 115, Sutton Road, Huntsville Road, and Hillside Road. Huntsville Creek continues along Hillside Rd for the next 3 miles.

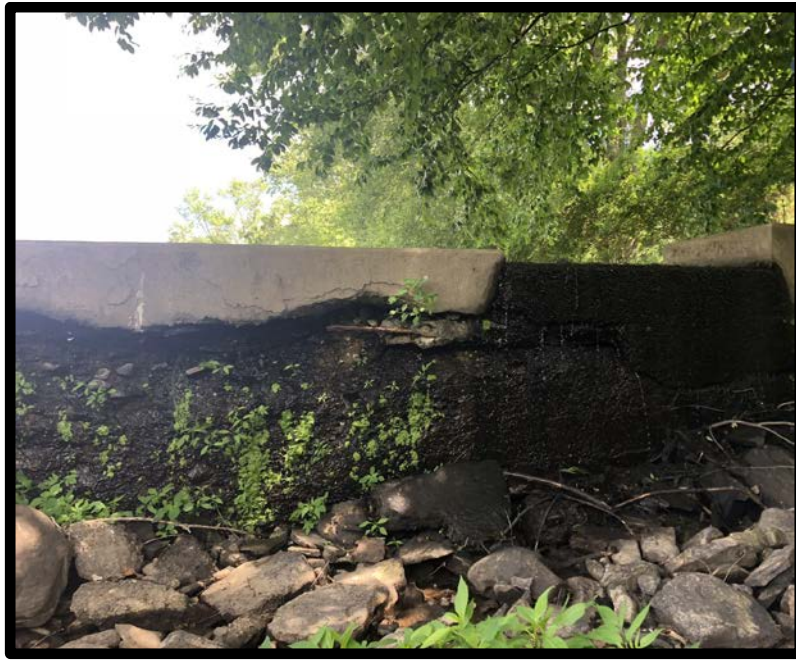
Figure 6. Posten Pond Dam on unnamed tributary to Huntsville Creek

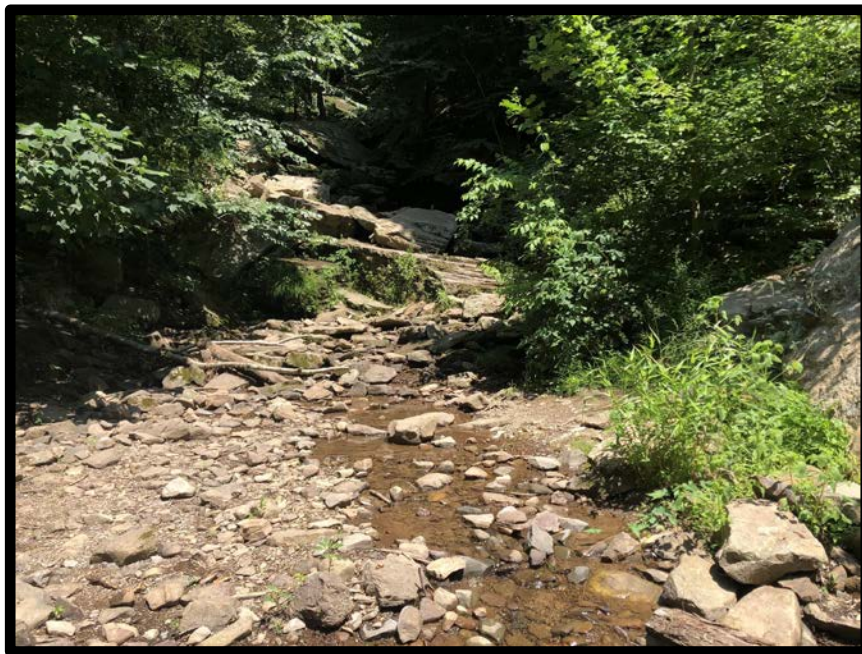
Figure 7. Looking upstream at the unnamed tributary from Bunker Hill, known as Wildcat Falls, just above the bridge over the Back Mountain Trail that flows into the Lower Toby Creek

Upper Toby Creek flows alongside the Memorial Highway for nearly four and a half miles through Kingston Township and Dallas Borough. After the confluence of Upper Toby Creek and Huntsville Creek, the stream becomes Lower Toby Creek. Behind the DAMA headquarters, an unnamed tributary flows from Bunker Hill feeding into Toby Creek in a steep ravine. There are several small ponds on Bunker Hill, along Bunker Hill Road. These natural springs gave way to the unnamed tributary flowing down the mountain into Toby Creek right next to the DAMA headquarters. This stream has been nicknamed "Wildcat Falls," and flows beneath a wooden trail bridge along the Back Mountain Trail before it cascades into Toby Creek.

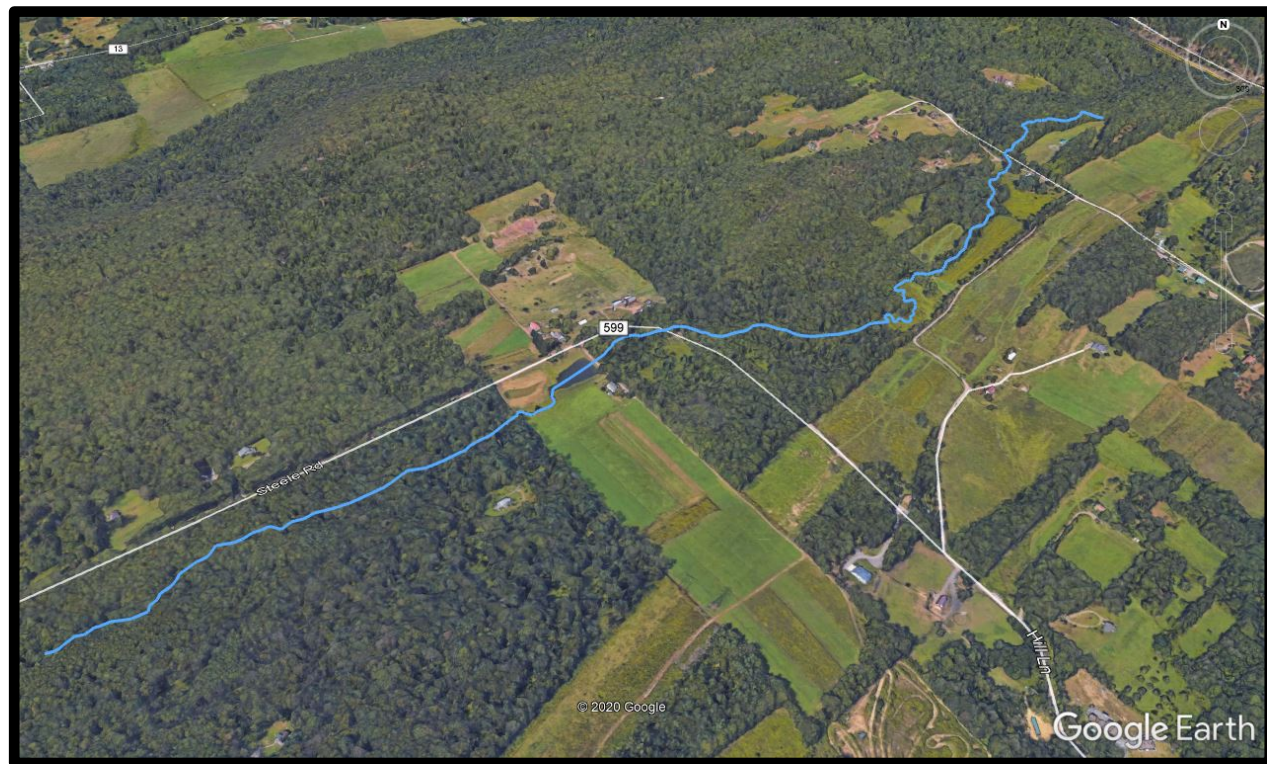
Figure 8. Stream Corridor flow path of an unnamed Tributary known as Buttermilk Falls, that flows across the top of Larksville Mountain down towards Courtdale Borough before cascading down to Toby Creek.

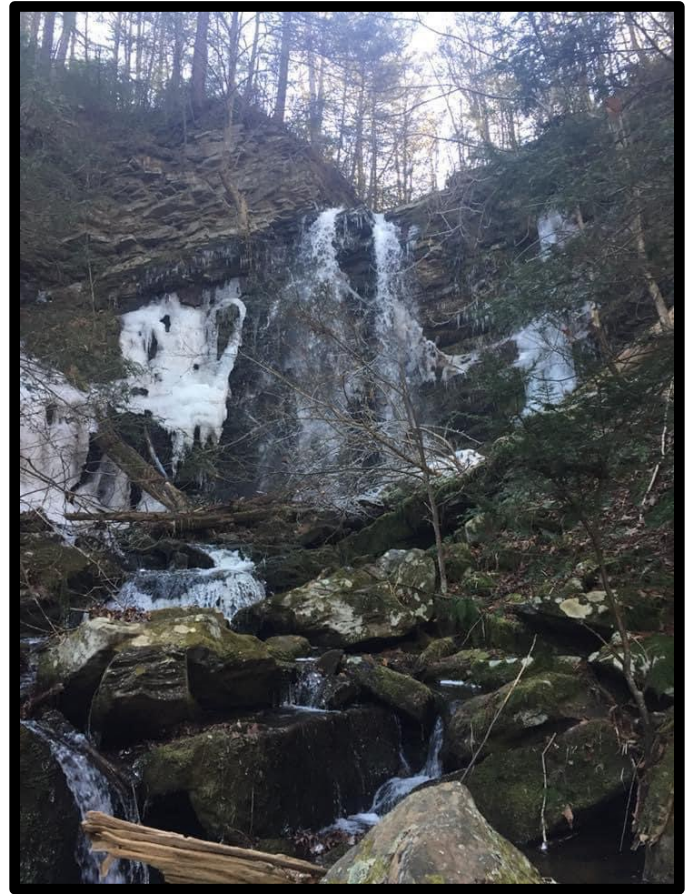
Figure 9. Shots of Buttermilk Falls that flow down over the steep series of step pools in the unnamed tributary to Toby Creek Gap that enters Toby Creek from its headwaters in Courtdale Borough along the right streambank just south of 430 S. Dallas Memorial Highway heading from the Back Mountain towards Luzerne Borough. DAMA Sewer line is exposed just before the confluence of the unnamed tributary with Toby Creek. Photo on the right taken by Paul Shaver.

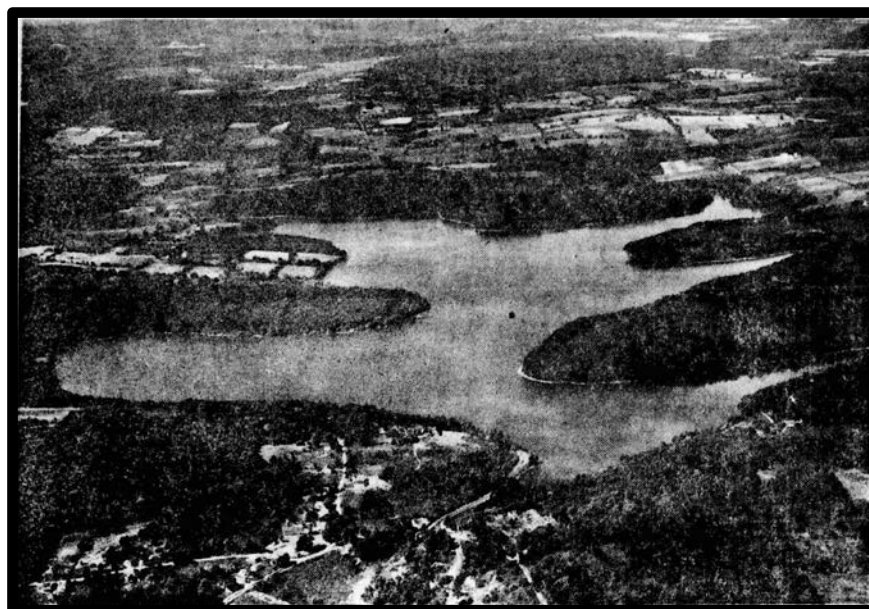
Figure 10. Aerial view of the Huntsville Reservoir (c. 1950)

The Huntsville Reservoir provides clean water for several towns in and around the Back Mountain including Dallas Borough, Kingston Township, Swoyersville Borough and Wyoming Borough. The reservoir currently spans **402** acres. Prior to the dam's construction, the acreage was made up of farmland, forests, and swamps. This area was formerly a hunting and trapping hotspot for various small game, according to an article in the *Wilkes-Barre Sunday Independent*³⁶ and *Citizens Voice*³⁷. The Fuller family were one of the early settler estates, farming in the Huntsville area. In 1890, the farm owner, Chester Fuller sold a portion of his land, between Jackson and Lehman Township to what was then the Wilkes-Barre Water Company. The dam was completed in 1892, and within 3 months, the reservoir was filled to capacity. The reservoir has changed hands over the years. It was constructed and owned by the Wilkes-Barre Water Company, then owned by the Spring Brook Water Service Company. In the late 1970s, it was owned by the PA Gas and Water Company. In 1978, an inspection judged the dam to be in good condition. It is now owned by PA American Water. It contains **2** billion gallons. It supplies water to **30,000** people³⁸

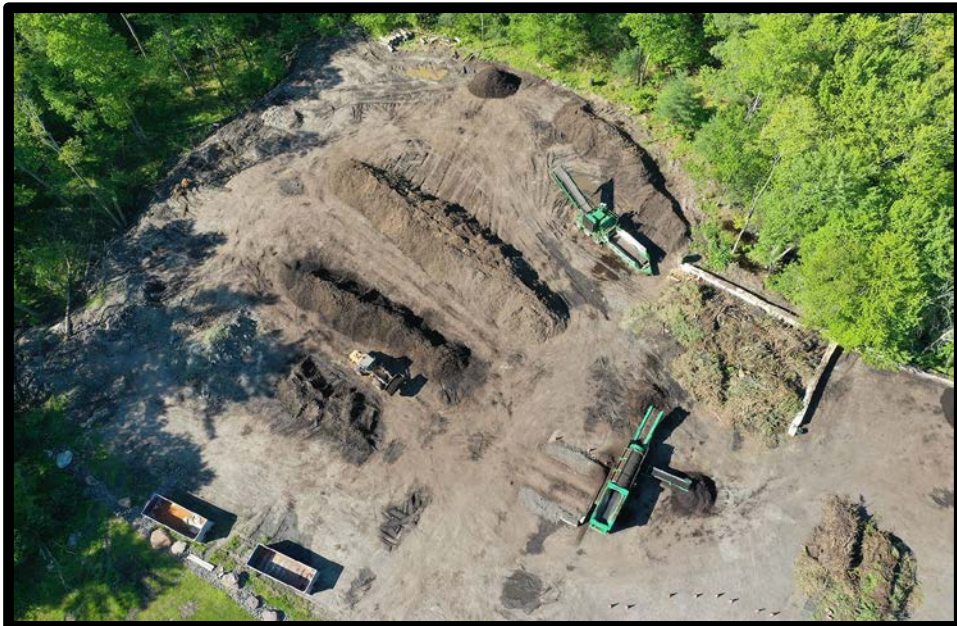
Figure 16. DAMA Yard Waste Composting (2019)

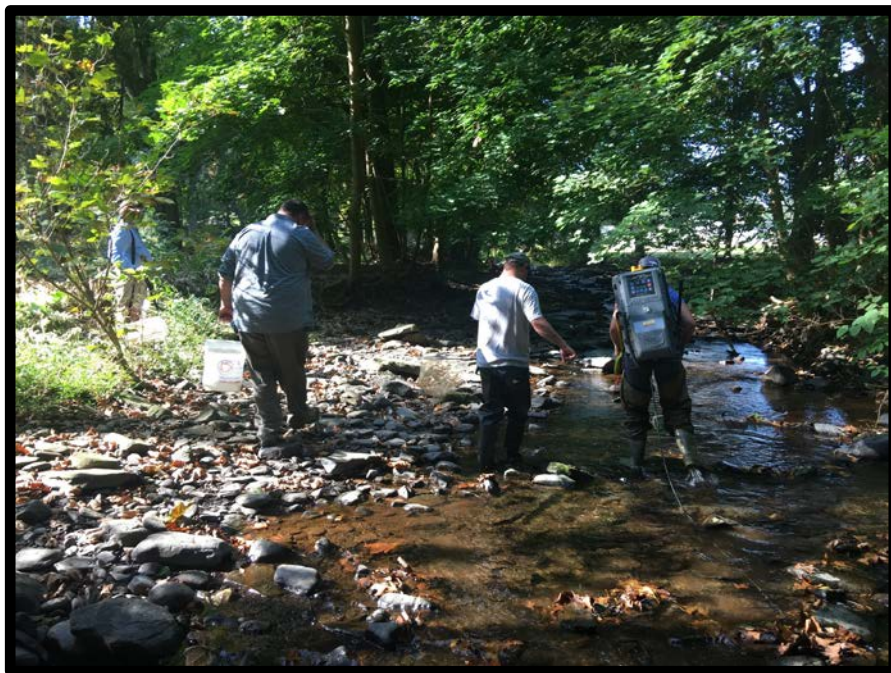
Figure 17. EPCAMR, DAMA, The Lands at Hillside Farms, Luzerne Conservation District, and Trout Unlimited conducting an electroshocking survey pass on Huntsville Creek just below The Lands at Hillside Farms at Site HC01

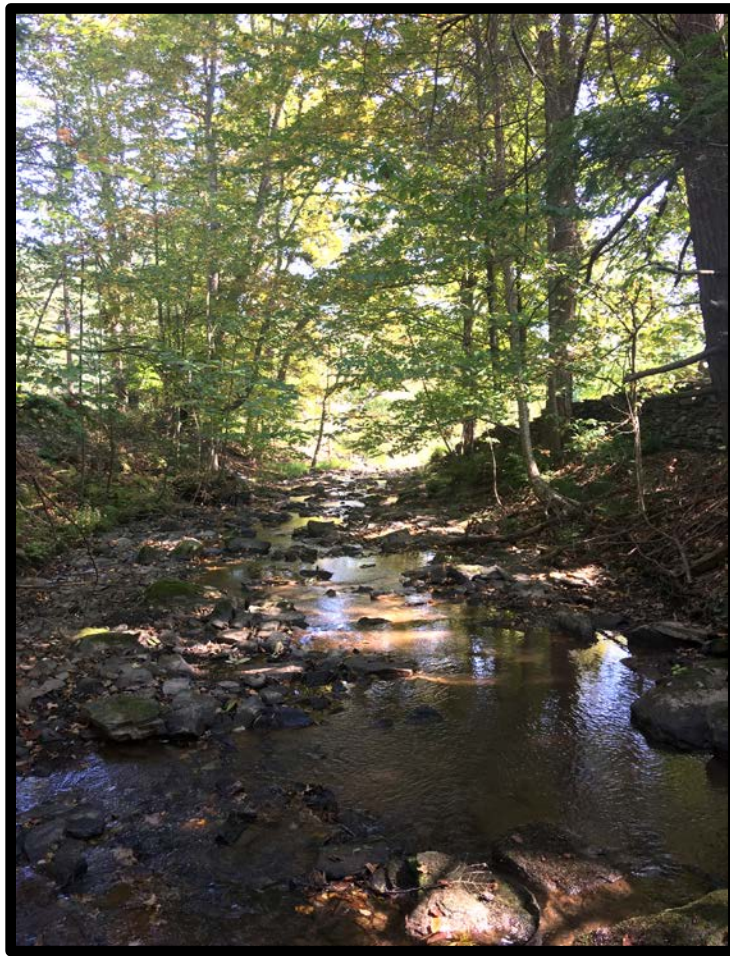
Figure 18. Looking upstream on Browns Creek at Site HC02 prior to running a pass with the electroshocking equipment with Trout Unlimited and our partners

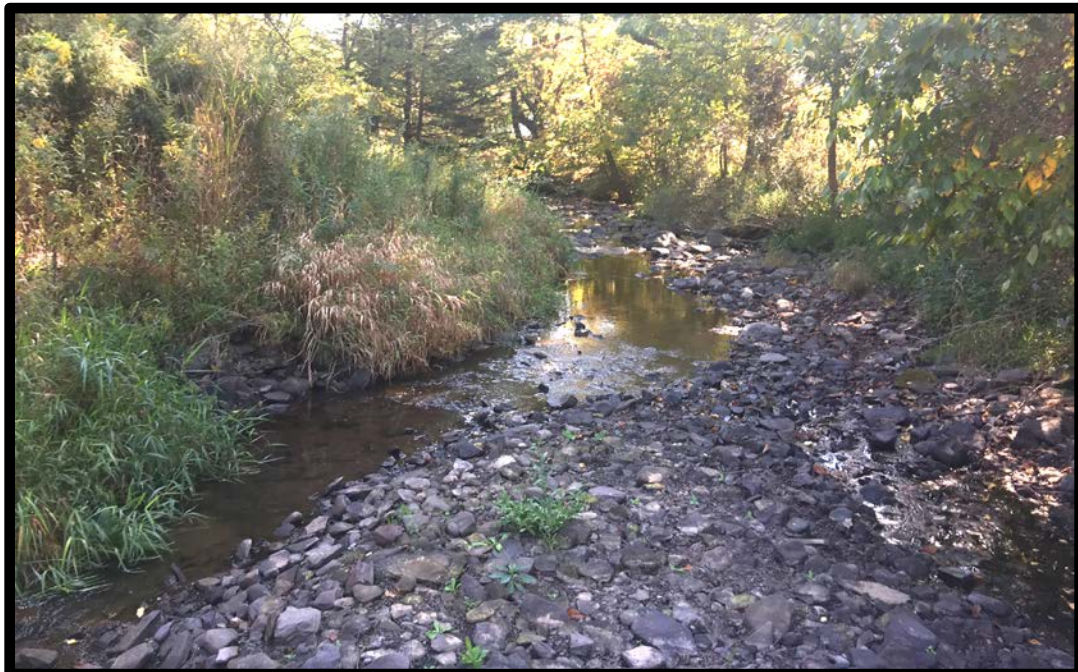
Figure 19. Looking downstream on the Browns Creek riparian corridor near the mouth of Huntsville Creek at Site HC03 along Chase Road

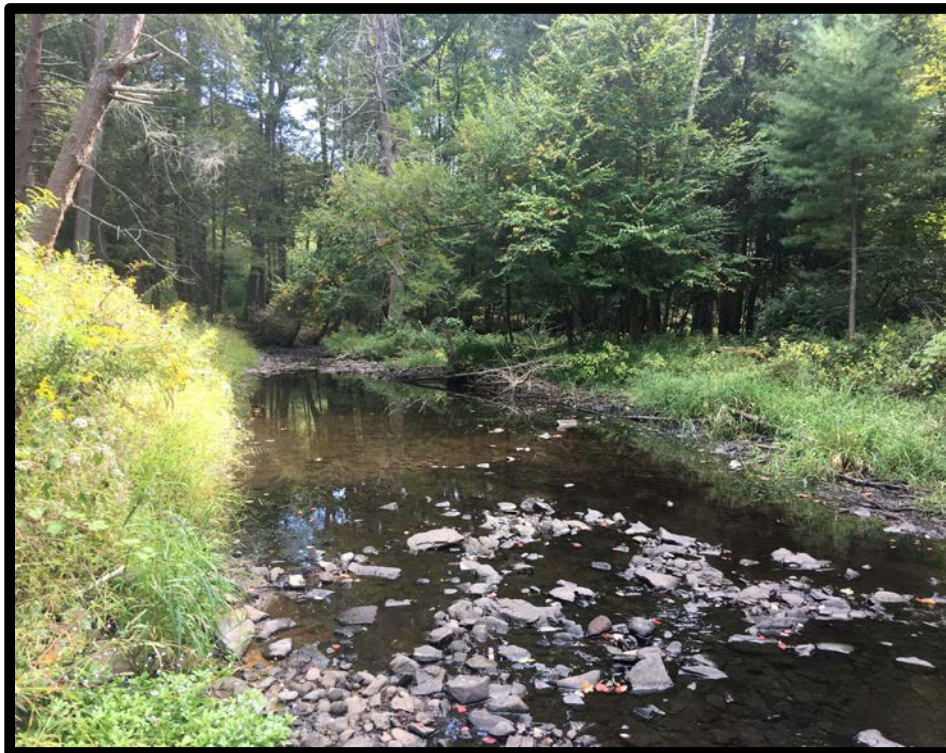
Figure 20. Looking downstream on Huntsville Creek below Gross Road and the Huntsville Reservoir at a wide pool that was electroshocked and surveyed at Site HC04

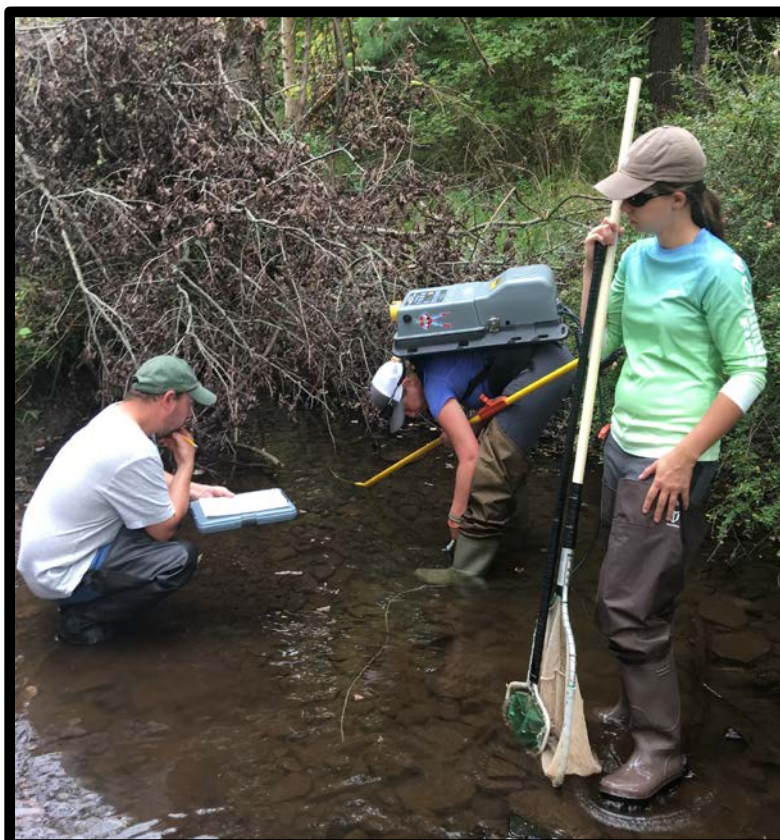
Figure 21. EPCAMR, DAMA, and Trout Unlimited electroshock one of the headwater unnamed tributaries to Huntsville Creek above the Lehman Nursery of State Route 118 and run into a fallen root wad that is providing excellent habitat cover for the fish we surveyed at Site HC05

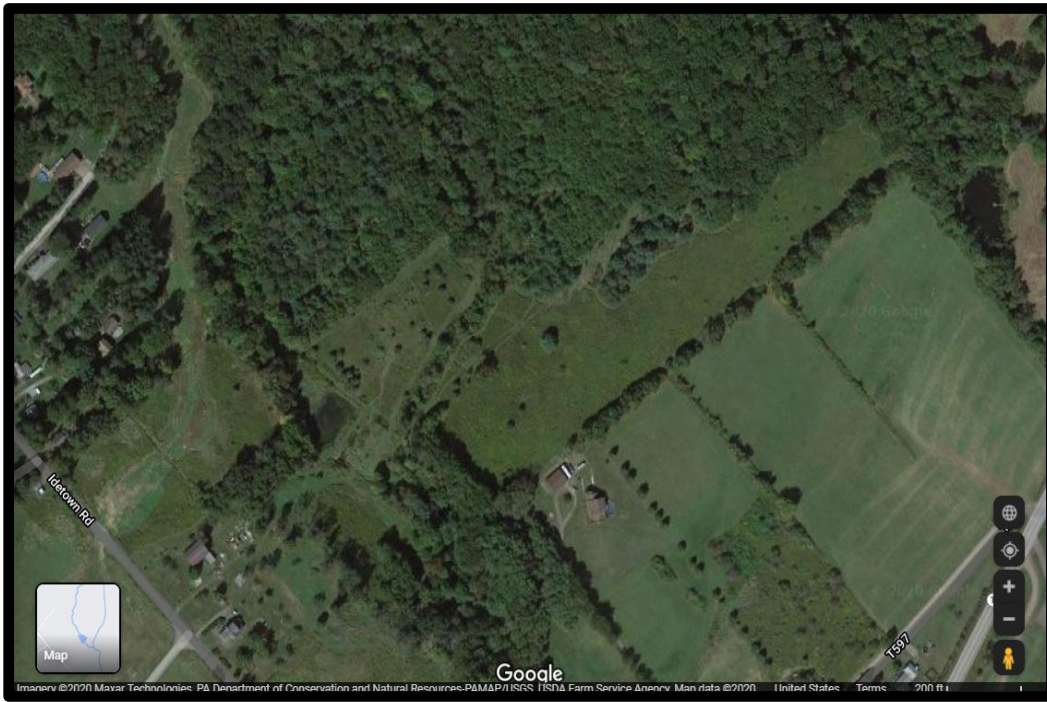
Figure 22. An aerial shot of the heavily forested and buffered headwaters (top center of image) of Huntsville Creek at Site HC06 on the Bernstein Property along Idetown Road, Dallas, PA

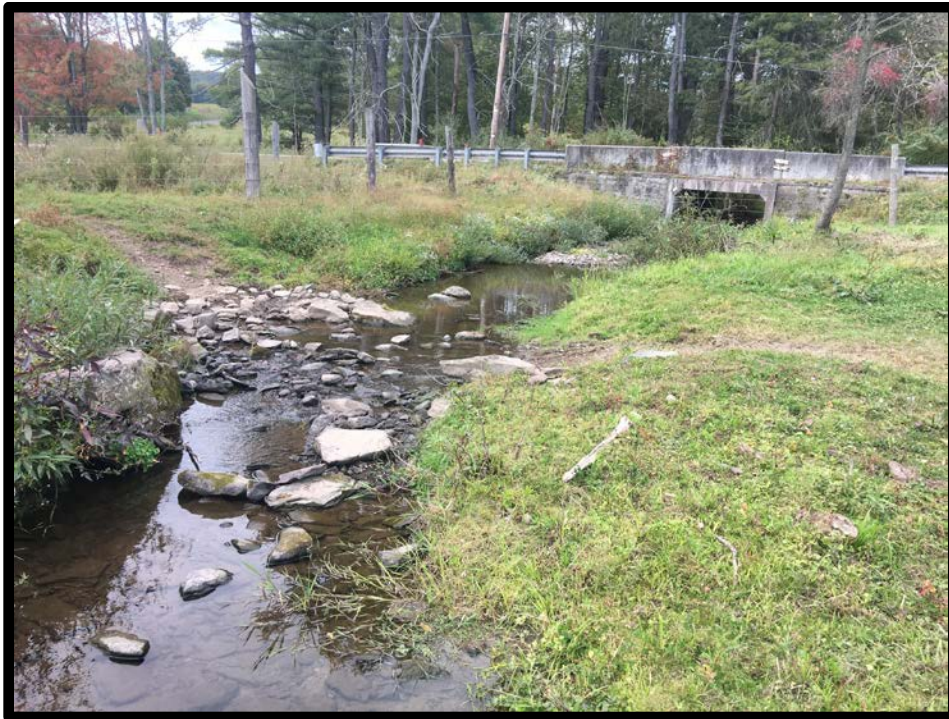
Figure 26. A stream crossing on the unnamed headwater tributary to the Huntsville Reservoir looking upstream toward the concrete bridge culvert on Park Road (T-597) in Dallas Township, PA

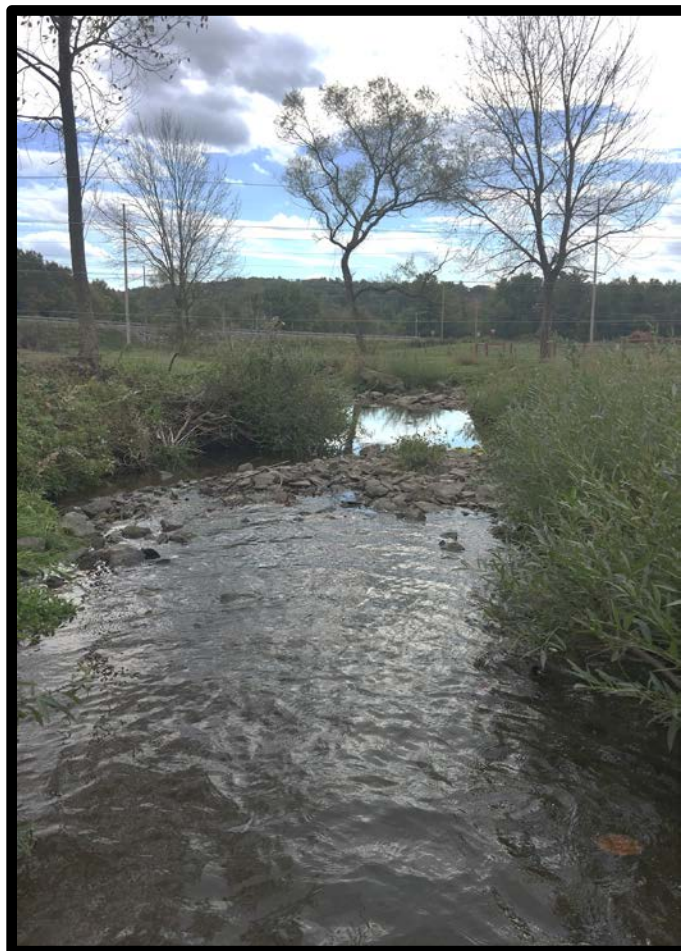
Figure 27. Looking downstream on the unnamed headwater tributary to the Huntsville Reservoir at a series of pools and a well established riparian area at the Lehman Nursery property

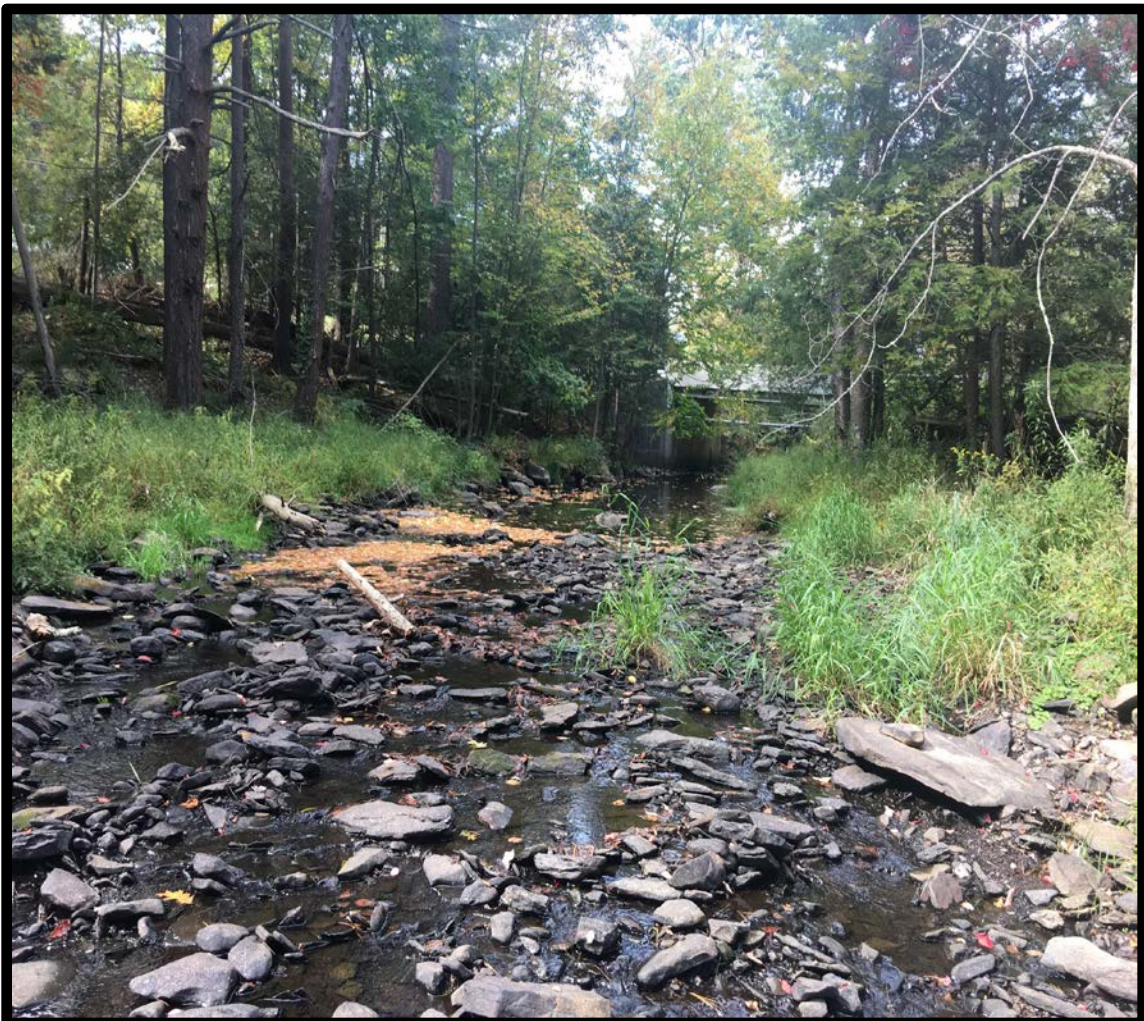
Figure 35. Looking upstream on Huntsville Creek during low flow period in the middle of September 2019 towards the bridge over Gross Road

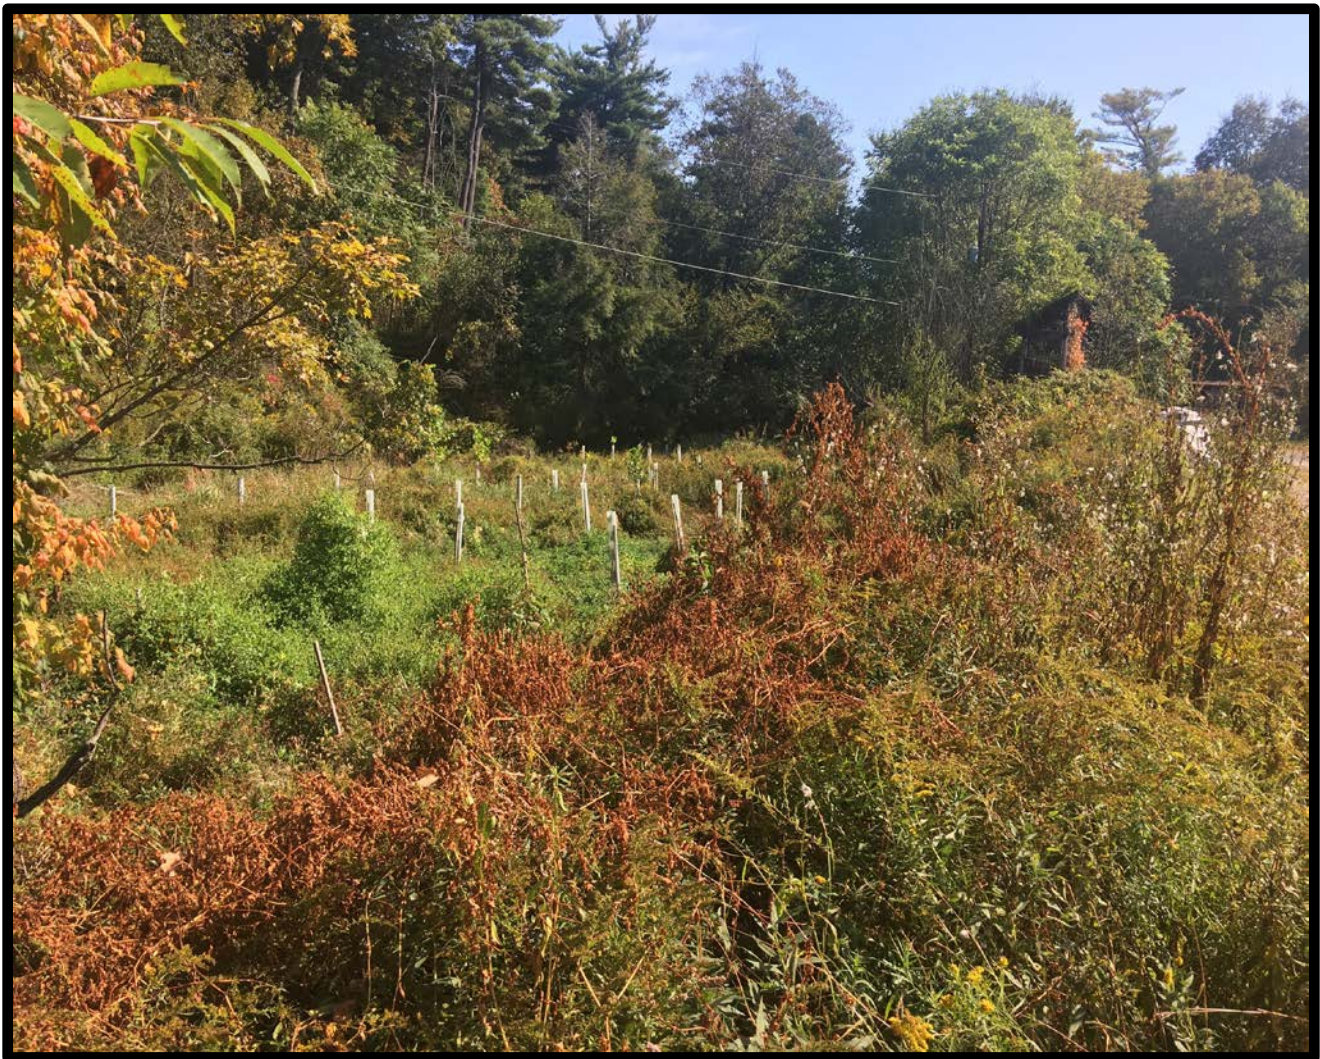
Figure 39. Looking downstream on Huntsville Creek just below the confluence with Browns Creek along Huntsville Road and on the property owned by The Lands at Hillside Farms where a riparian tree planting restoration project has already been established implemented by the Luzerne Conservation District and previous efforts of the Pennsylvania Environmental Council and PA American Water

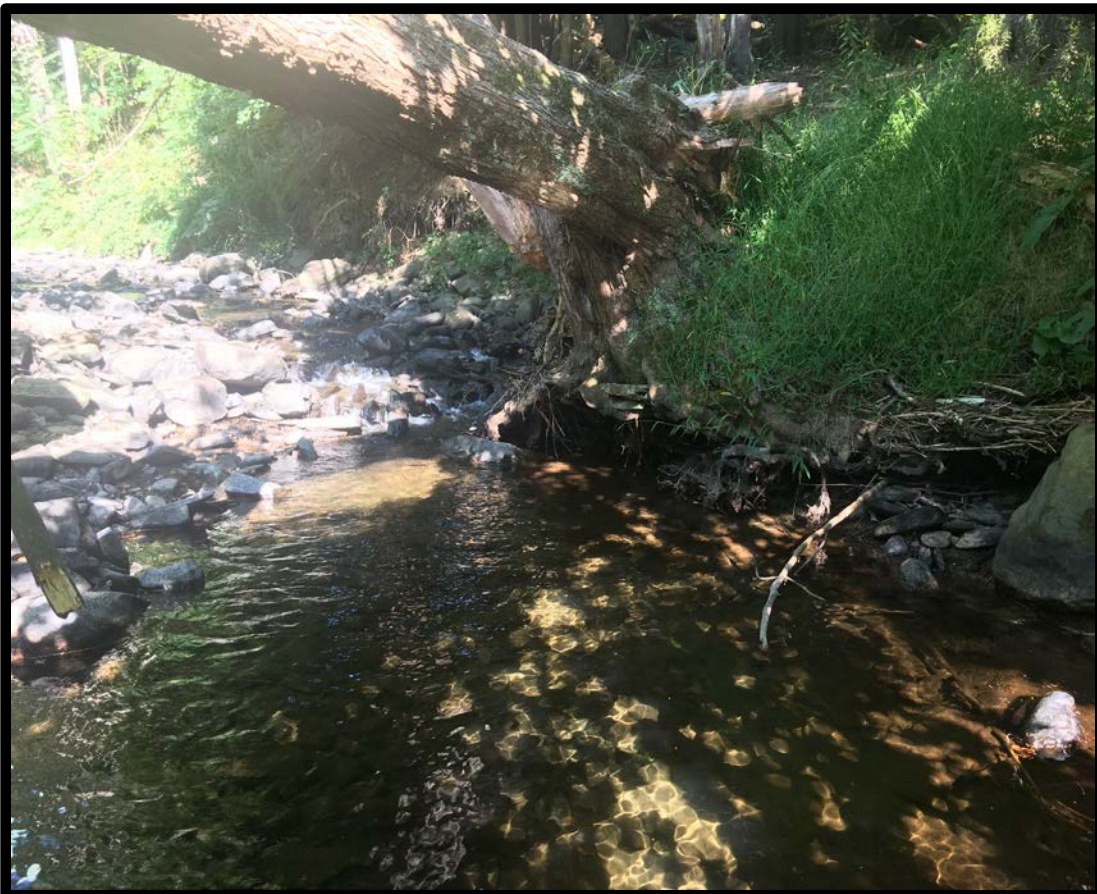
Figure 43. Looking upstream on Huntsville Creek at a fallen tree over the stream channel and a typical riffle-pool section

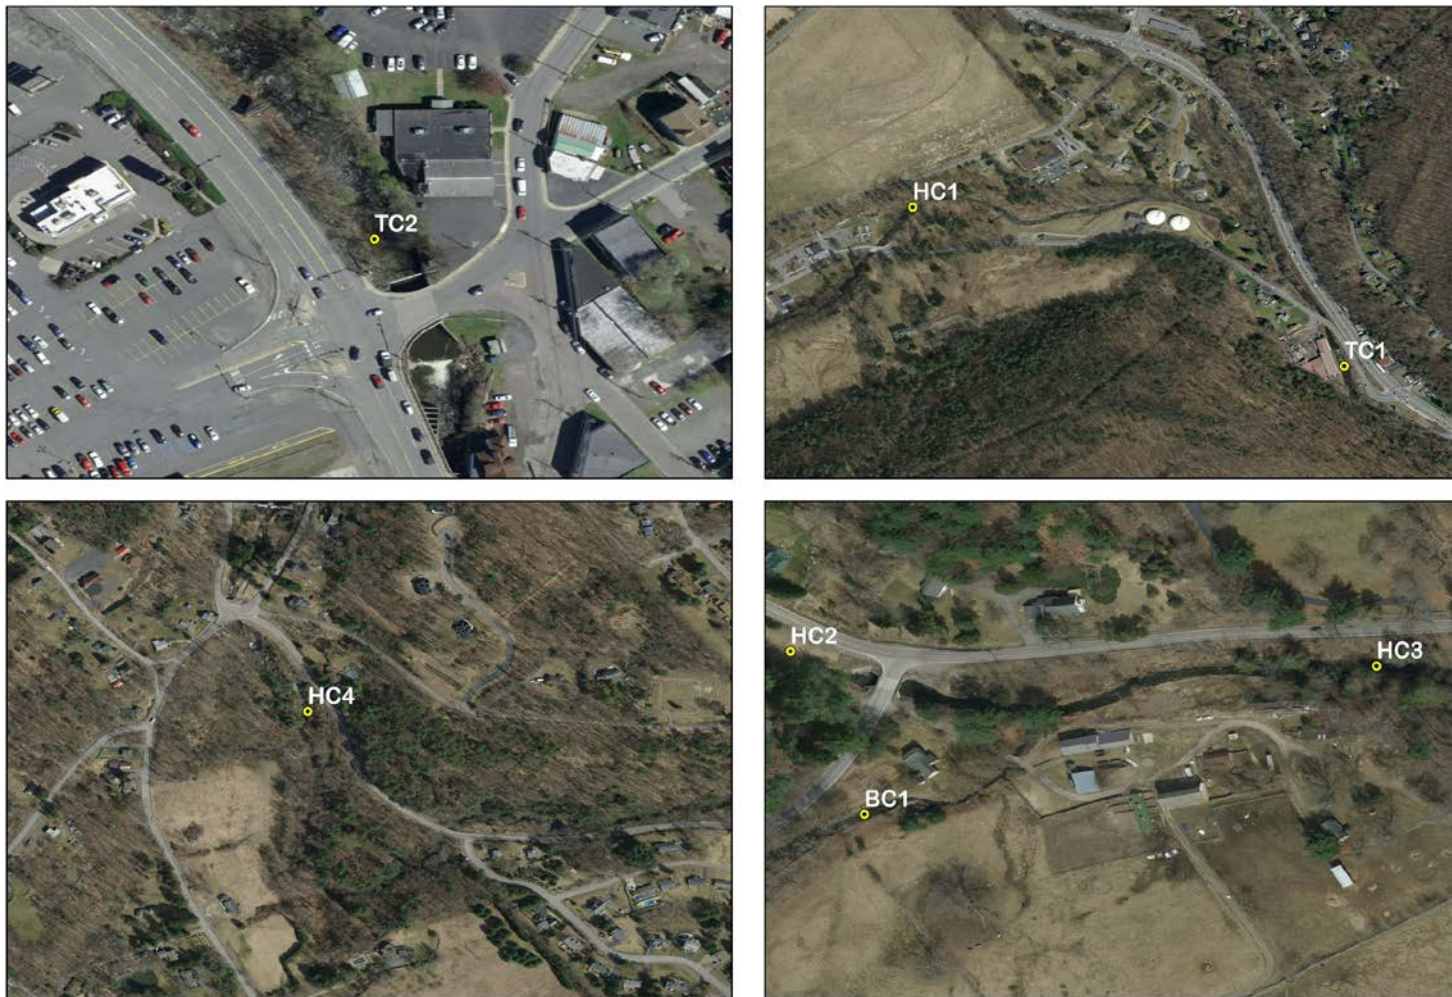
Figure 45. Huntsville Creek Macroinvertebrate Biological/Visual Habitat Assessment Sampling Locations

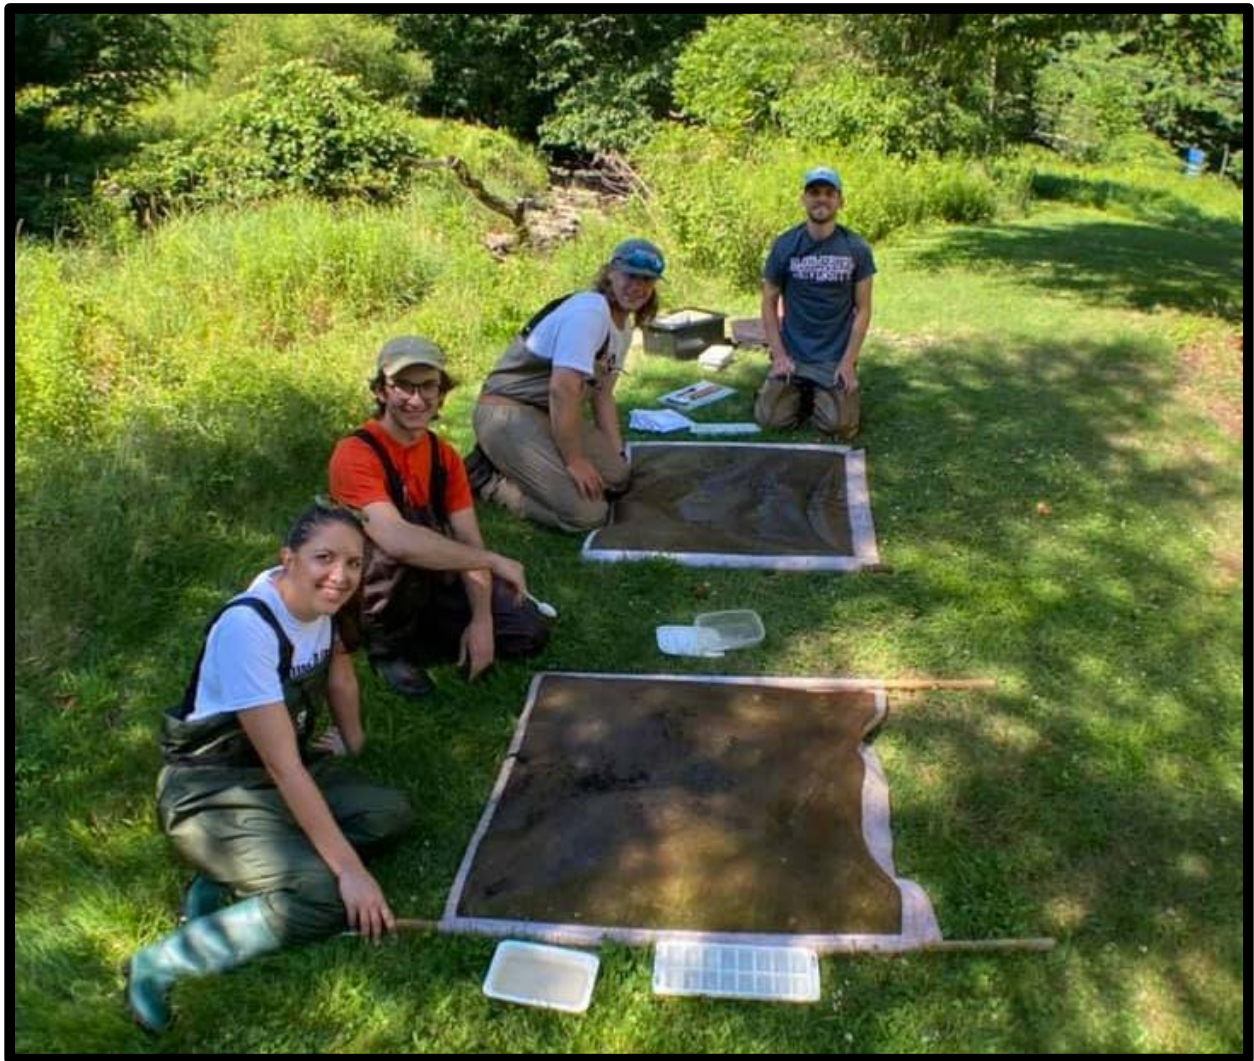
Figure 46. EPCAMR Staff and Interns performing biological sampling and macroinvertebrate identification on Browns Creek in the Huntsville Creek watershed on 7-21-20

EPCAMR Staff and Volunteers collected macroinvertebrate, biological, and chemical sampling data on 7-16-20 and 7-21-20. The results of the data collection and sampling locations are below.

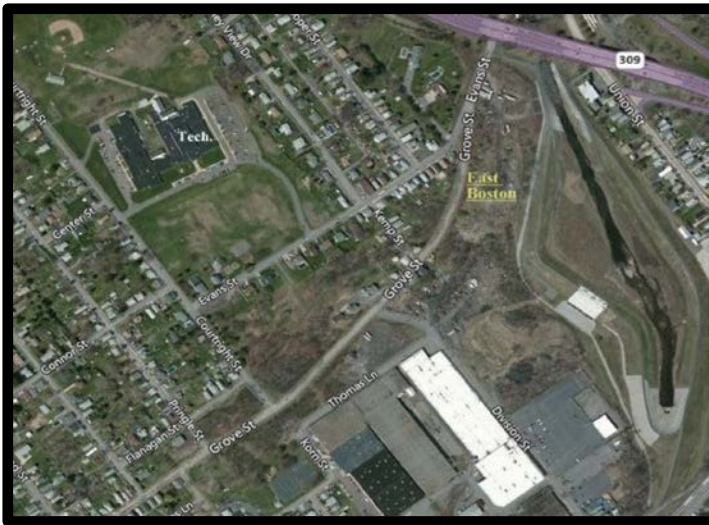
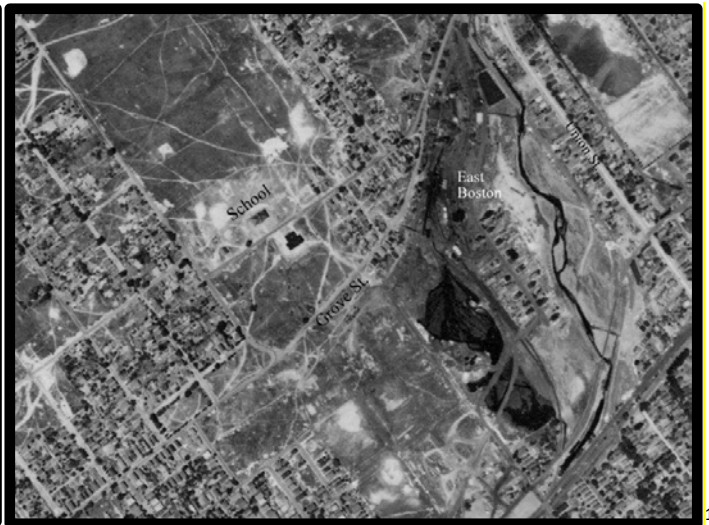
Figure 52. Impounding basin shown (on left) with the East Boston Colliery just west of it in 1939 at the intersection of Grove and Evans Streets

The East Boston Colliery, location on the west bank of Toby Creek in Pringle Borough, was founded in 1870 by Consumer Coal Company. Annually it produced roughly **125,000** tons of coal. The impounding basin on Toby Creek was built in 1943, and the breaker's operation eventually came to a halt. From 1947- 1956, the site was used exclusively as a mine and the breaker never operated.^{99,100}

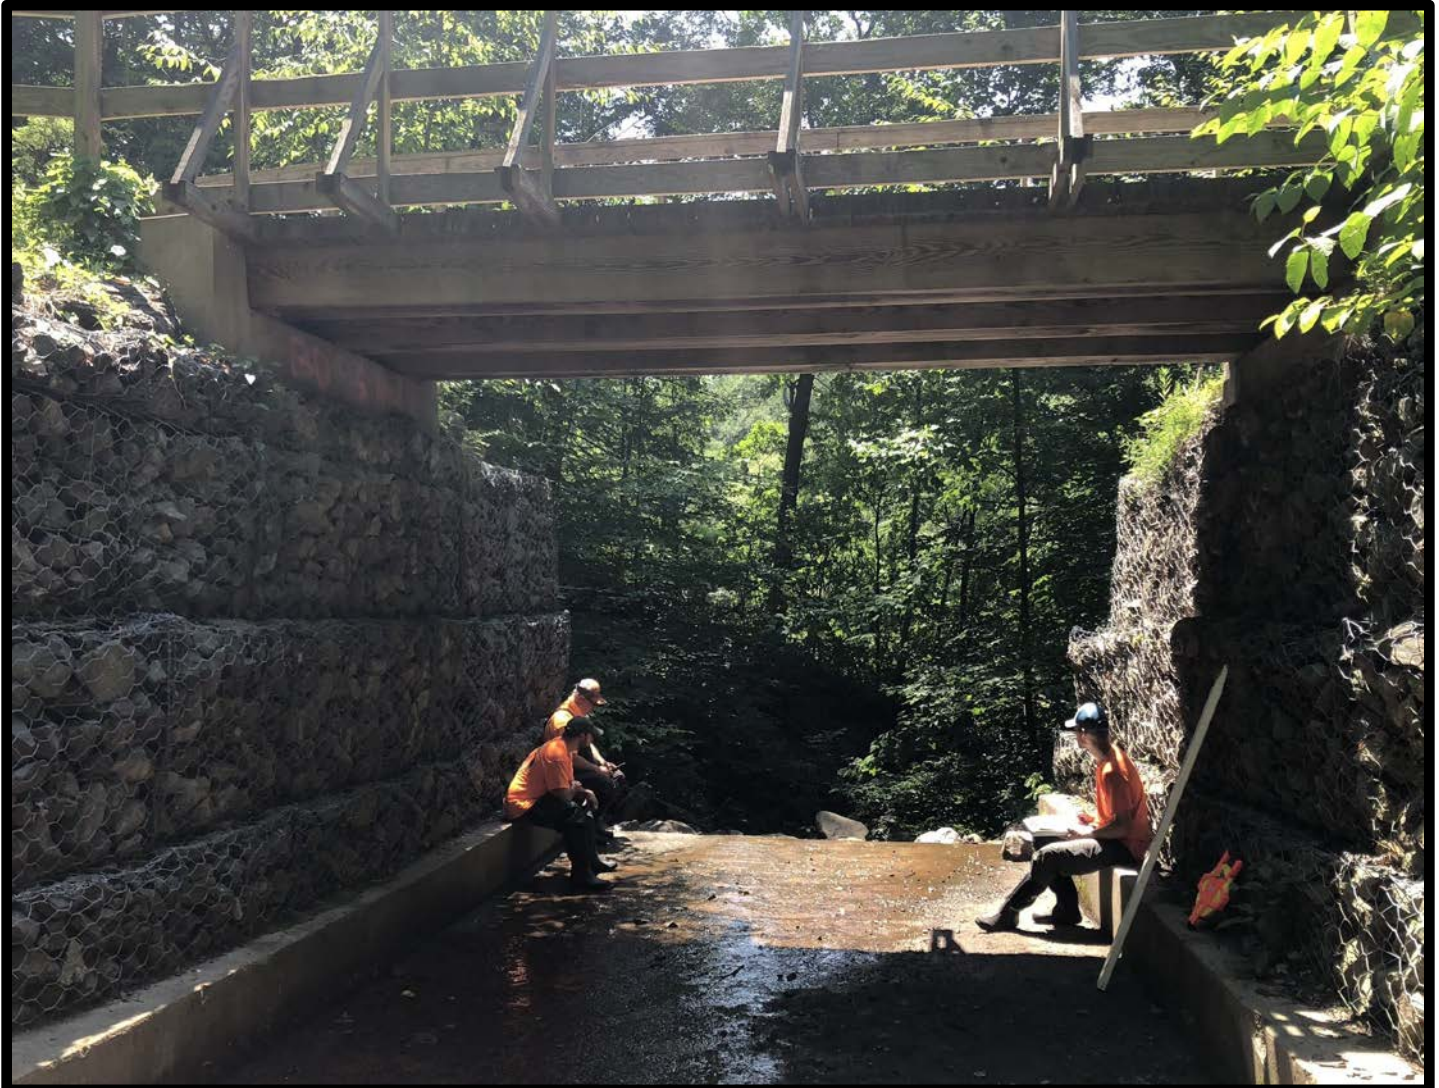
Figure 56. EPCAMR staff and partners beneath bridge above Wildcat Falls conducting a culvert assessment

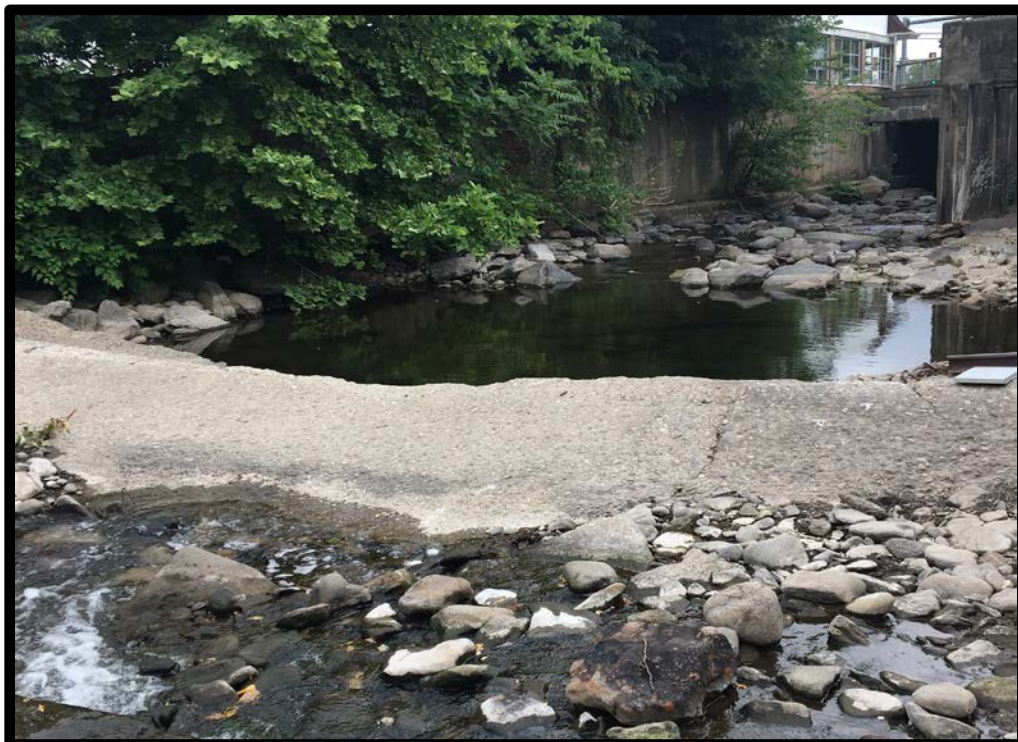
Figure 58. Concrete dam on Lower Toby Creek where Brown Trout were observed in Luzerne Borough

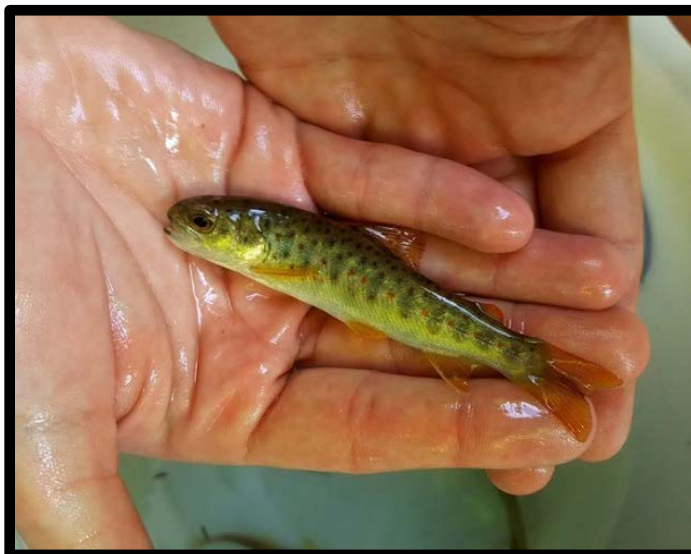
Figure 61. Brown trout measuring 100mm documented at site HC01

Brown trout (*Salmo trutta*) were documented at HC01, the most downstream site closest to the confluence with Toby Creek on Hillside Farms property (Figure 2). Four brown trout were captured at this site measuring 265mm, 100mm, 97mm, and 99mm. No brook trout (*Salvelinus fontinalis*) were documented at any site on Huntsville Creek. Brown trout of this size distribution and abundance would warrant a Naturally Reproducing Wild Trout designation from PFBC. This data has been submitted to PFBC as part of the Unassessed Waters Initiative (UWI) conducted by the agency and partners with the goal of identifying and protecting existing wild trout streams.
