## Eastern Brook Trout Stream Habitat Assessment

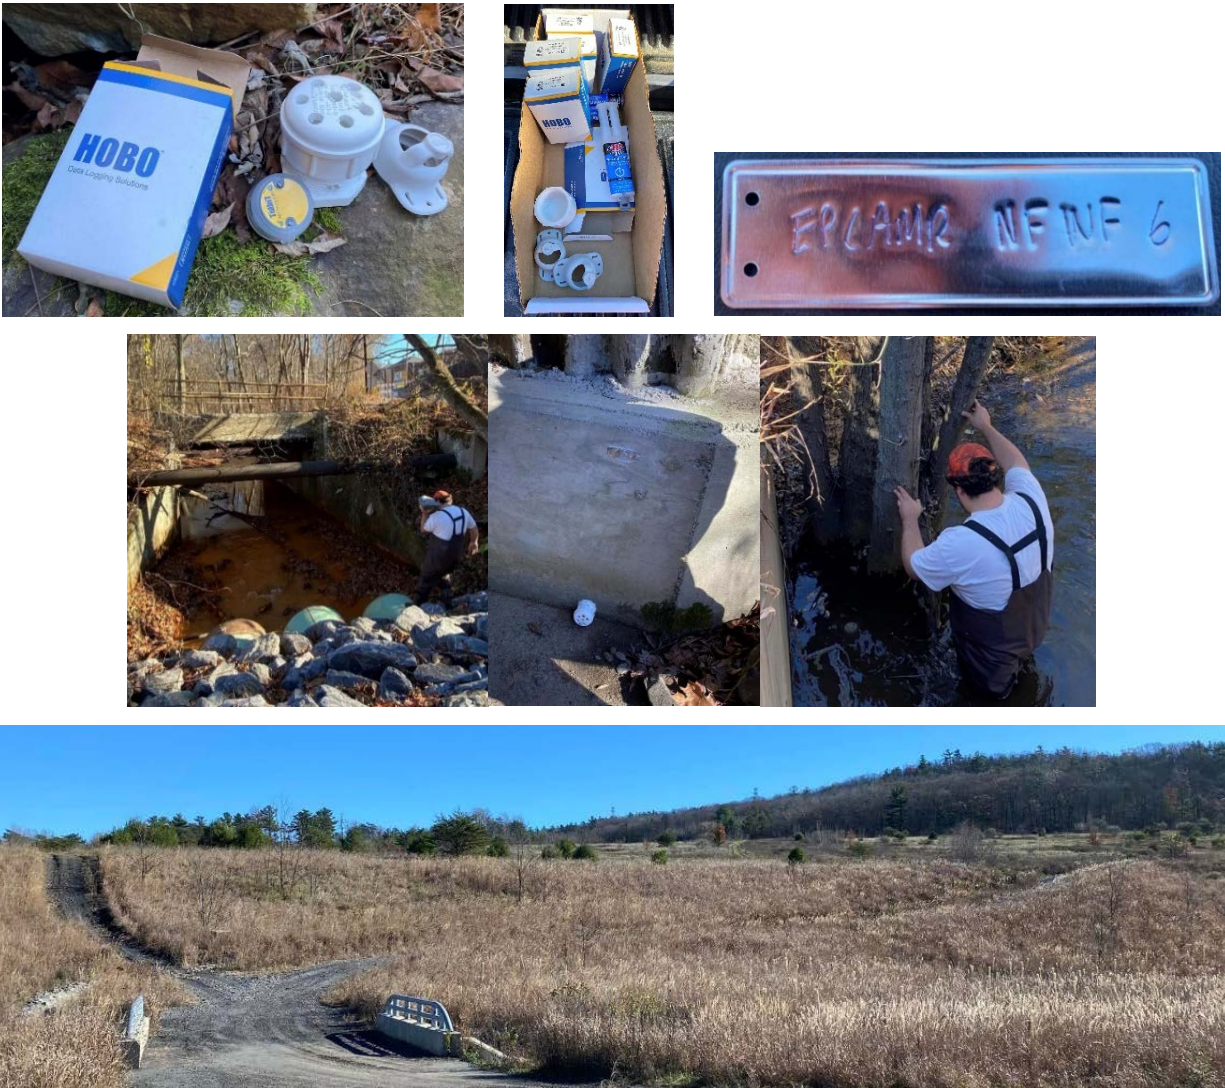
EPCAMR Staff installed and deployed 16 HOBO temperature probe units throughout the watersheds to obtain temperature readings continuously over time in November 2022. They were TidBiT MX Temp 400 and 5000 loggers. All their specifications were included as a part of our QAPP. Ten of the 16 units provided complete data and 6 of the units experienced technical malfunctioning throughout the project. A few of them were lost to extreme weather conditions even when they were deployed using waterproof epoxy on large boulders. Construction activities around another site possibly led to one of the probes along Warrior Creek to be scooped up and disposed of unknowingly by a machine operator. Vandalism could have been another cause for the loss of a few by curious youth. EPCAMR also purchased PVC bushings and caps to secure the HOBO temperature sensors. EPCAMR researched and reviewed Trout Unlimited's [A Handbook for Trout Unlimited Chapters: Stream Temperature Monitoring](#) (Dauwalter, et. al., 2018) and the [EPA Best Practices for Continuous Monitoring of Temperature and Flow in Wadeable Streams](#) (EPA, 2014), prior to installing and deploying the HOBO temperature sensors.

Figure 3. Photo Collage of EPCAMR Installing HOBO Temperature Sensors within the Southern Wyoming Valley Watersheds
