Toby Creek Field Reconnaissance Observations

September 26, 2018

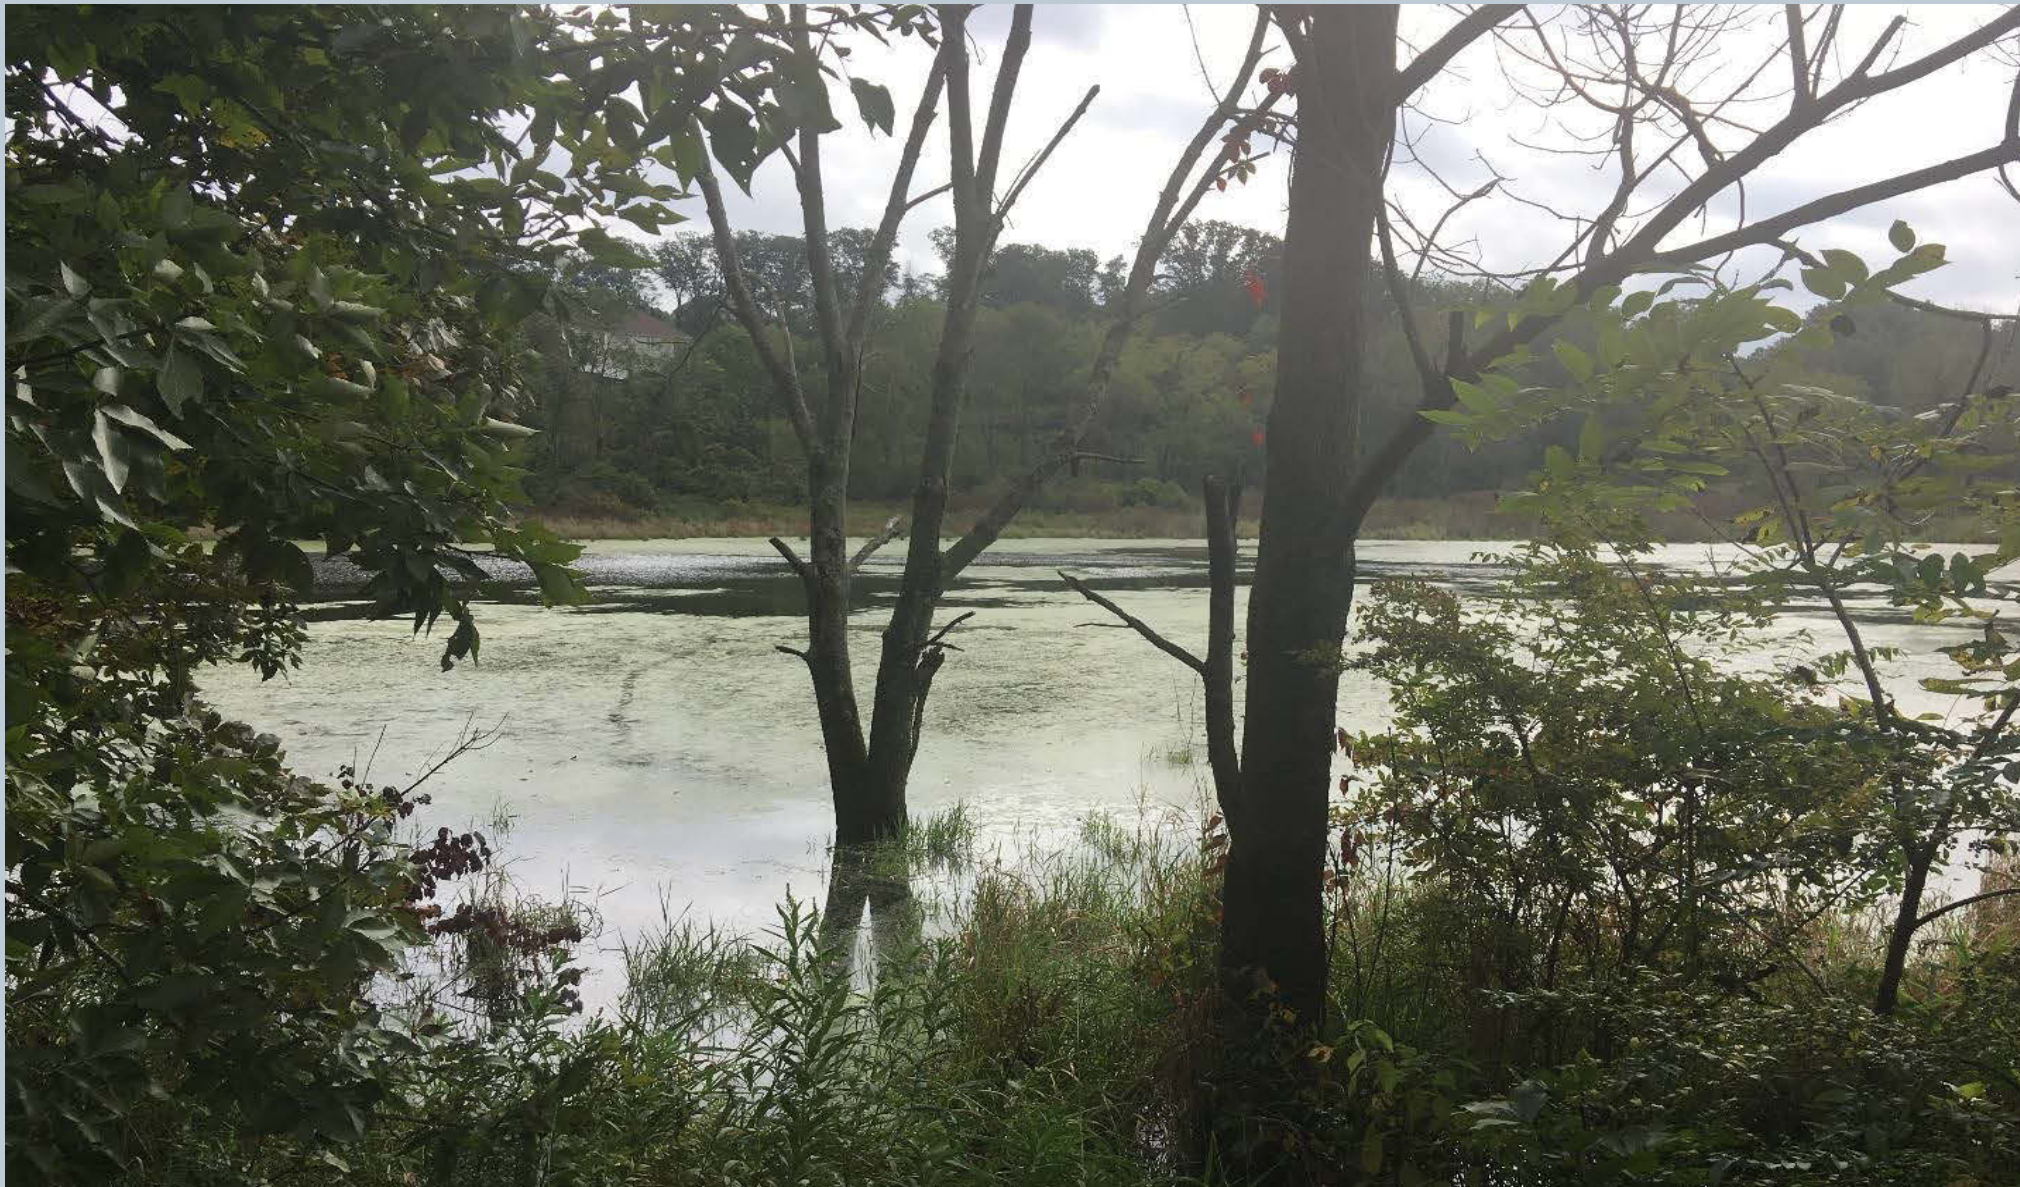
Figure 1. A shot of Green Pond. This location has a rock farm wall along the side of the road, and a headwall along the side of Green Drive, which requires remediation.

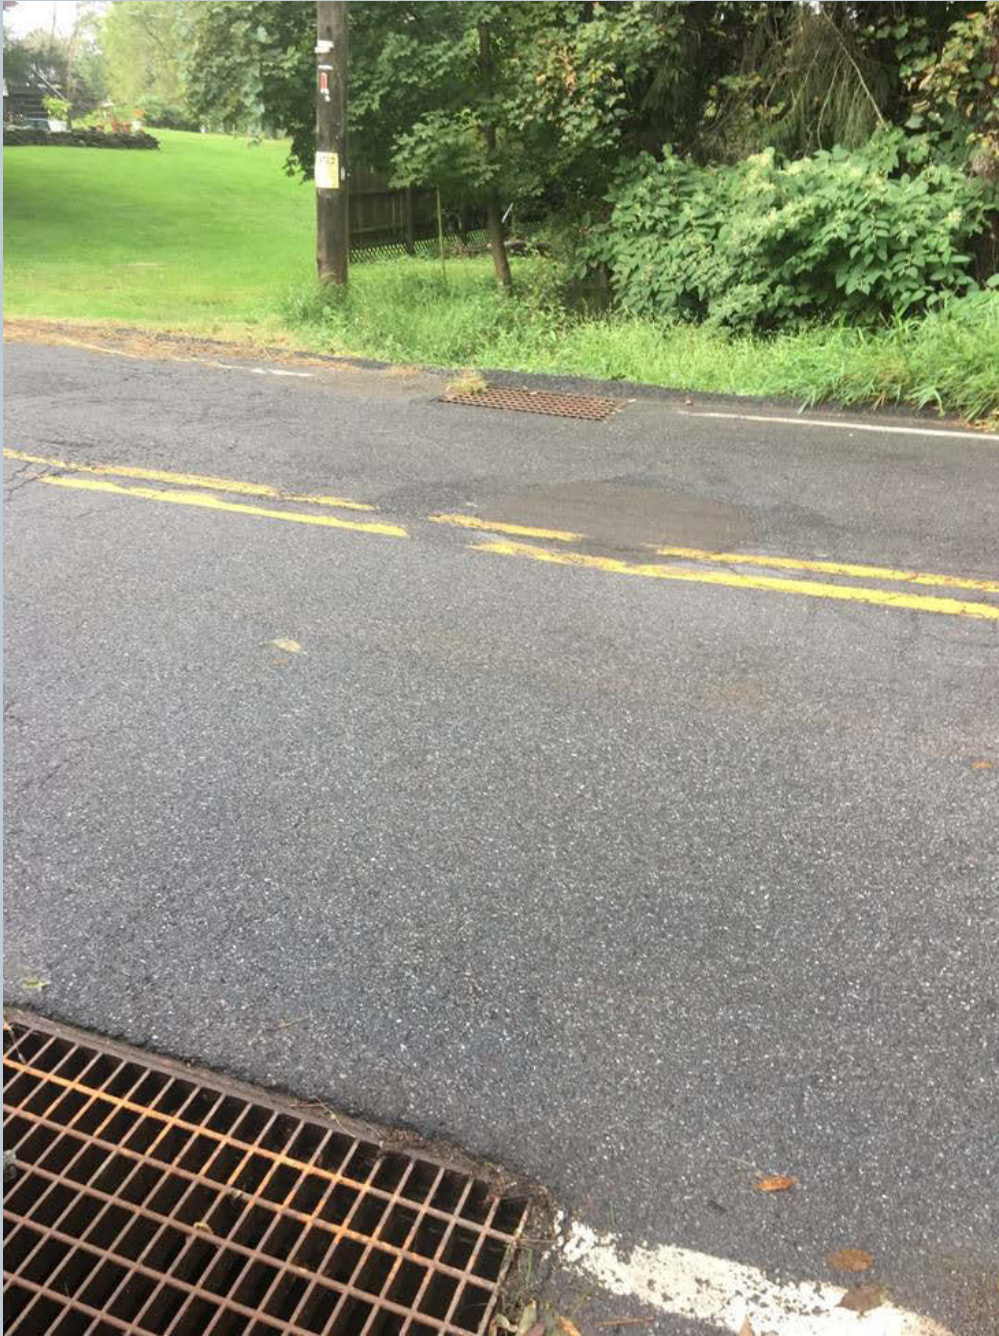
Figure 2. A stormwater drain for the overflow from Green Pond.

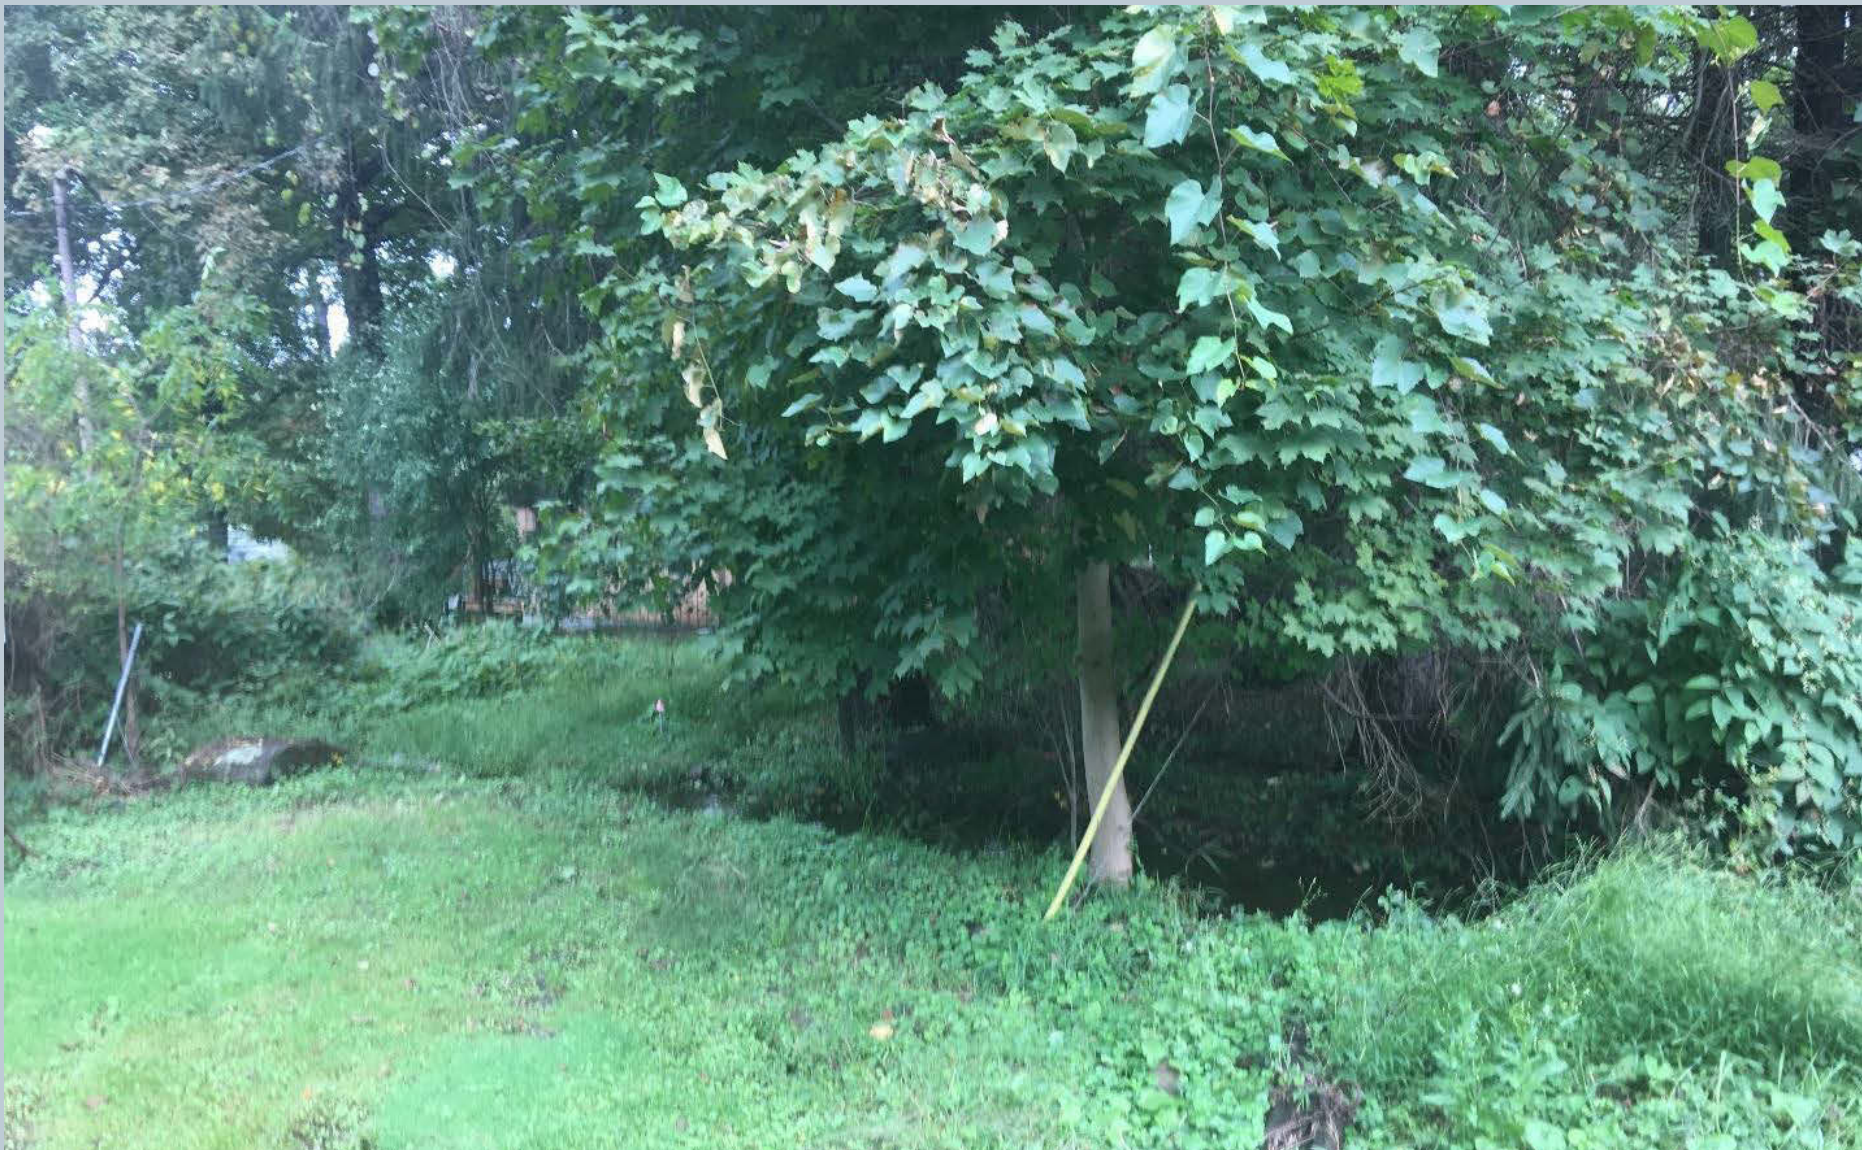
Figure 3. A stream outlet overflow from Green Pond that is densely populated with Japanese knotweed and poison ivy. This location can be found looking downstream of Green Pond from behind the residences along Green Drive.

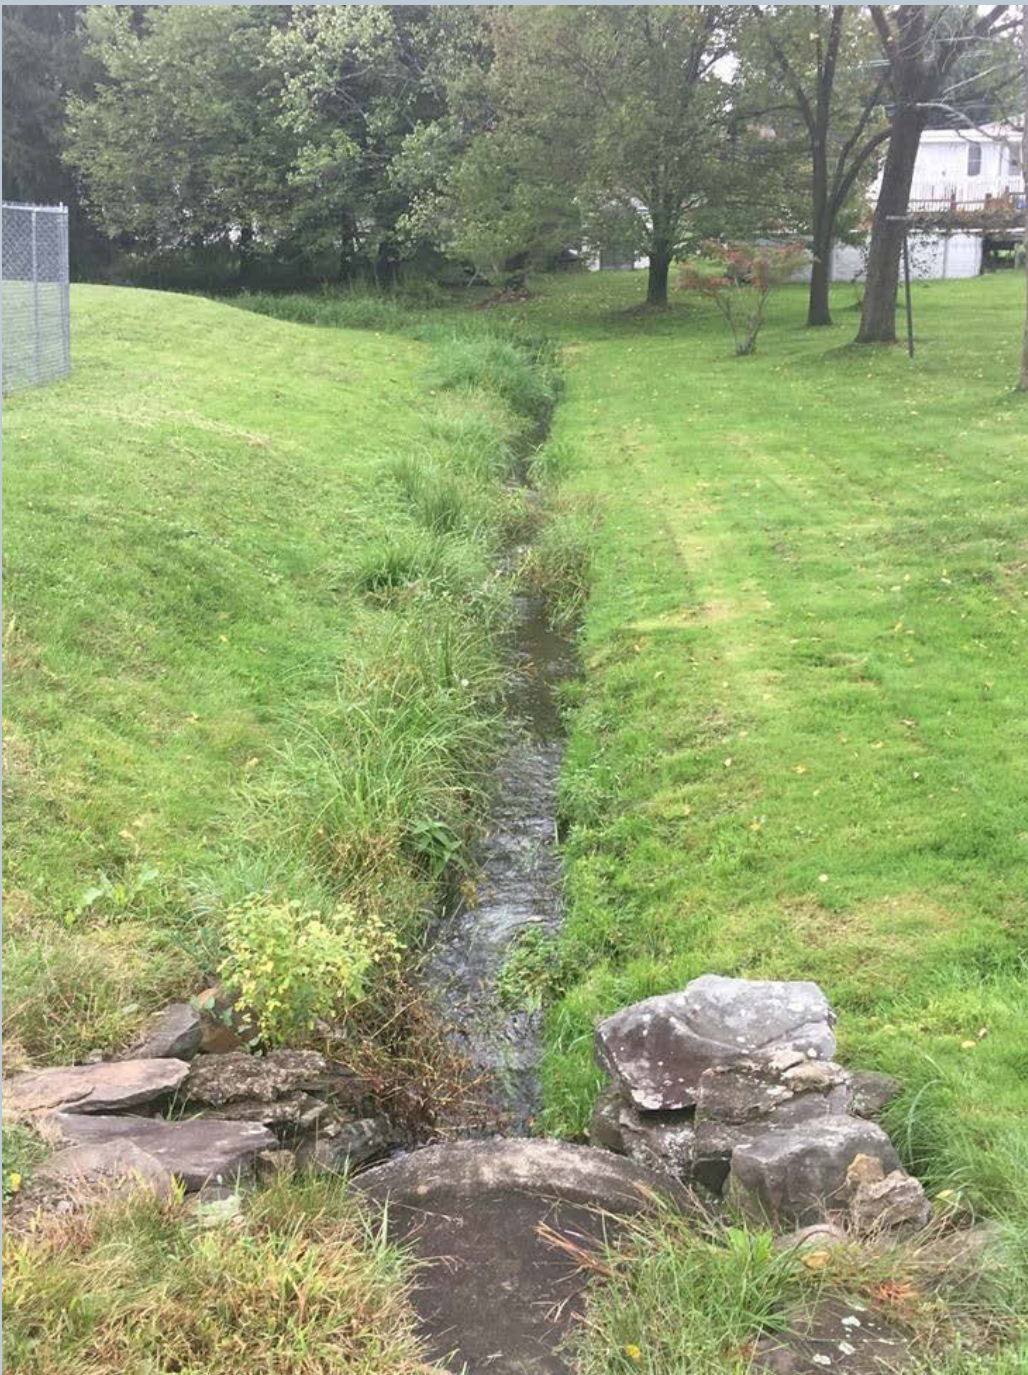
Figure 4. This photo is of an unnamed tributary at the intersection of Green Pond and Woodbine Drive. Natural vegetation is visible on one bank, and mowing is visible on both. Restoration of the riparian corridor can be achieved by mowing further from the streambank.

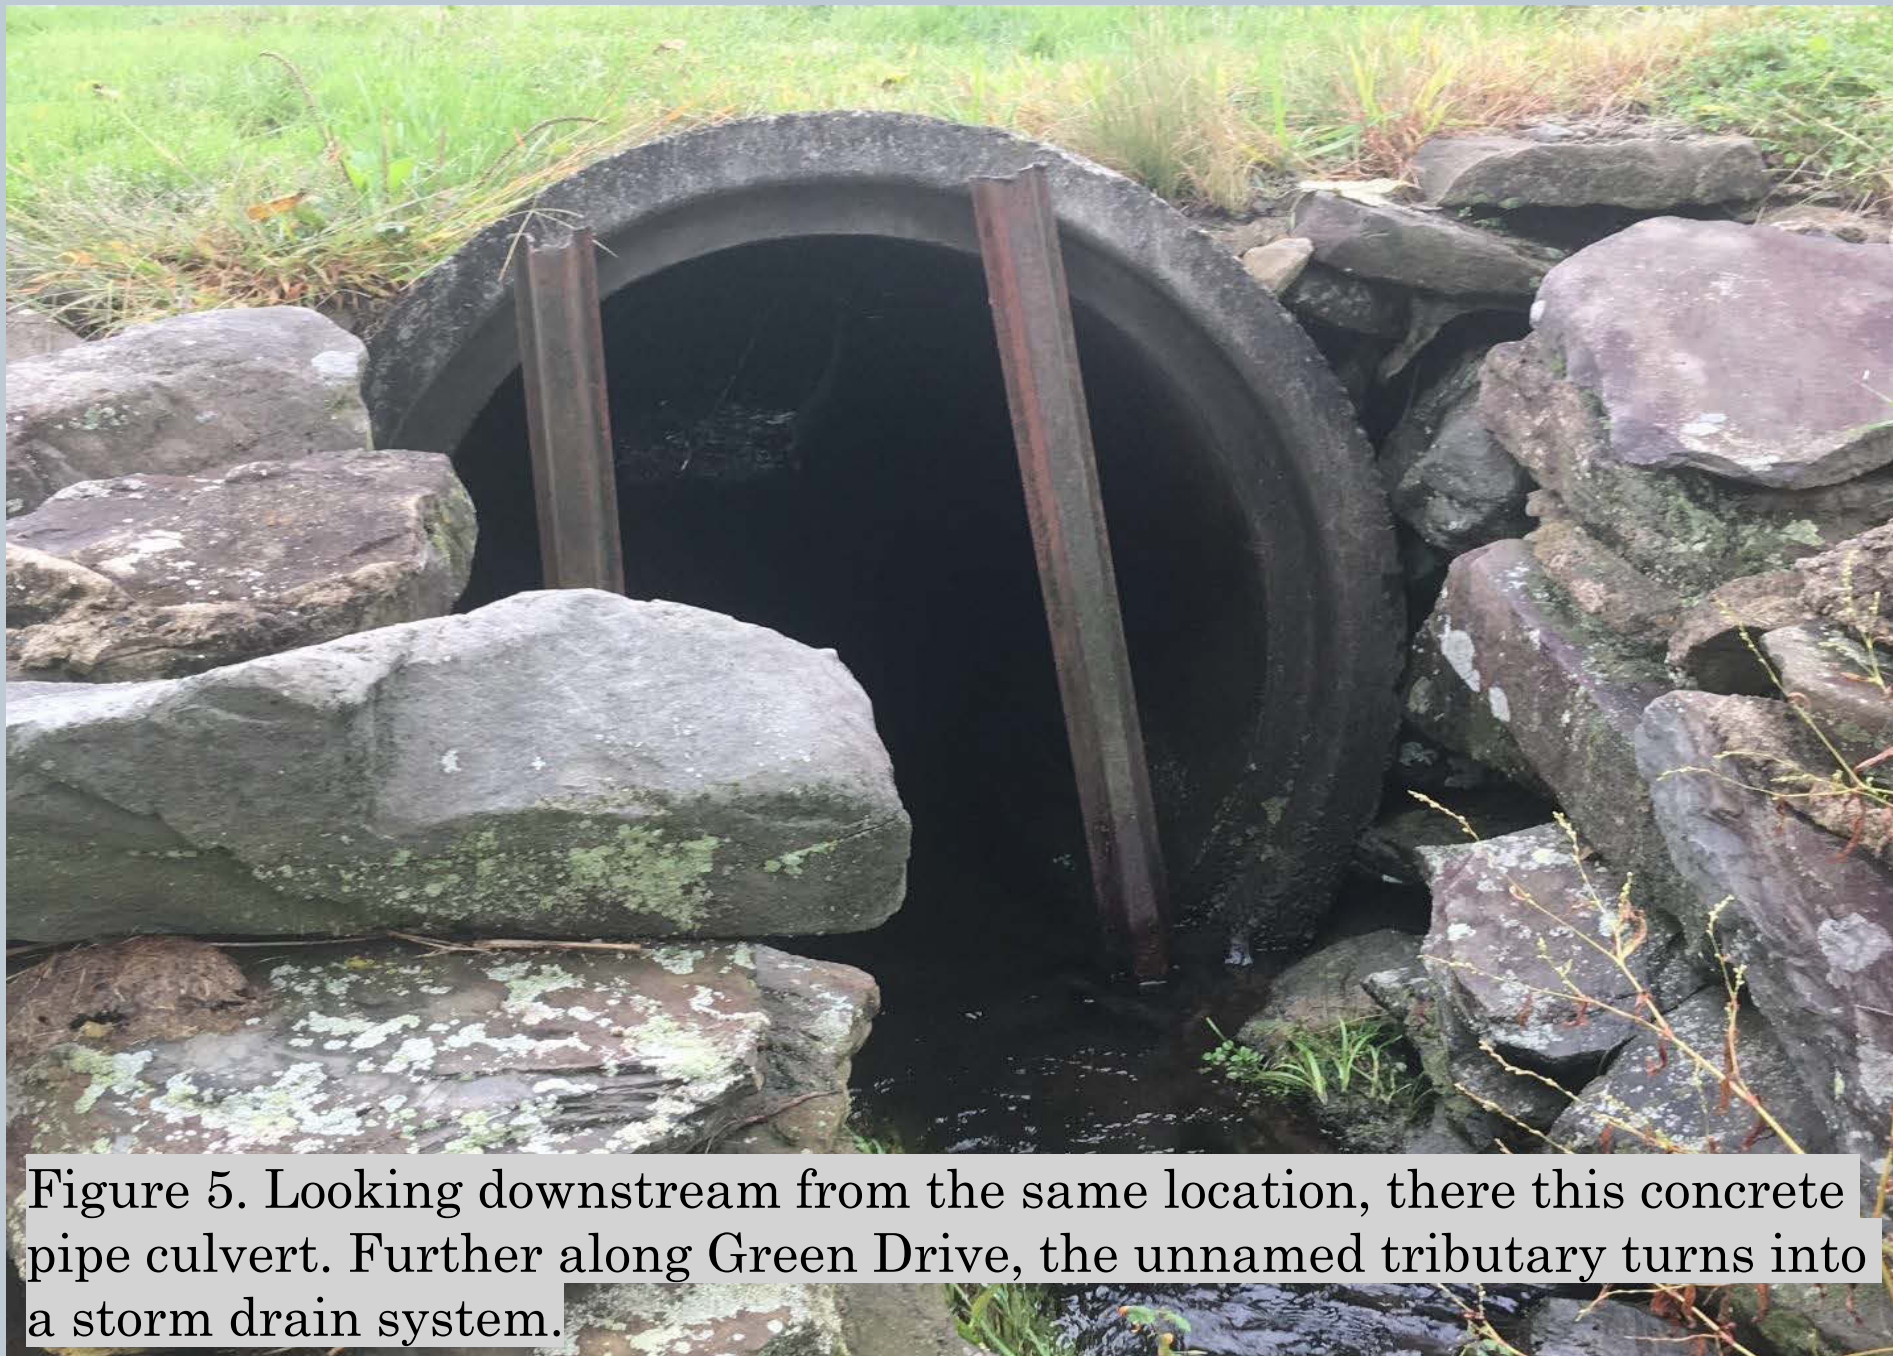
Figure 5. Looking downstream from the same location, there this concrete pipe culvert. Further along Green Drive, the unnamed tributary turns into a storm drain system.

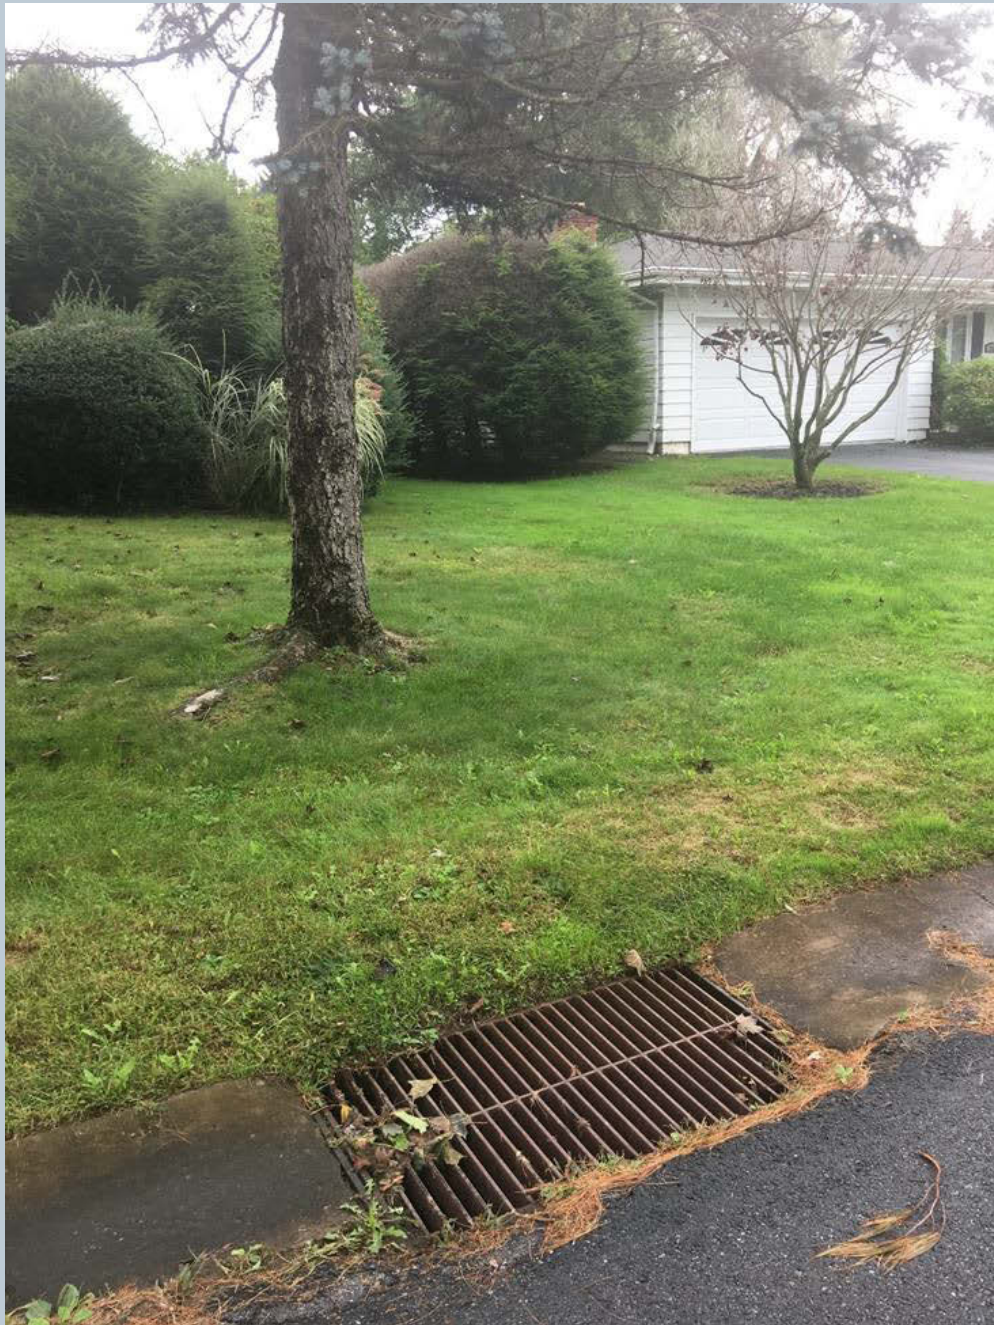
Figure 6. This property belongs to Bill Alles. The Green Pond unnamed tributary flows through a storm drain near the rear of his yard and discharges behind homes along Woodbine Drive and Harris Hill Road.

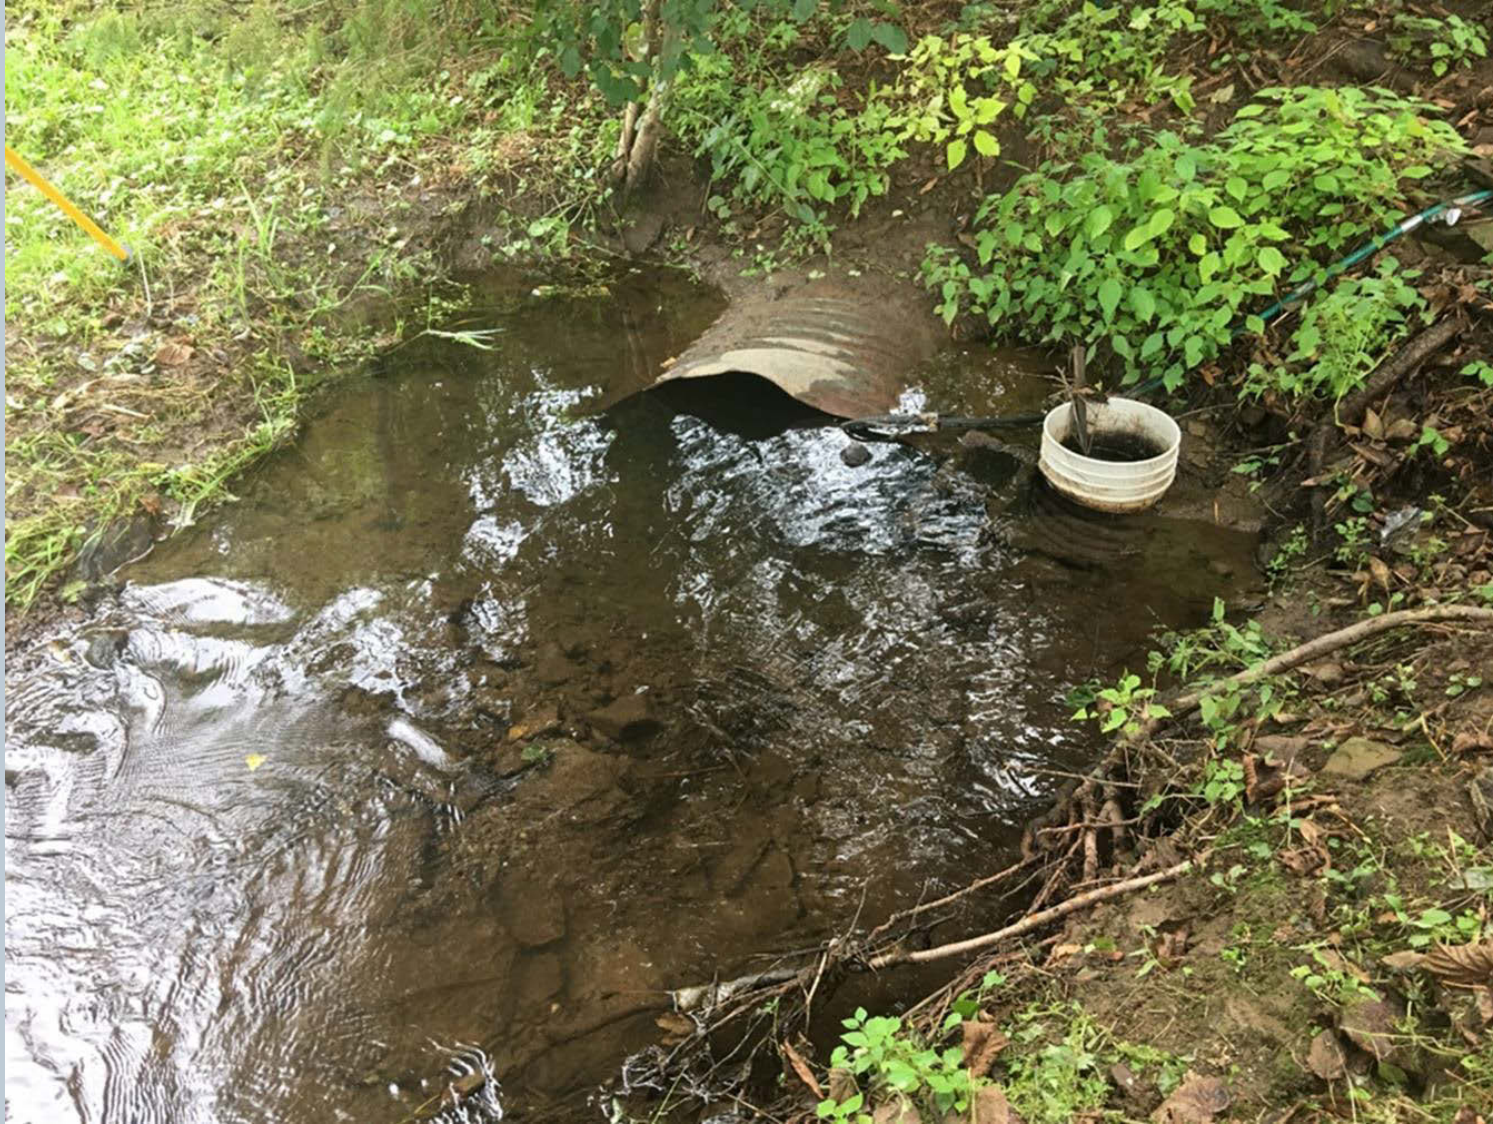
Figure 7. Found just before the rear of dozens of yards on Butternut Drive, this corrugated pipe is not aligned with the unnamed tributary, causing undercutting on the opposite bank. Possible remediation: an elbow pipe could be placed at the end of the corrugated pipe to align it with the Green Pond unnamed tributary. There are indications that there are high deer populations because of a lack of branches on the Arborvitae. If riparian restoration is intended, tubex protection will be necessary until trees have grown beyond browse and antler rub damages.

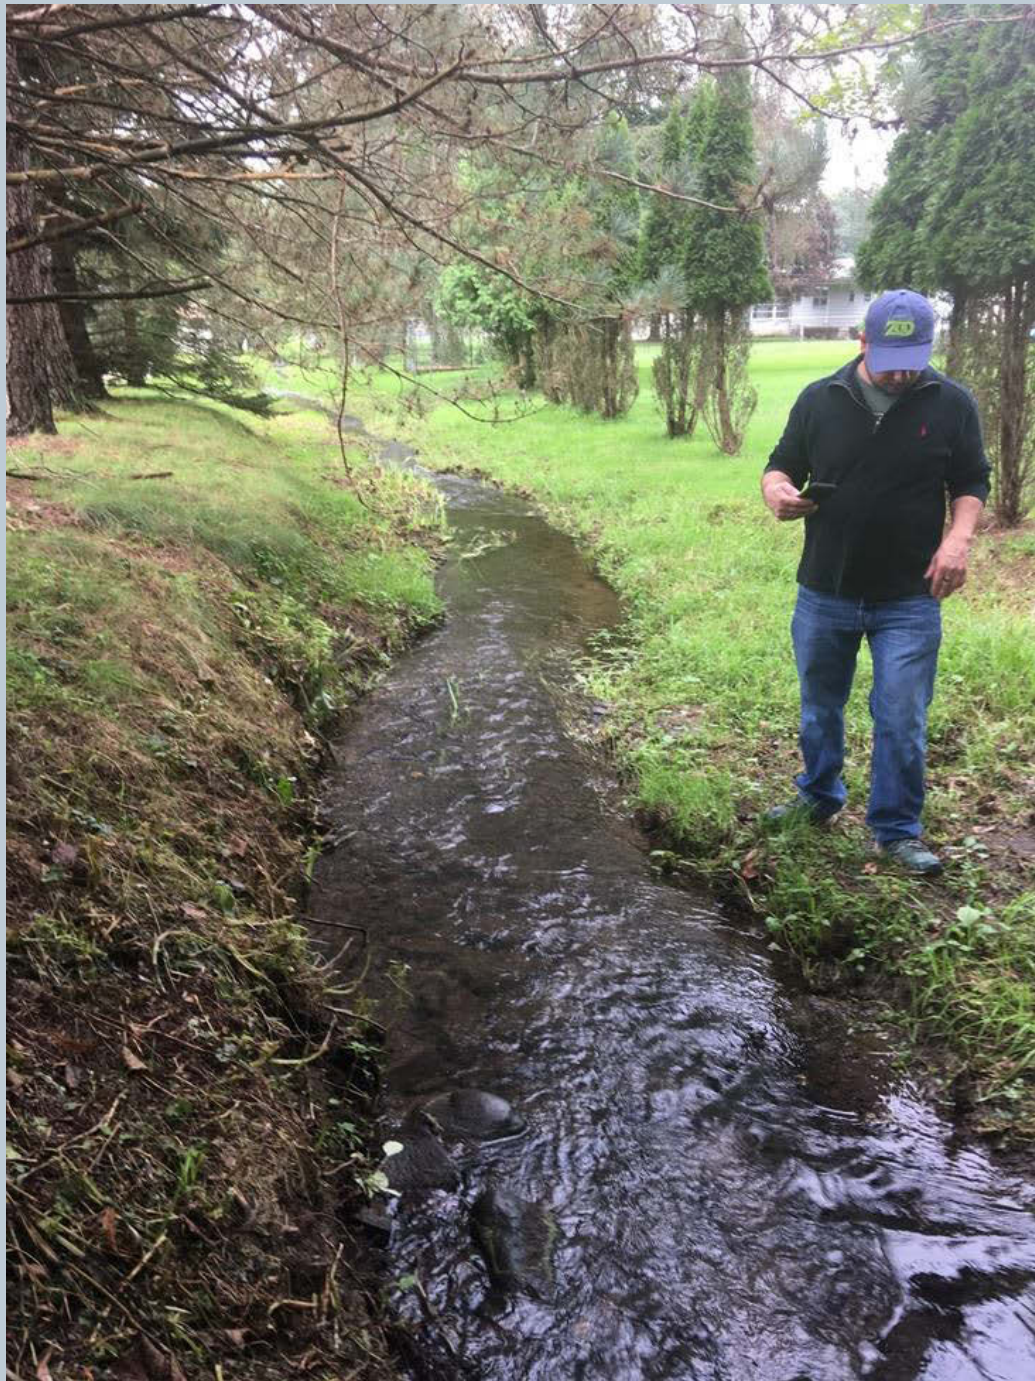
Figure 8. A downstream shot of the Green Pond unnamed tributary.

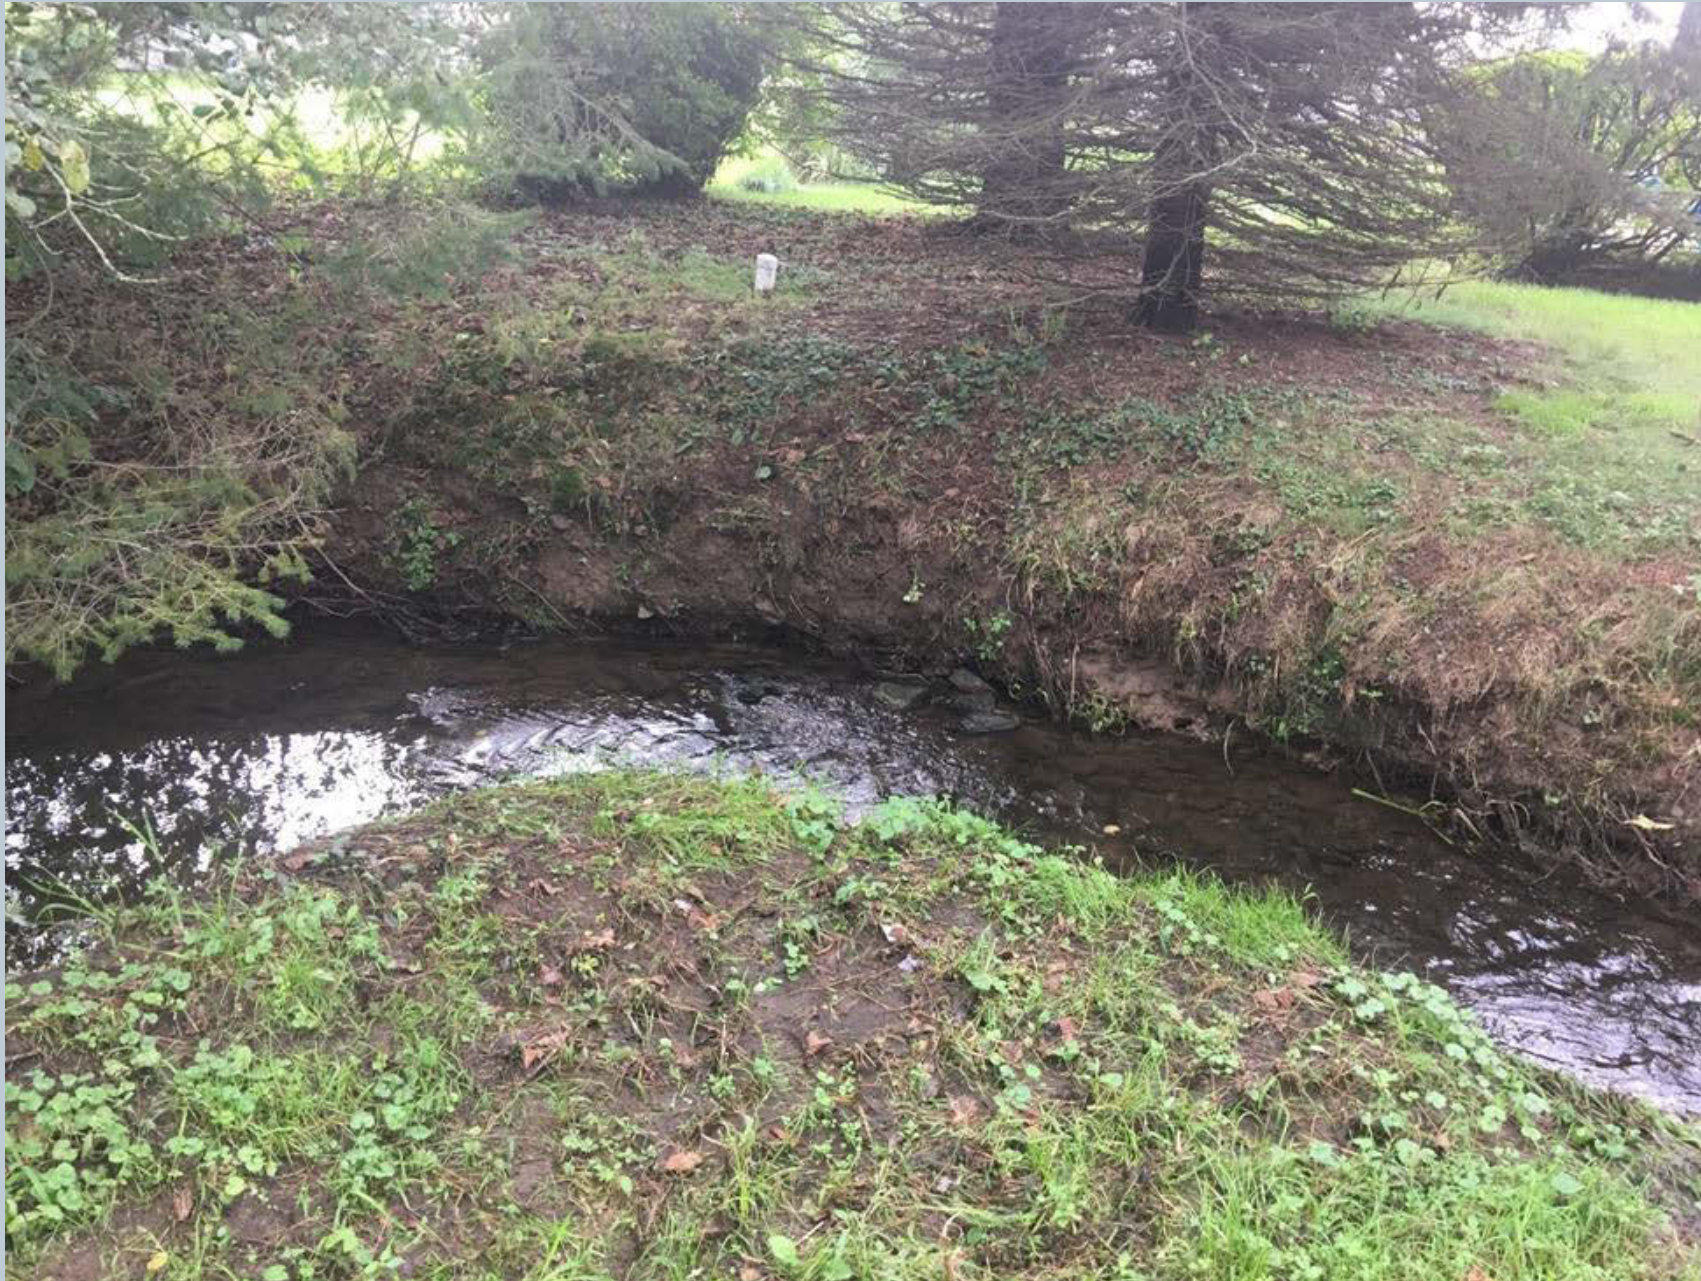
Figure 9. This photo shows 35 feet of potential streambank restoration planting behind 375 Woodbine Drive. White plastic pipes extended above the grade are suspected to be lateral cleanouts from the sewer or defunct water lines. Riparian restoration will require a utility mark out to be mindful of trees not impacting sewage flows from homes.

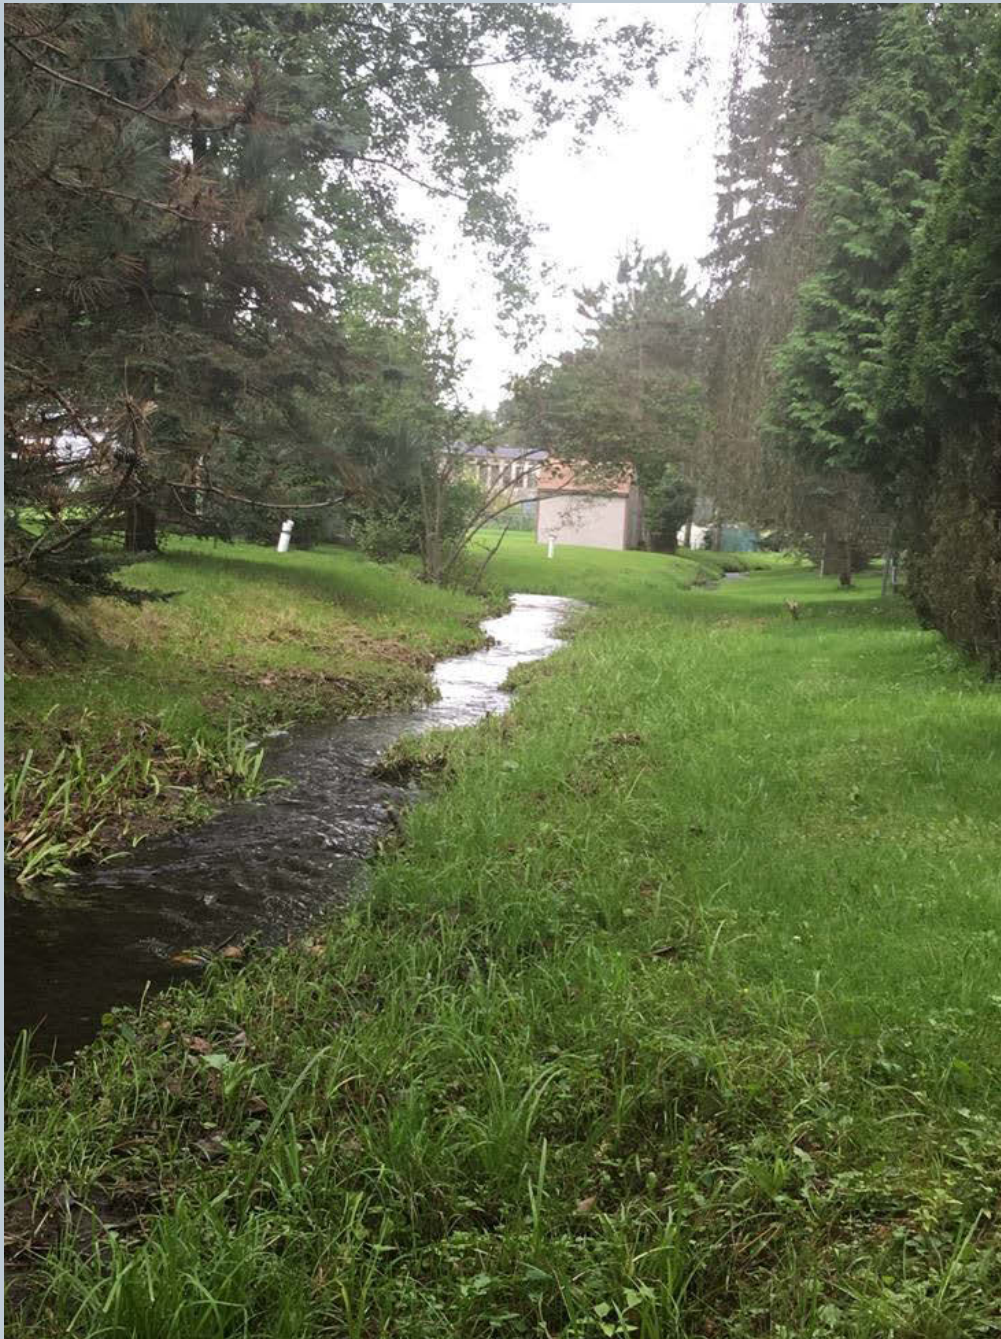
Figure 10. Looking upstream on the Green Pond unnamed tributary, the riparian corridor is intact. Less mowing along the streambank is recommended near Butternut Drive to maintain the riparian corridor. These locations appear to be fitting for woody riparian restoration.

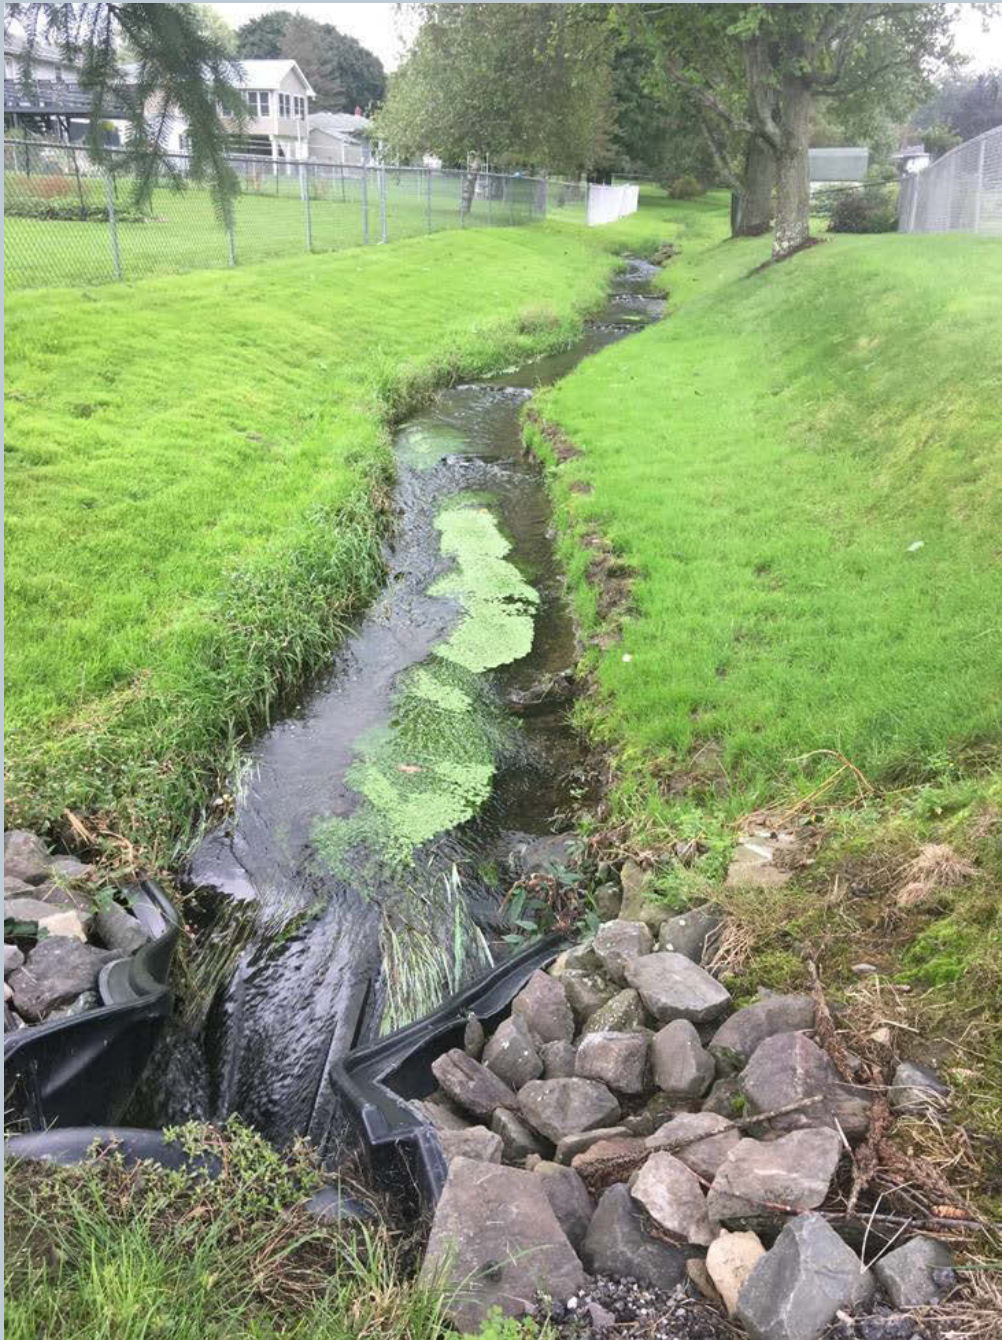
Figure 11. A constriction at the pipe caused by rock placement behind the plastic HDPE pipe culvert. The upstream end of the Green Pond unnamed tributary appears to be a good location for woody riparian restoration.

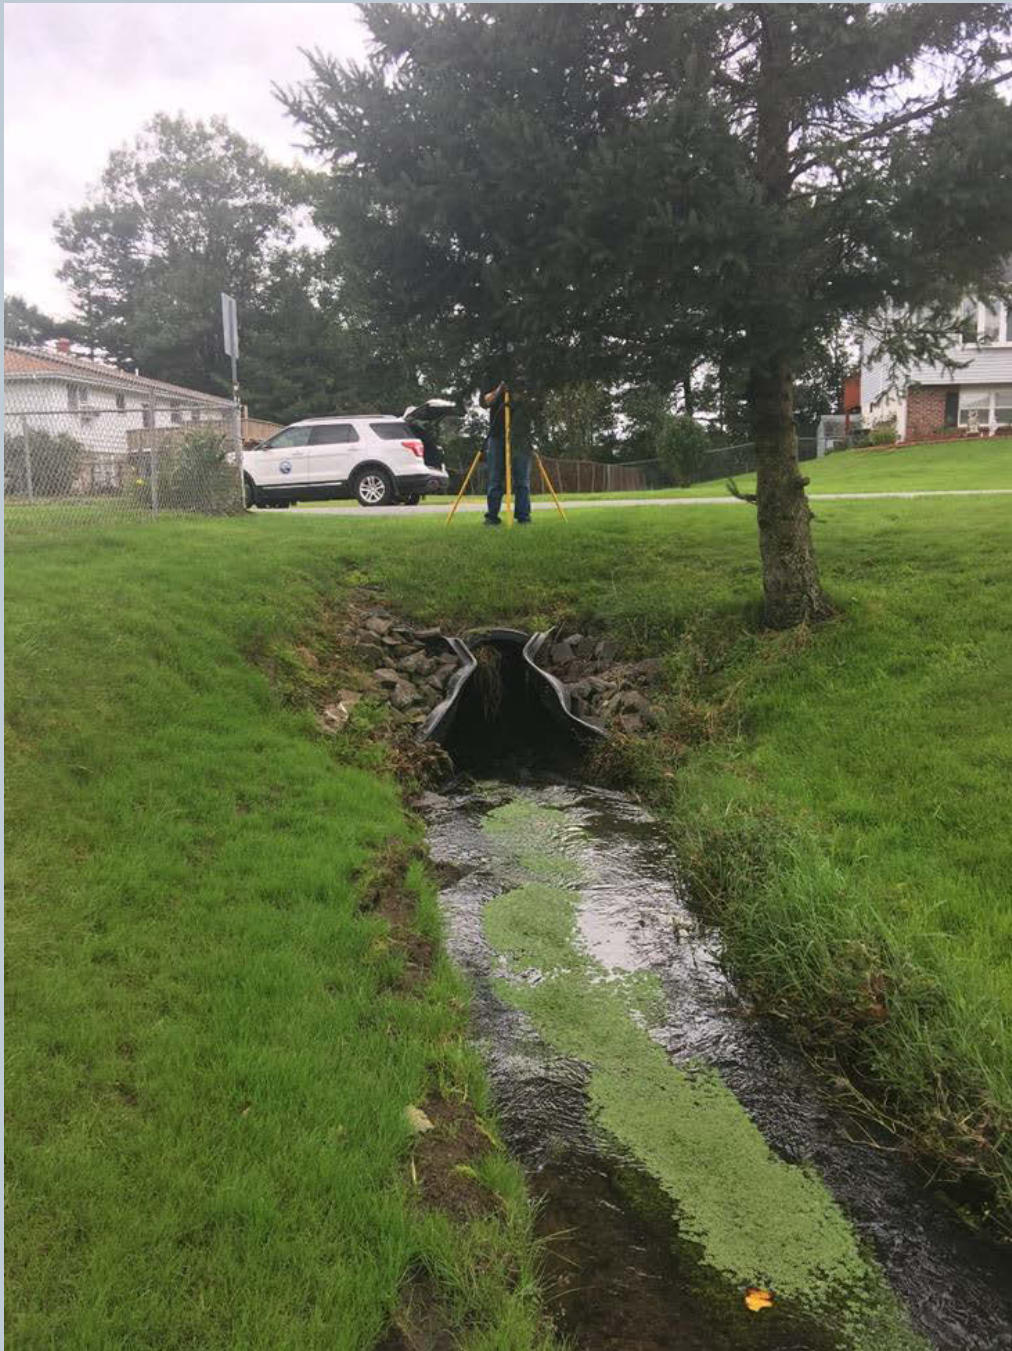
Figure 11a. Looking downstream at the Green Pond unnamed tributary duckweed, sediment, and pipe constriction are present.
