Toby Creek Field Reconnaissance Observations

September 26, 2018

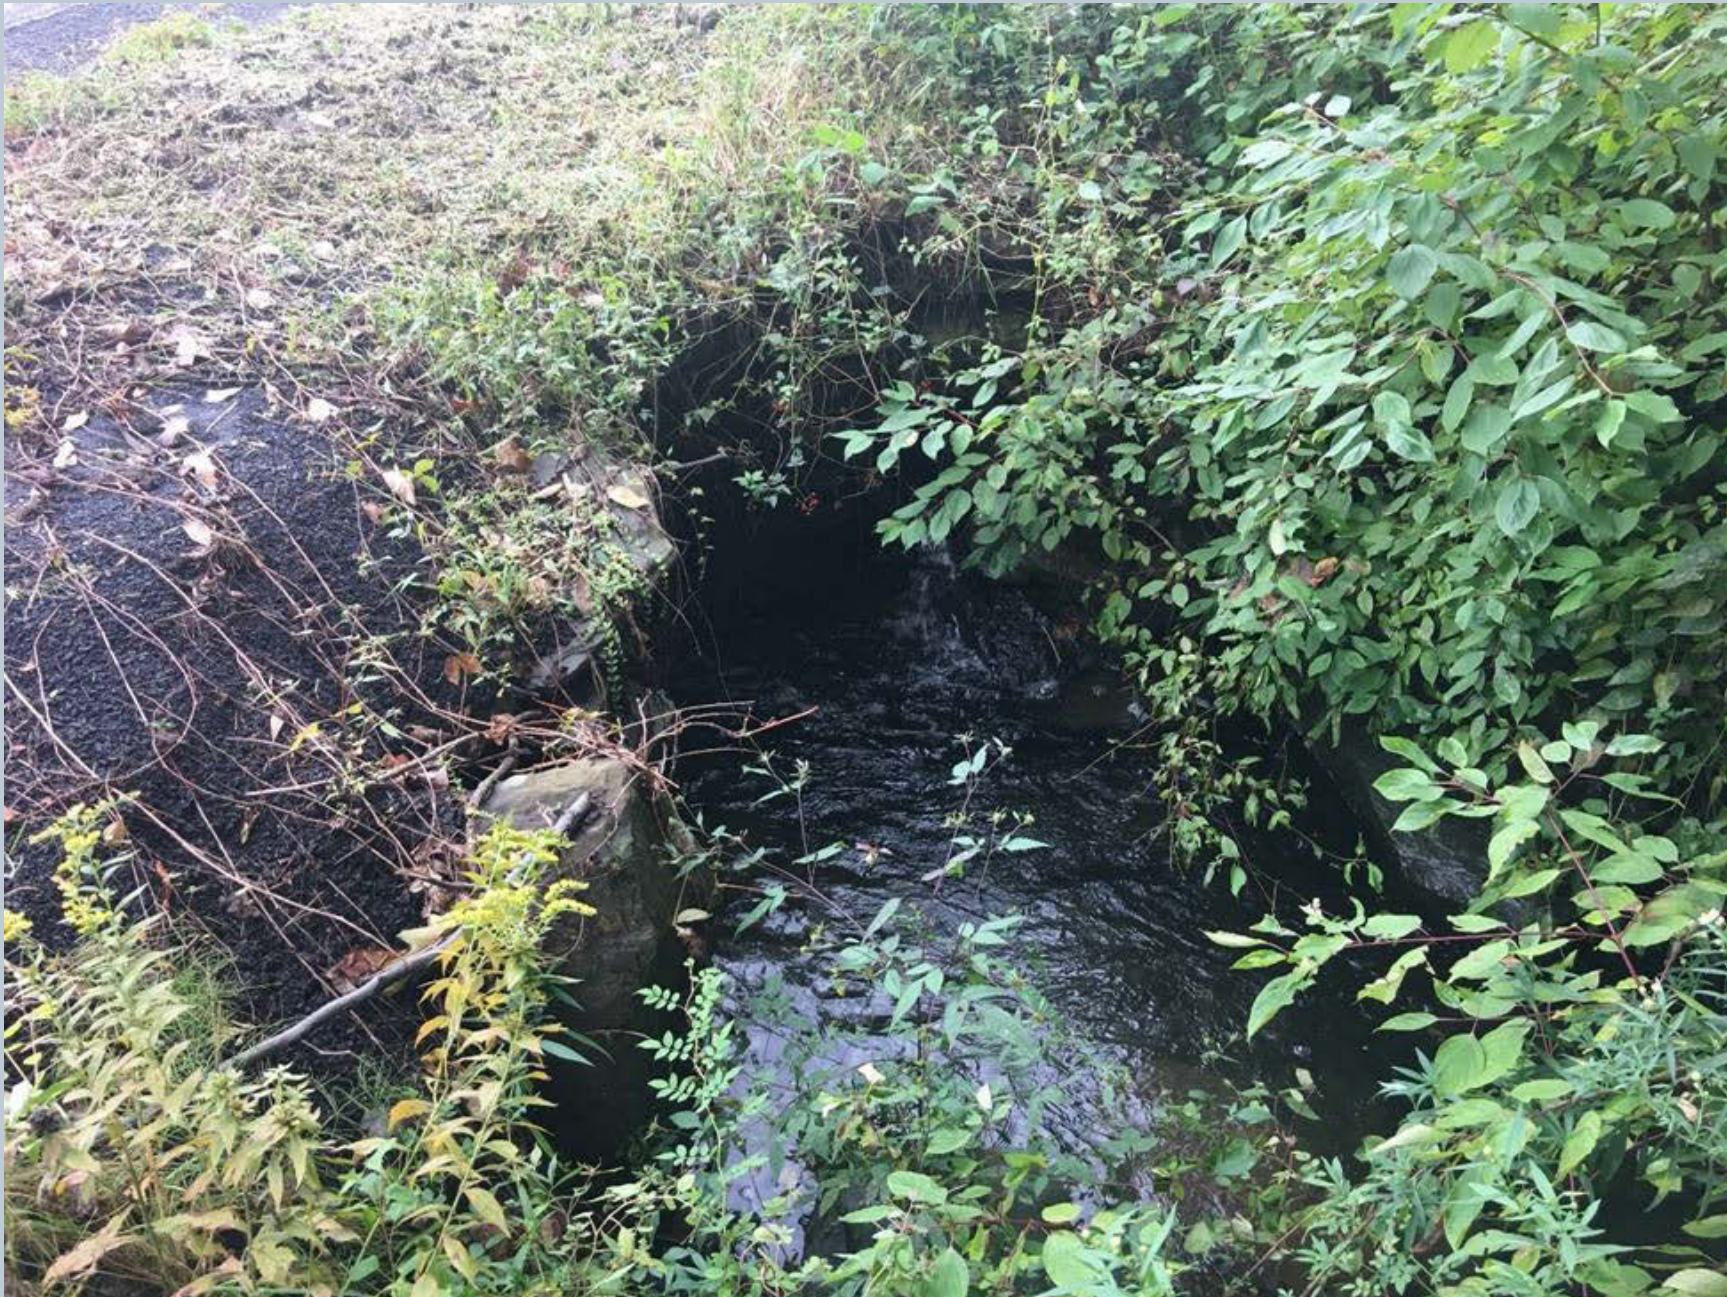
Figure 12. The Green Pond unnamed tributary flows across Harris Hill Road at this location. A 12-inch stormwater pipe in the unnamed tributary flows into a heavily wooded area before heading downstream along Harris Hill Road.

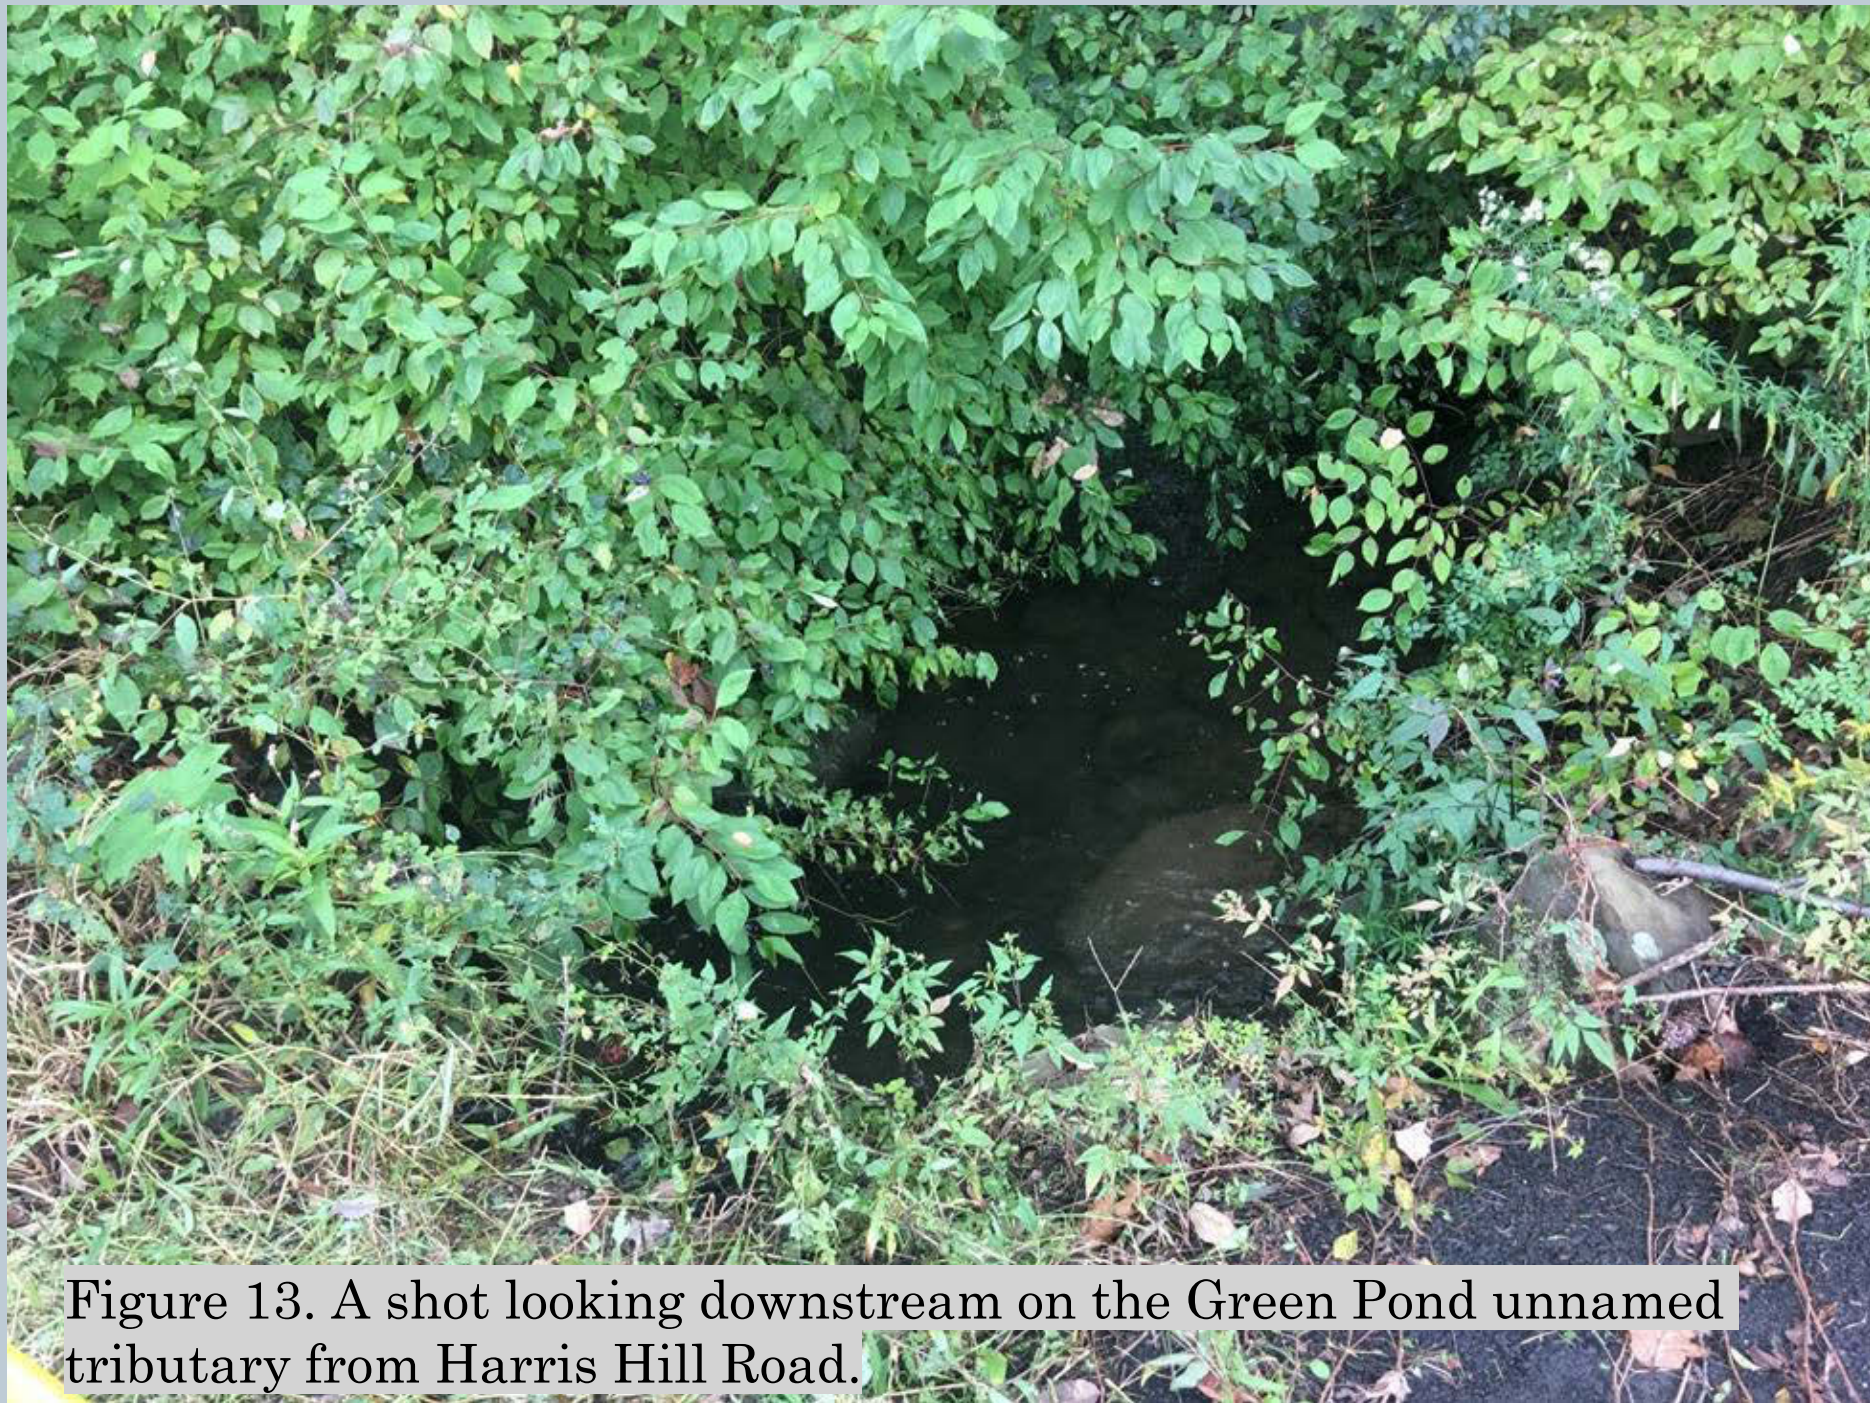
Figure 13. A shot looking downstream on the Green Pond unnamed tributary from Harris Hill Road.

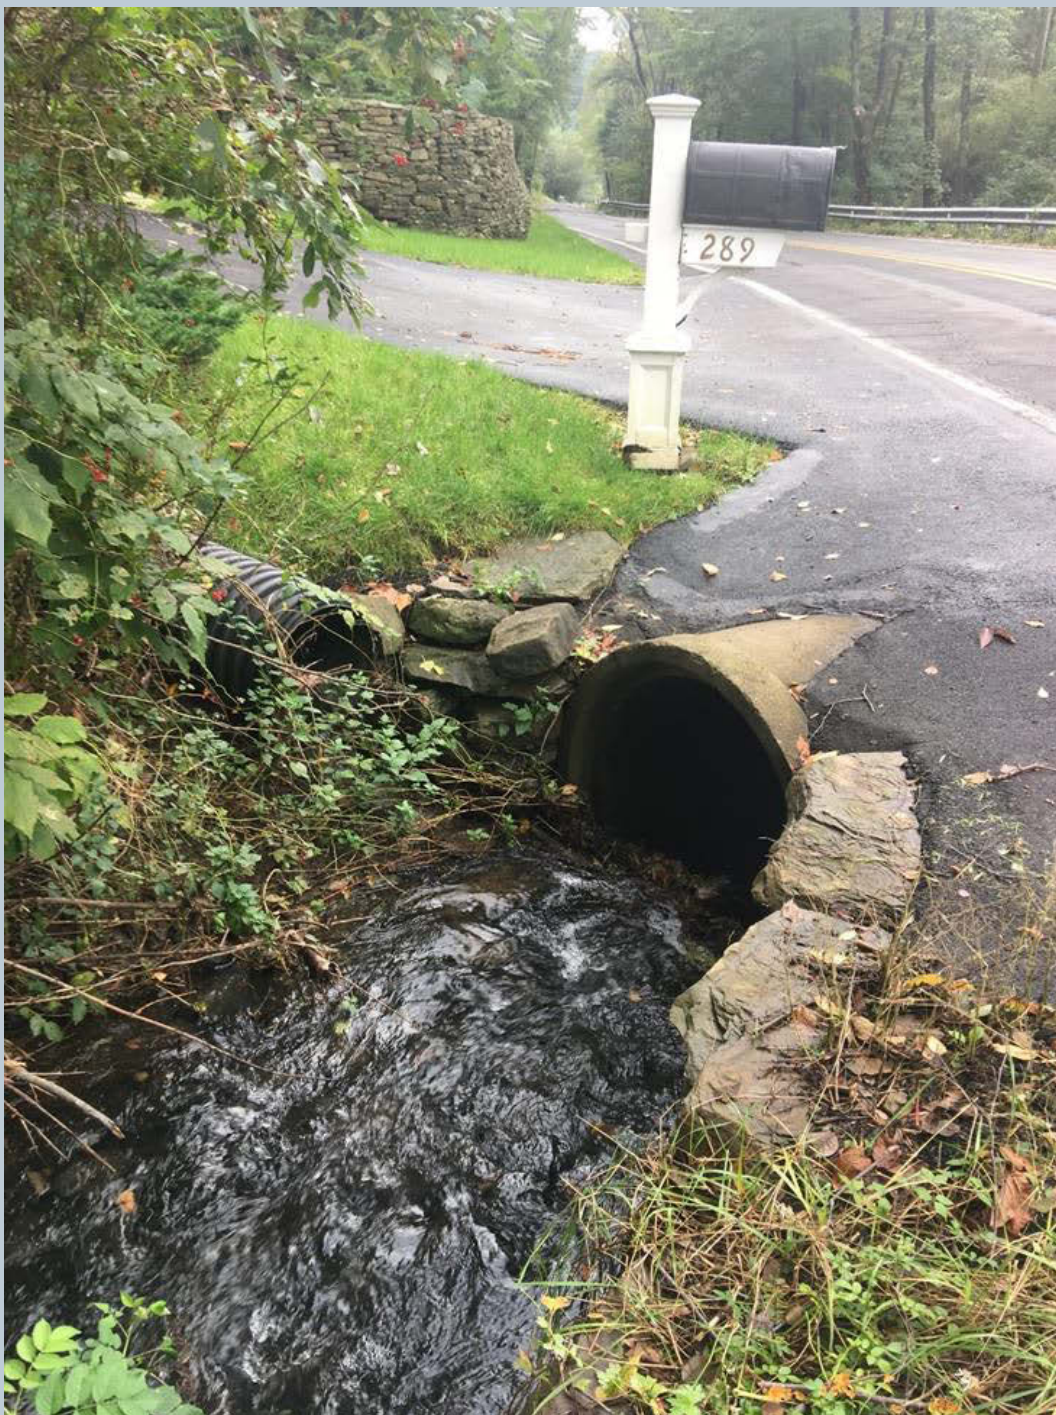
Figure 14. The Green Pond unnamed tributary concrete culvert pipe crosses the road heading downstream at 289 Harris Hill Road. There is an 18-inch black HDPE pipe to the left of the unnamed tributary, adjacent to the driveway.

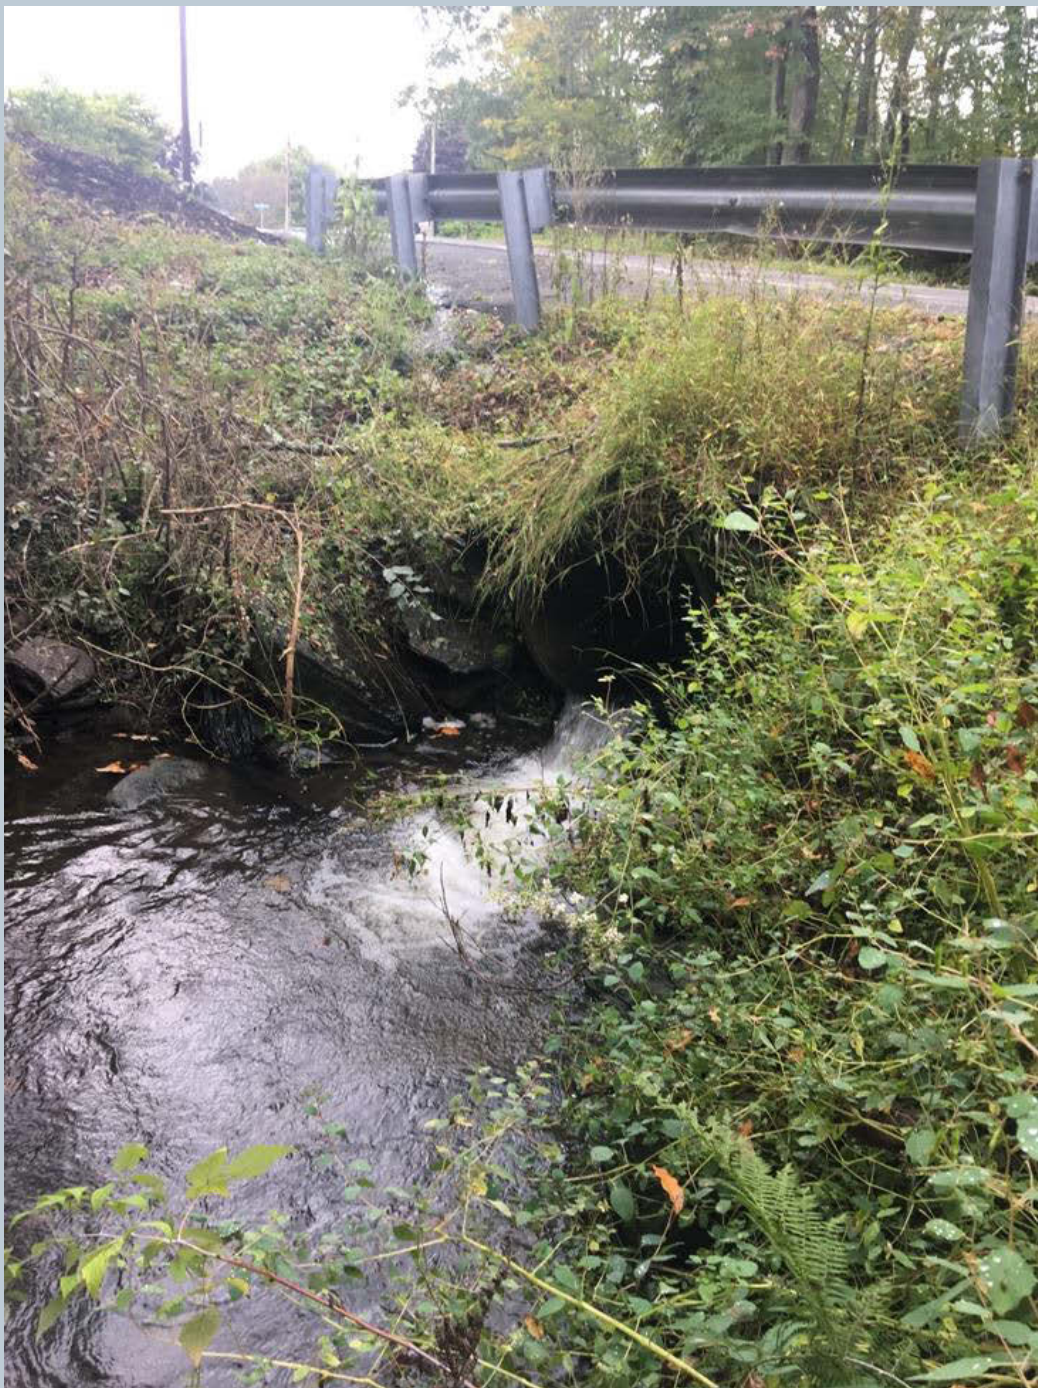
Figure 15. The concrete culvert has a 3-4-inch drop to the unnamed tributary, cascading into the downstream channel. A rock apron is recommended for aquatic connectivity and to prevent further scour from developing.

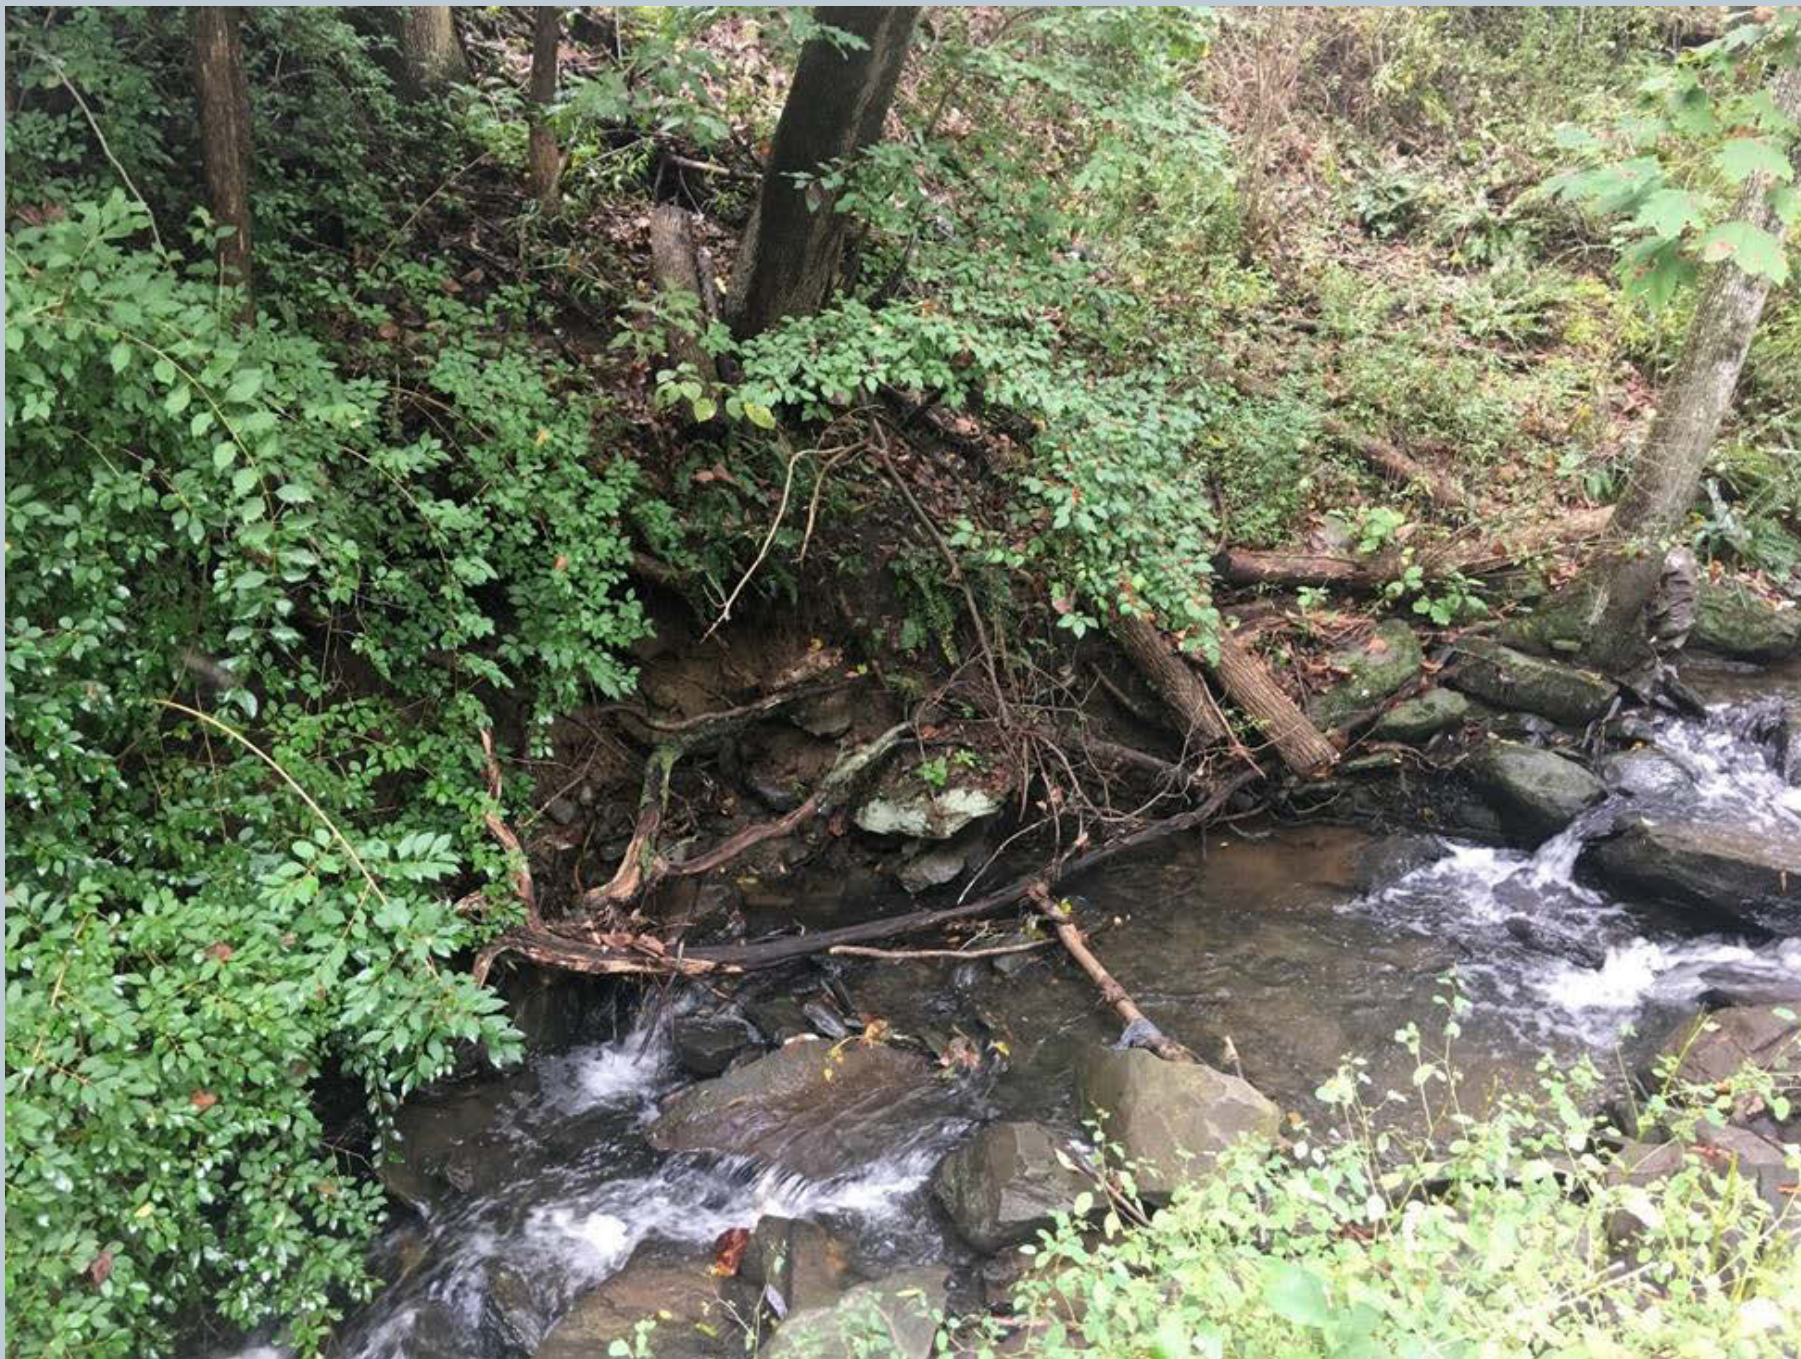
Figure 16. This photo shows bank erosion. This is a great habitat along the Green Pond unnamed tributary that could benefit from streamside planting.

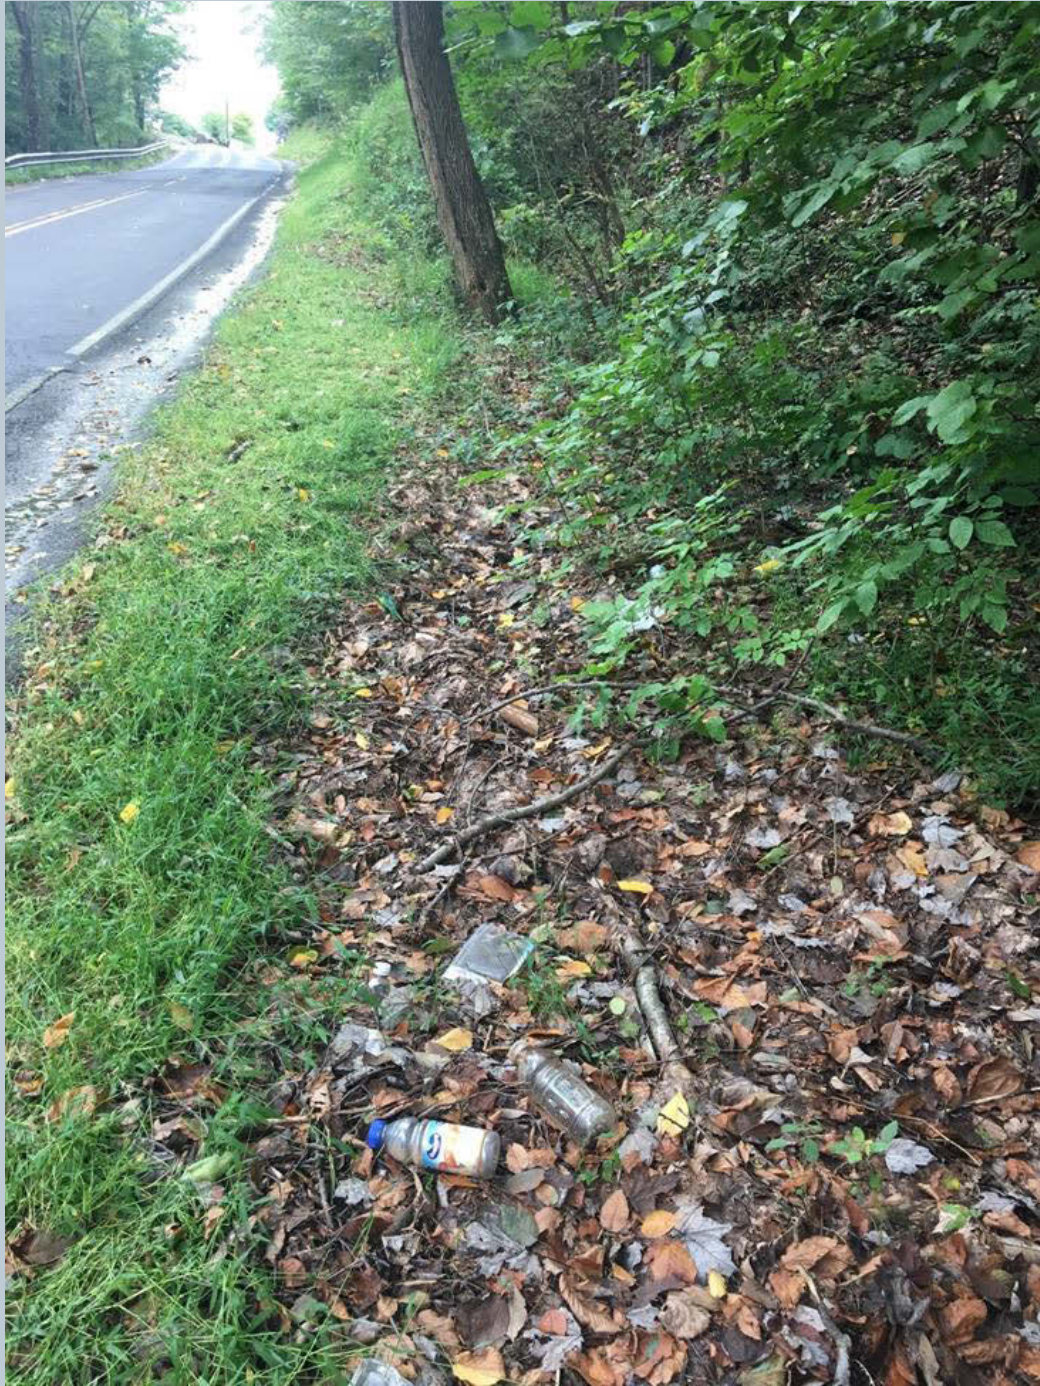
Figure 16a. Considering the busy traffic along Harris Hill Road, a small litter cleanup could be organized.

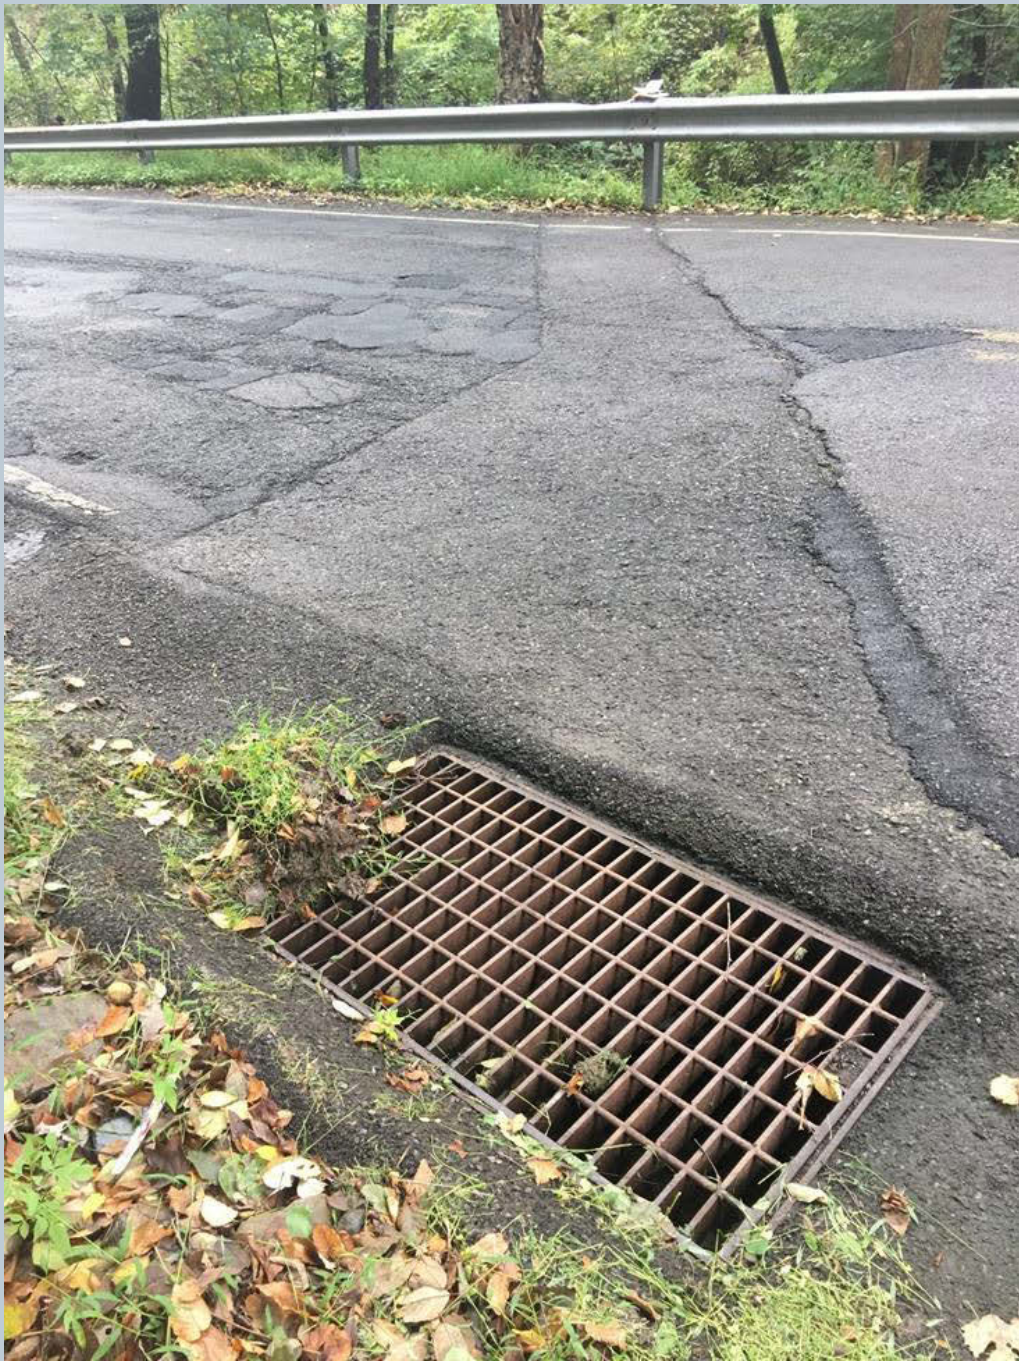
Figure 17. A storm drain on the opposite side of Harris Hill Road which drains to the Green Pond unnamed tributary.

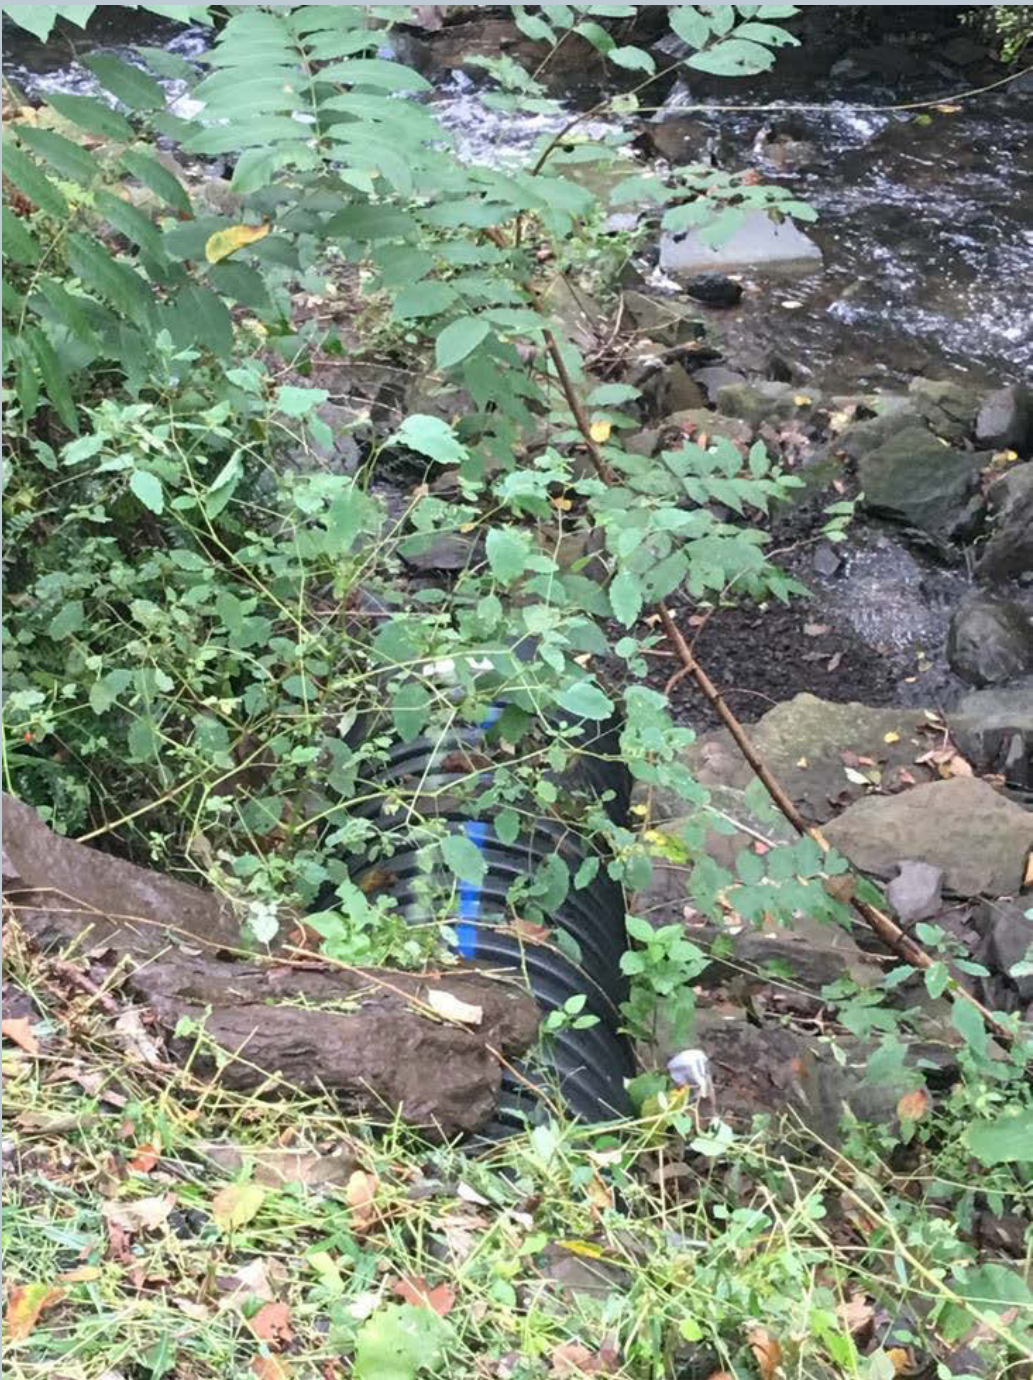
Figure 18. An 18-inch black HDPE stormwater pipe found 6 feet above the Green Pond unnamed tributary. There is no rock apron; it is recommended to either use existing rocks in the channel to construct an apron or cut the length of the pipe back.

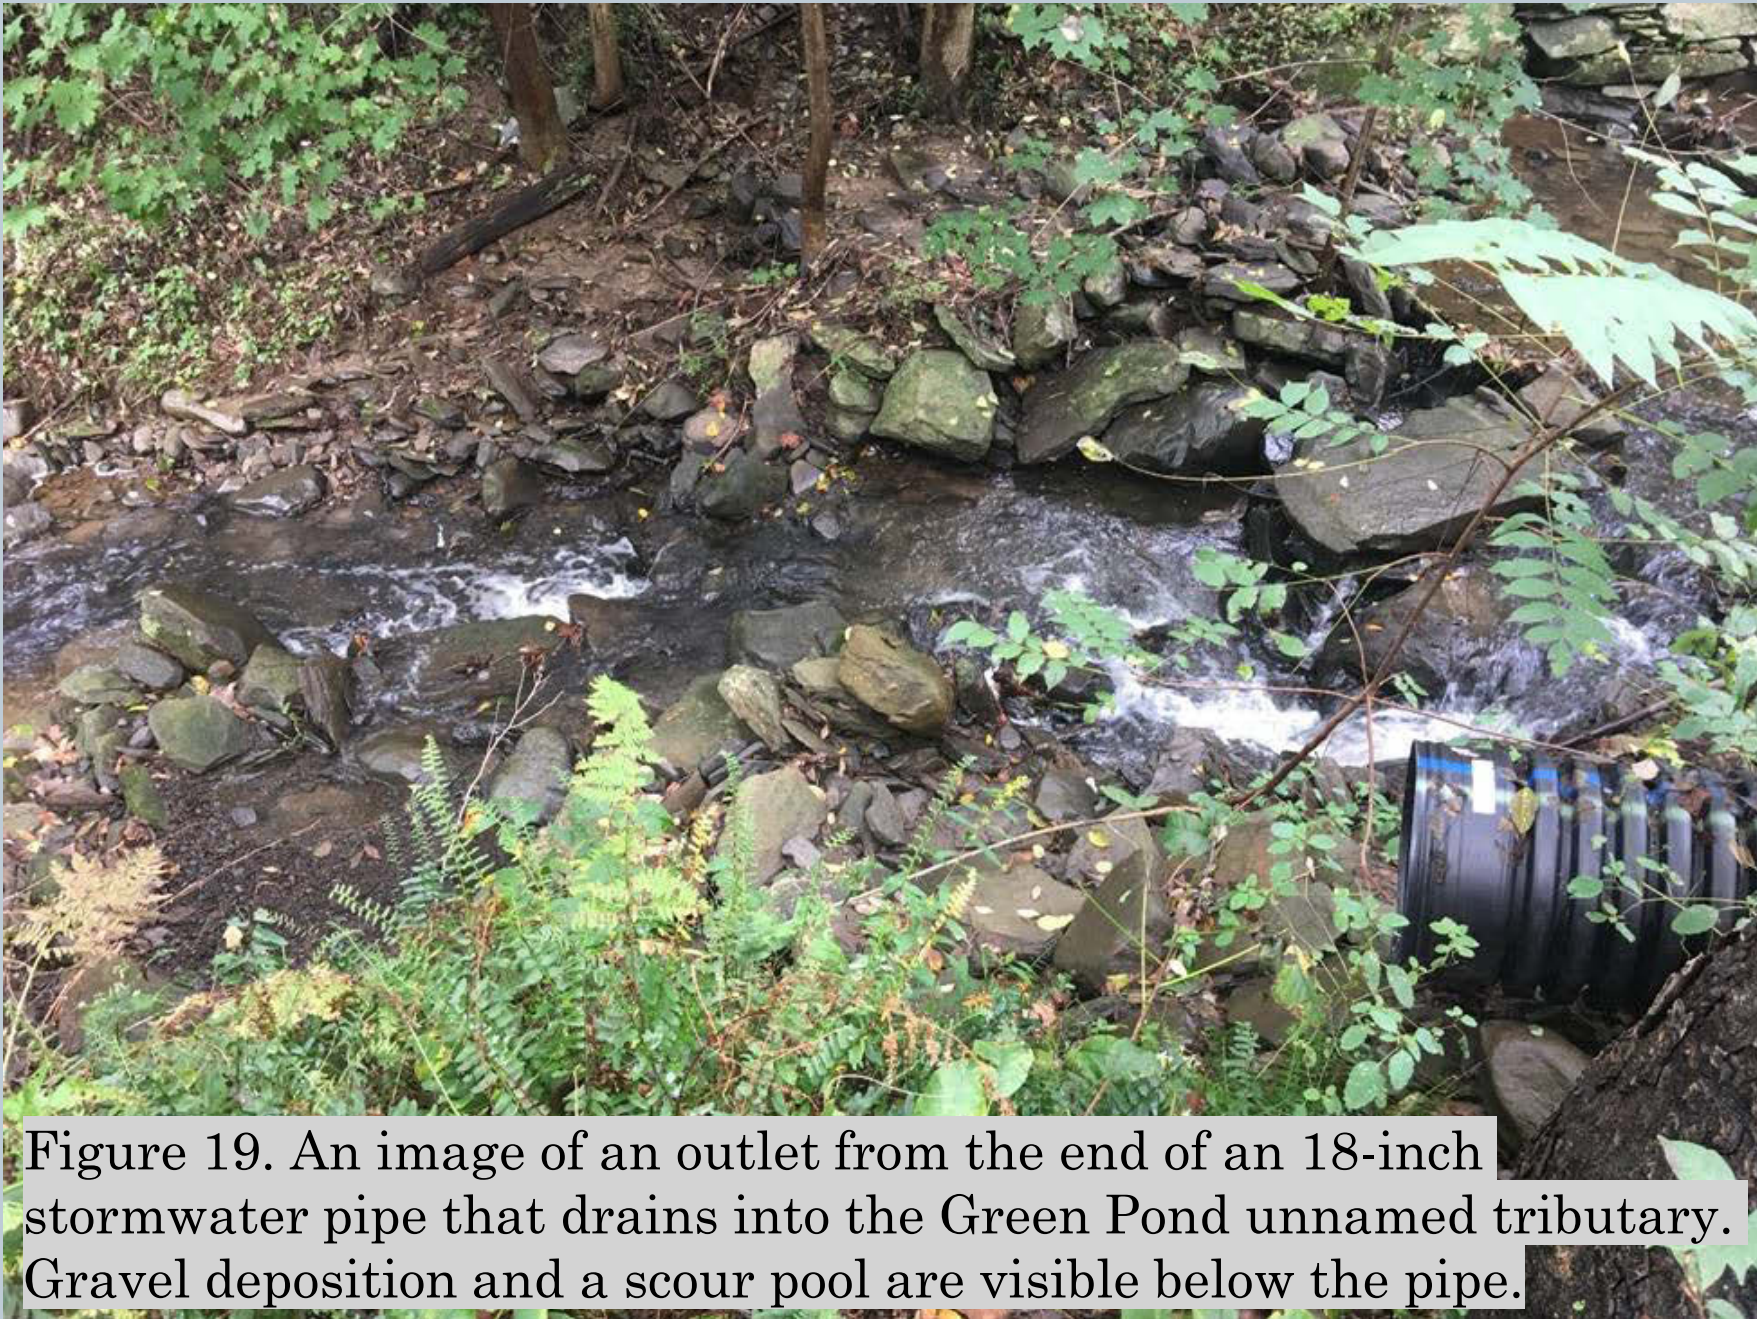
Figure 19. An image of an outlet from the end of an 18-inch stormwater pipe that drains into the Green Pond unnamed tributary. Gravel deposition and a scour pool are visible below the pipe.

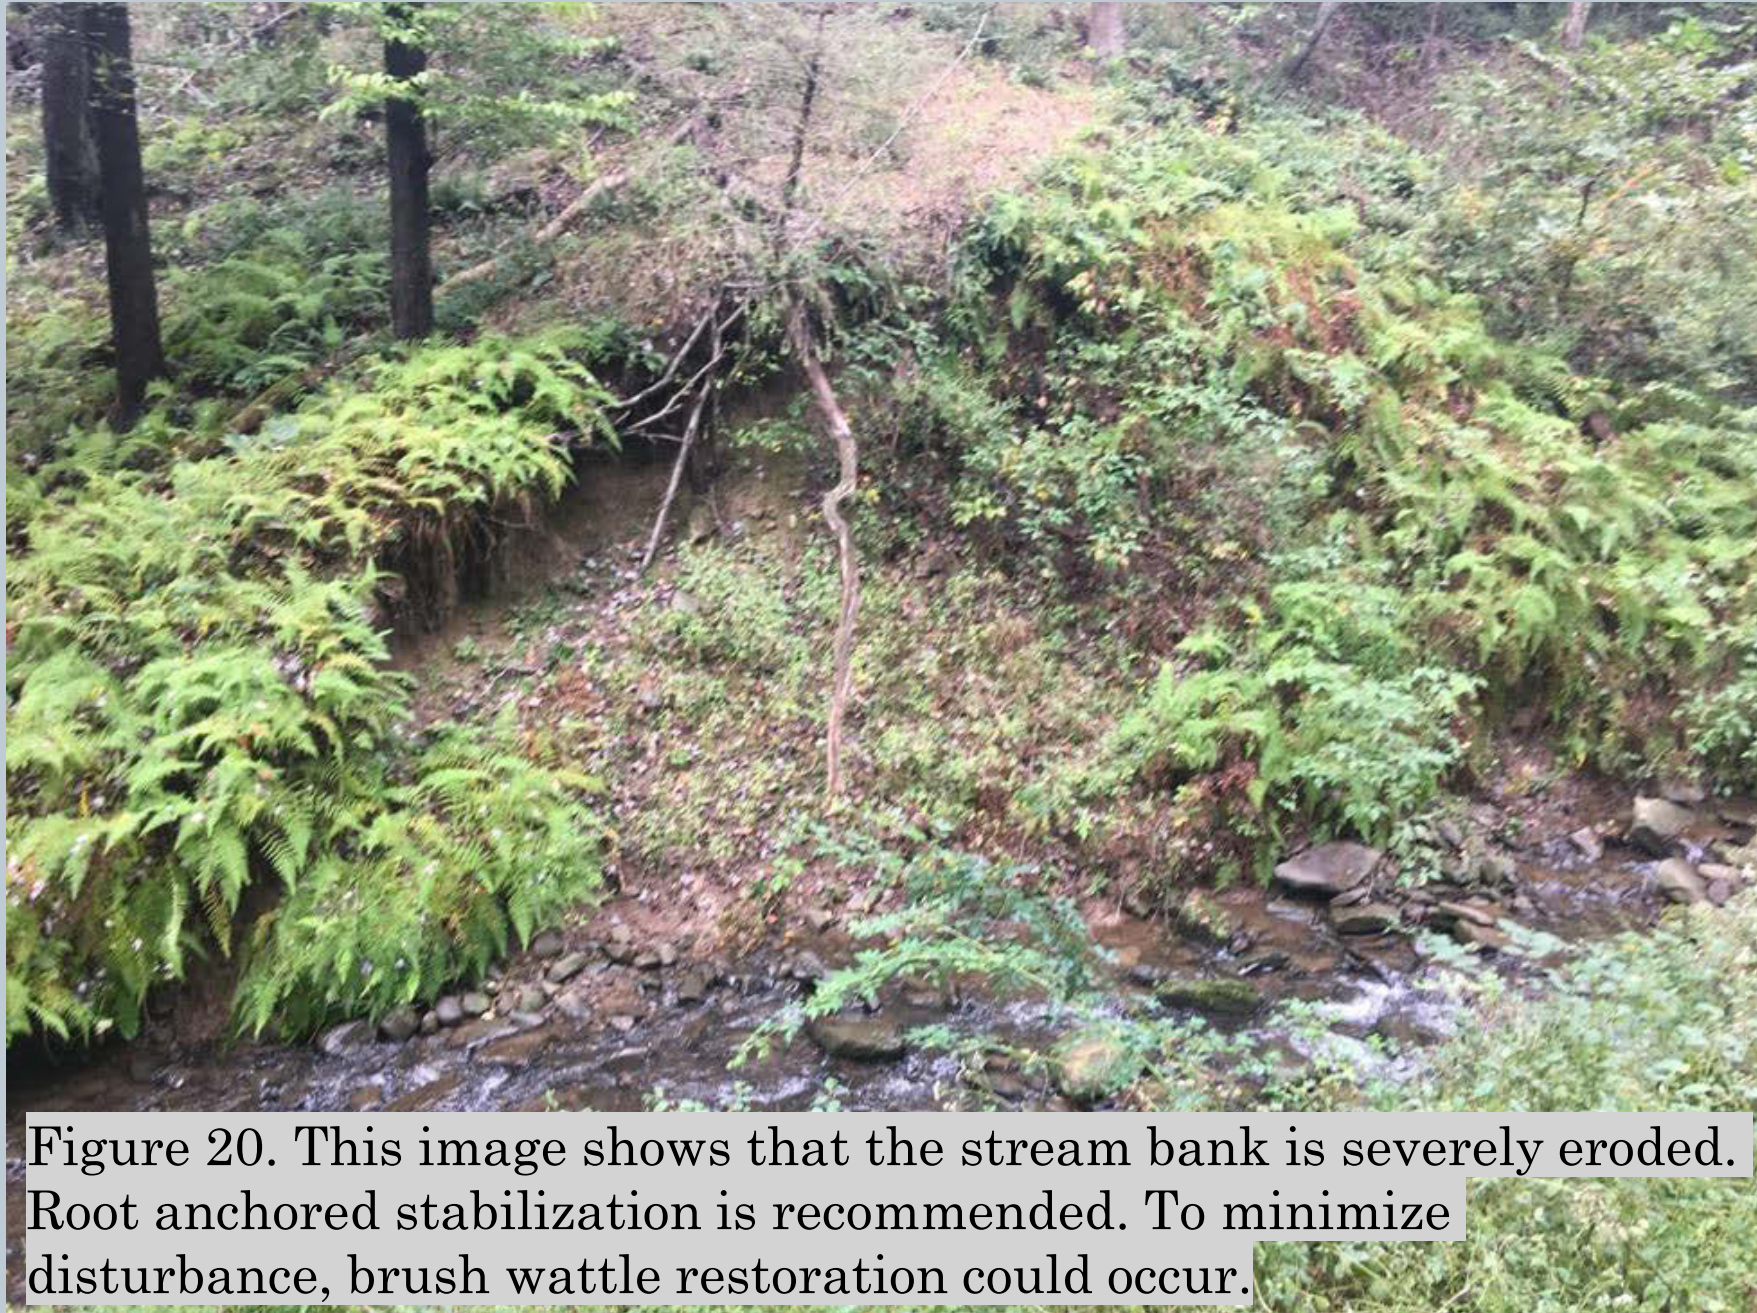
Figure 20. This image shows that the stream bank is severely eroded. Root anchored stabilization is recommended. To minimize disturbance, brush wattle restoration could occur.

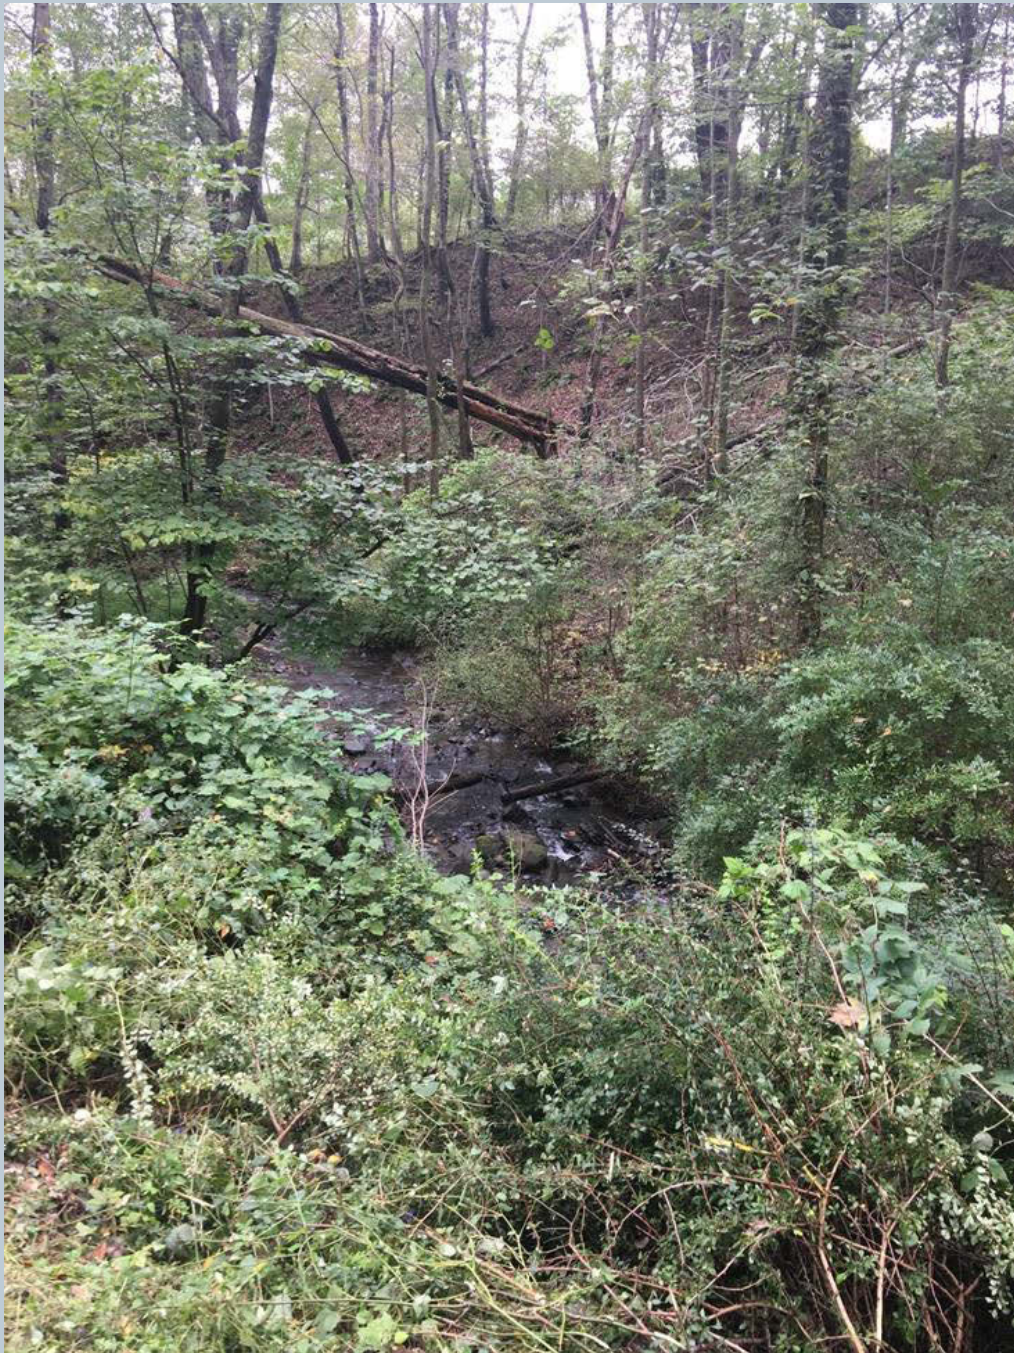
Figure 22. An 18-inch black HDPE stormwater pipe that outlets to the Green Pond unnamed tributary is present at this location. Invasive removal of Japanese barberry and Multi-flora roses is recommended.

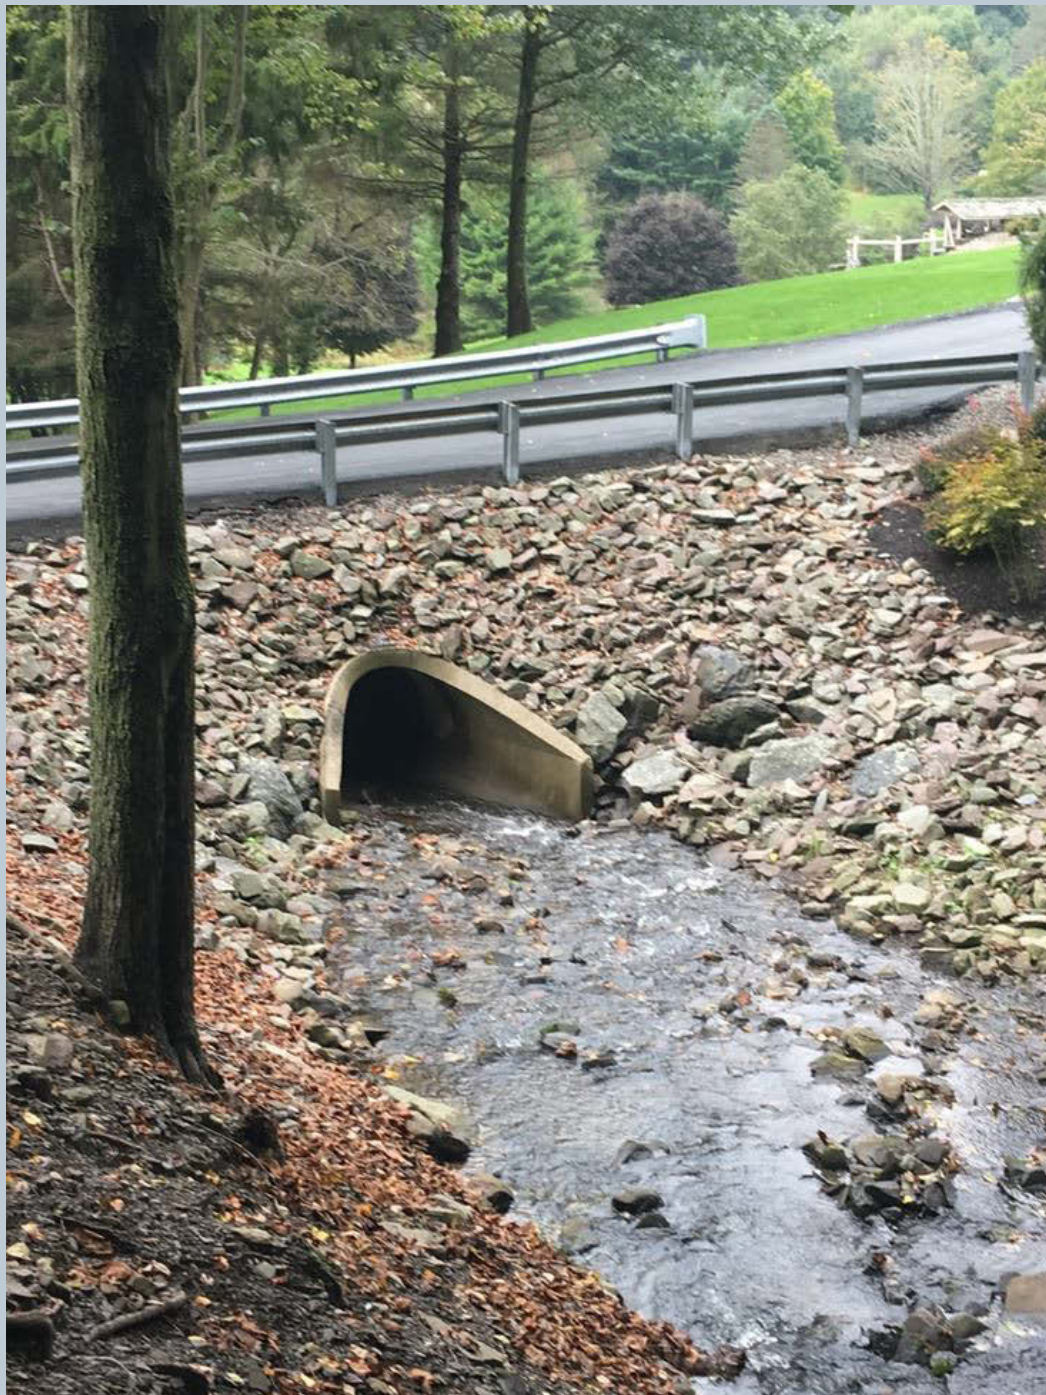
Figure 23. A shot of a concrete culvert under a private driveway that has a wide floodplain and a gravel bar deposit upstream. The driveway causes a rip-rap swale coming into the unnamed tributary.
