Toby Creek Field Reconnaissance Observations

September 26, 2018

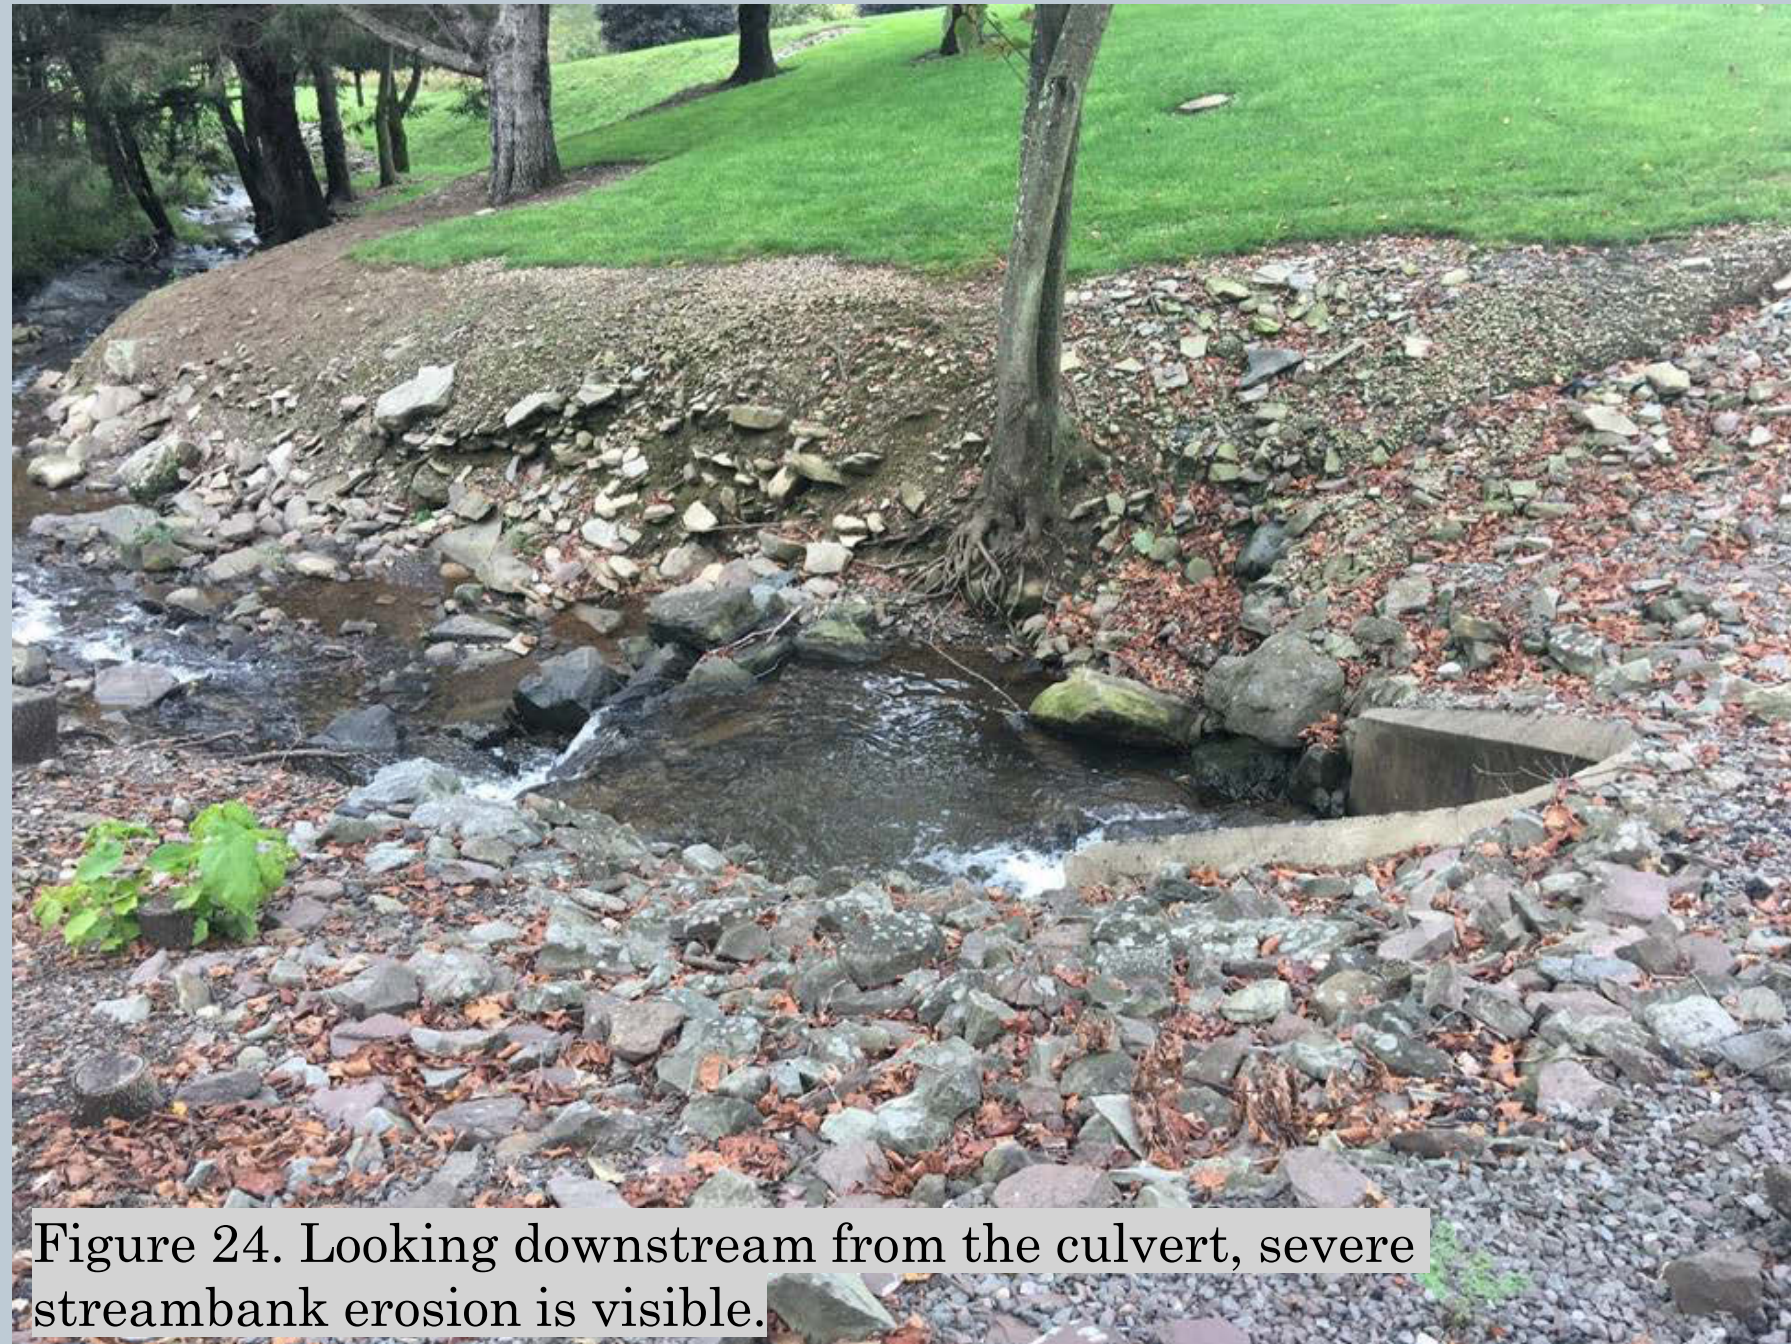
Figure 24. Looking downstream from the culvert, severe streambank erosion is visible.

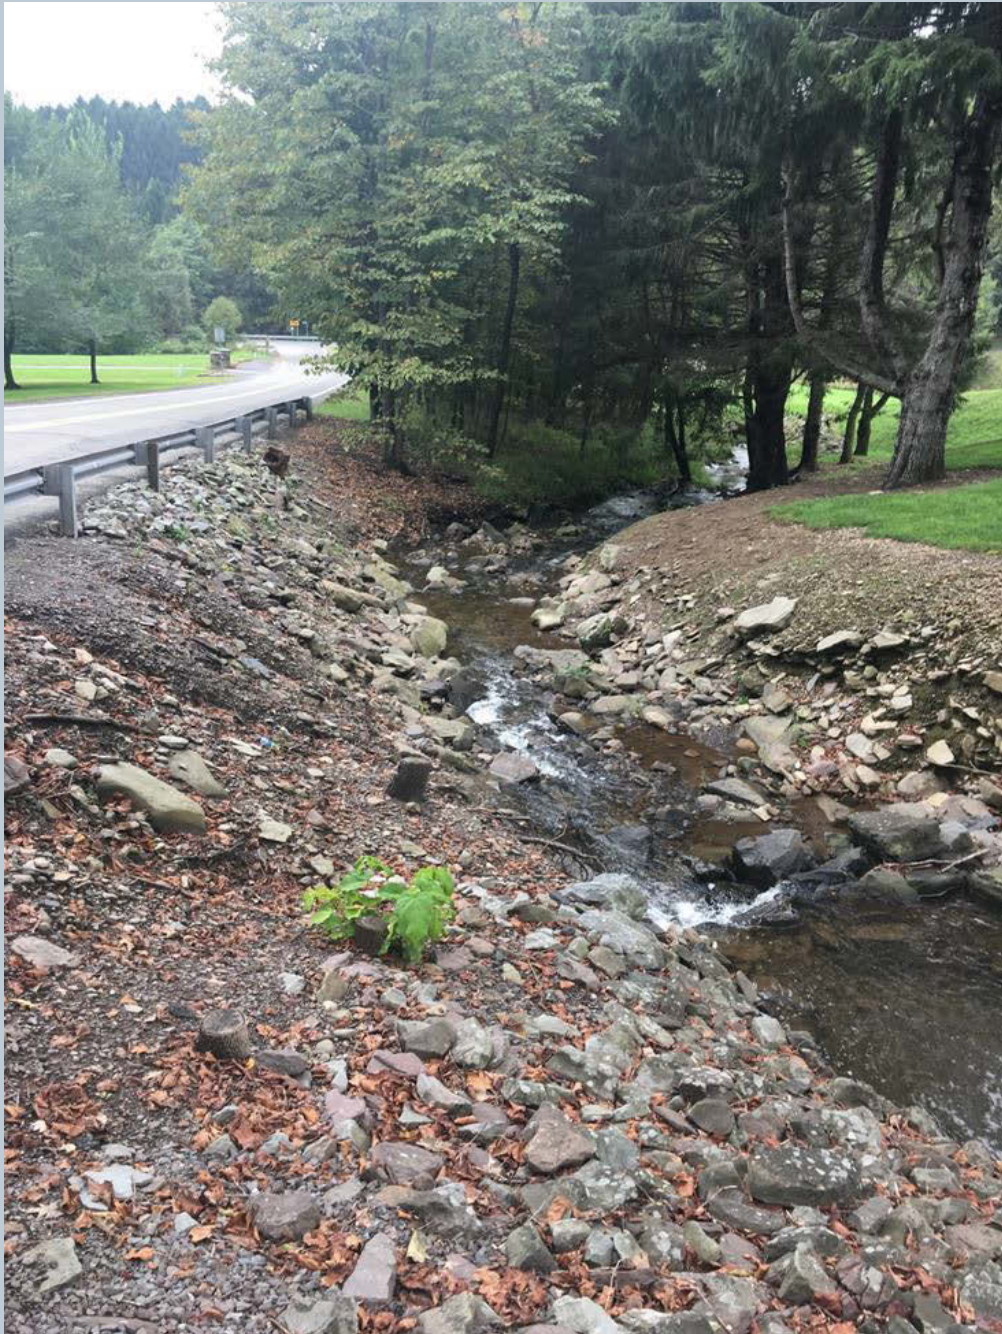
Figure 24a. A shot looking upstream toward the culvert along a private driveway.

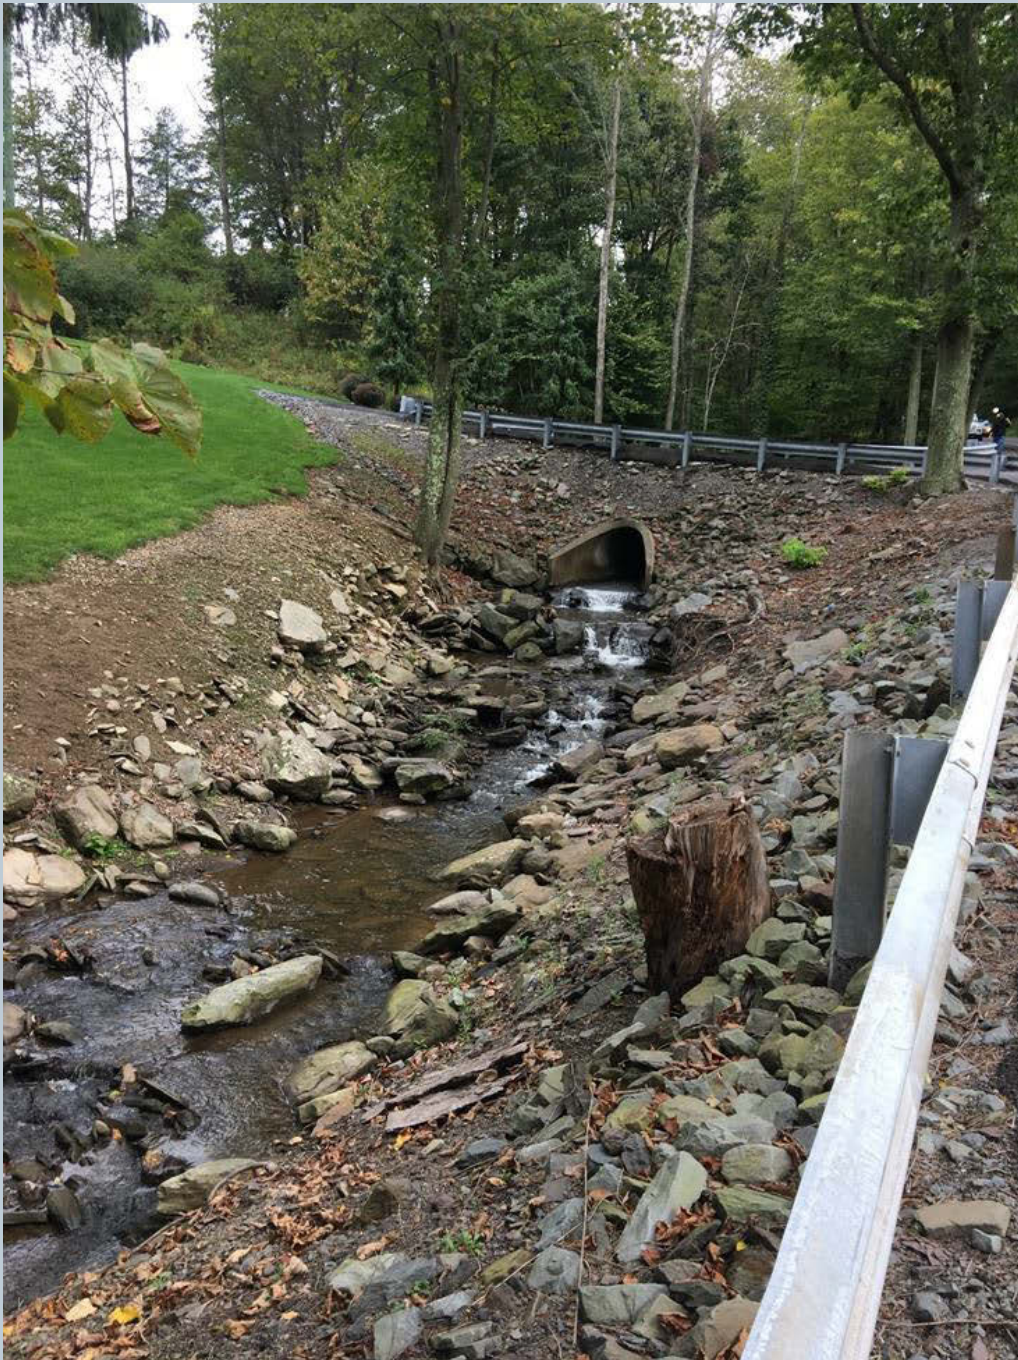
Figure 25. A log vane deflector or rip-rap are recommended, along with the removal of the rock check dam, to prevent further downcutting of the Green Pond unnamed tributary.

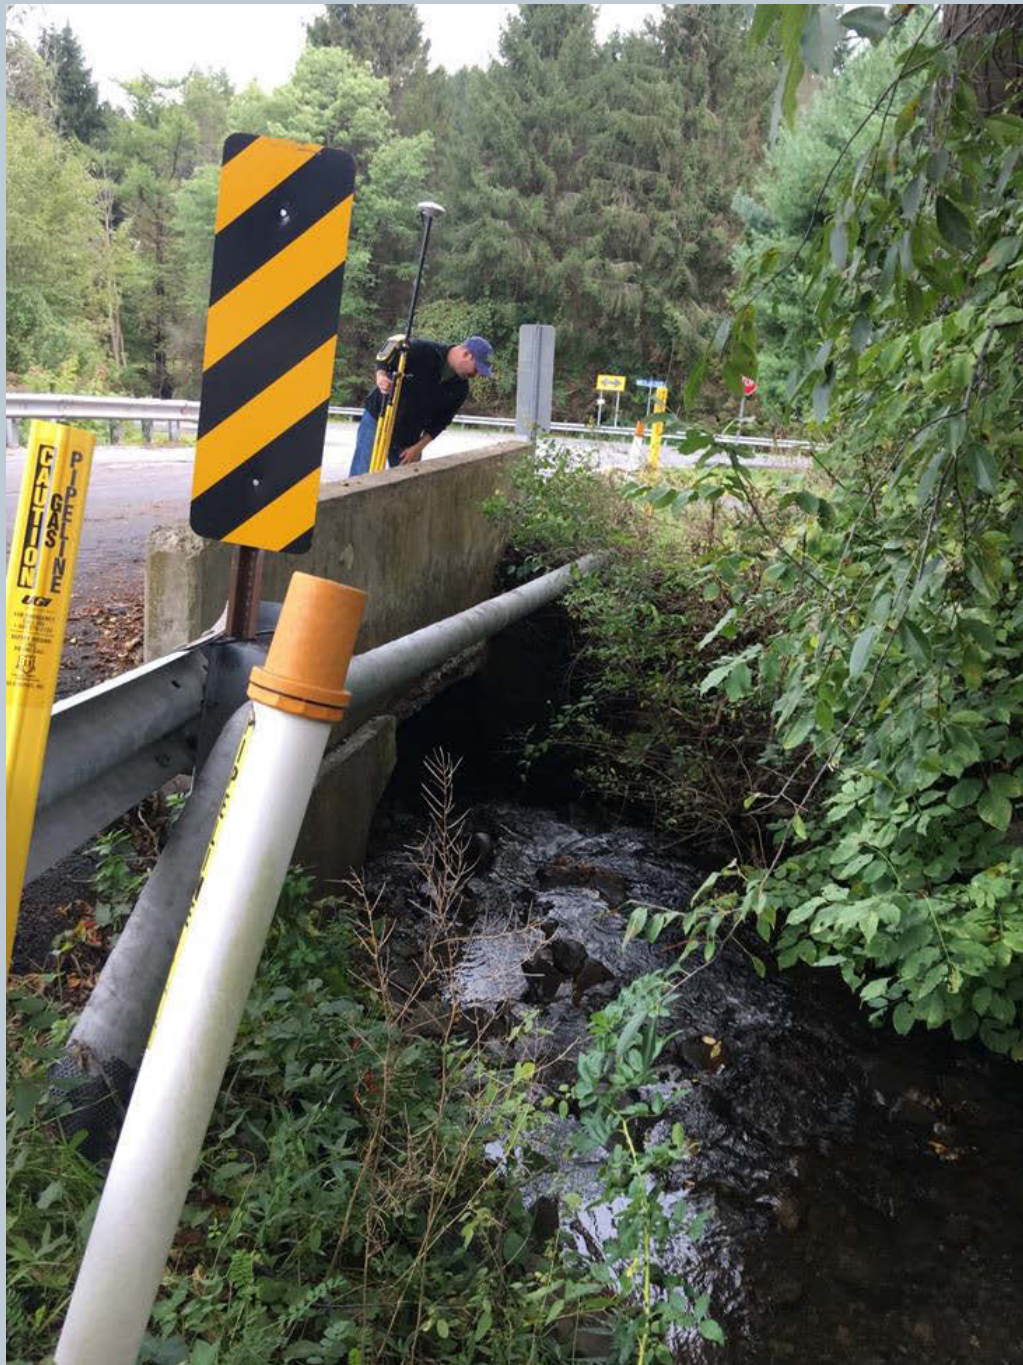
Figure 27. The Green Pond unnamed tributary flows under the bridge at the intersection of Harris Hill Road and E. Center Street. This view is looking downstream where a gas line lies along the unnamed tributary.

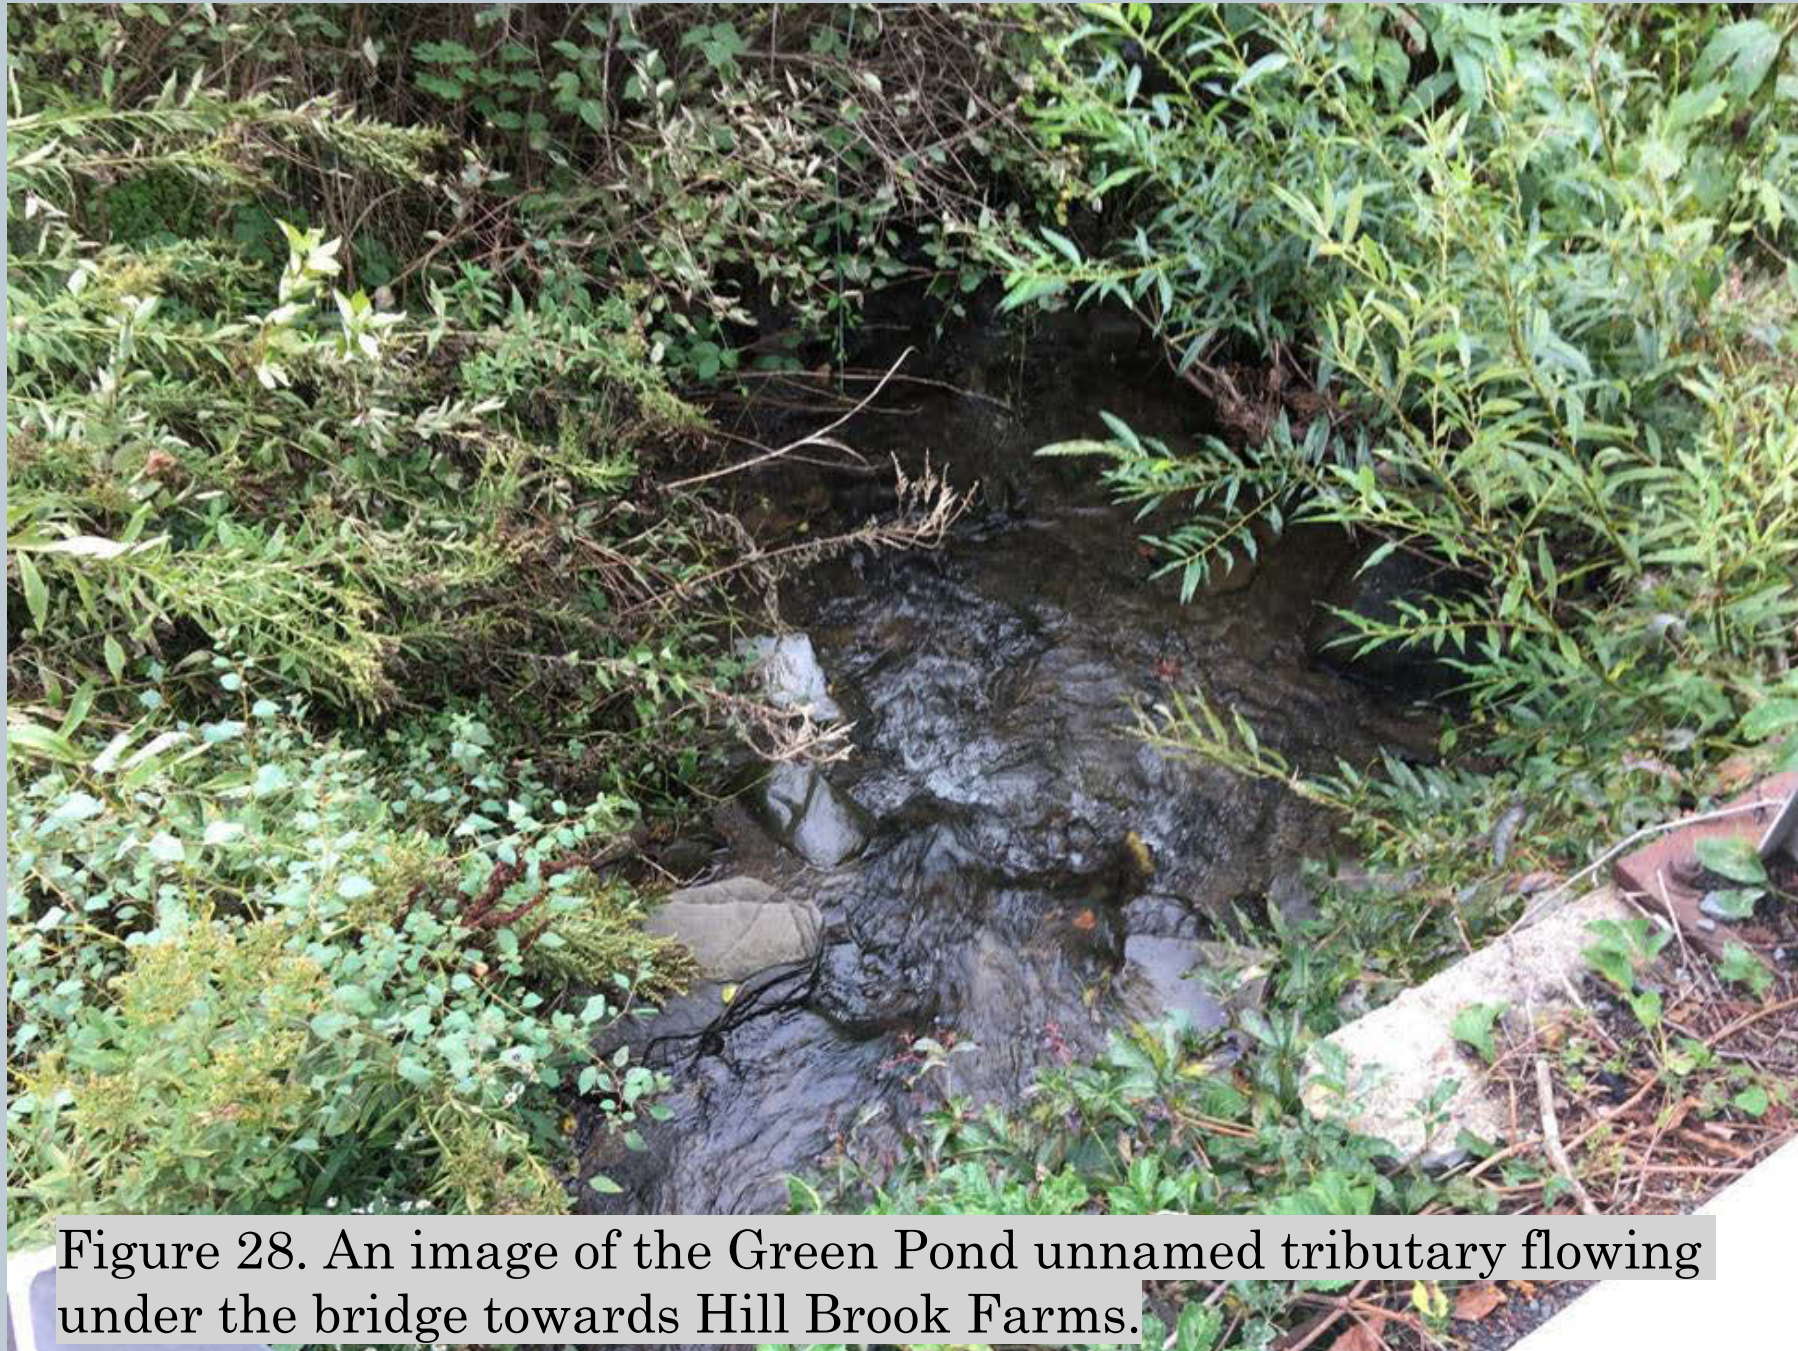
Figure 28. An image of the Green Pond unnamed tributary flowing under the bridge towards Hill Brook Farms.

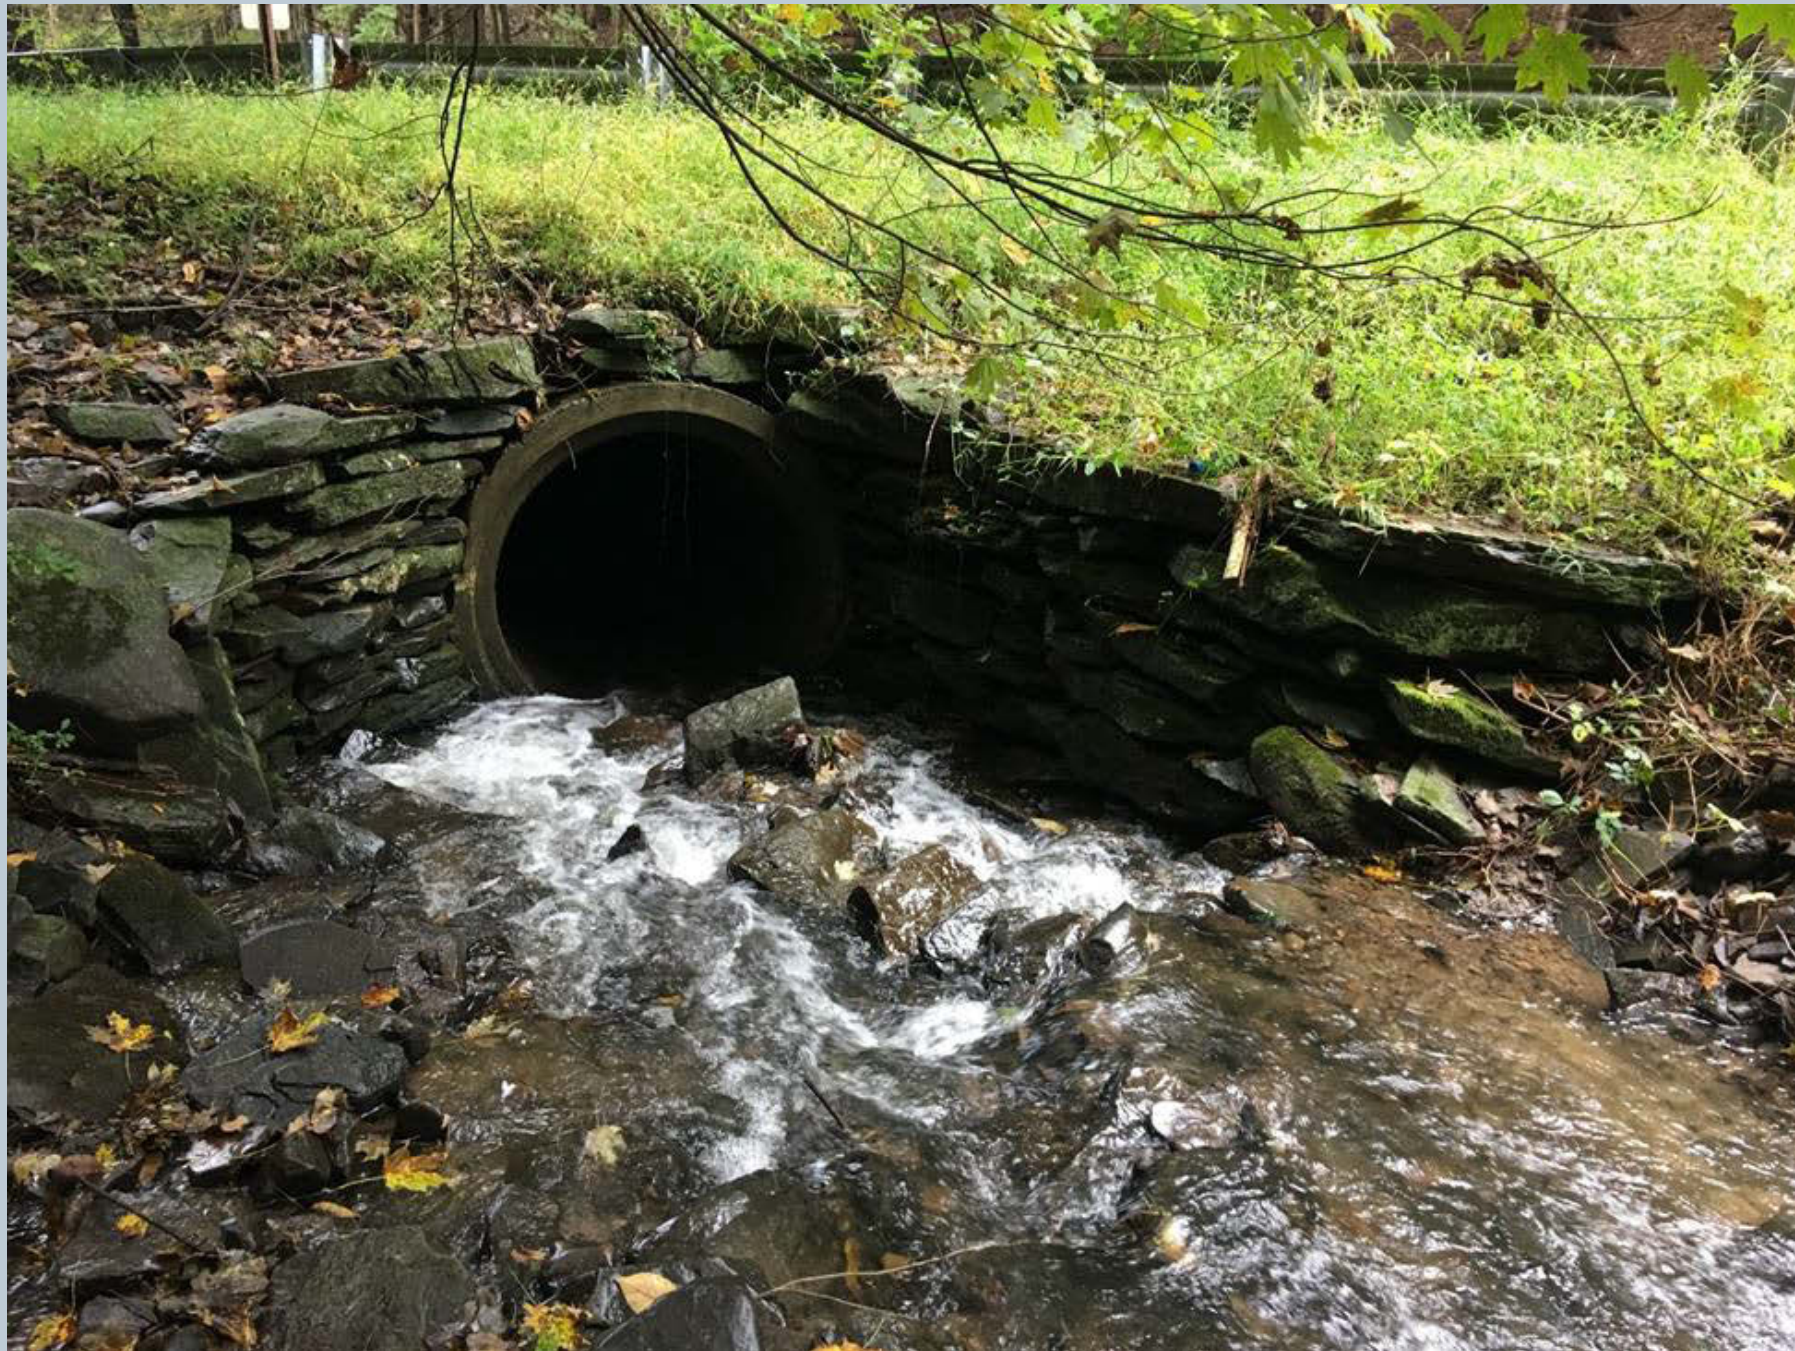
Figure 29. The Green Pond unnamed tributary looking downstream along E. Center Street. This is a shot of a 36-inch concrete pipe culvert with a masonry headwall. The left wall is failing, and the headwall can easily be reconstructed by hand.

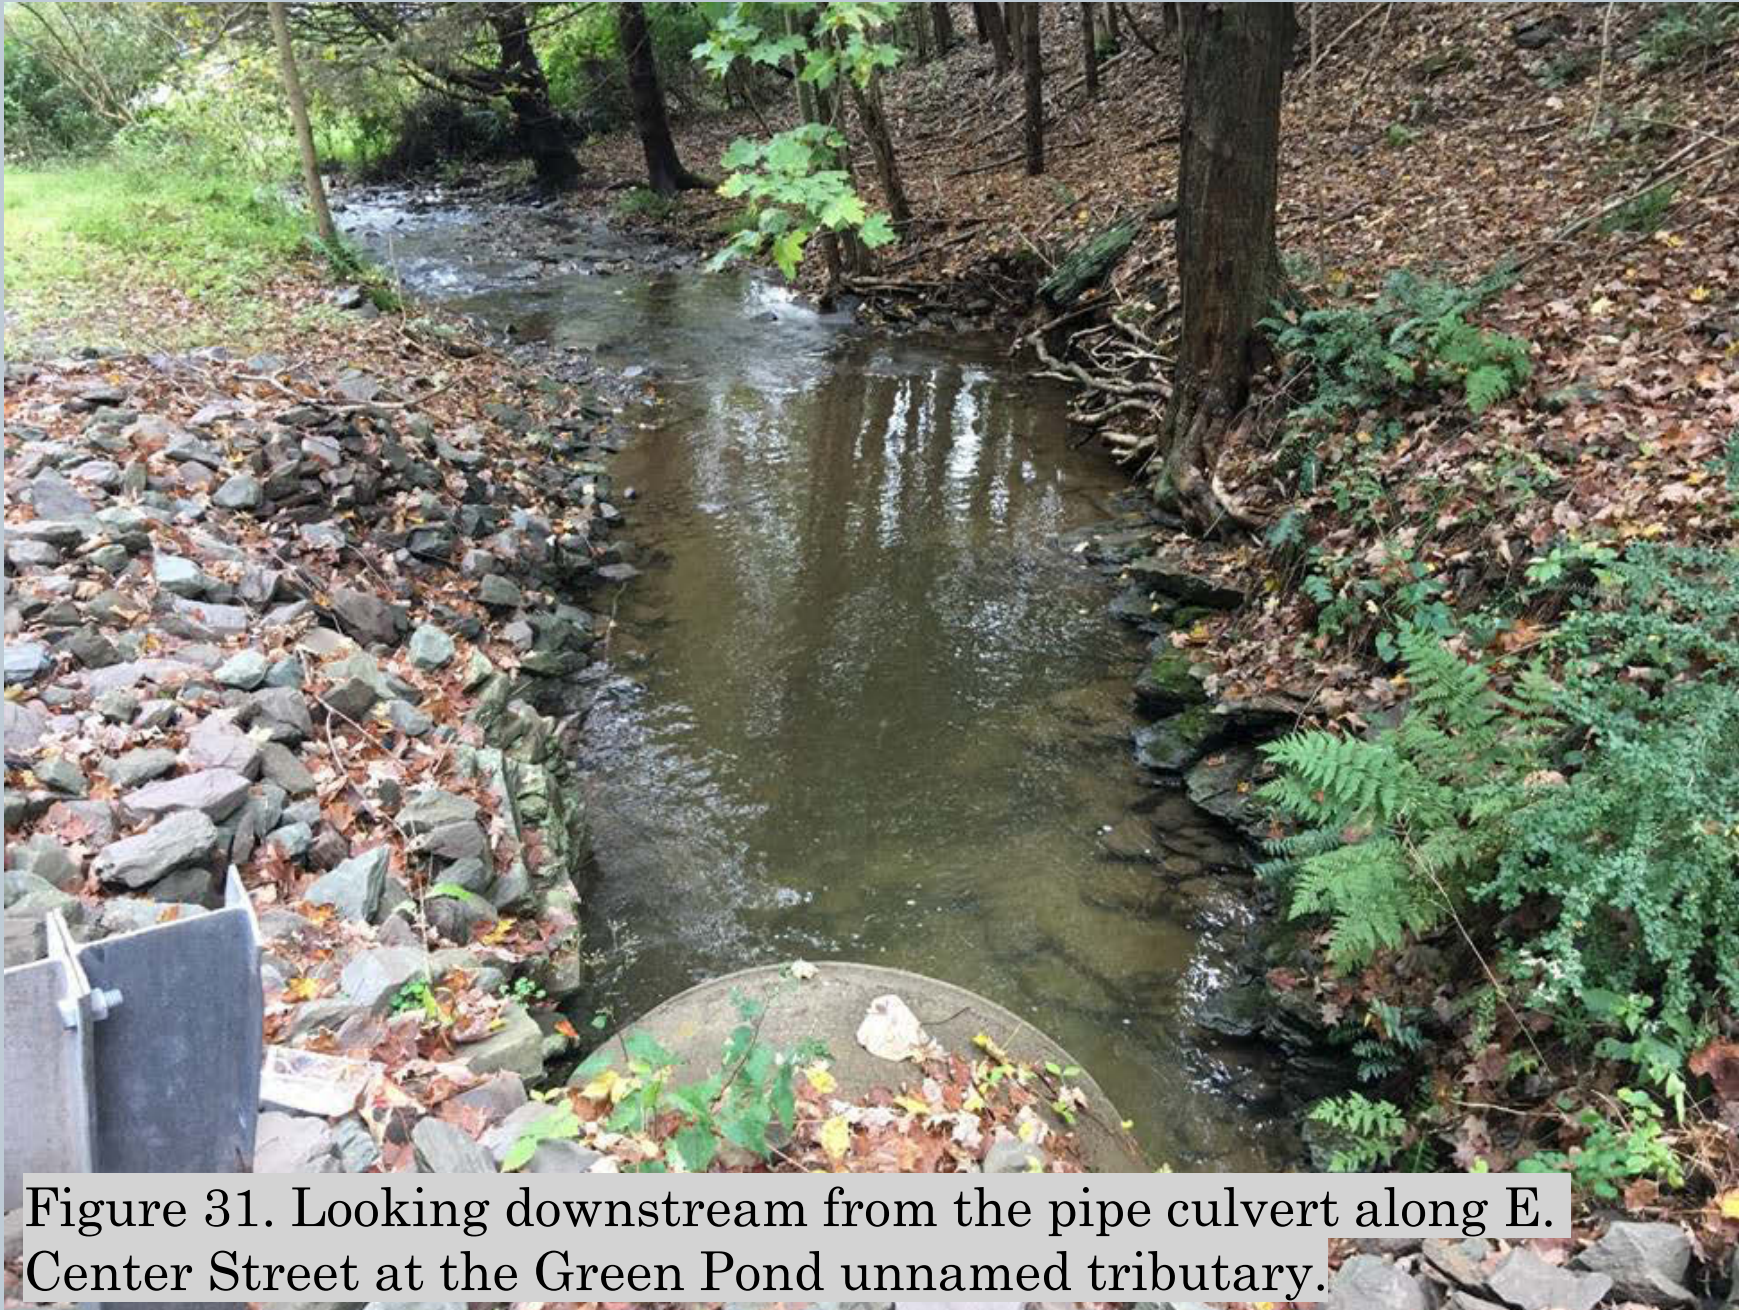
Figure 31. Looking downstream from the pipe culvert along E. Center Street at the Green Pond unnamed tributary.

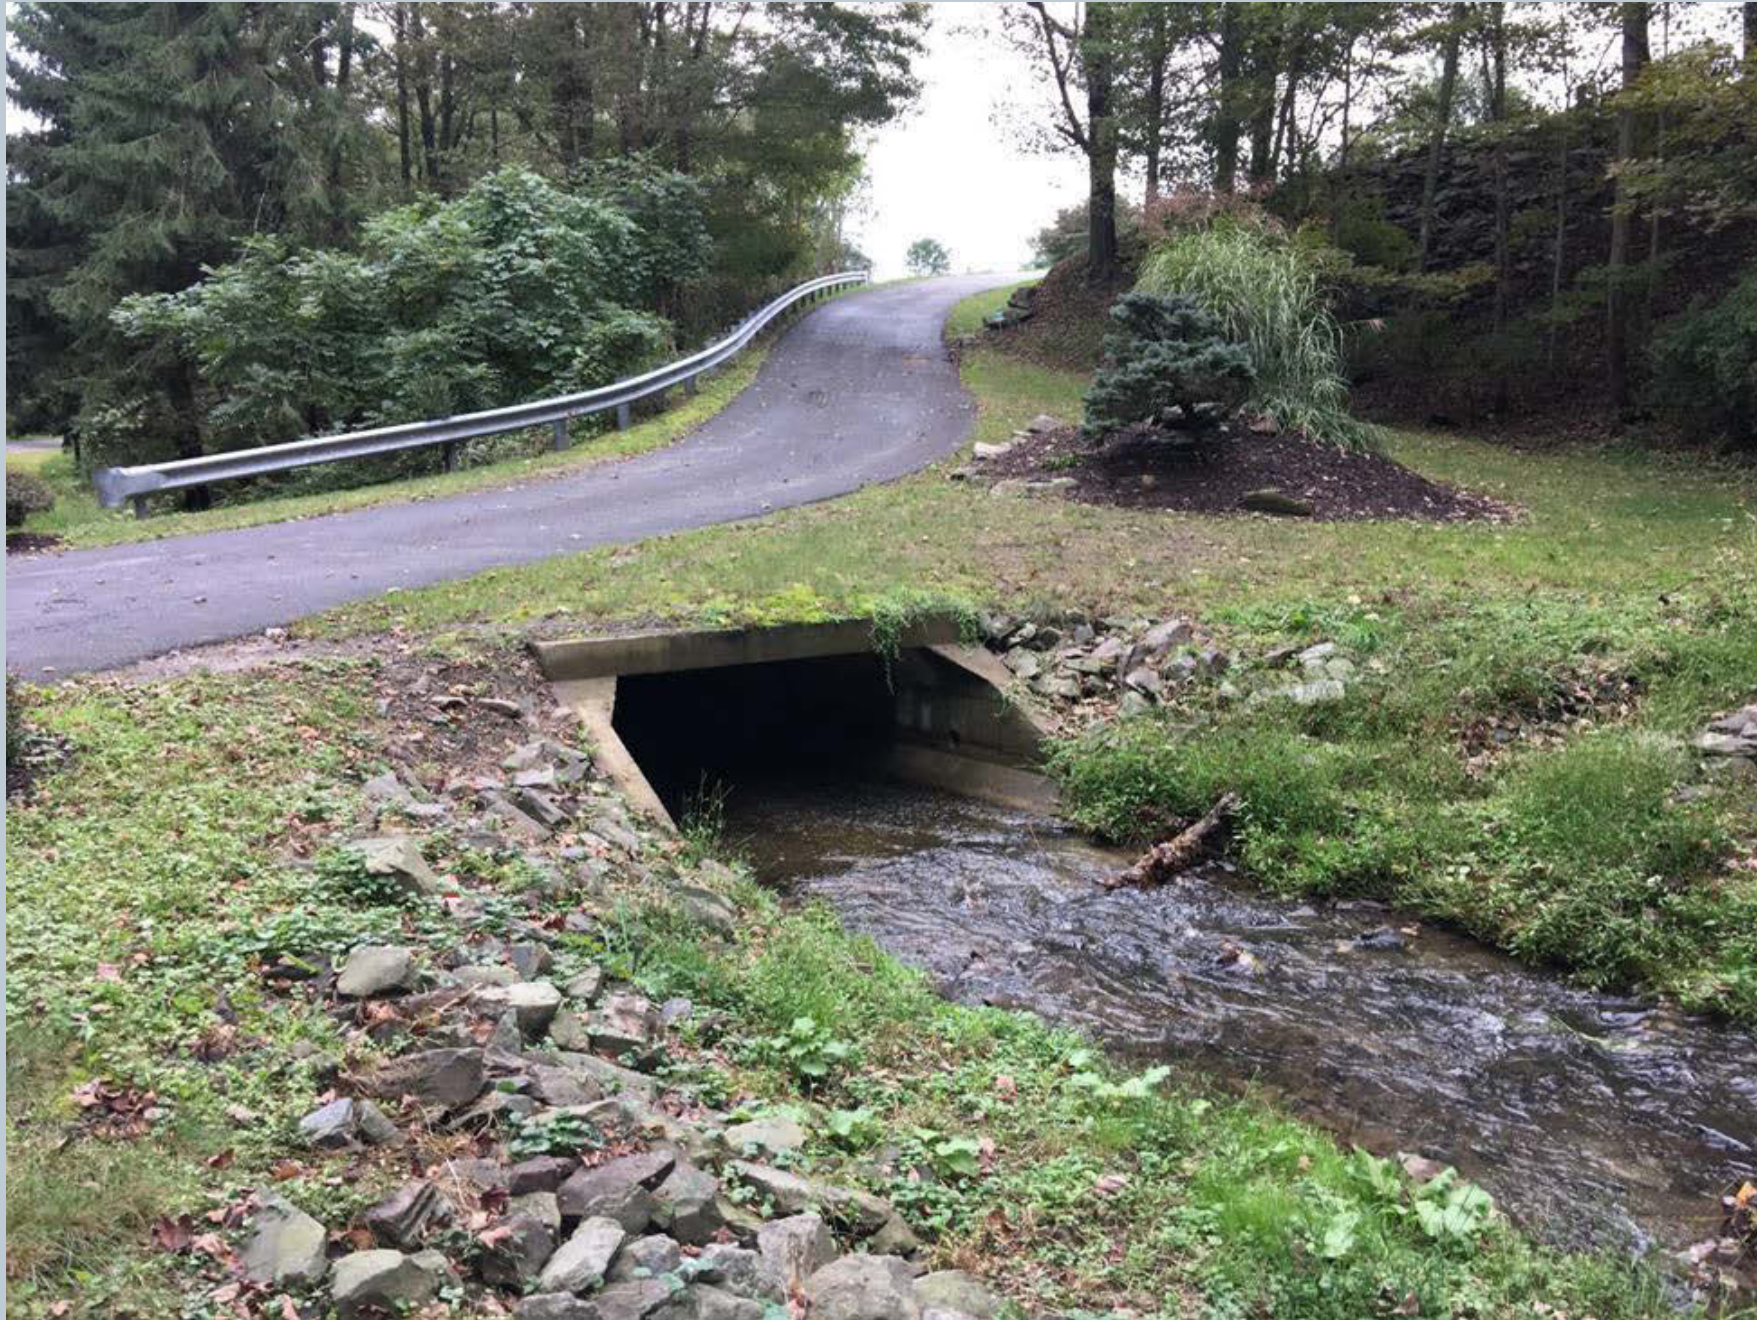
Figure 32. Looking downstream at the box culvert on the Green Pond unnamed tributary, located under the private driveway at 230 E. Center Street.

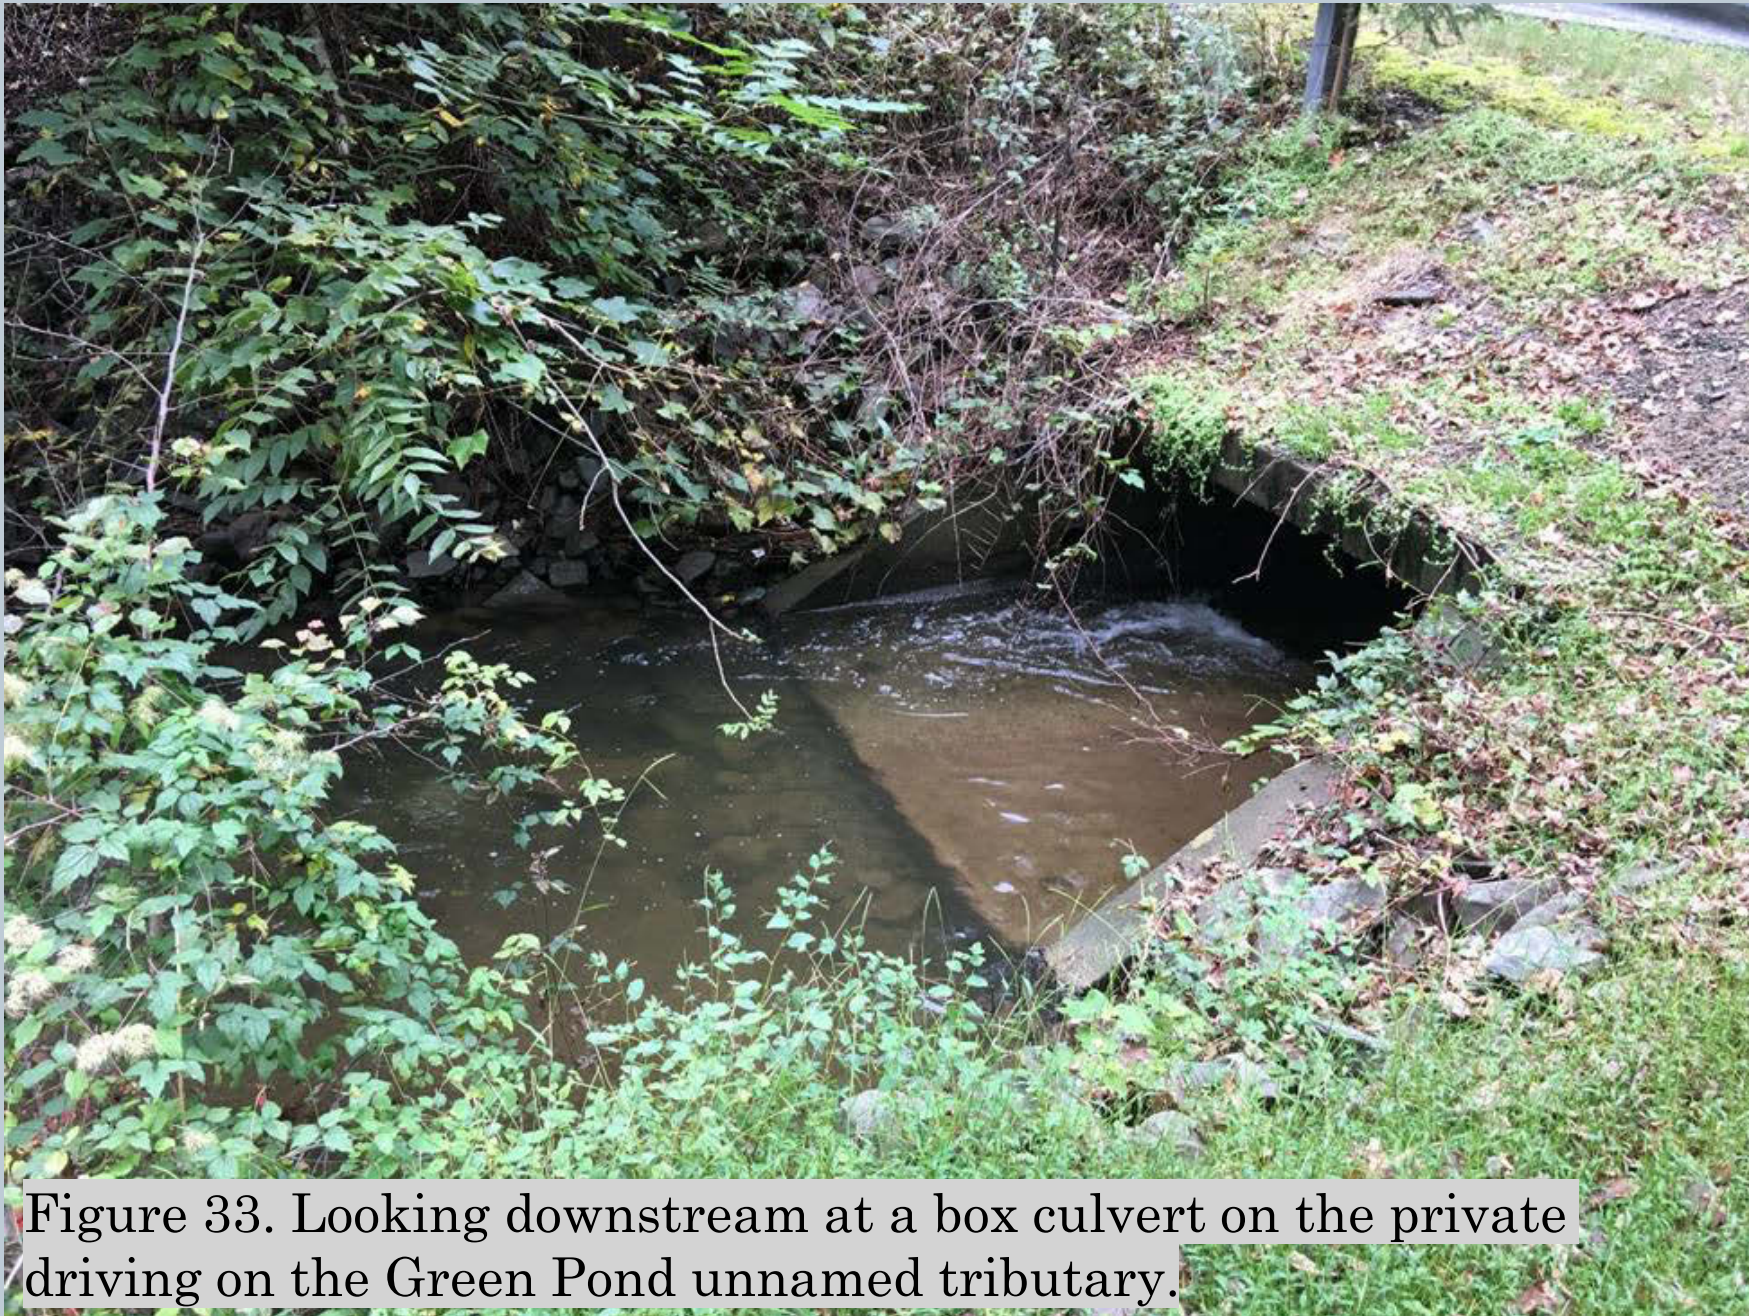
Figure 33. Looking downstream at a box culvert on the private driving on the Green Pond unnamed tributary.

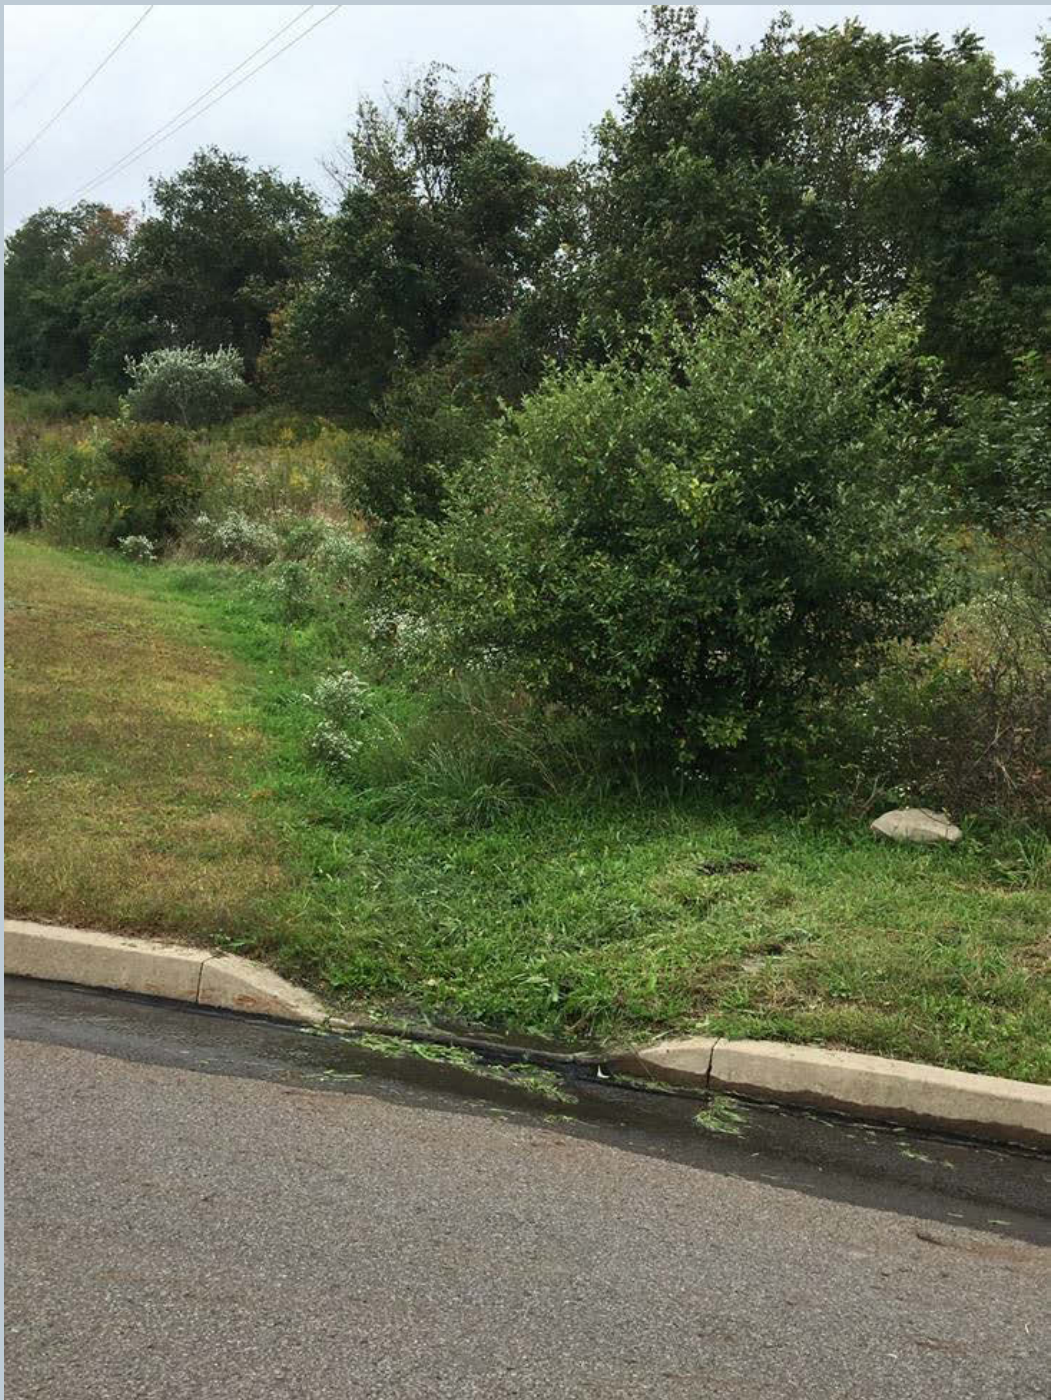
Figure 34. A photo of an unnamed tributary to the Green Pond unnamed tributary which flows from a curb cut in the Echo Valley Mobile Home Park.

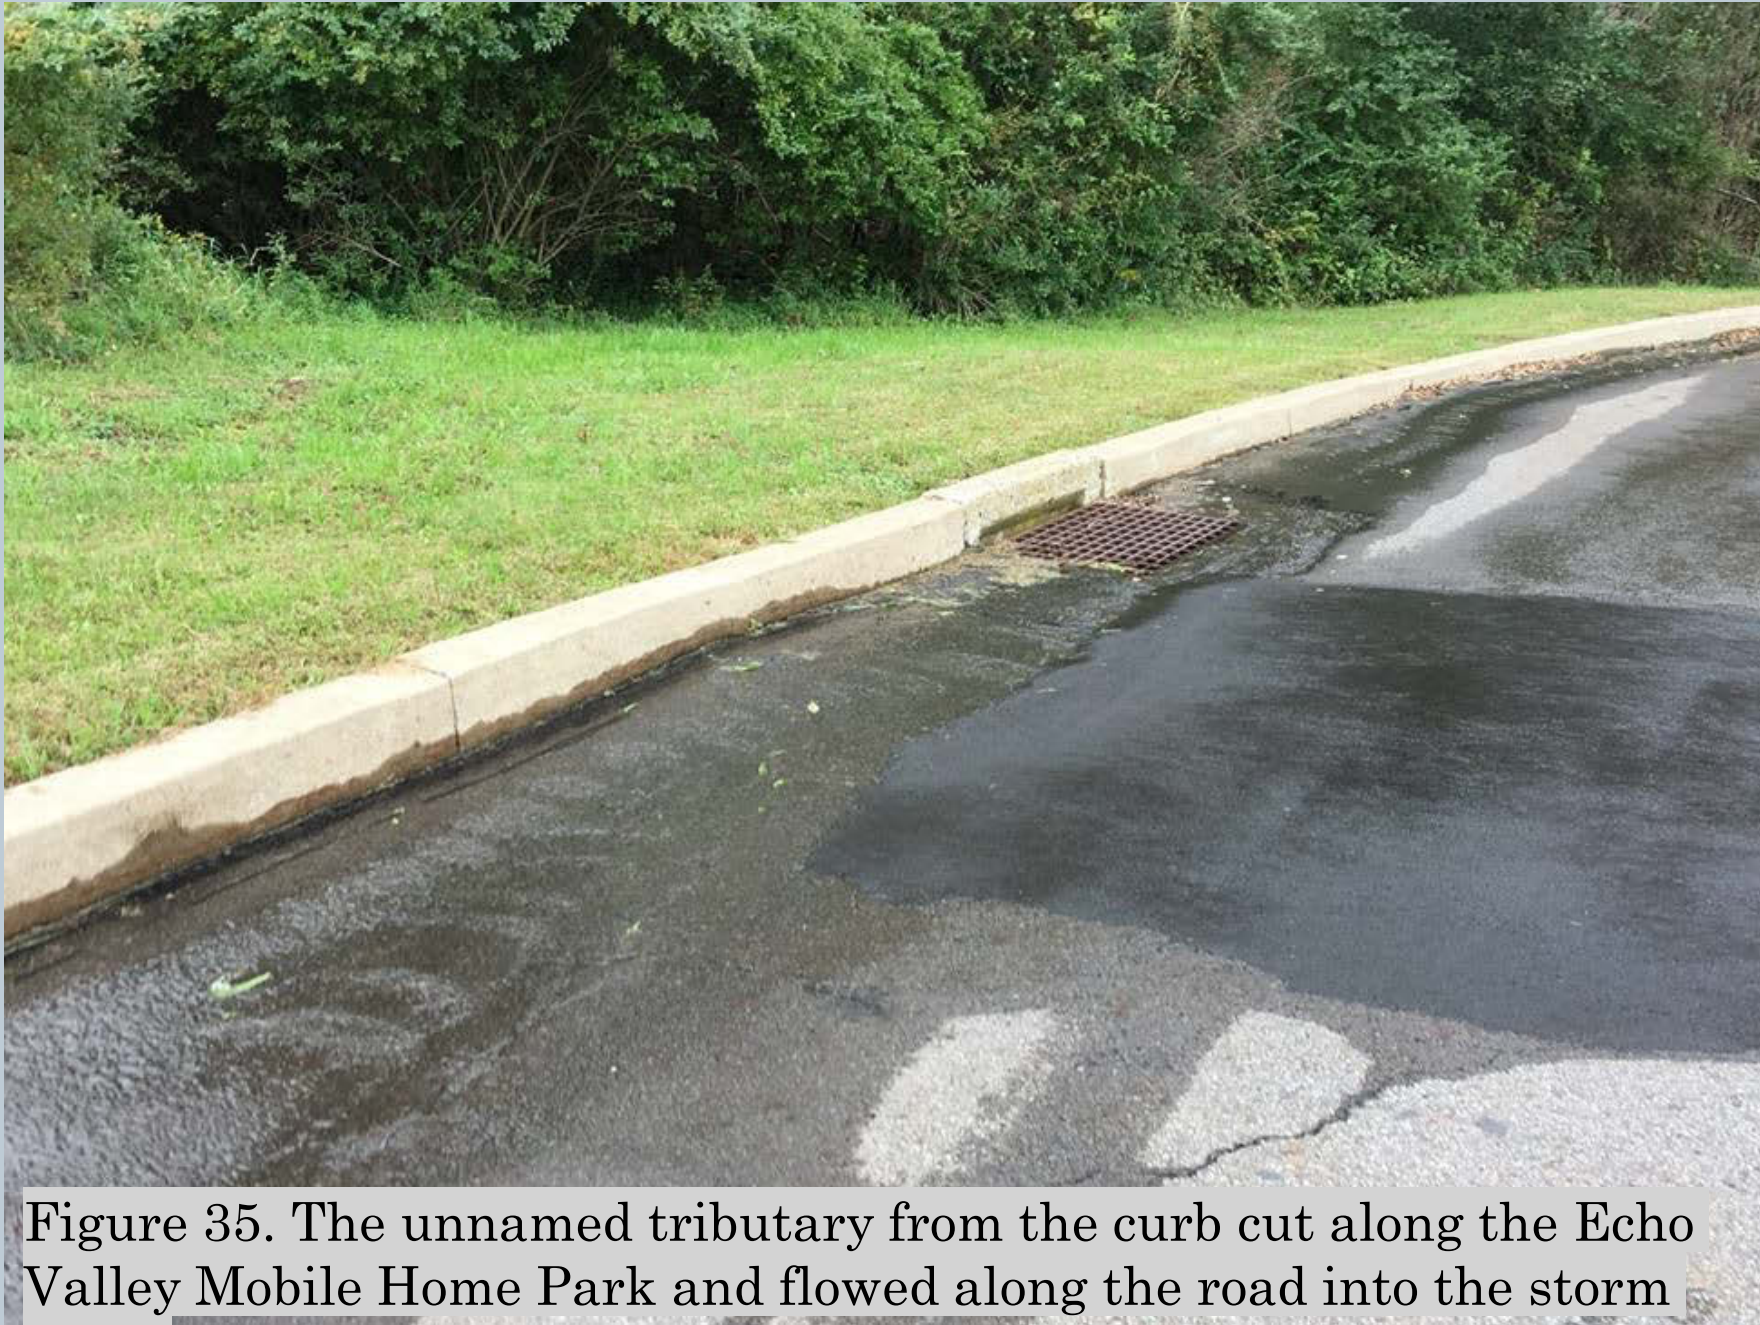
Figure 35. The unnamed tributary from the curb cut along the Echo Valley Mobile Home Park and flowed along the road into the storm drain.
