Toby Creek Field Reconnaissance Observations

September 26, 2018

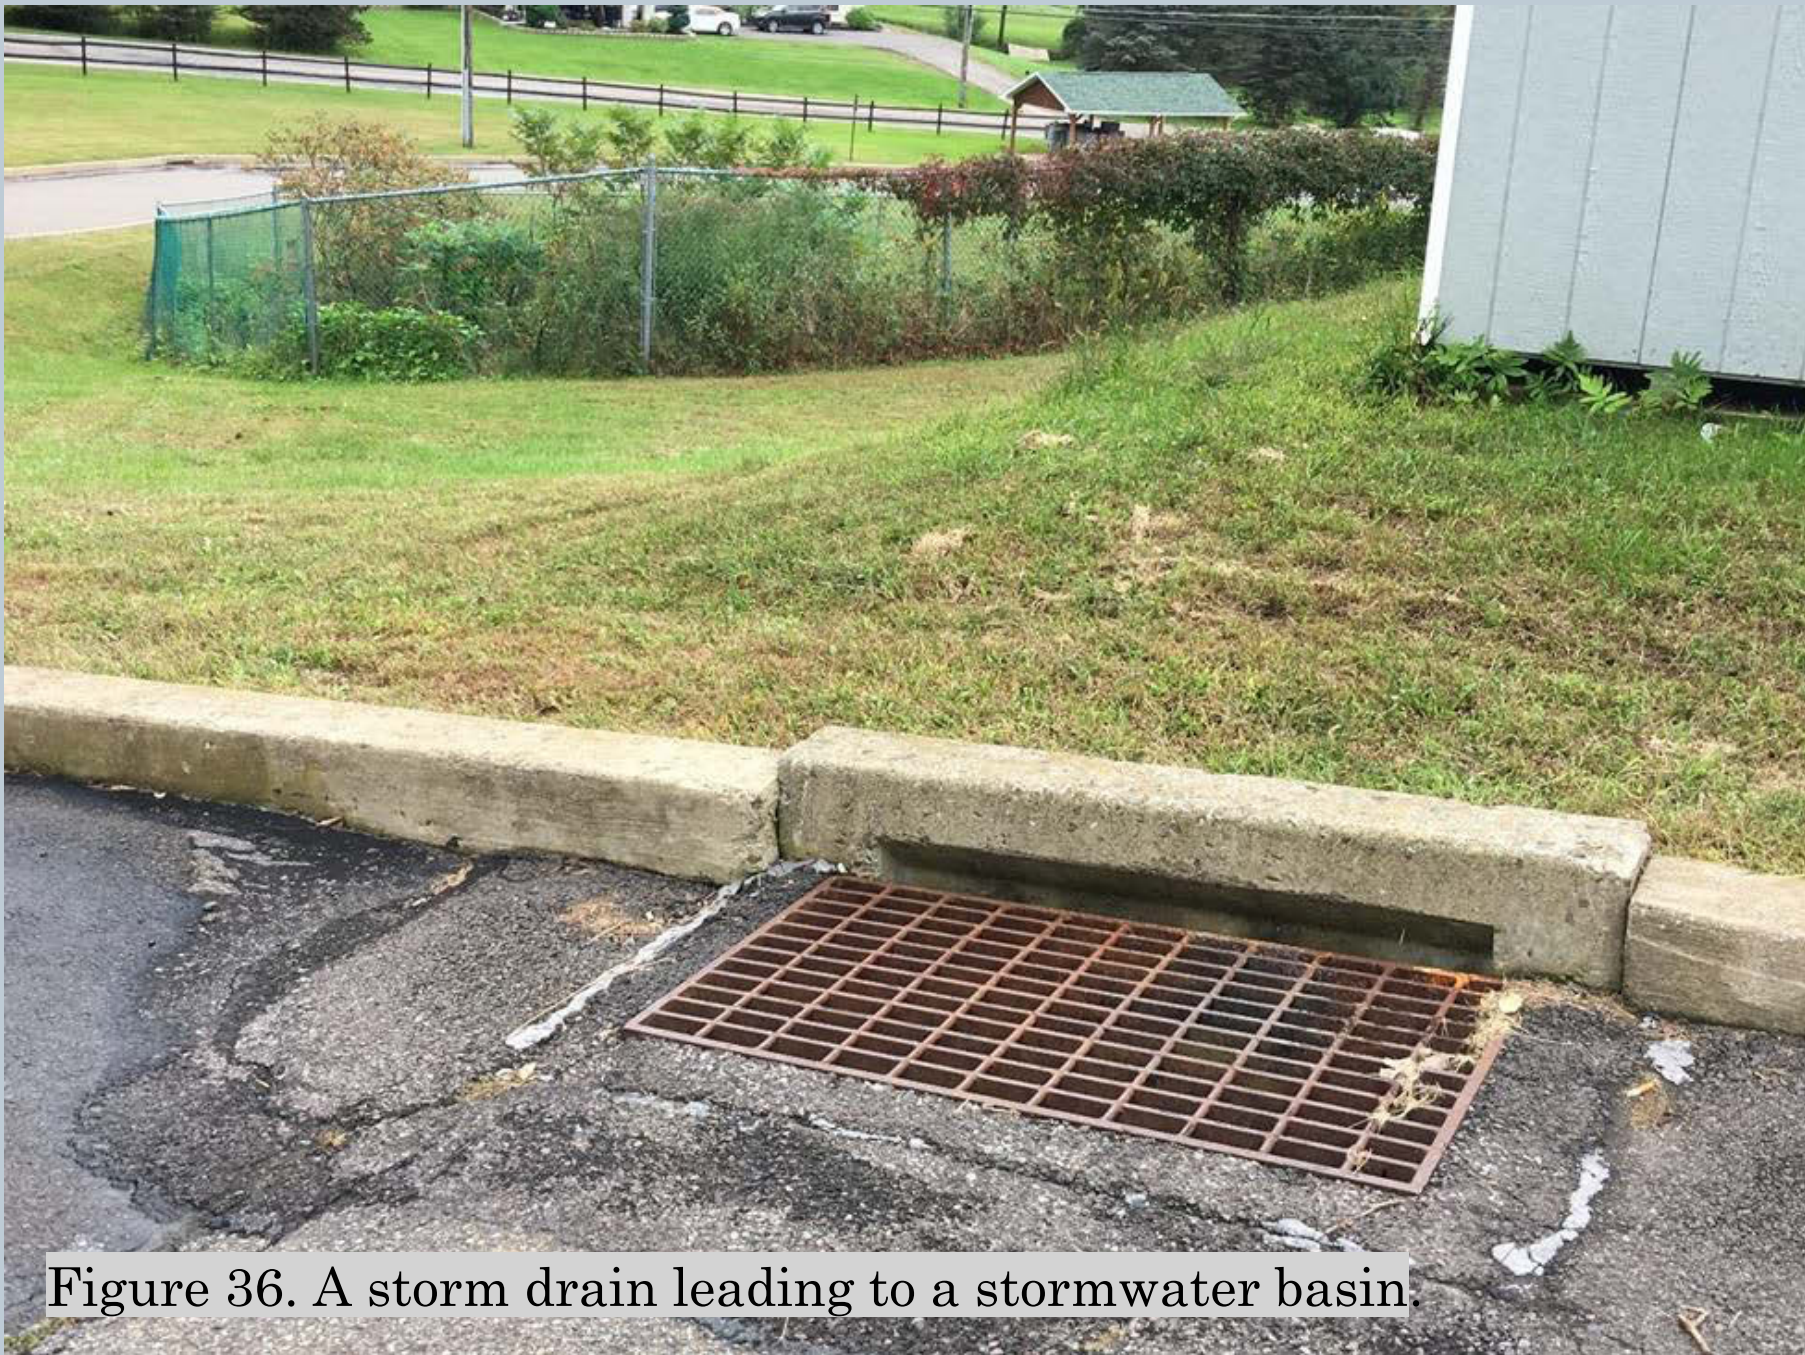
Figure 36. A storm drain leading to a stormwater basin.

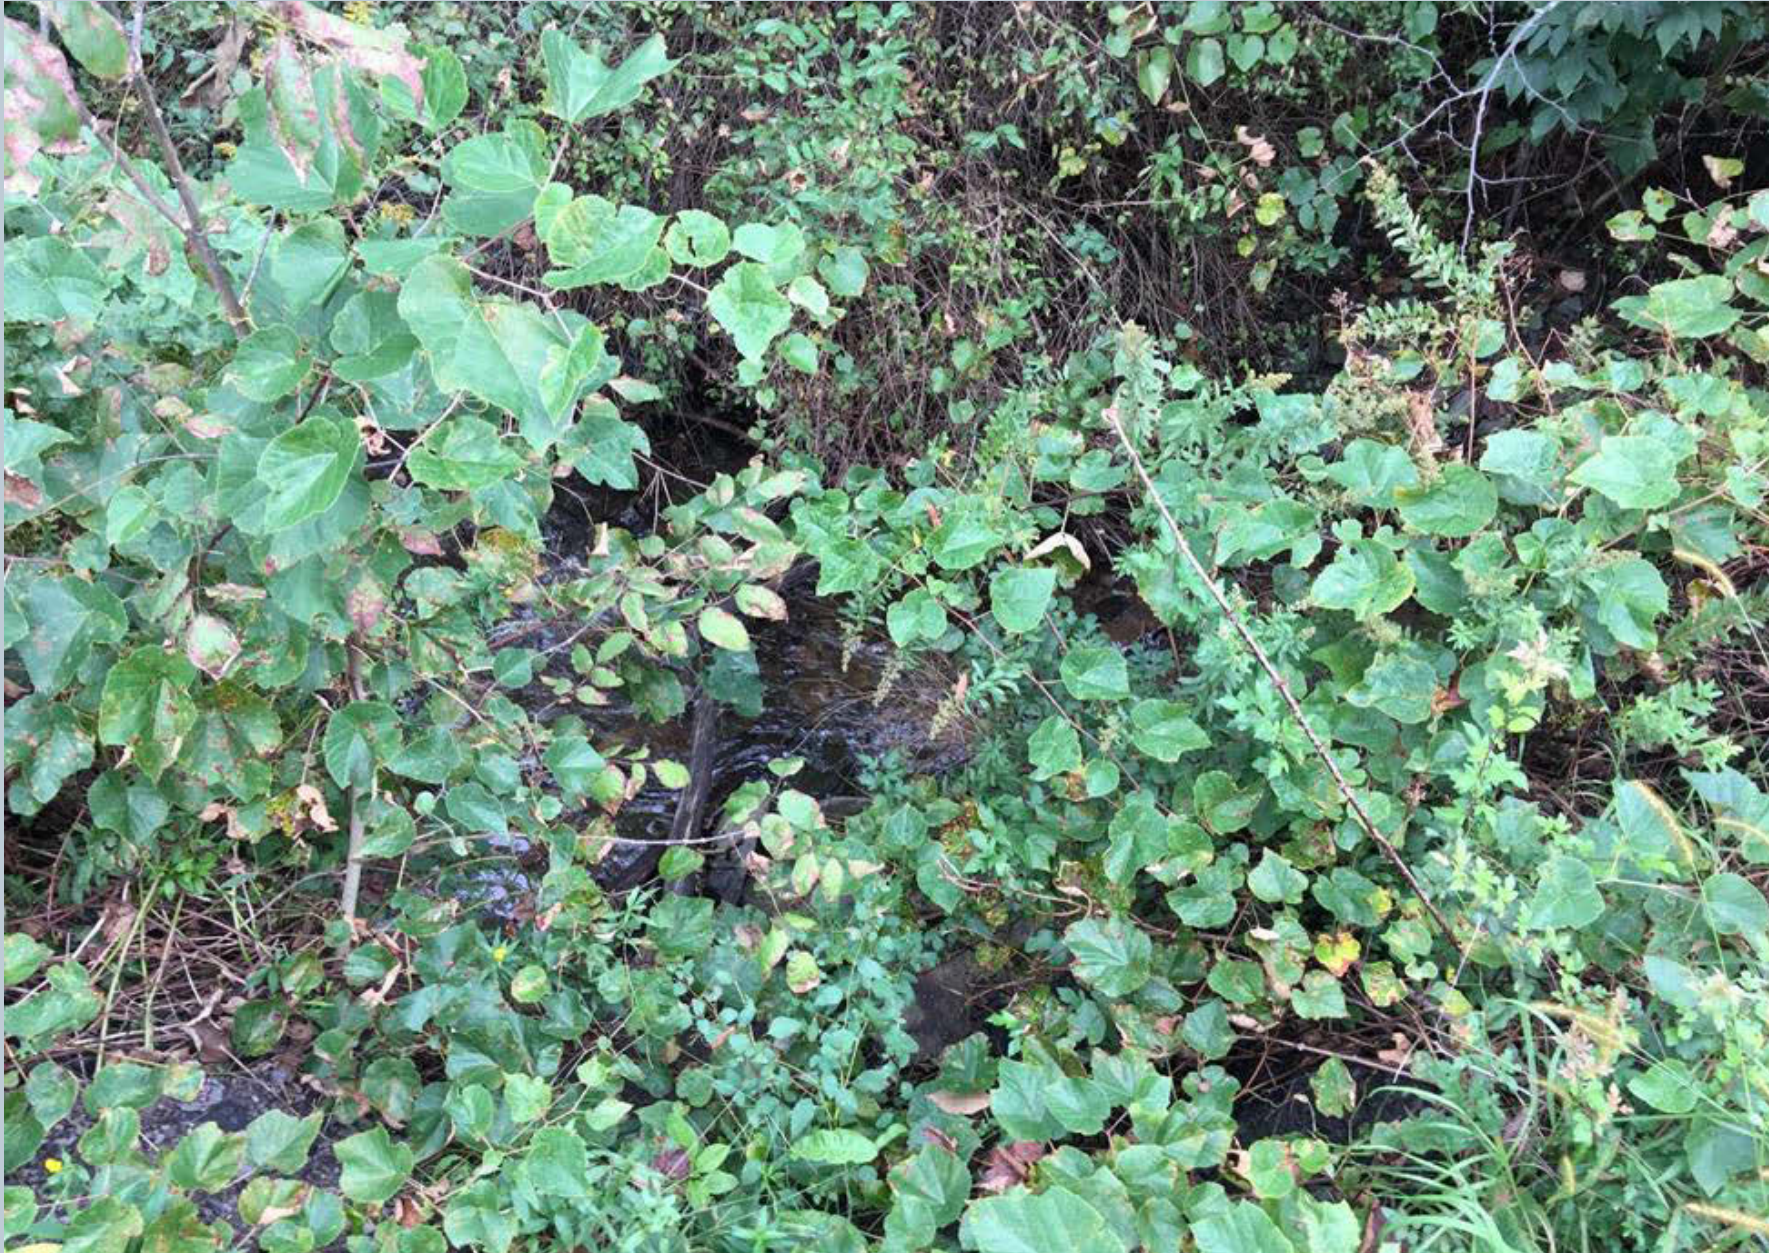
Figure 37. A box culvert on the Green Pond unnamed tributary, looking upstream.

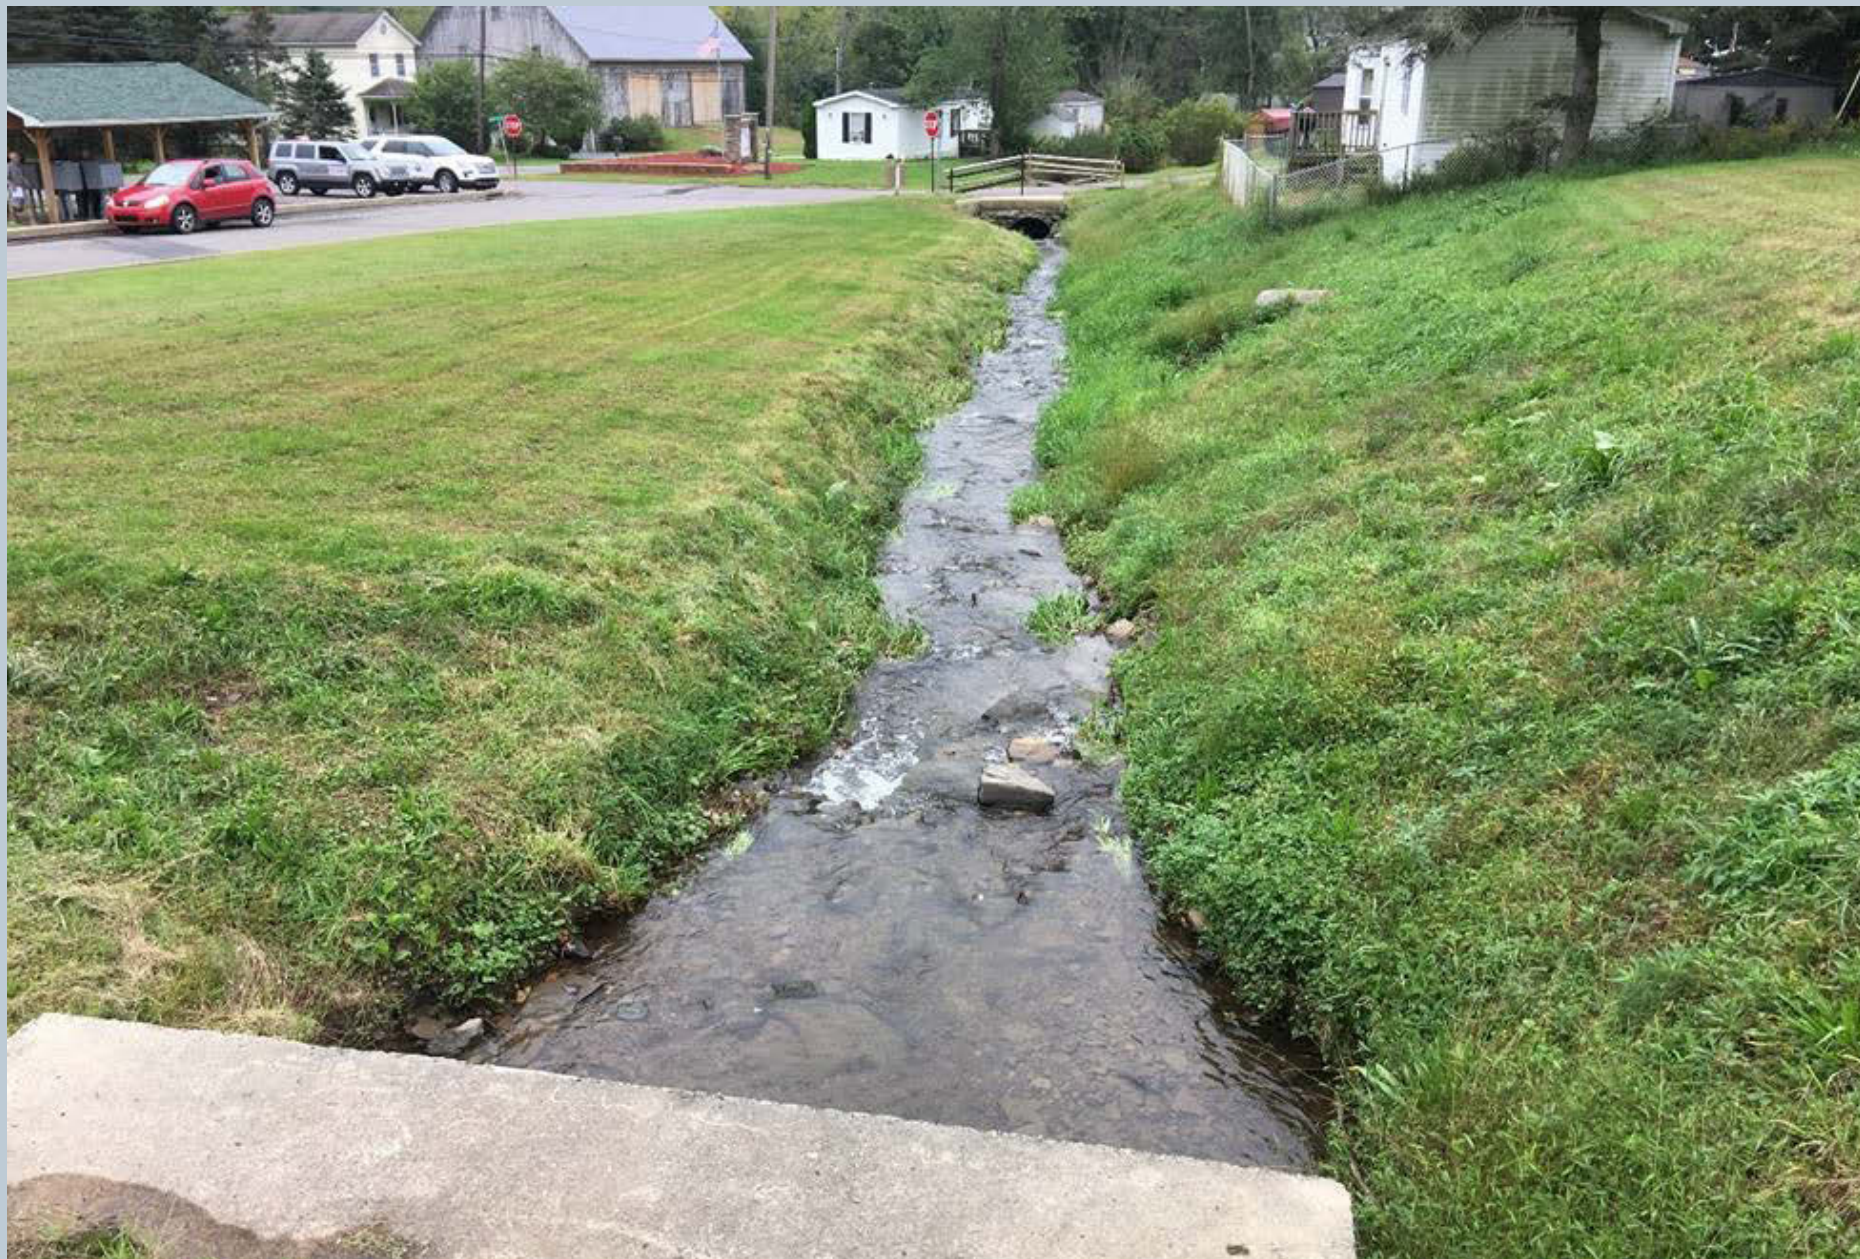
Figure 38. A box culvert on the Green Pond unnamed tributary, looking downstream.

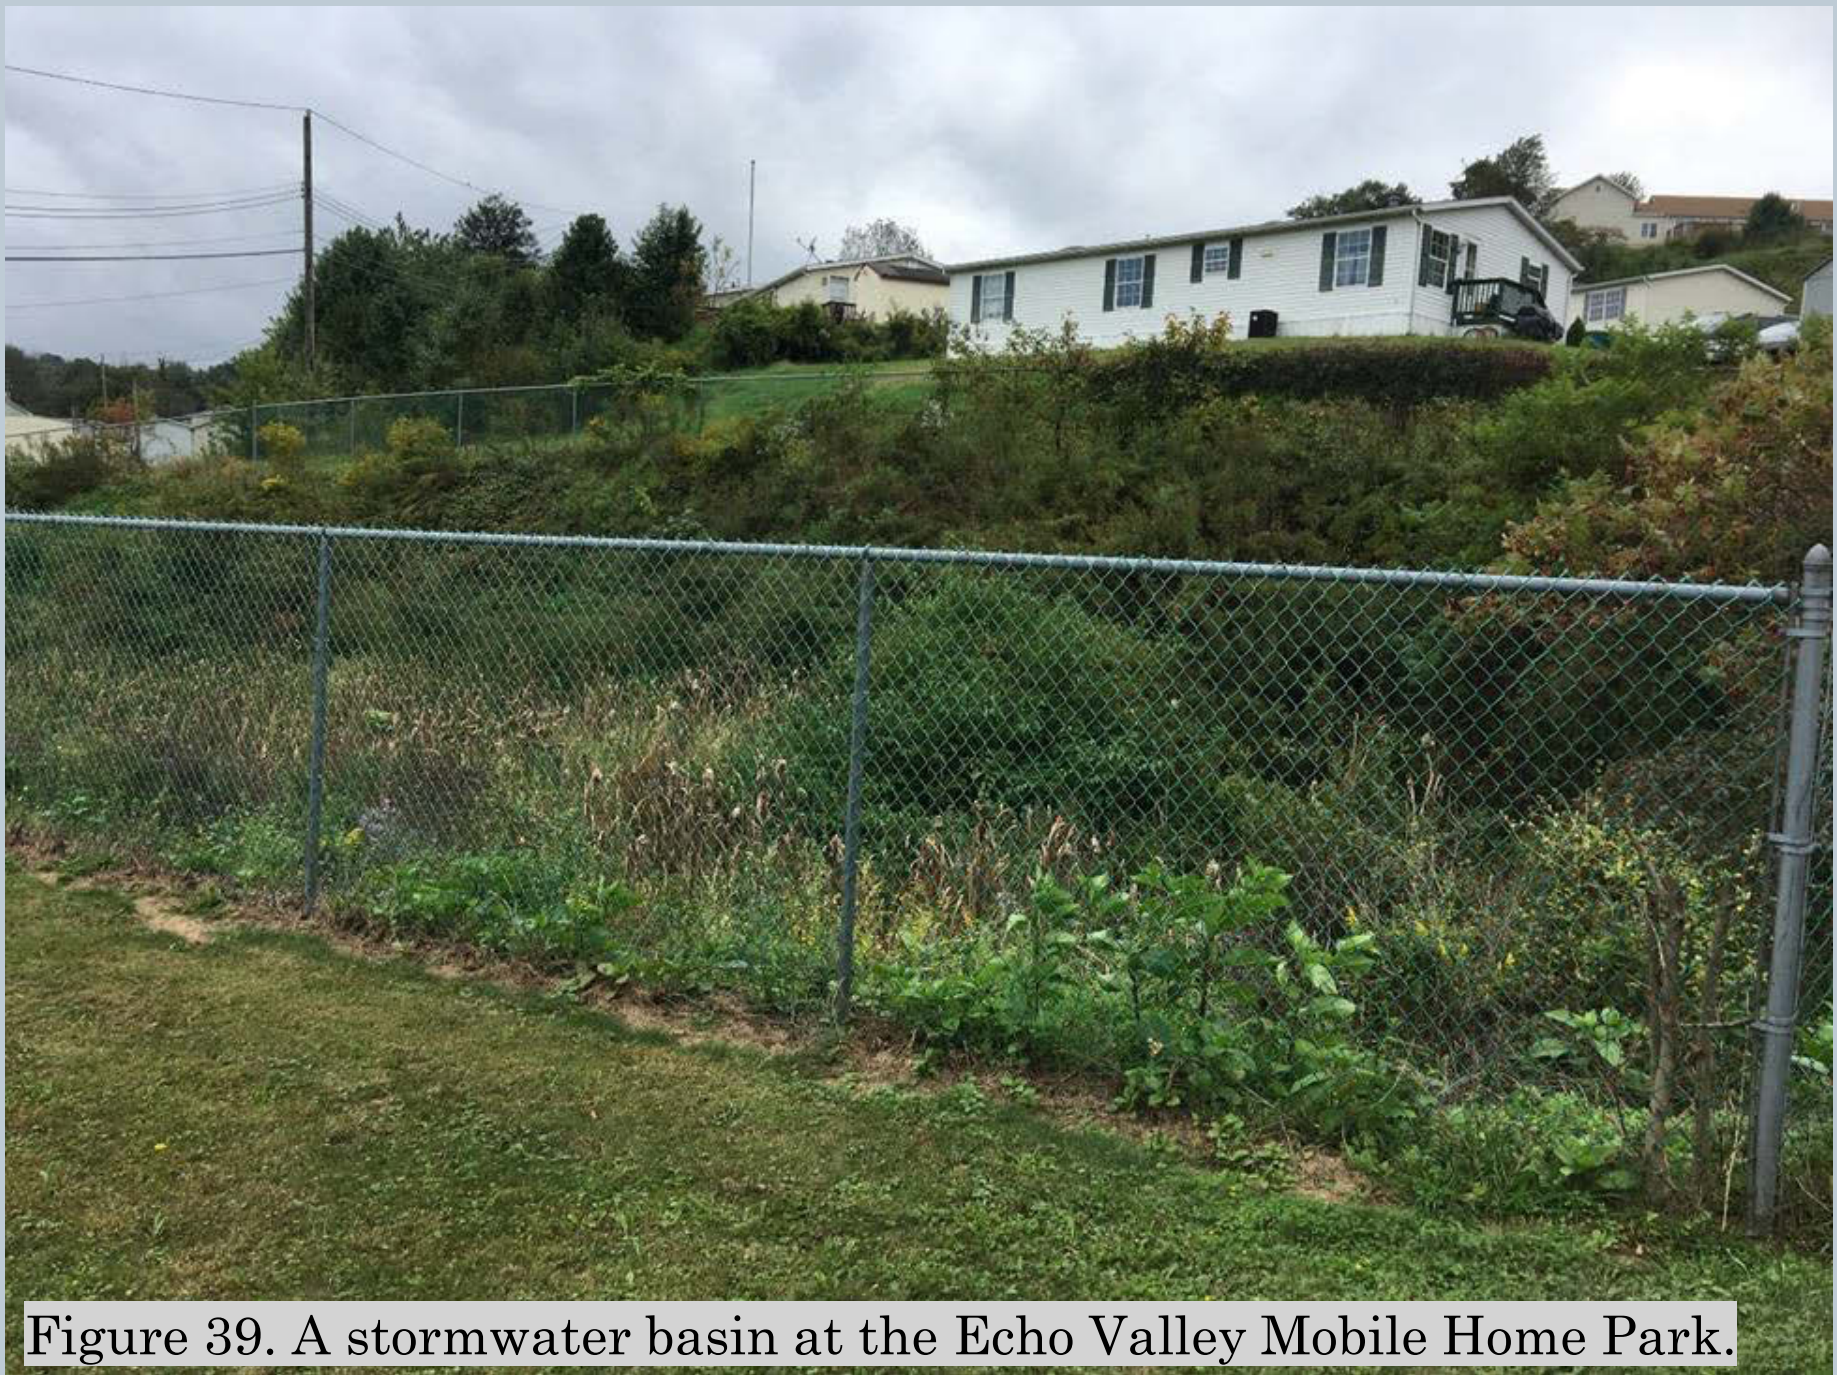
Figure 39. A stormwater basin at the Echo Valley Mobile Home Park.

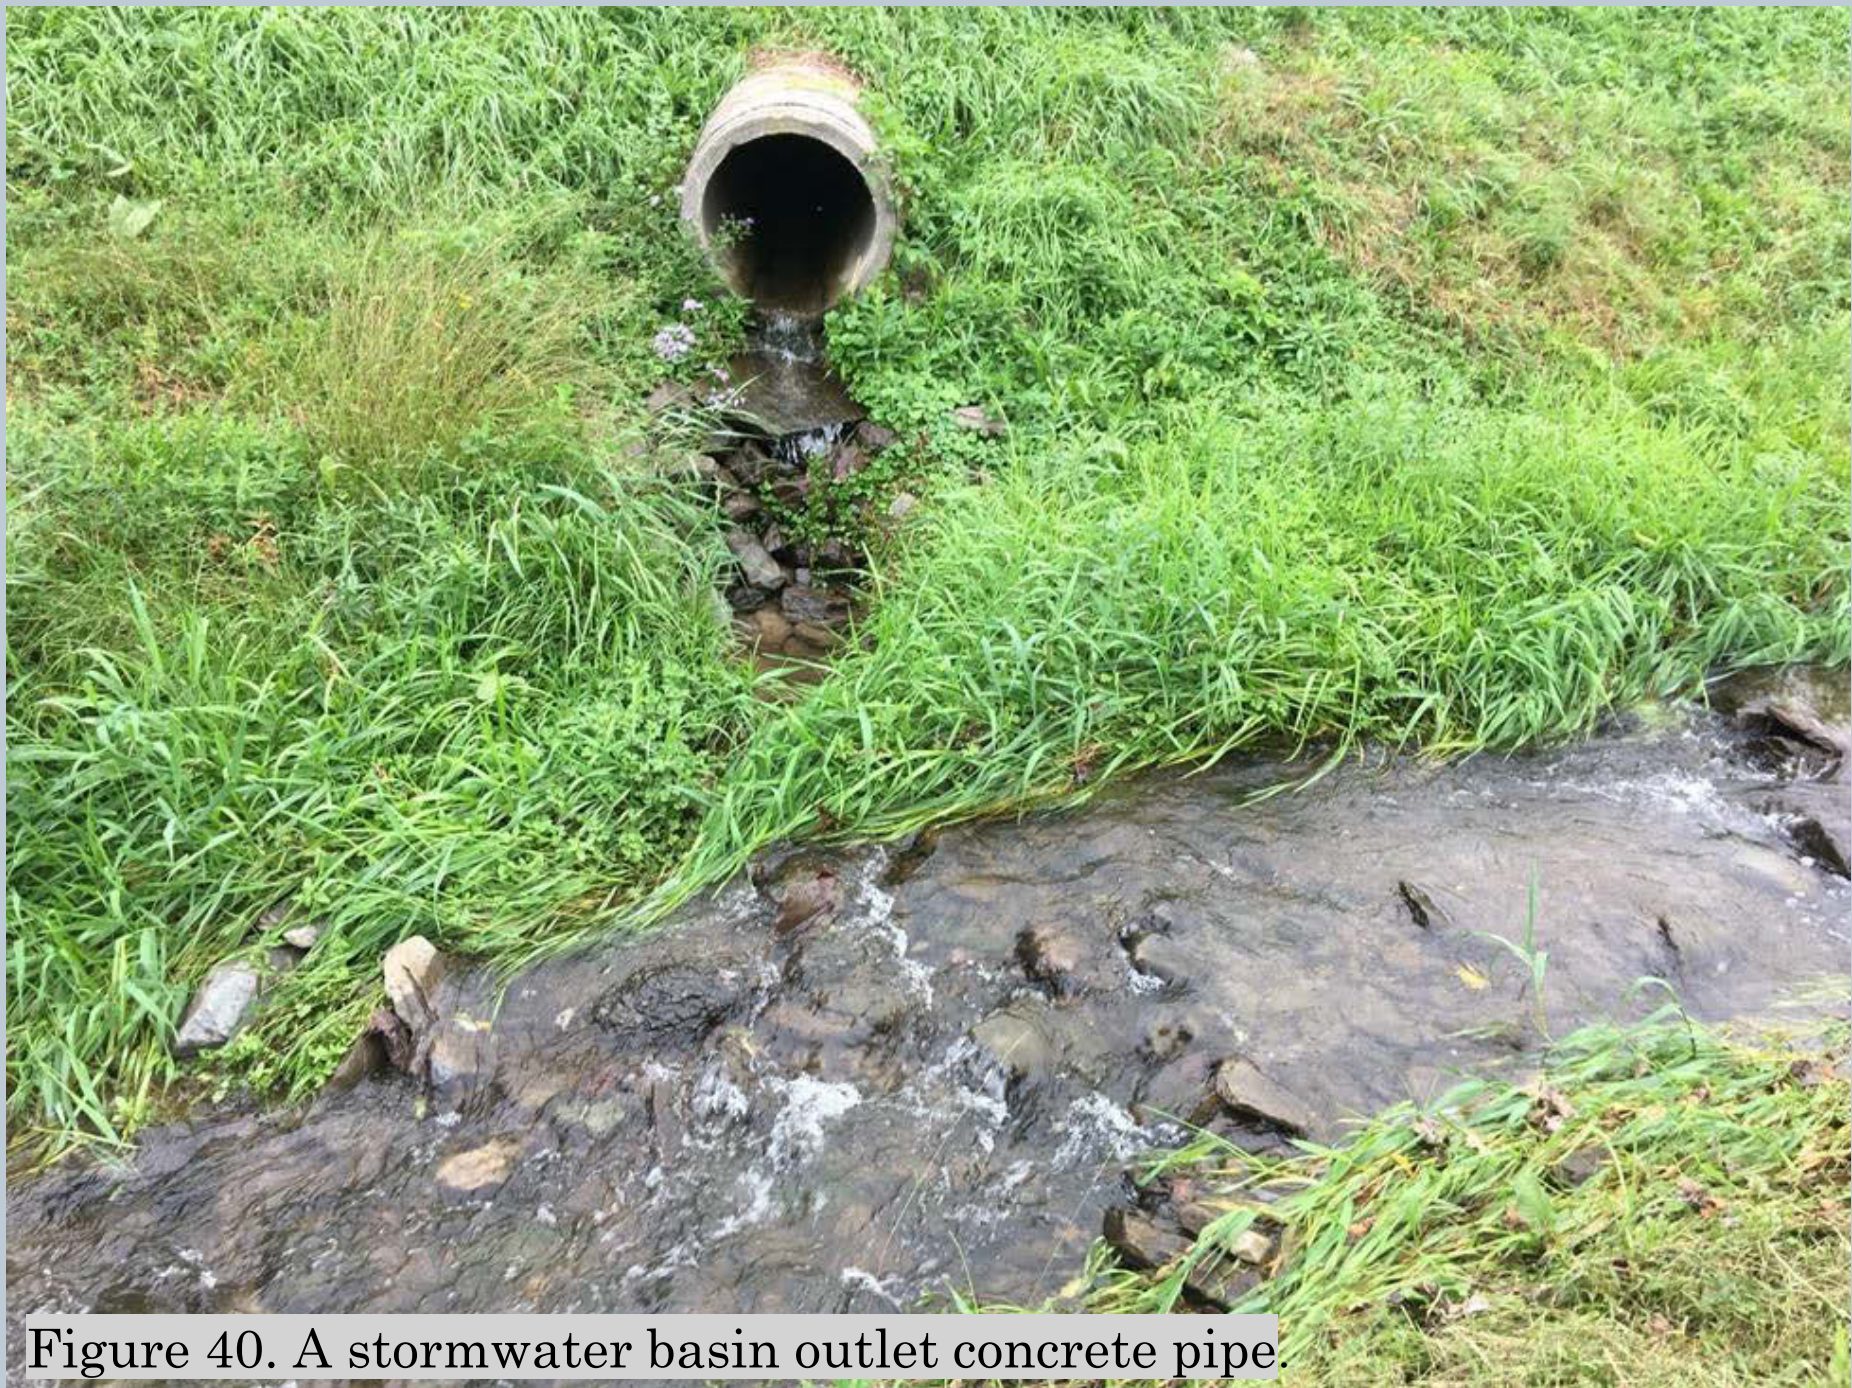
Figure 40. A stormwater basin outlet concrete pipe.

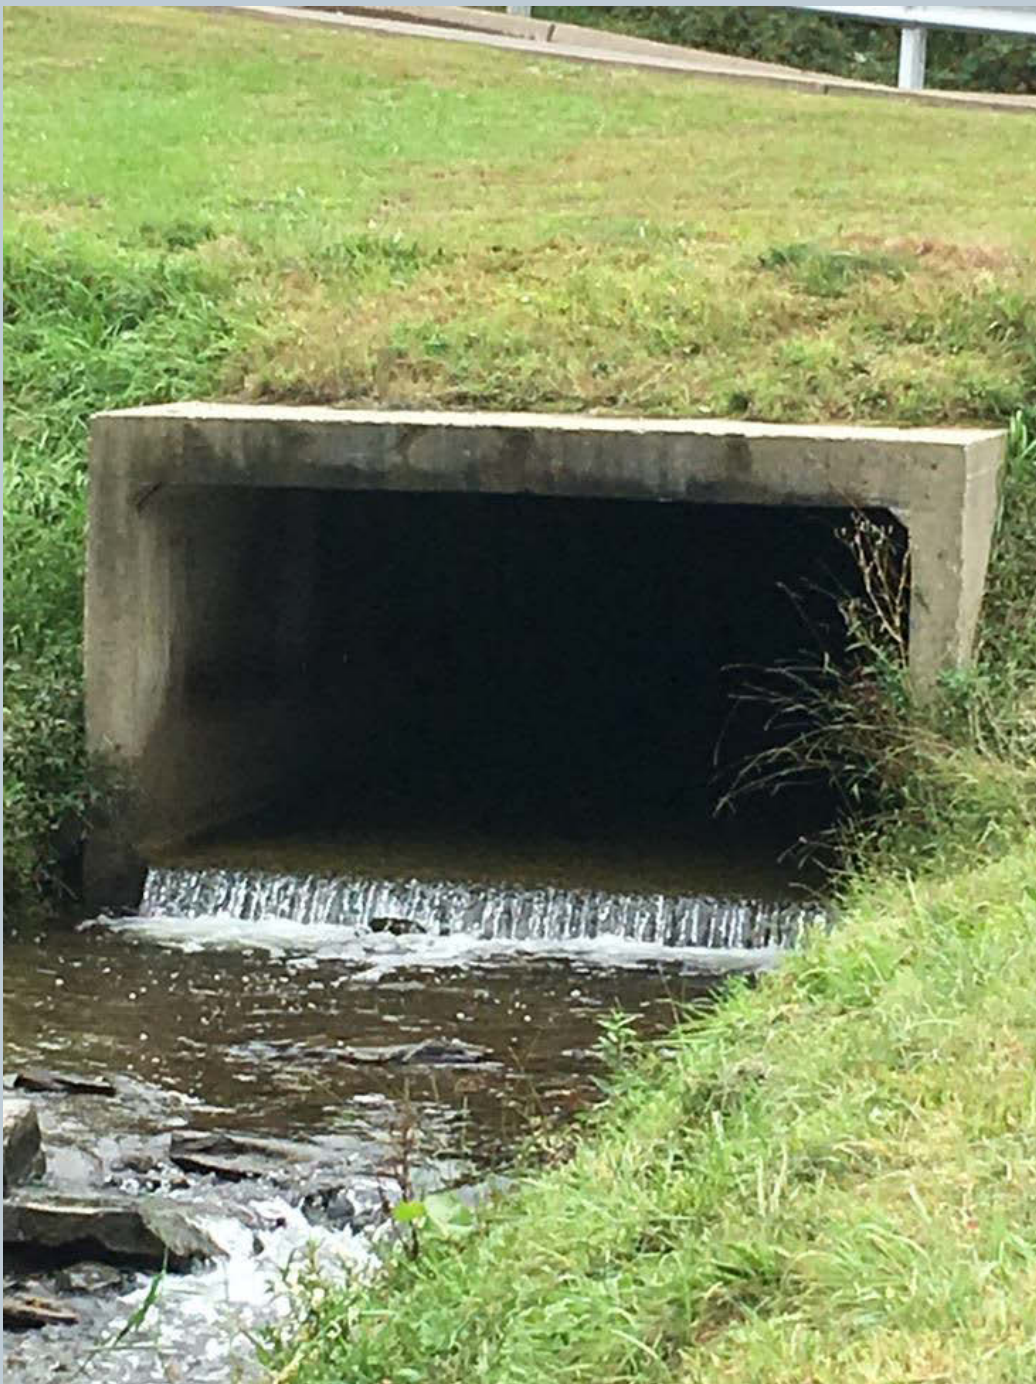
Figure 41. Looking upstream at the box culvert, this location cascades to the Green Pond unnamed tributary (around 3-inches). This location could use a rock apron for aquatic organism passage.

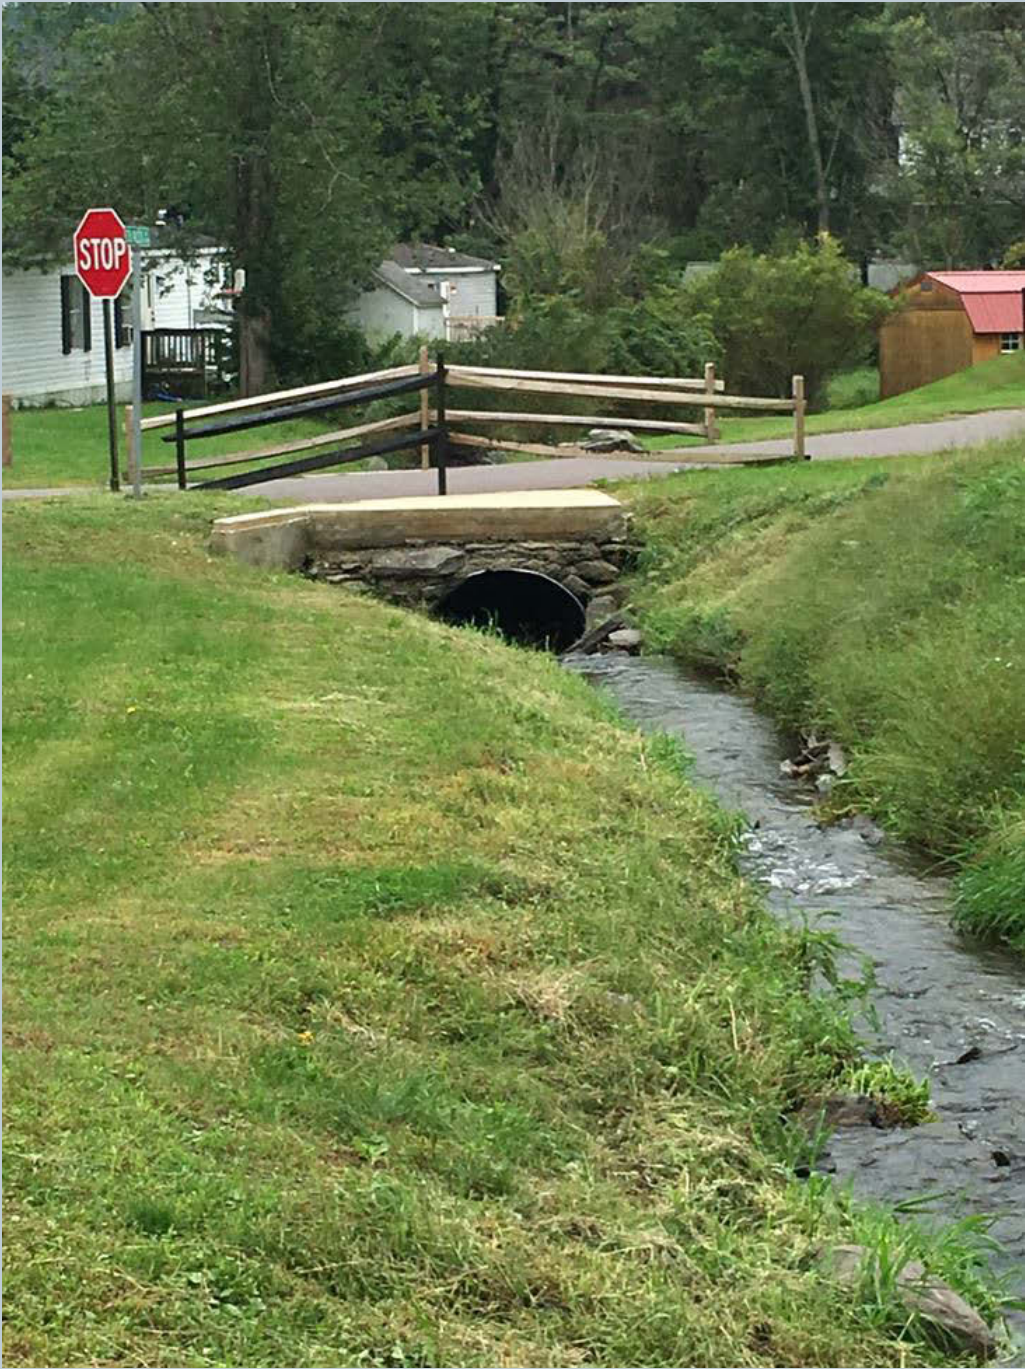
Figure 42. A shot looking downstream at a corrugated squash culvert pipe along Echo Valley Drive. This culvert is grouted and cemented with rock and rusted out completely at the bottom of the corrugated metal culvert pipe.

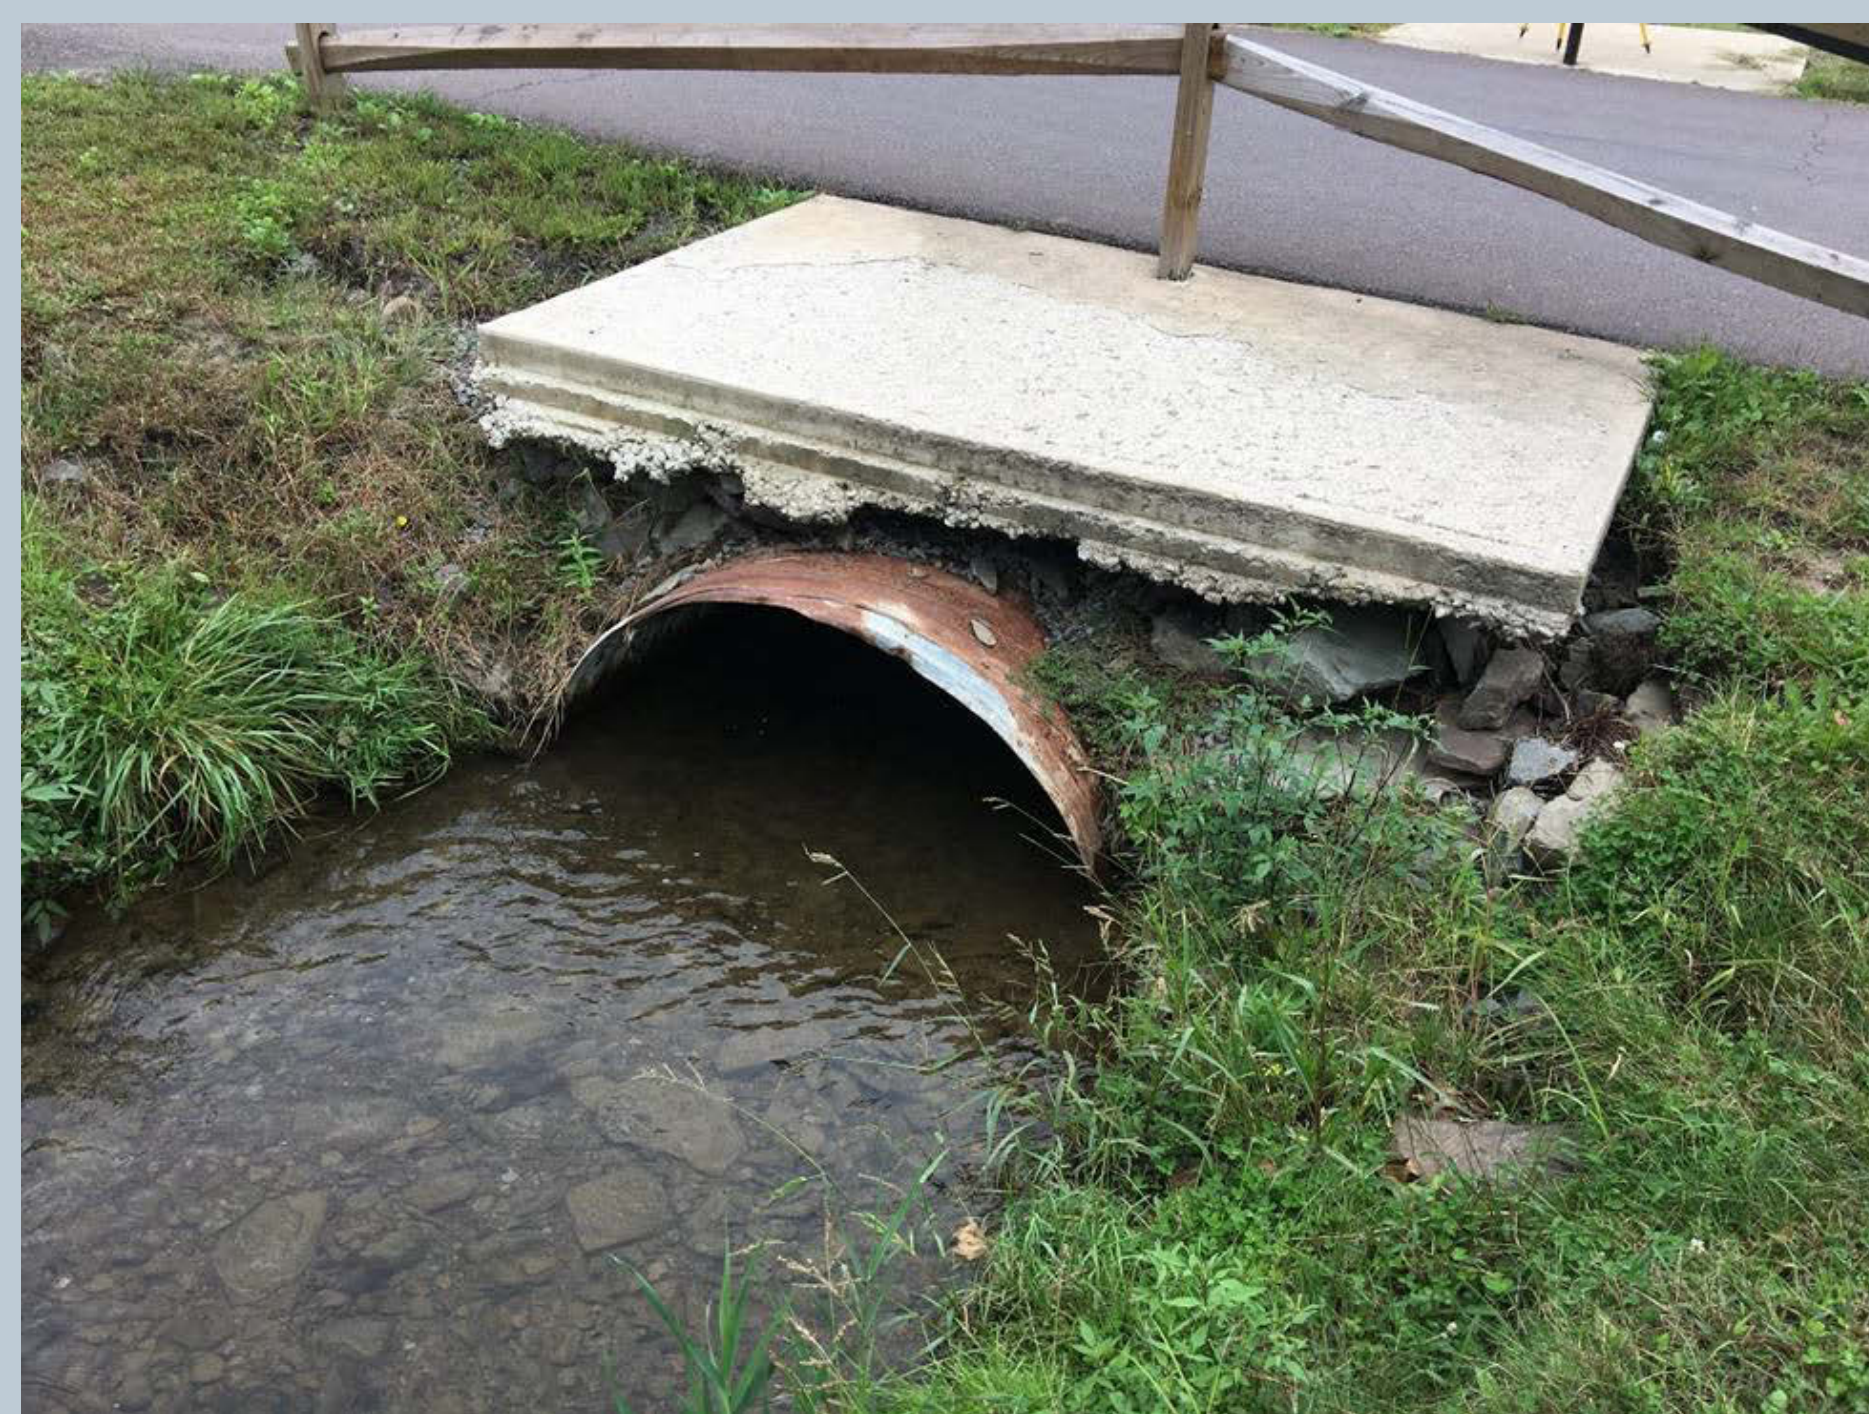
Figure 43. Looking upstream on corrugated squash pipe under Echo Valley Drive. This unnamed tributary is sediment-laden. (There is another unnamed tributary to the Green Pond unnamed tributary on the opposite side of Echo Valley Drive that was inaccessible).

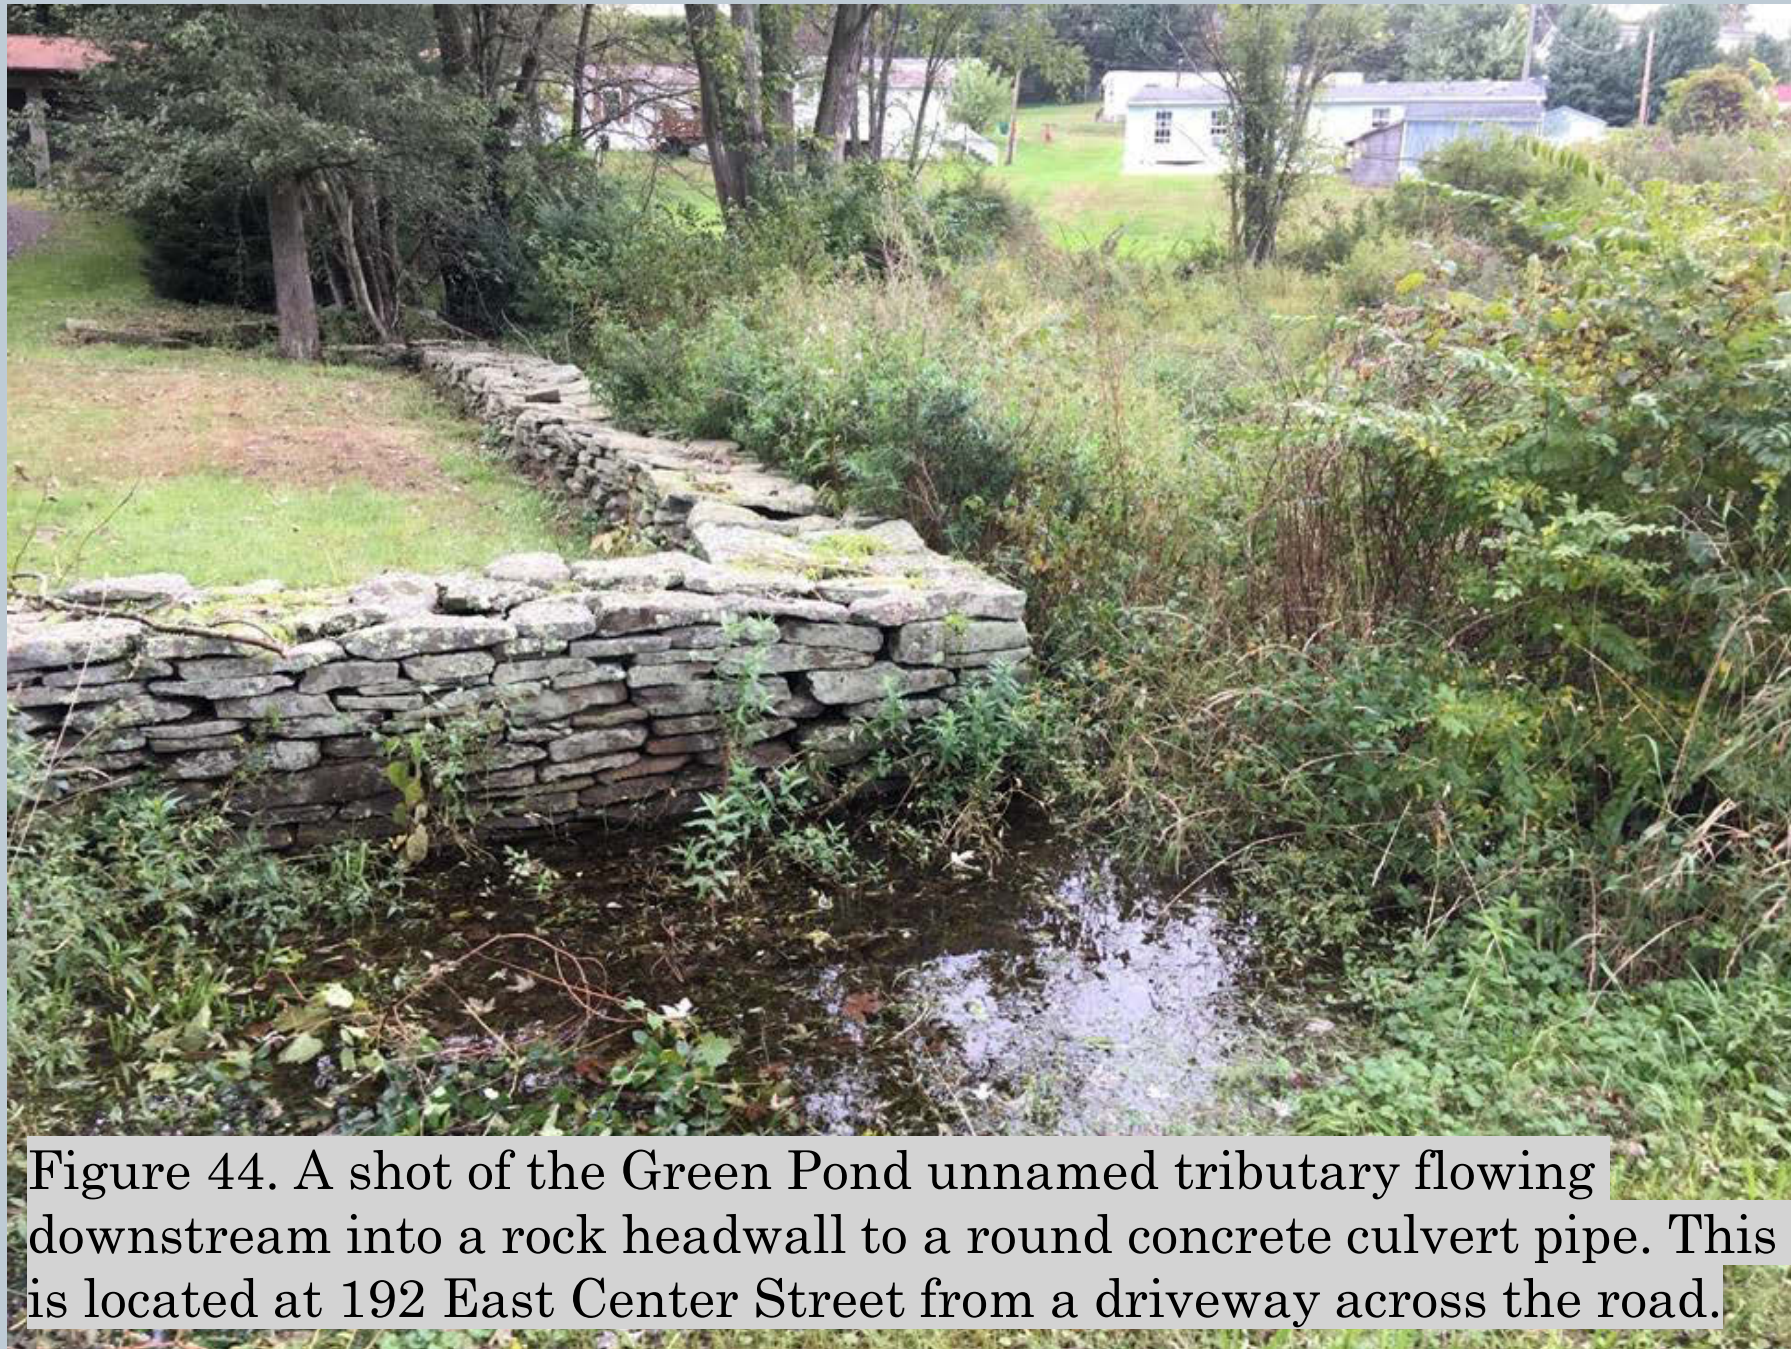
Figure 44. A shot of the Green Pond unnamed tributary flowing downstream into a rock headwall to a round concrete culvert pipe. This is located at 192 East Center Street from a driveway across the road.

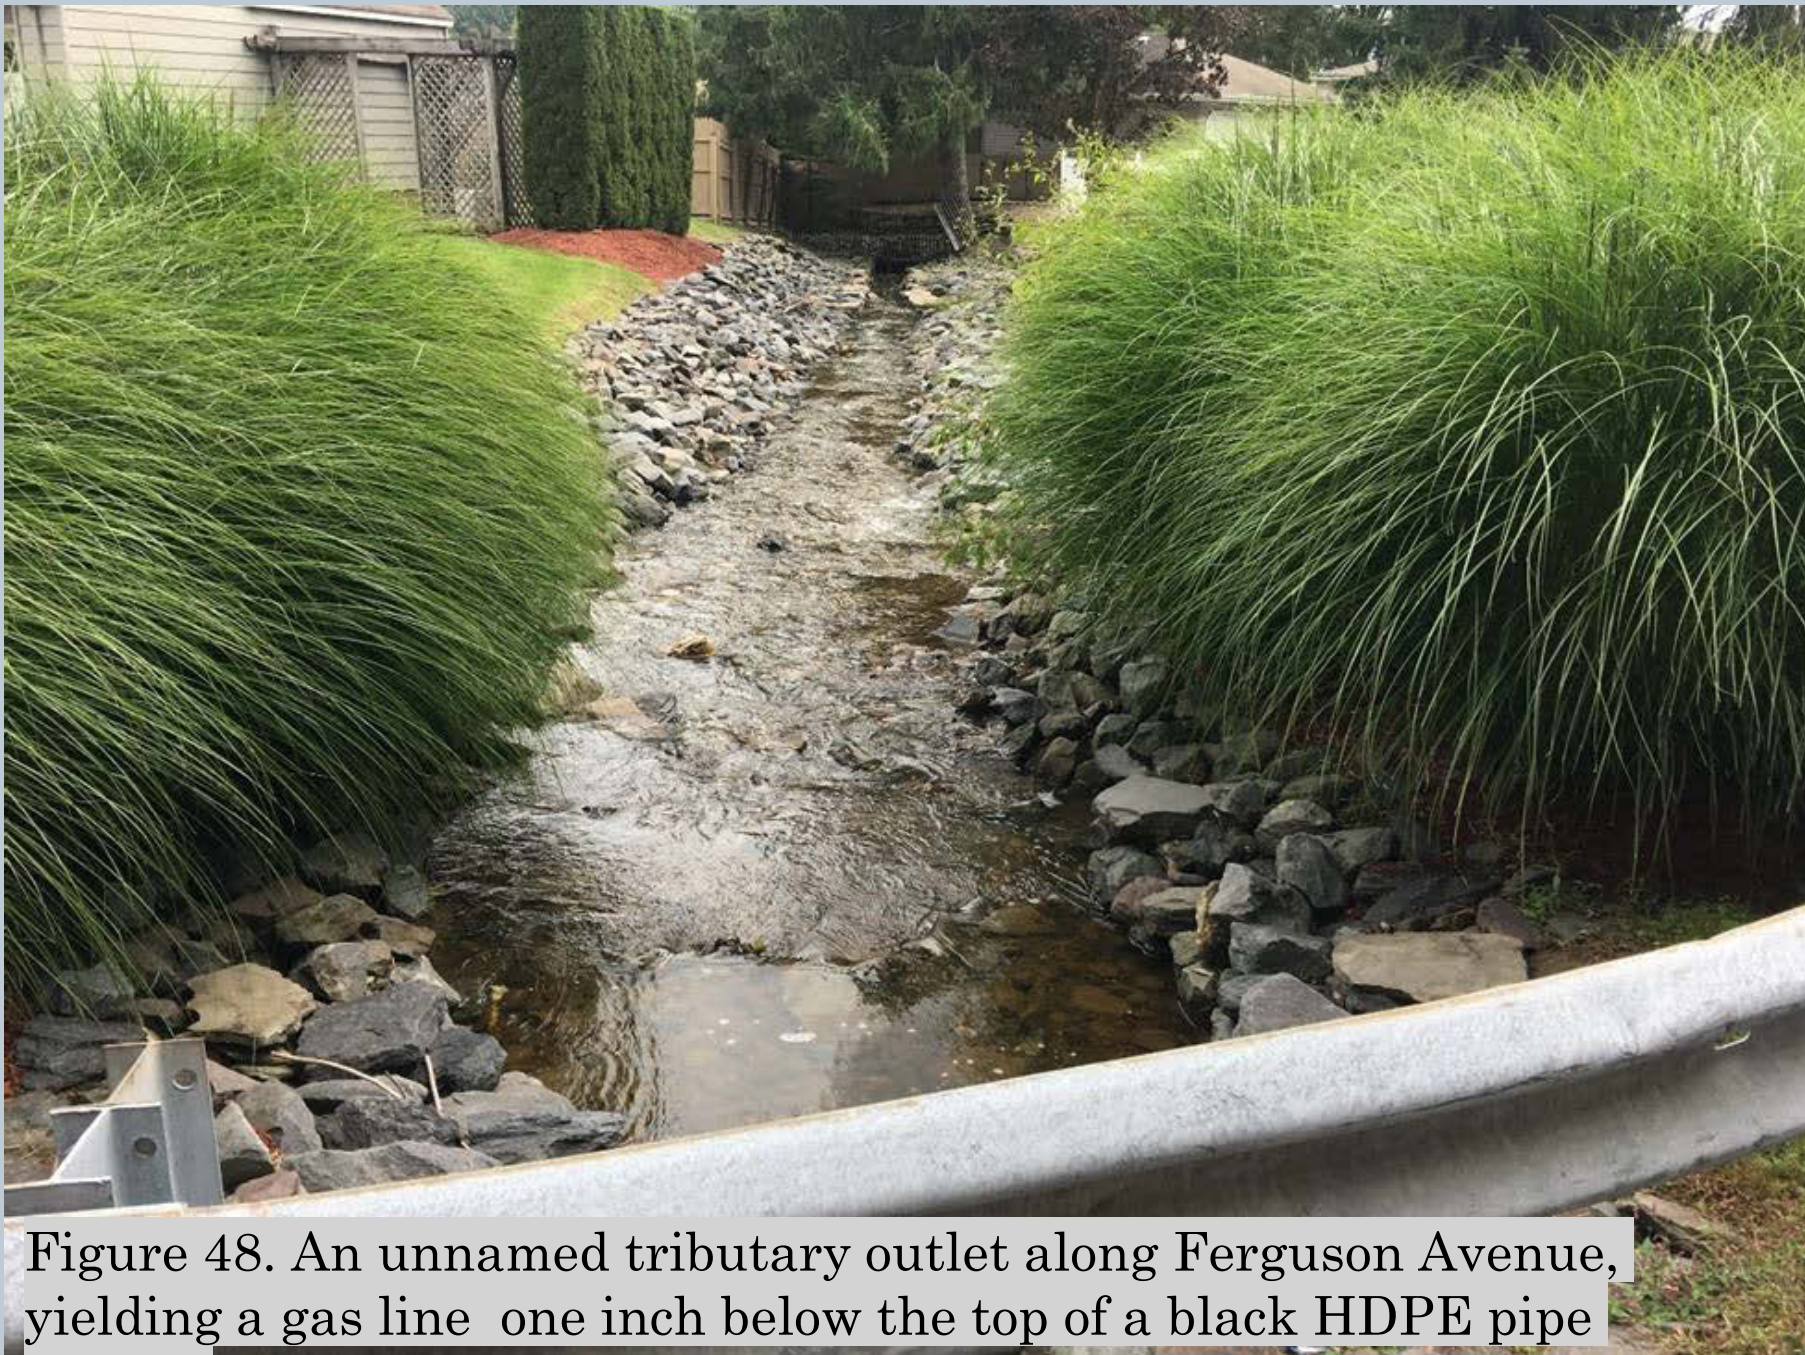
Figure 49. A headwall and concrete culvert pipe along the cul de sac on Ferguson Avenue. This is a shot of a 12-foot section of the unnamed tributary to Toby Creek.
