Toby Creek Field Reconnaissance Observations

September 26, 2018

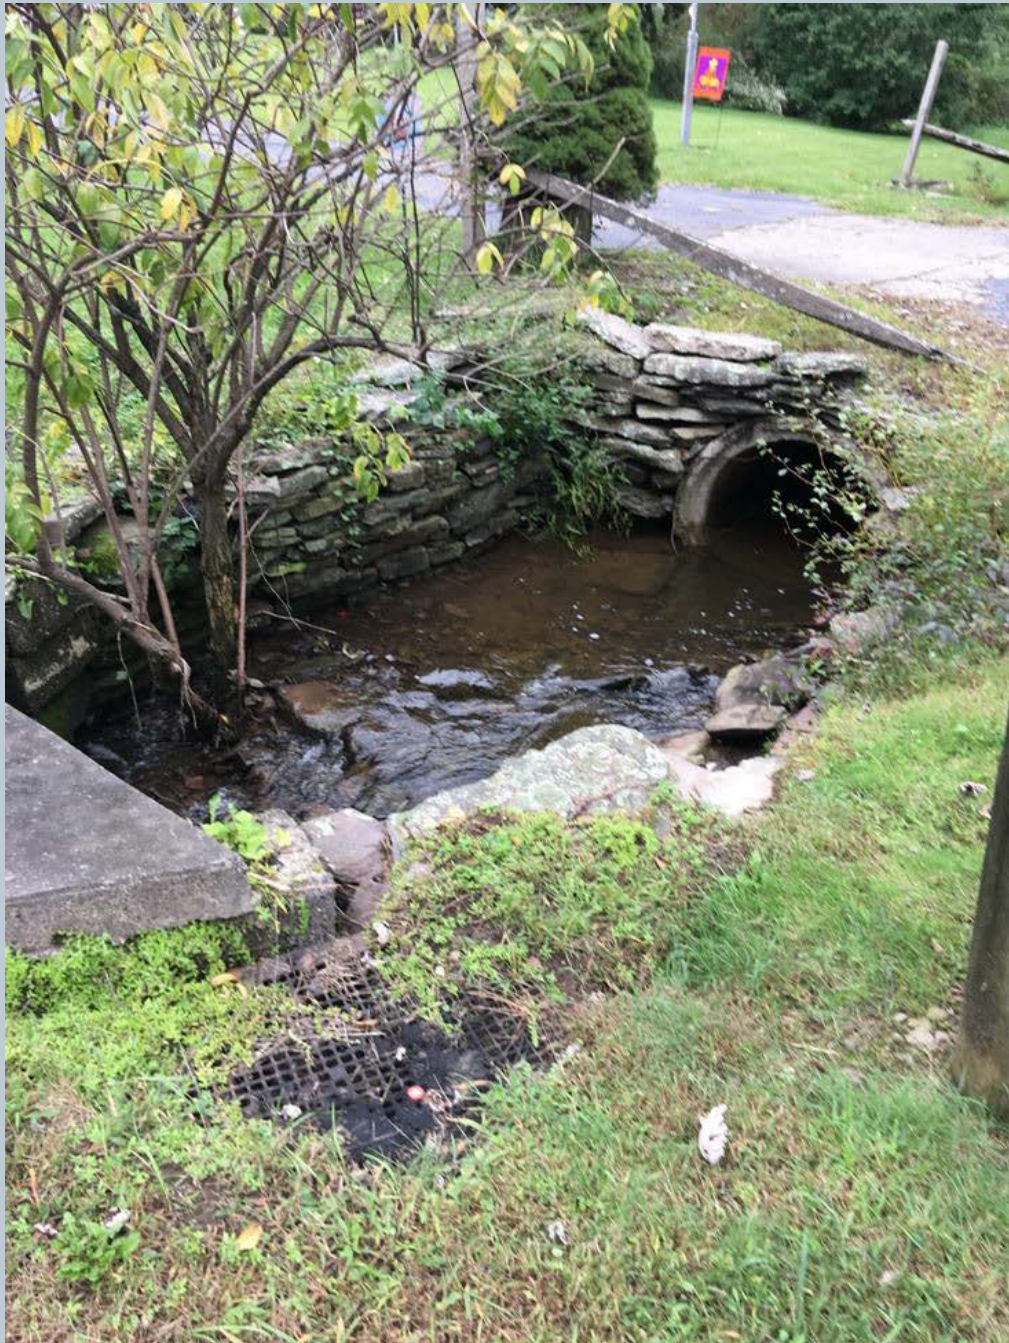
Figure 48. An unnamed tributary outlet along Ferguson Avenue, yielding a gas line one inch below the top of a black HDPE pipe culvert.

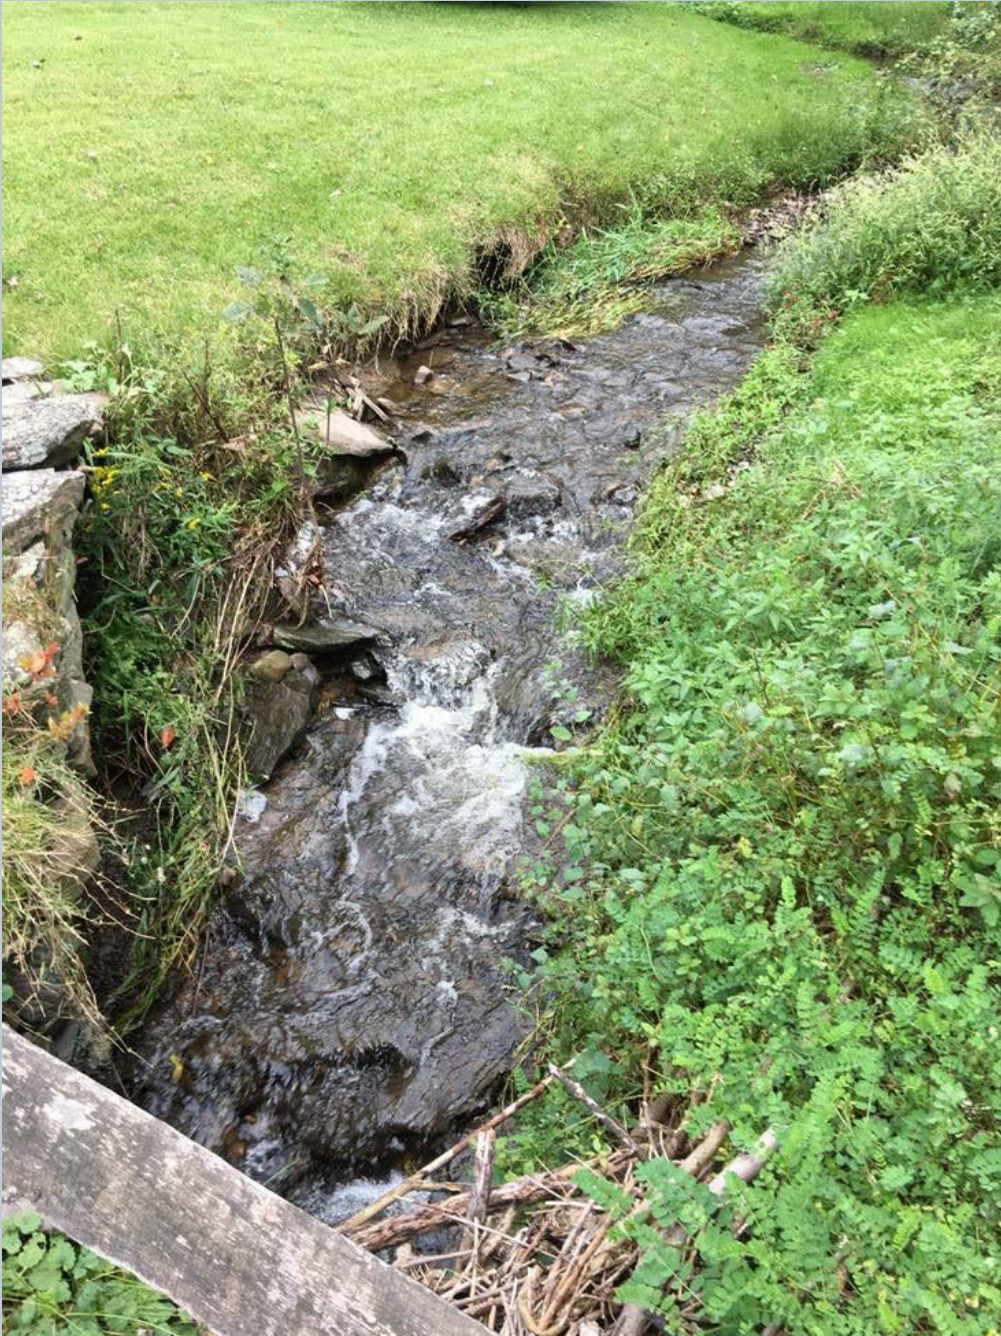
Figure 50. A photo looking upstream on the unnamed tributary to Toby Creek off Ferguson Avenue. Minor streambank erosion and undercutting are present.

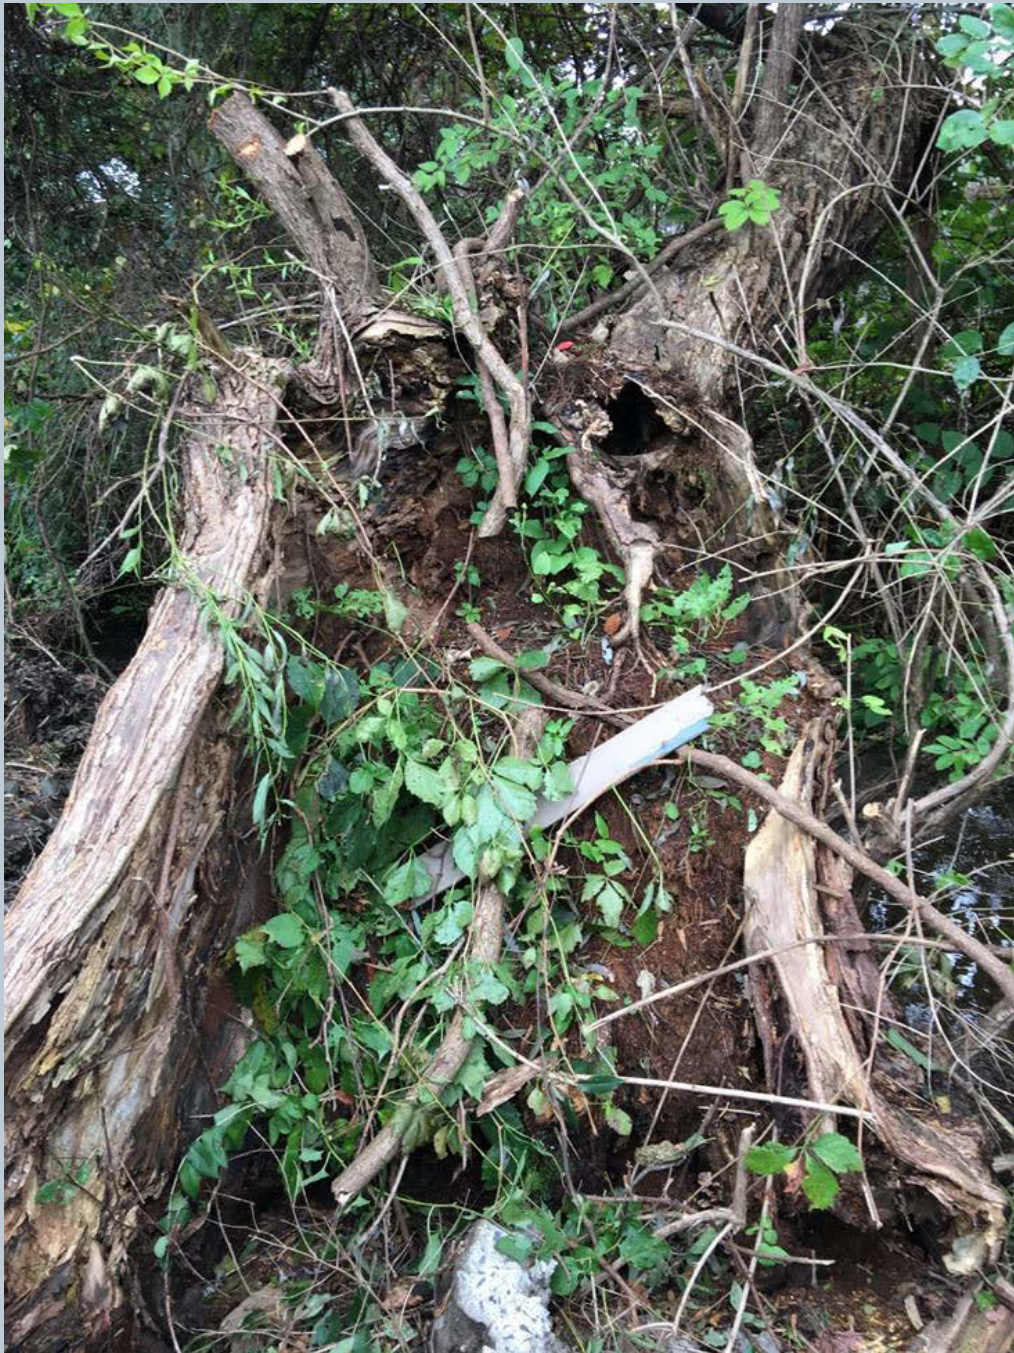
Figure 52. This shot shows woody debris blockage due to a large willow tree that has fallen. The tree needs to be cut and removed.

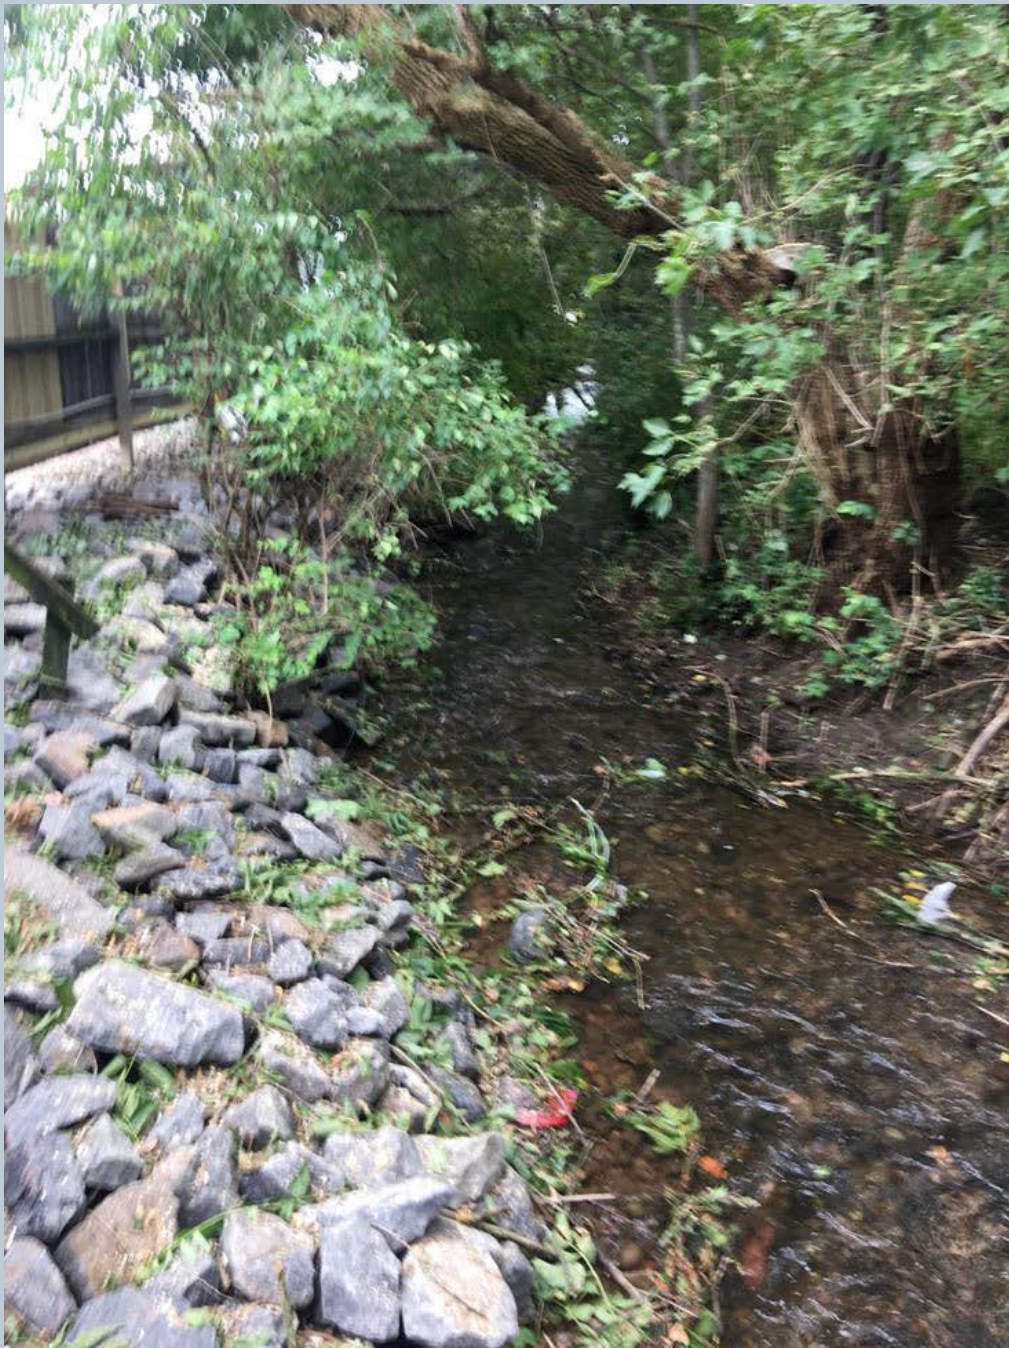
Figure 53. Gravel deposition on the unnamed tributary to Toby Creek.

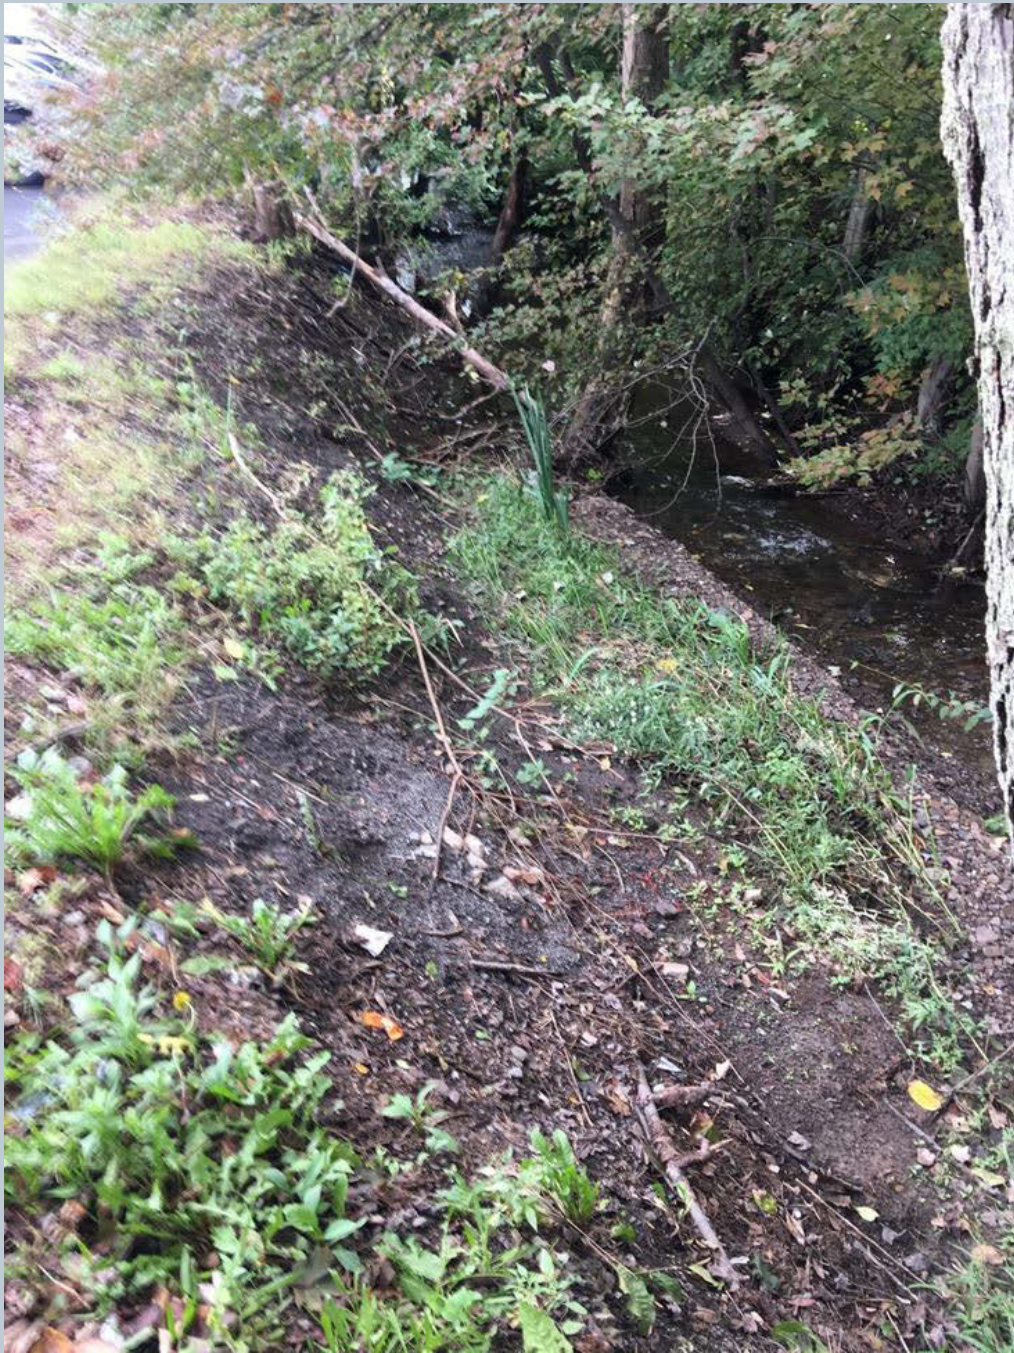
Figure 54. Gravel bars on the unnamed tributary to Toby Creek. Streambank stabilization is recommended in this area. The fallen willow tree could be used as a log deflector to help with keeping the unnamed tributary in its banks.

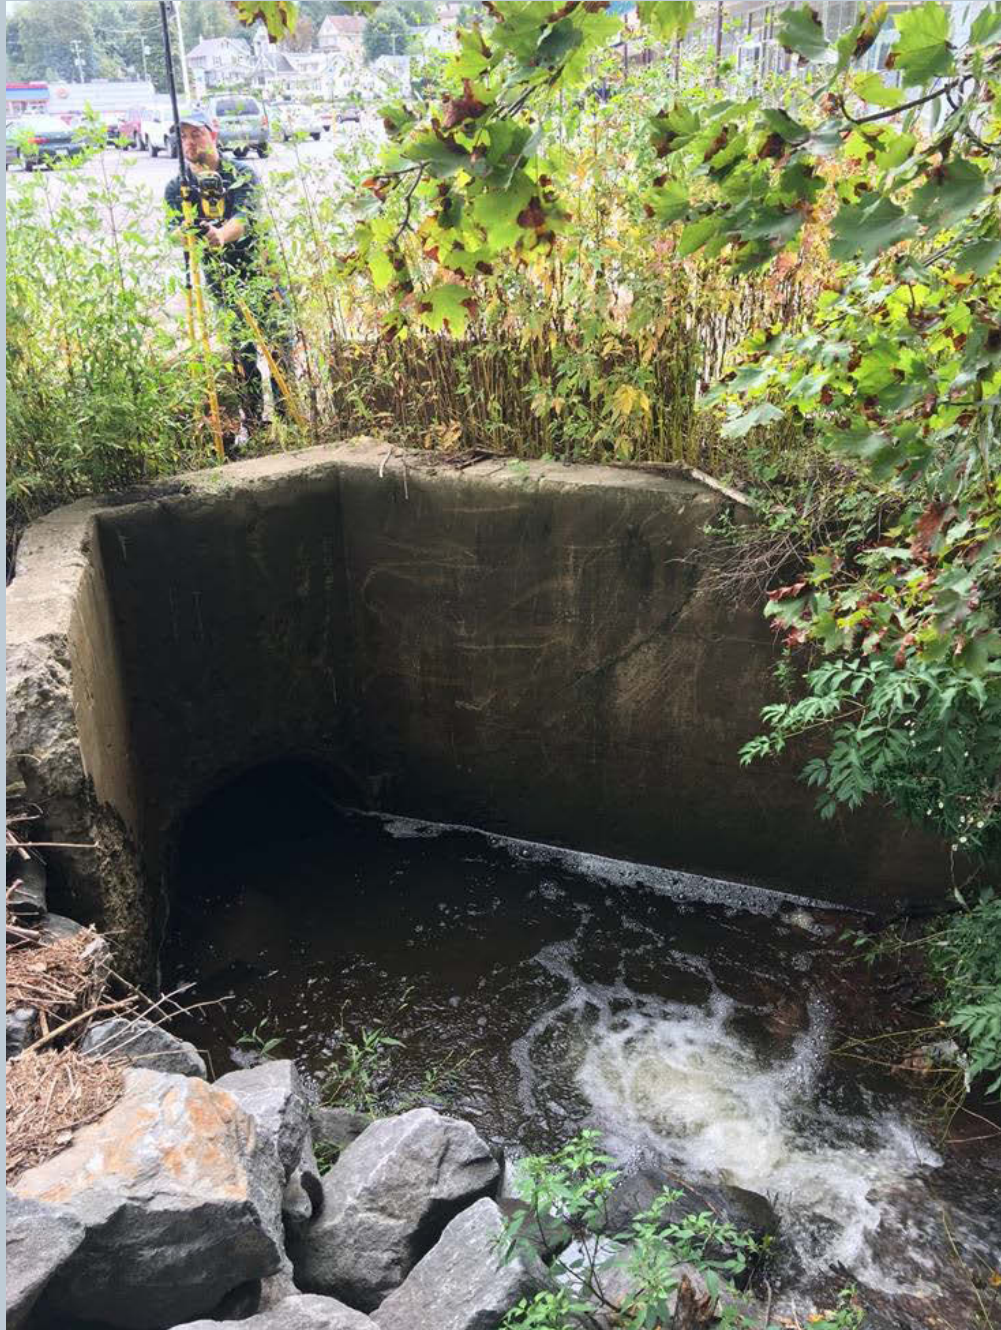
Figure 55. A wingwall box culvert. This shot shows a small plunge pool looking downstream towards the Dollar General parking lot. The culvert flows under the Dollar General Parking lot.

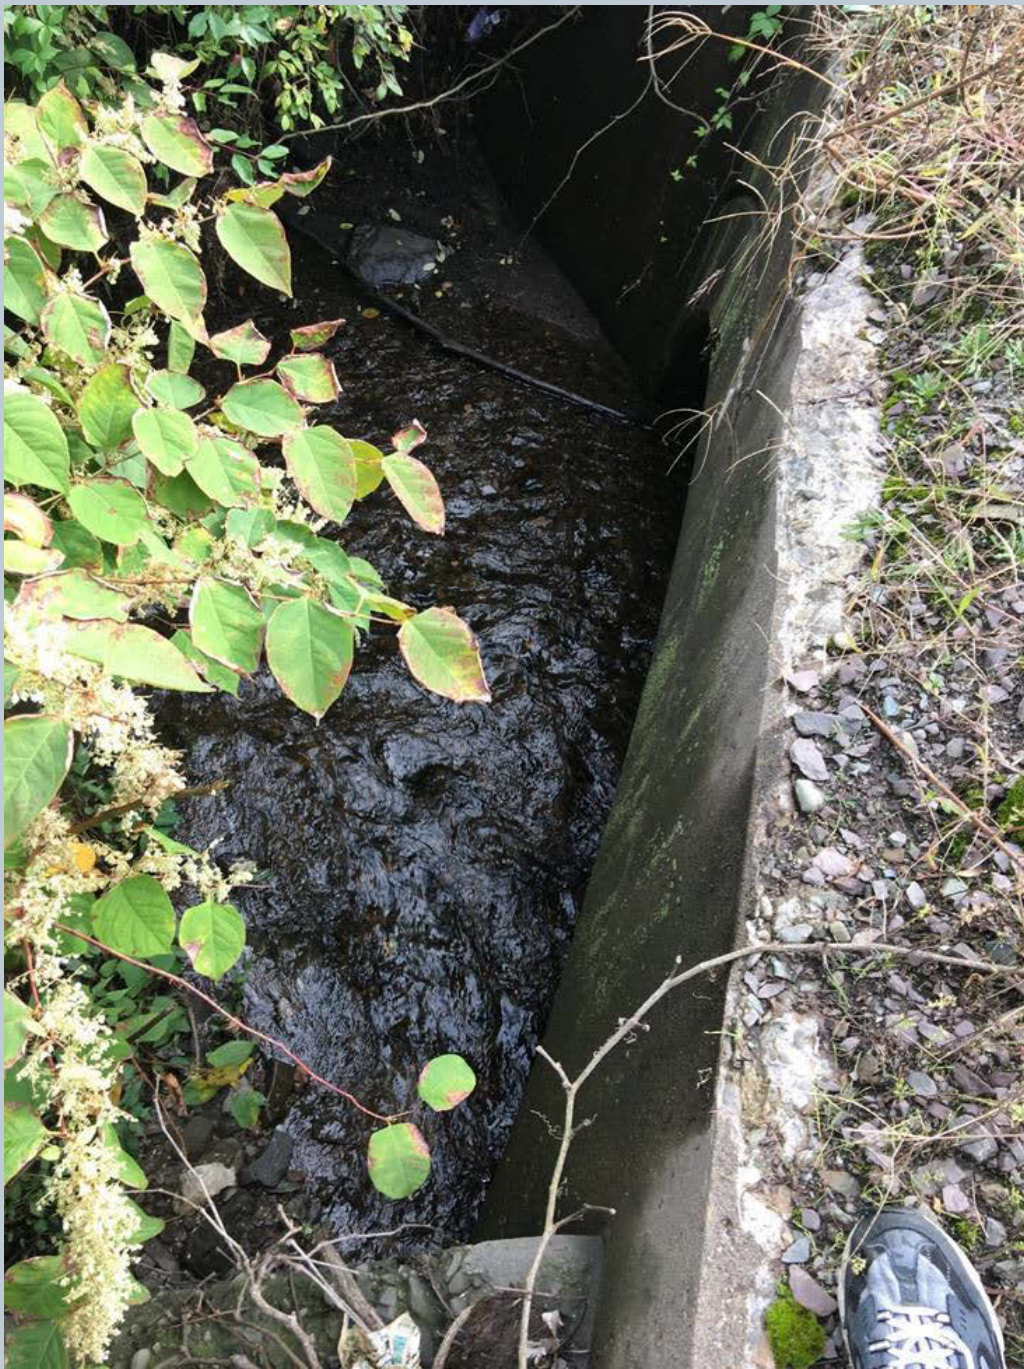
Figure 56. An unnamed tributary to Toby Creek behind Amelia's Diner. The unnamed tributary flows out of a much wider box culvert before reaching Toby Creek. This location is sediment-laden and has a presence of Japanese knotweed.

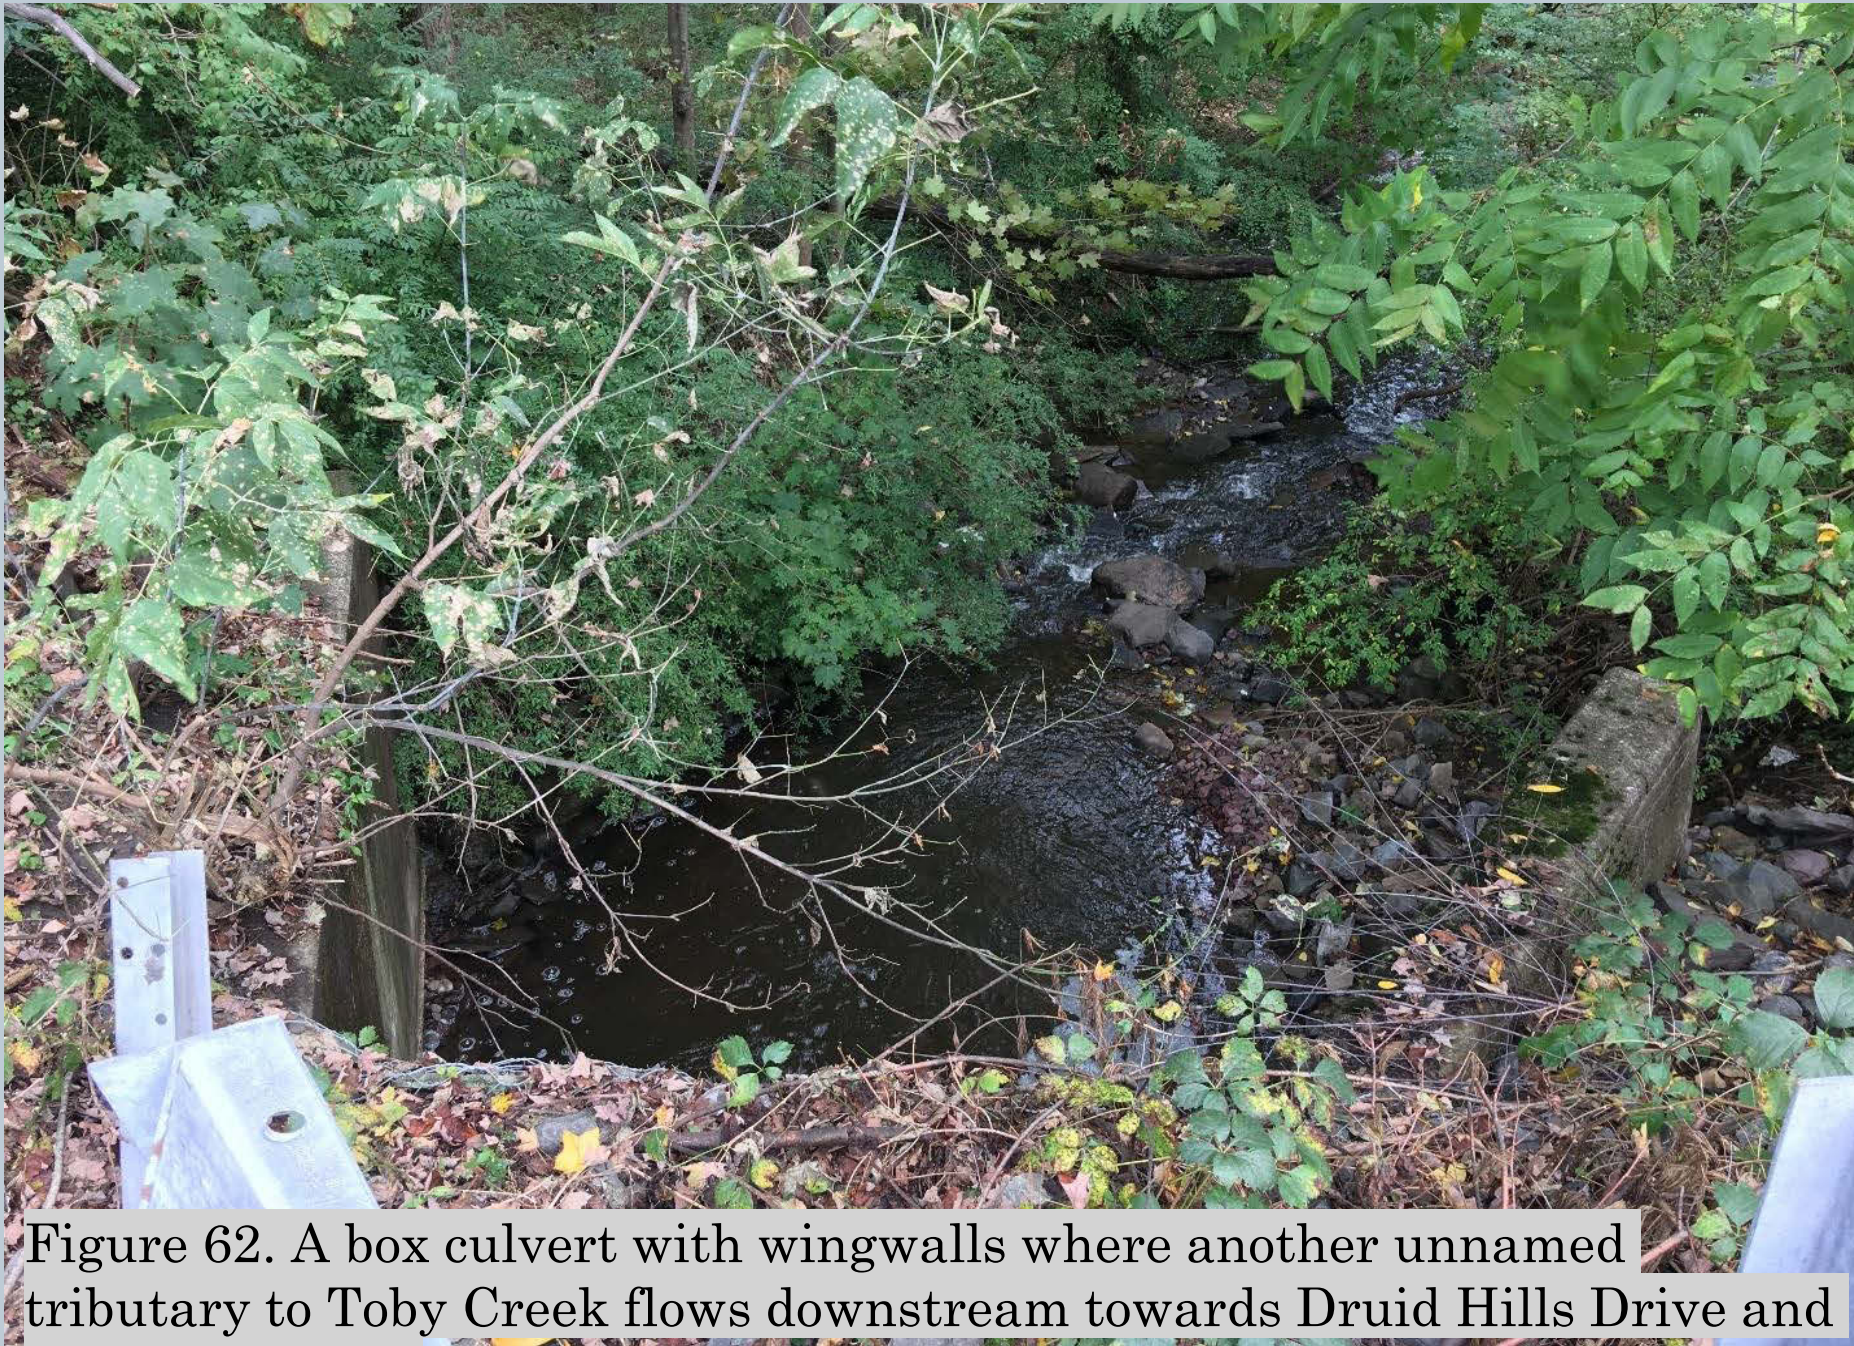
Figure 62. A box culvert with wingwalls where another unnamed tributary to Toby Creek flows downstream towards Druid Hills Drive and Ferguson Drive.

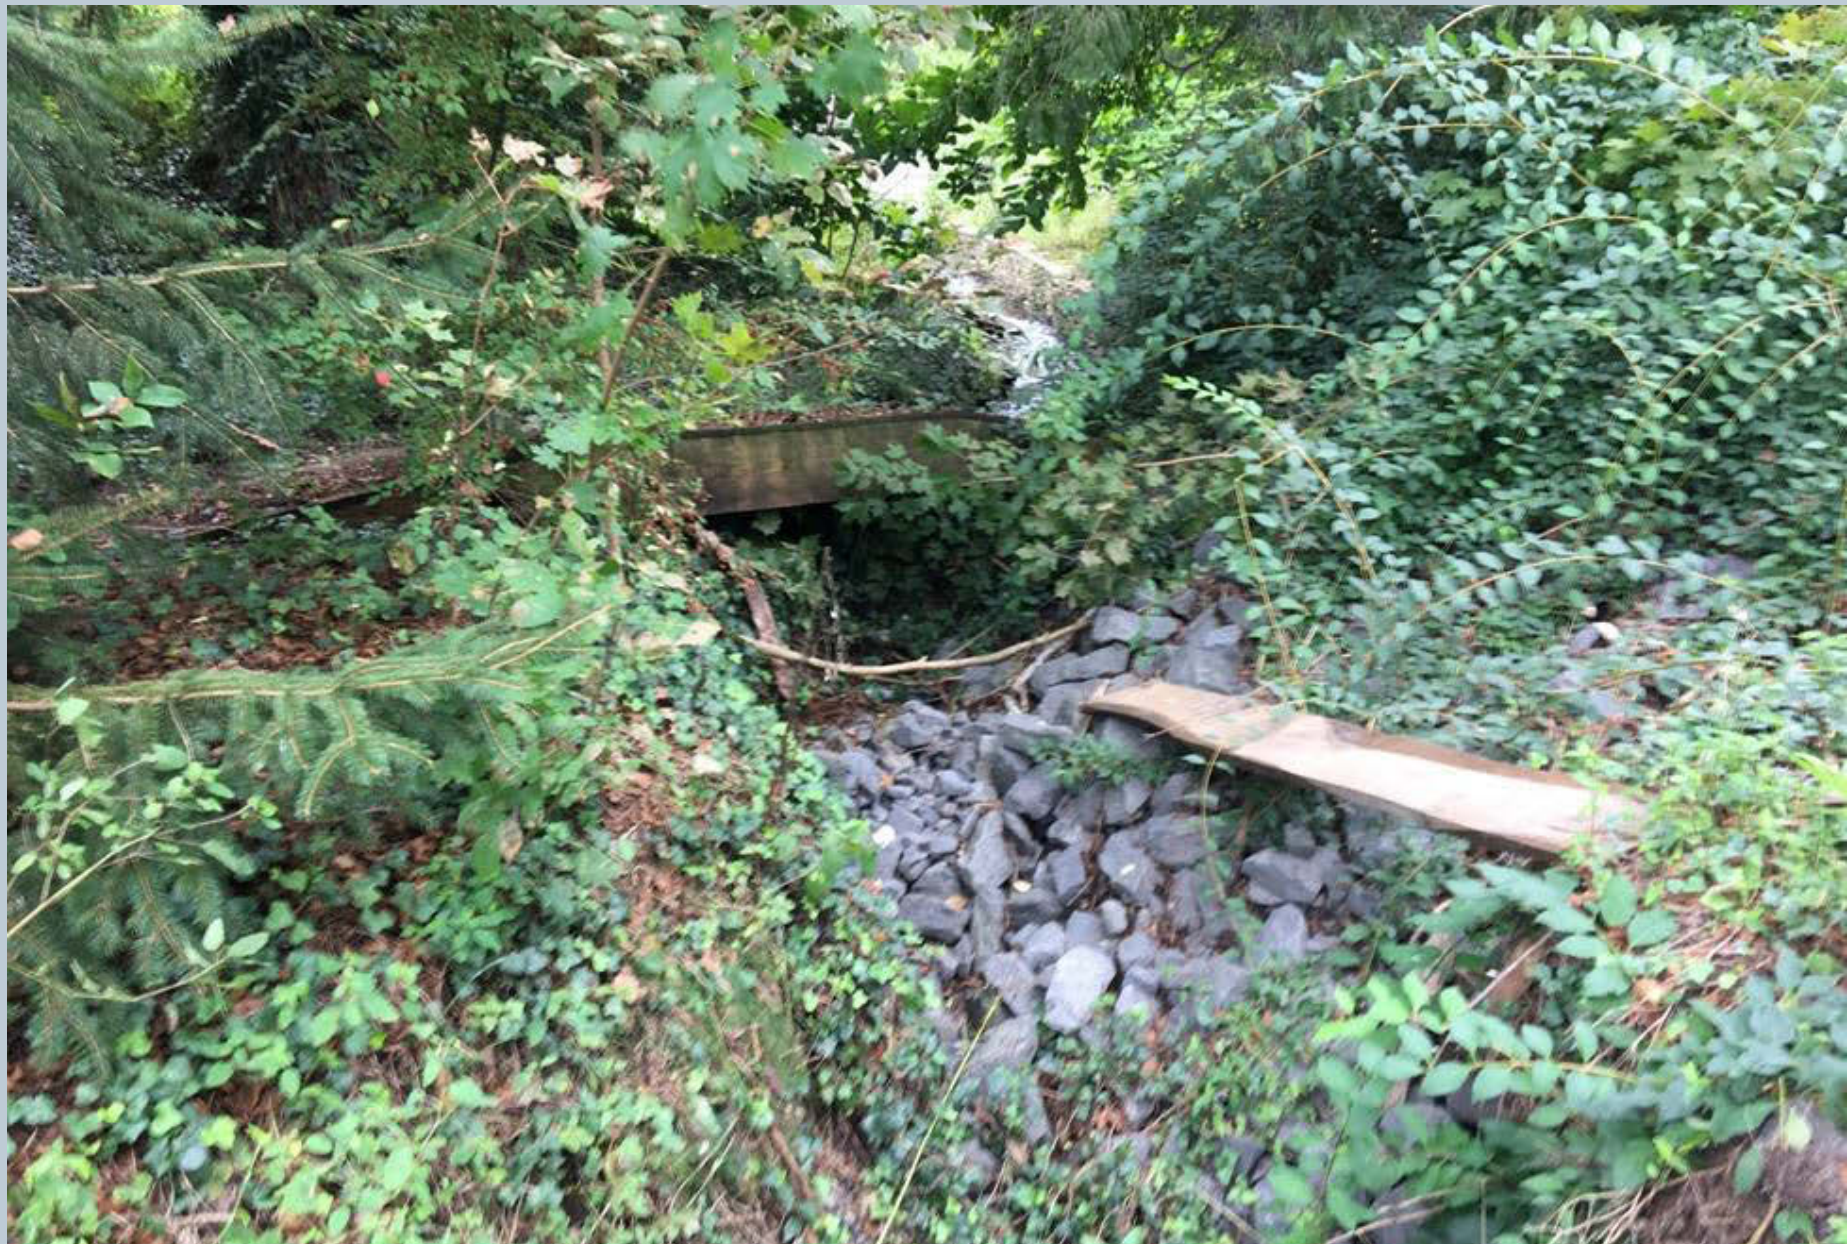
Figure 63. A collapsed area on the upstream end of another unnamed tributary to Toby Creek off Pioneer Avenue and Overbrook Road.

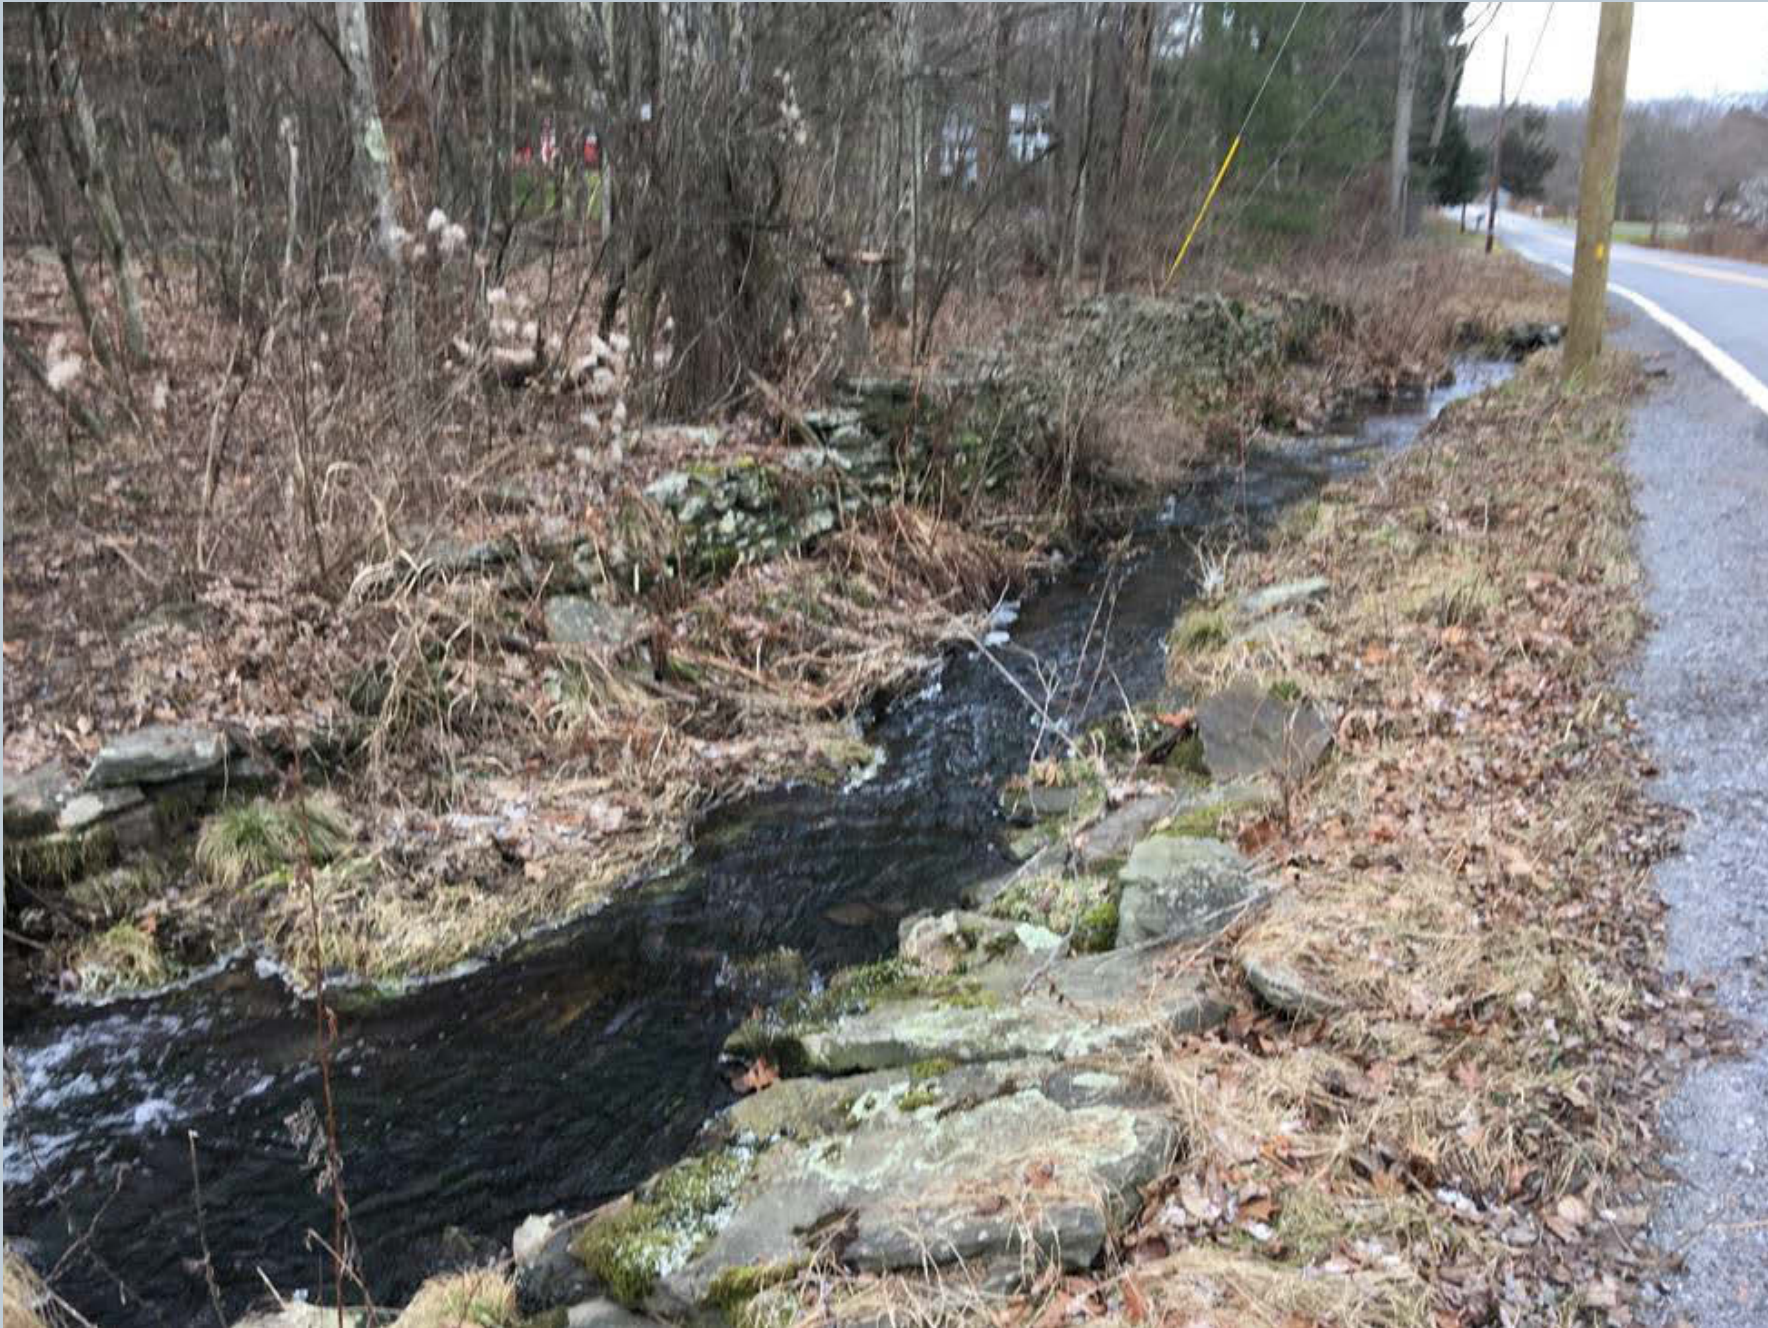
Figure 64. A shot of Trout Brook flowing through a heavily wooded area on private property located to the east of Wyoming Road, alongside of Lower Demunds Road, and through a 24-inch black HDPE pipe crossing over Lower Demunds Road into a large forested wetland area.

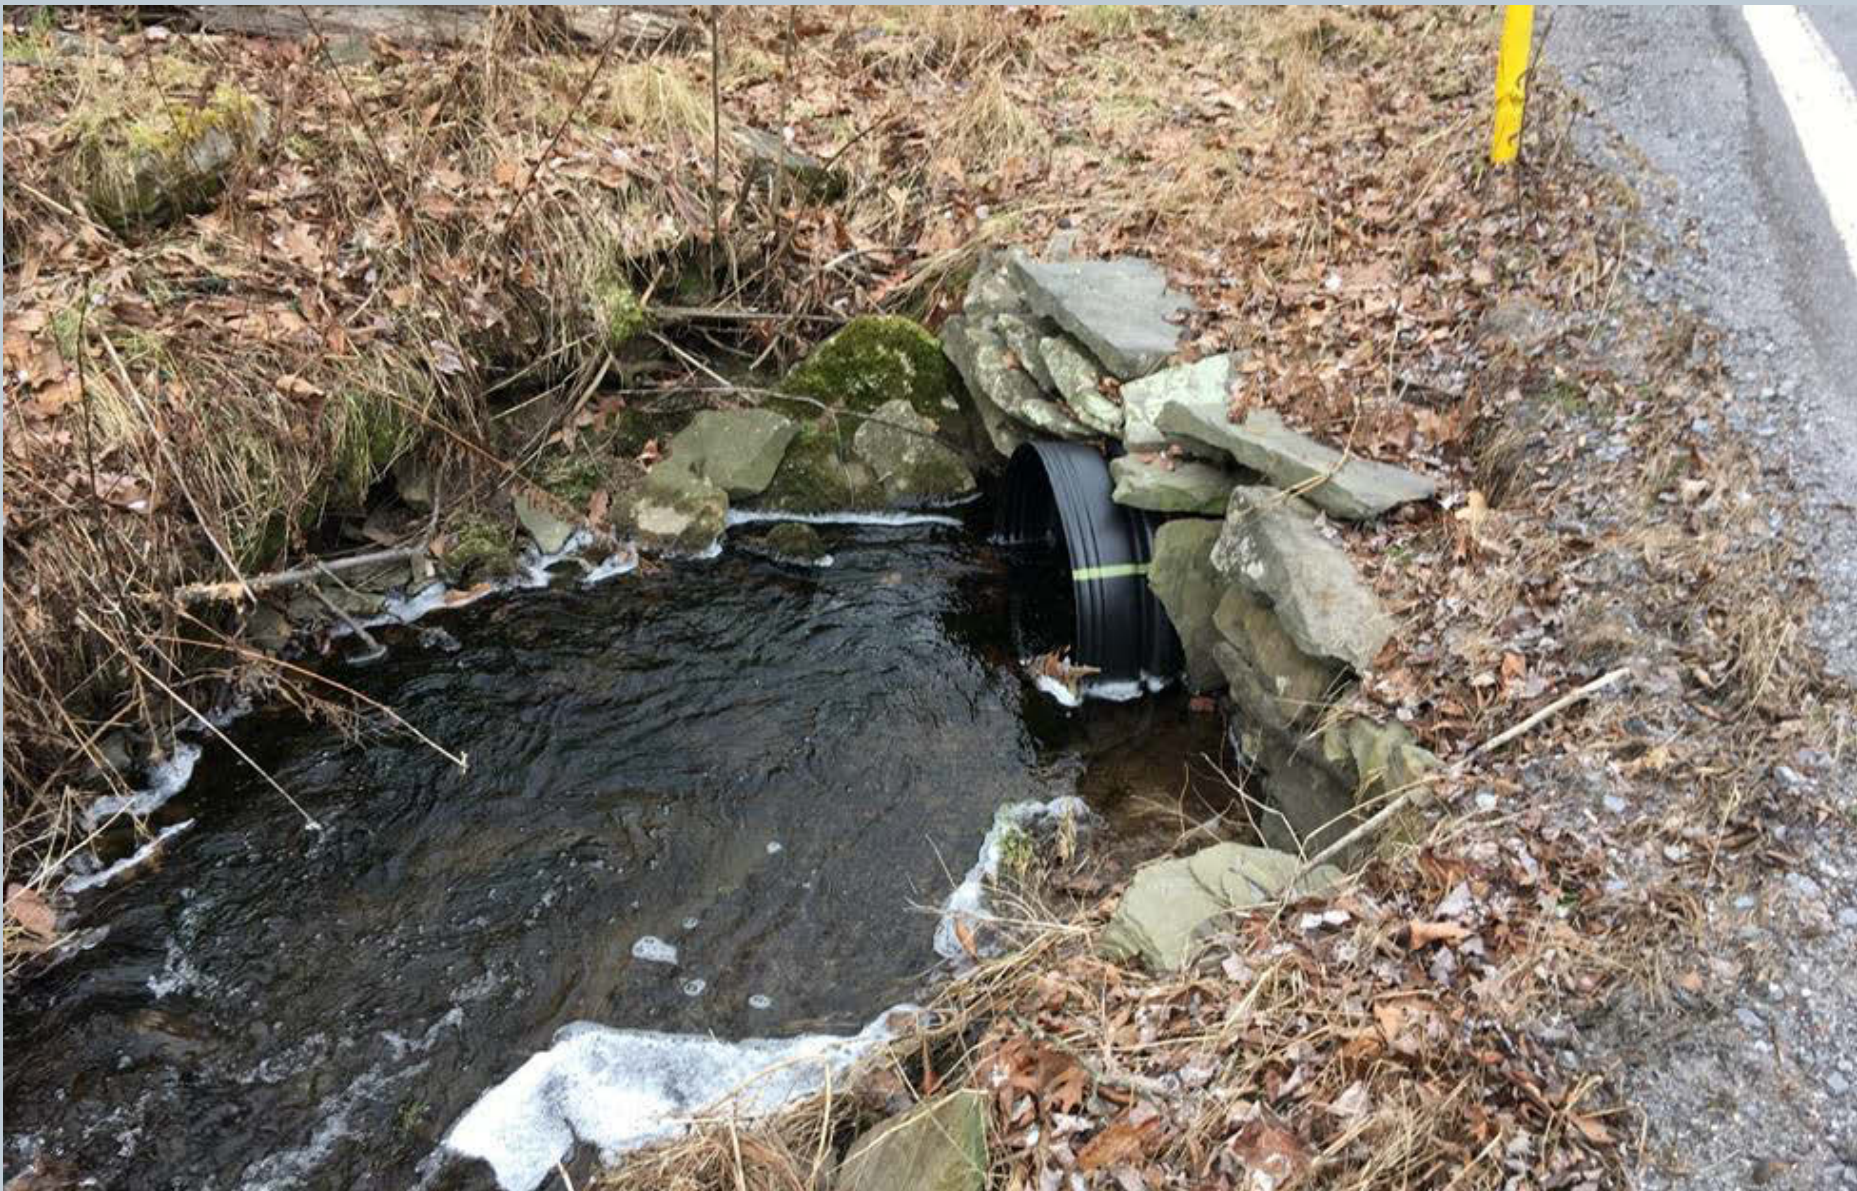
Figure 65. A shot of Trout Brook flowing through the black HDPE pipe culvert into a large forested wetland area that is located on private property. The culvert is not aligned beneath Lower Demunds Road.

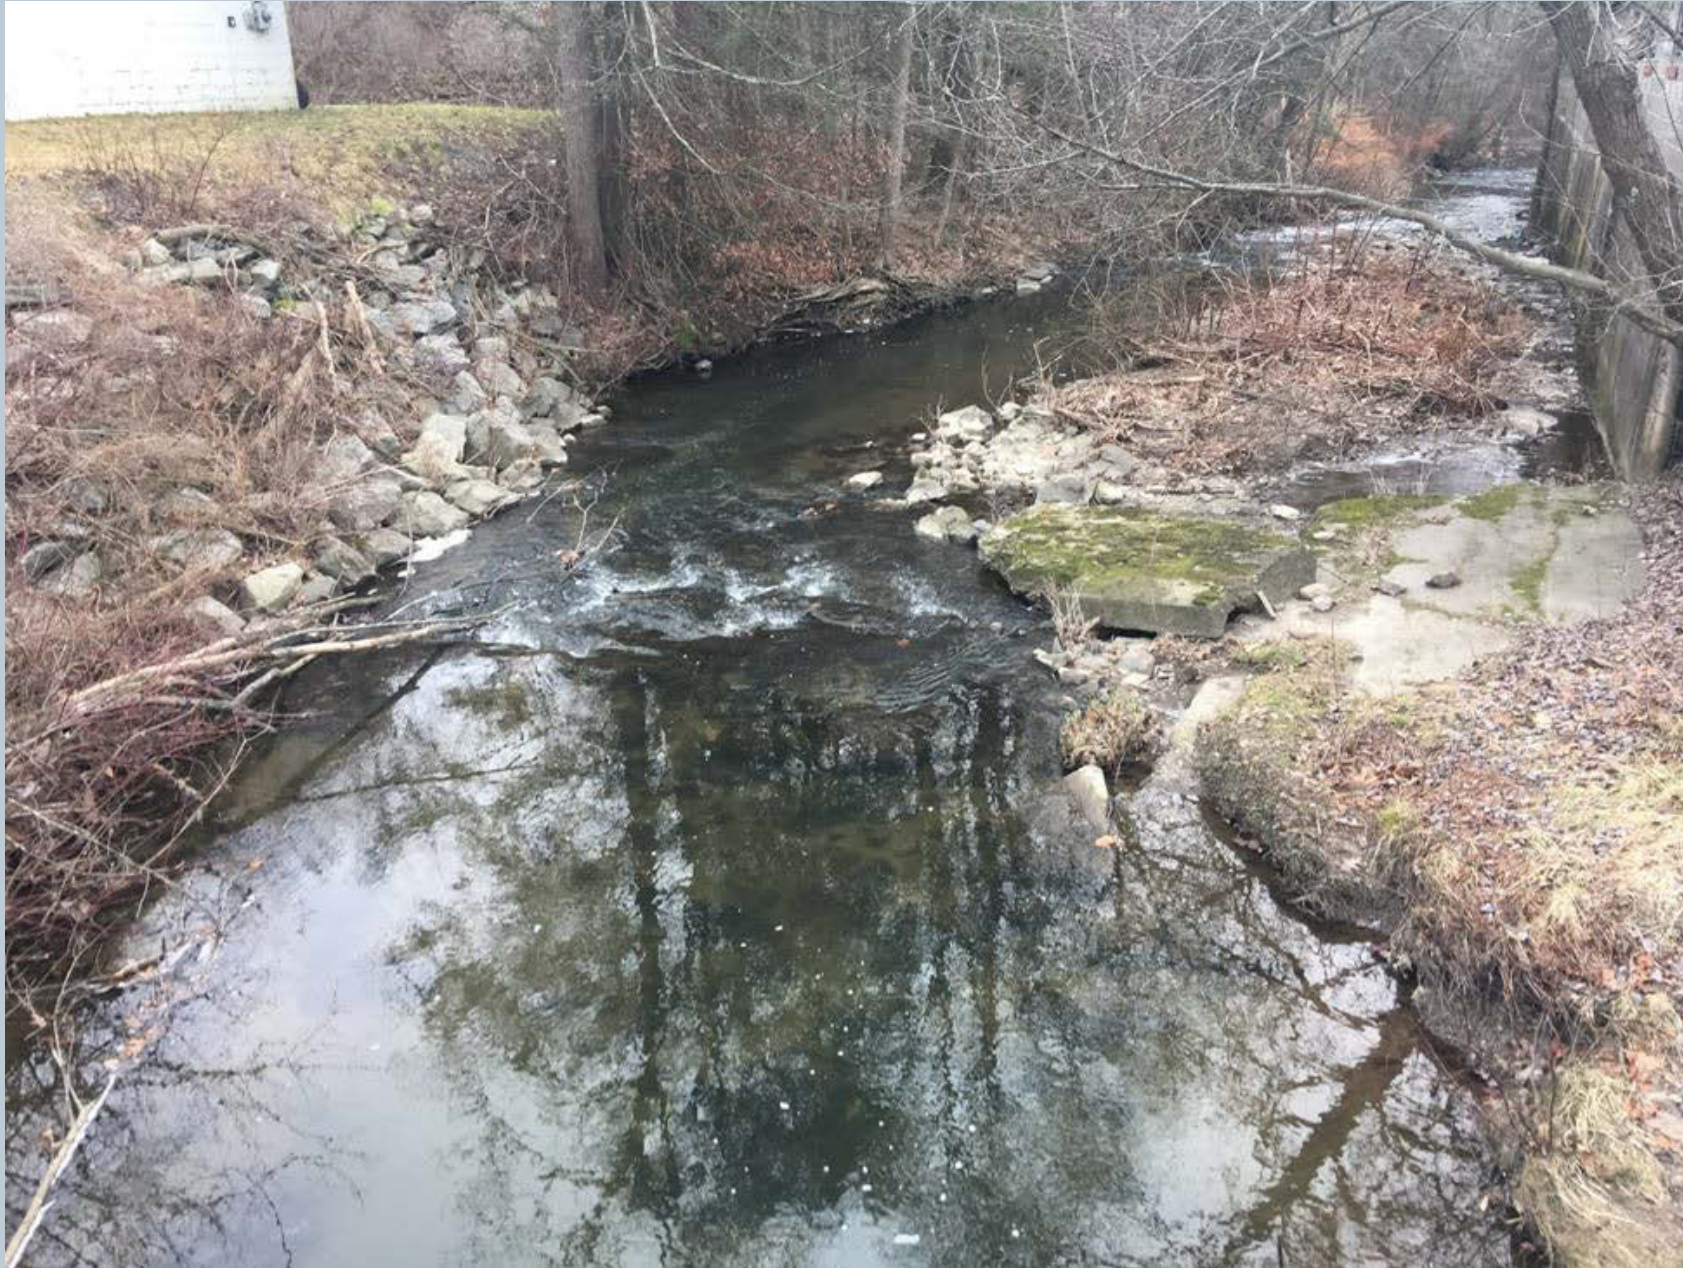
Figure 75. Looking downstream on Toby Creek from behind the Pen Fern Oil Gas Station from the bridge over Lower Demunds Road. A large historic rock stabilization placement is seen along the left bank while looking downstream, and there is bed rock present looking to the right of the stream. This bed rock is found adjacent to the Pen Fern Oil Gas Station's foundation that runs up against the right bank of Trout Brook.
