Toby Creek Field Reconnaissance Observations

September 26, 2018

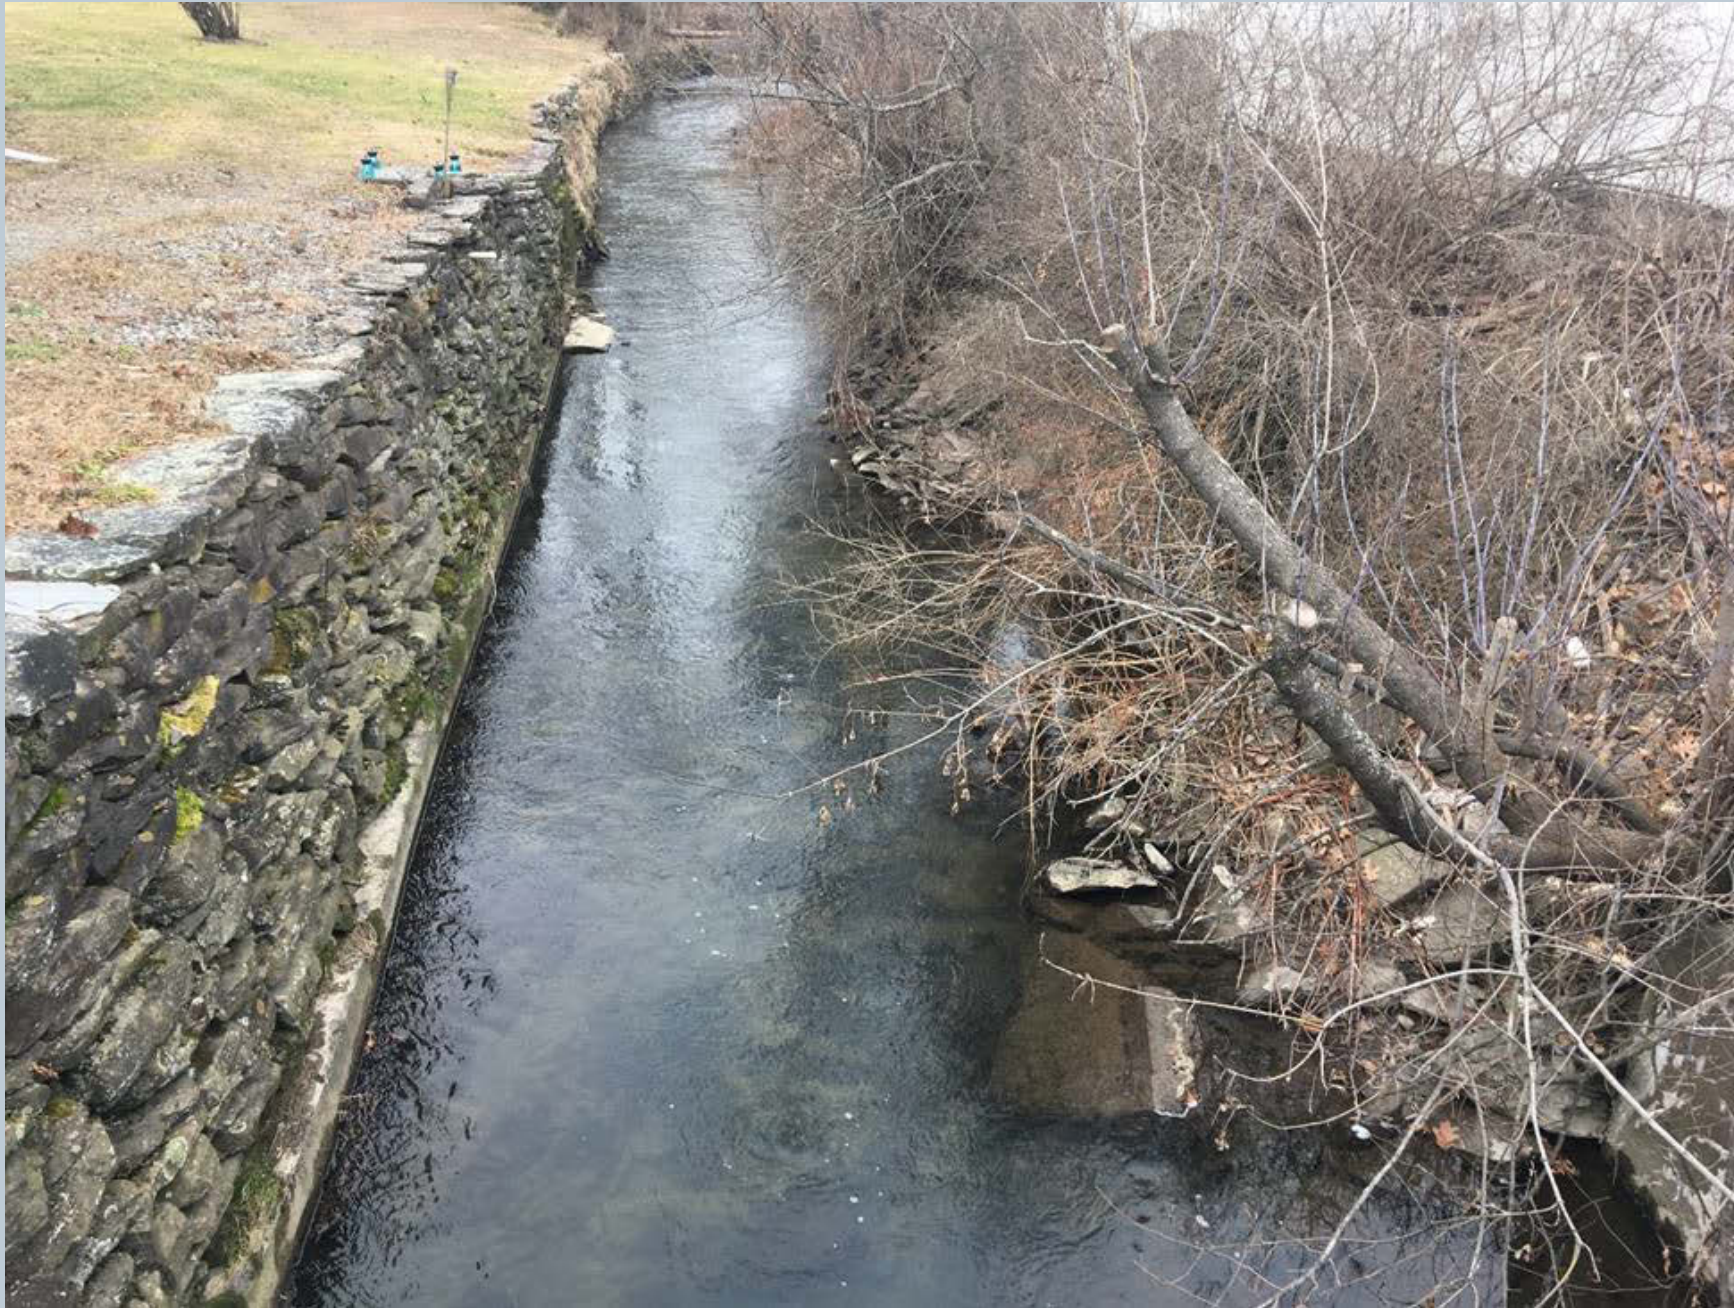
Figure 76. This location is looking upstream on Toby Creek, before it flows along N. Main Street and back into Dallas Borough, from the bridge over Lower Demunds Road. A large manmade stone-stacked retaining wall has been historically constructed along the left streambank looking upstream. The retaining wall has created a very straight morphology for the creek for several hundred feet.

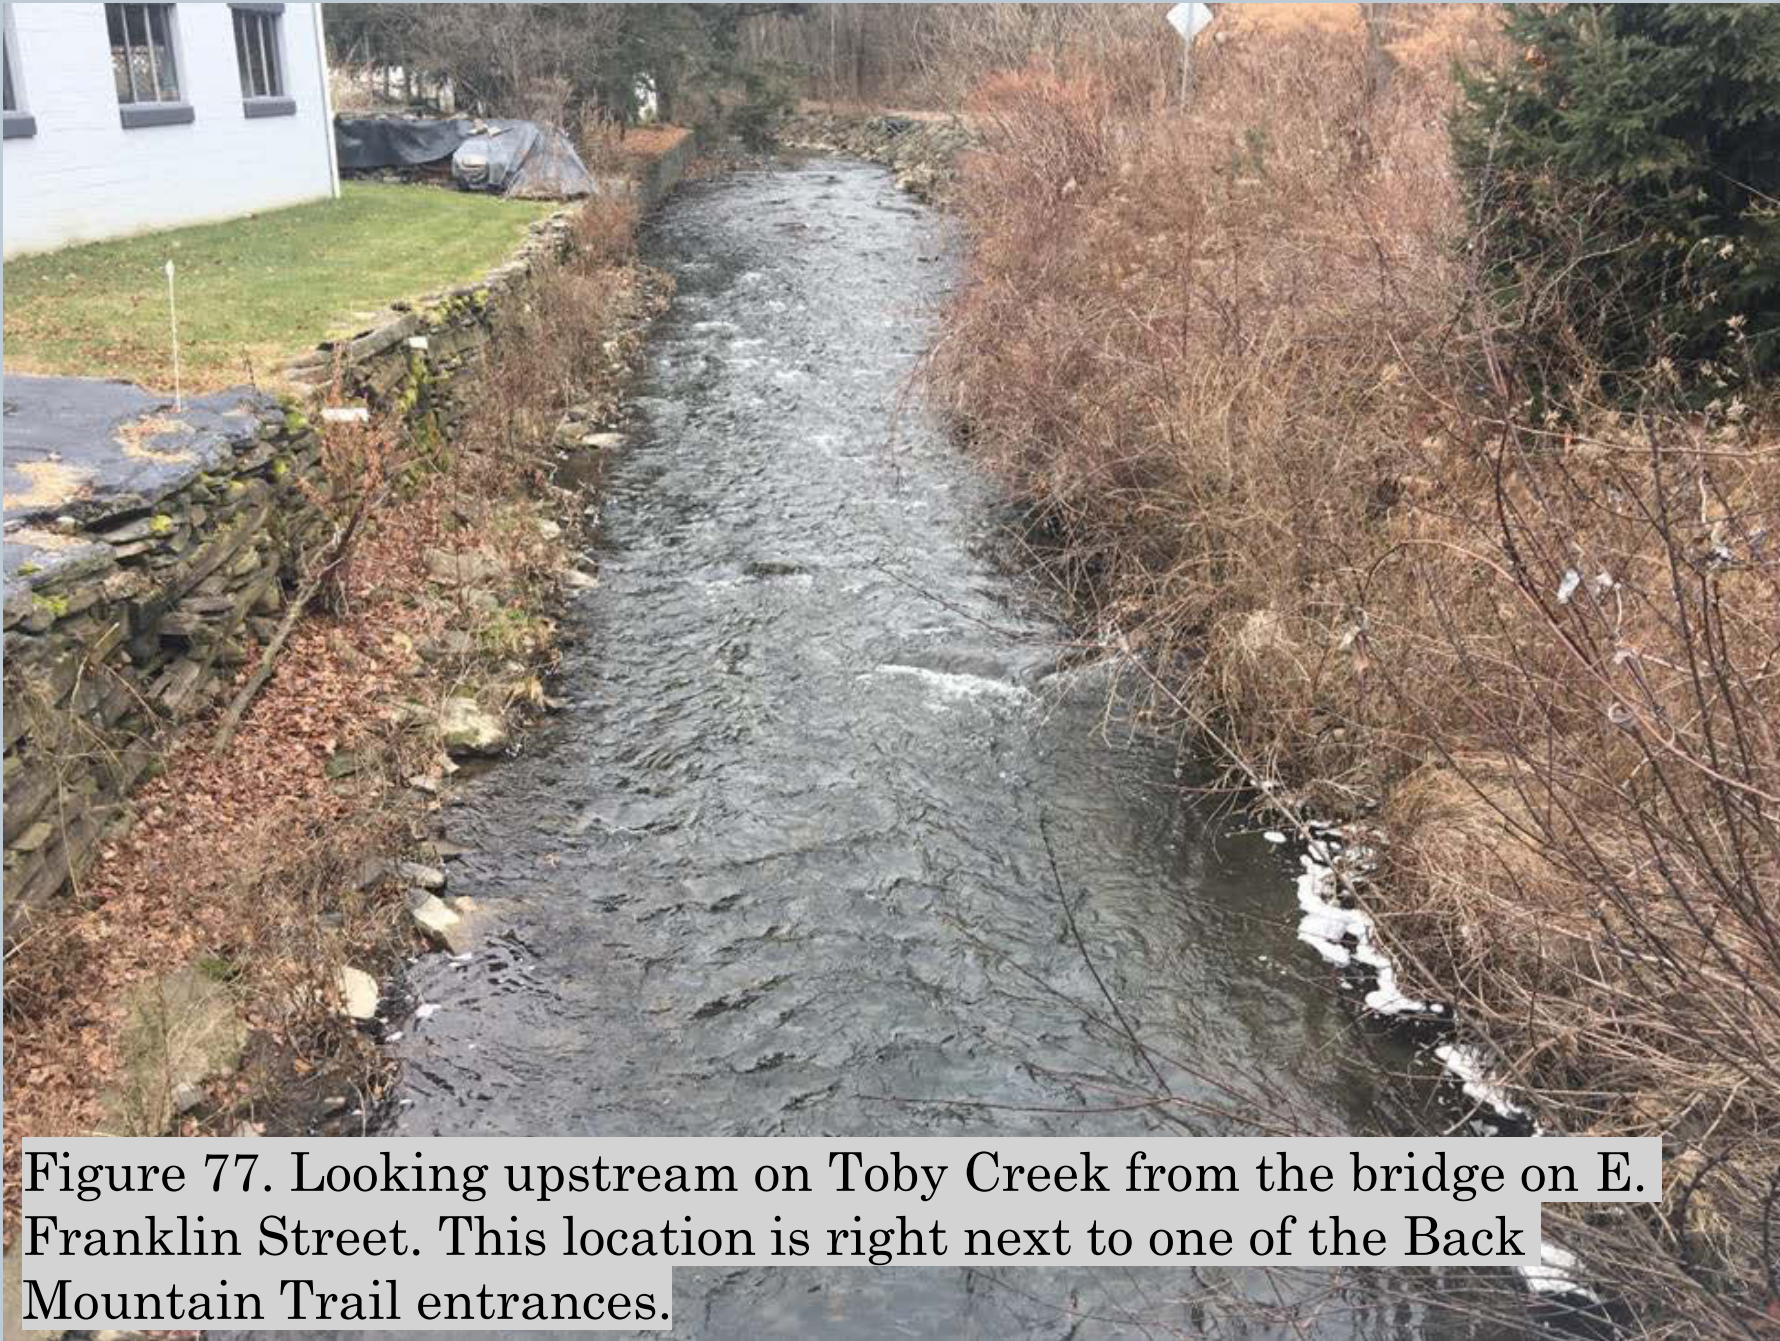
Figure 77. Looking upstream on Toby Creek from the bridge on E. Franklin Street. This location is right next to one of the Back Mountain Trail entrances.

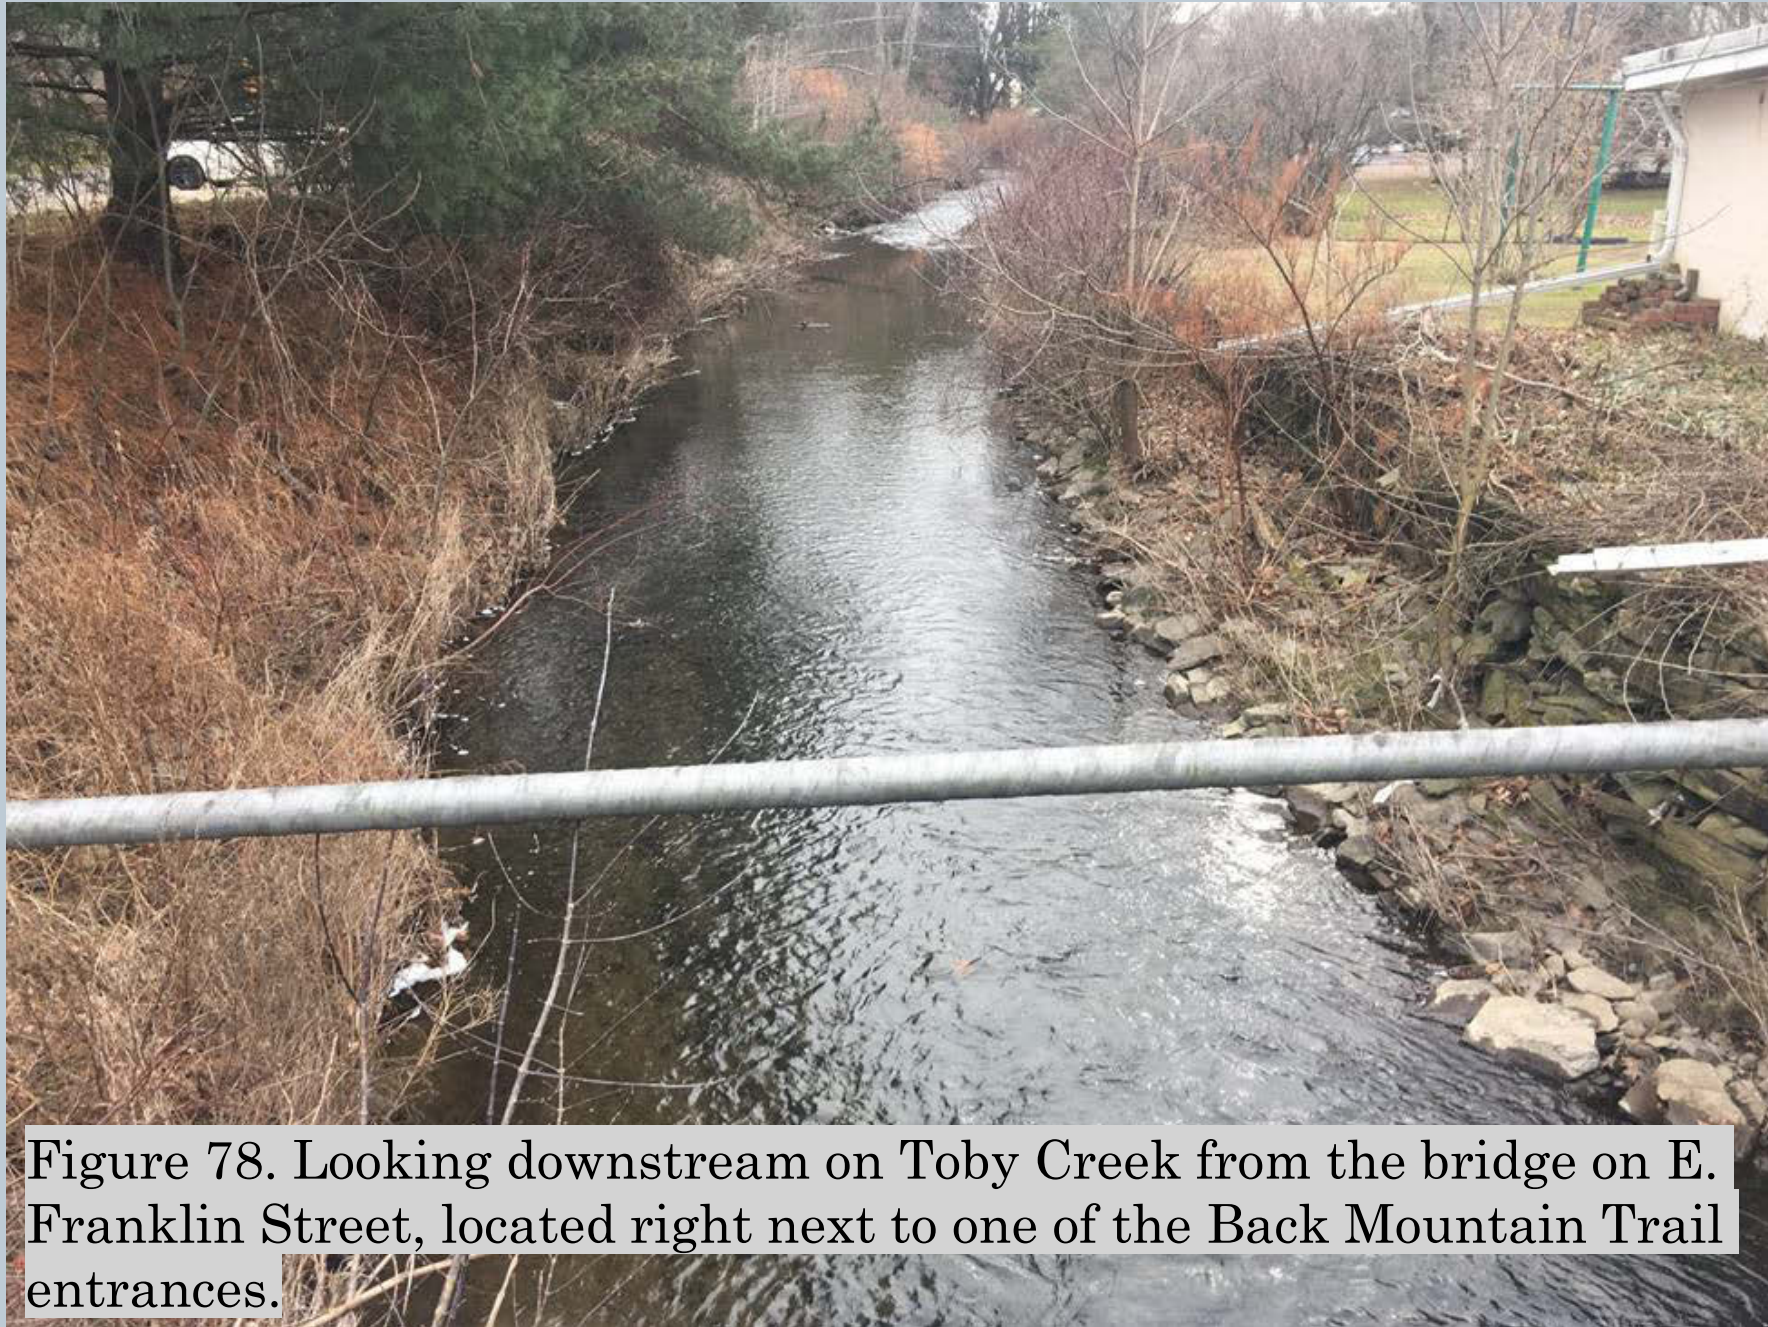
Figure 78. Looking downstream on Toby Creek from the bridge on E. Franklin Street, located right next to one of the Back Mountain Trail entrances.

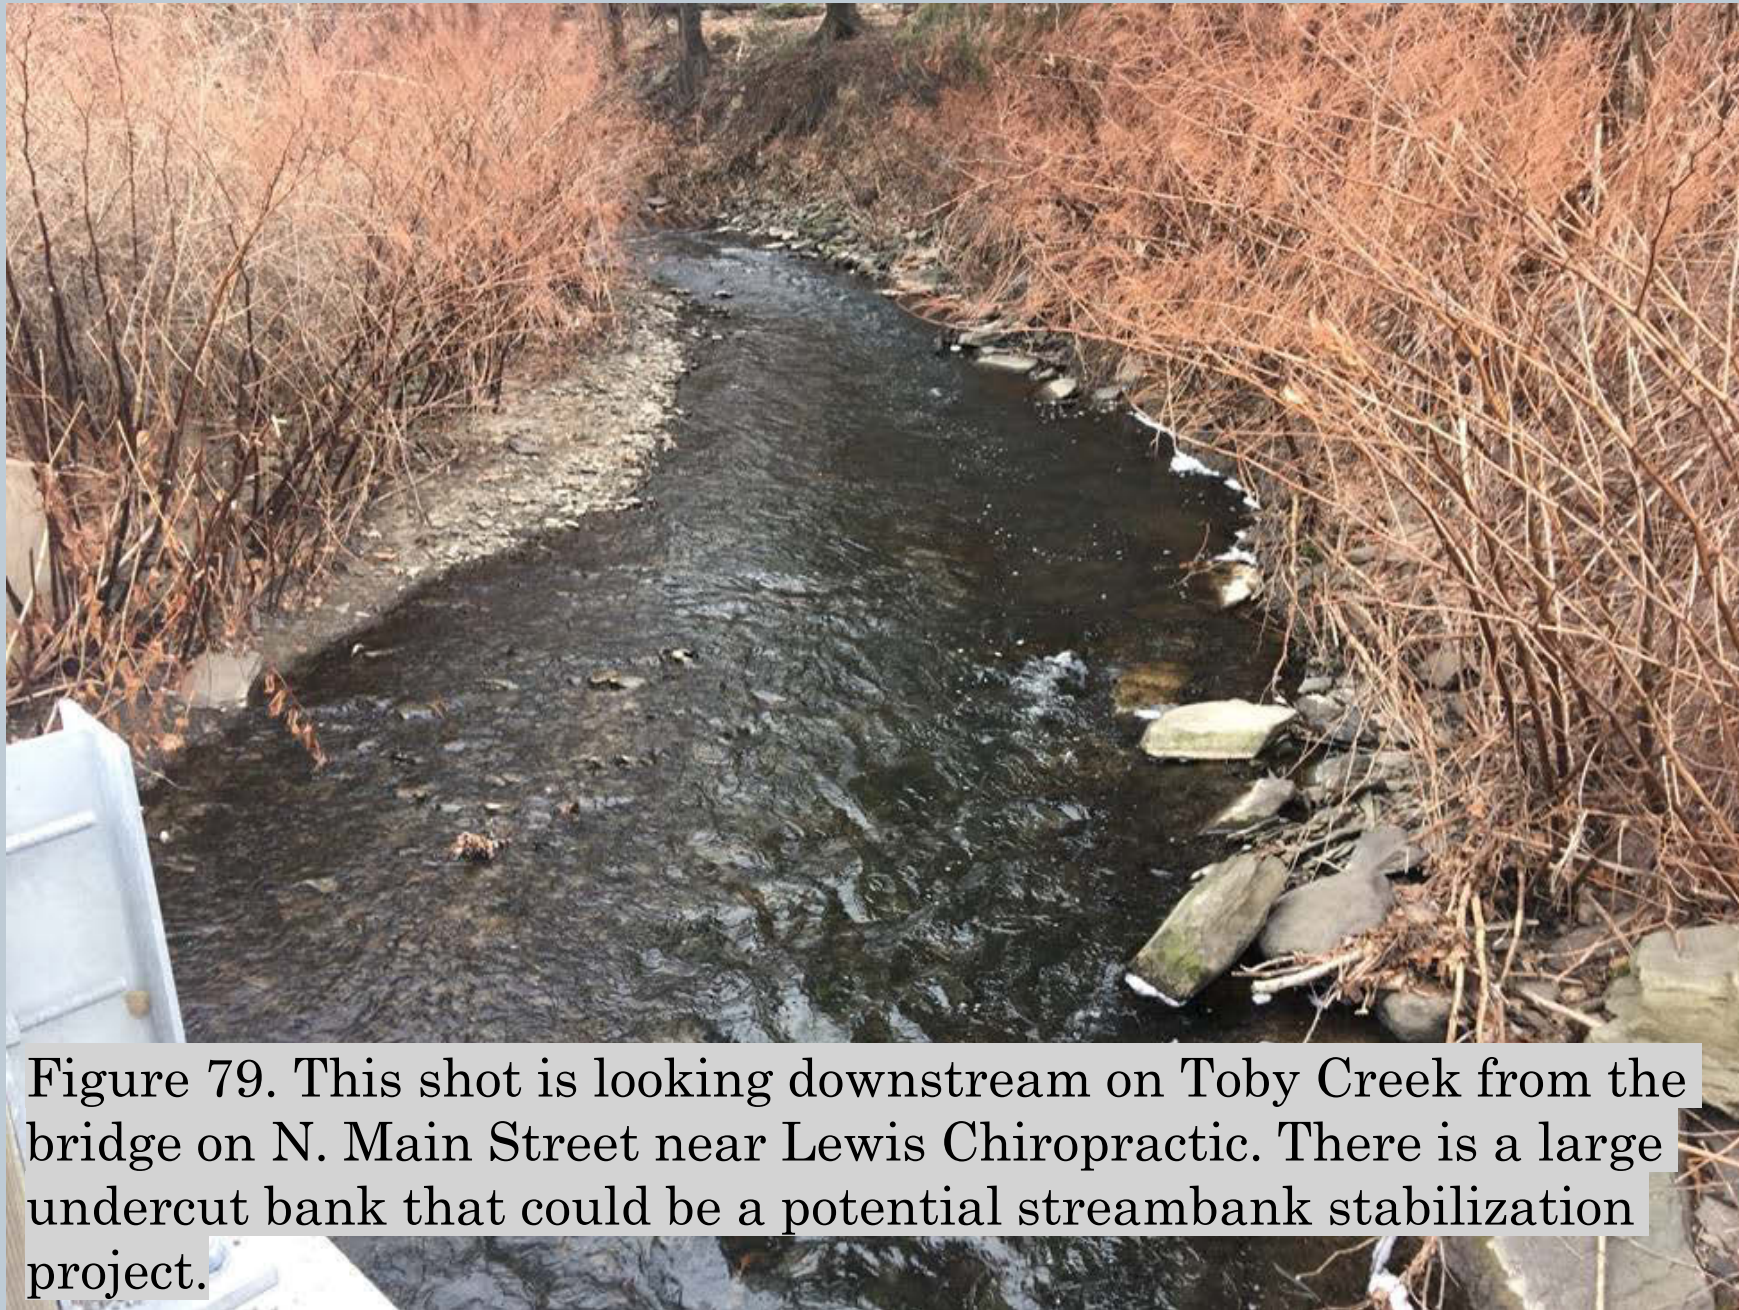
Figure 79. This shot is looking downstream on Toby Creek from the bridge on N. Main Street near Lewis Chiropractic. There is a large undercut bank that could be a potential streambank stabilization project.

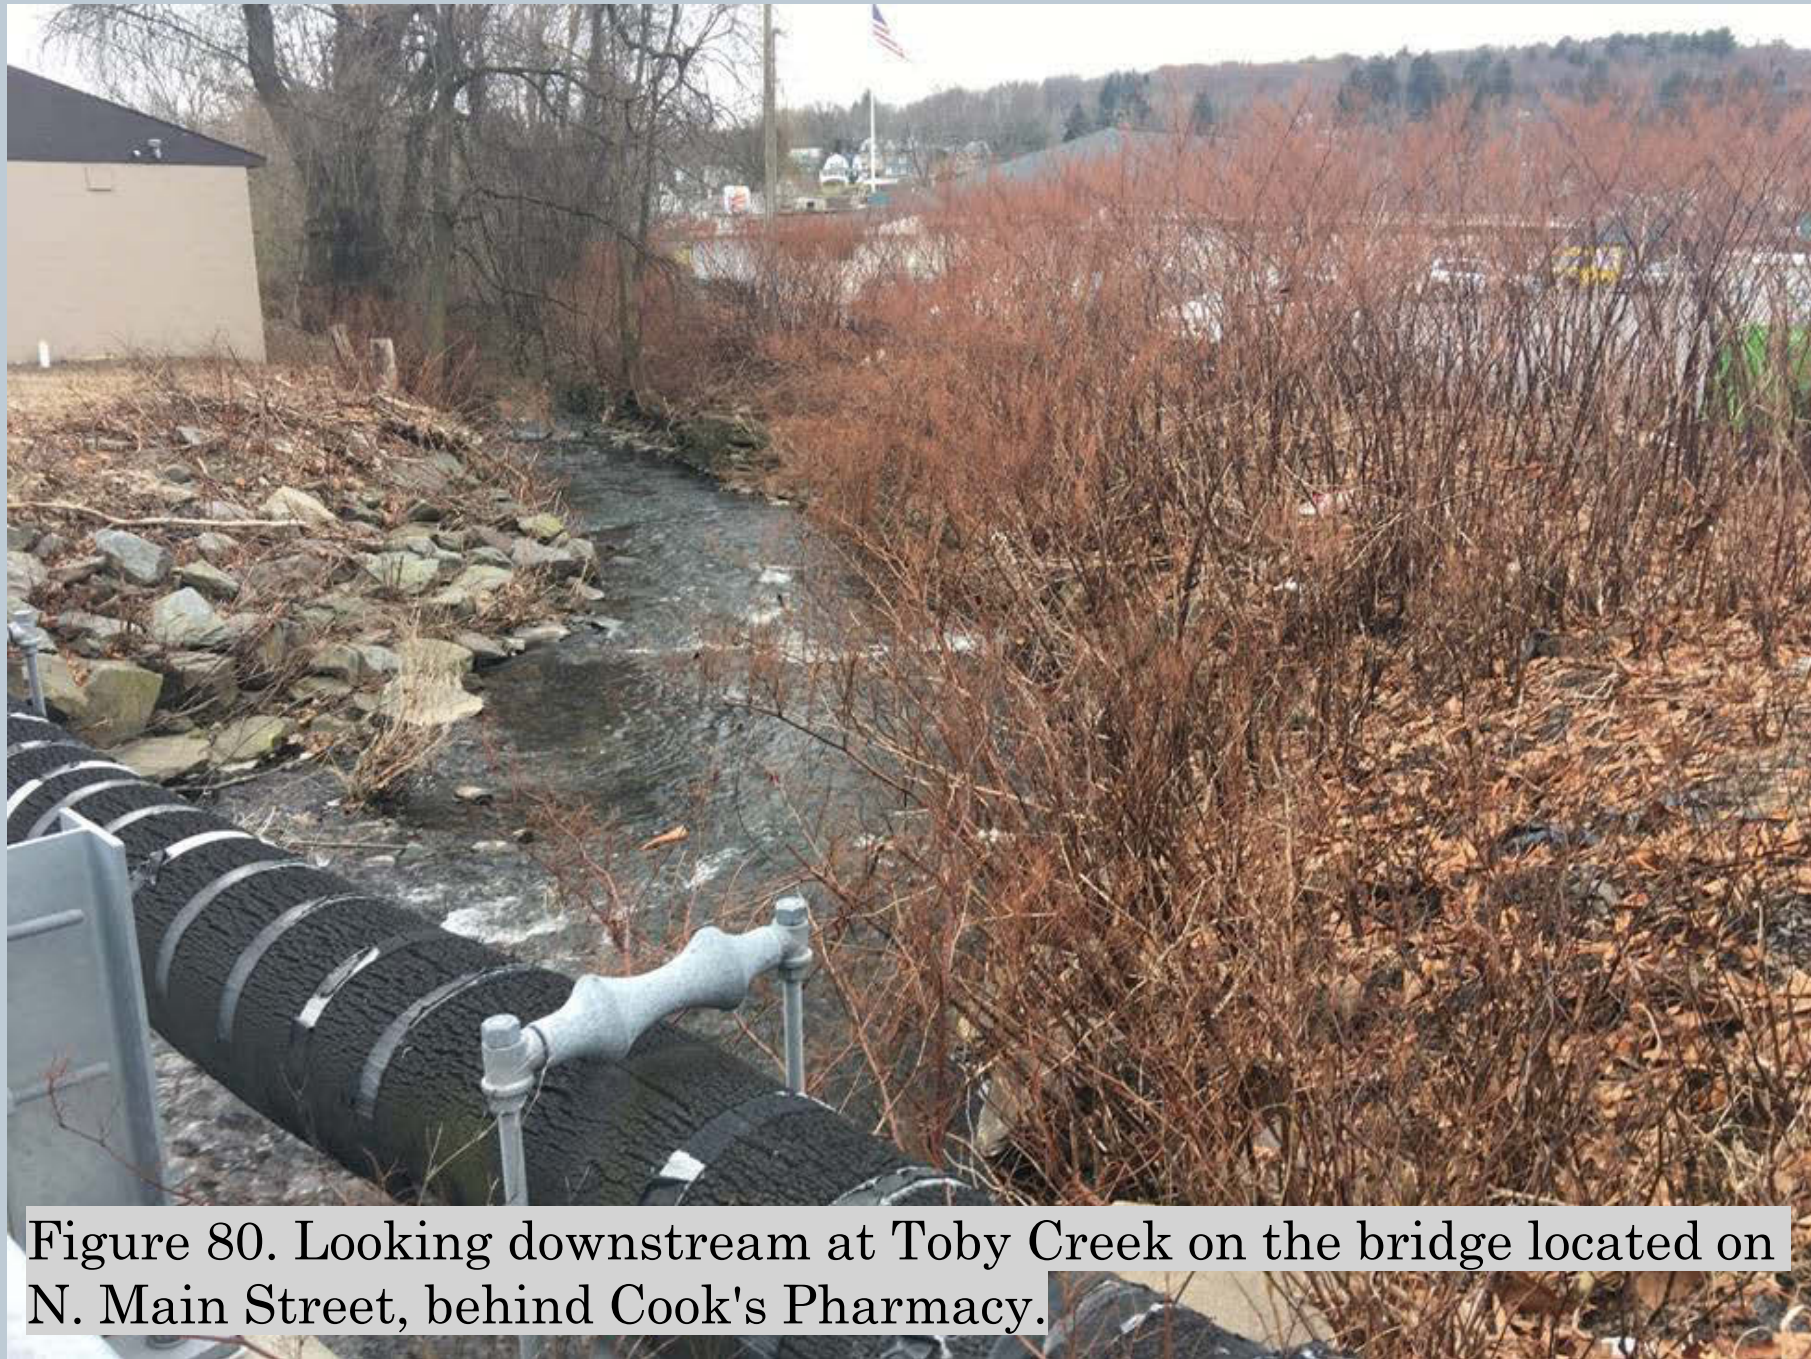
Figure 80. Looking downstream at Toby Creek on the bridge located on N. Main Street, behind Cook's Pharmacy.

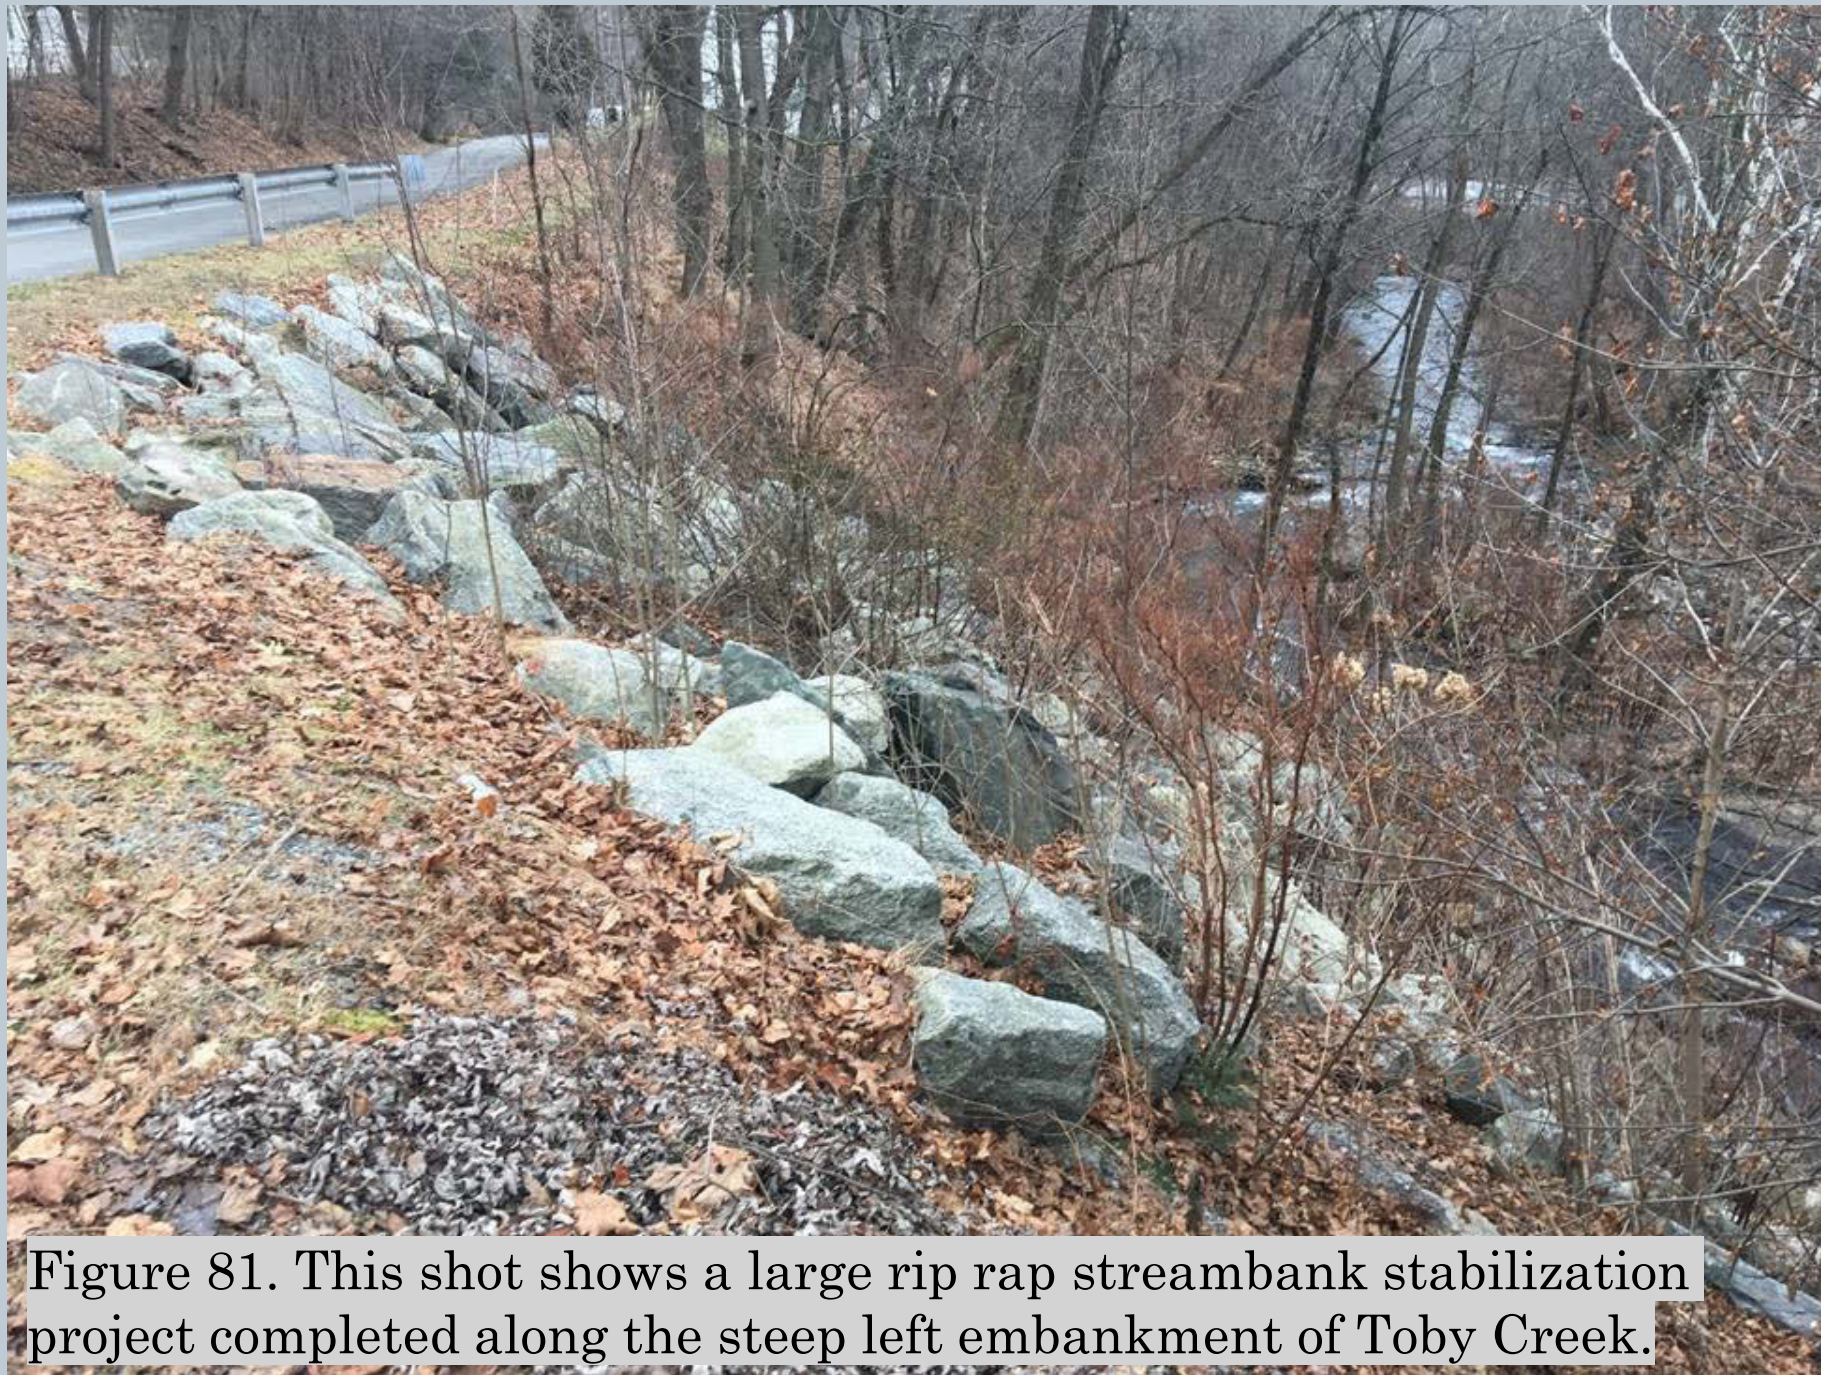
Figure 81. This shot shows a large rip rap streambank stabilization project completed along the steep left embankment of Toby Creek.

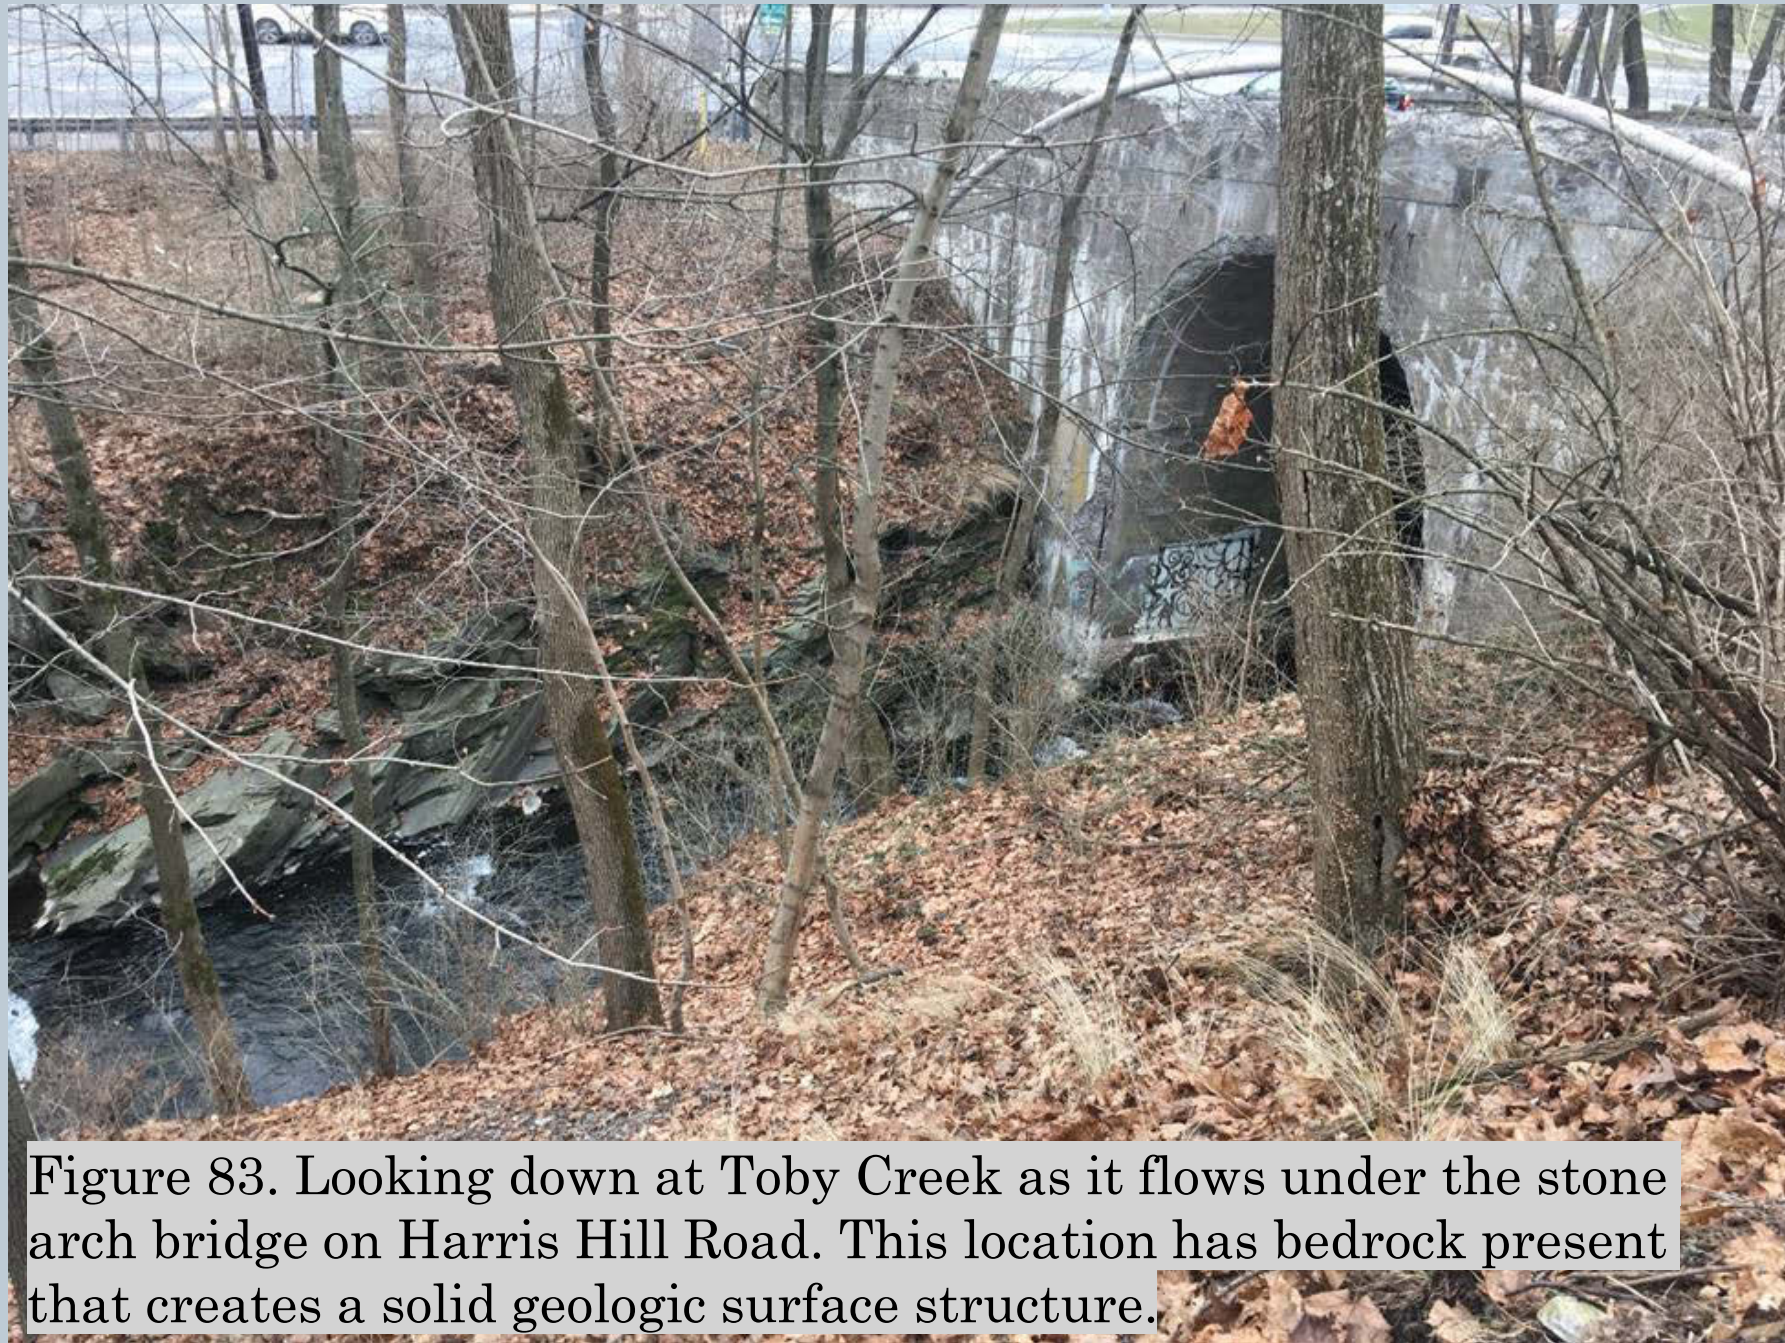
Figure 83. Looking down at Toby Creek as it flows under the stone arch bridge on Harris Hill Road. This location has bedrock present that creates a solid geologic surface structure.

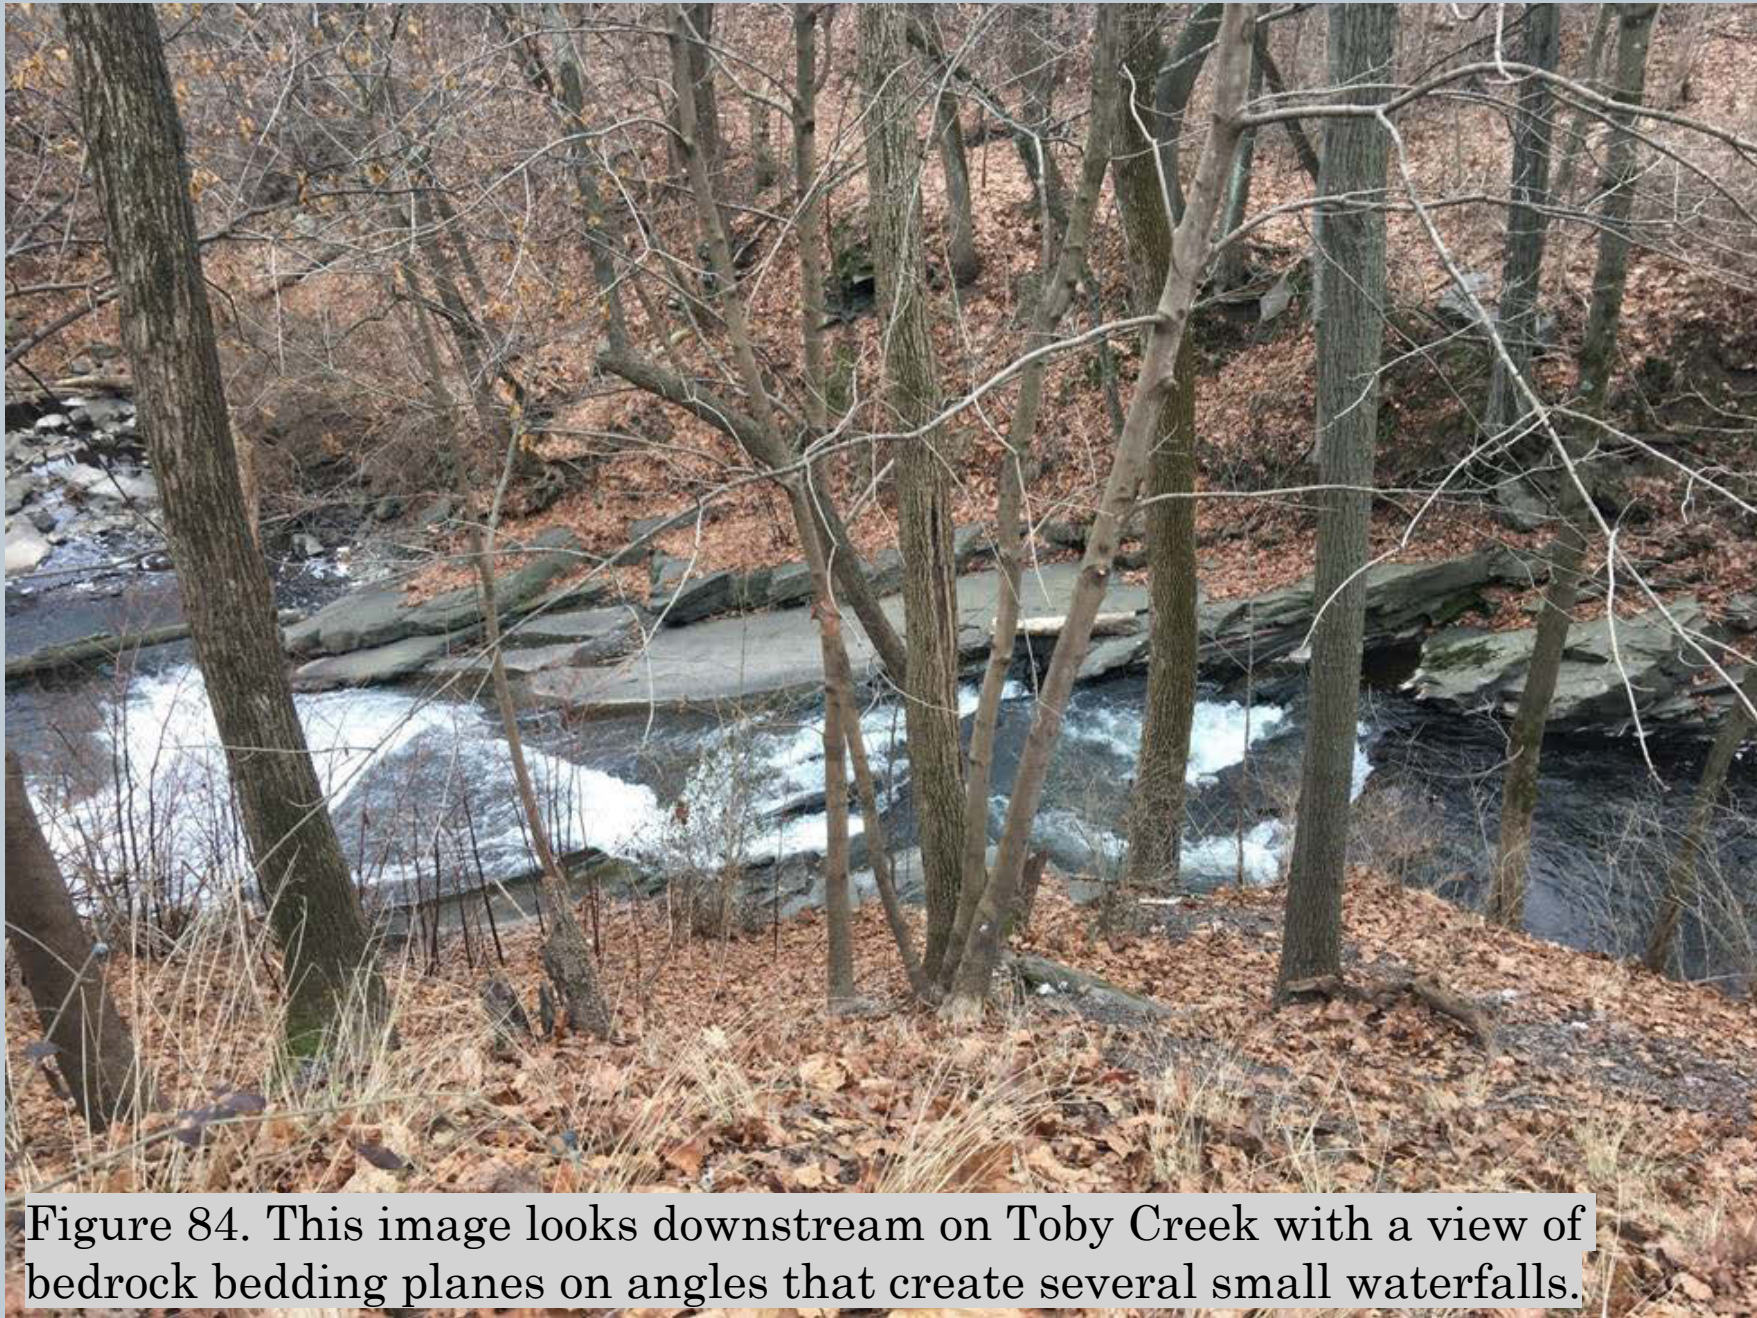
Figure 84. This image looks downstream on Toby Creek with a view of bedrock bedding planes on angles that create several small waterfalls.

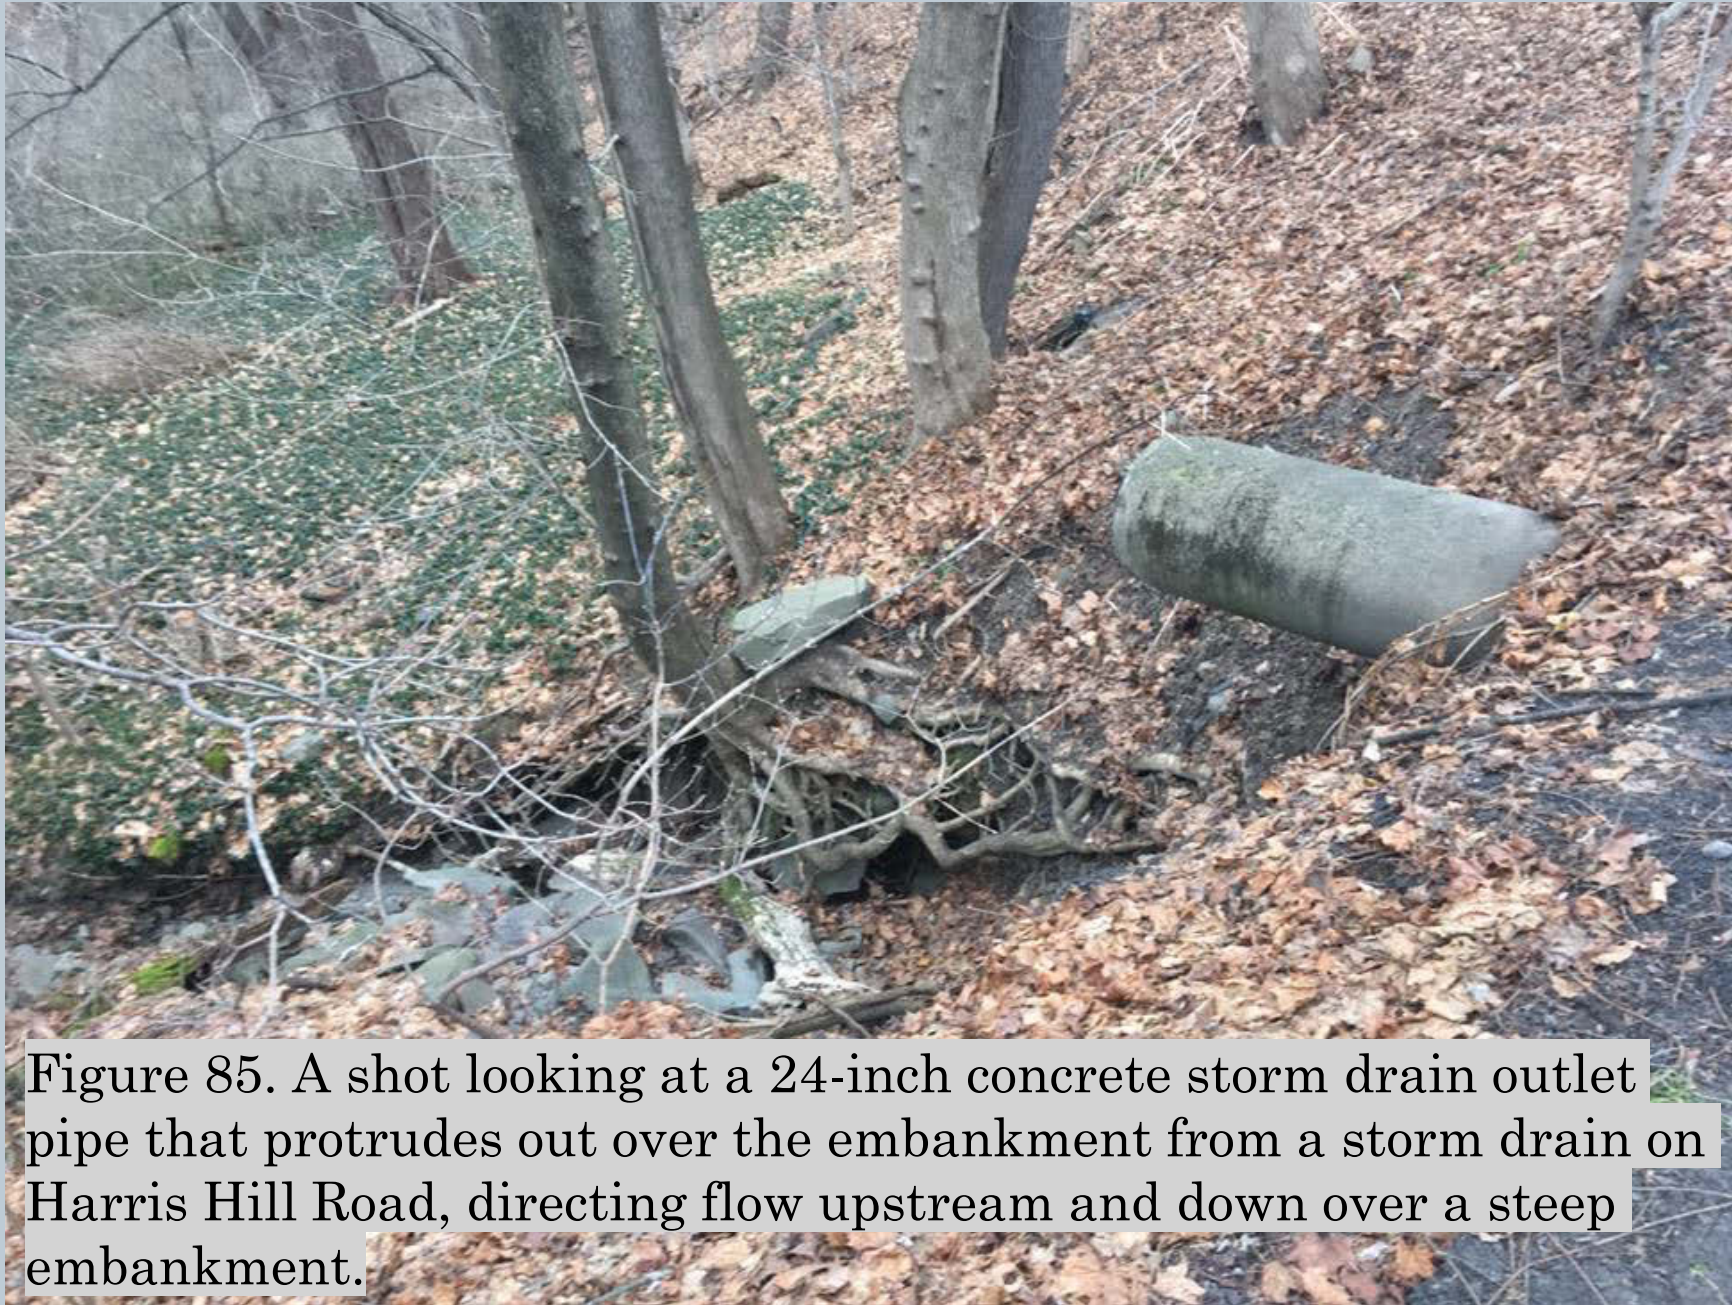
Figure 85. A shot looking at a 24-inch concrete storm drain outlet pipe that protrudes out over the embankment from a storm drain on Harris Hill Road, directing flow upstream and down over a steep embankment.
