Toby Creek Field Reconnaissance Observations

September 26, 2018

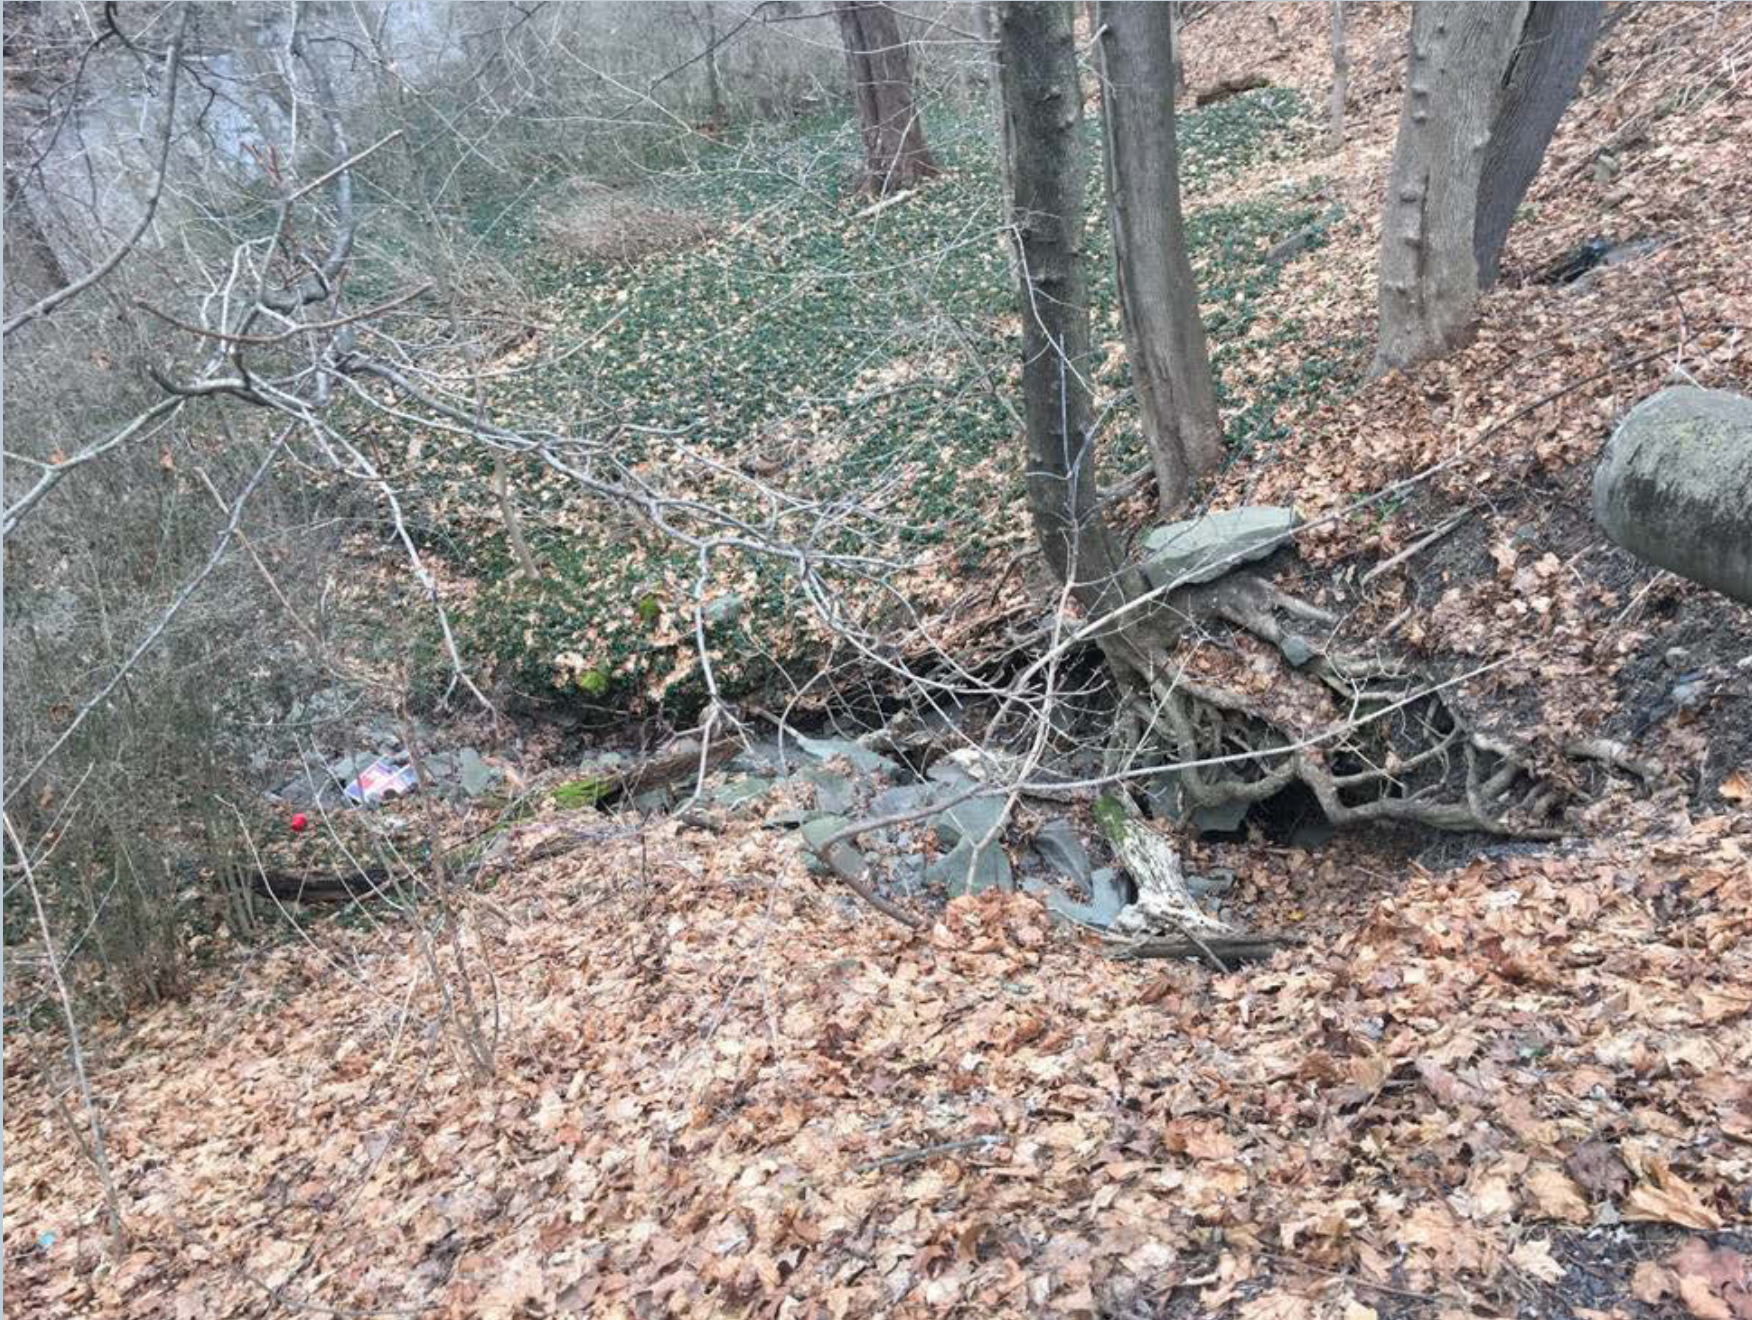
Figure 86. A shot of the severe drop from the storm drain outlet pipe. This has created a massive undercutting of the bank and stormwater channel all the way down to Toby Creek. A rip rap or large boulder step-pool reinforcement channel conveyance down to Toby Creek is needed to redirect stormwater downstream into Toby Creek rather than upstream.

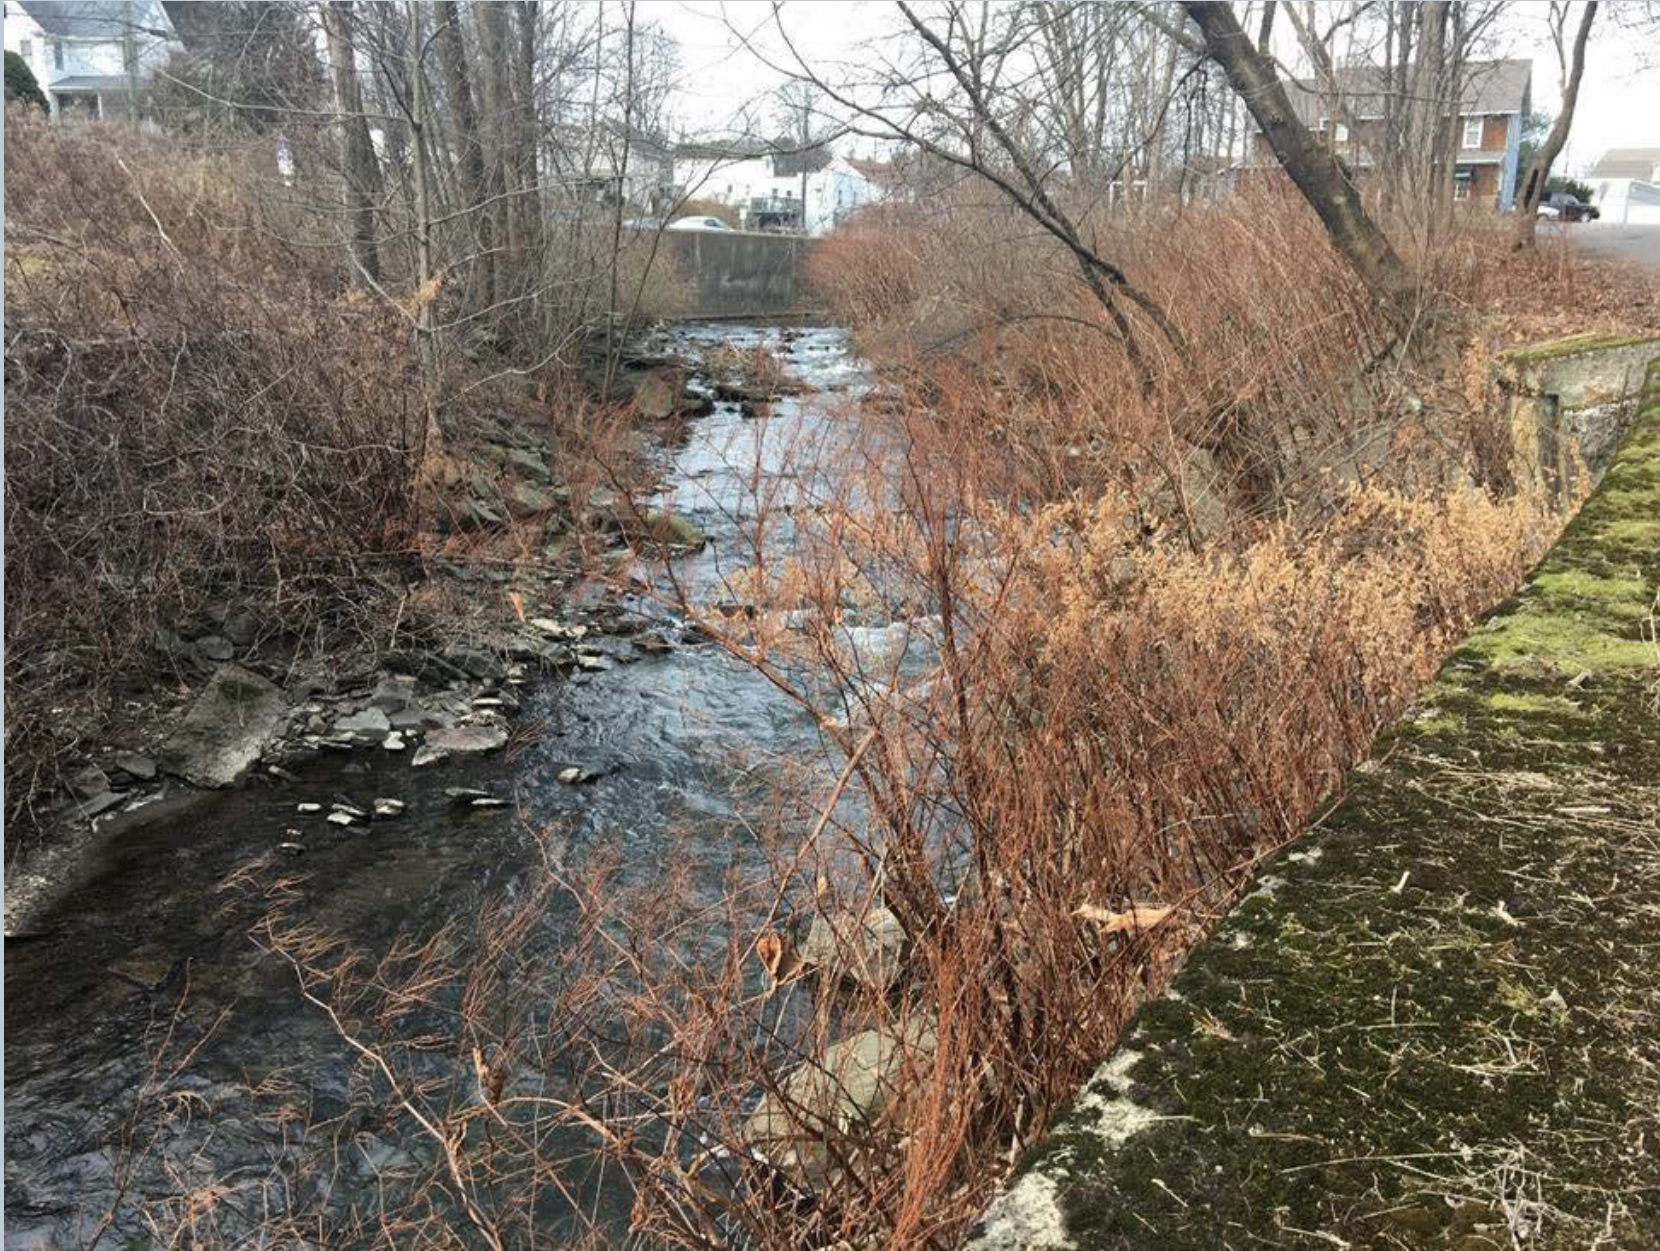
Figure 89. A shot looking upstream at Toby Creek from curved concrete retaining wall located along N. Main Avenue. Oriented in the direction of the Lonn Dean Salon and the North Memorial Highway concrete retaining wall, the presence of Japanese knotweed, an invasive, and a gravel bar deposition, opposite the retaining wall, on the inside of the bend of Toby Creek are present.

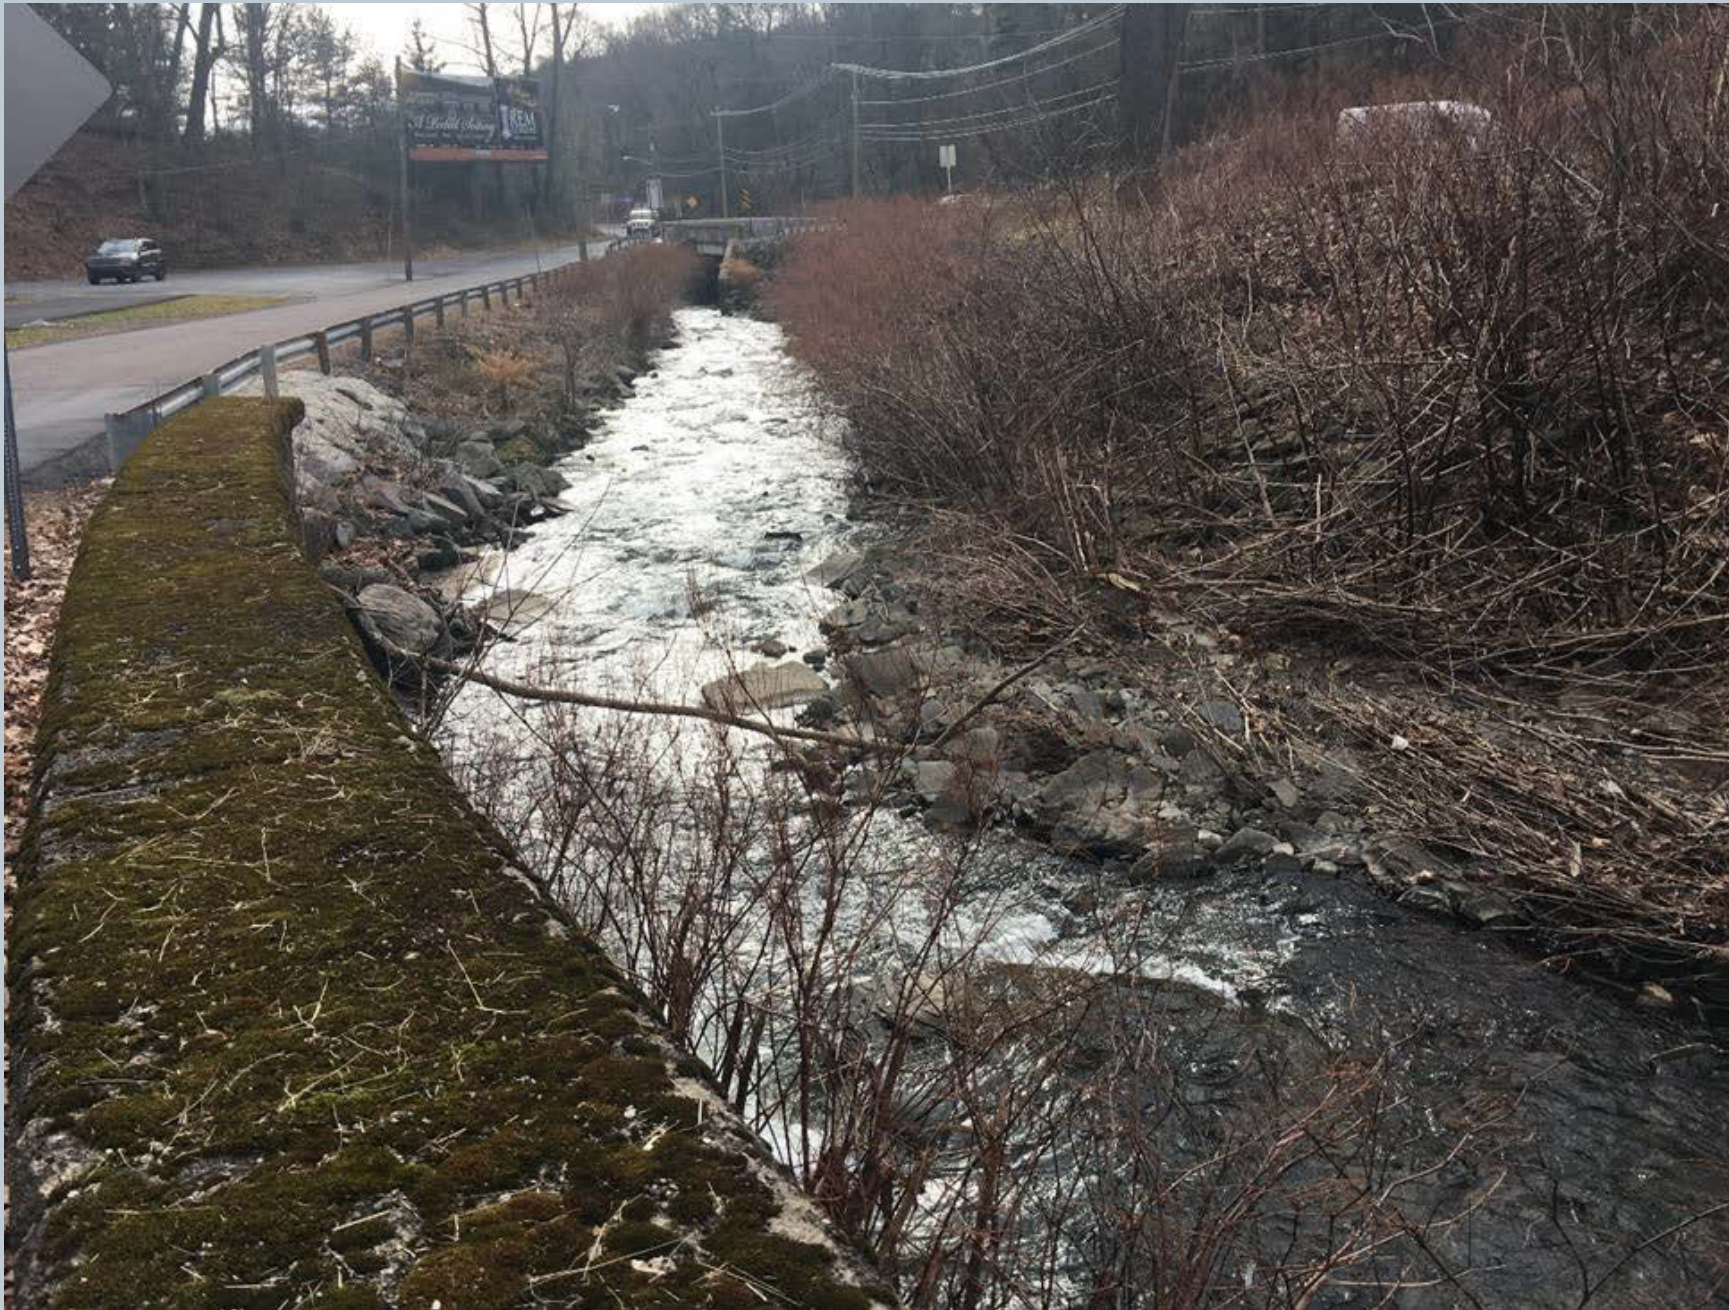
Figure 90. Looking downstream on Toby Creek from a curved concrete retaining wall along N. Main Street towards Plum Ave. This location has shotcrete rip rap along N. Main Street which is used to stabilize the streambank and protect the road from a historic undercutting that occurs just below the curved retaining wall on the left side of the bank.

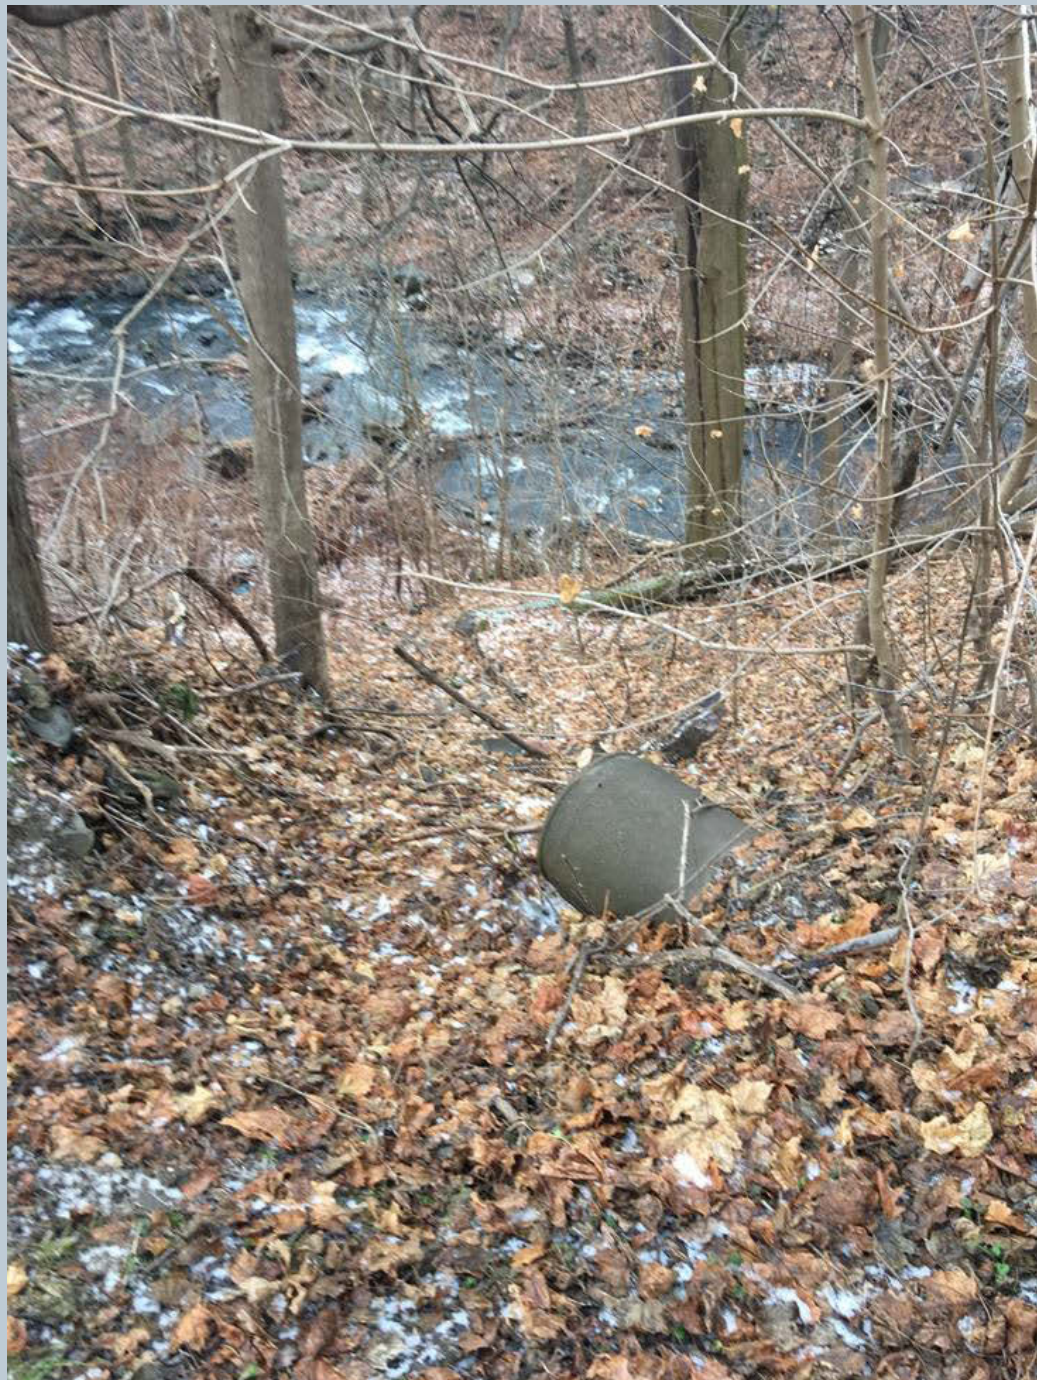
Figure 91. A dry 18-inch concrete stormwater outfall pipe structure located under Heller's Grove Road, sticking out over the steep bank that is aligned downstream with Toby Creek.

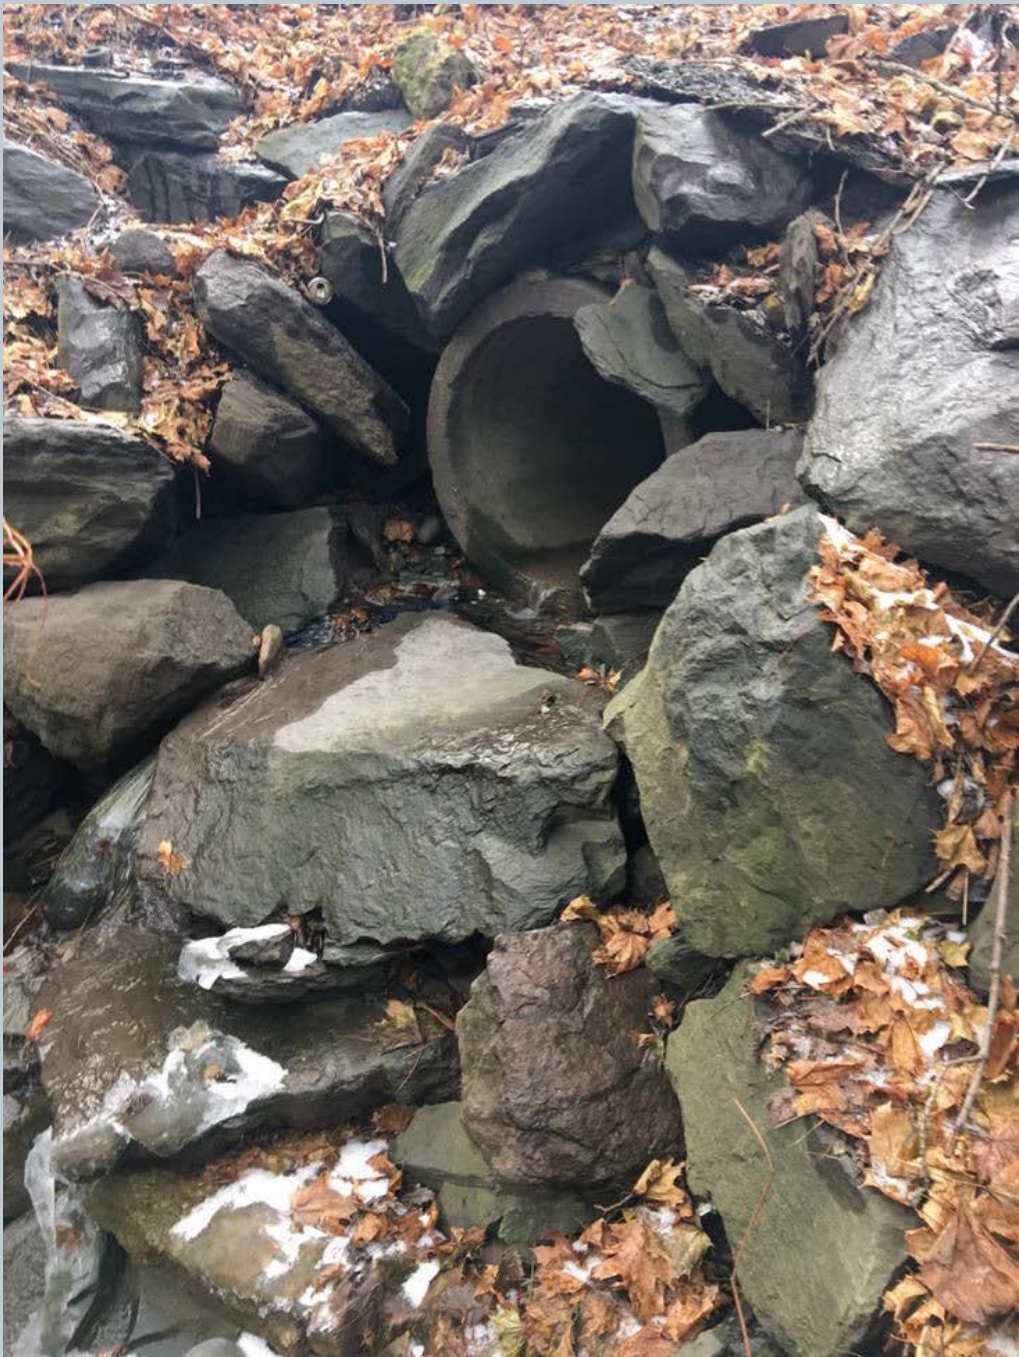
Figure 92. A shot of a dry 24-inch concrete stormwater outfall pipe structure that is located along the left bank of Toby Creek, looking upstream along State Route 309. This structure is draining stormwater from S. Pioneer Avenue and State Route 309.

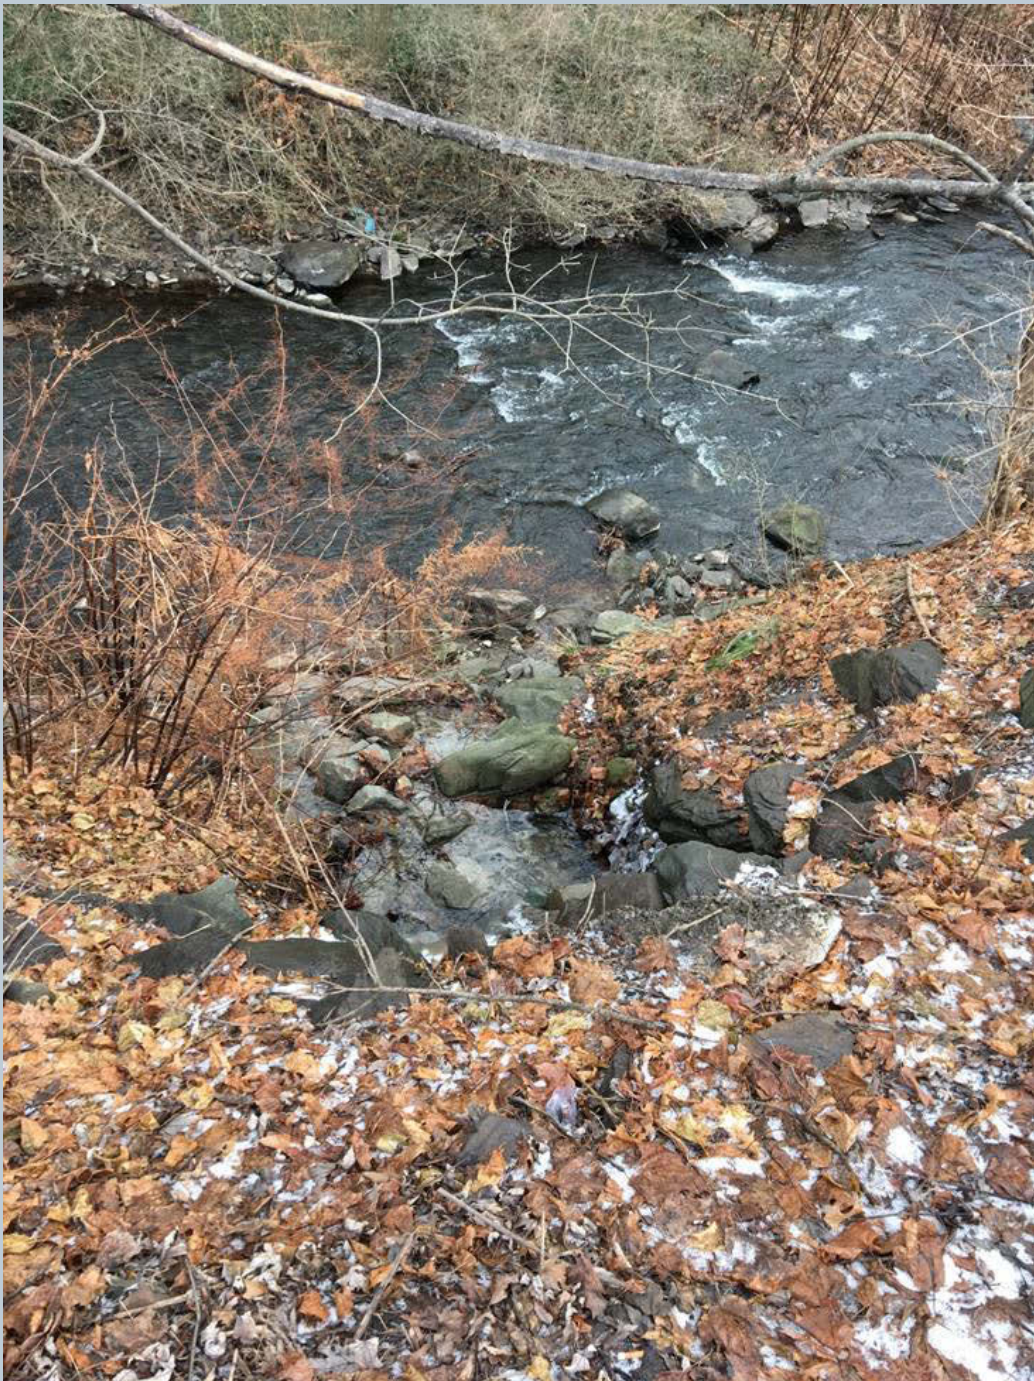
Figure 93. Taken looking downstream on Toby Creek at a scour pool that has resulted from a 24-inch concrete stormwater outfall pipe structure.

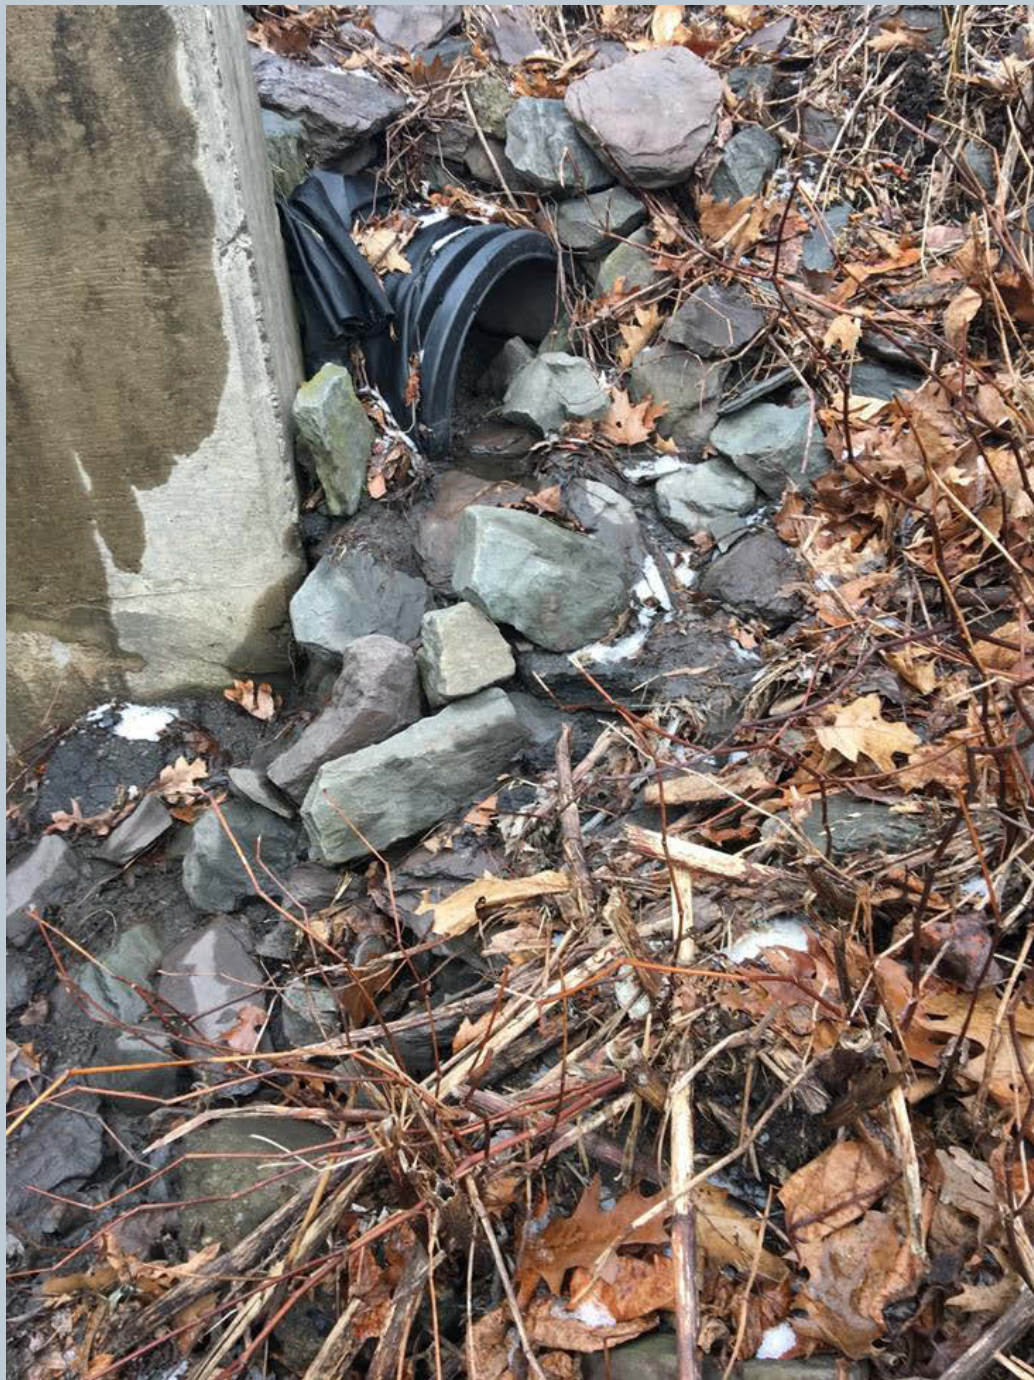
Figure 94. An 18-inch black HDPE stormwater outfall pipe structure along a bridge abutment next to Newell Fuel, along Toby Creek, that is half-filled with sediment. To obtain credit for removal, it is recommended that a DAMA Vac Truck removes the sediment and calculate the volume or weight of the sediment removed.

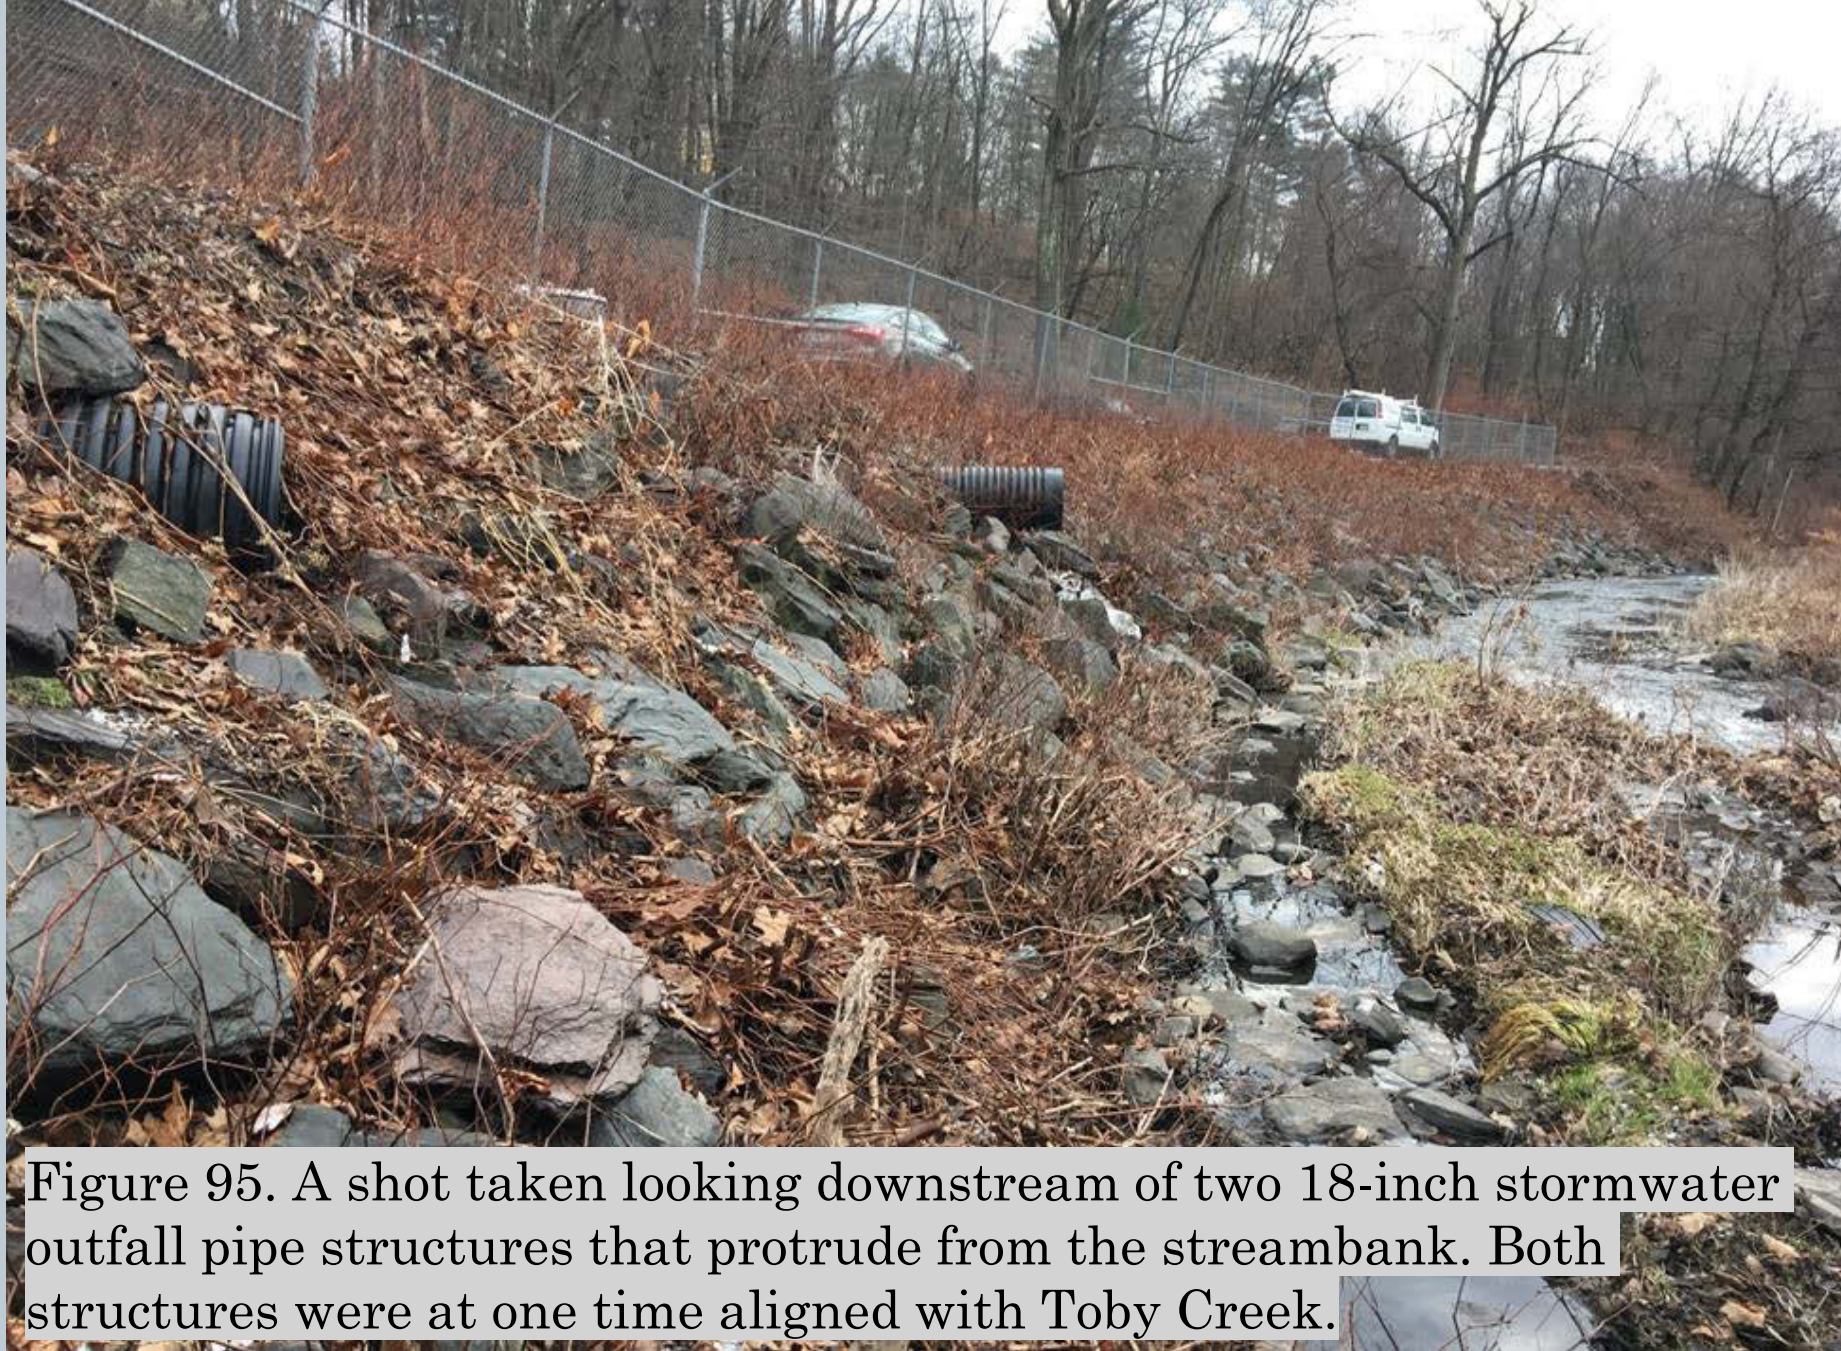
Figure 95. A shot taken looking downstream of two 18-inch stormwater outfall pipe structures that protrude from the streambank. Both structures were at one time aligned with Toby Creek.

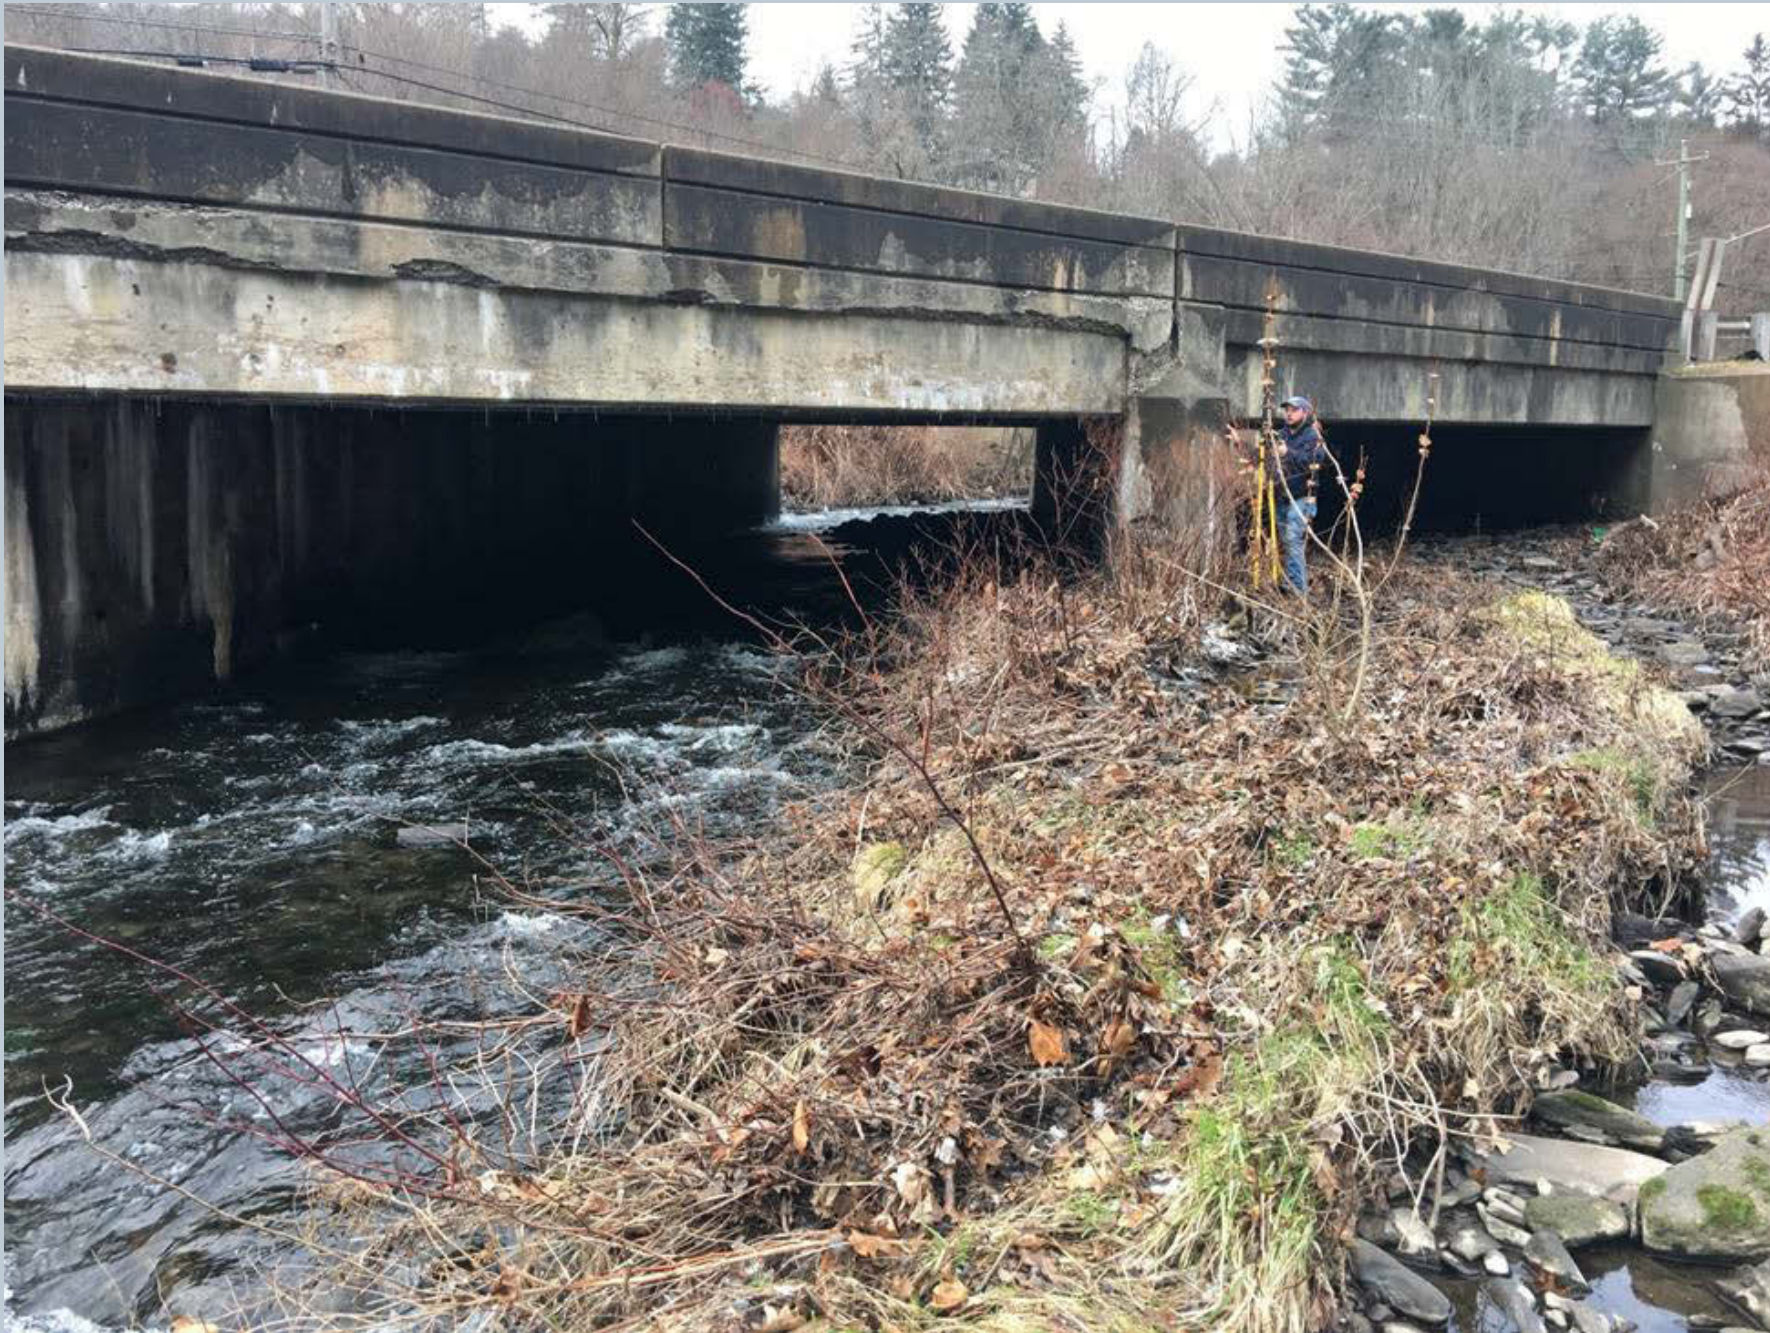
Figure 96. A shot looking upstream on Toby Creek at a double box culvert bridge on State Route 309. 100% of the flow is contained beneath the left box and no flow was present in the right box, 50% of the left box contained cobble, and 100% of the right box contained cobble.

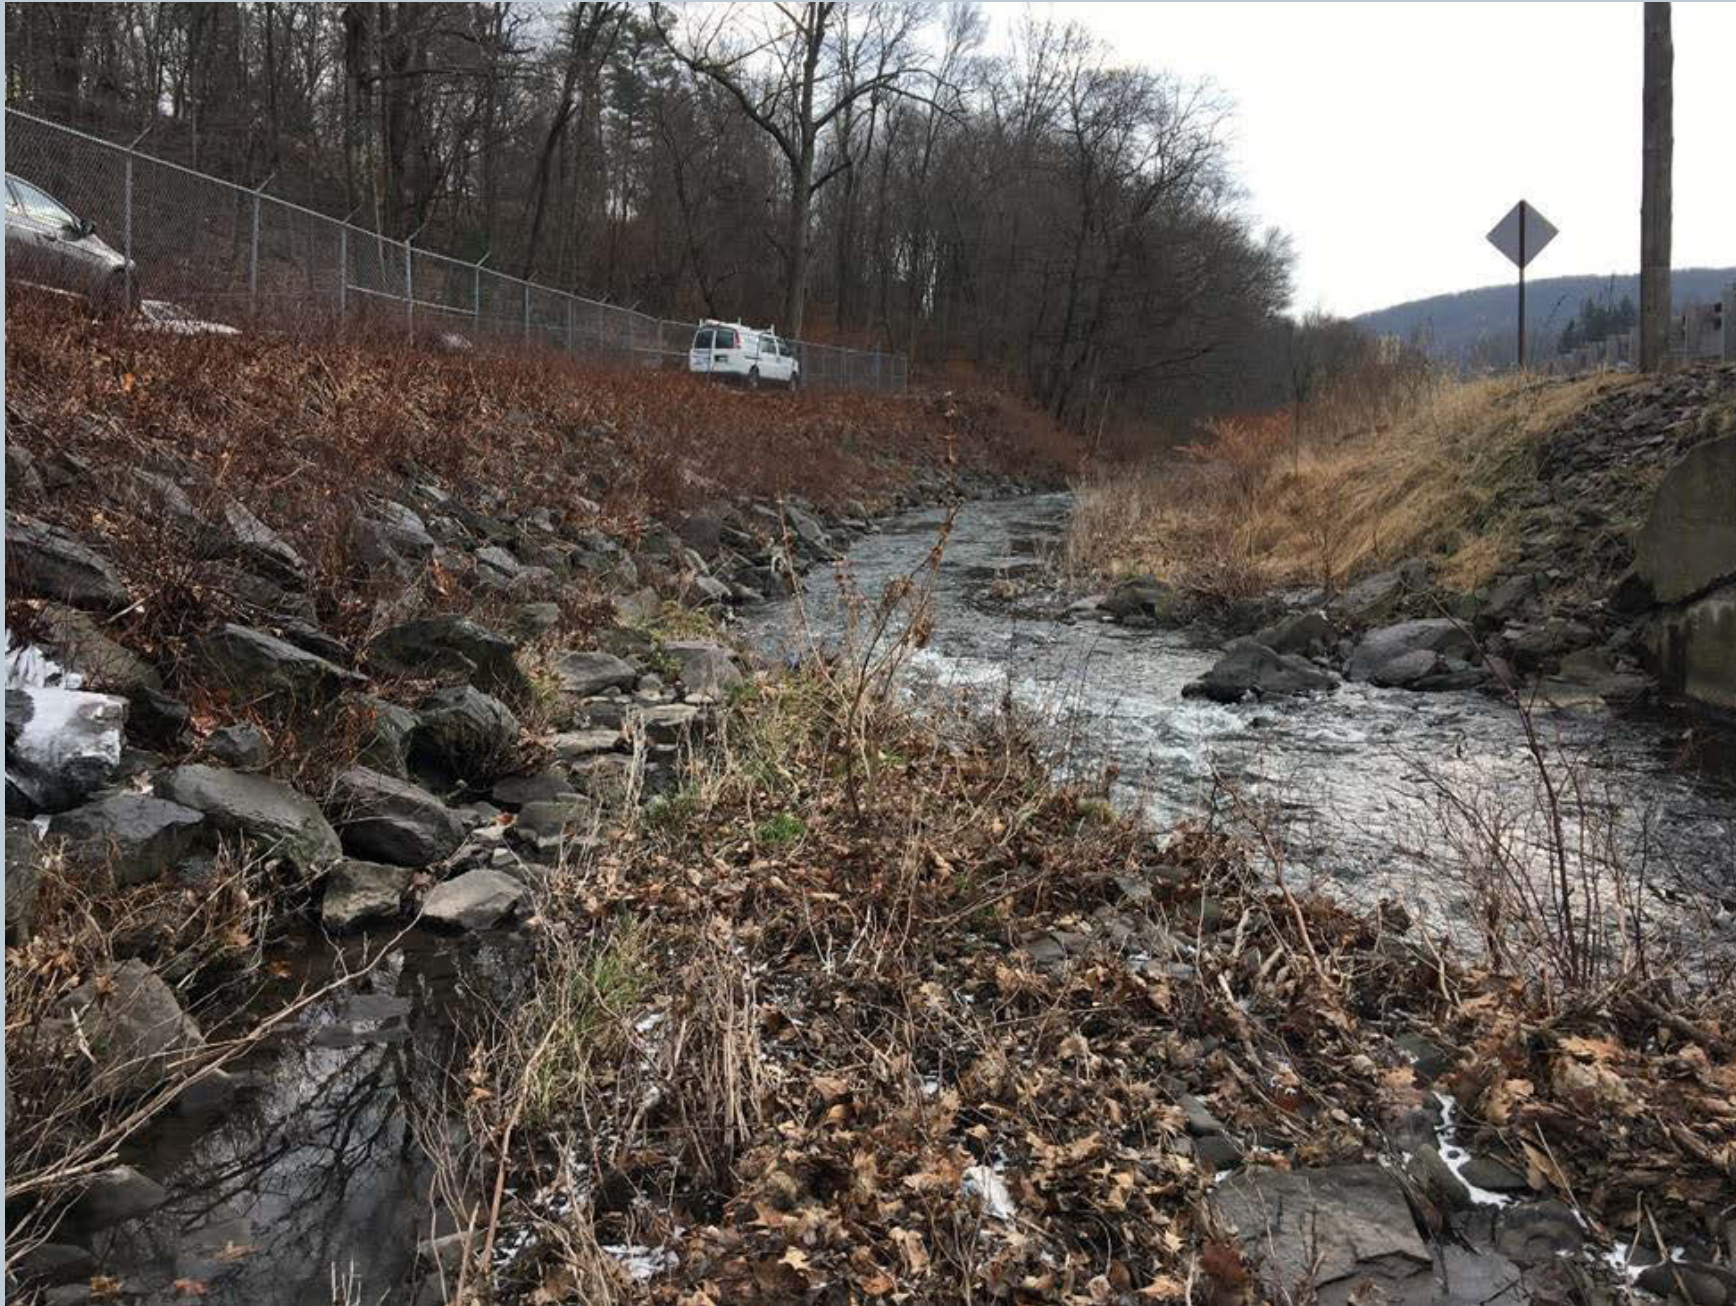
Figure 97. A shot looking downstream on Toby Creek from a historic hard-armored streambank stabilization project. Aggradation of cobble and gravel in the right box culvert, under the bridge over State Route 309, has created point bar gravel and cobble deposition.

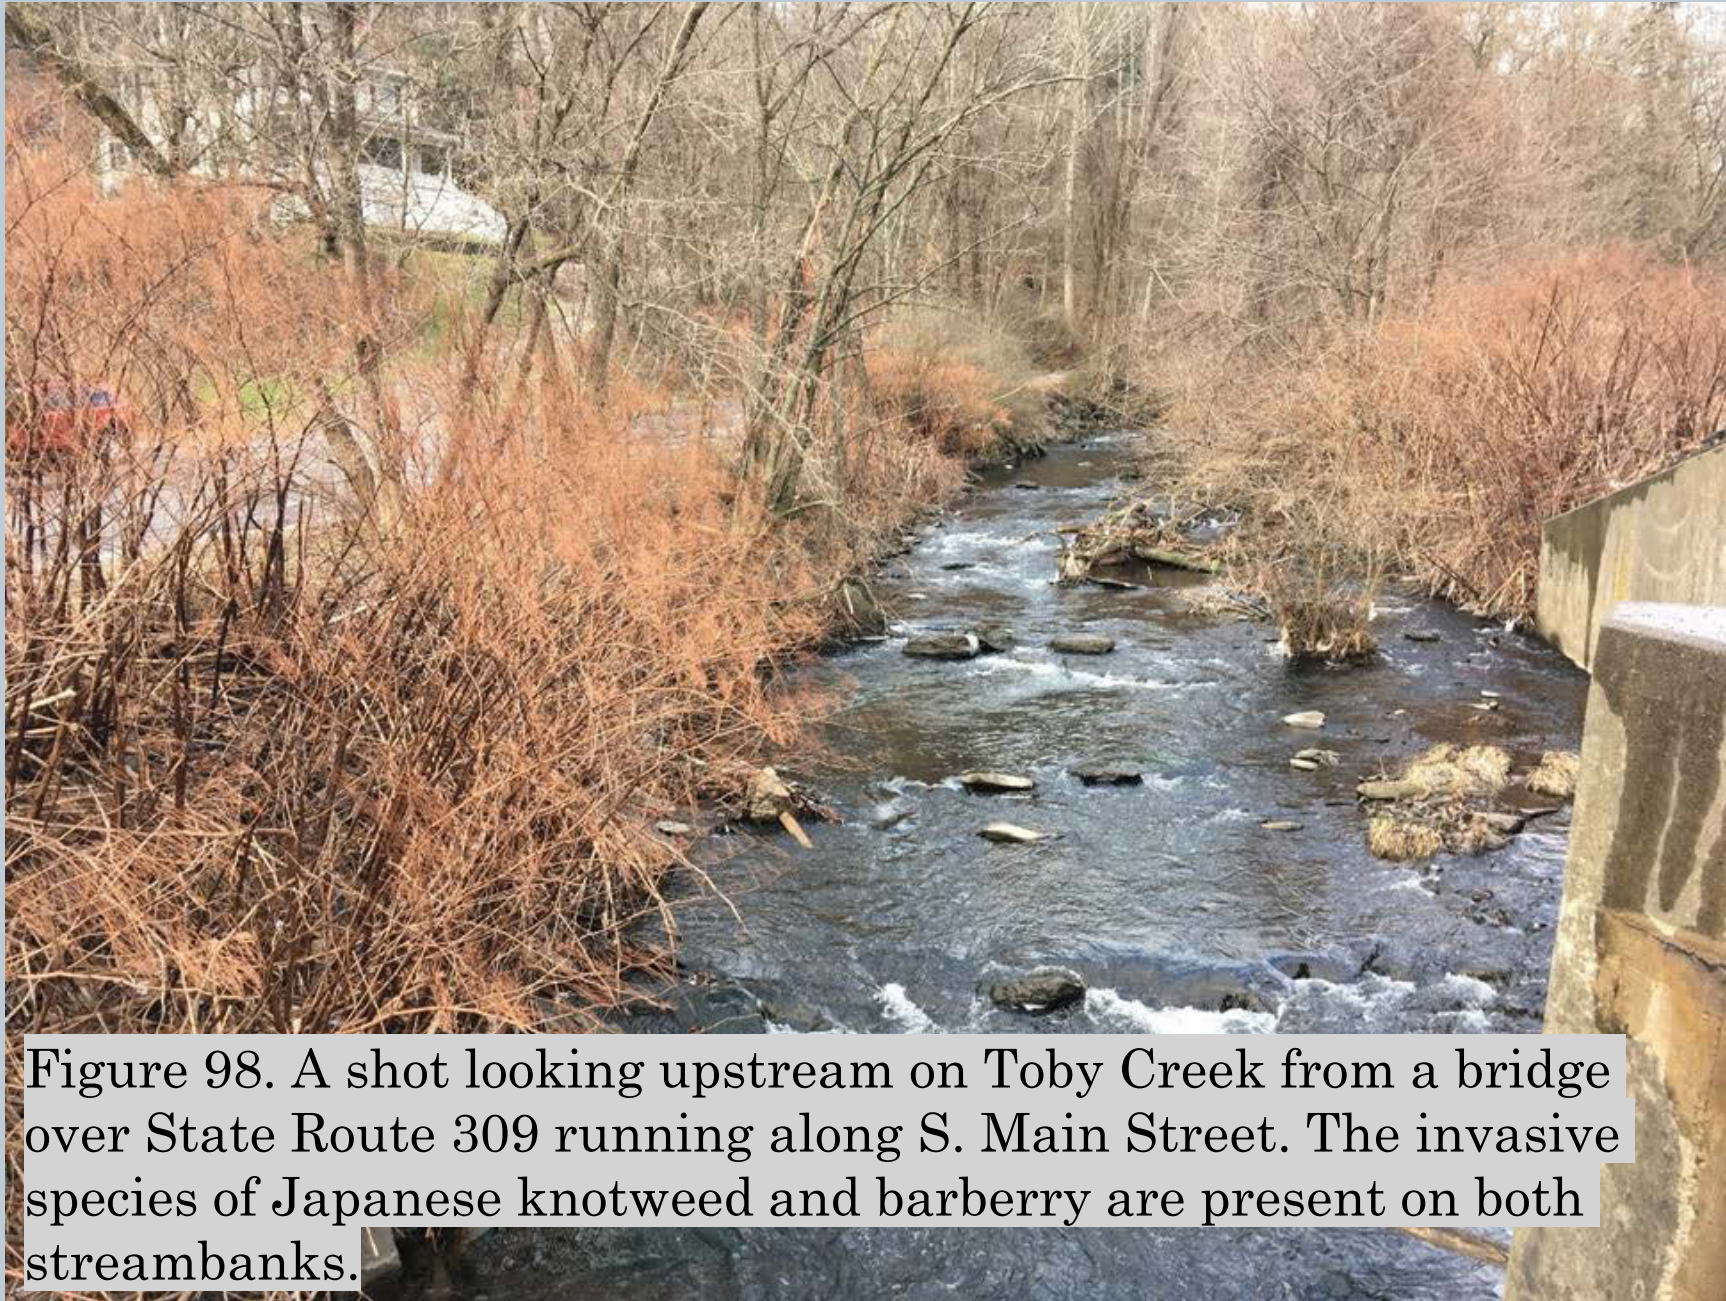
Figure 98. A shot looking upstream on Toby Creek from a bridge over State Route 309 running along S. Main Street. The invasive species of Japanese knotweed and barberry are present on both streambanks.
