Toby Creek Field Reconnaissance Observations

September 26, 2018

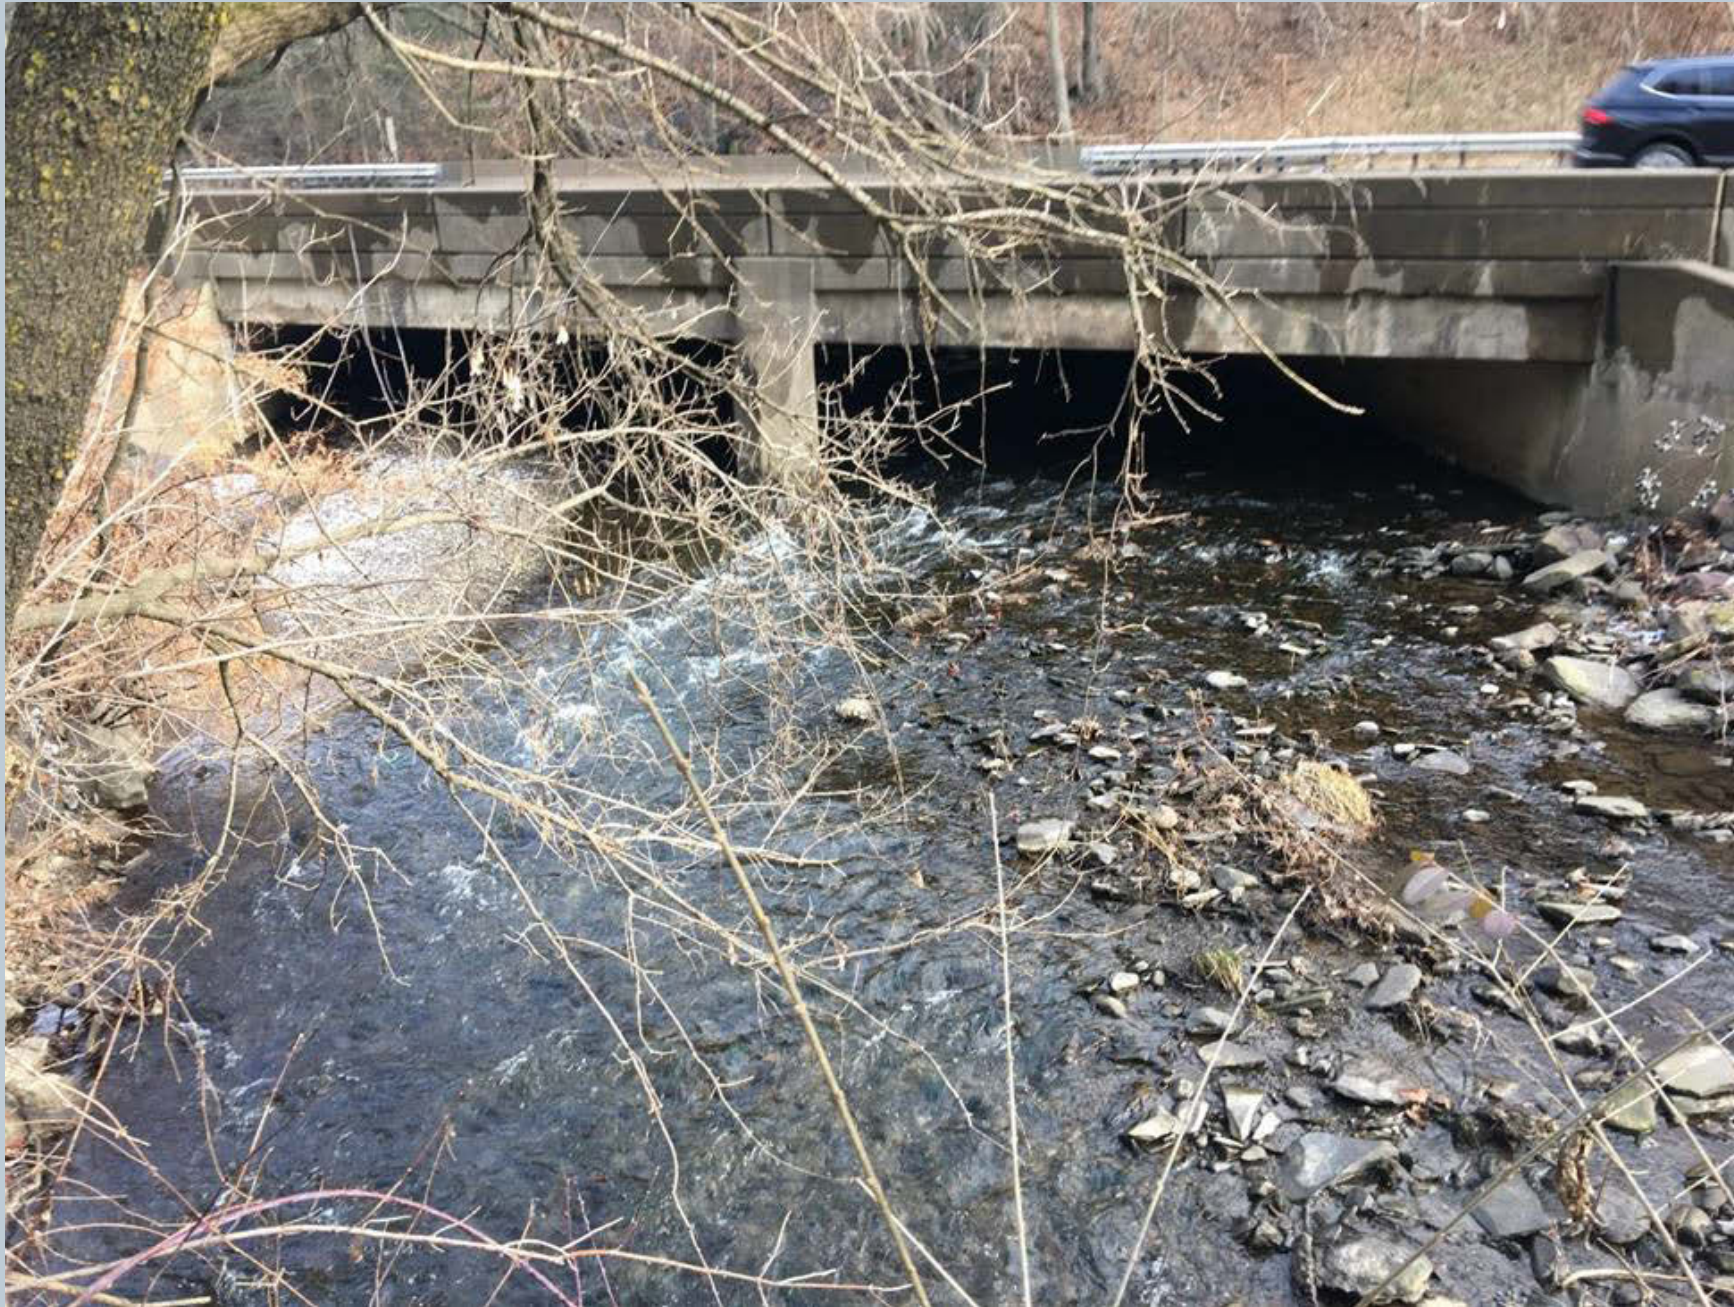
Figure 99. Taken looking upstream from S. Main Street along an old concrete retaining wall at a bend in Toby Creek. From just 50 feet below the double box culvert bridge running over State Route 309 (pictured), gravel and cobble deposition is seen in the left box, which carries about 30% of the flow. The right box carries the remaining 70% of the flow.

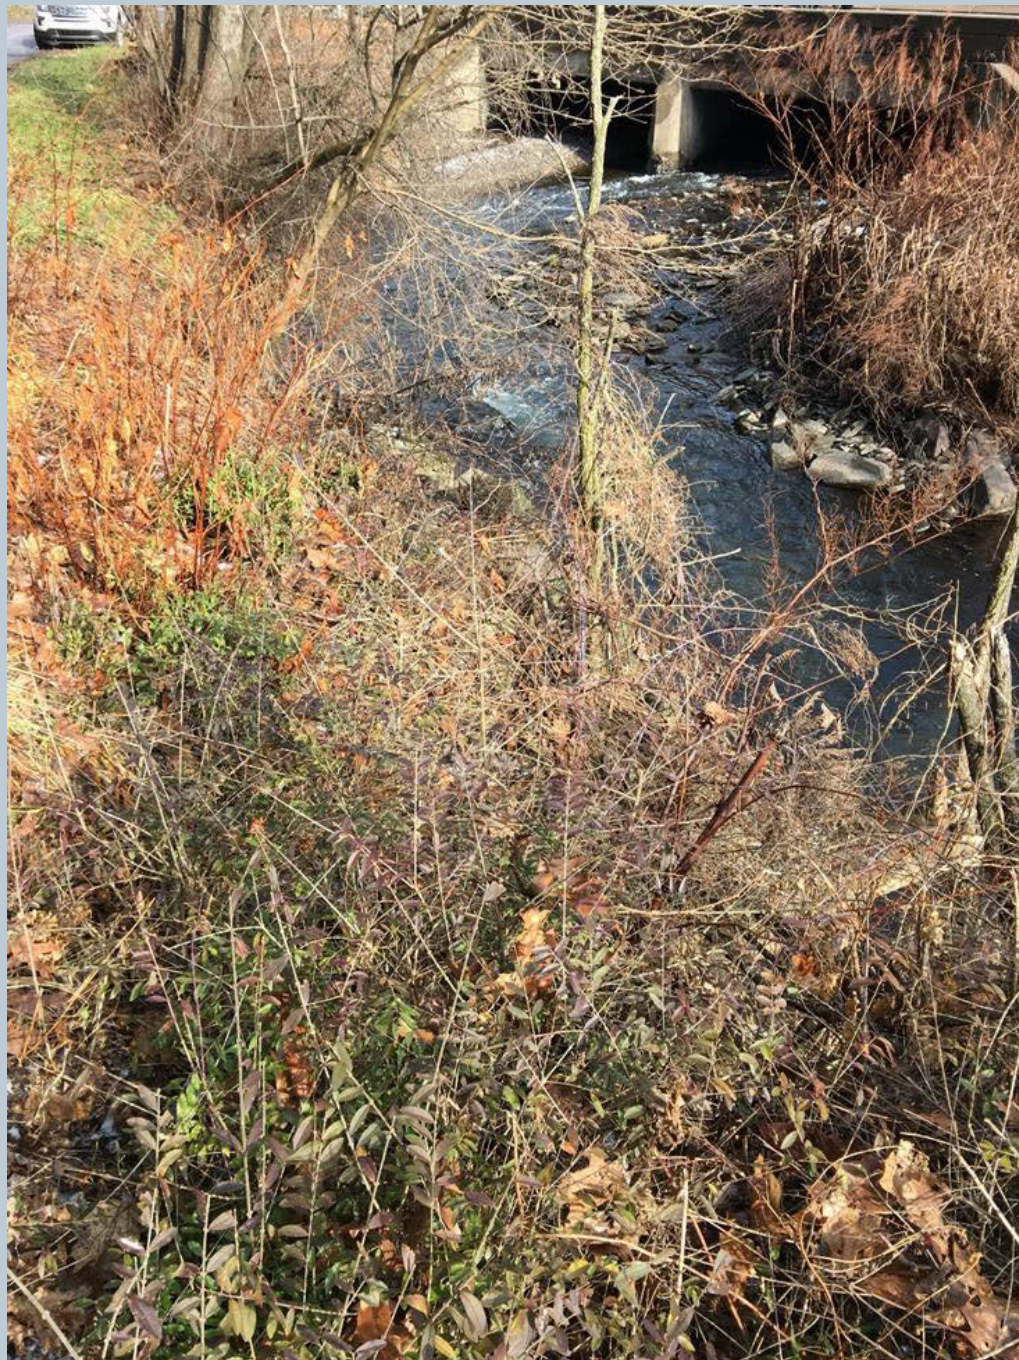
Figure 100. A shot looking upstream at a vertical bank, which has been estimated to be about 12 feet high, along the left bank along S. Main Street. This location is ideal for fishing; this could be a future location for sampling and electroshock surveying.

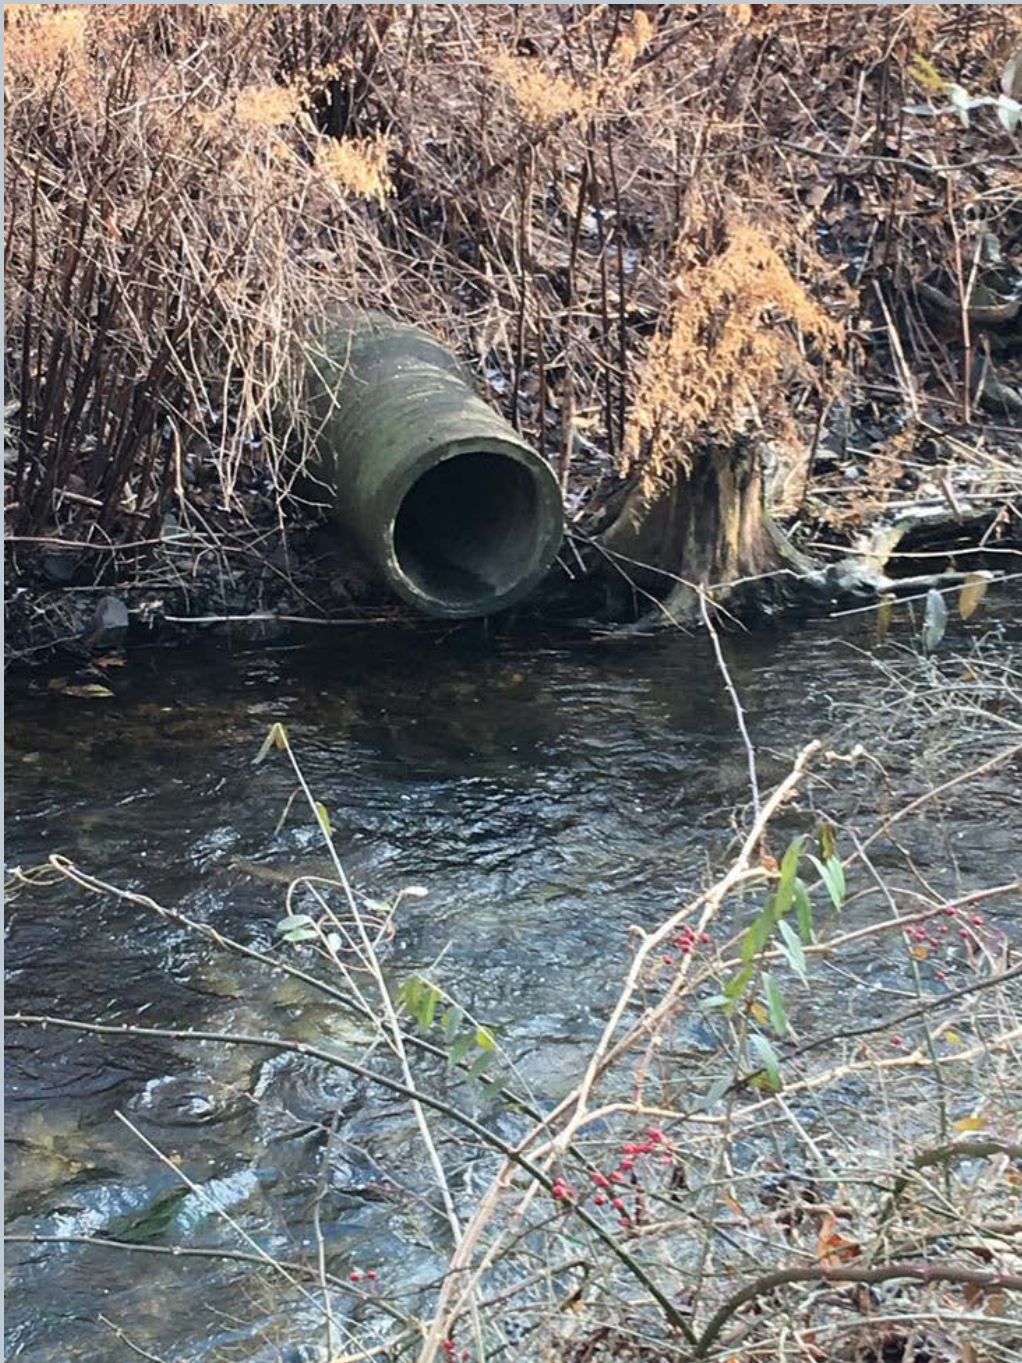
Figure 101. A dry 24-inch concrete stormwater pipe structure. The pipe runs perpendicular to Toby Creek, and is not aligned with the creek.

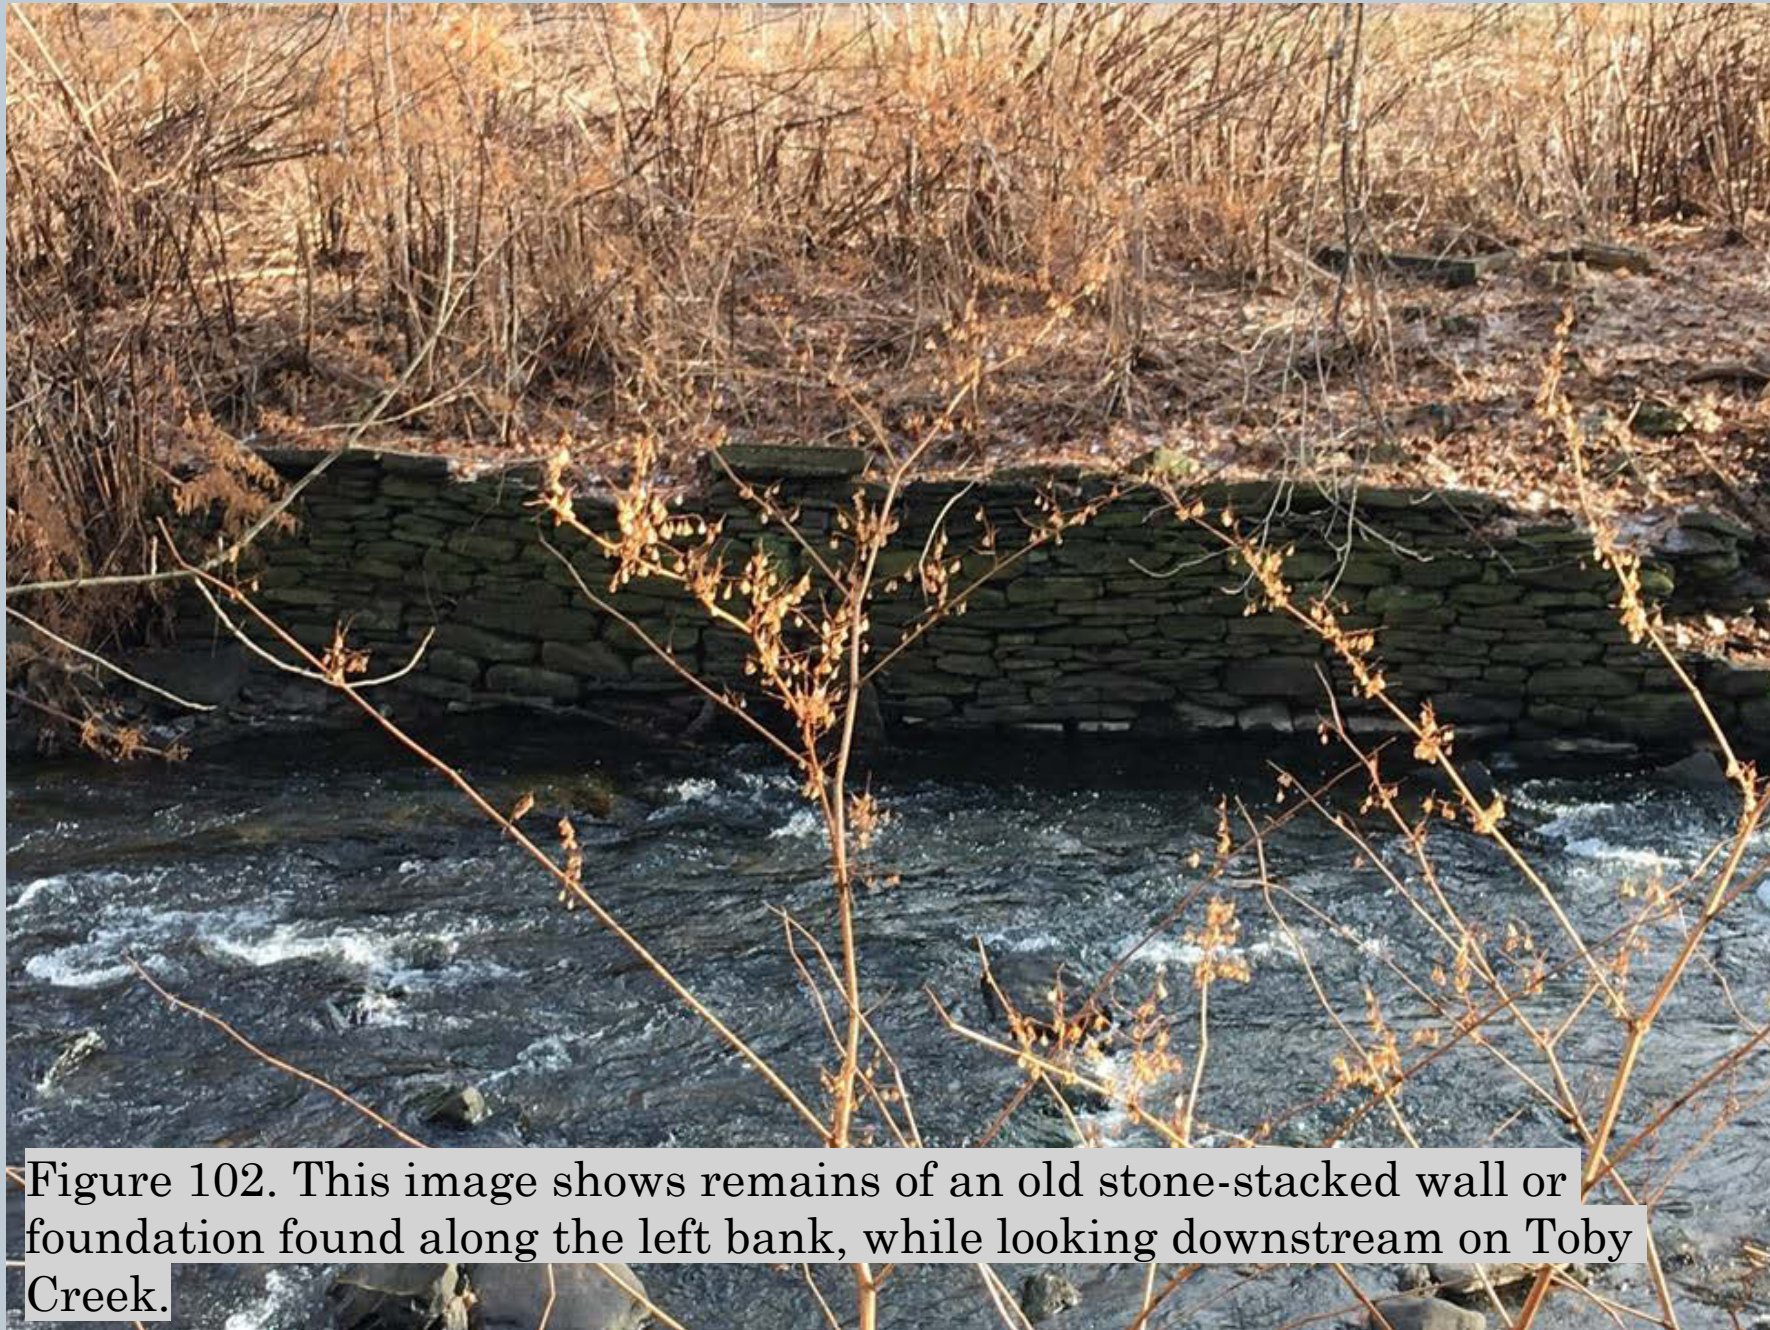
Figure 102. This image shows remains of an old stone-stacked wall or foundation found along the left bank, while looking downstream on Toby Creek.

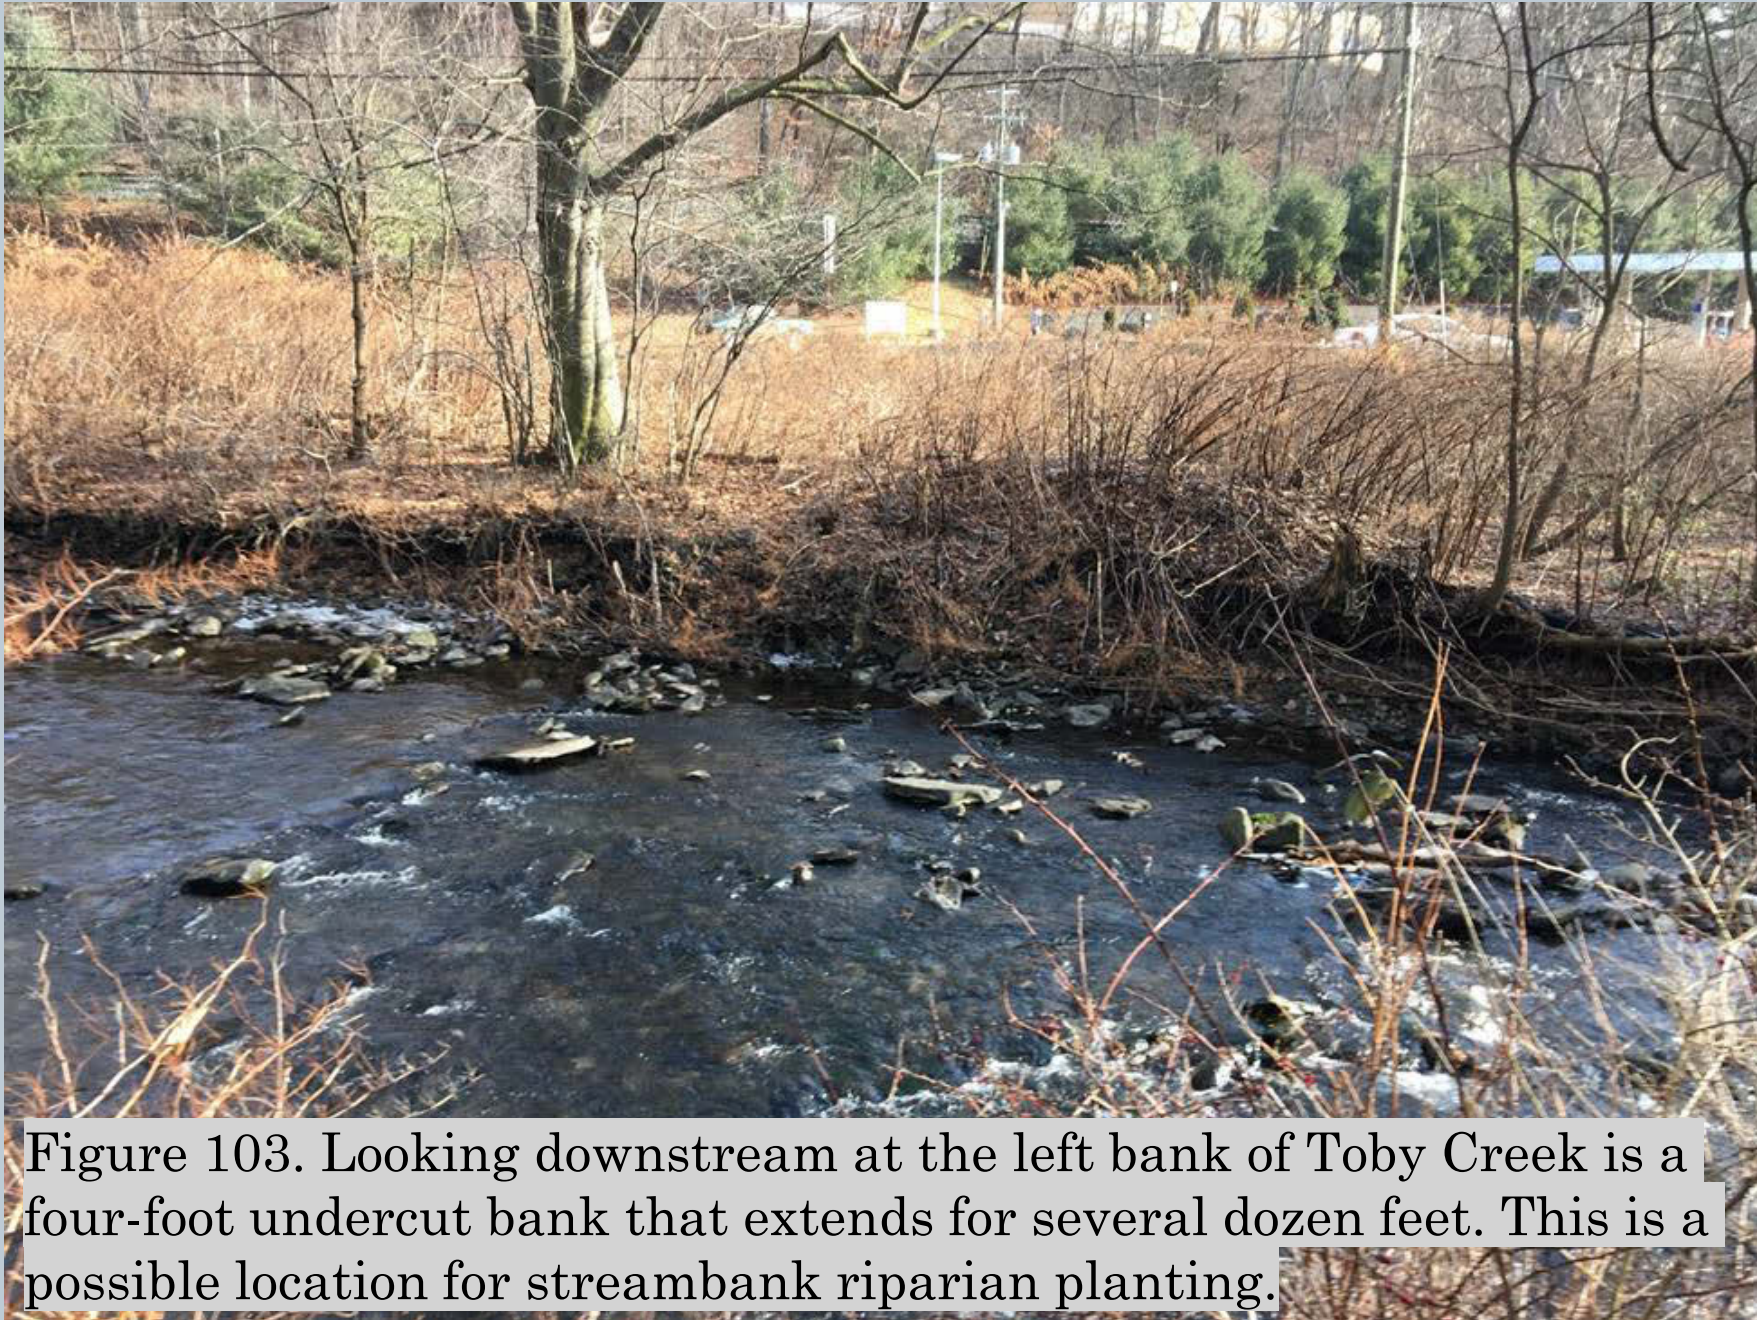
Figure 103. Looking downstream at the left bank of Toby Creek is a four-foot undercut bank that extends for several dozen feet. This is a possible location for streambank riparian planting.

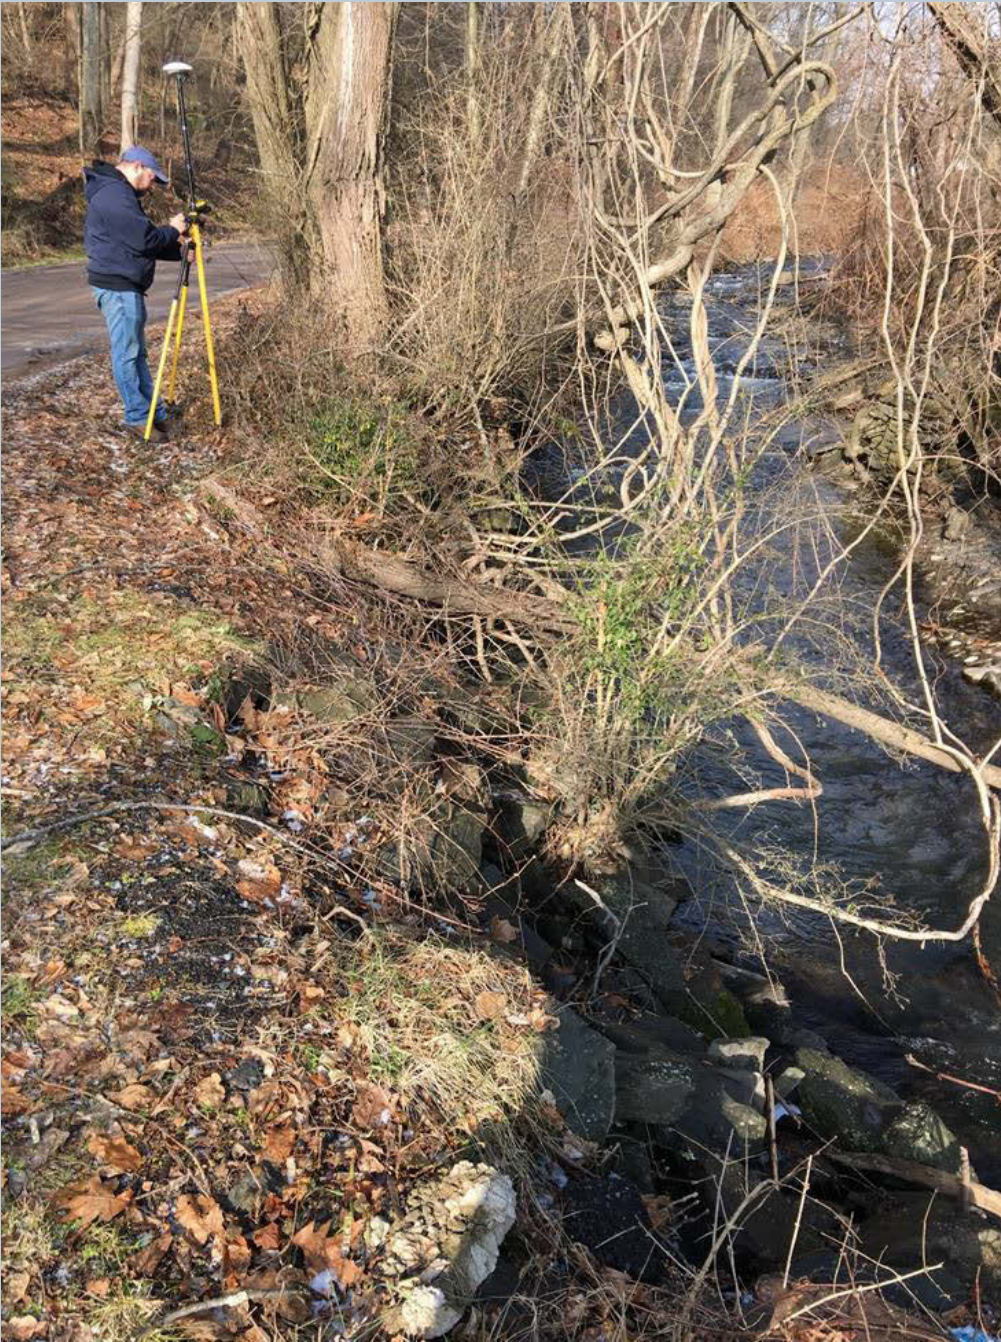
Figure 104. Looking upstream, a stormwater outfall structure is present under the right streambank.

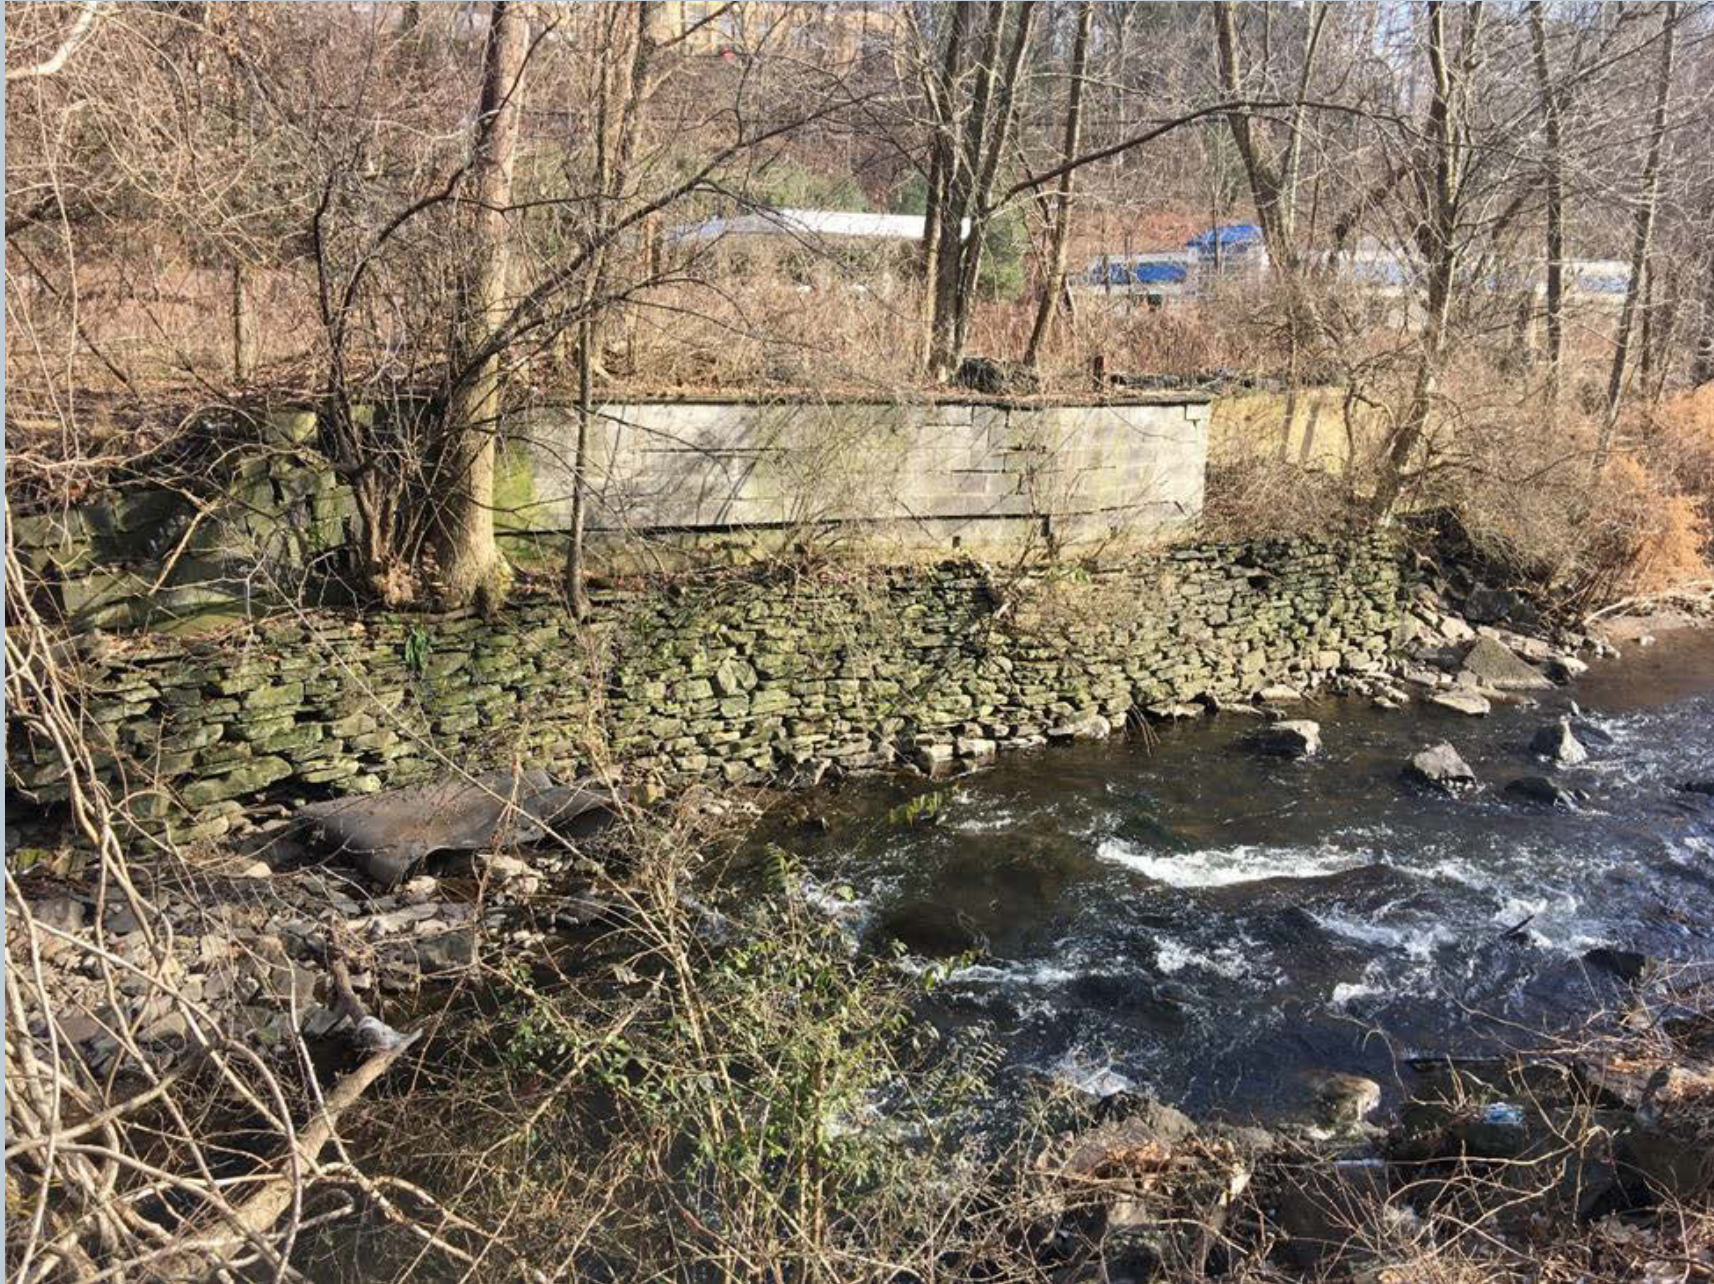
Figure 105. An old stone-stacked wall with a concrete block foundation is located above the floodplain bench and streambank. Upstream, where the wall has failed, there are gravel bar deposits. Near this location, just under a dozen tires have been illegally dumped. A small cleanup along this stretch of Toby Creek, along S. Main Street, would easily remove the tires.

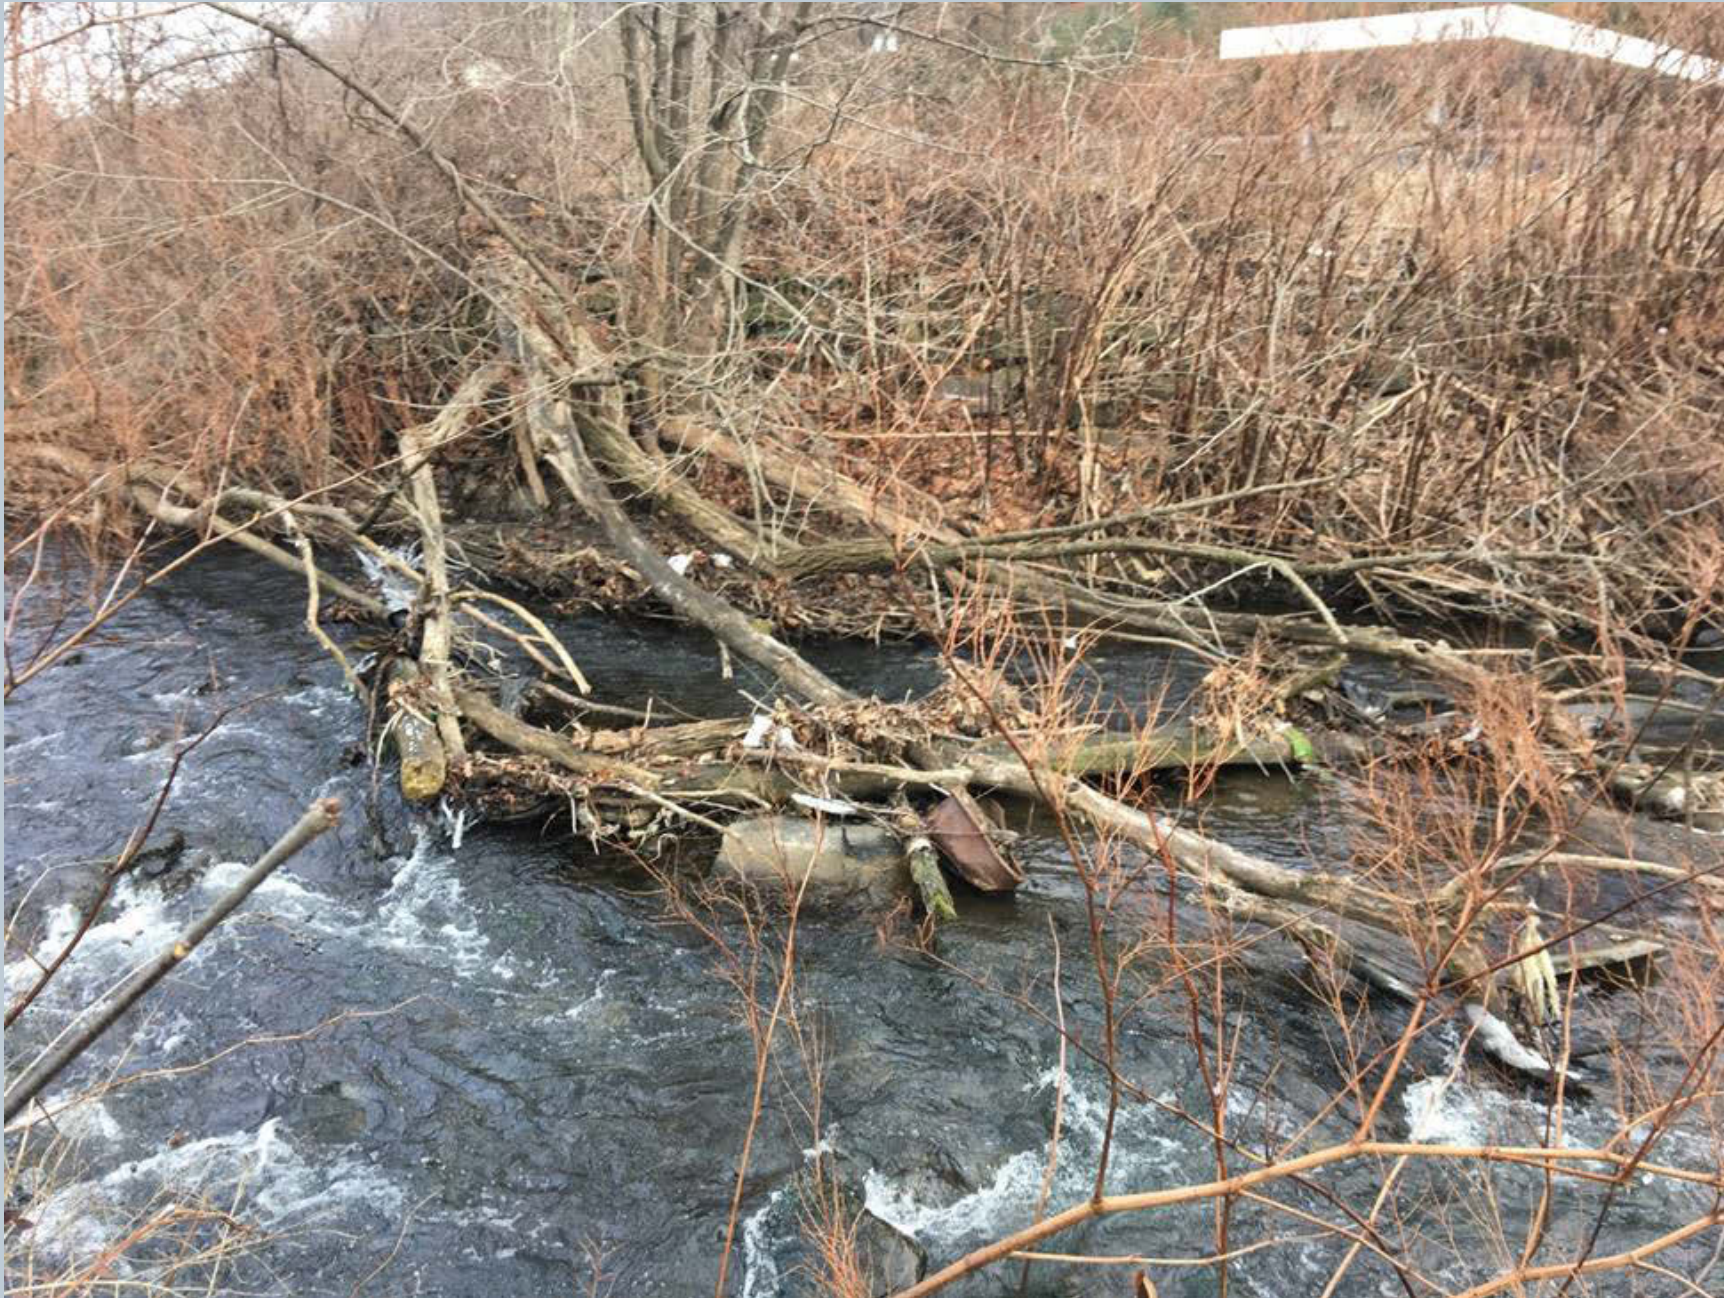
Figure 106. A very large fallen tree and some woody debris that has landed in Toby Creek, redirecting flow to one of the boxes in the bridge. This has created a gravel bar deposition behind the tree, just upstream of the bridge over State Route 309, along S. Main Street.

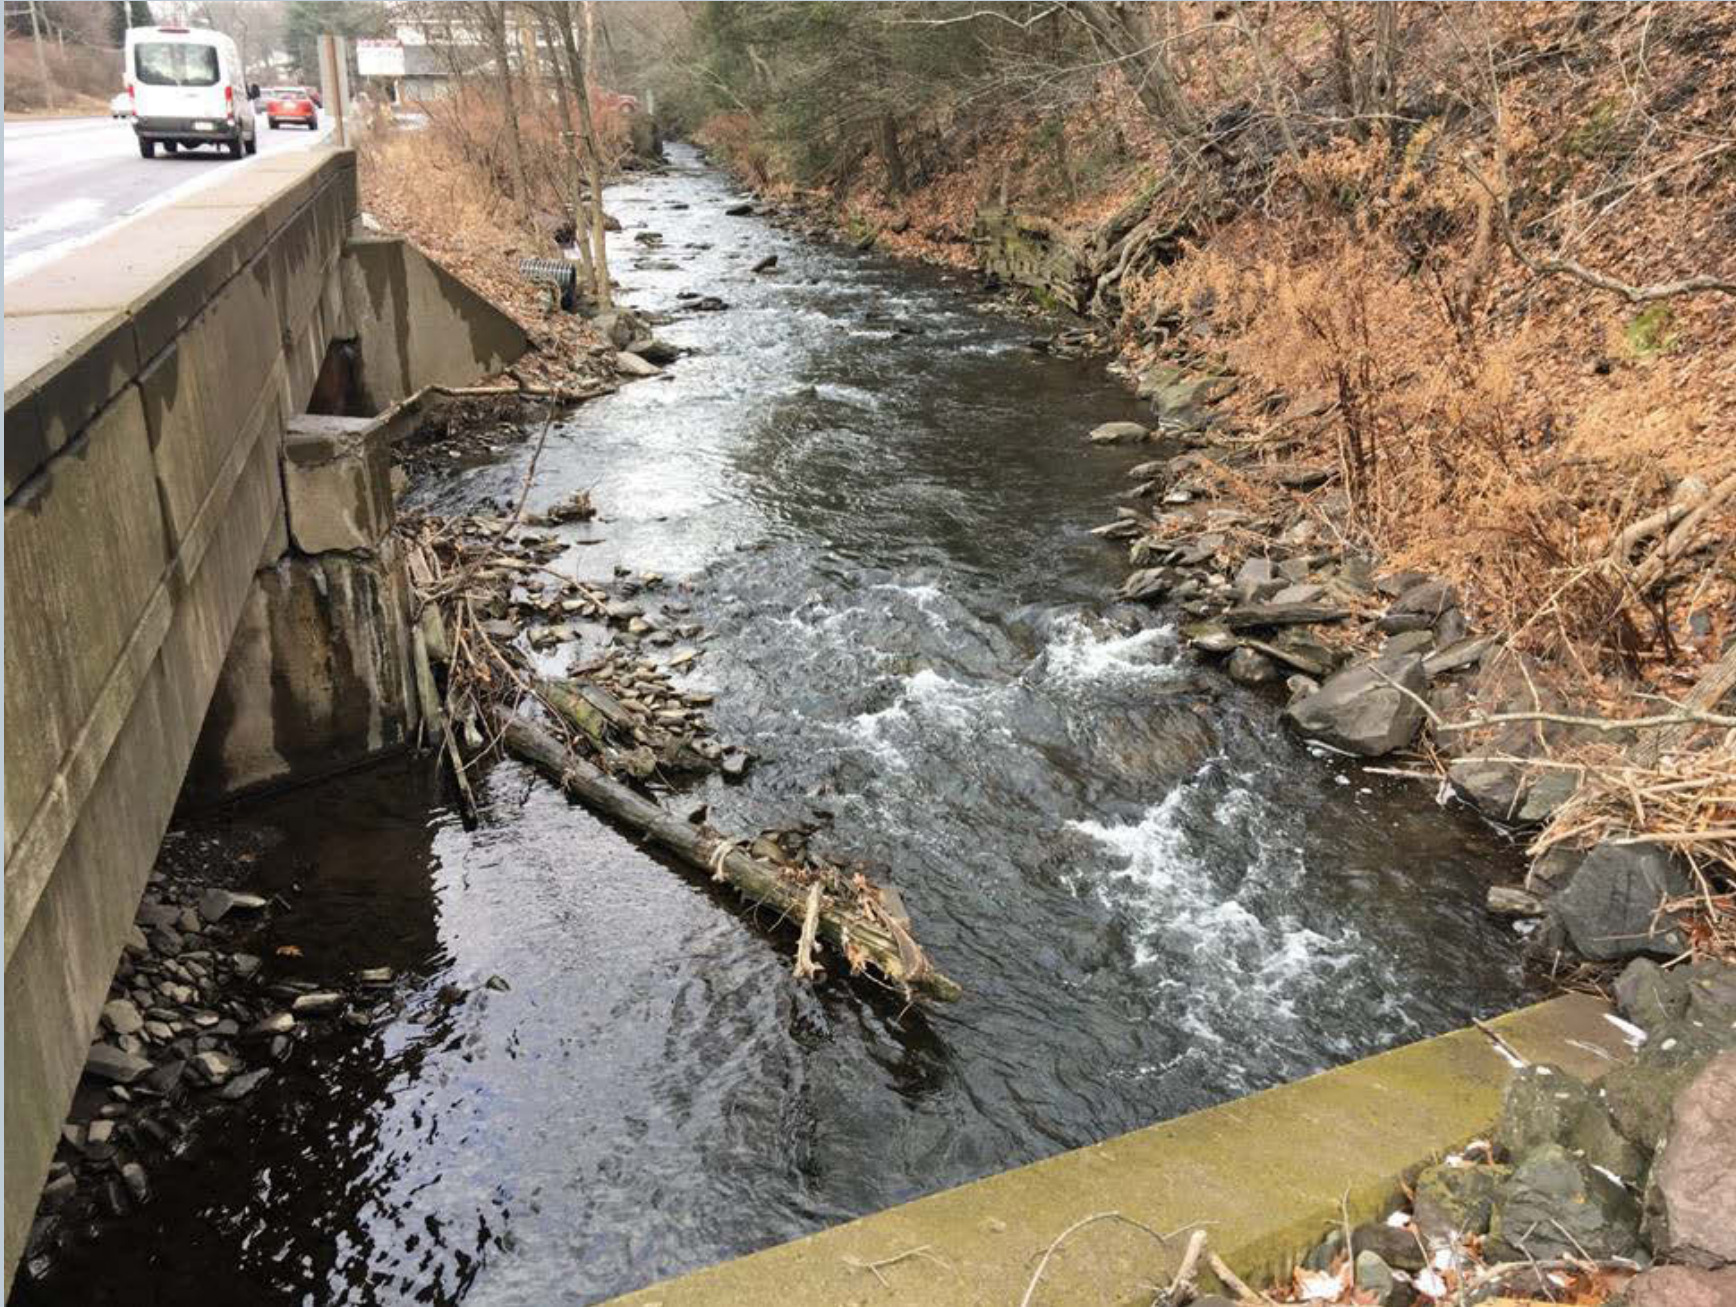
Figure 107. Looking upstream on Toby Creek from the double box culvert bridge over State Route 309, debris can be seen piled up against the middle abutment. 70% of the creek flows through the left box on the upstream side of the bridge.

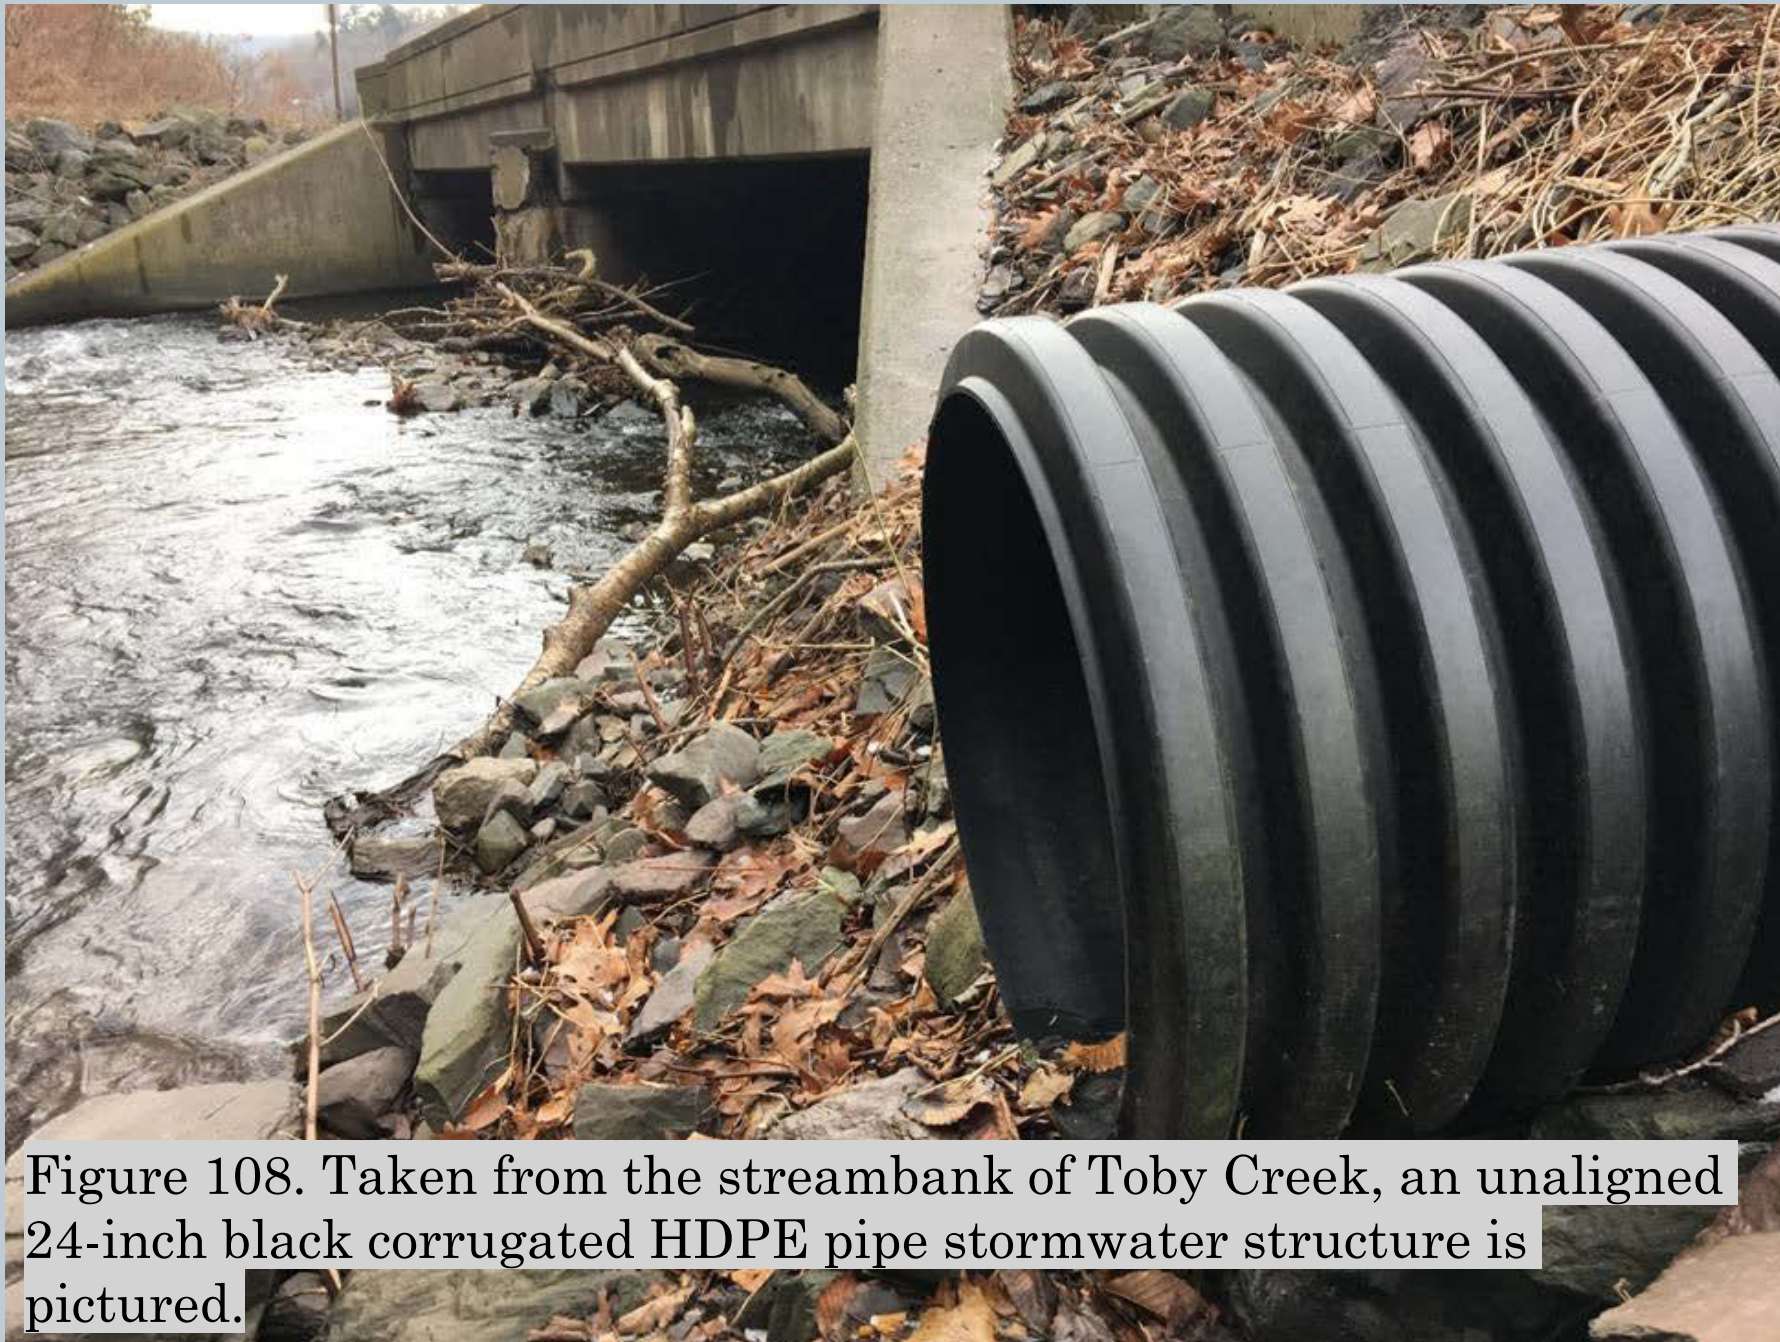
Figure 108. Taken from the streambank of Toby Creek, an unaligned 24-inch black corrugated HDPE pipe stormwater structure is pictured.

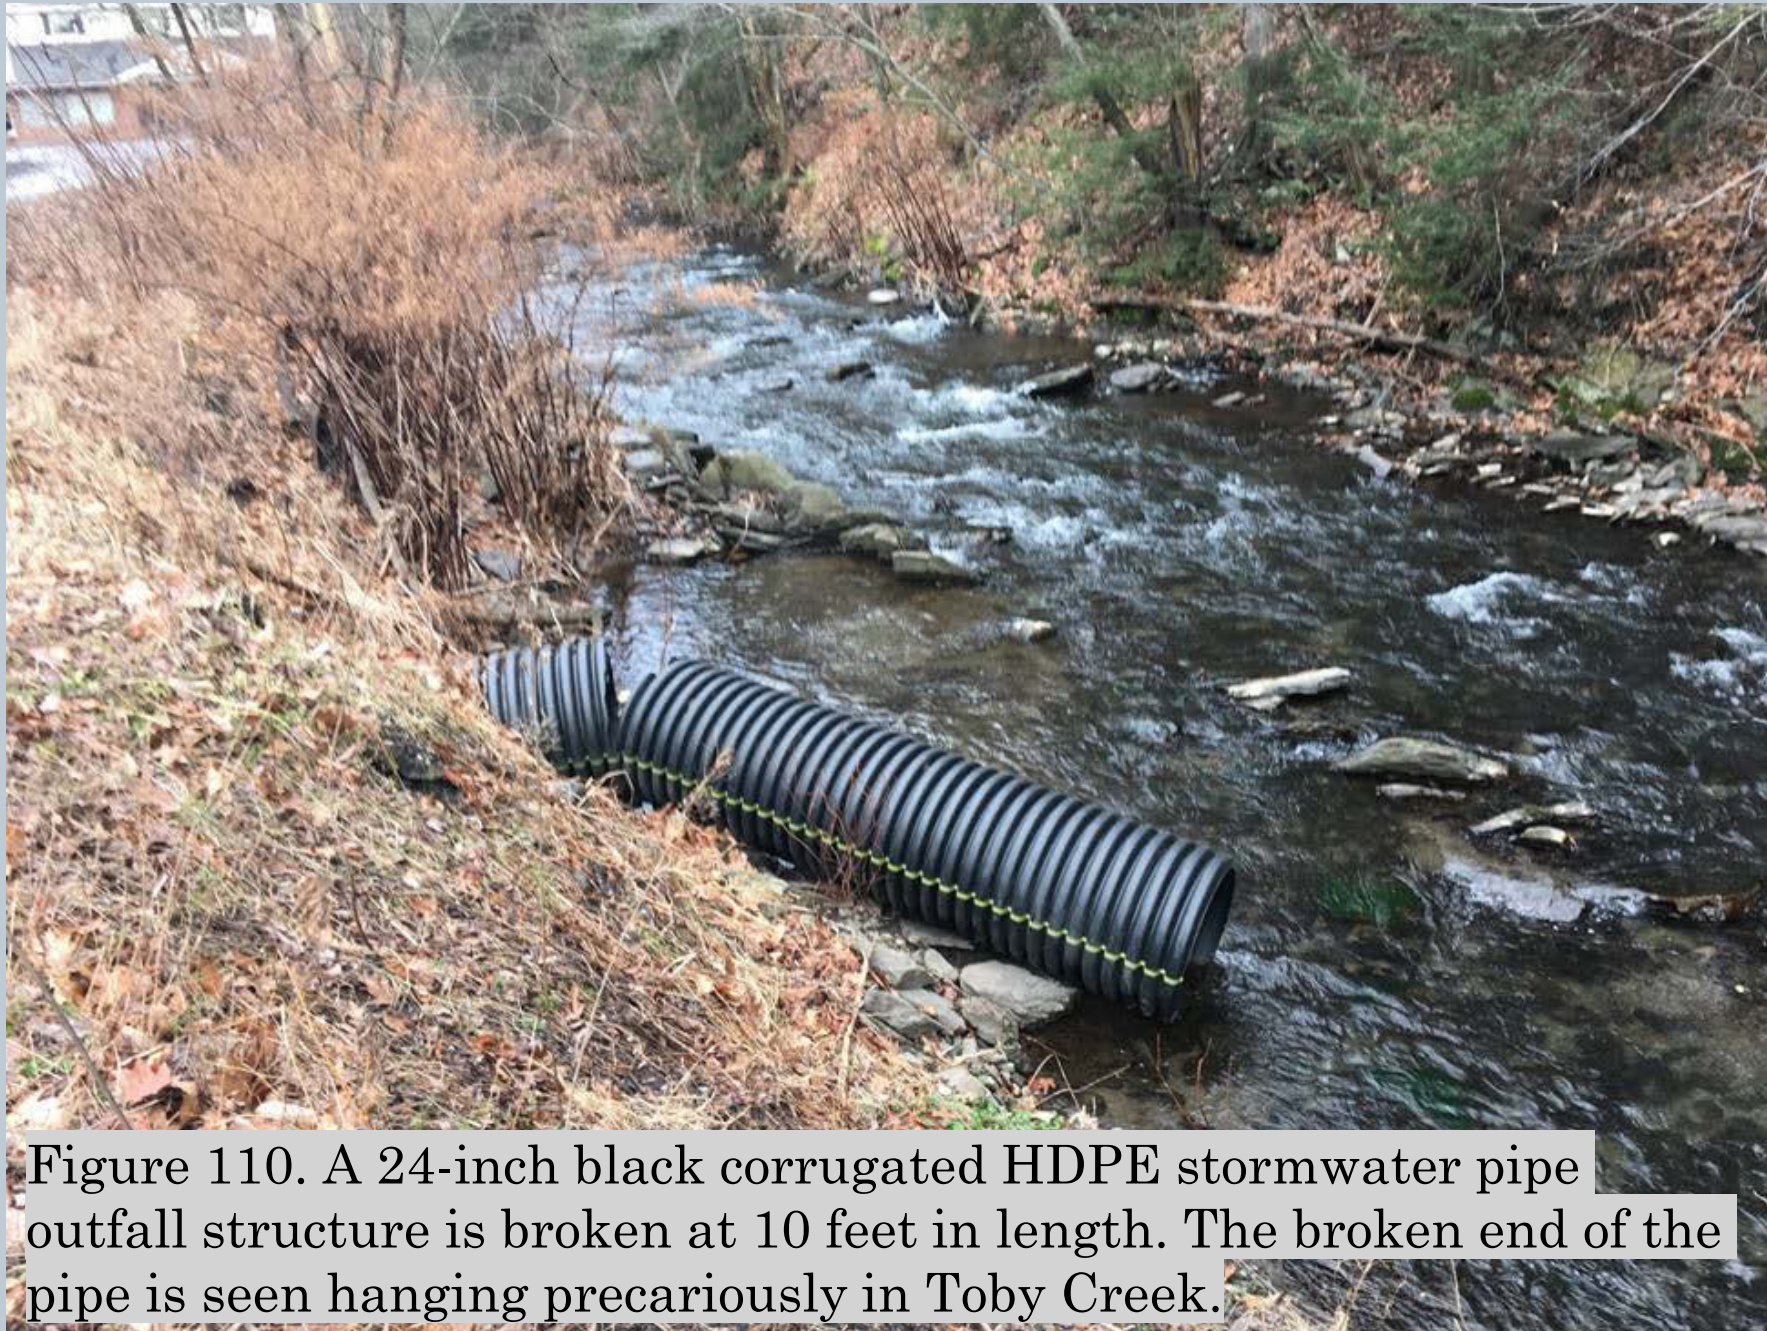
Figure 110. A 24-inch black corrugated HDPE stormwater pipe outfall structure is broken at 10 feet in length. The broken end of the pipe is seen hanging precariously in Toby Creek.
