Toby Creek Field Reconnaissance Observations

September 26, 2018

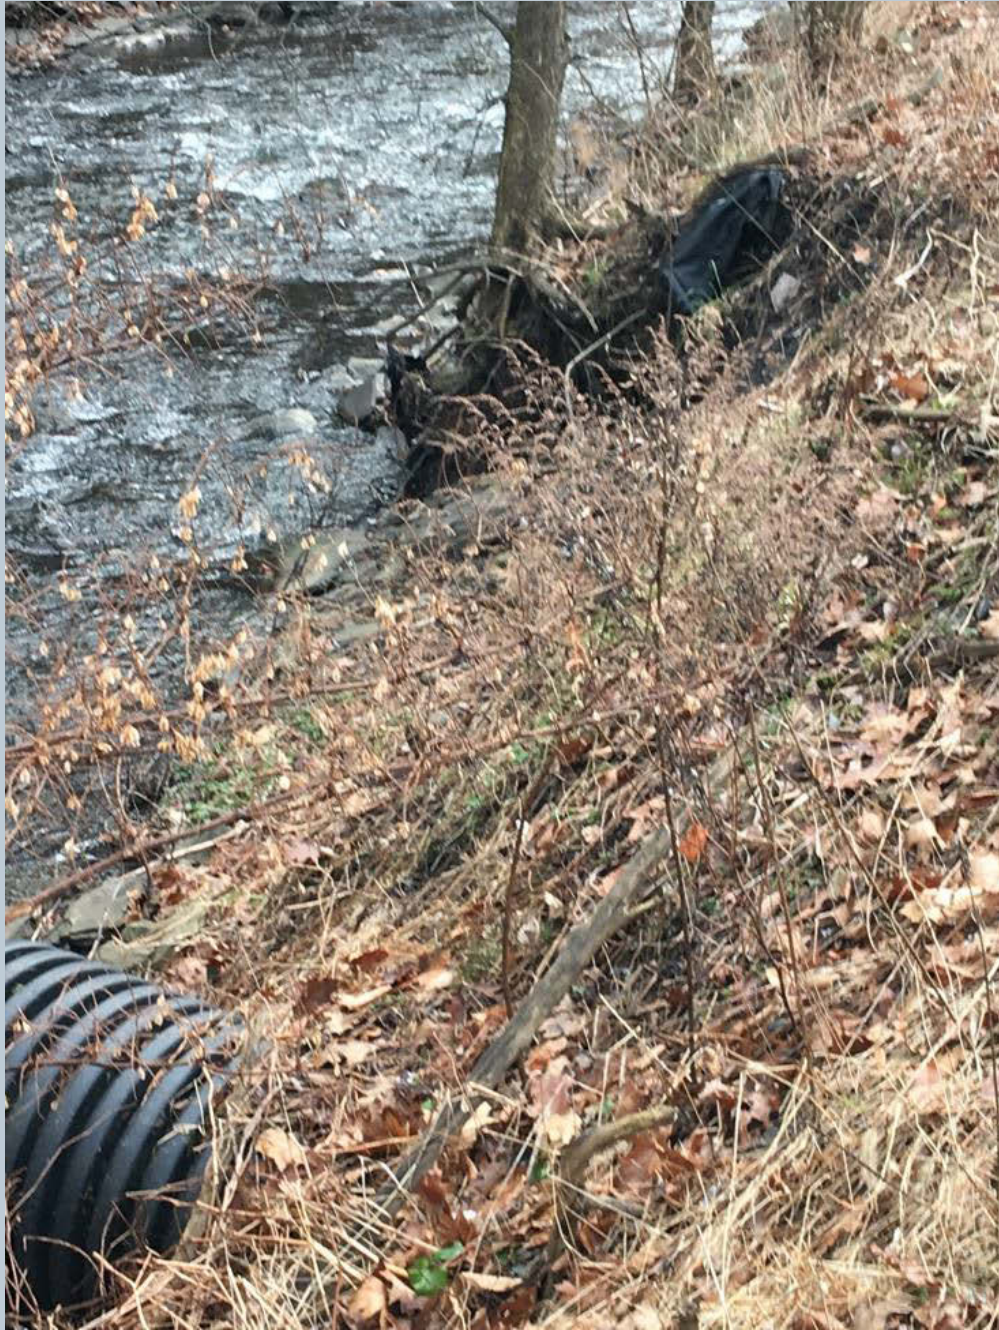
Figure 111. A shot of some minor streambank erosion on the right bank of Toby Creek, looking downstream, just beyond the broken HDPE pipe.

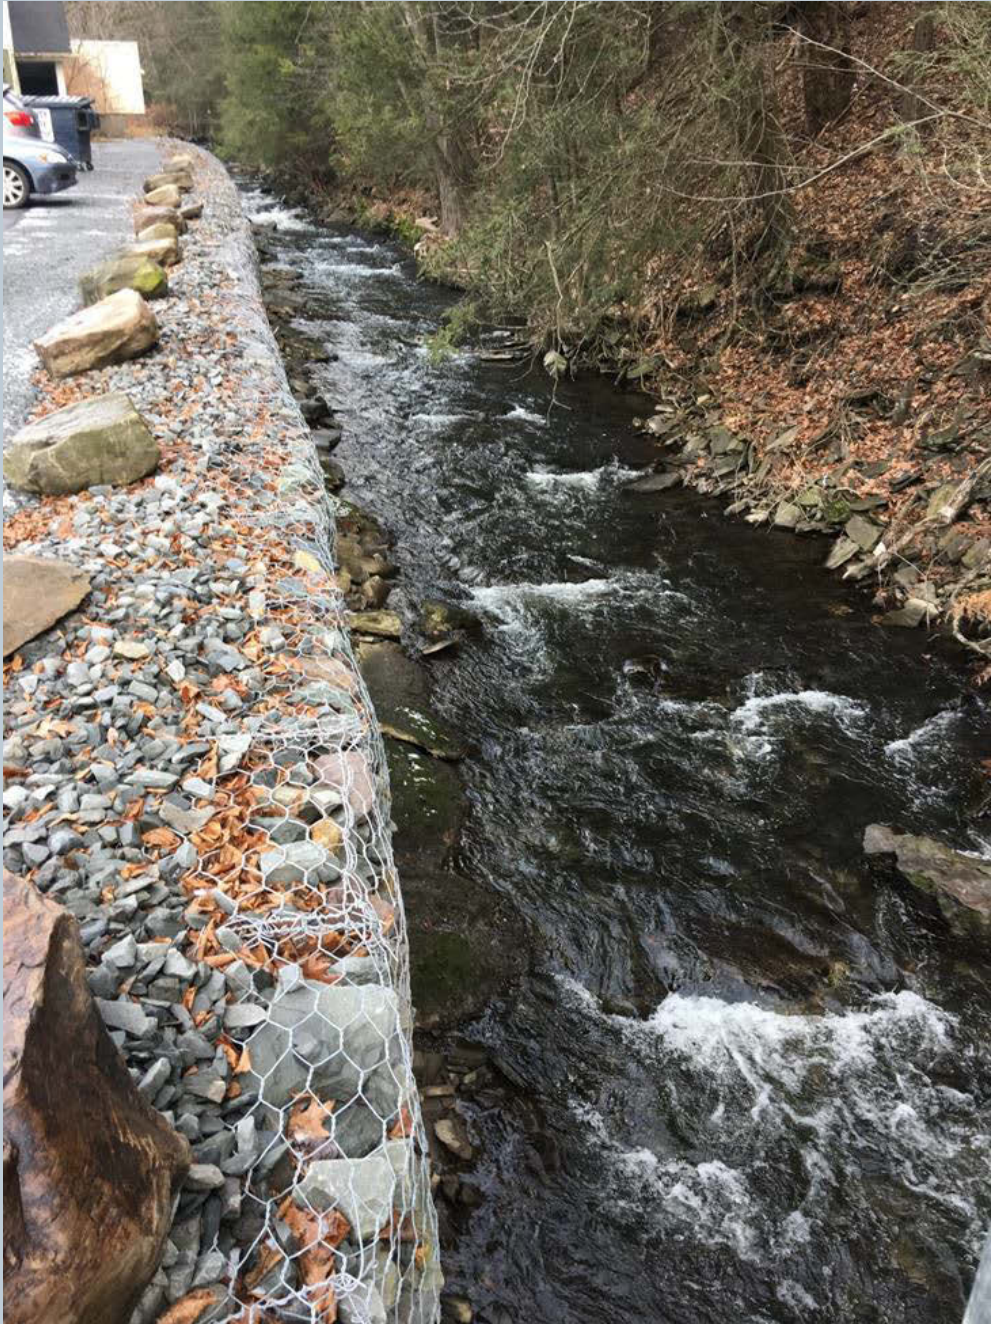
Figure 112. A rock gabion basket retaining wall is in place for several hundred feet along the 309 Professional Building as a streambank stabilization effort. This wall is in place from historic flooding and previous damage to the area.

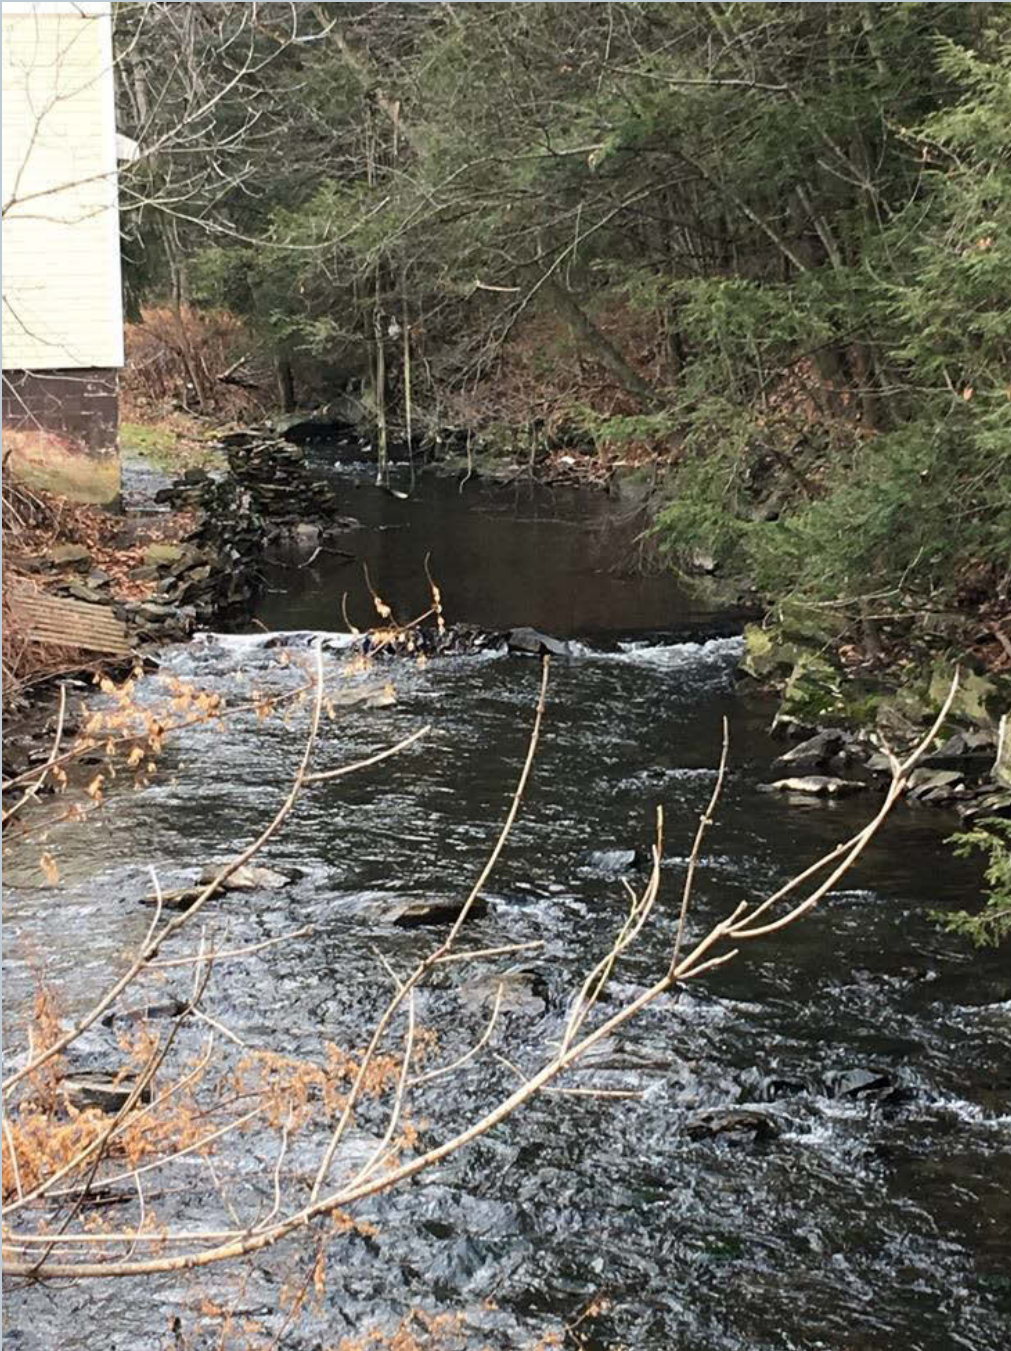
Figure 113. Behind Modern the Floor Store, a small dam is in Toby Creek which is creating a small pool.

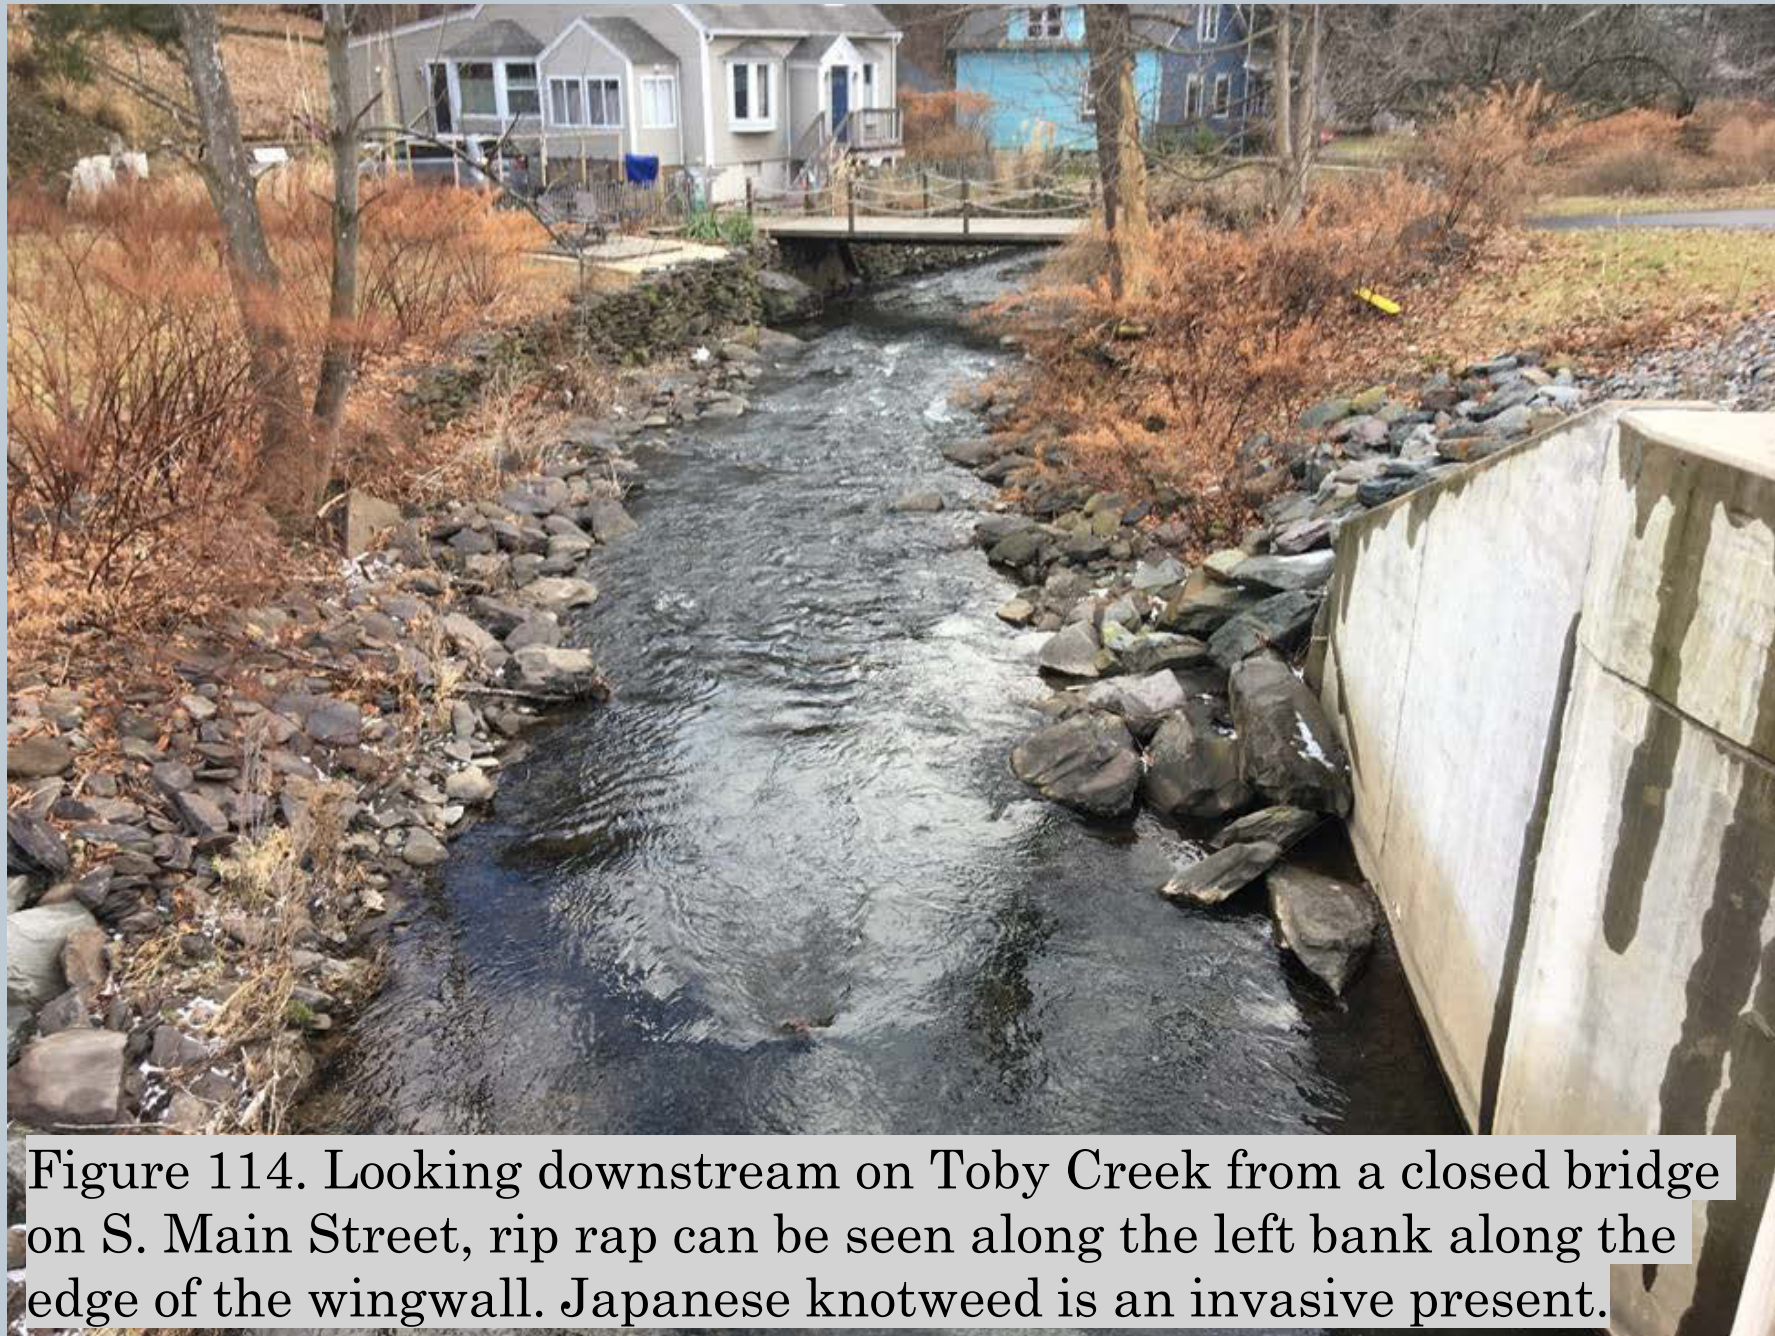
Figure 114. Looking downstream on Toby Creek from a closed bridge on S. Main Street, rip rap can be seen along the left bank along the edge of the wingwall. Japanese knotweed is an invasive present.

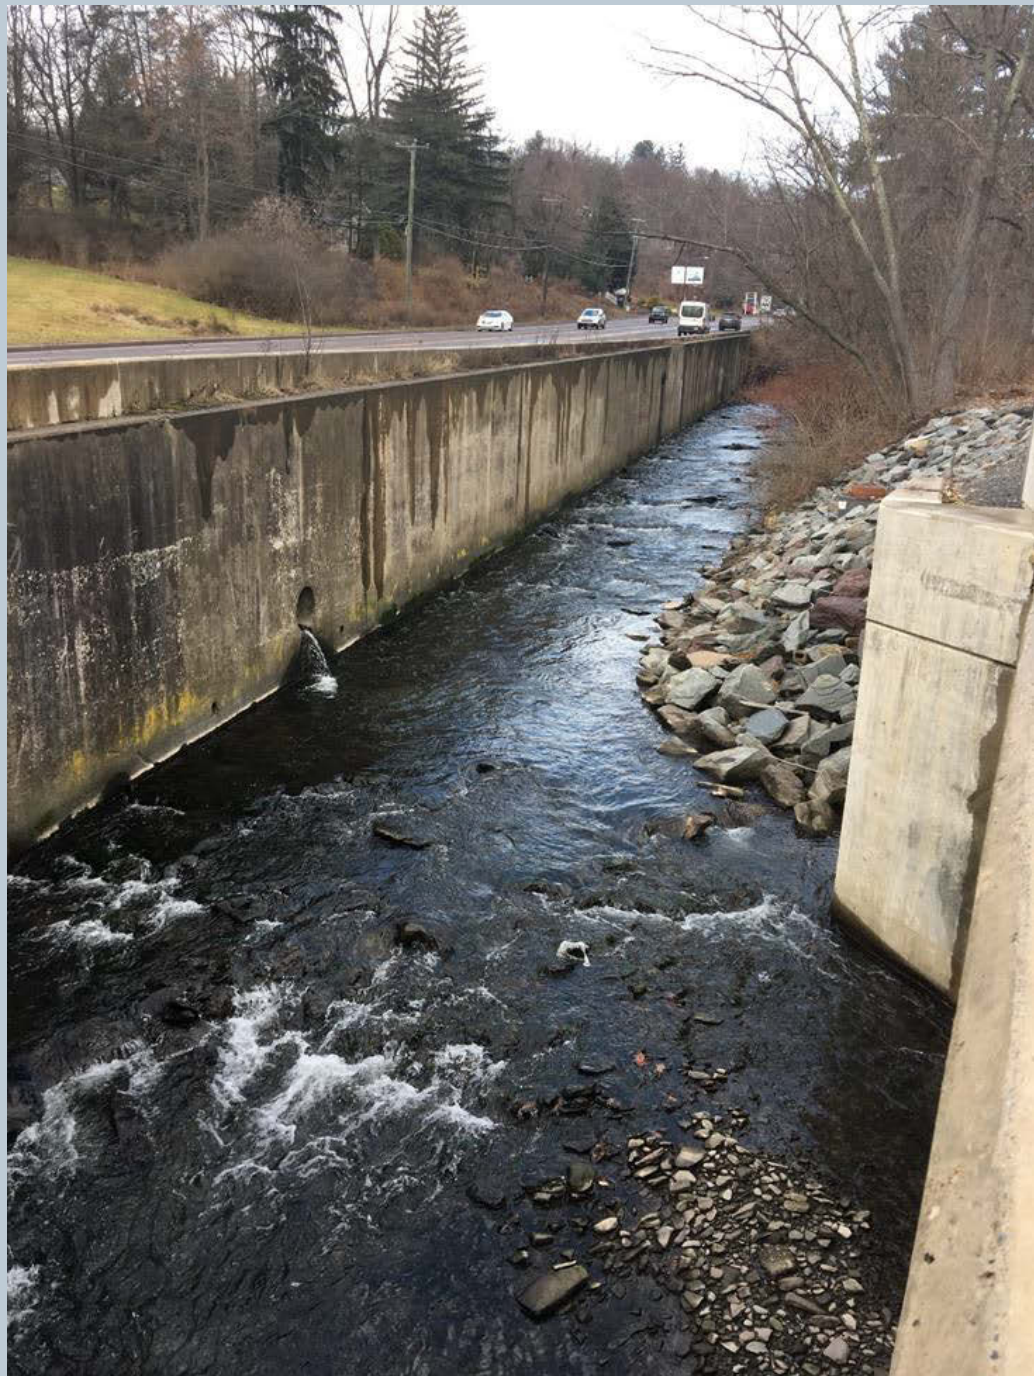
Figure 115. Looking upstream on Toby Creek from the closed S. Main Street bridge, there is a long concrete retaining wall that continues along the entire length of State Route 309 in this area.

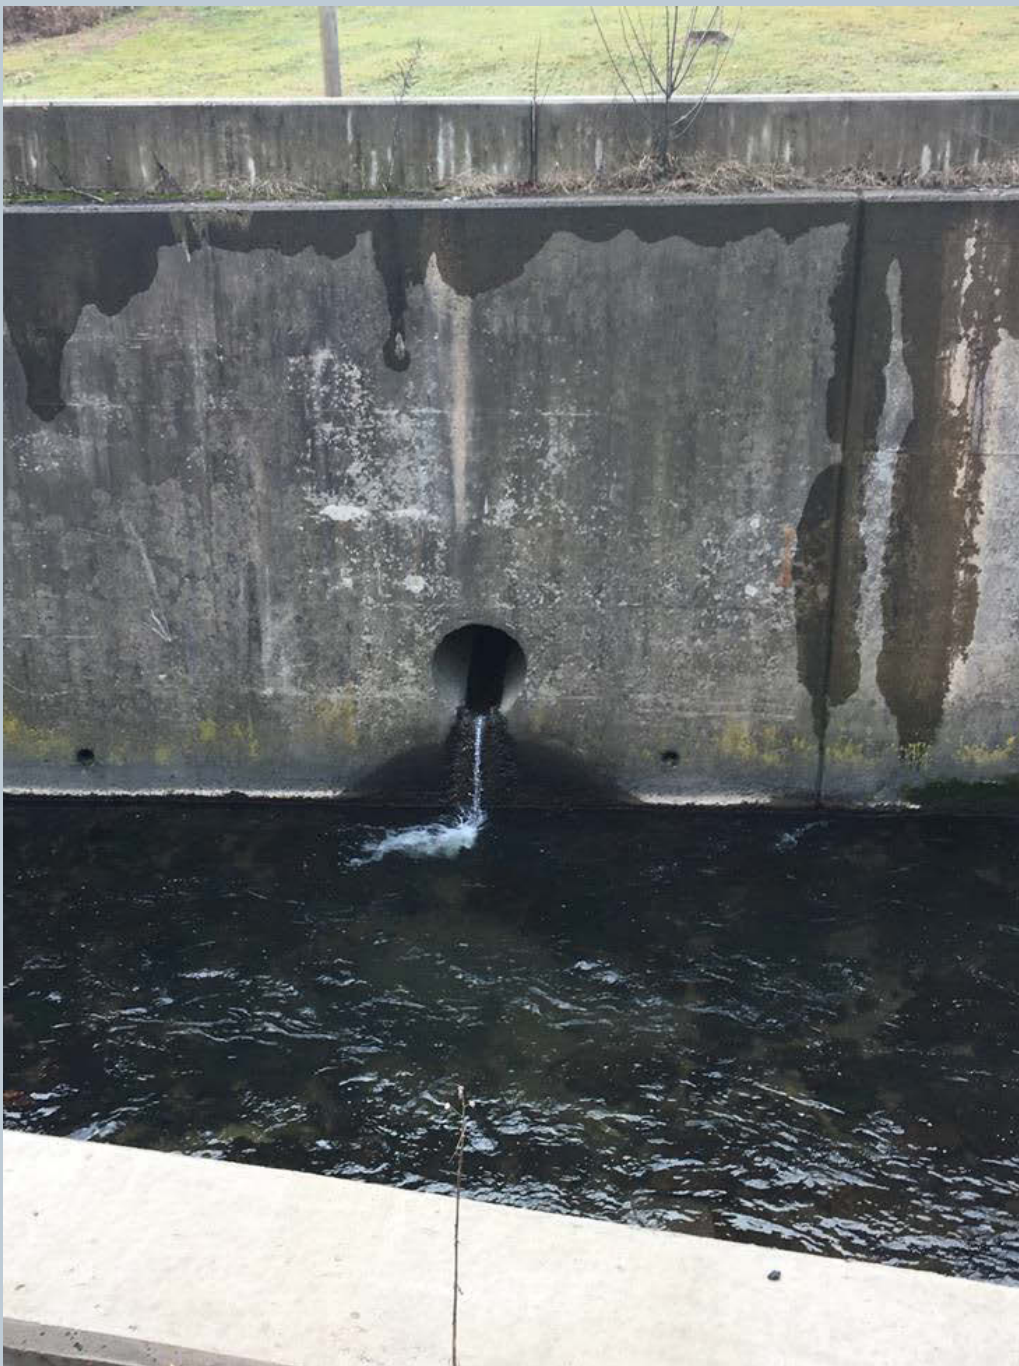
Figure 116. Flowing through the lower portion of the retaining wall, an UNT from Mt. Greenwood Cemetery flows into Toby Creek.

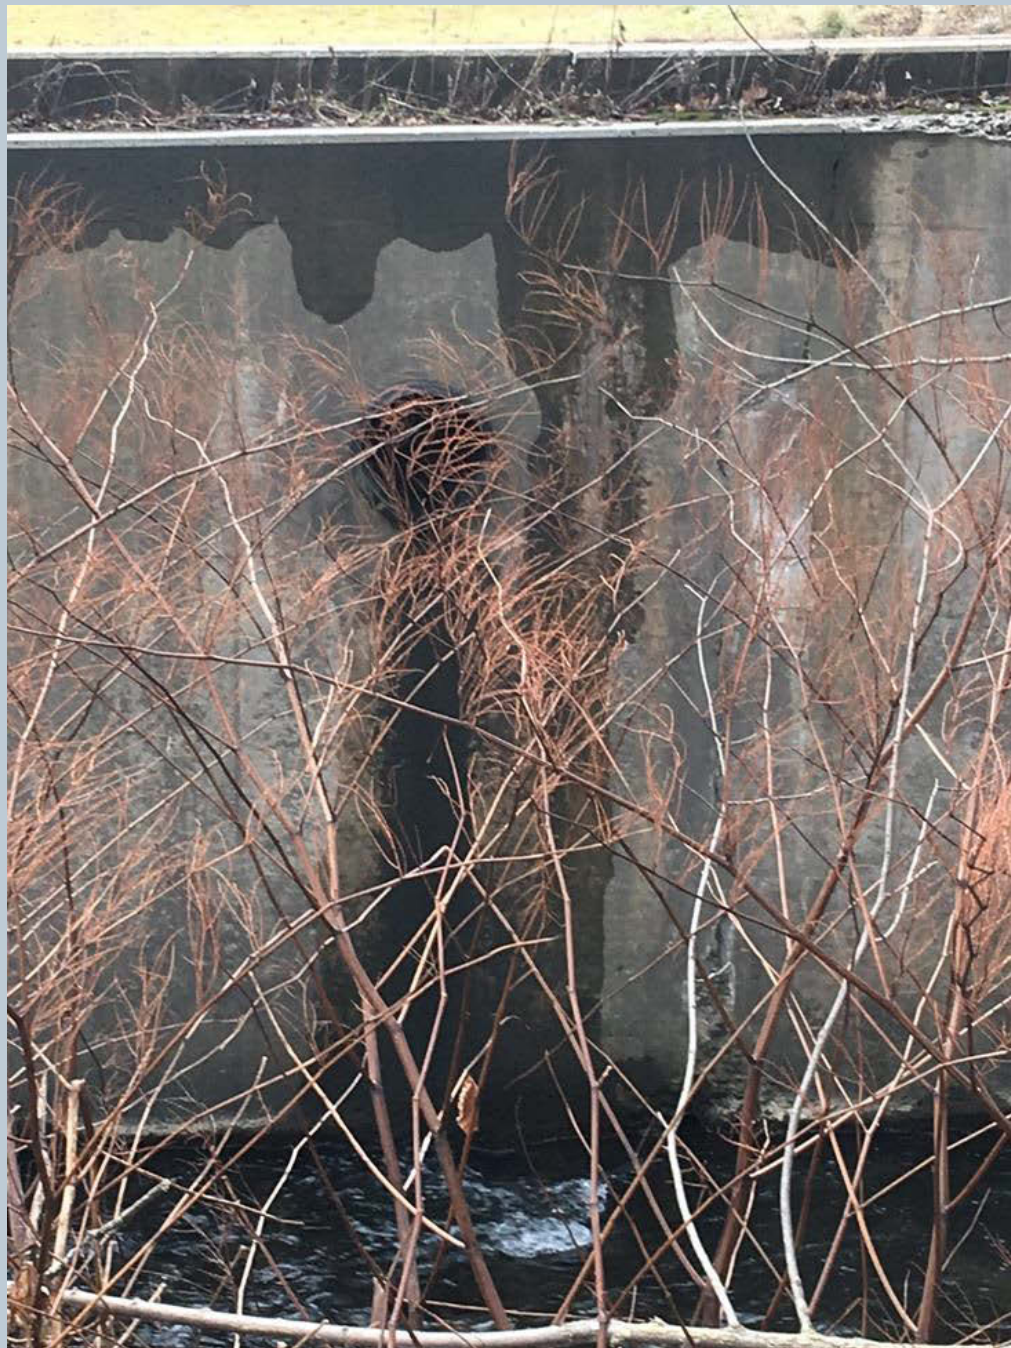
Figure 117. An 18-inch dry black HDPE stormwater pipe comes through the upper retaining wall, which is draining from State Route 309.

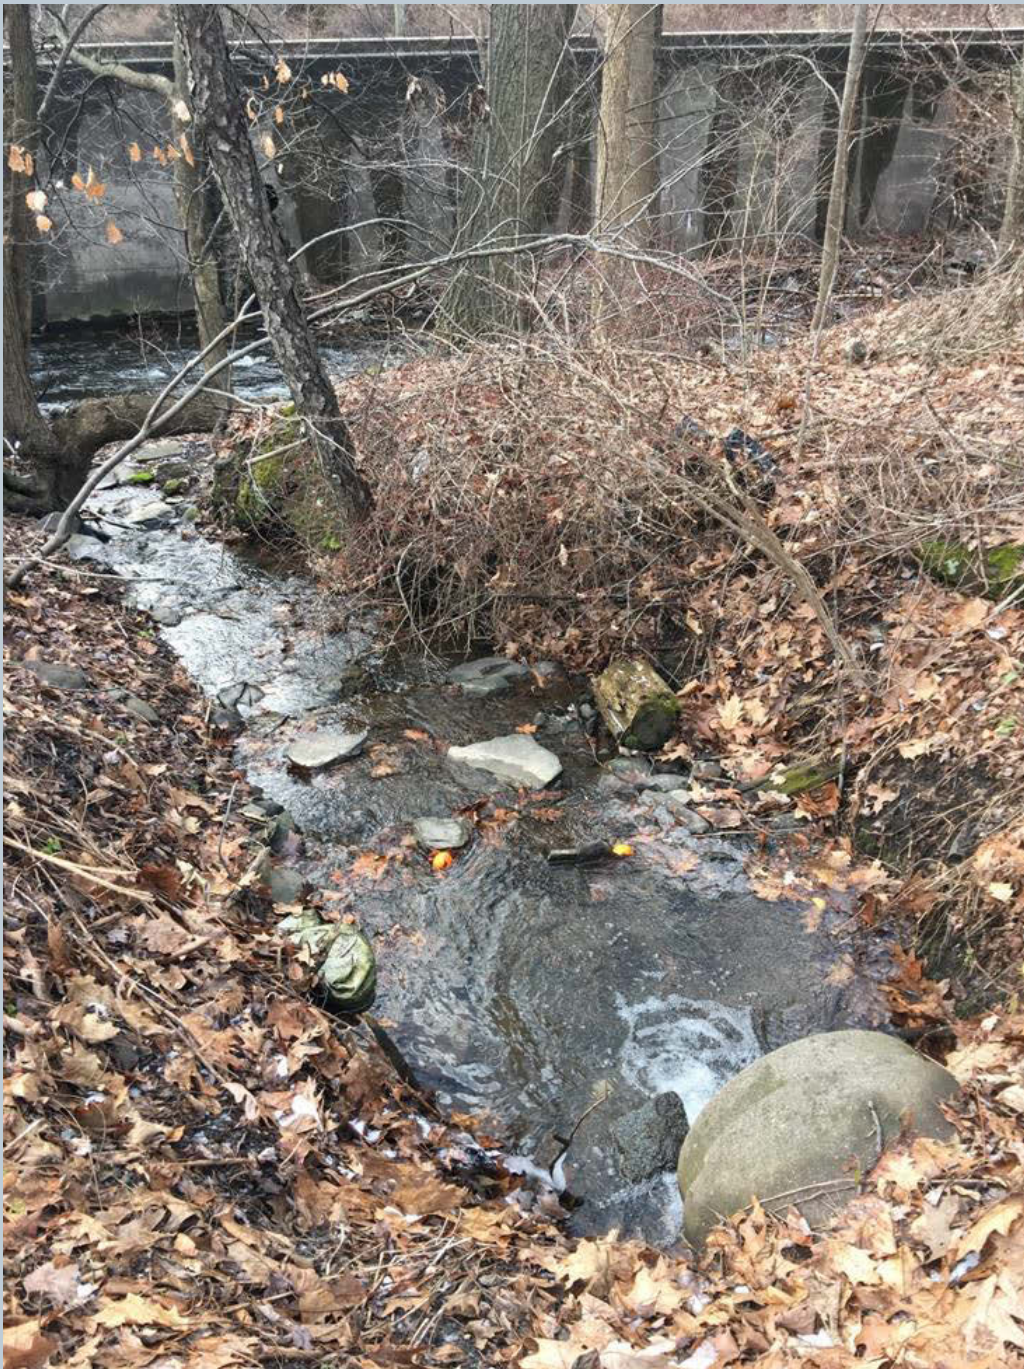
Figure 118. An UNT to Toby Creek flows from an 18-inch concrete pipe along N. Main Street and Division Street, which is aligned with Toby Creek.

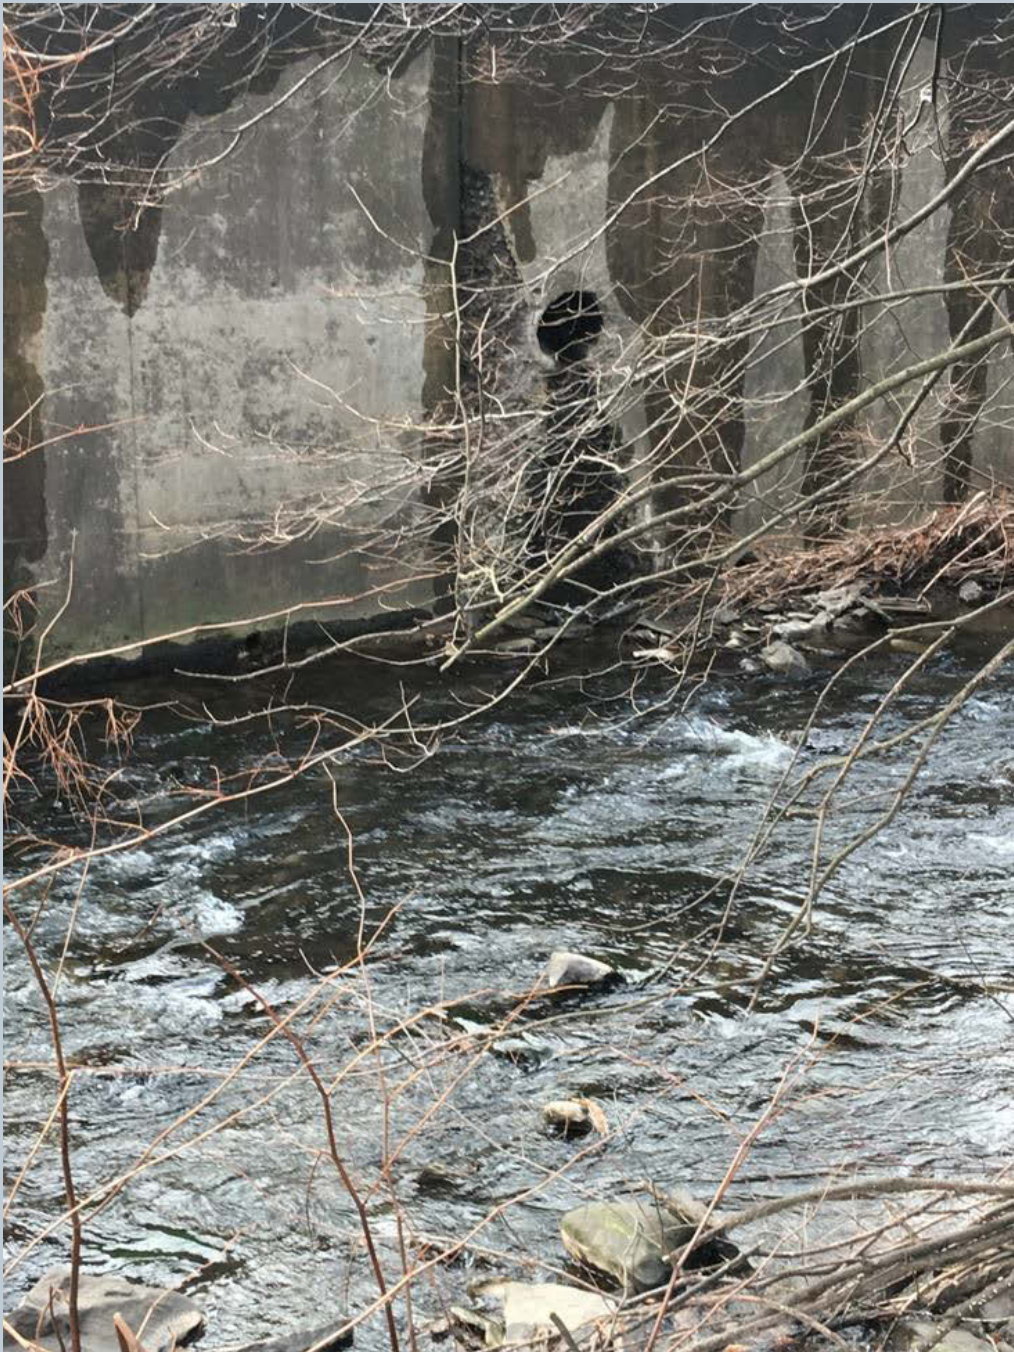
Figure 119. An UNT to Toby Creek flows from the middle of the concrete retaining wall (pictured) along N. Main Street and Division Street.

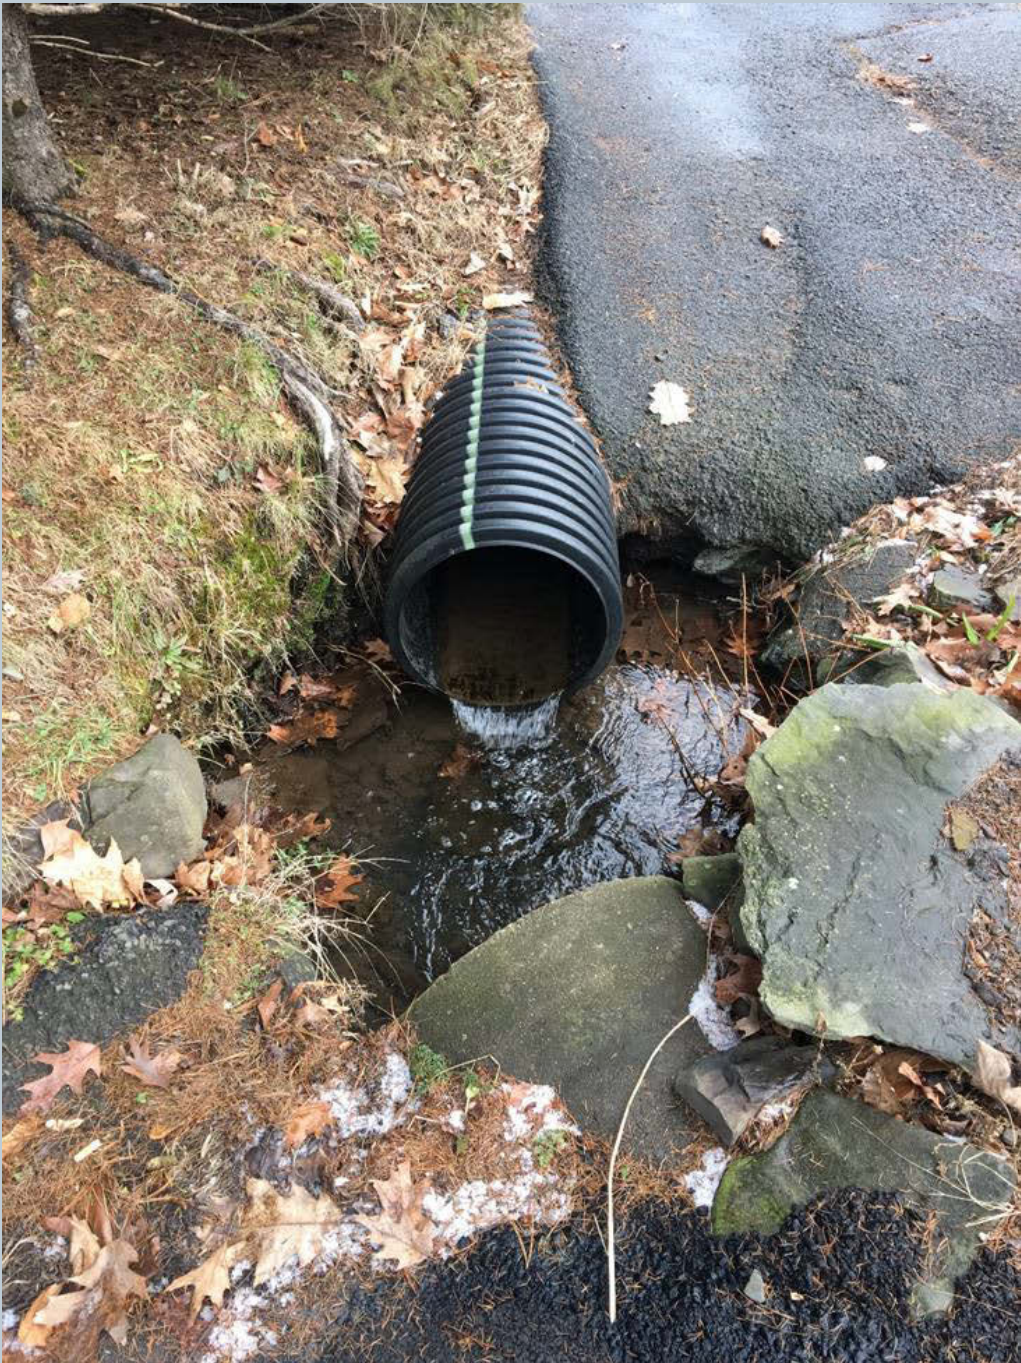
Figure 120. A shot of an 18-inch black HDPE pipe that is disconnected from another 18-inch concrete pipe at the corner of N. Main Street and Division Street, separated by a two-foot gap and drop that allows for roadside runoff. This runoff then enters the 18-inch concrete pipe that carries the stormwater and the UNT to Toby Creek.

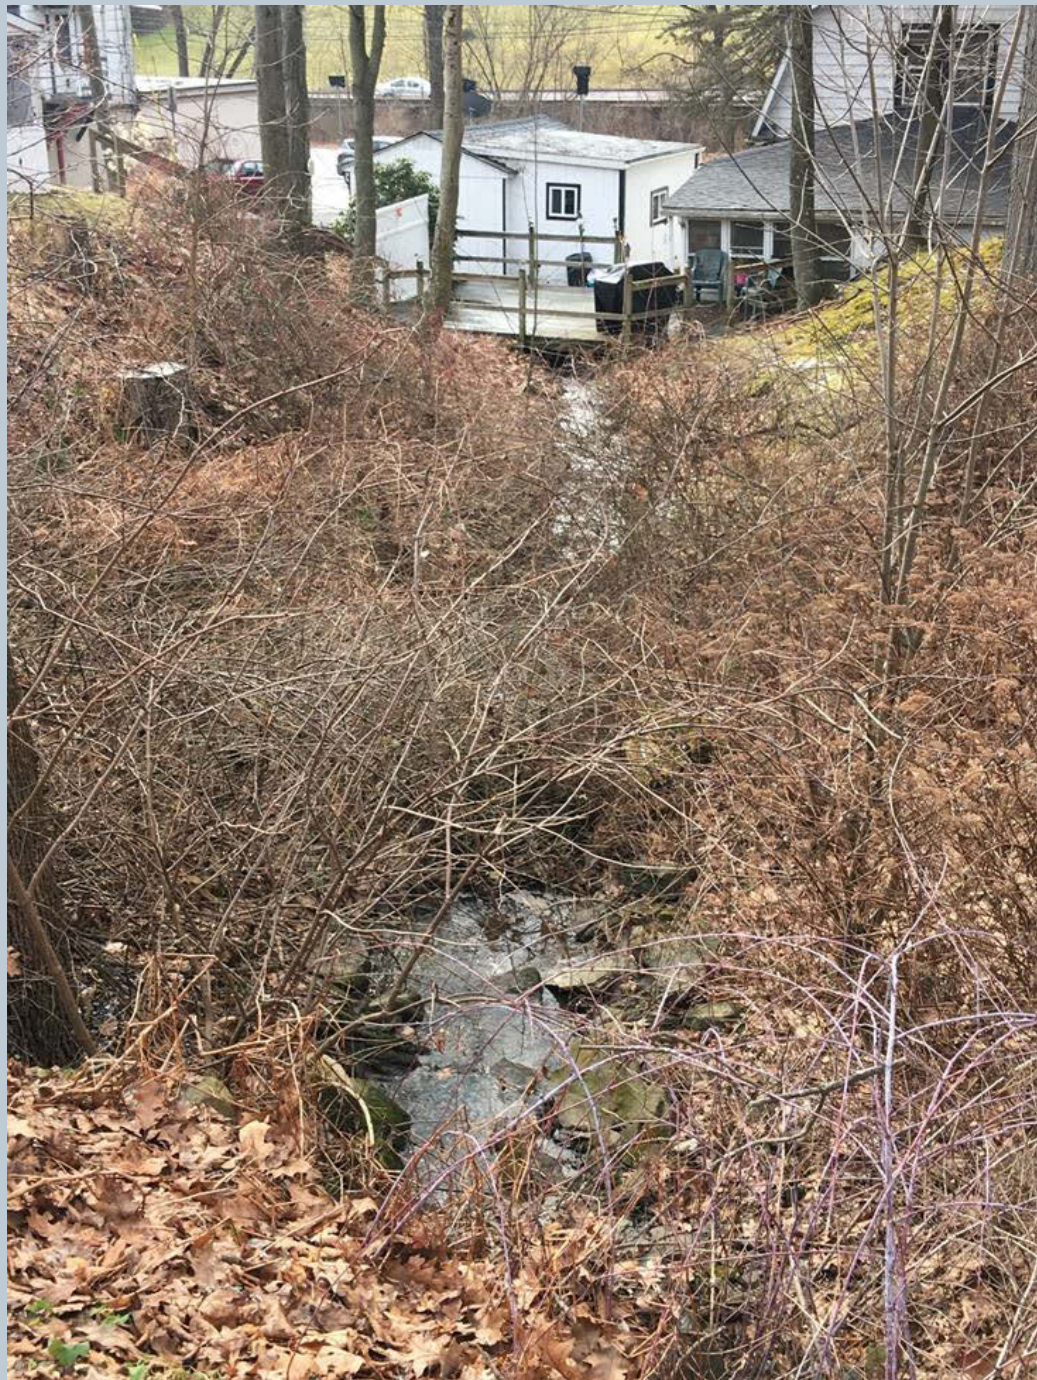
Figure 121. An UNT to Toby Creek that flows through a stone culvert beneath Railroad Street, directly under the deck and shed of a private residence on the corner of N. Main Street and Division Street.

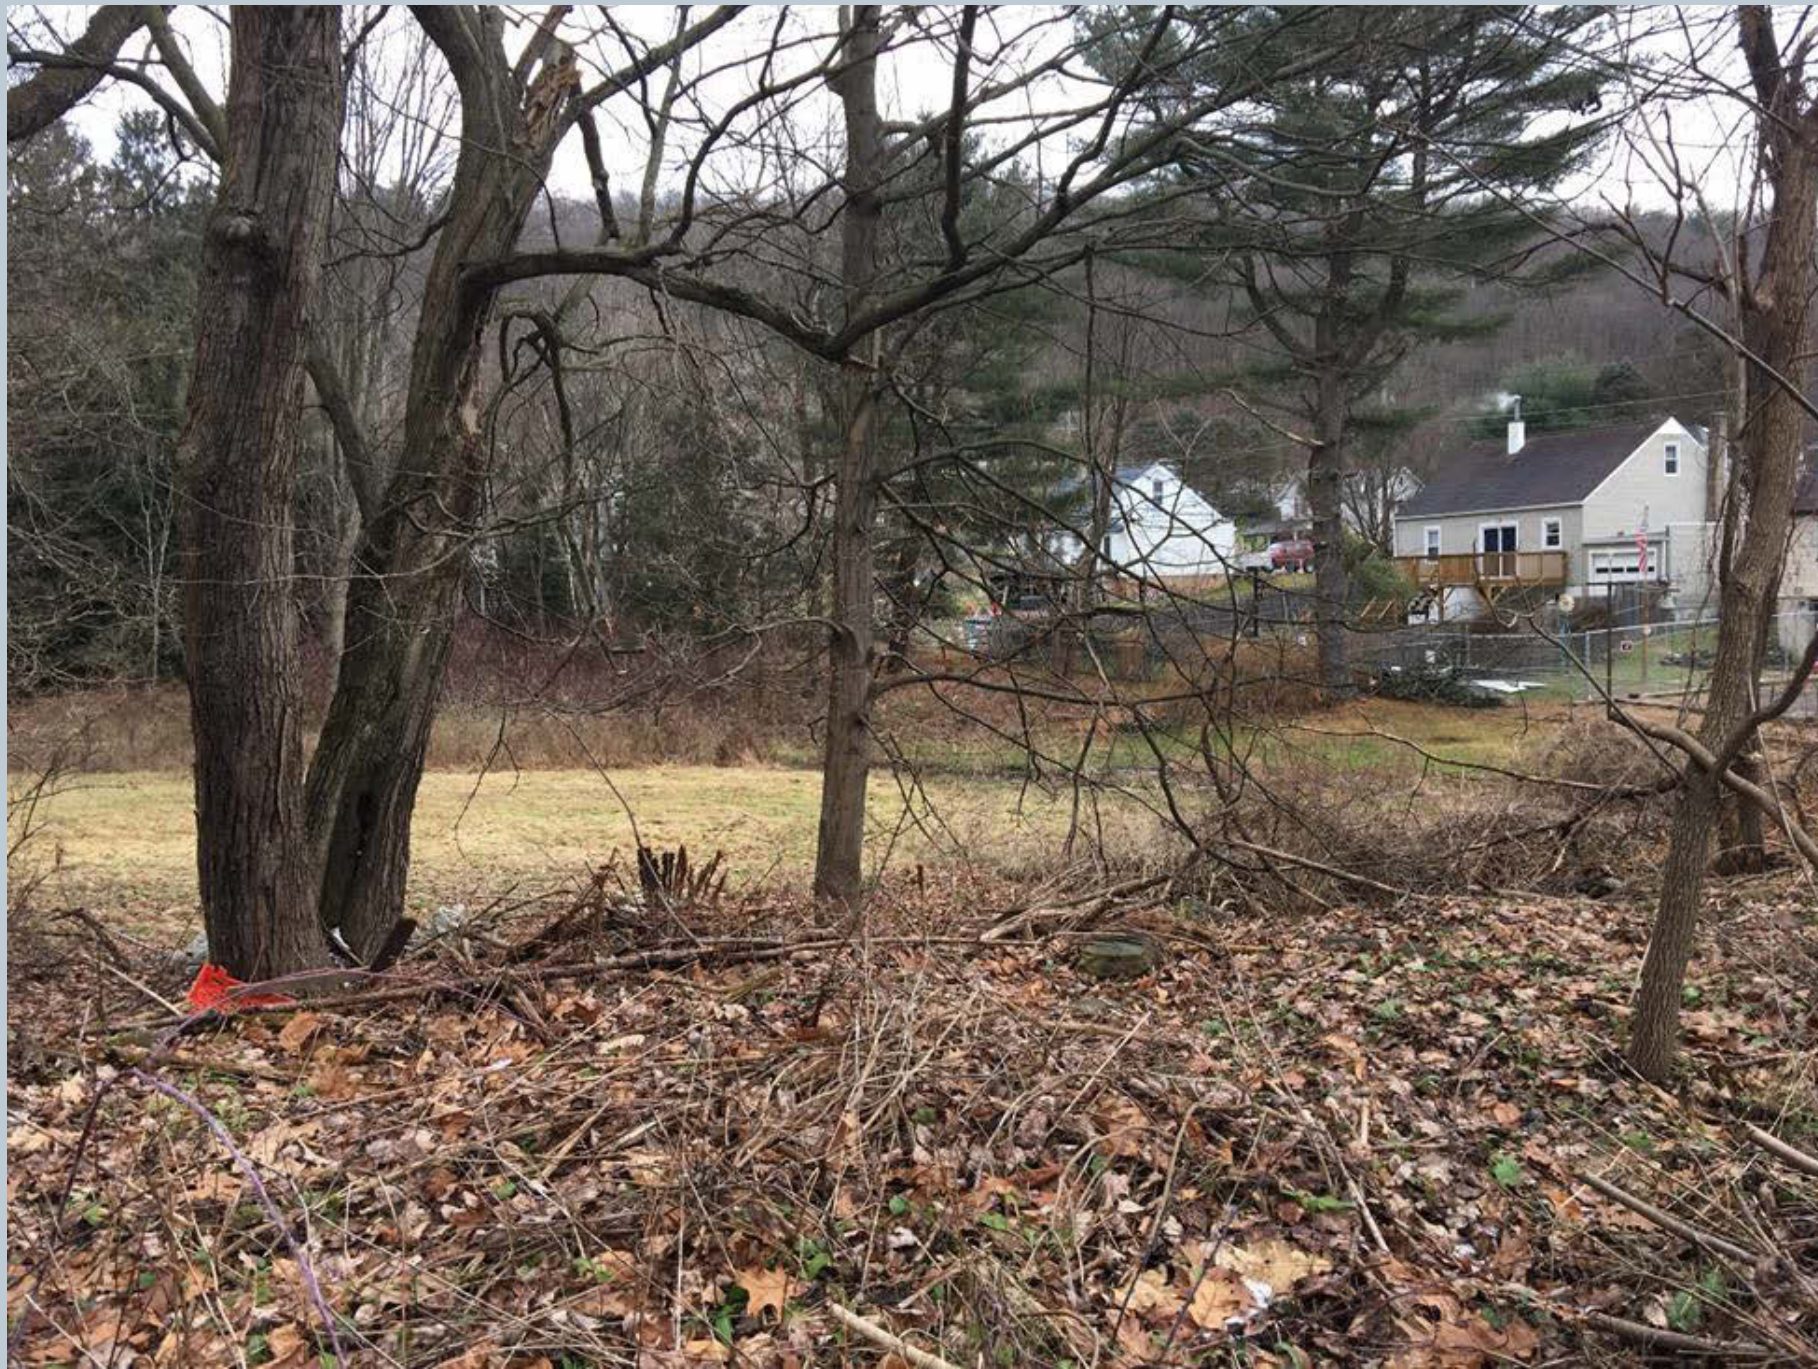
Figure 122. An UNT located upstream of Railroad Street in a wetland area, before entering the stone culvert under Railroad Street. In the future, this could possibly be a detention area and wetland enhanced basin to reduce the flow and slow down the UNT through the stone culvert. The property owner(s) will need to be identified to discuss further possibilities.

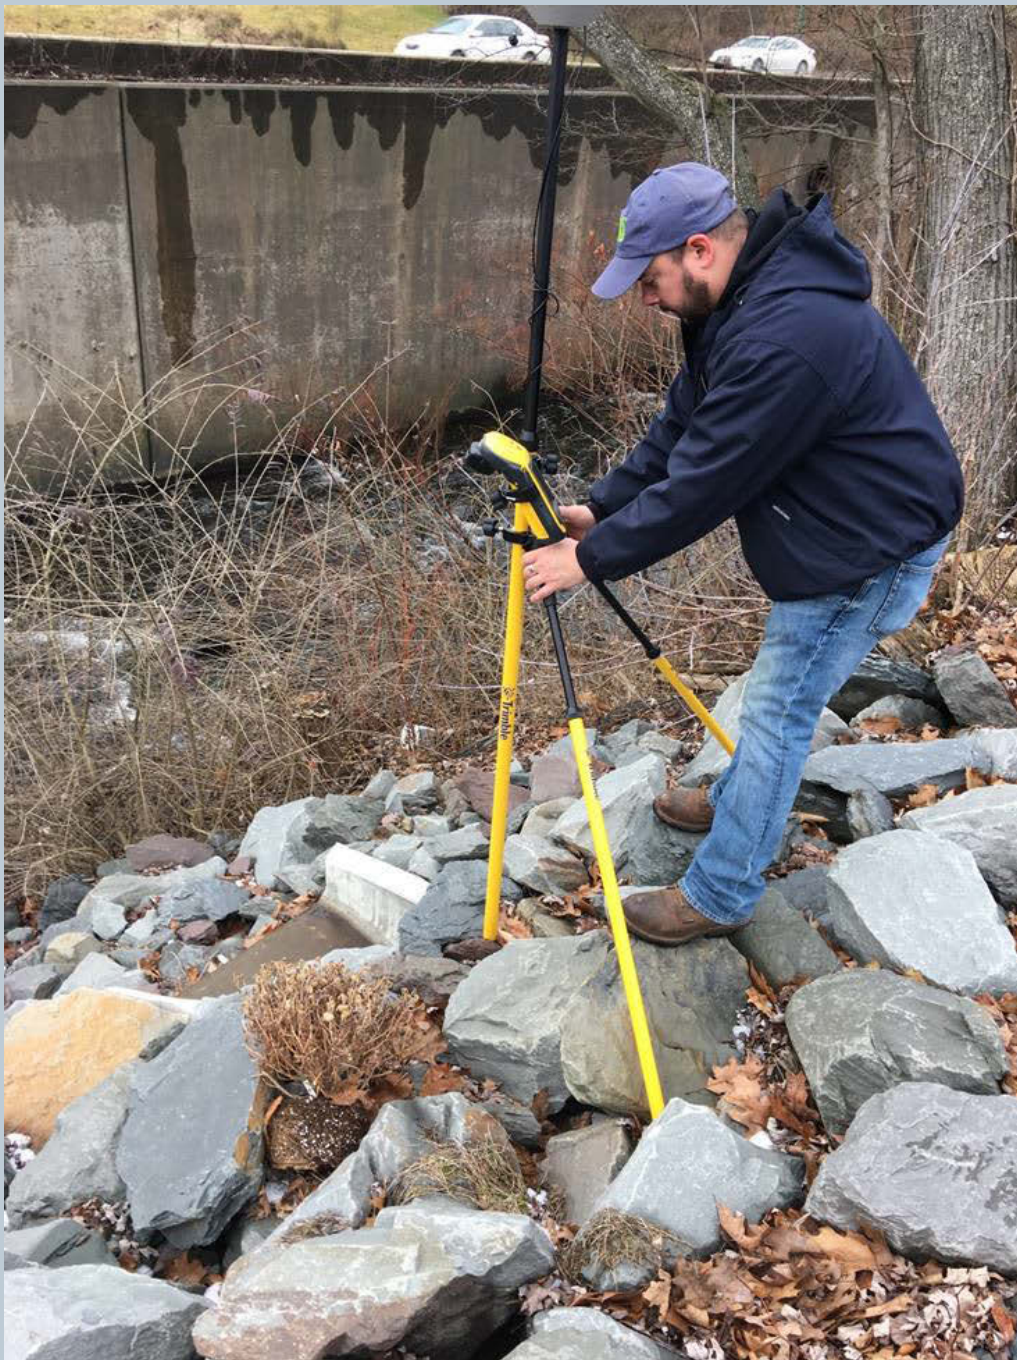
Figure 123. A stormwater outlet structure that is not aligned with Toby Creek, taken from N. Main Street.

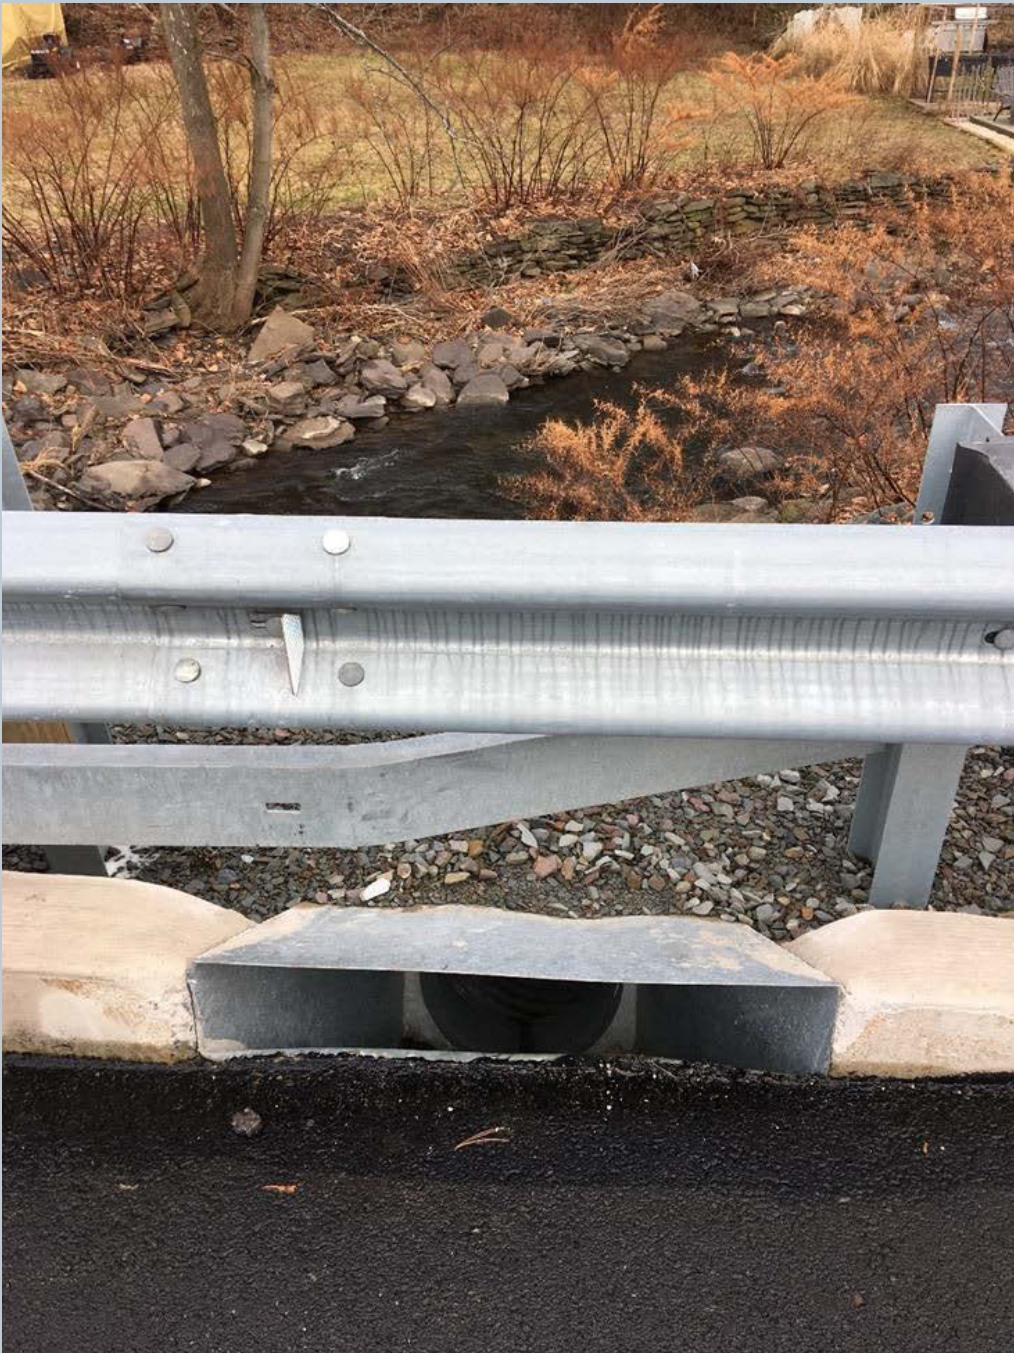
Figure 124. An image of a galvanized sheet metal drop inlet stormwater structure on the closed bridge over N. Main Street.
