Toby Creek Field Reconnaissance Observations

September 26, 2018

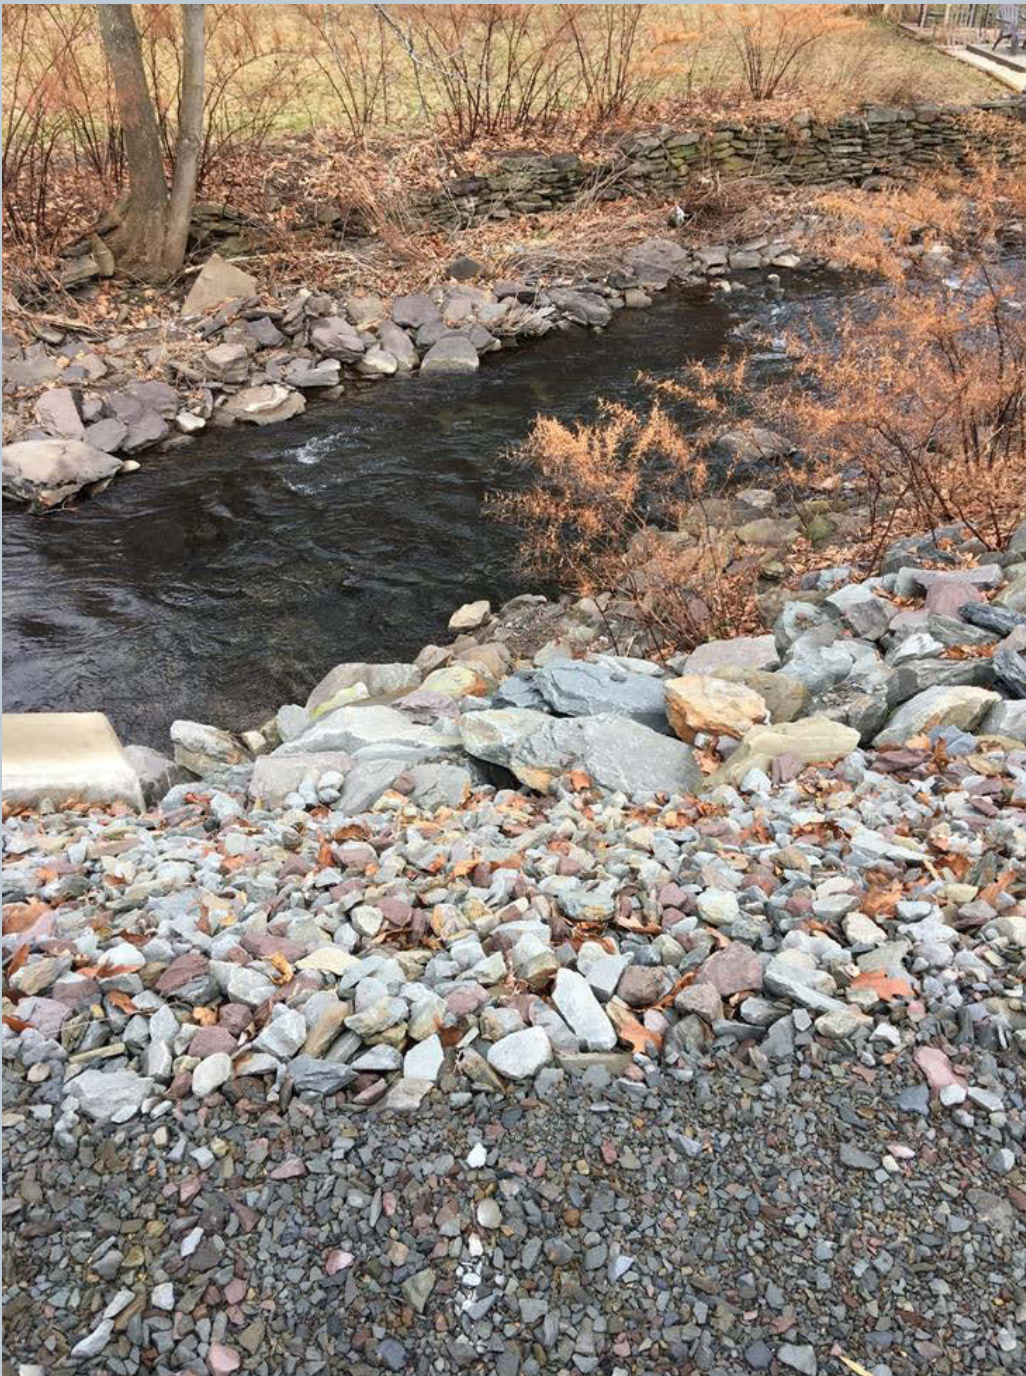
Figure 125. Looking downstream at an 18-inch galvanized stormwater pipe (dry) structure, covered with rip rap for protection. The structure is aligned to Toby Creek from the drop inlet structure on the closed bridge over N. Main Street.

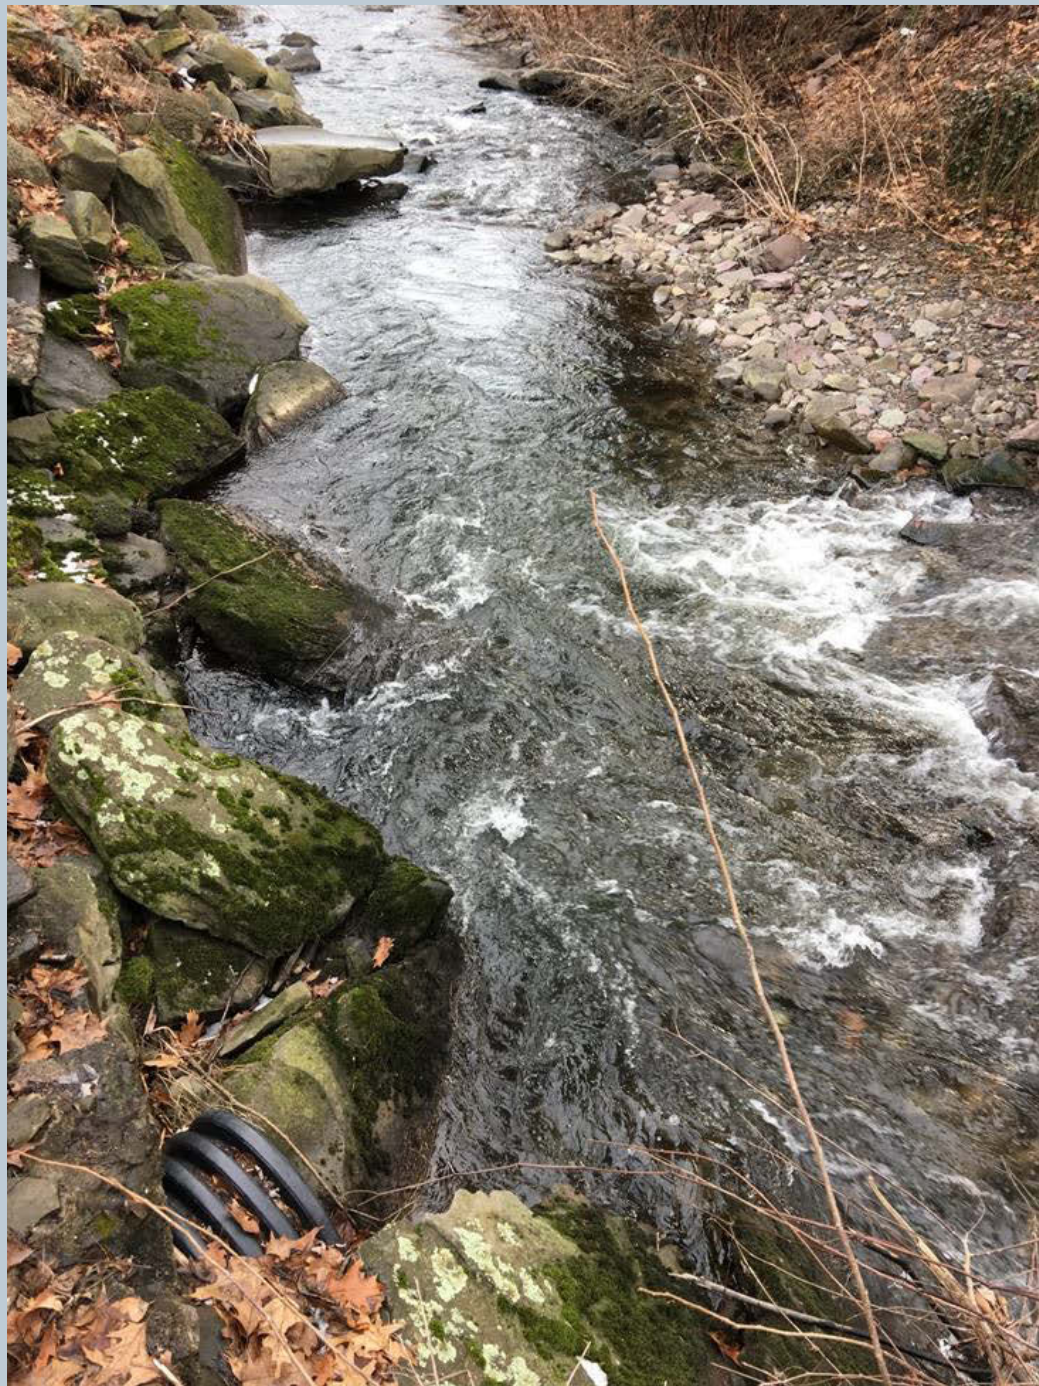
Figure 126. A 24-inch black dry HDPE pipe for stormwater across N. Main Street is aligned with Toby Creek, looking downstream. Gravel bar deposition is present on the outside bend of Toby Creek. Additionally, N. Main Street was previously undercut in this area.

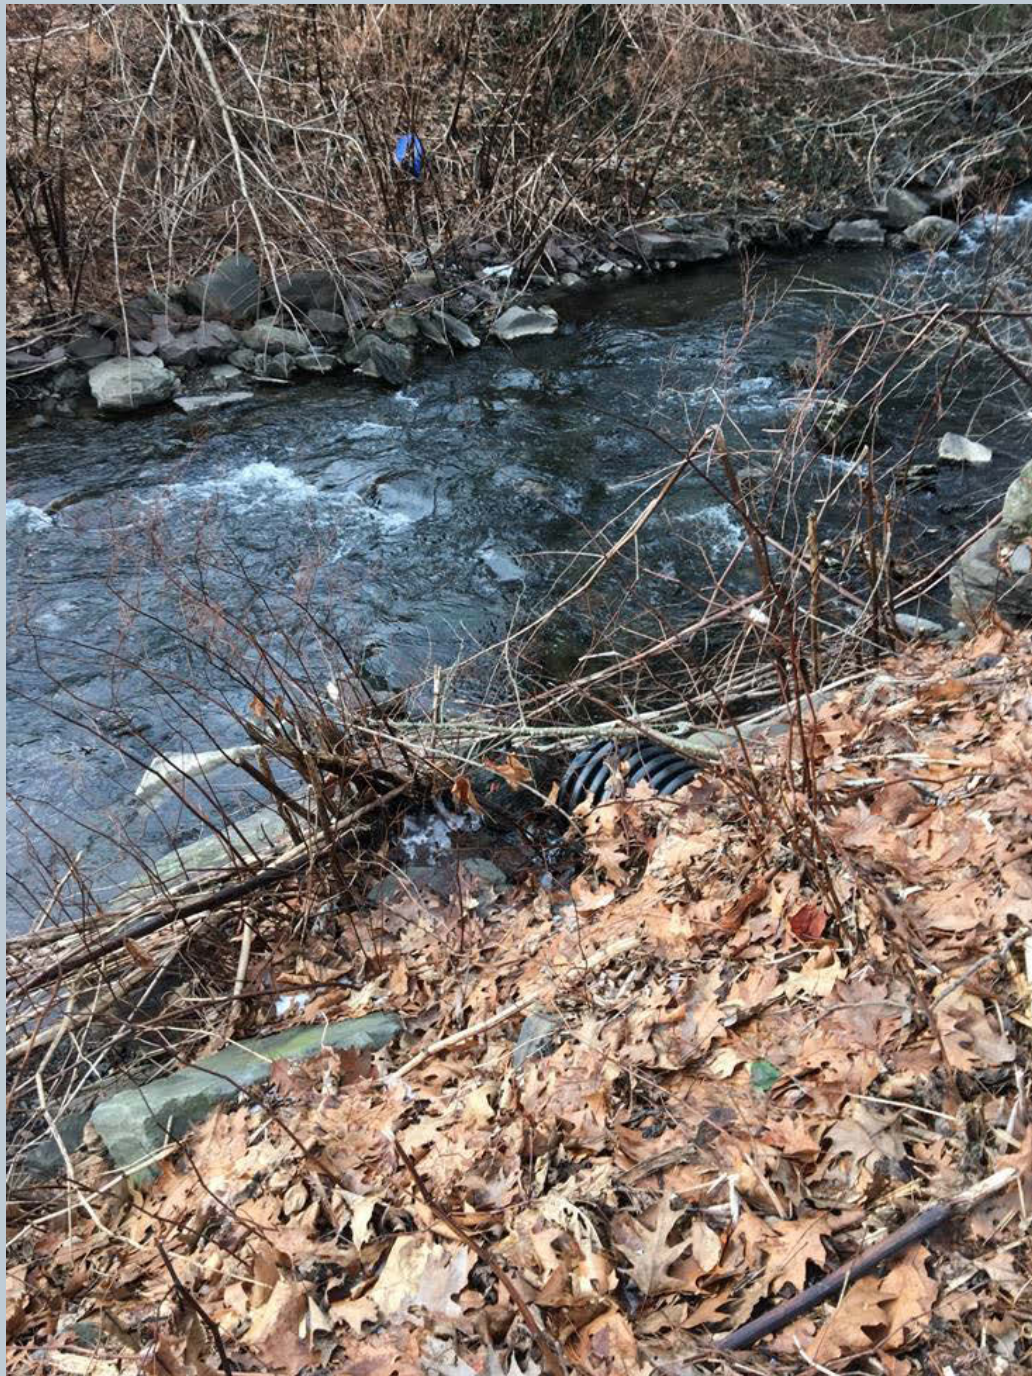
Figure 127. A 24-inch black HDPE pipe (flowing) that is not aligned, carrying an UNT across N. Main Street, perpendicular to Toby Creek.

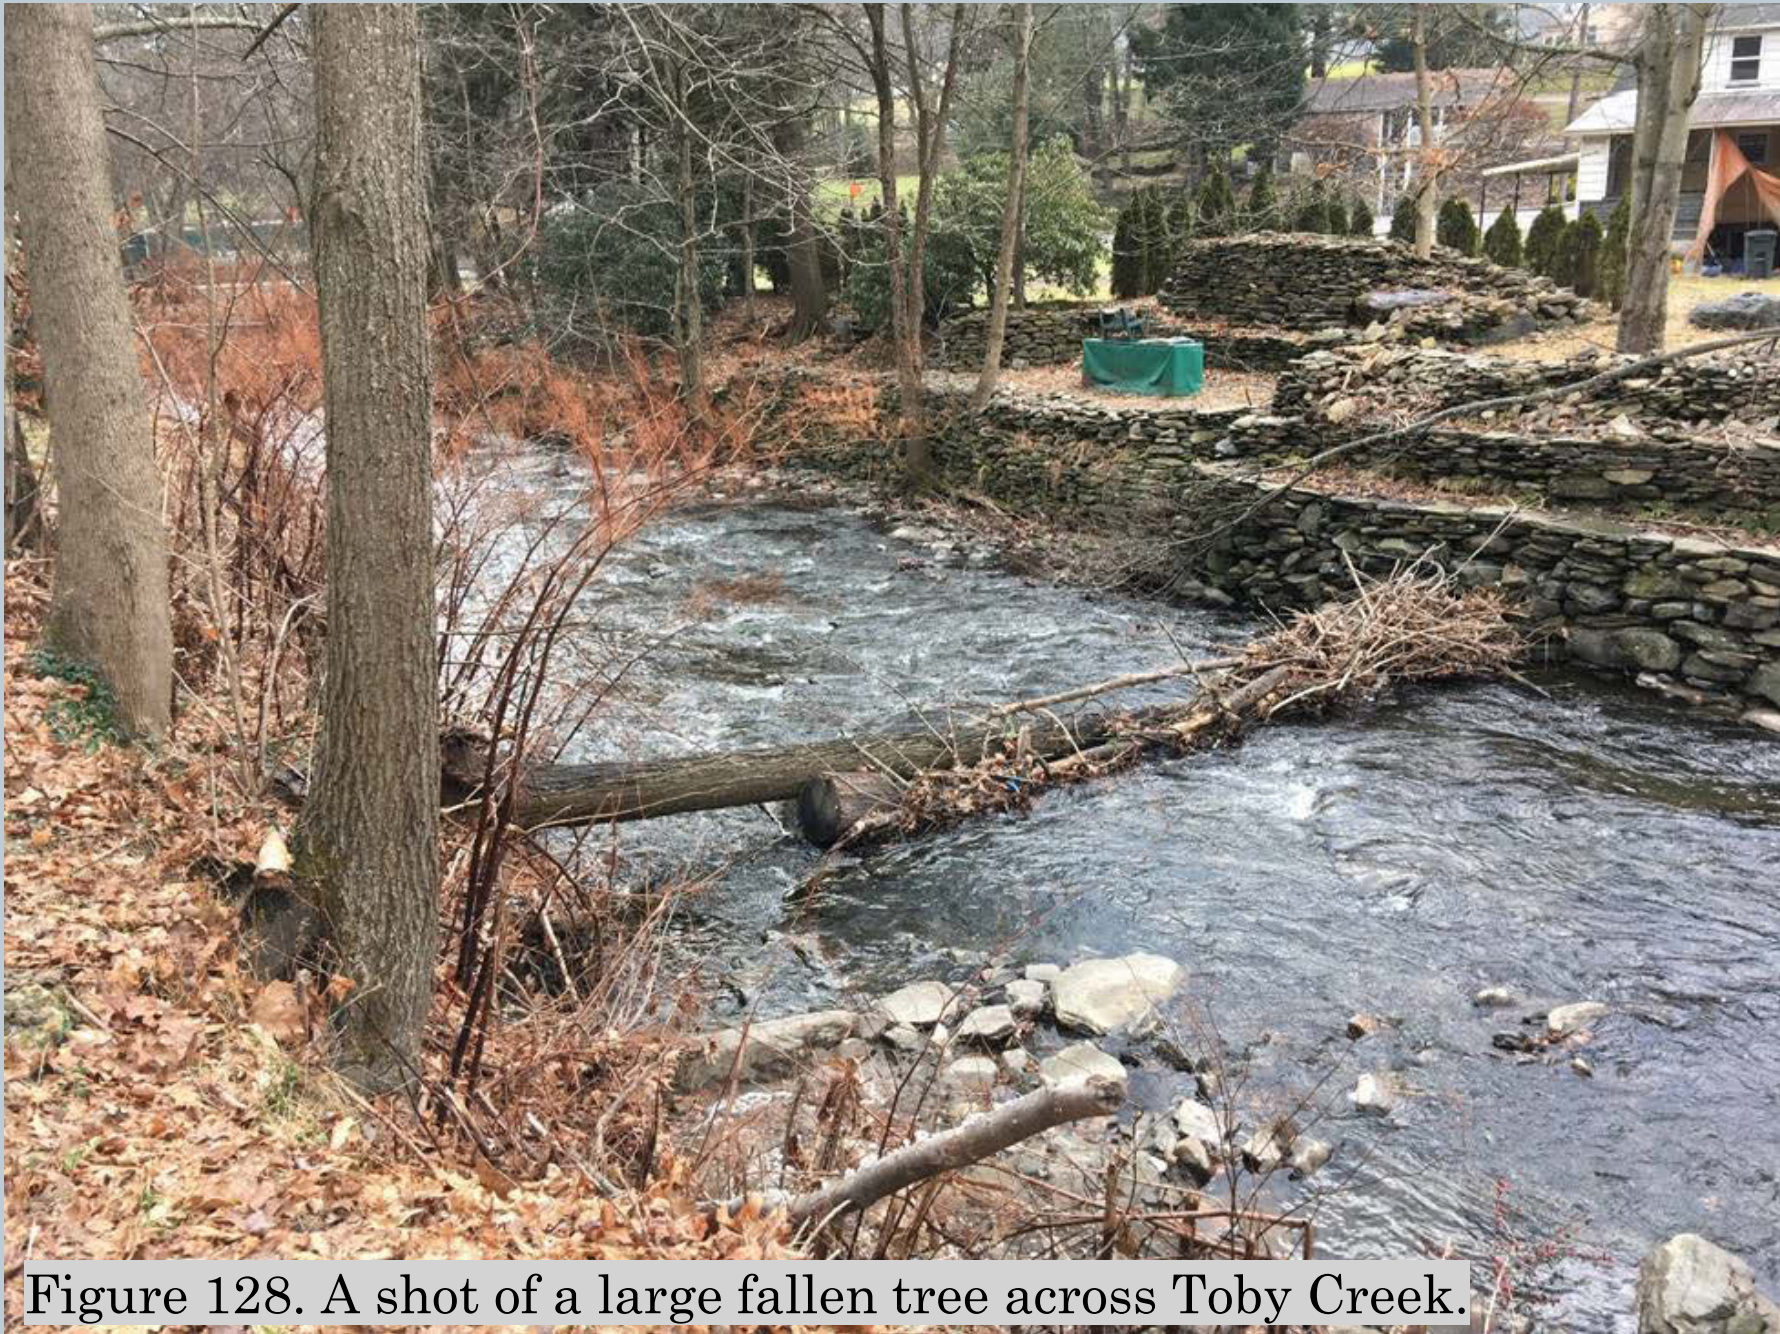
Figure 128. A shot of a large fallen tree across Toby Creek.

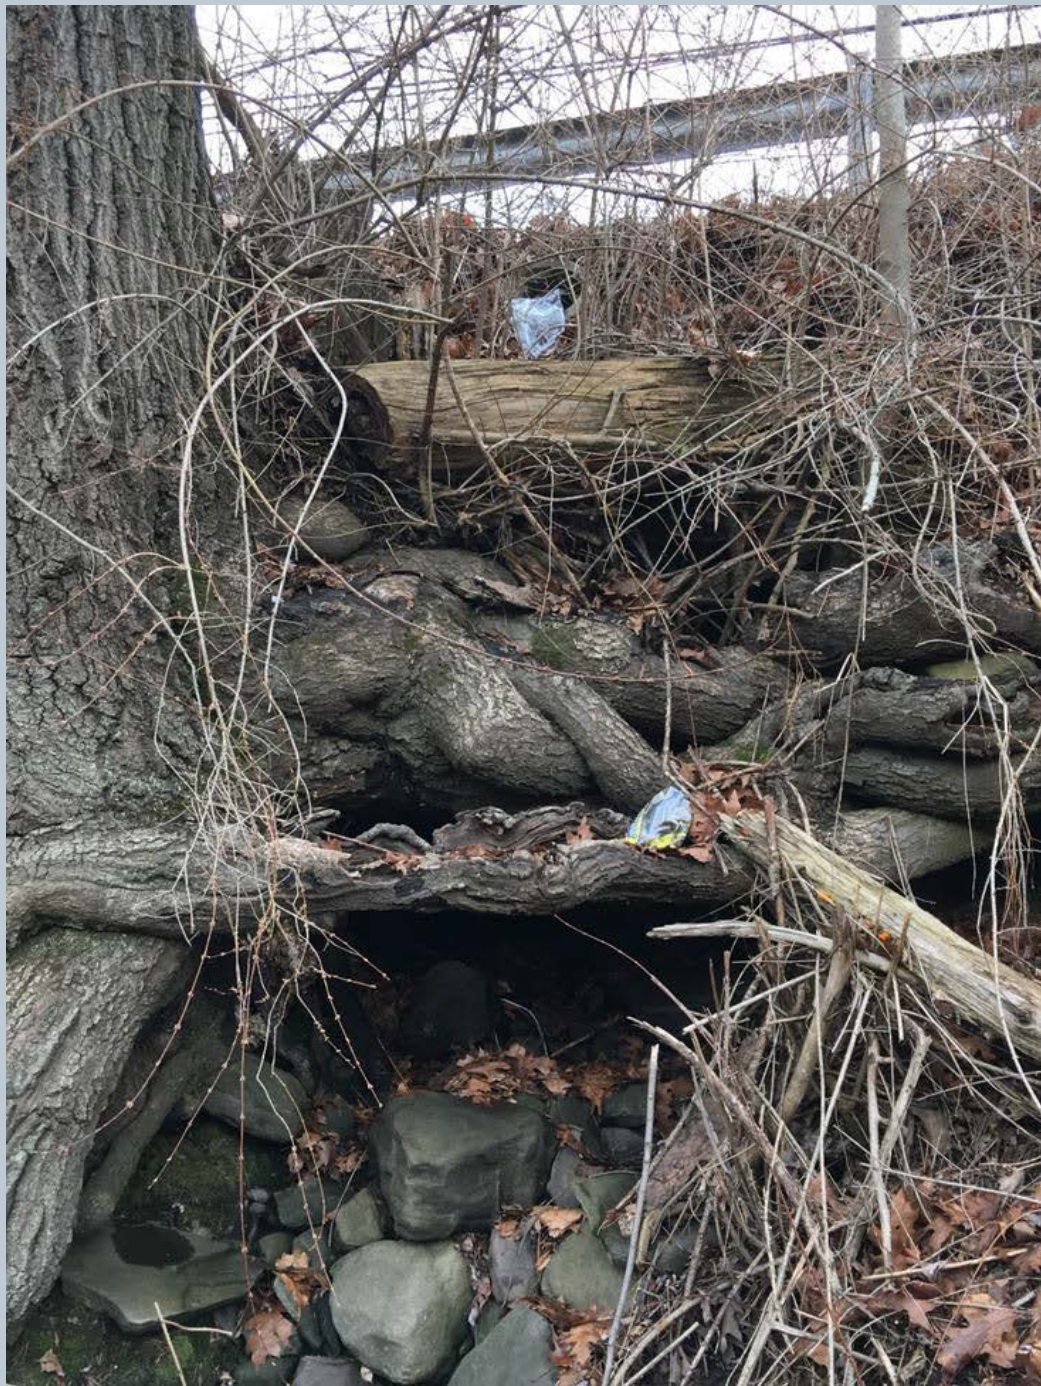
Figure 129. An old 12-foot concrete pipe (dry) for stormwater runoff from Shaver Avenue directed over a steep embankment, down to N. Main Avenue.

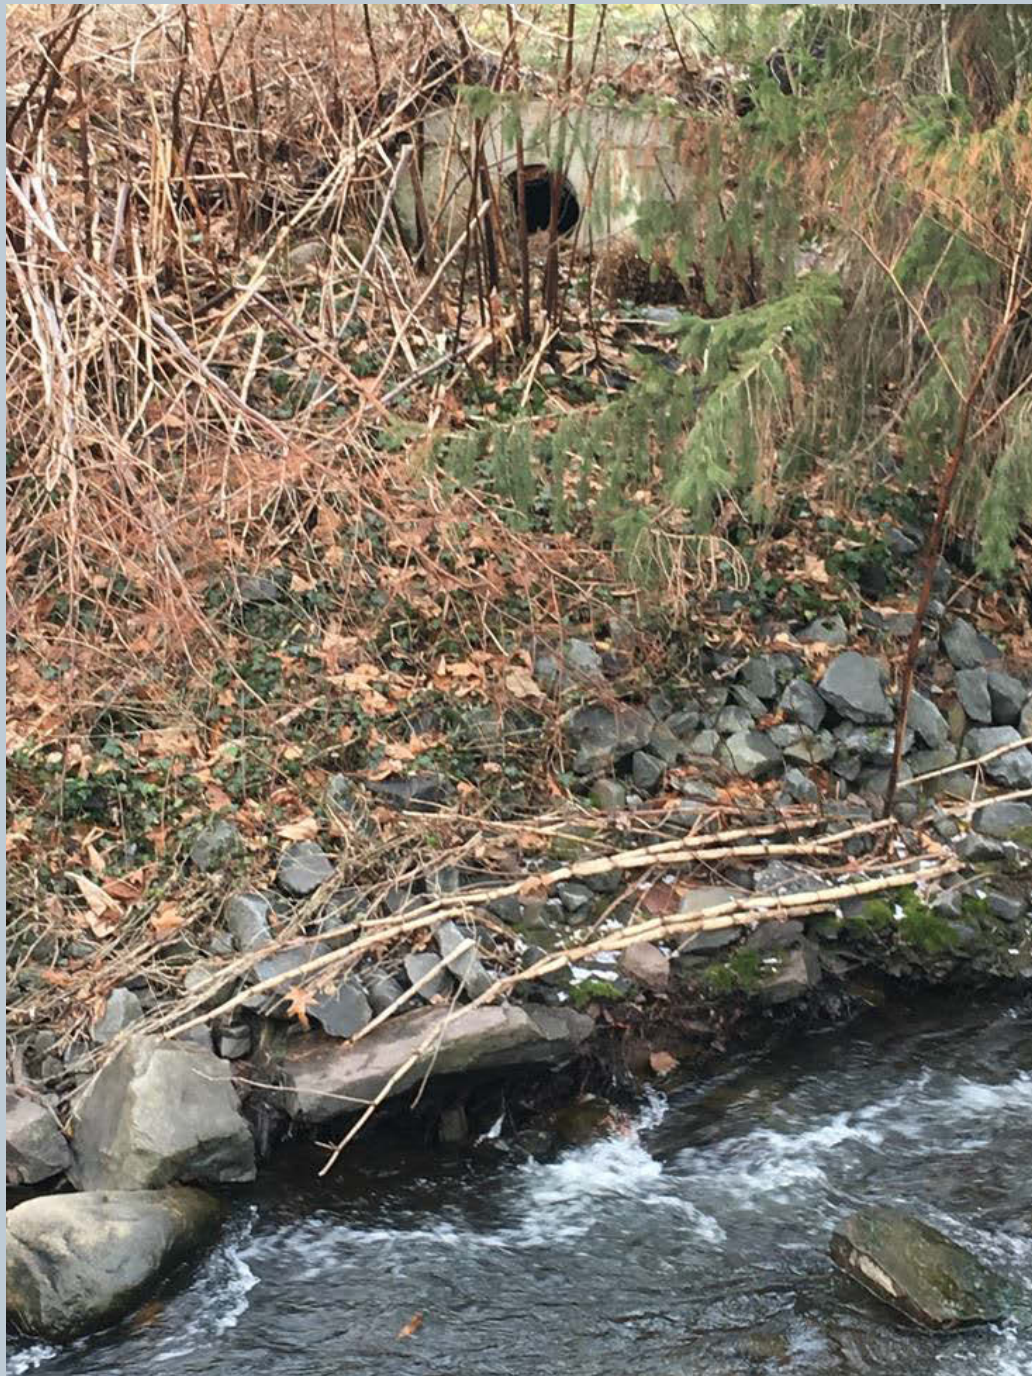
Figure 130. A 12-foot culvert from Kost Tire aligned along the left bank, looking upstream.

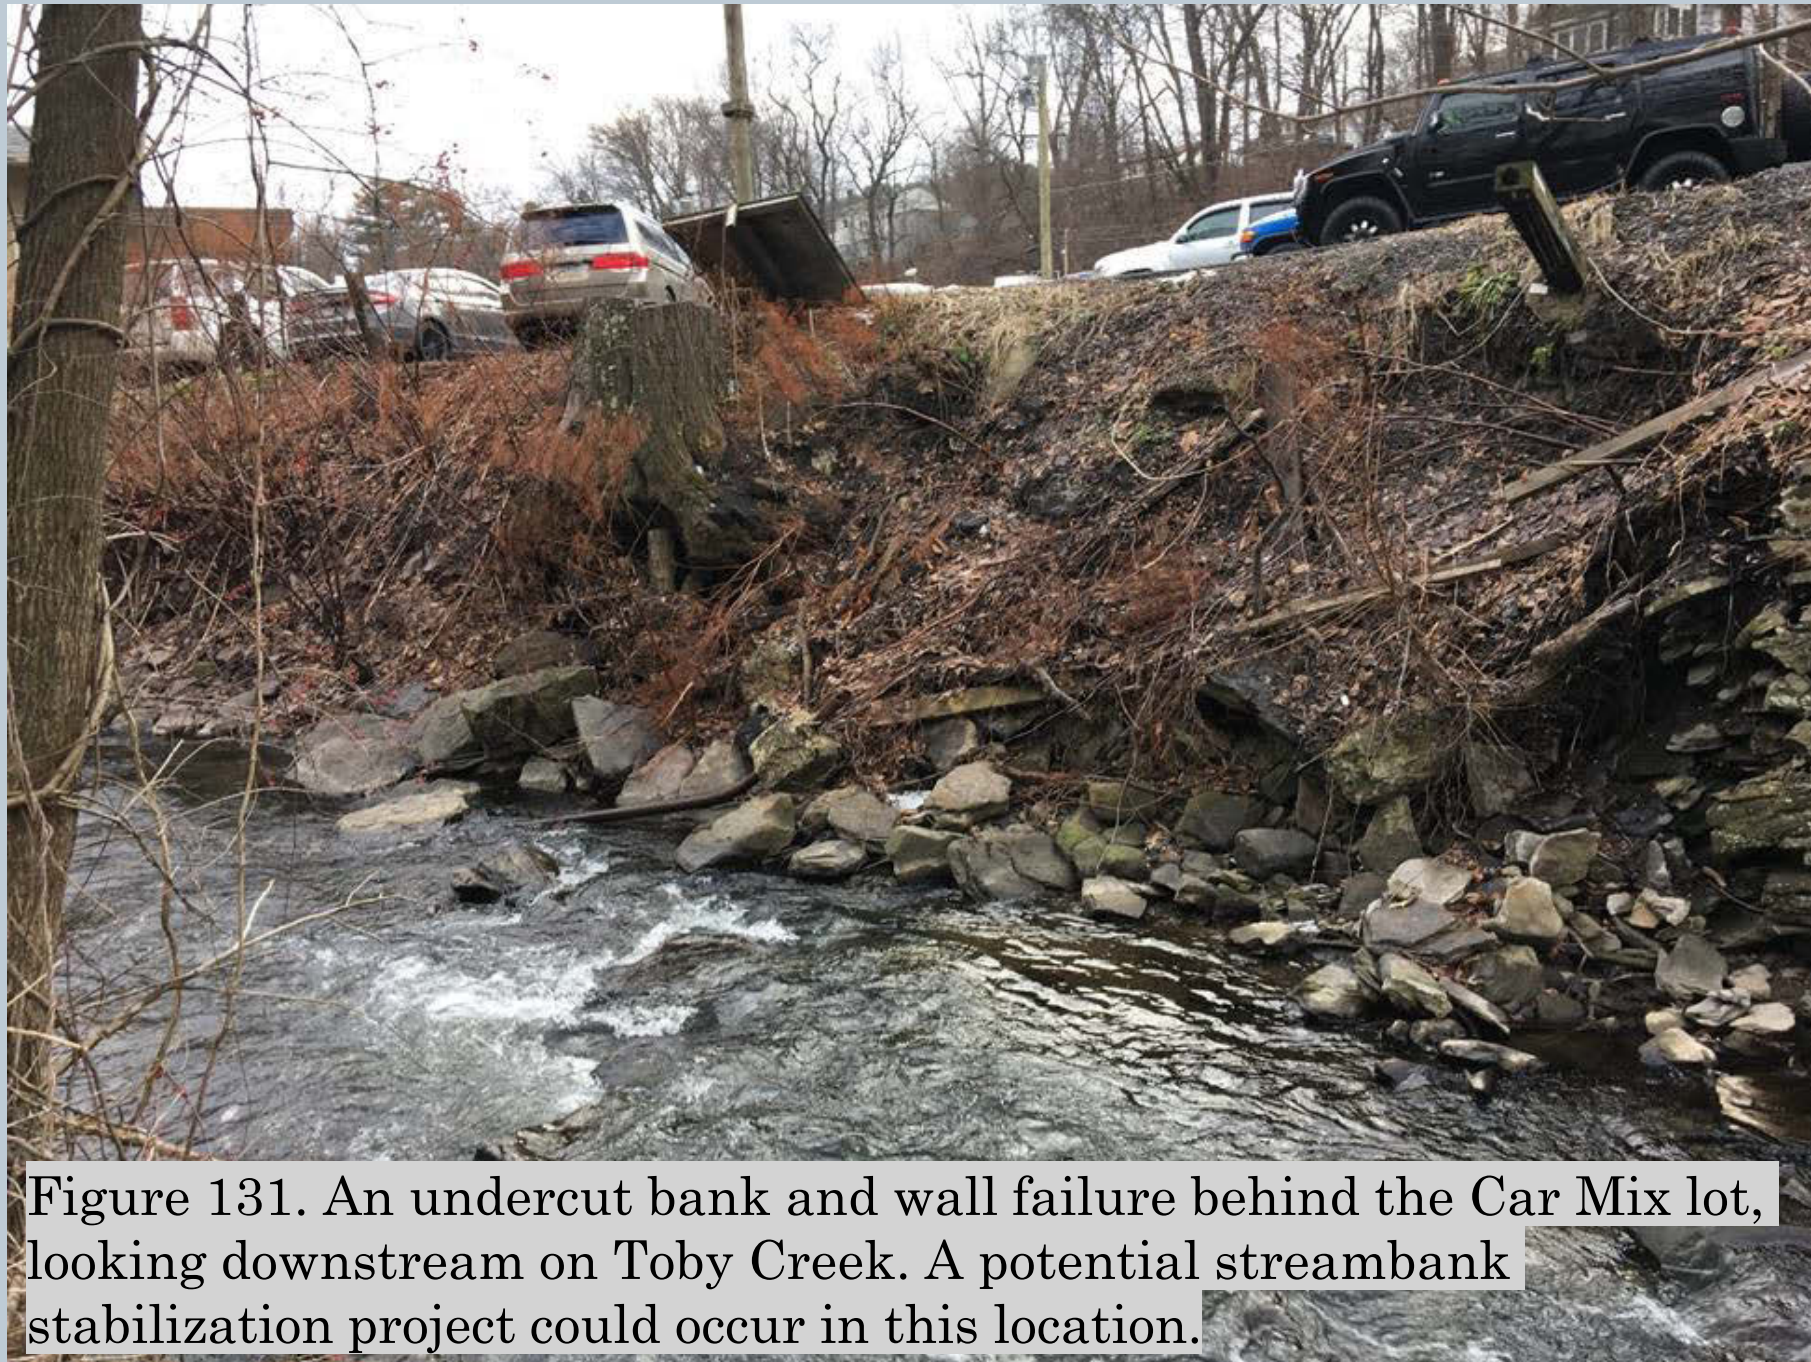
Figure 131. An undercut bank and wall failure behind the Car Mix lot, looking downstream on Toby Creek. A potential streambank stabilization project could occur in this location.

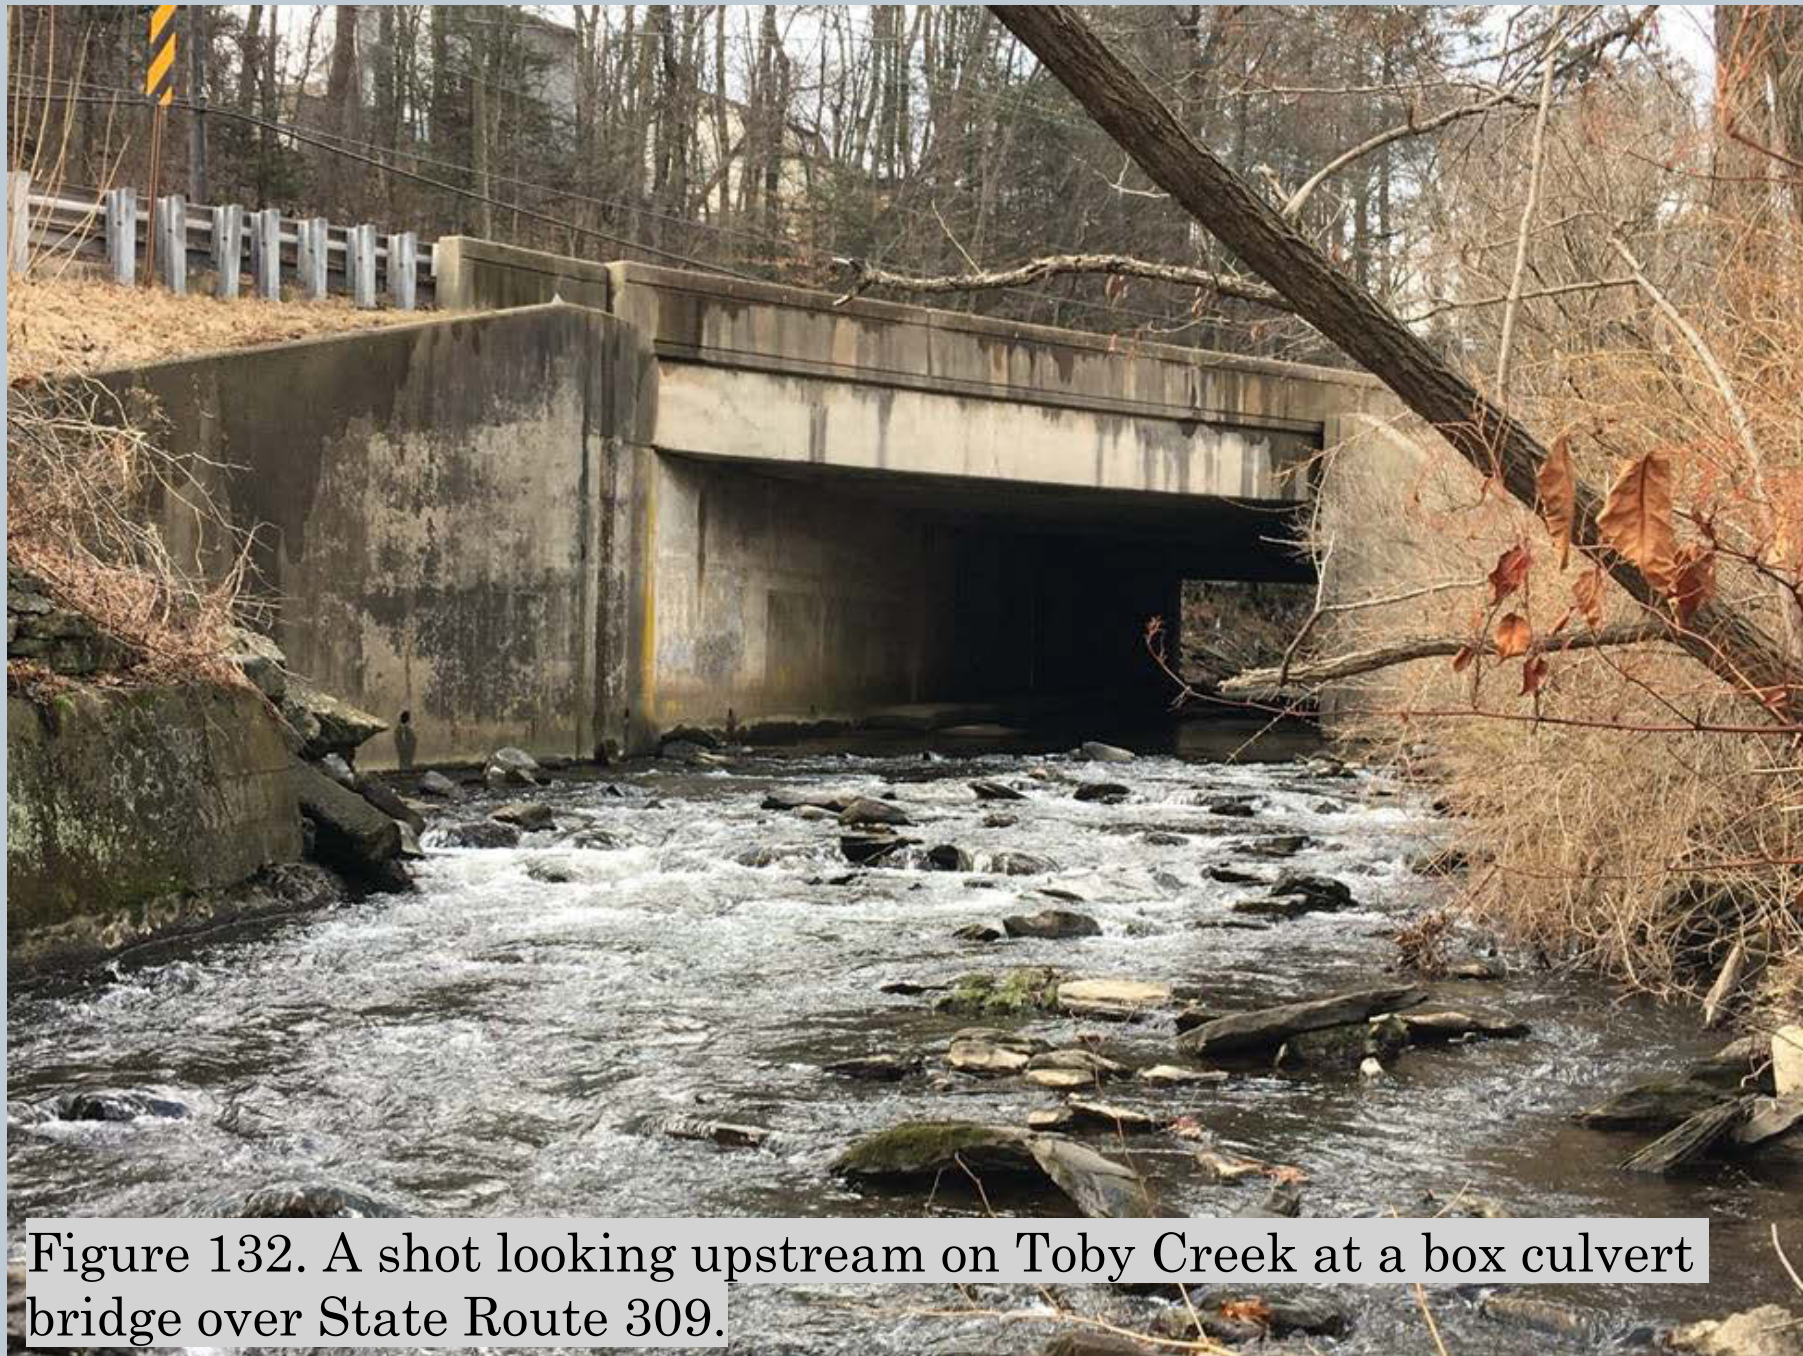
Figure 132. A shot looking upstream on Toby Creek at a box culvert bridge over State Route 309.

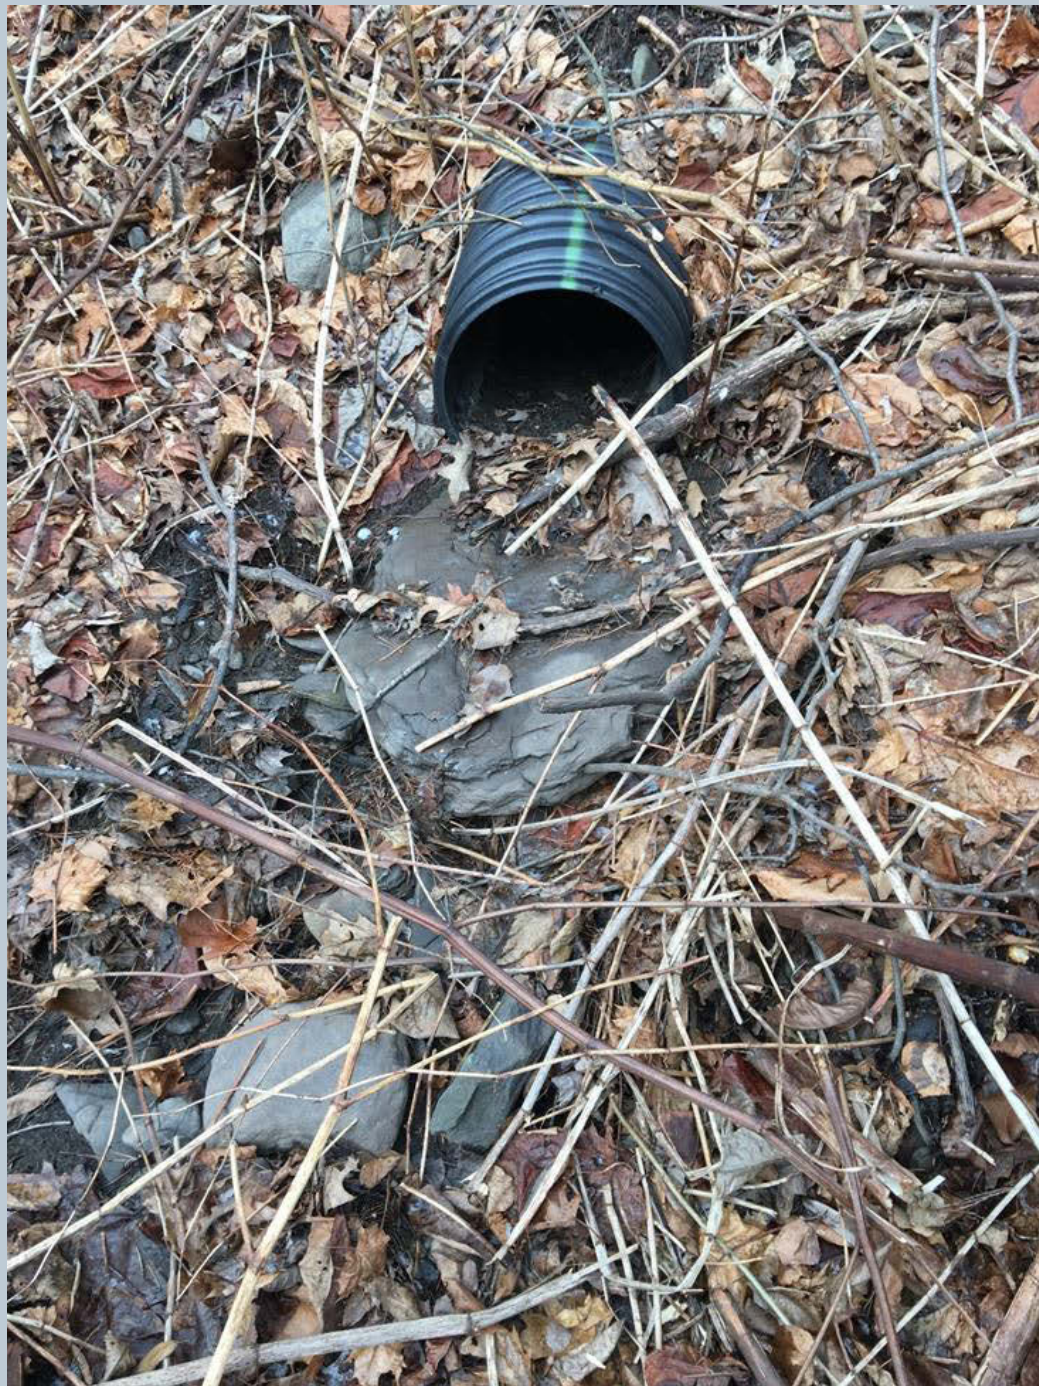
Figure 133. A 12-inch black HDPE stormwater pipe (dry) aligned with Toby Creek.

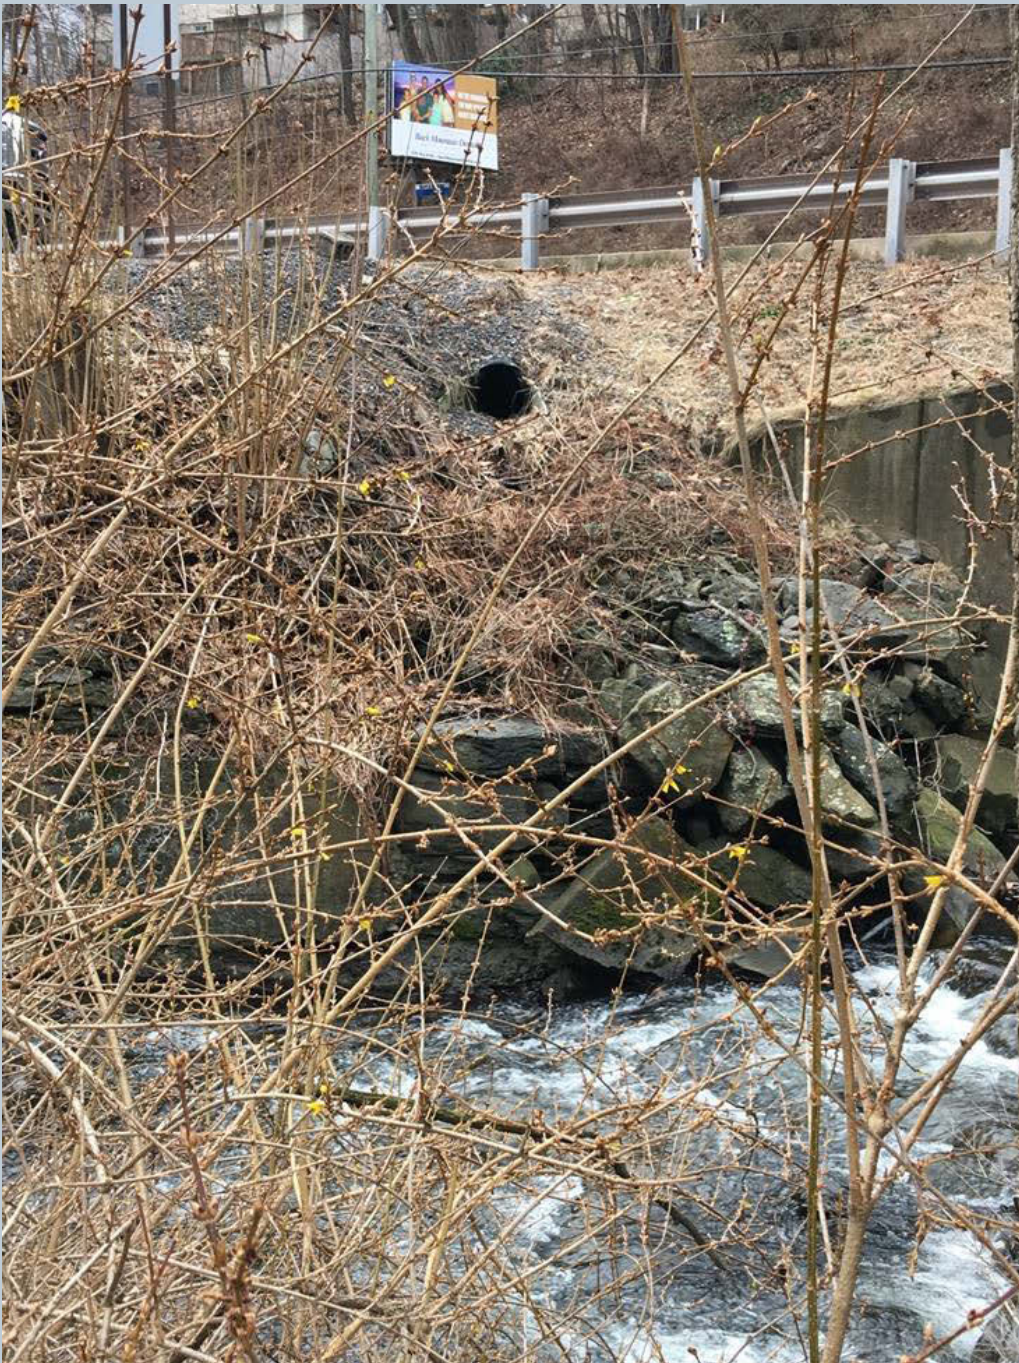
Figure 134. A 24-inch black HDPE stormwater pipe (dry) not aligned on State Route 309. This location is just before the bridge that is north of the Car Mix lot.

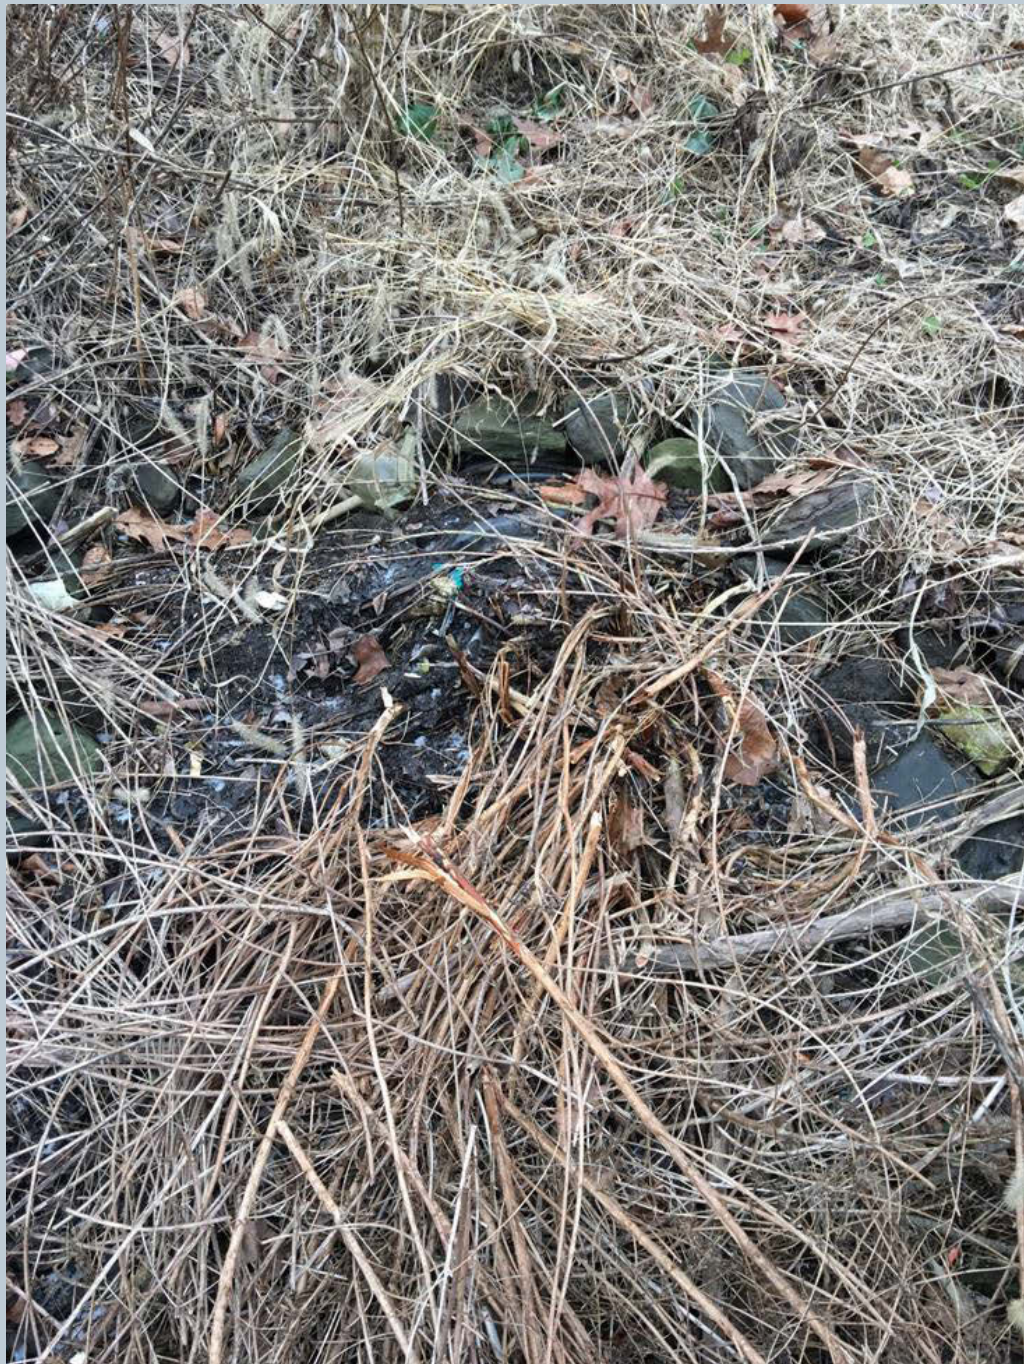
Figure 135. An 18-inch black HDPE stormwater pipe that is 100% blocked with sediment from the storm drain drop box inlet along State Route 309, that is filled and covered with leaves.

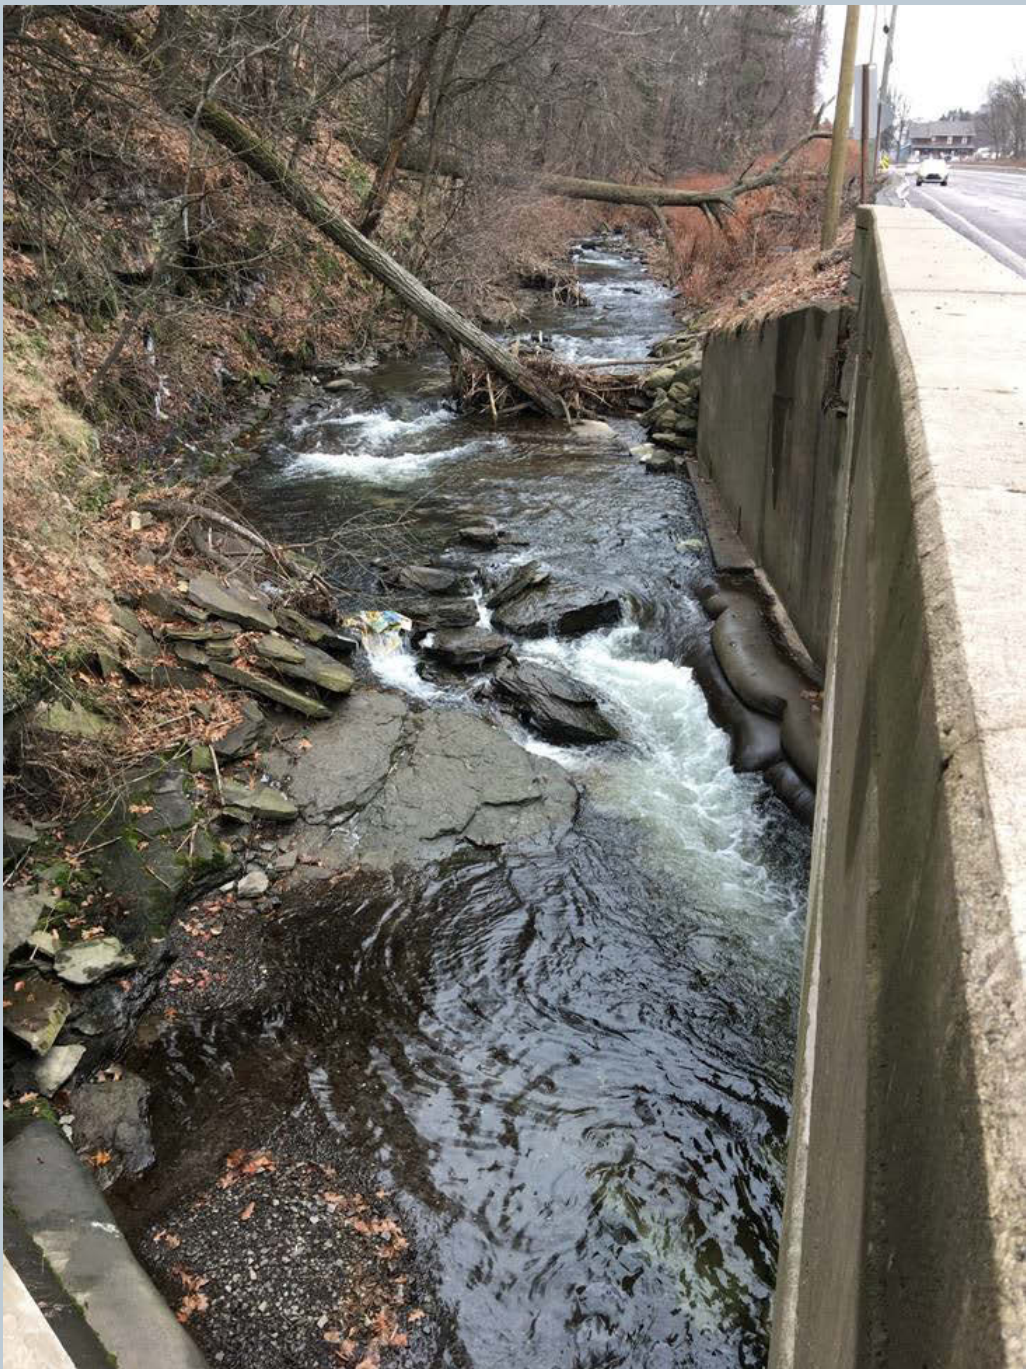
Figure 136. Looking upstream on Toby Creek, just north of the bridge over State Route 309, near the end of N. Main Street. This shot captures a large fallen tree that is angled into Toby Creek above the bridge, which raises future concerns. There has also been severe undercutting of the bedrock along the left wingwall abutment.

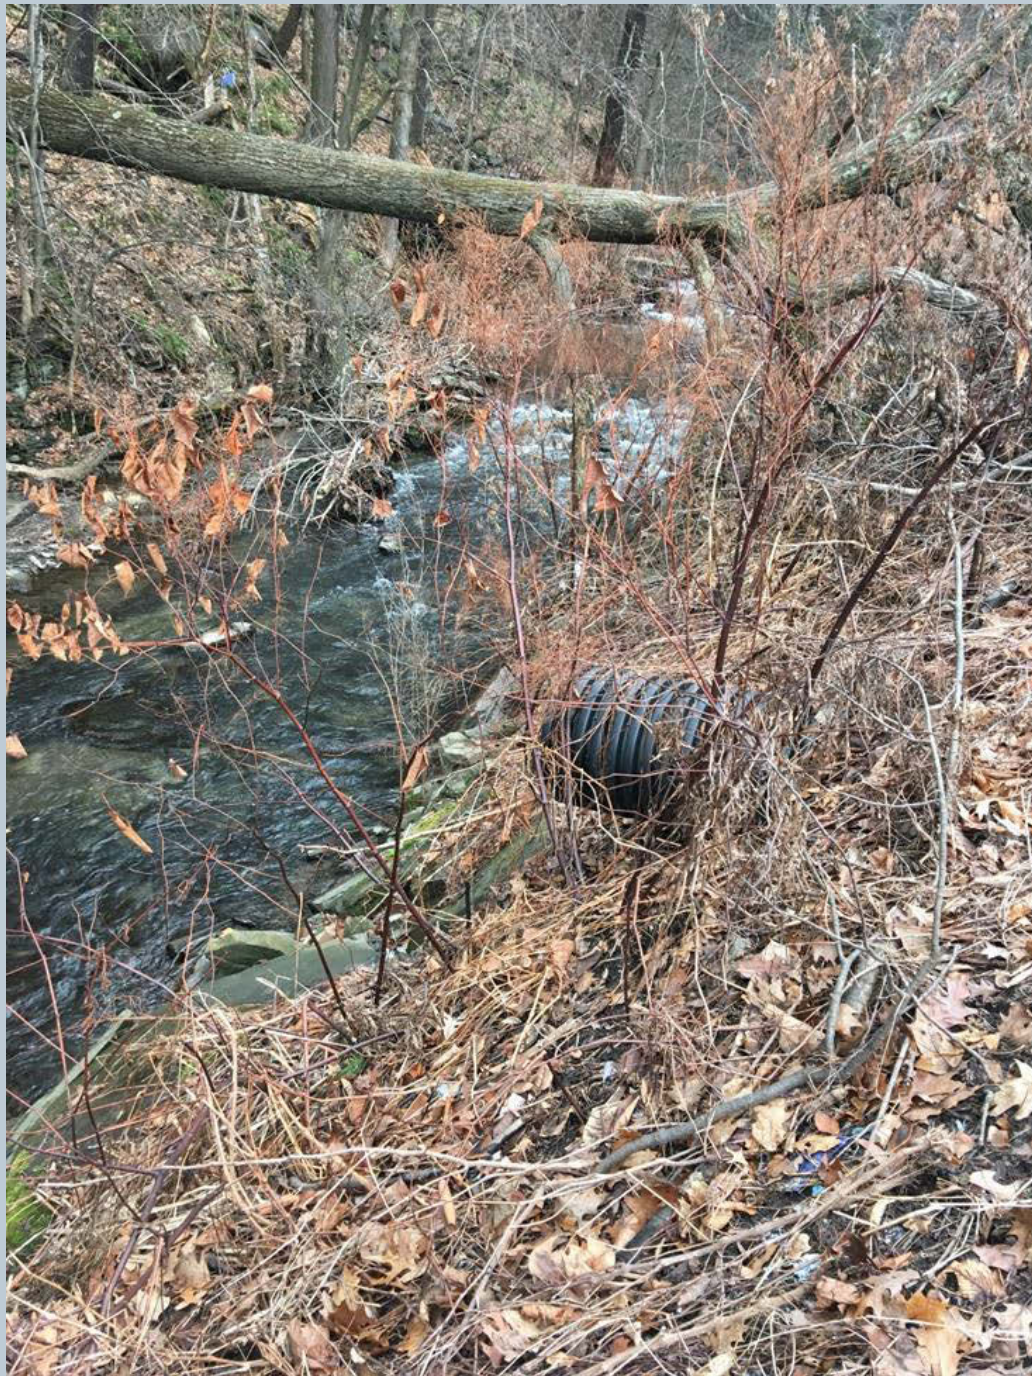
Figure 137. A 24-inch black HDPE stormwater outfall pipe (dry) structure that lies perpendicular to, and is not aligned with, Toby Creek.
