Toby Creek Field Reconnaissance Observations

September 26, 2018

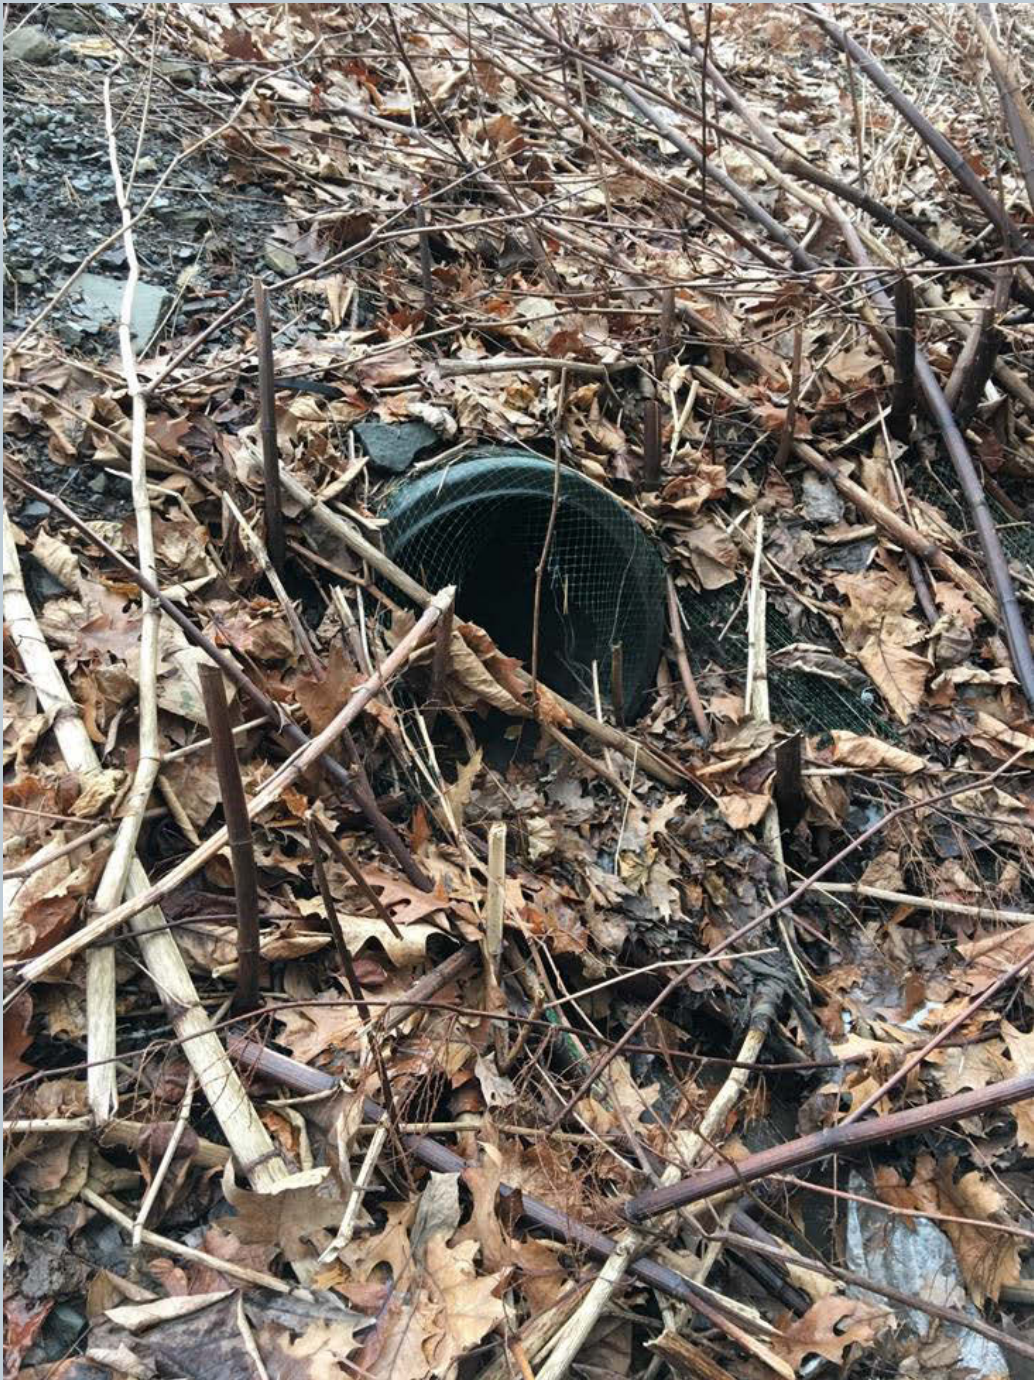
Figure 138. A 24-inch black HDPE stormwater outfall pipe (dry) structure that is not aligned with Toby Creek.

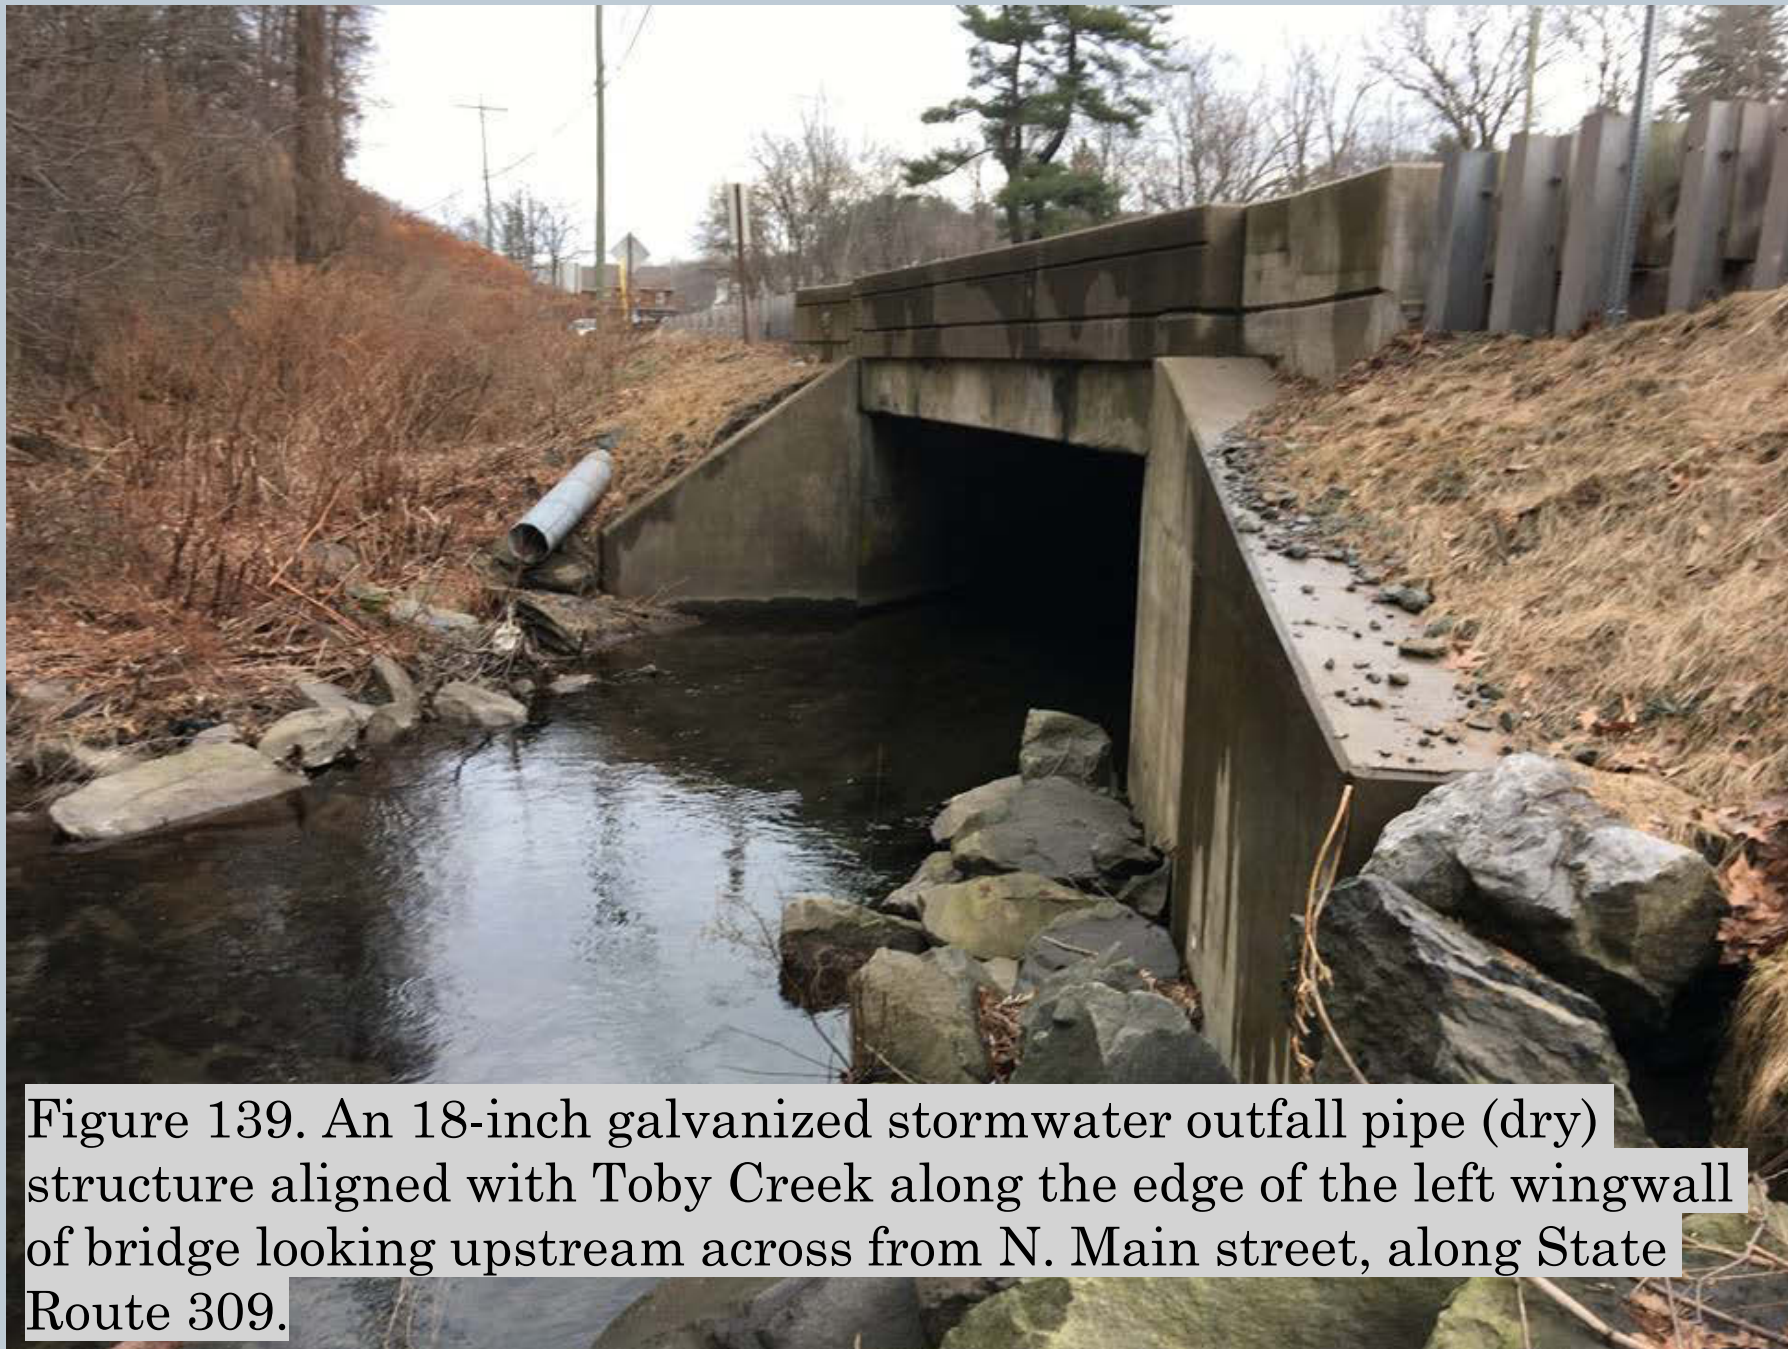
Figure 139. An 18-inch galvanized stormwater outfall pipe (dry) structure aligned with Toby Creek along the edge of the left wingwall of bridge looking upstream across from N. Main street, along State Route 309.

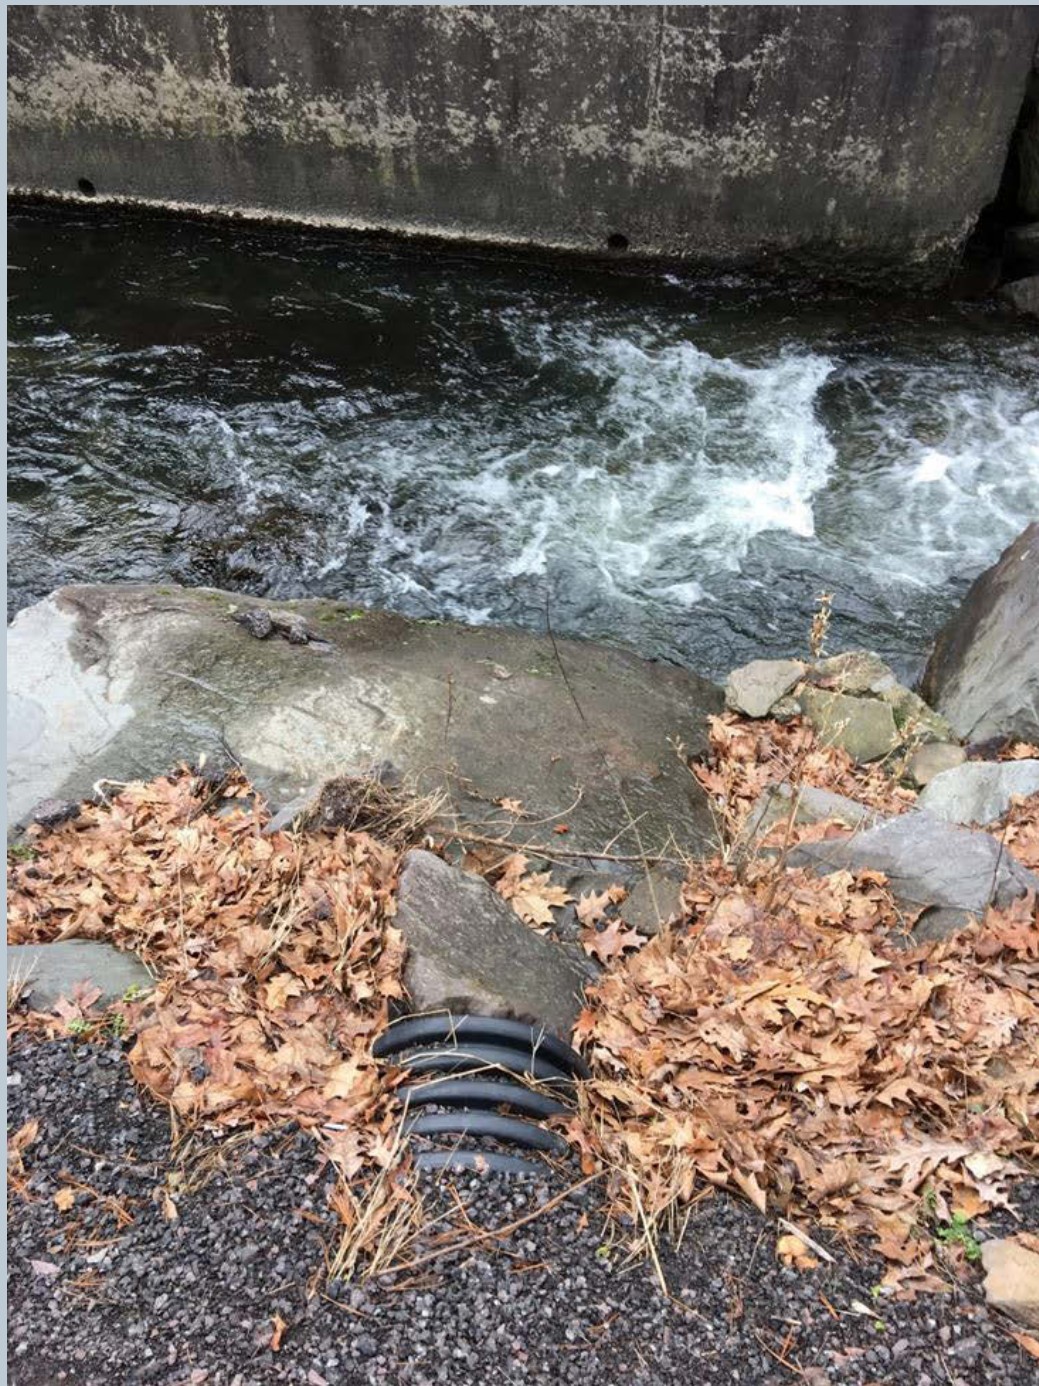
Figure 140. A shot of 12-inch black HDPE stormwater outfall pipe (dry) structure perpendicular and not aligned to Toby Creek.

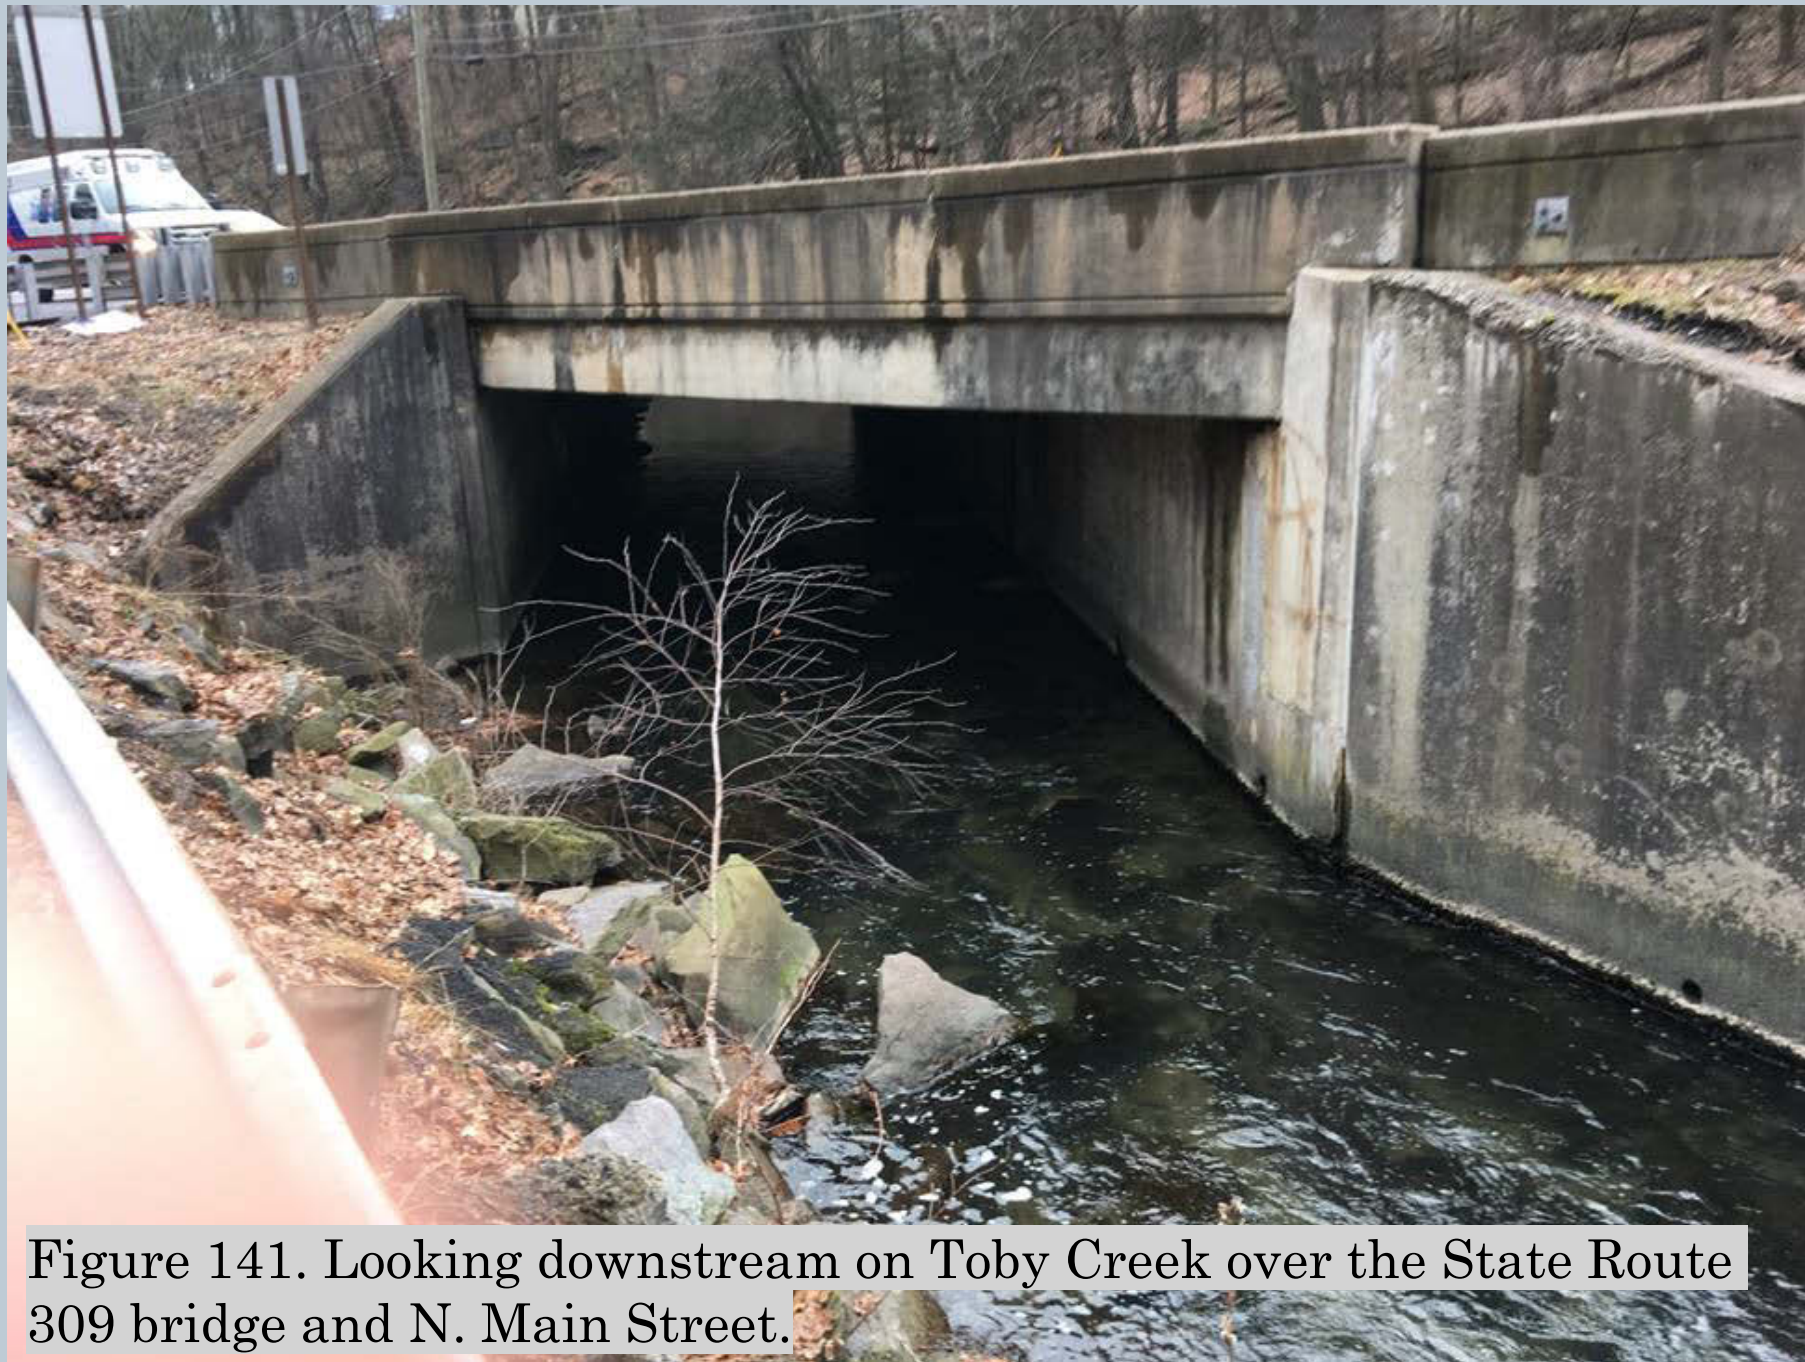
Figure 141. Looking downstream on Toby Creek over the State Route 309 bridge and N. Main Street.

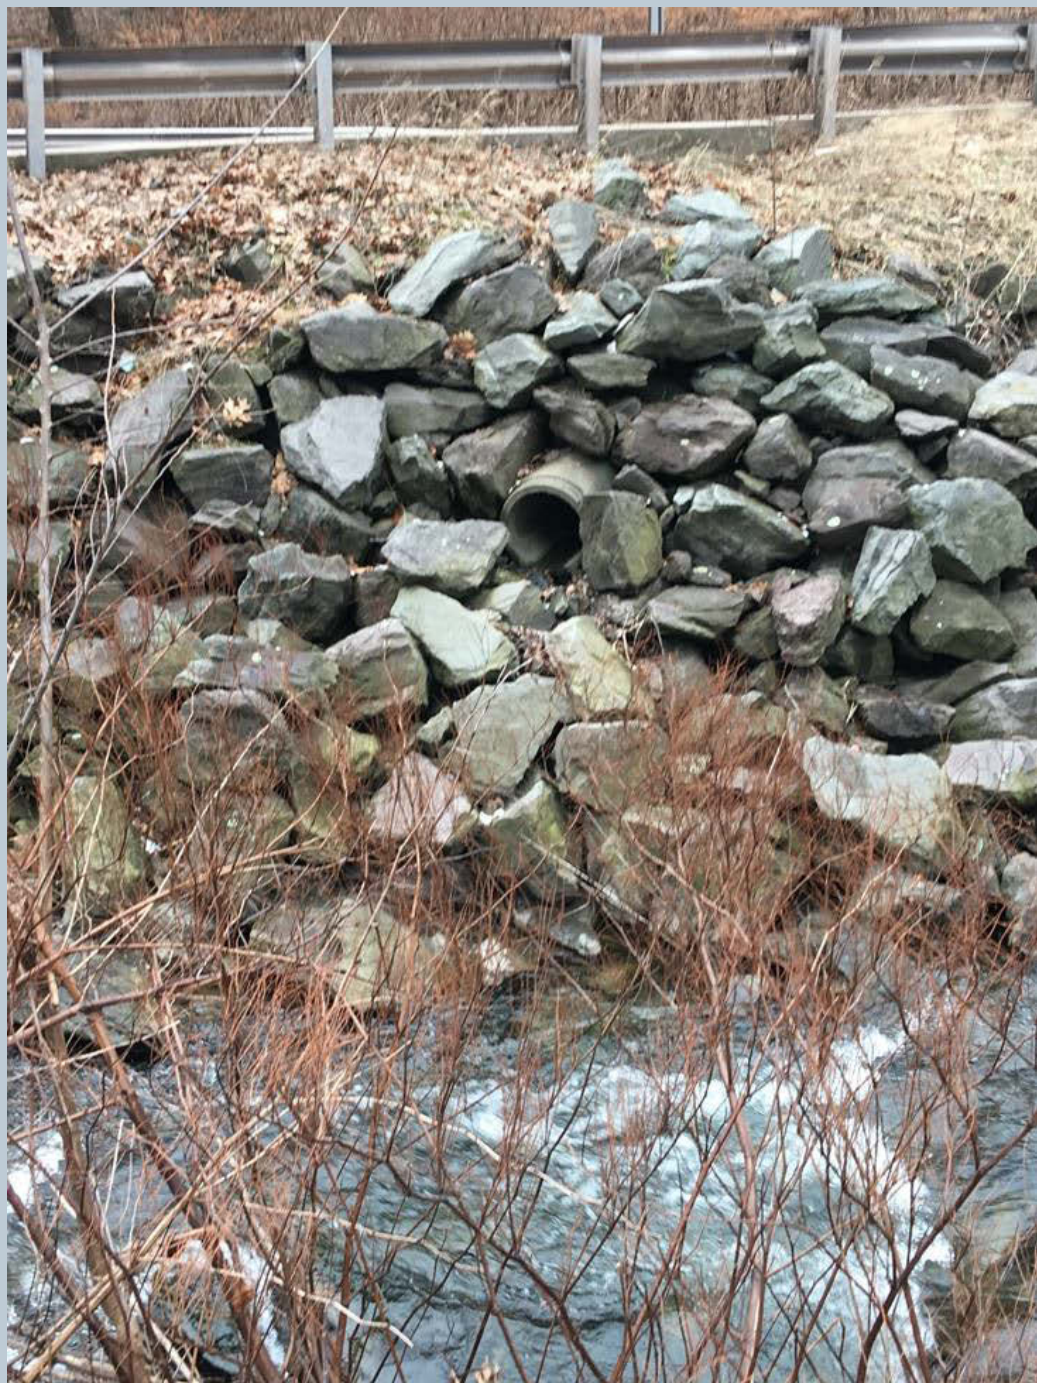
Figure 142. A shot of a 12-inch concrete outfall stormwater pipe (dry) structure aligned with Toby Creek. This is located along State Route 309 with rip-rap present.

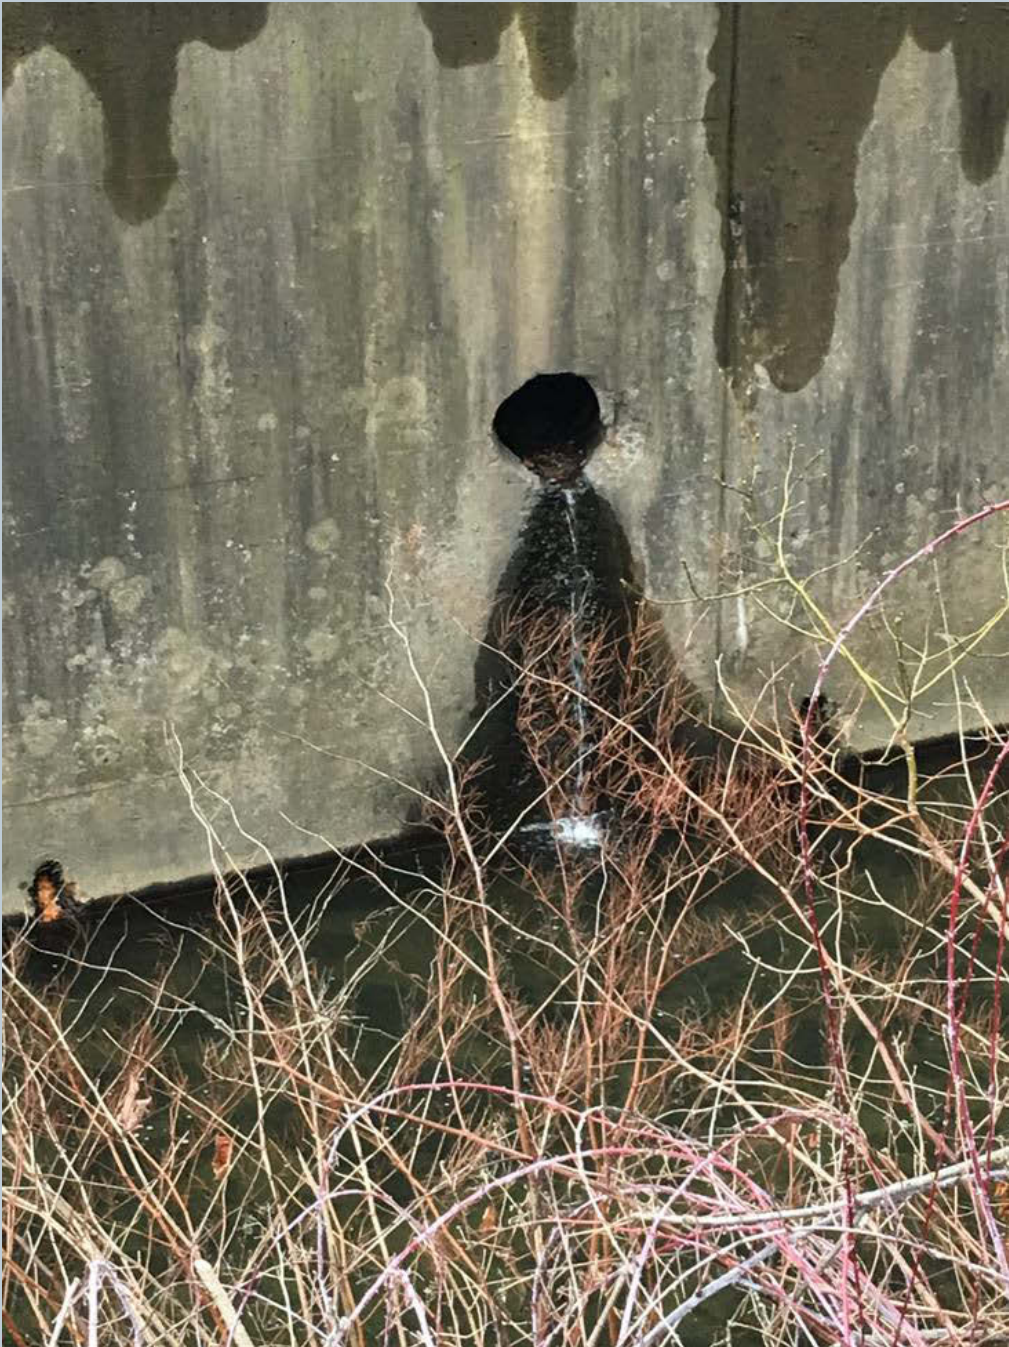
Figure 143. An UNT to Toby Creek outfall from 12-inch opening in retaining wall from State Route 309.

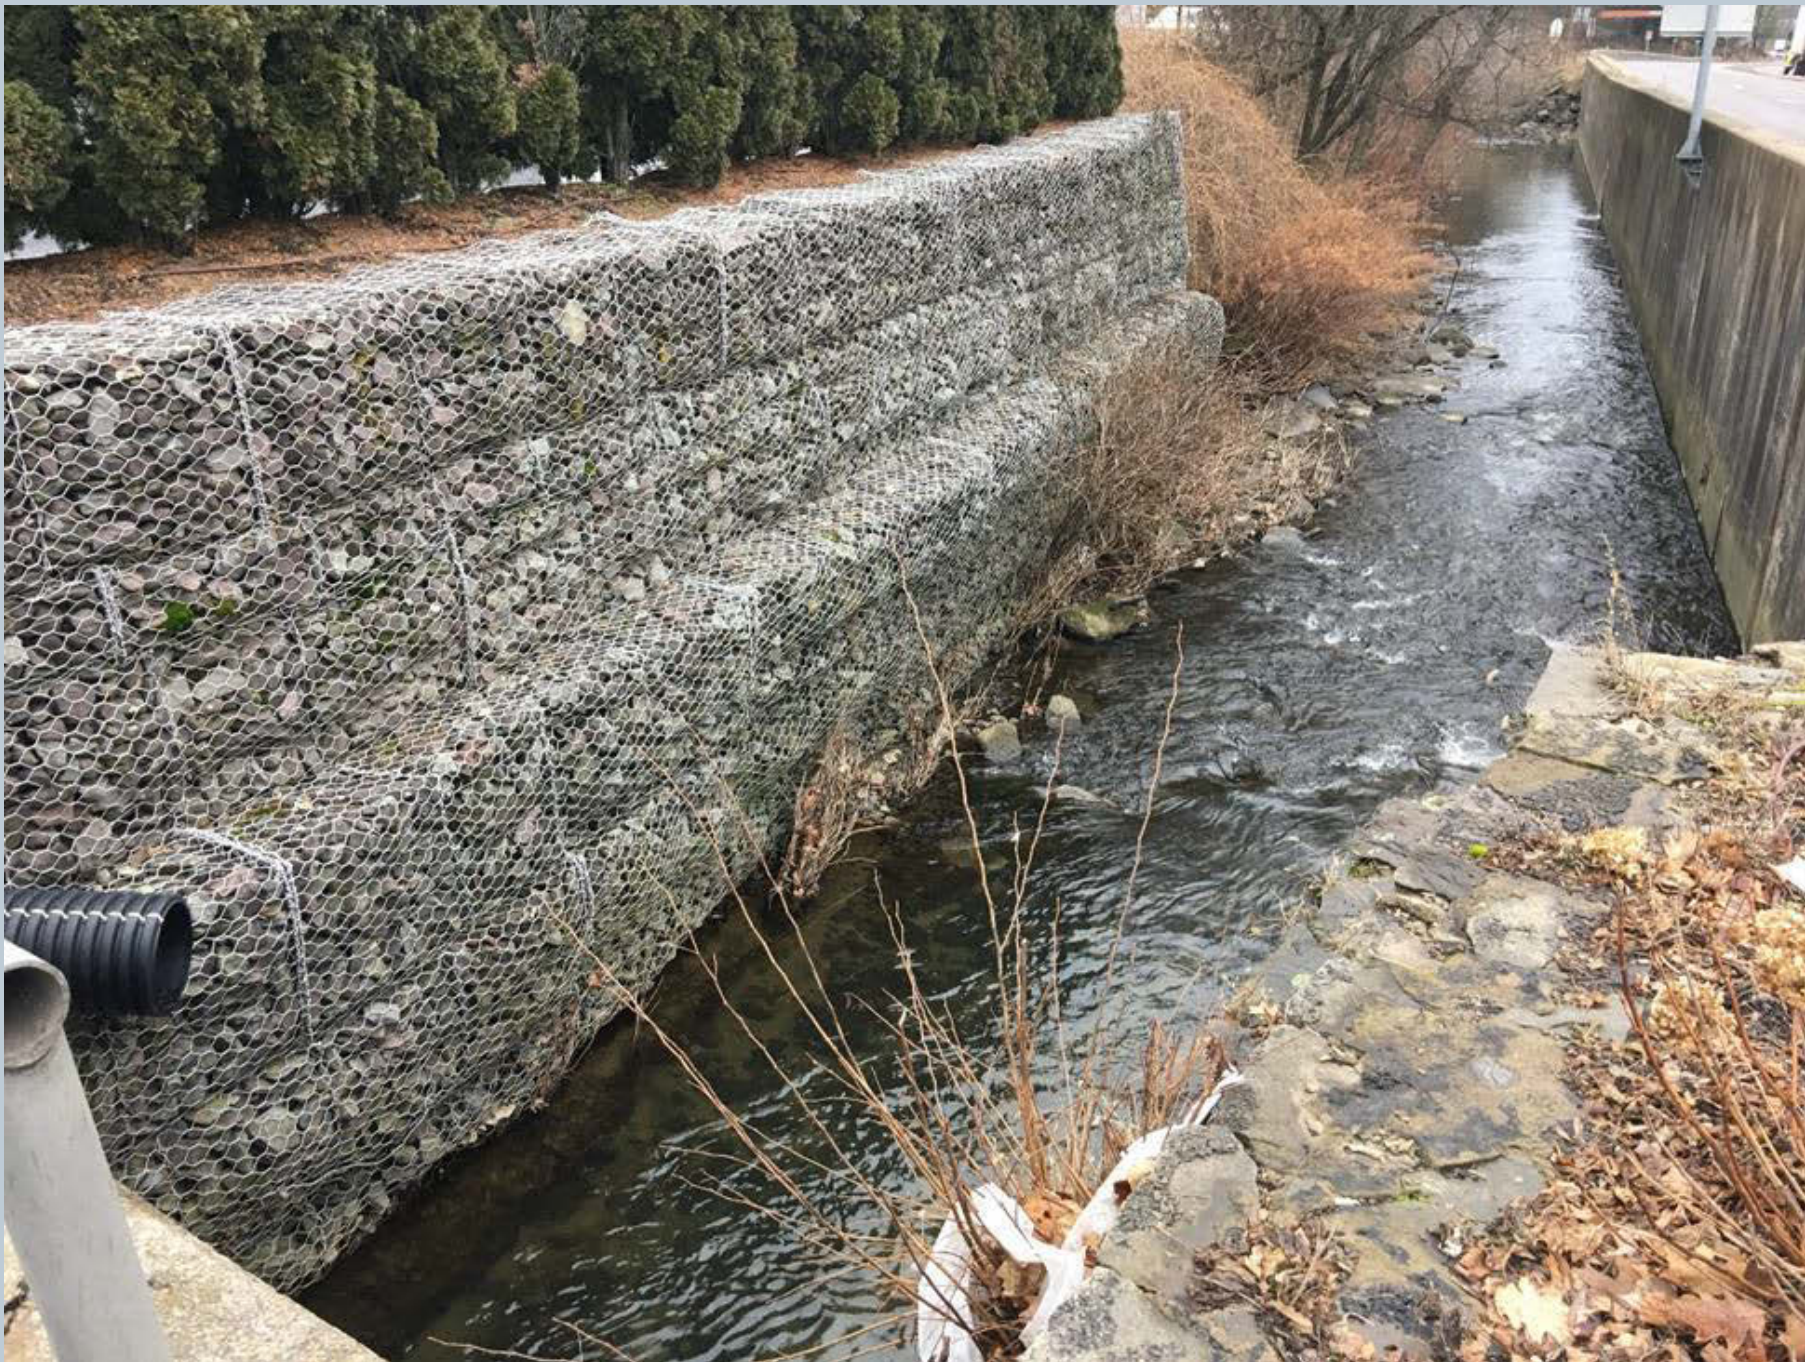
Figure 144. Looking downstream on Toby Creek from the Age of Innocence Parking Lot, gabion rock-filled baskets are in place as a stabilization project along the left wall for nearly 200-feet. There is a 12-inch black corrugated HDPE pipe is floating 9-foot above the Toby Creek draining parking lot.

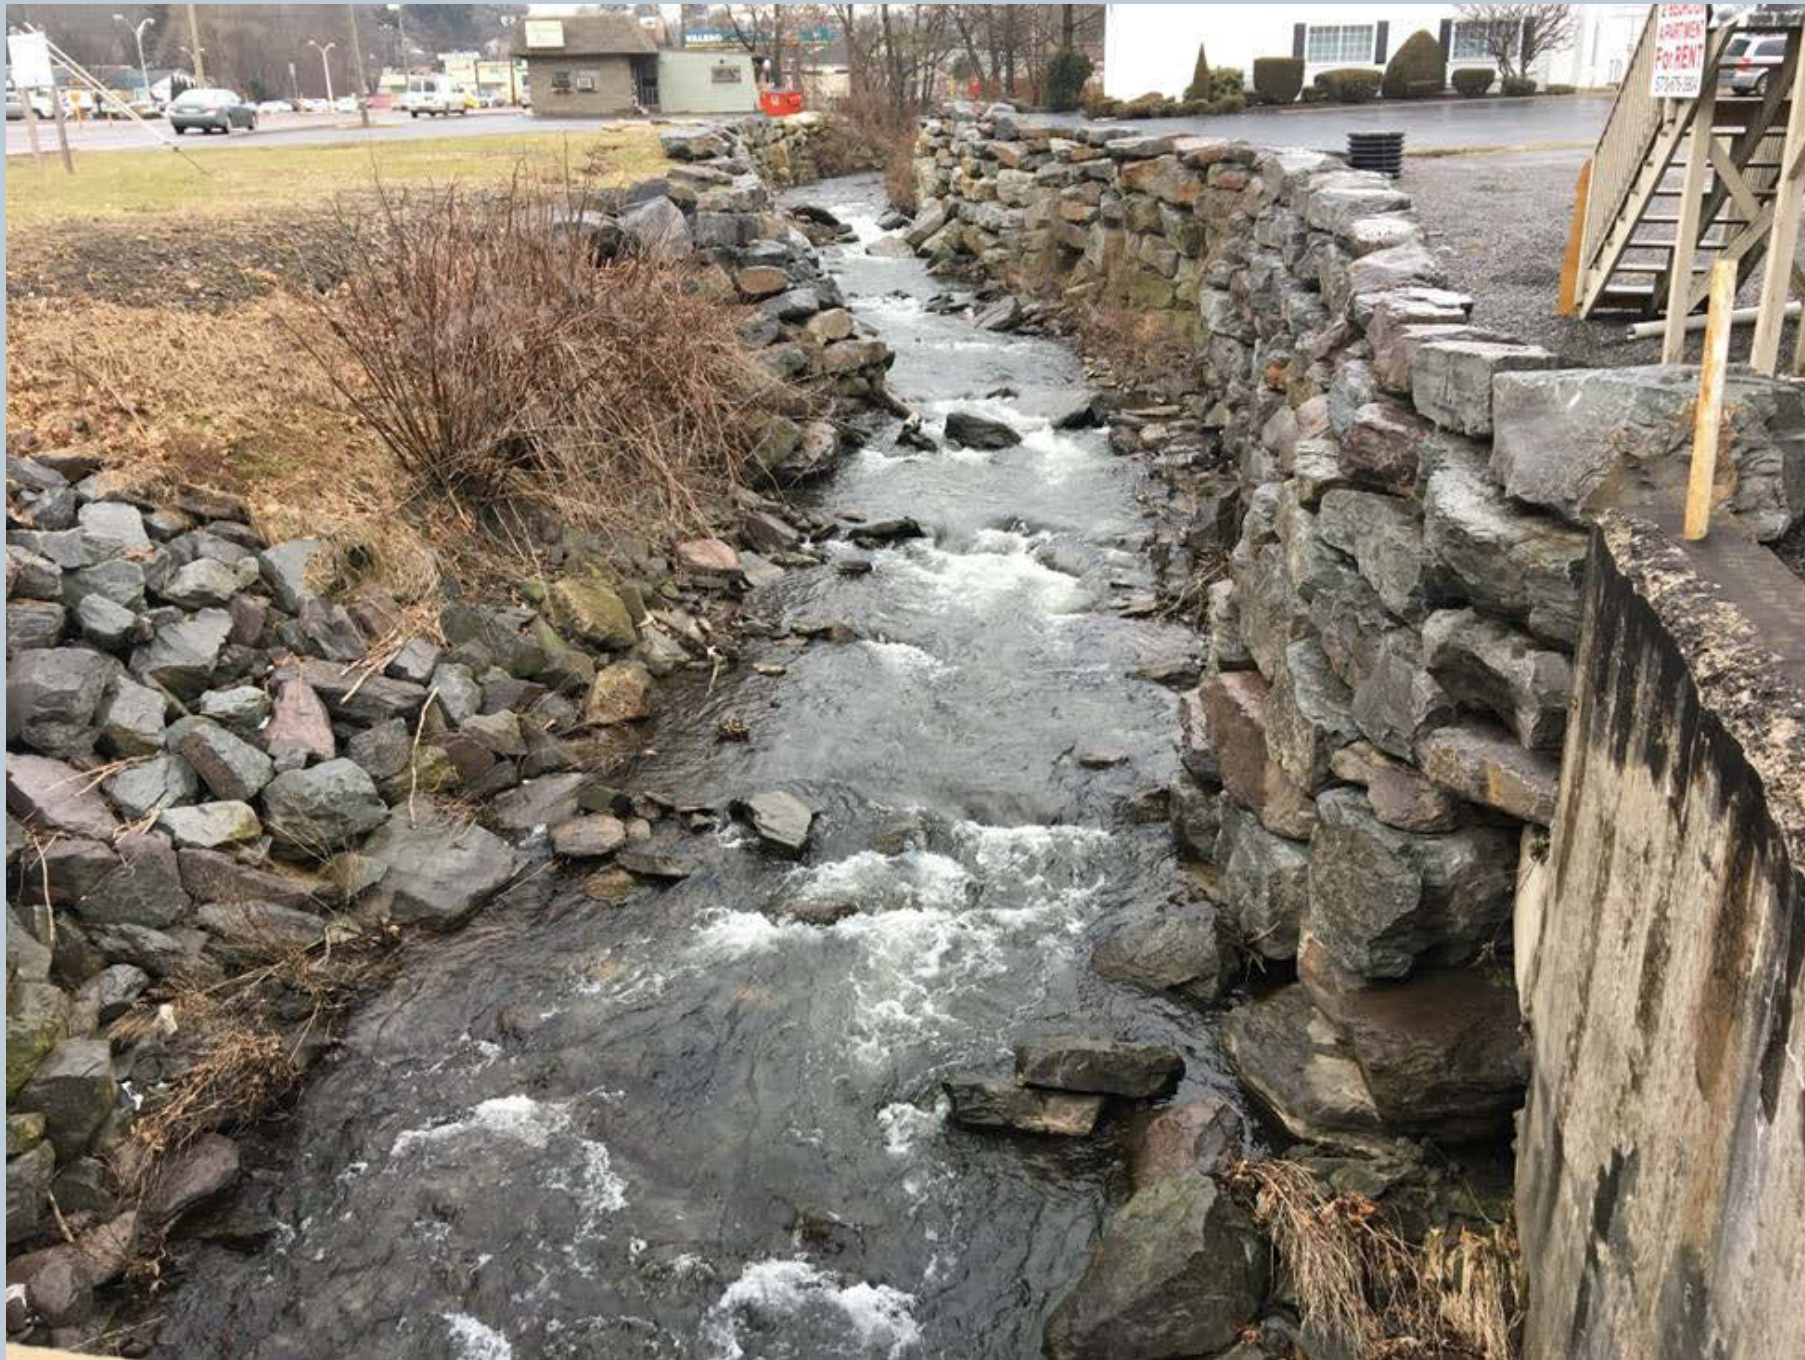
Figure 145. Looking upstream on Toby Creek from the W. Center Street bridge towards the Snowdon Funeral Home, this section of Toby Creek has a large historic streambank stabilization project that follows along both sides of the creek.

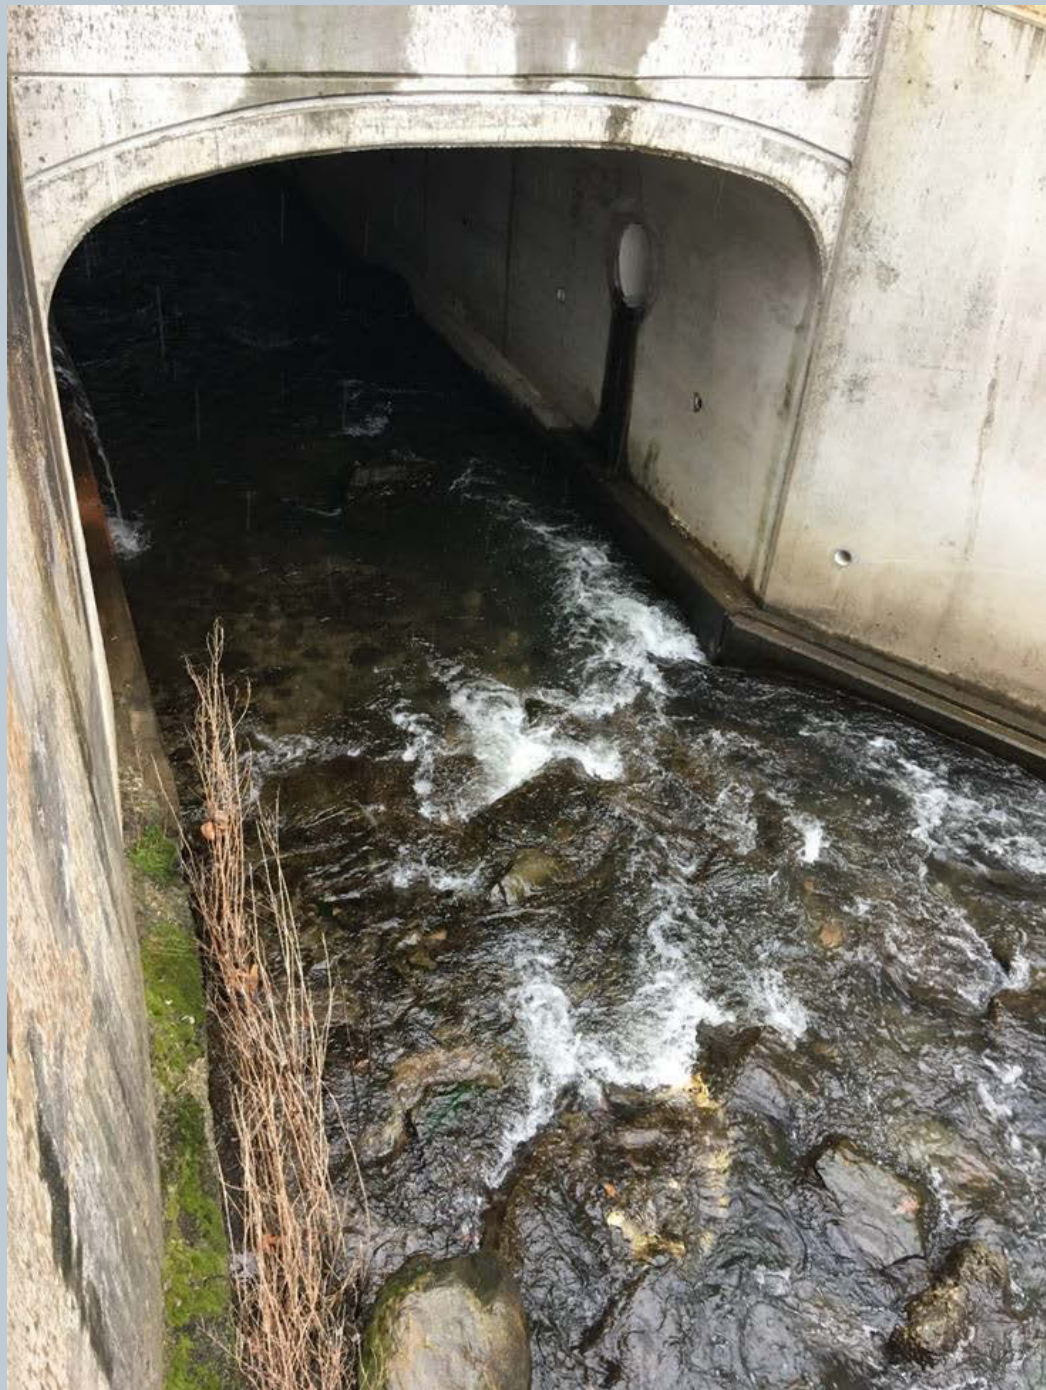
Figure 146. Beneath the W. Center Street Bridge there is an UNT that enters Toby Creek through an outfall pipe structure on the left bank of the retaining wall while looking downstream.

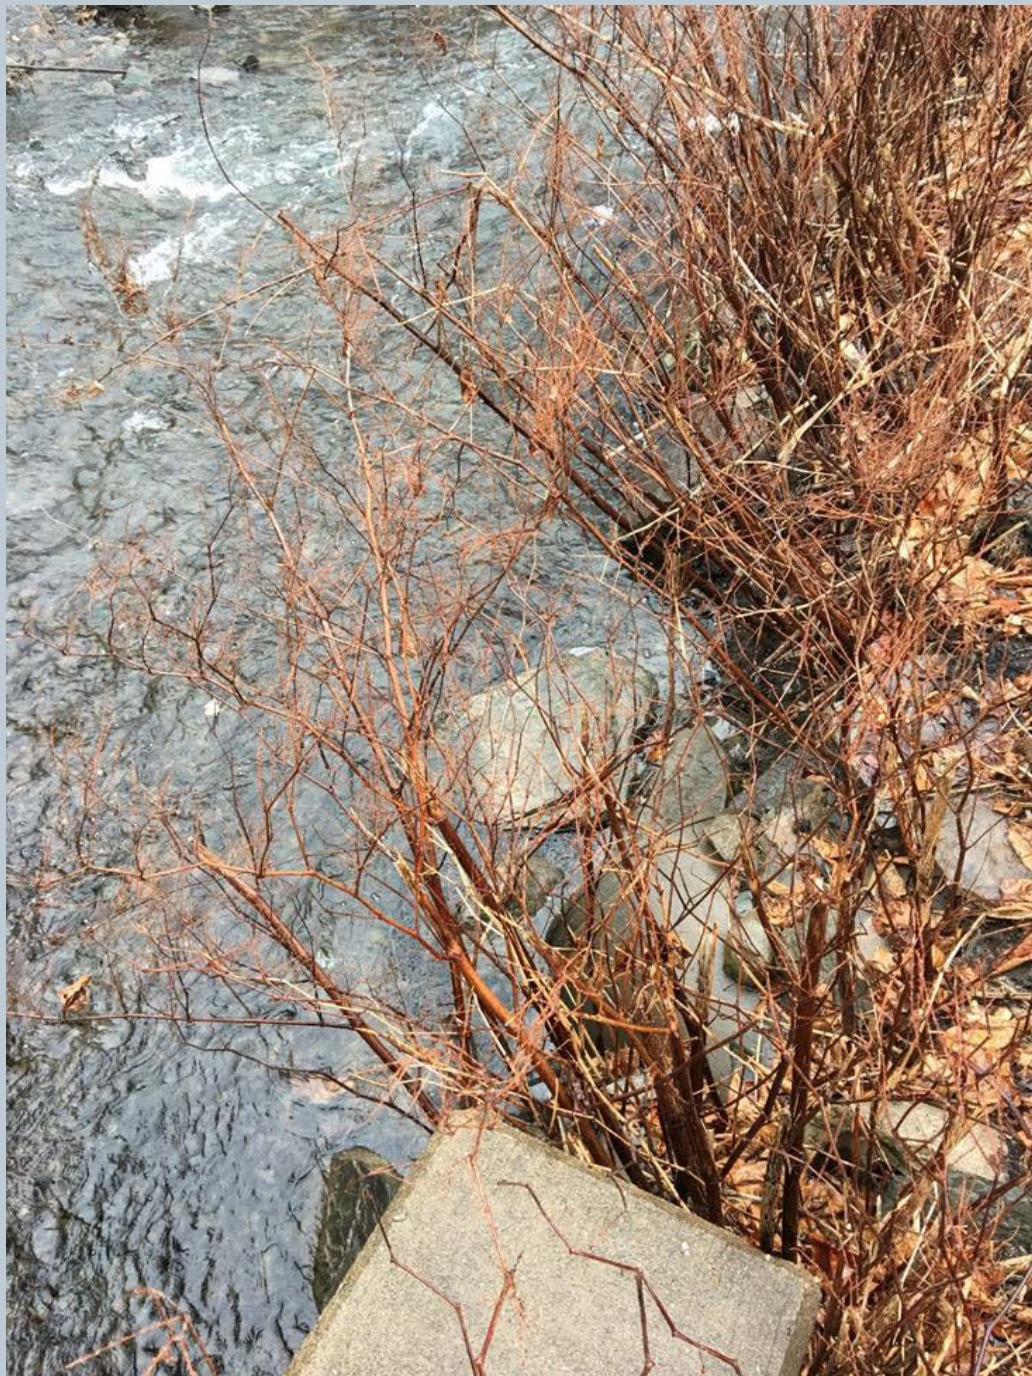
Figure 147. A shot of a 24-inch concrete stormwater pipe (dry) aligned with Toby Creek, below the wingwall off of N. Main Street.

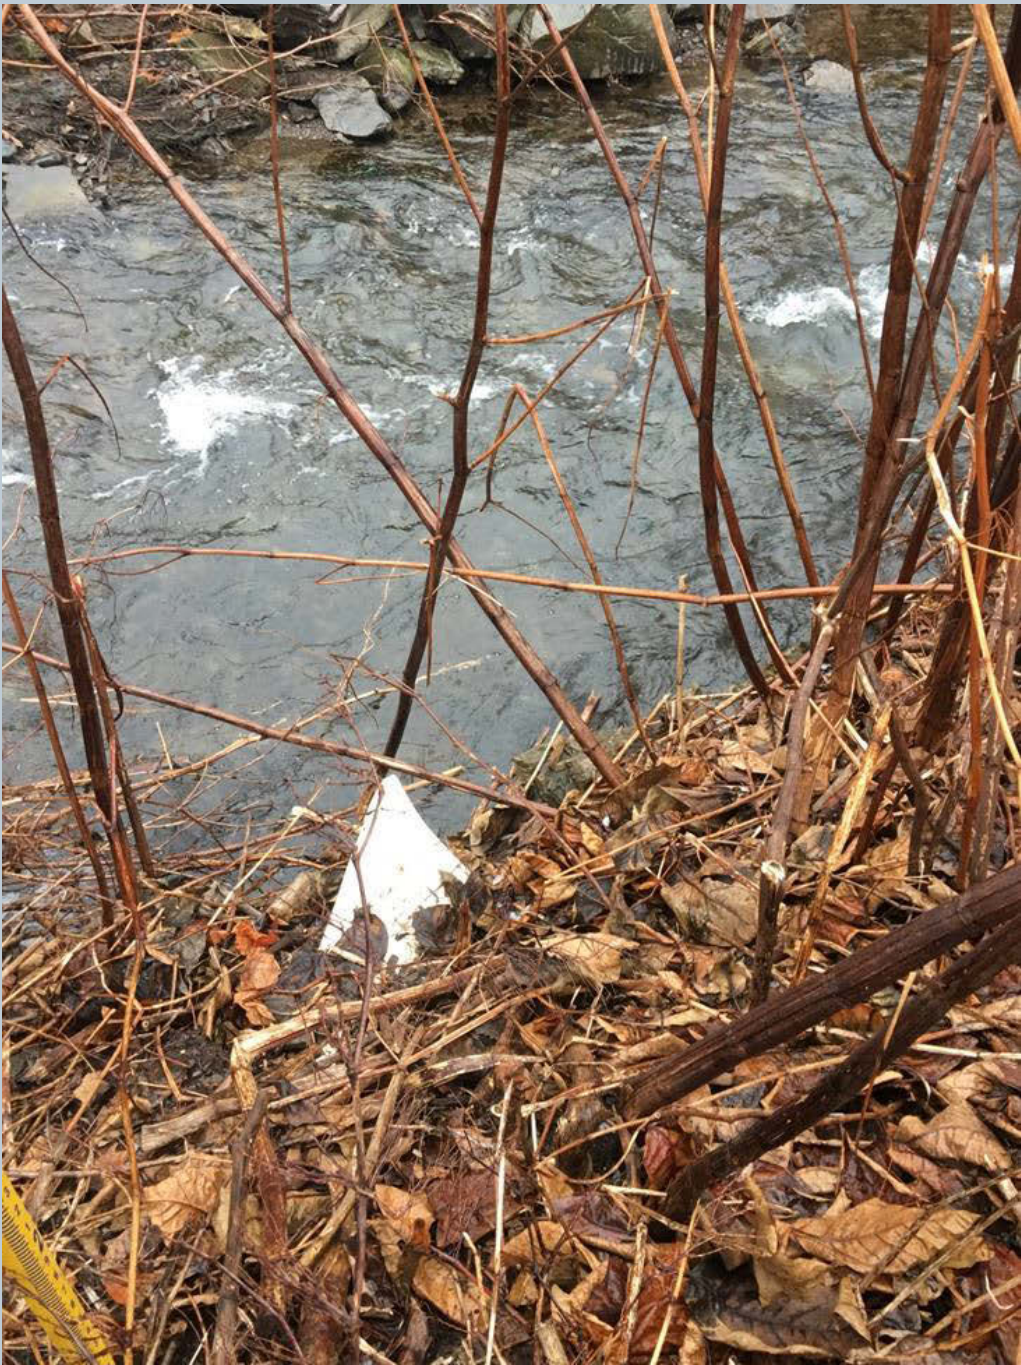
Figure 148. A 12-inch white PVC-like stormwater pipe, aligned with Toby Creek, is located two feet above the water level along an old retaining wall, located behind the clothing recycling bins near Cook's Pharmacy.

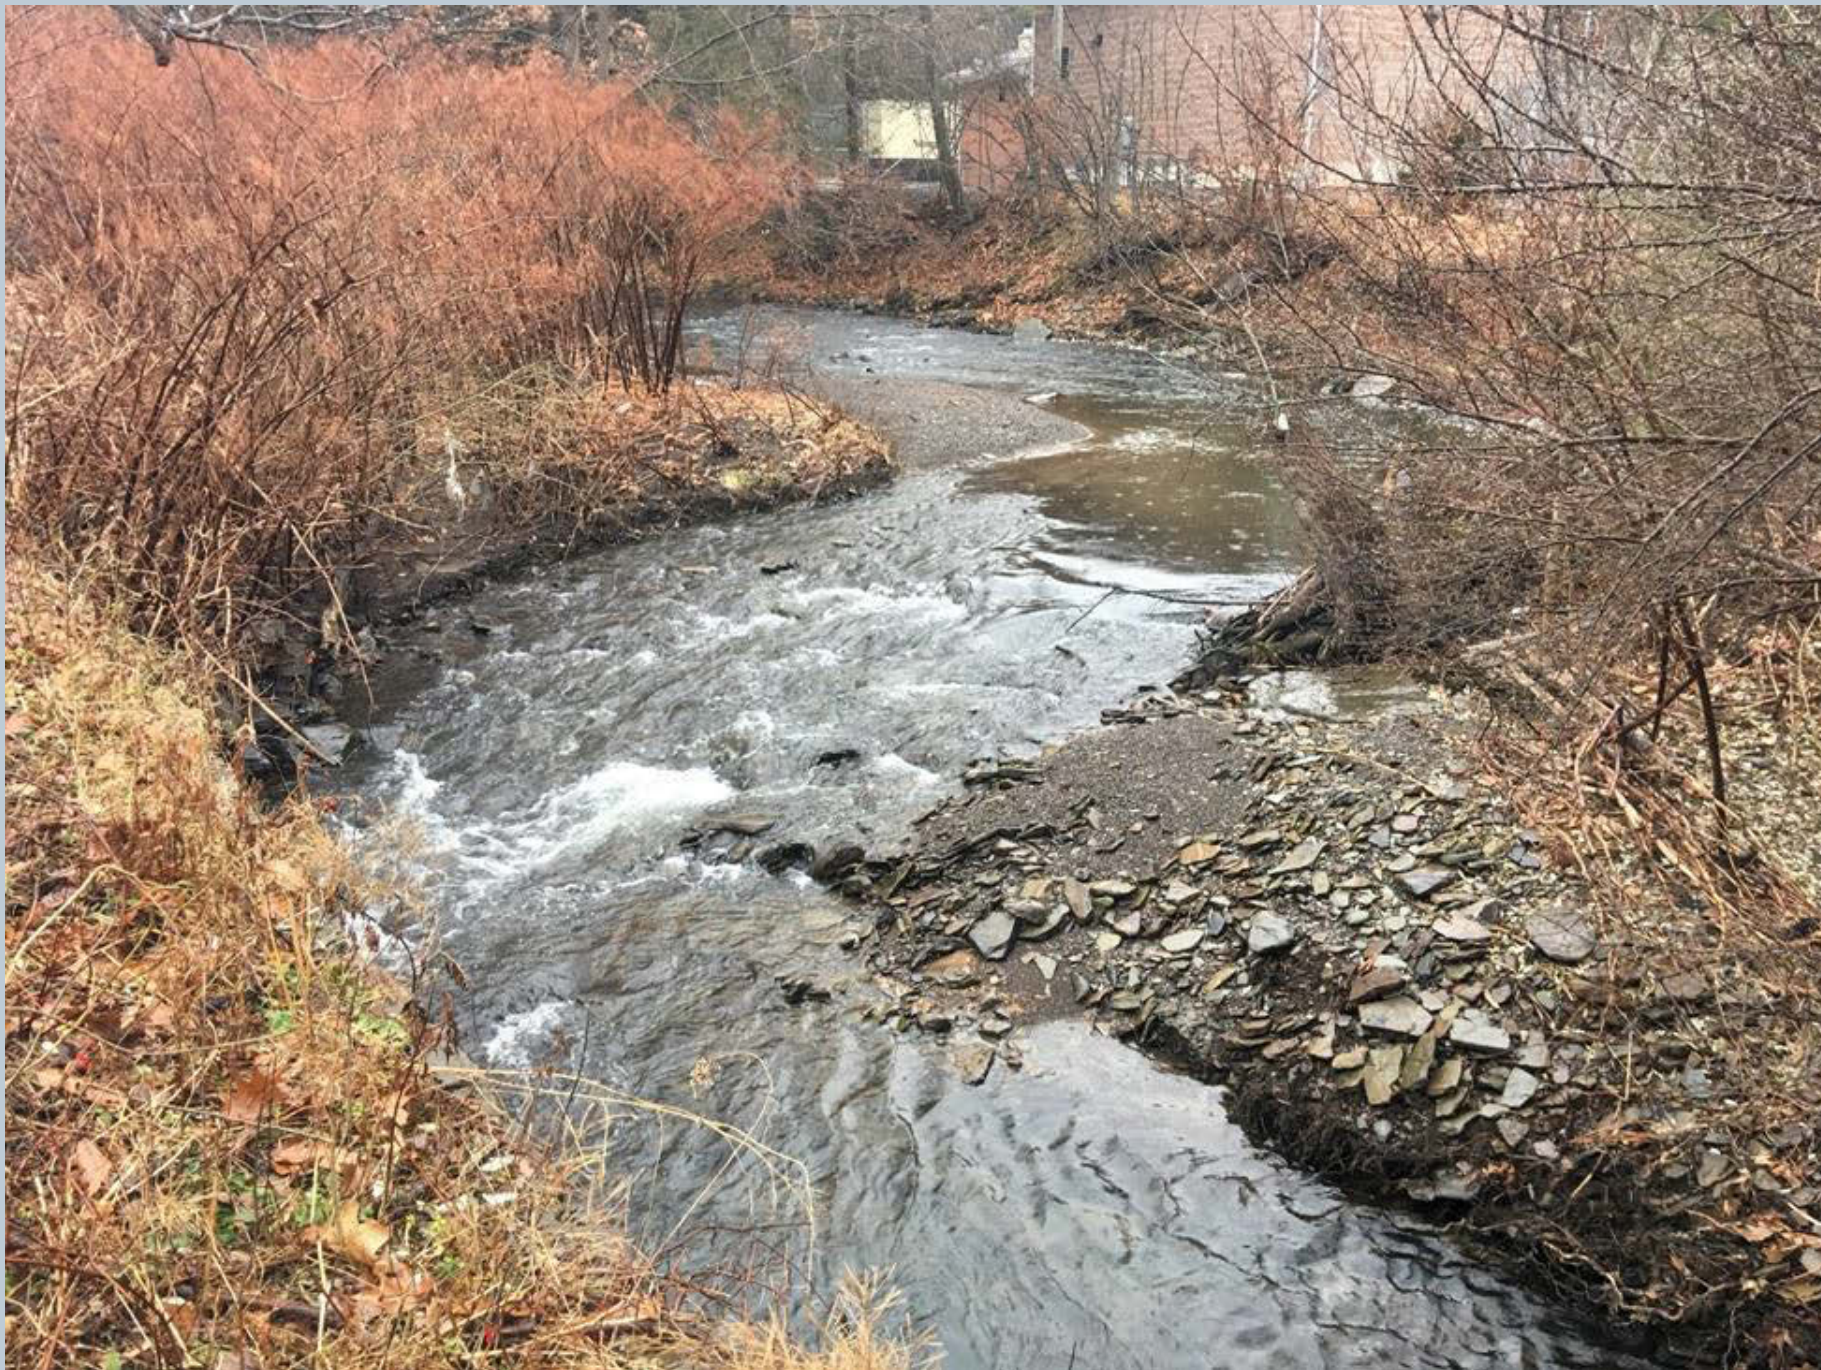
Figure 149. In this section of Toby Creek, there is severe undercutting of the streambank along N. Main Street and the opposite bank, alongside a utility shed. This is due to the 90-degree turn into the right bank, while looking upstream. A streambank stabilization project is recommended.
