Toby Creek Field Reconnaissance Observations

September 26, 2018

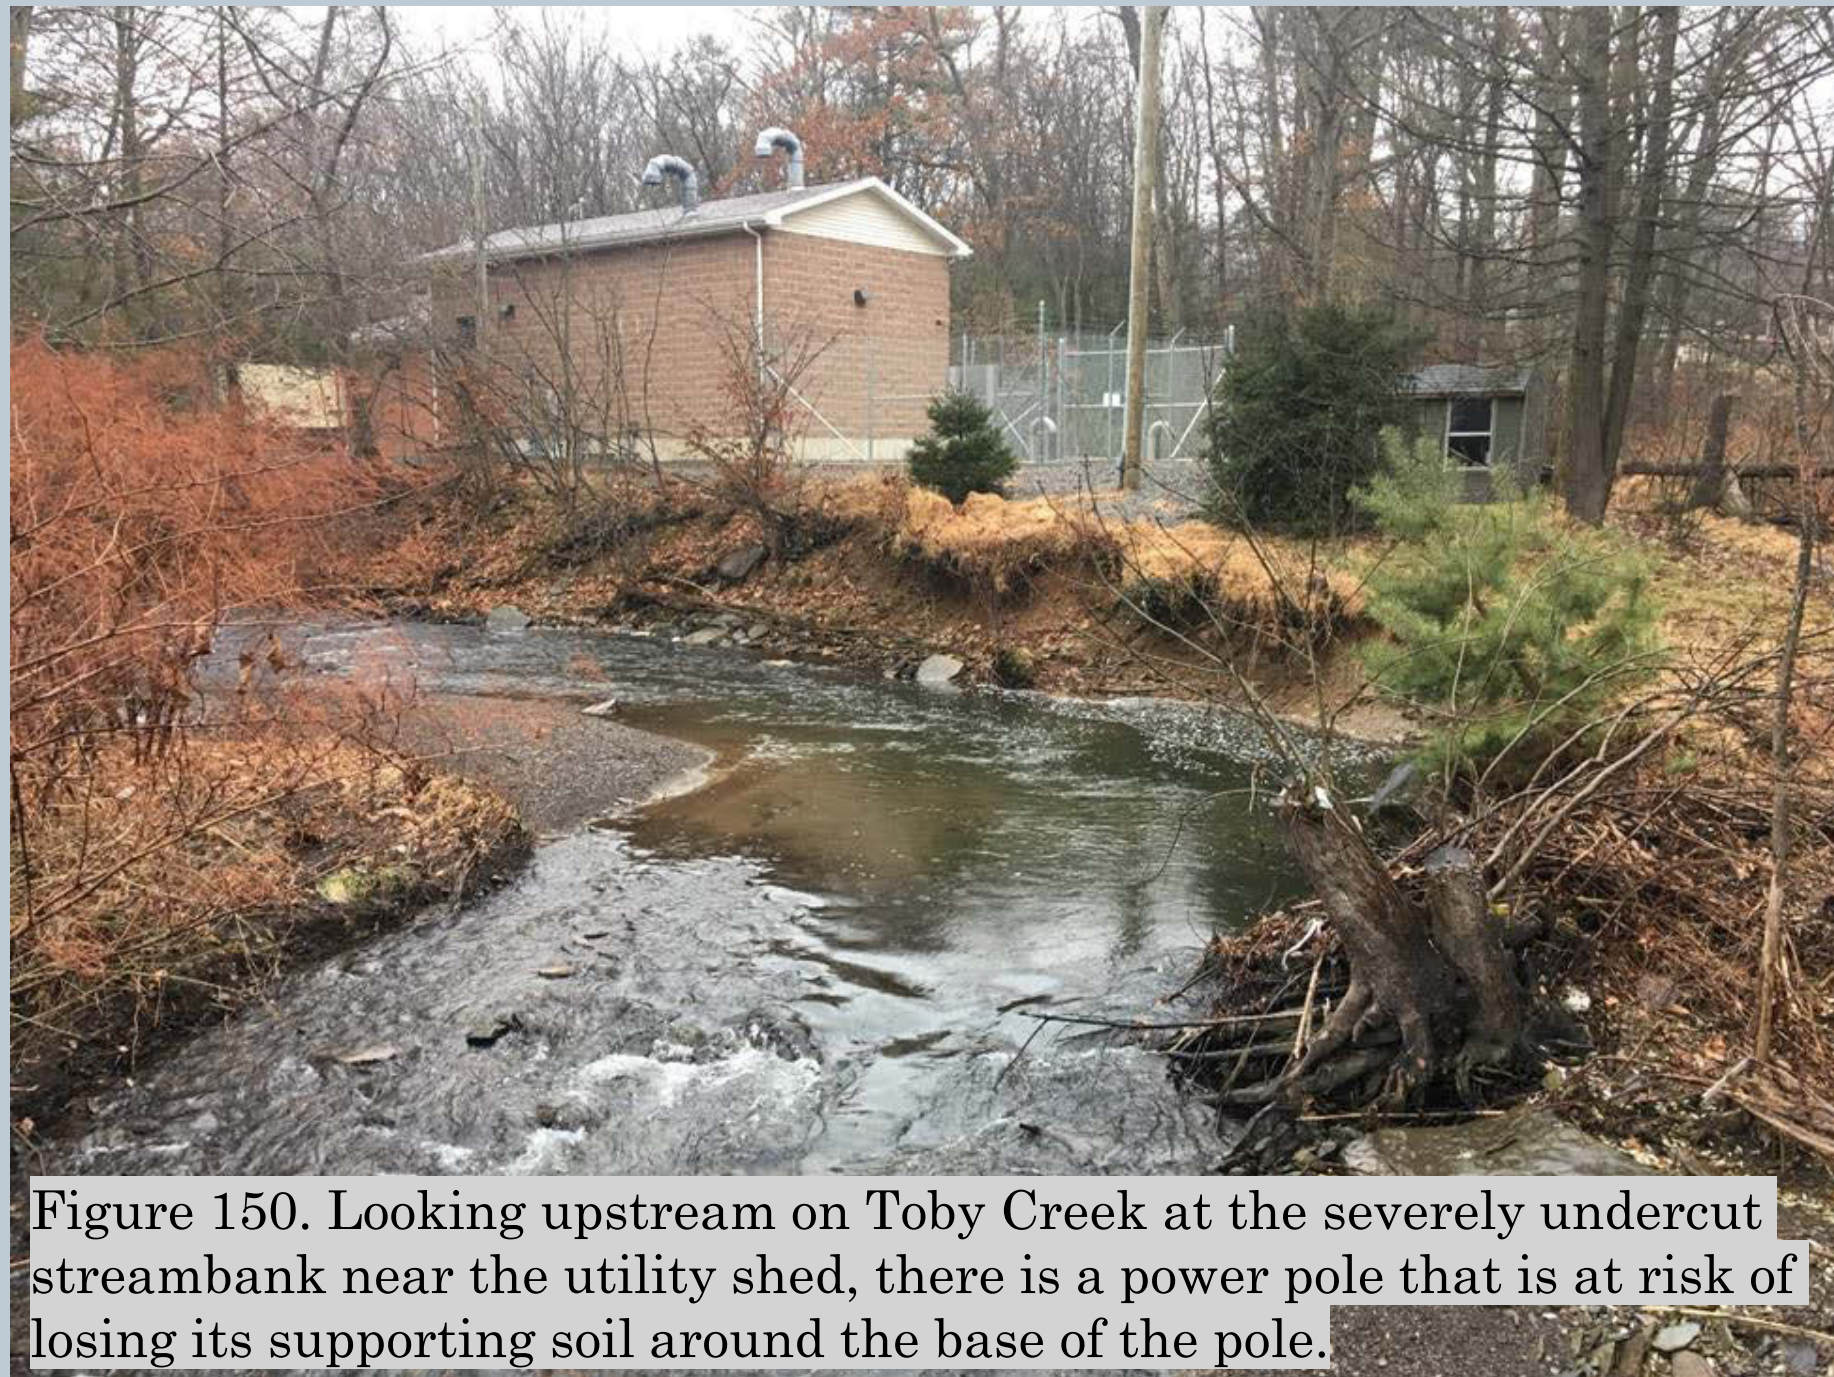
Figure 150. Looking upstream on Toby Creek at the severely undercut streambank near the utility shed, there is a power pole that is at risk of losing its supporting soil around the base of the pole.

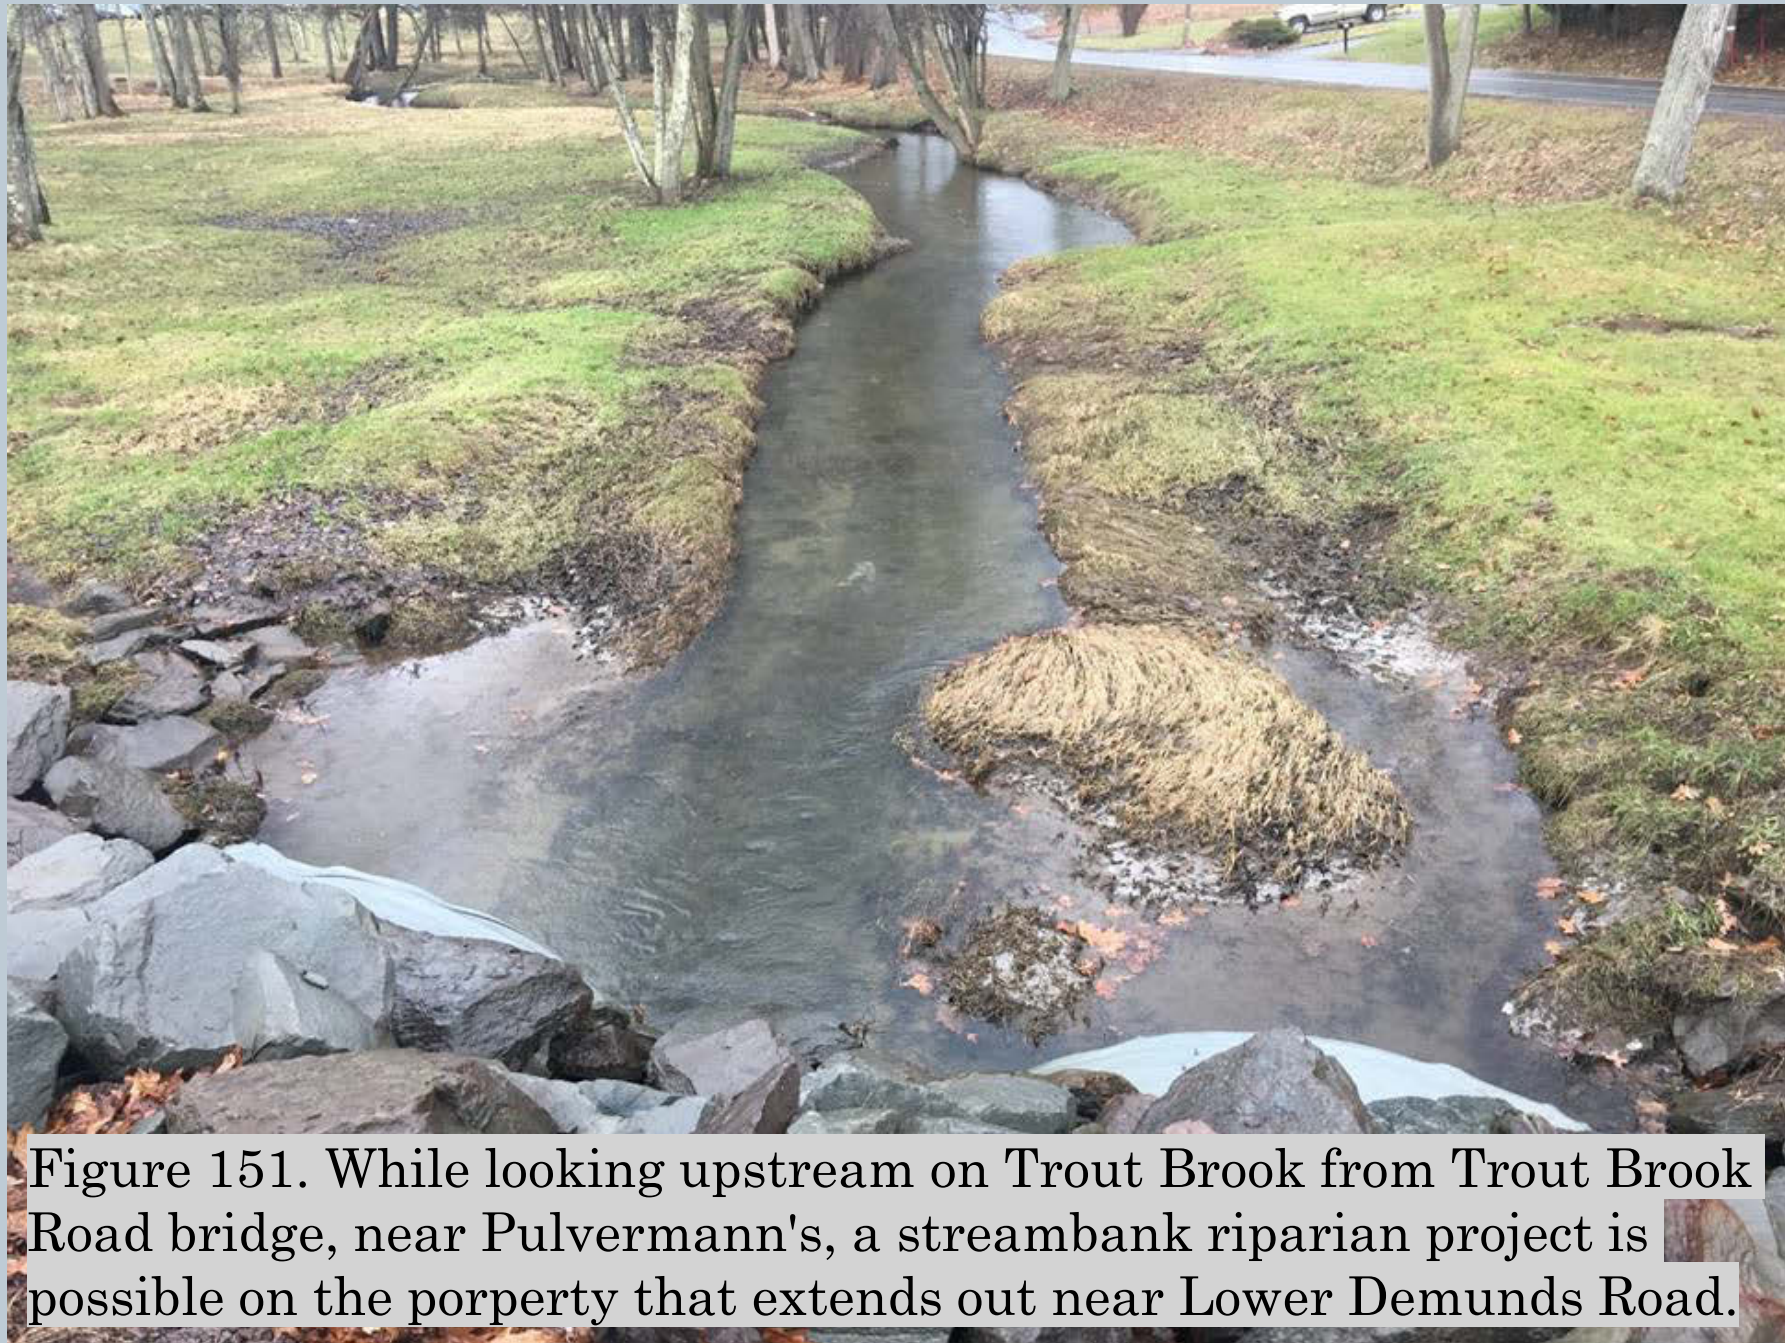
Figure 151. While looking upstream on Trout Brook from Trout Brook Road bridge, near Pulvermann's, a streambank riparian project is possible on the property that extends out near Lower Demunds Road.

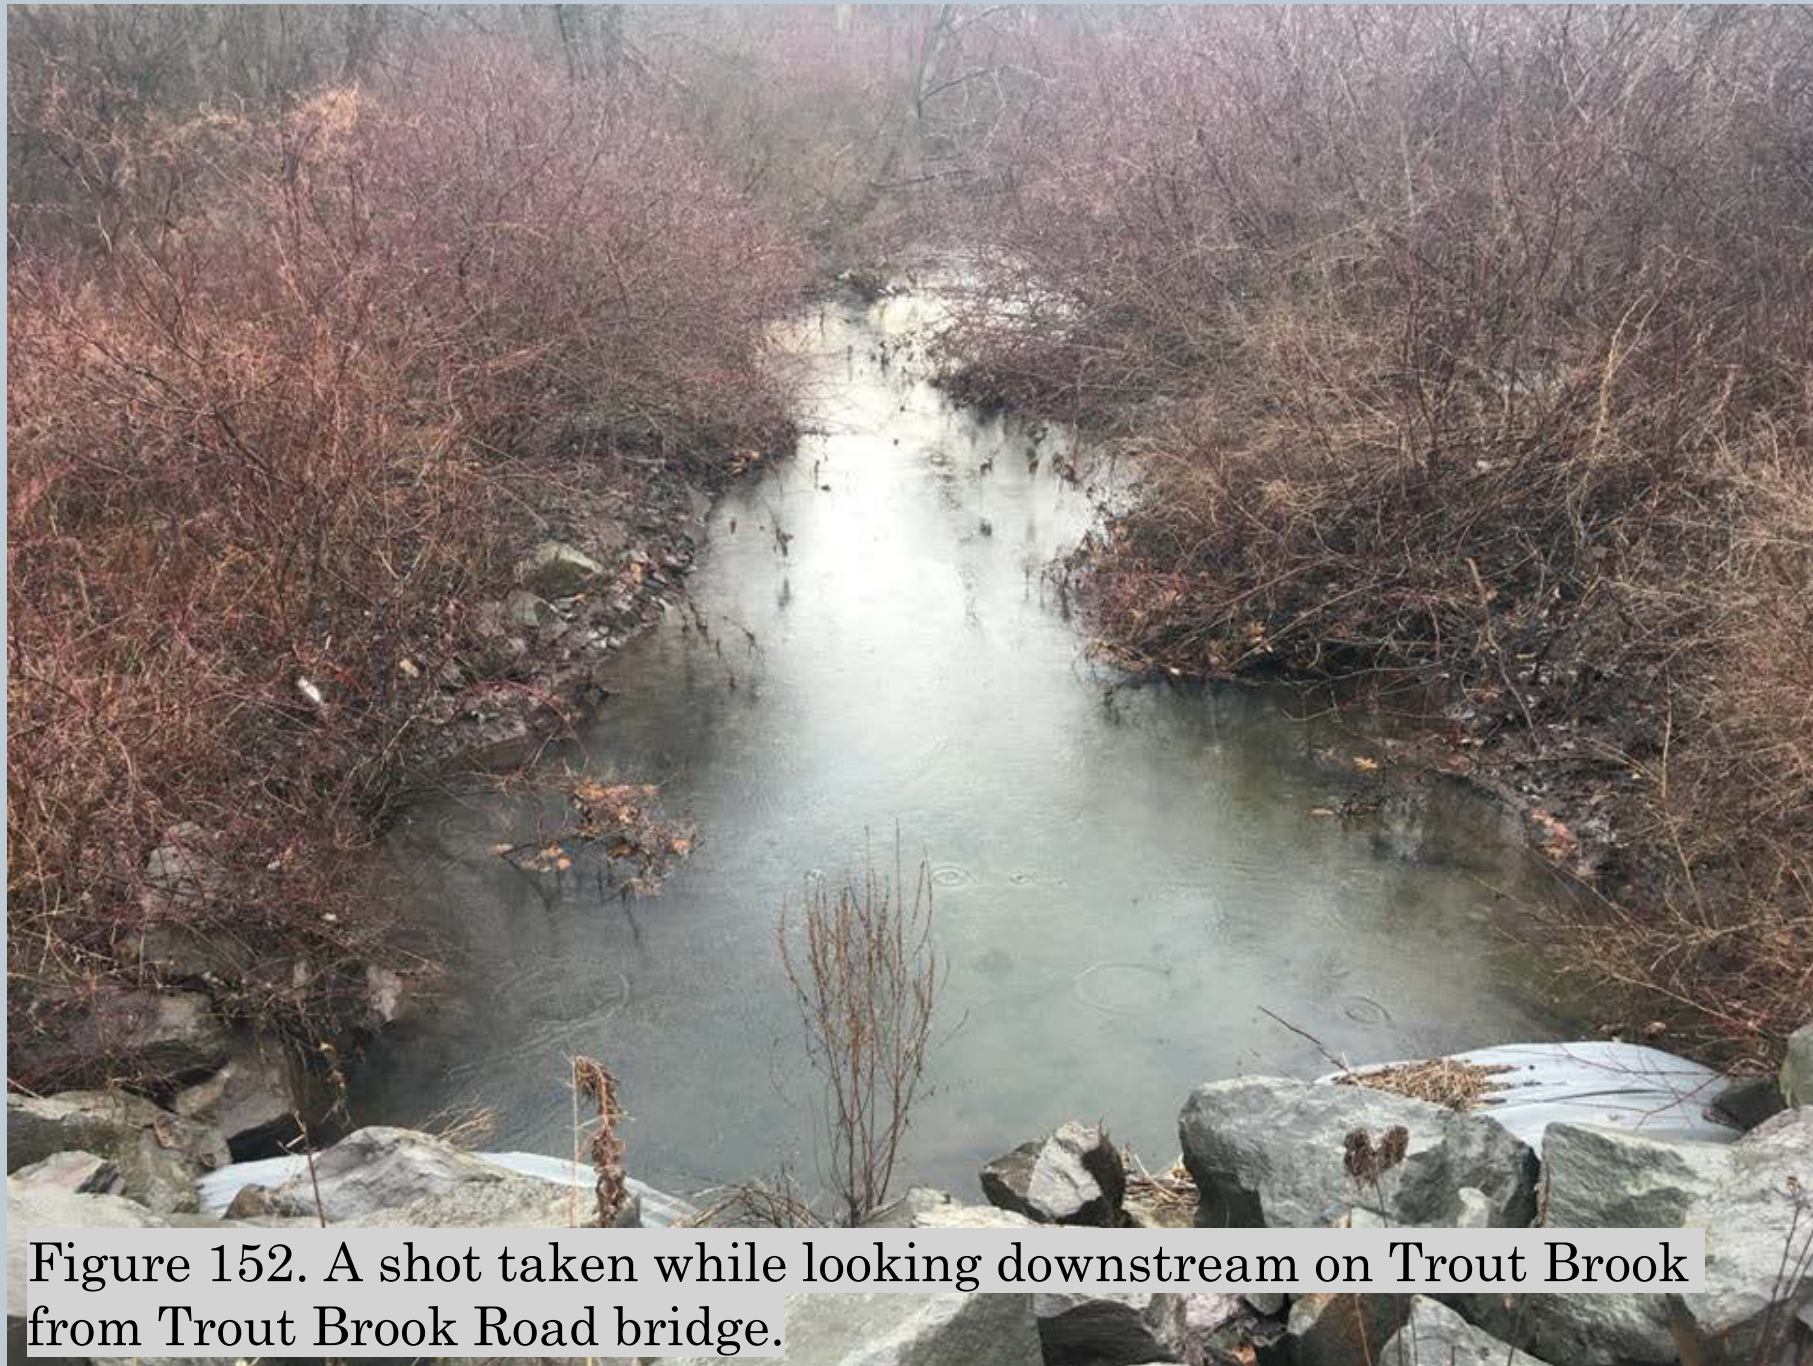
Figure 152. A shot taken while looking downstream on Trout Brook from Trout Brook Road bridge.

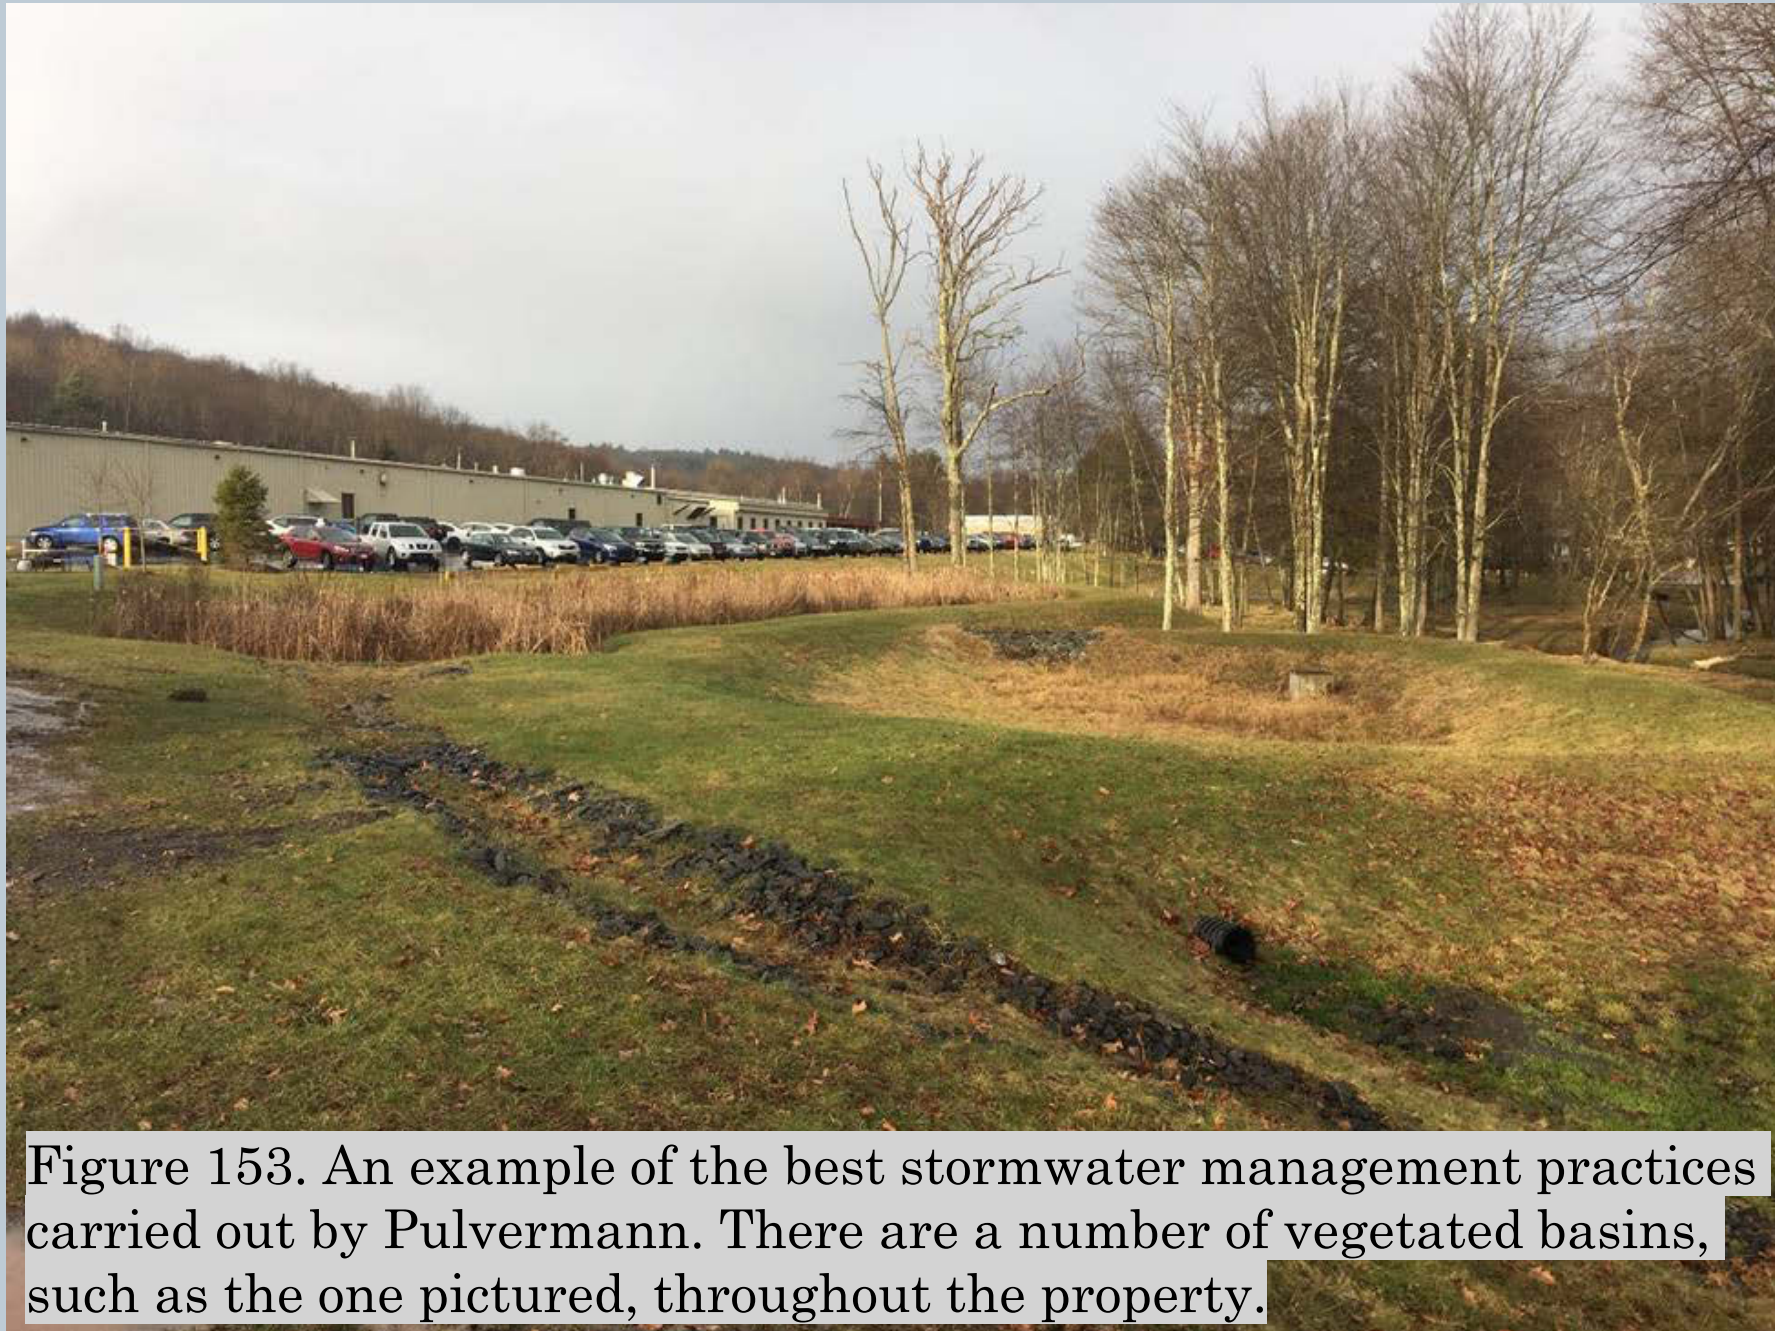
Figure 153. An example of the best stormwater management practices carried out by Pulvermann. There are a number of vegetated basins, such as the one pictured, throughout the property.

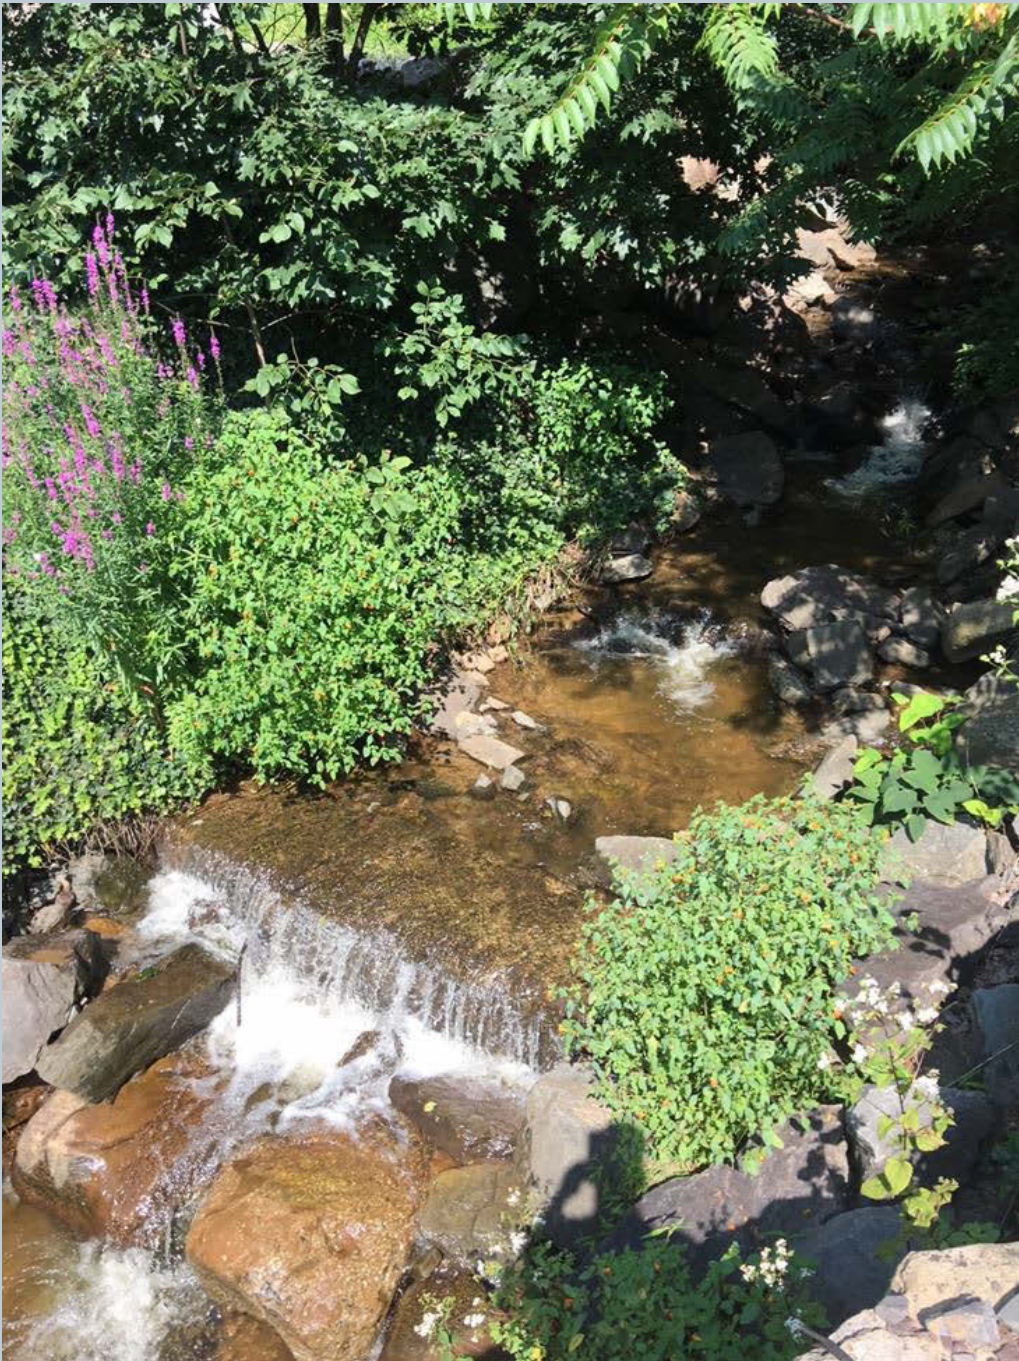
Figure 154. A shot of "Wildcat Falls", an UNT to Toby Creek. This UNT flows down along the steep slope of the mountain cut, which also crosses under the Back Mountain Trail Bridge. The DAMA plant can be found to the northwest. There is a sewer line incased with concrete that crosses the tributary and enters the DAMA plant. There is also a culvert that runs southeast under the DAMA Plant road before exiting along Toby Creek.

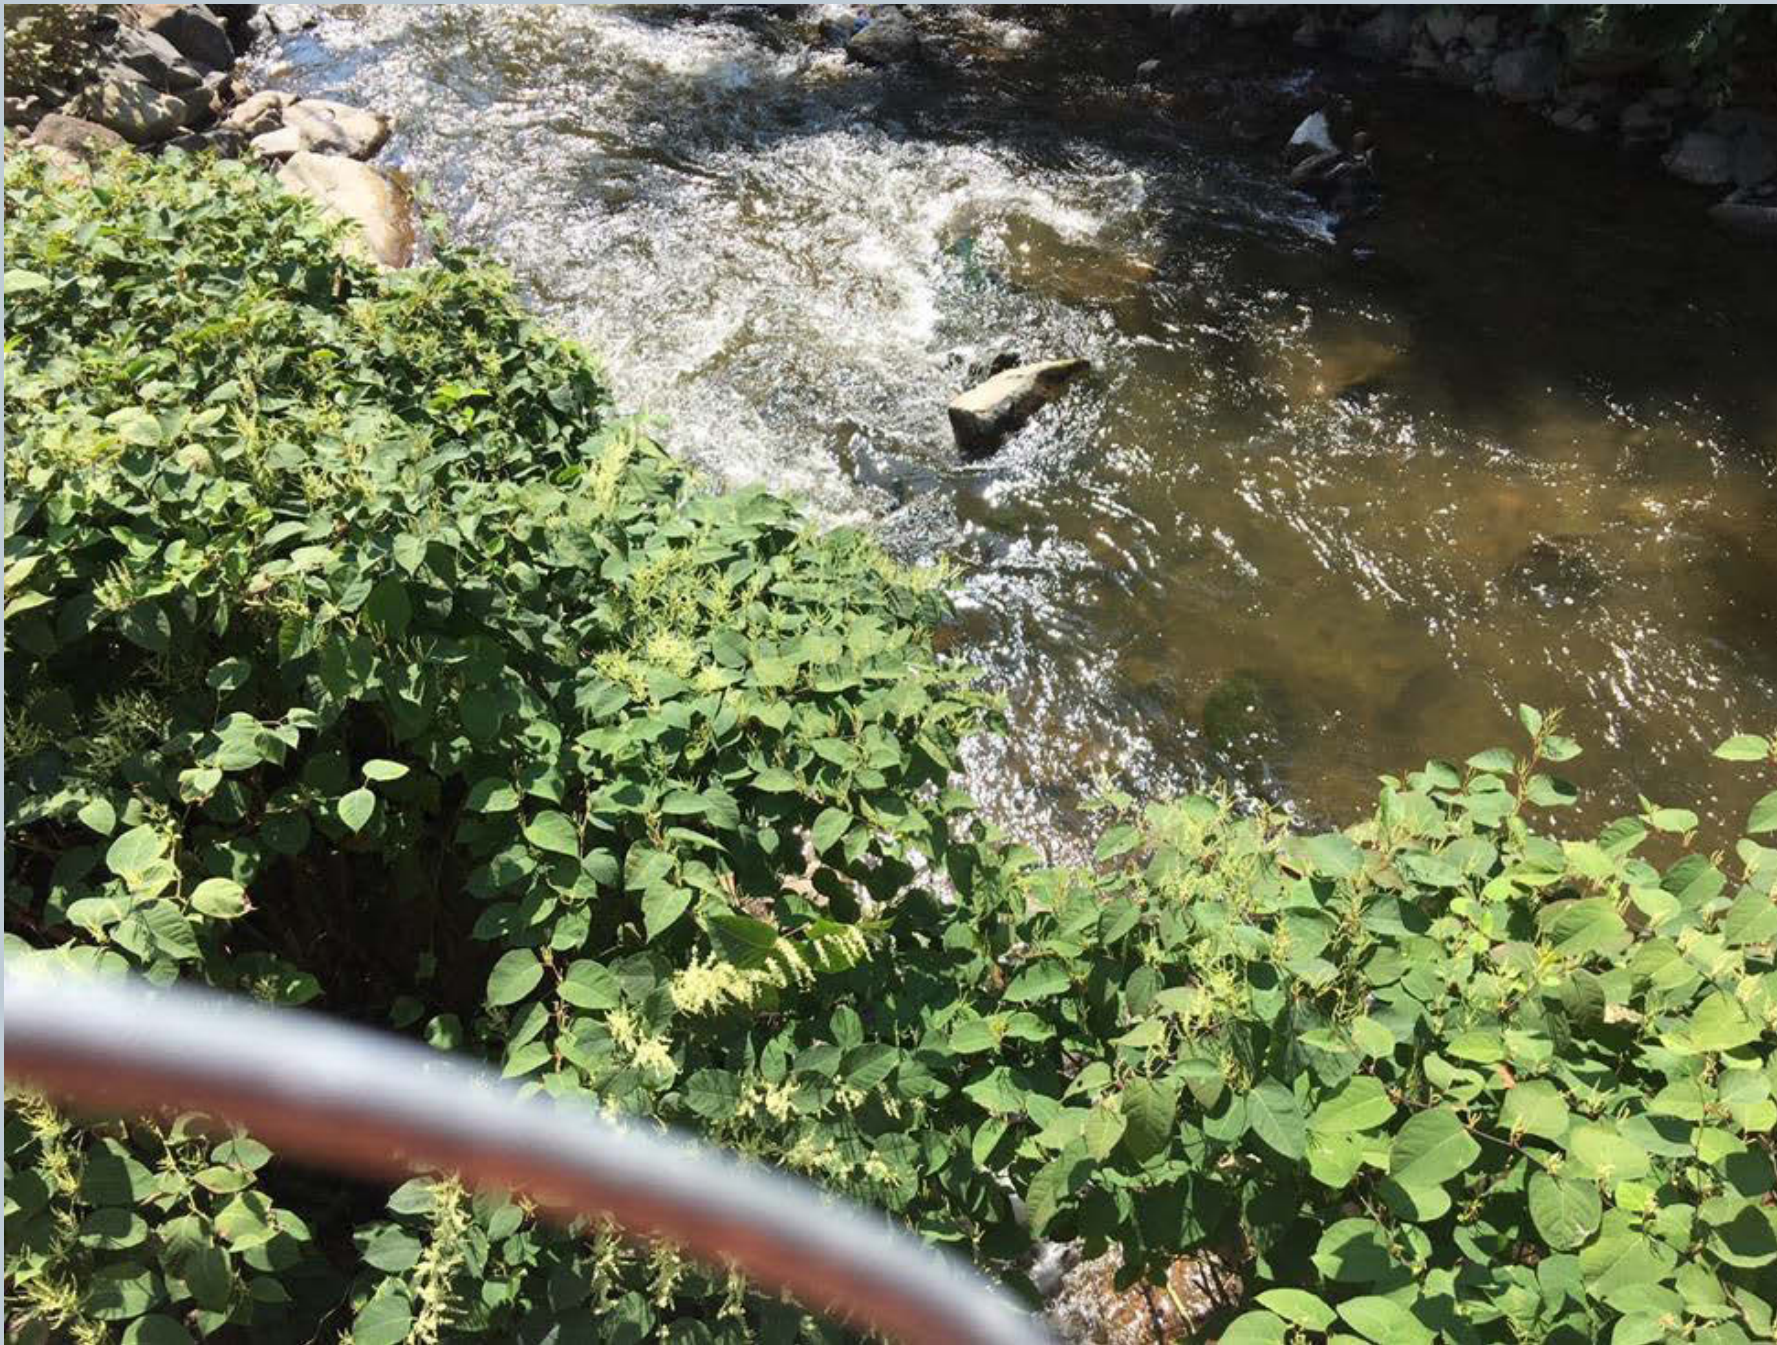
Figure 155. Wildcat Falls entering Toby Creek downstream. The outlet to the culvert is found on the other side of the DAMA fence and is only accessible from an upstream point on Toby Creek. This point has two large culverts which are located at the other end of the DAMA Plant property. The invasive, Japanese knotweed, is prevalent along both banks looking up and downstream.

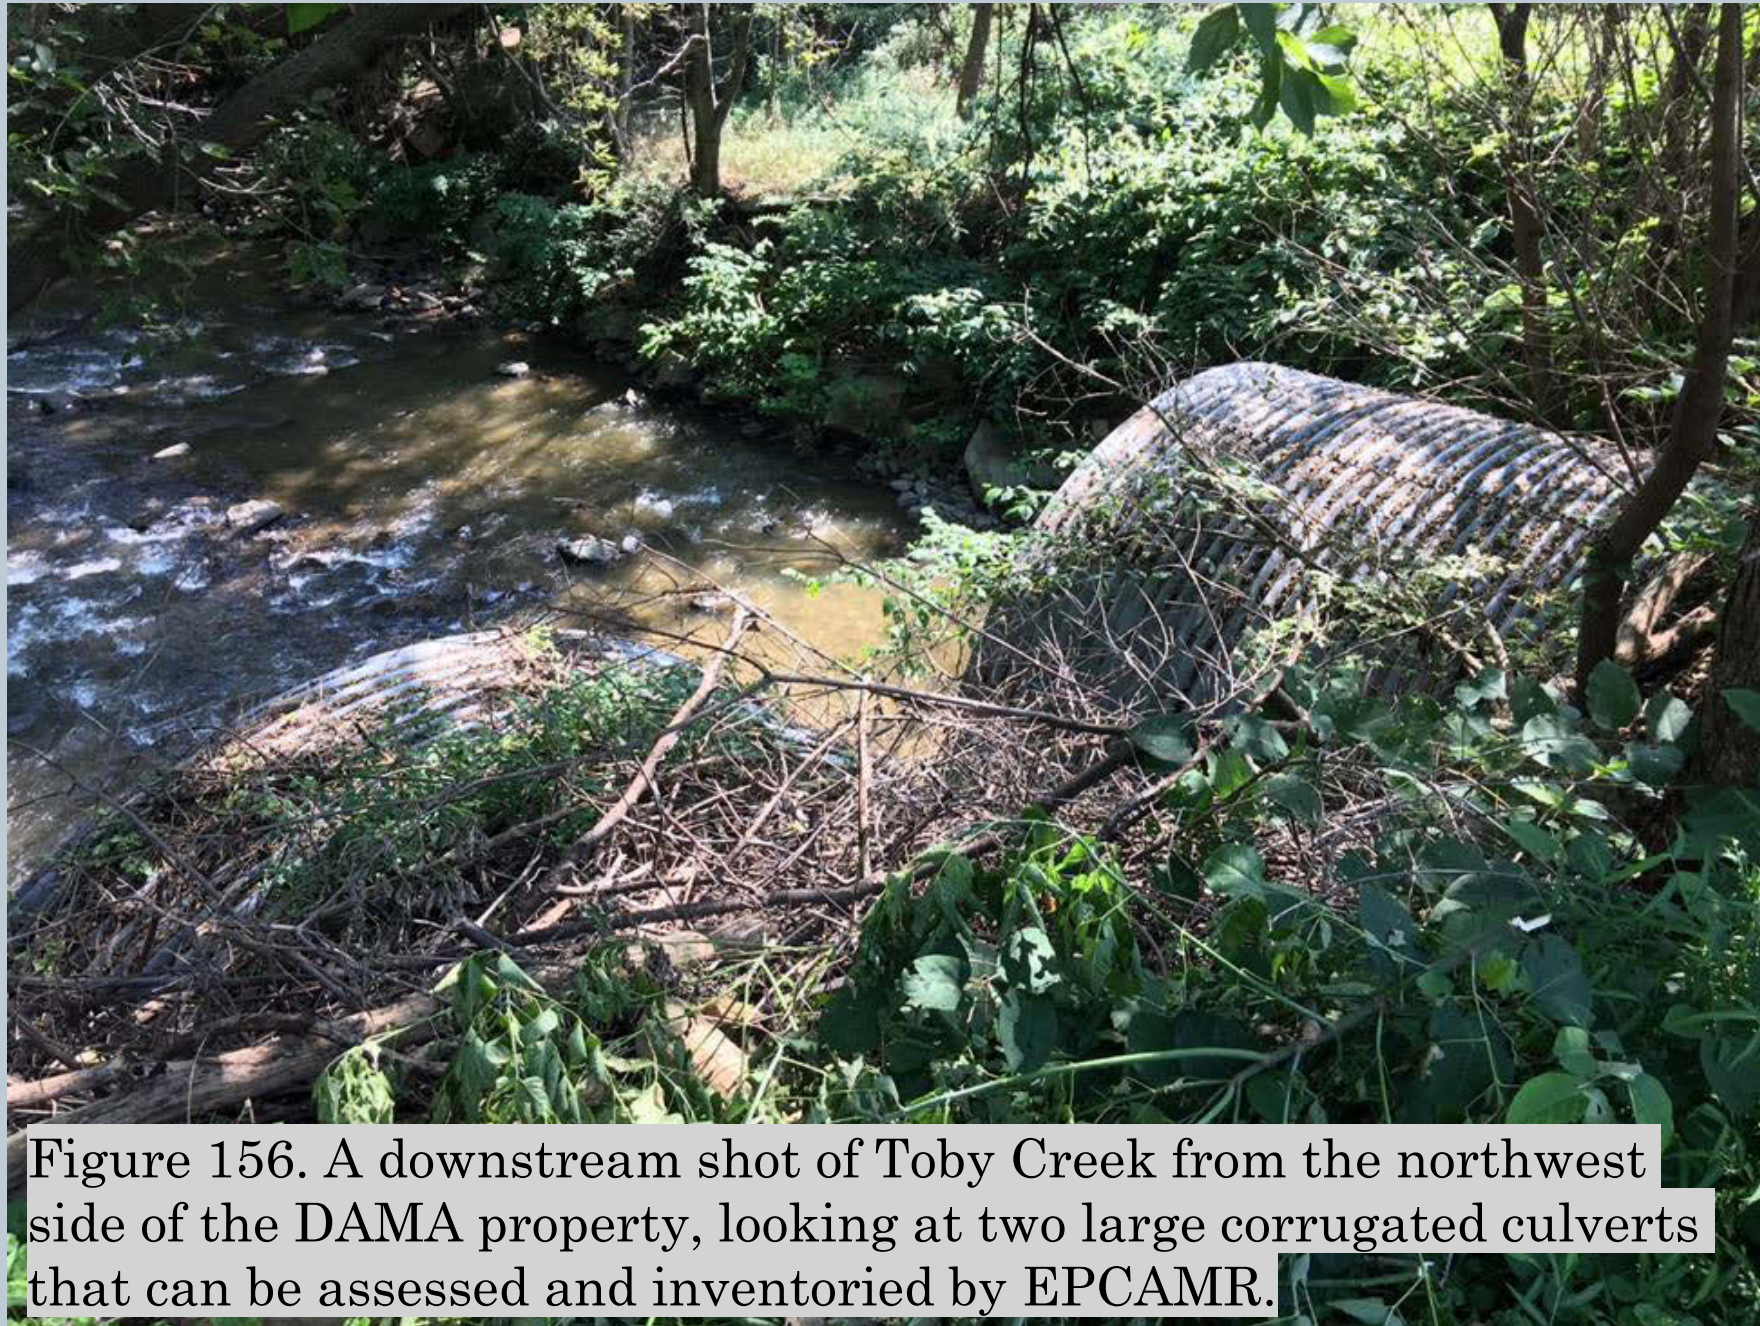
Figure 156. A downstream shot of Toby Creek from the northwest side of the DAMA property, looking at two large corrugated culverts that can be assessed and inventoried by EPCAMR.

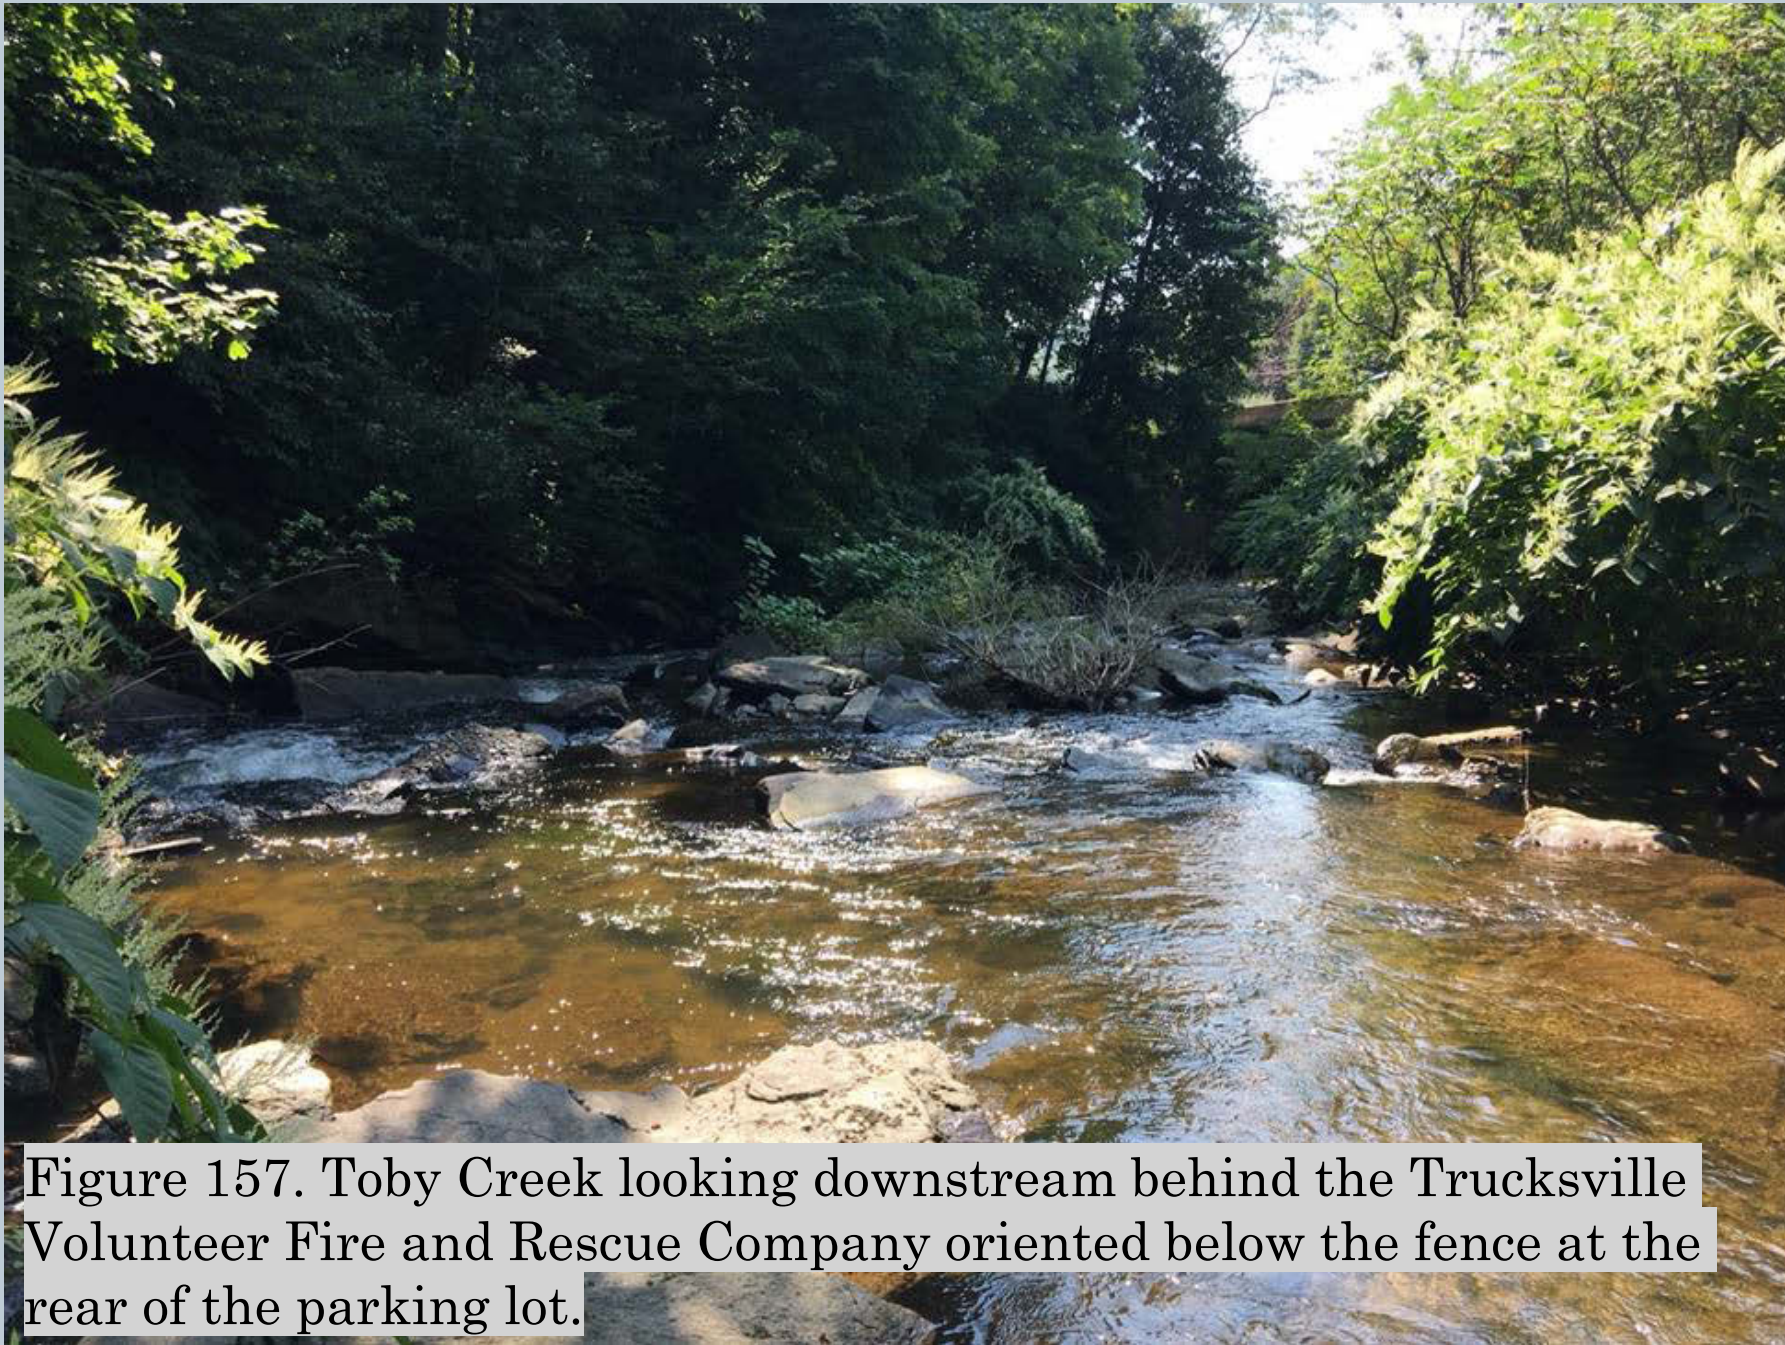
Figure 157. Toby Creek looking downstream behind the Trucksville Volunteer Fire and Rescue Company oriented below the fence at the rear of the parking lot.

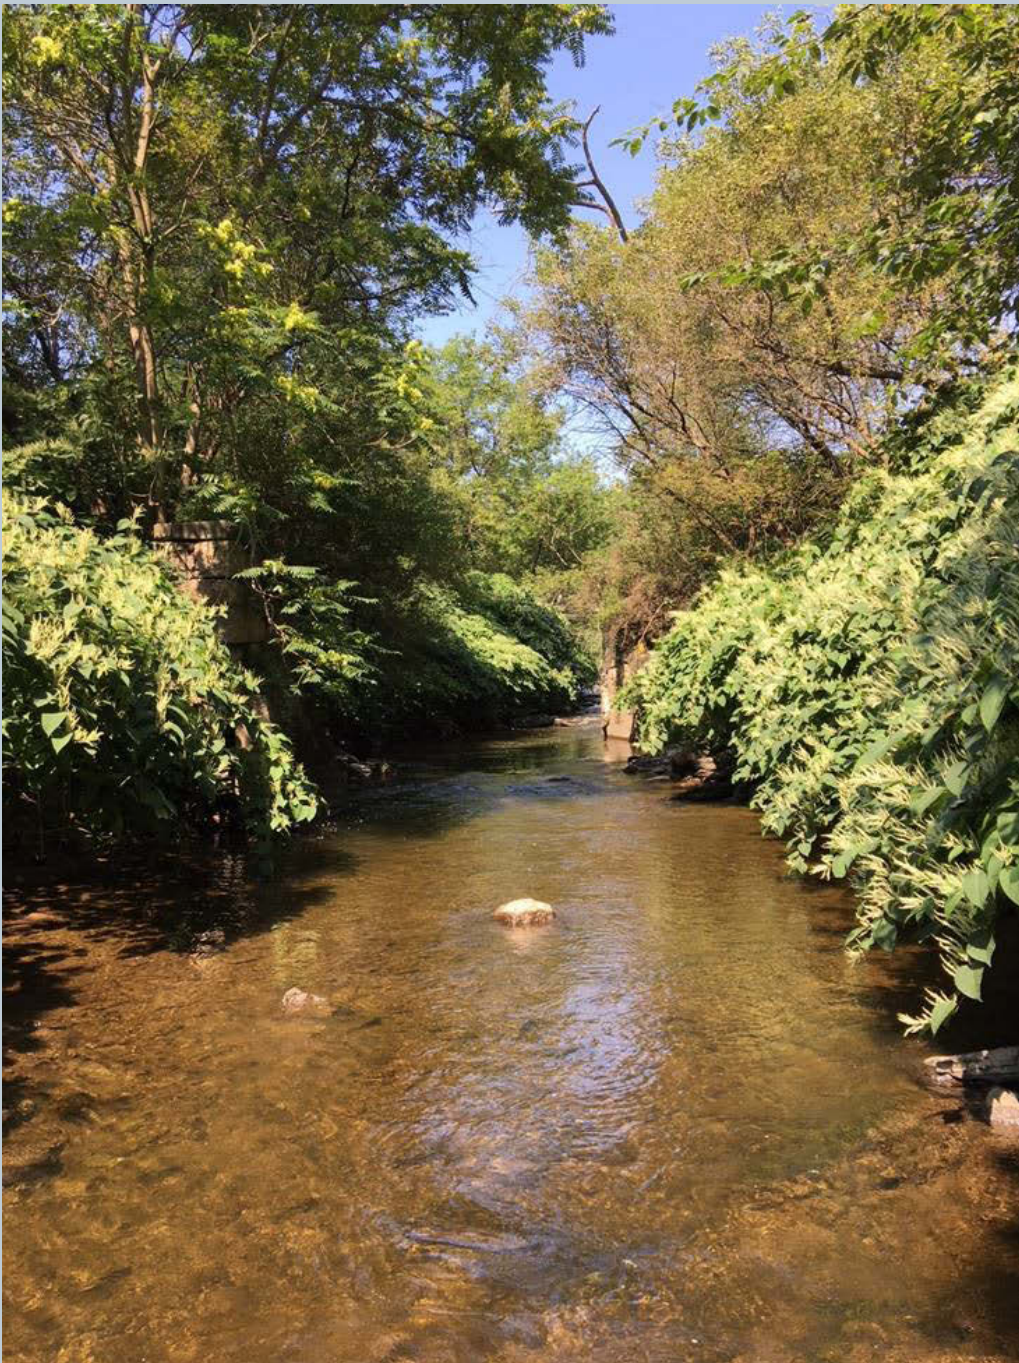
Figure 158. A shot of Toby Creek from behind the Trucksville Volunteer Fire and Rescue Company, looking upstream at old quarry-cut stone from a historic bridge abutment. This may have been a railroad or bridge crossing. Streambanks along both sides have a presence of Japanese knotweed.

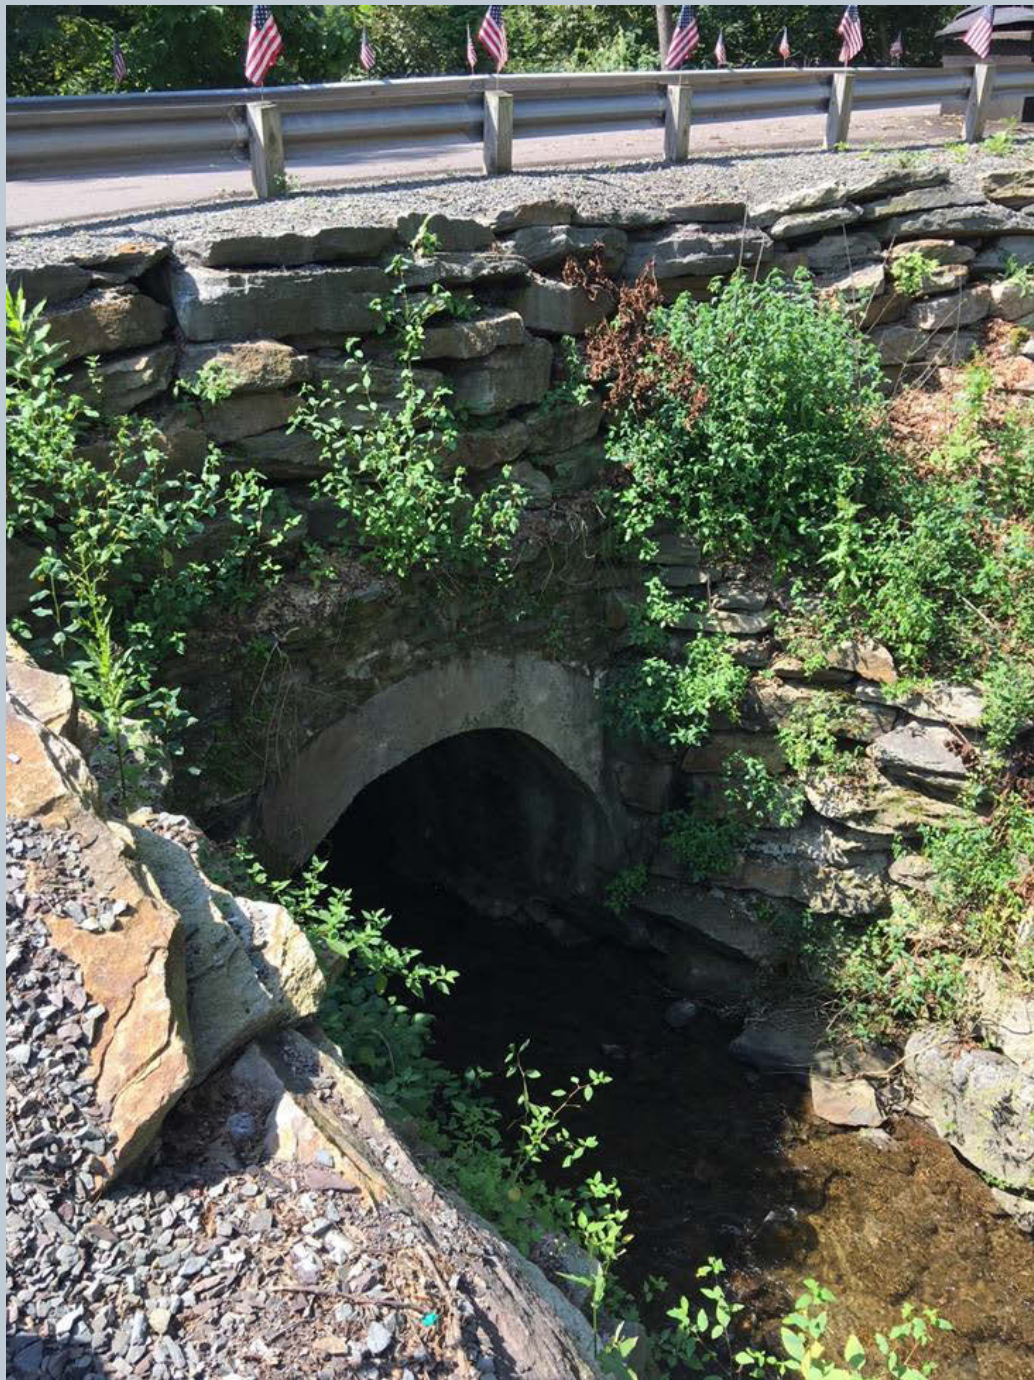
Figure 159. This photo is looking downstream at a stone arch that is over a concrete culvert. The culvert is on another UNT that flows along Carverton Road behind Pizza Perfect, in Trucksville. A hard armoring and rip-rap with a shot-crete and a quarry-cut retaining wall is found alongside of the northeastern side of the streambank, behind Pizza Perfect, and along the opposite bank from the meander to the stone arch culvert.

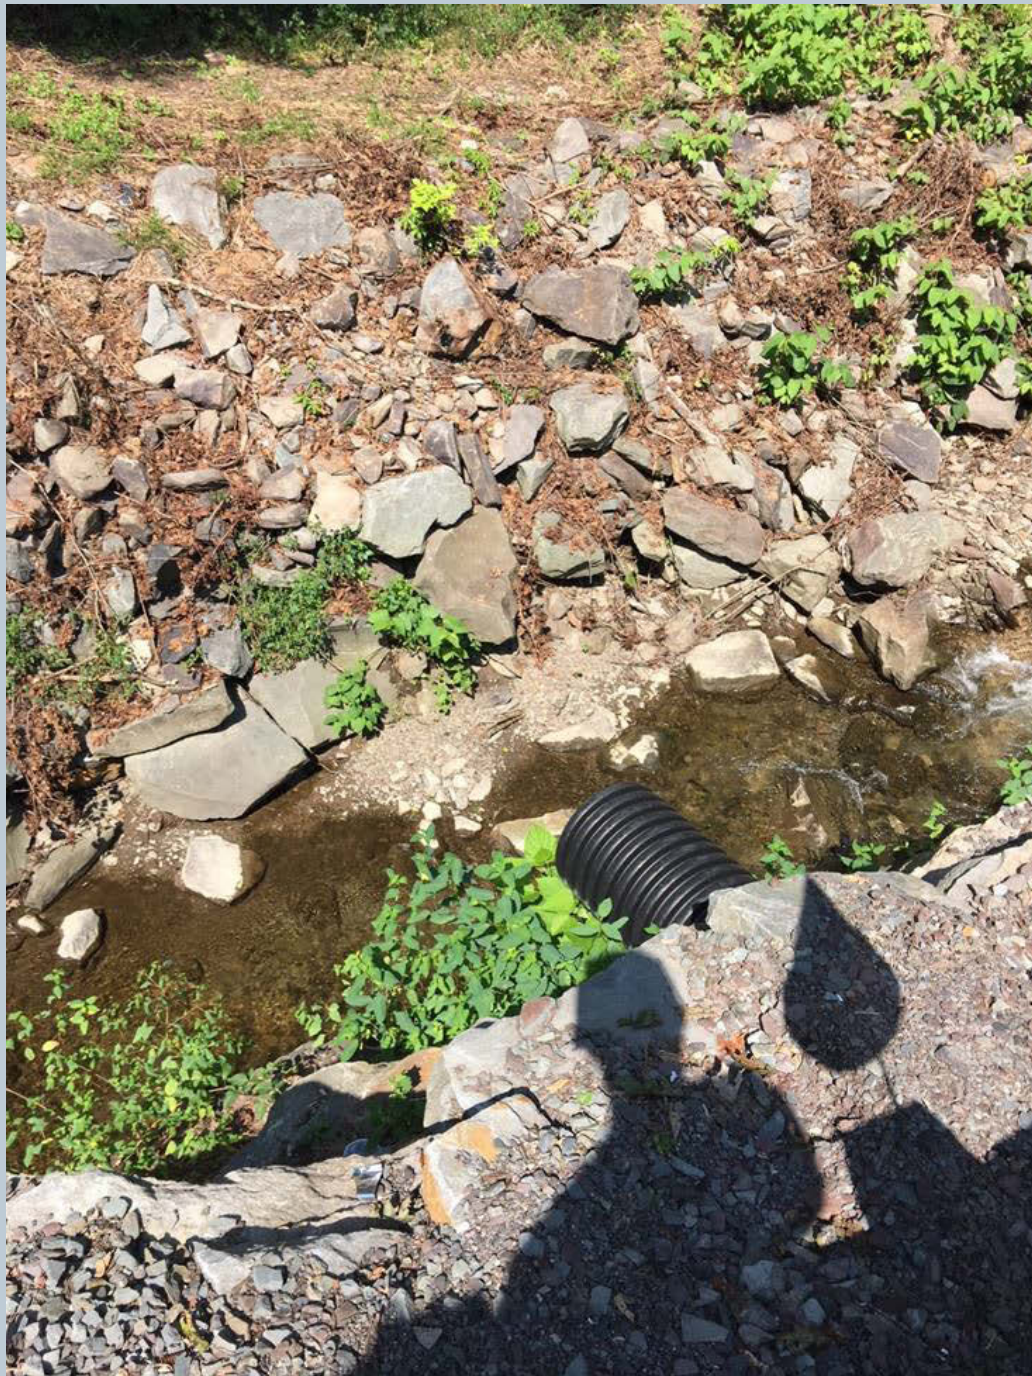
Figure 160. A shot of a black HDPE pipe sticking out from the retaining wall that drains a stormwater from the parking lot.
