Toby Creek Field Reconnaissance Observations

September 26, 2018

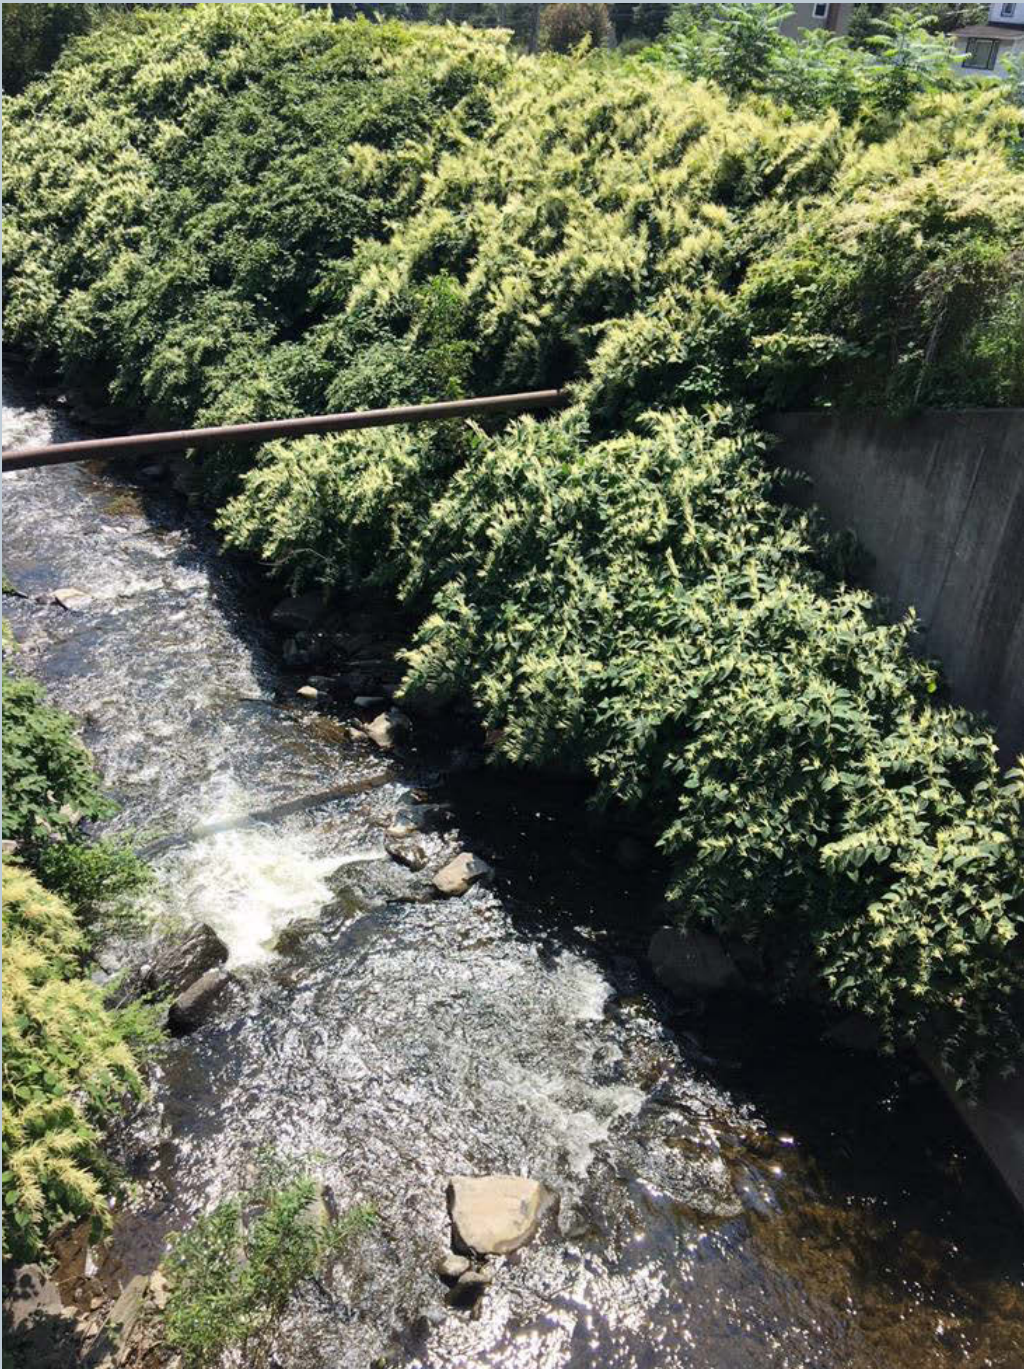
Figure 163. A shot of Toby Creek, looking downstream from a bridge at Carverton Road and State Route 309. A water or sewer line is secured overhead and above Toby Creek at approximately 20 feet. This line comes out of a retaining wall from the Trucksville Volunteer Fire and Rescue Company.

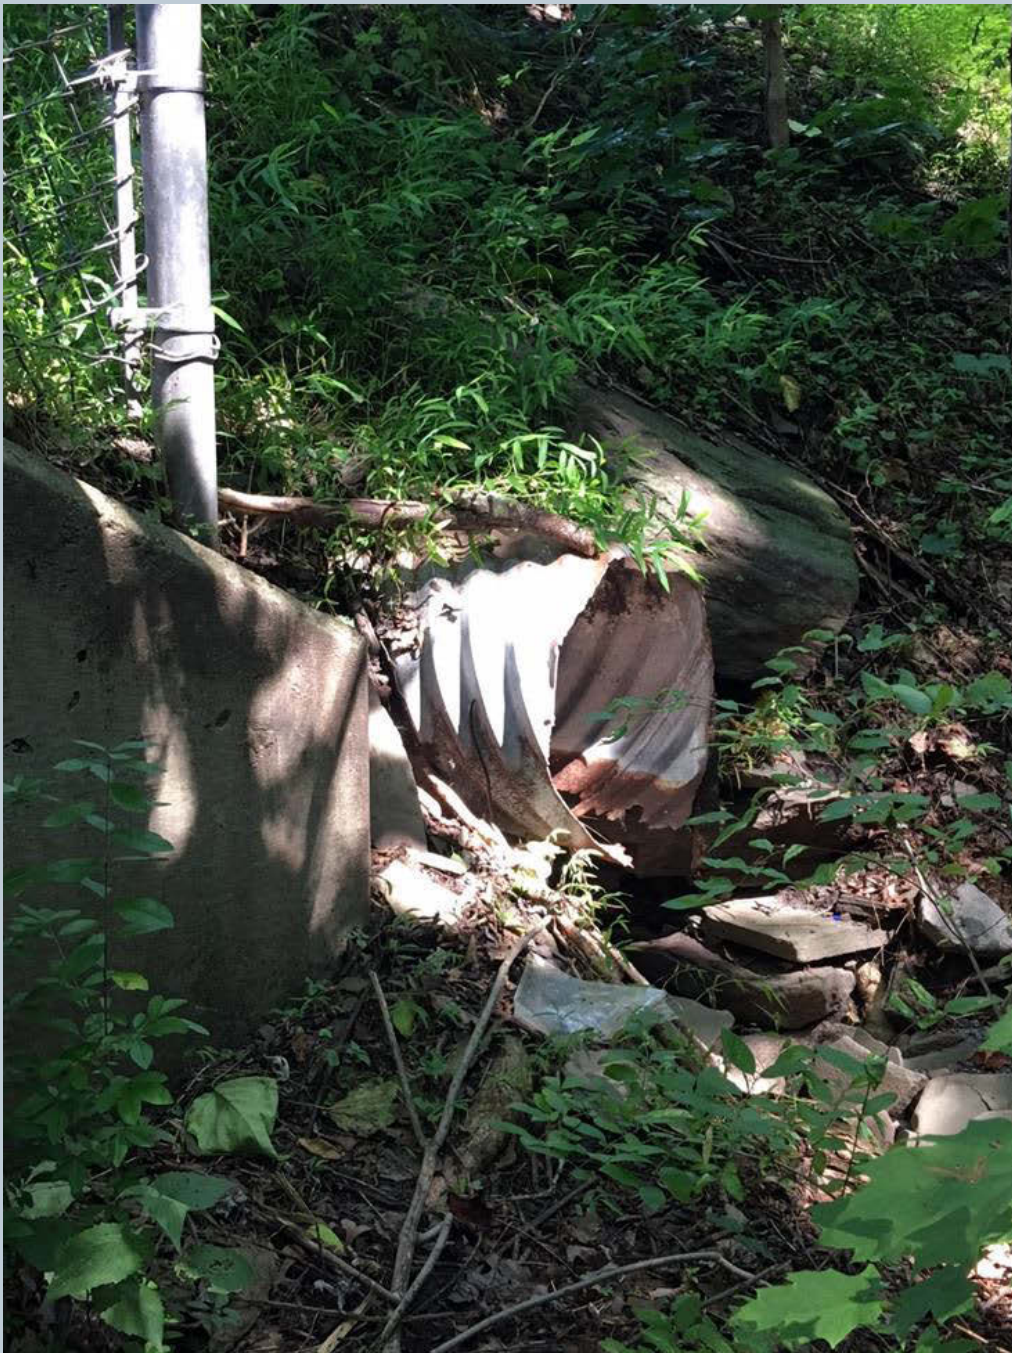
Figure 166. A rusted 18-inch corrugated pipe facing upstream. The pipe is not aligned when entering the UNT, creating a scour pool next to a large root wad from a tree along the streambank.

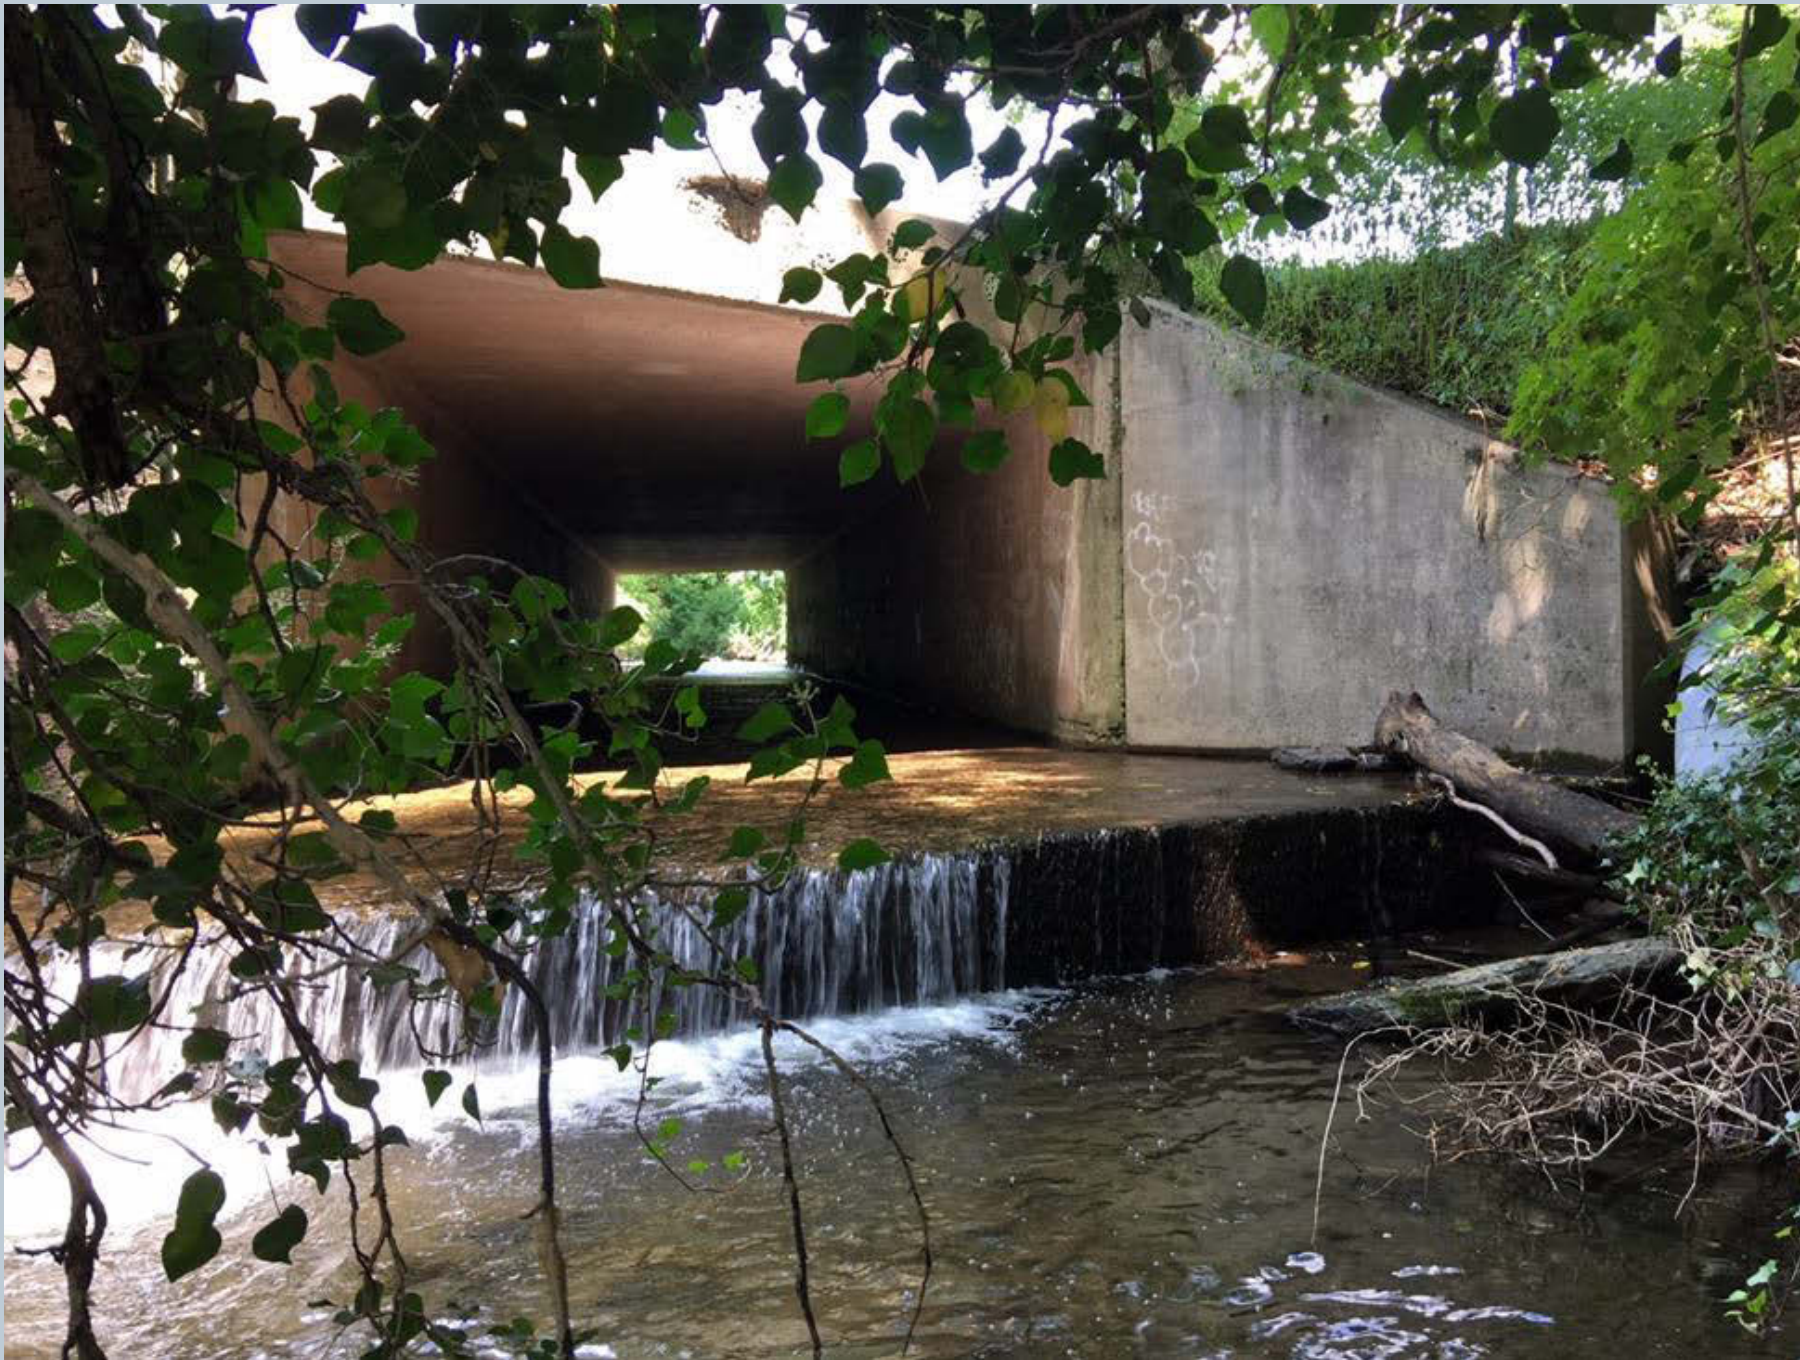
Figure 168. A shot of a two-foot concrete dam located below the bridge that is over the UNT to Toby Creek. An 18-inch corrugated metal pipe that enters the UNT from the northwesterly direction along the right bank, looking upstream. It is currently undetermined if the concrete dam is in an encased sewer line.

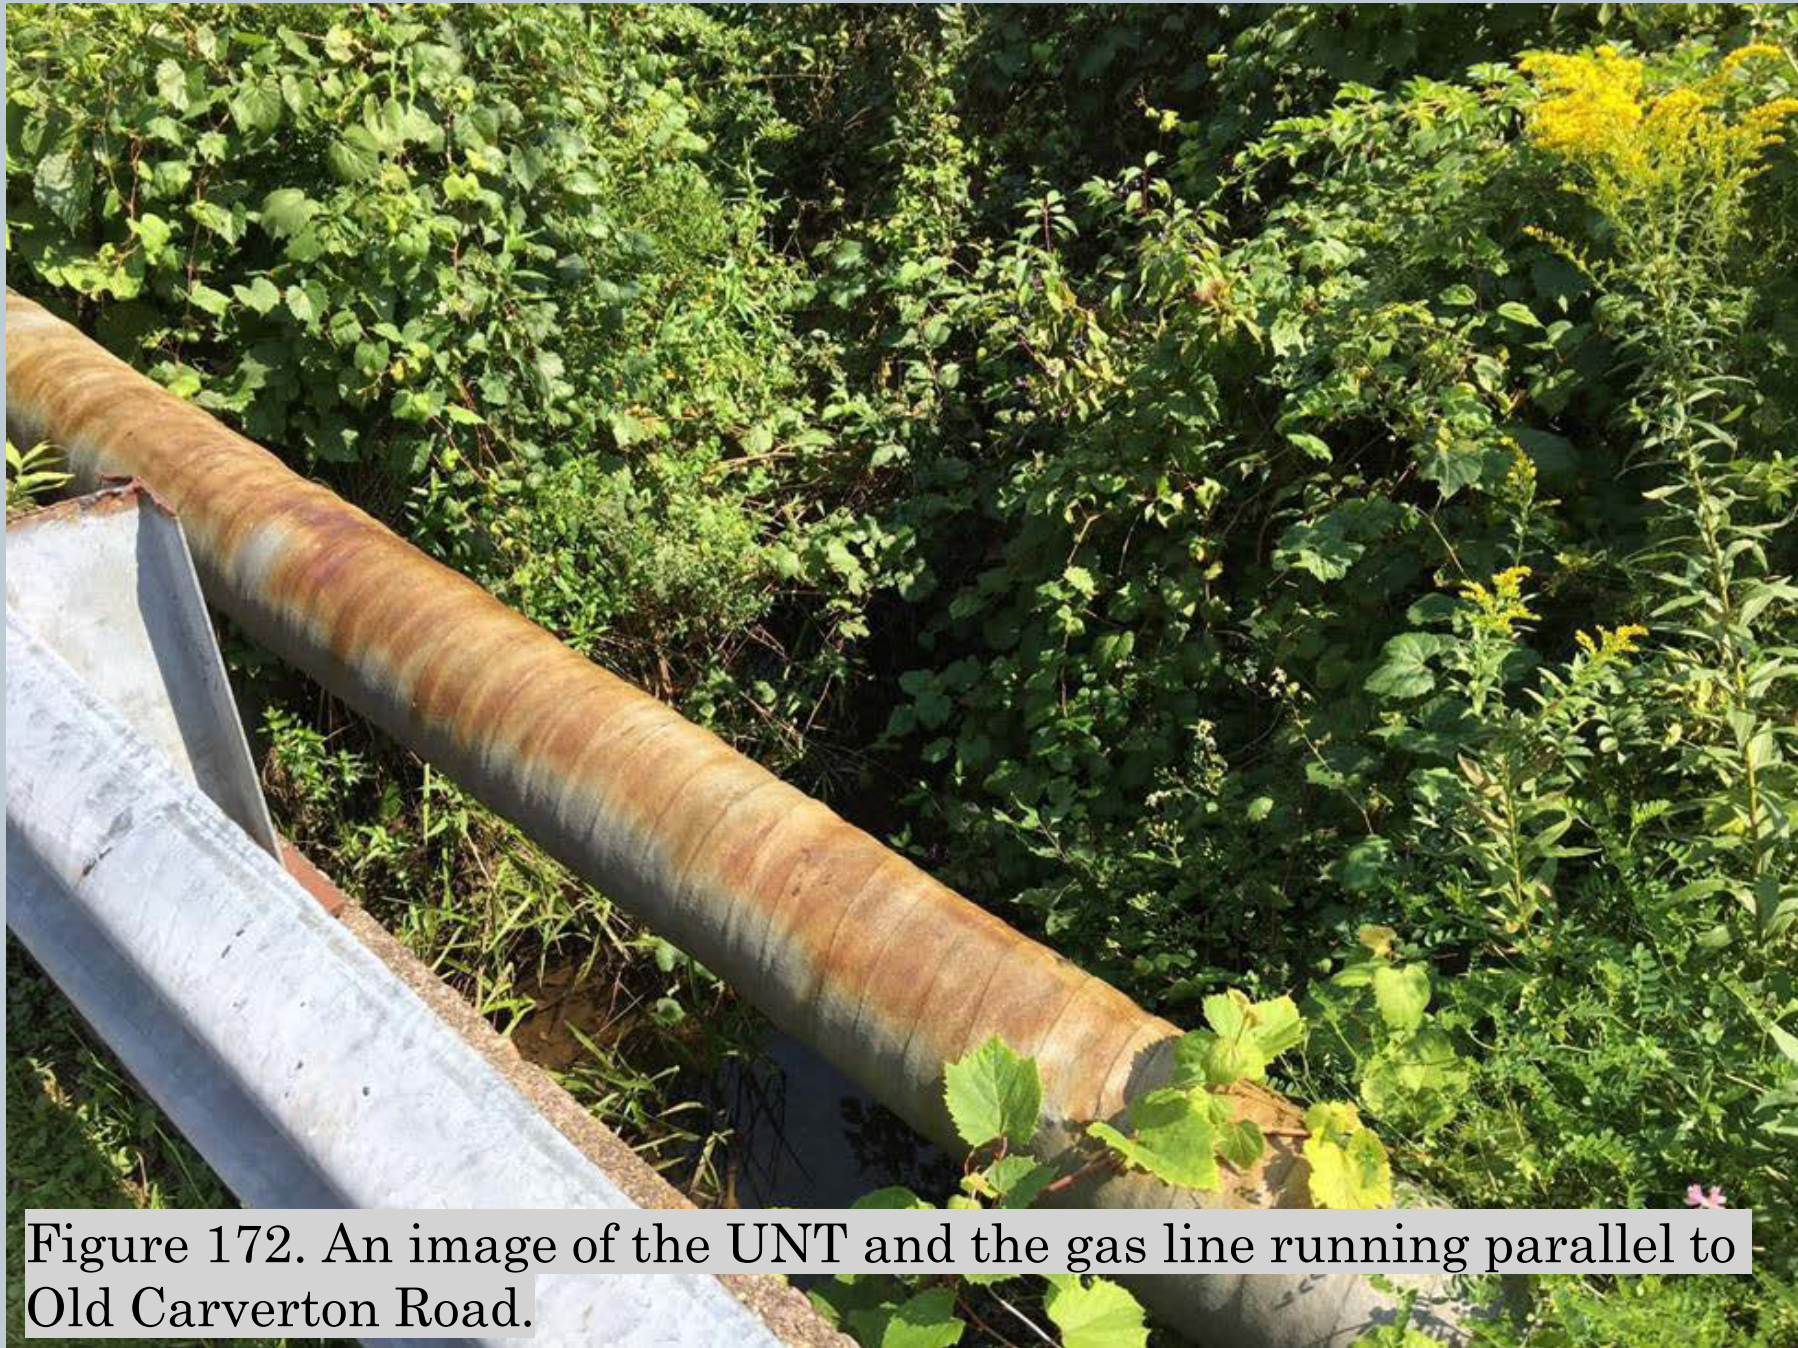
Figure 172. An image of the UNT and the gas line running parallel to Old Carverton Road.

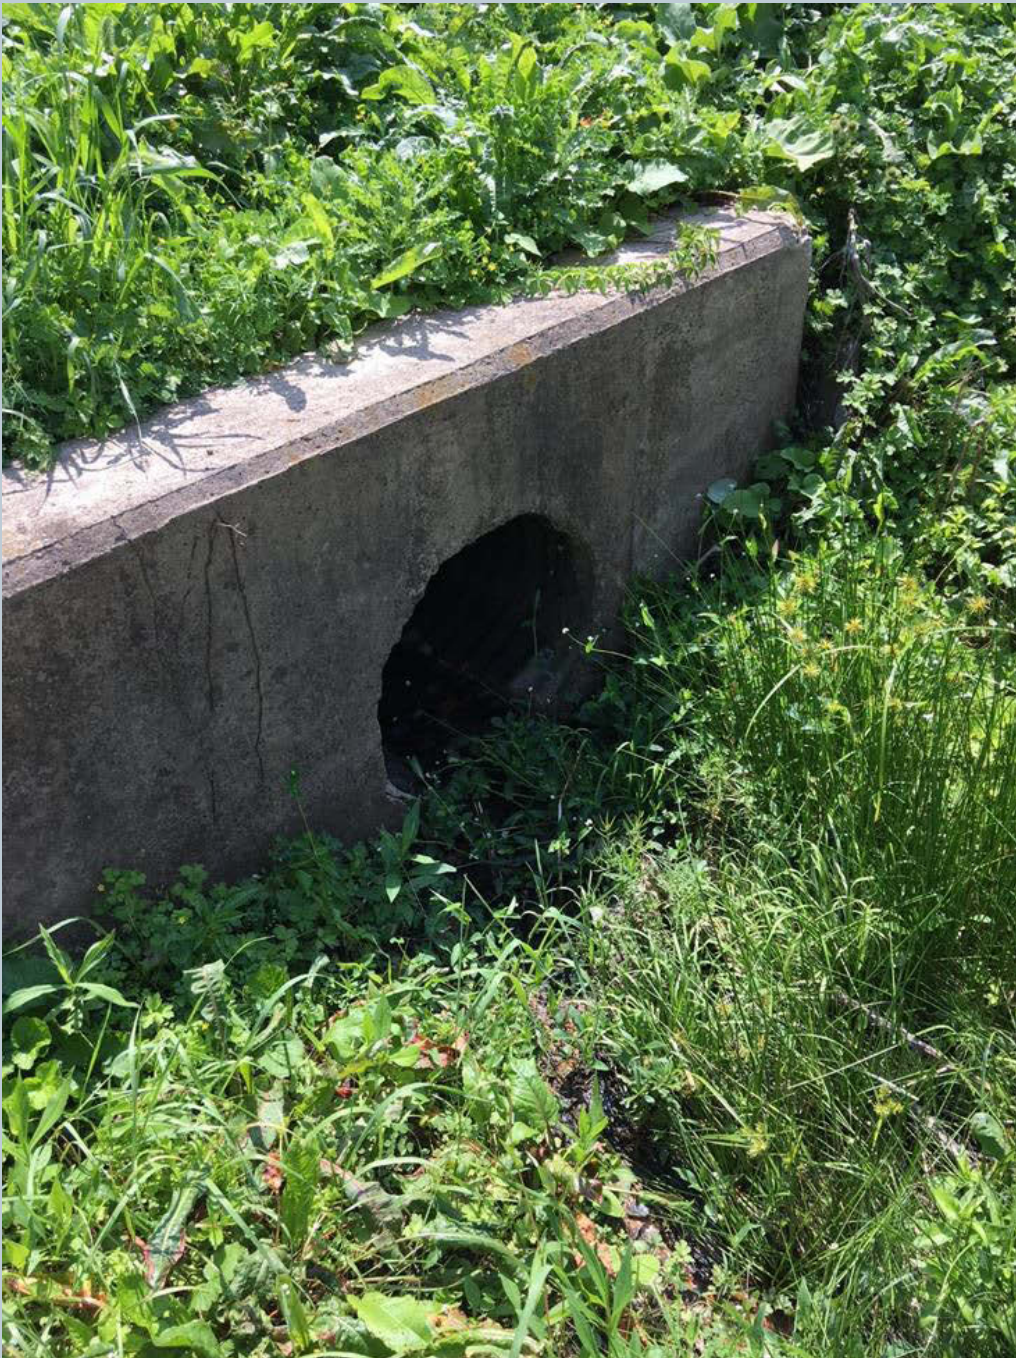
Figure 174. A shot of an 18-inch or 24-inch corrugated pipe and headwall to the larger wetlands complex, located downstream of Dug Road. This pipe is located between Terrace Road and Carverton Road.

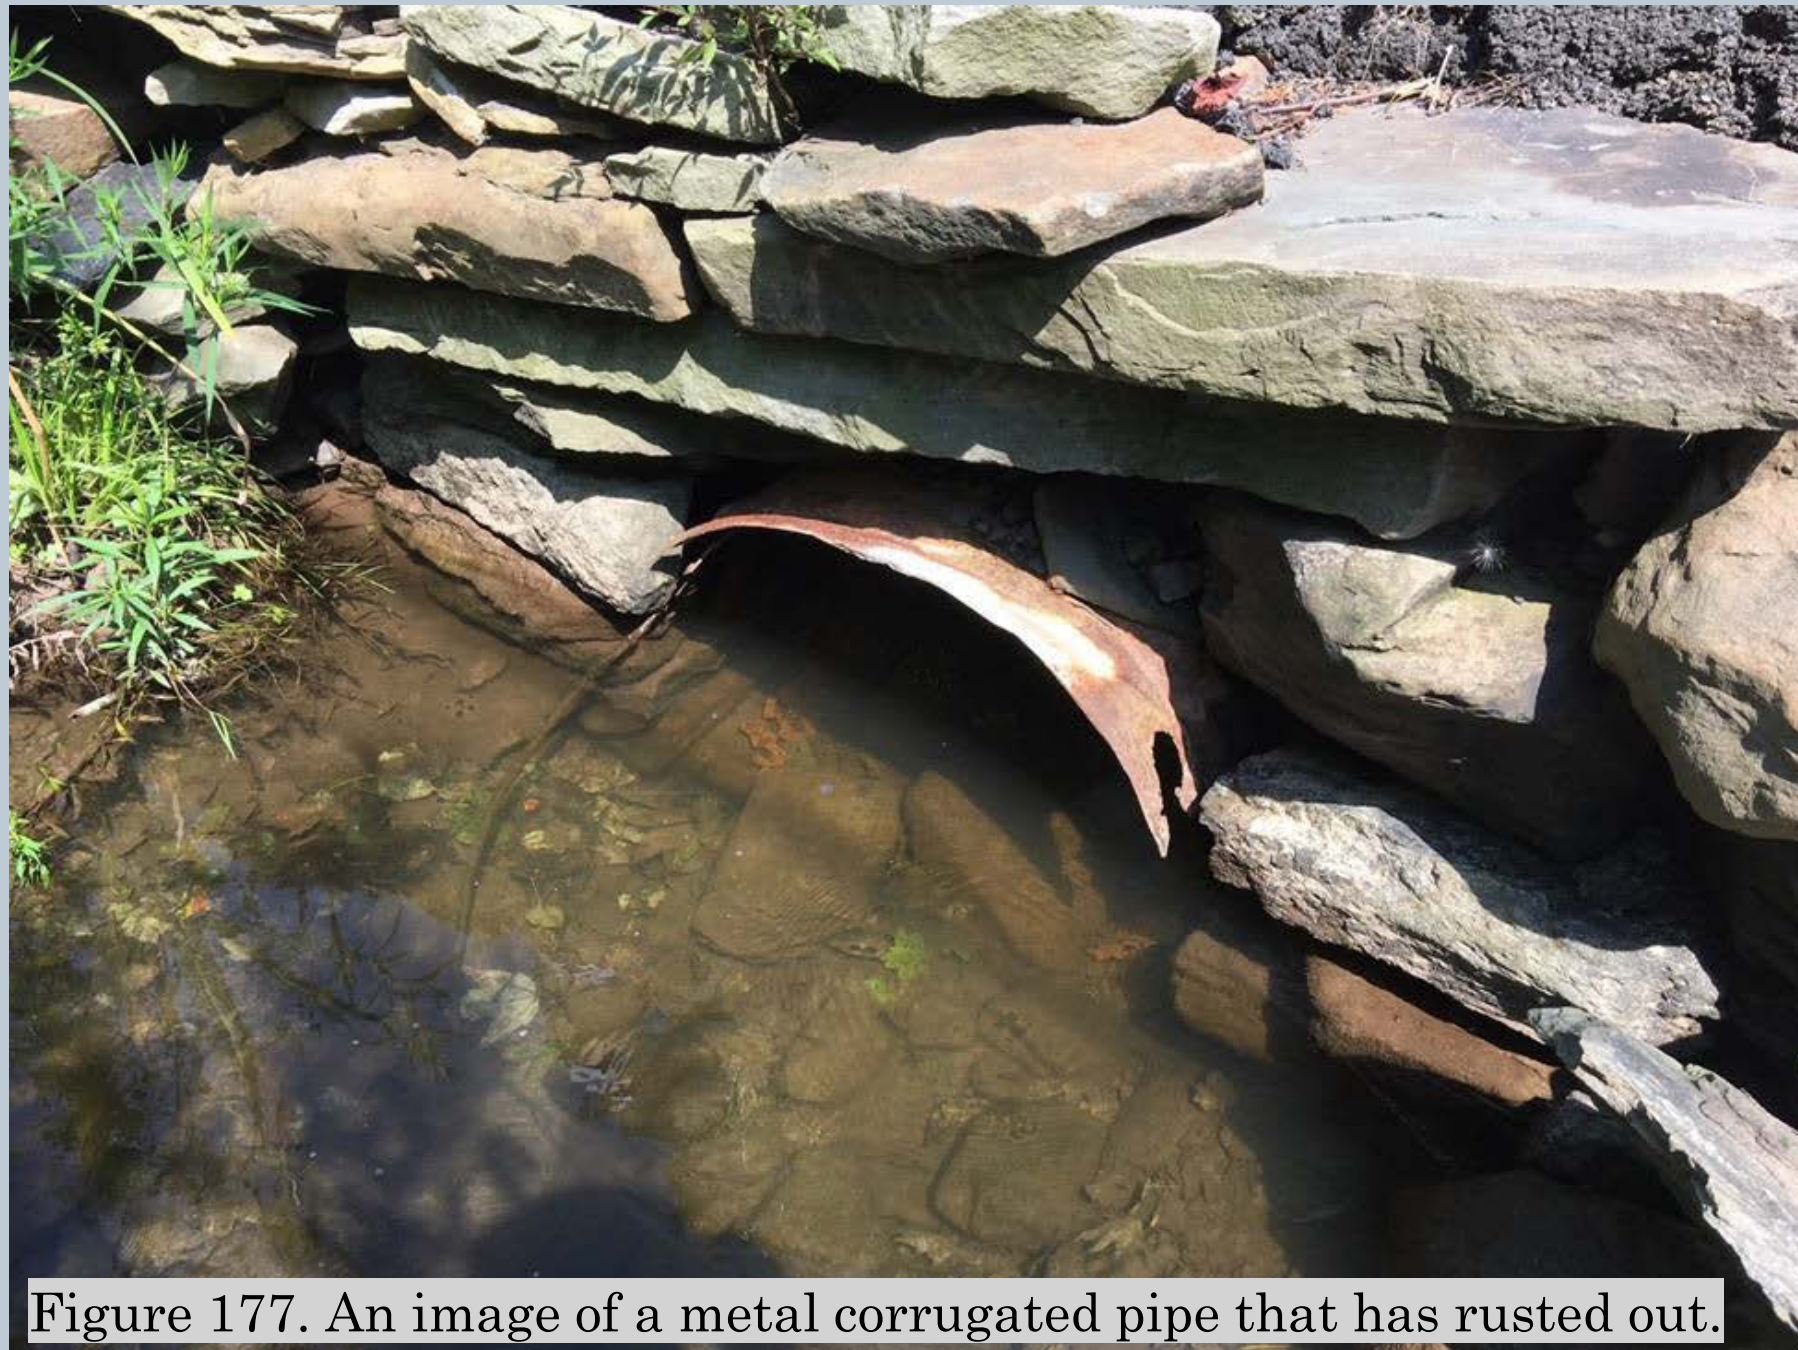
Figure 177. An image of a metal corrugated pipe that has rusted out.

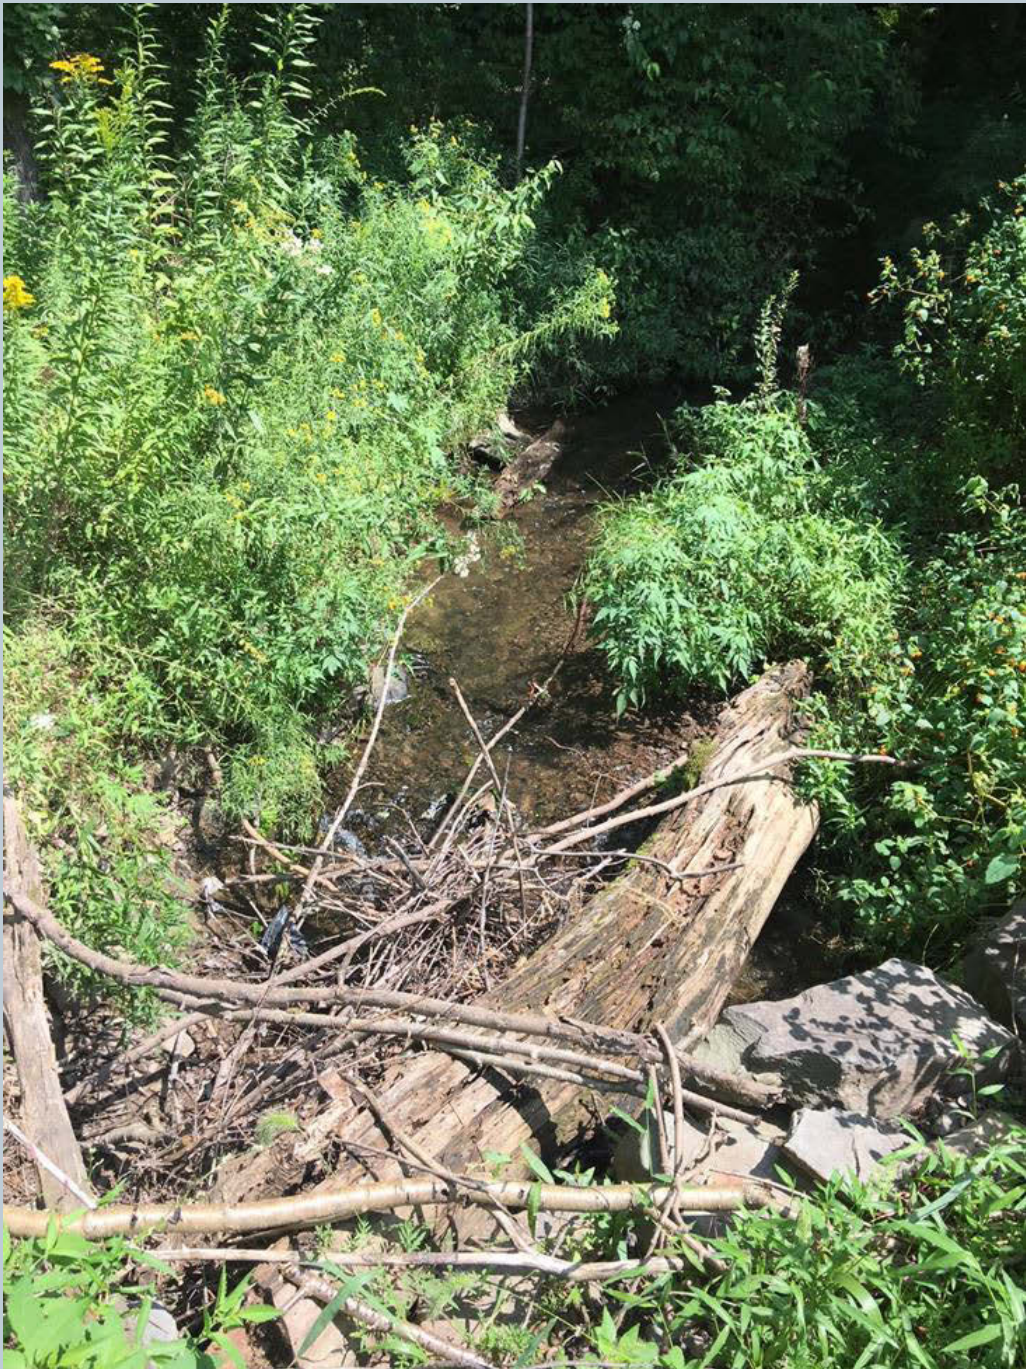
Figure 178. A shot taken looking upstream on the UNT to the northeast of Dug Road, where large woody debris is found blocking the culvert from a previous high-water event. The debris pile can easily be removed by hand to make the UNT passable through the pipe culvert.

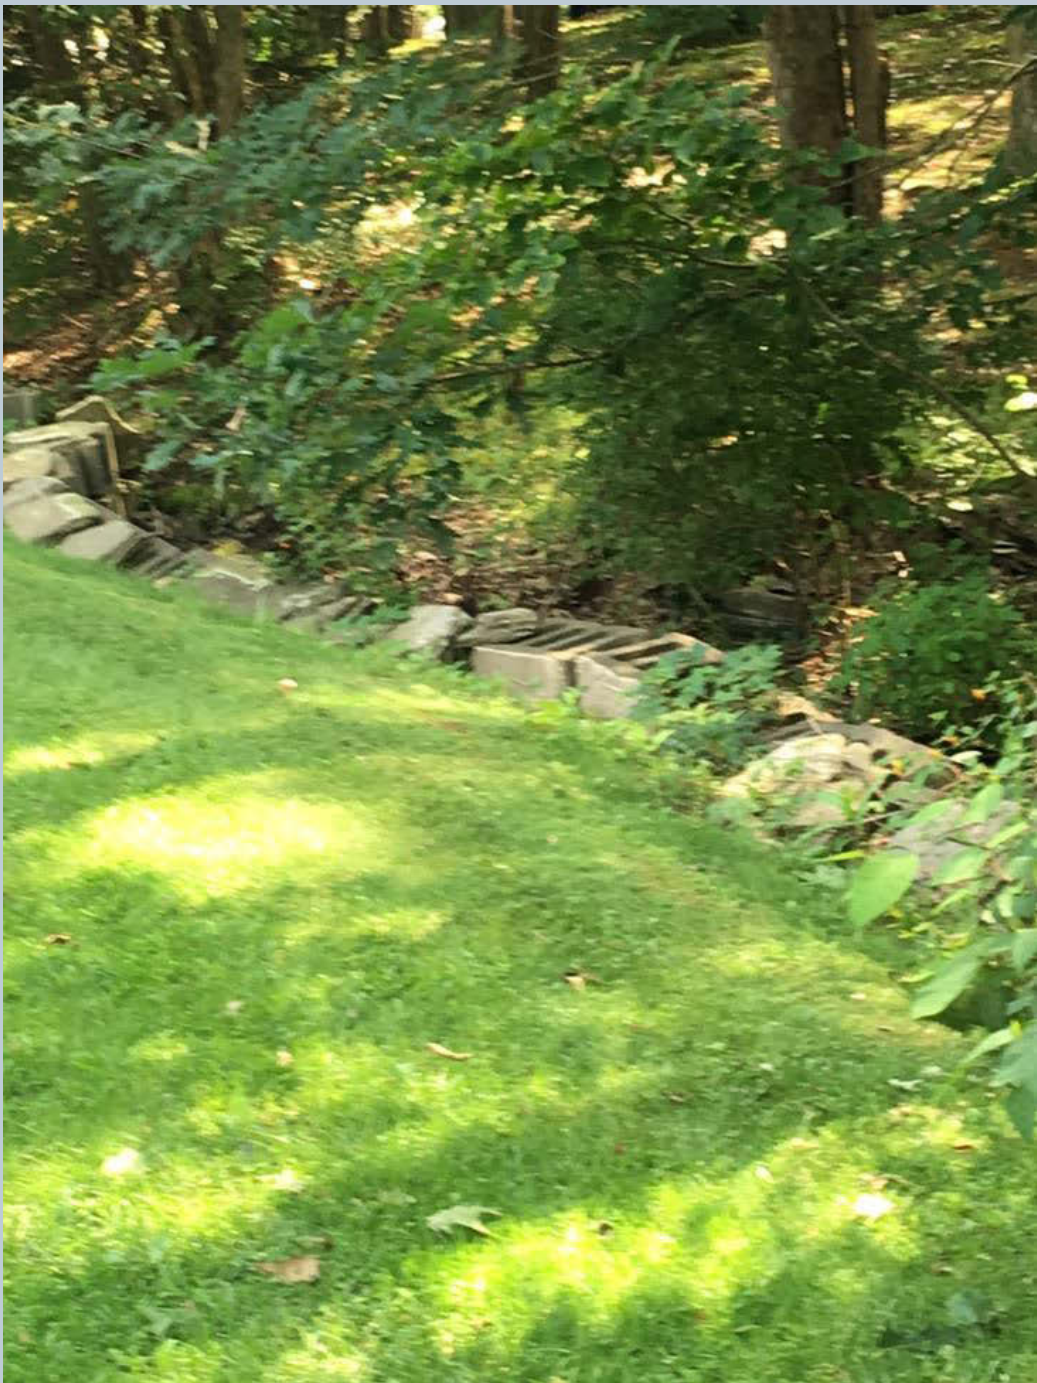
Figure 180. A shot of cinderblocks along the streambank on the Swago property.

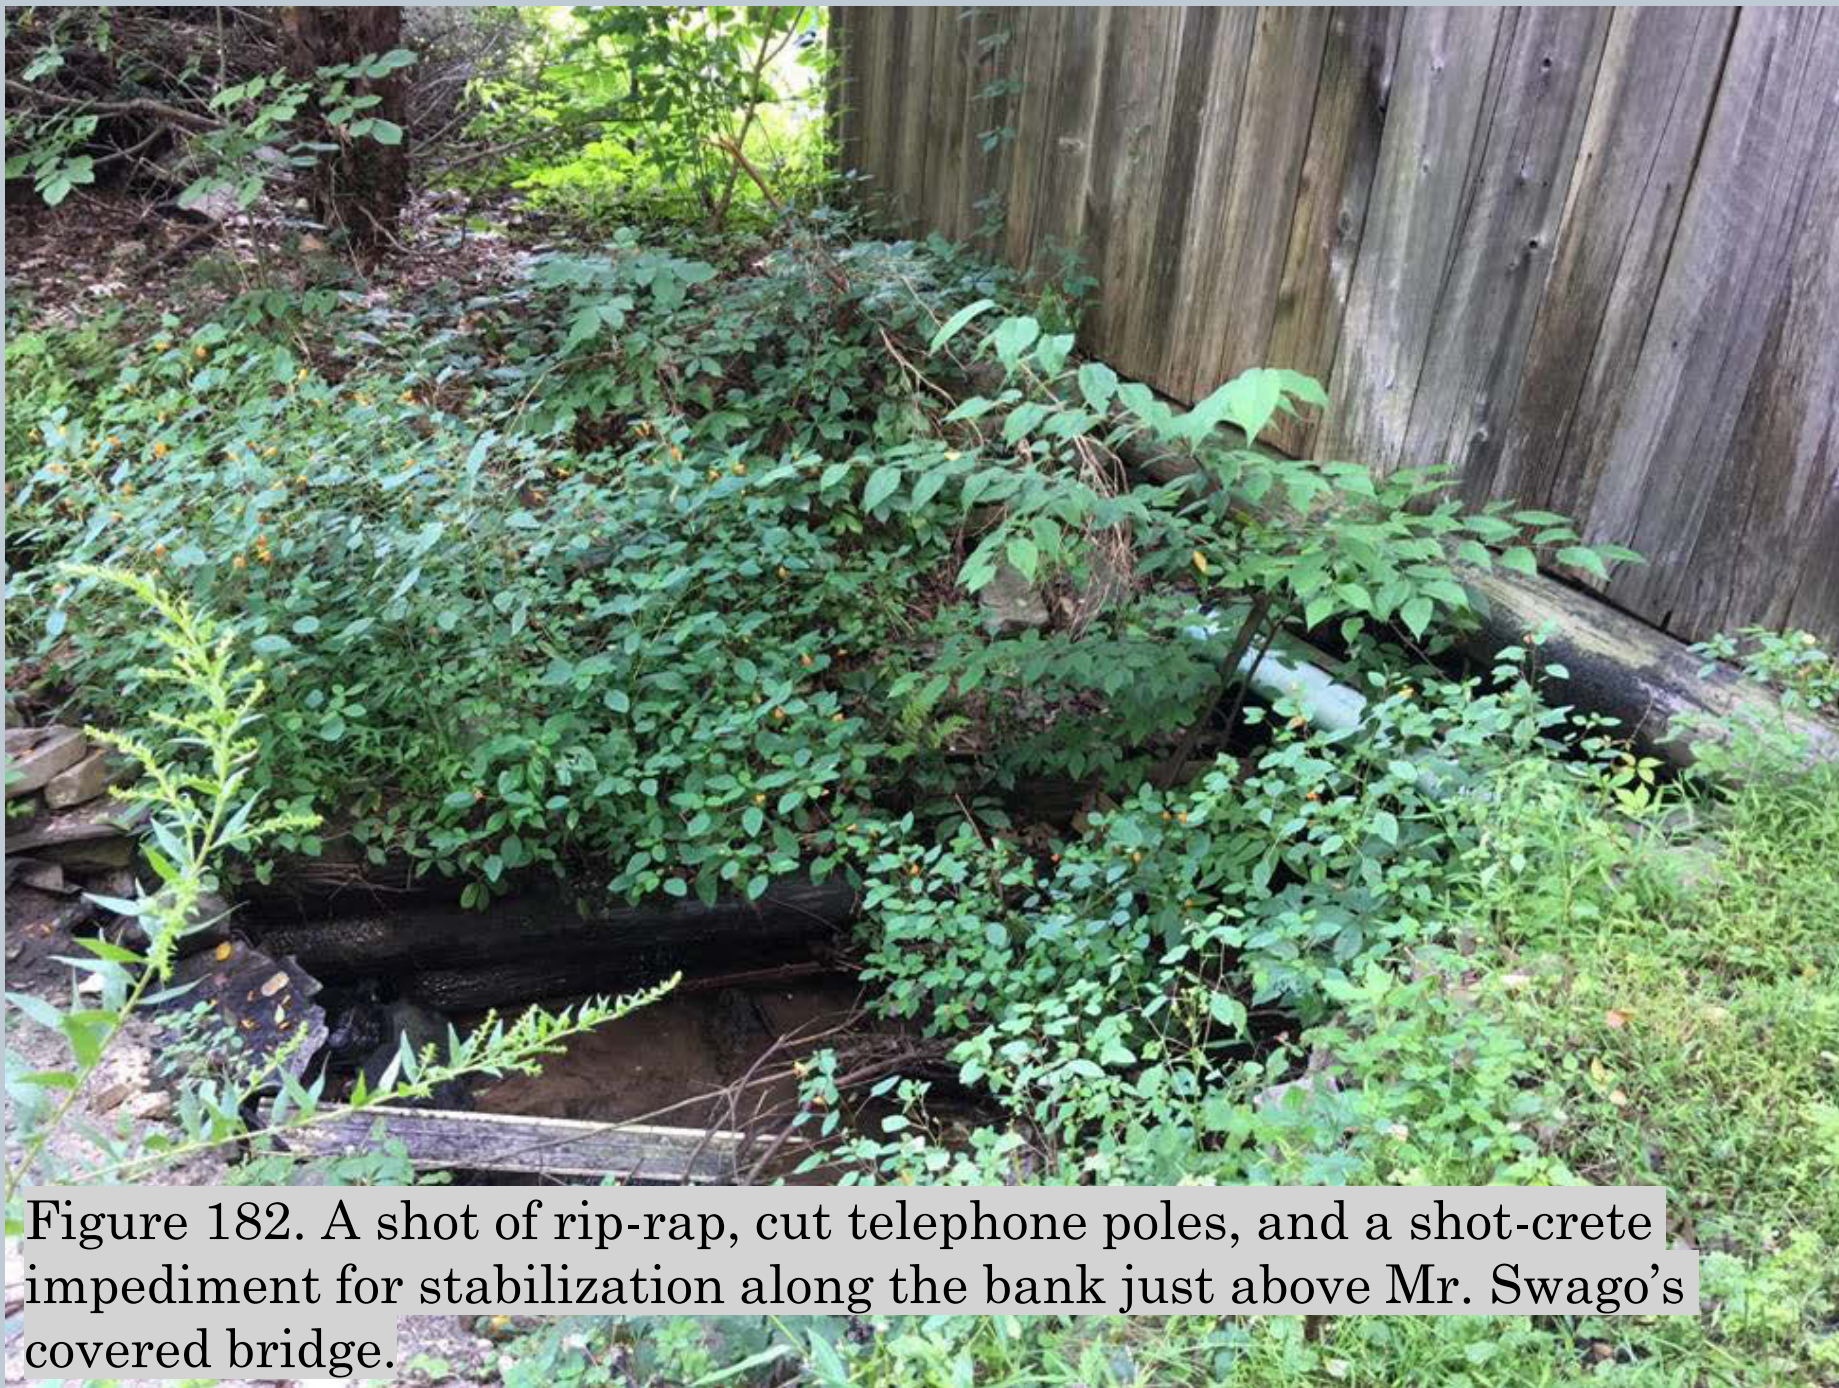
Figure 182. A shot of rip-rap, cut telephone poles, and a shot-crete impediment for stabilization along the bank just above Mr. Swago's covered bridge.

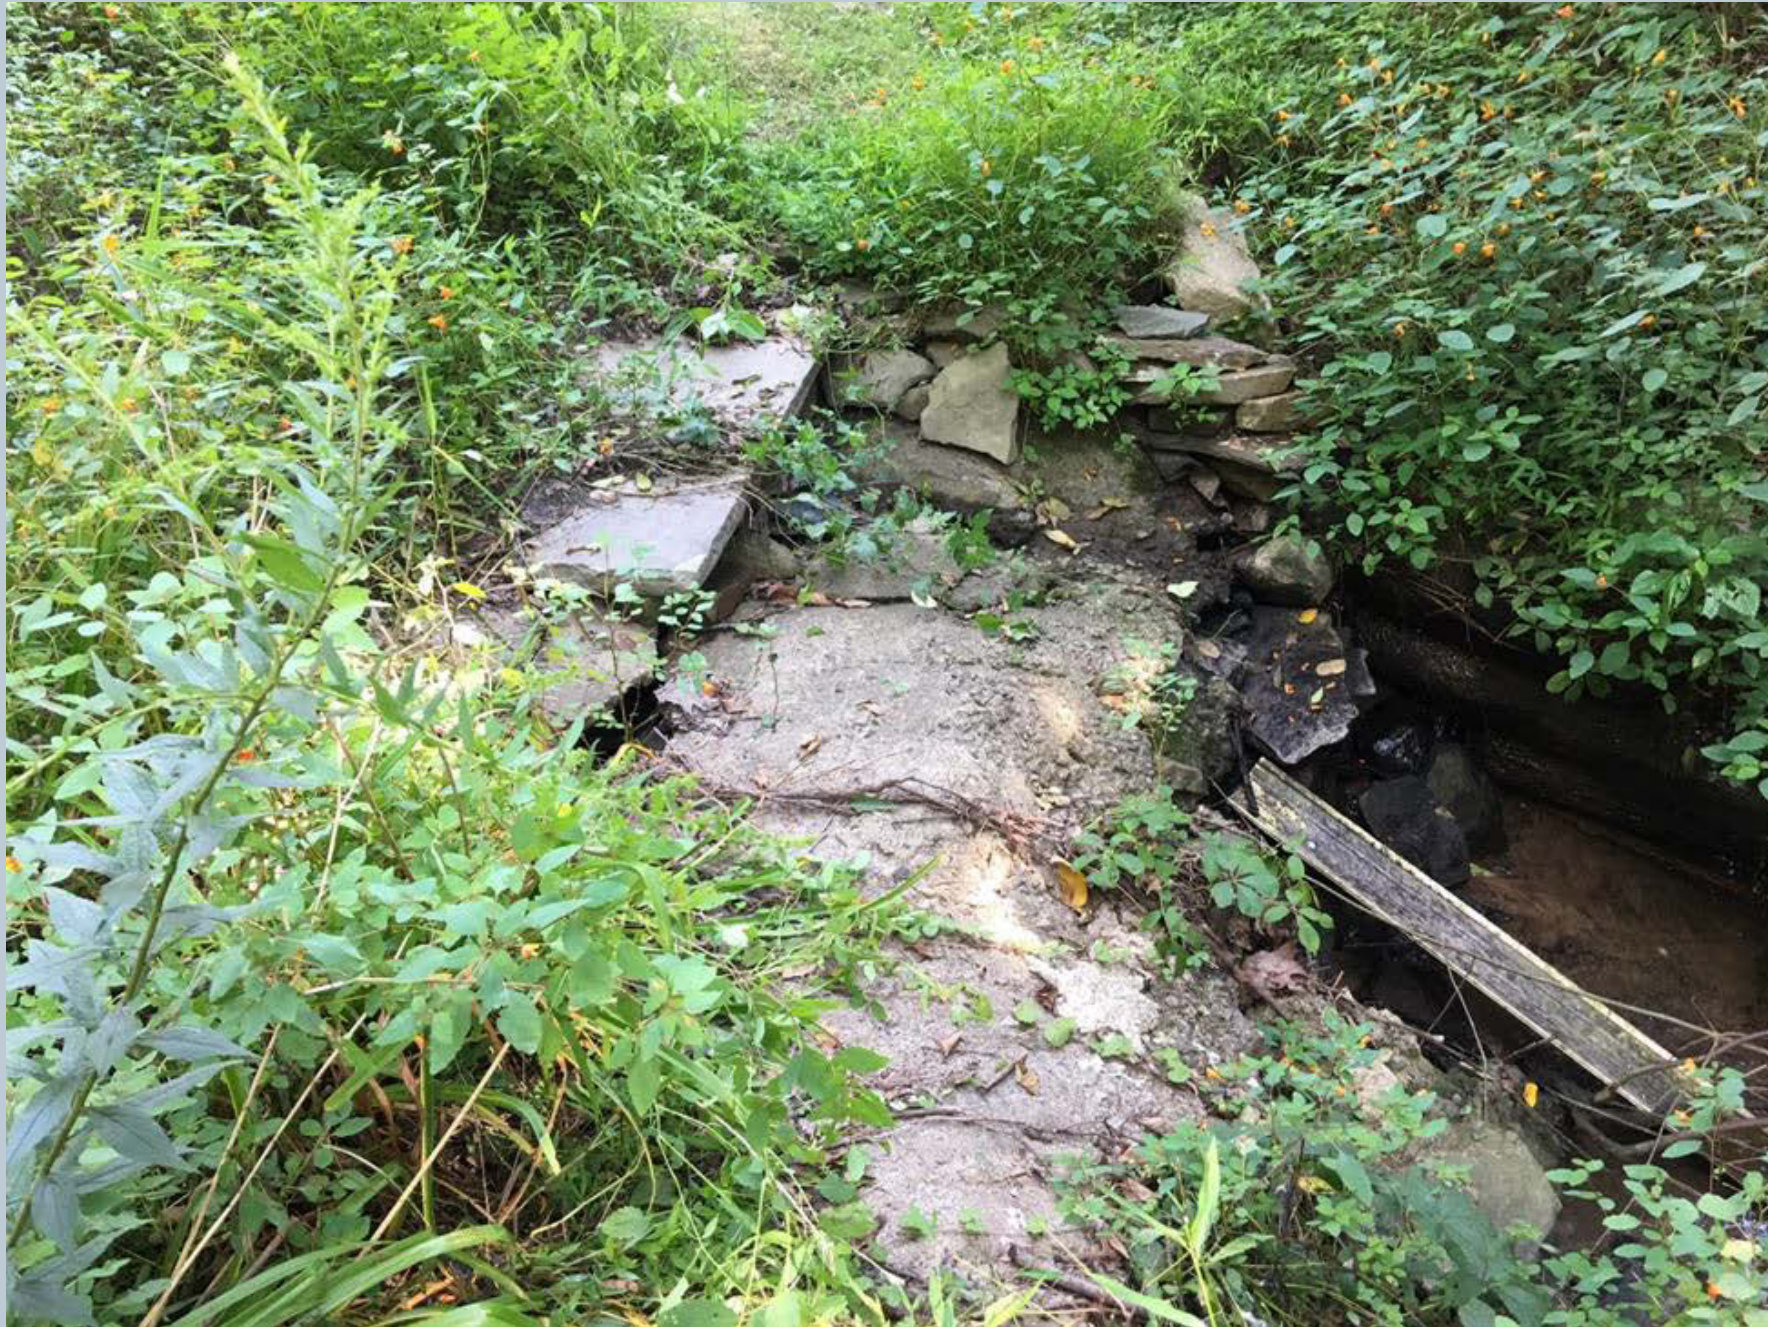
Figure 183. A shot of some rip-rap impediment on the UNT. This impediment could be removed and replaced with a small cross-vane to keep the flow of the UNT in the center of the stream channel to allow the high water flows to pass under the covered bridge. Some engineering may be necessary in this location.

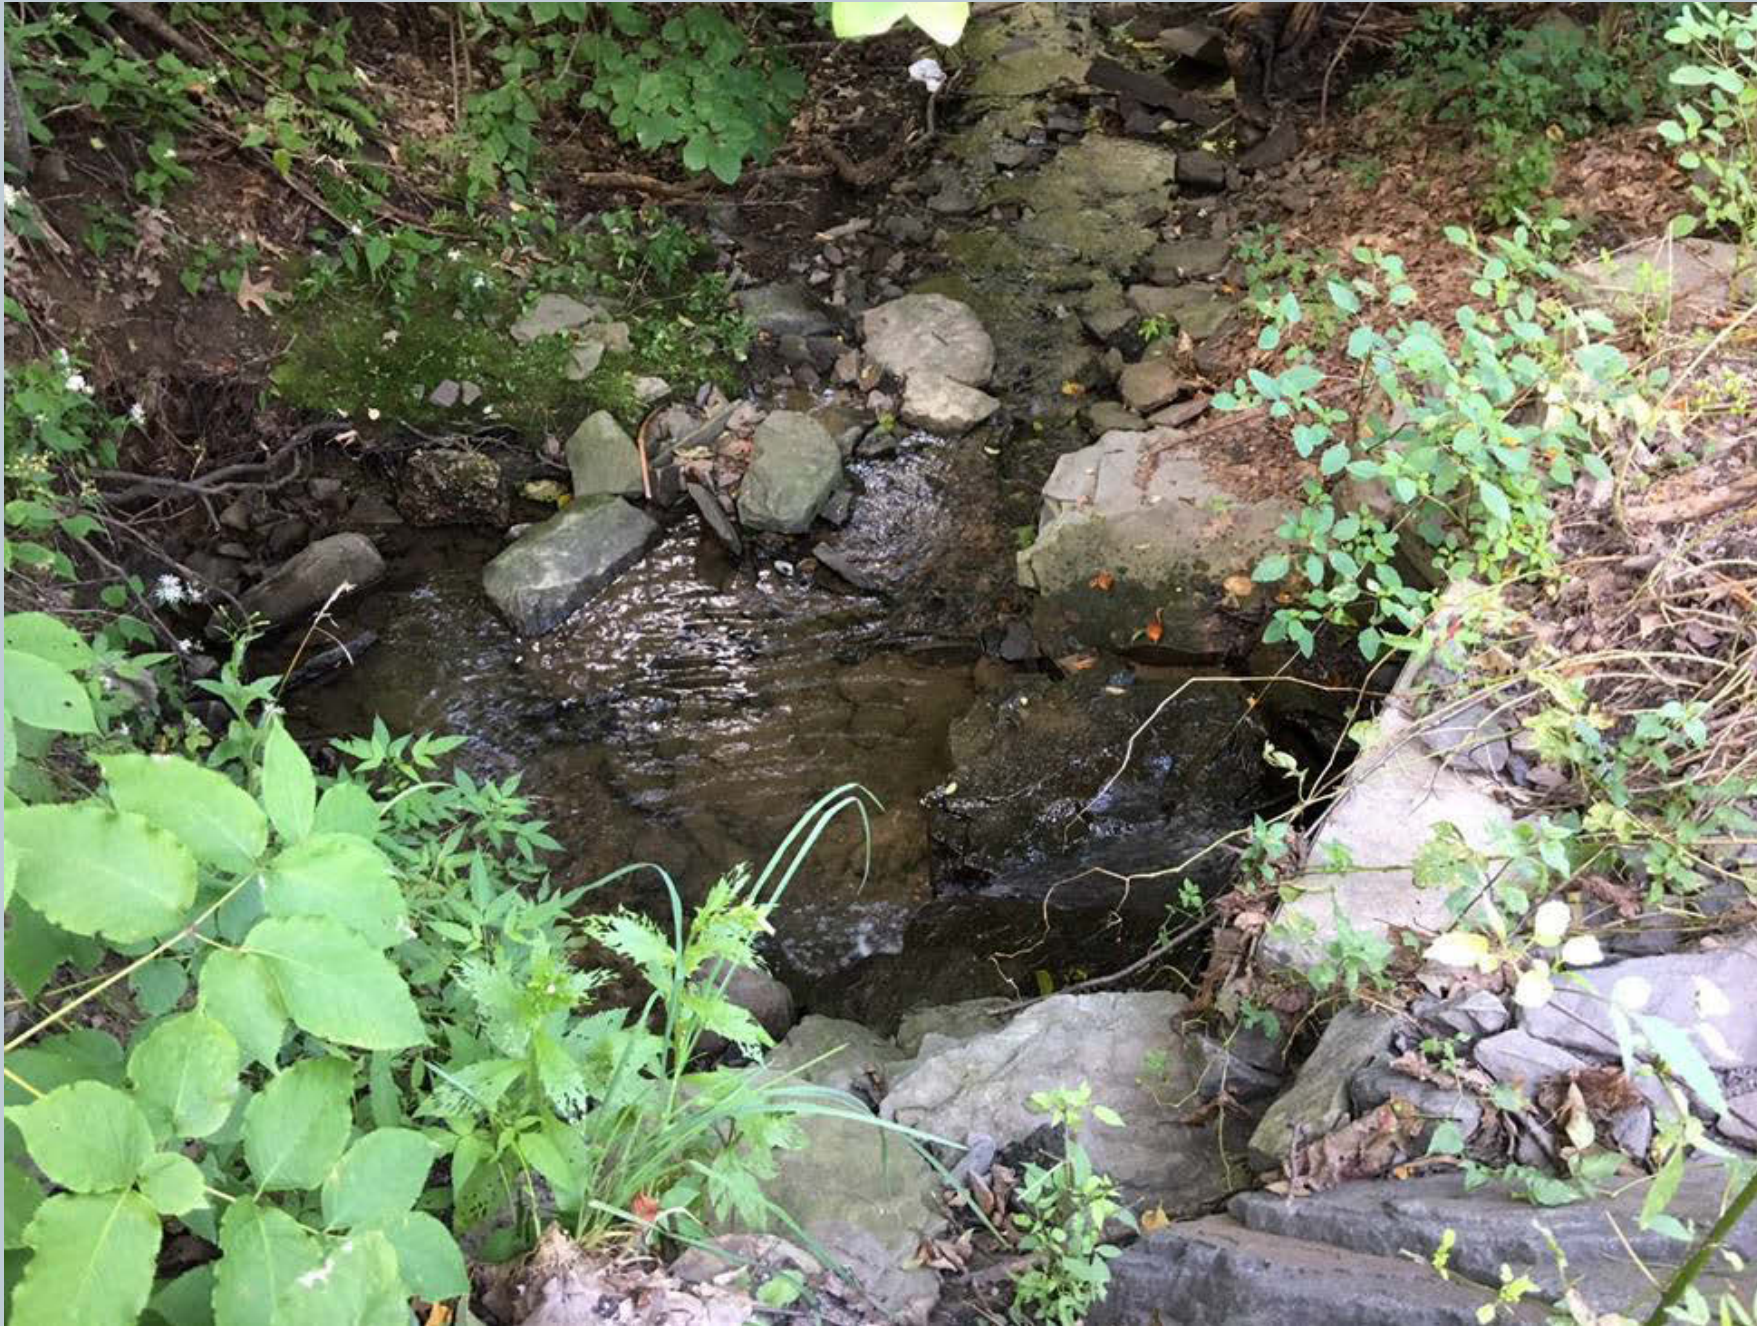
Figure 186. A shot of another UNT flowing downstream through an 18-inch or 24-inch black HDPE culvert pipe along Manor Road. The downstream outlet from the pipe culvert has a small scour pool and highly eroded streambank opposite the pipe that could use some rock reinforcement along the streambank or willow staking to reinforce the streambank and stabilize it.
