Toby Creek Field Reconnaissance Observations

September 26, 2018

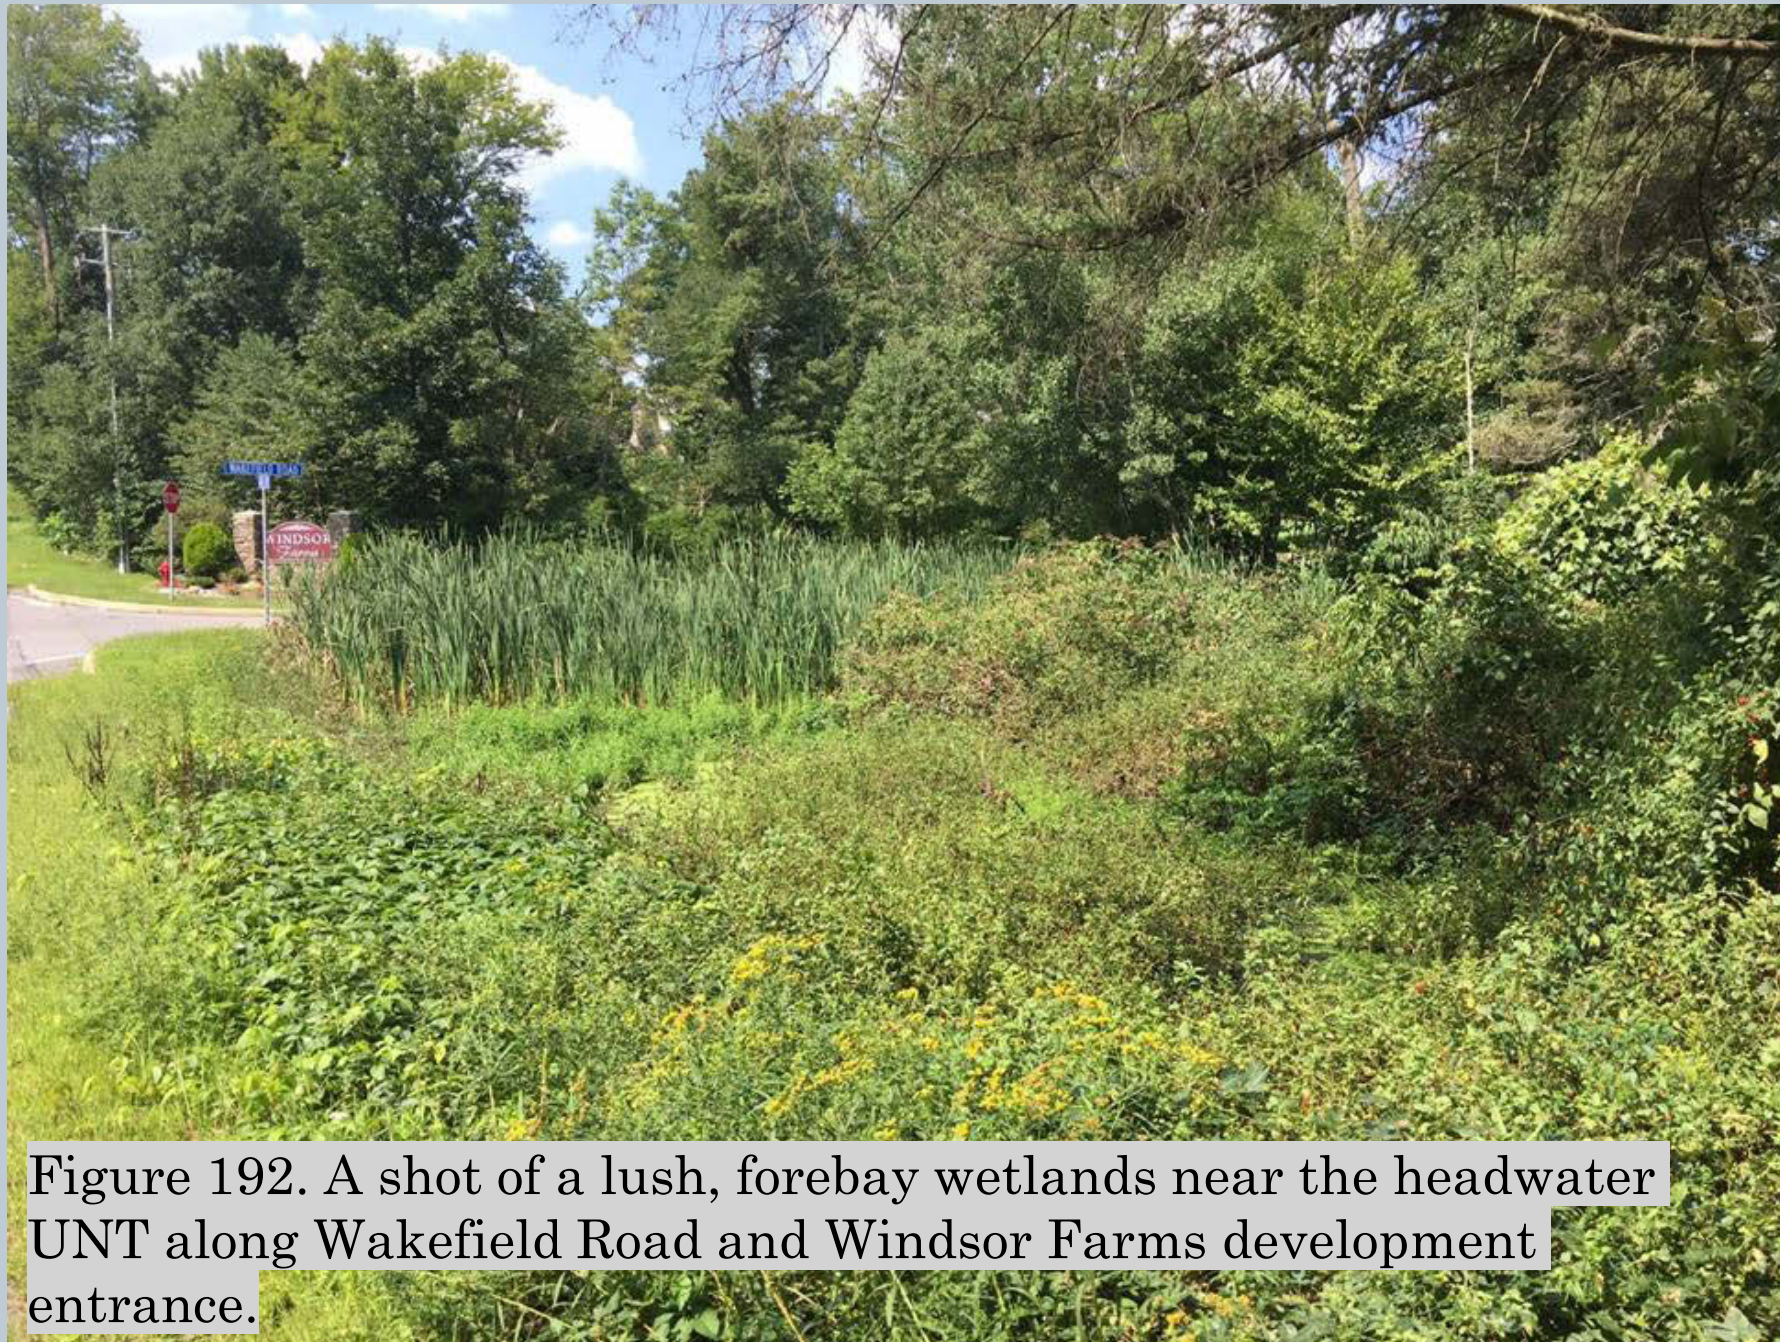
Figure 191. Two smaller stormwater headwalls with 18-inch pipes feed runoff towards a grassed waterway conveyance swale that is well vegetated and full of poison ivy.

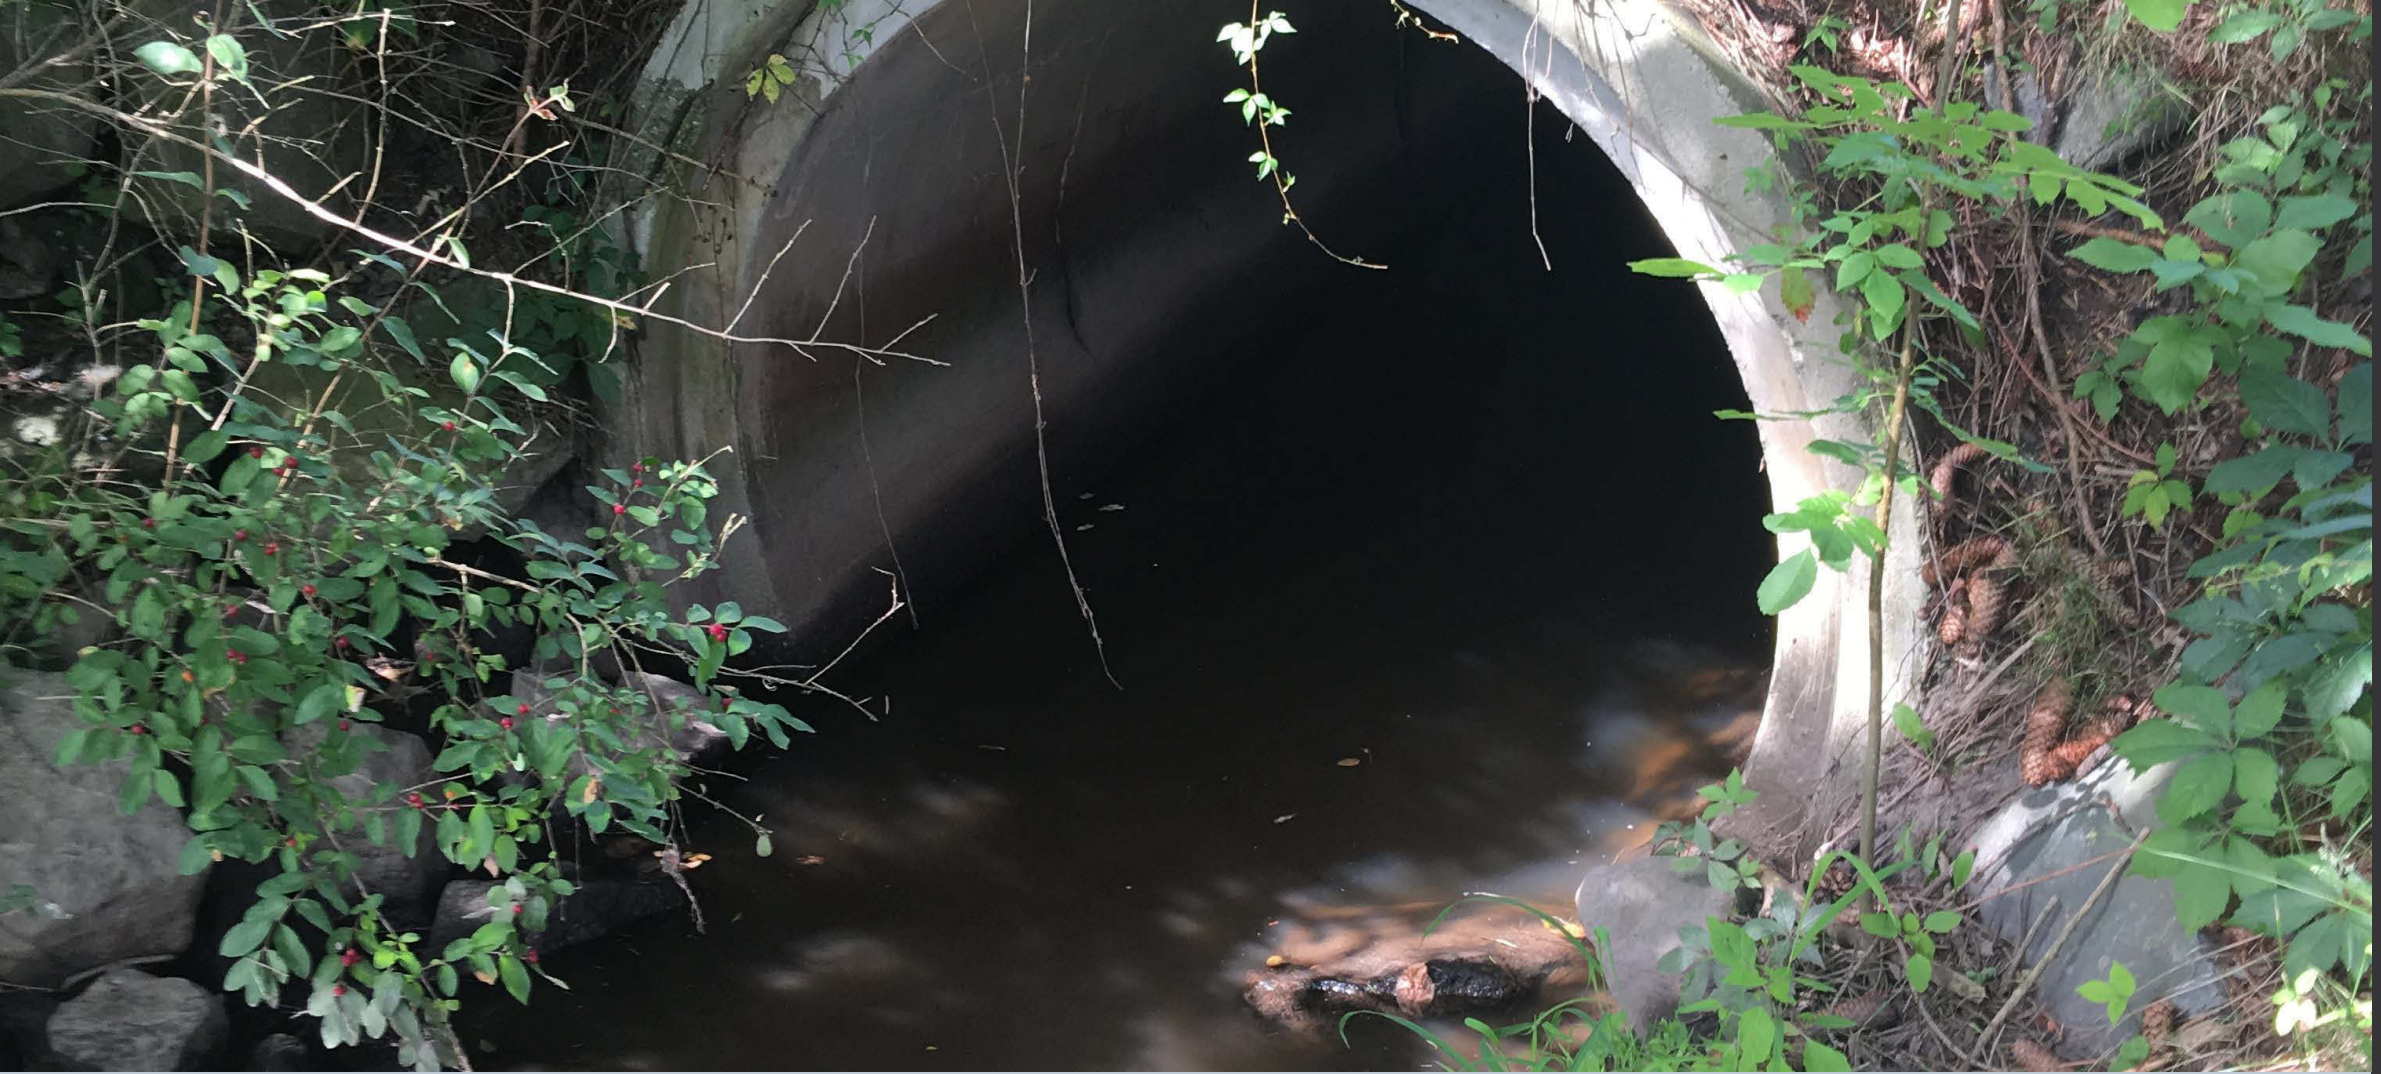
Figure 193. Inlet pipe at the dip in Irem Road at the bottom of the hill. Catfish were present. A severe constriction exists upstream and beneath the road to the other side of the golf course. Pipe is recommended to be replaced to a larger box culvert.

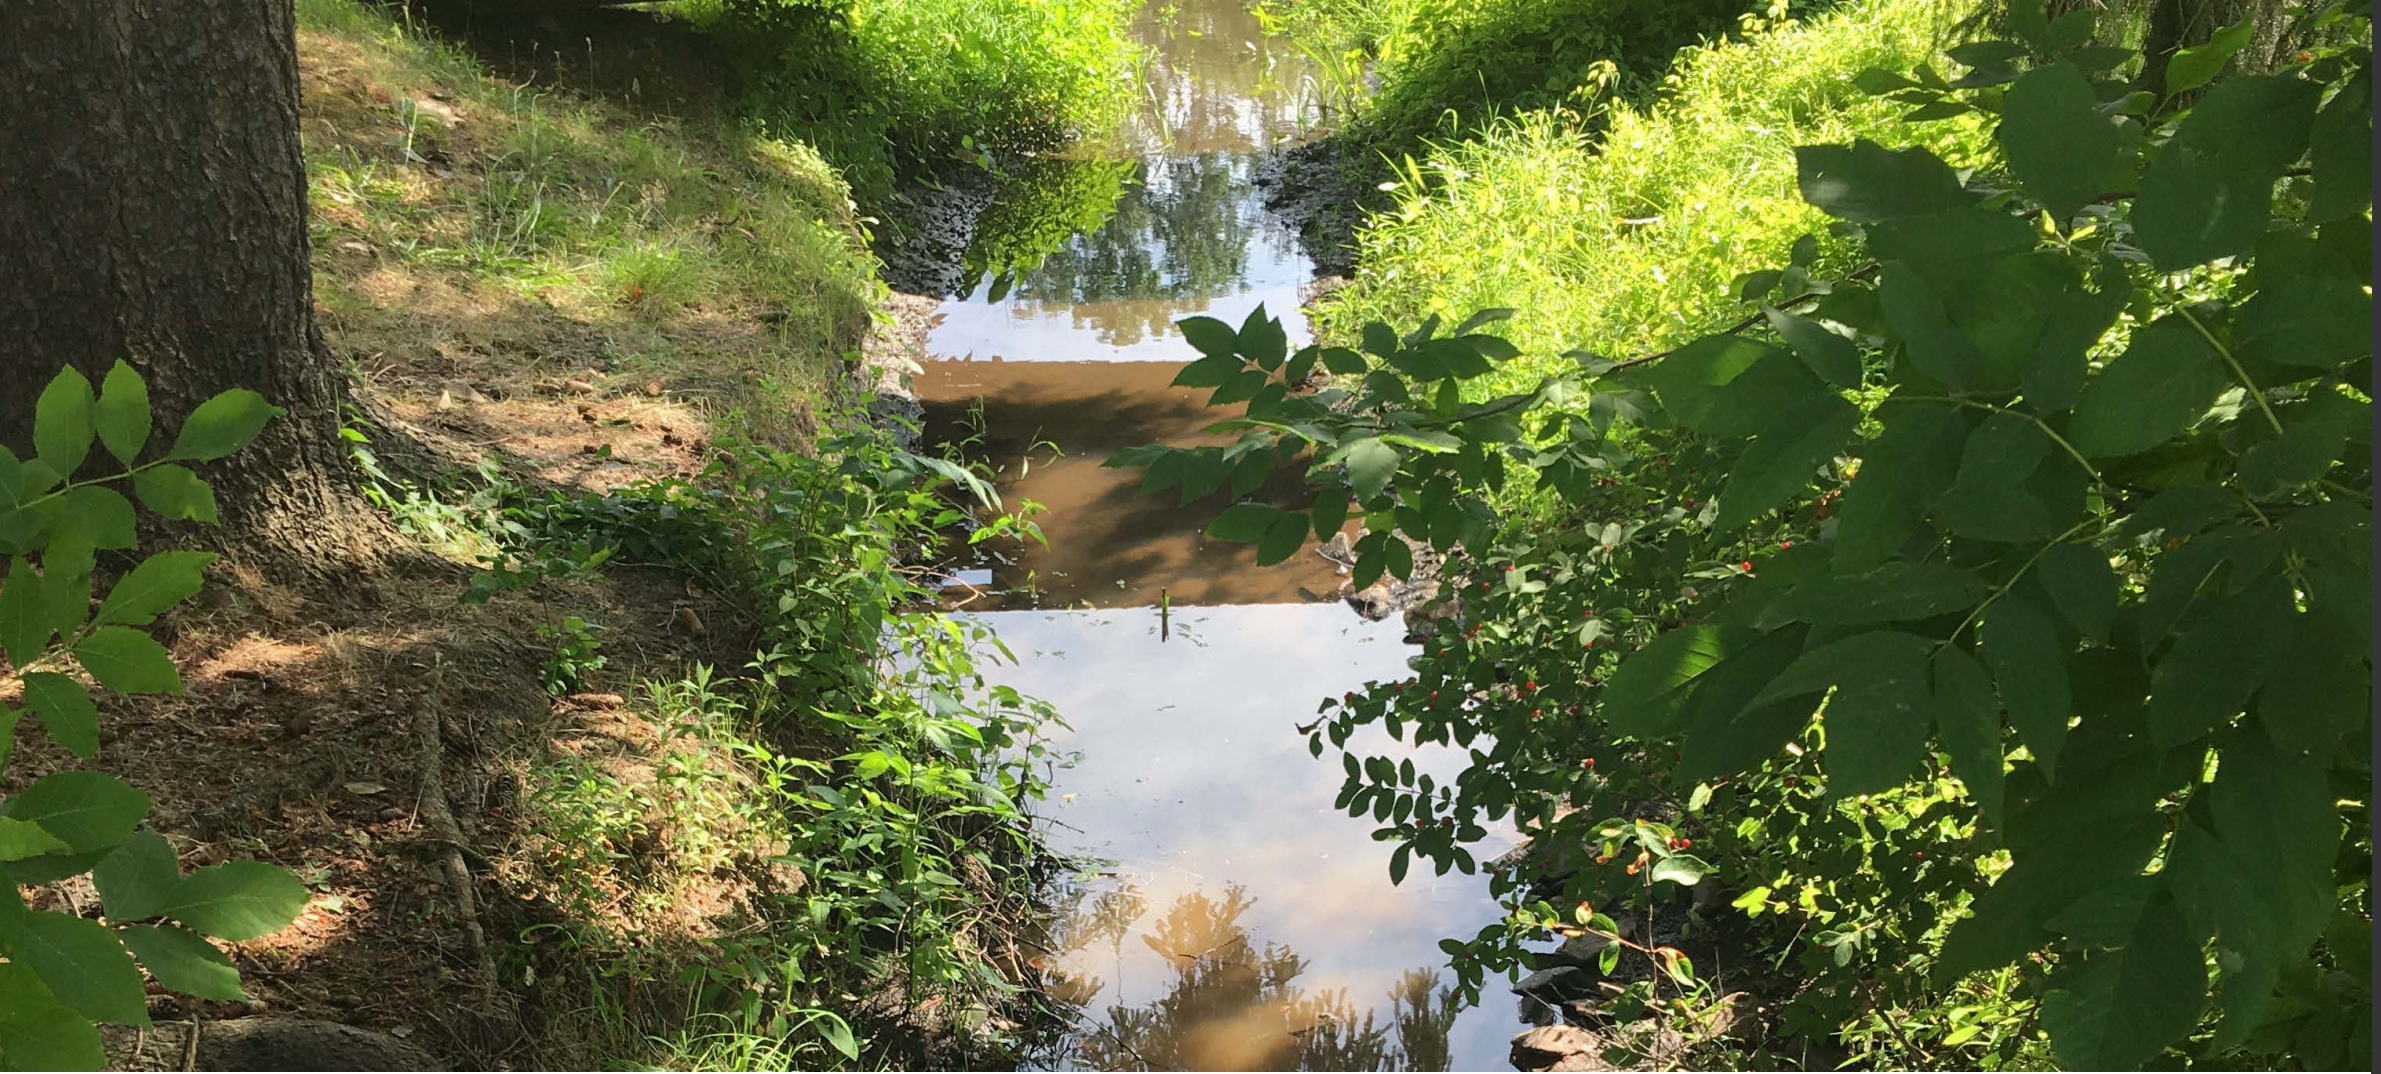
Figure 194. Upstream of Inlet pipe at the dip in Irem Road at the bottom of the hill. Catfish were present. A severe constriction exists upstream. Pipe is recommended to be replaced to a larger box culvert. A small riparian restoration could be implemented in this area.

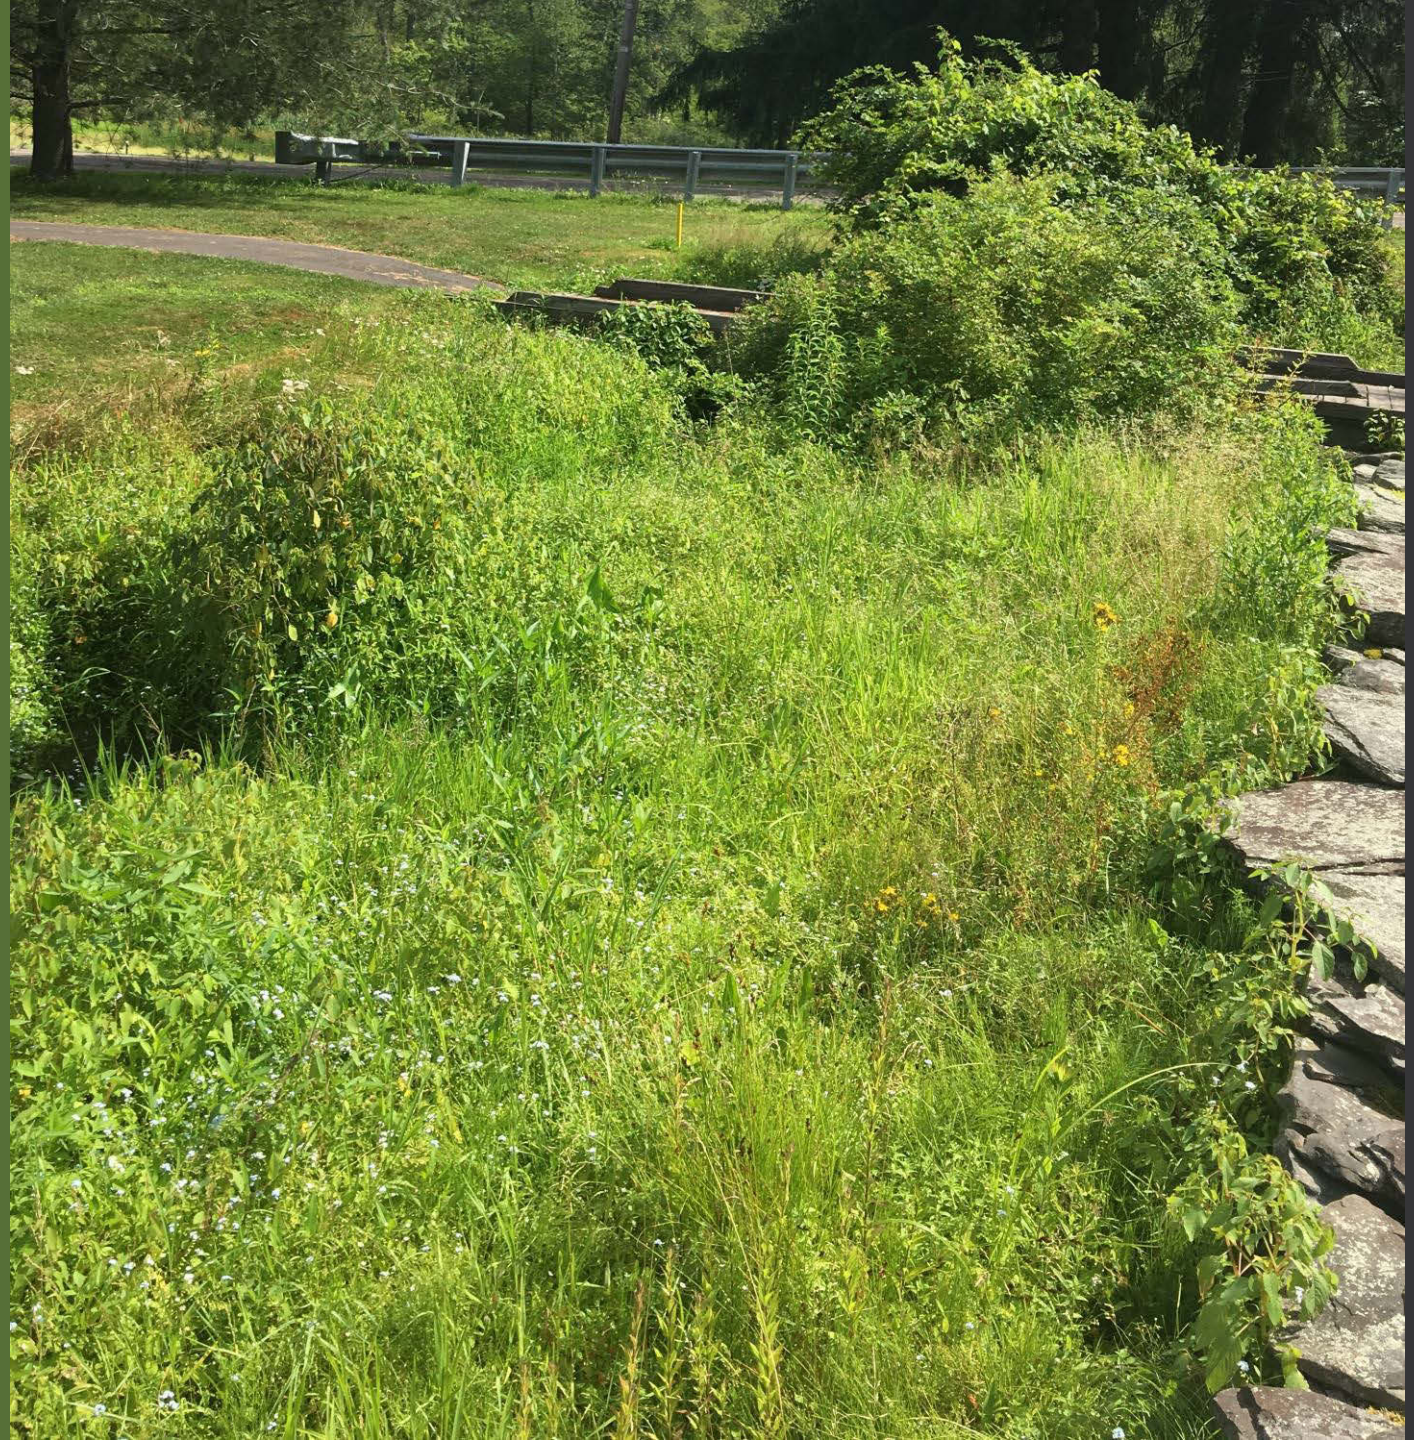
Figure 197. Ephemeral stream channel along the intersection of Country Club Road and Ridgeway Drive where the baseflow of the unnamed tributary passes below the pipe culvert.

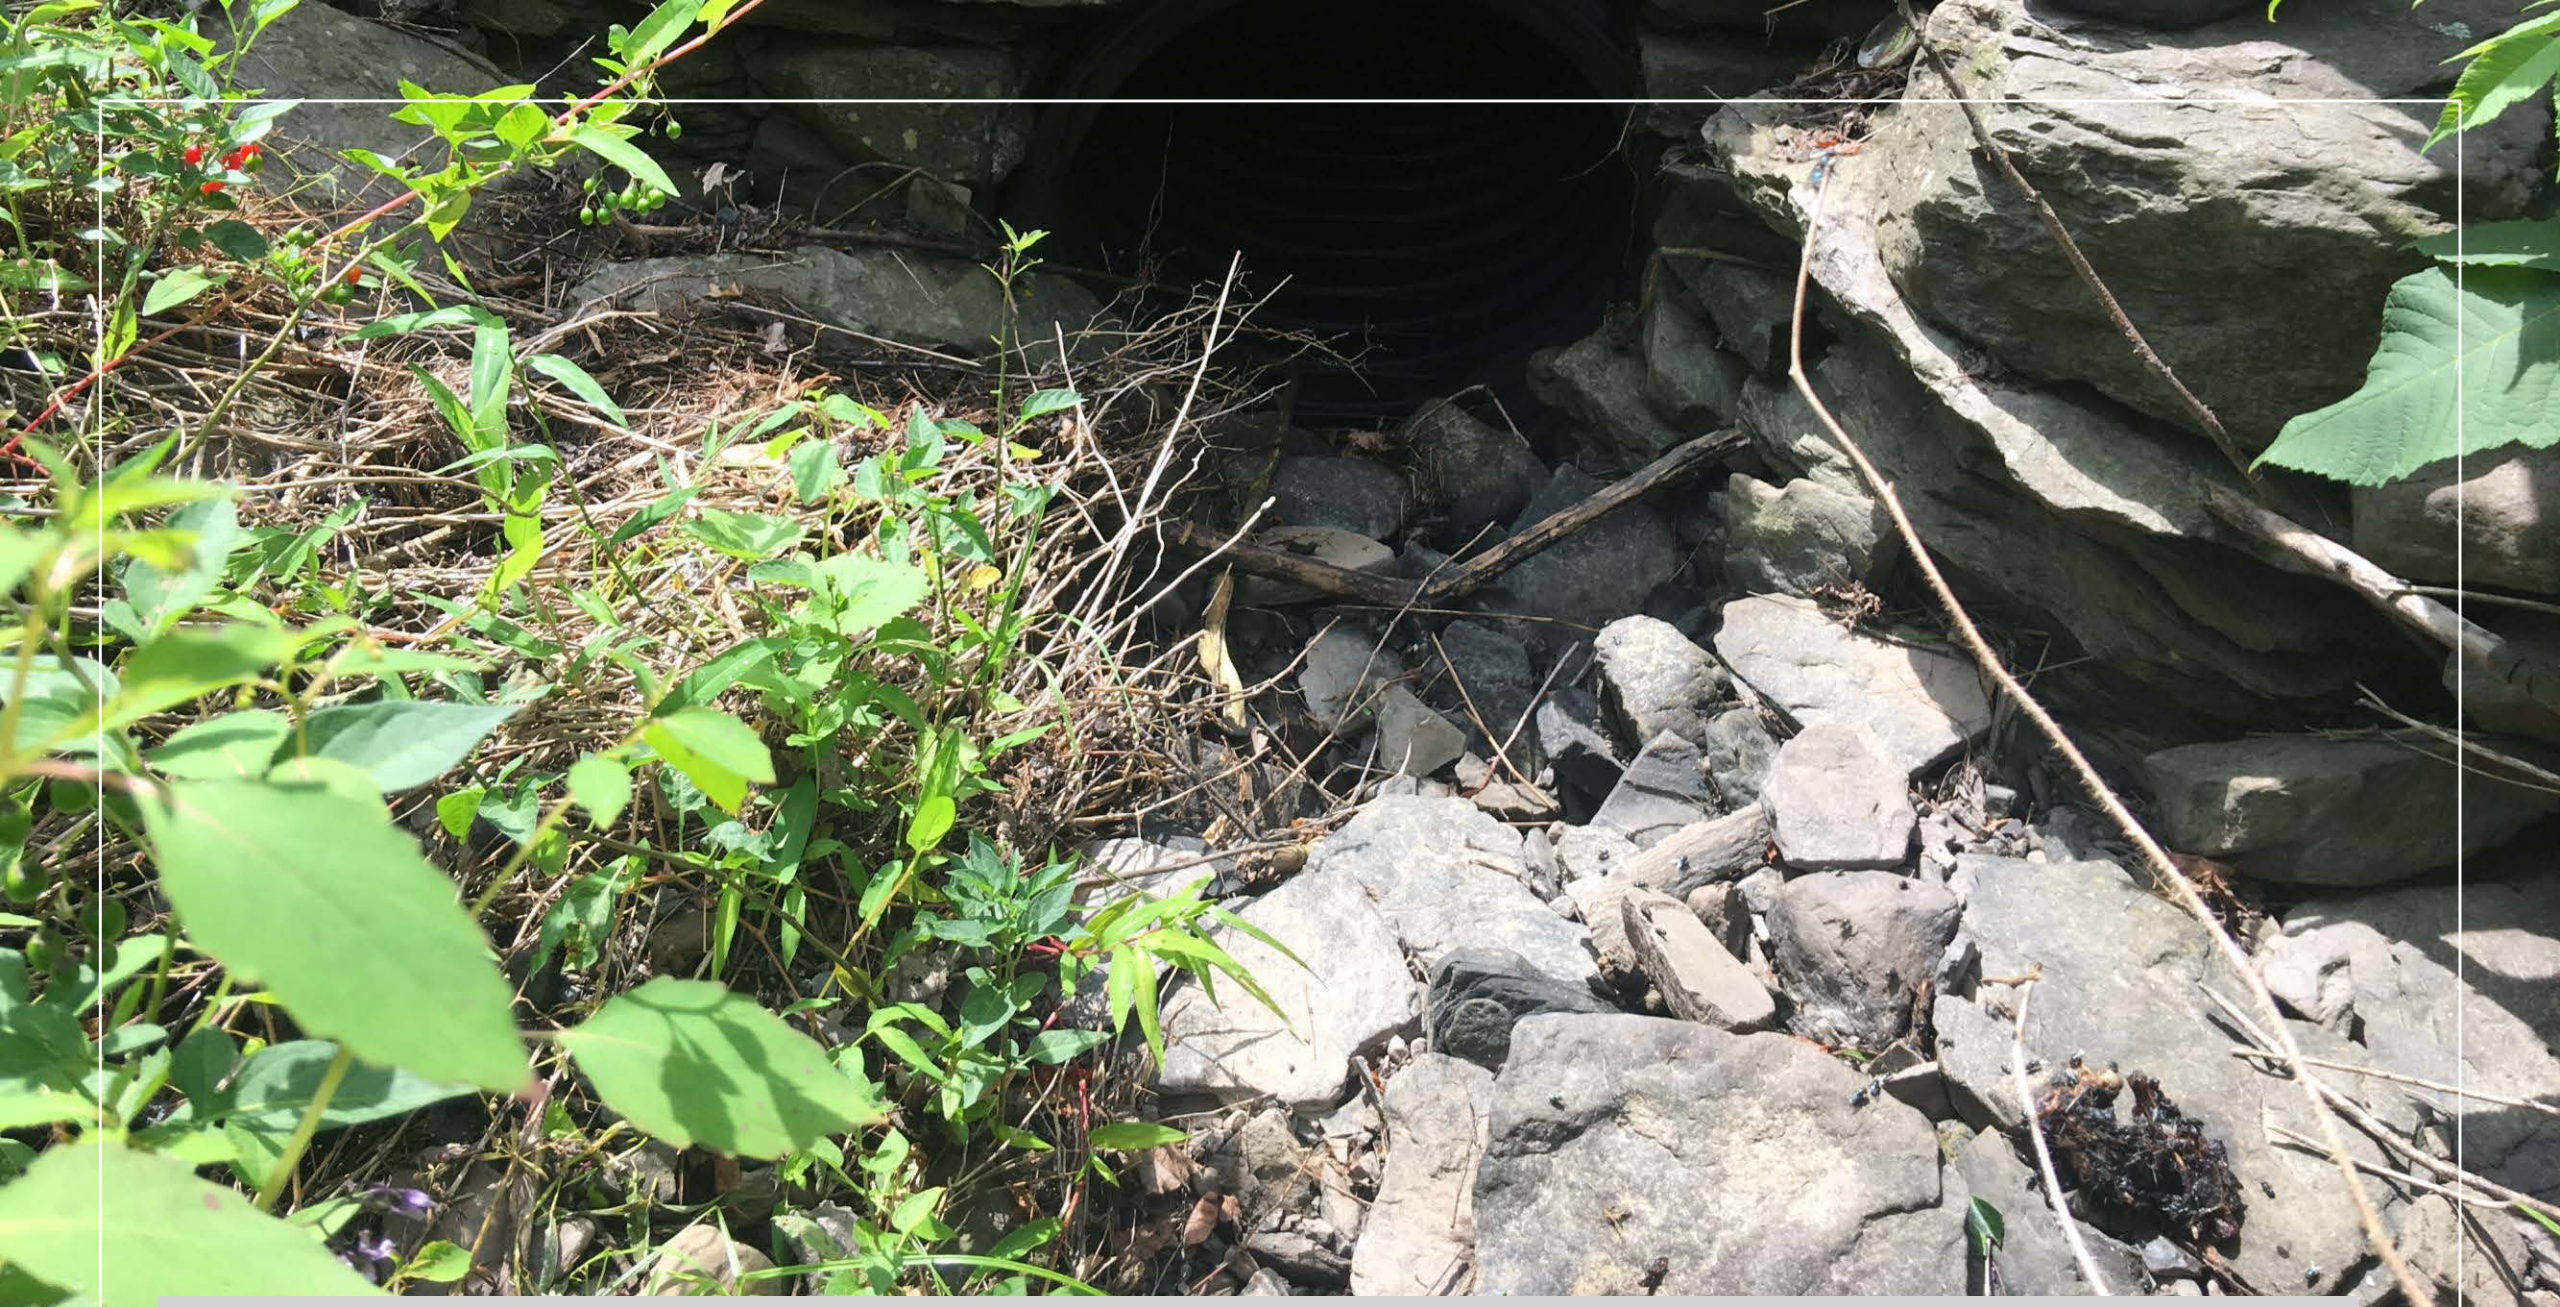
Figure 198. Ephemeral stream channel along the intersection of Country Club Road and Ridgeway Drive where the headwall is failing causing a cascading feature leading into the inlet of the culvert.

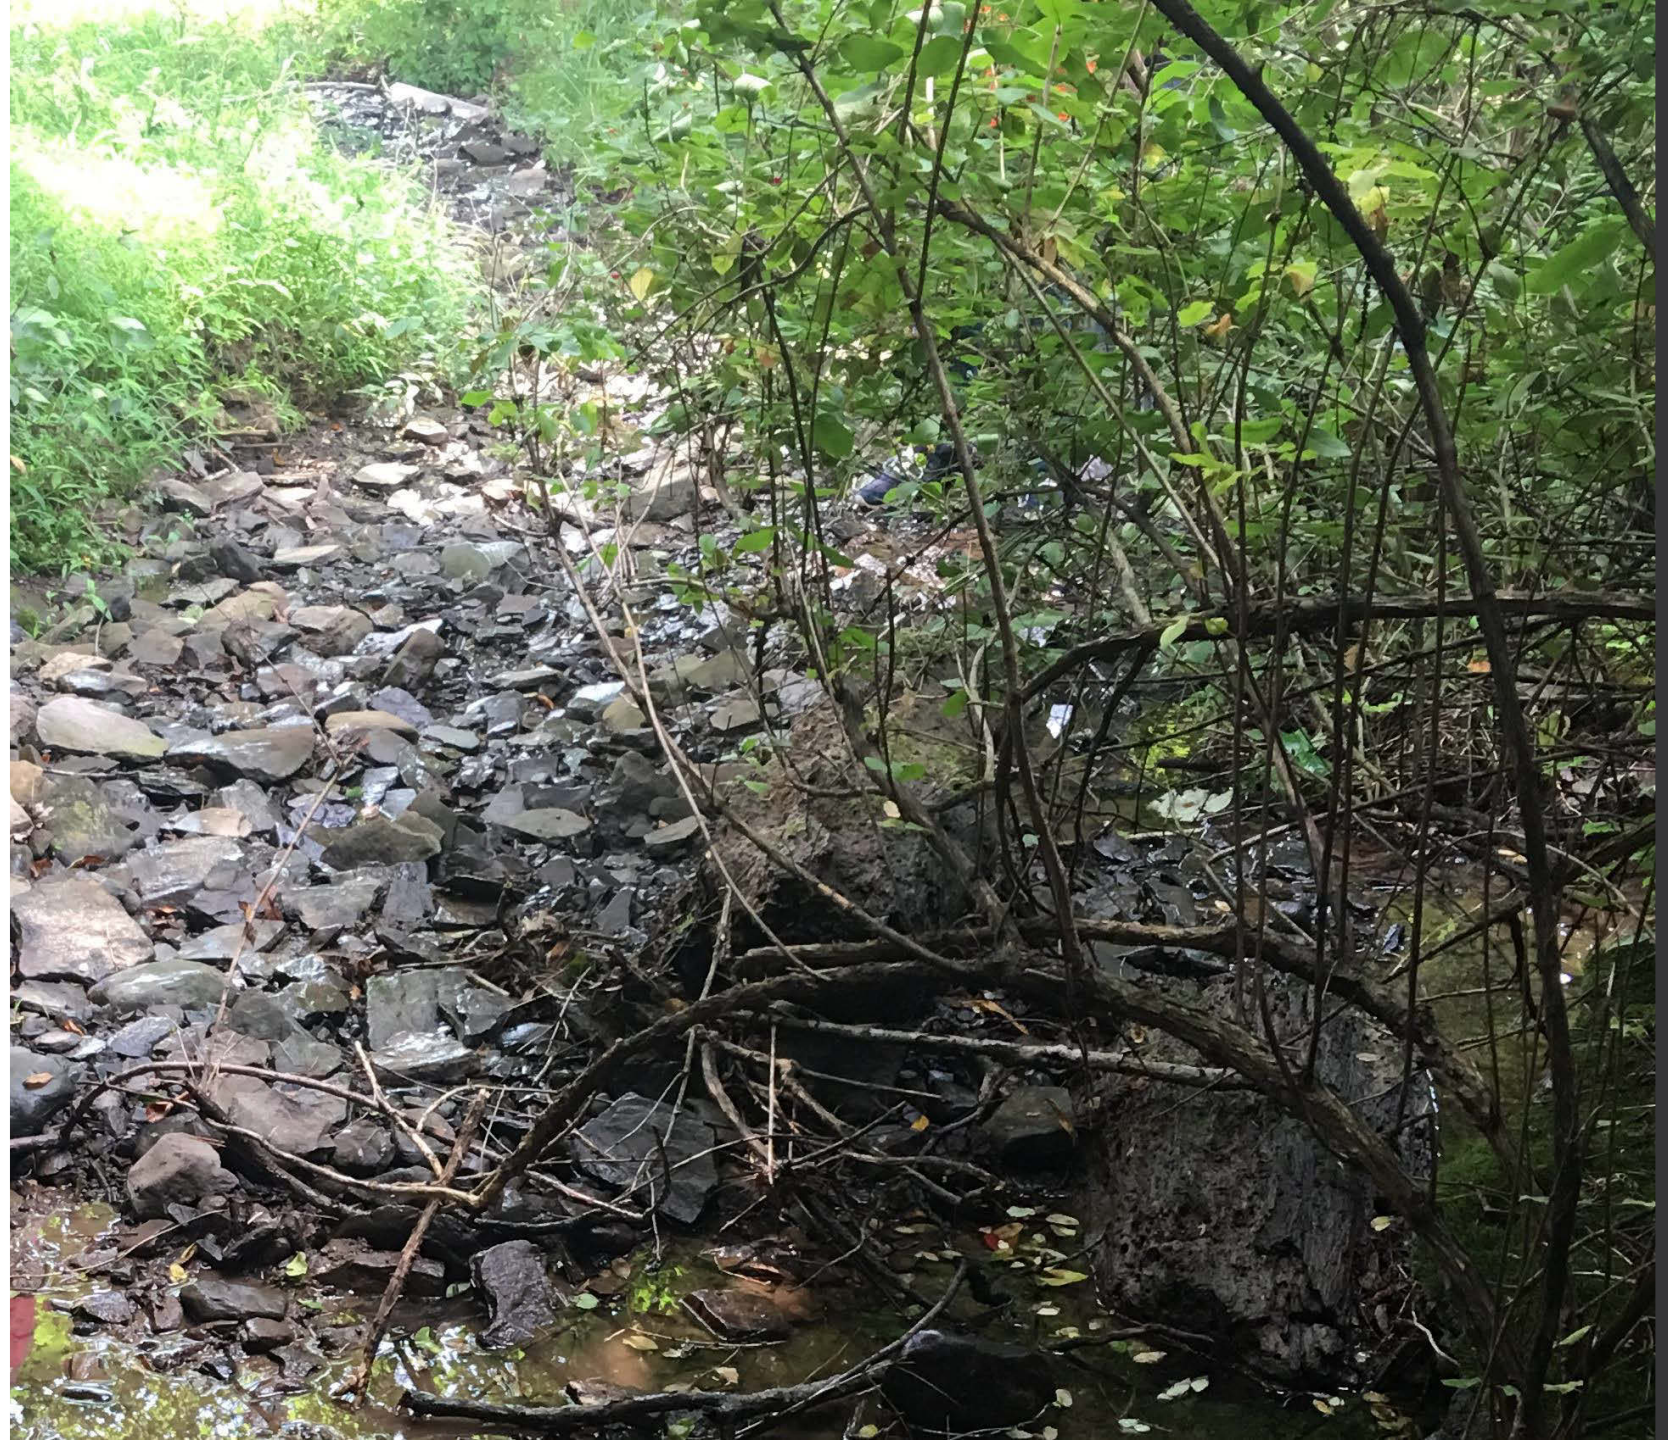
Figure 199. Downstream channel of the unnamed tributary along the intersection of Country Club Road and Ridgeway Drive where the baseflow is extremely low.

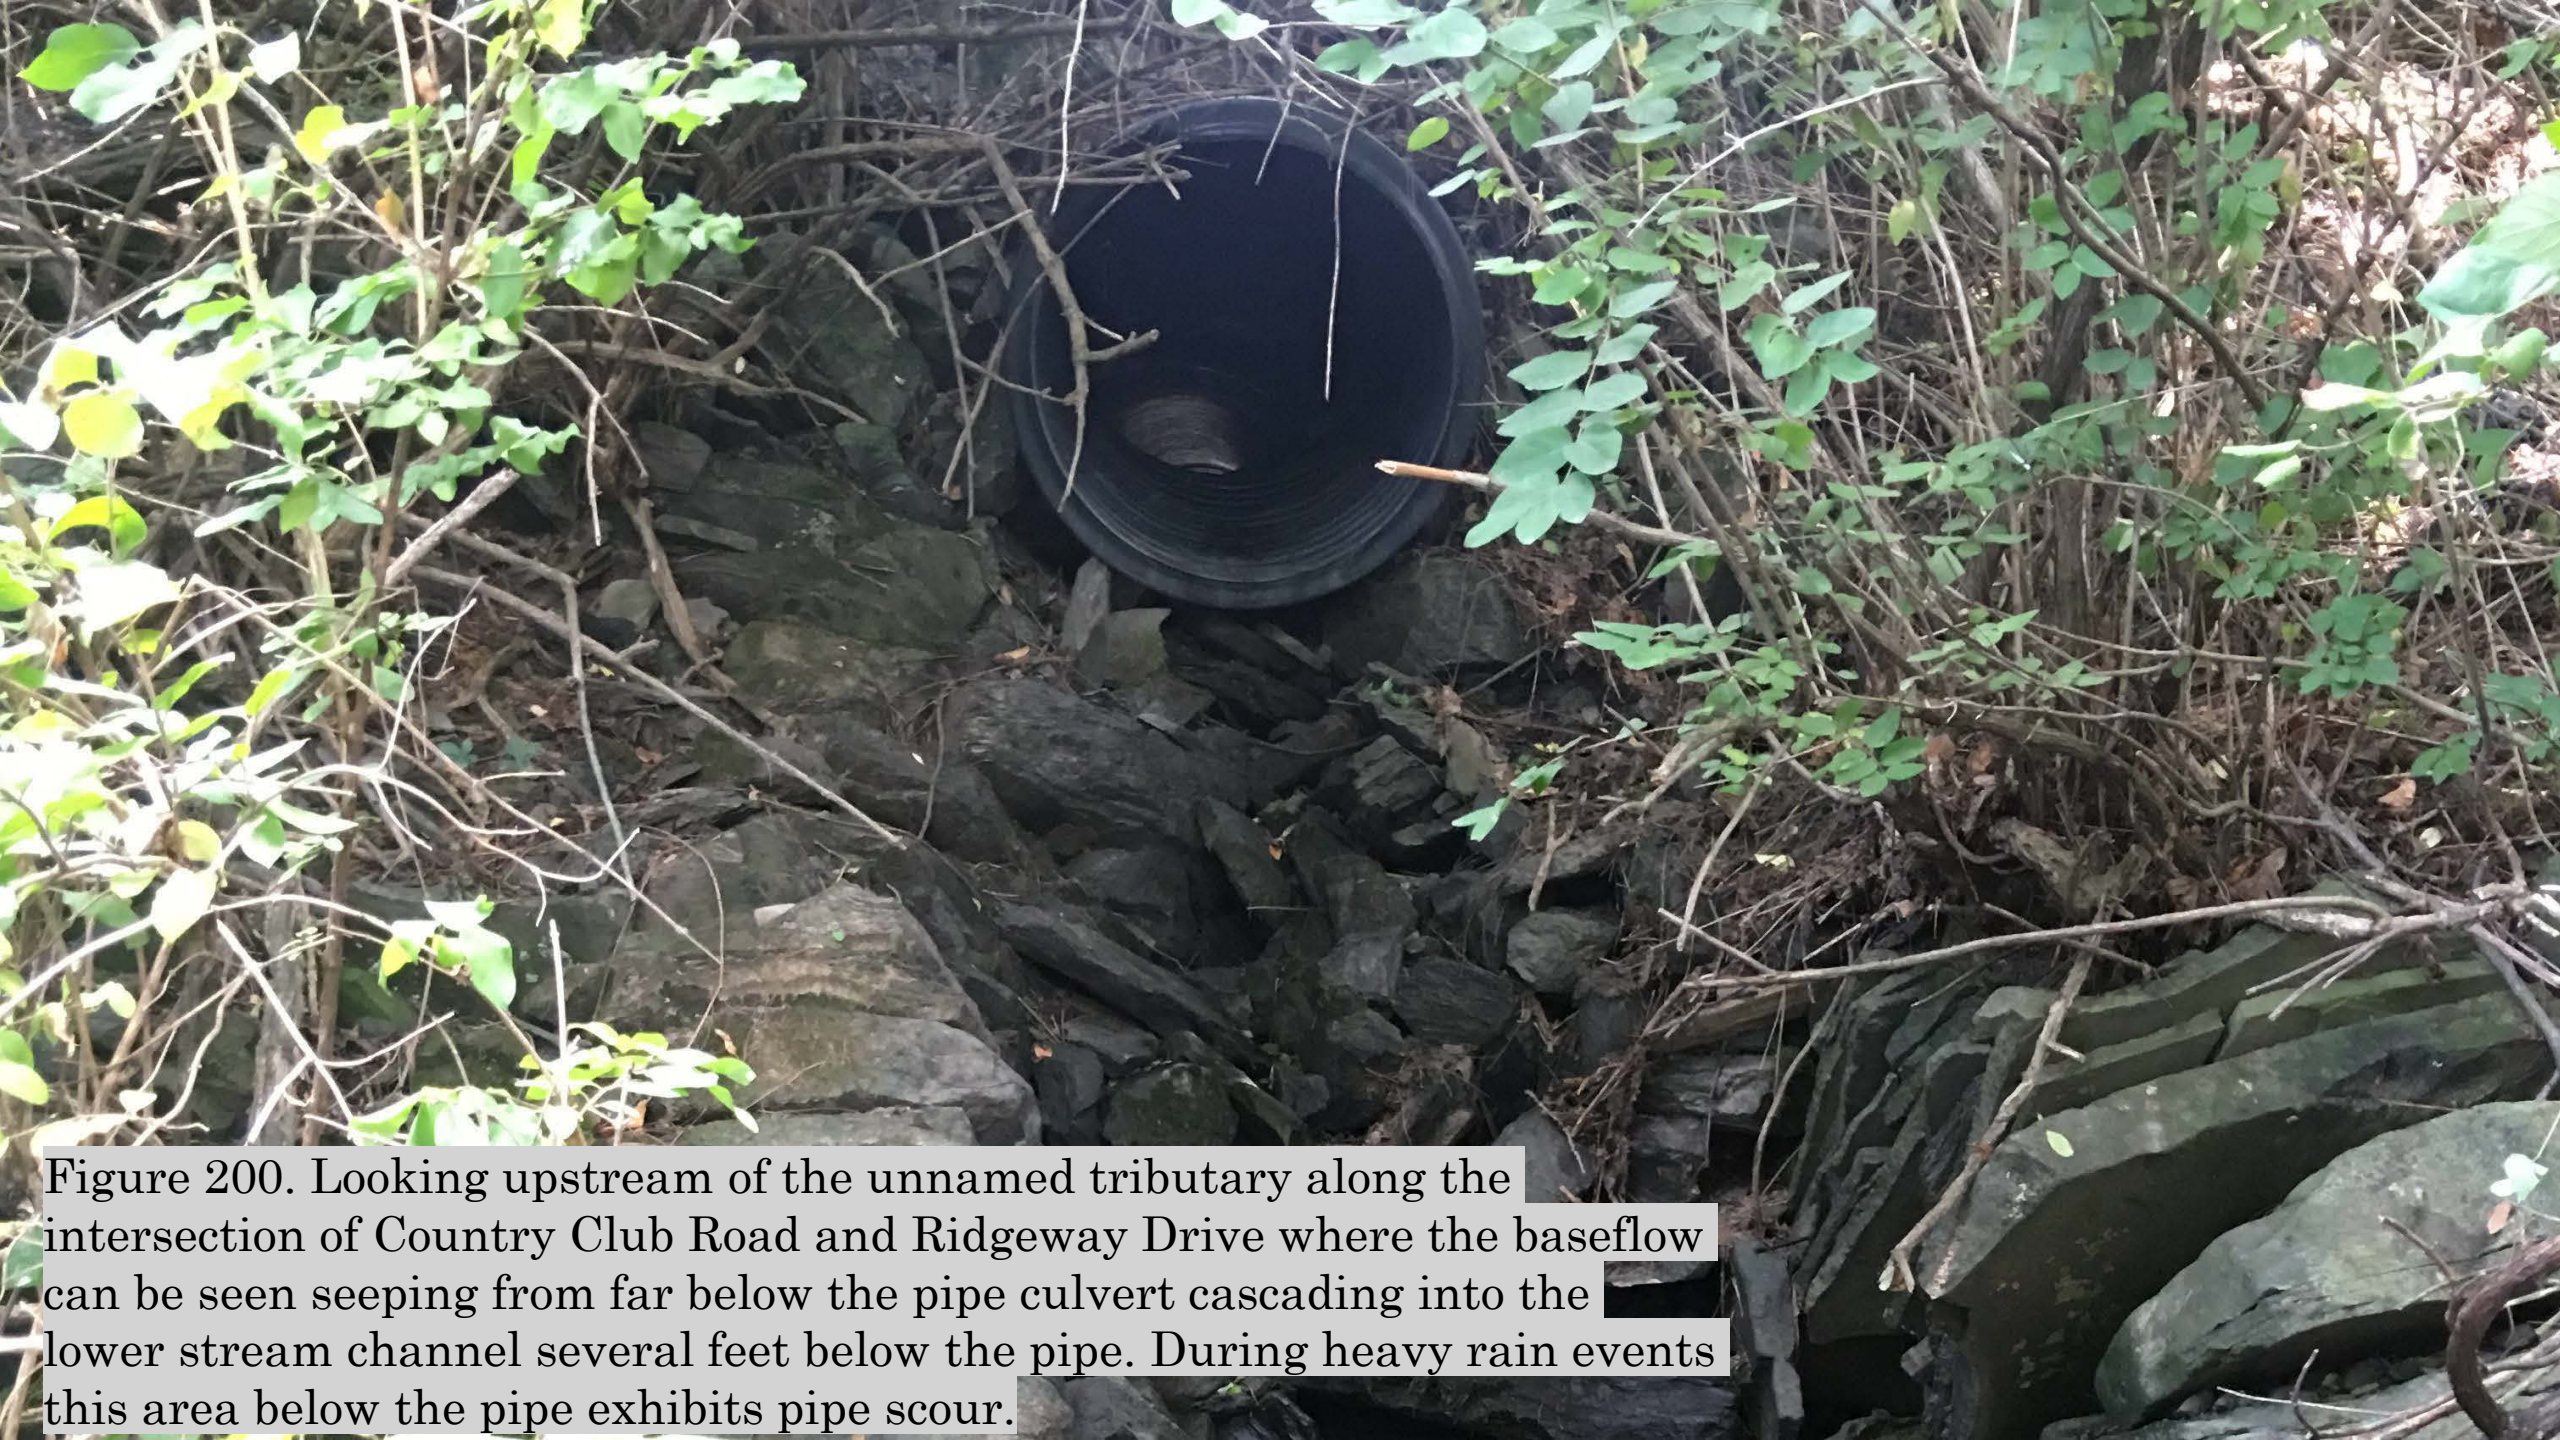
Figure 200. Looking upstream of the unnamed tributary along the intersection of Country Club Road and Ridgeway Drive where the baseflow can be seen seeping from far below the pipe culvert cascading into the lower stream channel several feet below the pipe. During heavy rain events this area below the pipe exhibits pipe scour.

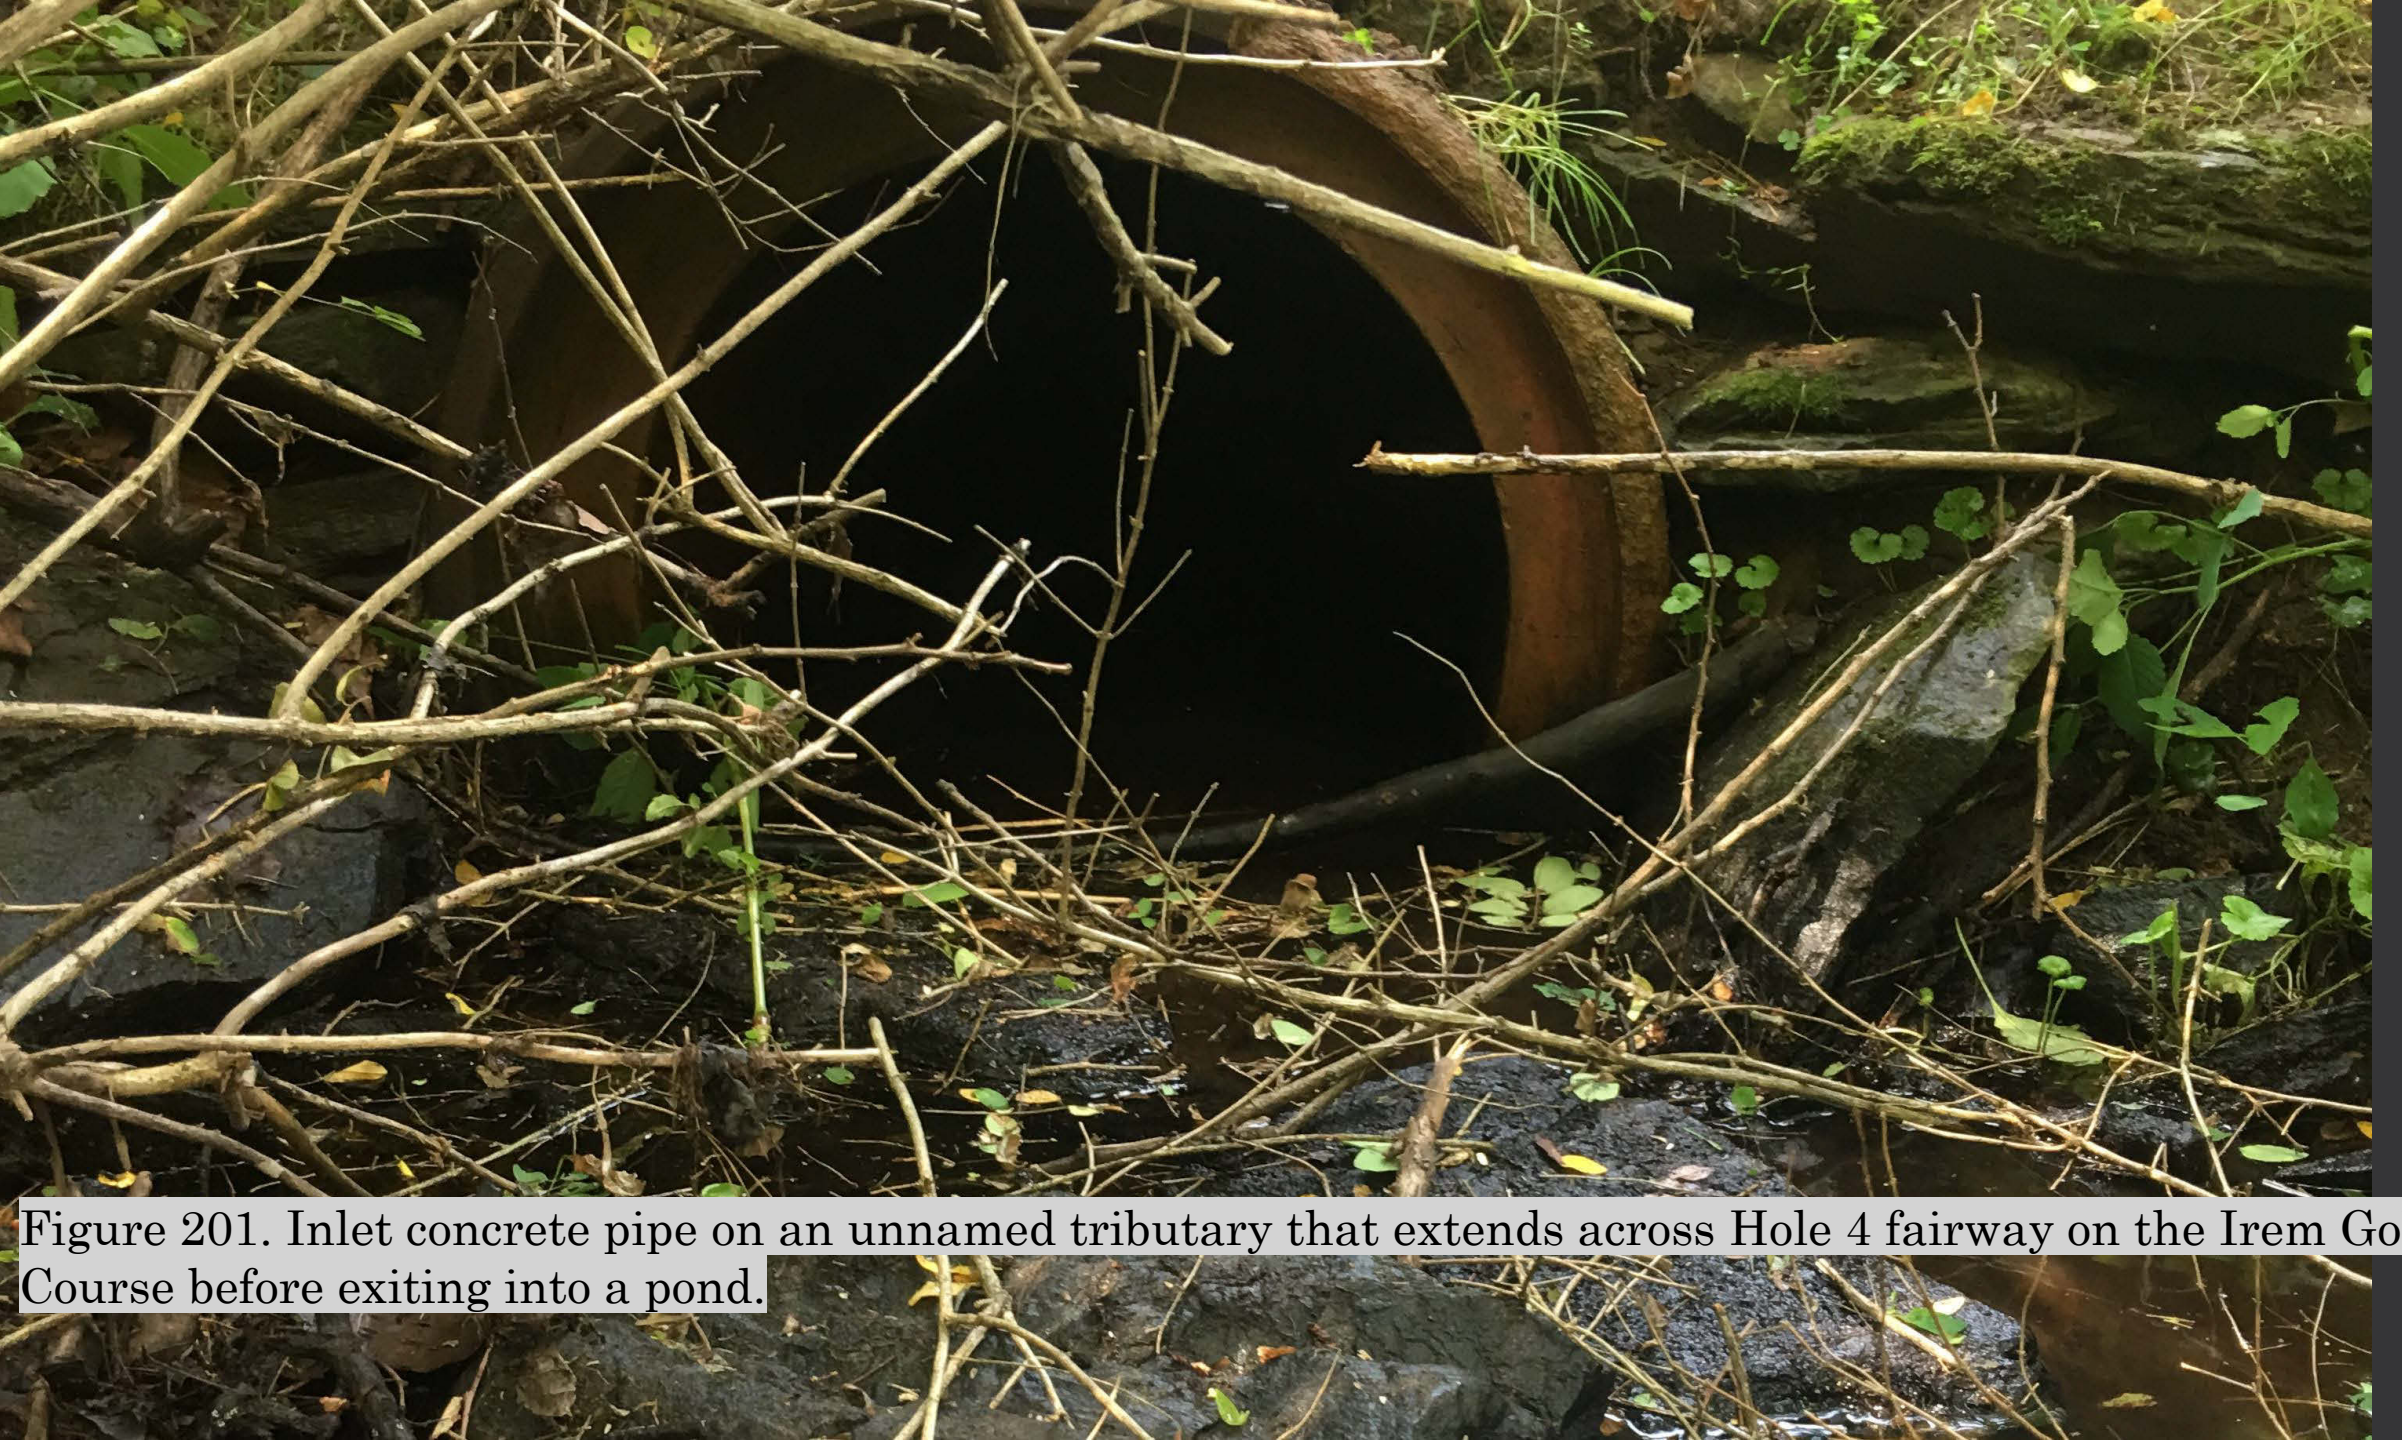
Figure 201. Inlet concrete pipe on an unnamed tributary that extends across Hole 4 fairway on the Irem Golf Course before exiting into a pond.
