Toby Creek Field Reconnaissance Observations

September 26, 2018

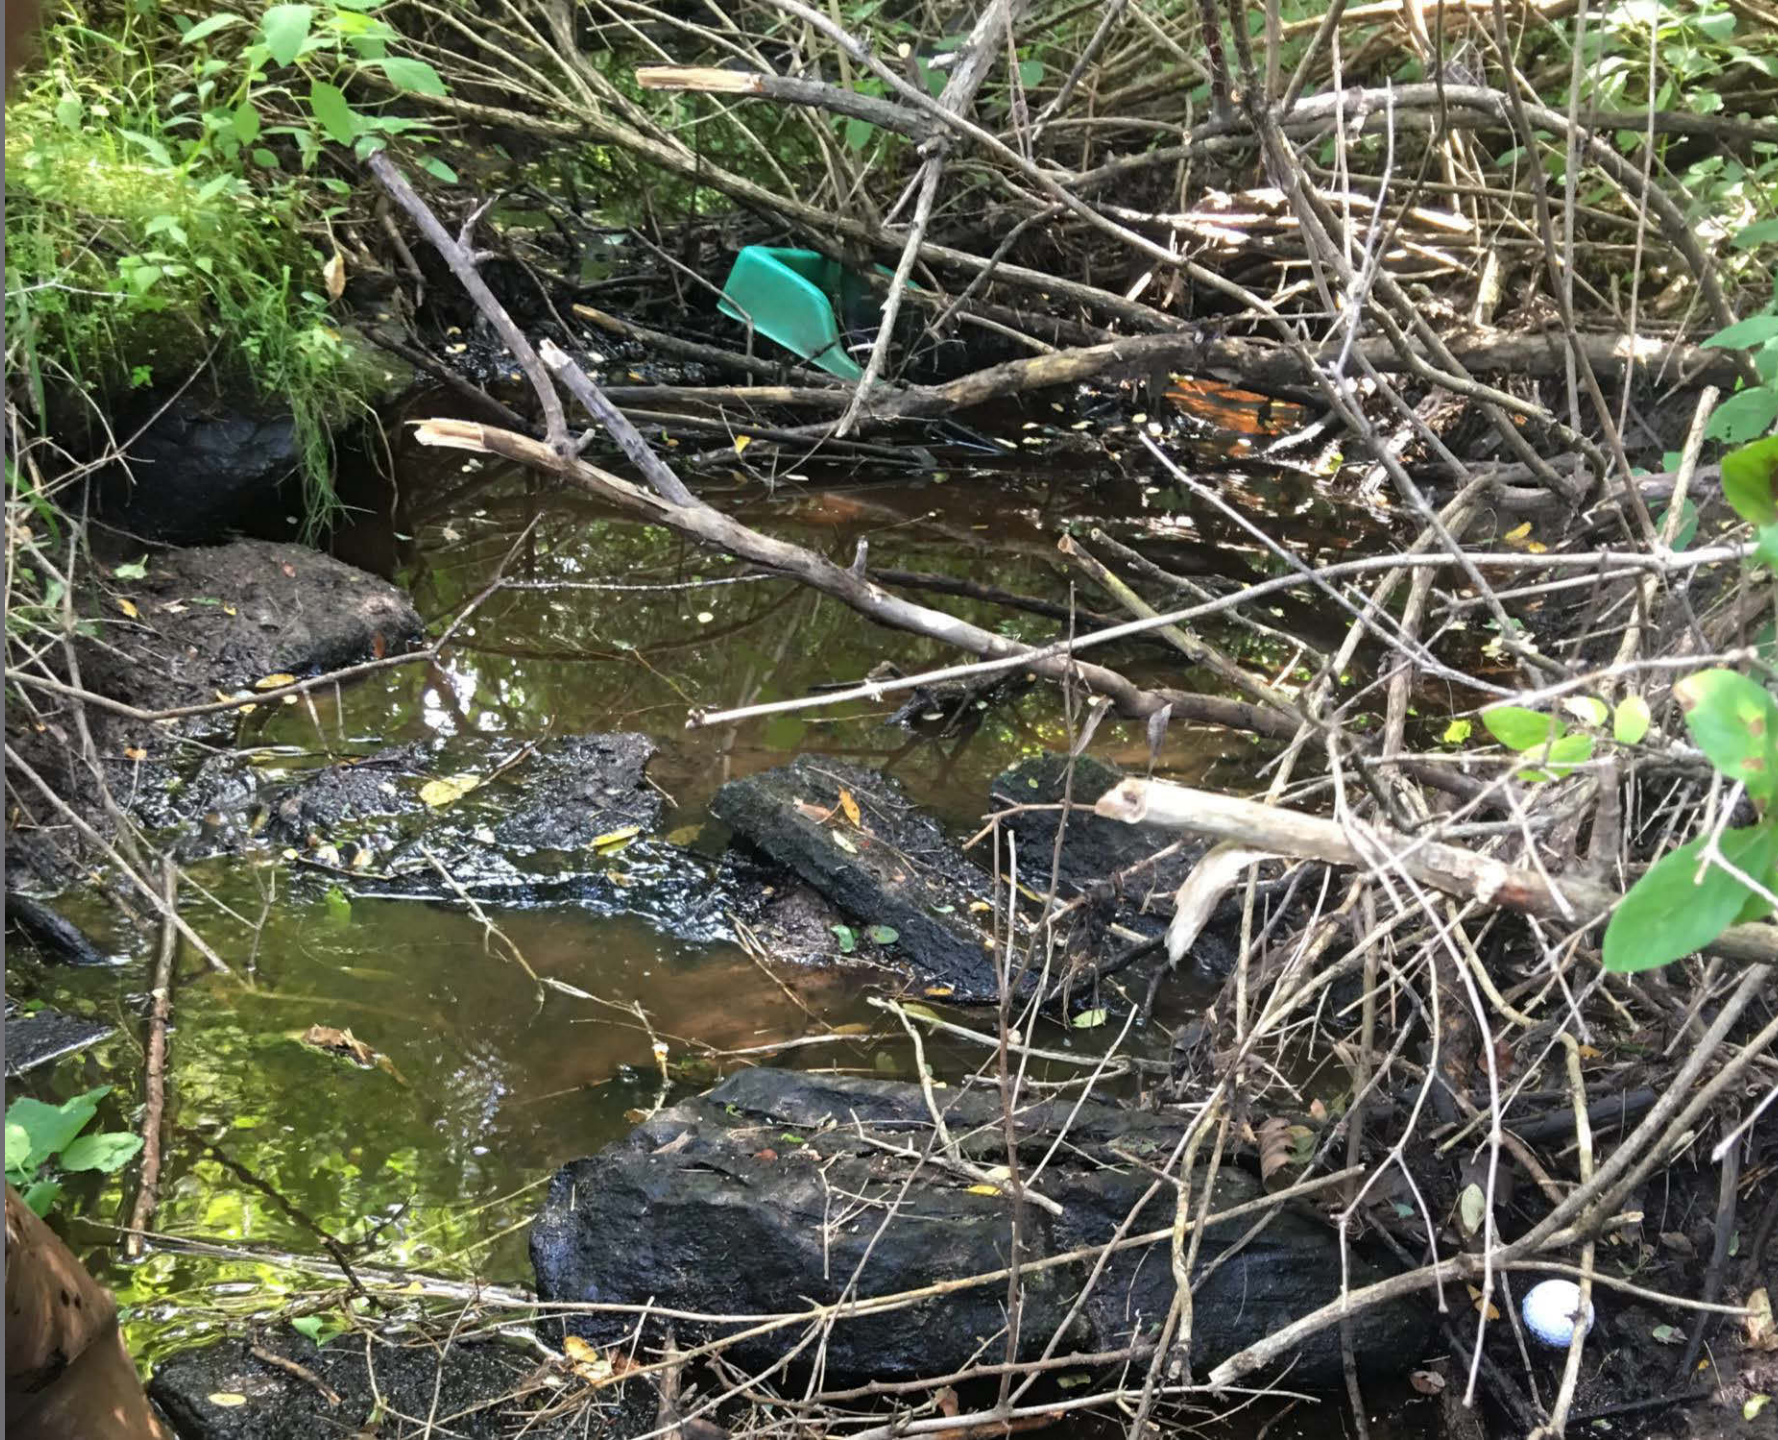
Figure 202. Looking upstream of culvert on unnamed tributary above Hole 4 on the Irem Golf Course. Litter is present and a small cleanup is recommended.

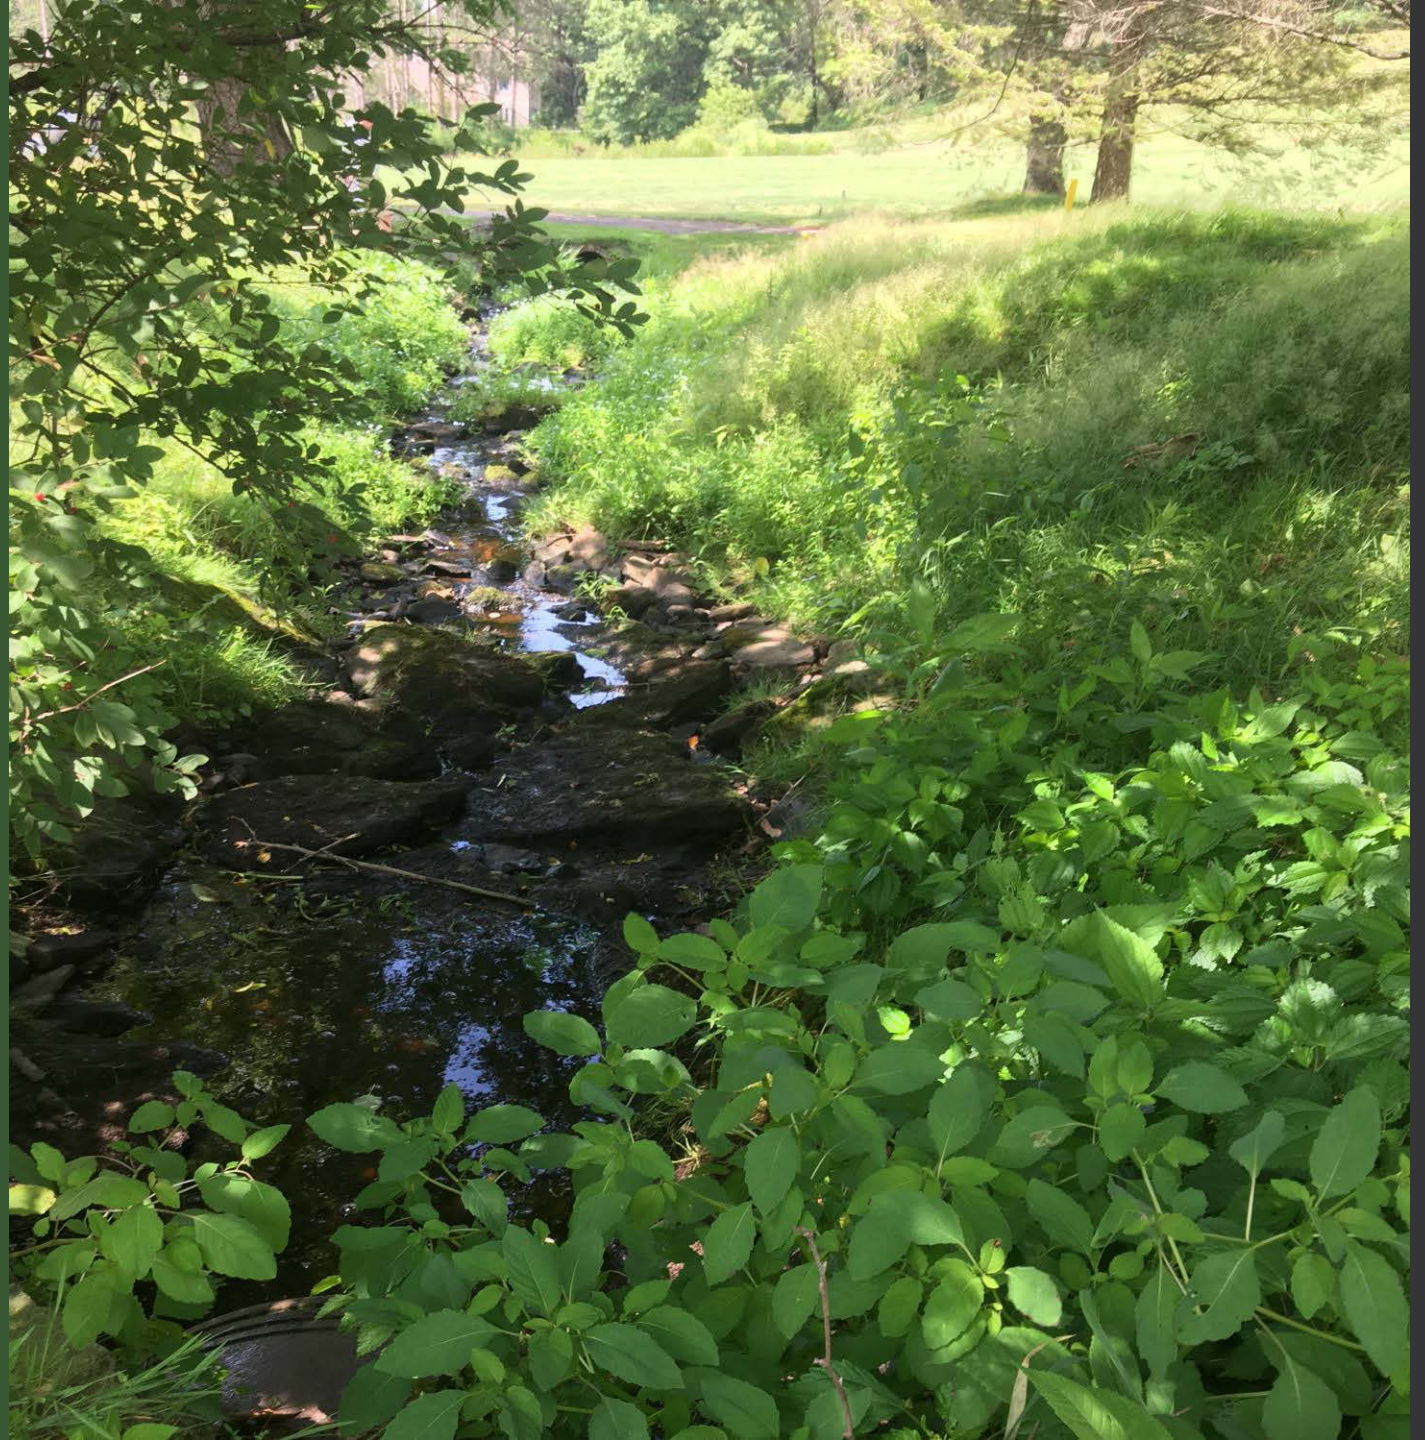
Figure 203. Outlet of concrete pipe on an unnamed tributary looking downstream that extends across Hole 4 and is piped once beneath the fairway on the Irem Golf Course before exiting into a pond.

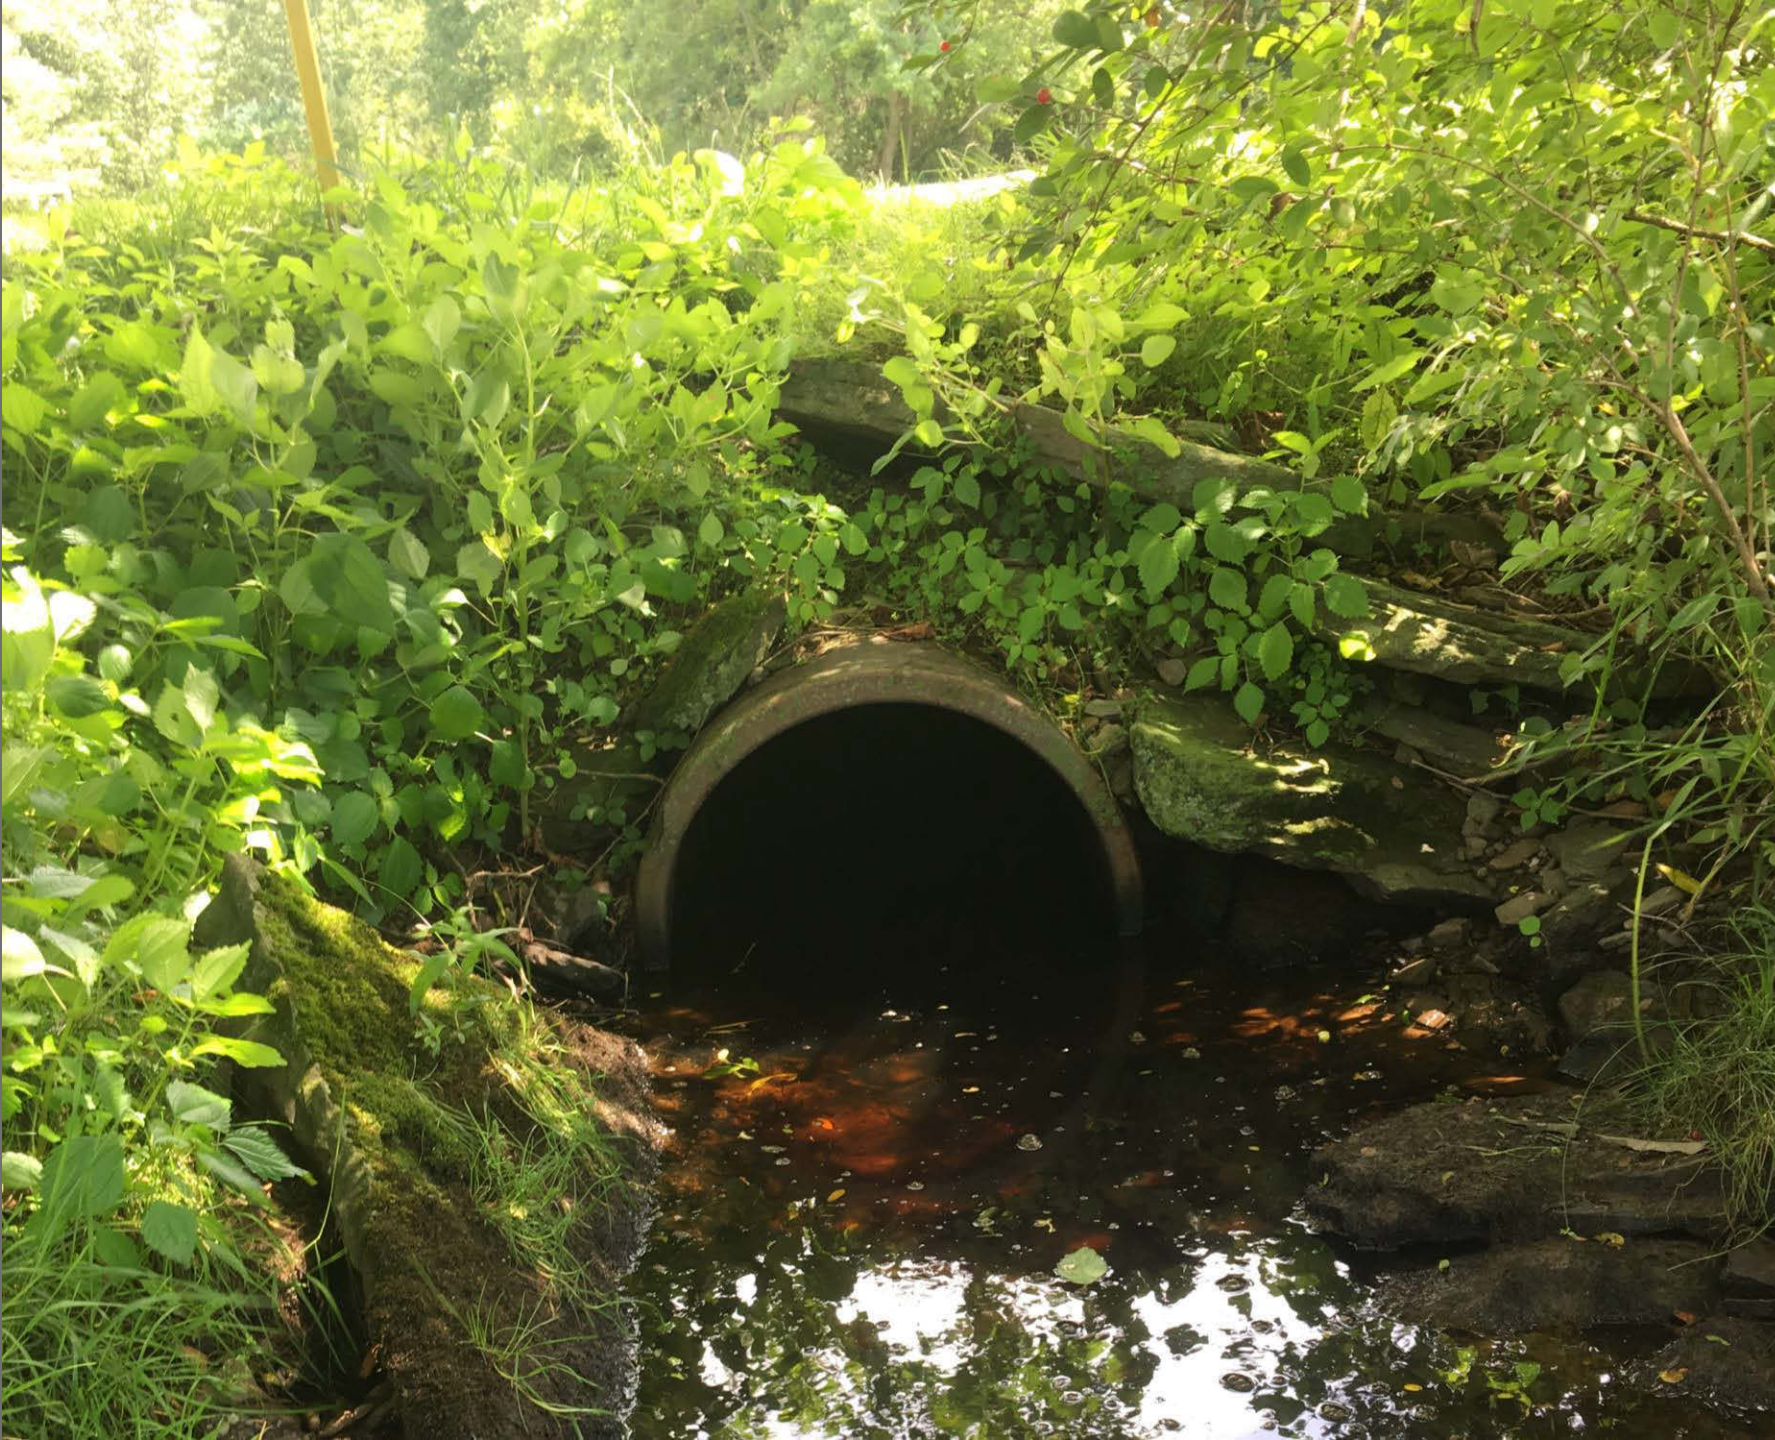
Figure 204. Outlet of concrete pipe on an unnamed tributary that extends across Hole 4 and is piped once beneath the fairway on the Irem Golf Course.

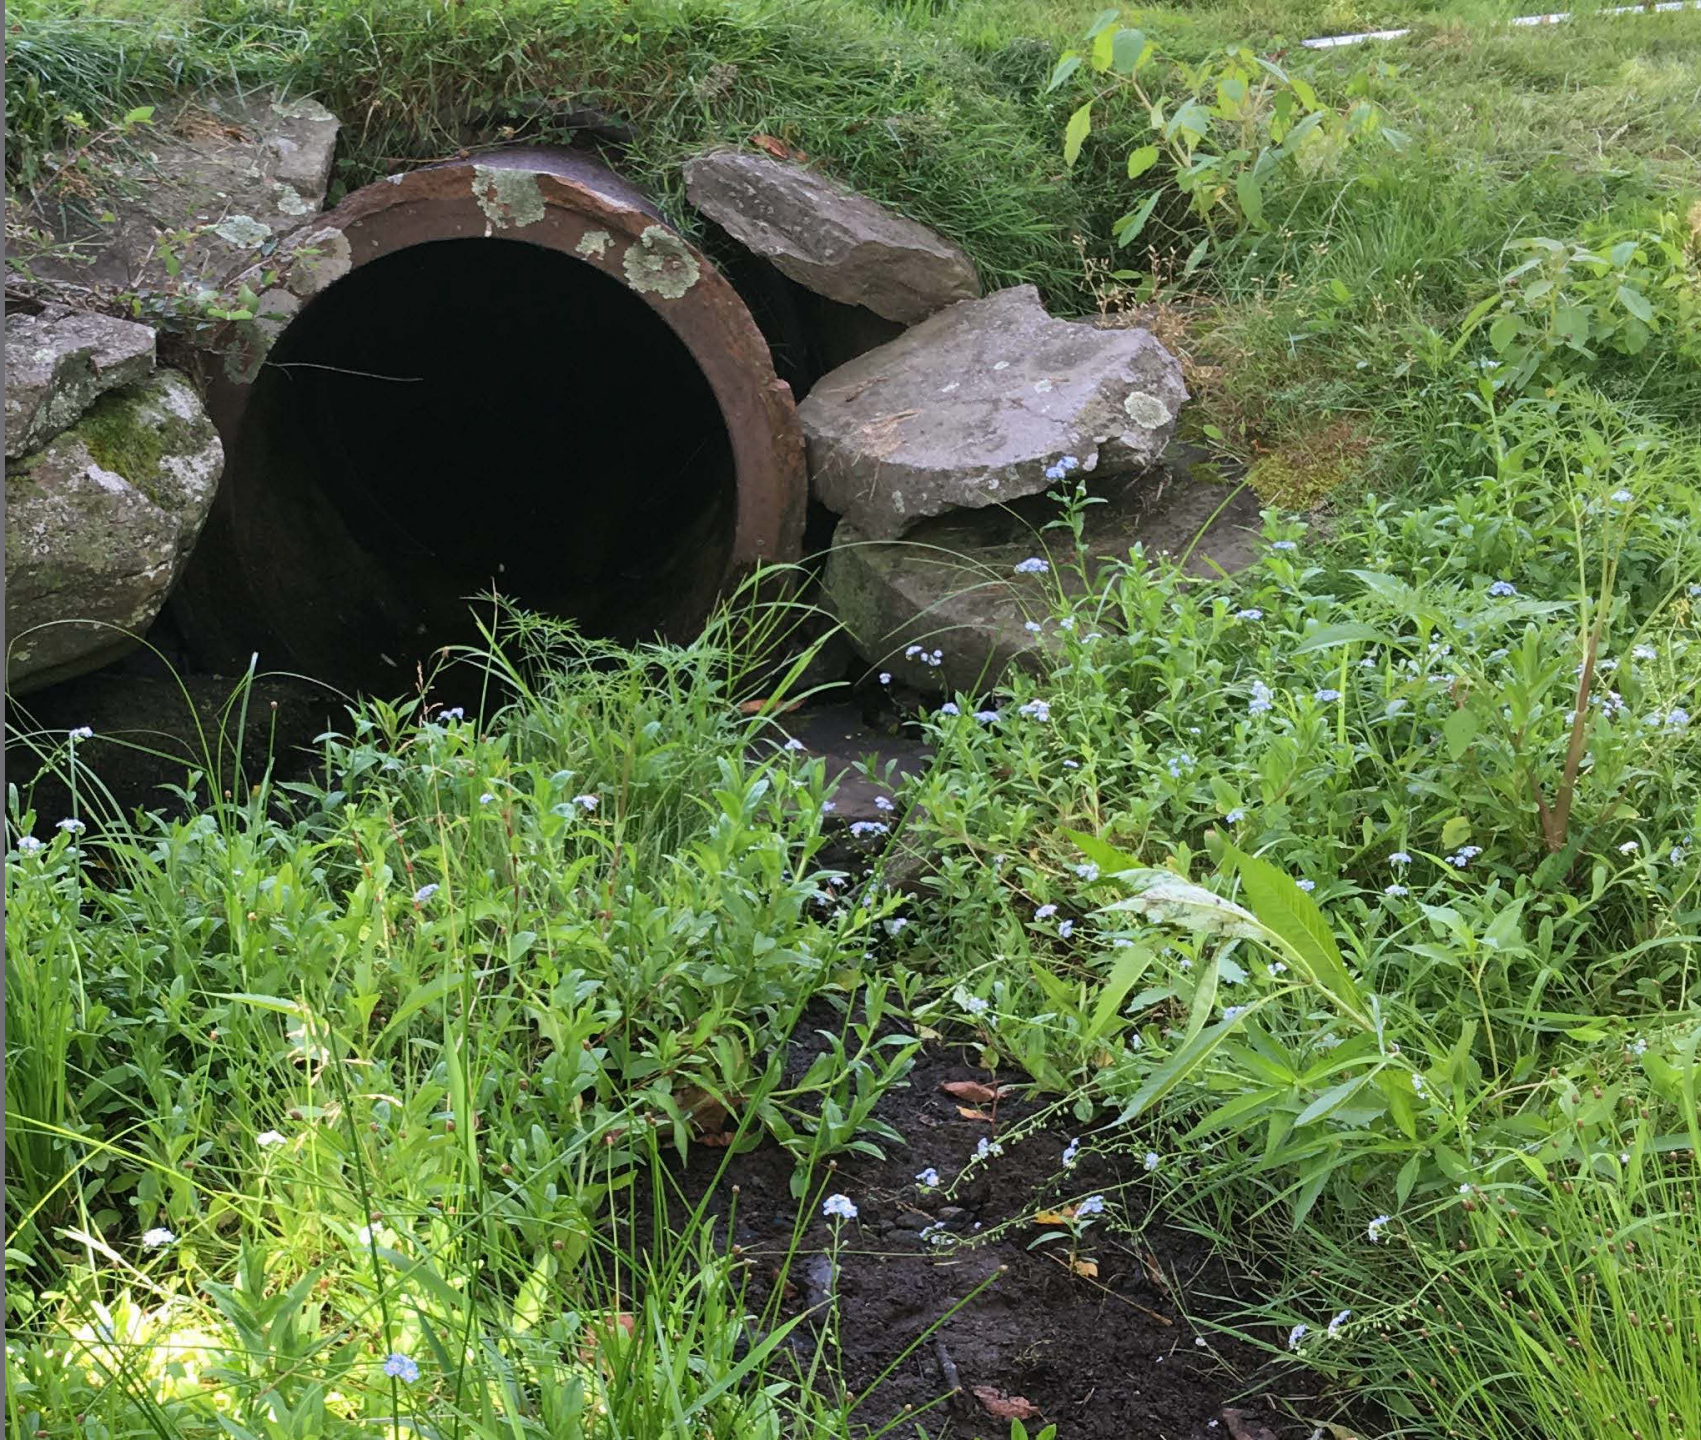
Figure 205. Inlet of another concrete section of pipe on an unnamed tributary that extends across Hole 4 and is piped once beneath the fairway on the Irem Golf Course.

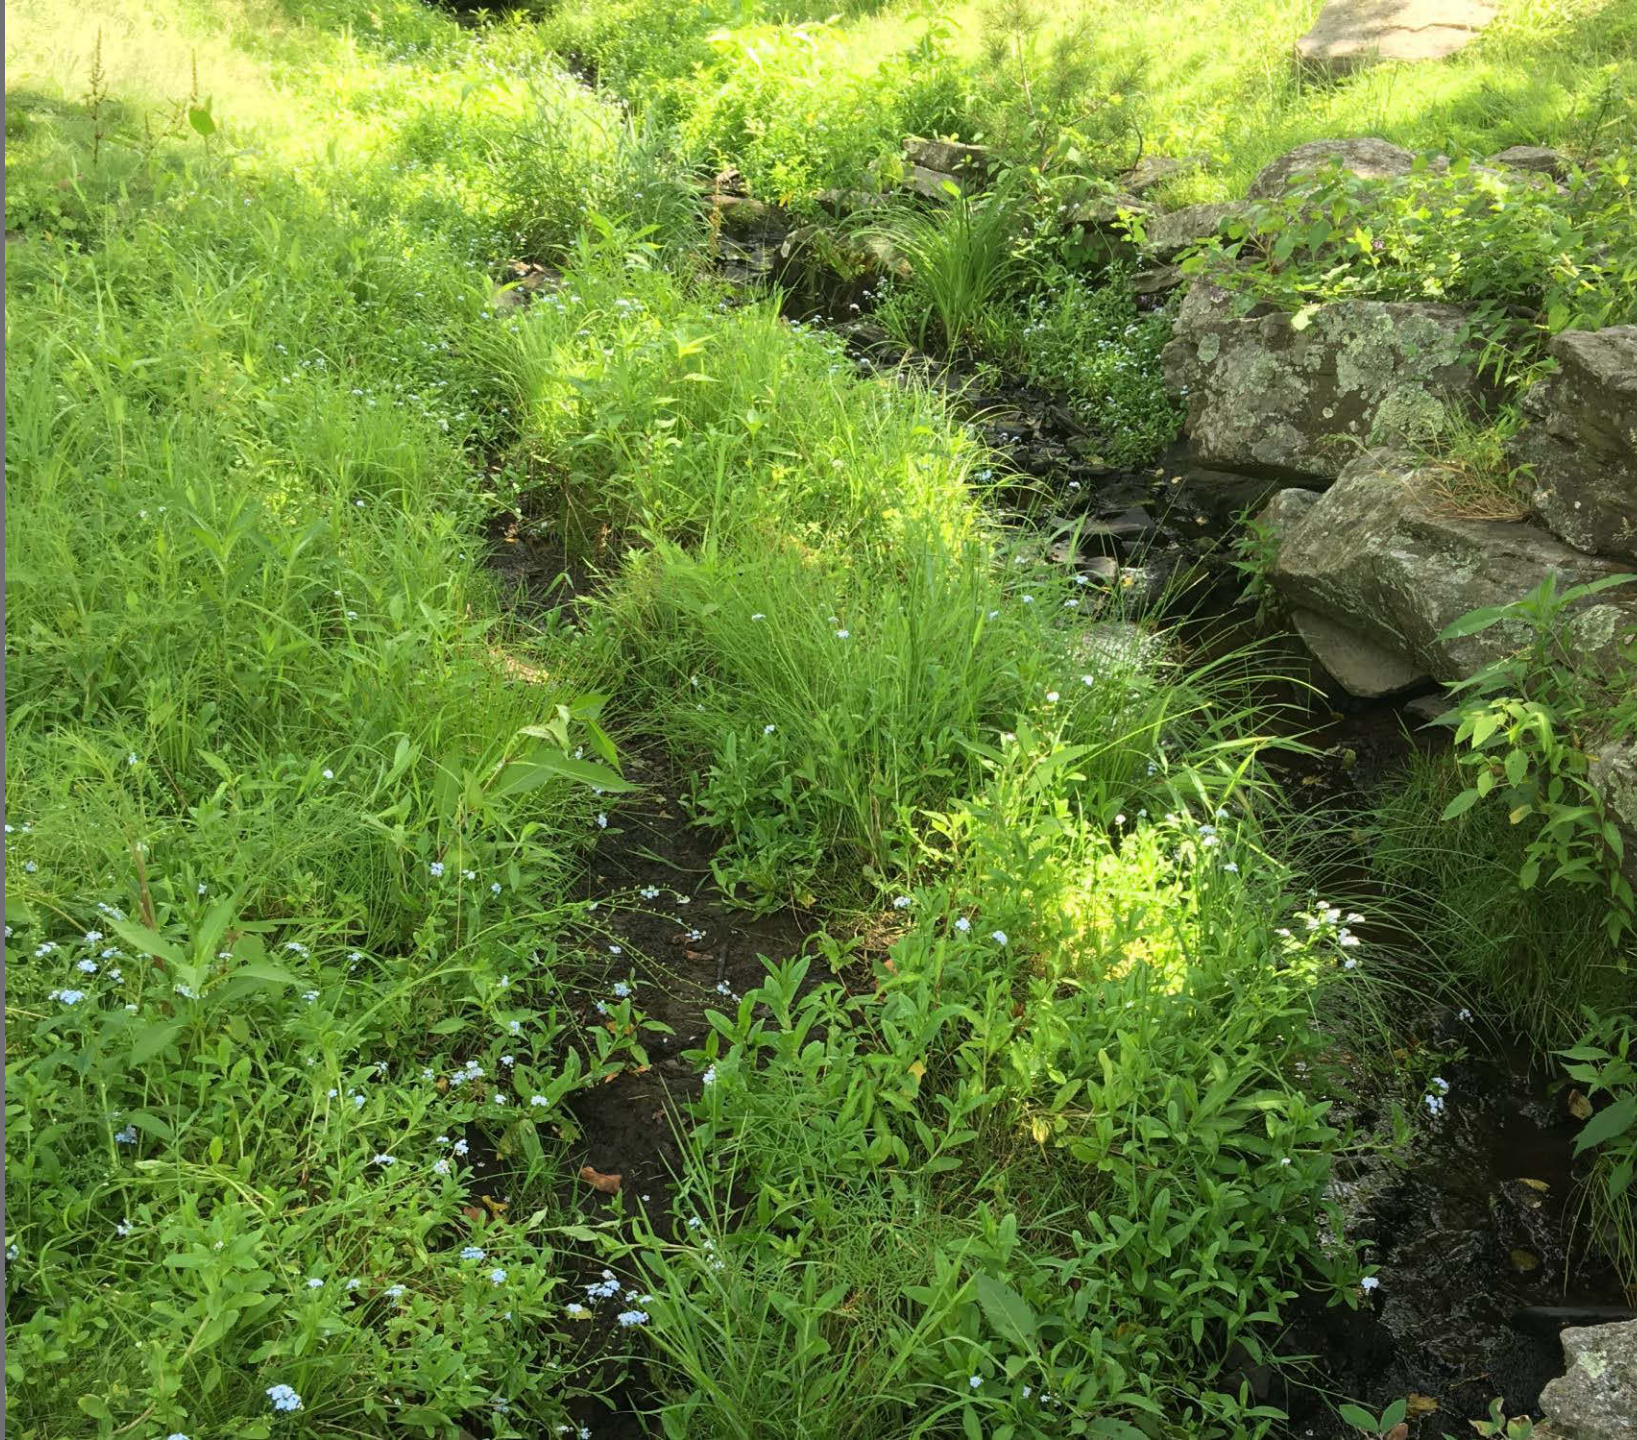
Figure 206. Outlet of another concrete section of pipe on an unnamed tributary that extends across Hole 4 and is piped once beneath the fairway on the Irem Golf Course with an excellent riparian area of native vegetation.

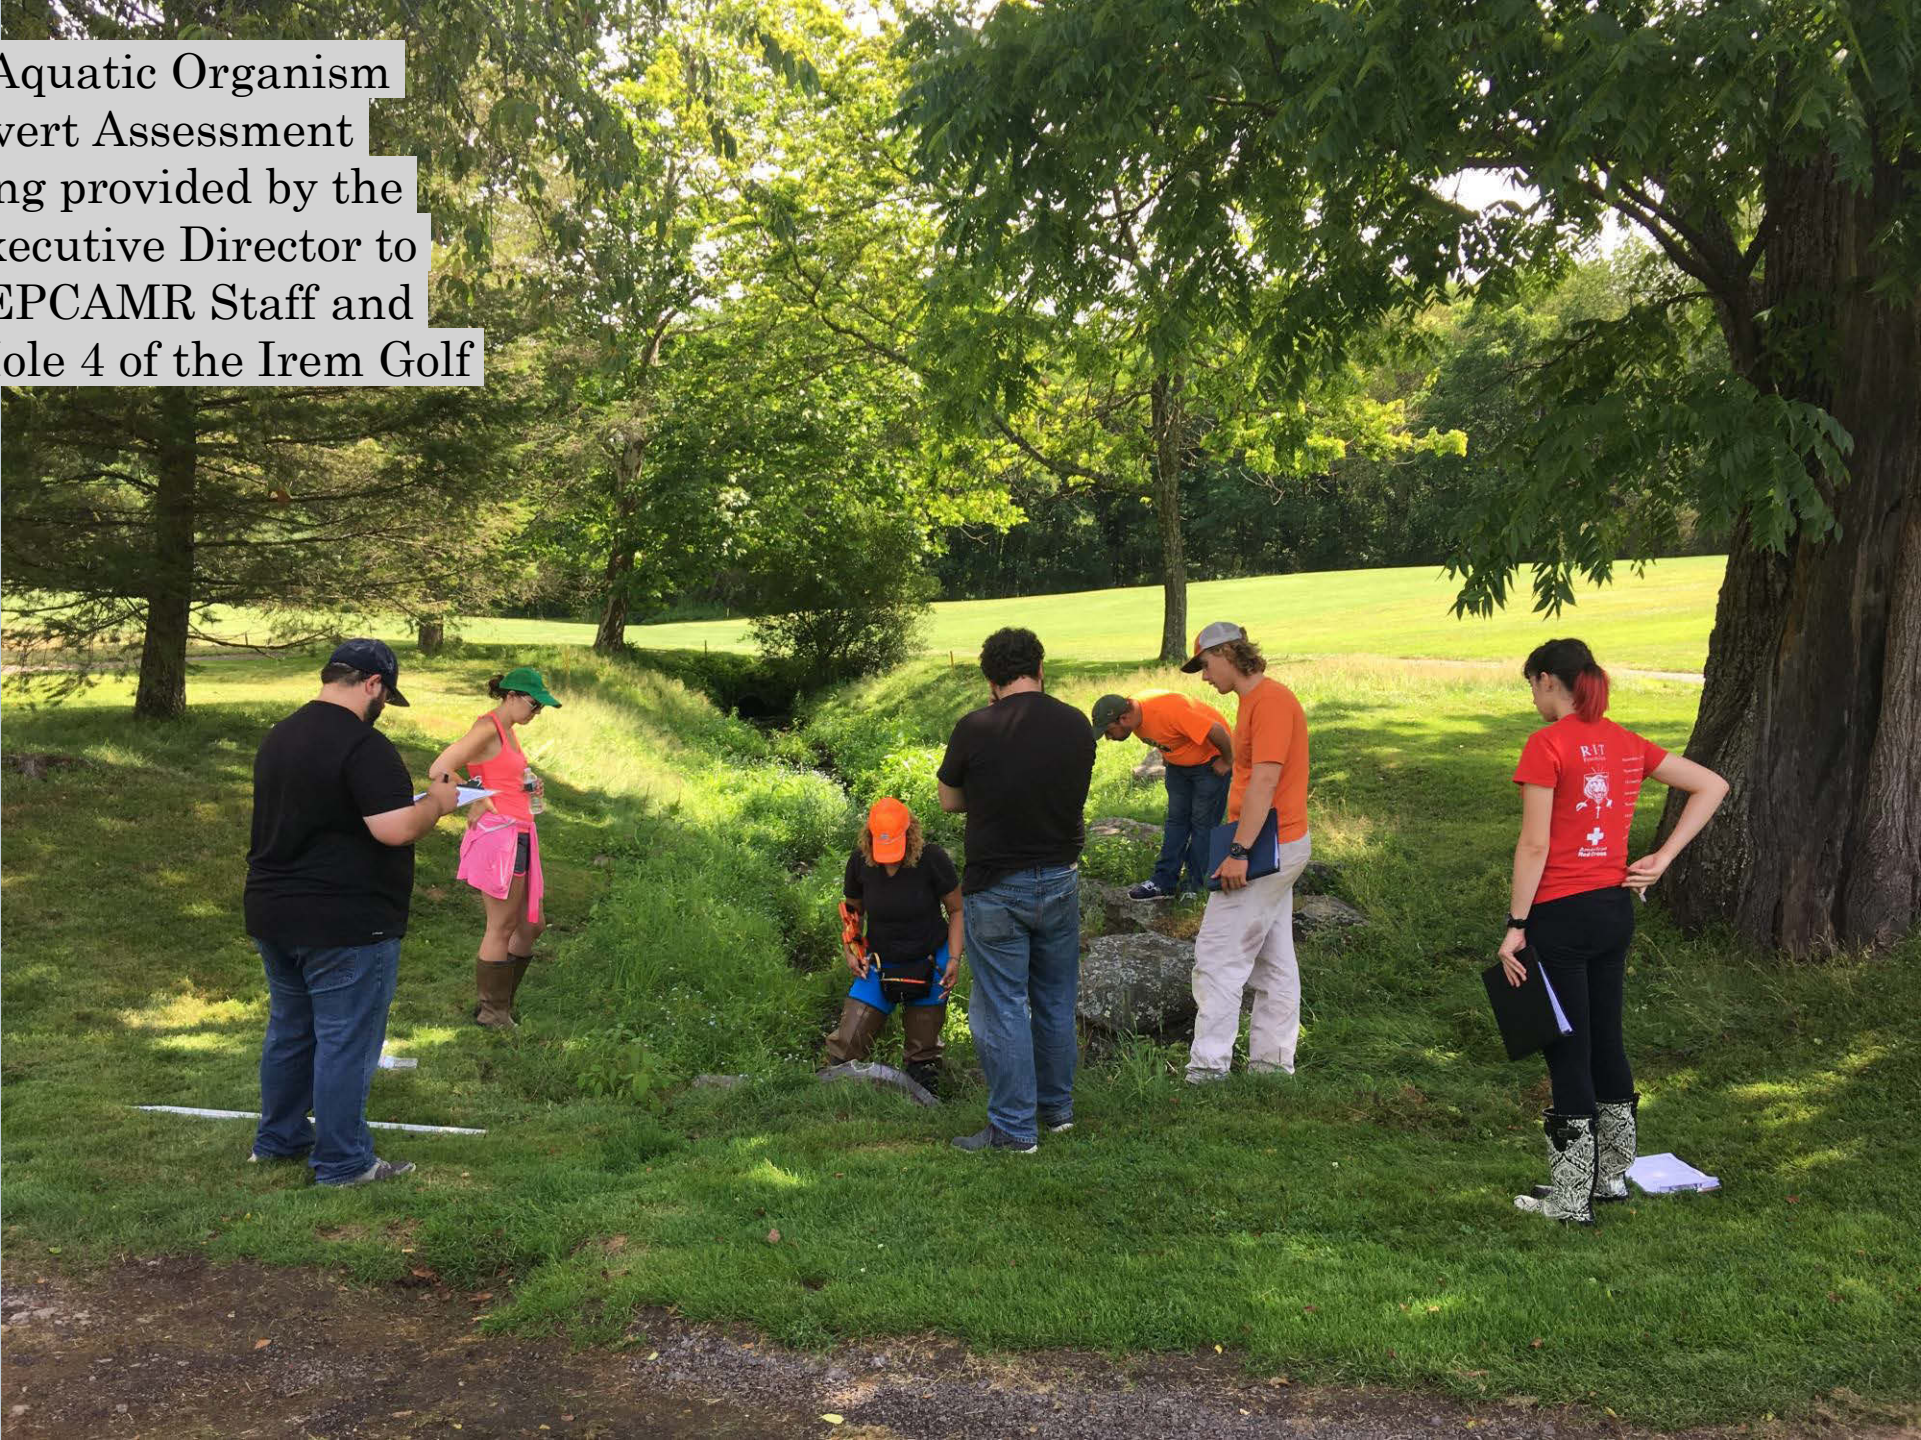
Figure 208. Outlet HDPE Pipe with an outlet drop freefall into the pond on Hole 4 of the Irem Golf Course.

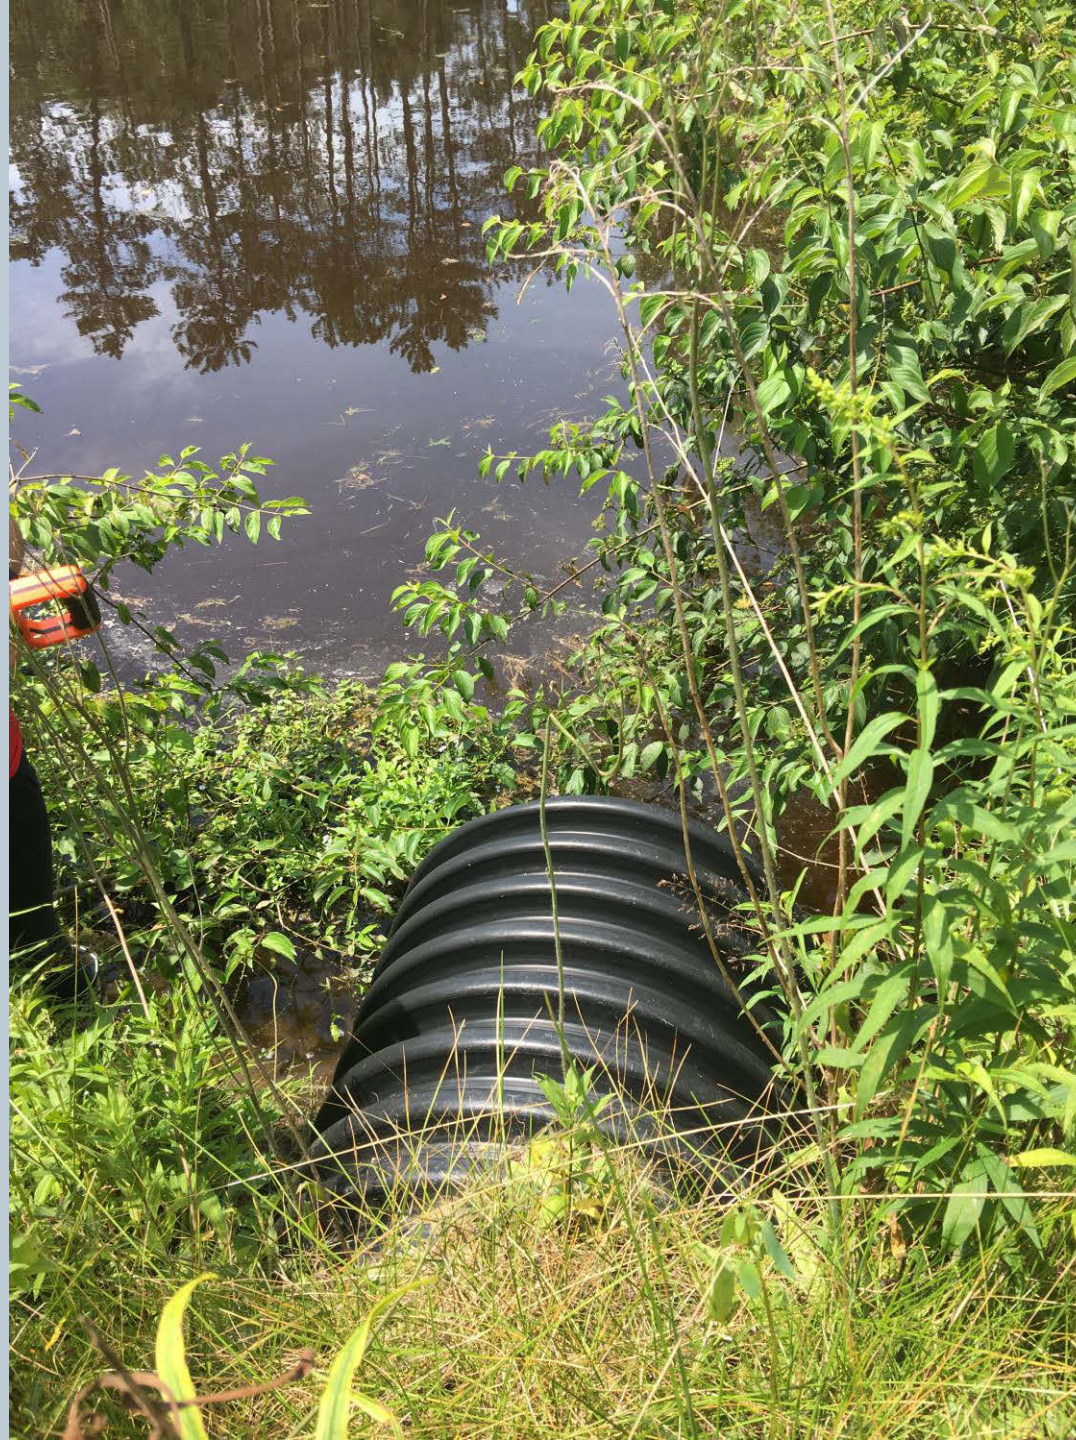
Figure 209. Outlet HDPE Pipe with an outlet drop freefall into the pond on Hole 4 of the Irem Golf Course.

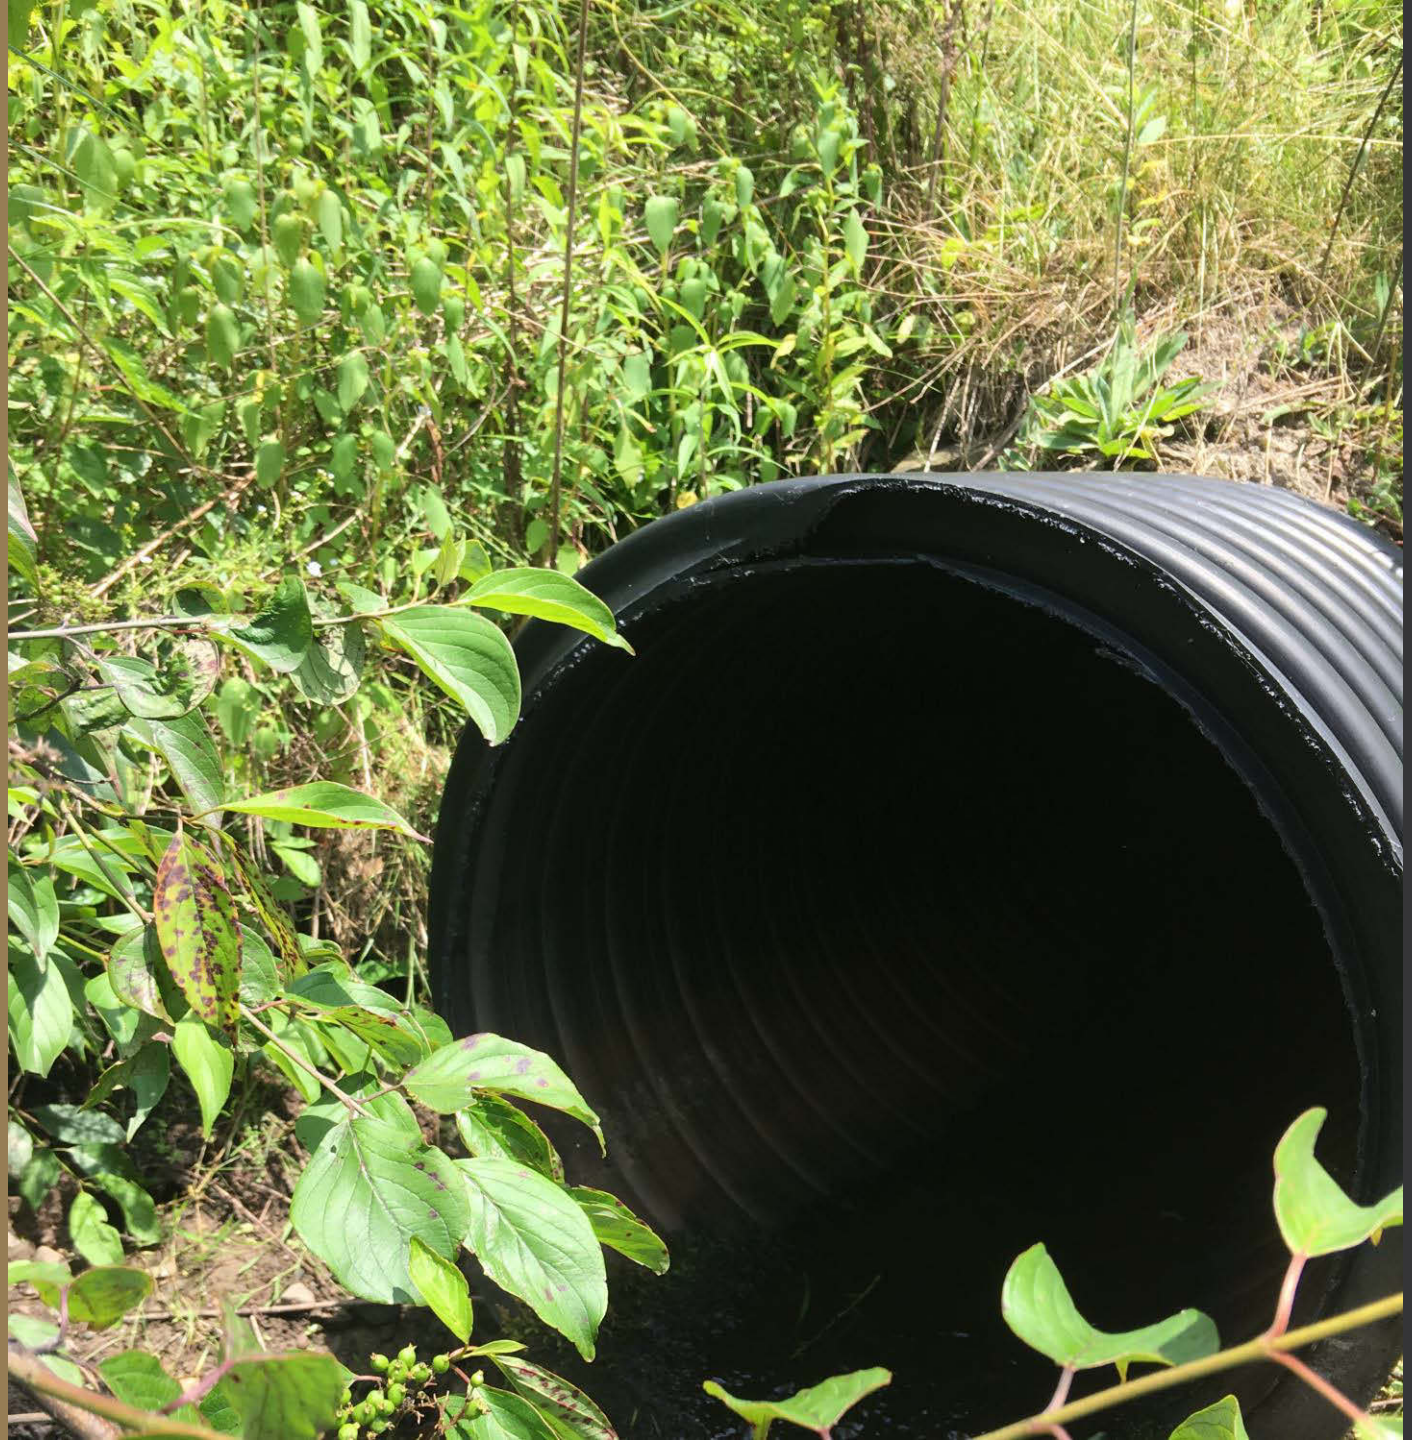
Figure 210. Outlet of corrugated metal pipe on Irem Road below Hole 3 where a rock wall is constructed on the upstream end of the pipe that is filled with woody debris.

Recommend removing woody debris and reason for why the headwall is constructed away from the culvert creating an inlet drop and scour area before the unnamed tributary enters the culvert.

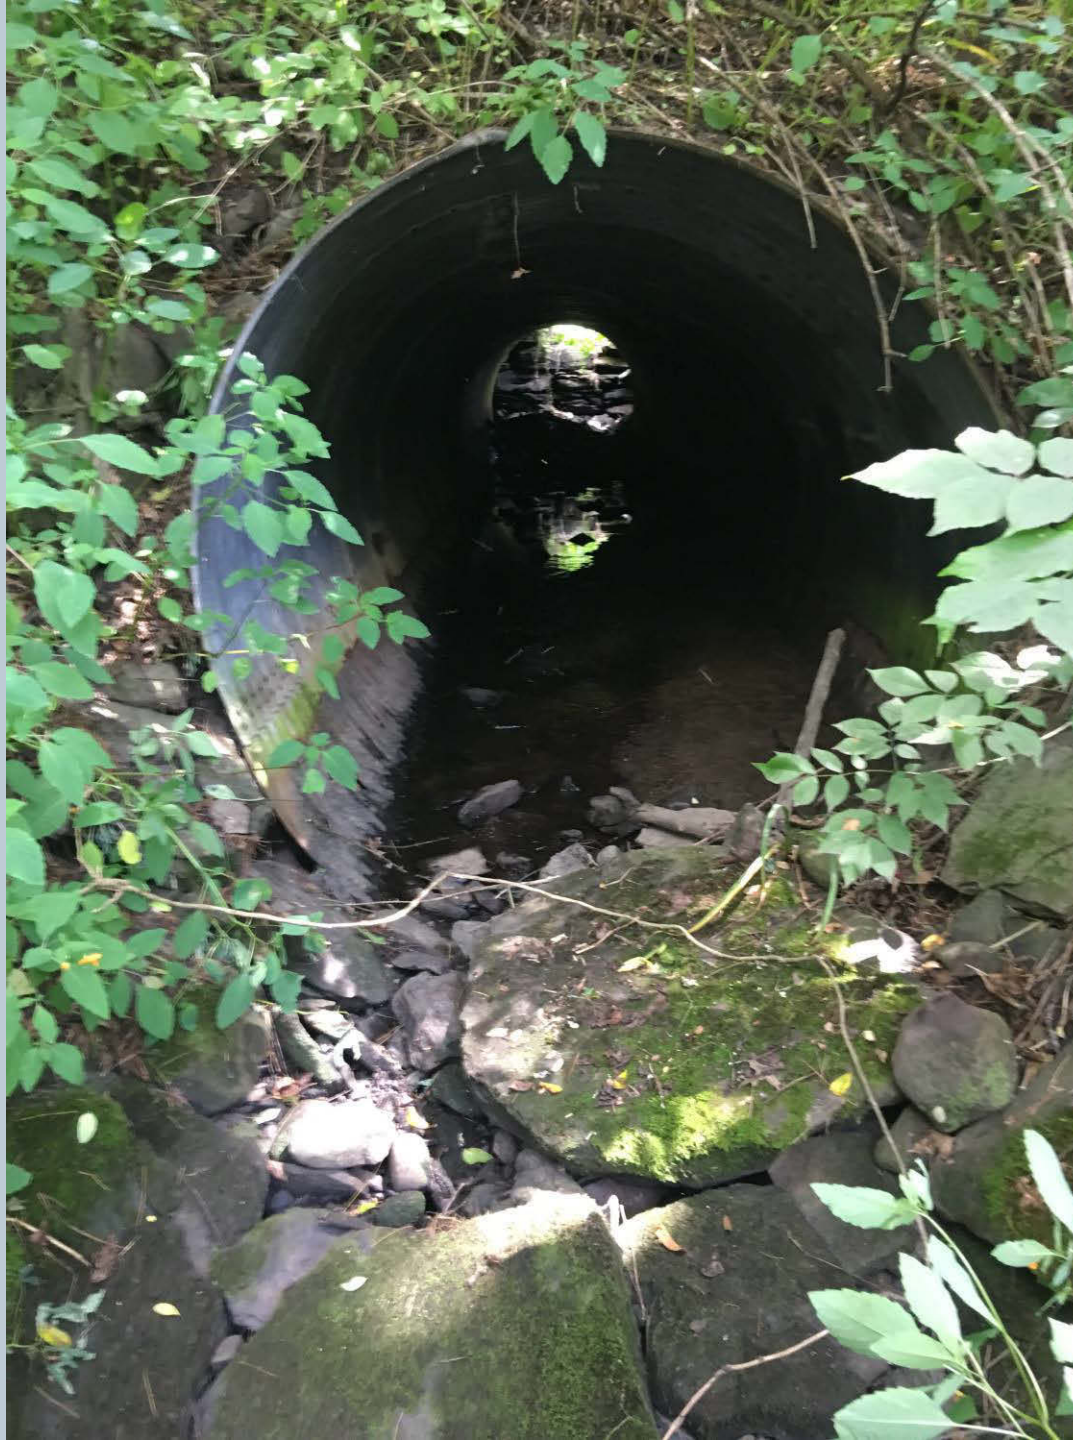
Figure 211.
An
unnamed
tributary to
Toby Creek
at an inlet
of
corrugated
metal pipe
on Glenn
Riddle Lane
with a
moderate
constriction.

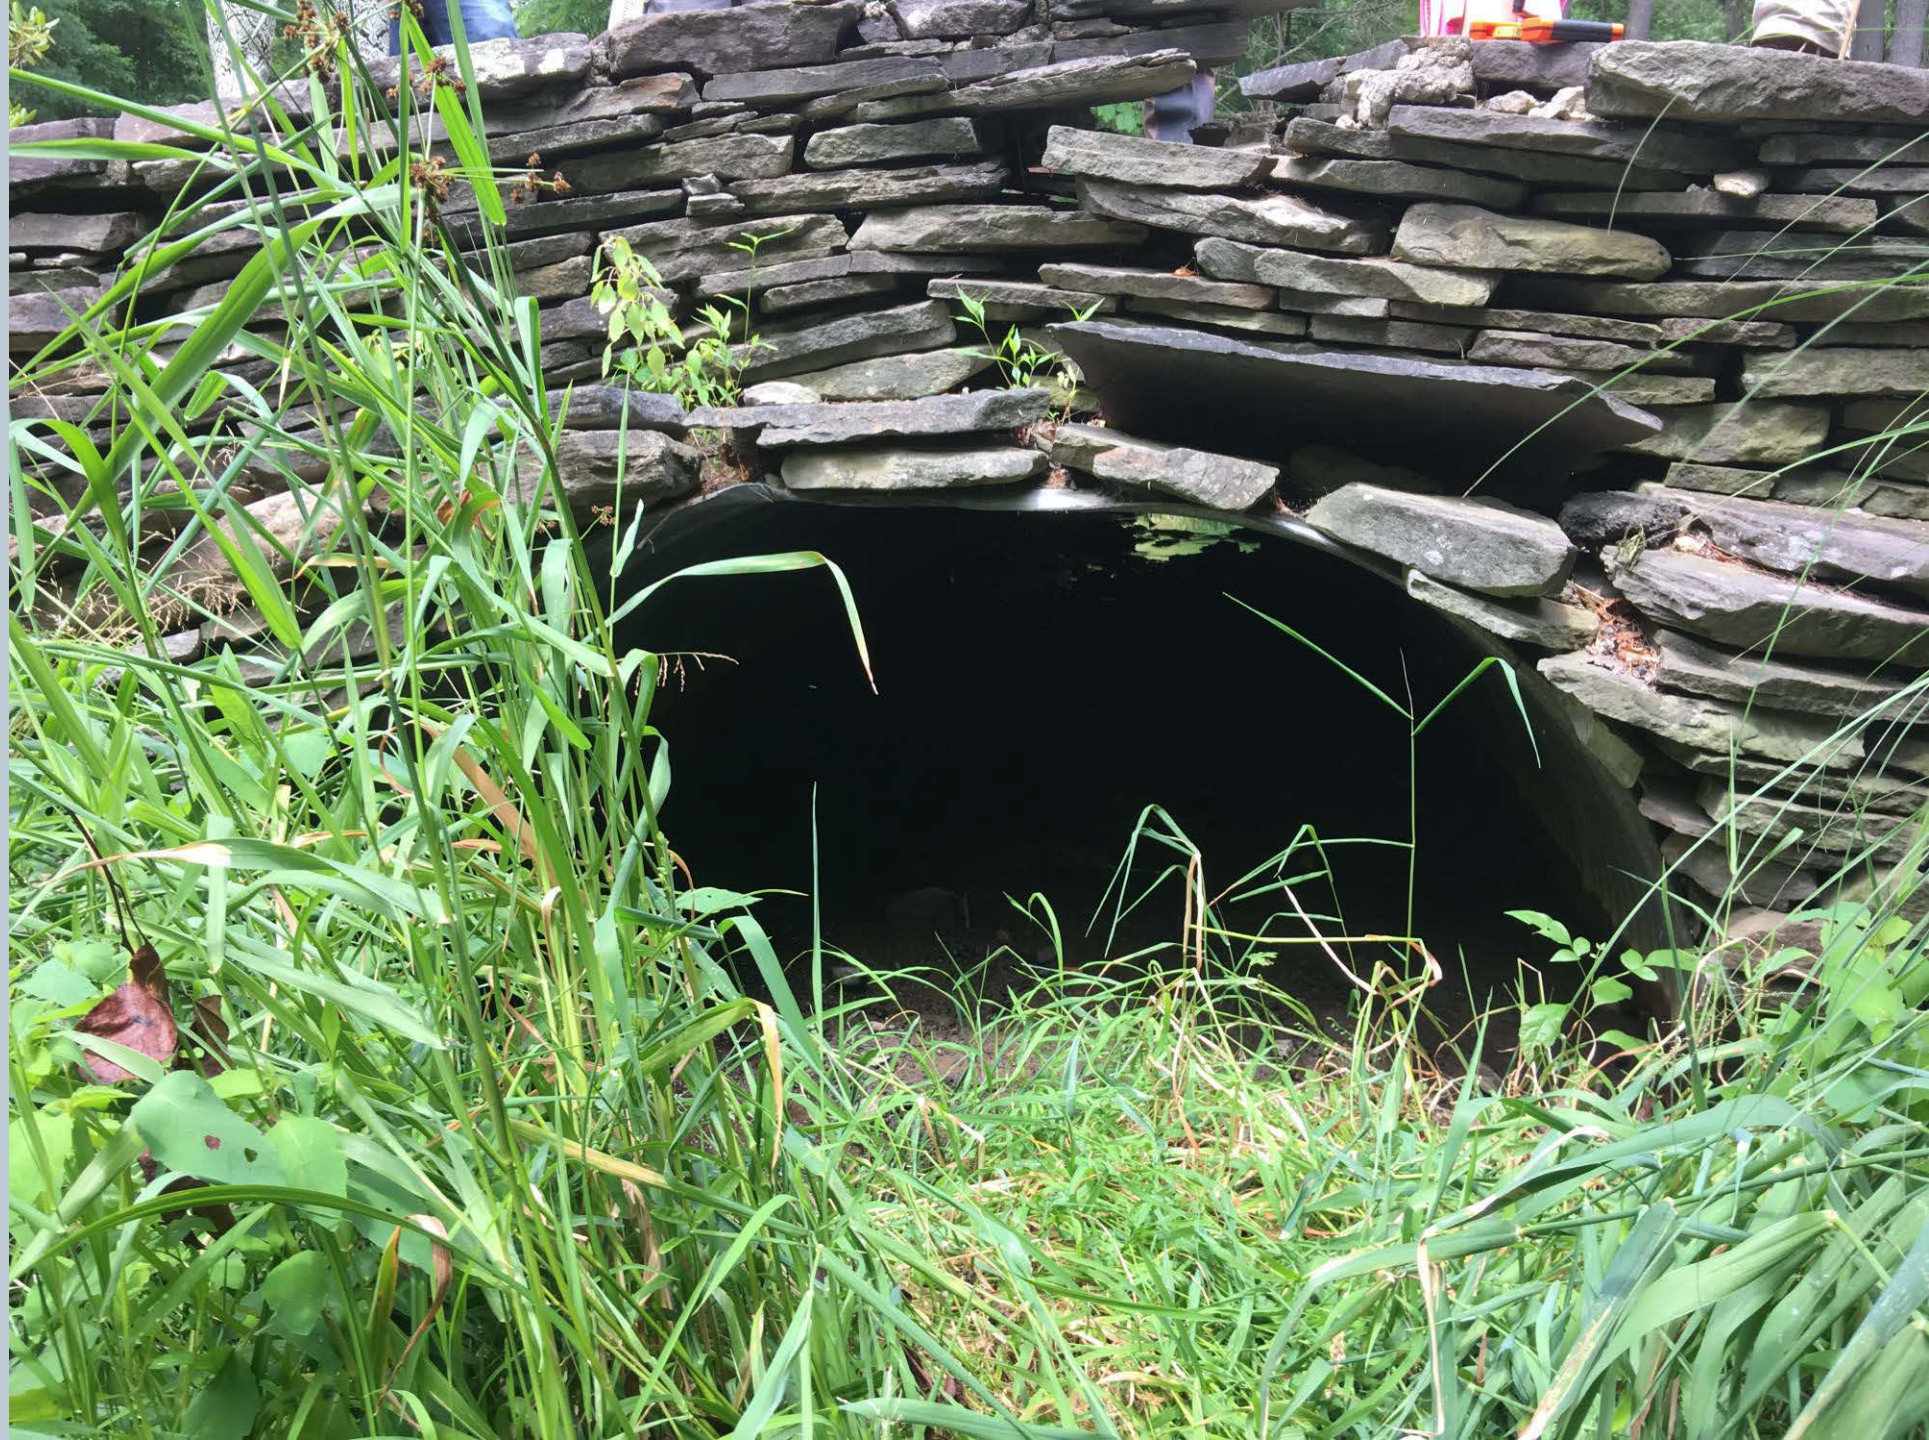
Figure 215. An unnamed tributary to Toby Creek looking downstream of the inlet corrugated metal pipe on Sunny Brook Lane. A riparian restoration projects is recommended here as opposed to placing rock in the entire stream channel.
