Toby Creek Field Reconnaissance Observations

September 26, 2018

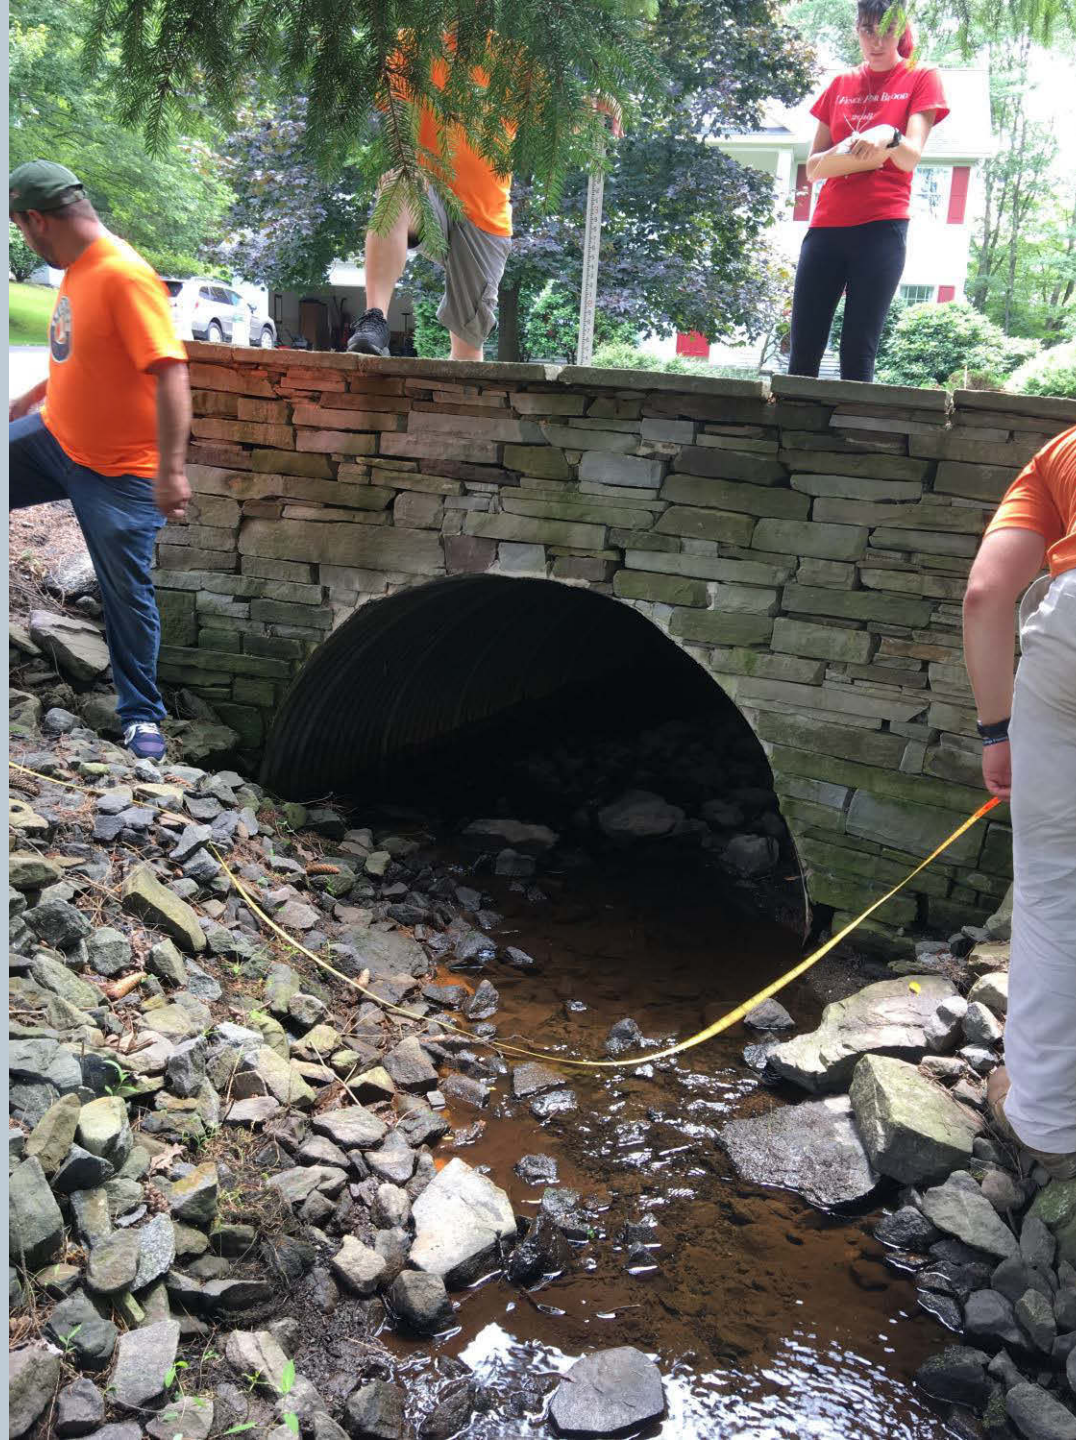
Figure 216. An unnamed tributary to Toby Creek looking upstream of the inlet corrugated metal pipe on Sunny Brook Lane. A riparian restoration projects is recommended here as opposed to placing rock in the entire stream channel that is being washed away periodically.

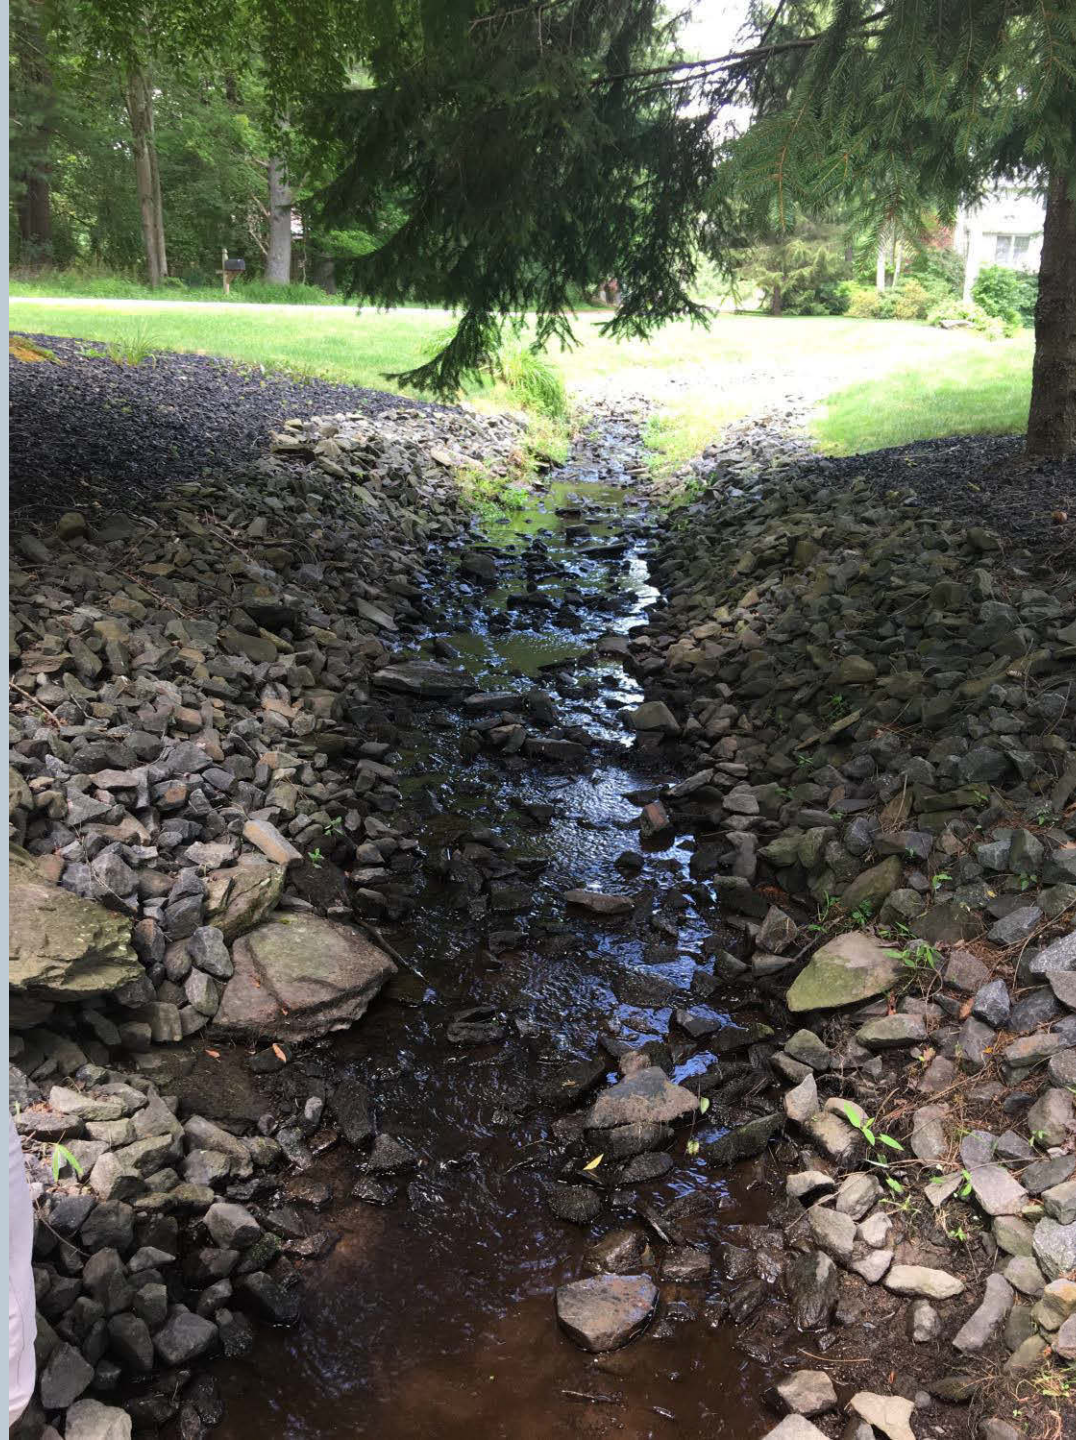
Figure 217. An unnamed tributary to Toby Creek looking upstream of the outlet corrugated metal pipe on Sunny Brook Lane. The pipe is full of sediment and is slightly rusted out.

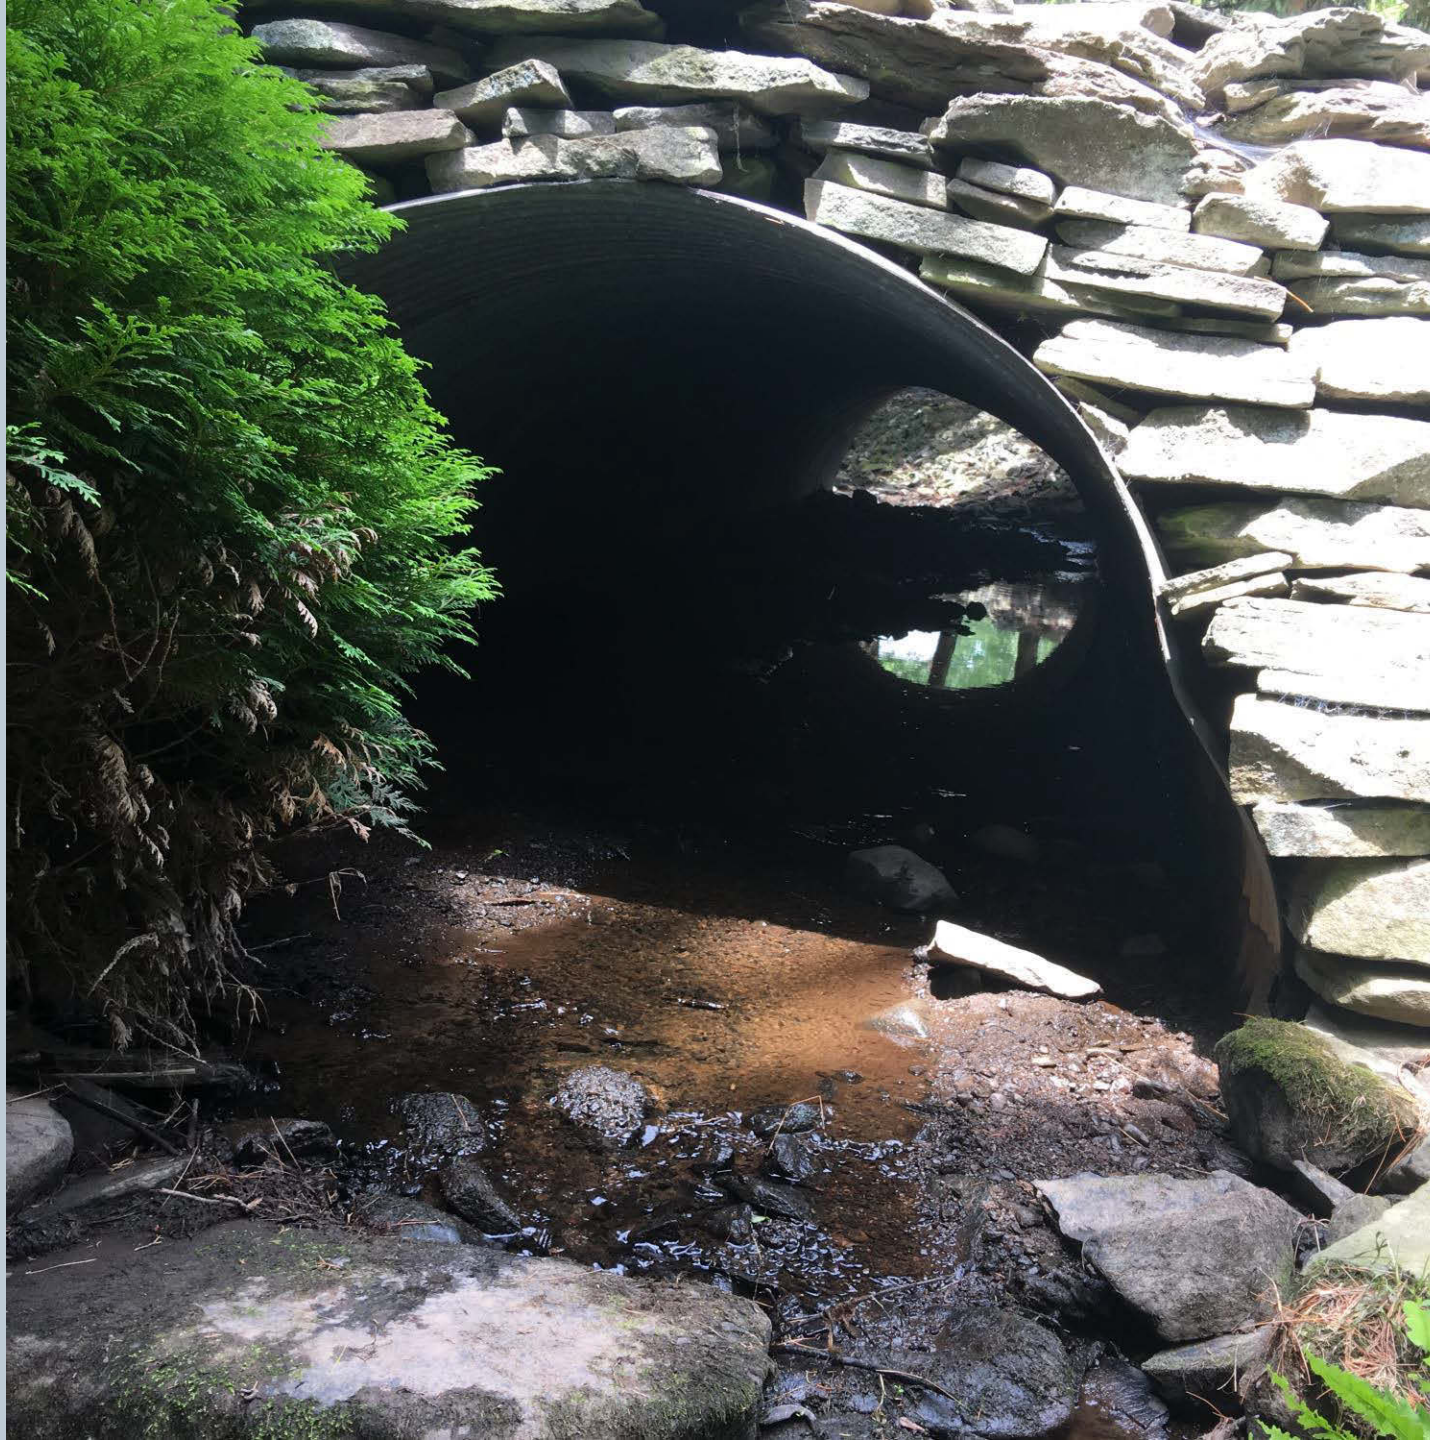
Figure 218. An unnamed tributary to Toby Creek looking downstream of the outlet corrugated metal pipe on Sunny Brook Lane. A riparian restoration projects is recommended here as opposed to placing rock in the entire stream channel that is being washed away periodically.

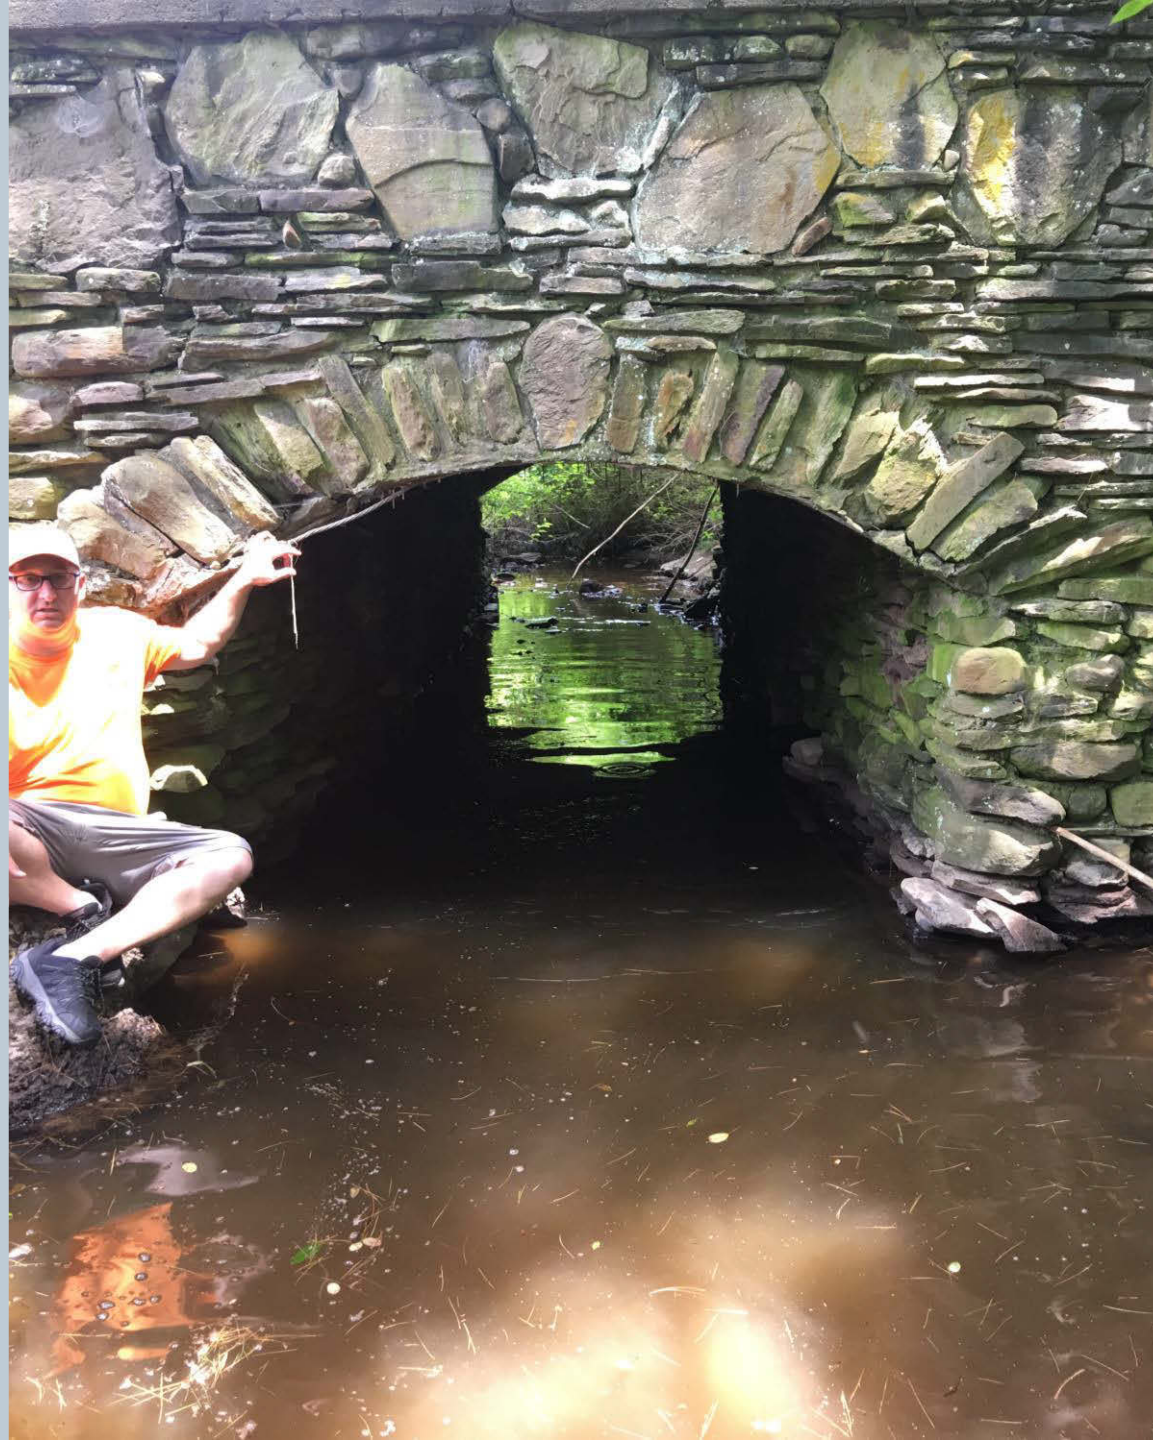
Figure 222. An unnamed tributary to Toby Creek looking downstream from the bridge on Midland Drive at the entrance to Fern Knoll Cemetery. Many fish were present at this location and it was one of the electroshocking sites for the fishery survey. Removal of a check dam and a riparian restoration project along the righthand streambank is recommended.

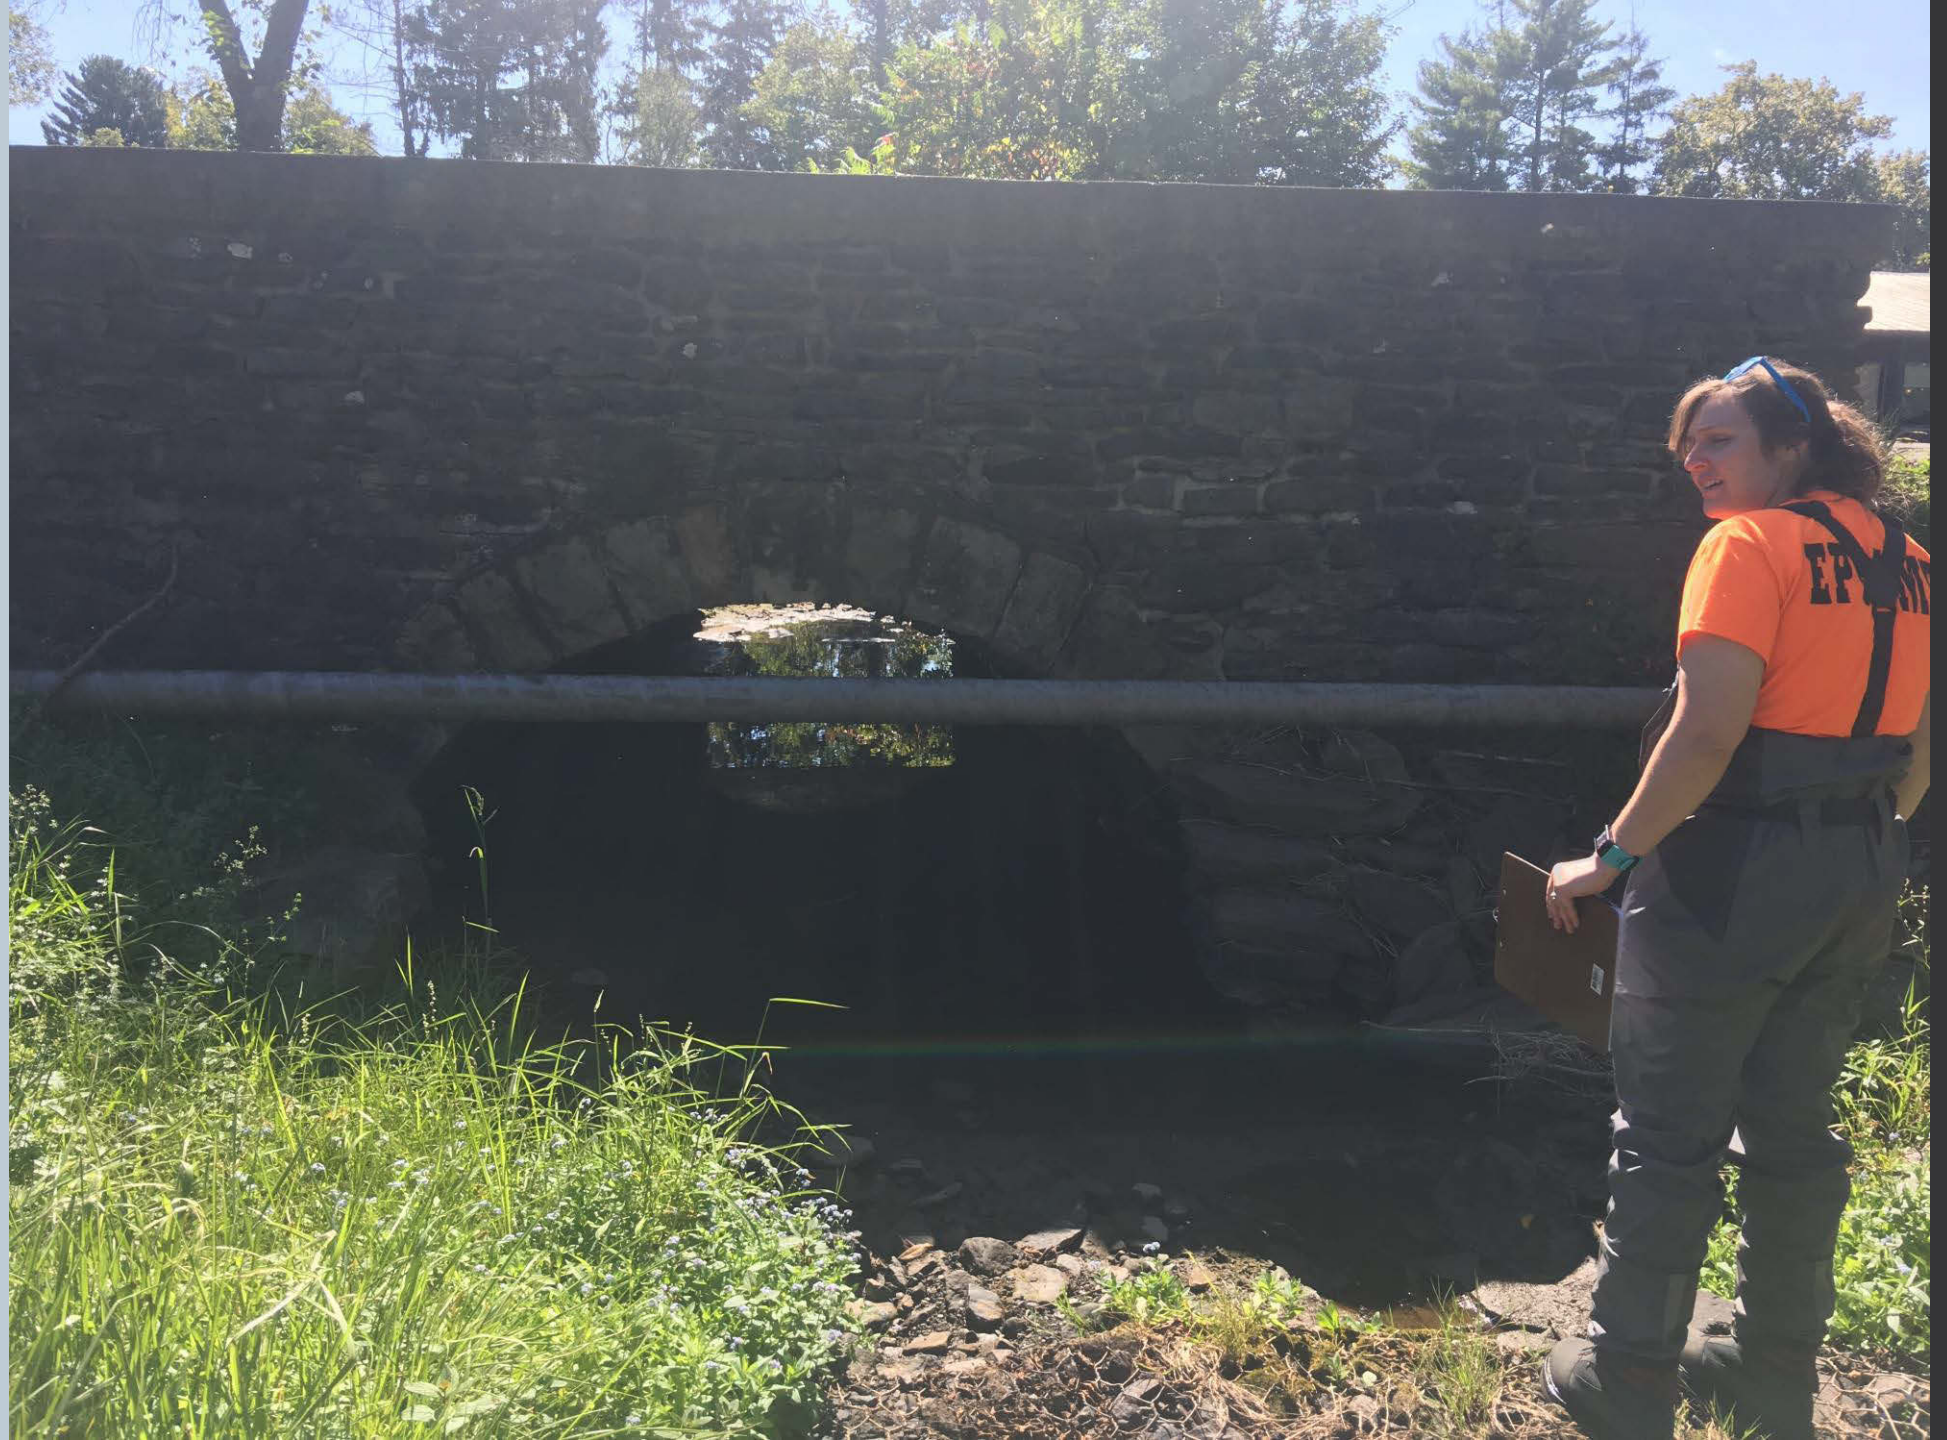
Figure 239.
Looking upstream
on an unnamed
tributary to Toby
Creek off that
flows through the
Meadows Nursing
Home property
with
DHL/EPCAMR
Volunteers and
DAMA
Stormwater
Coordinator along
Center Hill Road.

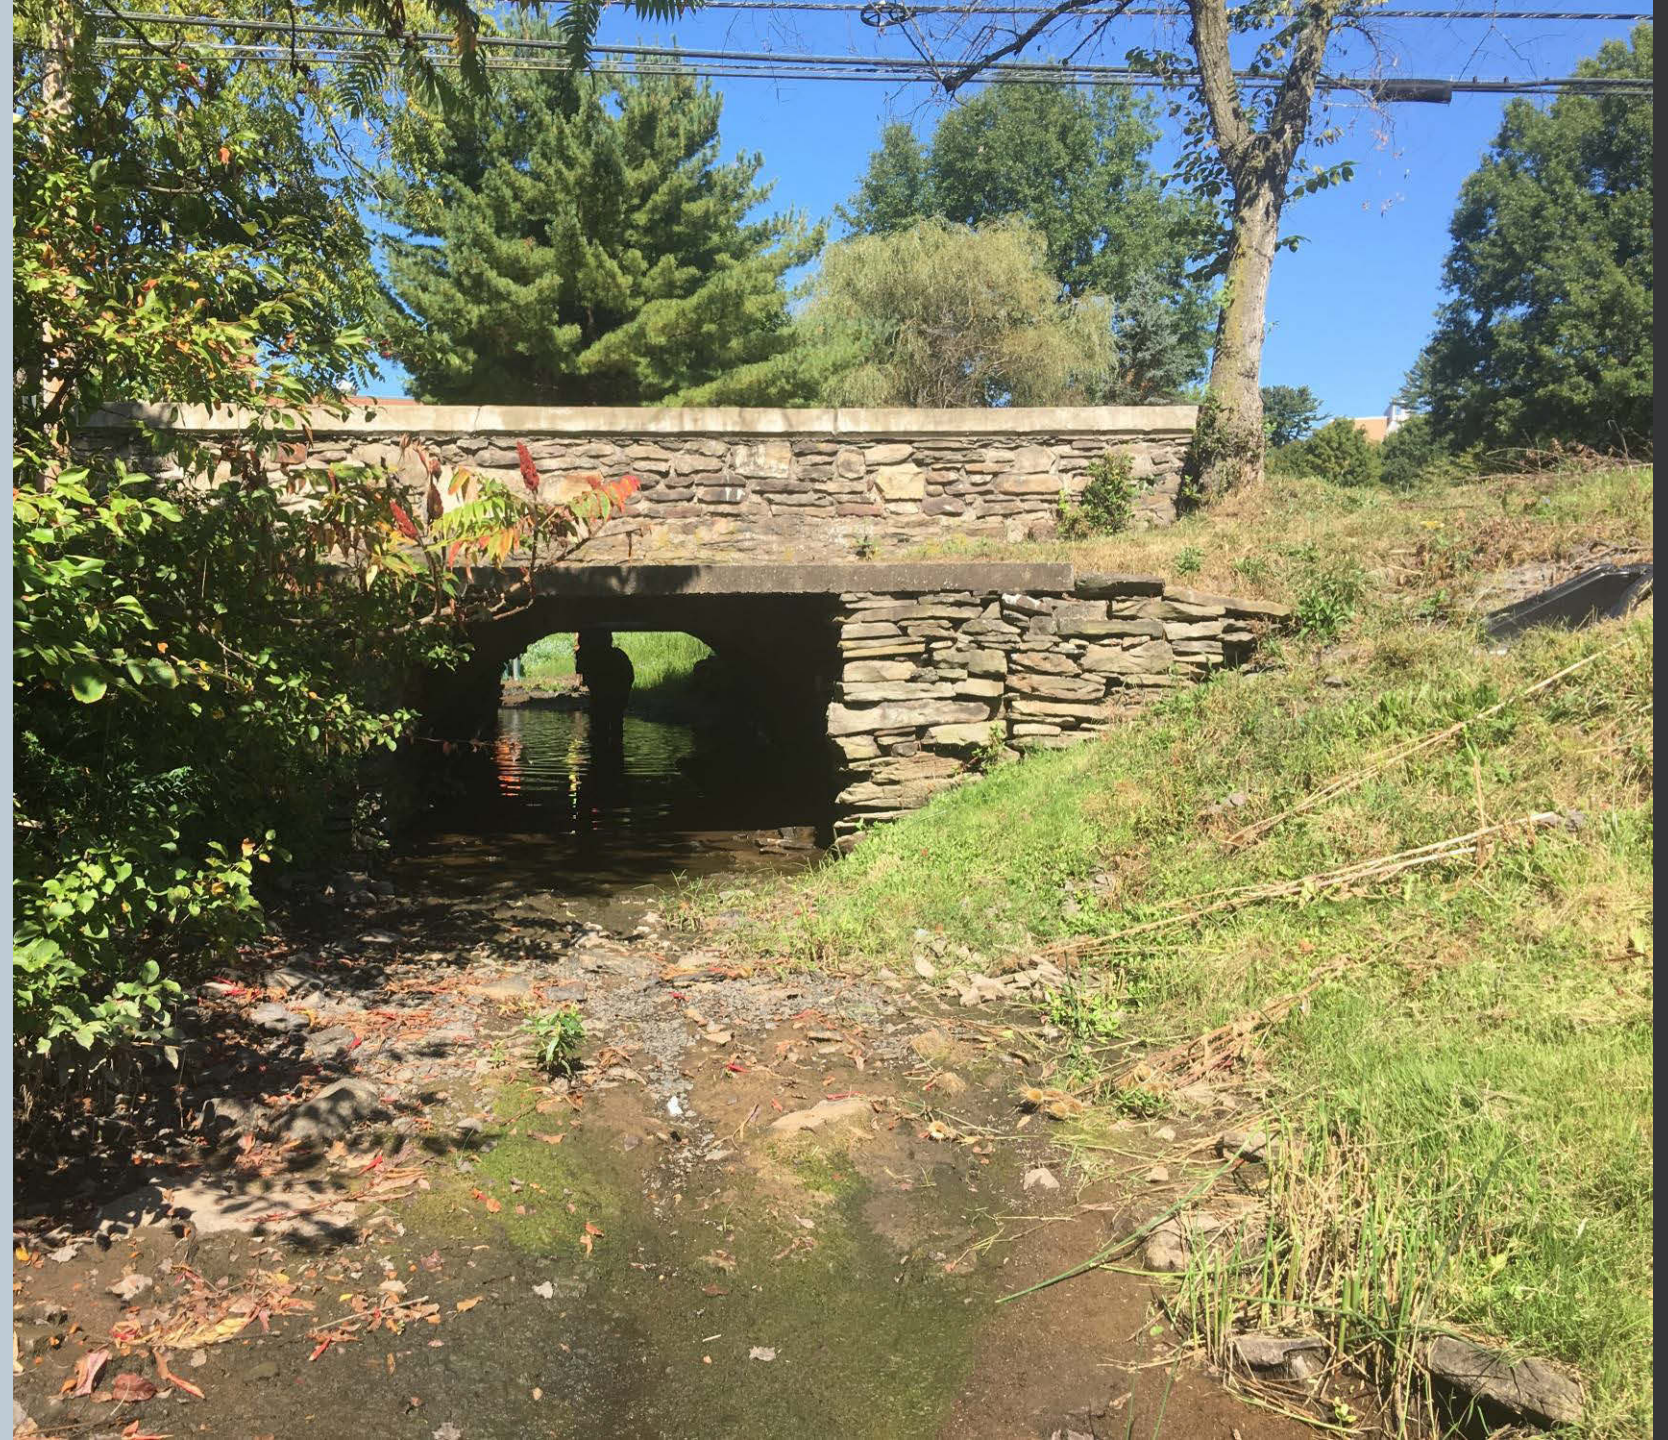
Figure 242. Looking upstream on Toby Creek that flows along the Dallas Memorial Highway and the newly constructed Lake Street Community Park. This was an electroshocking location. This section of the main stem is heavily silted from roadside stormwater runoff. A recommended streambank riparian planting should be considered on the upstream right-hand side streambank.

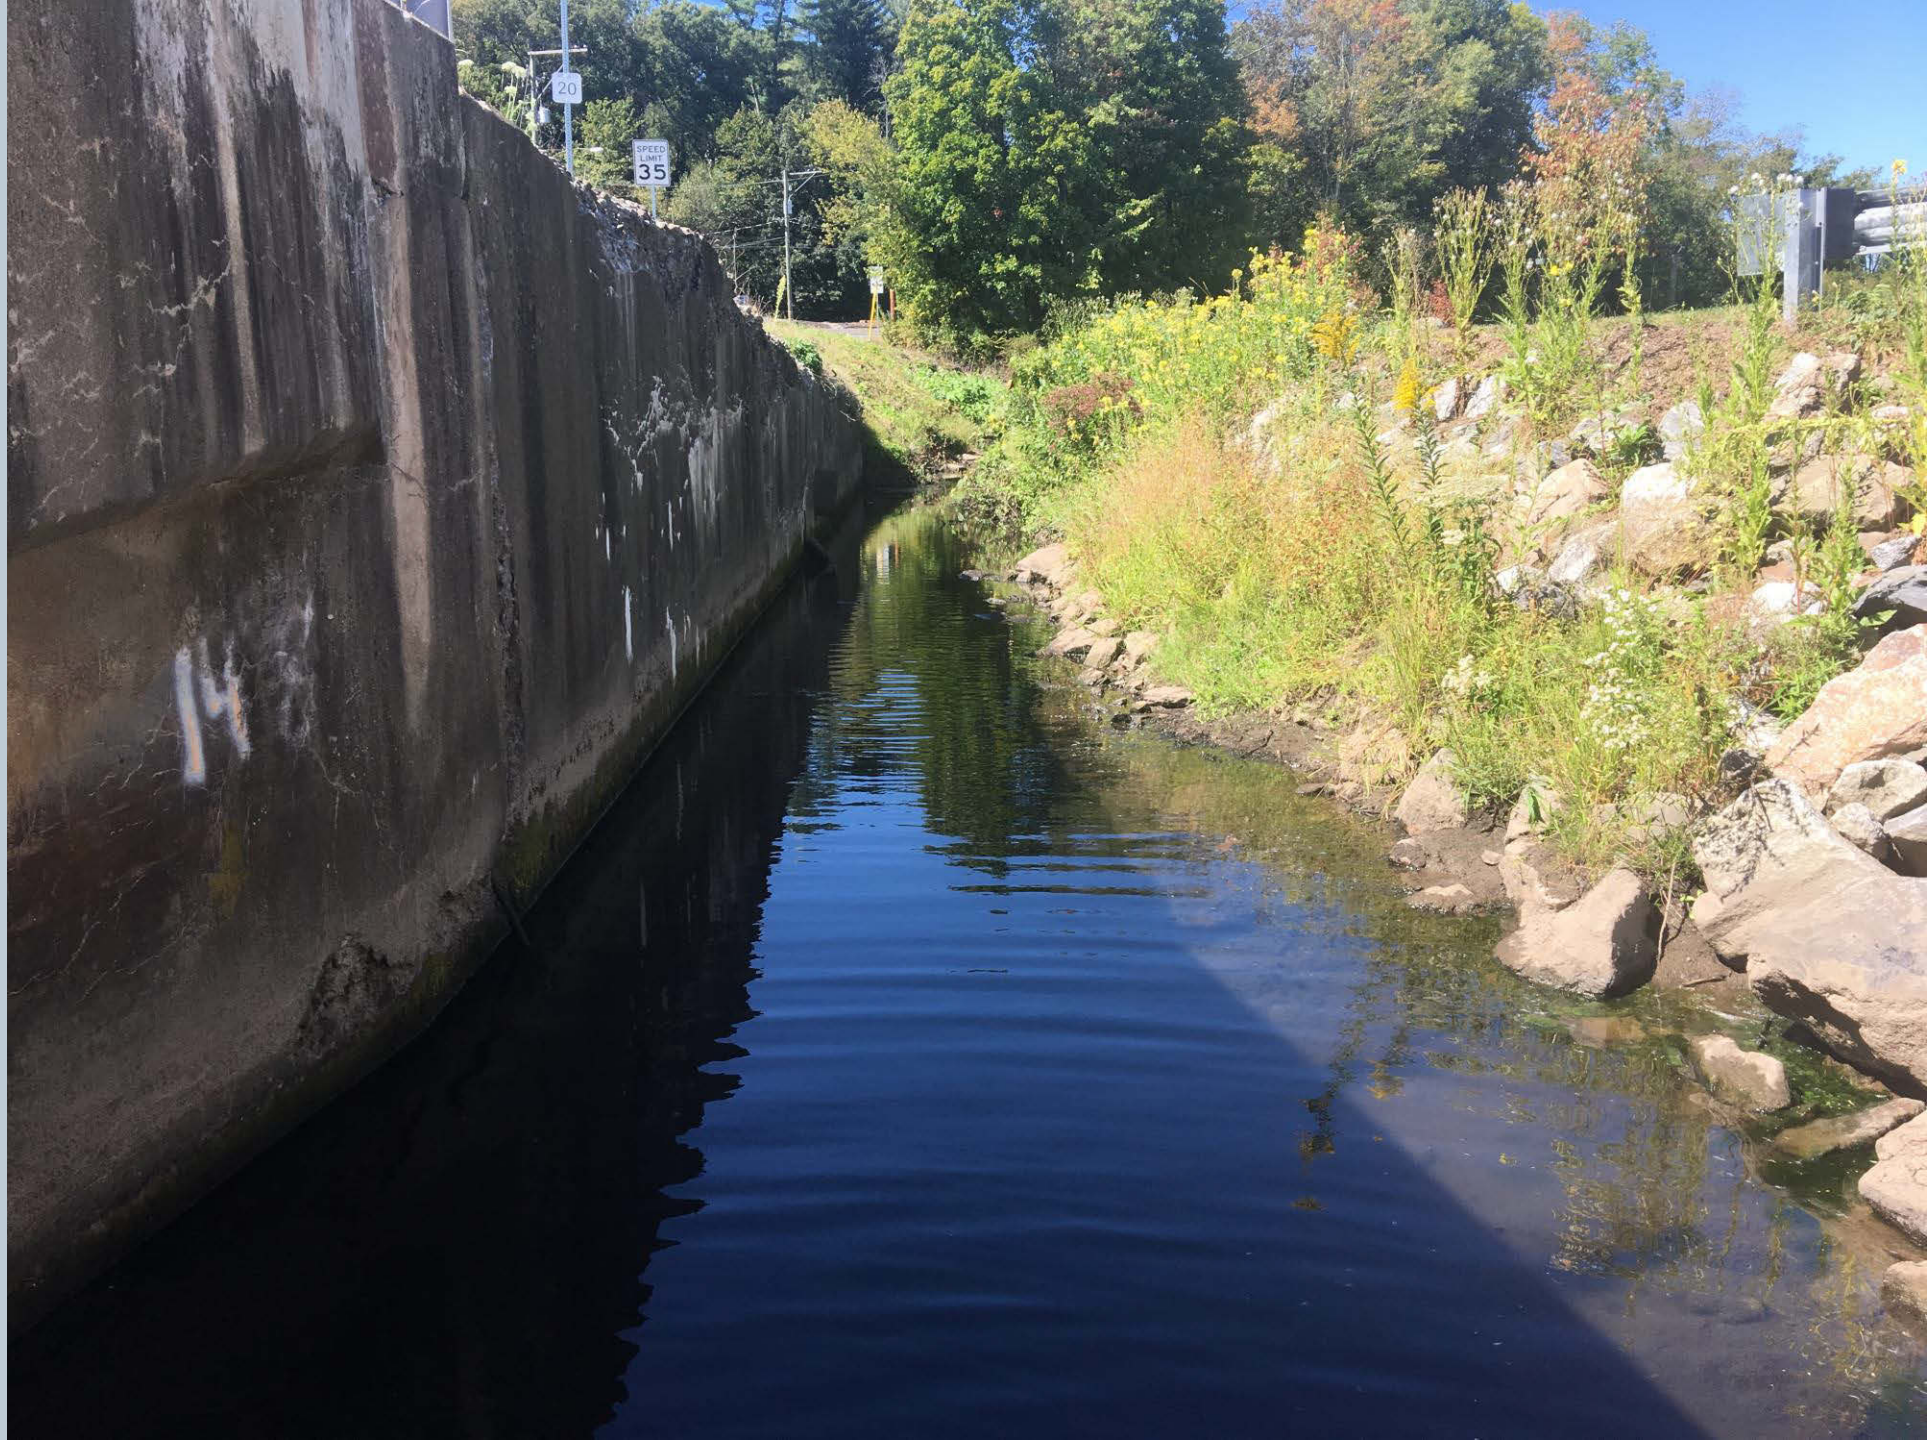
Figure 243. Looking downstream on Toby Creek that flows along the Dallas Memorial Highway towards the roundabout in Dallas. This section of the main stem is heavily silted from roadside stormwater runoff. Beneath the culvert the entire stretch of Toby Creek is full of sediment.

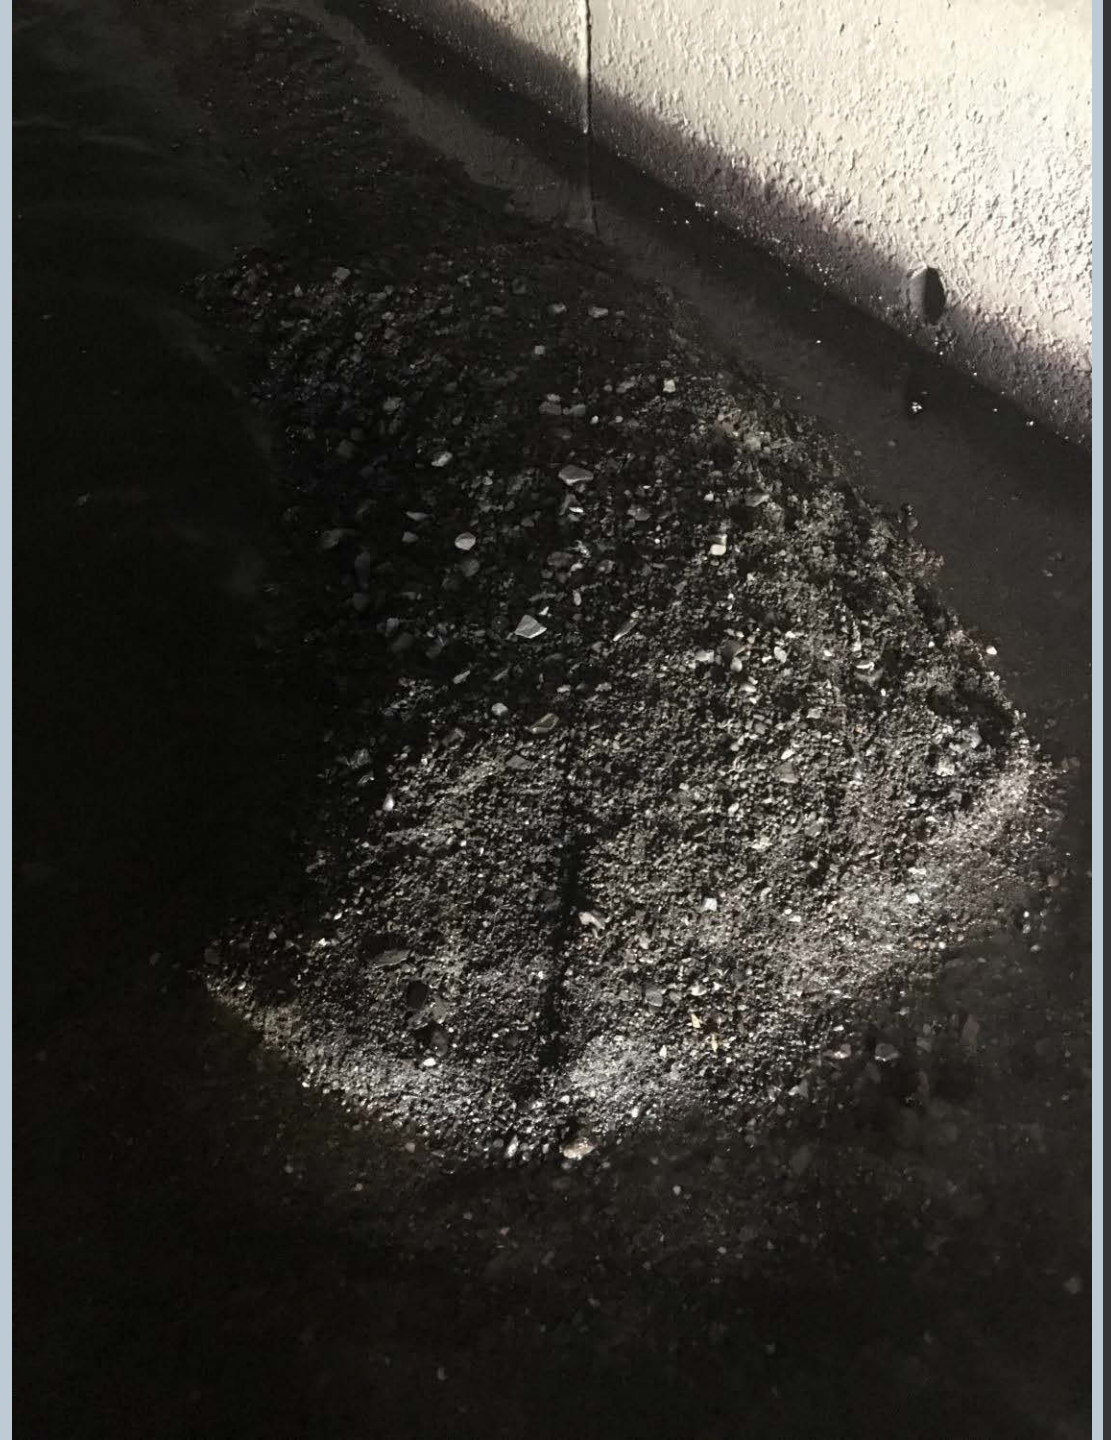
Figure 245. Culvert pipe draining to Toby Creek from somewhere above the roundabout in Dallas. This section of the main stem is heavily silted from roadside stormwater runoff. Beneath the culvert the entire stretch of Toby Creek is full of sediment. A DAMA Vac Truck is recommended to remove the sediment.

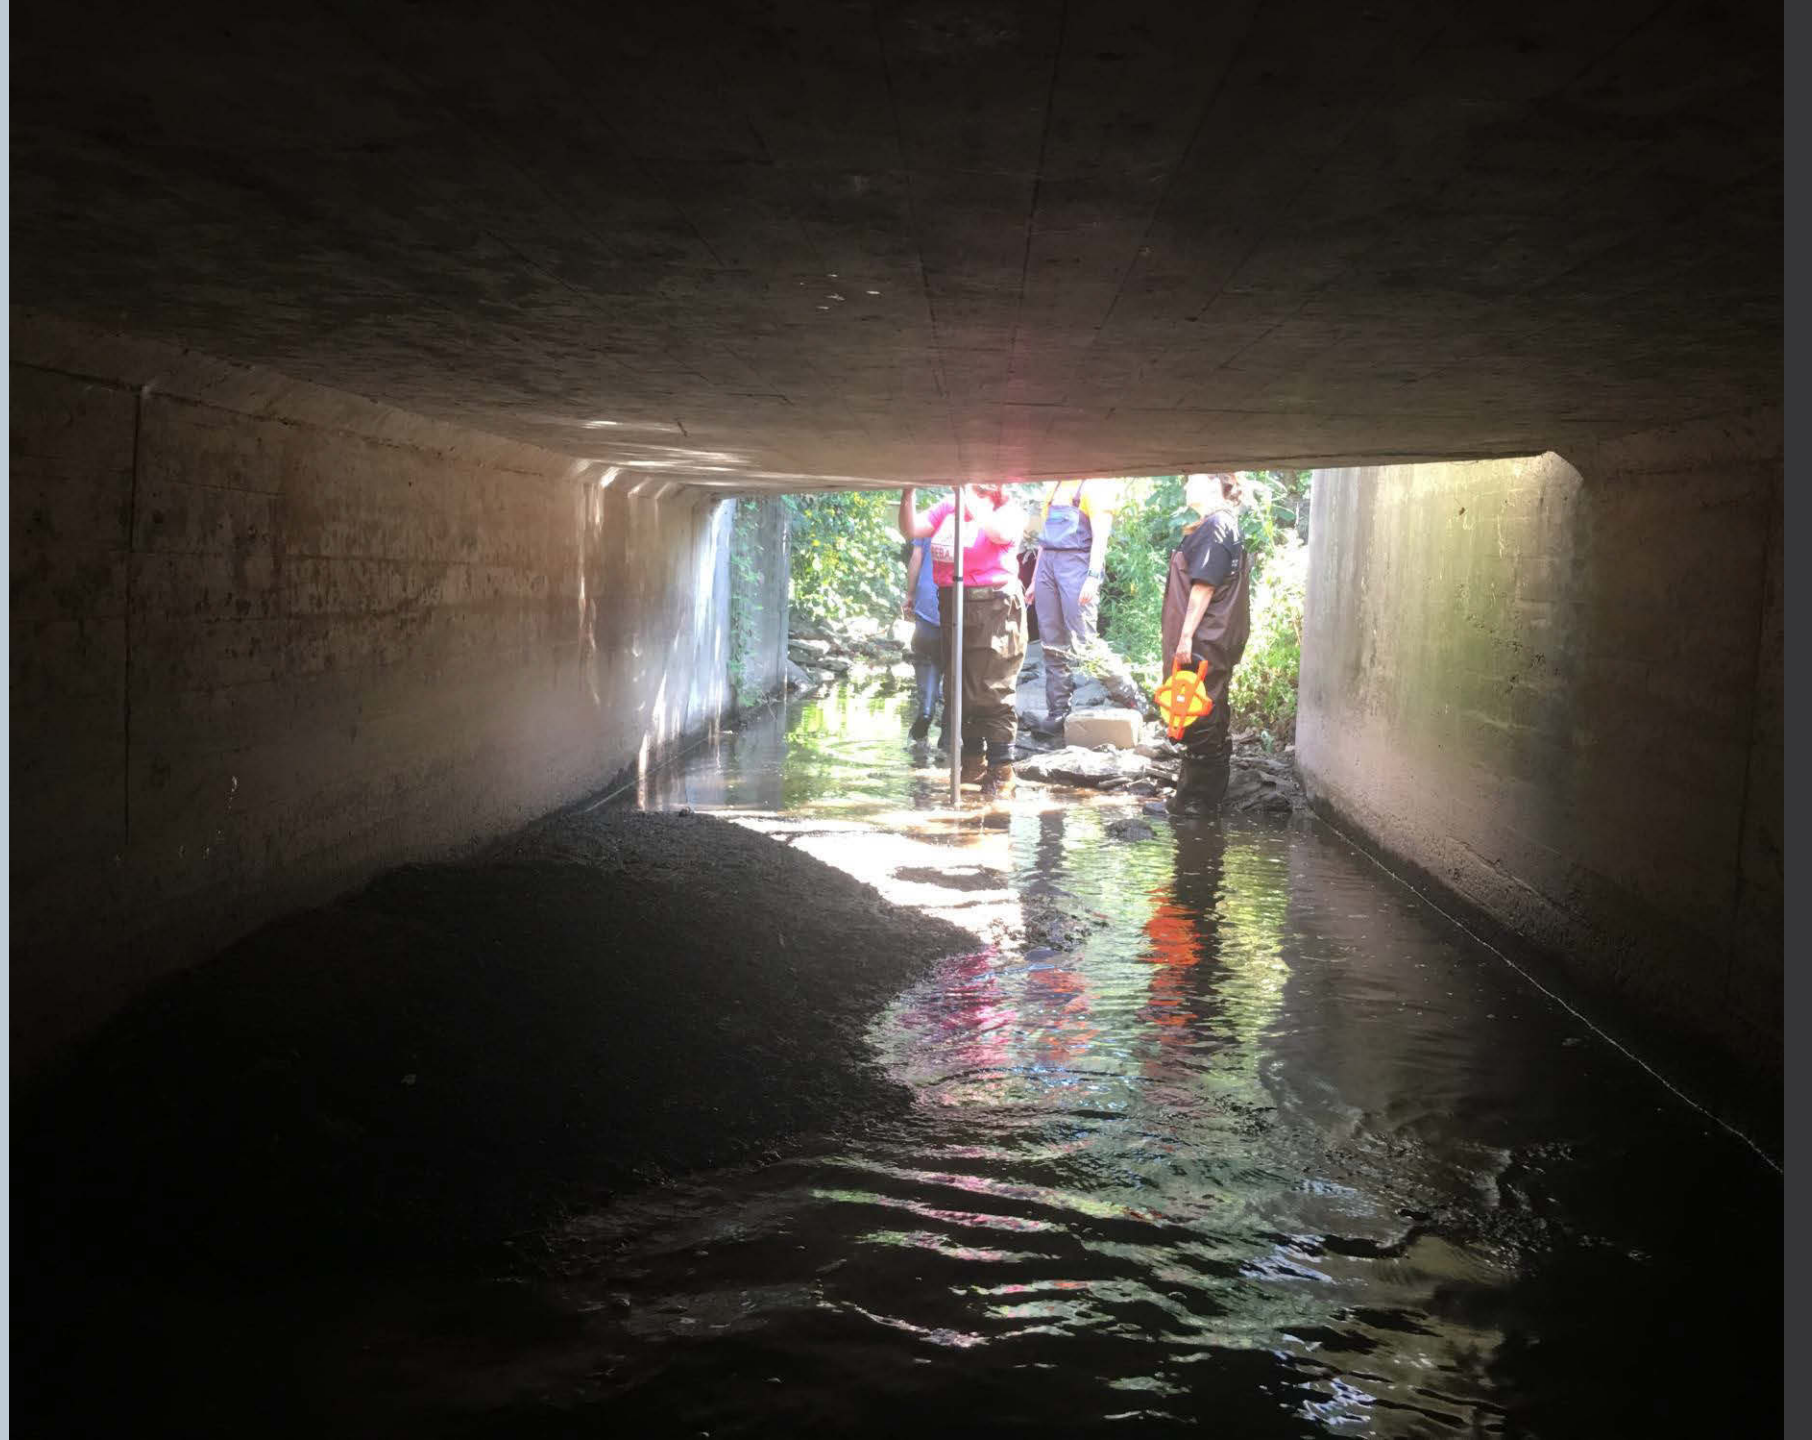
Figure 248. Open area before the next culvert that directs Toby Creek from beneath Main Street, under the commercial district, until it outlets along Verve Vertu in Dallas. This is an open section before going into another culvert under the commercial district in Dallas.

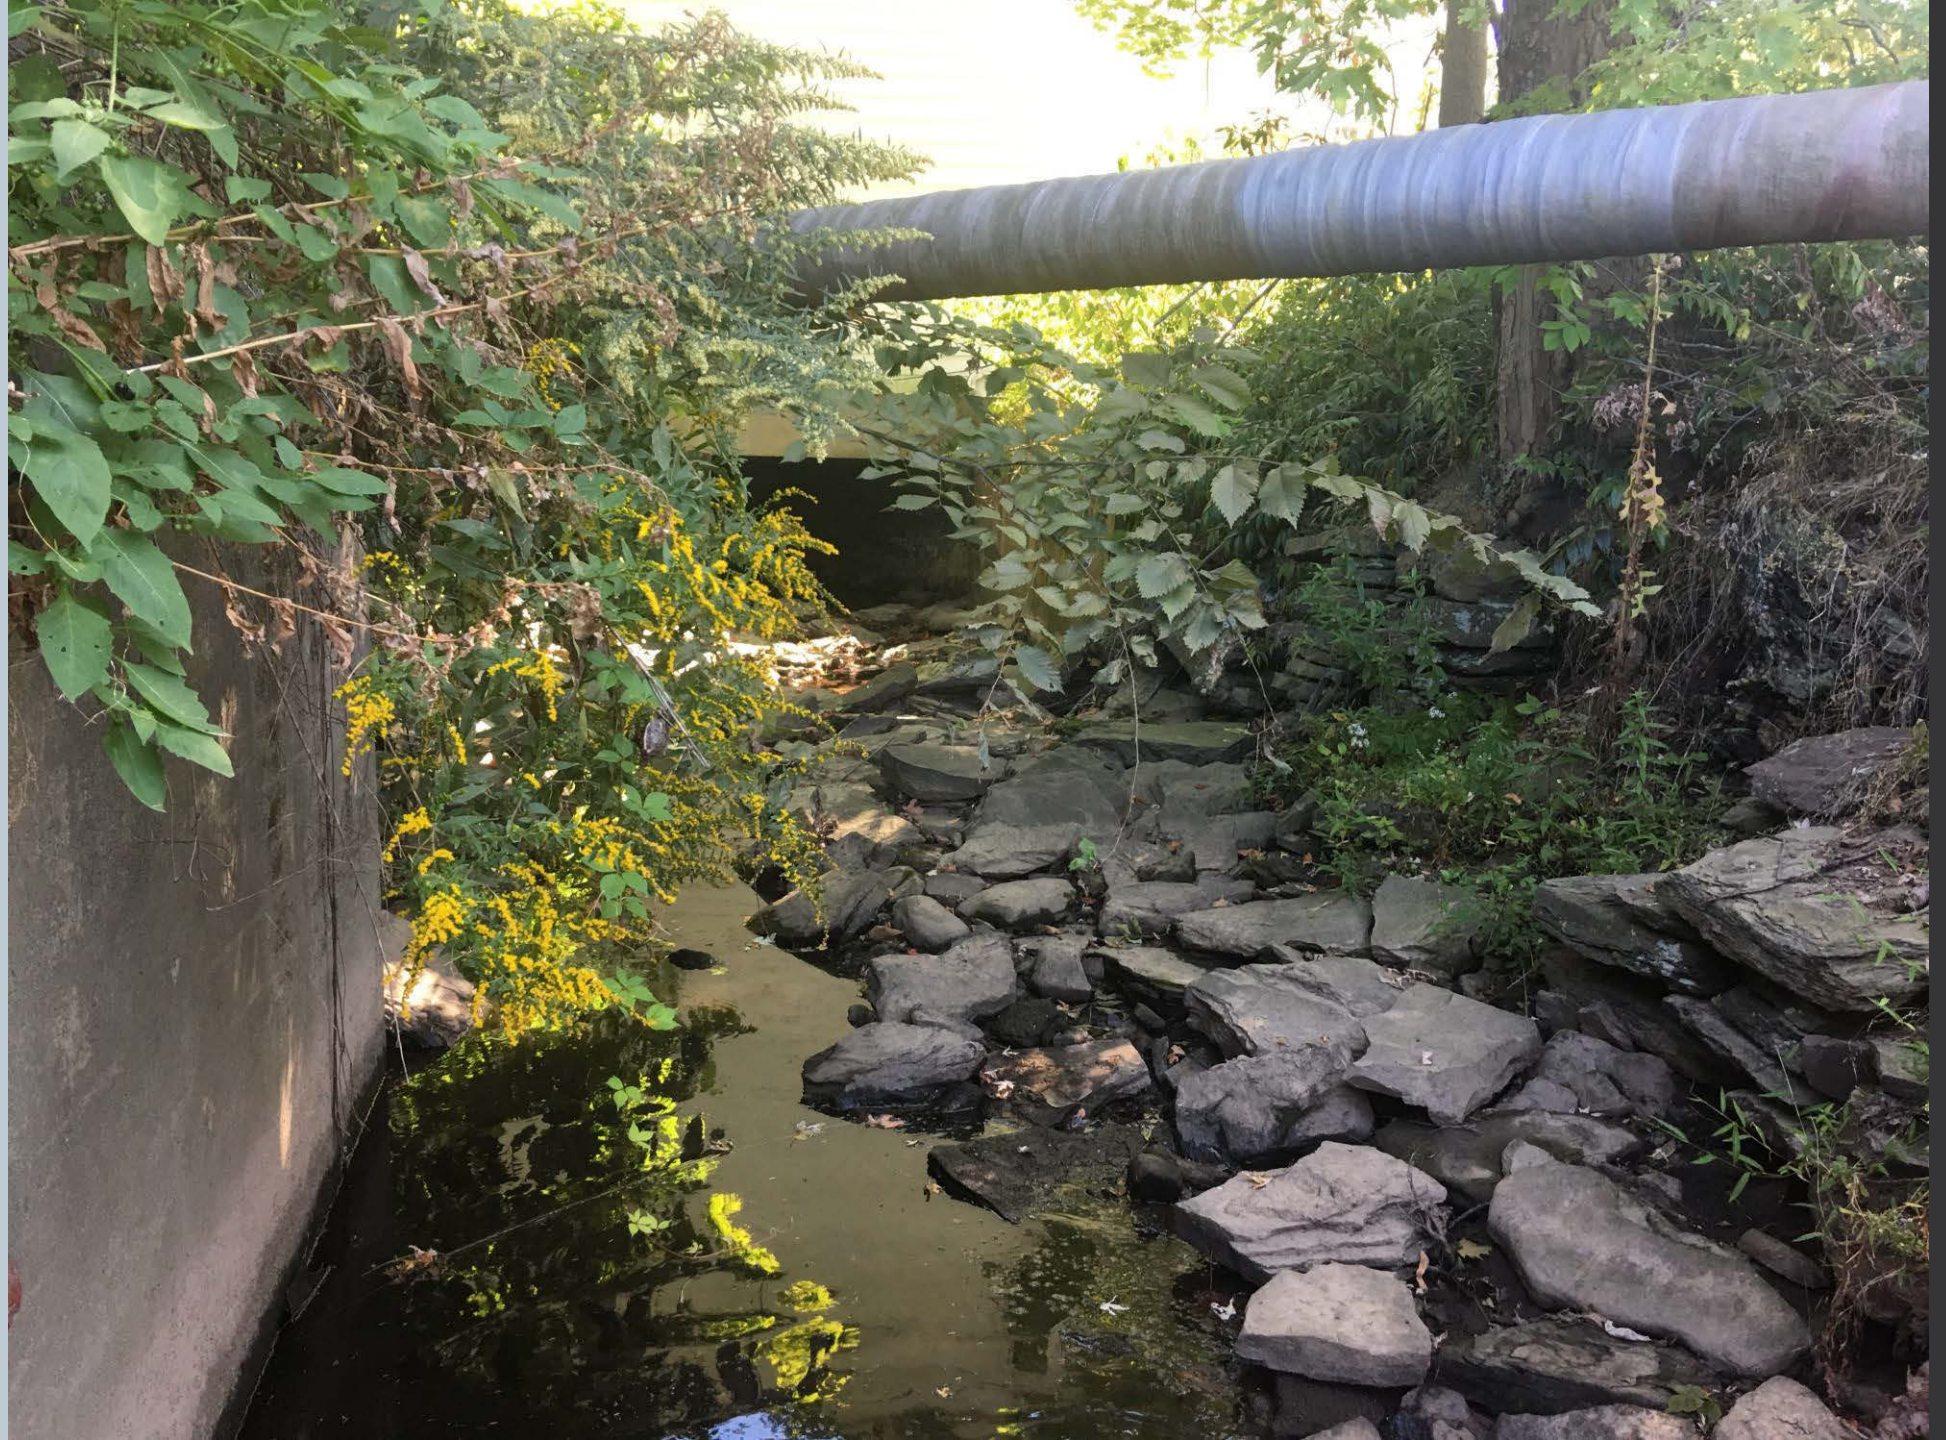
Figure 249. Culvert that directs Toby Creek from beneath Main Street, under the commercial district, until it outlets along Verve Vertu in Dallas. This is an open section before going into another culvert under the commercial district in Dallas.
