Toby Creek Field Reconnaissance Observations

September 26, 2018

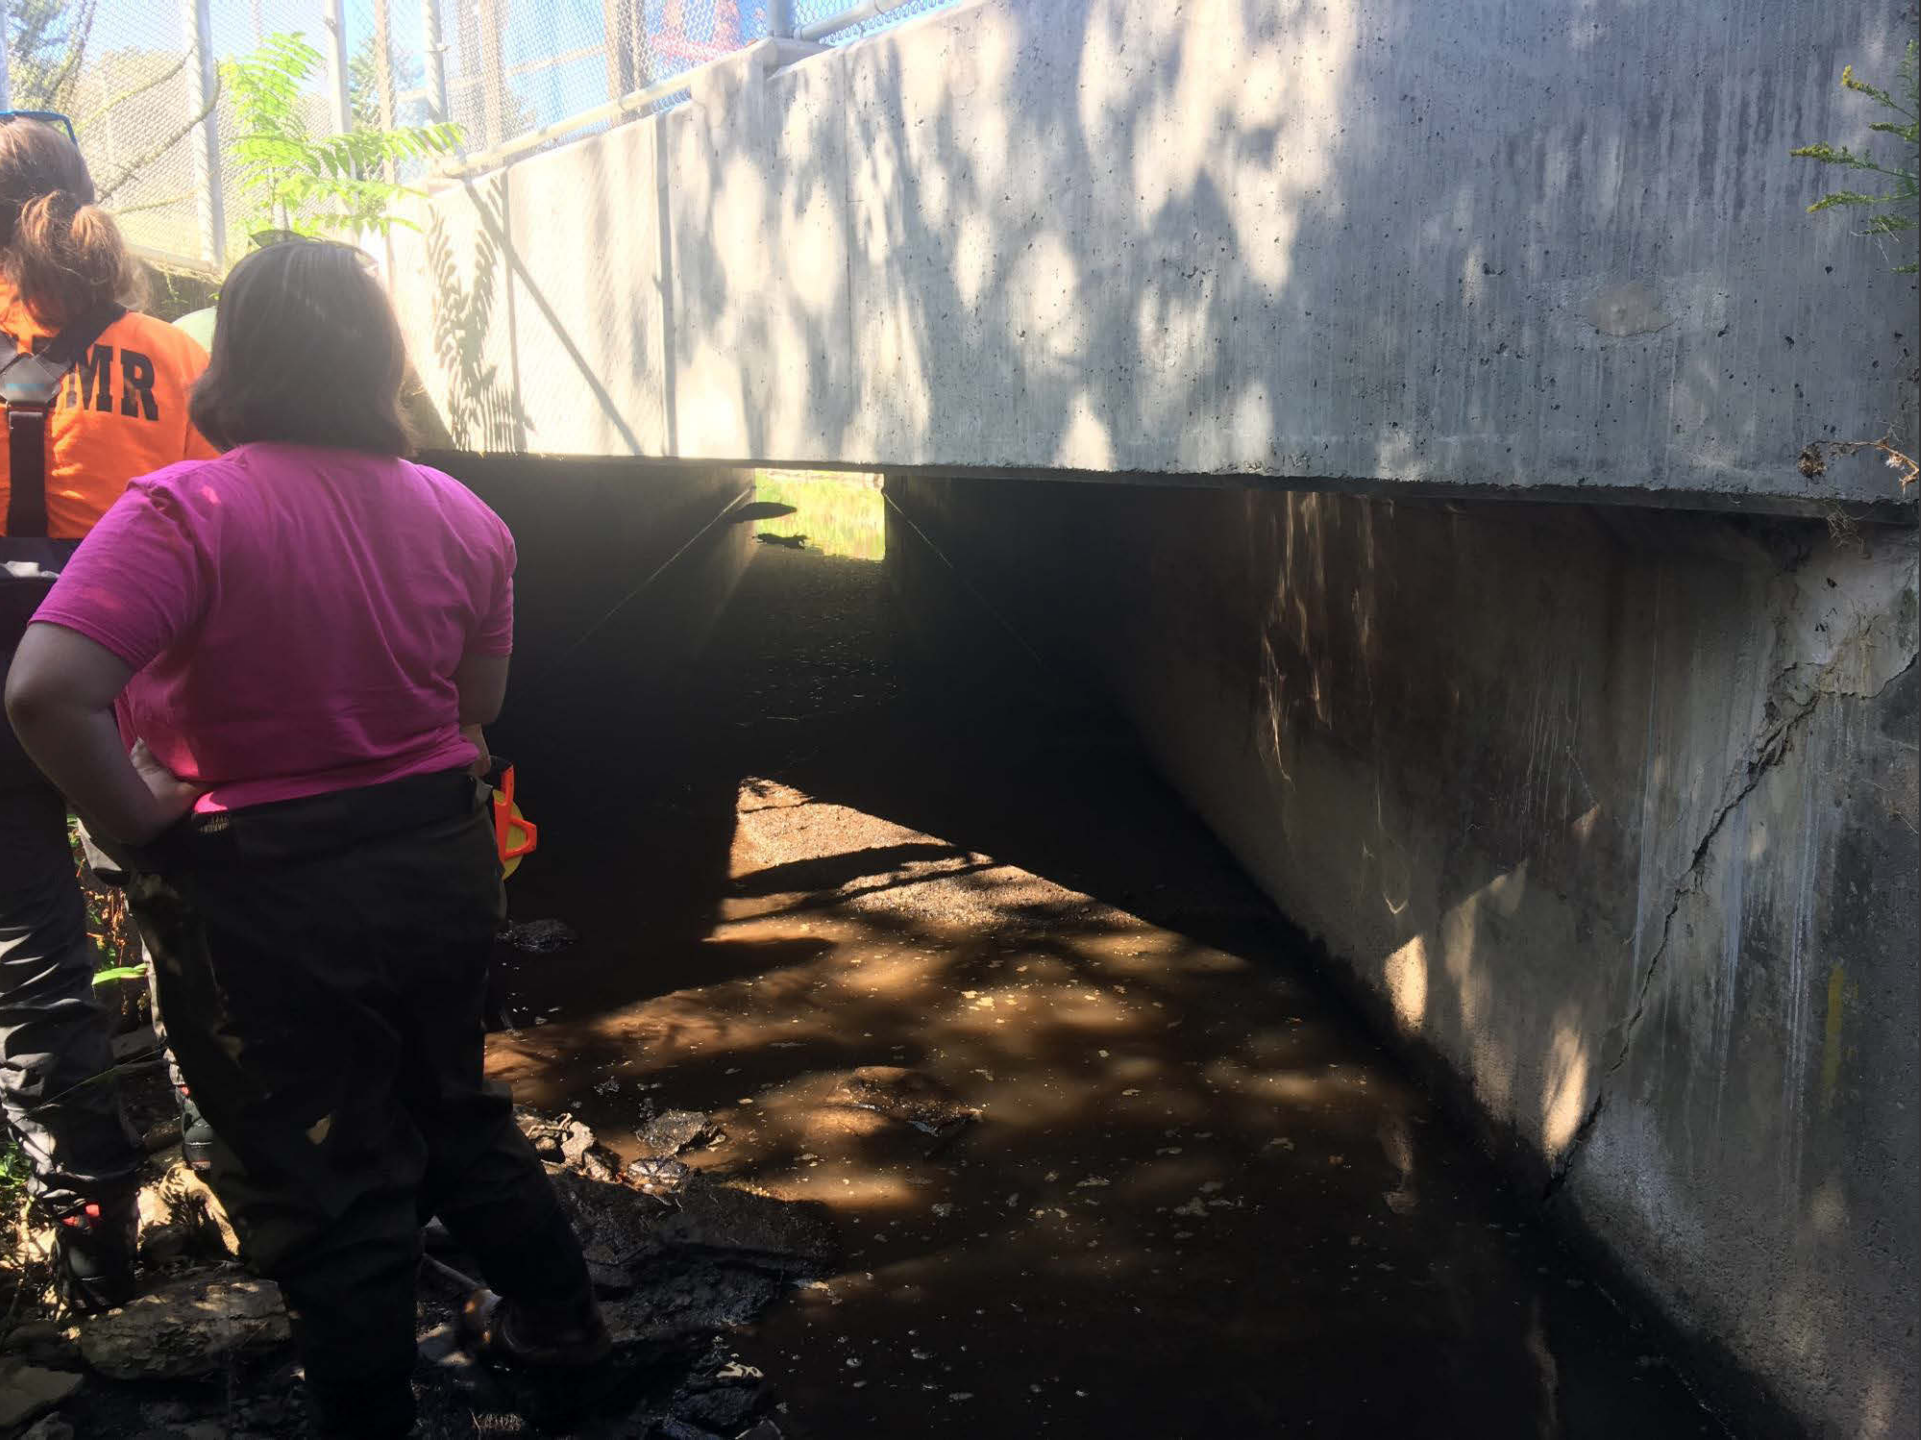
Figure 250. Culvert that directs Toby Creek from beneath Main Street, under the commercial district, until it outlets along Verve Vertu in Dallas. This is an open section before going into another culvert under the commercial district in Dallas.

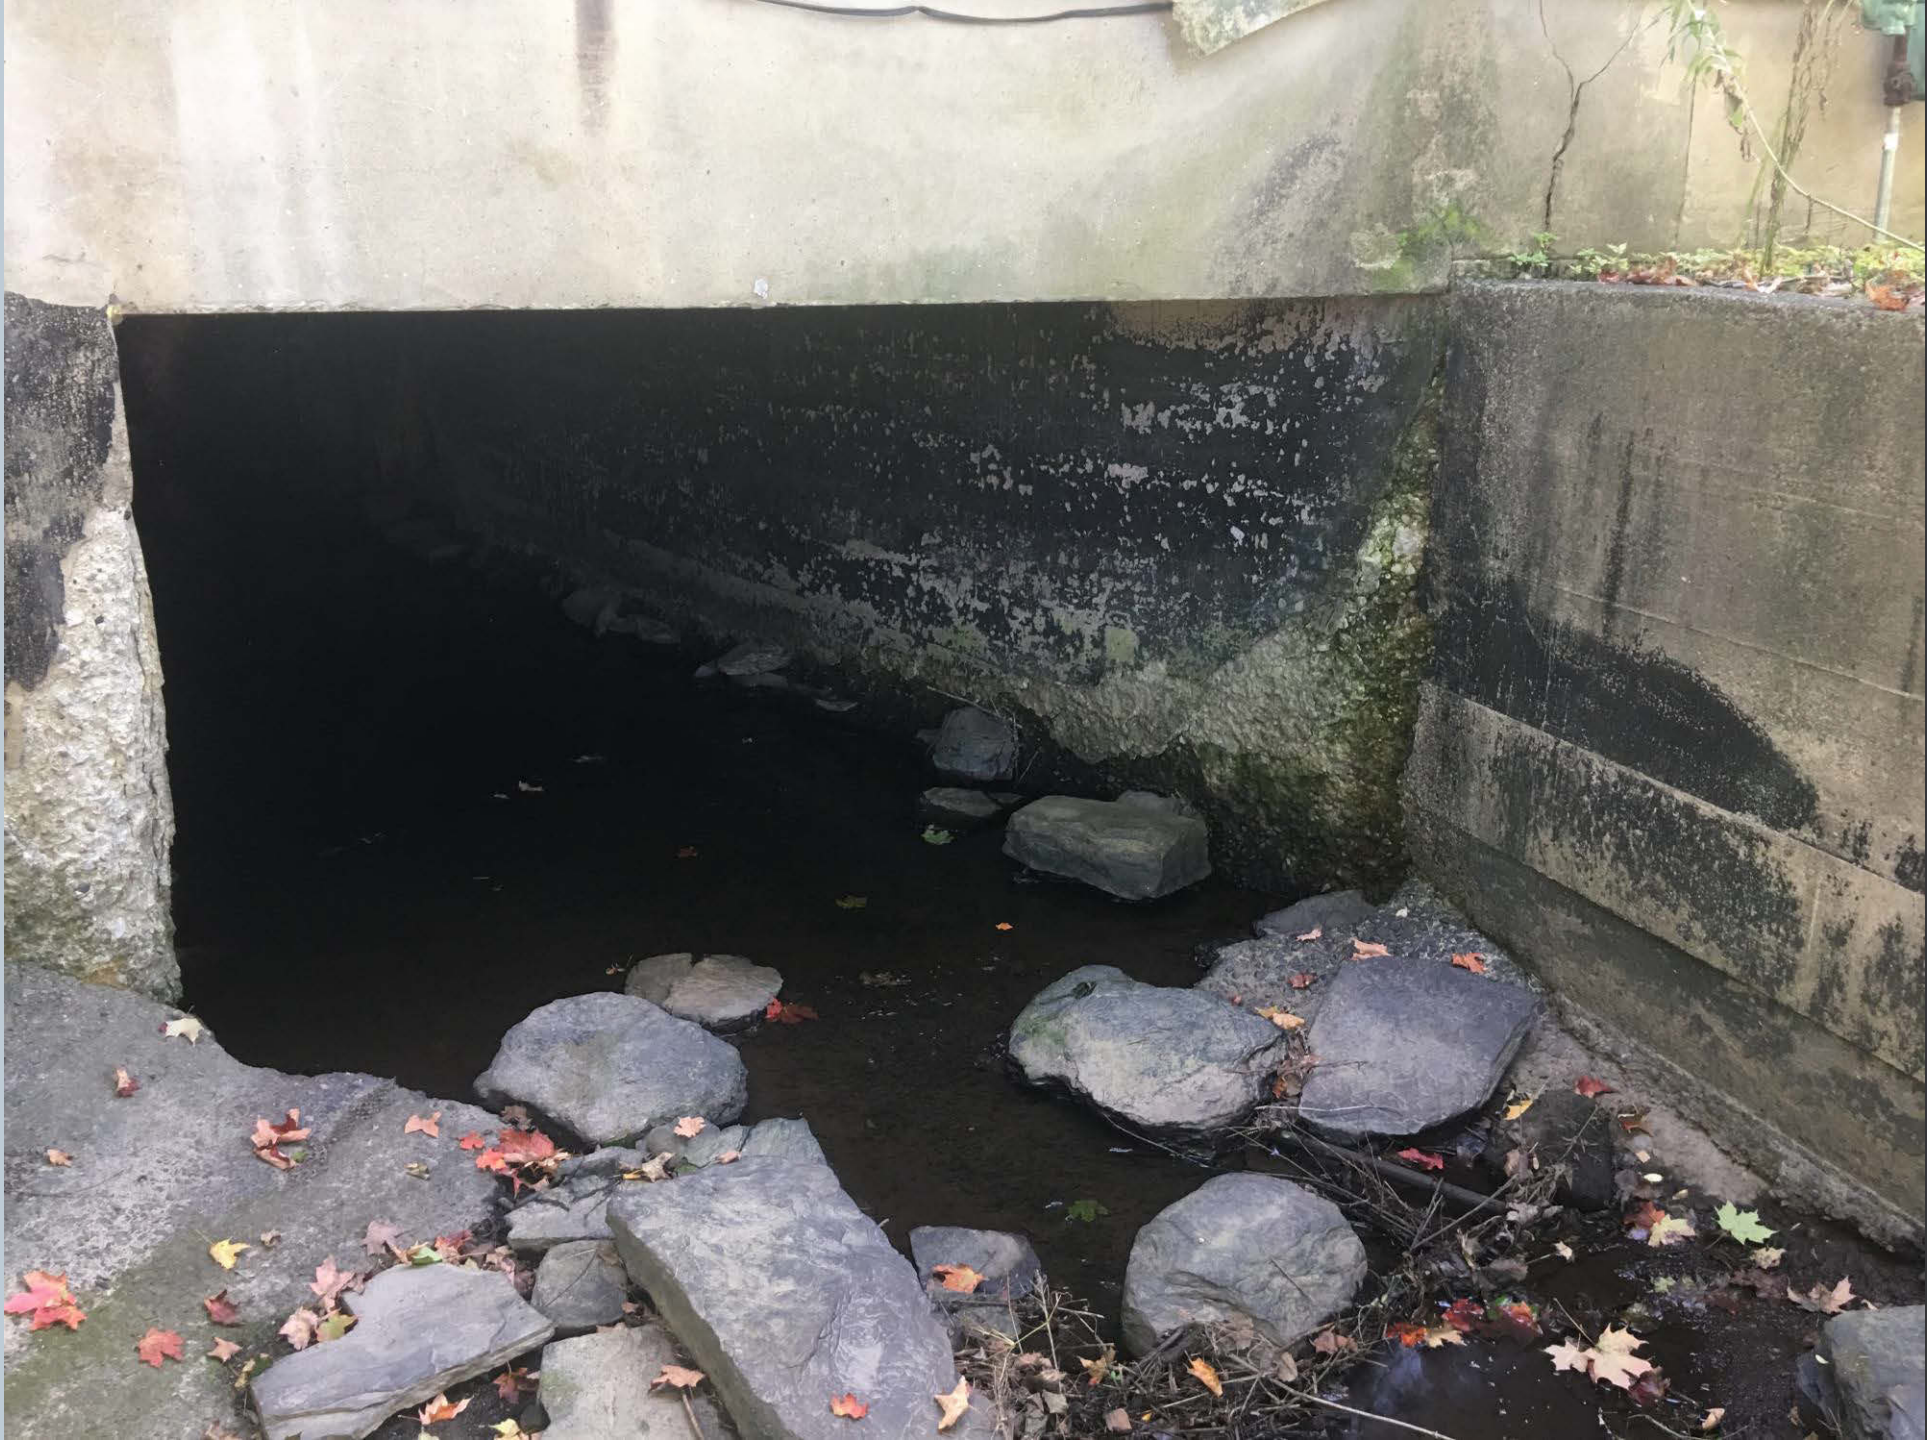
Figure 251. Looking upstream at the culvert and old stone masonry work beneath Main Street in Dallas under the commercial district, until it outlets along Verve Vertu in Dallas. Invasives are present downstream of this area, including Japanese Knotweed.

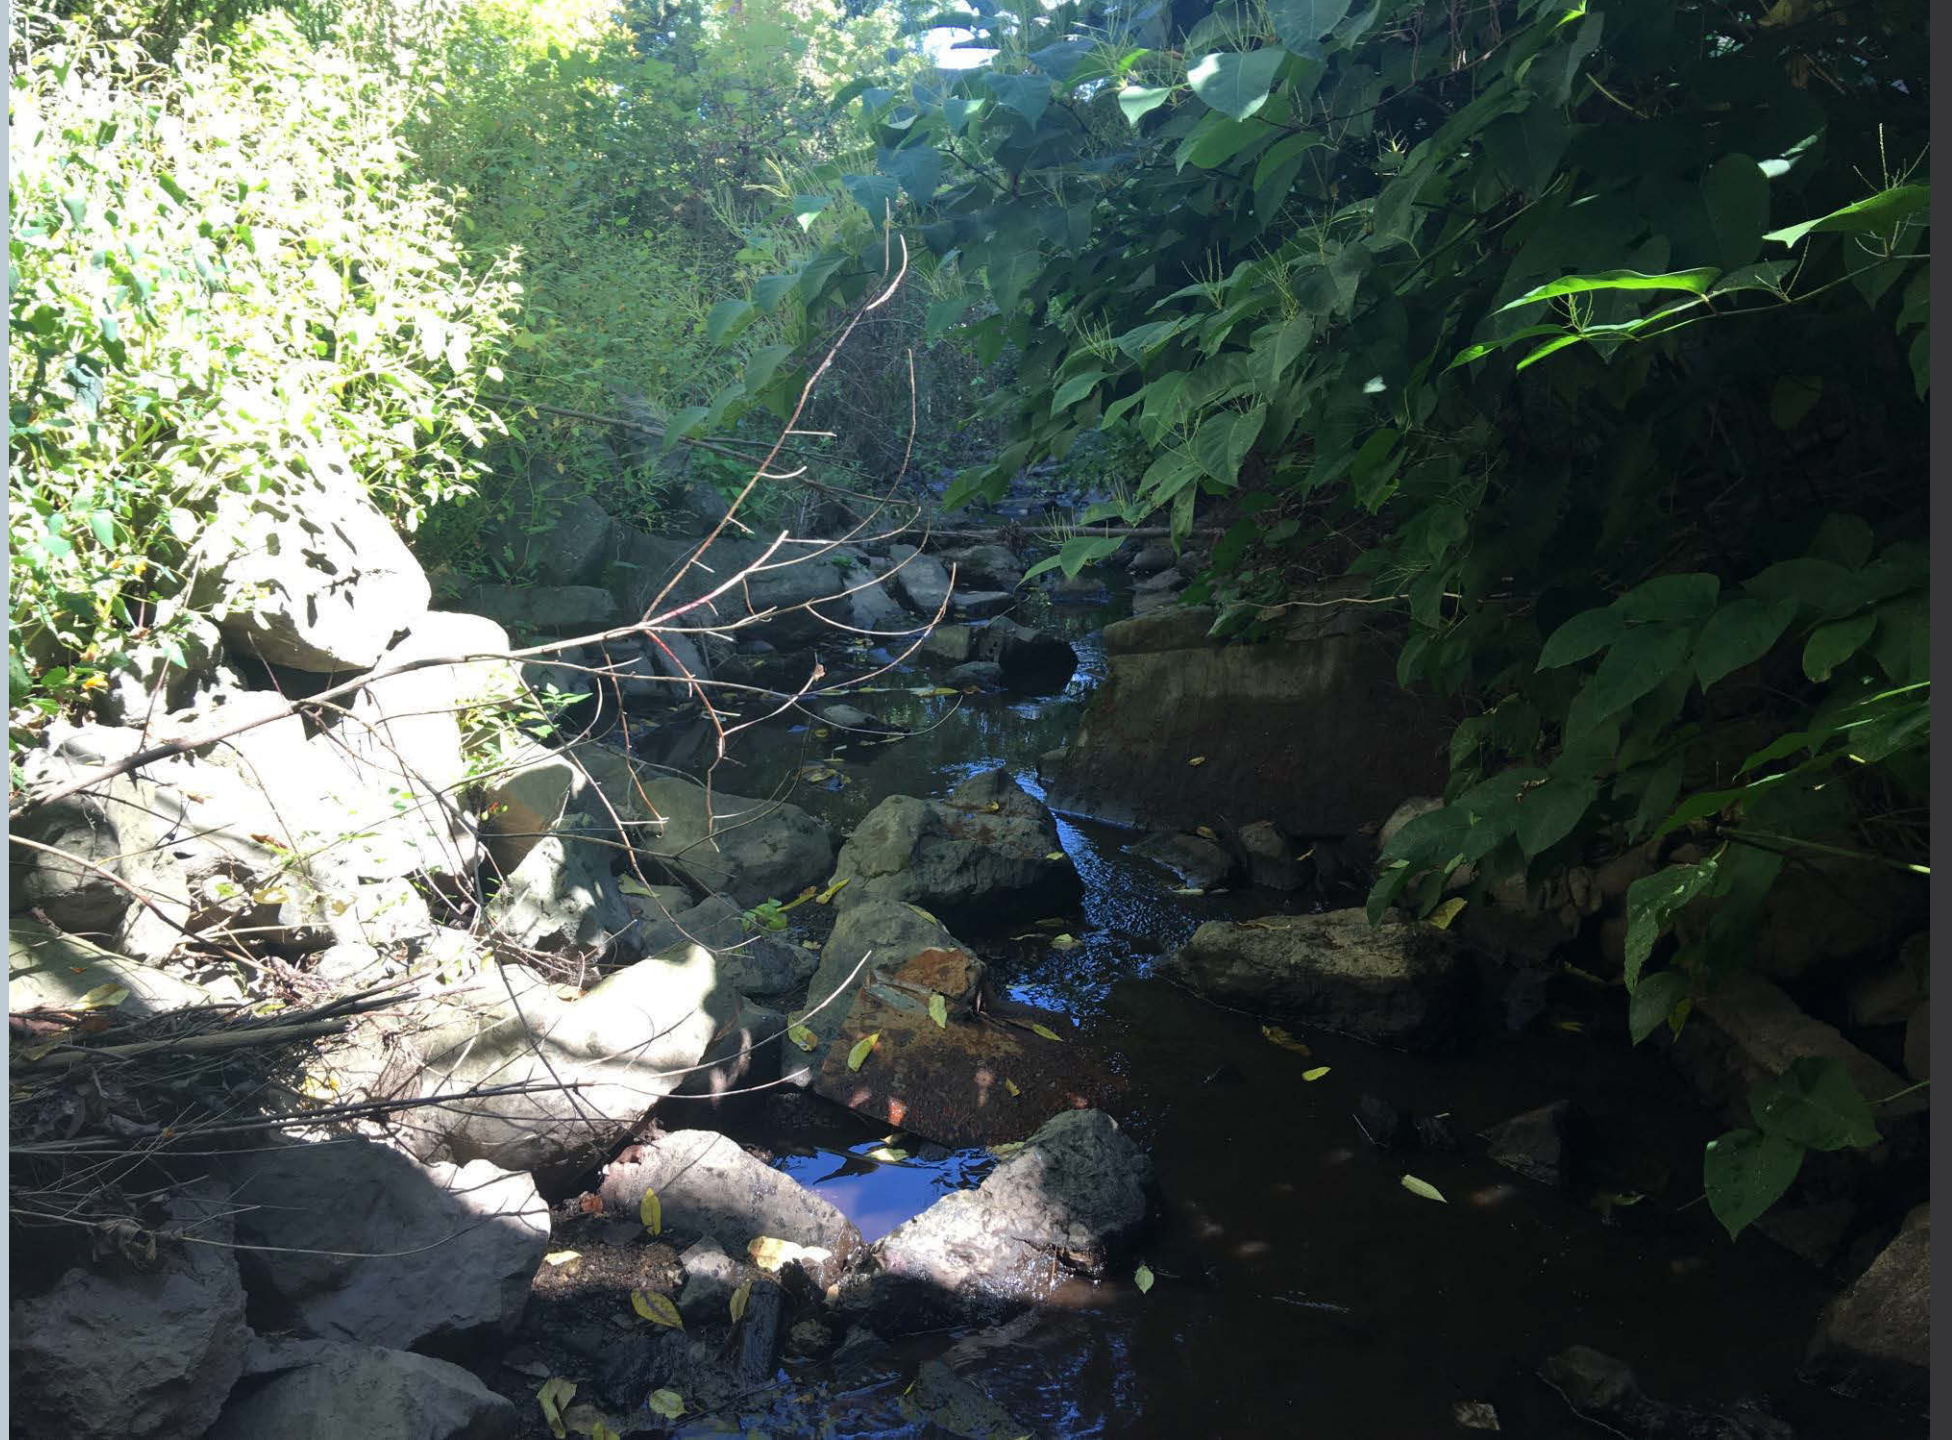
Figure 253. Looking downstream on two corrugated metal pipe culverts on an unnamed tributary to Toby Creek from Pioneer Ave. and Overbrook Road with the culvert on the right severely collapses. Replacement of both structures is recommended.

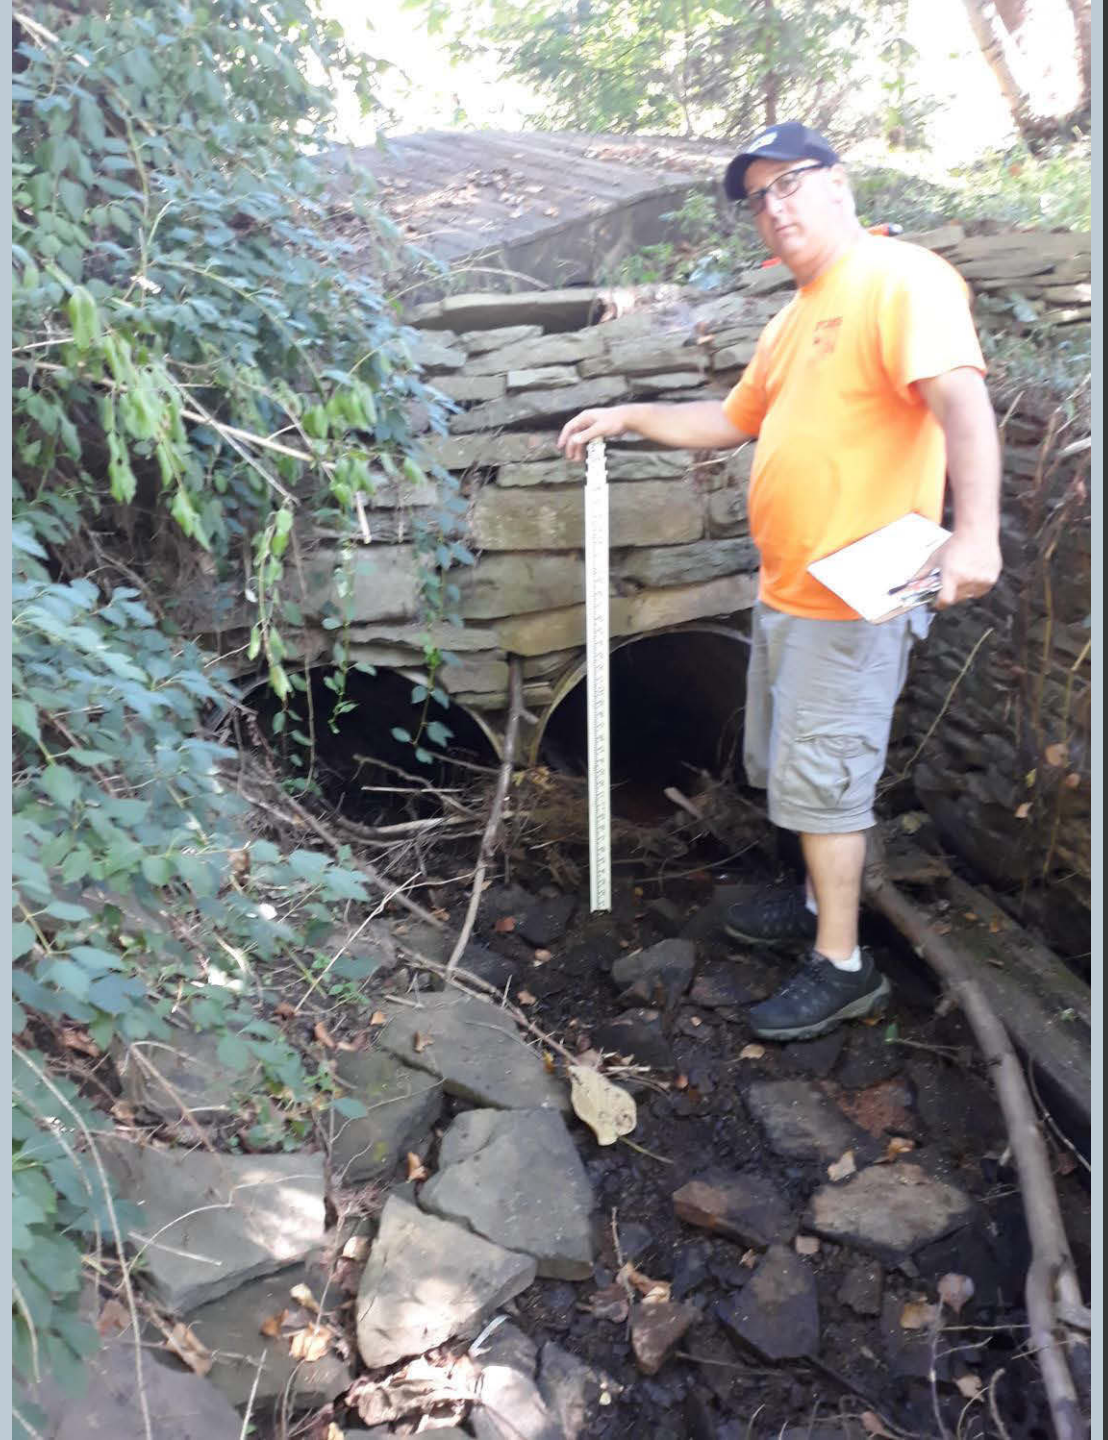
Figure 254. Looking upstream at the erosion caused by stormwater runoff behind the wingwall of the multiple culverts that are failing beneath Pioneer Avenue and Overbrook Road. Rerouting of the stormwater drainage into a properly functioning inlet structure is recommended at this intersection.

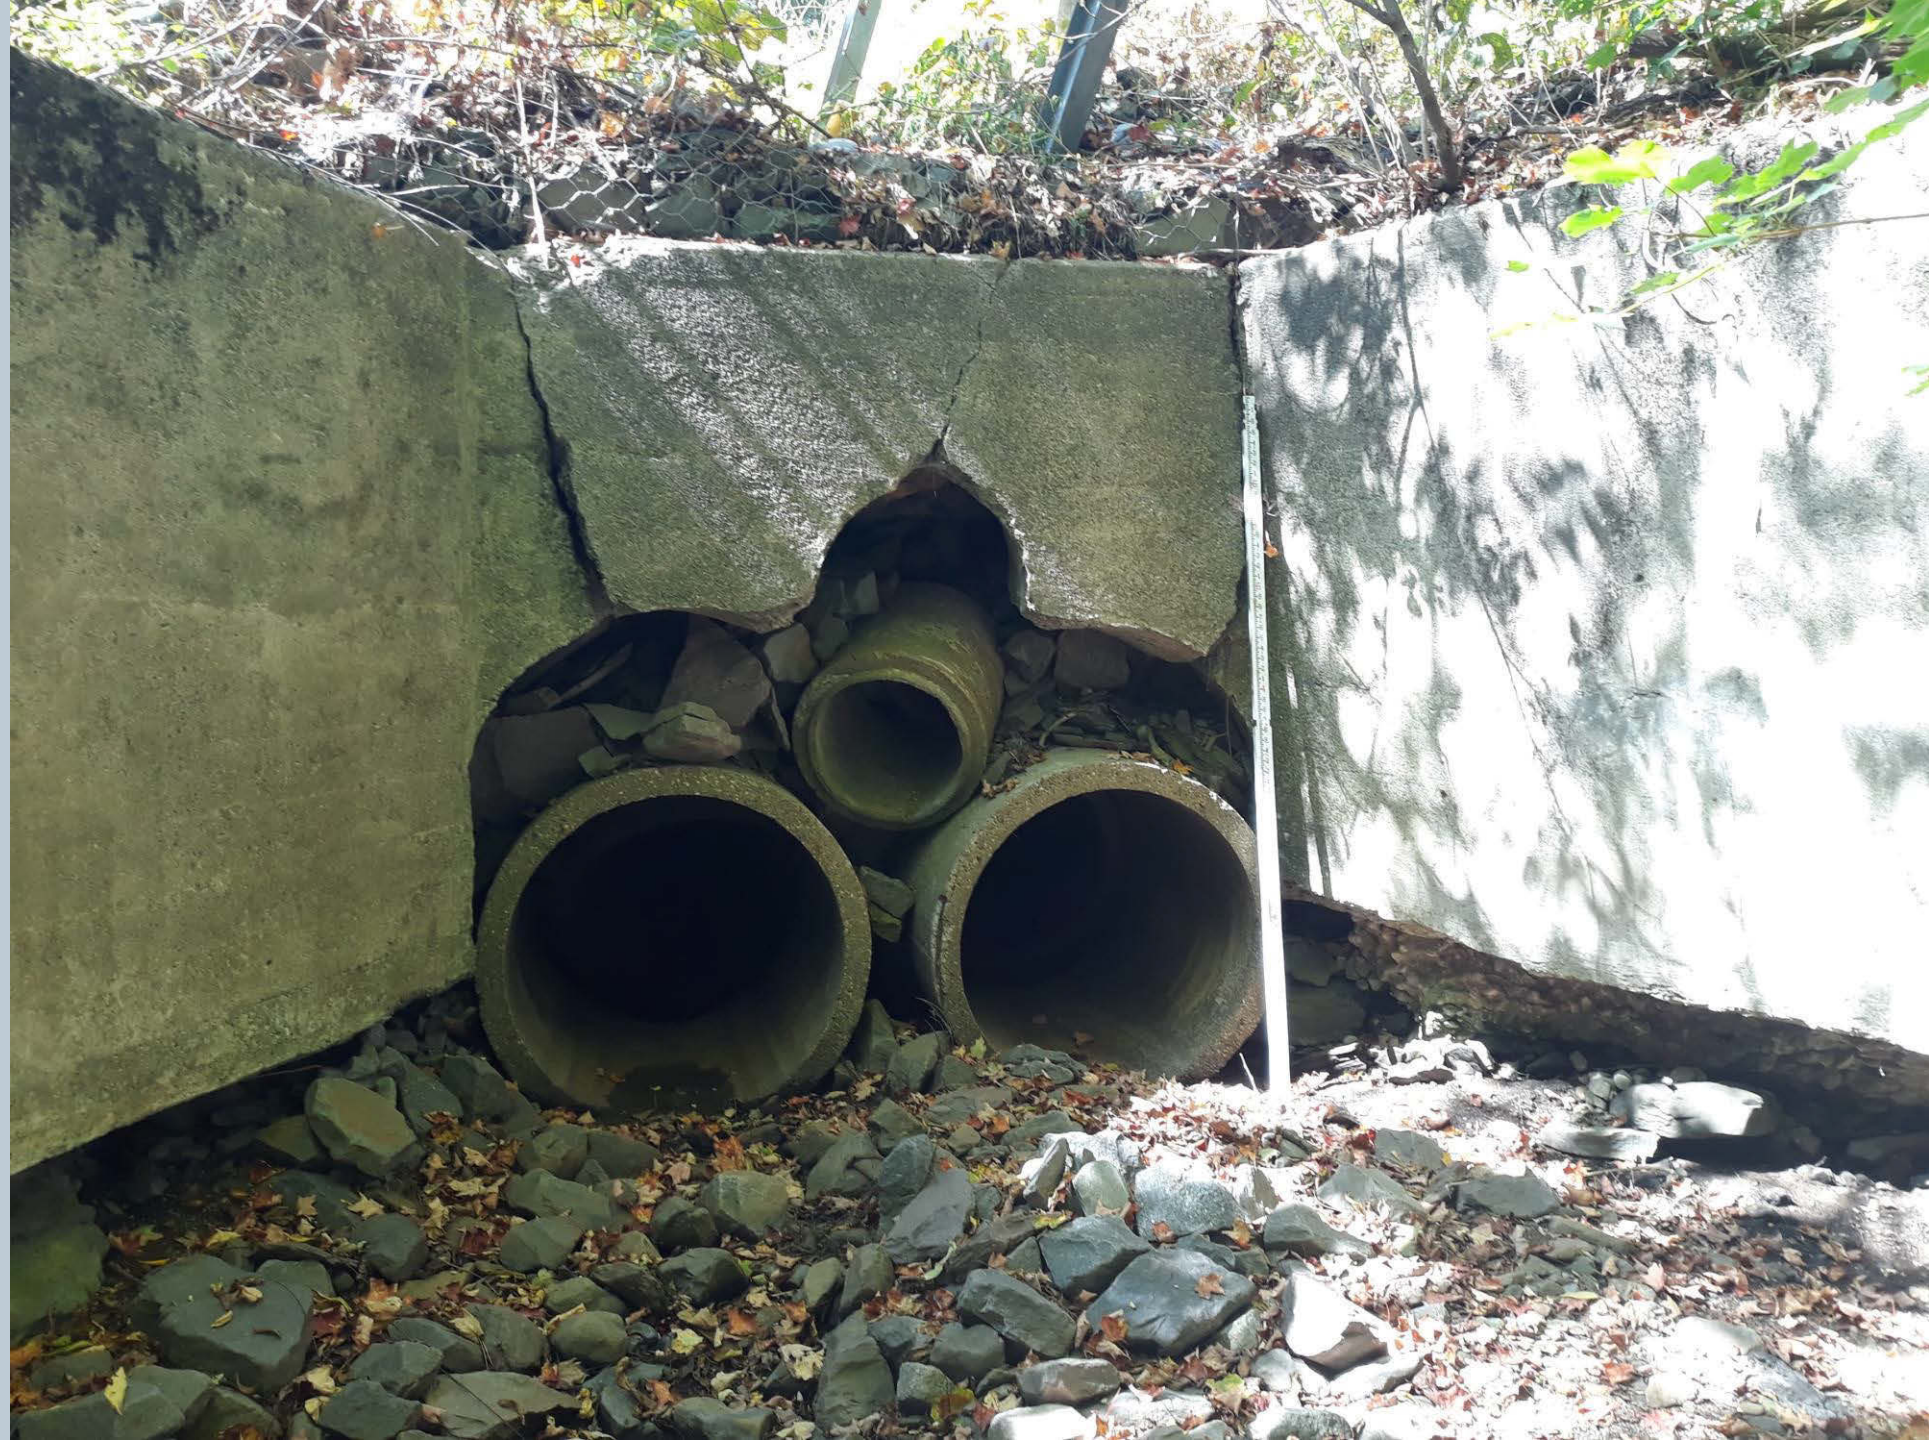
Figure 258. Multiple concrete pipe structures are collapsed and disconnected from an unnamed tributary to Toby Creek that conveys mostly stormwater through Druid Hills below Pioneer Avenue and Overbrook Road. The wingwalls of the culvert foundation are undermined with very little support beneath it. Replacement of the entire structure and foundation should be designed and constructed is recommended.

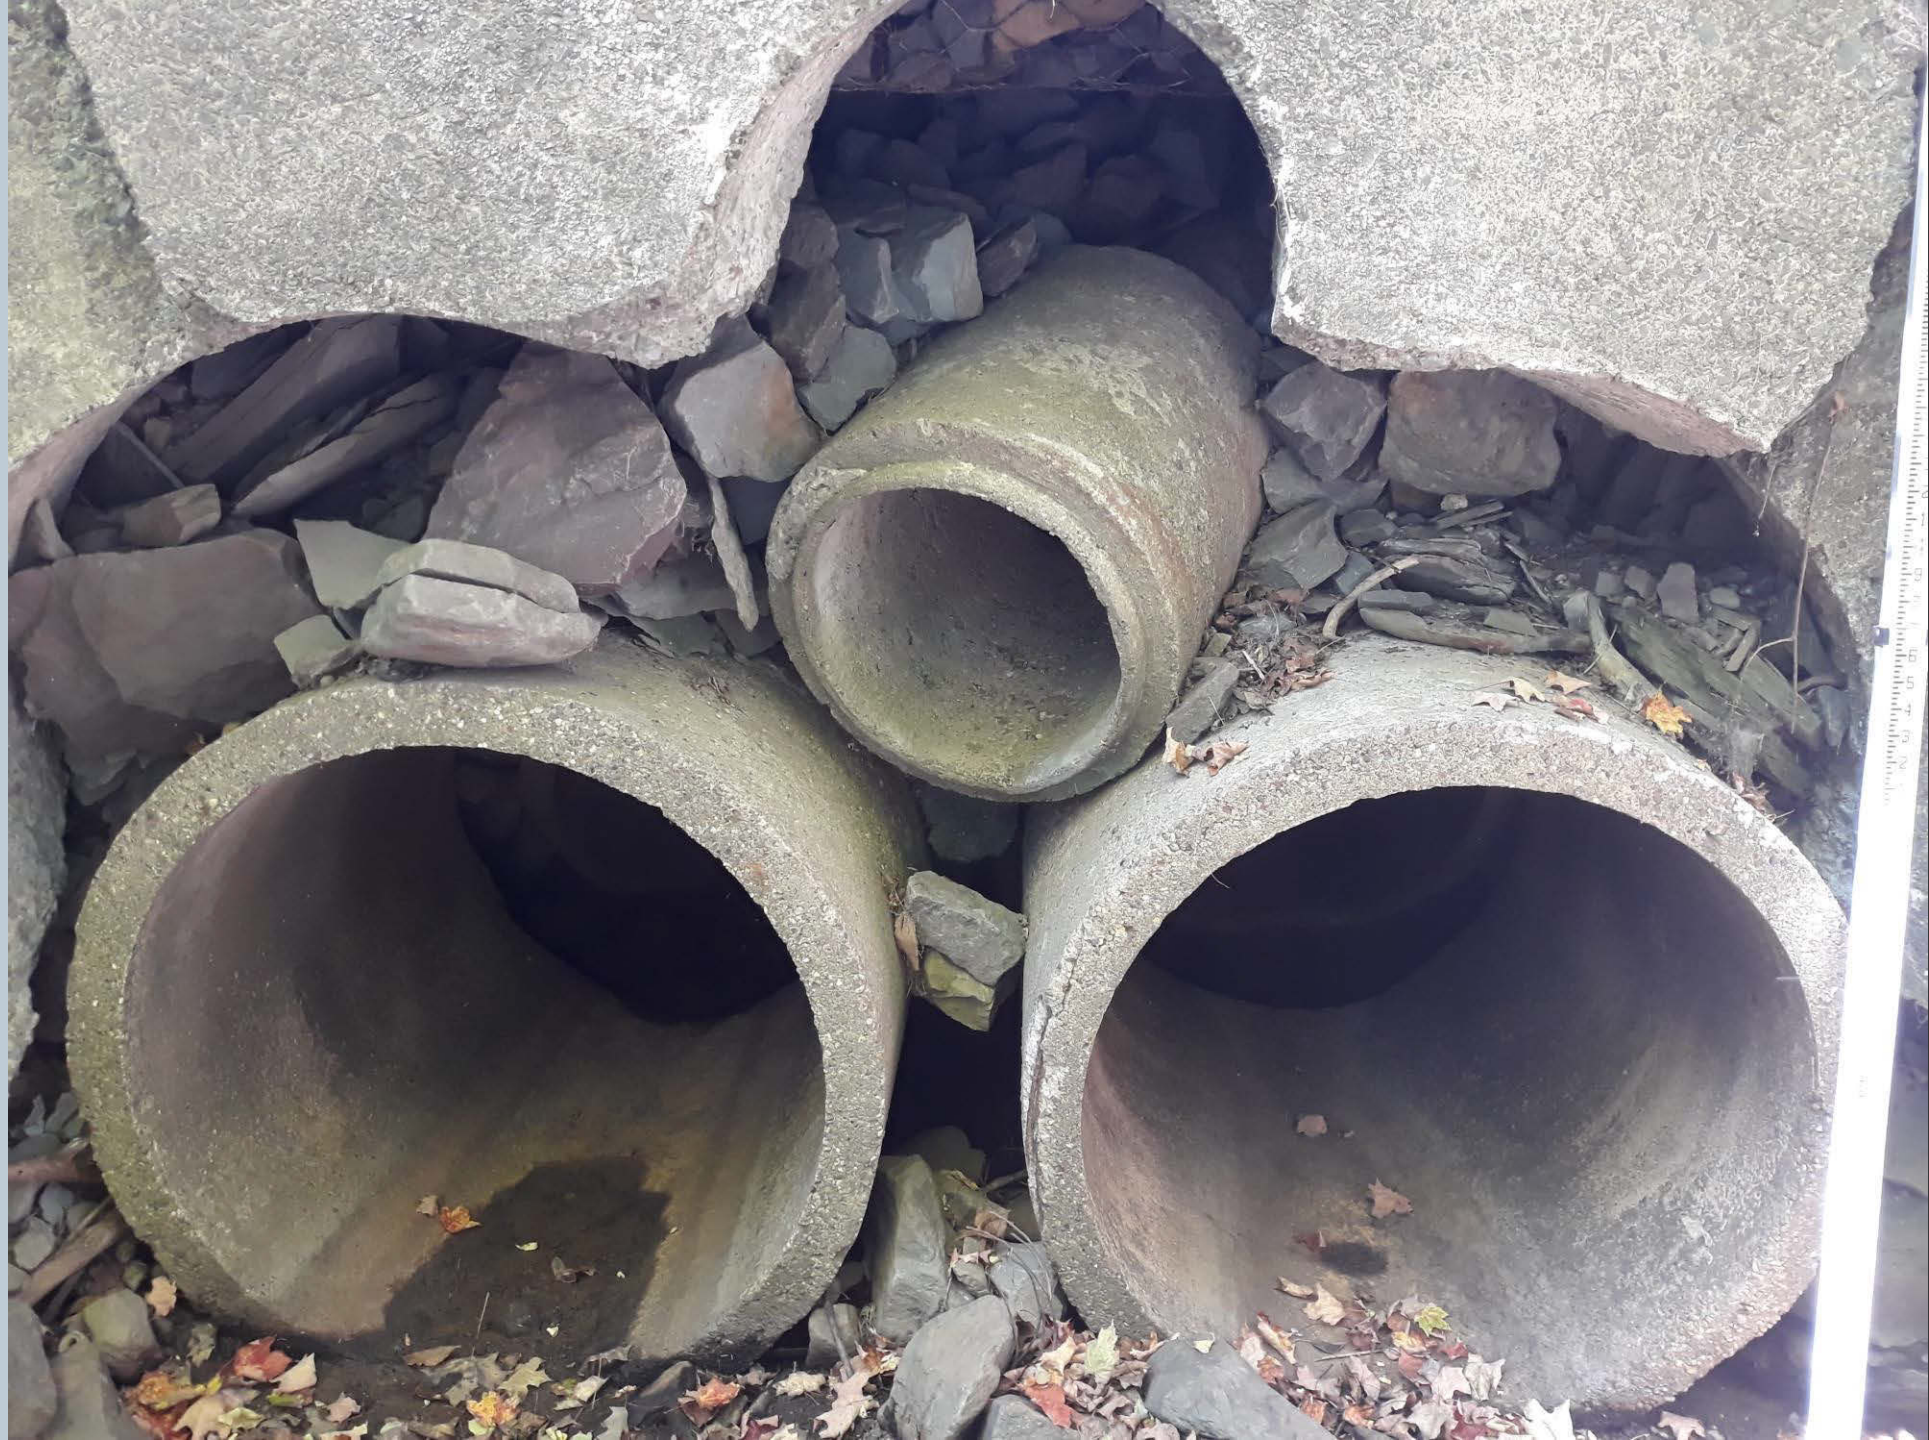
Figure 259. Dry, unnamed tributary to Toby Creek and black HDPE pipe at the corner of W. Franklin and Ferguson Avenue.

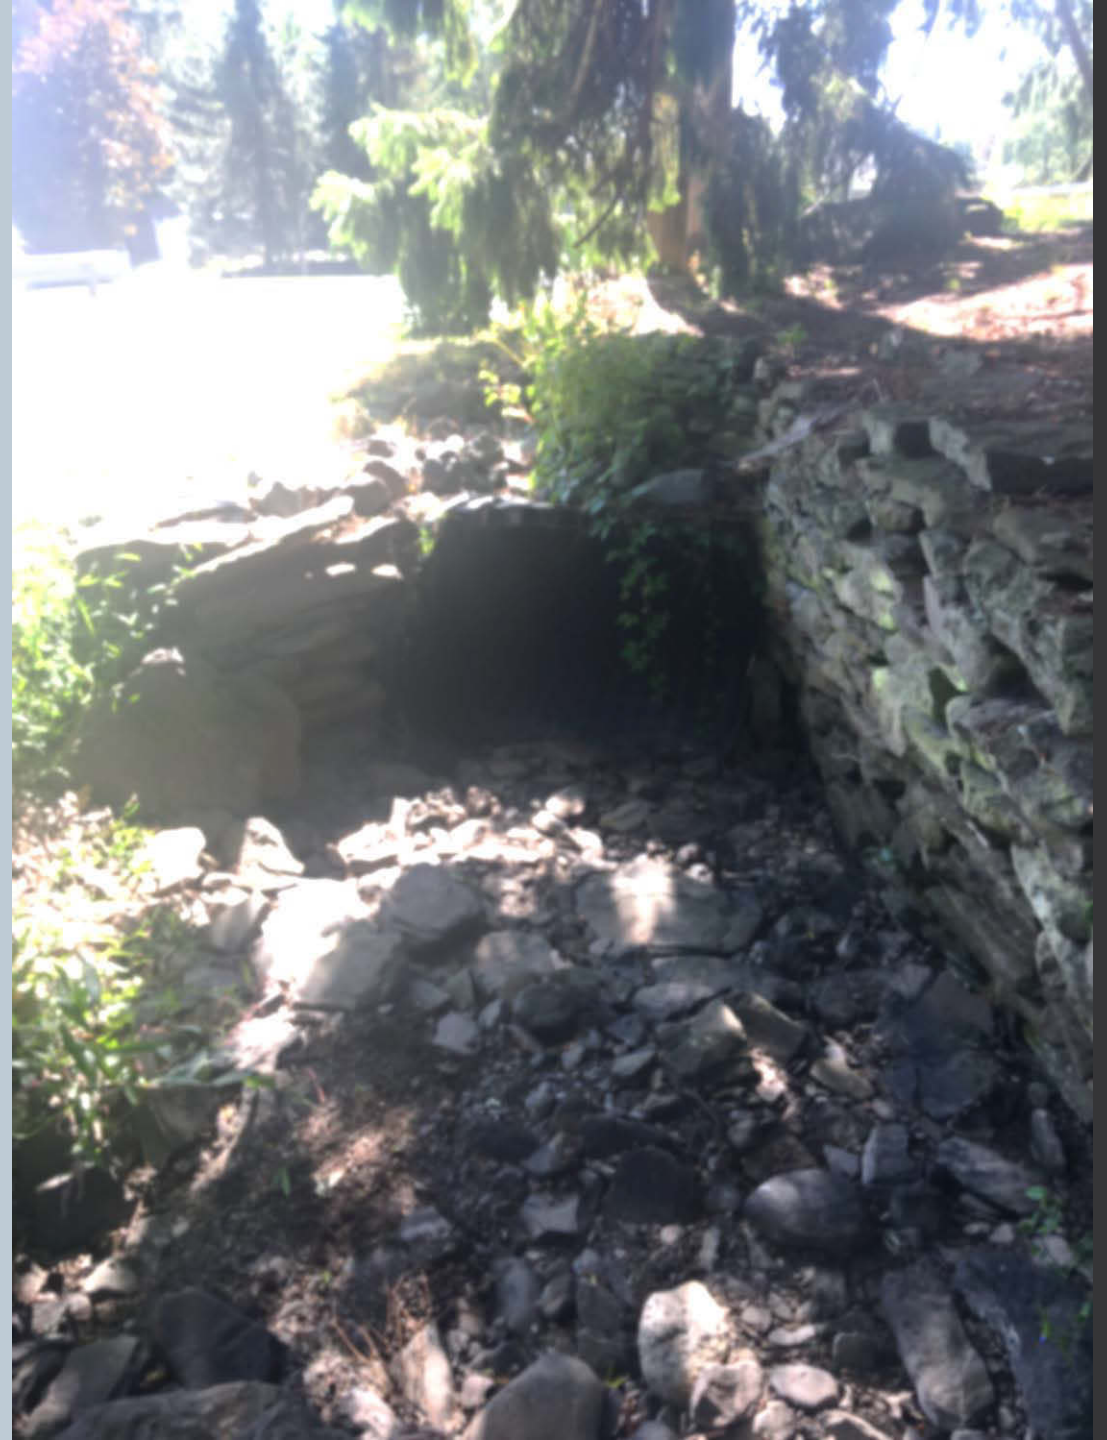
Figure 260. Dry, unnamed tributary to Toby Creek at the corner of W. Franklin and Ferguson Avenue filled with sediment. Recommend removal of sediment with a DAMA Vac Truck since the culvert is nearly filled with fine gravels.

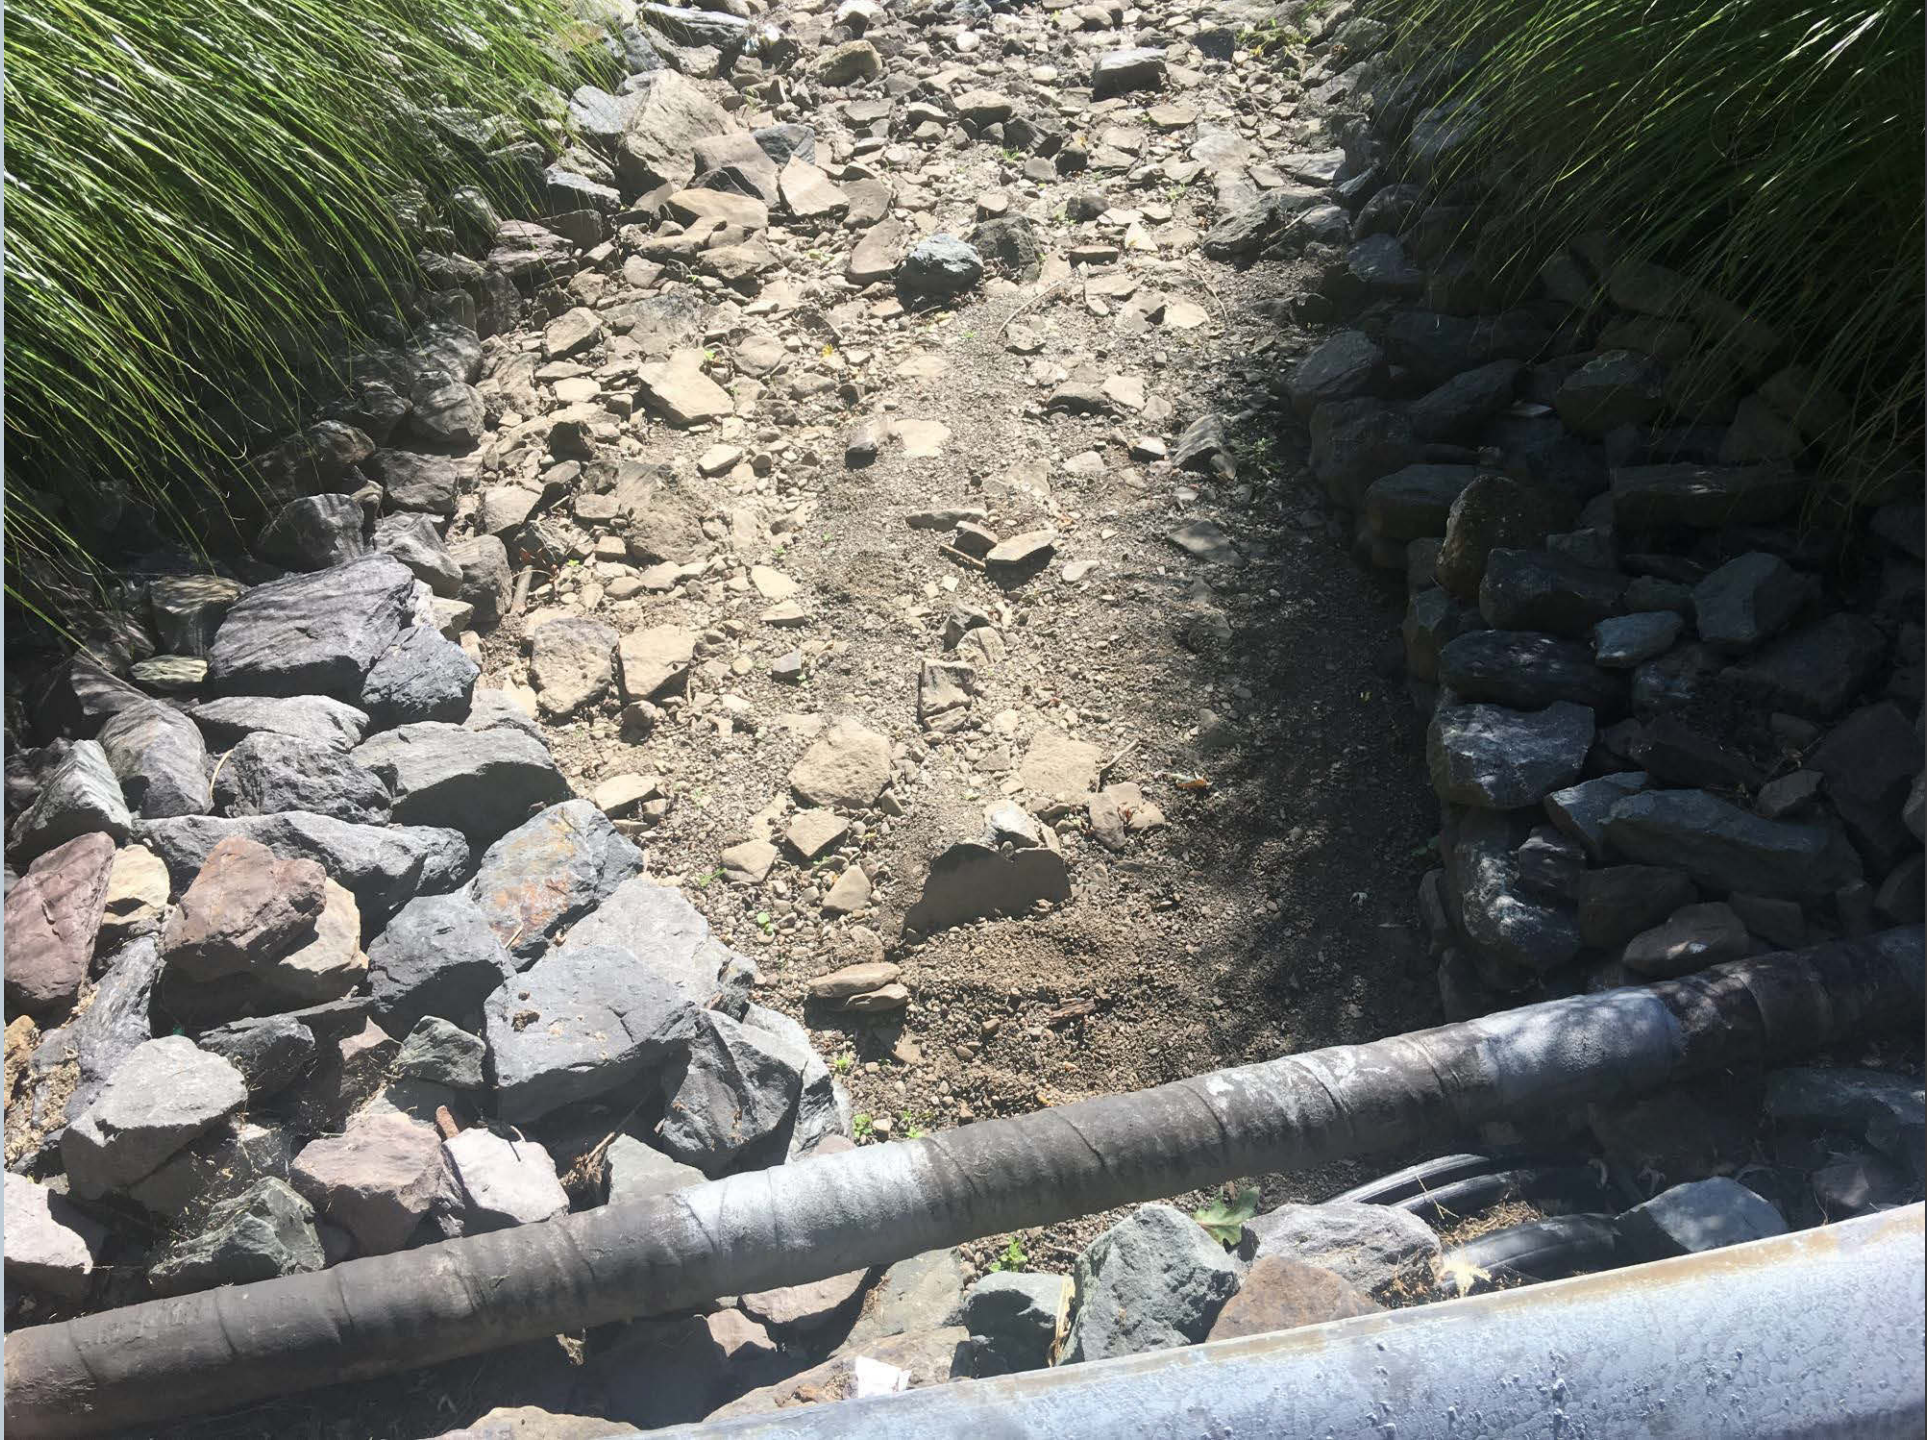
Figure 261. Dry, unnamed tributary to Toby Creek at the corner of W. Franklin and Ferguson Avenue filled with sediment. Recommend removal of sediment with a DAMA Vac Truck since the culvert is nearly filled with fine gravels.

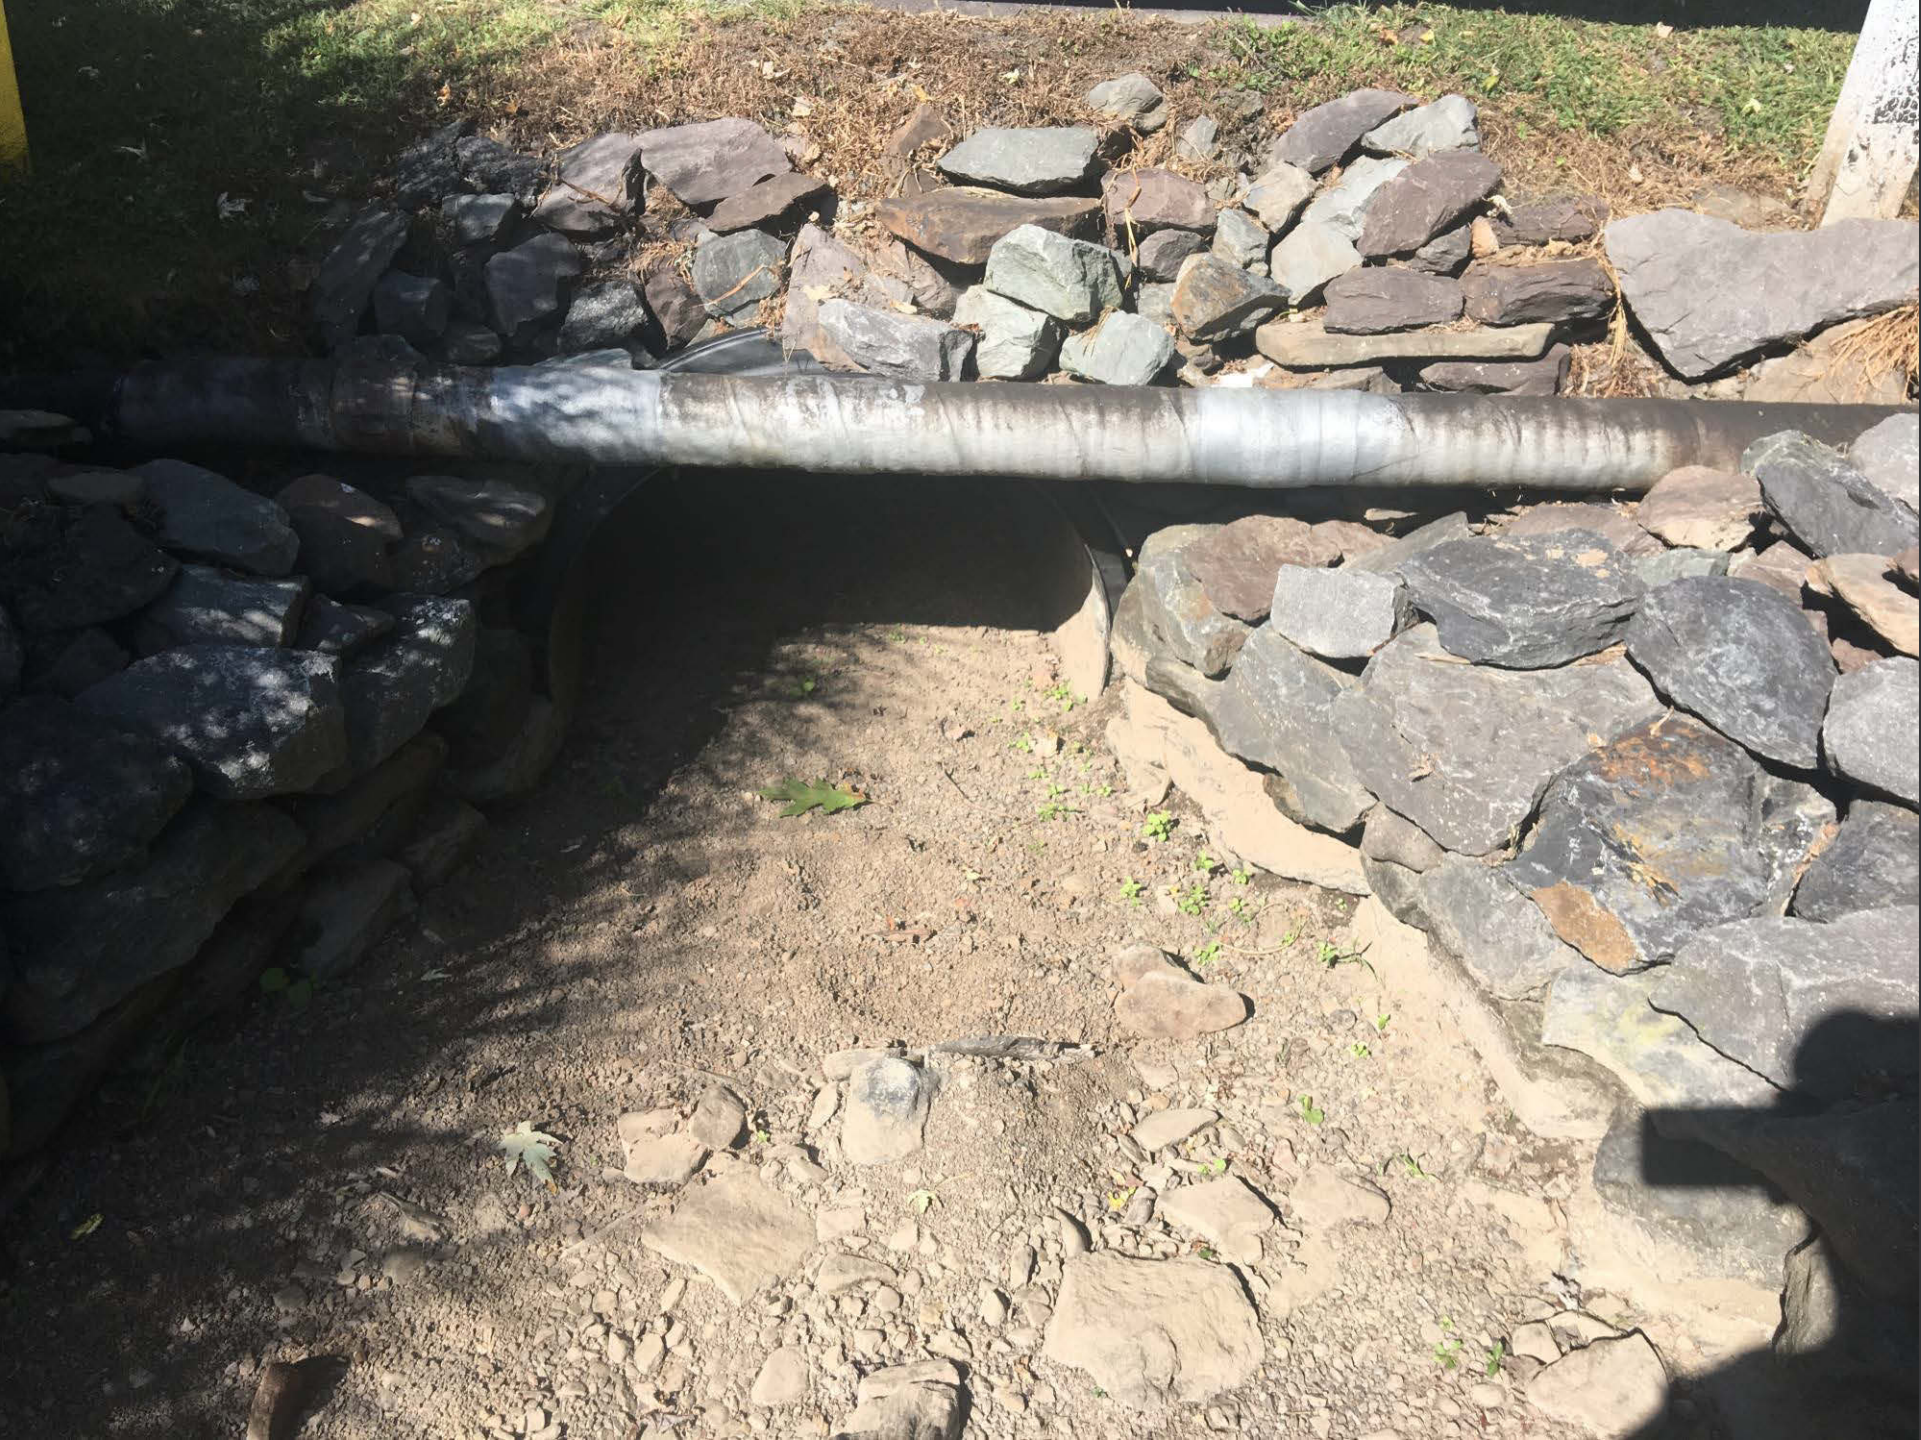
Figure 262. Dry, unnamed tributary to Toby Creek at the corner of W. Franklin and Ferguson Avenue filled with fallen rock from around the inlet corrugated metal pipe. DHL/EPCAMR Volunteer taking measurements of the culvert. Recommend removal of rocks from the pipe inlet to improve stormwater flows through the private property.
