Toby Creek Field Reconnaissance Observations

September 26, 2018

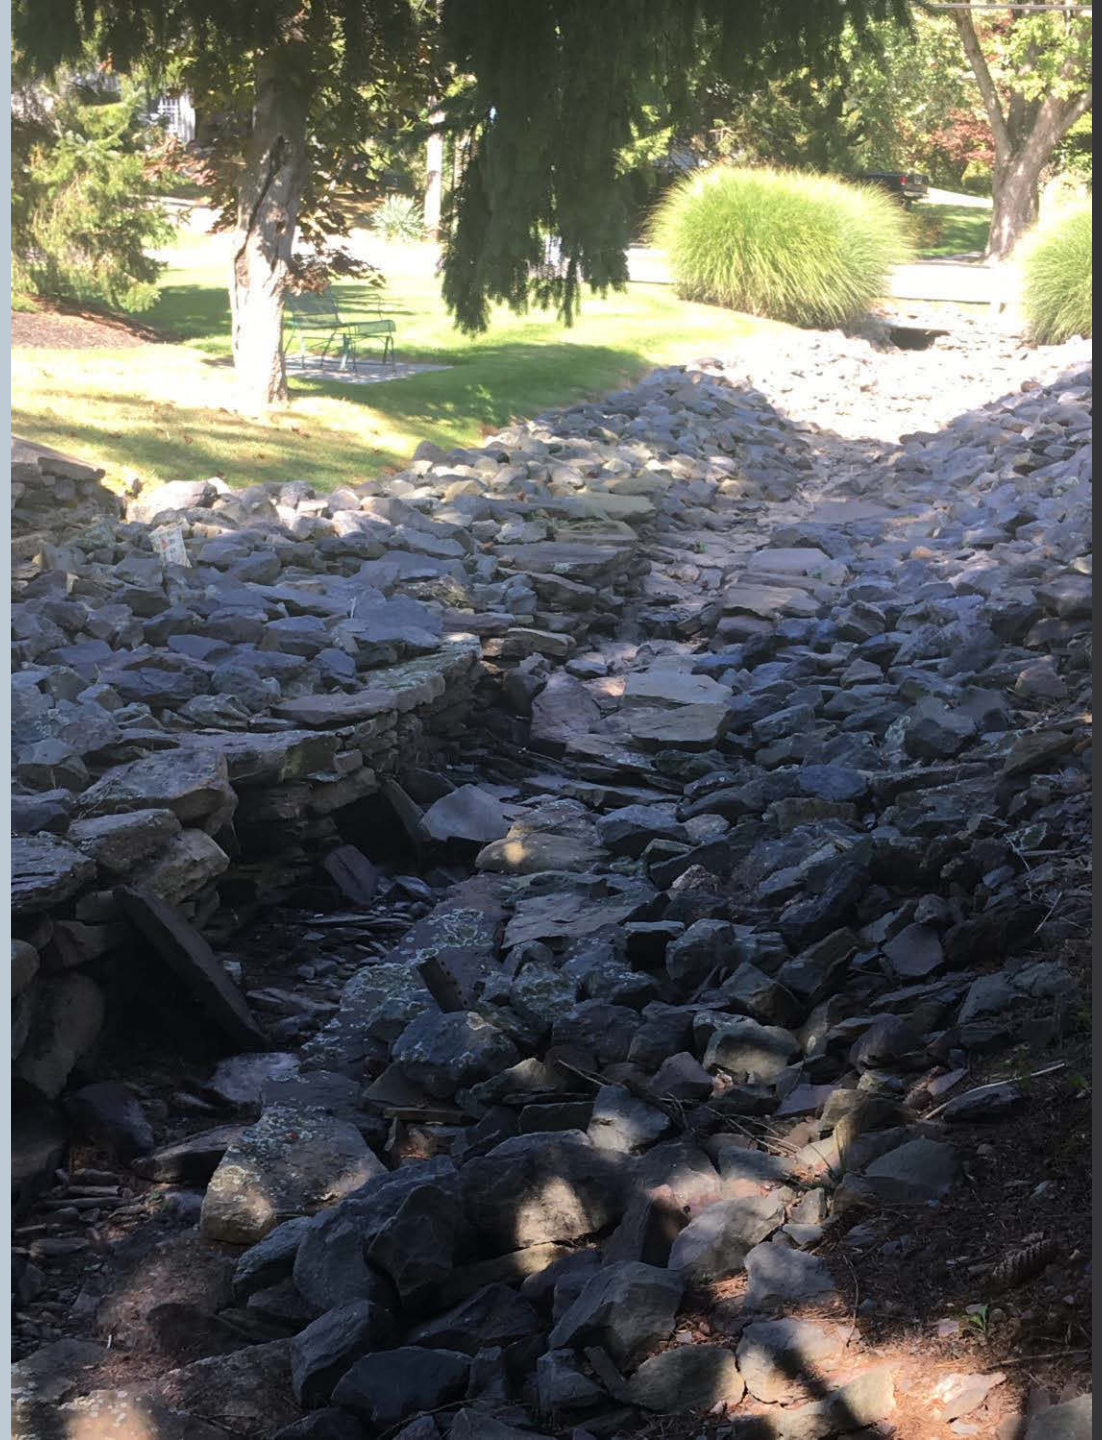
Figure 264. Dry, unnamed tributary to Toby Creek at the outlet of the metal corrugated pipe from the rear of the private residence along West Franklin and Ferguson Avenue. The pipe is half full of sediment. The DAMA Vac Truck is recommended for cleanout of this outlet pipe that is located behind the fence at the rear of the McDonald's.

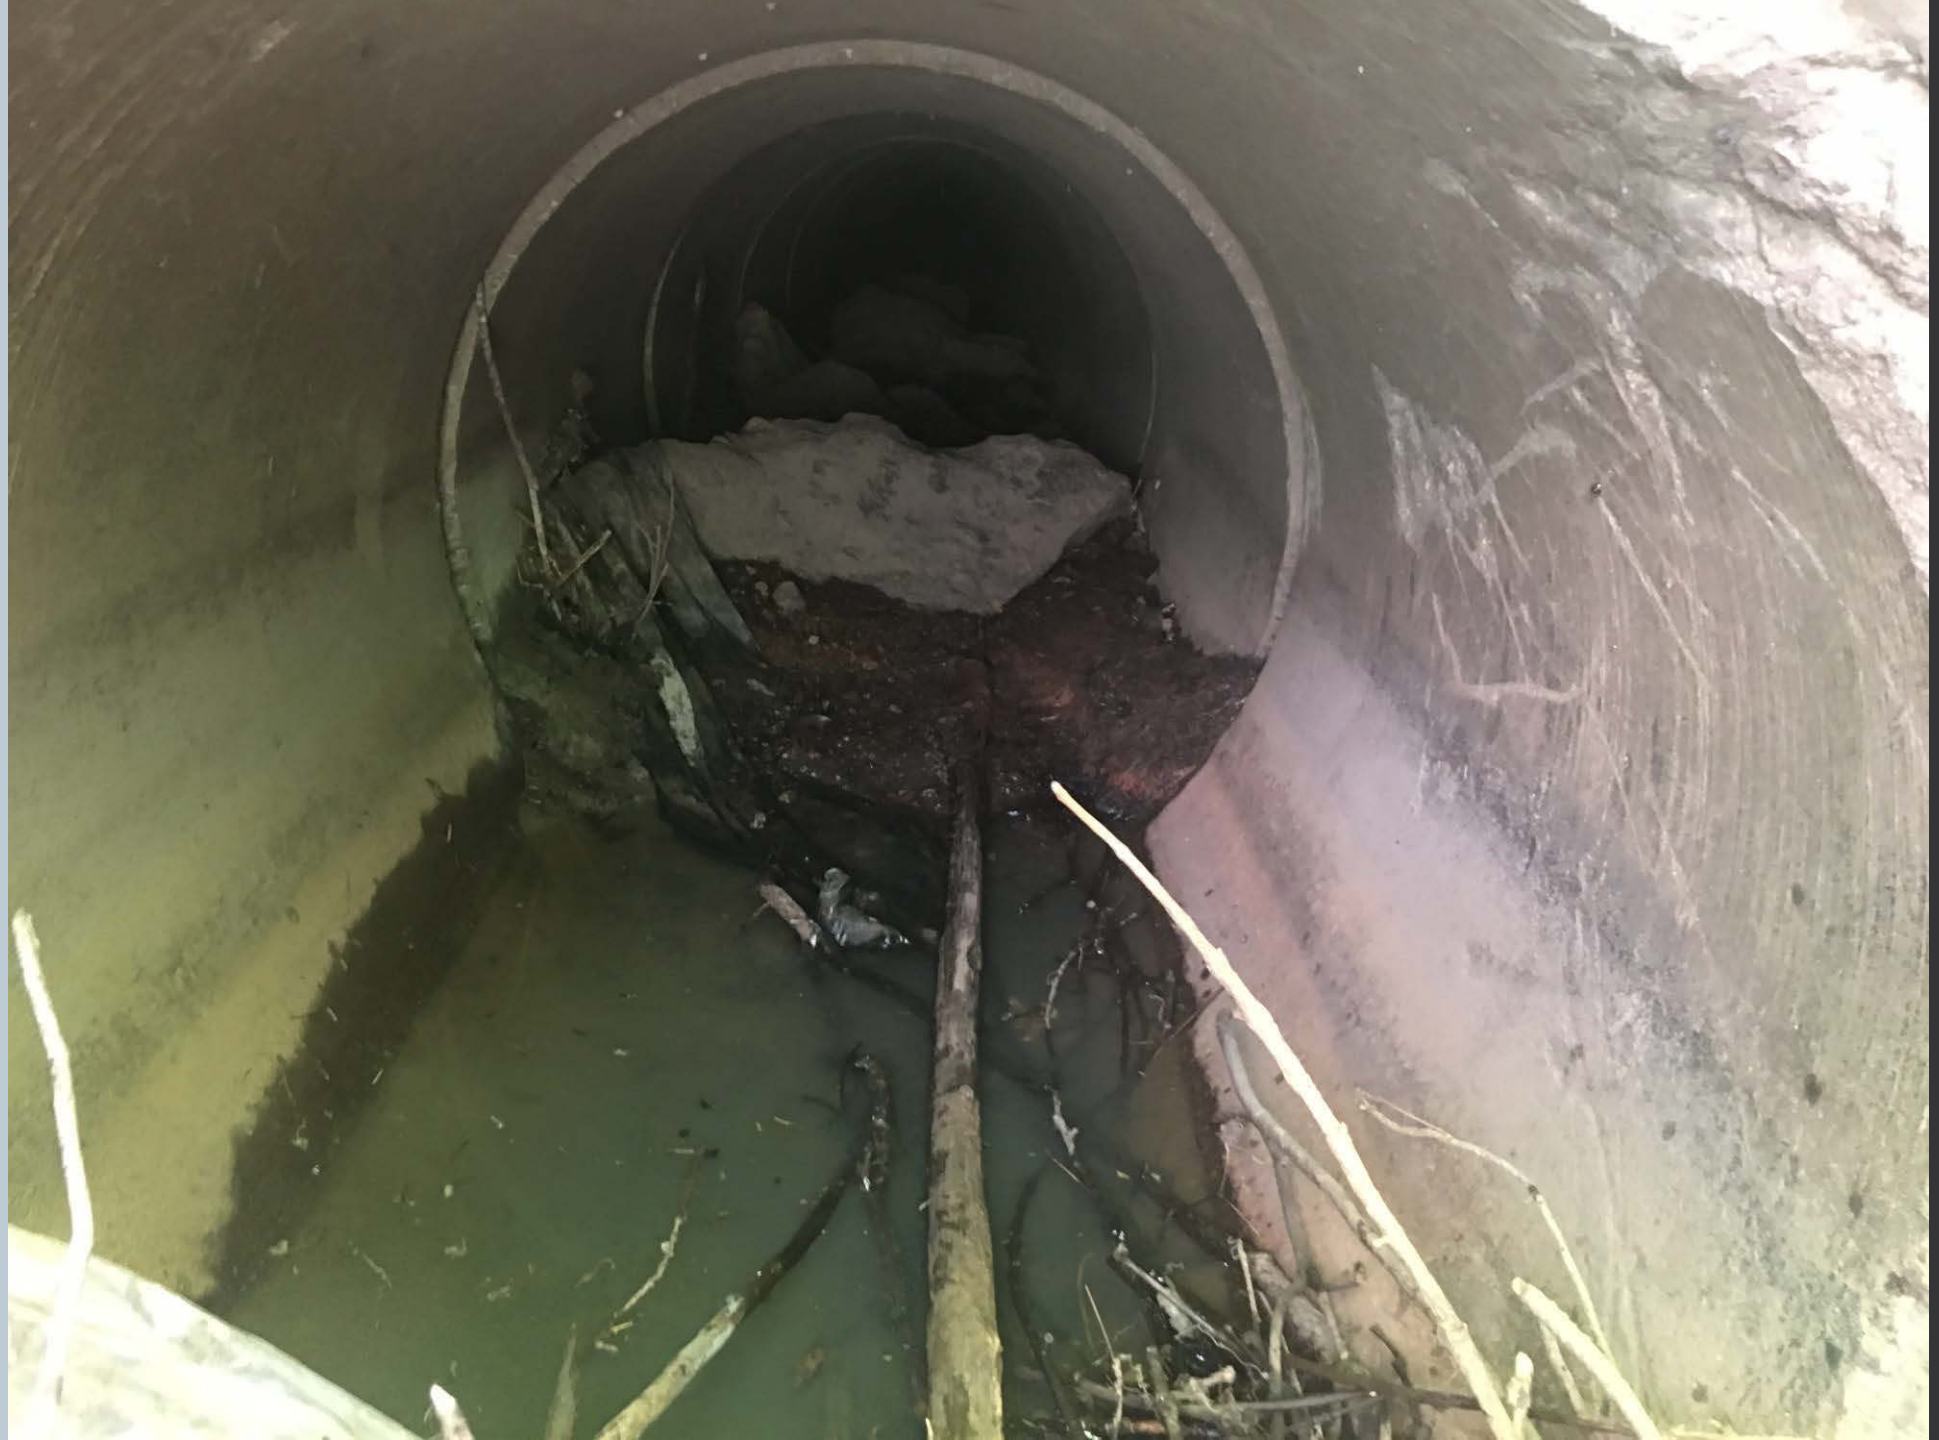
Figure 269. Looking upstream into the large culvert that combines flows from several other culverts beneath the Back Mountain Shopping Center that are draining two unnamed tributaries to Toby Creek. This larger culvert is constructed beneath the Dallas Memorial Highway adjacent to Amelia's and the Gas Station. The other unnamed tributary comes from W. Center Street and N. Pioneer Avenue across from the Cemetery.

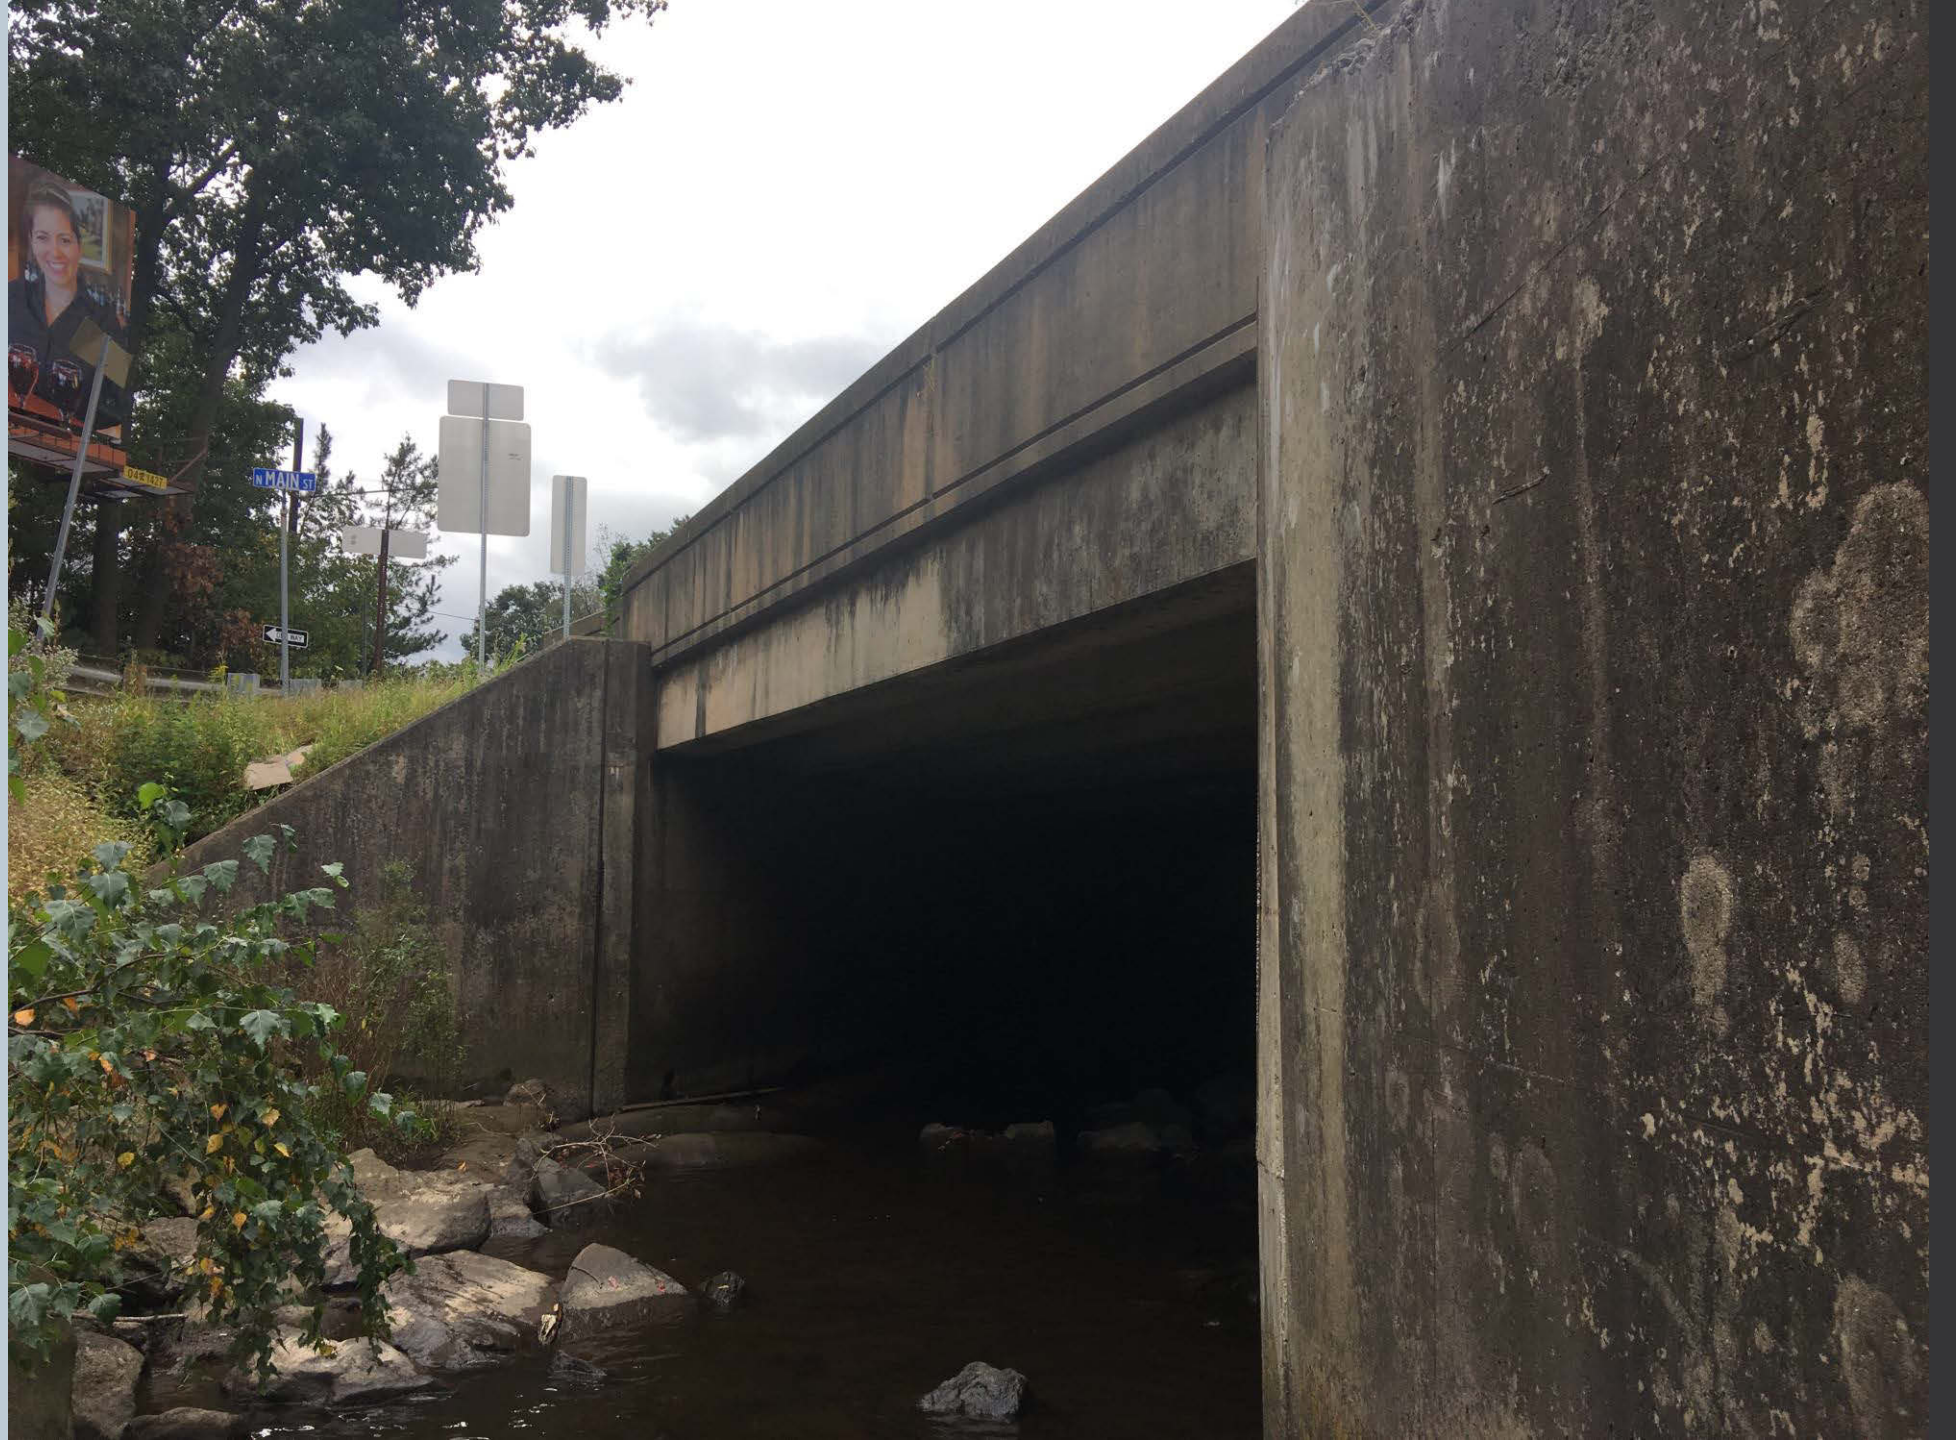
Figure 278. Looking upstream on Toby Creek standing in front of the inlet side of the bridge culvert over the Dallas Memorial Highway. Large rip rap rock has been placed along the streambank along N. Main Street to prevent further erosion. DHL/EPCAMR Volunteer is taking notes.

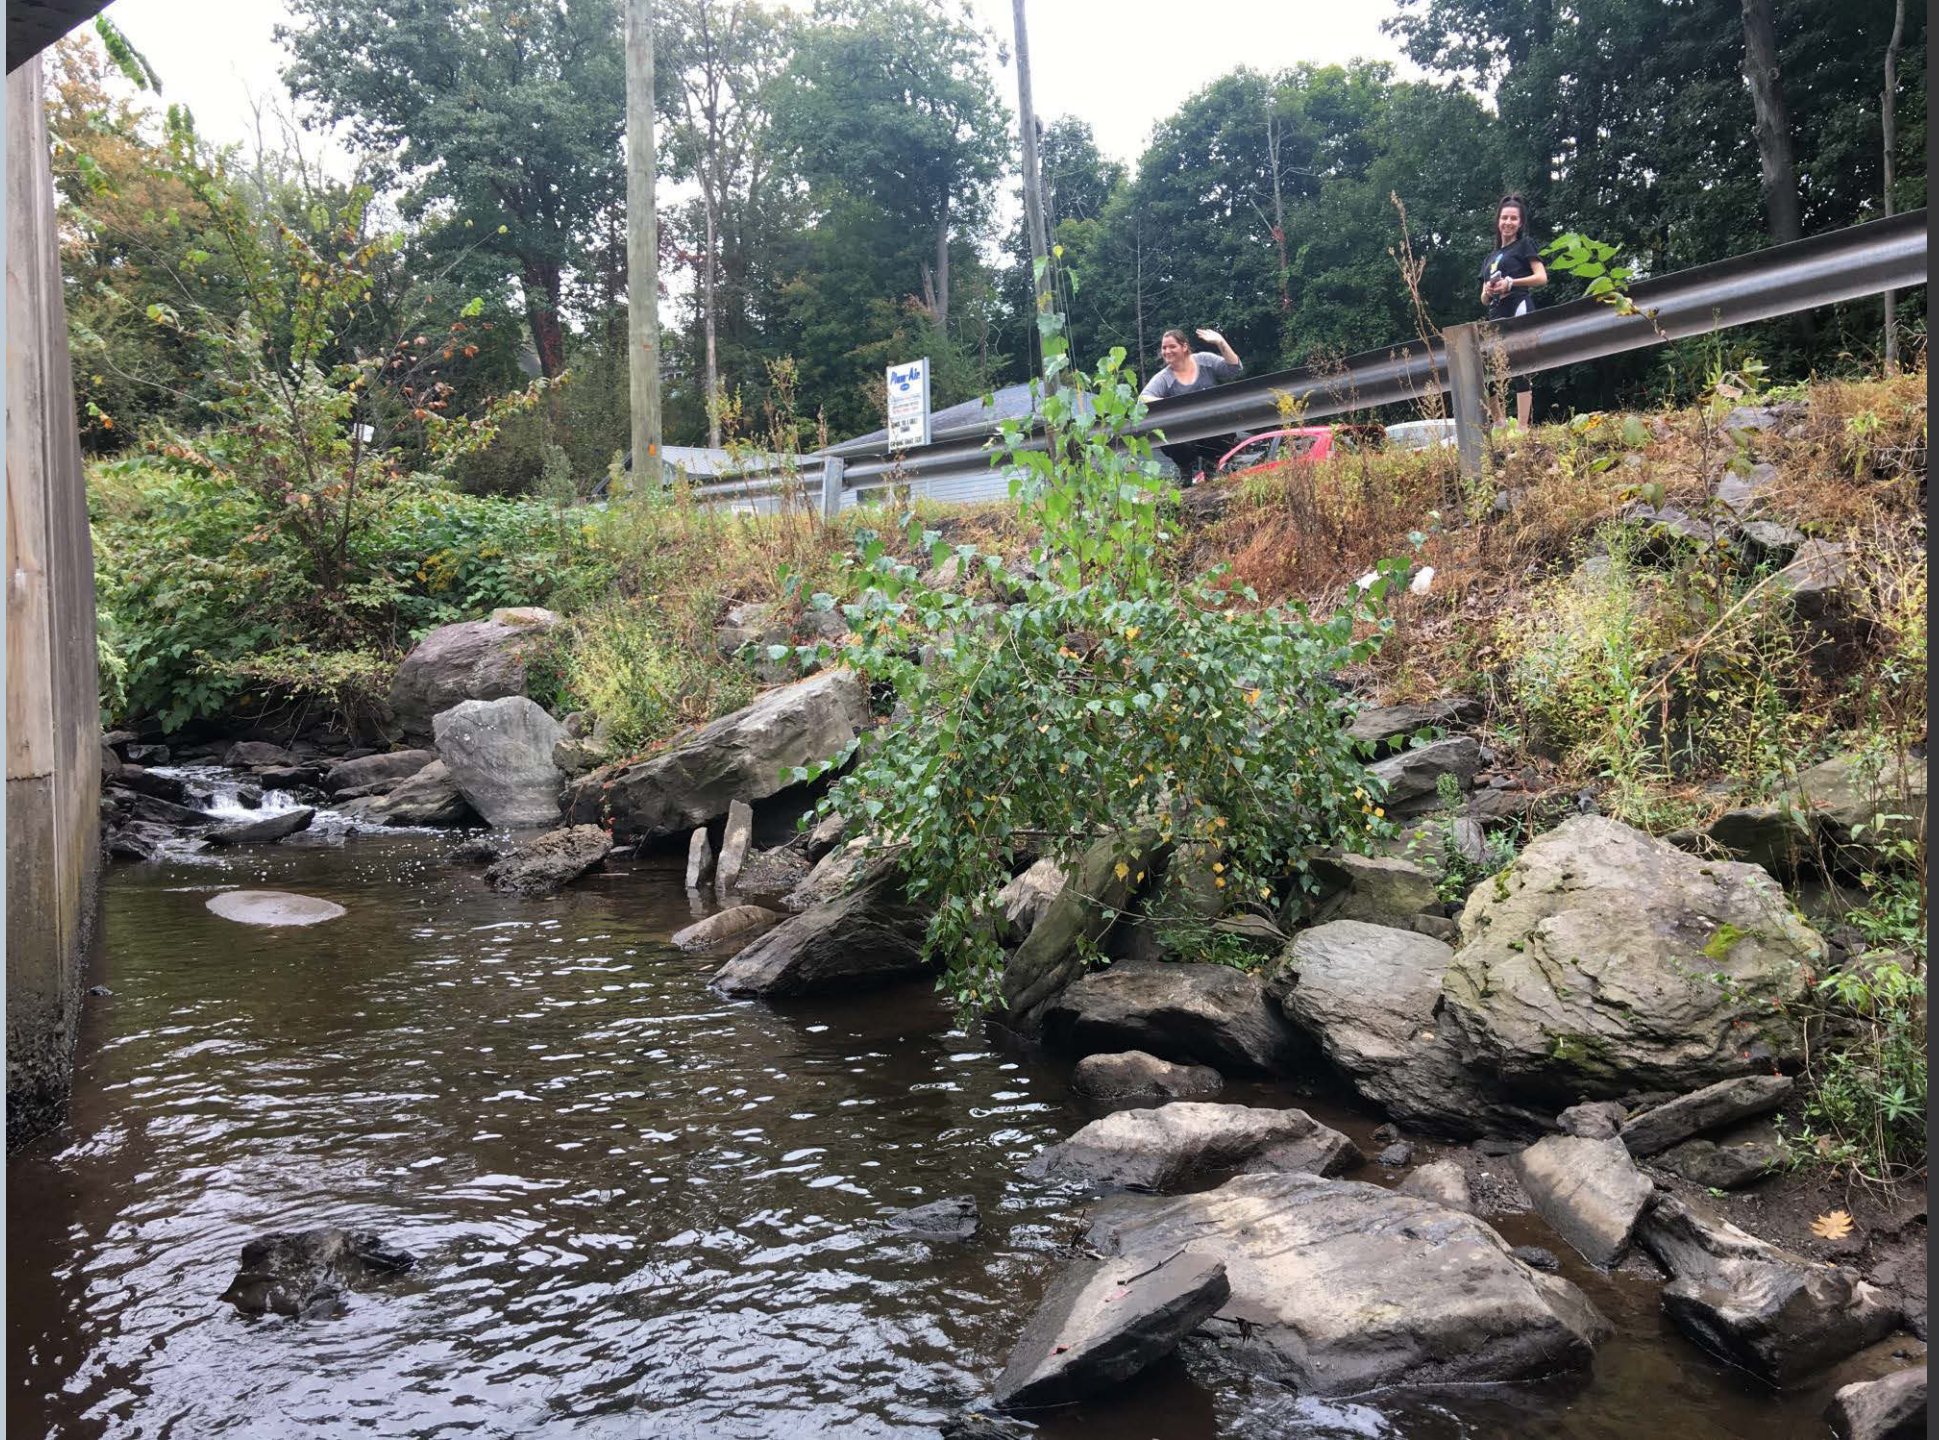
Figure 279. Looking upstream on Toby Creek standing in front of the outlet side of the bridge culvert over the Dallas Memorial Highway on the other side of N. Main Street. Large rip rap rock has been placed along the streambank on the downstream side to prevent to prevent further erosion. DHL/EPCAMR Volunteers are taking culvert measurements for aquatic organism passage.

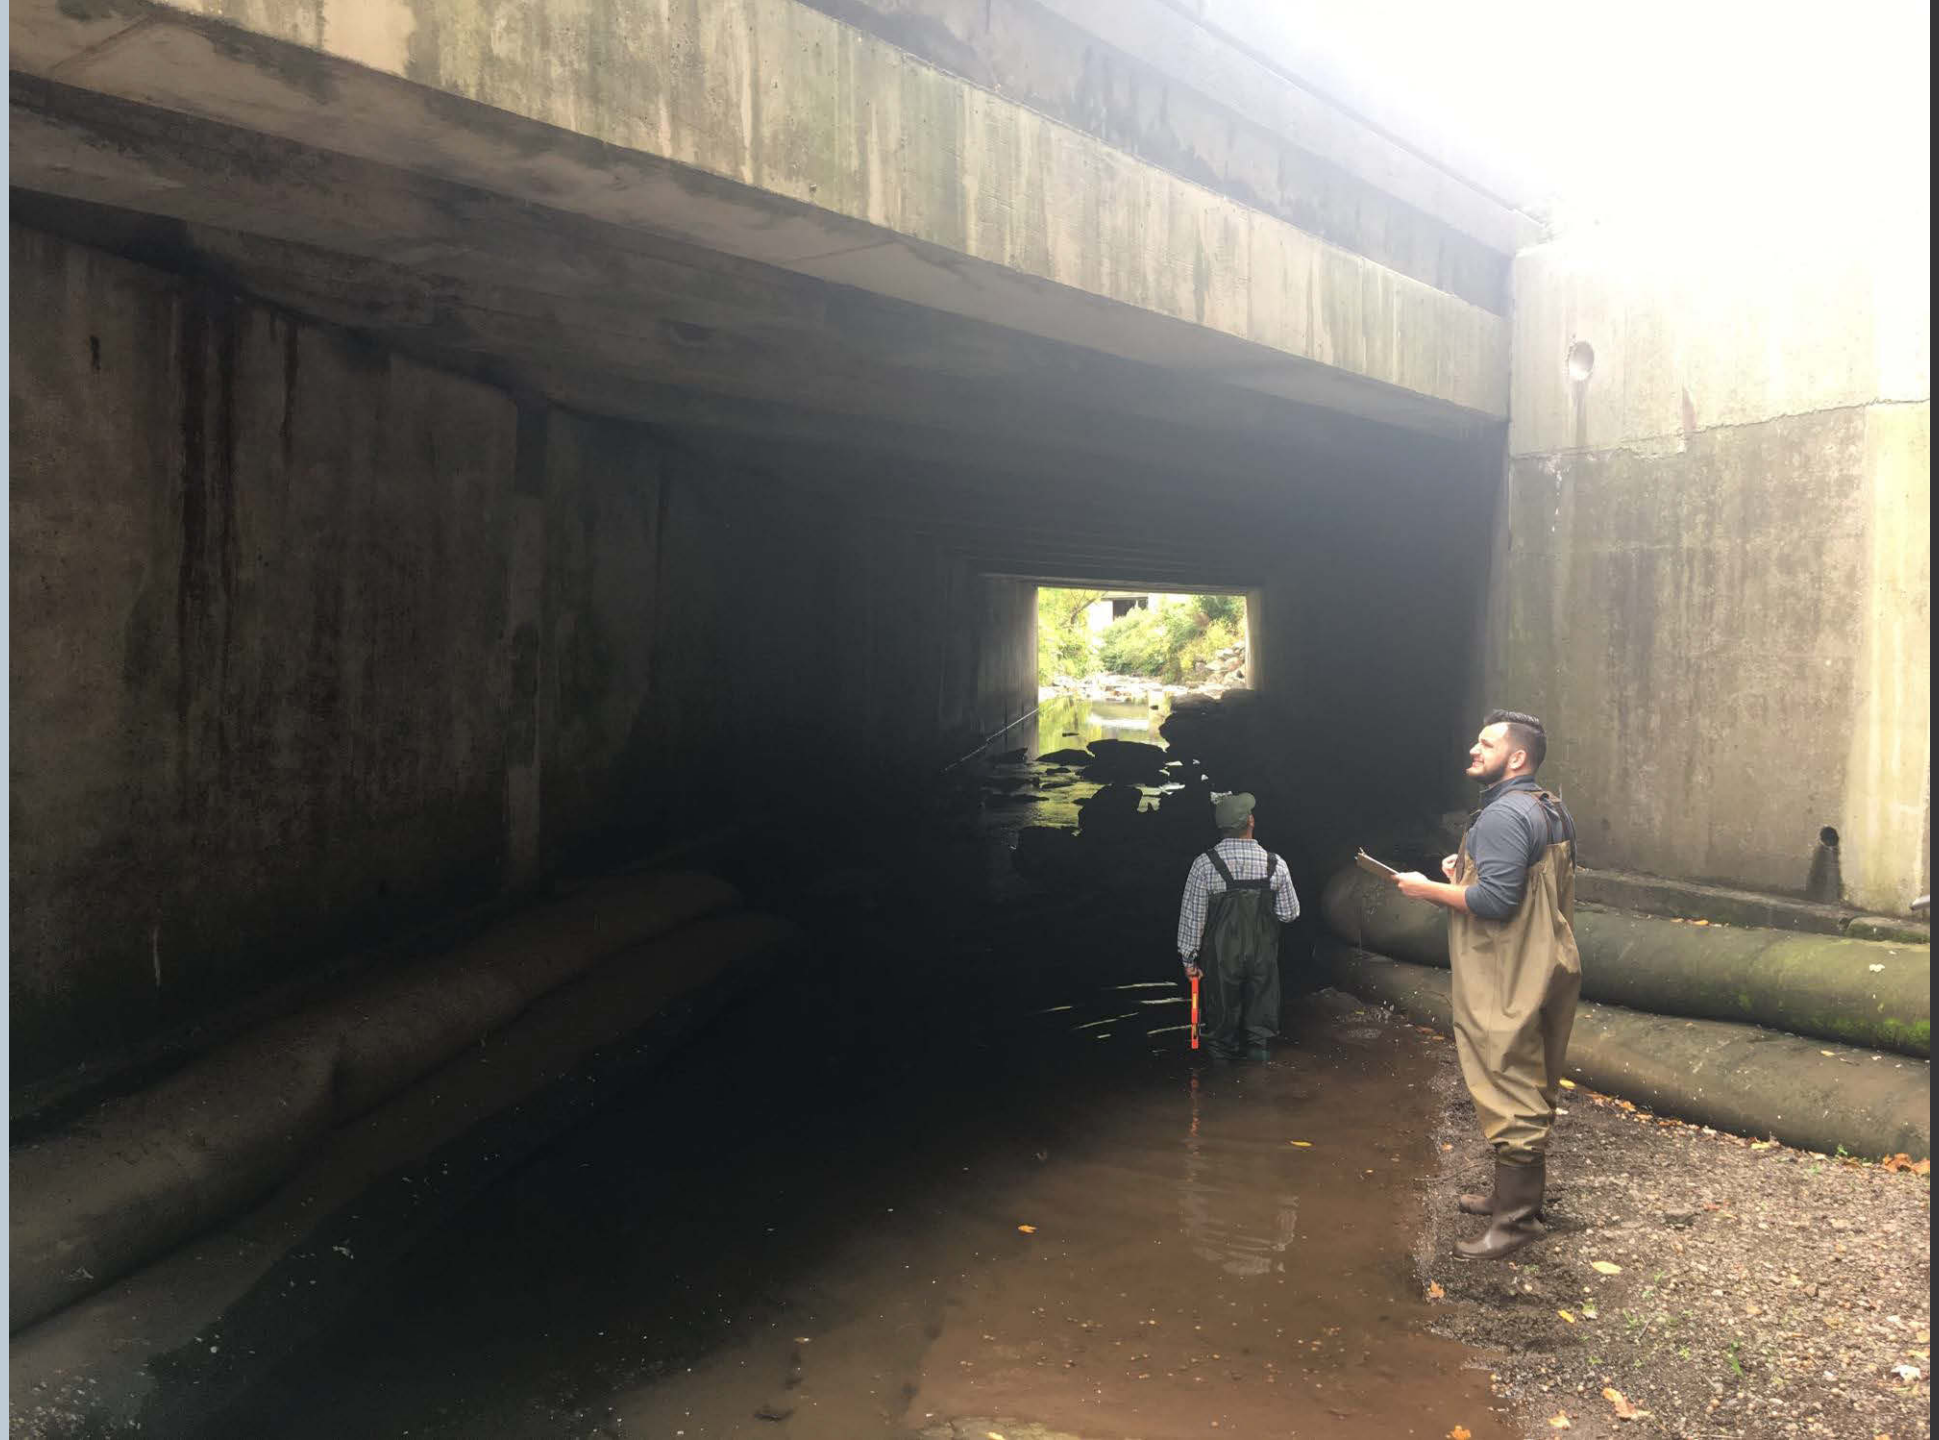
Figure 283. Looking downstream on Toby Creek standing in front of the outlet side of the bridge culvert over the Dallas Memorial Highway. DHL/EPCAMR Volunteer was taking culvert measurements for aquatic organism passage while standing in a large pool that was sediment-laden.

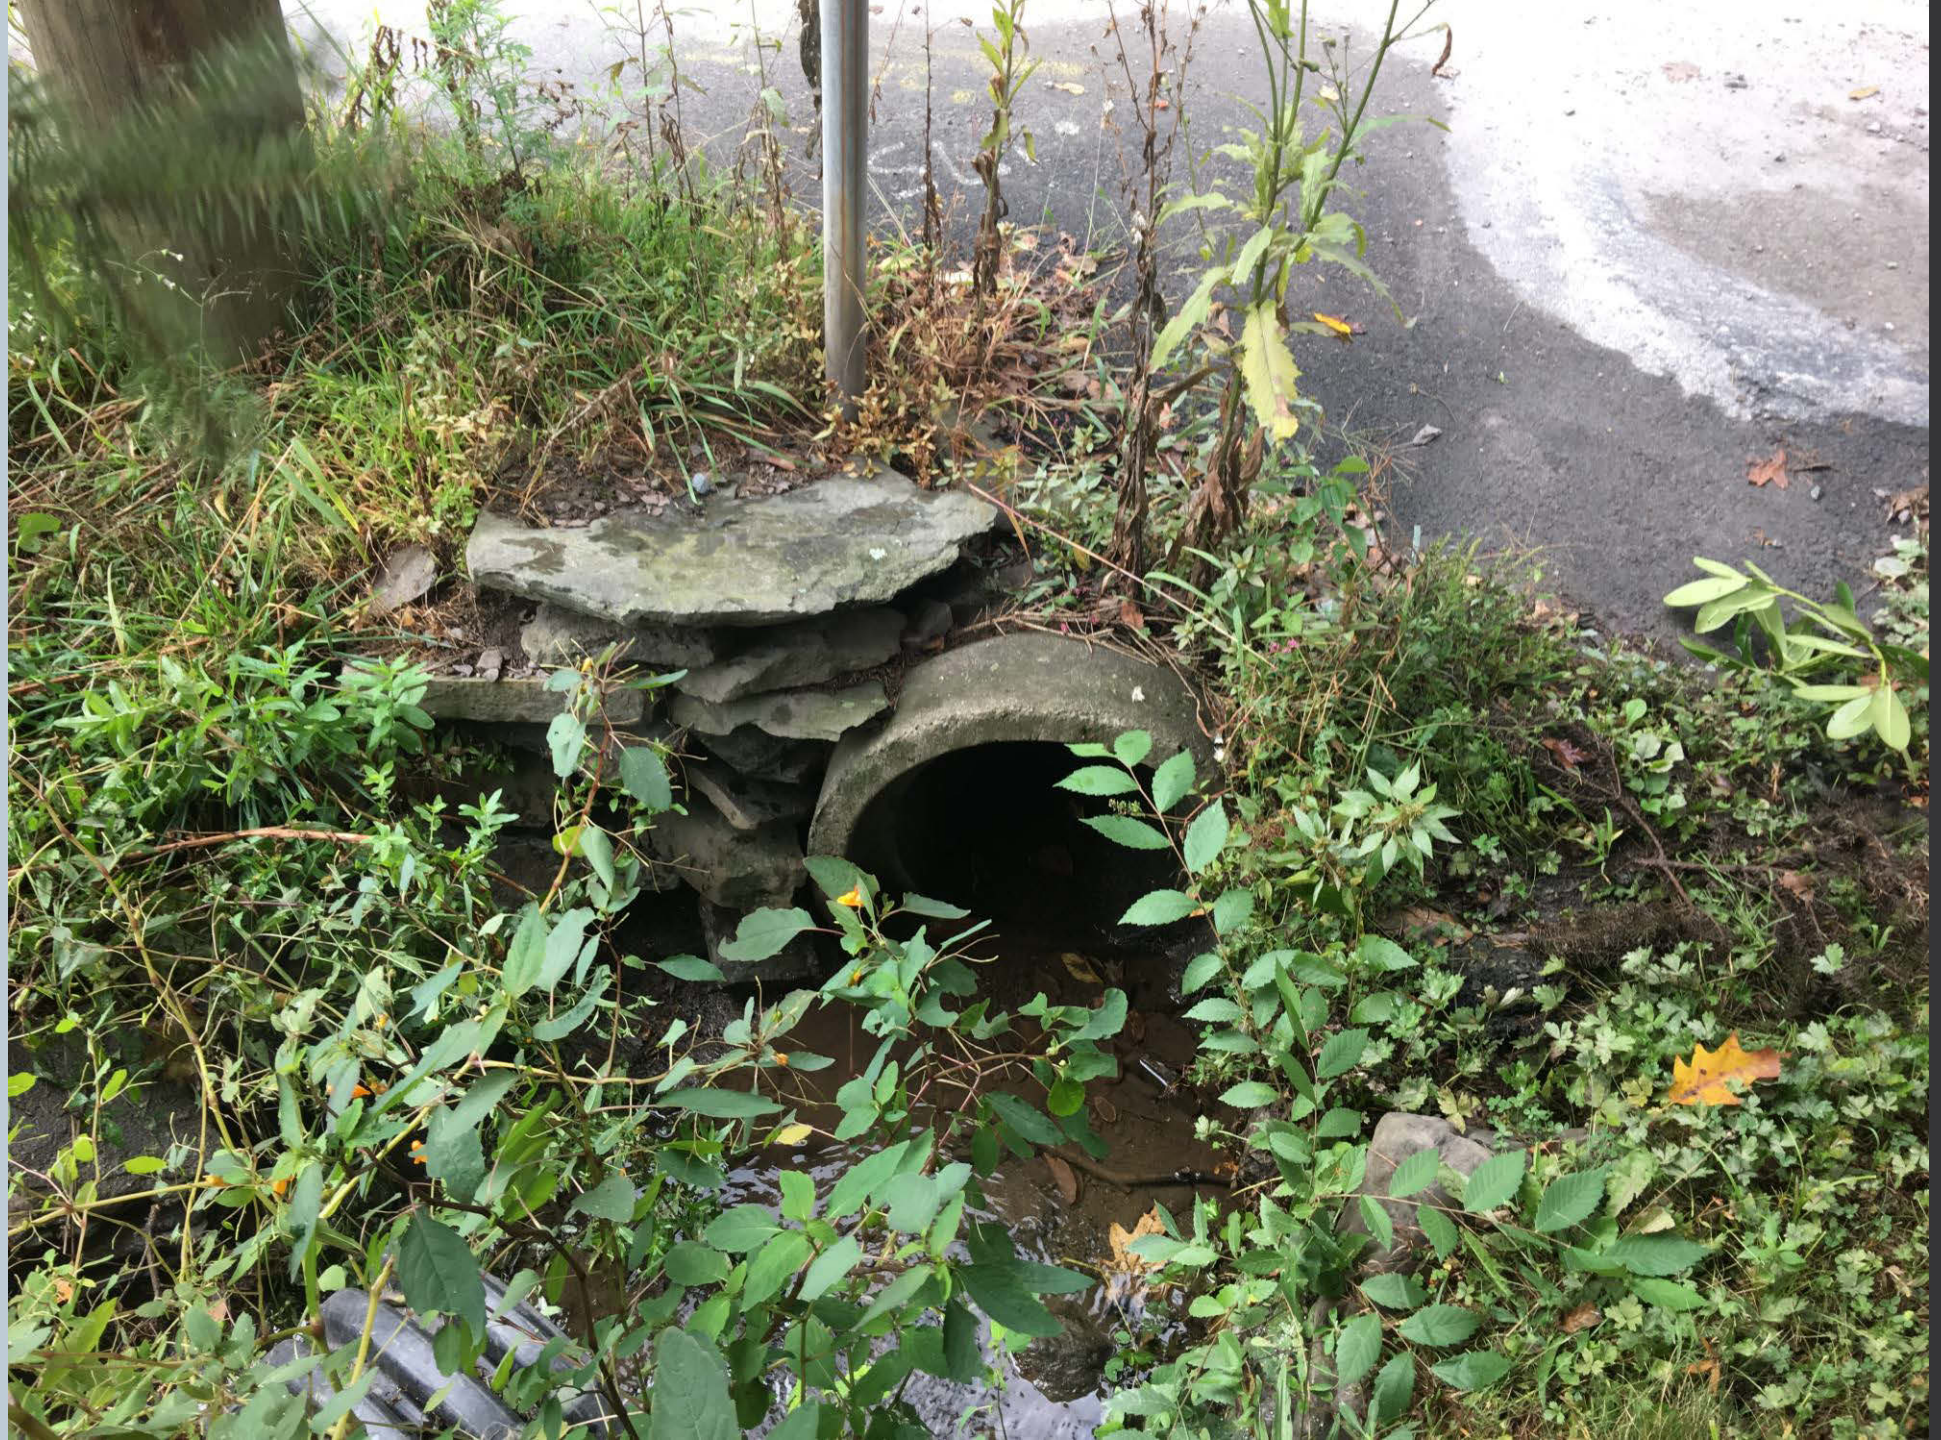
Figure 287.
Looking
downstream at a
concrete pipe
culvert that is
carrying flow from
an unnamed
tributary to Toby
Creek that flows
along Division
Street down to the
intersection with
N. Main Street
that drops into a
scour pool and then
flows into the
concrete pipe
before crossing N.
Main Street
creating another
scour pool before
entering Toby
Creek.

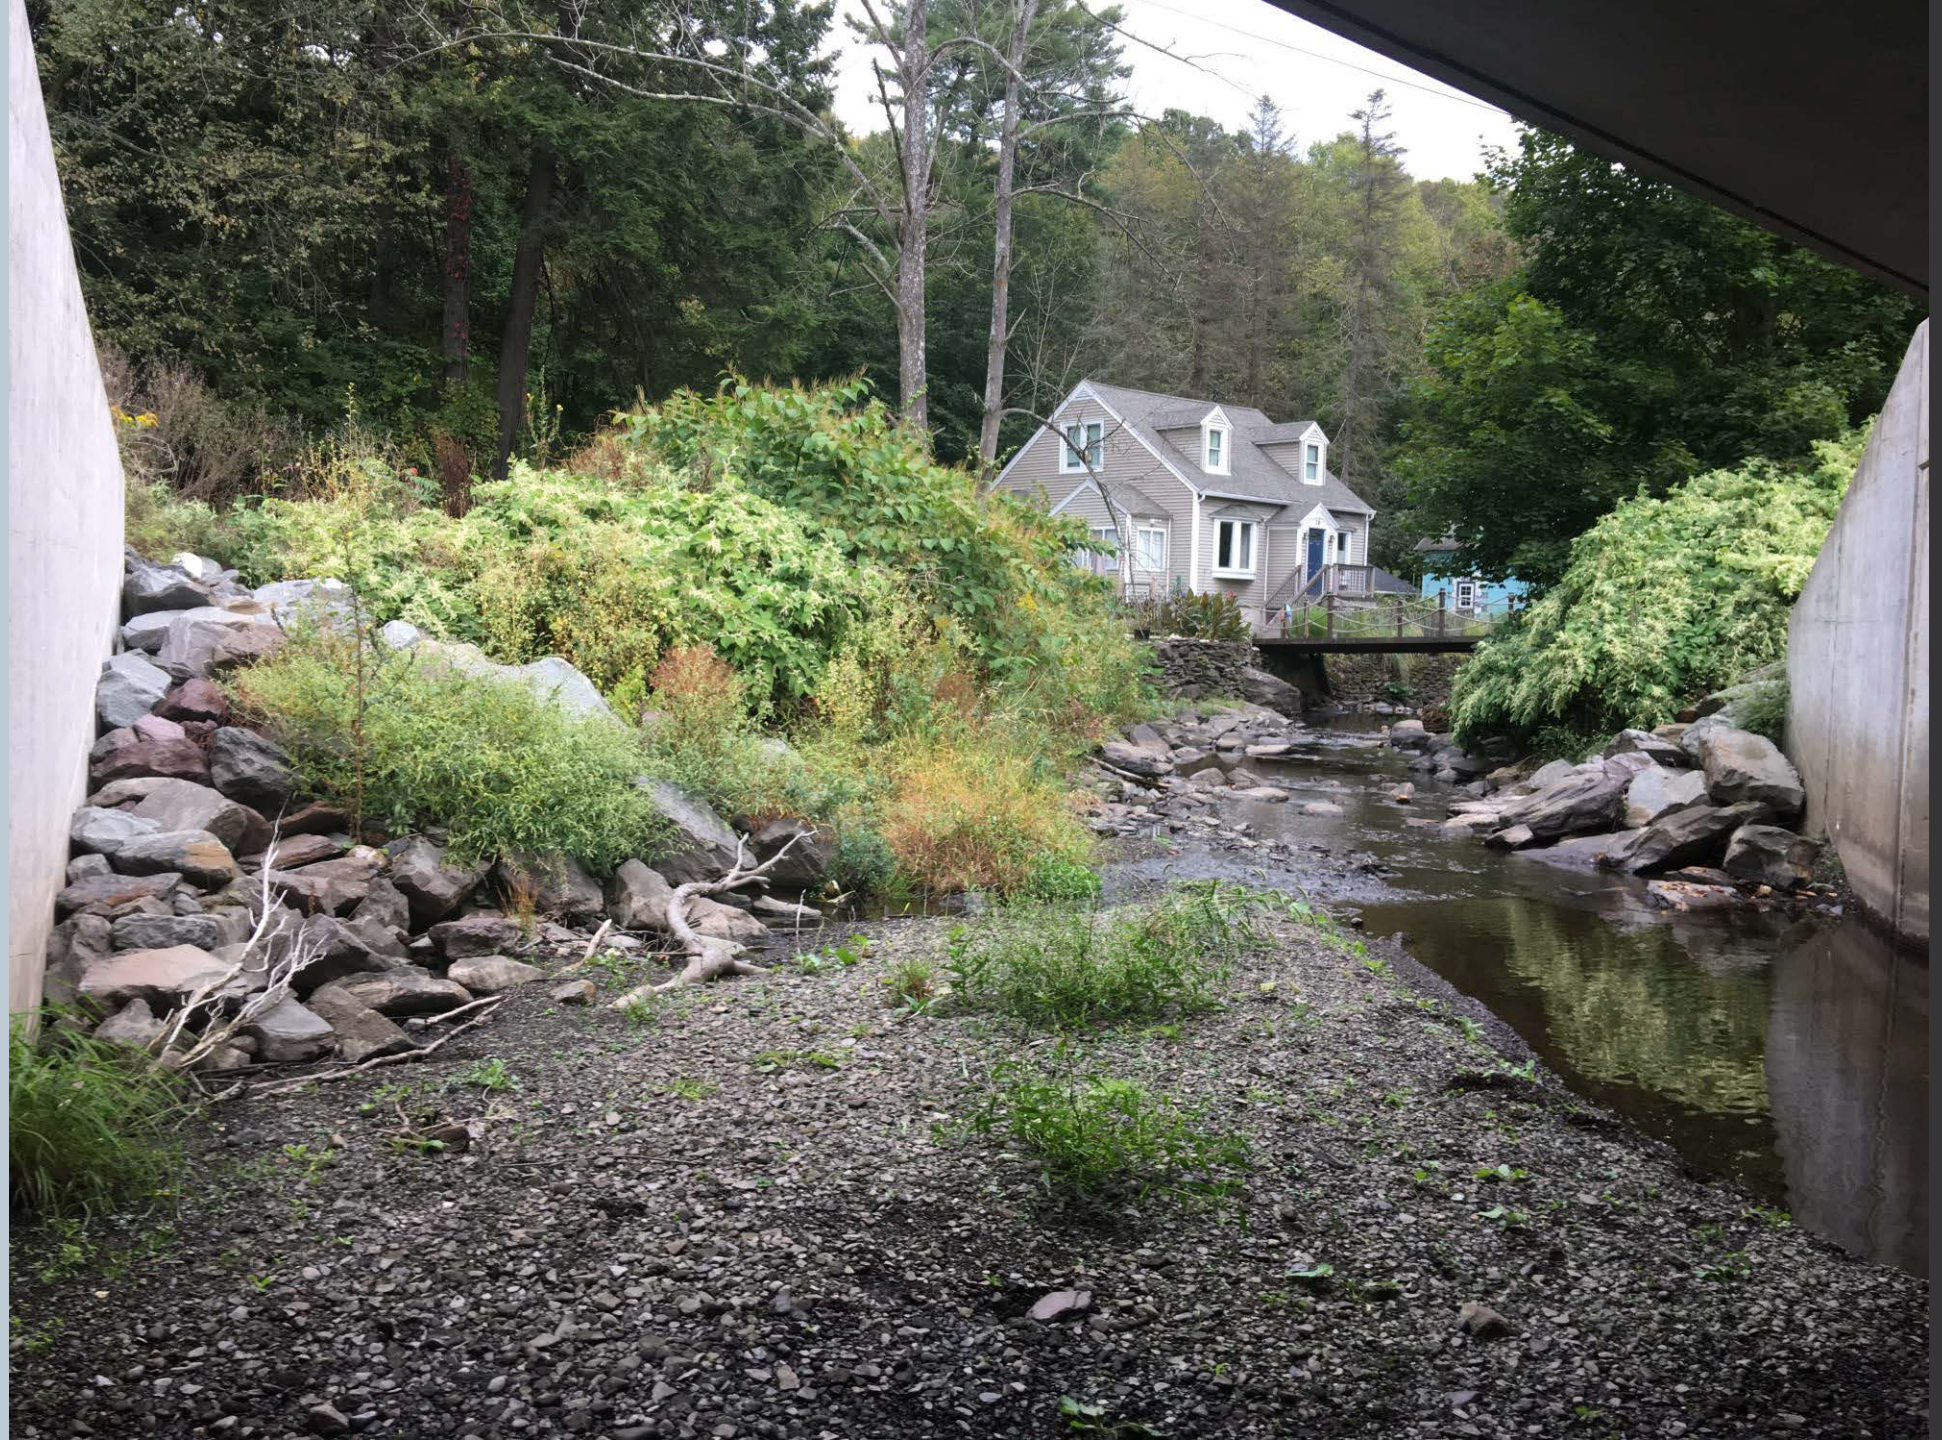
Figure 293. Looking downstream on Toby Creek along W. Center Street and a Great Blue Heron can be seen plucking fish from the stream channel while we were assessing the culvert and the stream.

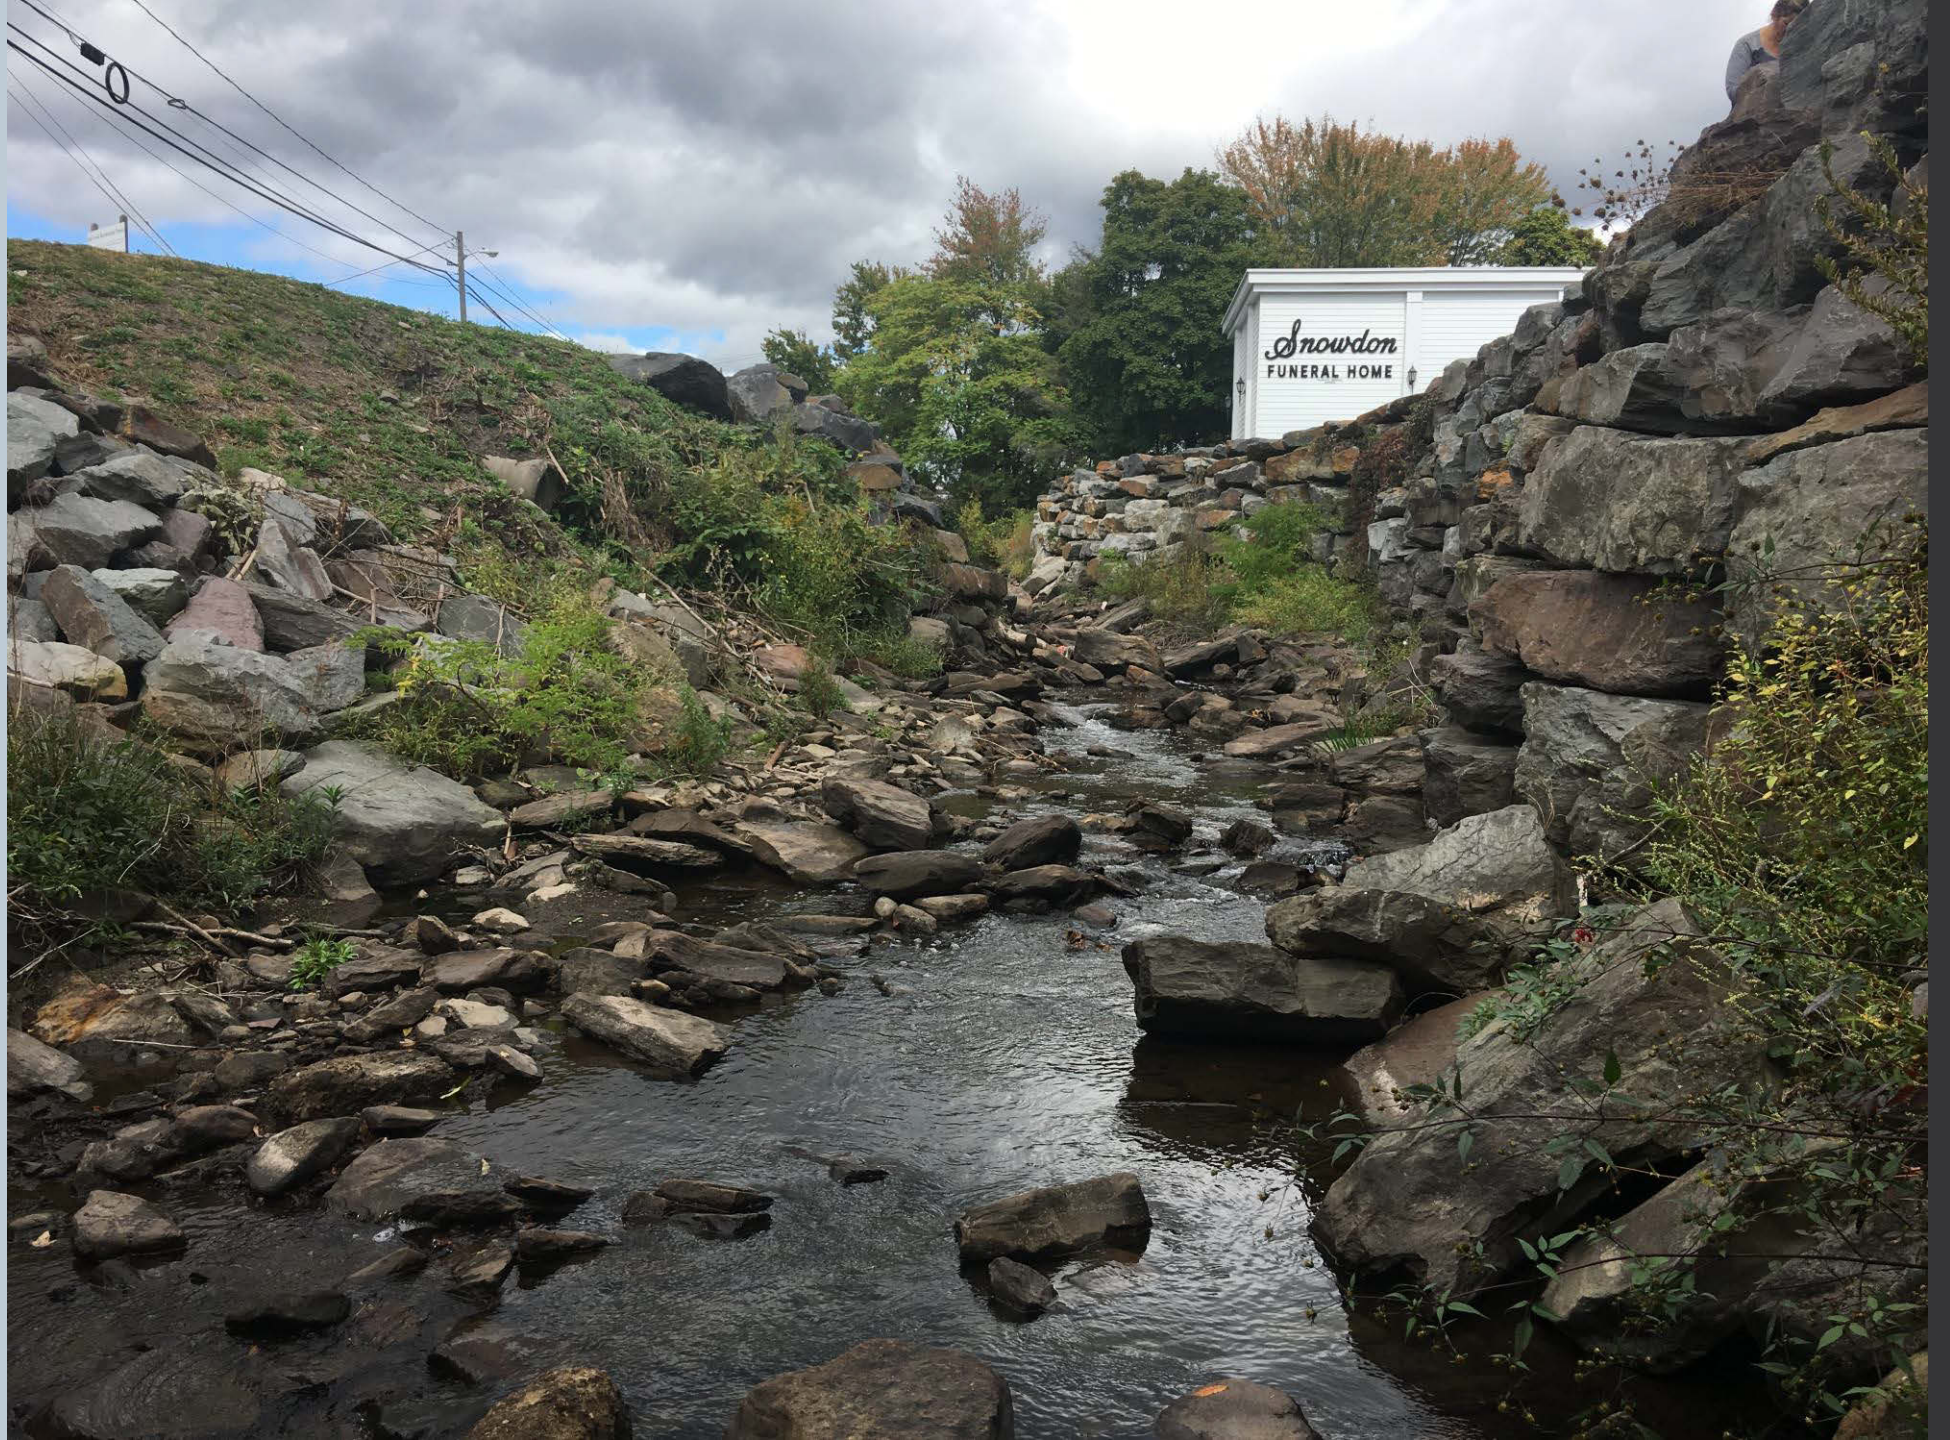
Figure 296.
DHL/EPCAMR
Volunteers and
DAMA Stormwater
Coordinator take
notes on the
stormwater pipe
entering Toby
Creek from W.
Center Street and
the Dallas
Memorial Highway
and grab a GPS
location for the
culvert.
