Toby Creek Field Reconnaissance Observations

September 26, 2018

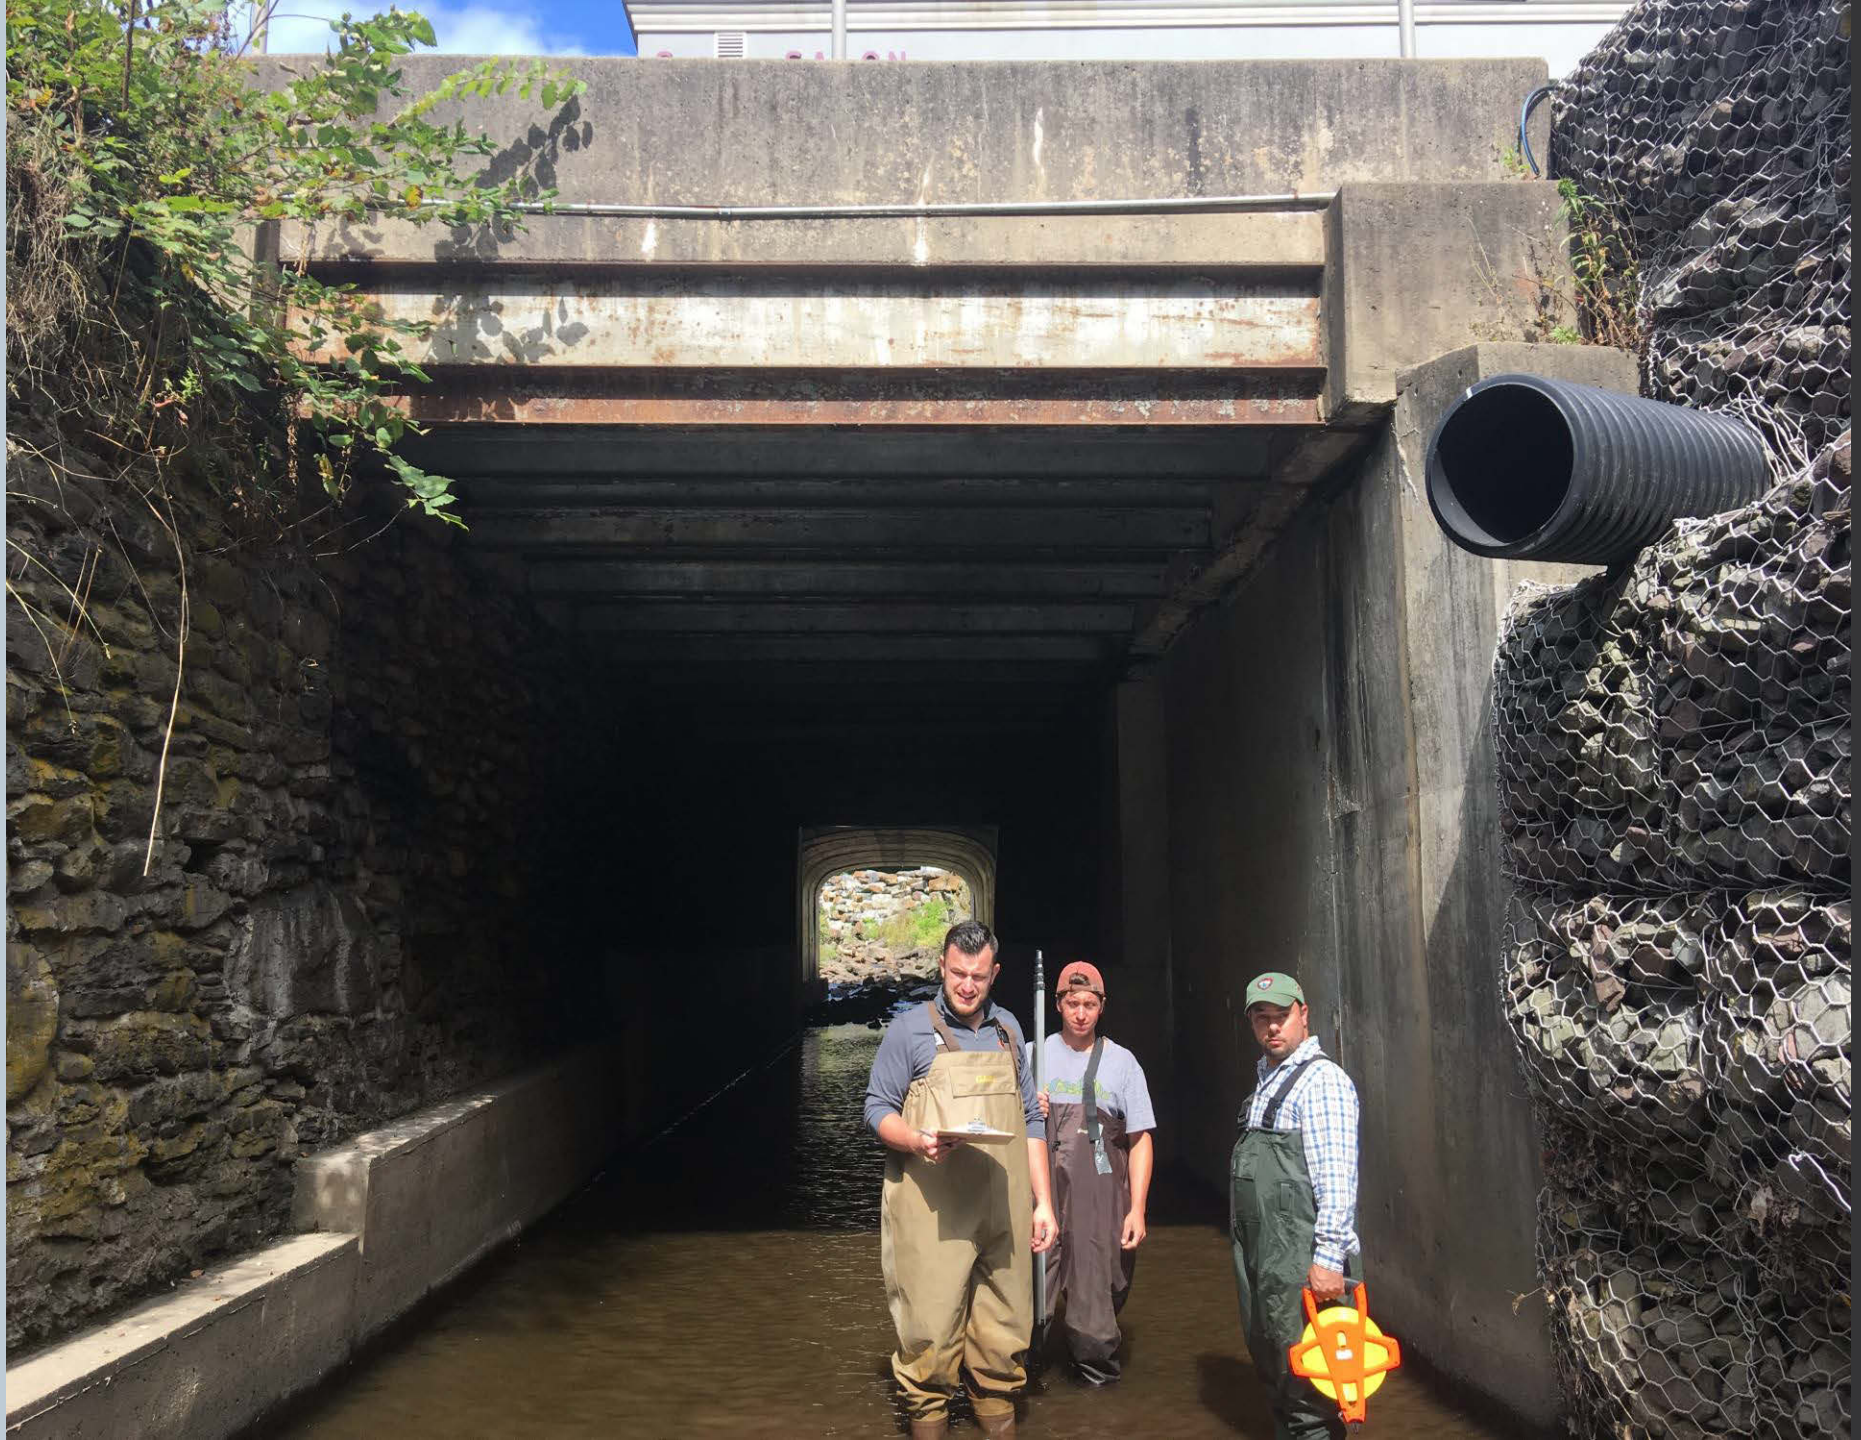
Figure 299. Bridge culvert over Carverton Road adjacent to the Trucksville Pocket Park. A stormwater corrugated metal pipe is pointed directly into the unnamed tributary causing a scour pool formation below the concrete dam. Heavy sediment below the concrete dam. Fish present below the outlet of the culvert. This dam is impeding aquatic passage. Recommend design and construction of a step pool feature to allow for fish passage and realignment and grading of the stormwater pipe along the right bank looking upstream.

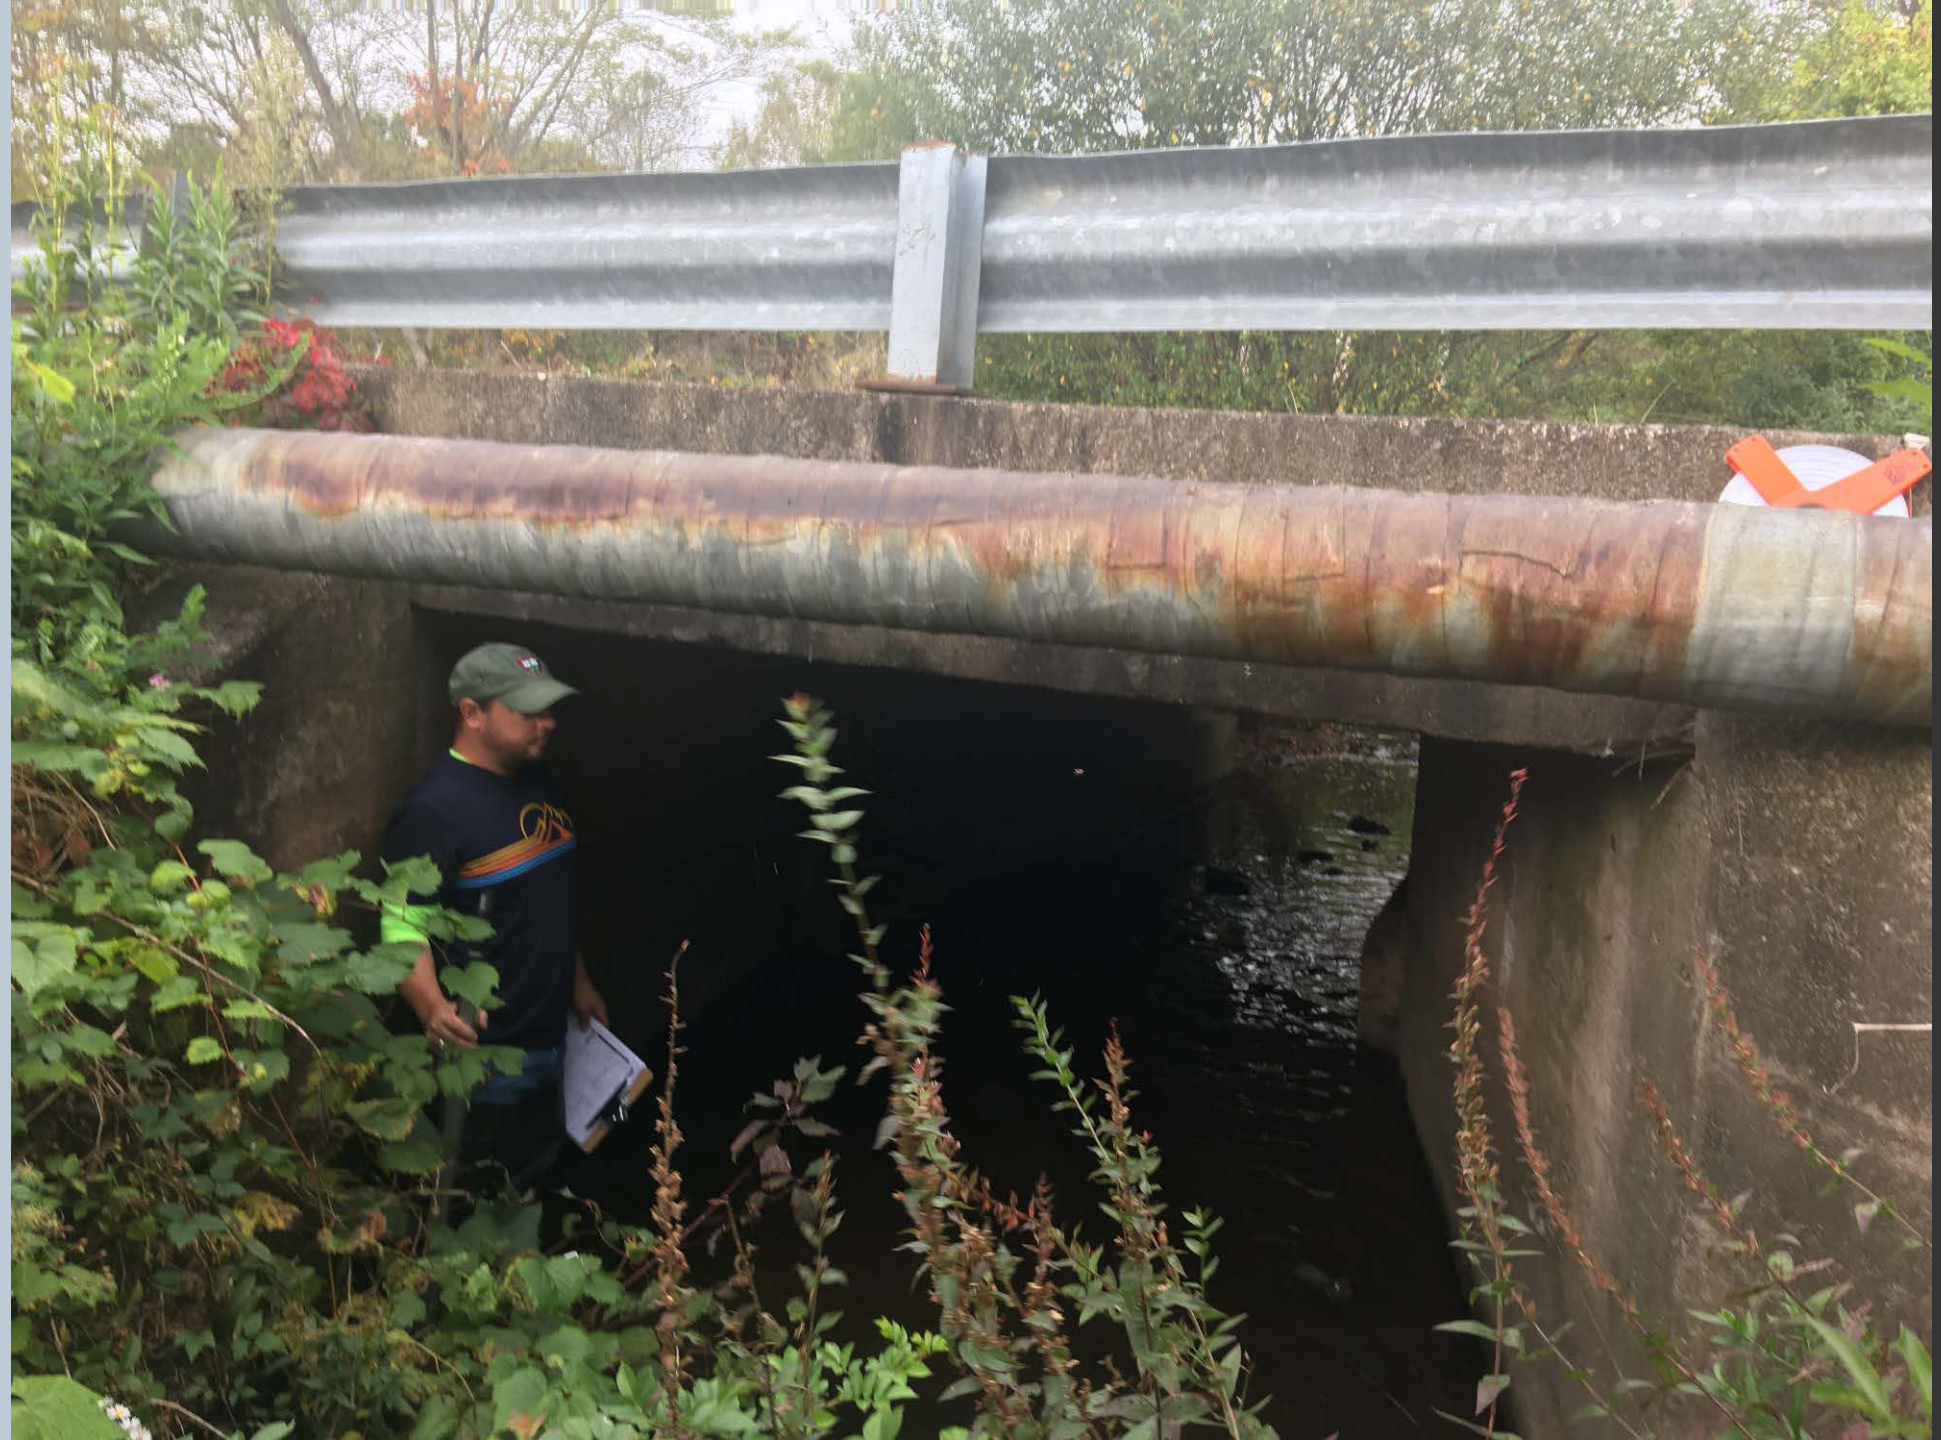
Figure 307.
Looking upstream
on stormwater
forebay at the
entrance to
Windsor Farms
development on an
unnamed tributary
to Toby Creek
along Manor
Drive.

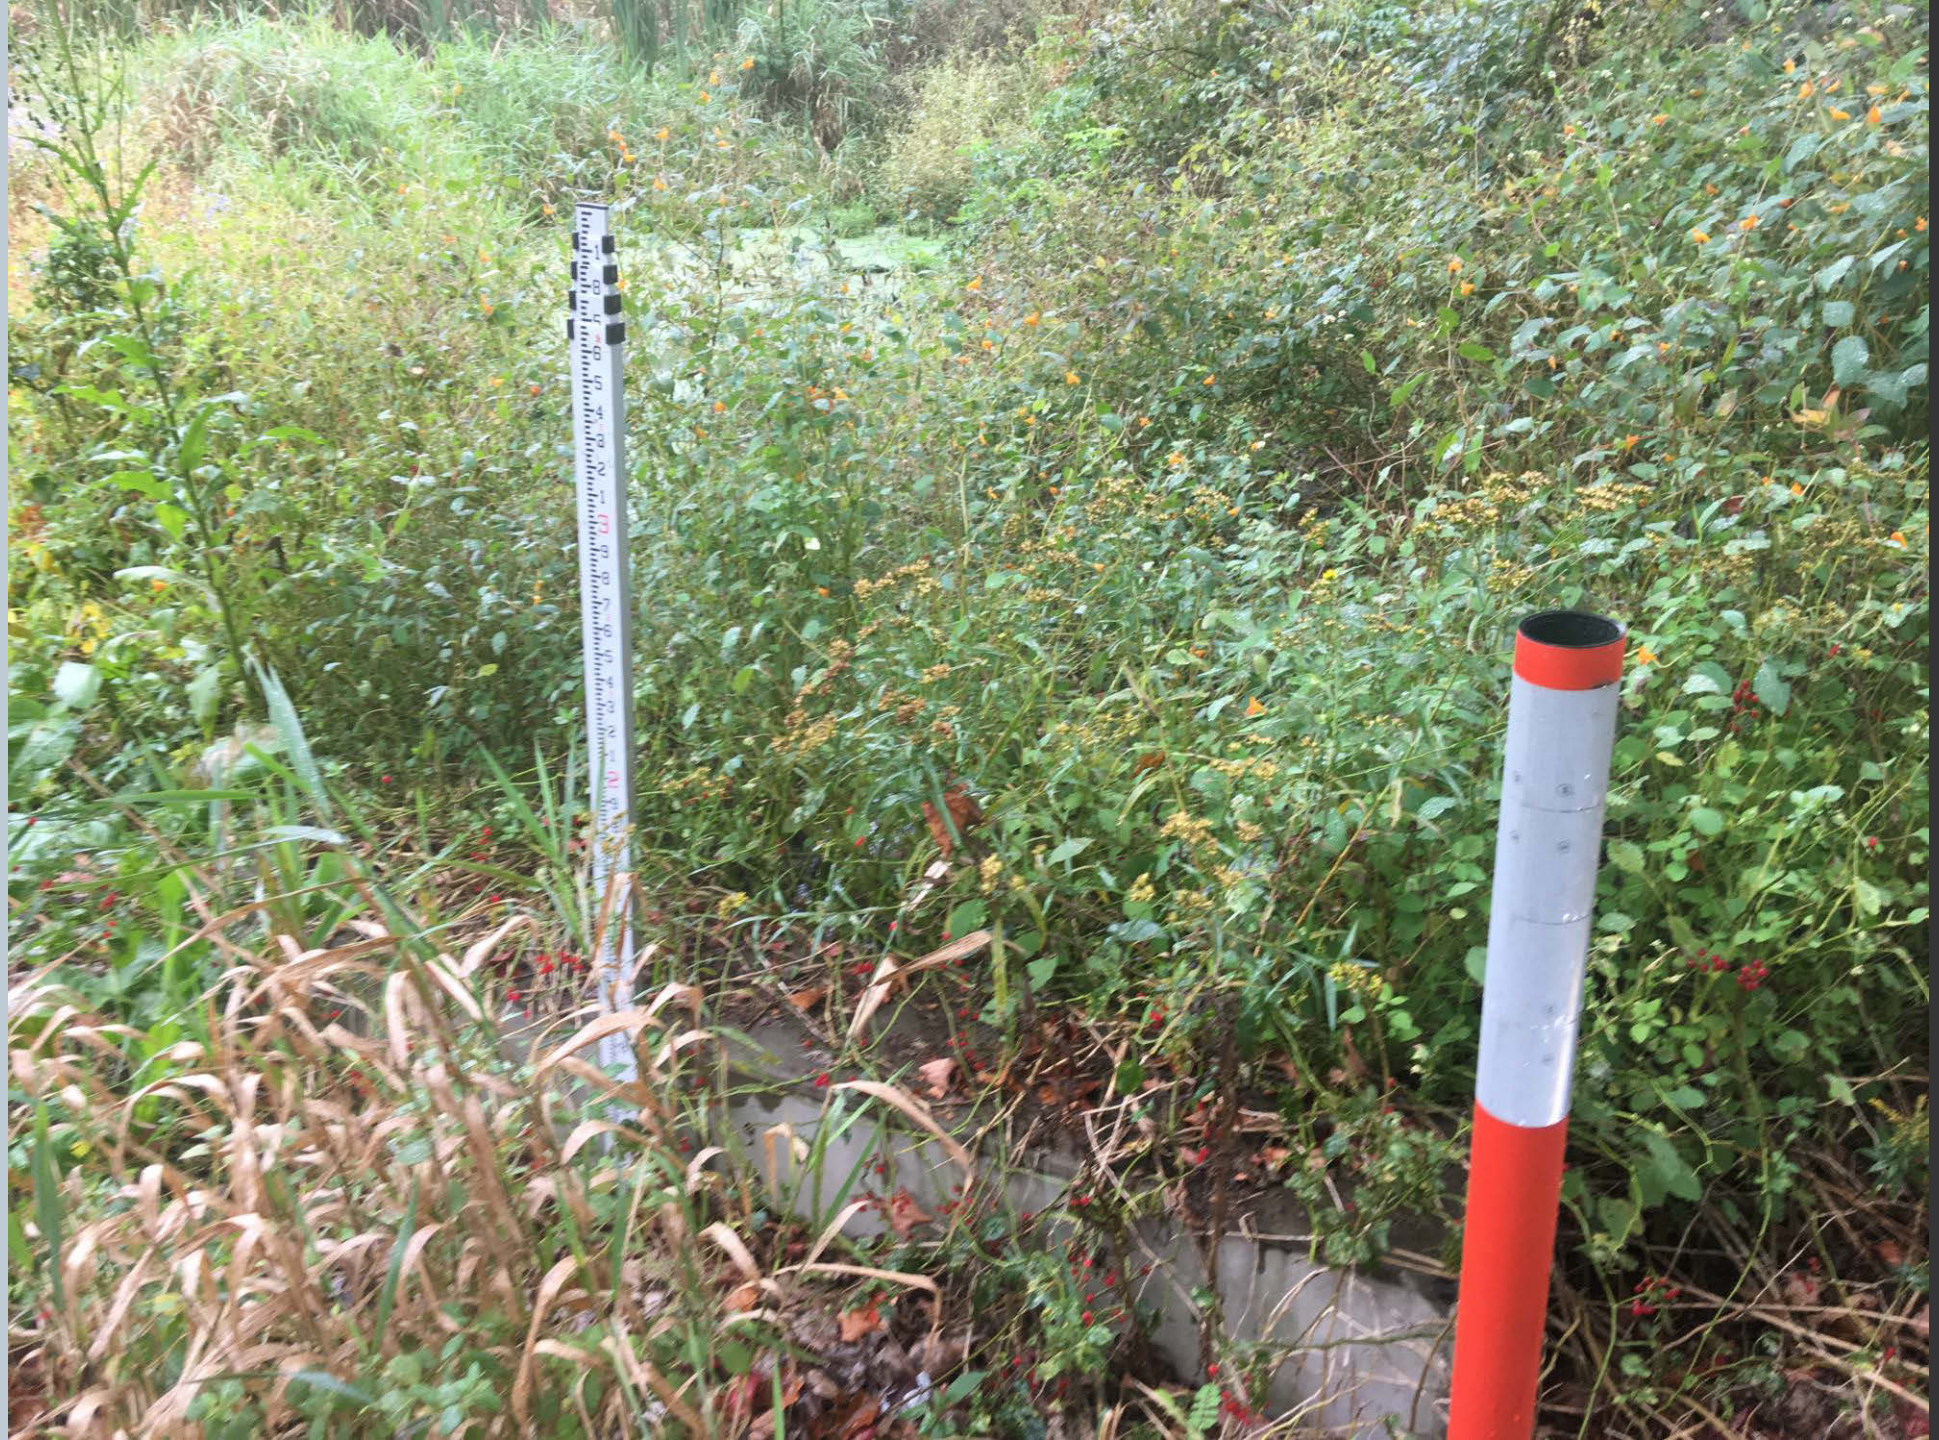
Figure 308.
Looking
downstream on
stormwater
forebay at the
entrance to
Windsor Farms
development on
an unnamed
tributary to Toby
Creek along
Manor Drive.
Lots of poison ivy
present and
jewelweed.

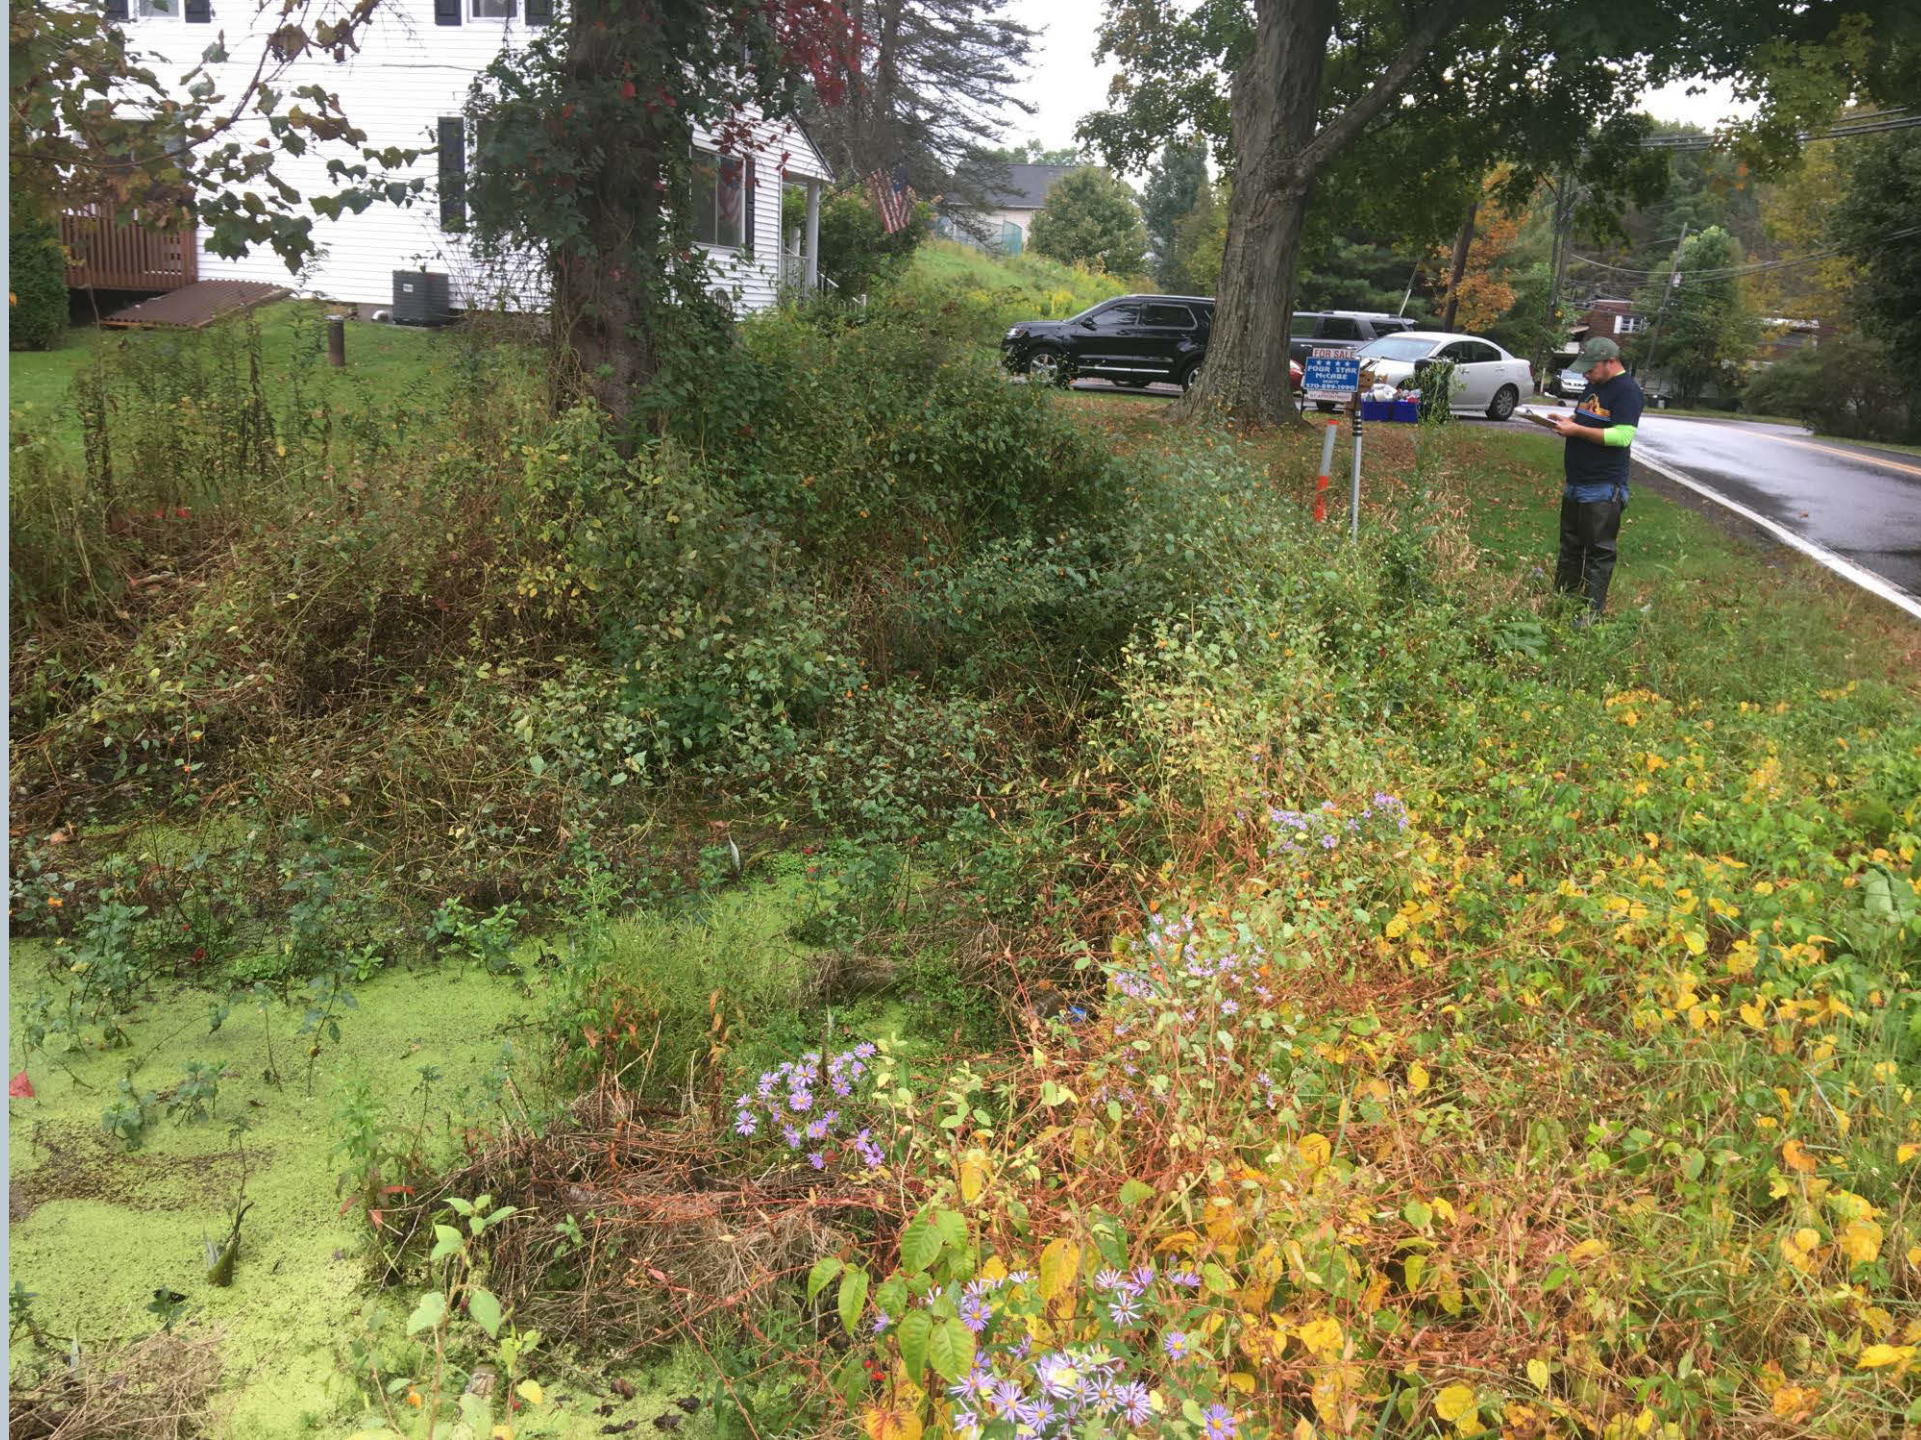
Figure 309.
Looking
downstream on
stormwater
forebay at the
entrance to
Windsor Farms
development on
an unnamed
tributary to Toby
Creek along
Manor Drive.

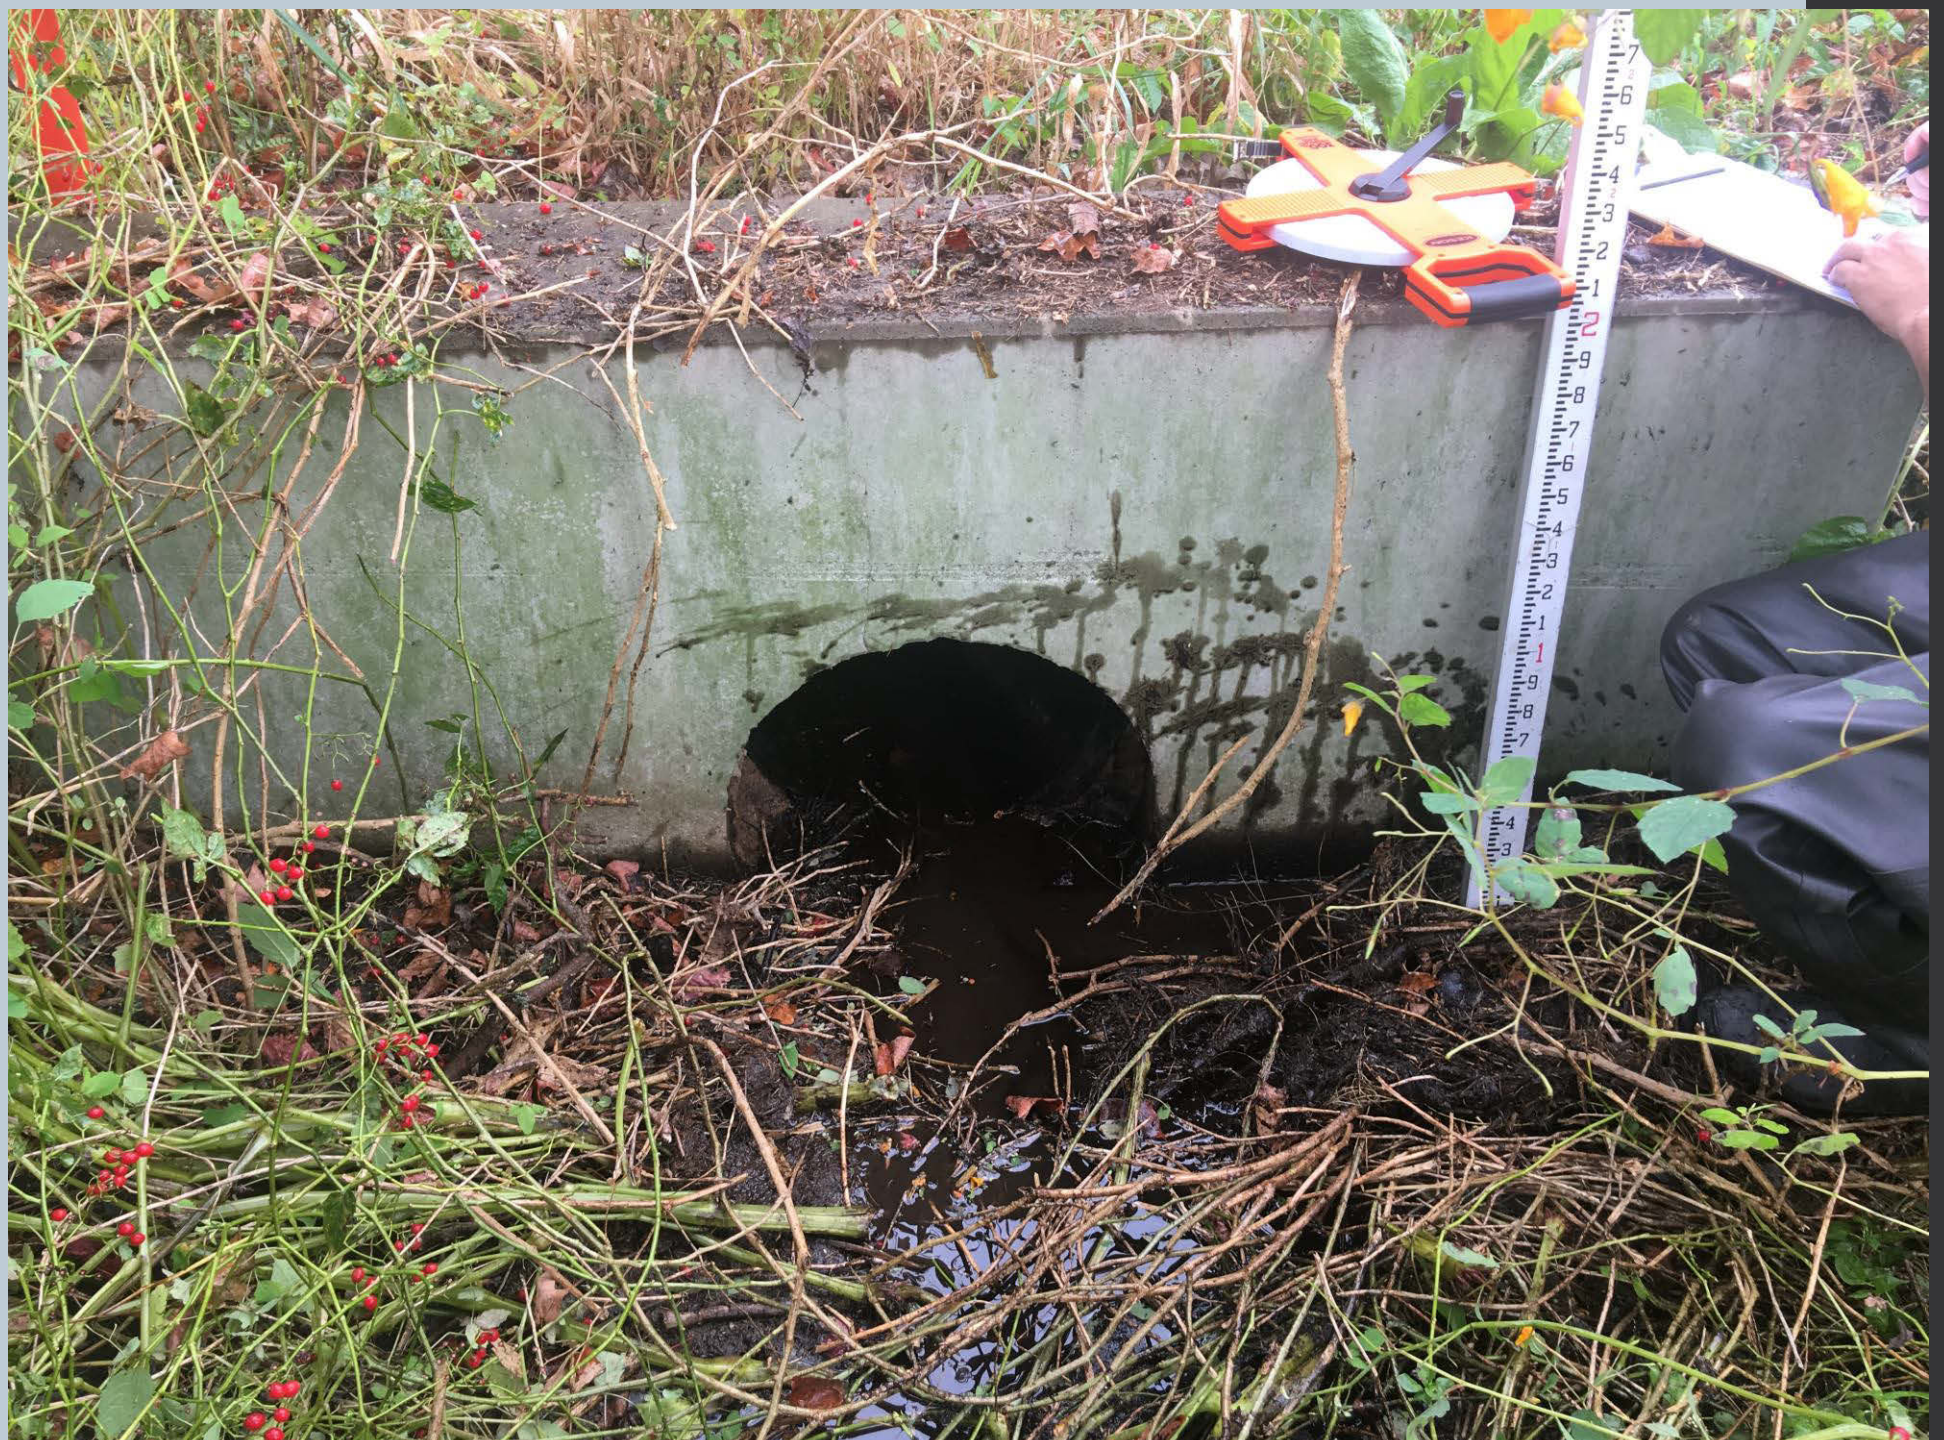
Figure 310. Looking upstream on concrete culvert coming across Manor Drive from stormwater forebay at the entrance to Windsor Farms development on an unnamed tributary to Toby Creek. A flagstone rock wall constriction is at the outlet of the pipe culvert that has some undermined rock.

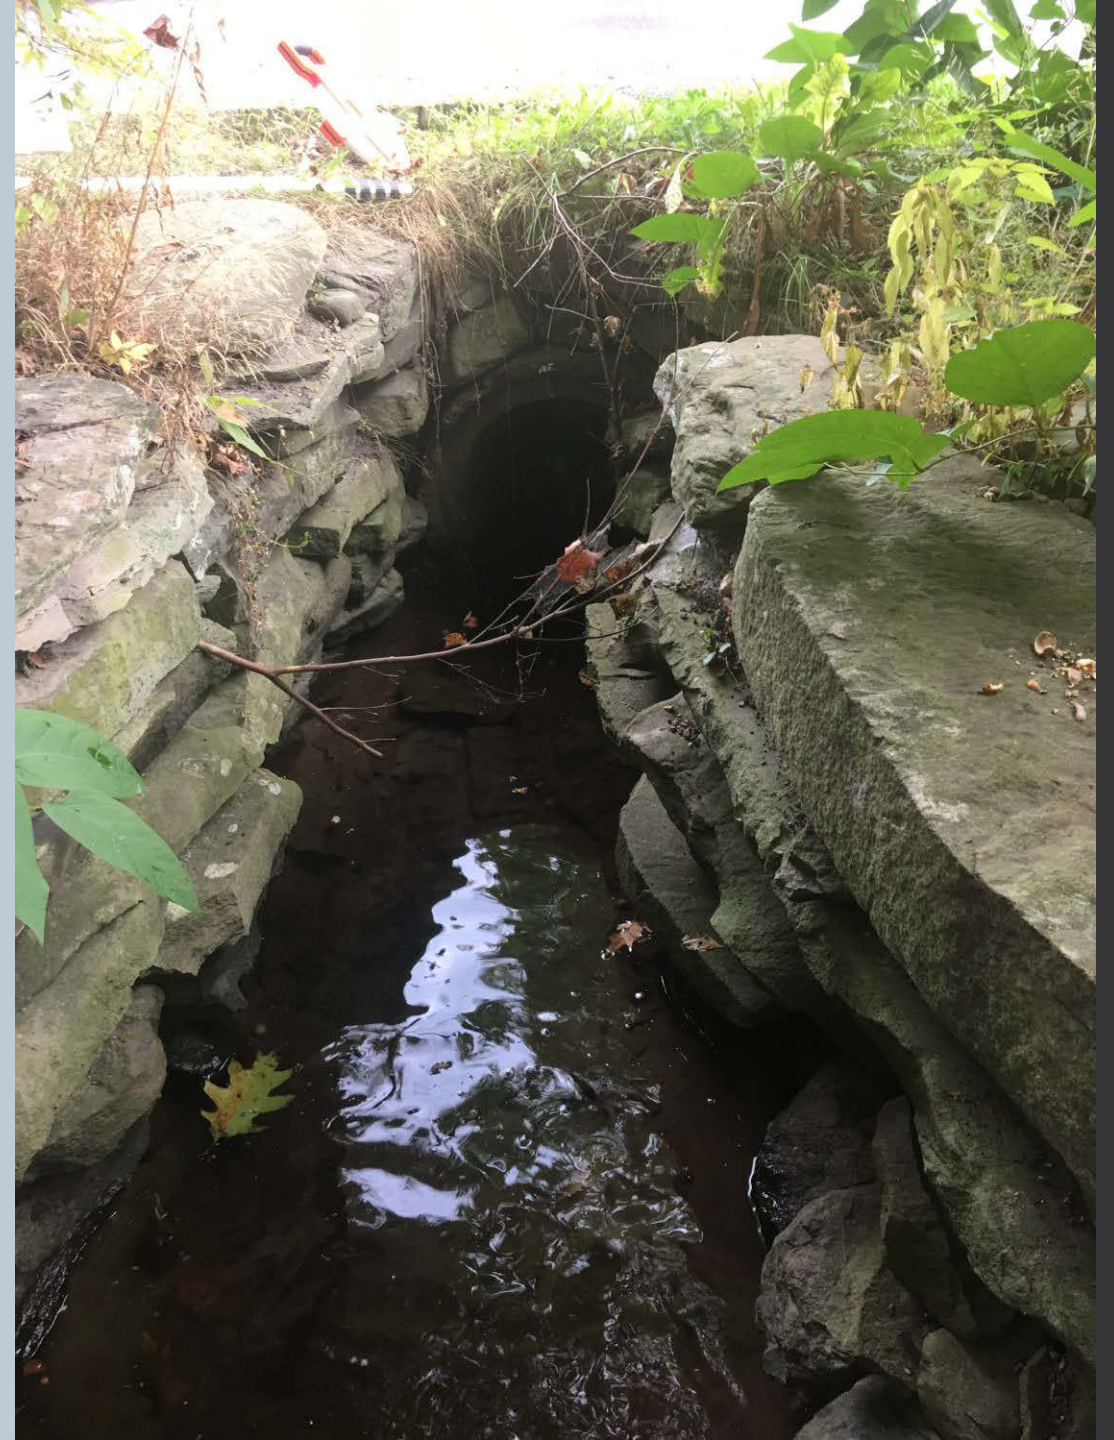
Figure 311. Looking downstream on the Swoga property where a severe blockage is on the unnamed tributary along Manor Drive. Sidewalls are failing beneath the covered bridge and litter and debris have blocked the unnamed tributary. Recommend a small cleanout of the area and shoring up of the culvert wall. There is a several foot drop to the channel that could use a step pool structure constructed to prevent further scouring of the area under the bridge.

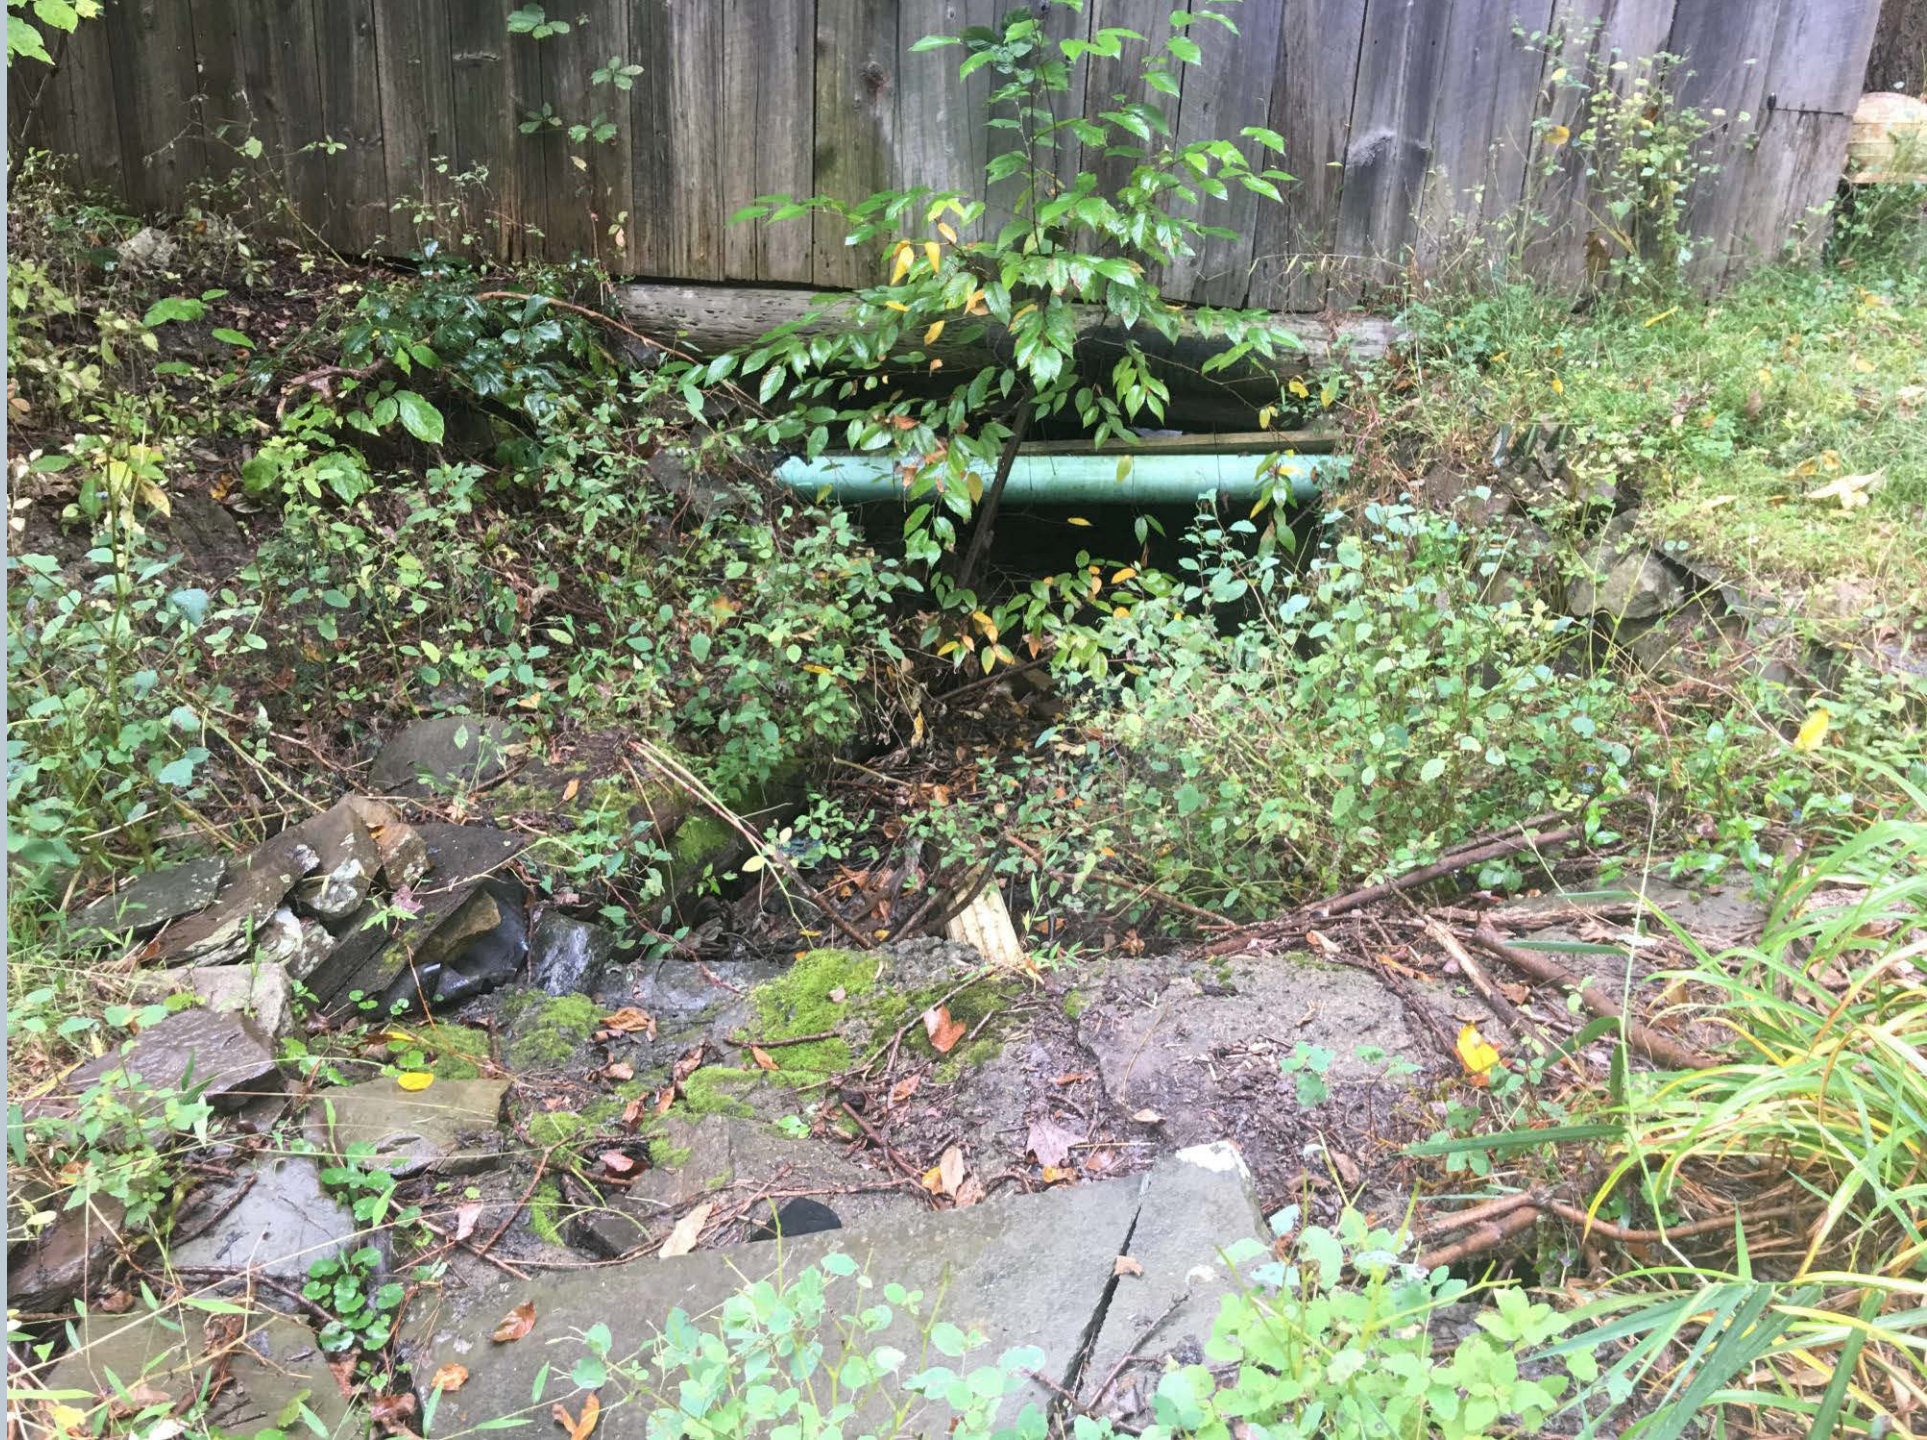
Figure 312. Looking upstream on the Swoga property where a severe blockage is on the unnamed tributary along Manor Drive. Recommend a small cleanout of the area and shoring up of the culvert wall. There is a several foot drop to the channel where a recommended step pool structure could be designed and constructed to prevent further scouring of the area under the bridge.

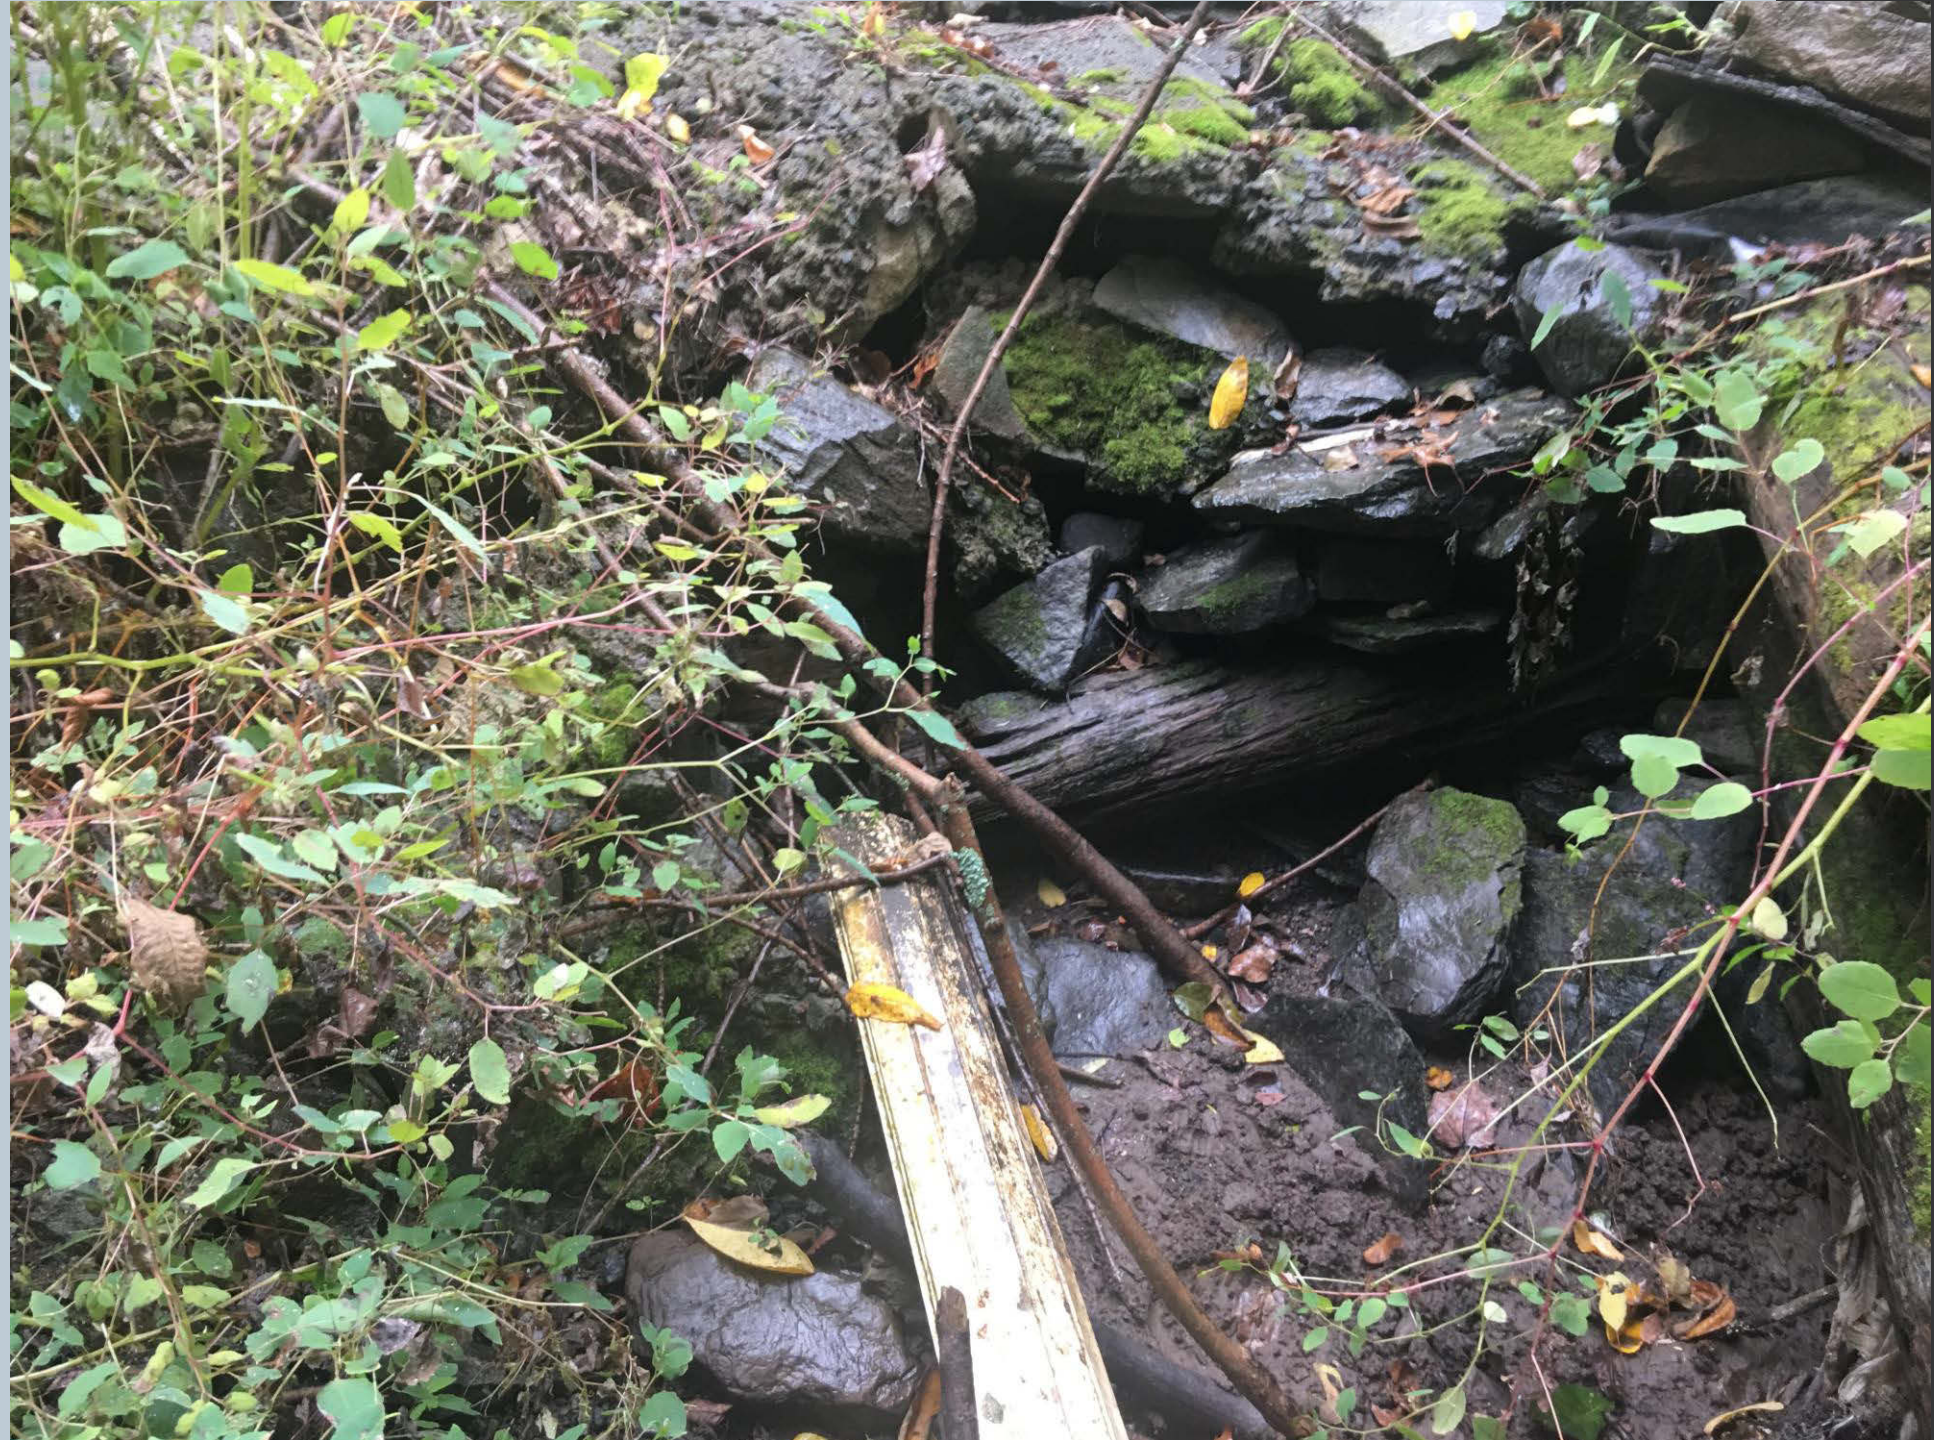
Figure 313.

Looking downstream on the Swoga property at the outlet of the culvert on the unnamed tributary along Manor Drive. There is a several foot drop to the channel where a recommended step pool structure could be designed and constructed to prevent further scouring of the area below the bridge.
