Toby Creek Field Reconnaissance Observations

September 26, 2018

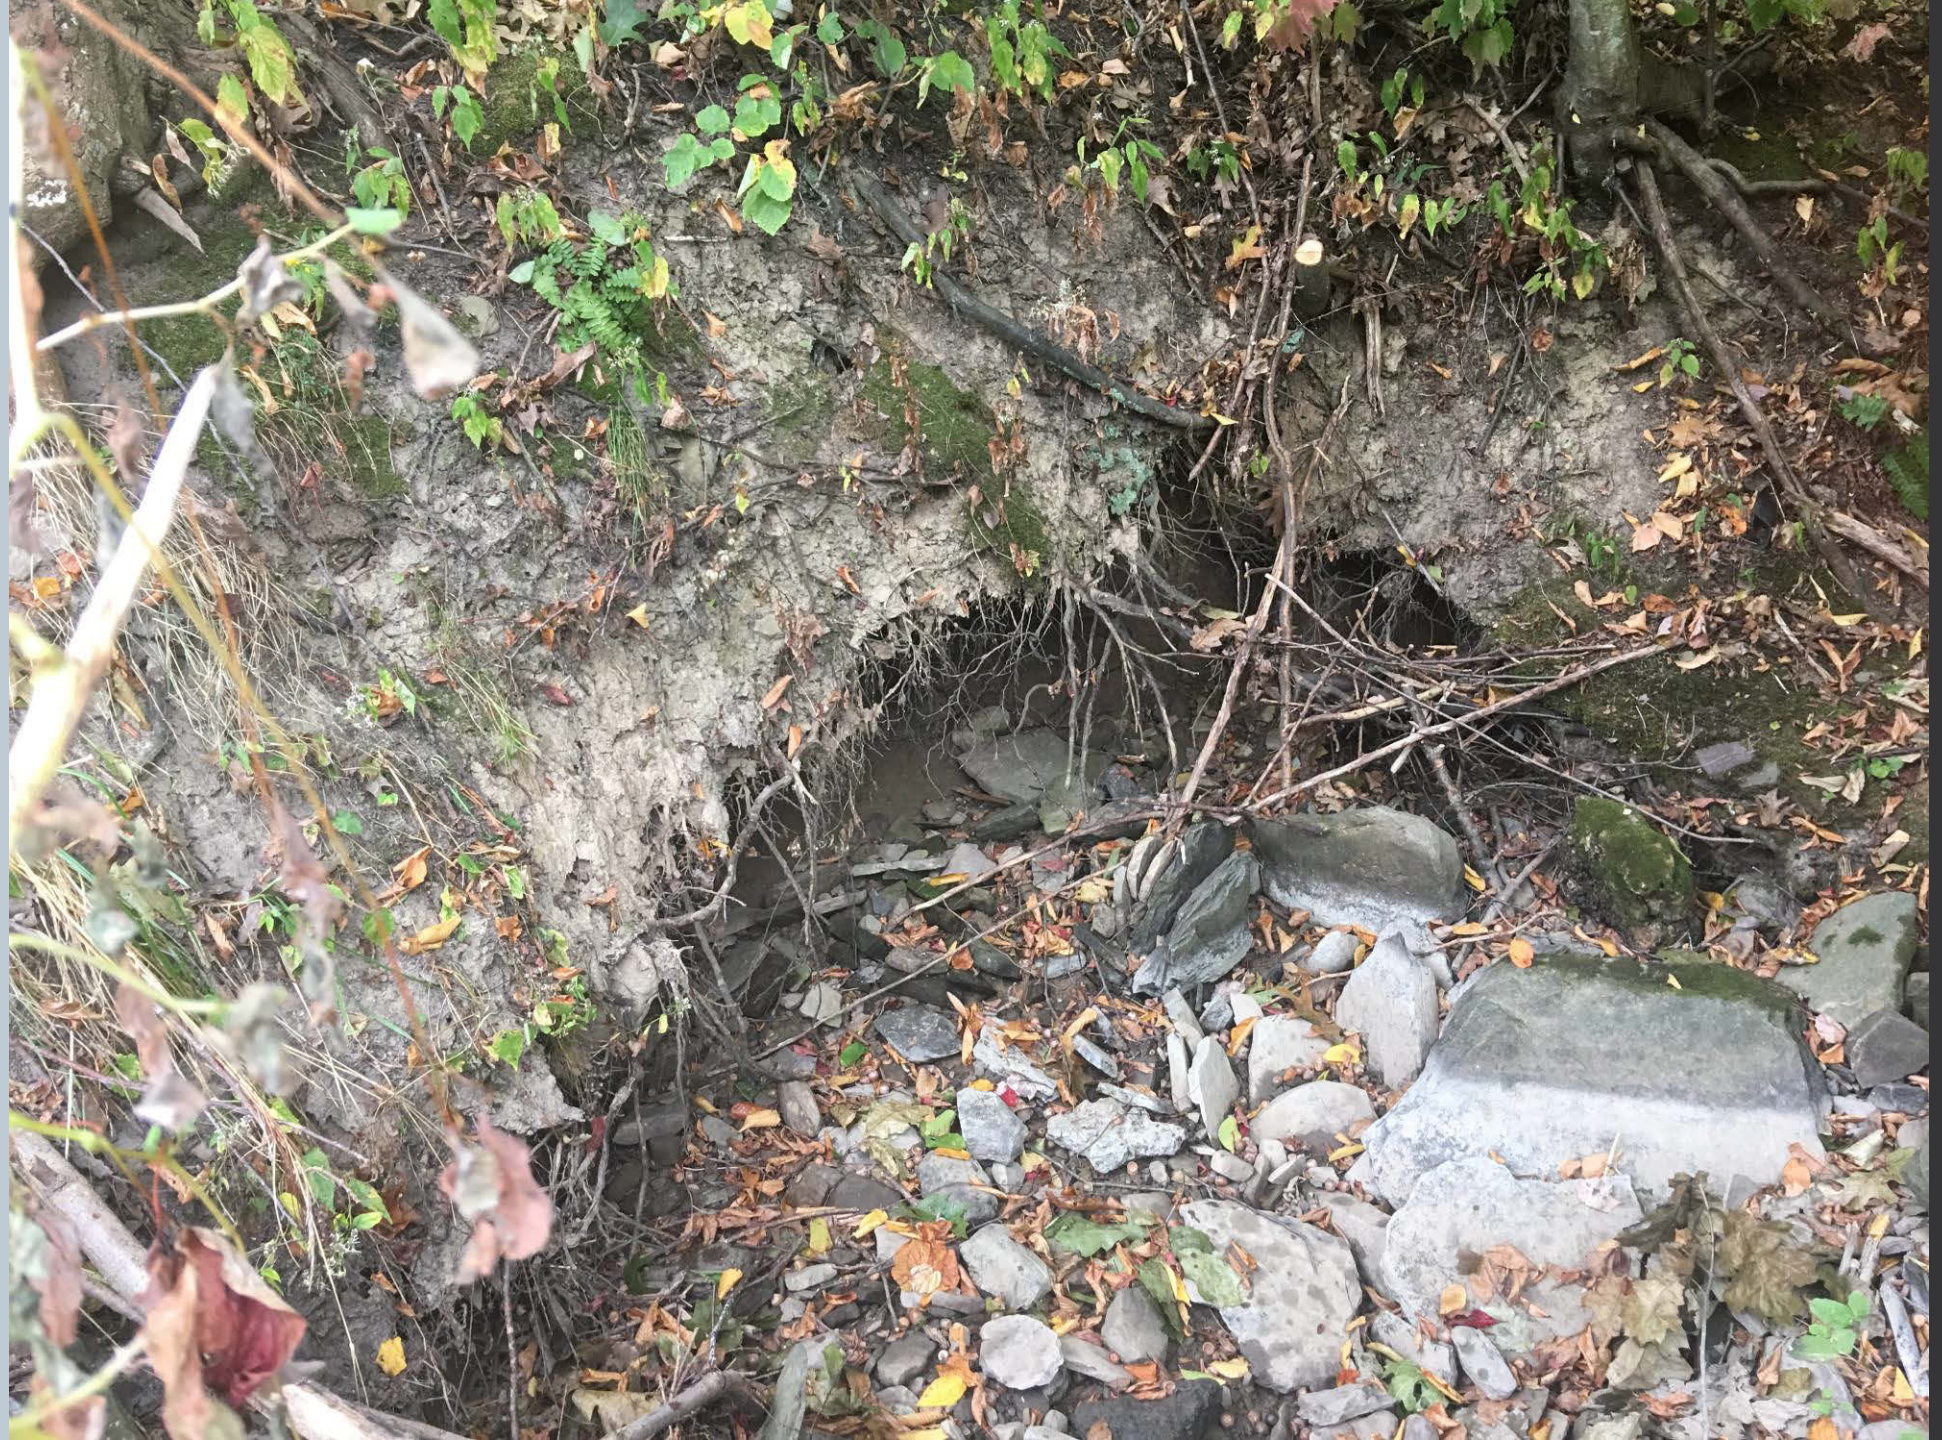
Figure 319. Looking downstream along the bend in Manor Drive from the large scour pool area to where this stormwater flow and unnamed tributary meets up with the other unnamed tributary from the Swago property below the covered bridge.

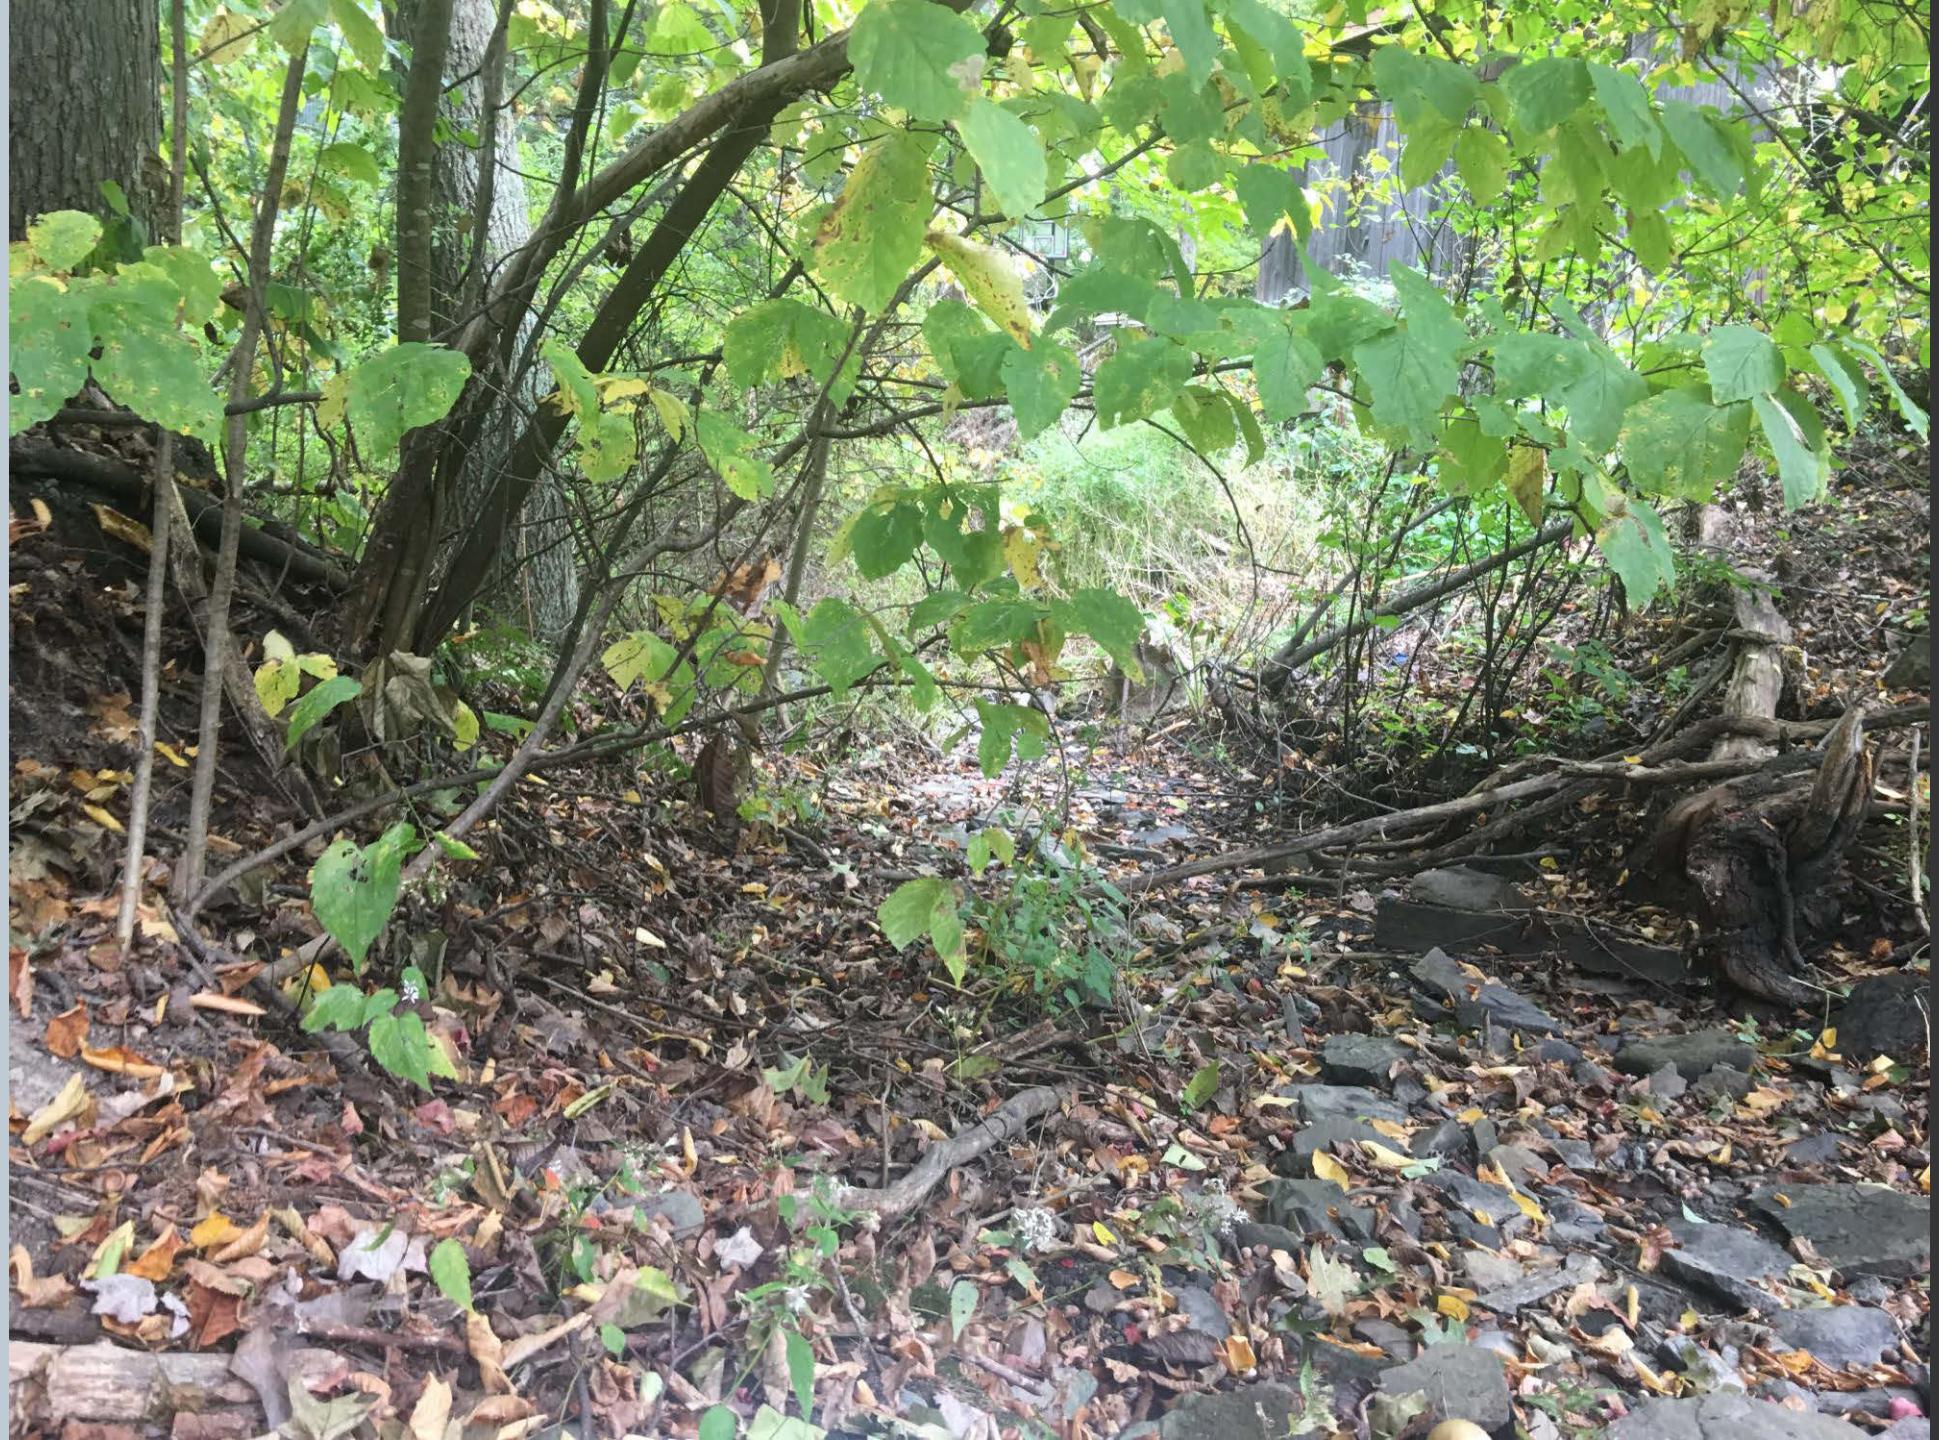
Figure 320. Looking upstream on the Swoga property at the outlet of the culvert on the unnamed tributary along Manor Drive. There is a several foot drop to the channel and blockage of woody debris and loose rock where a recommended step pool structure could be designed and constructed to prevent further scouring of the area below the bridge.

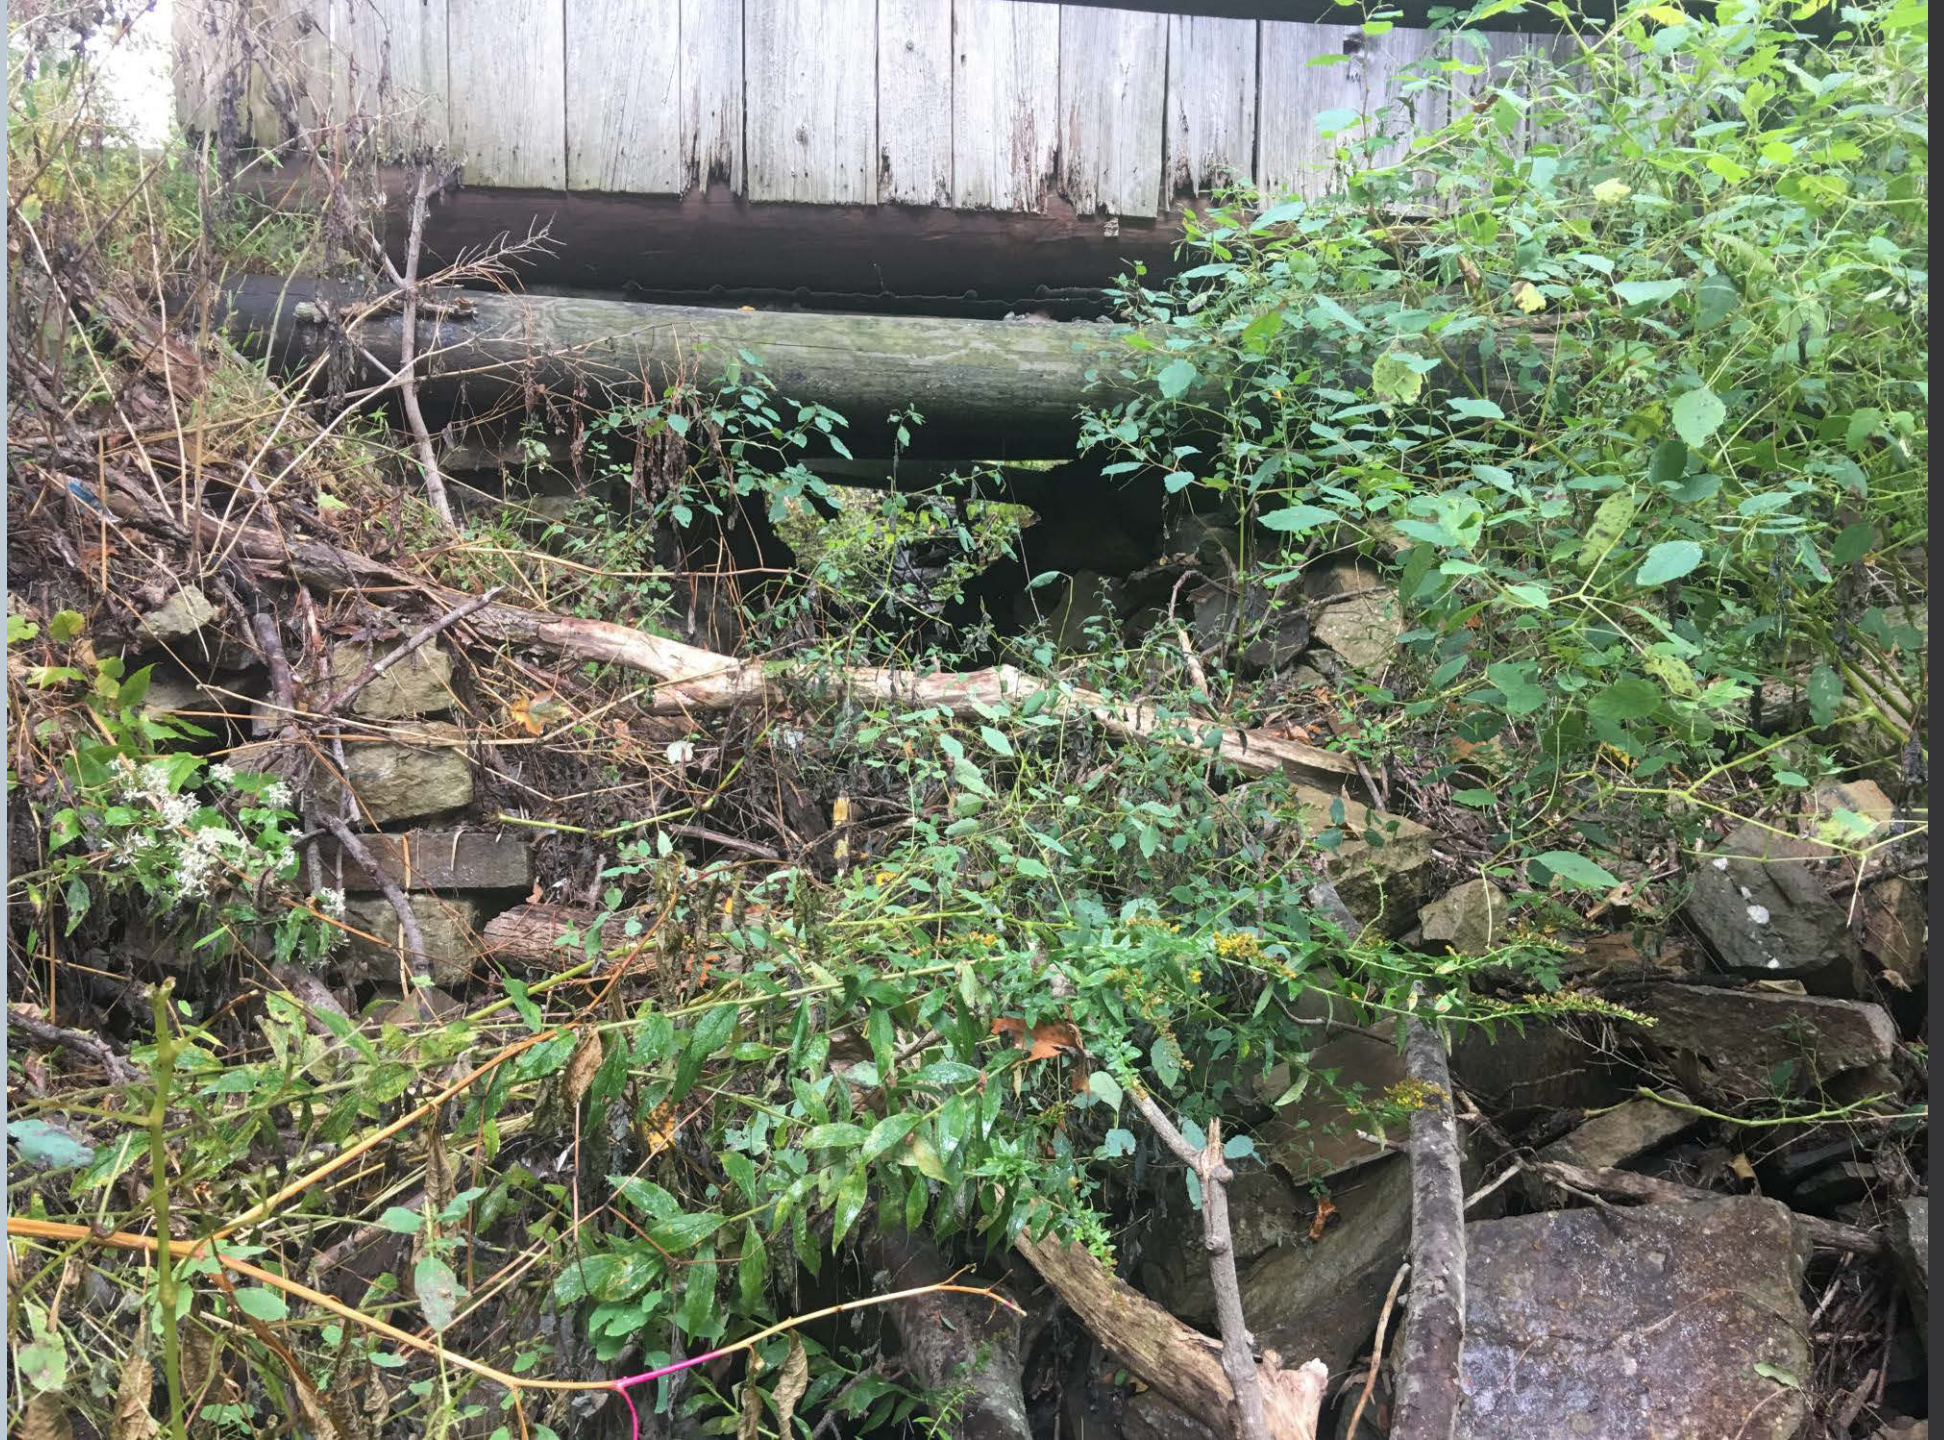
Figure 321.
Looking along one
of the stormwater
conveyance
channels along
Dug Road at the
dip across from the
Day Care Center
where woody
debris blockage
and some litter has
accumulated.
Recommend
clearing out the
woody debris from
the area in front of
the culvert.

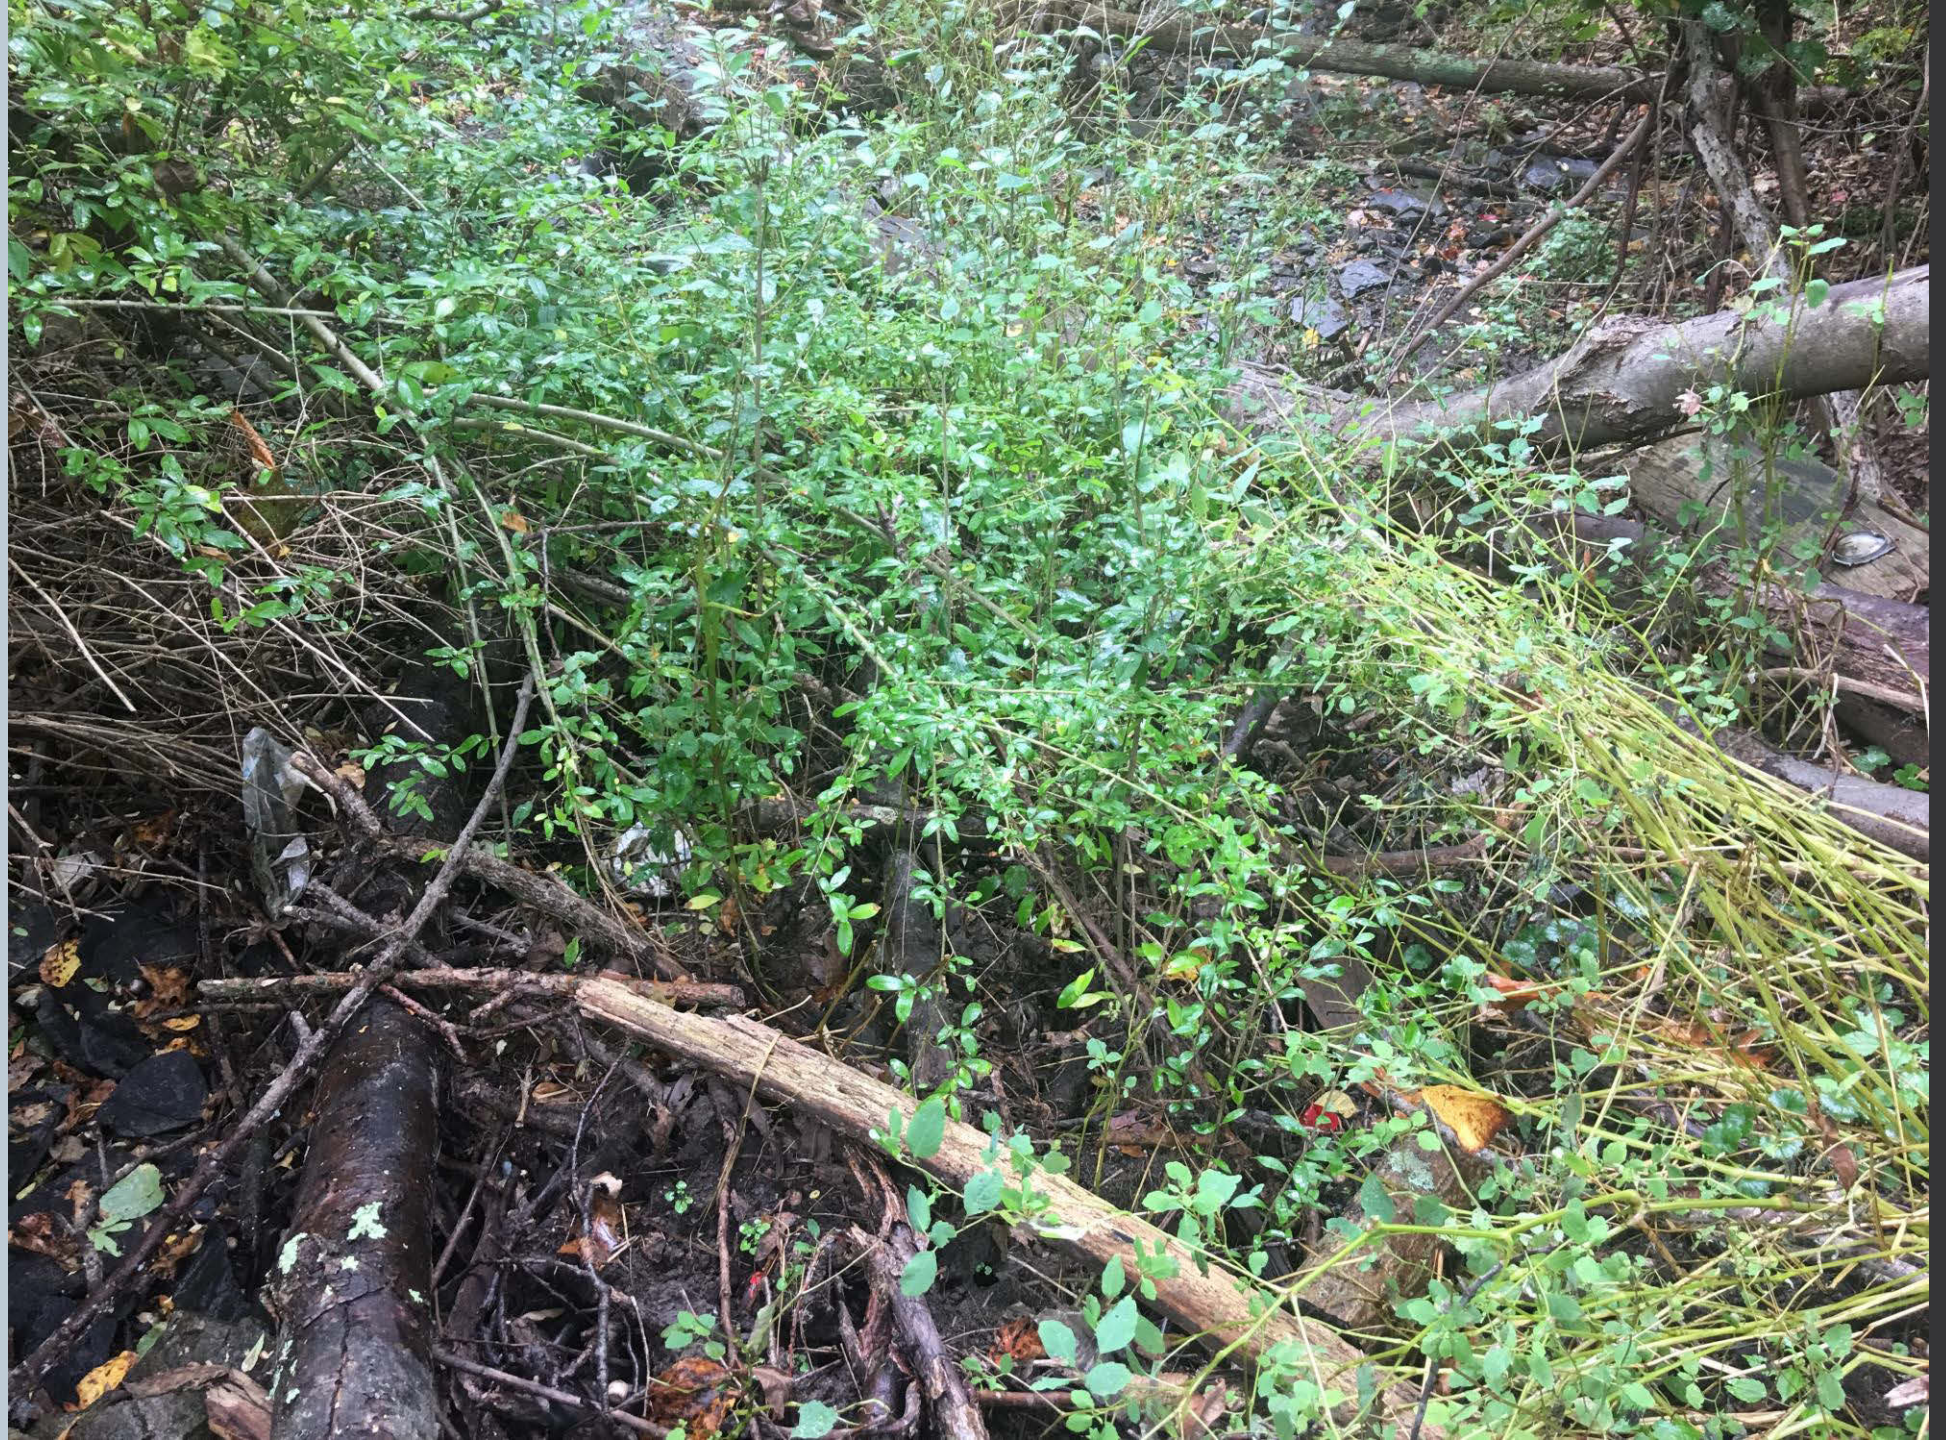
Figure 322.
Looking upstream
of the culvert along
Dug Road where a
sediment gravel
bar is present and
a scour pool
created by the two
stormwater
conveyances that
come off of both
hillsides along Dug
Road in both
directions to this
low lying area.
Fish present.

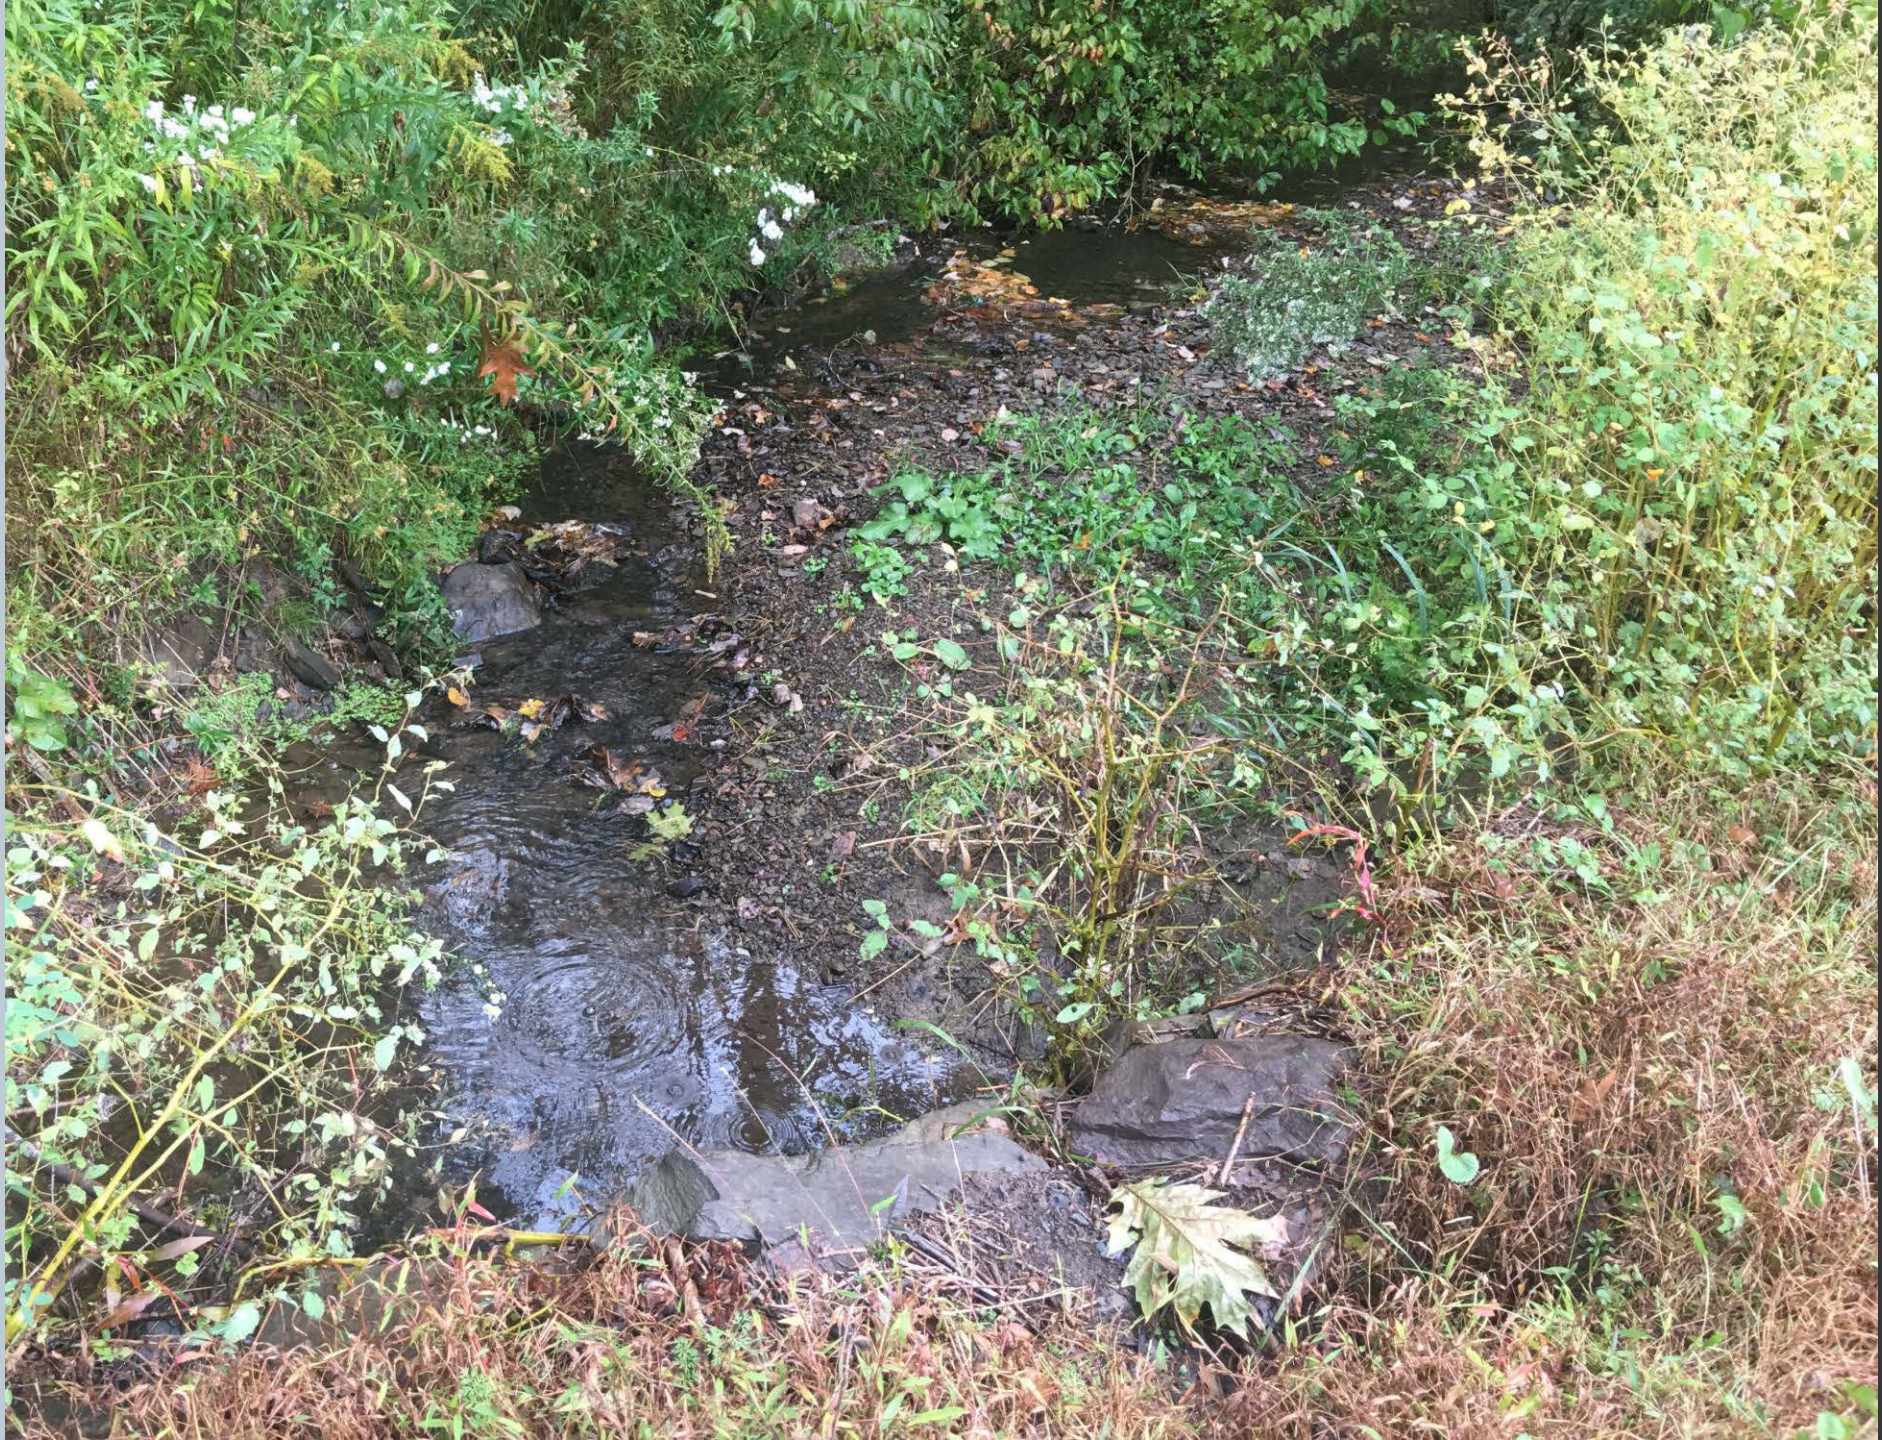
Figure 323.
Looking
downstream
of the culvert
inlet along
Dug Road
where a
sediment
gravel bar is
present and a
scour pool
created by
the two
stormwater
conveyances
that come off
of both
hillsides
along Dug
Road in both
directions to
this low lying
area. Fish
present.

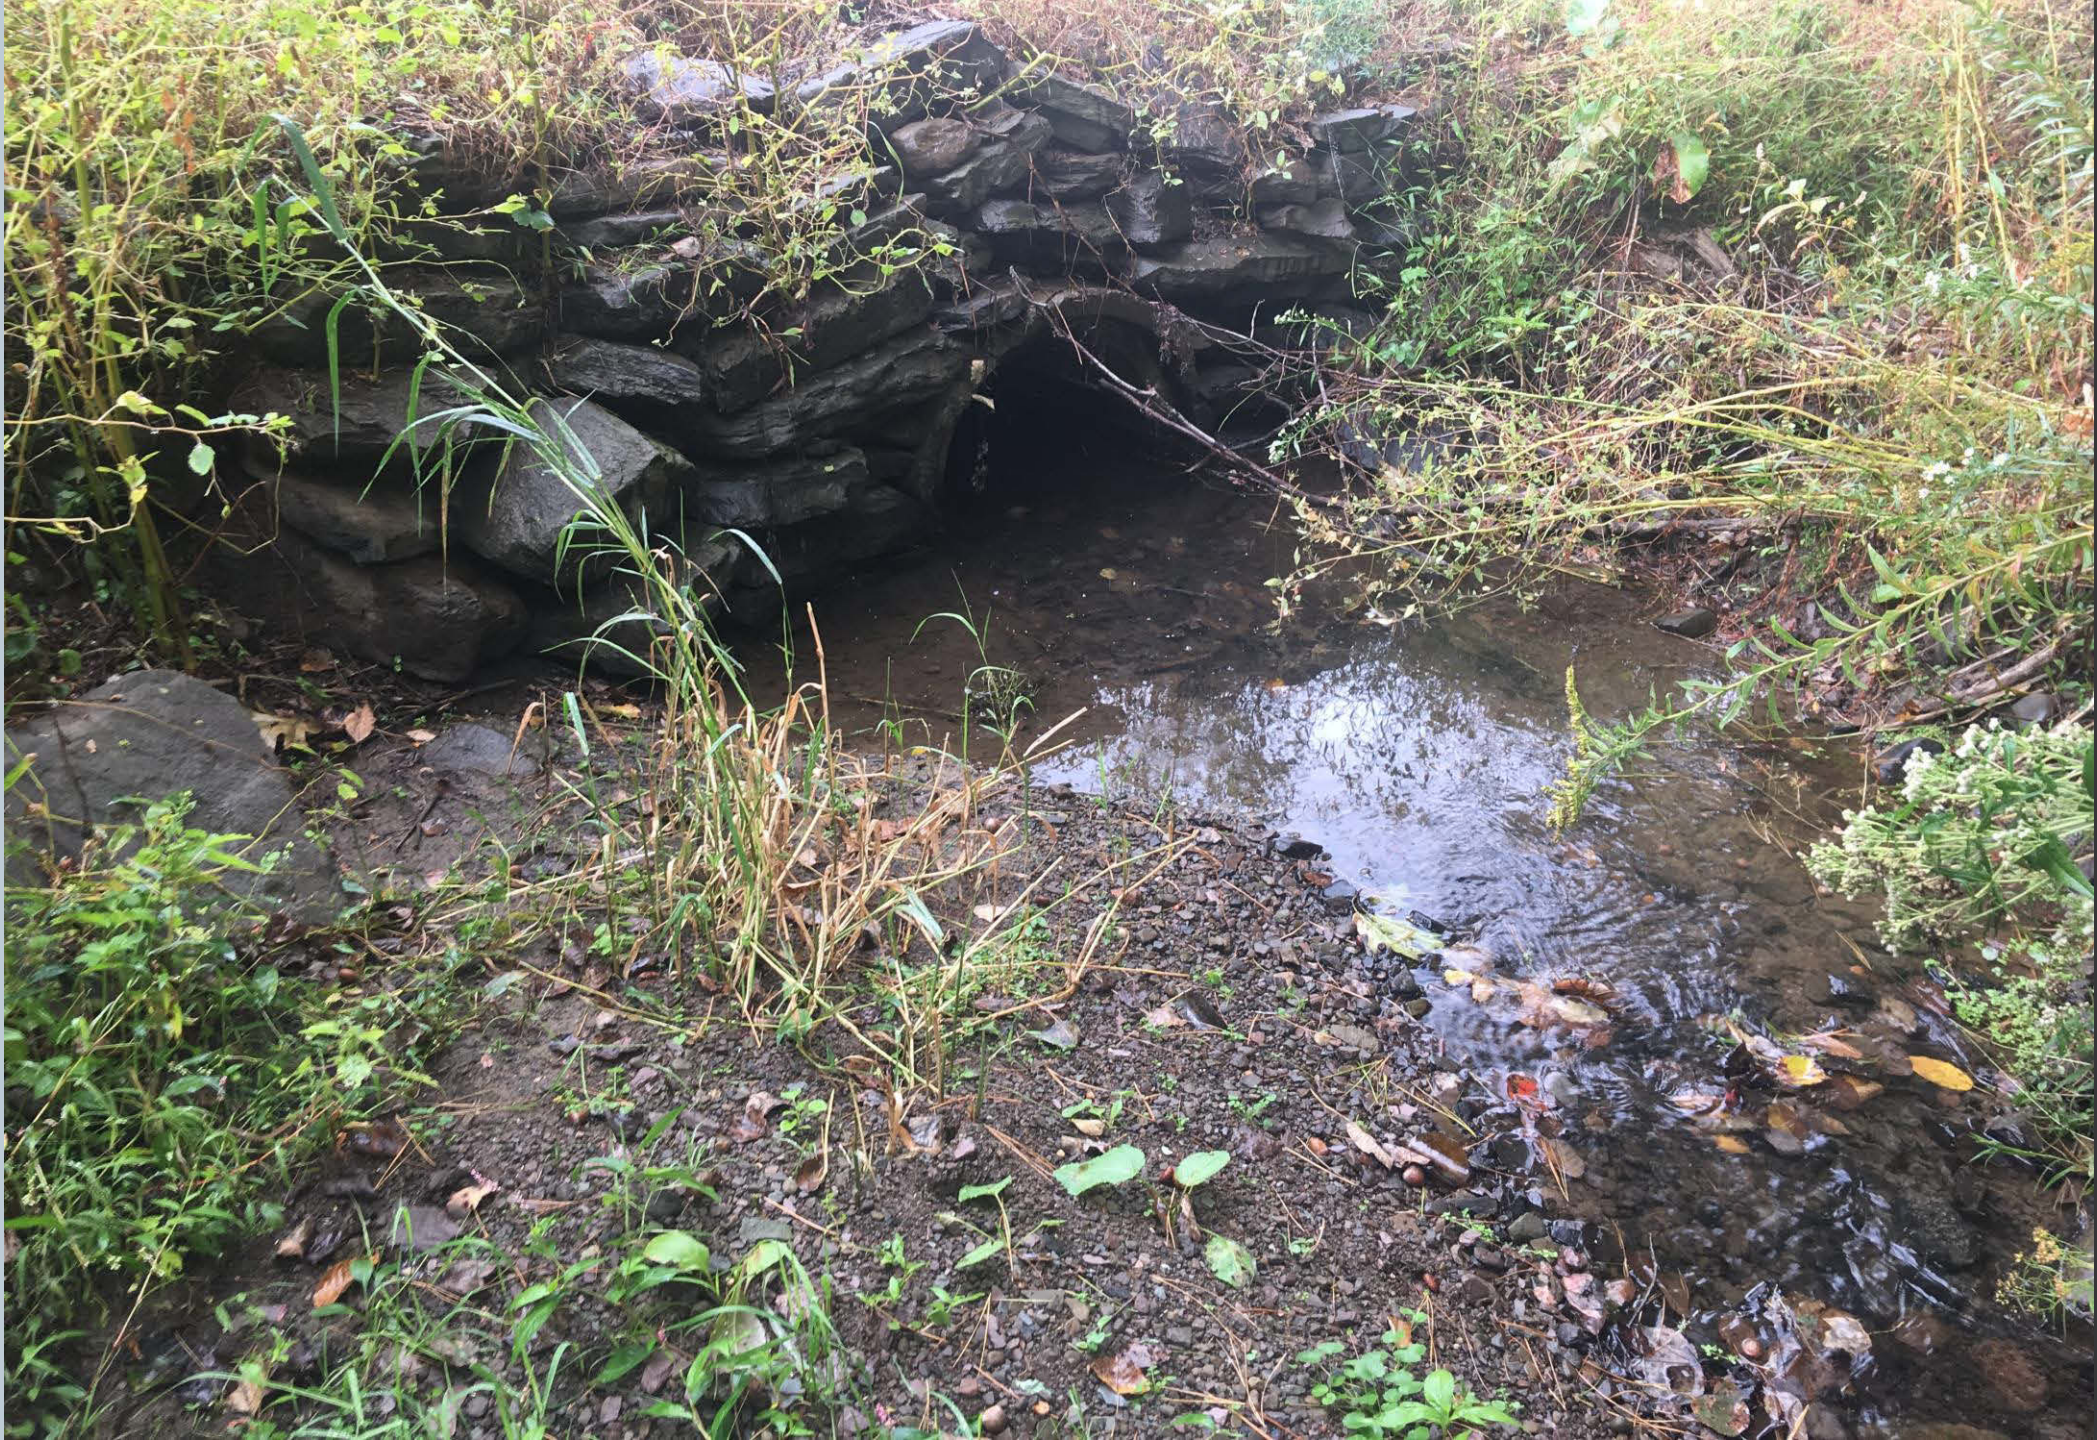
Figure 324. Looking downstream of the culvert outlet along Dug Road where a sediment gravel bar is present and a scour pool created by the two stormwater conveyances that come off of both hillsides along Dug Road in both directions to this low lying area. Fish present. The bottom of the corrugated metal pipe is rusted out and is recommended to be replaced.

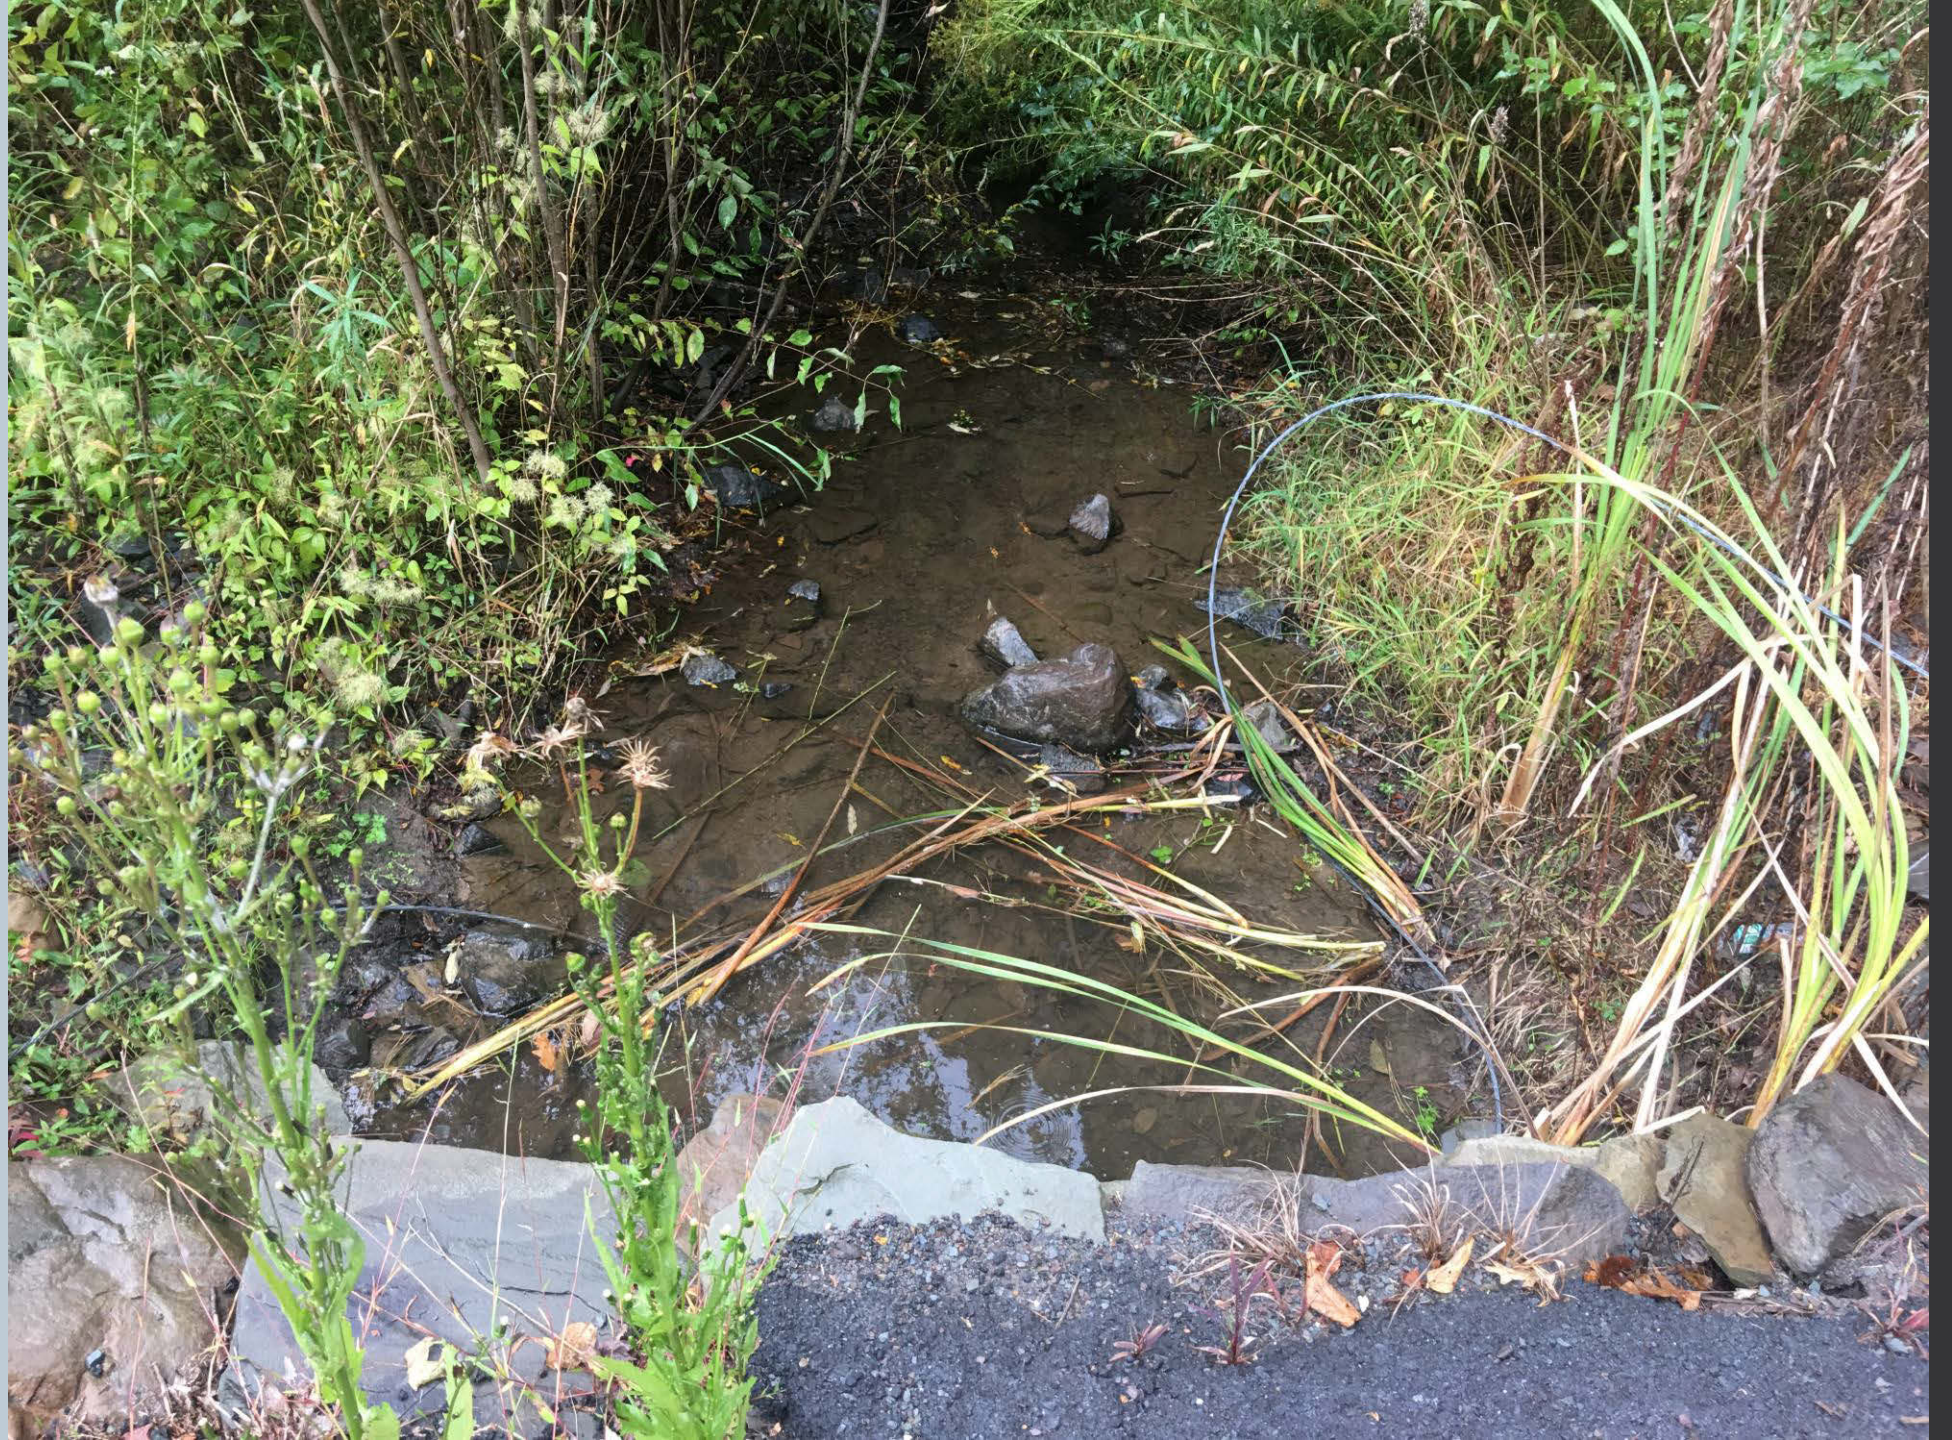
Figure 325. Looking downstream of the culvert outlet along Dug Road where a sediment gravel bar is present and a scour pool created by the two stormwater conveyances that come off of both hillsides along Dug Road in both directions to this low lying area. Fish present. The bottom of the corrugated metal pipe is rusted out and is recommended to be replaced. A cable is also laying in the unnamed tributary that should be removed.

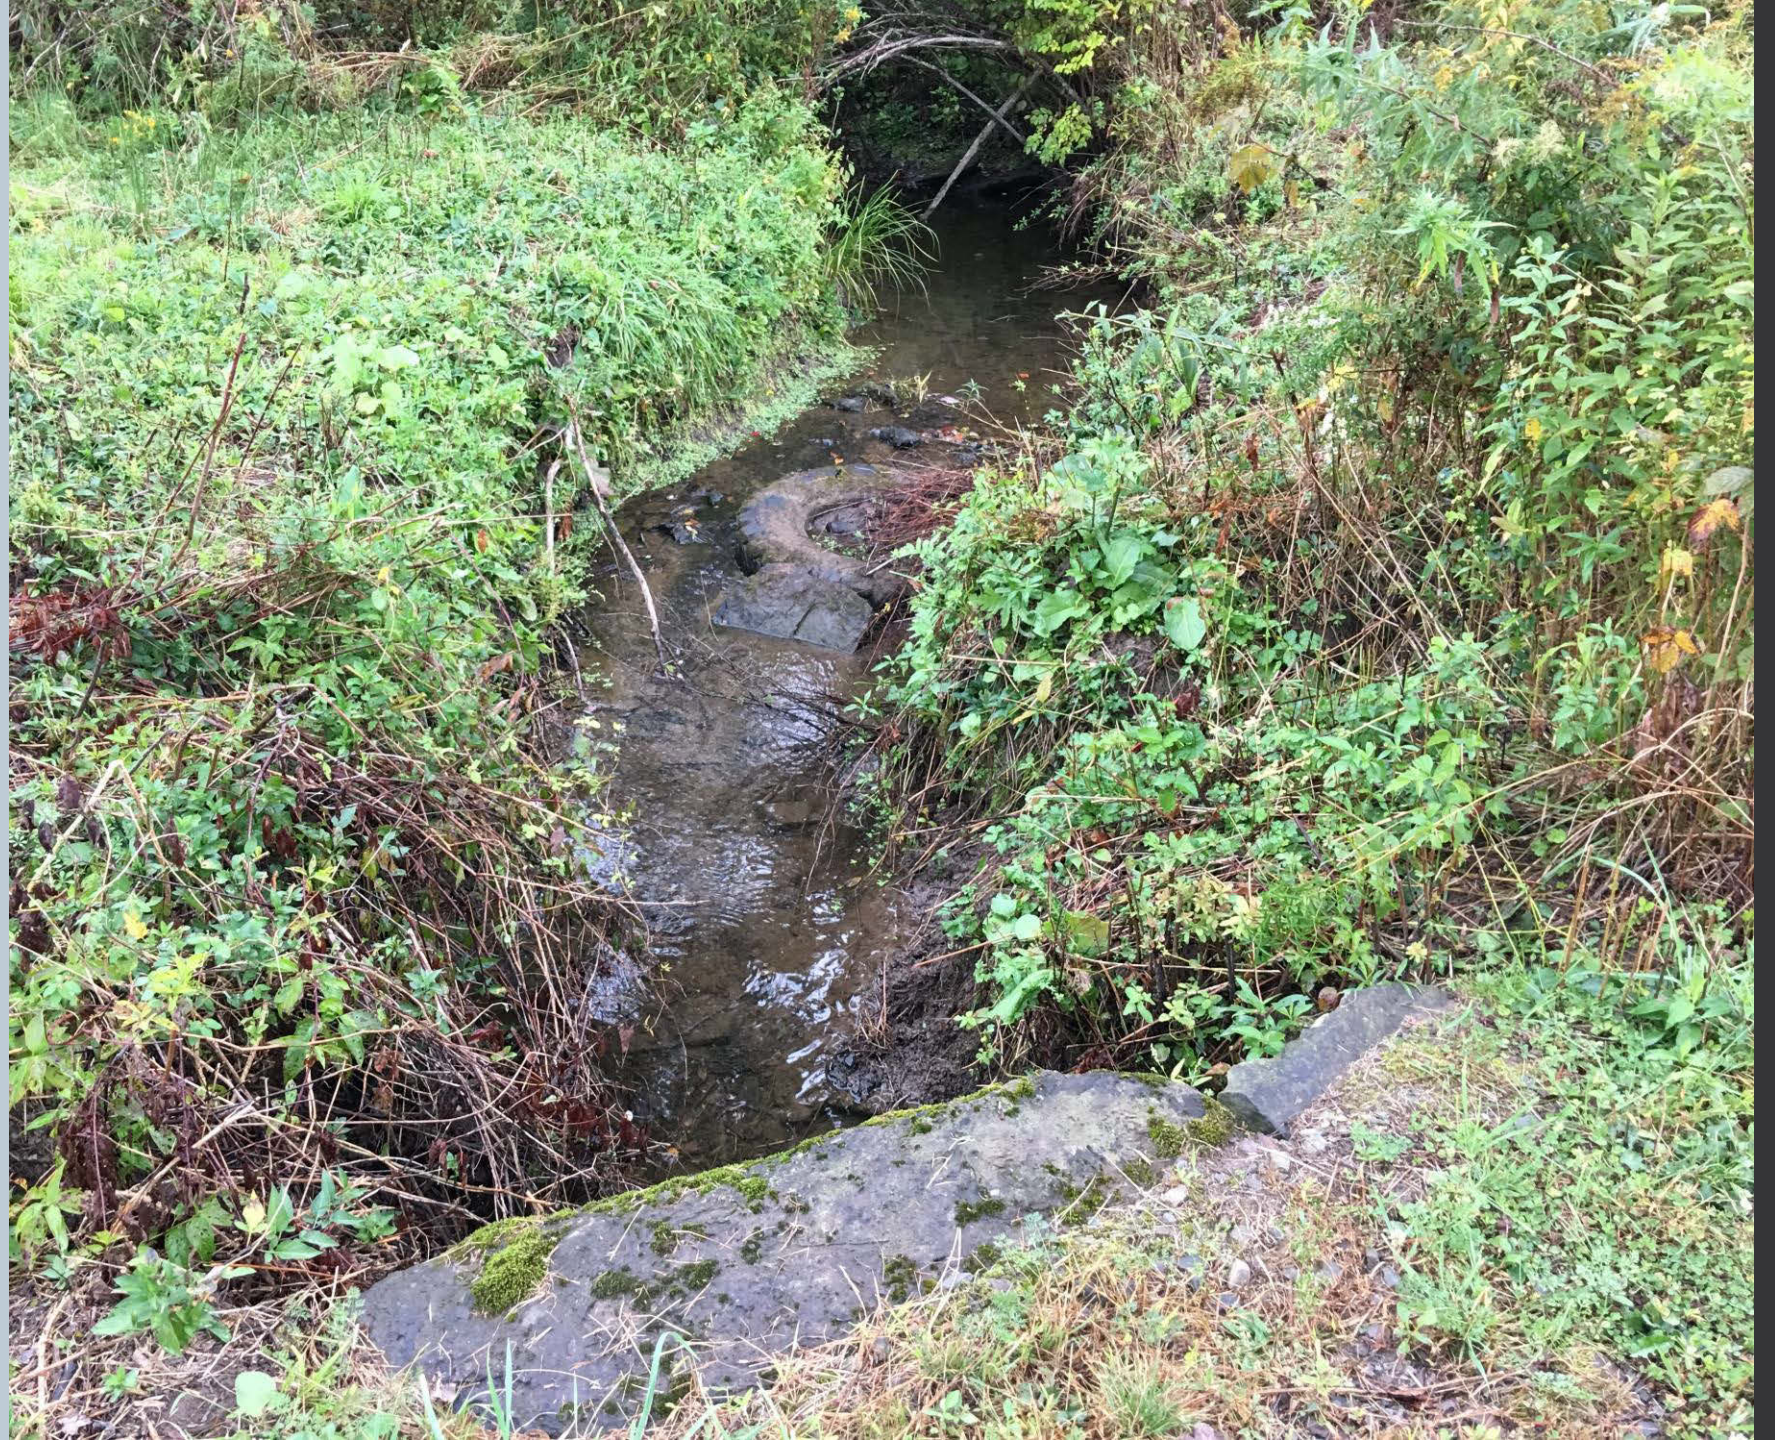
Figure 327. Looking downstream of the culvert outlet along Terrace Drive where a tire is embedded in unnamed tributary below Dug Road. Fish present.
