Toby Creek Field Reconnaissance Observations

September 26, 2018

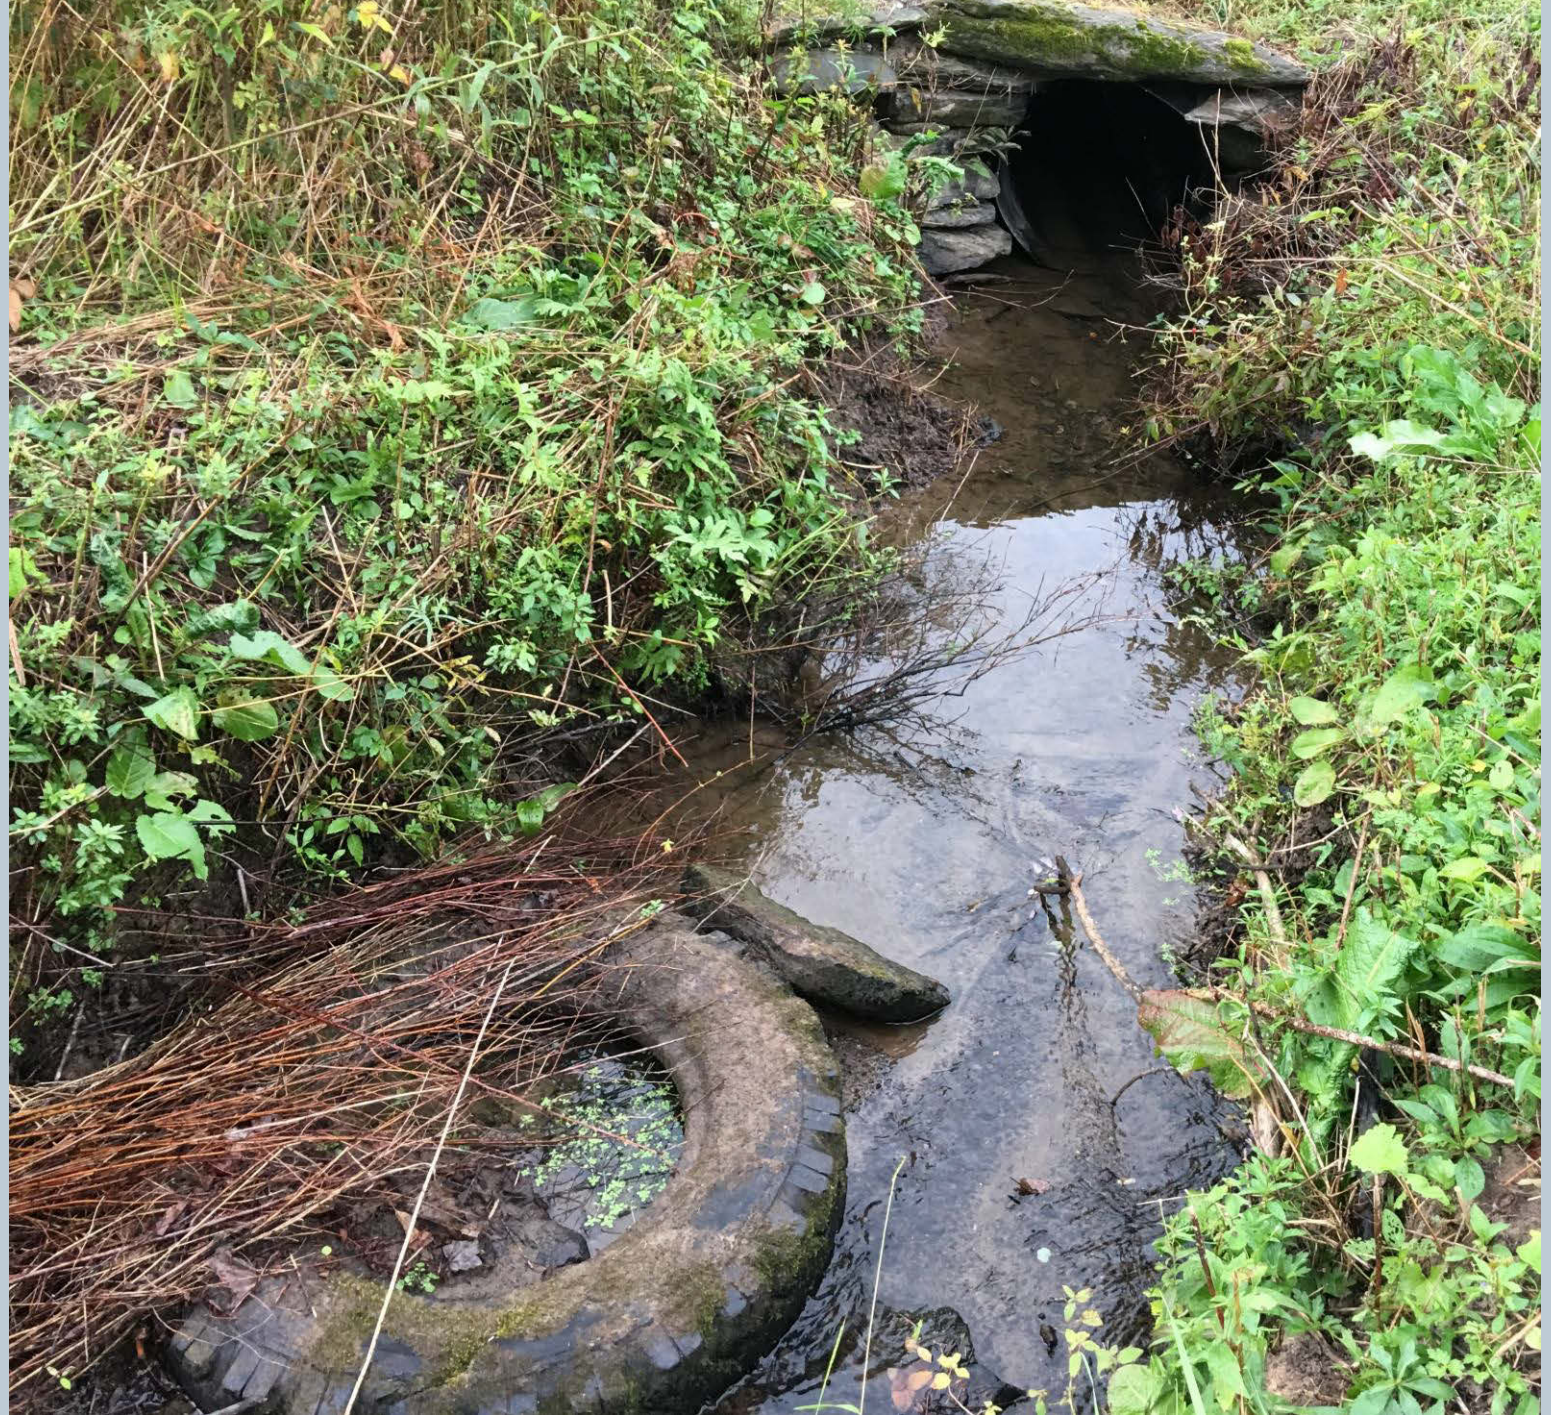
Figure 328.
Looking
downstream of
the culvert
outlet along
Terrace Drive
where a tire is
embedded in
unnamed
tributary below
Dug Road. Fish
present. The
riparian corridor
is excellent.

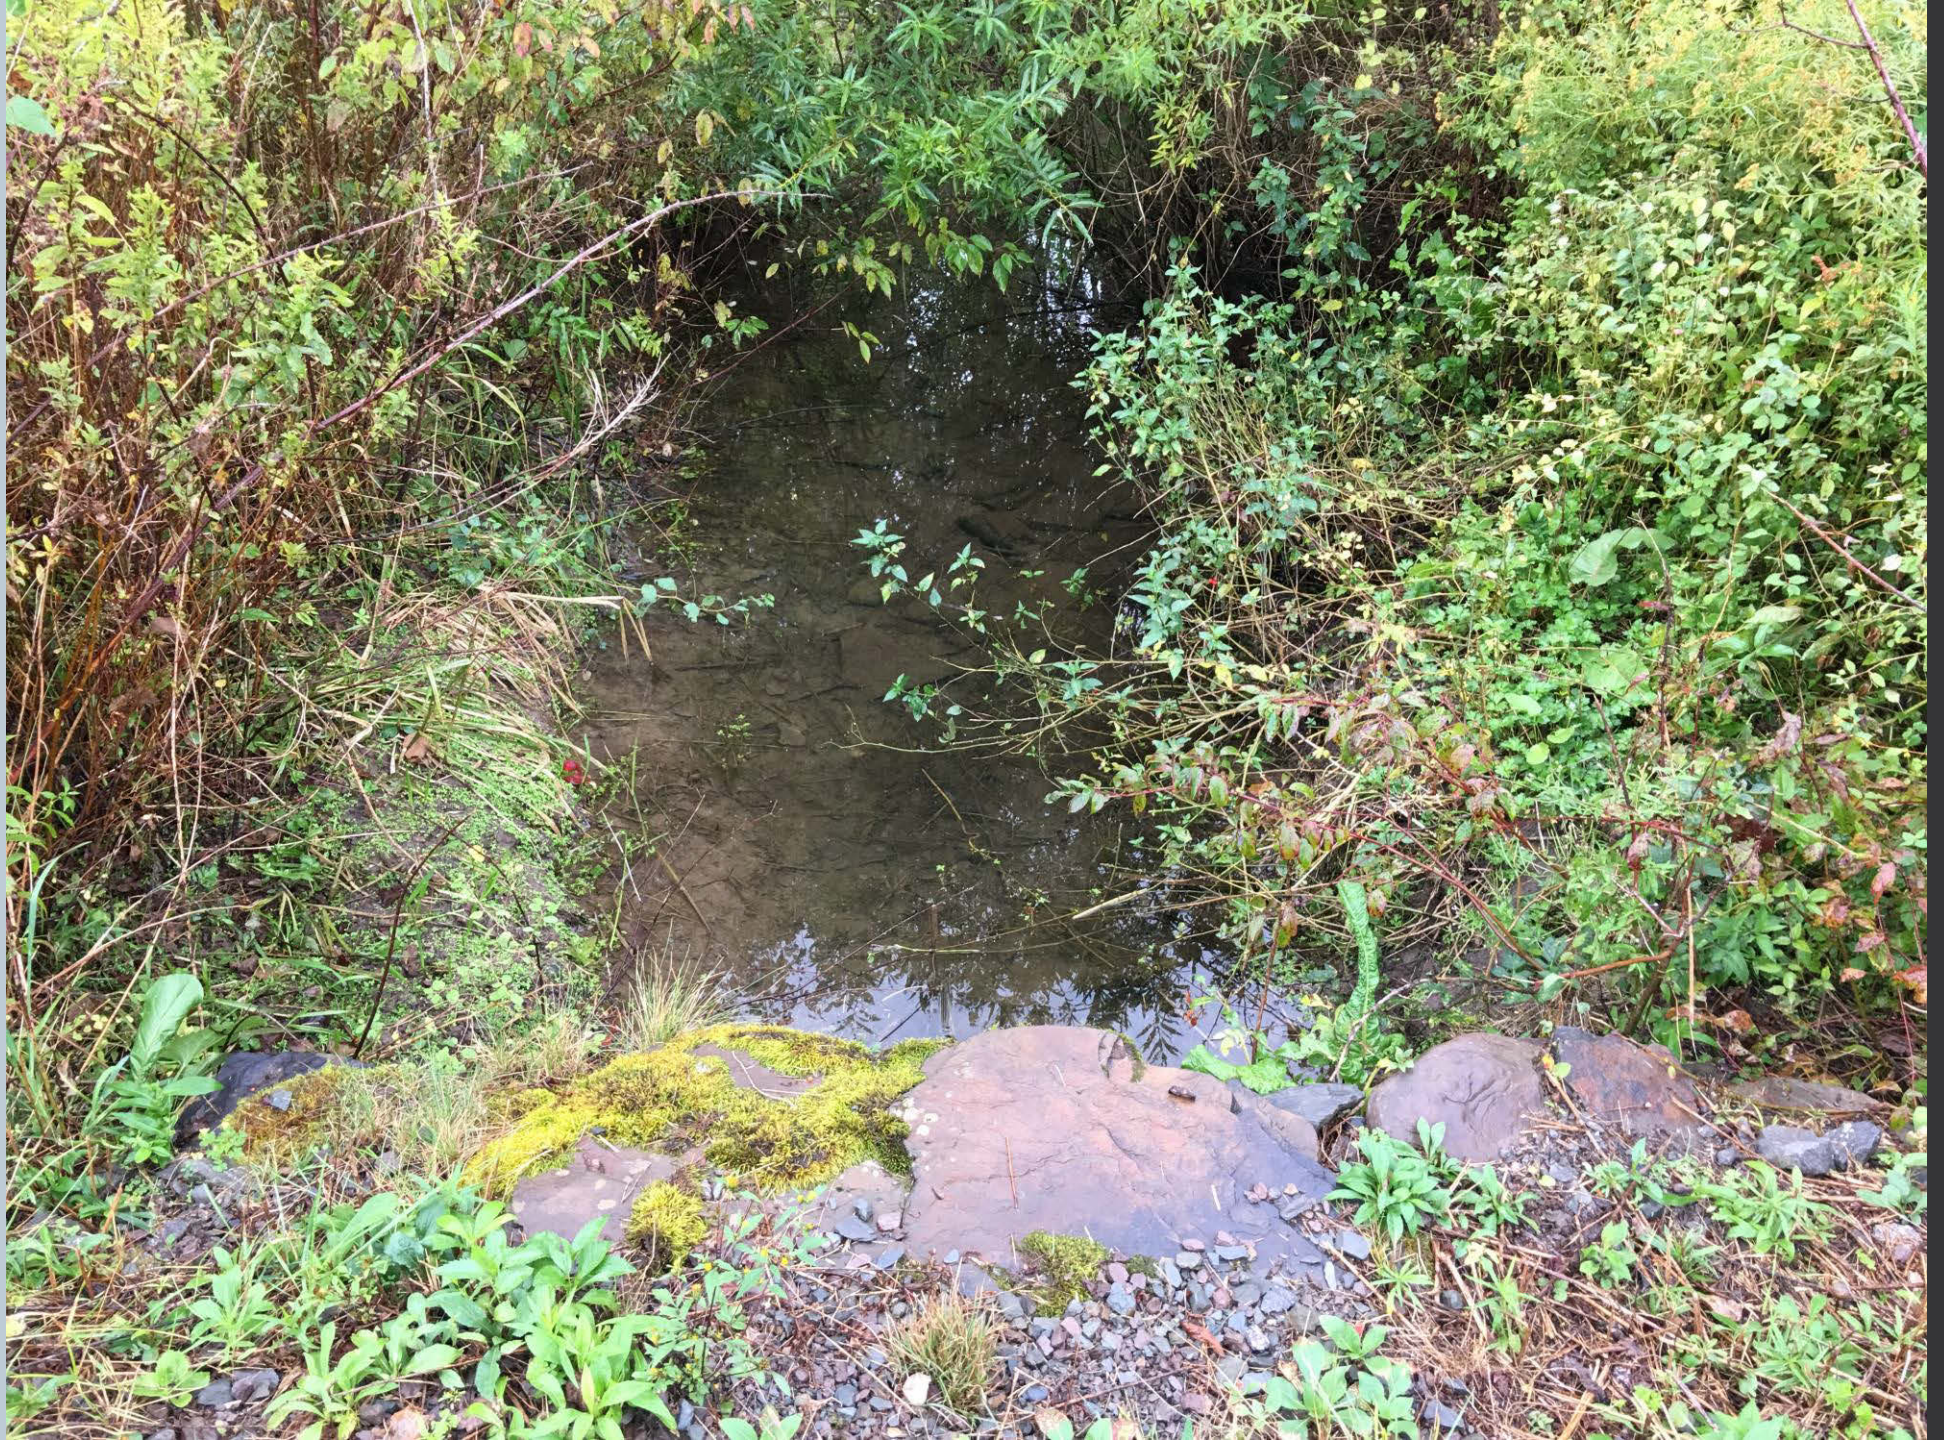
Figure 329.
Looking
upstream of the
culvert outlet
along Terrace
Drive where a
tire is embedded
in unnamed
tributary below
Dug Road. Fish
present. The
riparian corridor
is excellent.

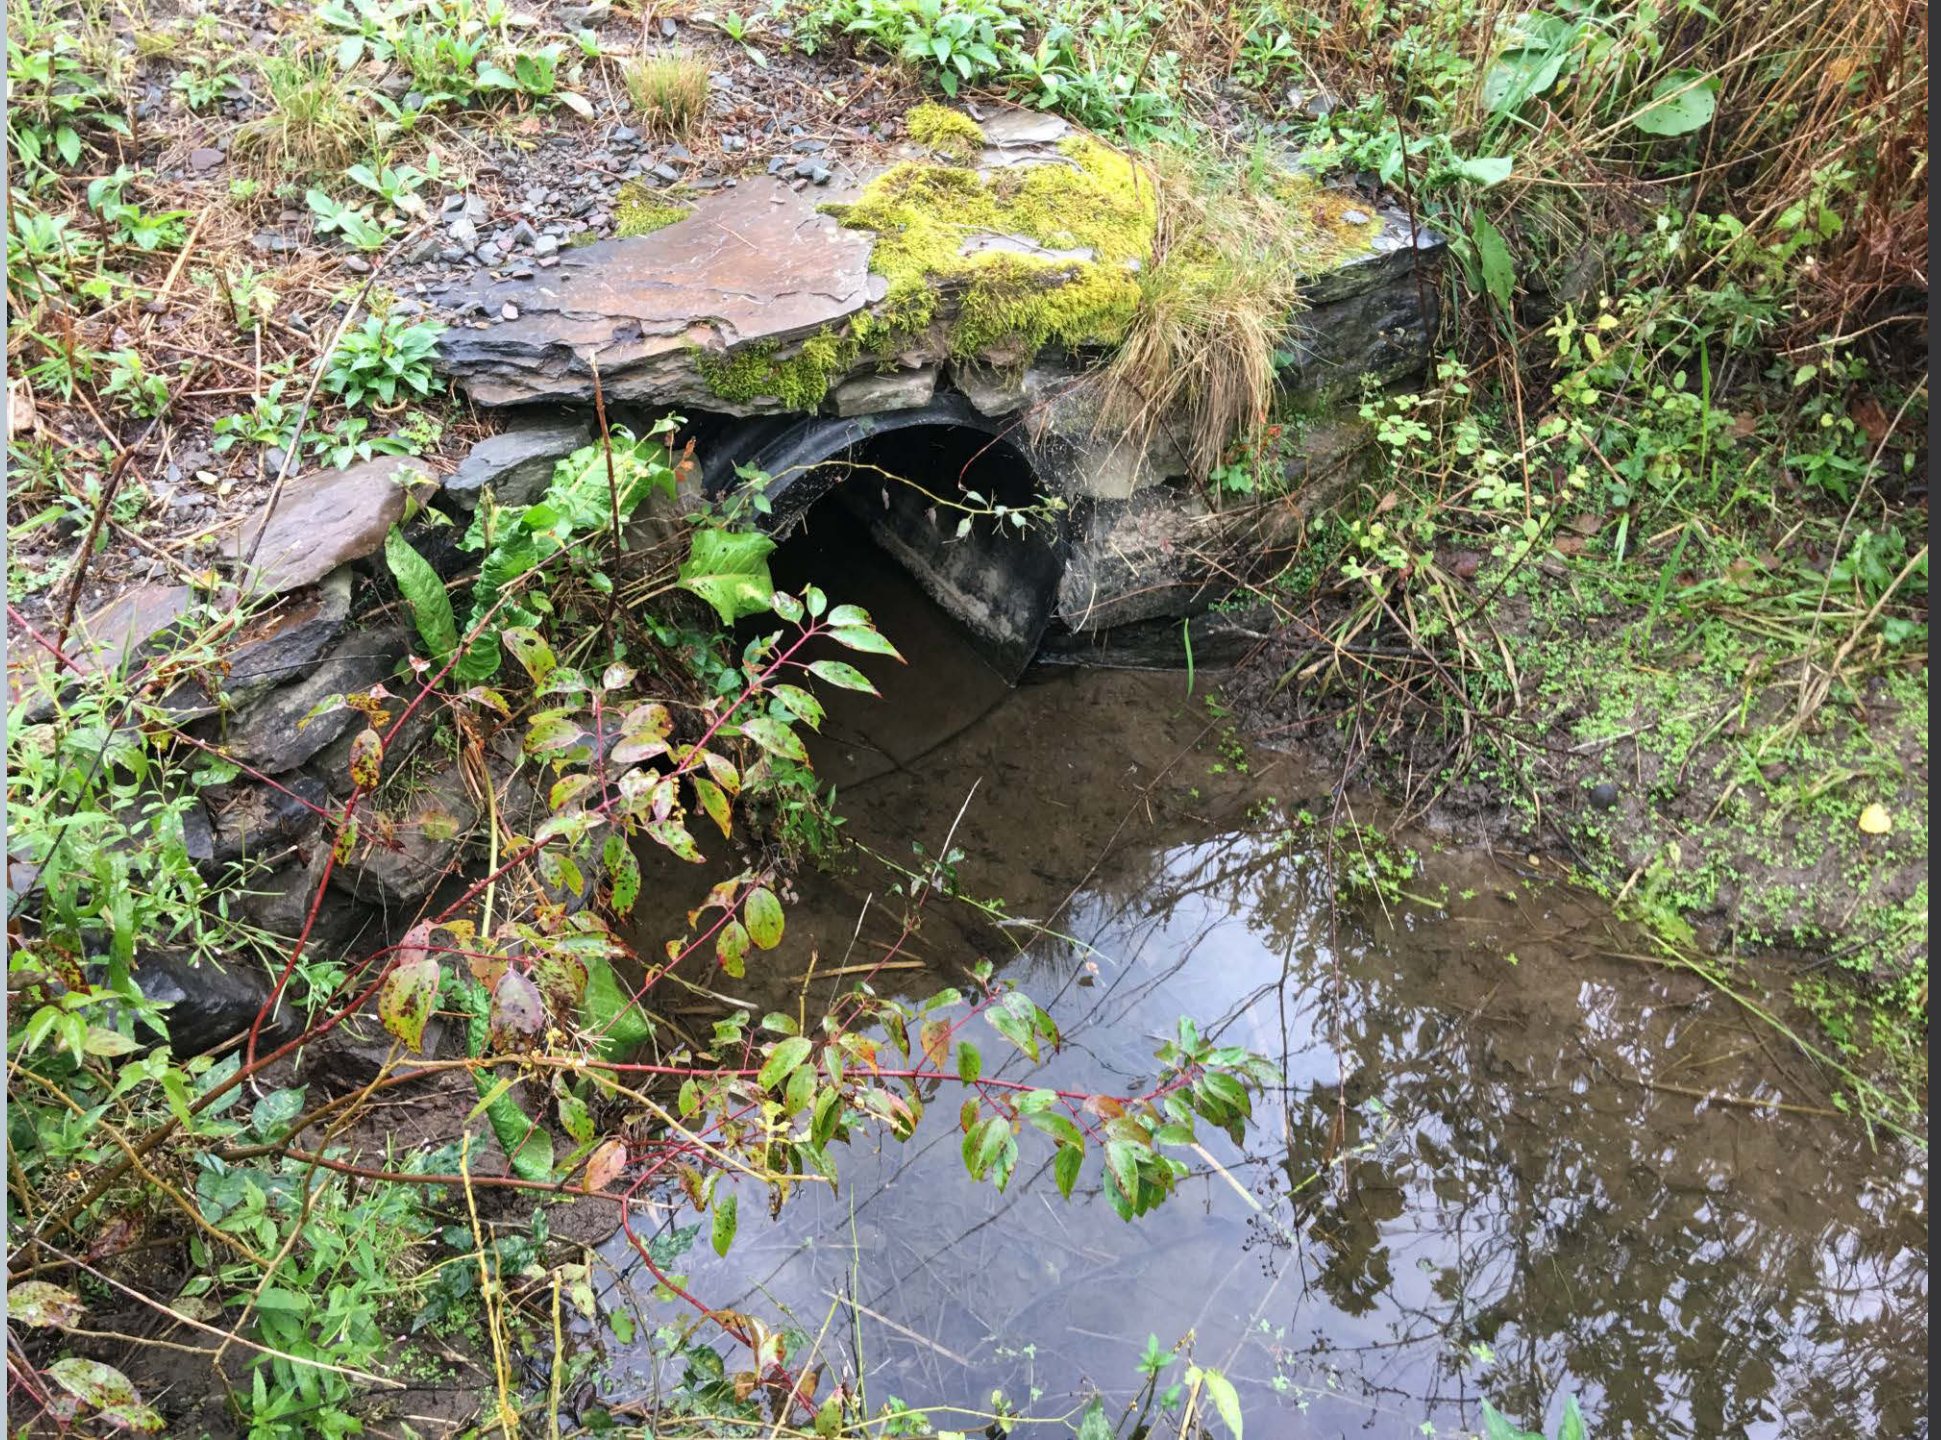
Figure 330.
Looking
downstream of
the culvert inlet
along Carverton
Road which joins
with the
unnamed
tributary from
Dug Road. Fish
present.

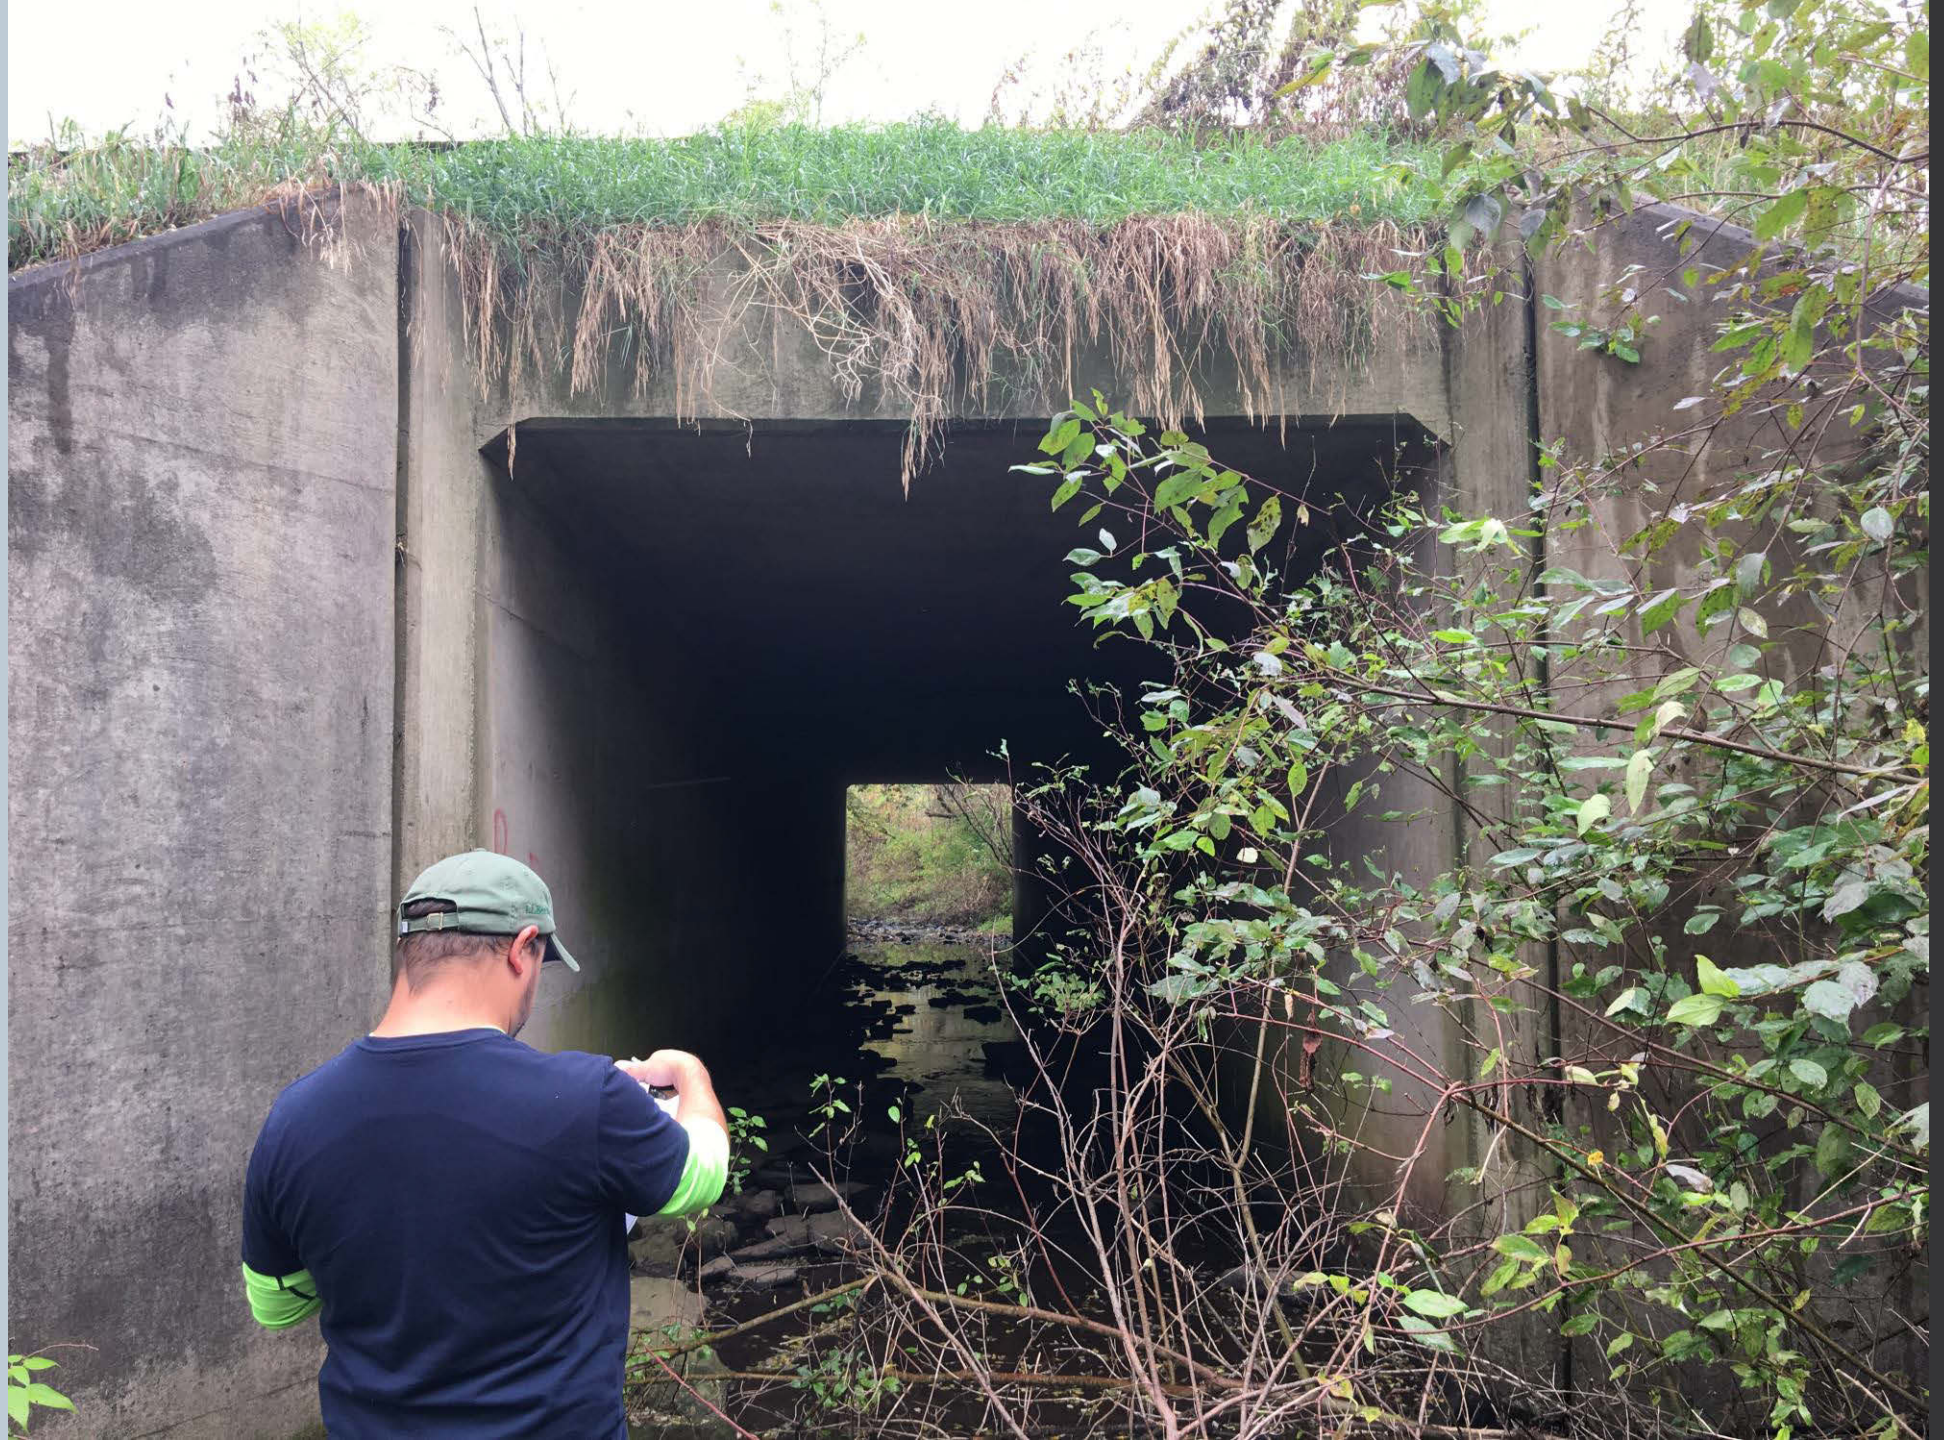
Figure 331. Looking upstream from the culvert inlet along Carverton Road which joins with the unnamed tributary from Dug Road. Fish present.

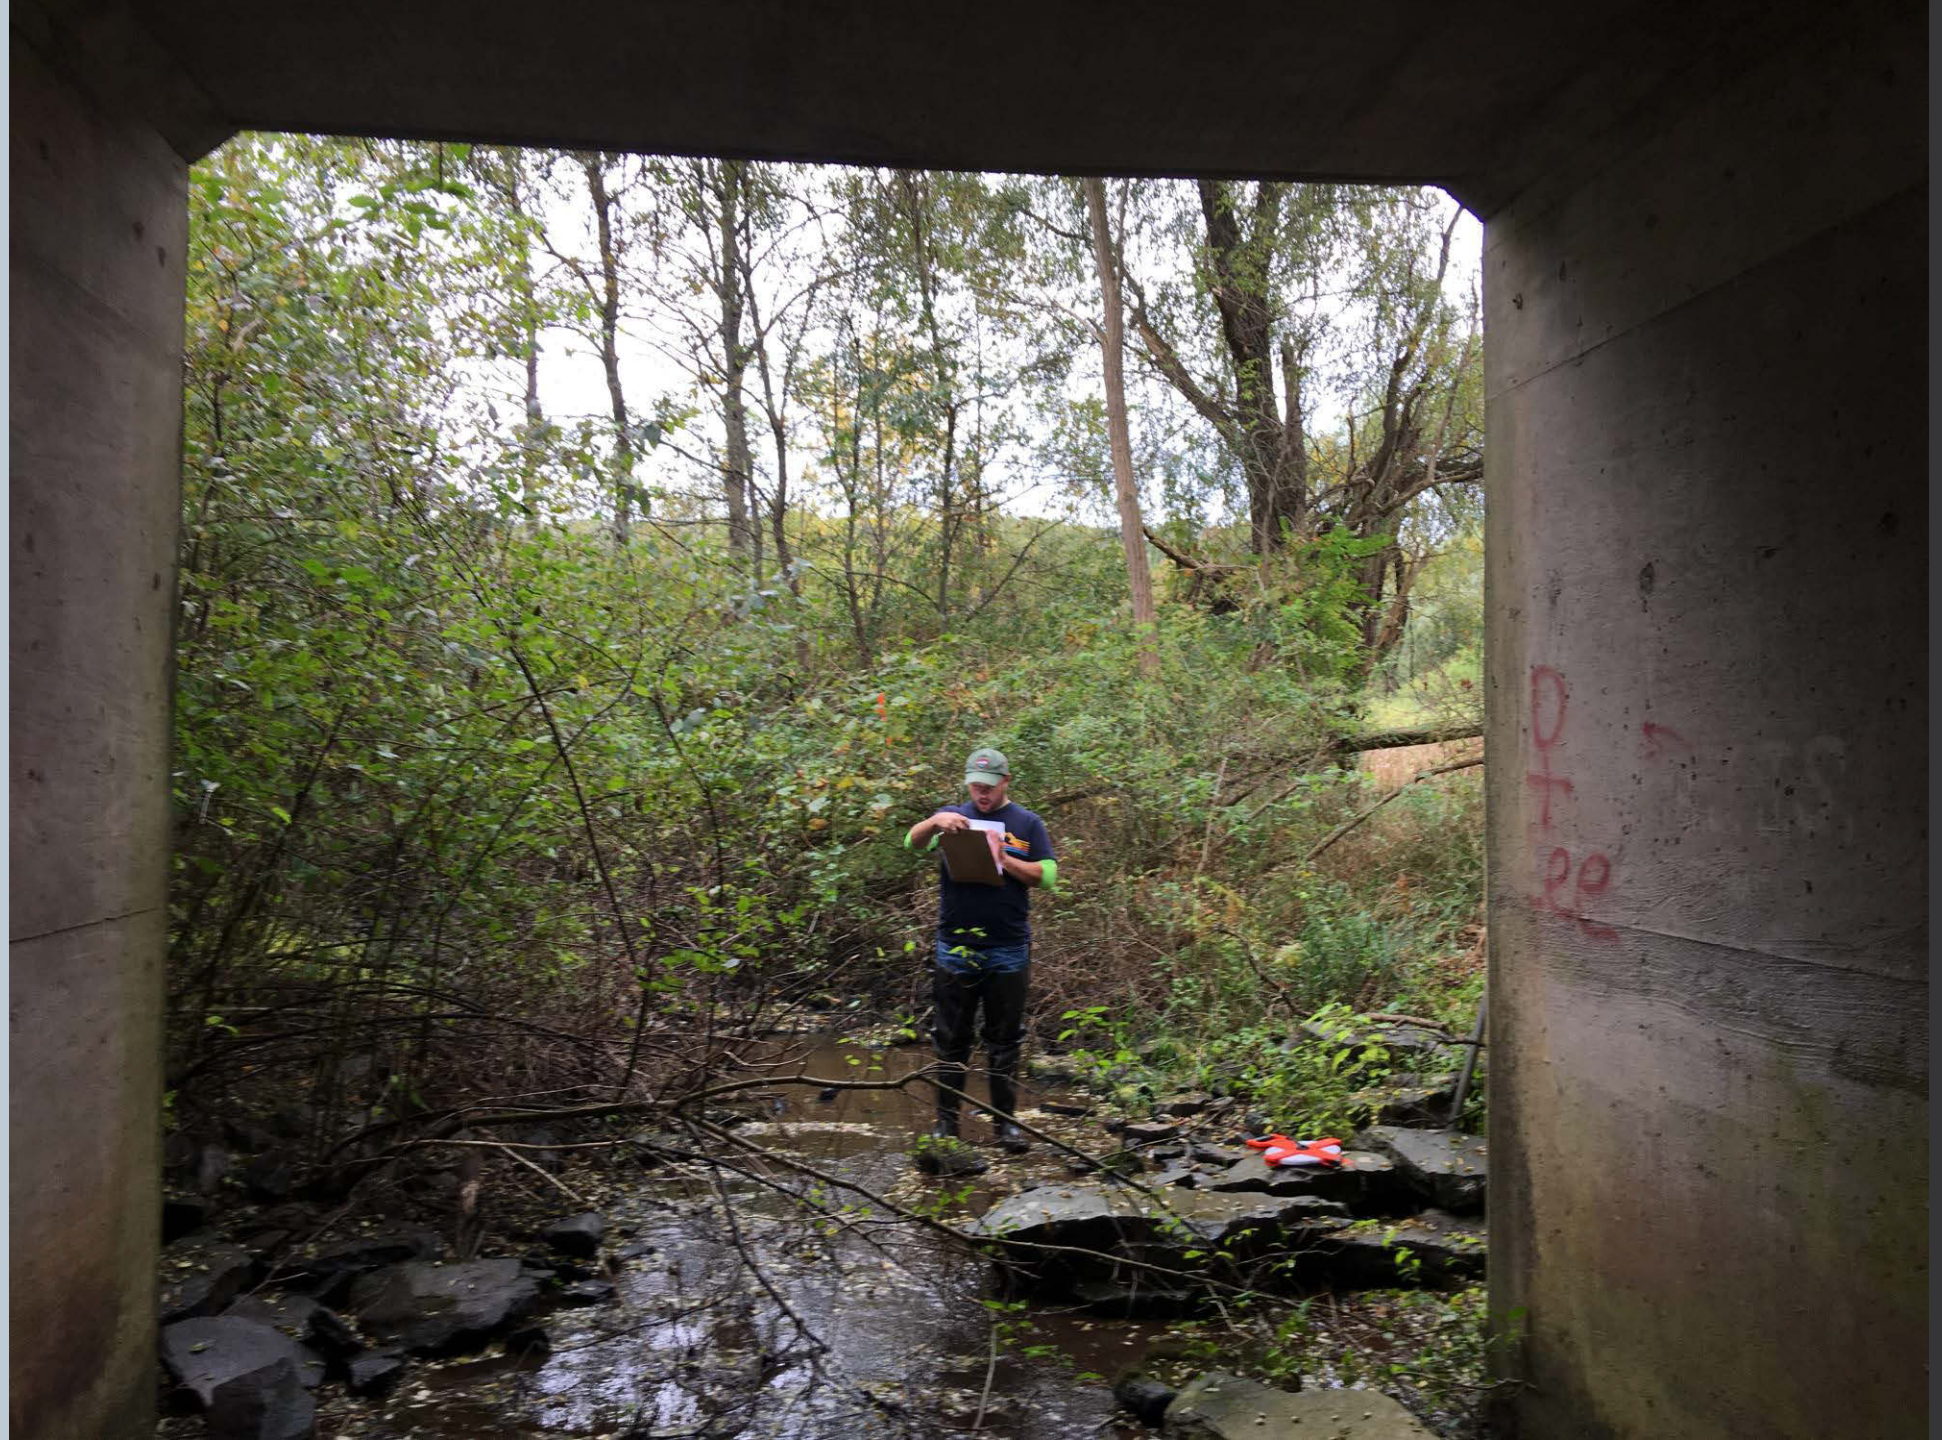
Figure 332. Looking downstream from the culvert outlet along Carverton Road which joins with the unnamed tributary from Dug Road. Fish present.

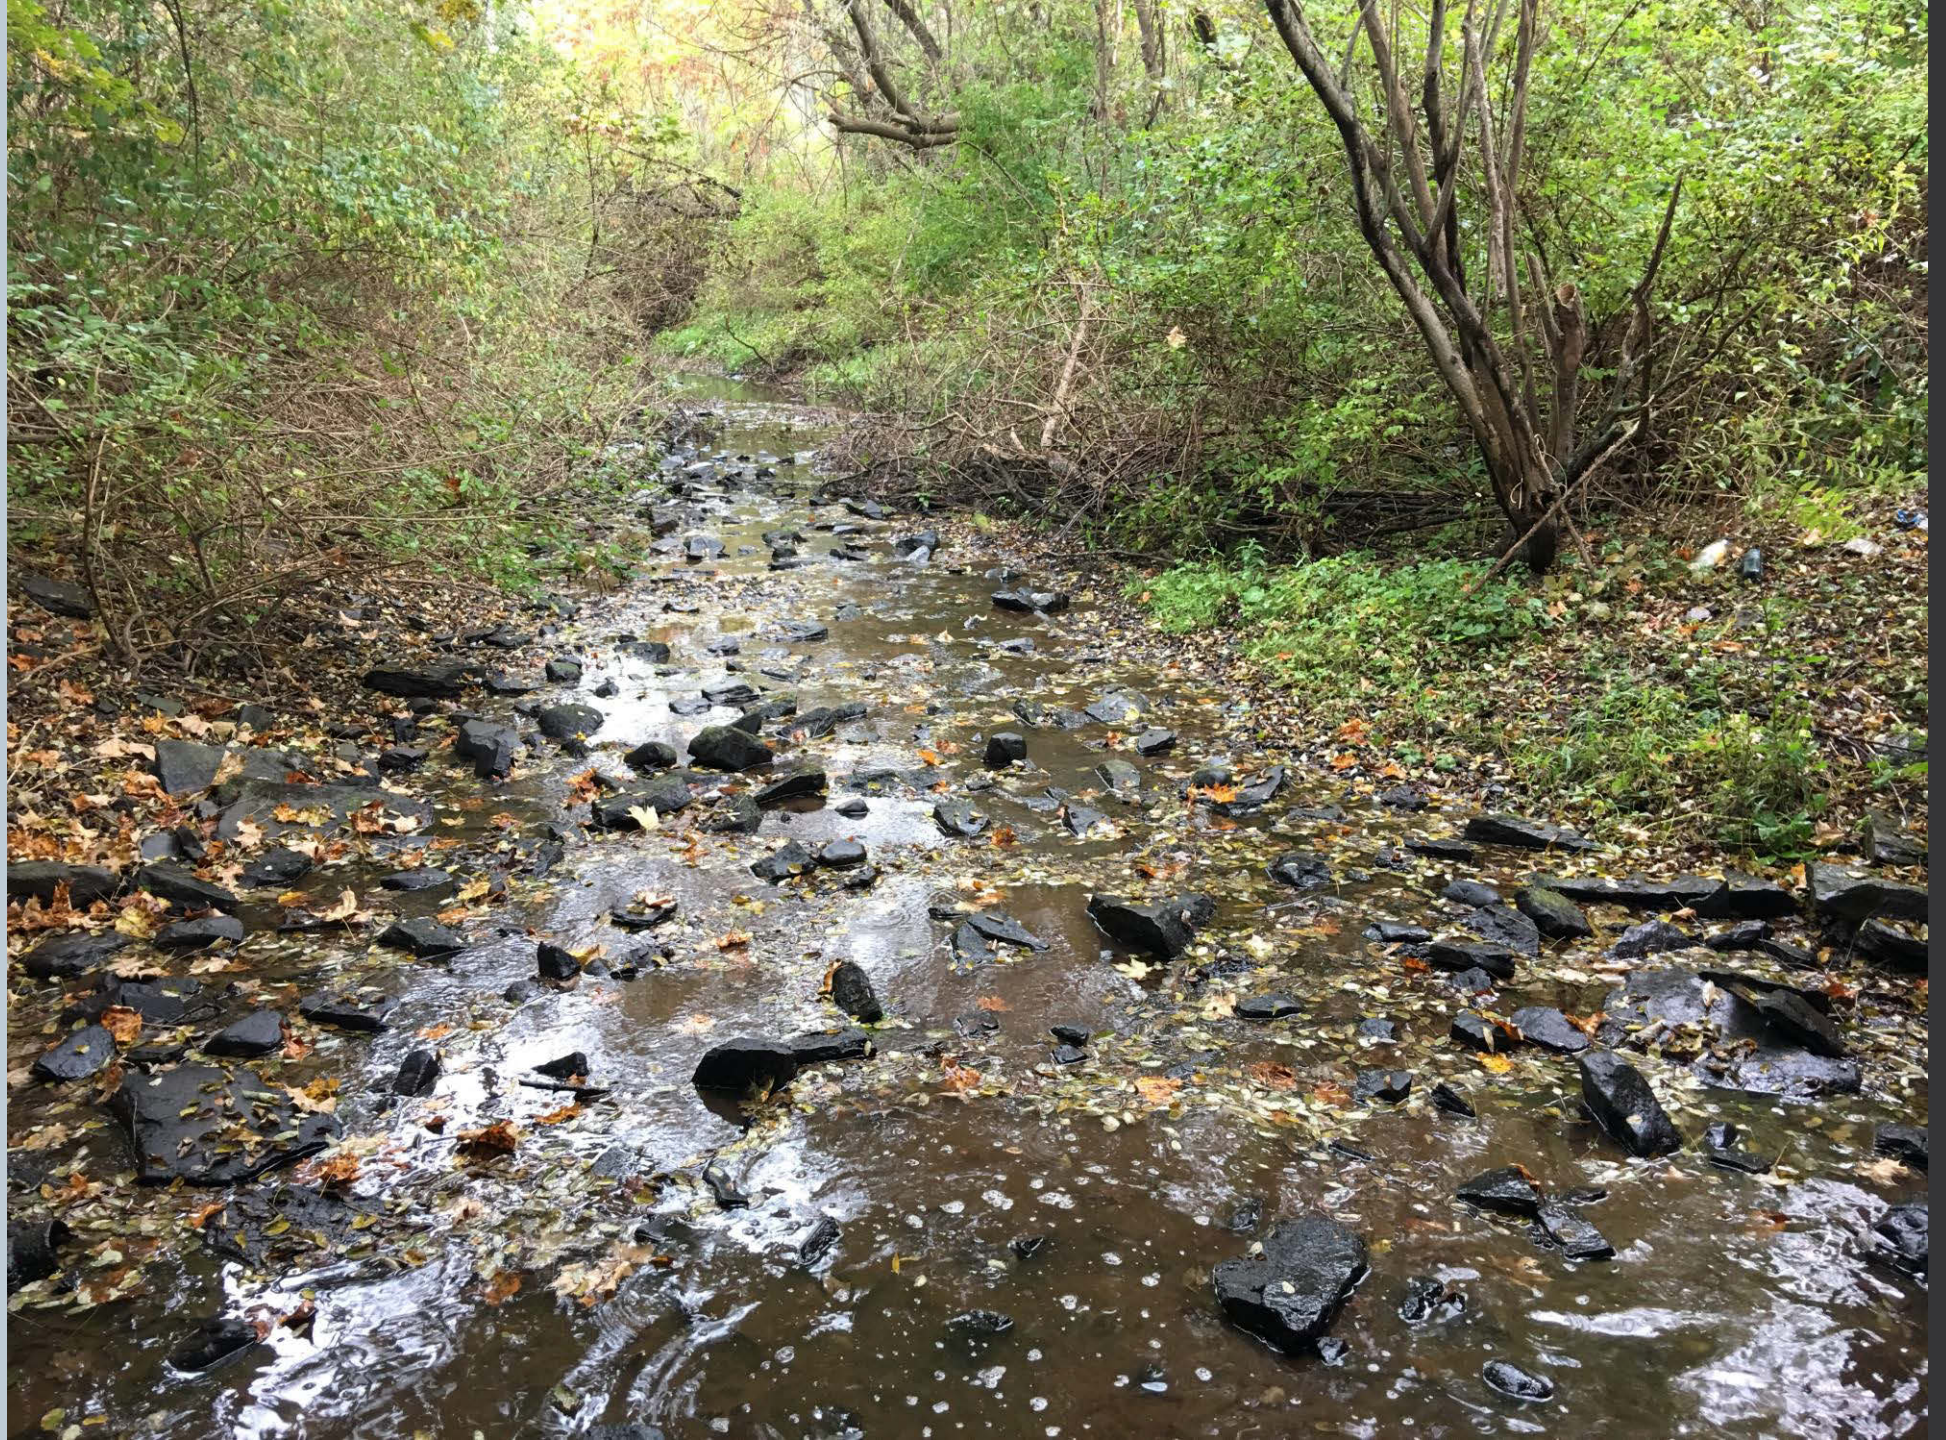
Figure 333. Looking upstream on Toby Creek that was literally dry from the culvert outlet along W. Center Hill Road and the Dallas Memorial Highway near Leggio's parking lot. Sediment filled the length of the entire culvert.

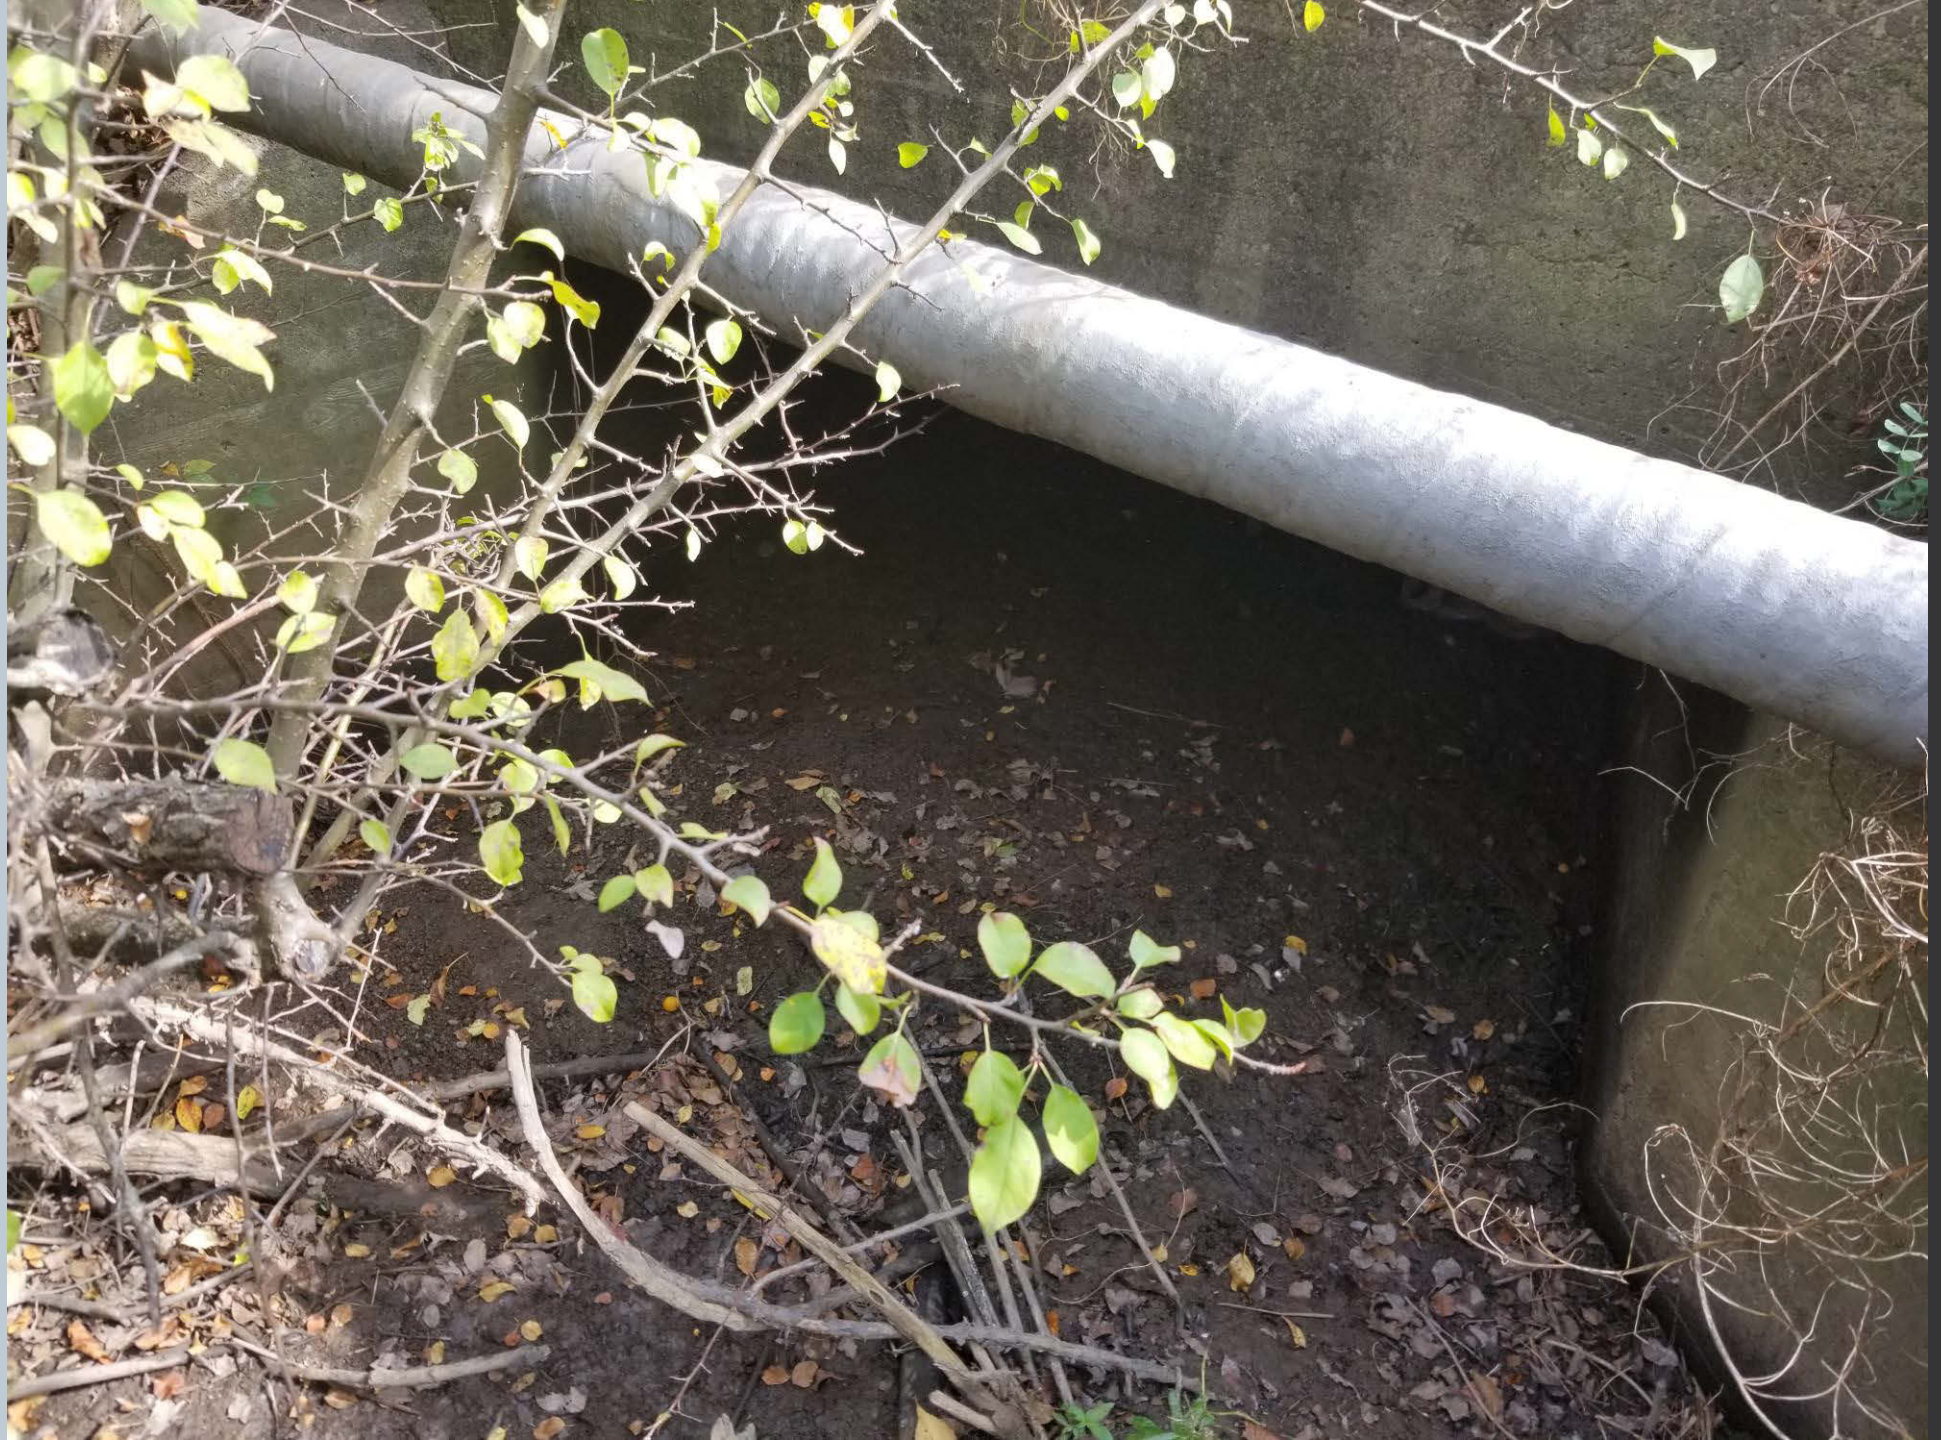
Figure 334.
Looking
upstream on
Toby Creek of
the culvert
inlet along W.
Center Hill
Road and the
Dallas
Memorial
Highway. The
stream was dry
and the
riparian area
thick and
dense.

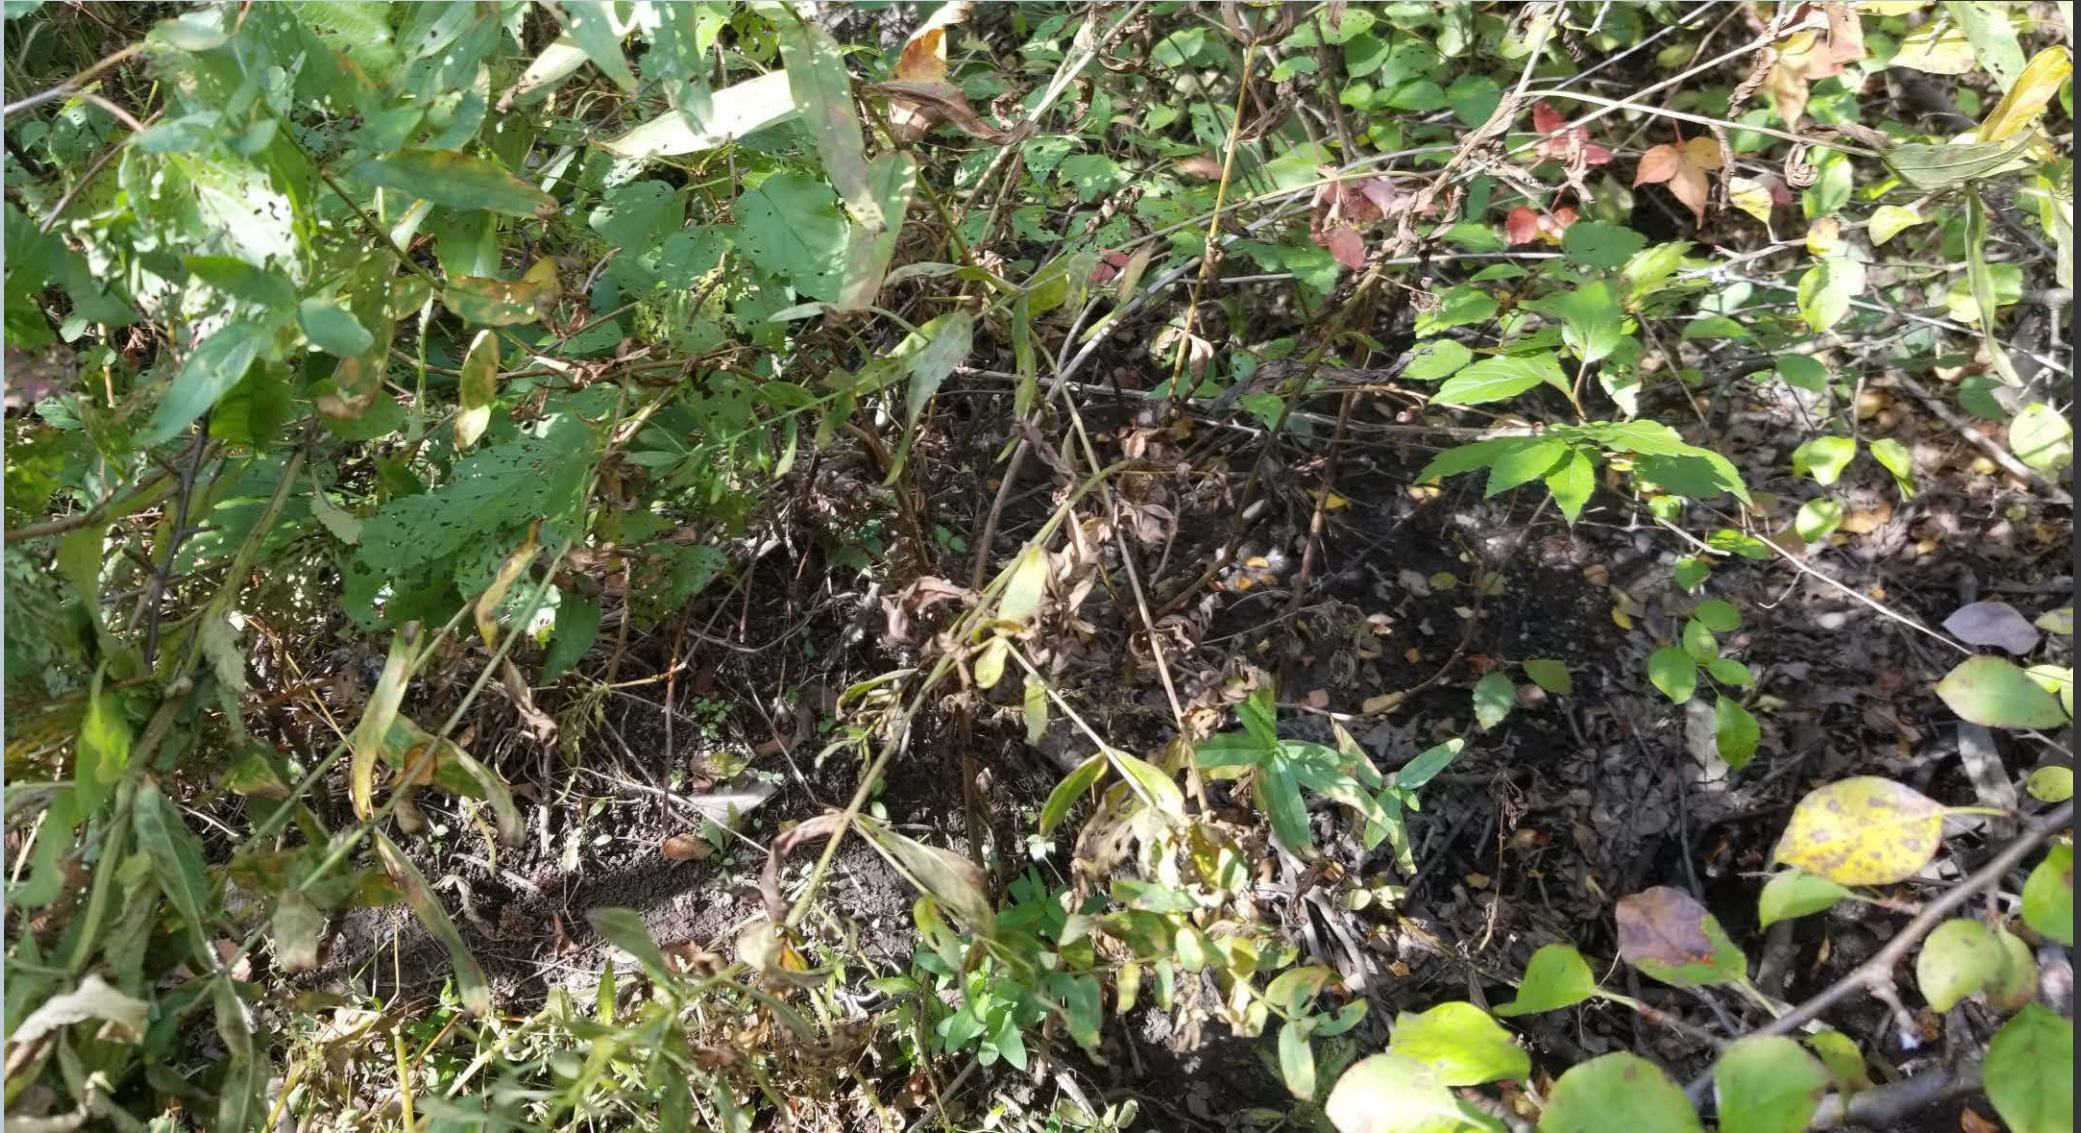
Figure 335. Looking upstream on Toby Creek towards the culvert outlet along W. Center Hill Road along the Dallas Memorial Highway from the parking lot of Leggio's. The area is grassed, however, it is also mowed up to the streambank's edge. Recommend a riparian stream restoration along this entire length of Toby Creek.
