Toby Creek Field Reconnaissance Observations

September 26, 2018

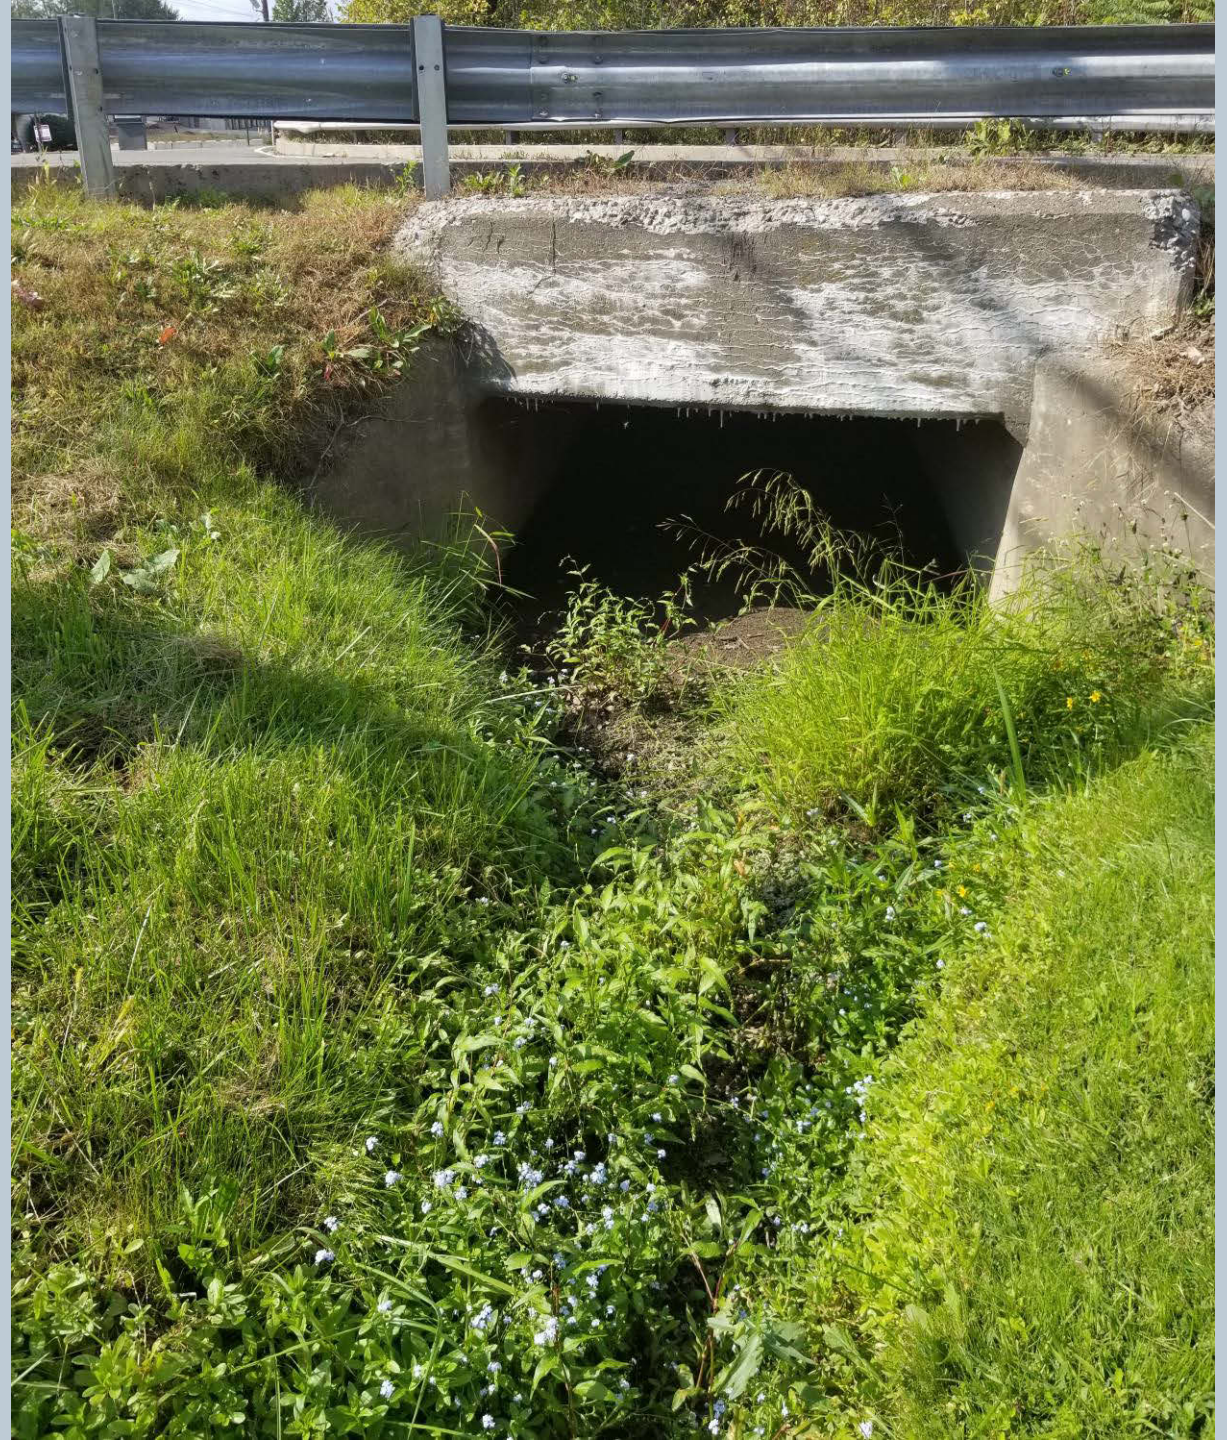
Figure 336. Looking downstream of Toby Creek from the culvert outlet next to the Leggio's parking lot. A riparian planting is recommended along both sides of the streambank and discontinuation of the mowing that frequently occurs.

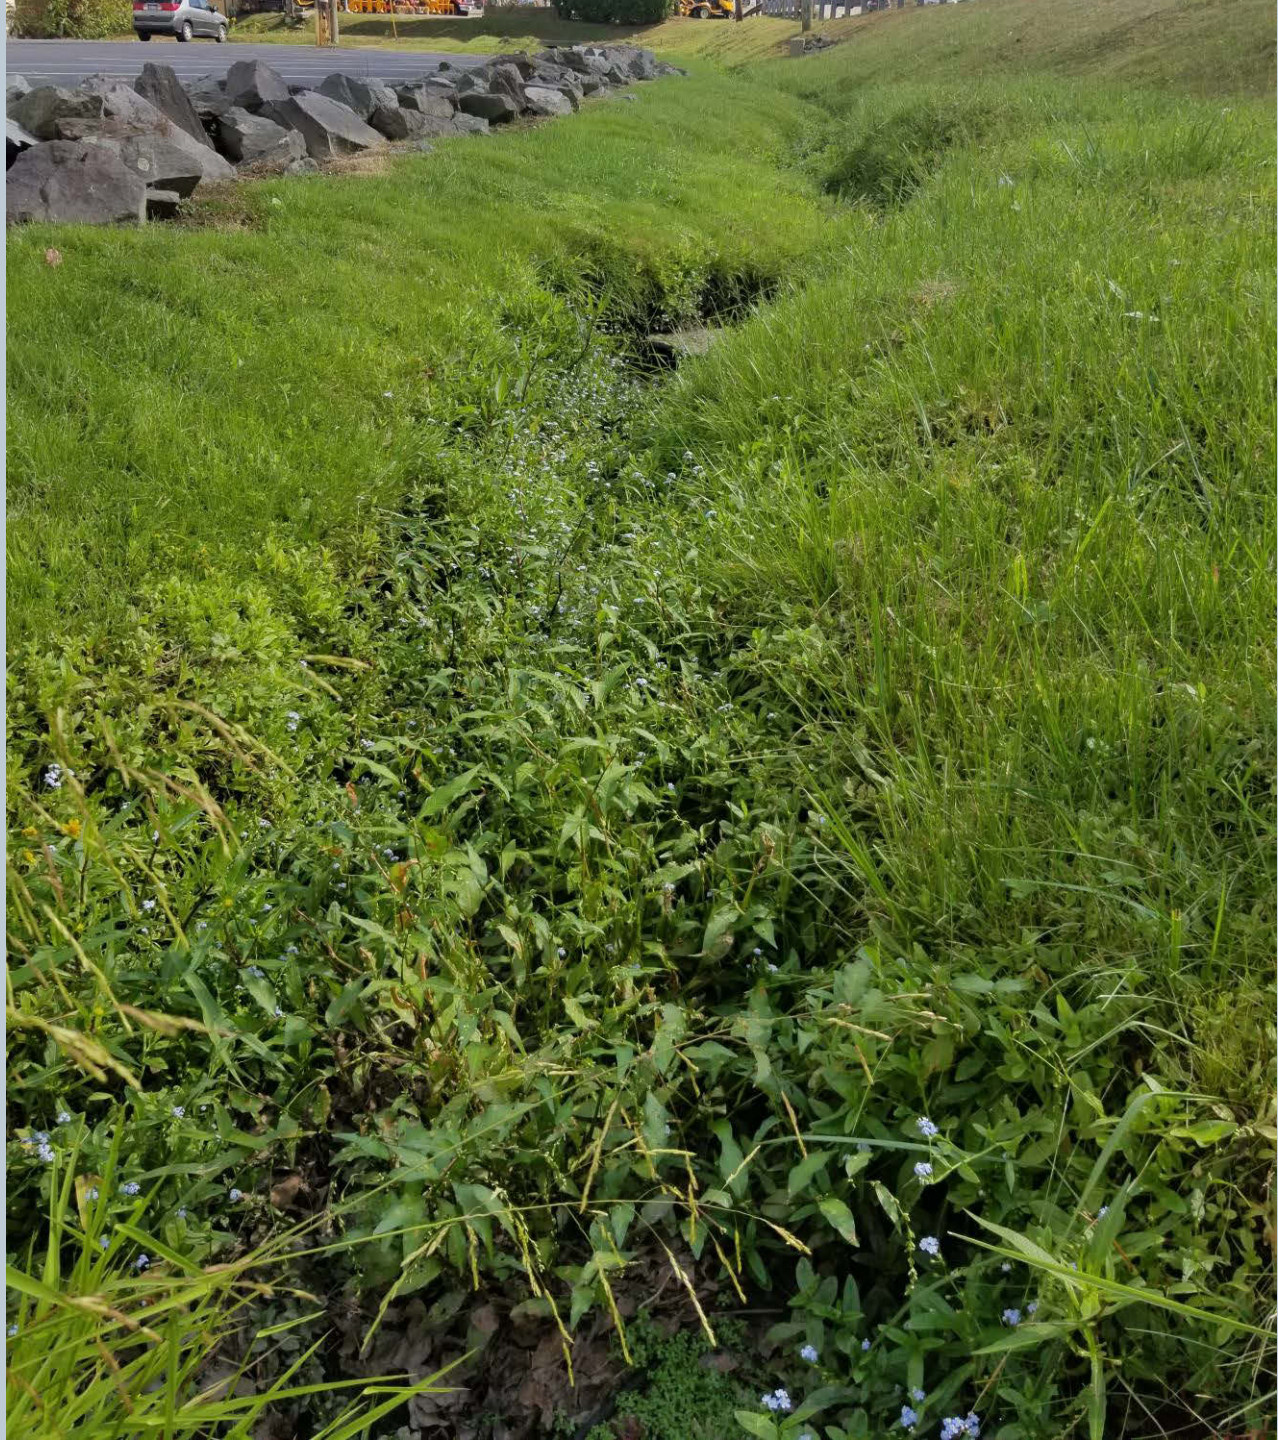
Figure 337. Looking upstream on Toby Creek on the inlet side of the culvert that crosses a private road to the Meadows Nursing Home. Riparian area is well established.

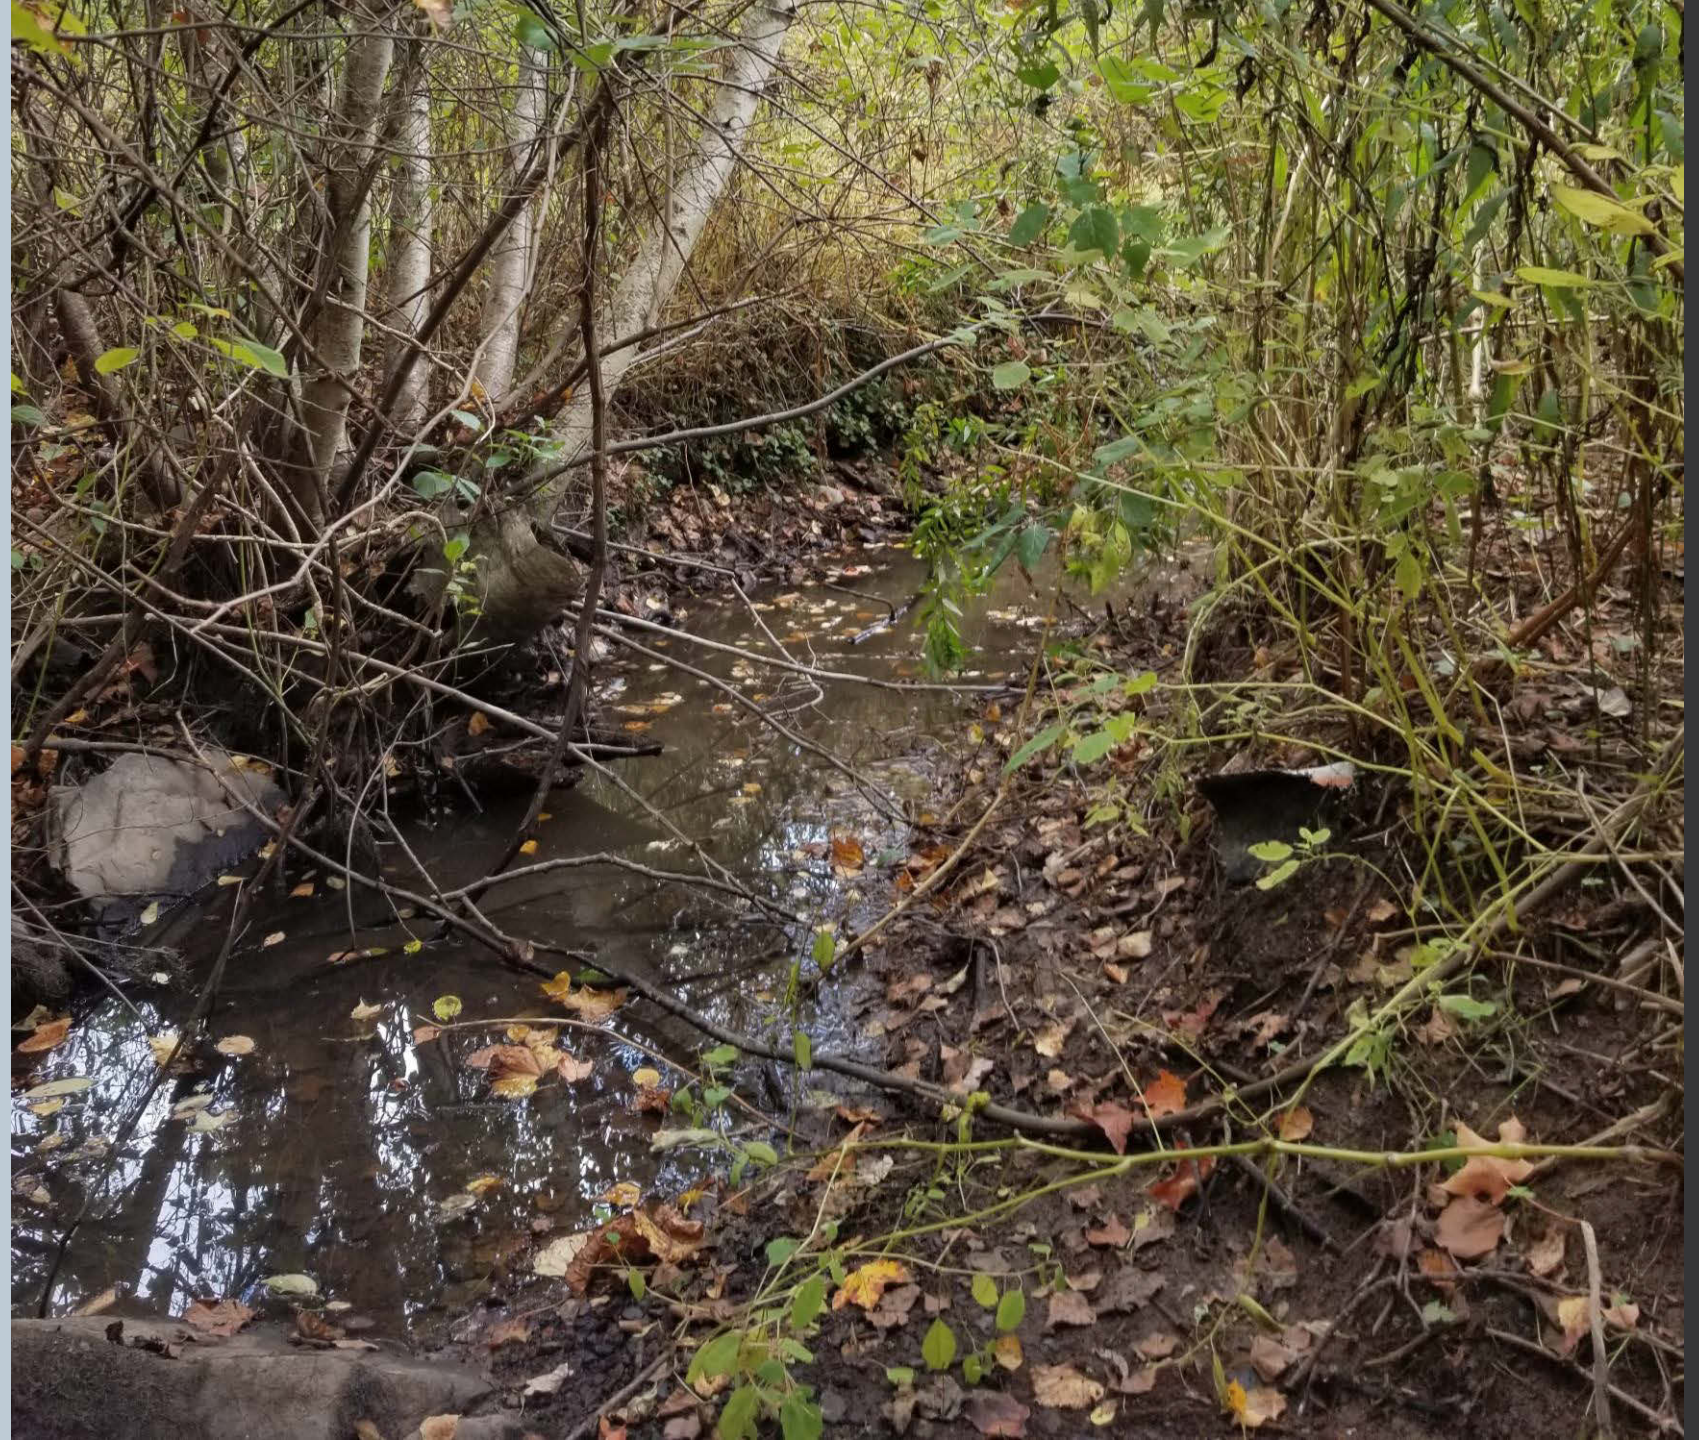
Figure 338. Looking downstream on Toby Creek on the outlet side of the culvert that crosses a private road to the Meadows Nursing Home. The culvert is filled with sediment and the baseflow of the stream is below the sediment deposition.

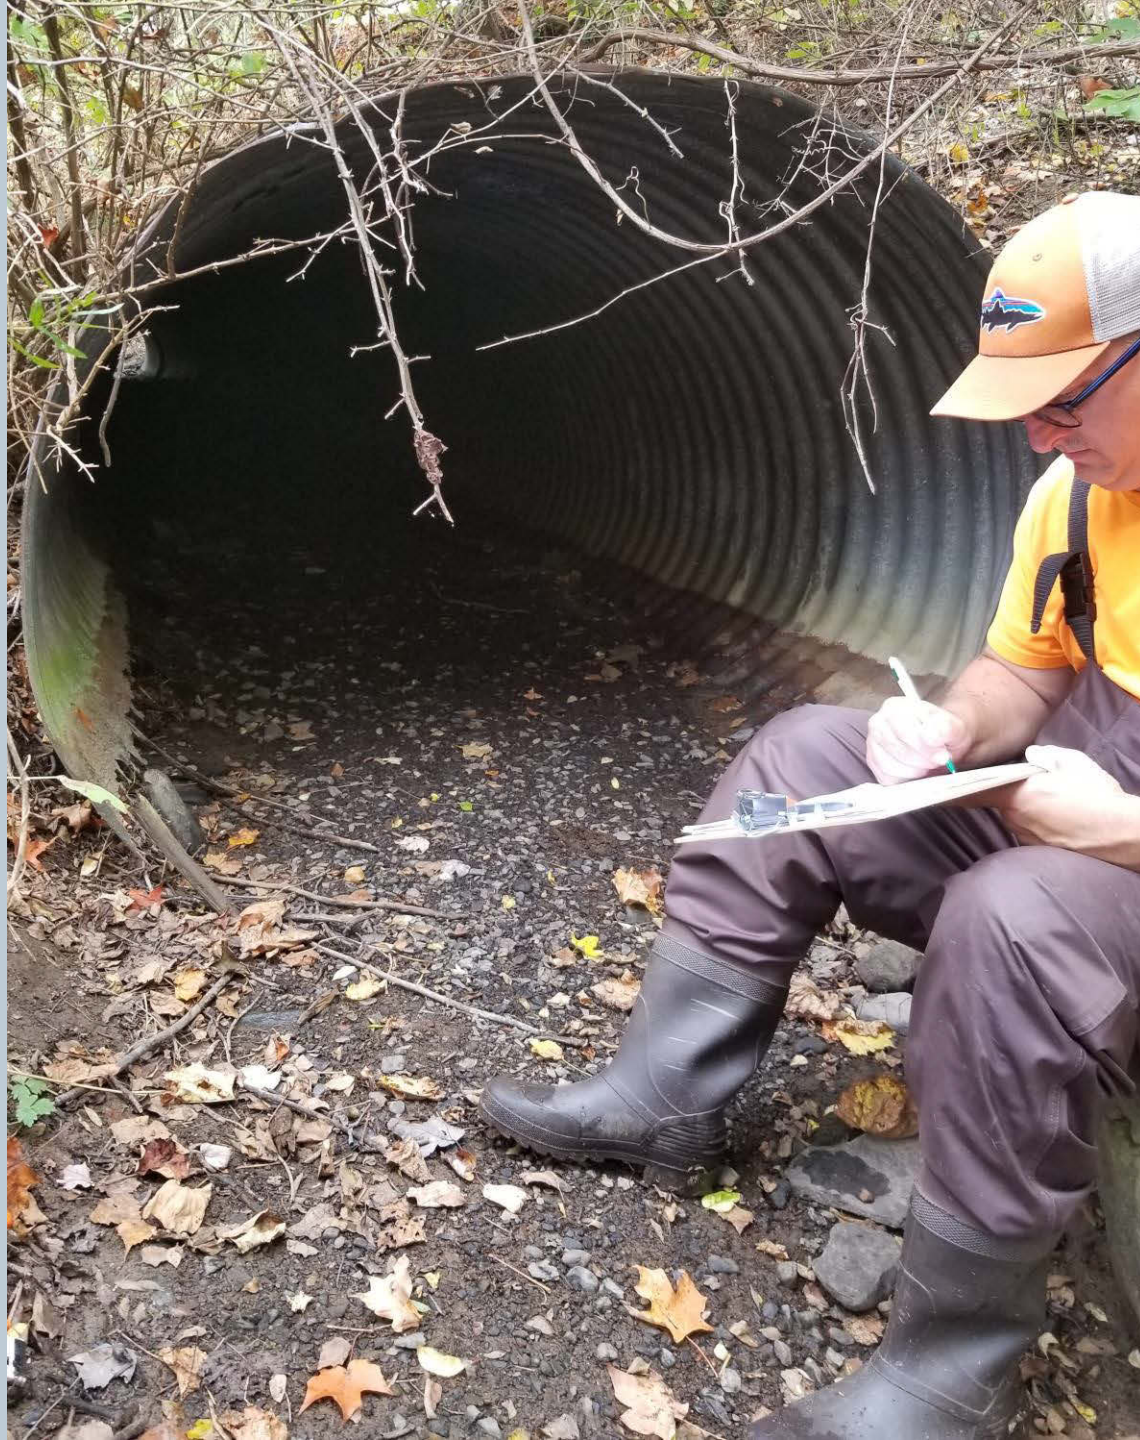
Figure 339. Looking downstream on Toby Creek from the culvert pipe that extends across the private road to the Meadows Nursing Home.

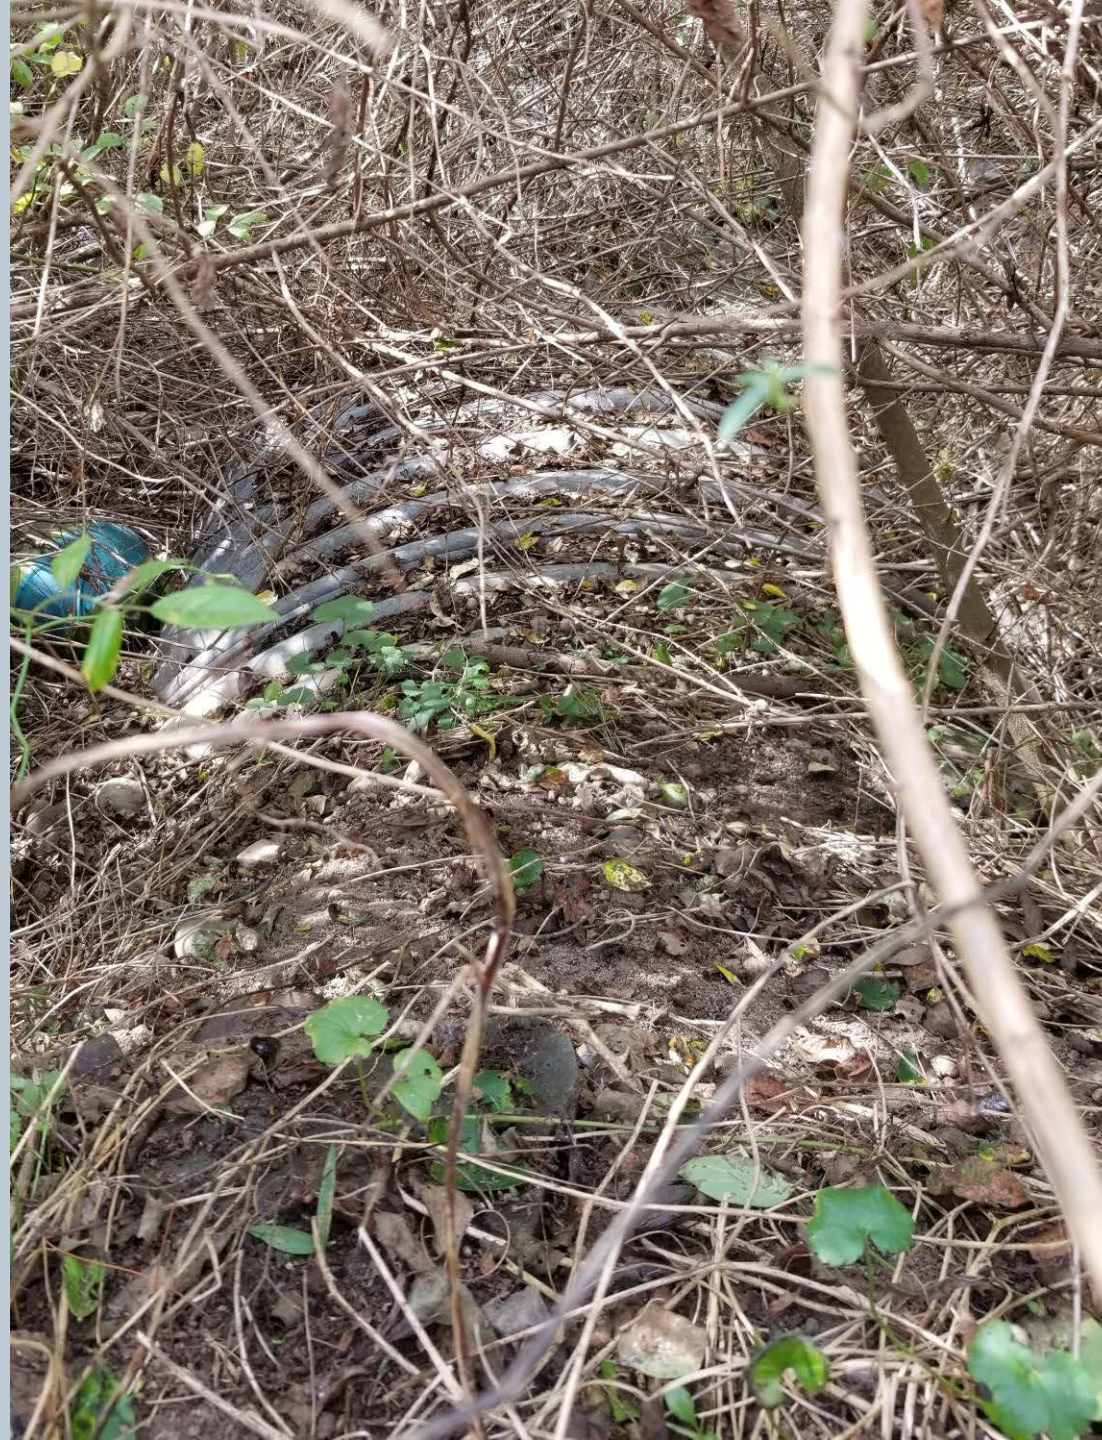
Figure 340. Looking downstream on Toby Creek from the culvert pipe that extends across the private road to the Meadows Nursing Home. Fish and frogs were present in some of the shallow pools of water within the stream channel that meanders back and forth in this area behind J & J's Subs. Riparian area is well established.

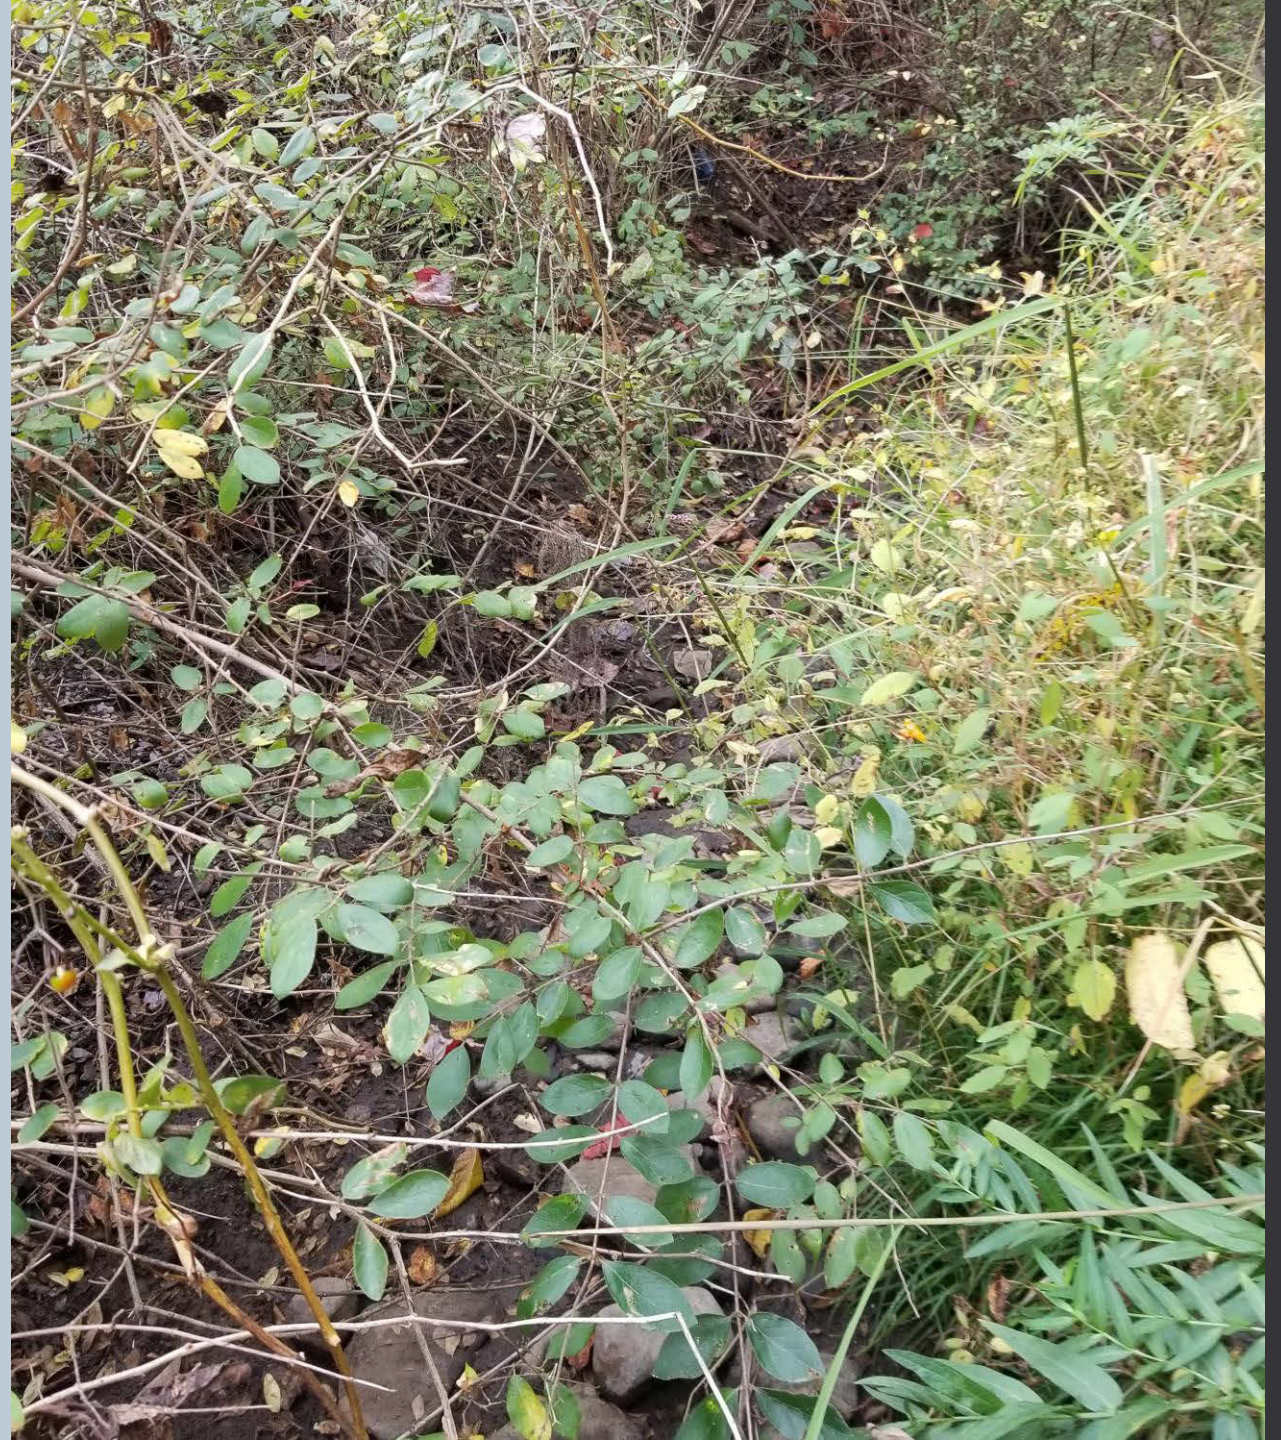
Figure 341. Looking downstream above the culvert inlet on Toby Creek near the former Payne Printing Company that is now owned by Misericordia University.

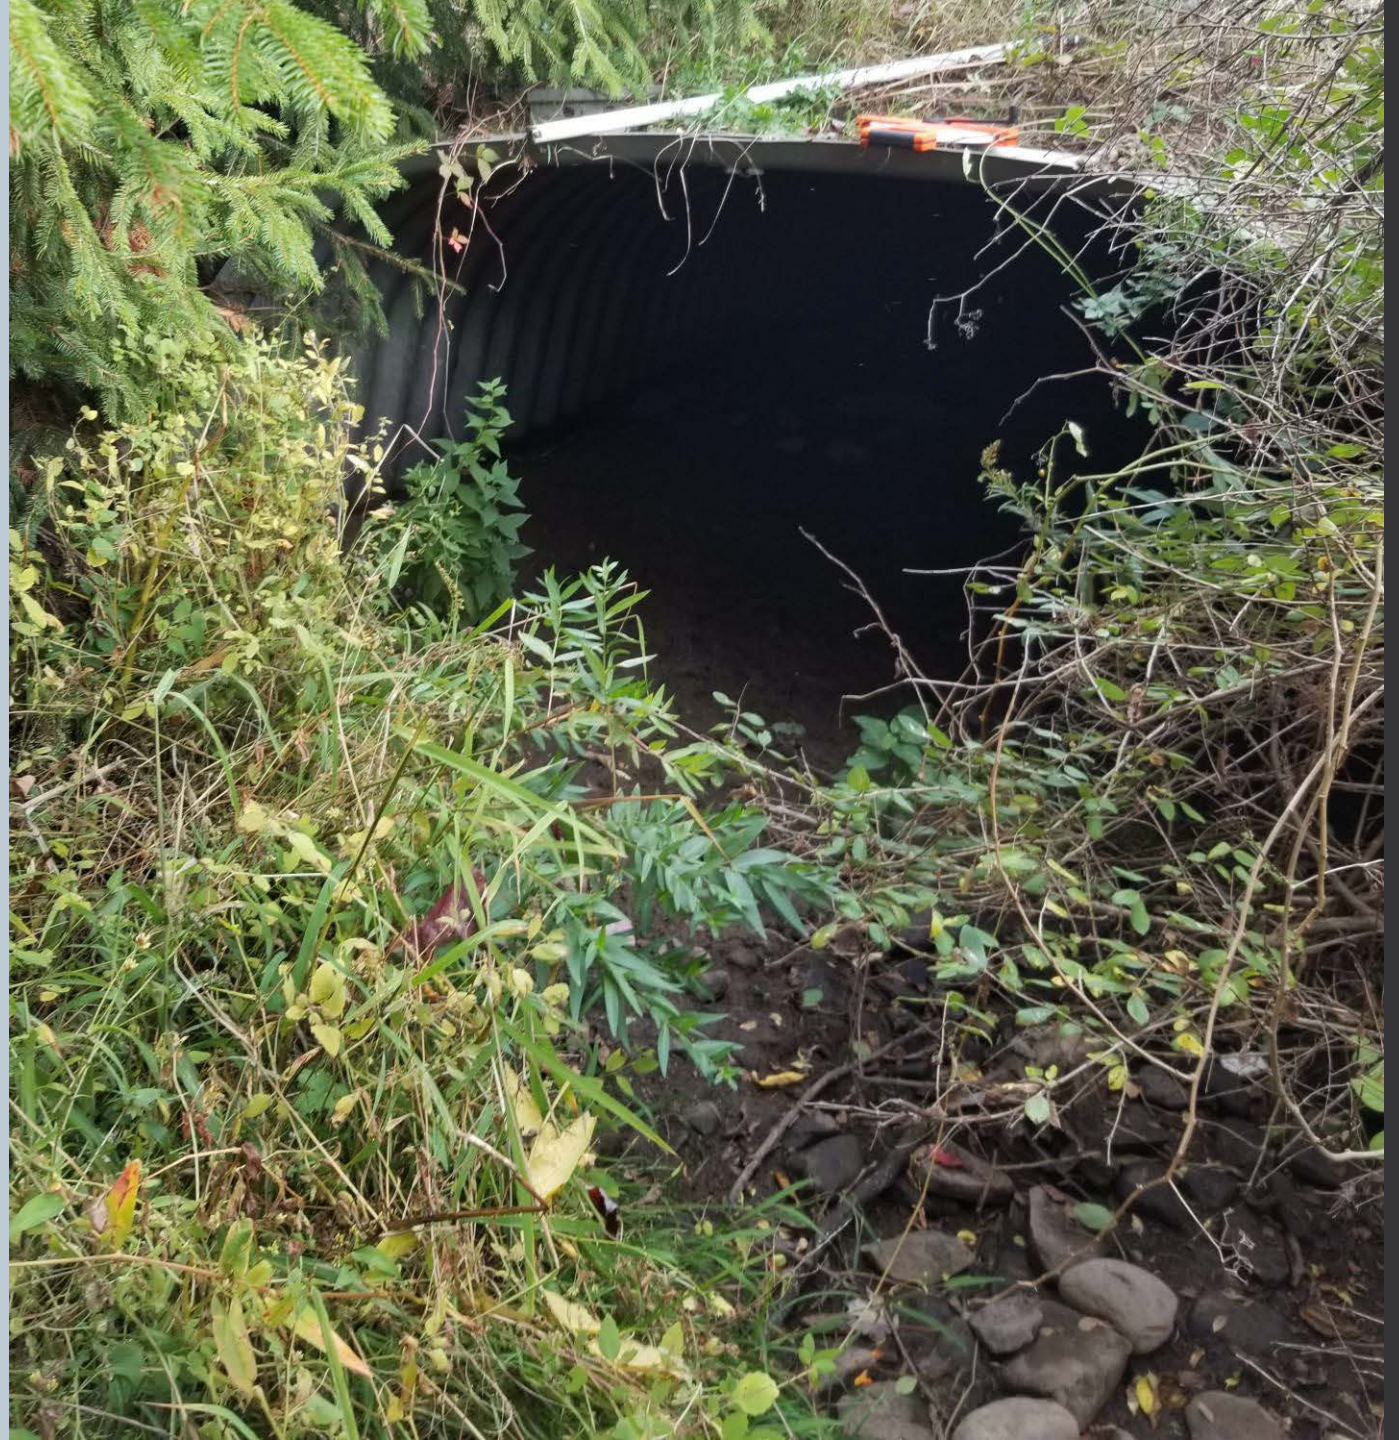
Figure 342. Looking upstream on Toby Creek below the culvert outlet near the former Payne Printing Company that is now owned by Misericordia University. A sumac tree is growing in front of the culvert that is creating a blockage in the channel. A small pool of water contained fish minnows on this stretch of road. Recommend removing the sumac tree.

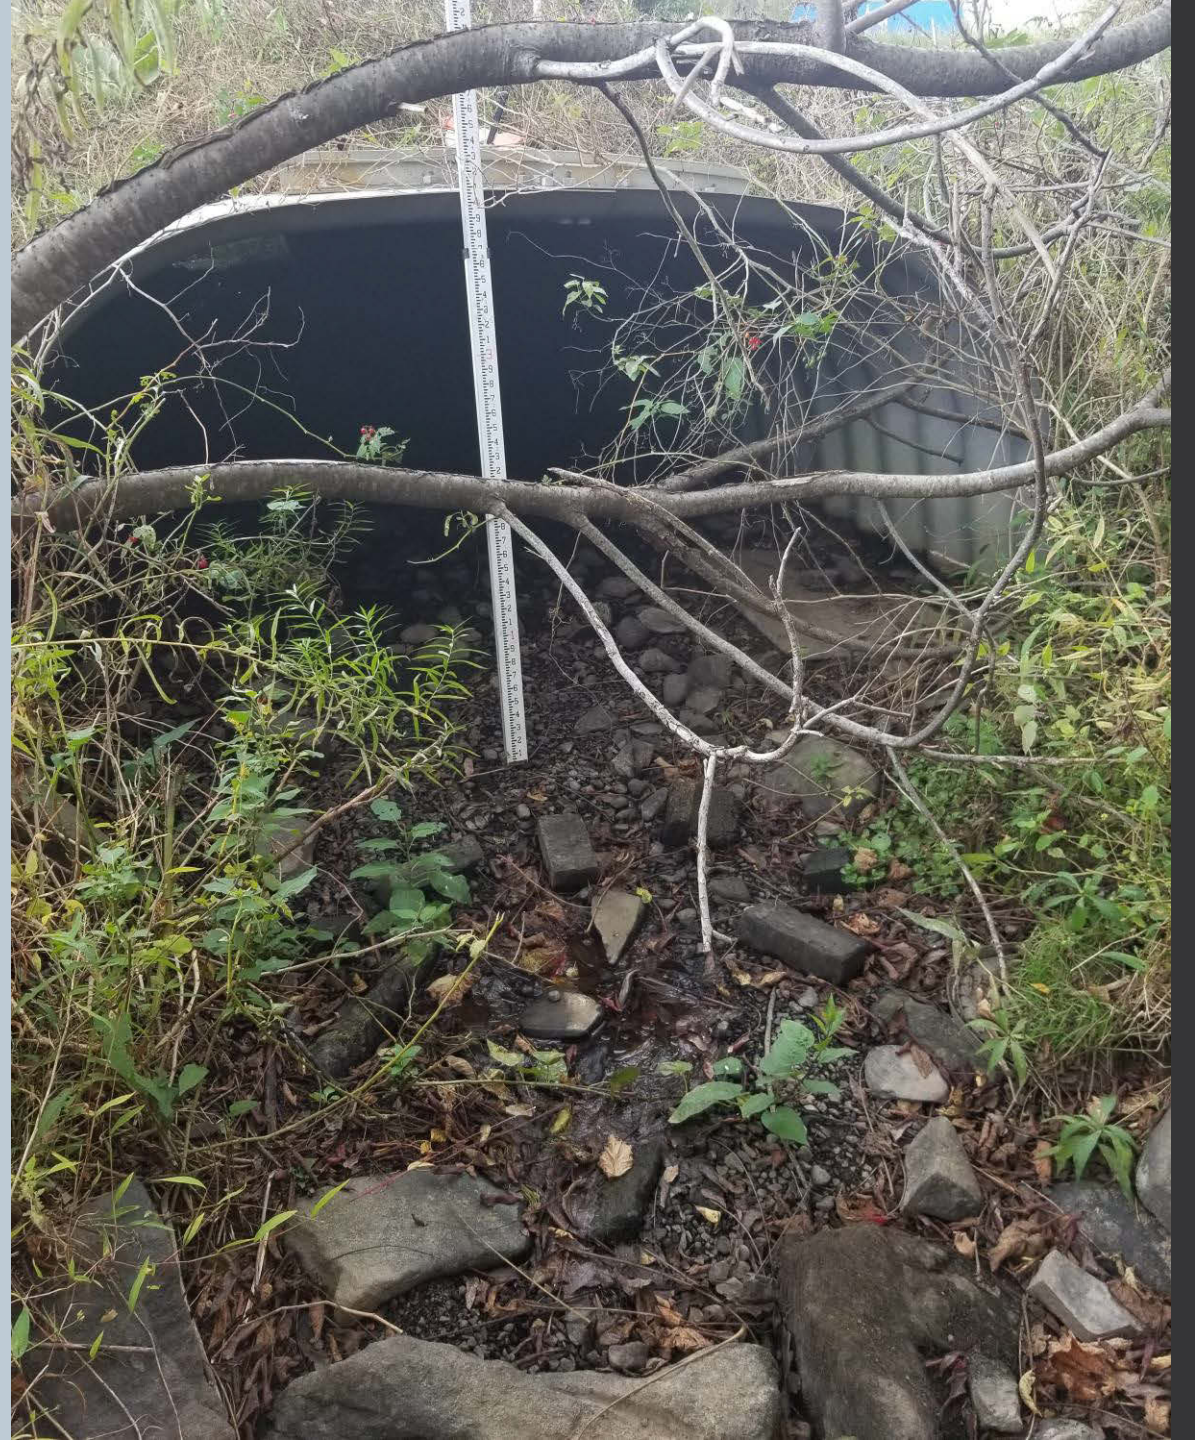
Figure 343. Looking downstream on Toby Creek below the culvert outlet near the former Payne Printing Company that is now owned by Misericordia University. A sumac tree is growing in front of the culvert that is creating a blockage in the channel. A small pool of water contained fish minnows on this stretch of road. Recommend removing the sumac tree and a small roadside litter cleanup of the area.

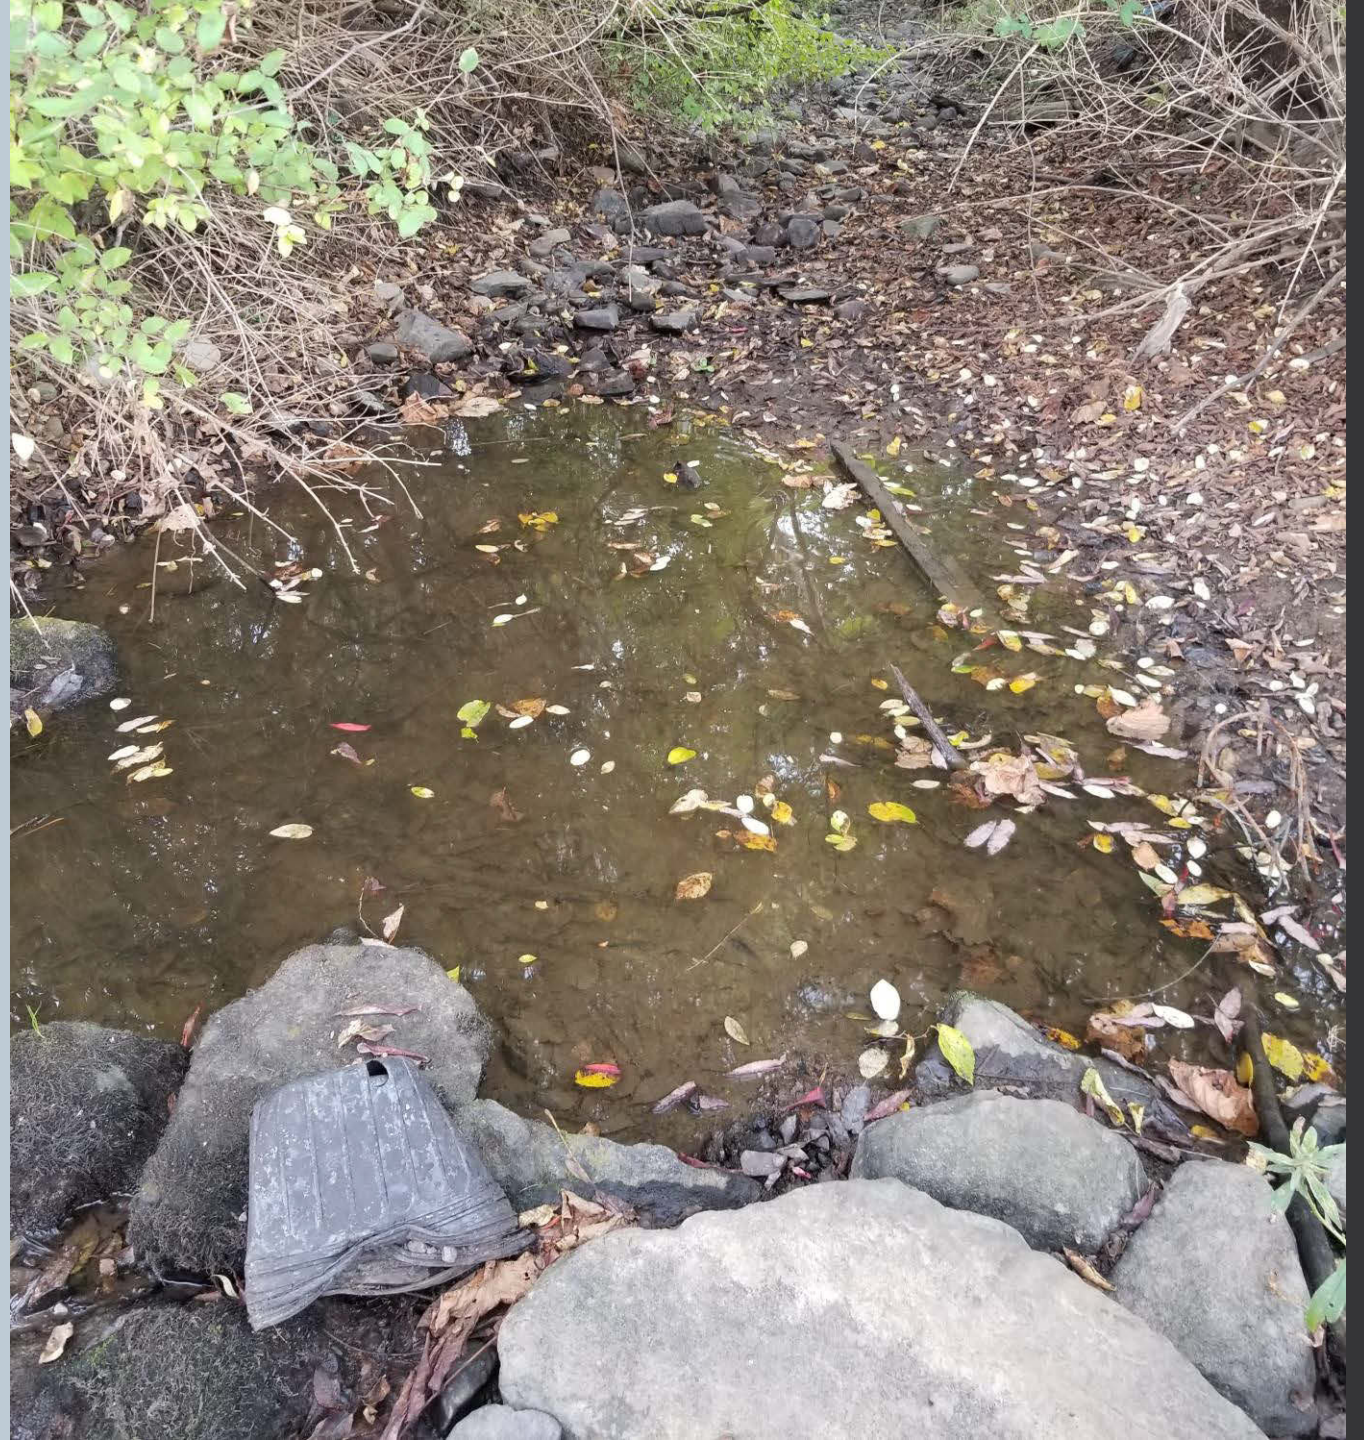
Figure 344. Looking upstream on an unnamed tributary to Toby Creek within Newberry Estates along a private road. A large number of green frogs were present. The rock-lined channel upstream is recommended to be redesigned into a riparian restoration area for the headwaters of the unnamed tributary if the Golf Course owners would be willing to partner on a project.

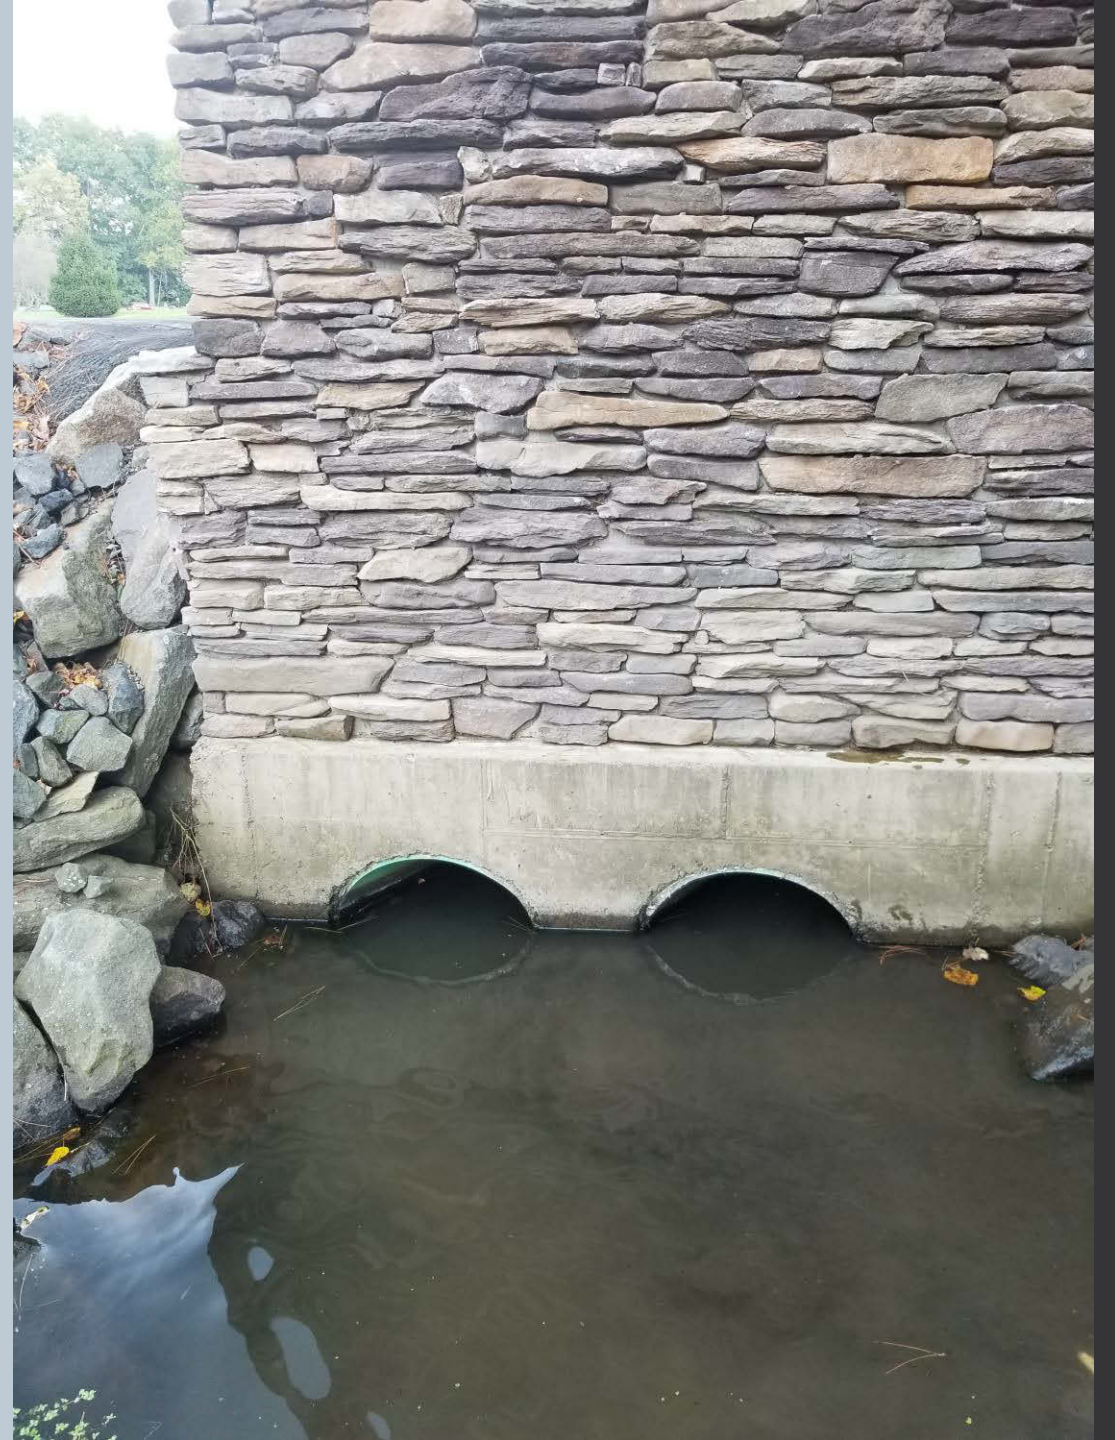
Figure 347. Looking upstream on the unnamed tributary to Toby Creek at the double structure pipe culvert beneath the bridge over the private road within Newberry Estates. The pool in front of the structures is sediment-laden and the half full of sediment and green algae growth.

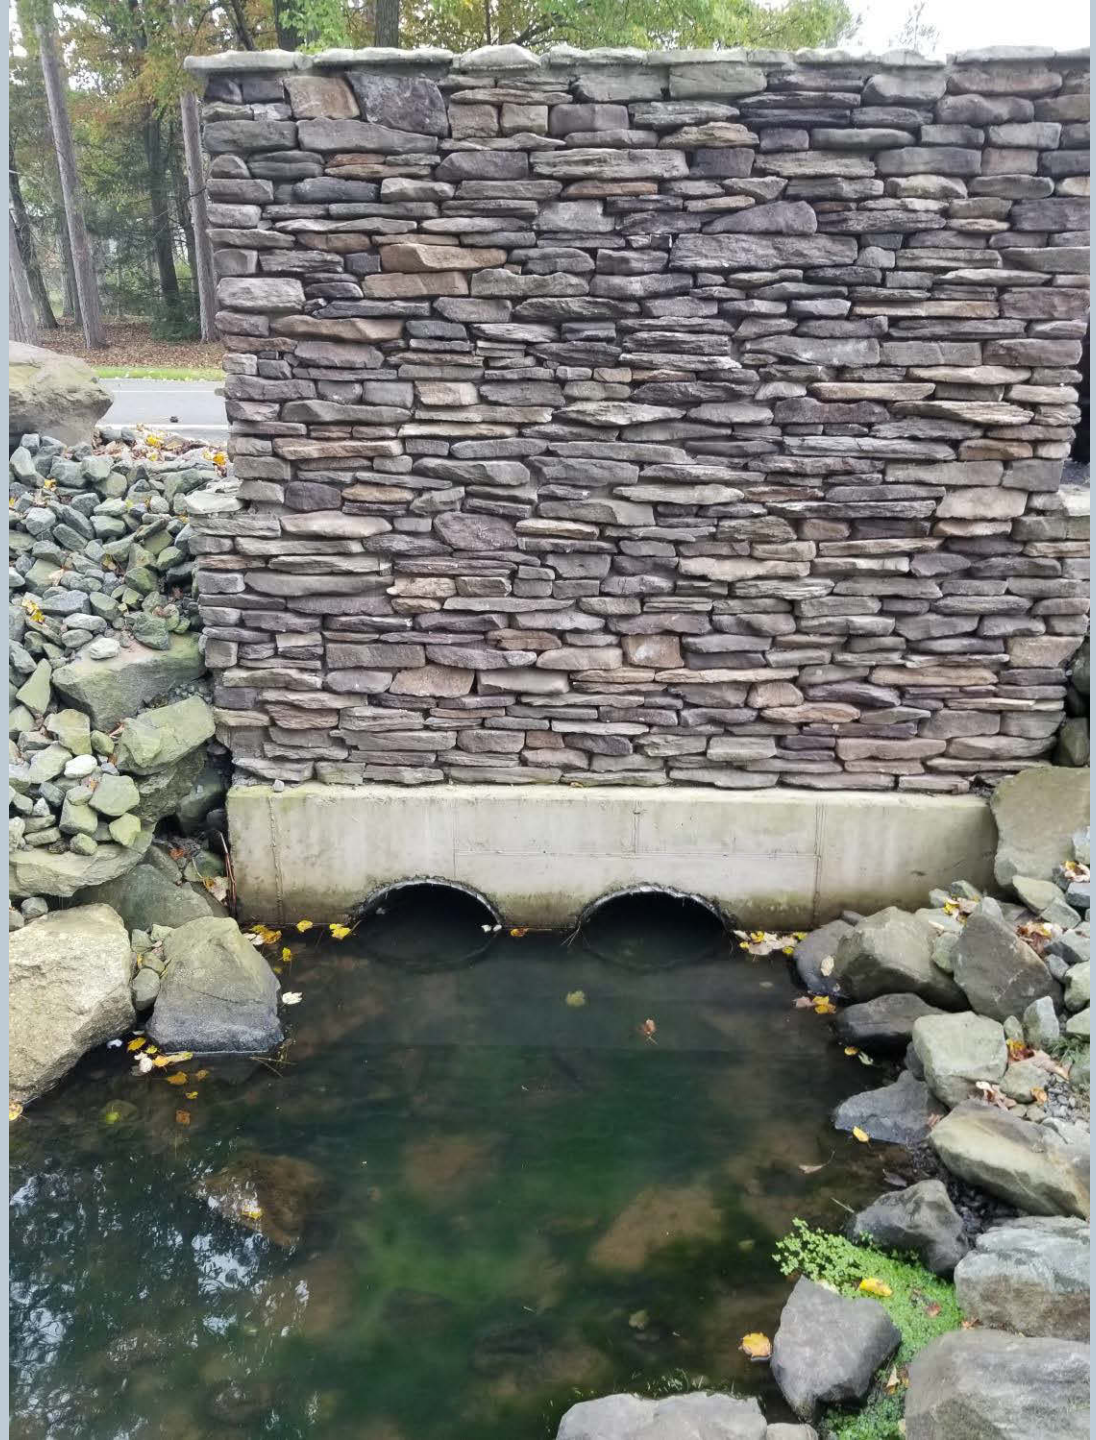
Figure 348. Looking downstream on the unnamed tributary to Toby Creek at the double structure pipe culvert beneath the bridge over the private road within Newberry Estates. The pool in front of the structures is sediment-laden and the half full of sediment and green algae growth. Lots of green frogs were present.

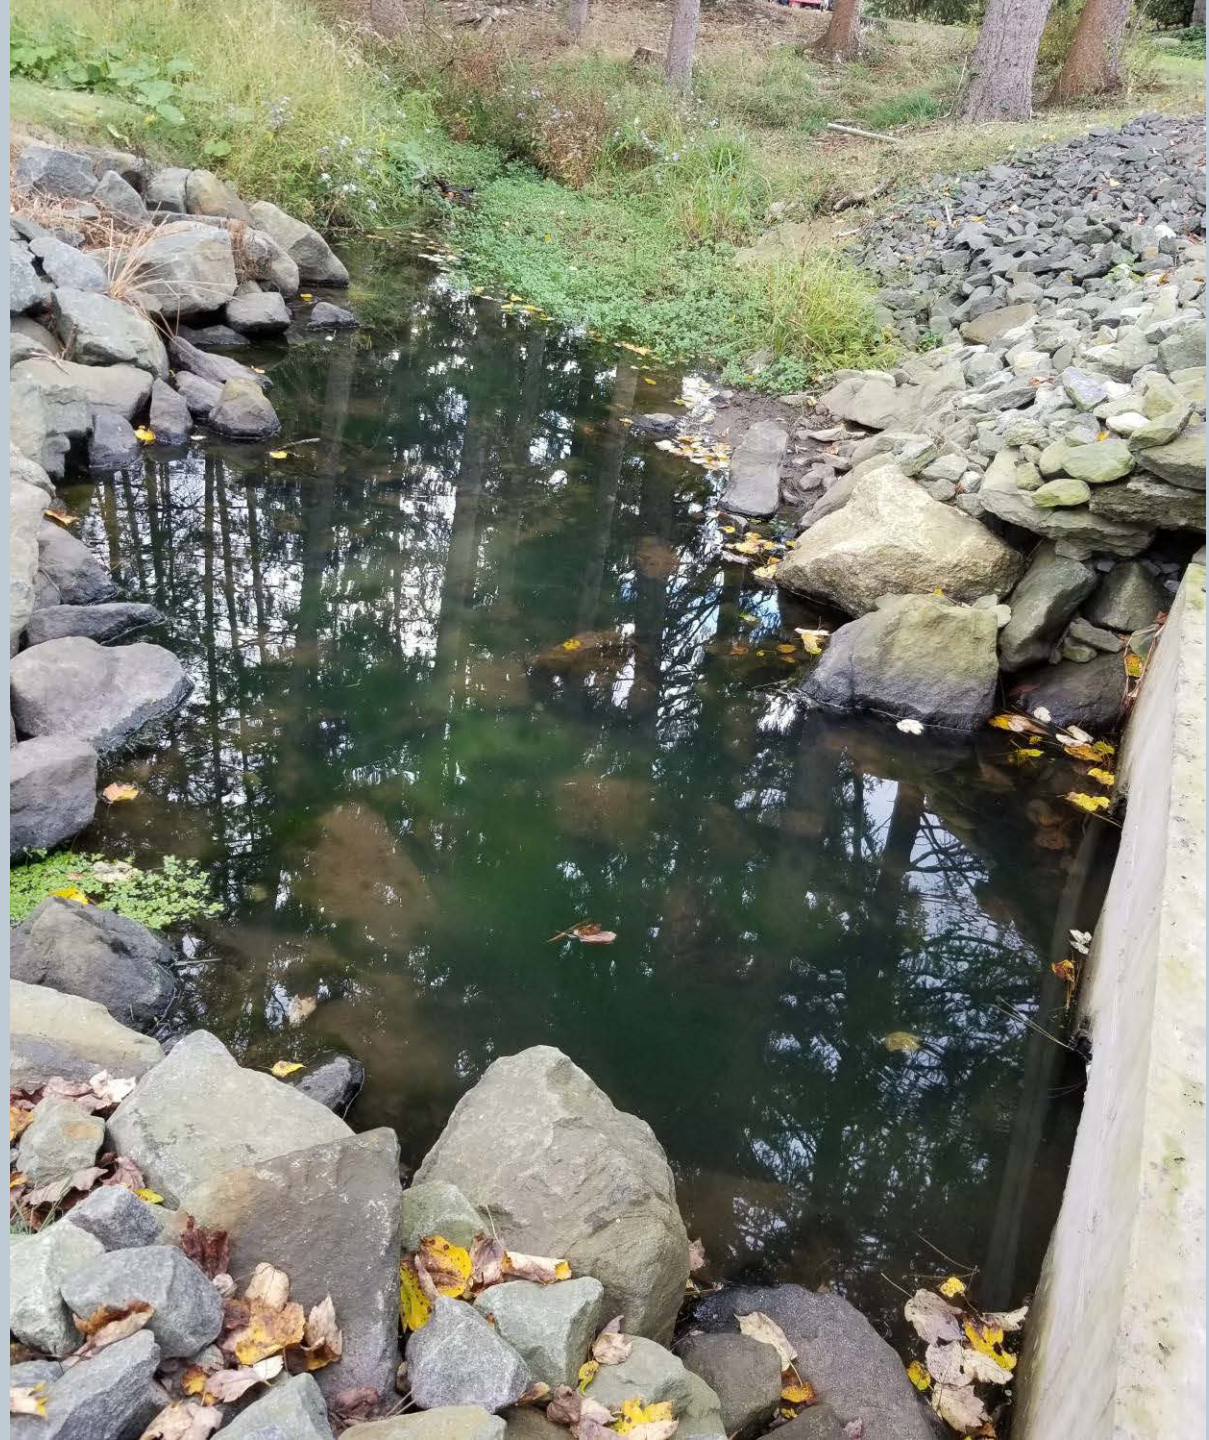
Figure 349. Looking upstream on the ponded area of the unnamed tributary to Toby Creek above another bridge further downstream that connects and drains to a lower pond within Newberry Estates along the private road. Algal bloom presence in the pond.
