Toby Creek Field Reconnaissance Observations

September 26, 2018

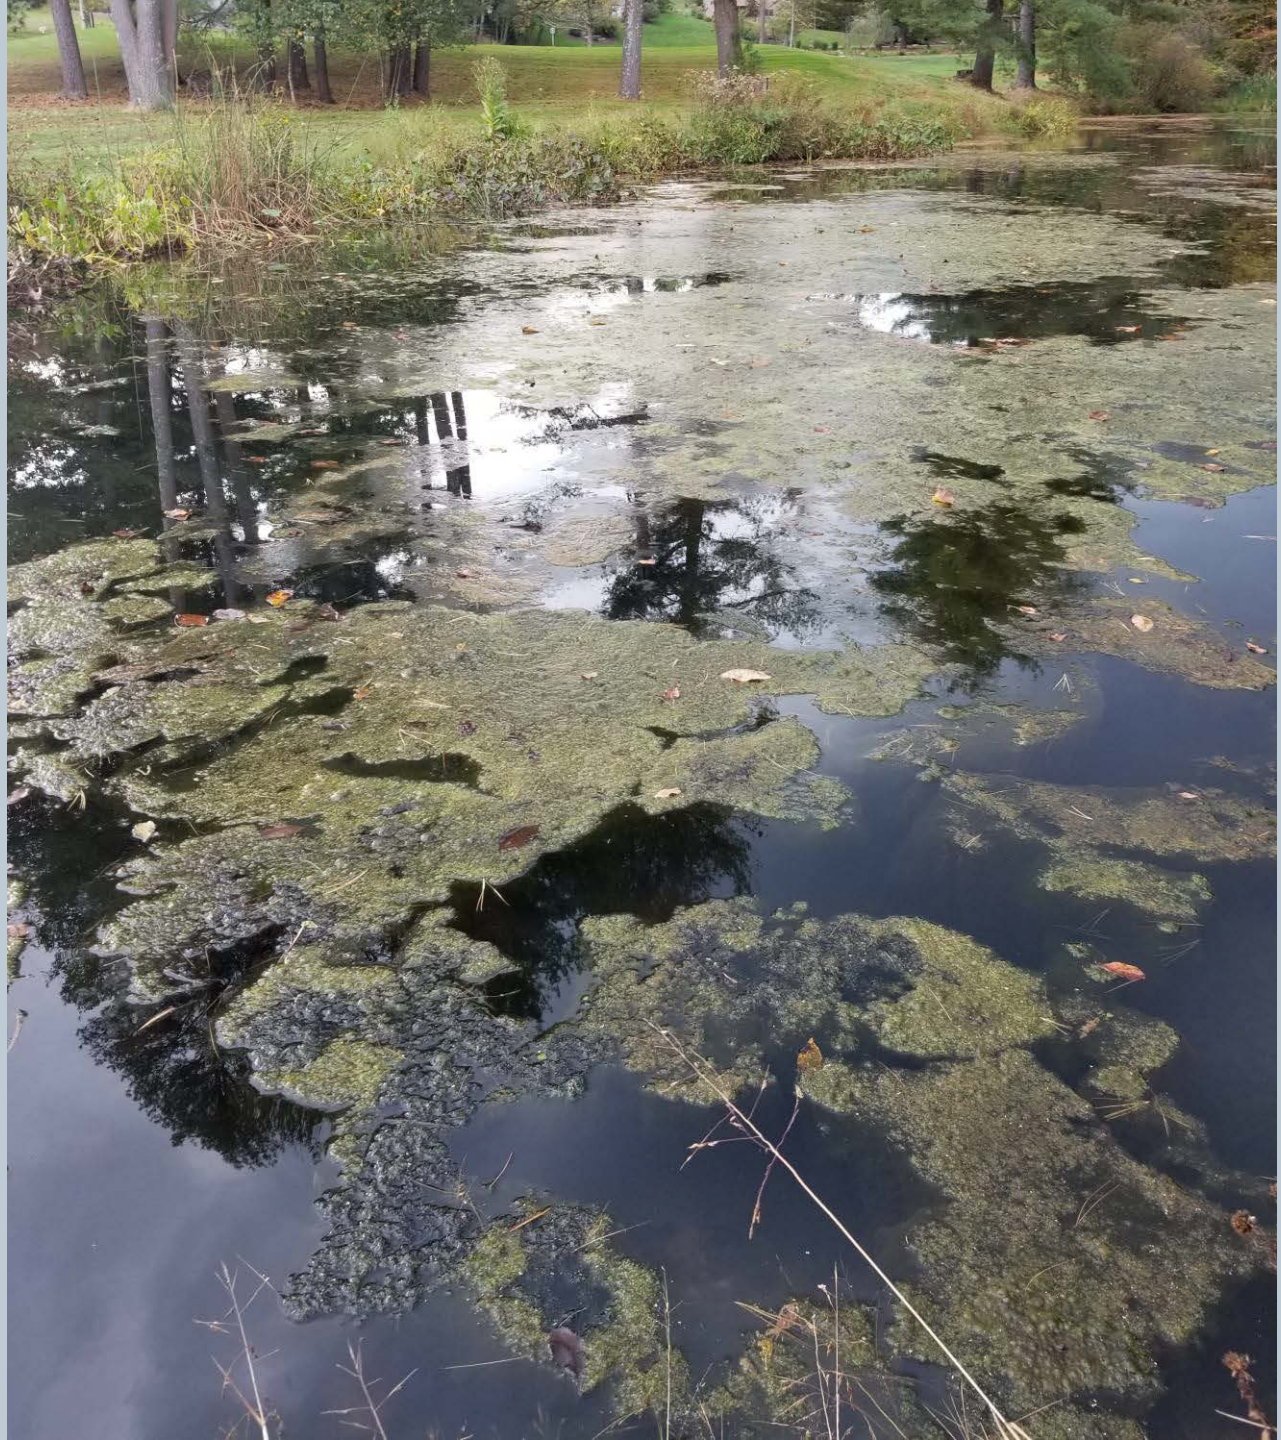
Figure 350. Looking downstream at a double culvert structure with a wooden weir to control the flow of water from the unnamed tributary out of the upper pond to the lower pond along the private road in Newberry Estates. Algal bloom presence in the pond.

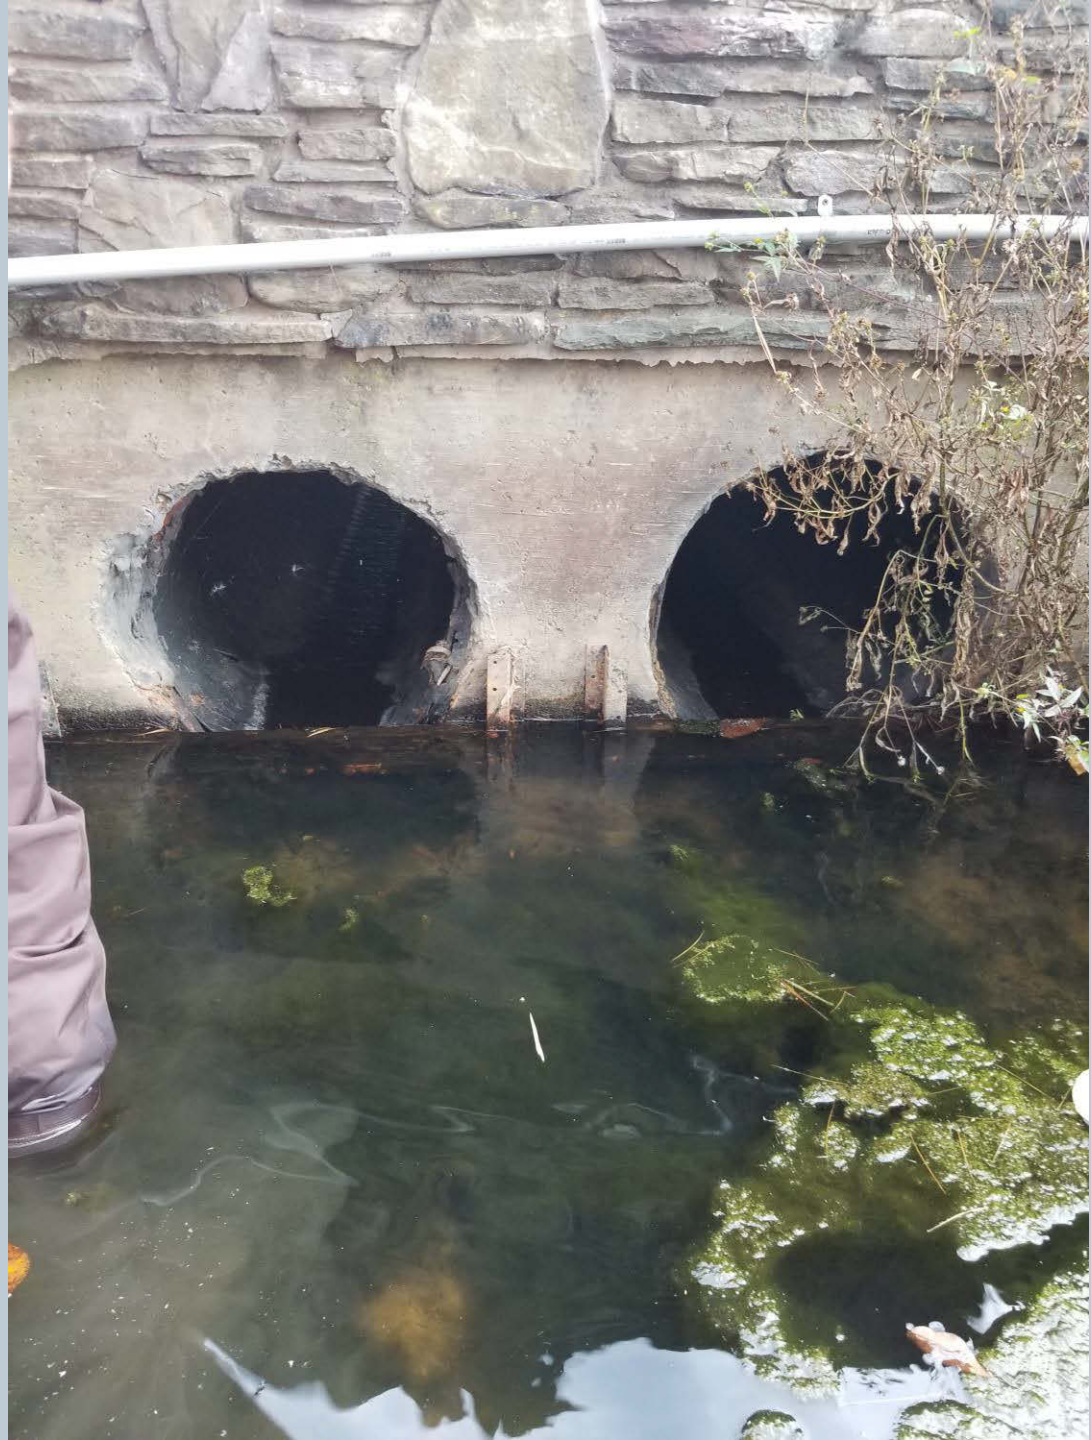
Figure 351. Looking upstream at a double culvert structure that is slowly draining the upper pond through a concrete sluiceway into a lower pond along the private road in Newberry Estates.

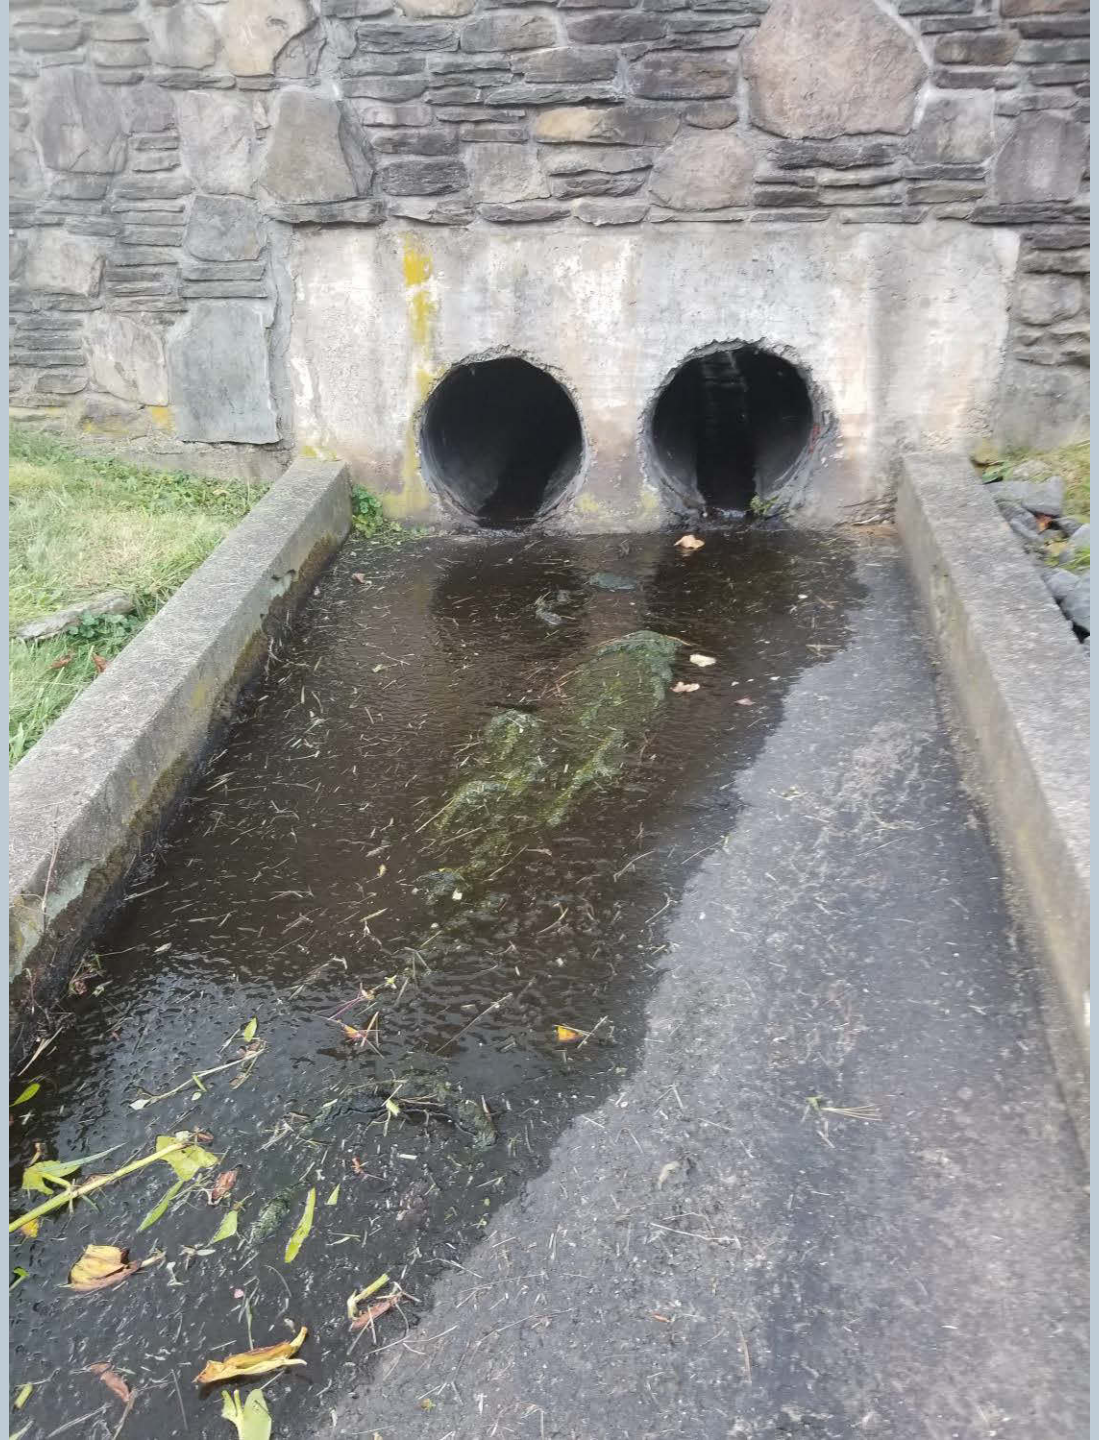
Figure 352. Looking downstream at the lower pond at a concrete sluiceway that drains the upper pond on from the unnamed tributary to Toby Creek into a lower pond along the private road in Newberry Estates. Plenty of aeration being provided to the lower pond from the aerator in the background at the center of the lower pond.

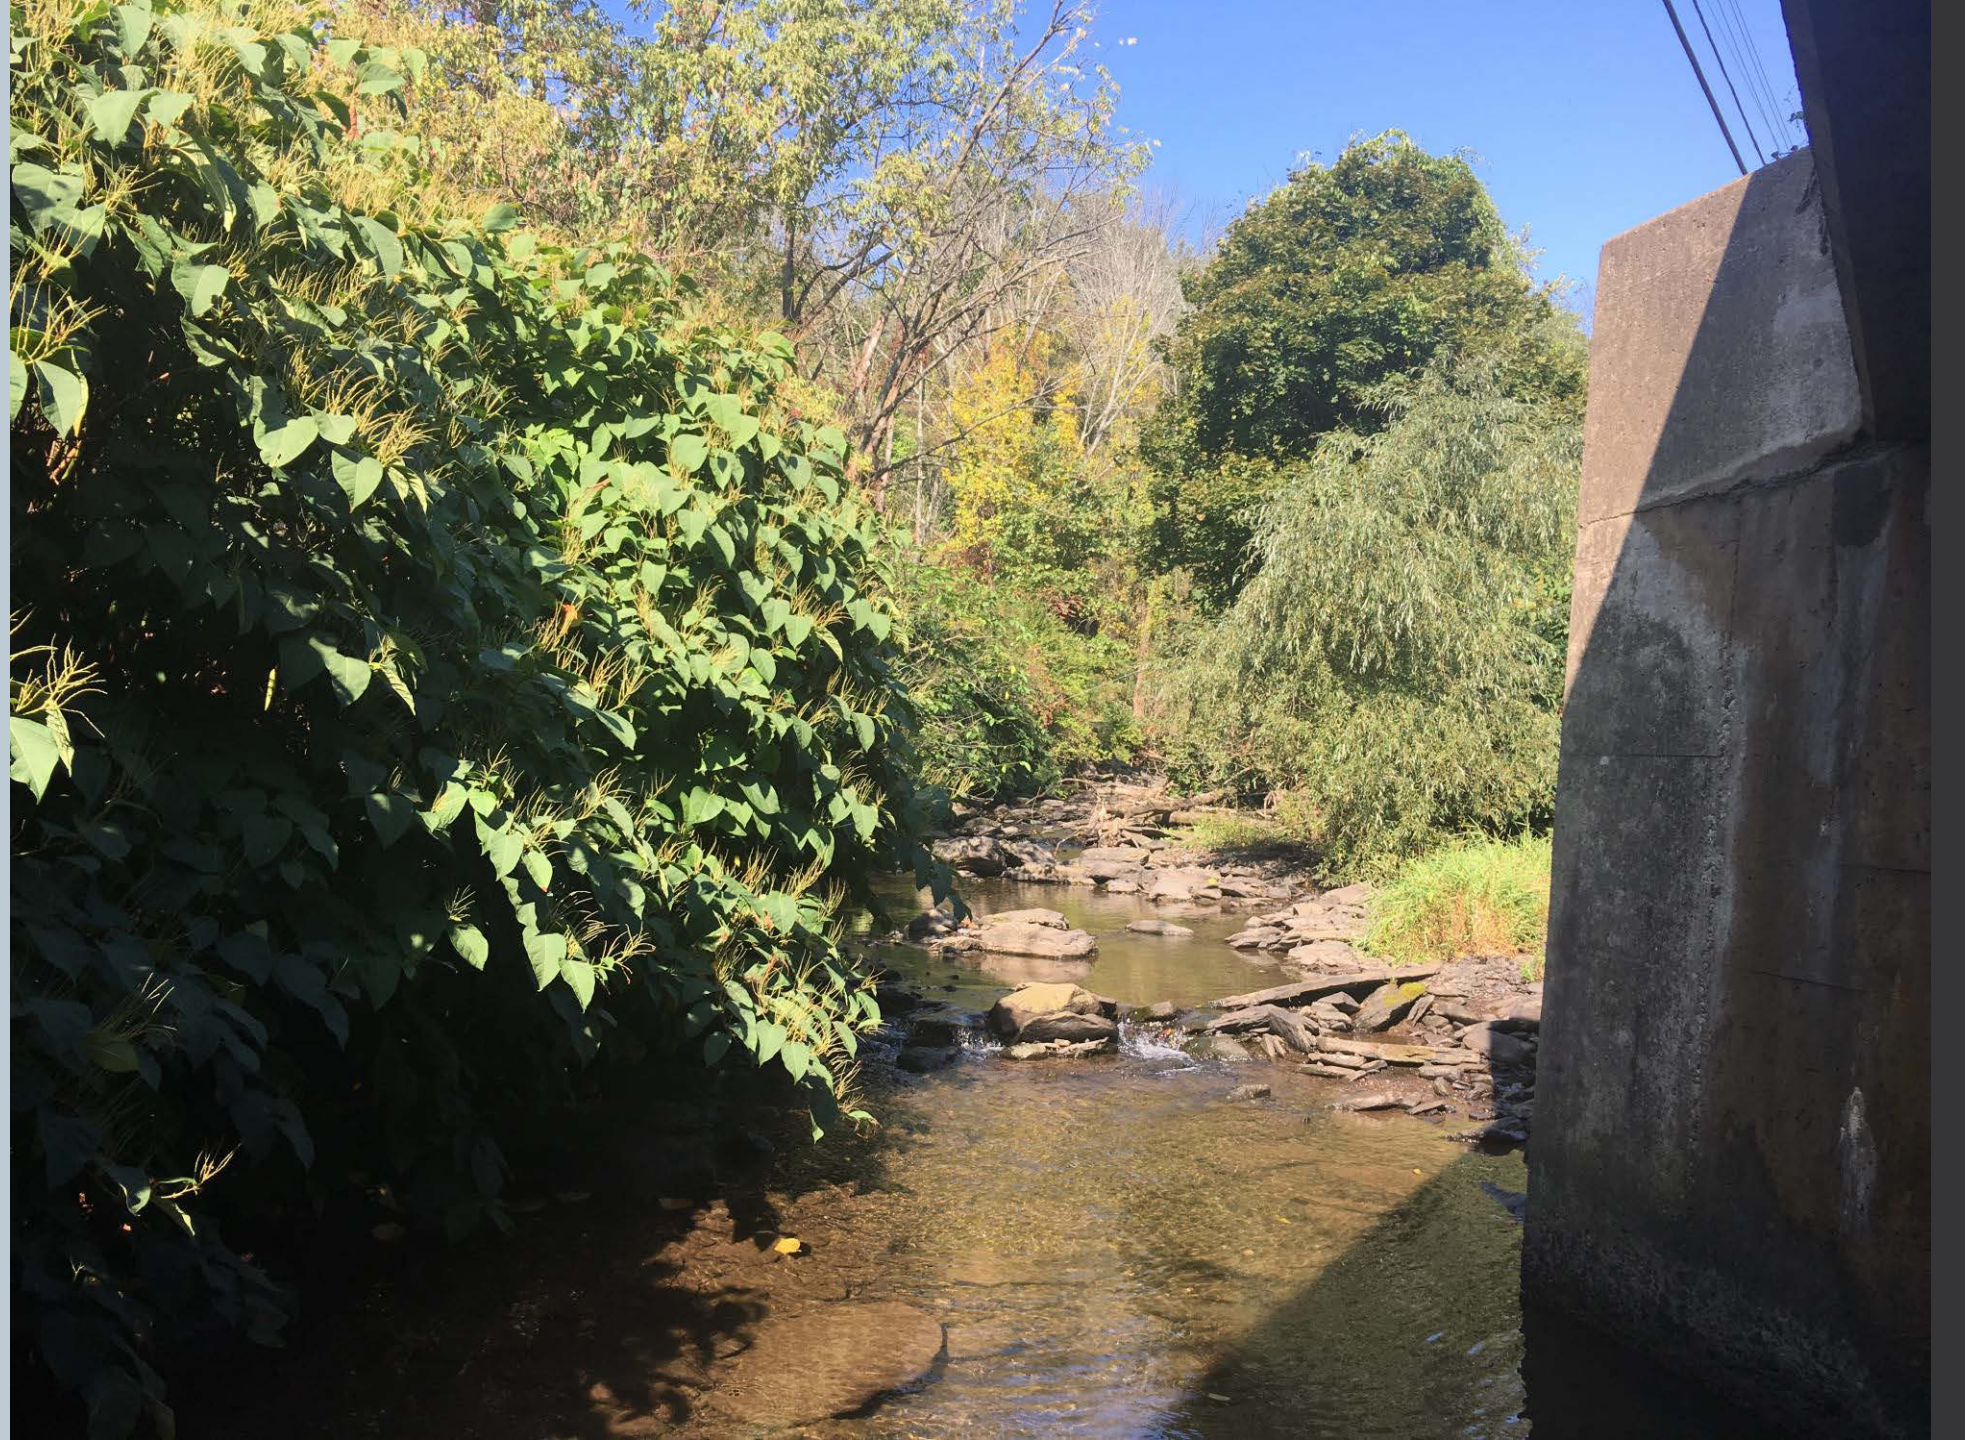
Figure 354. Looking downstream on Toby Creek along the Dallas Memorial Highway in Kingston Township. The majority of the flow of Toby Creek is flowing through the structure along the right bank looking downstream.

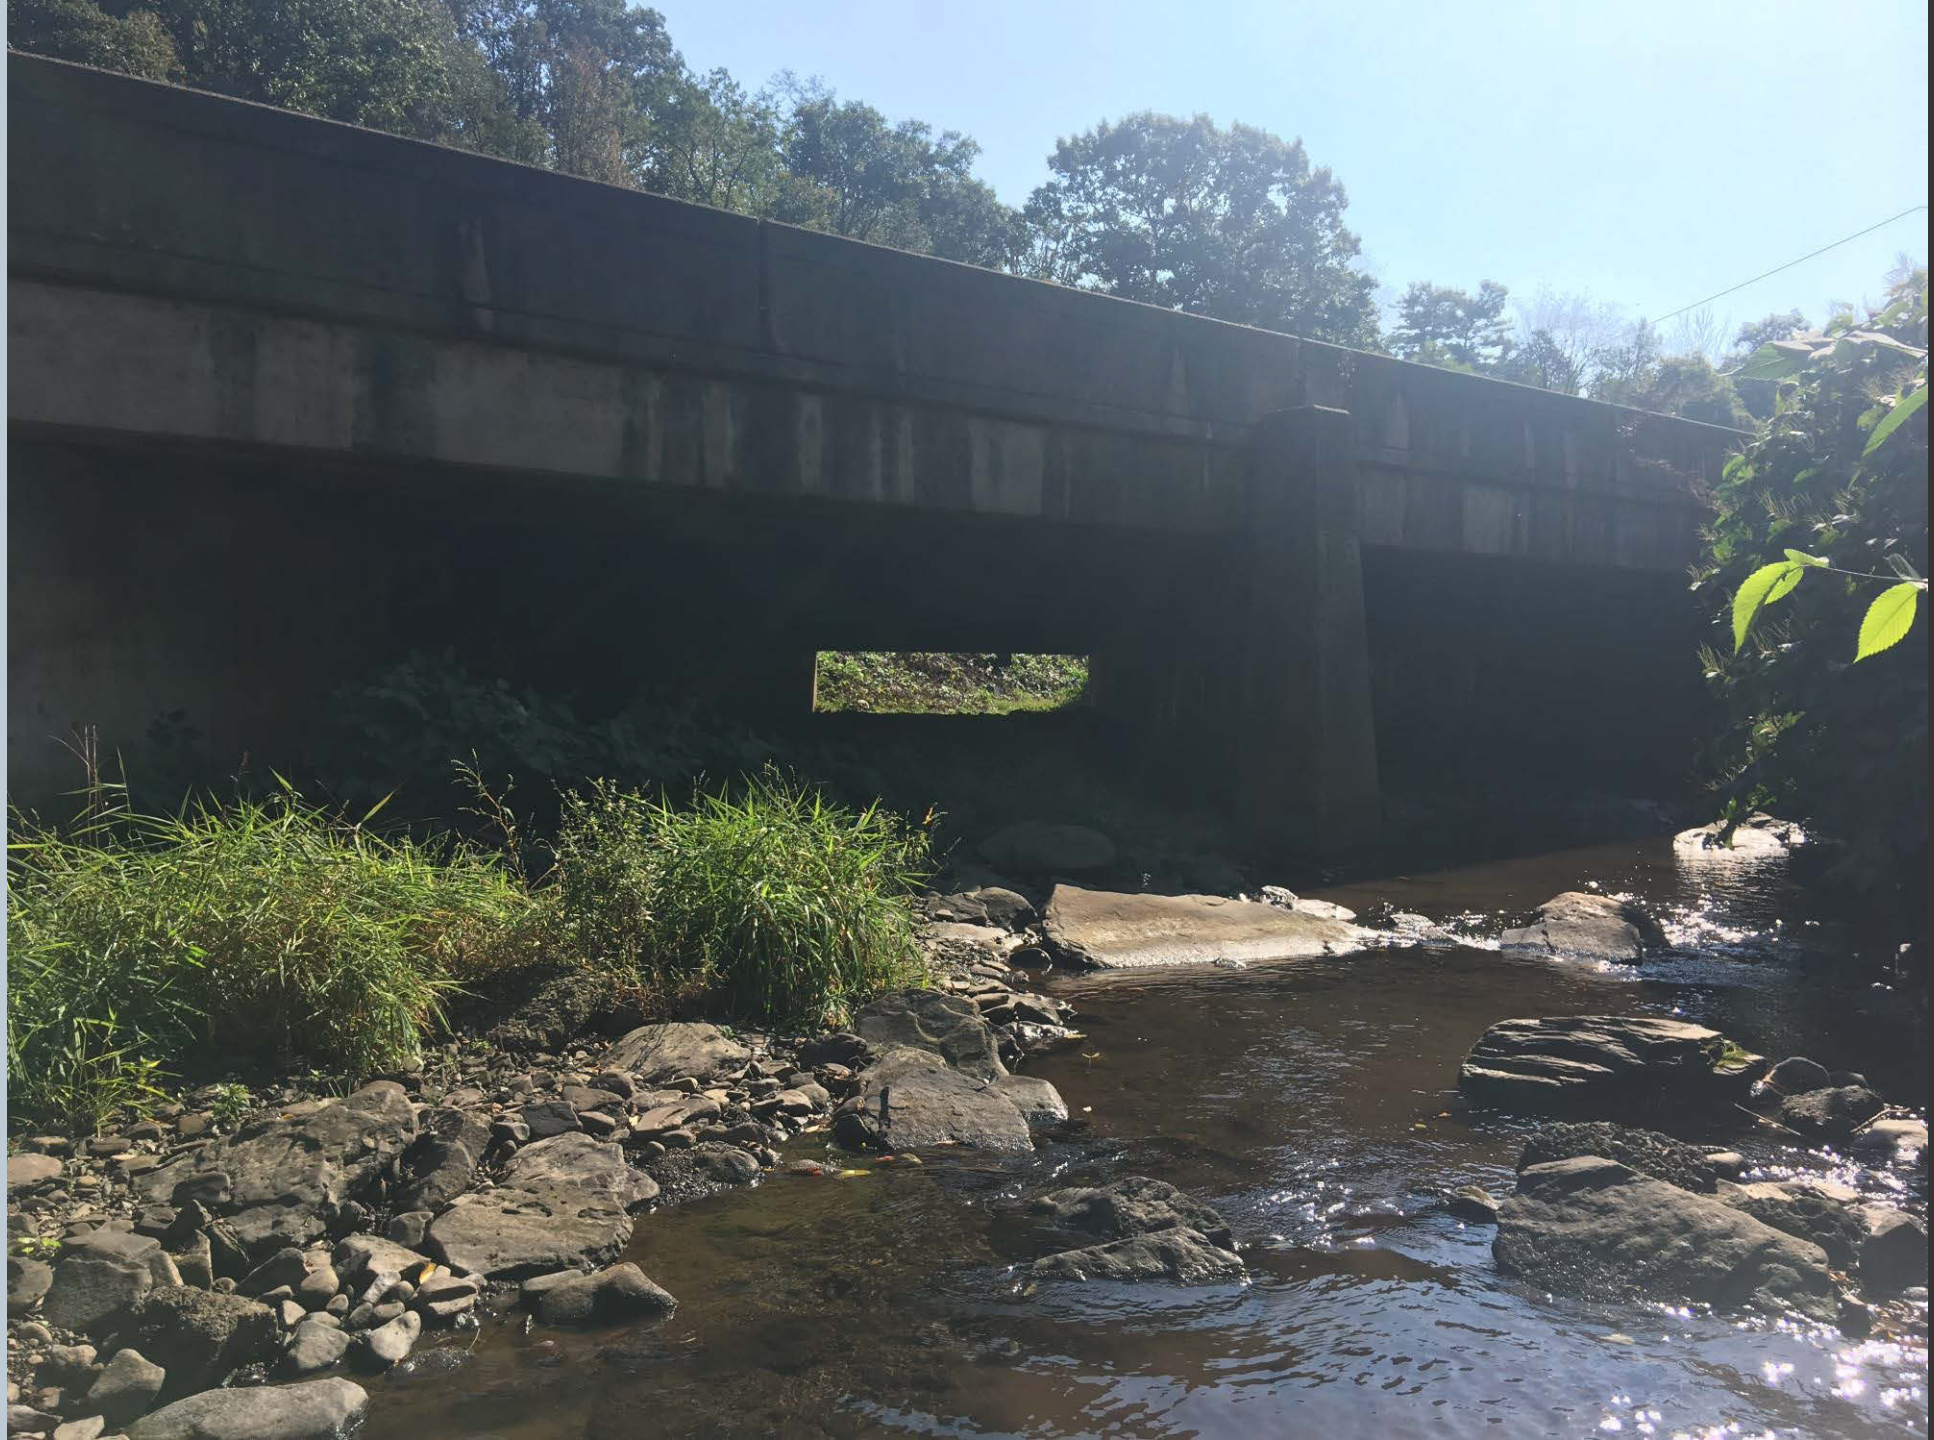
Figure 355. Looking downstream on Toby Creek along the Dallas Memorial Highway in Kingston Township. The majority of the flow of Toby Creek is flowing through the structure along the right bank looking downstream.

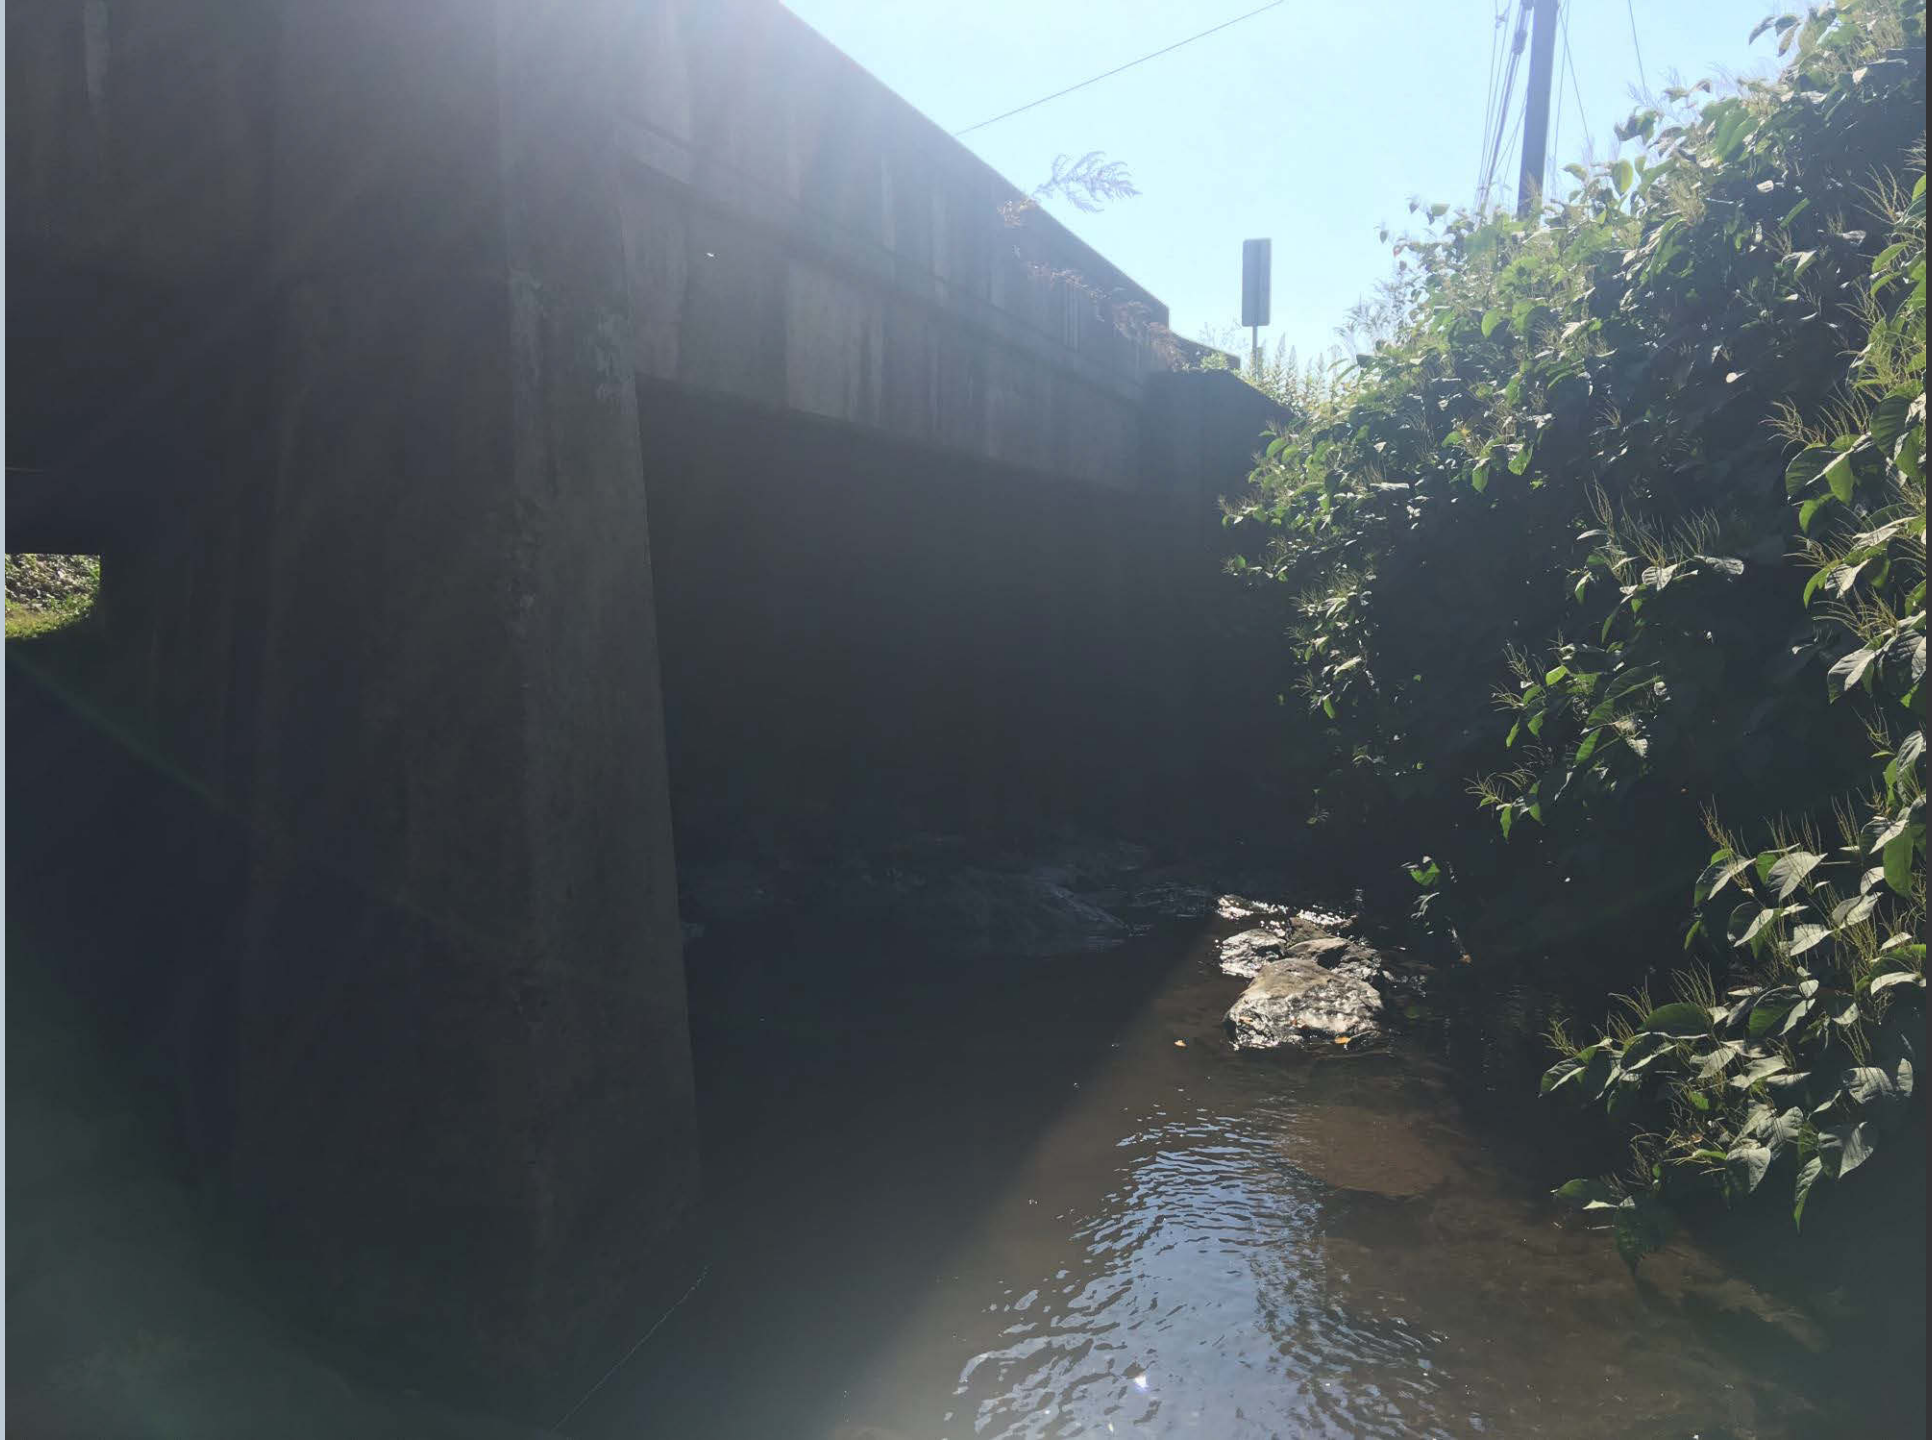
Figure 356. Looking downstream on Toby Creek along the Dallas Memorial Highway in Kingston Township. The structure on the left side of the channel is dry and filled with boulders and cobble and aggraded with a large sediment load over the entire length beneath the bridge span.

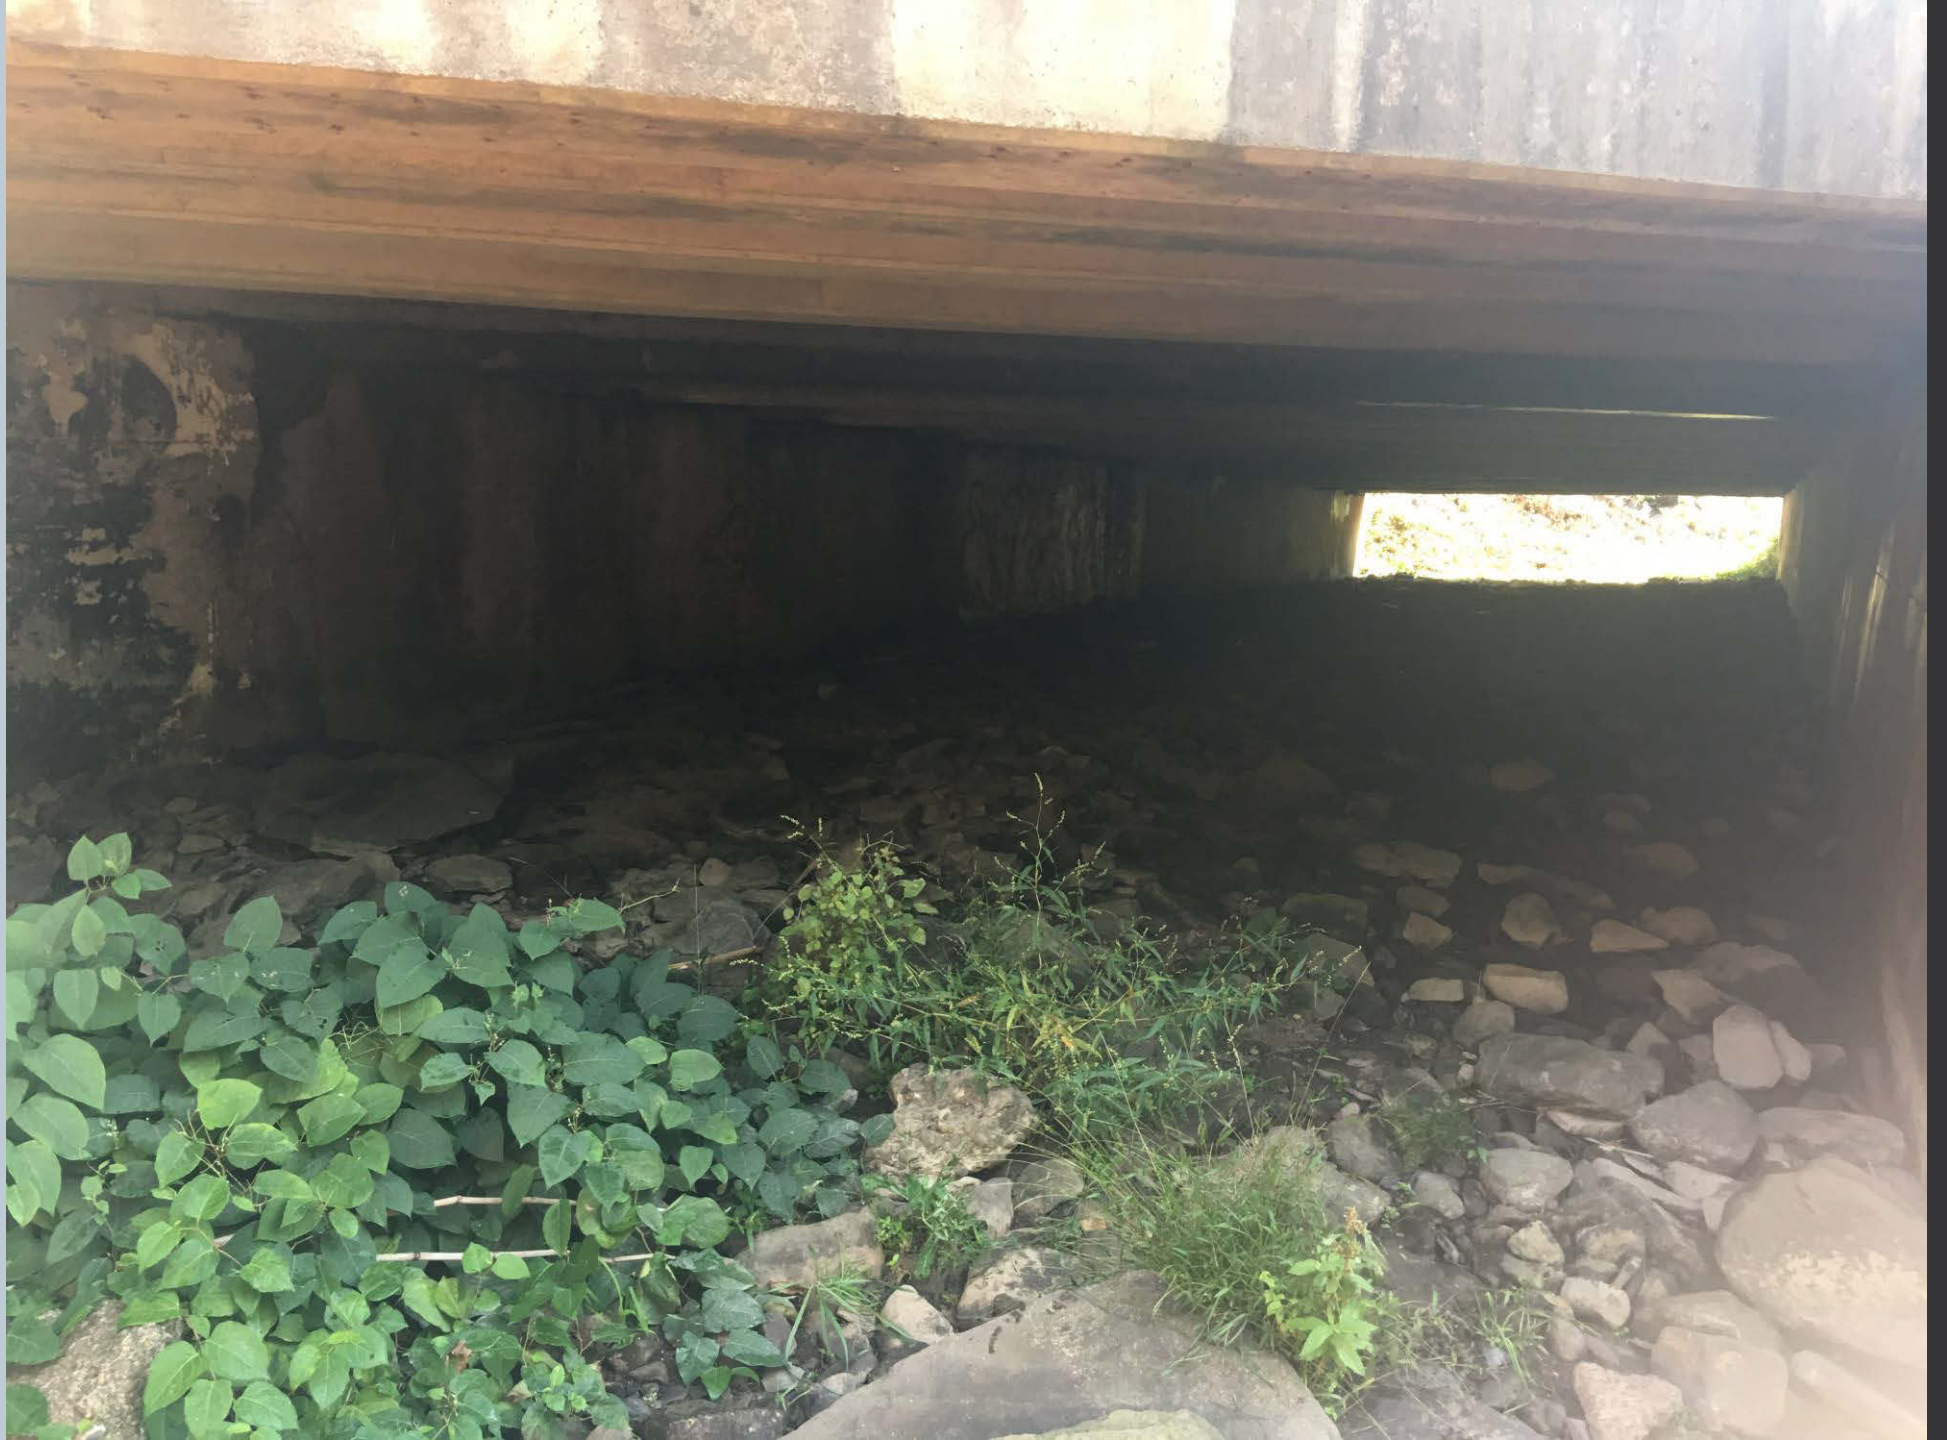
Figure 357. Looking downstream on Toby Creek where a large gravel bar is in the channel along the structure flowing under the bridge. A large amount of Japanese knotweed is present along the left-hand bank looking downstream next to Newell's Fuel.

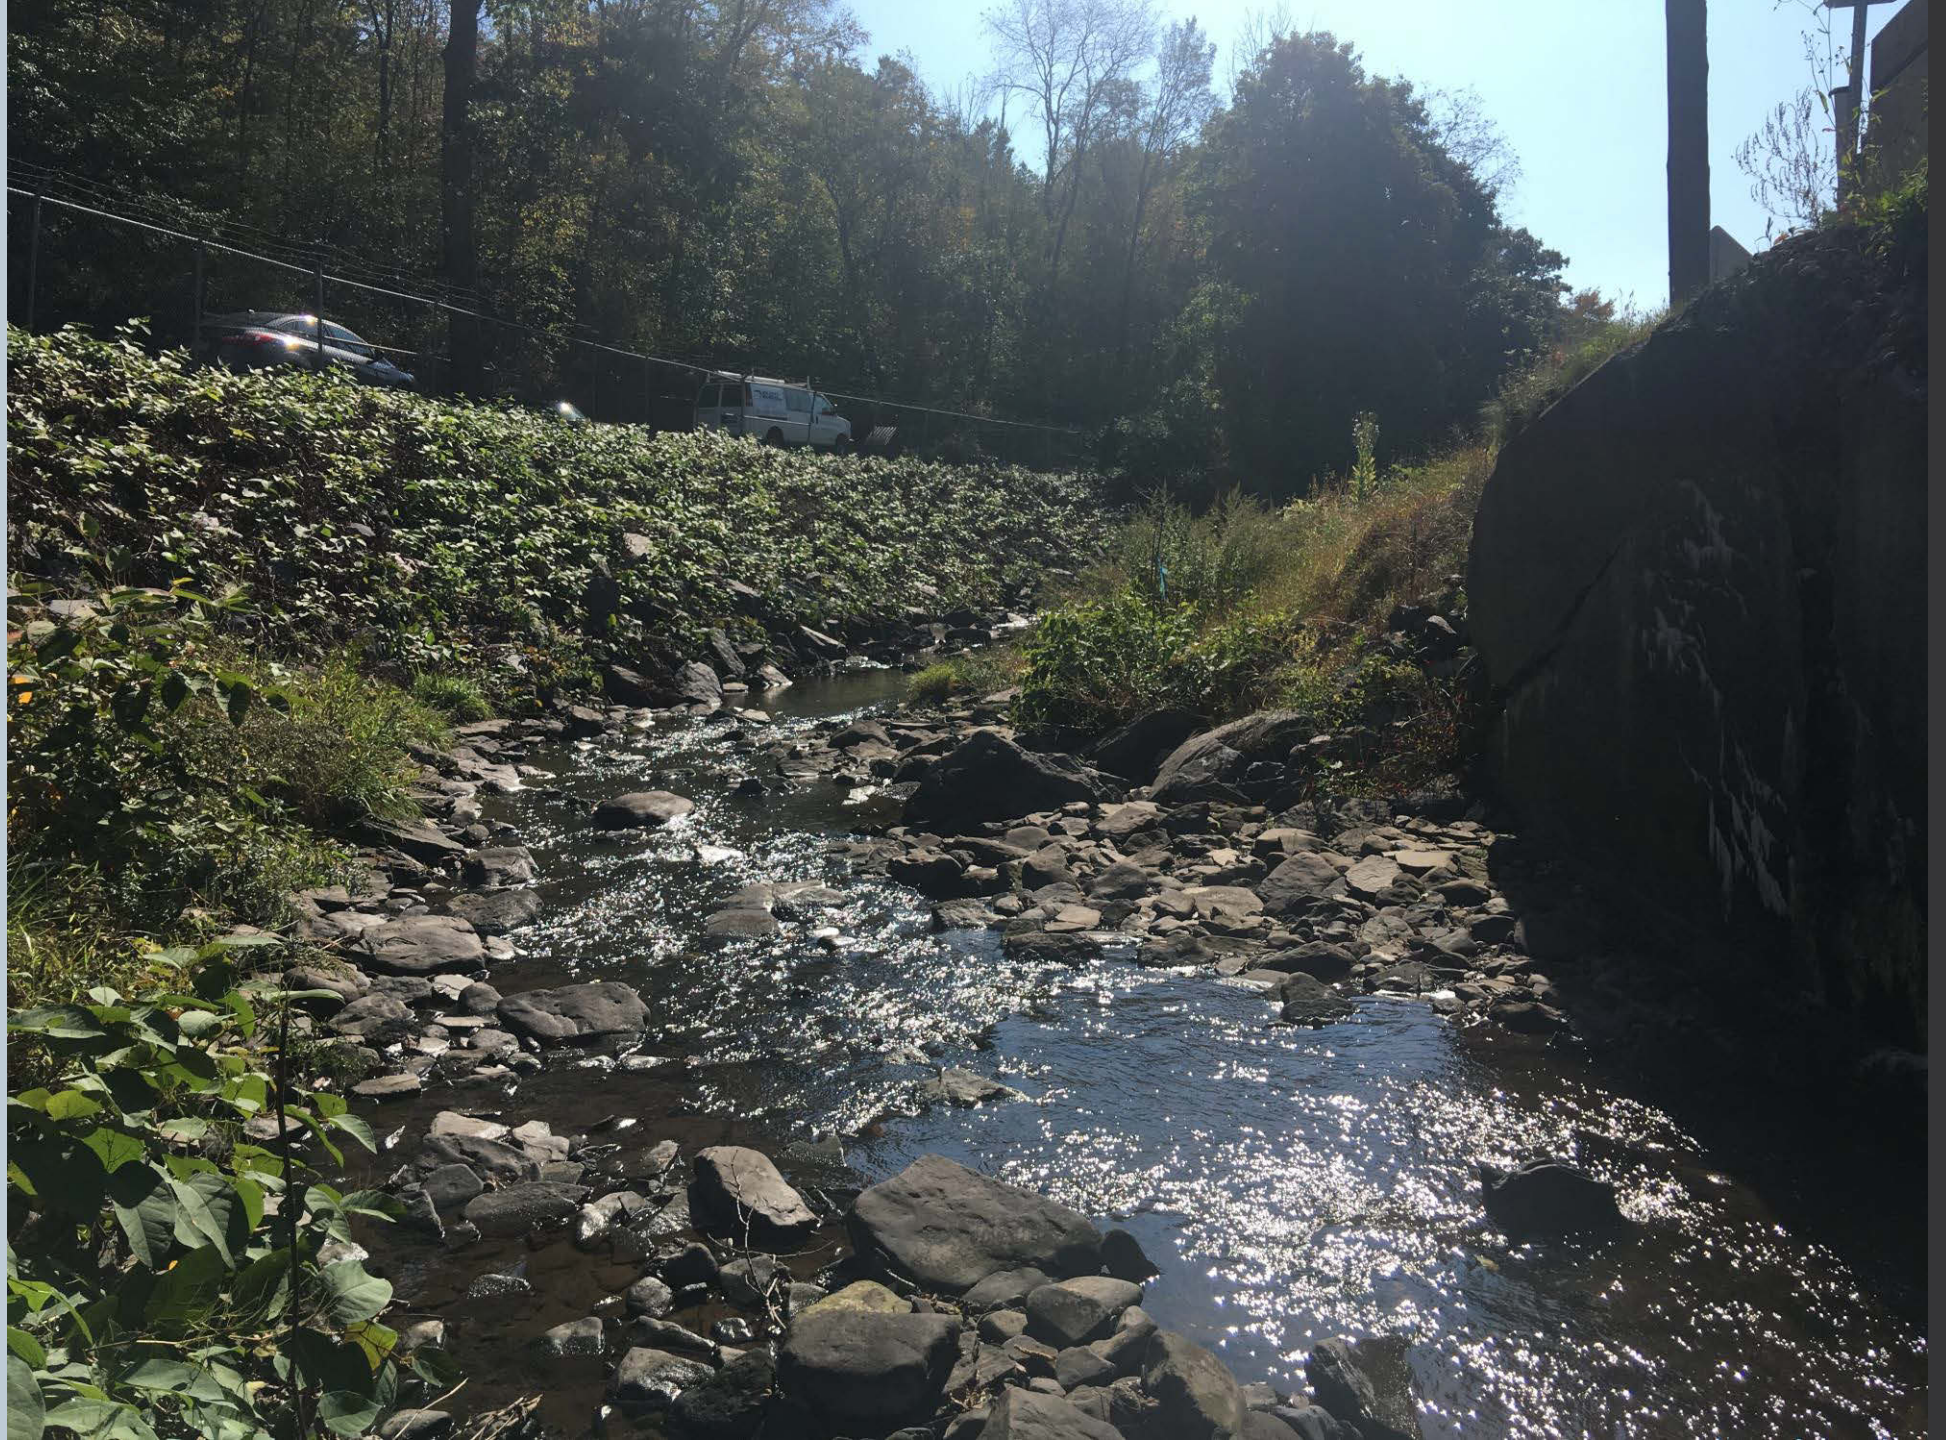
Figure 358. Looking upstream on Toby Creek at the double structure bridge culvert over the Dallas Memorial Highway next to Newell's Fuel. Gravel bar is present in the structure to the right over the entire length of the bridge span.

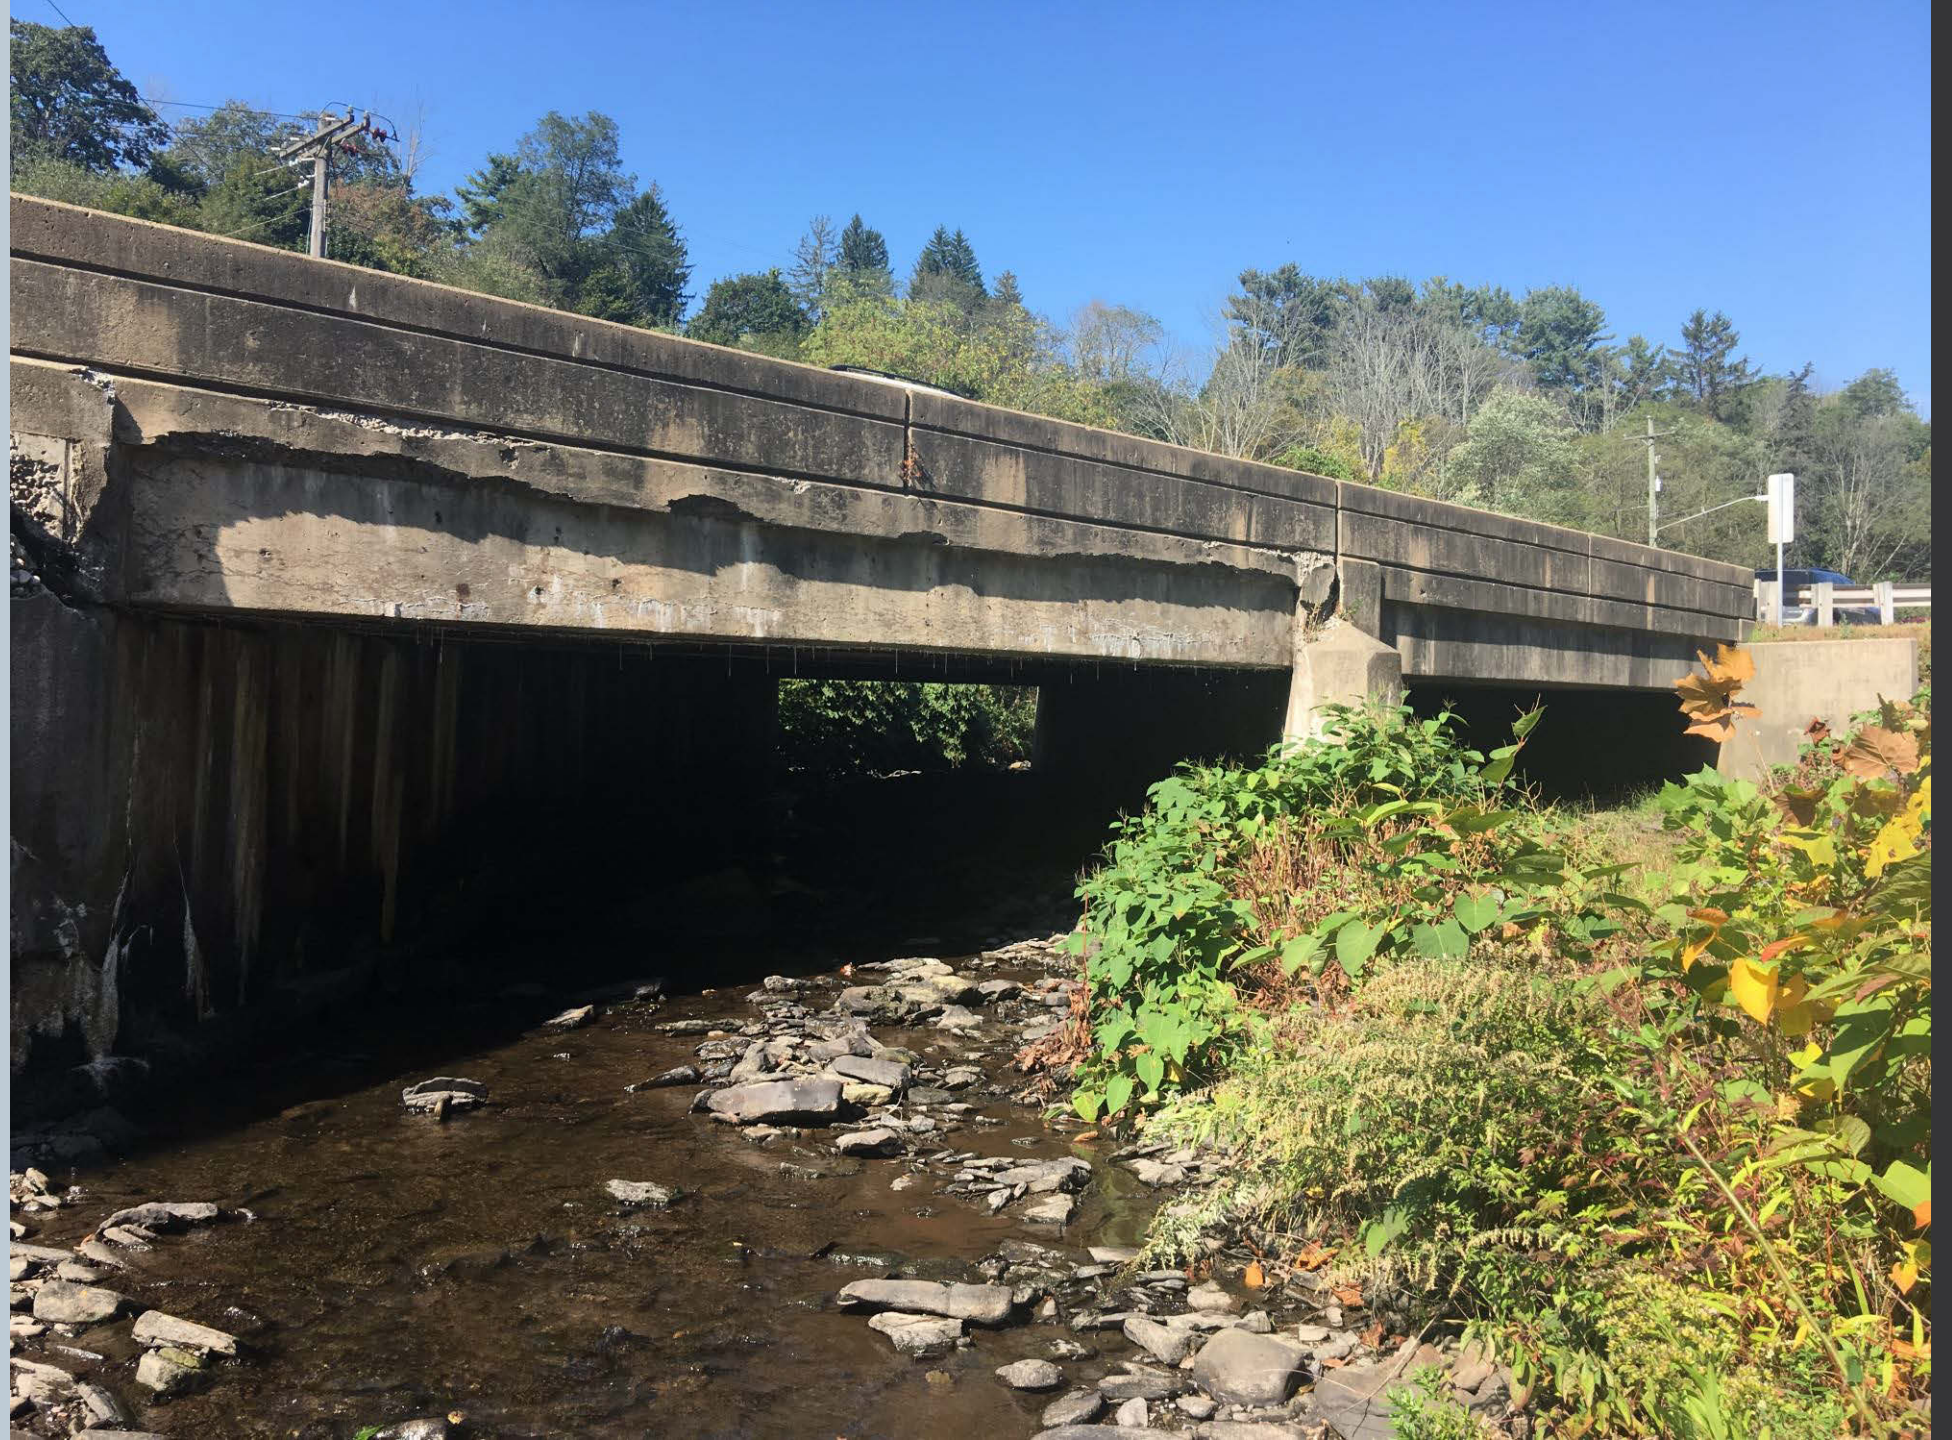
Figure 359. Looking at an elevated black HDPE stormwater pipe sitting several feet above Toby Creek that has led to the created of a gravel bar formation below the pipe when scour occurs during storm events. It's recommended to realign the pipe facing downstream and to bring it to grade or create a rock apron to dissipate the energy of the water that freefalls into Toby Creek during storm events.
