Toby Creek Field Reconnaissance Observations

September 26, 2018

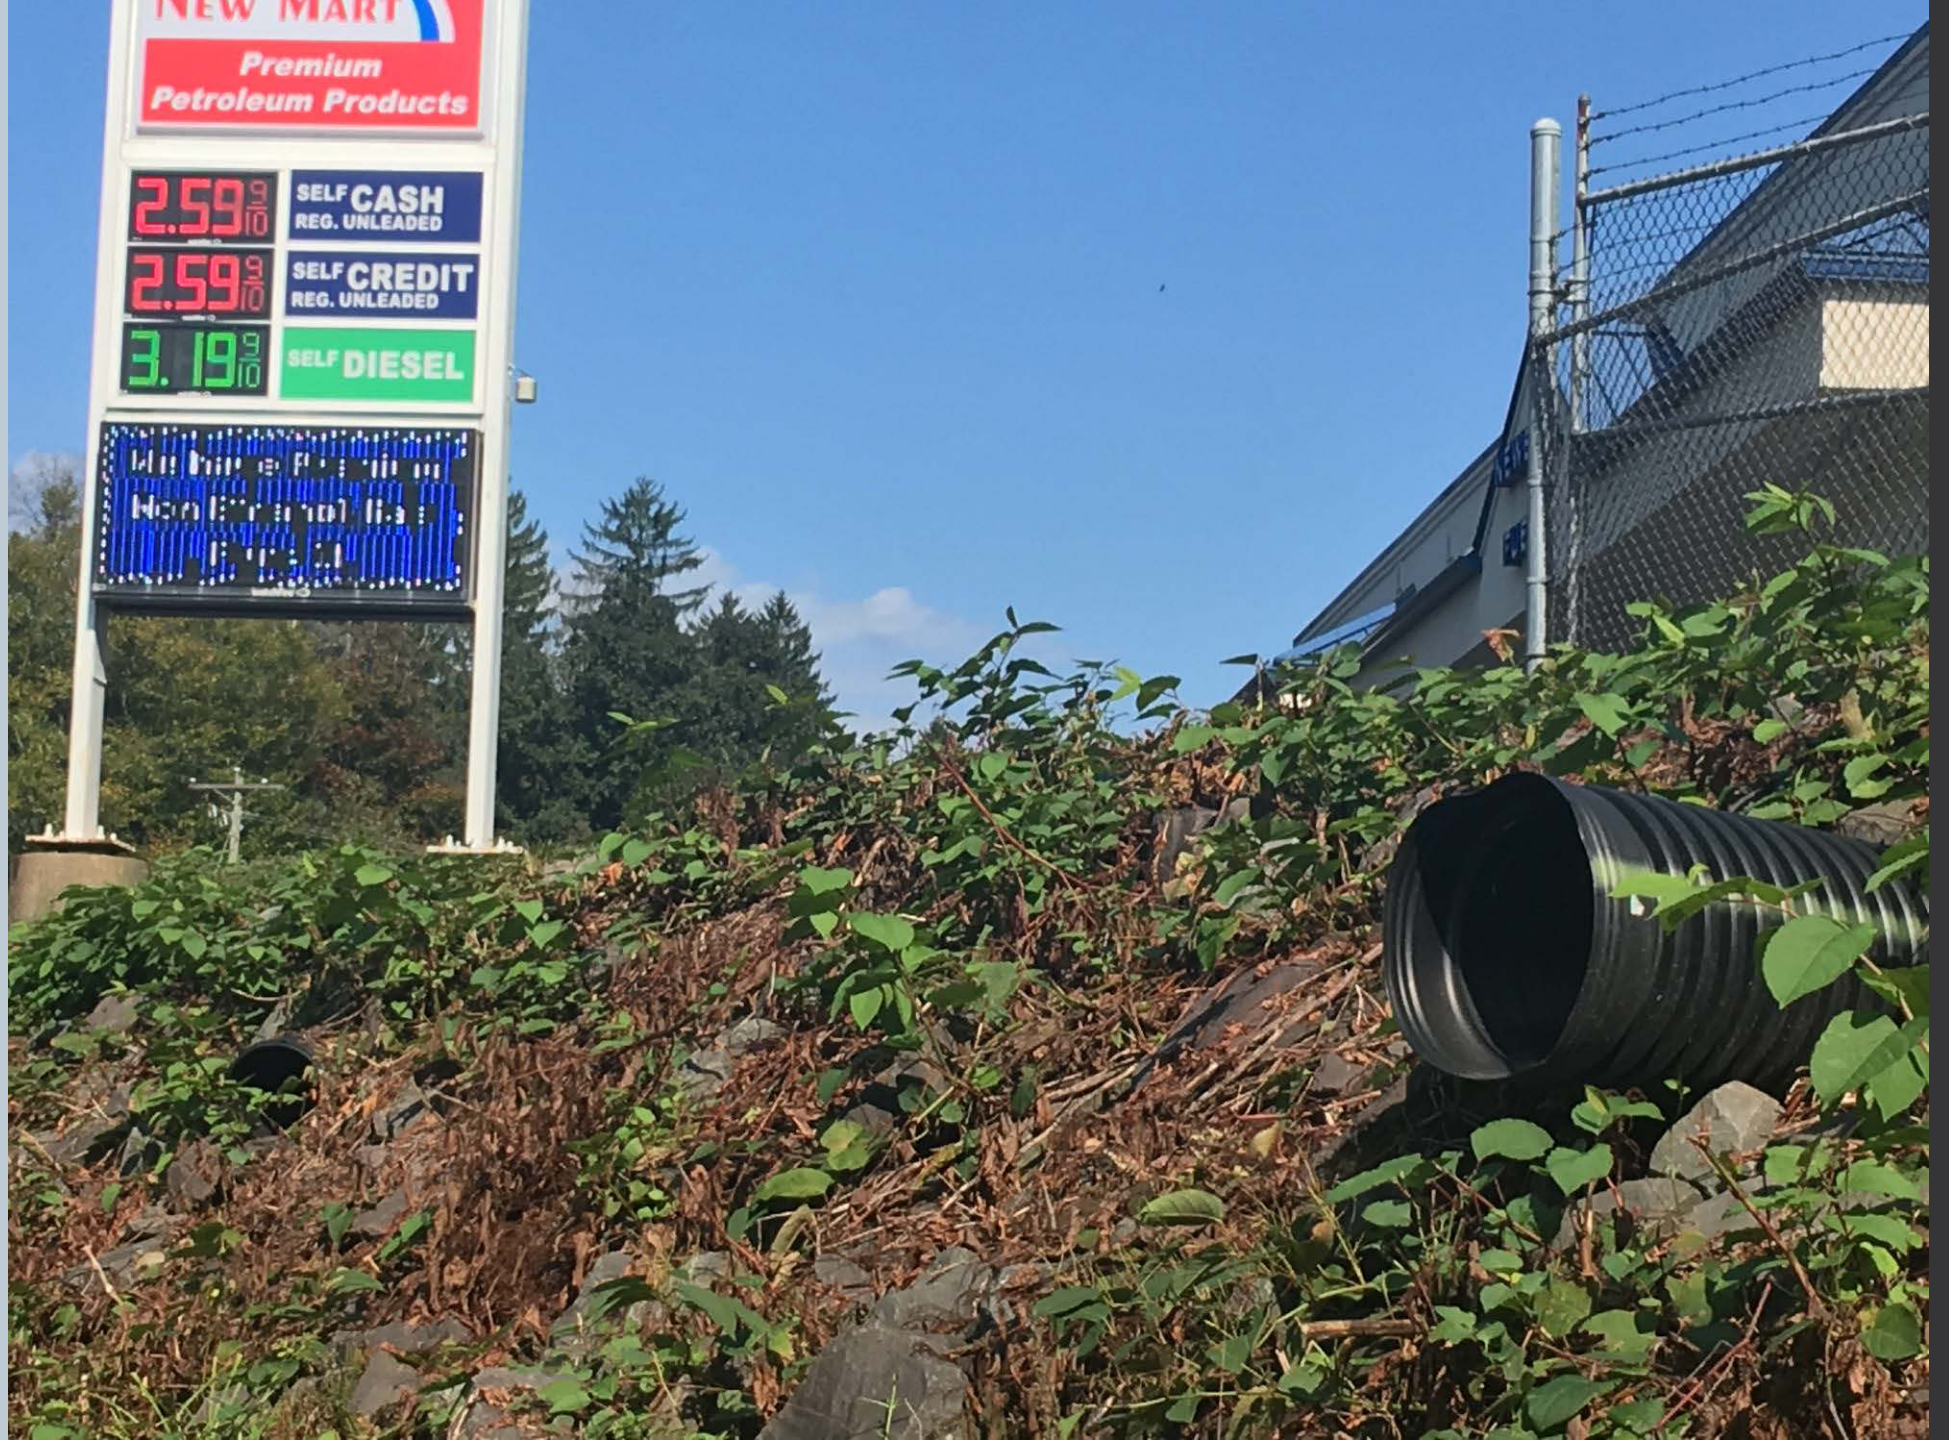
Figure 360. Looking downstream on Toby Creek near Modern Floors Professional Building from the outlet of one of the structures from the bridge culvert over the Dallas Memorial Highway.

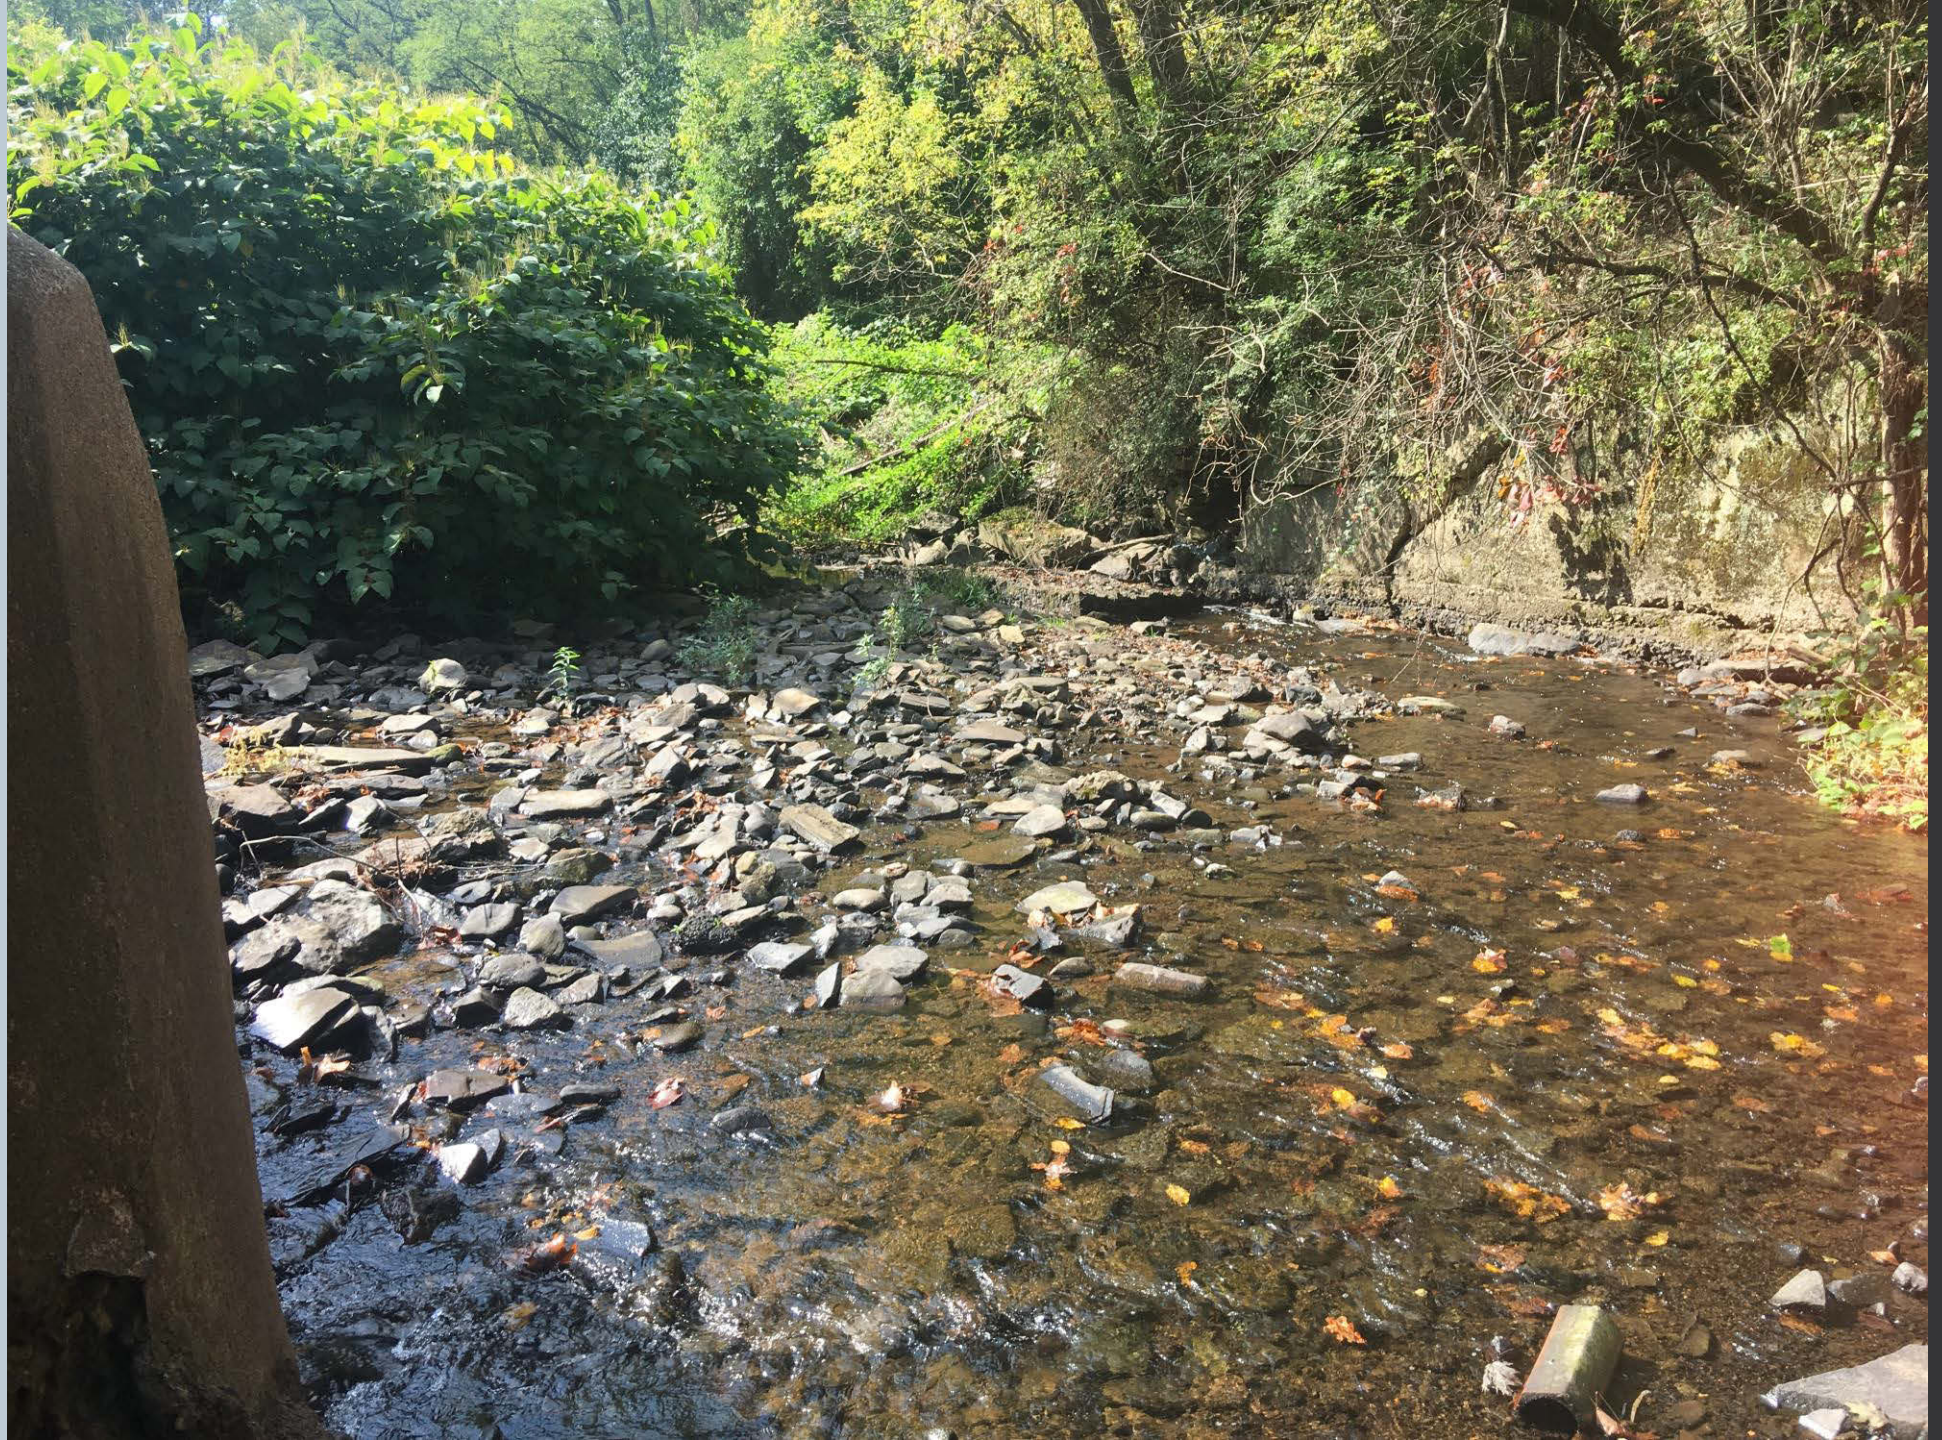
Figure 361. Looking upstream from the outlet culvert on Toby Creek near Modern Floors Professional Building from the outlet of one of the structures from the bridge culvert over the Dallas Memorial Highway. A large gravel bar has formed a large sediment deposition under the entire length of the structure to the left hand side looking upstream.

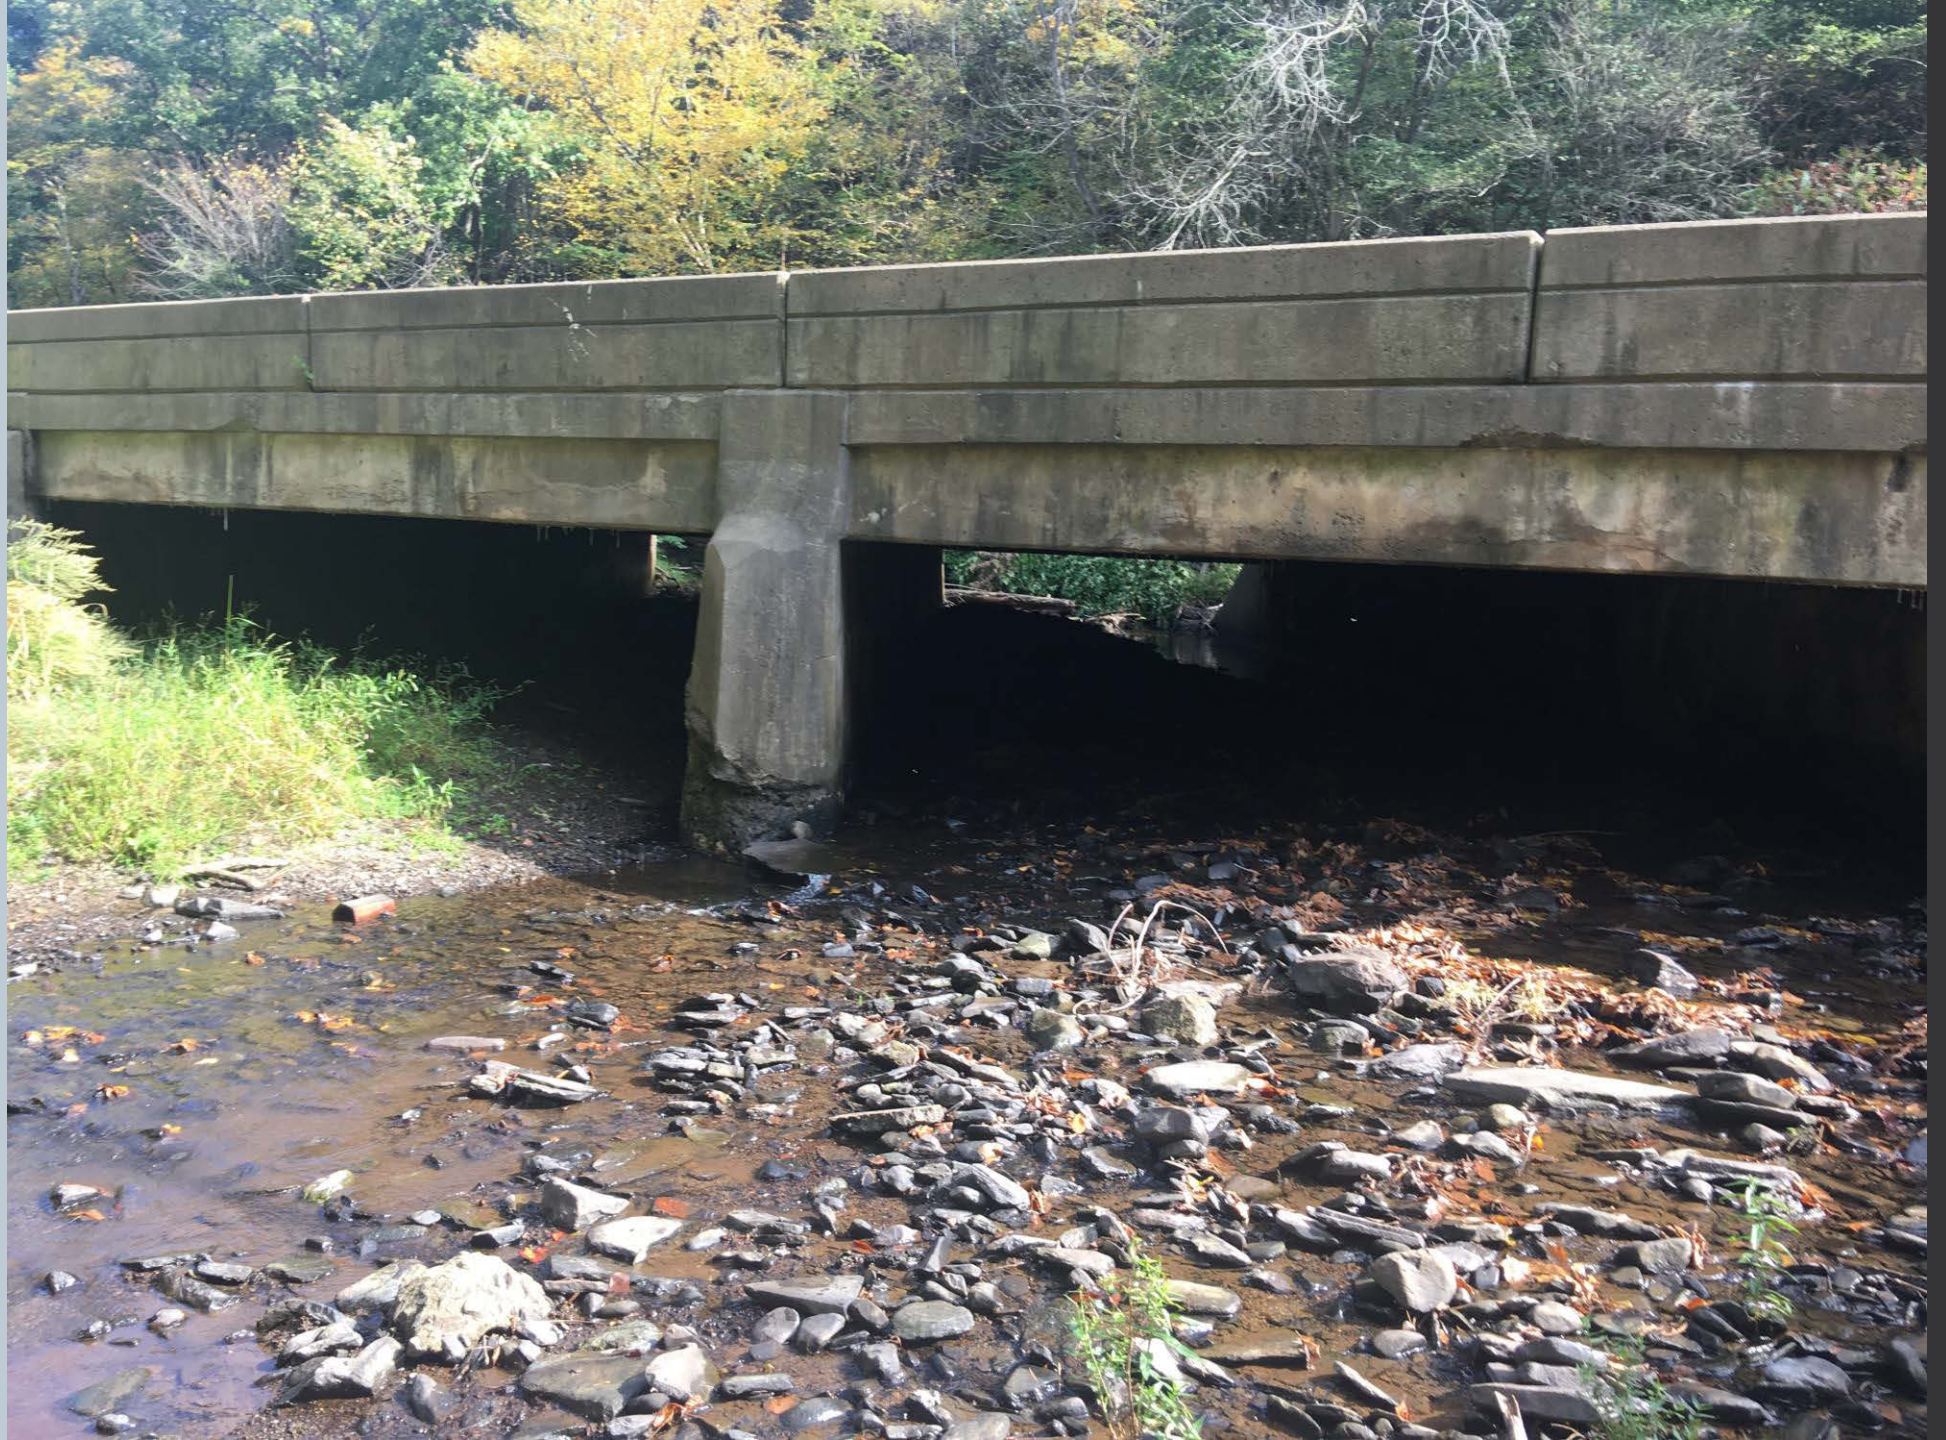
Figure 362. Looking upstream on Toby Creek near Modern Floors Professional Building from the outlet of one of the structures from the bridge culvert over the Dallas Memorial Highway where the majority of the flow can be seen and a gravel bar deposition at the inlet side of the structure of the culvert. Fish present.

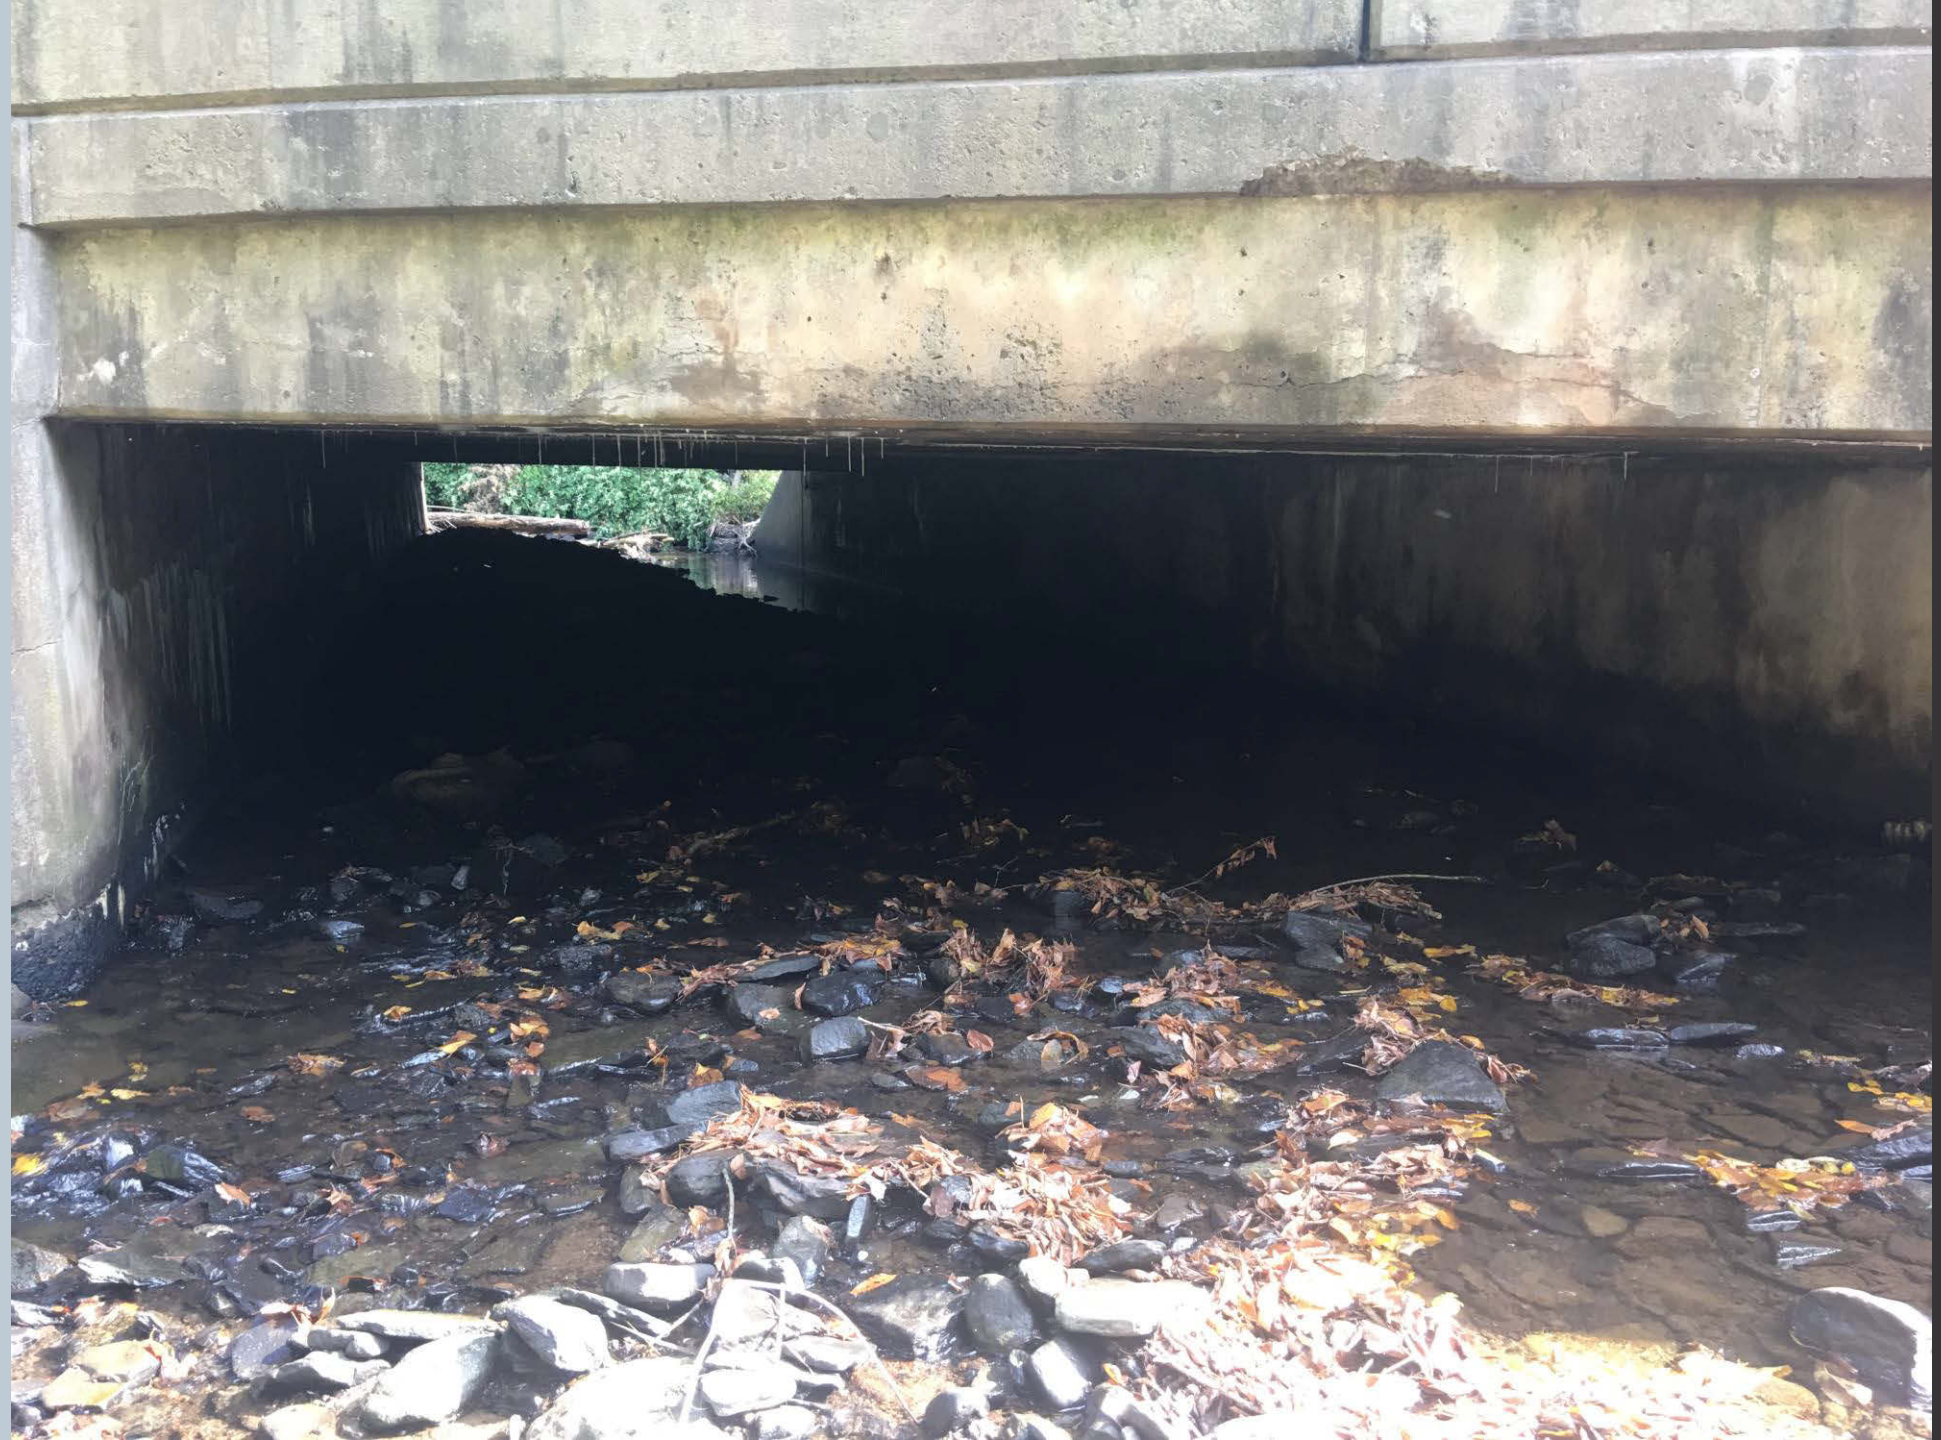
Figure 363. Looking upstream on Toby Creek near Modern Floors Professional Building from the outlet of one of the structures from the bridge culvert over the Dallas Memorial Highway where a gravel bar deposition at the outlet side of the structure of the culvert.

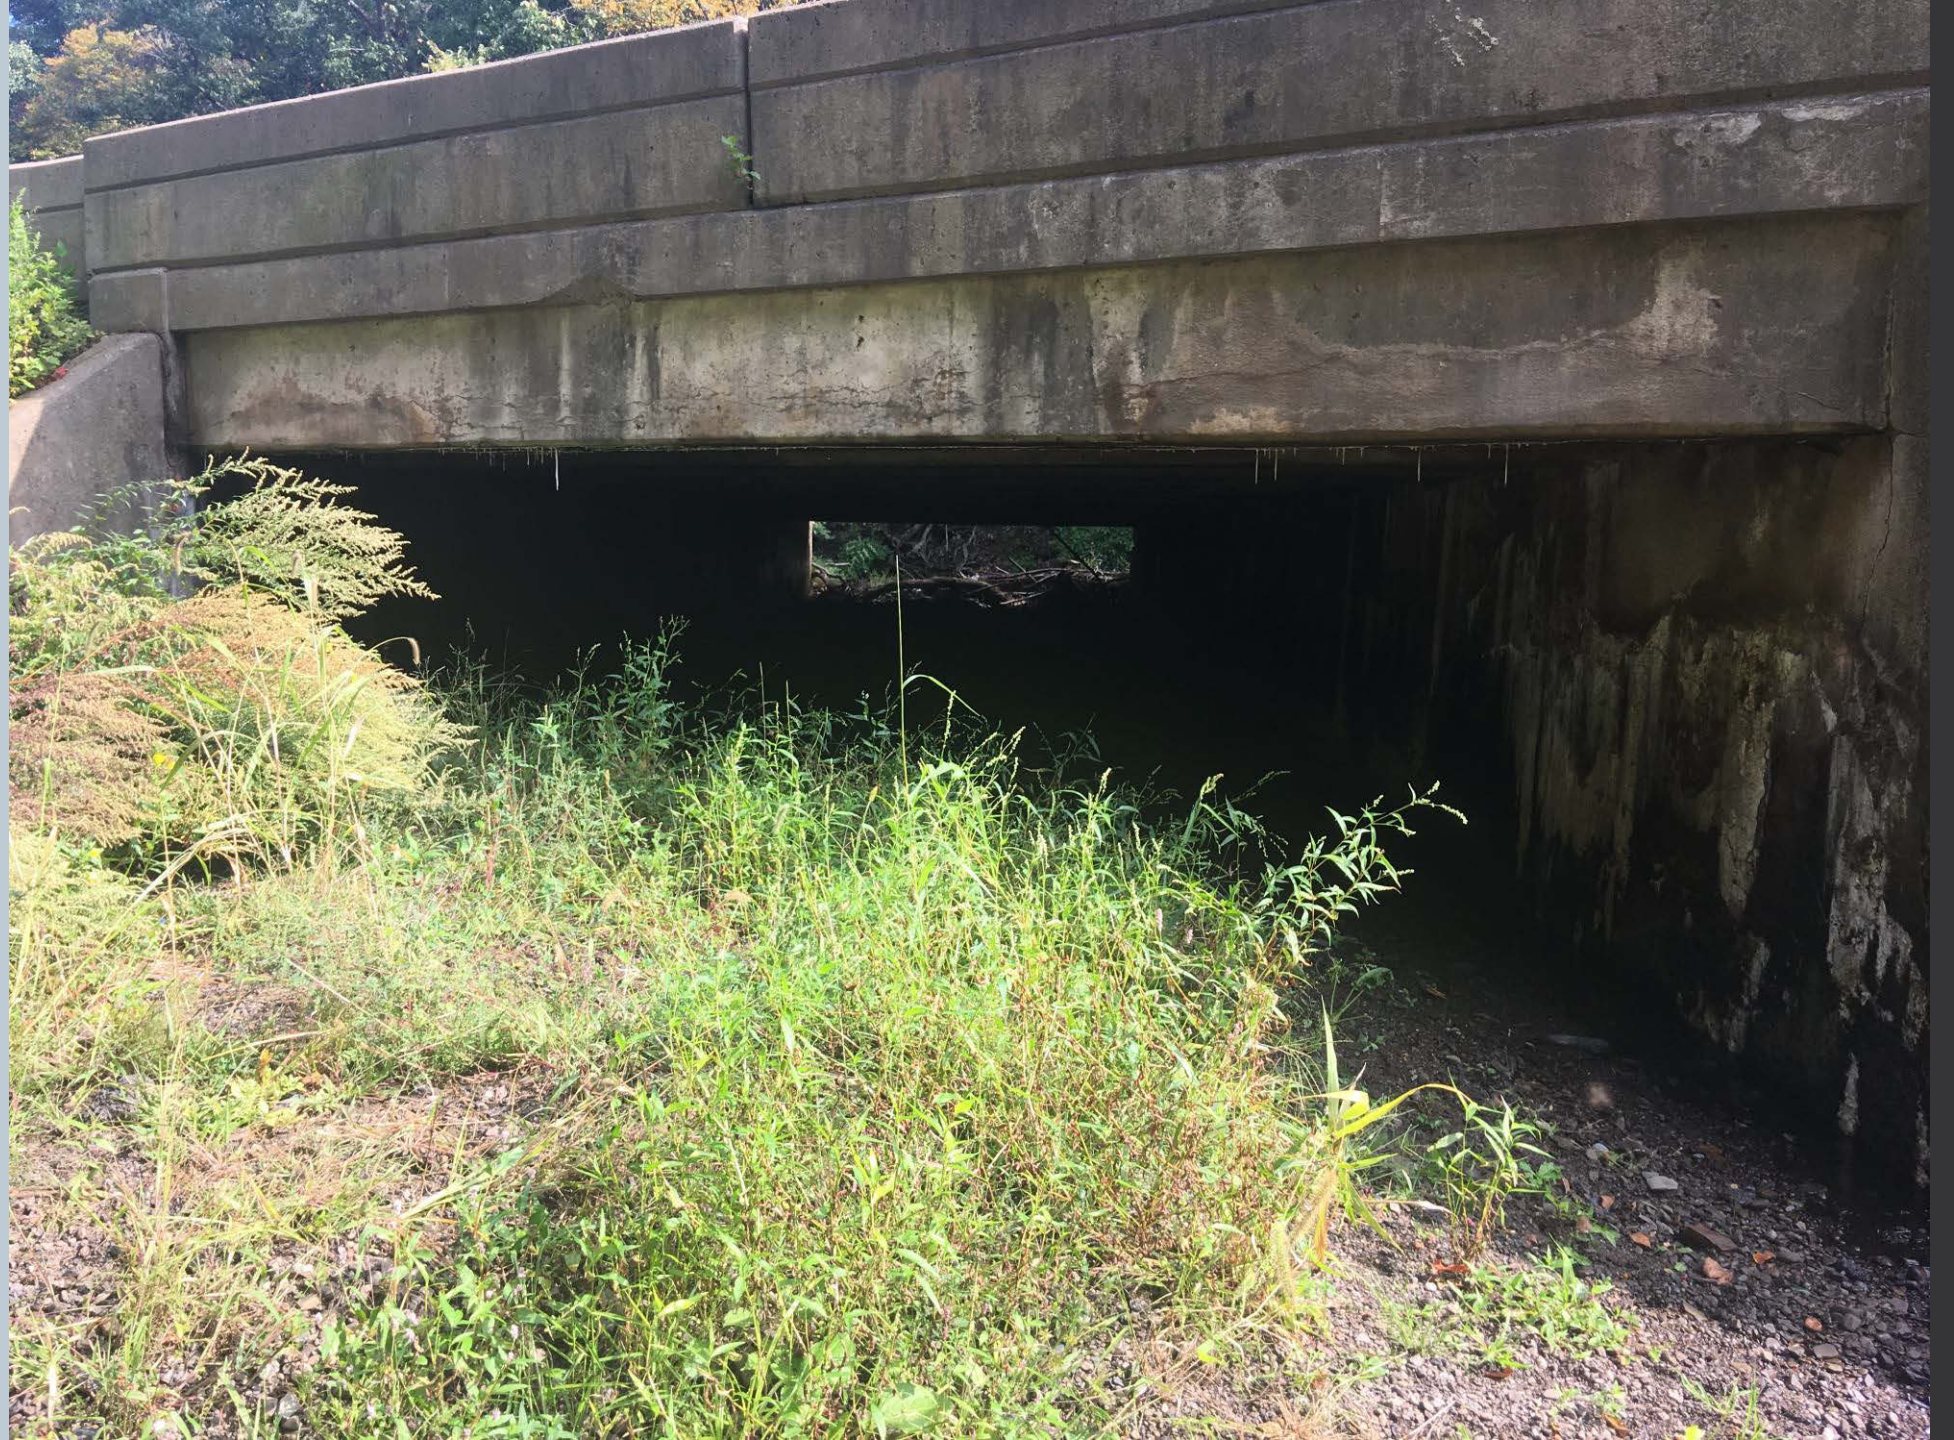
Figure 364. Looking downstream on Toby Creek at a major woody debris blockage with several fallen trees and debris that have redirected the flow to the one structure to the left-hand side of the structure. This bridge is just below Modern Floors. Recommend the removal of the trees and debris with a small cleanup to unblock the inlets of the two structures.

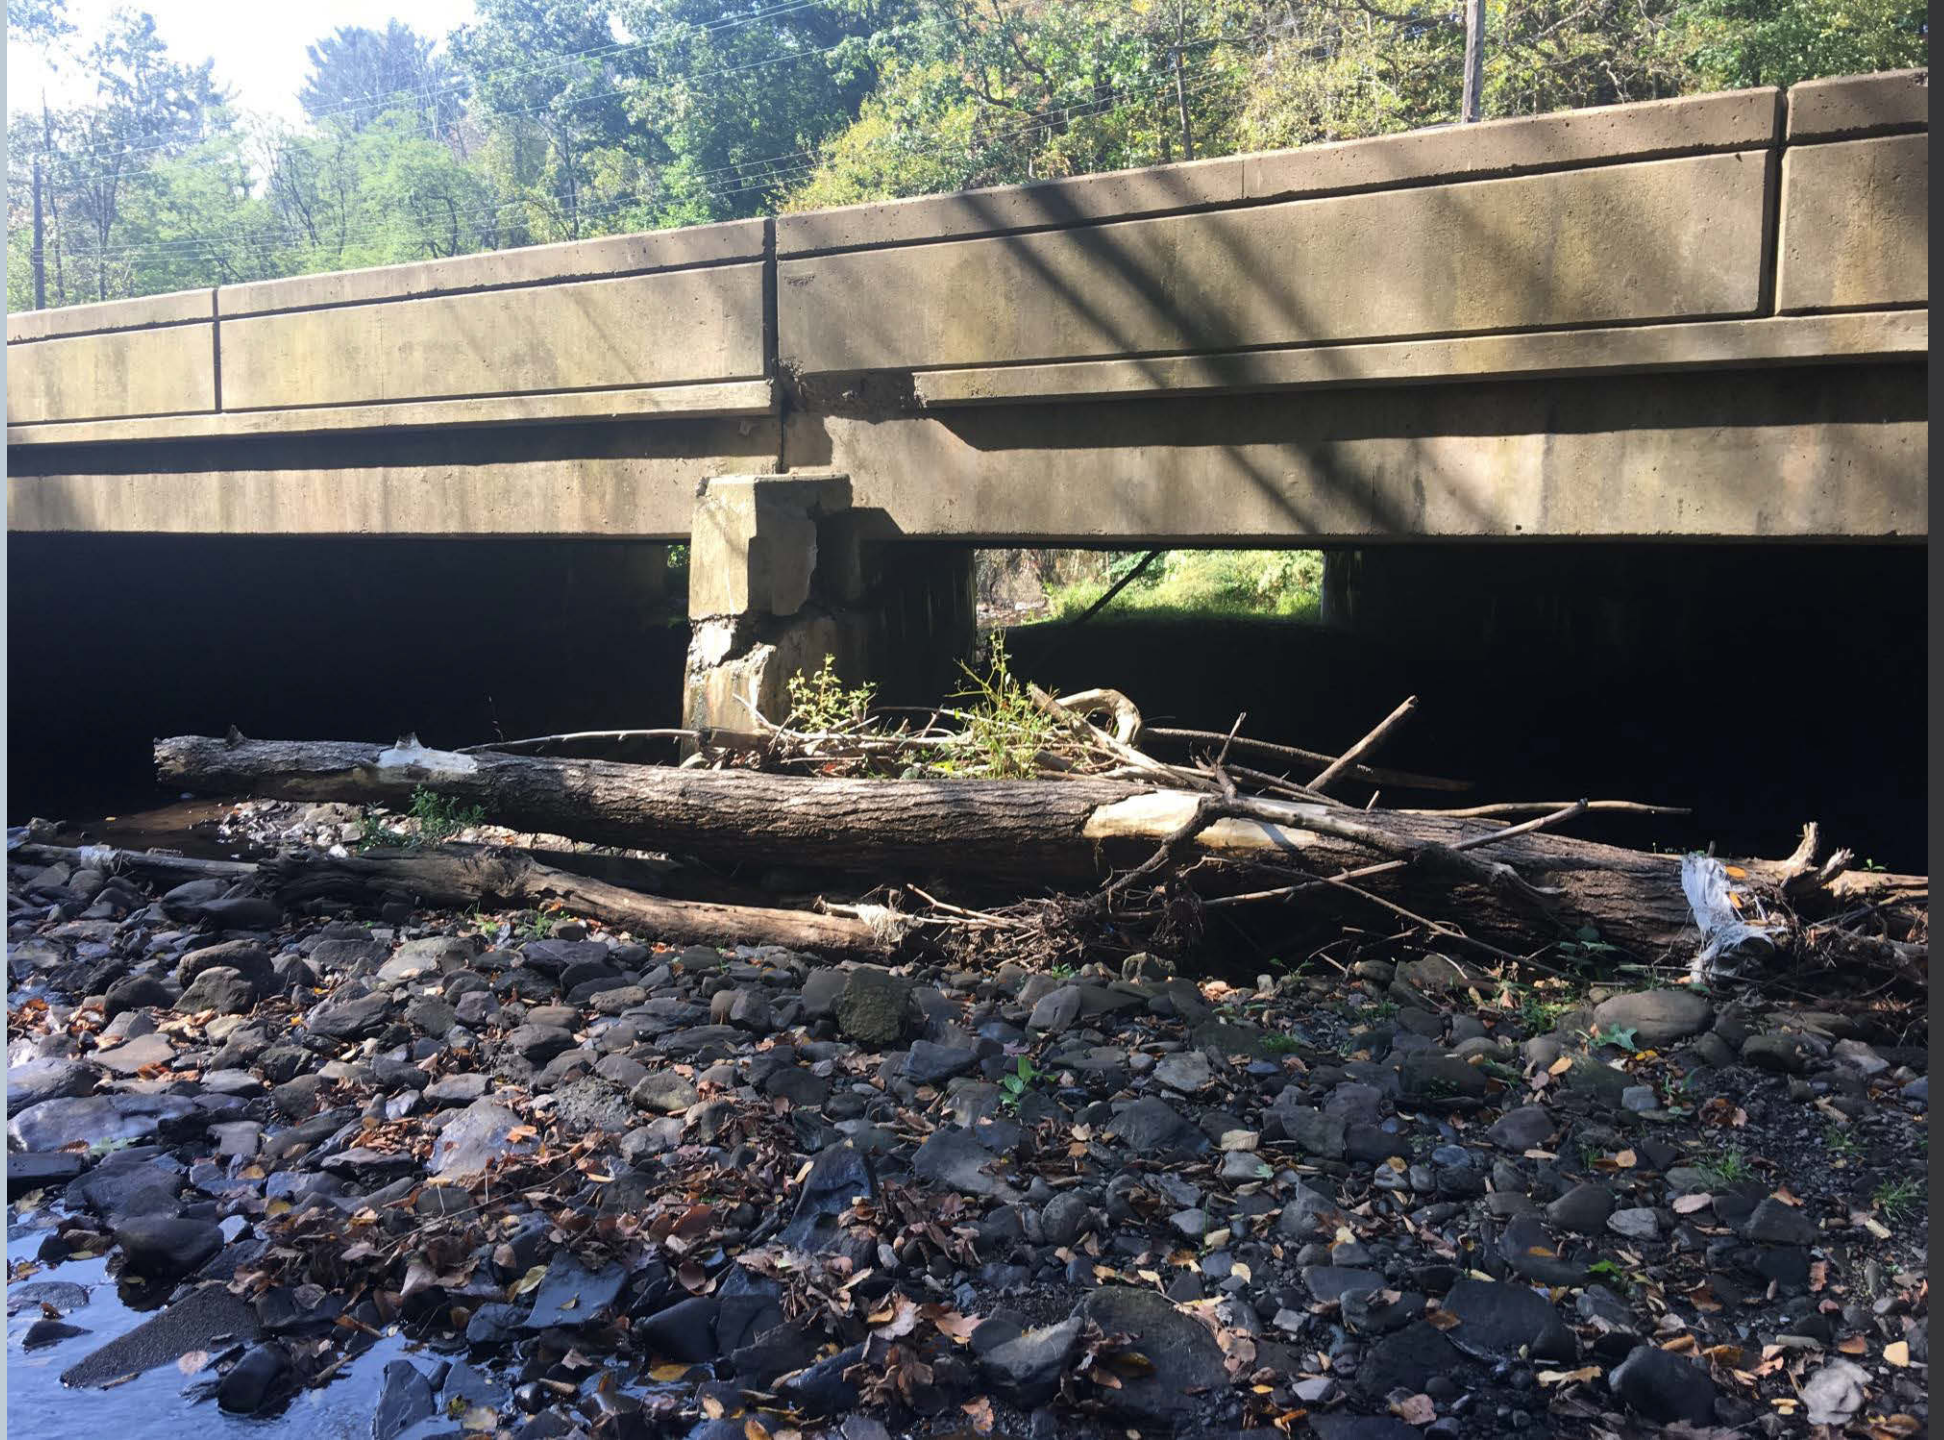
Figure 365. Looking upstream on Toby Creek where a fallen tree is across the channel well above it hanging precariously in the air. This area is just below Modern Floors. Japanese knotweed present along the entire left bank looking upstream. Recommend an Invasives removal project and a native riparian restoration planting along the corridor in this area.

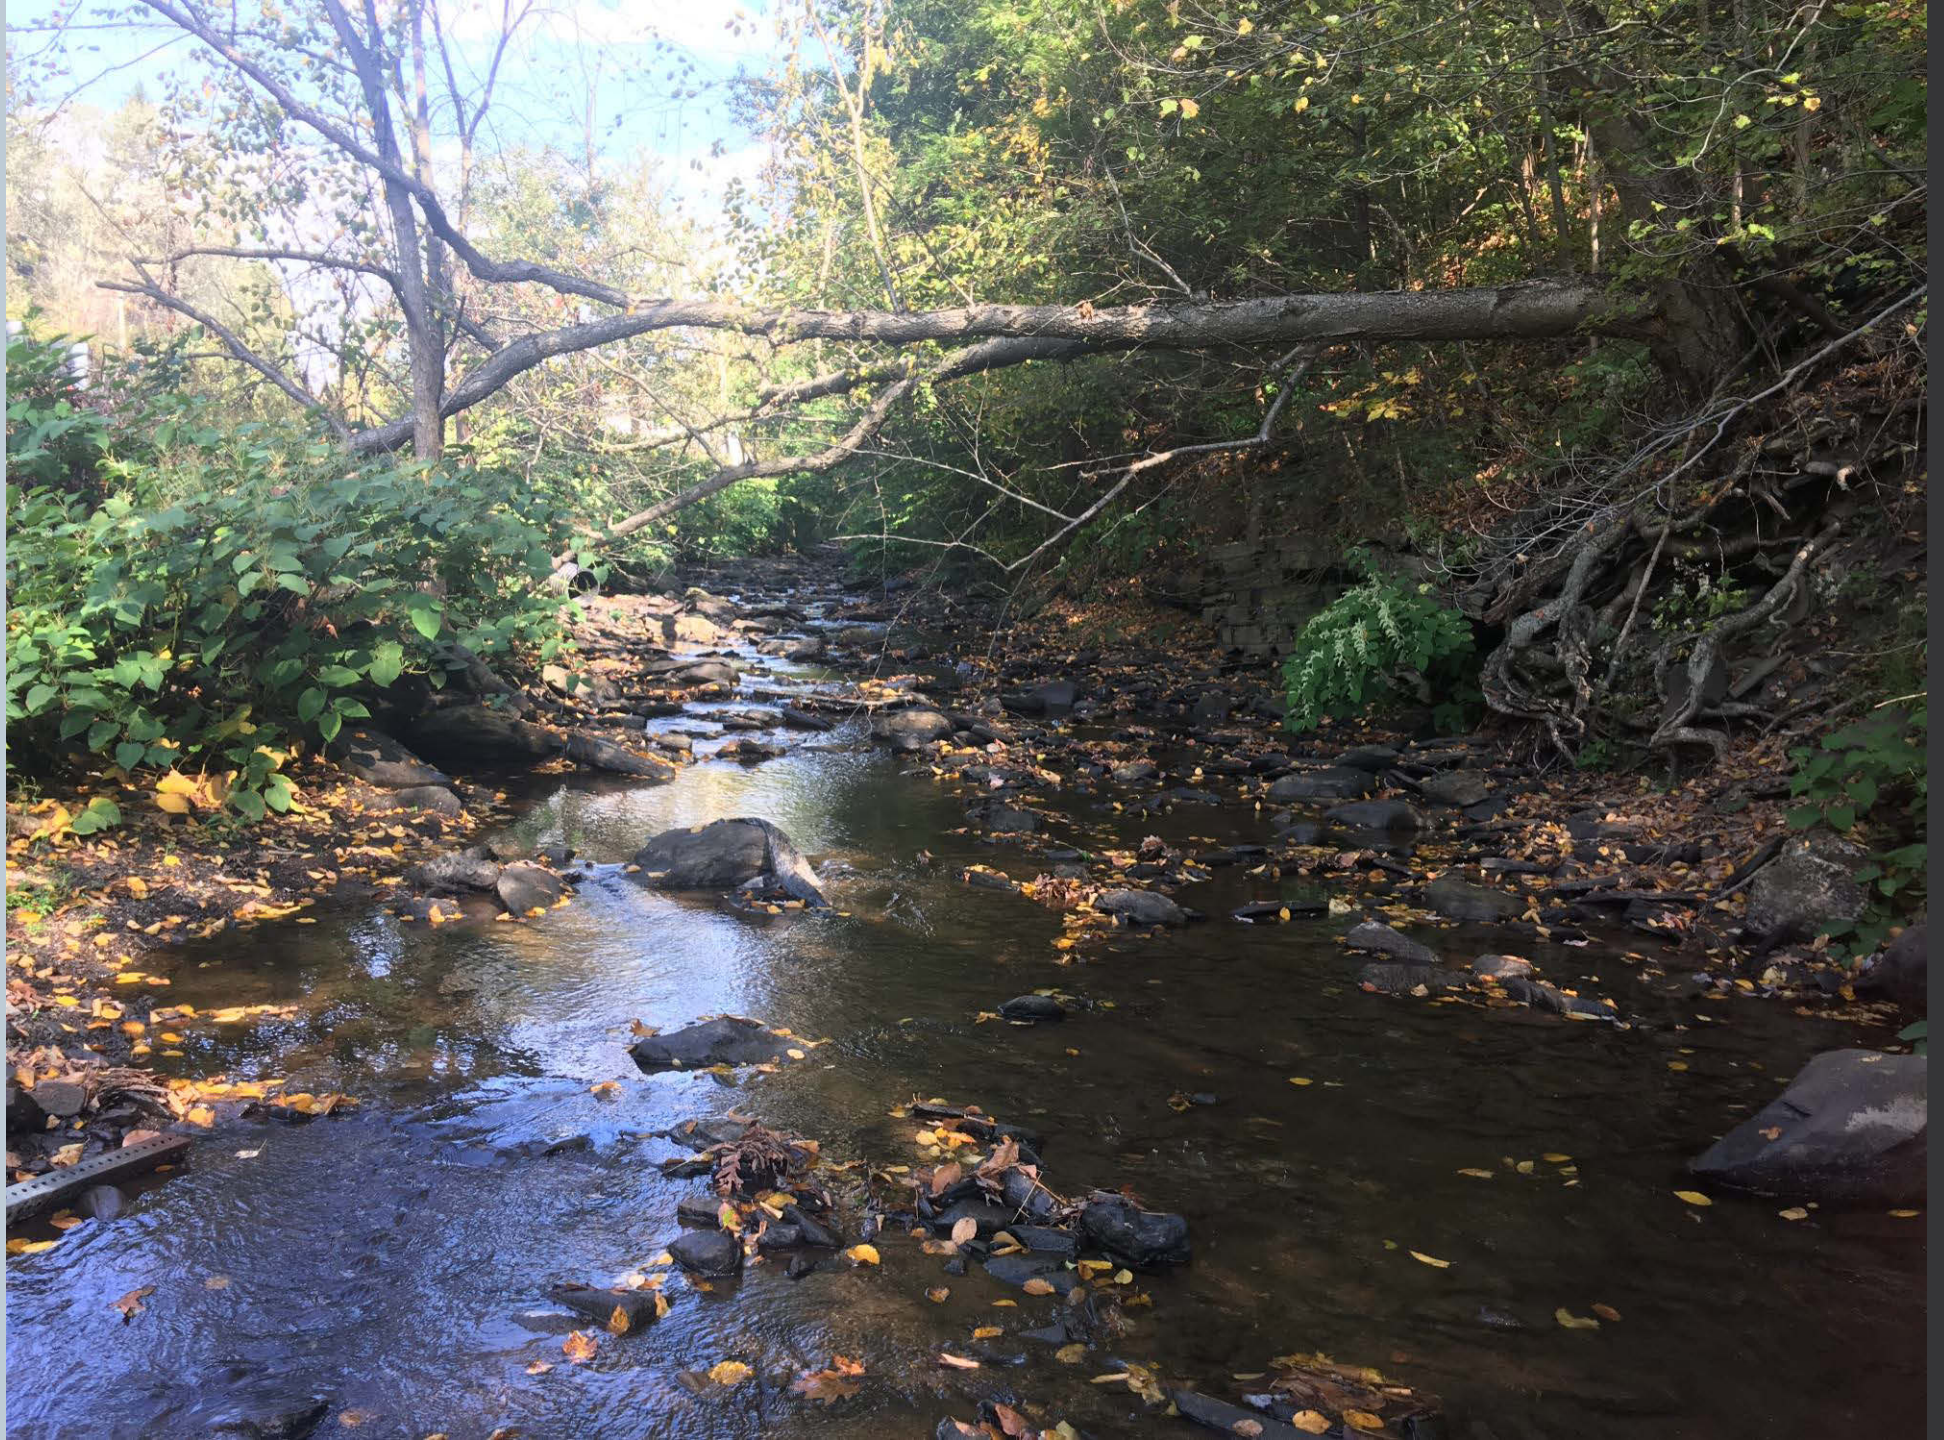
Figure 366.
Looking
downstream on
Toby Creek below
the Barber Shop
parking lot that
flows under the
bridge culvert
towards Offset
Paperback on the
other side of the
Dallas Memorial
Highway. An
unnamed
tributary flows in
from the pipe
culvert that
comes through
the right wing-
wall that starts
to flow up behind
Jack Williams.

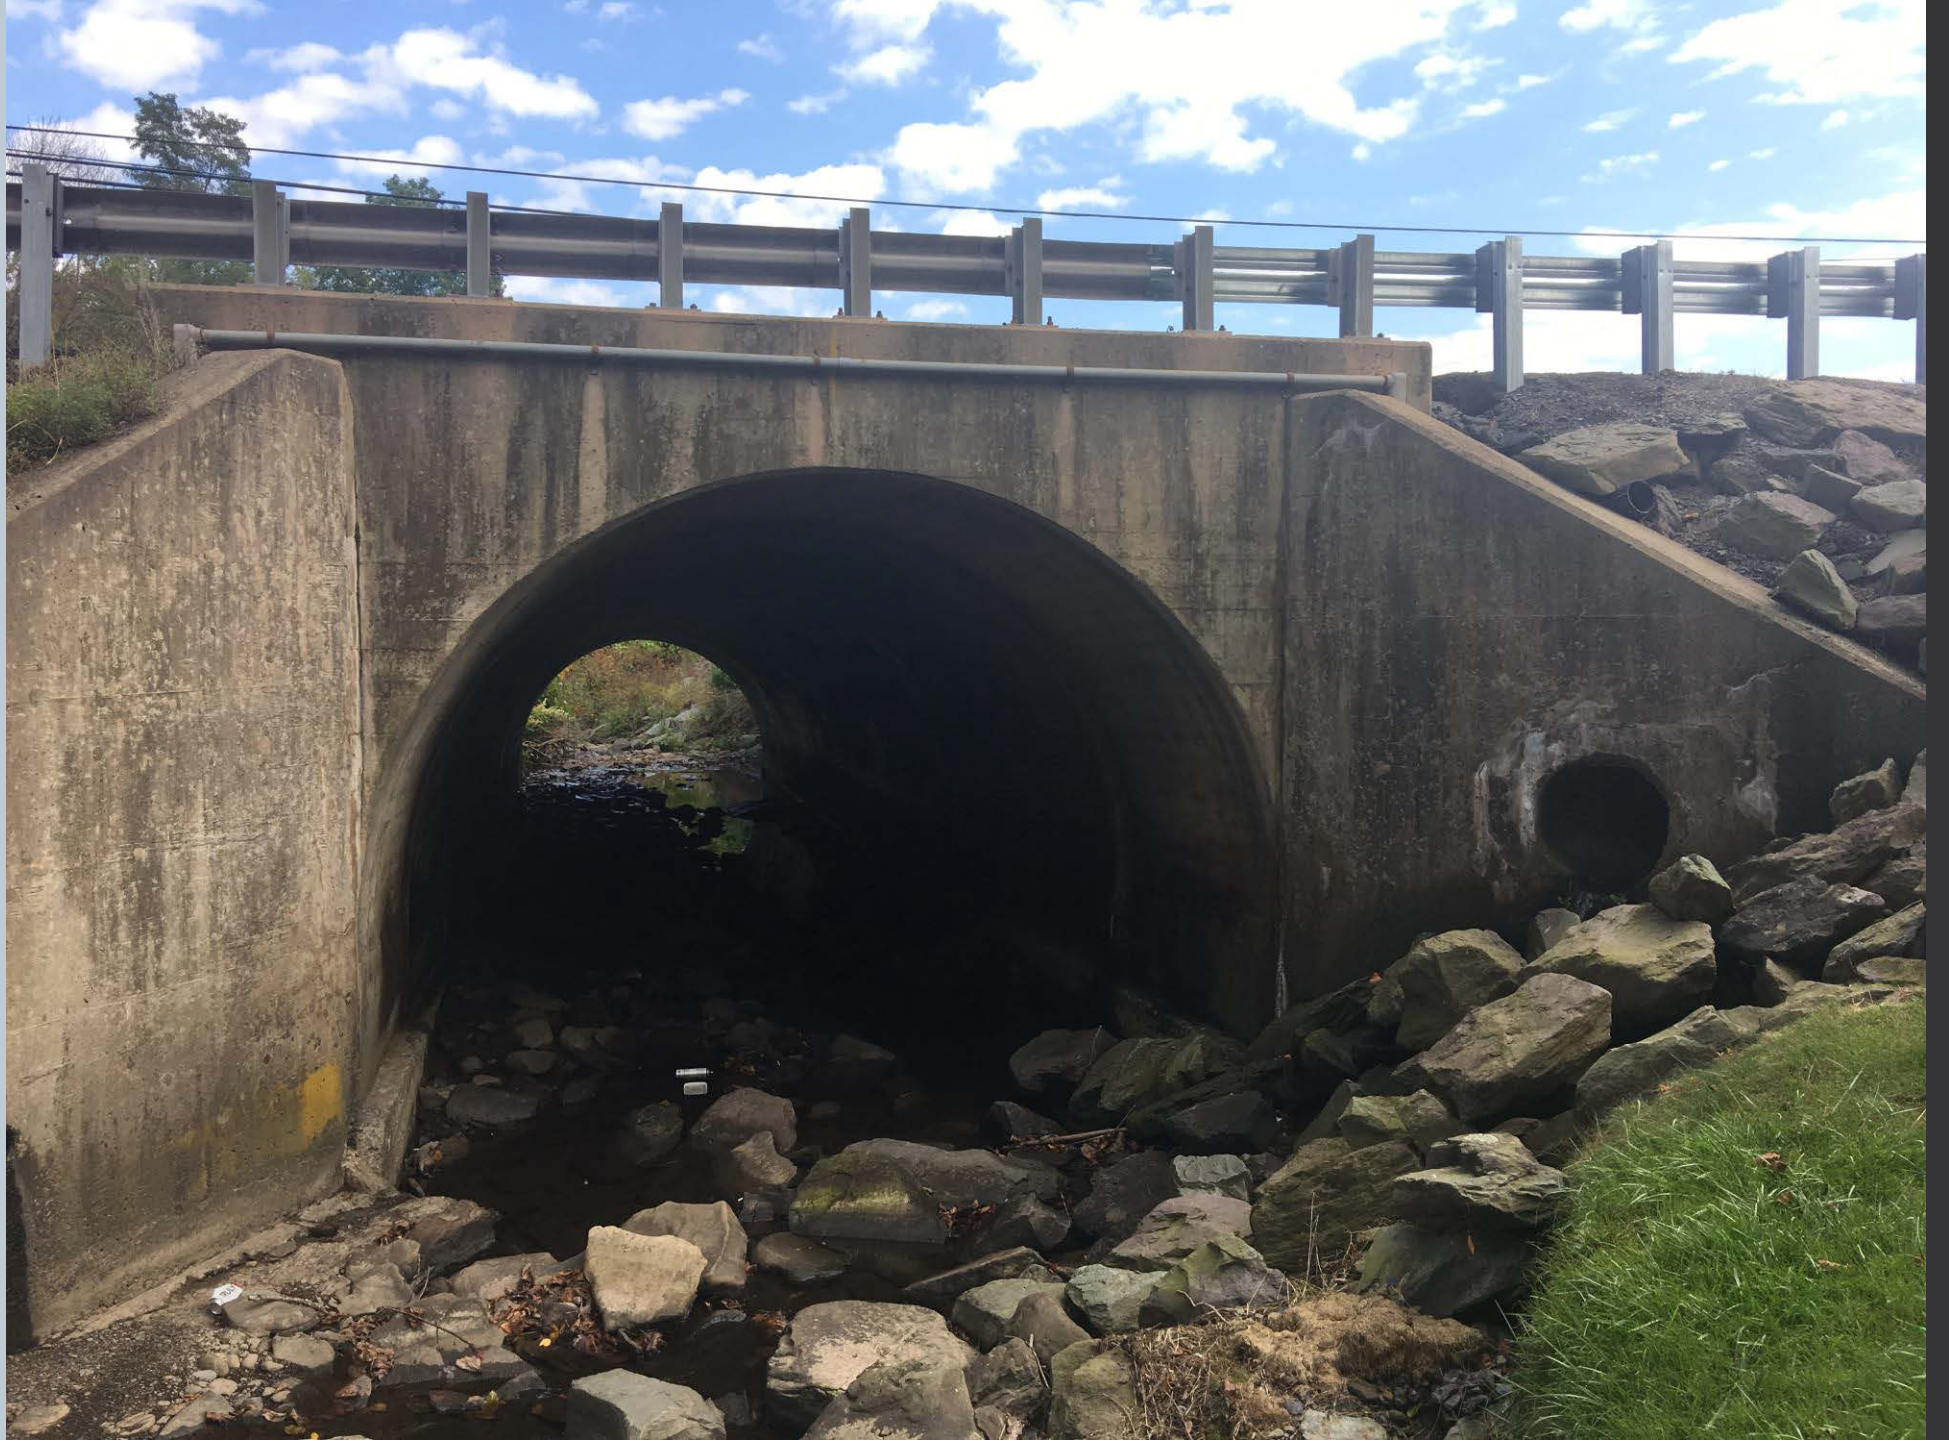
Figure 367. Looking upstream on Toby Creek below the Barber Shop parking lot. Some Japanese knotweed is present along the right bank looking upstream. Streambank erosion is along the left bank that undercuts it moderately before entering the bridge culvert crossing. Recommend small Invasives removal project and riparian restoration and creating a log deflector to protect the bank and redirect the flow before it enters the culvert.
