Toby Creek Field Reconnaissance Observations

September 26, 2018

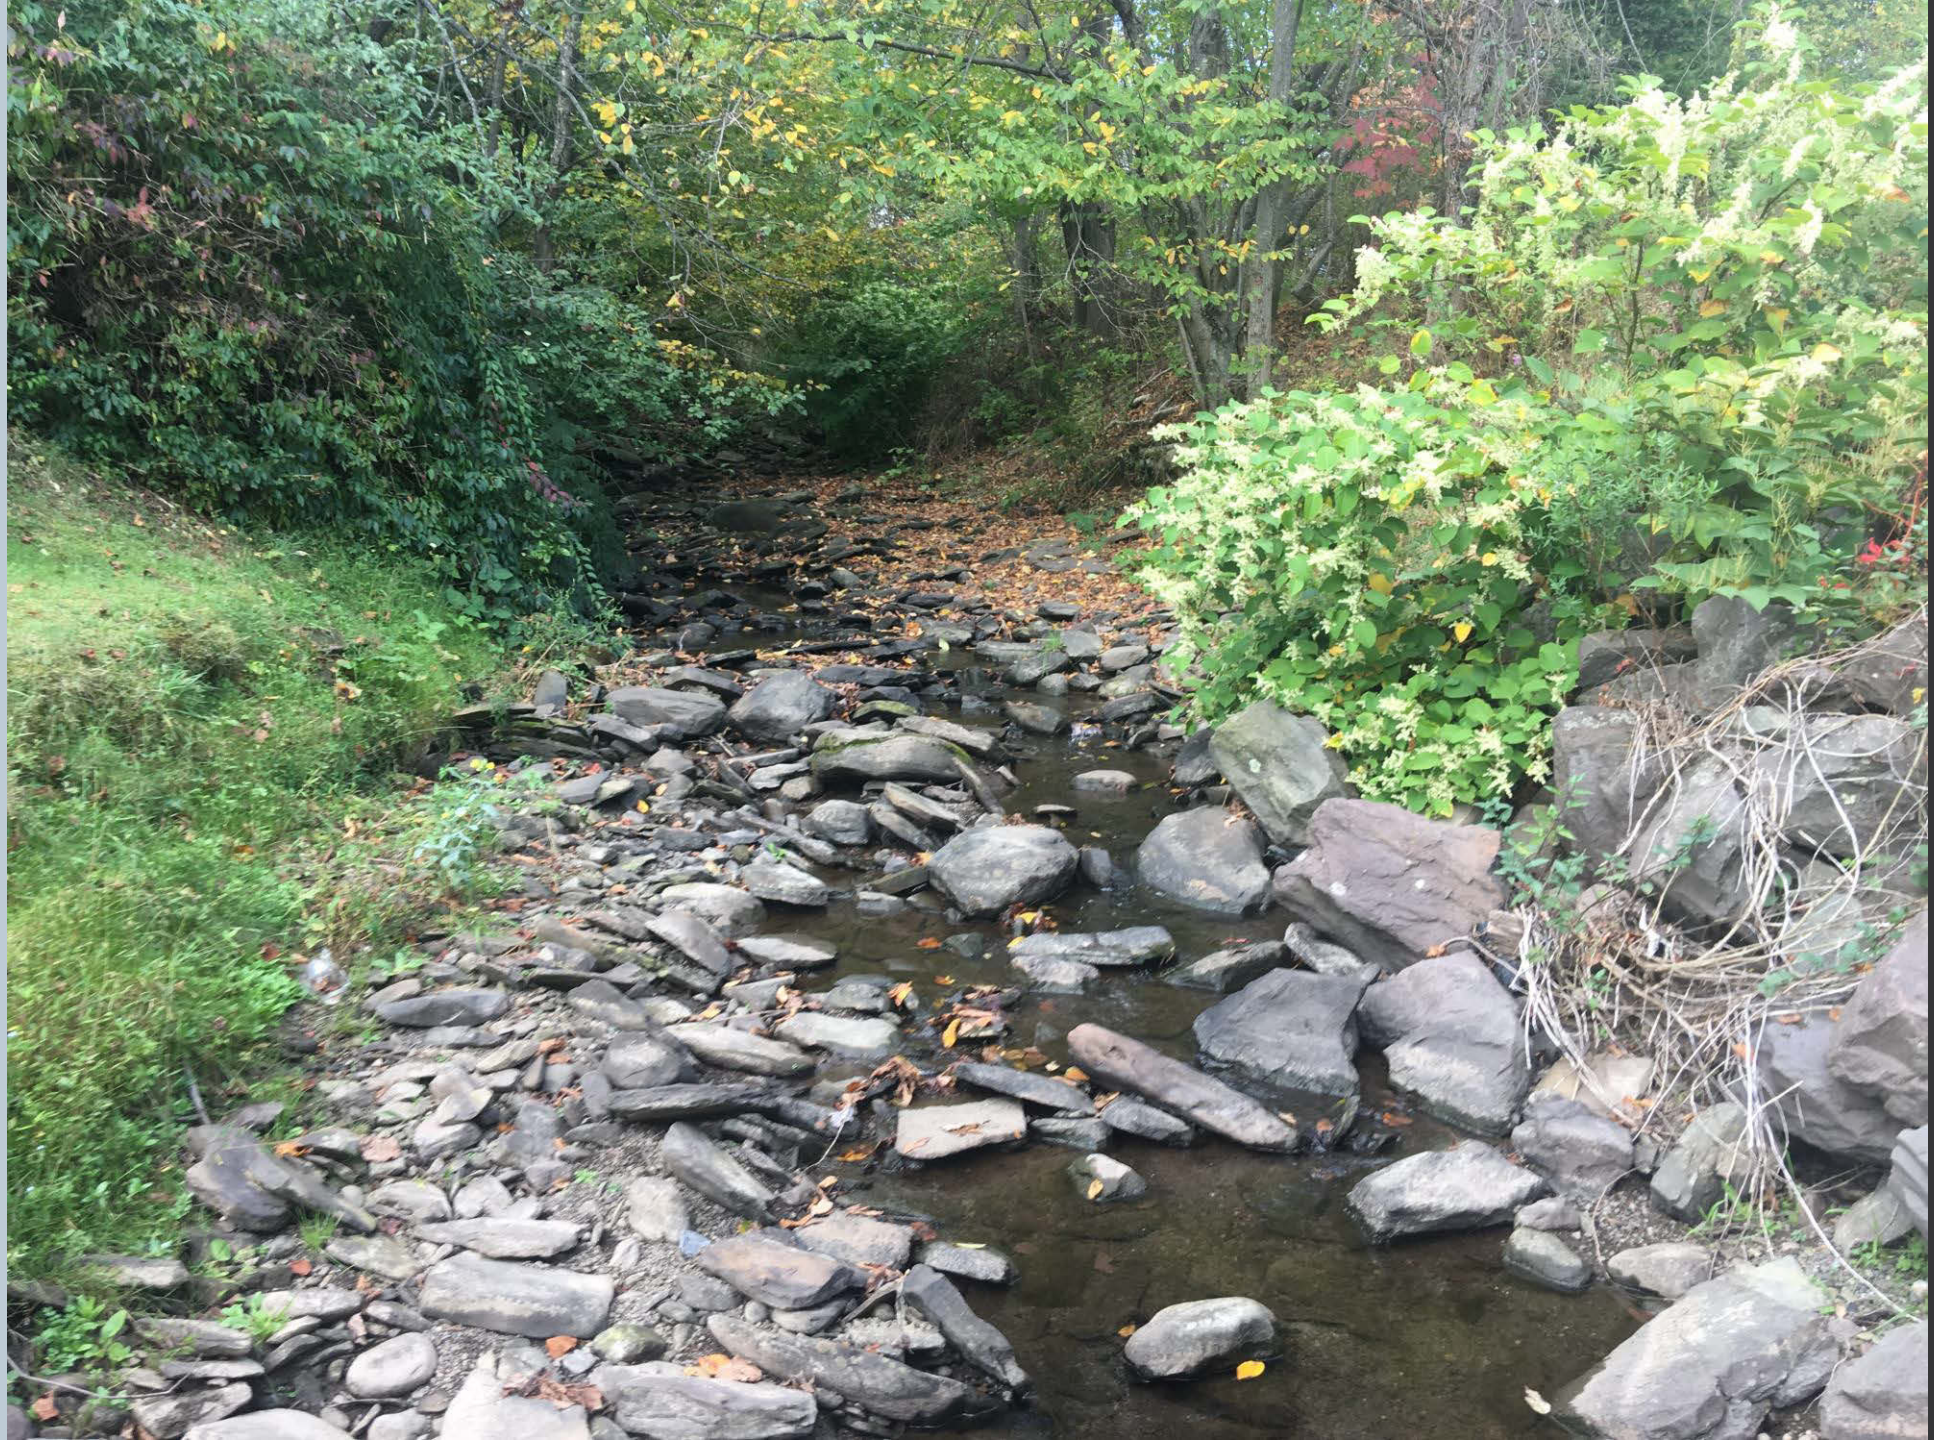
Figure 368. An unnamed tributary flows into Toby Creek near the Barber Shop from the pipe culvert that comes through the right wing-wall that starts to flow up behind Jack Williams and flows through a series of storm drains along the Dallas Memorial Highway.

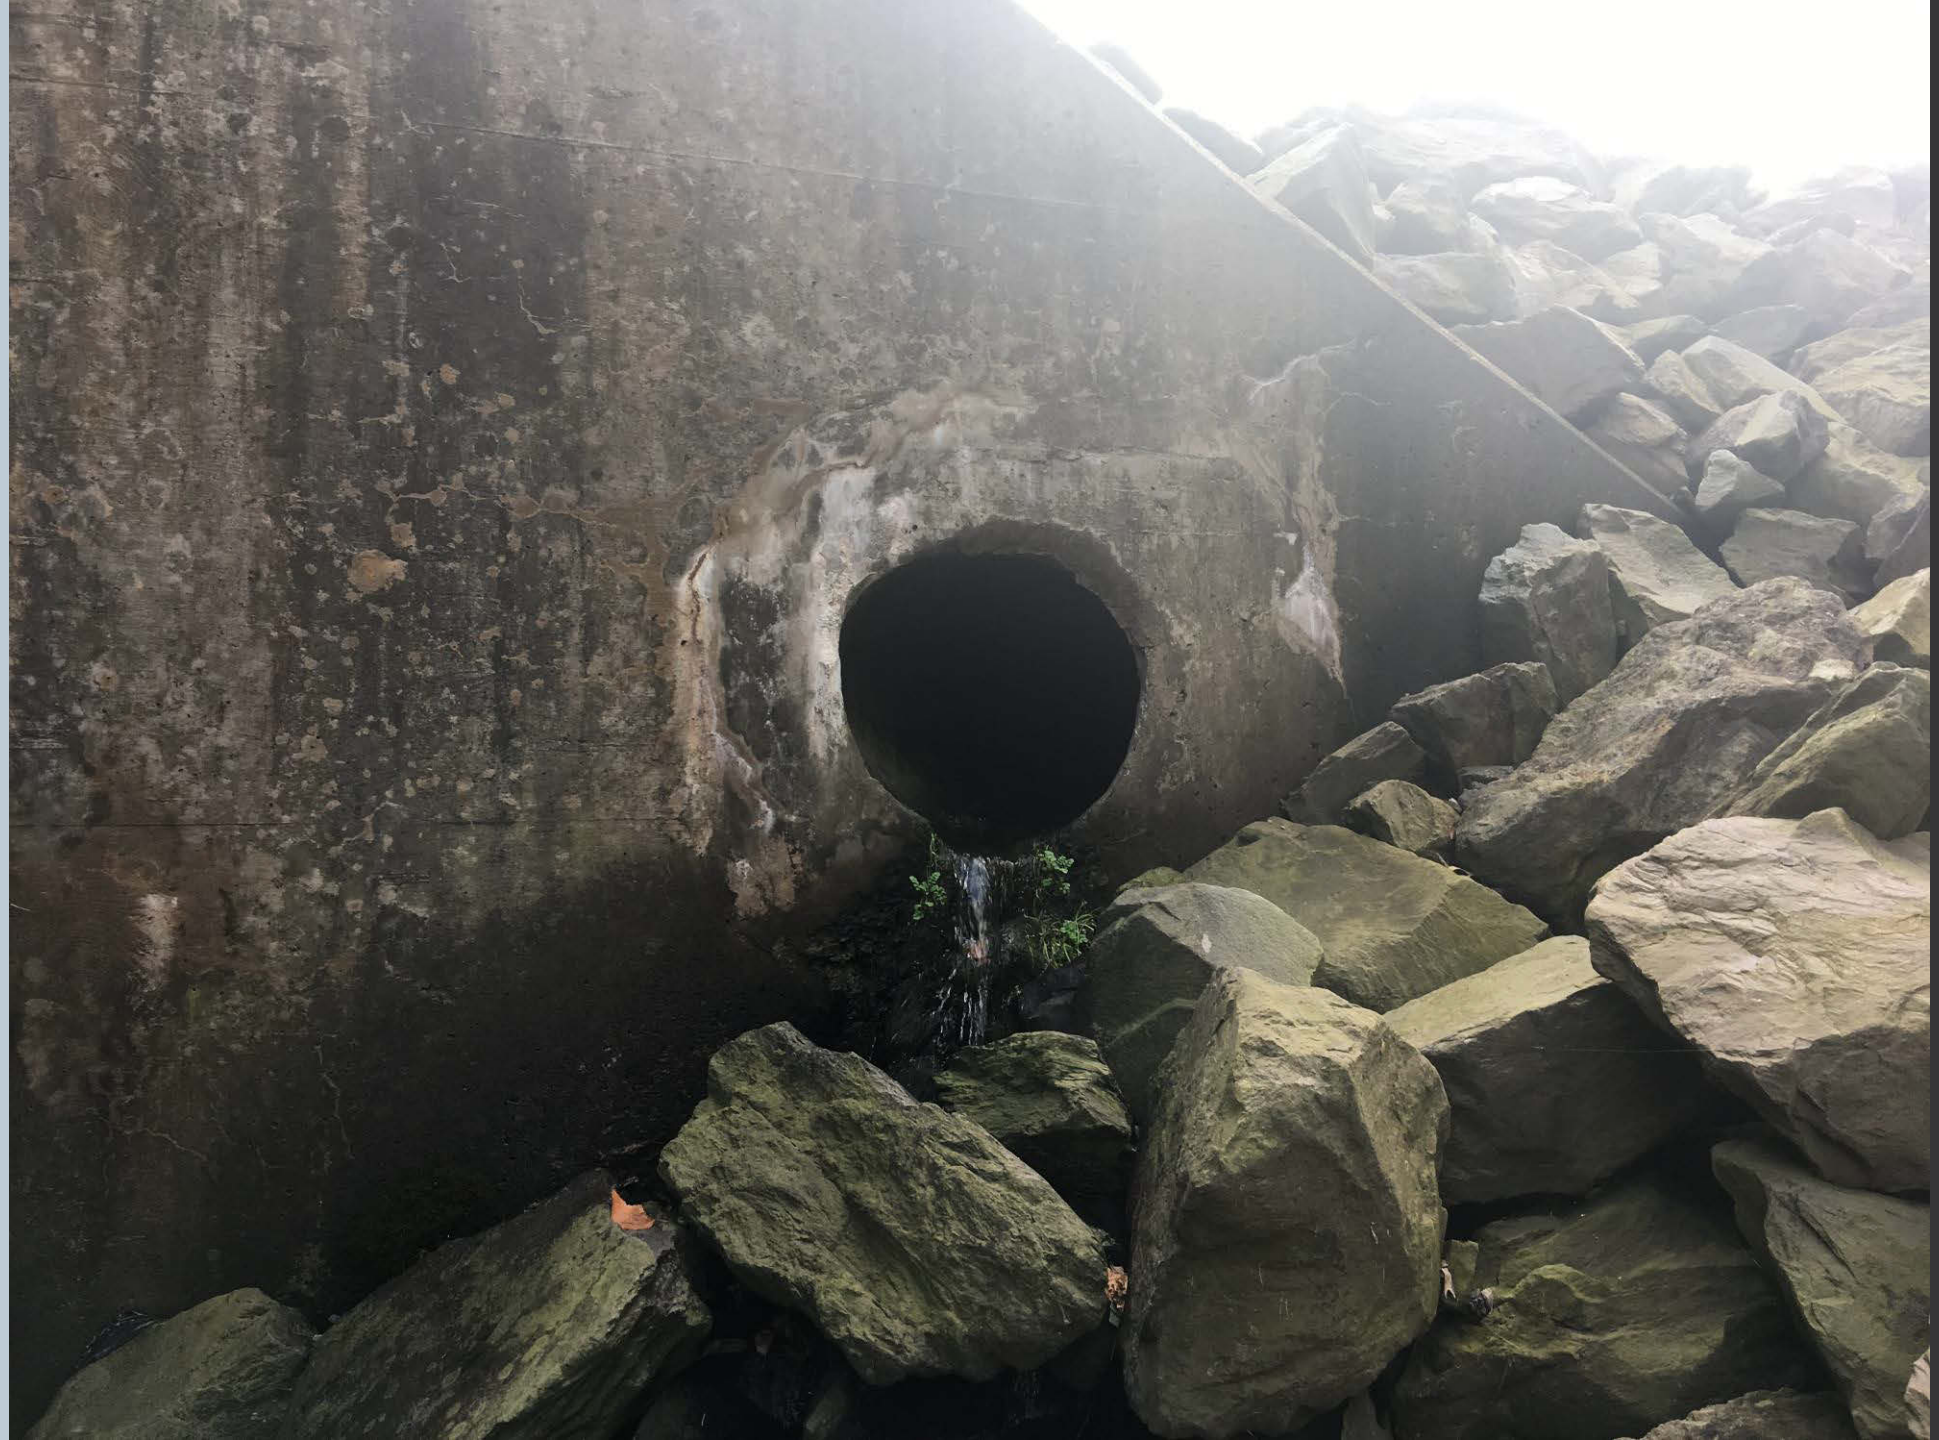
Figure 369. Looking downstream on Toby Creek from the bridge culvert over the Dallas Memorial Highway next to Offset Paperback. Japanese knotweed is prevalent here. Recommend an Invasives Removal Project and native riparian restoration in partnership with Offset Paperback.

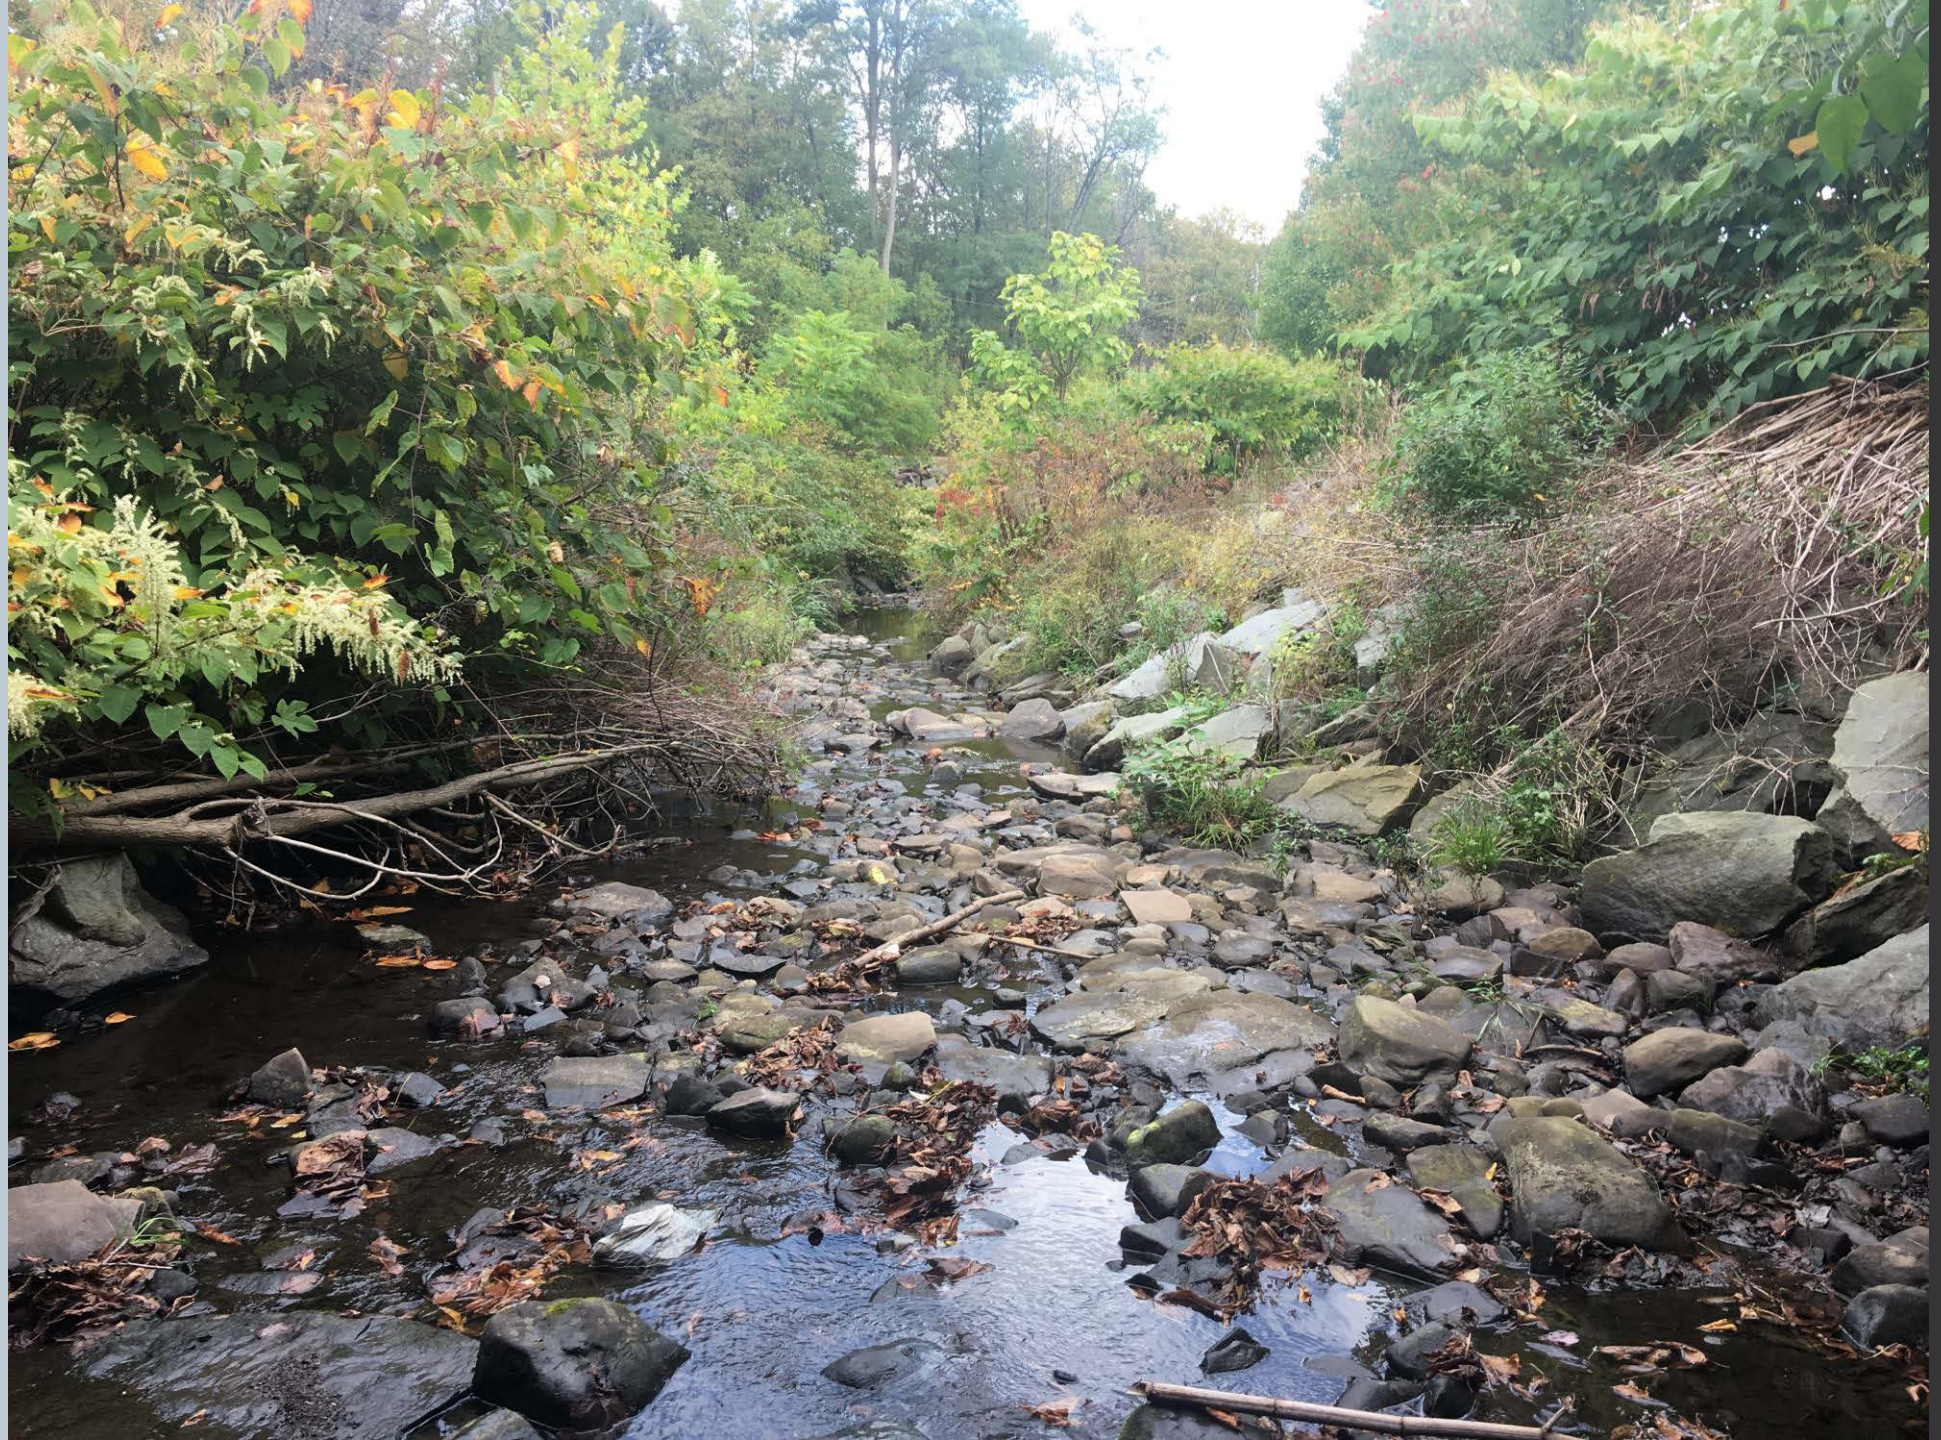
Figure 370. Looking downstream on Toby Creek from the bridge and primary access road to Walgreen's from the Dallas Memorial Highway. Minnows were present in great abundance as were sculpins and crayfish. This area was heavily sediment-laden beneath the bridge in the pool. Japanese knotweed is prevalent. Recommend an Invasives Removal Project and native riparian planting in this area.

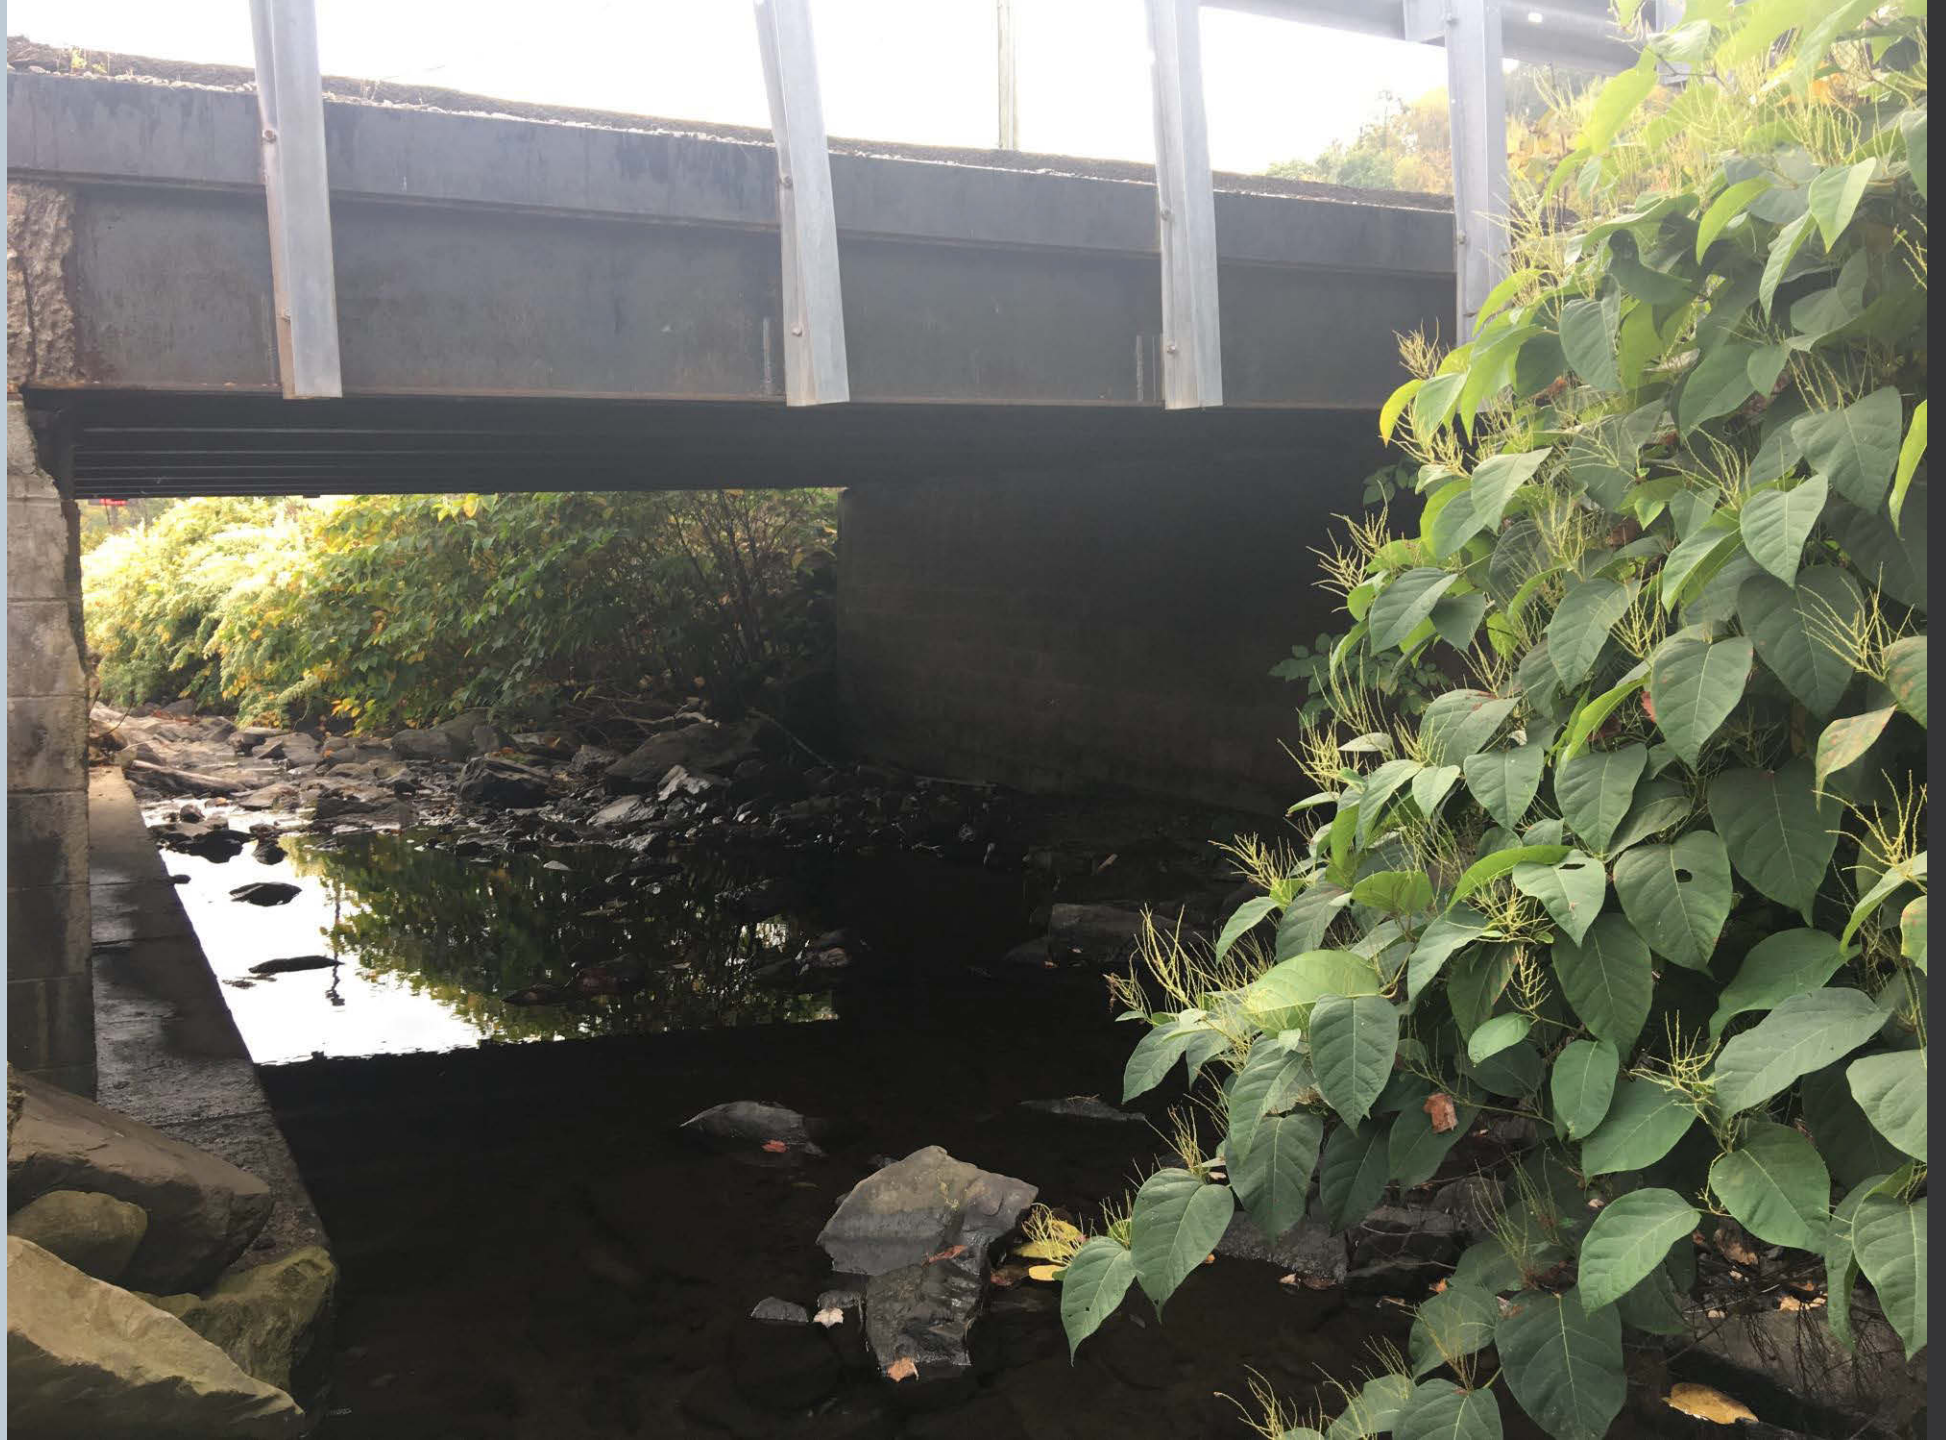
Figure 371. Looking upstream on Toby Creek from the bridge and primary access road to Walgreen's from the Dallas Memorial Highway. Minnows were present in great abundance as were sculpins and crayfish. This area was heavily sediment-laden beneath the bridge in the pool. Japanese knotweed is prevalent. Recommend an Invasives Removal Project and native riparian planting in this area.

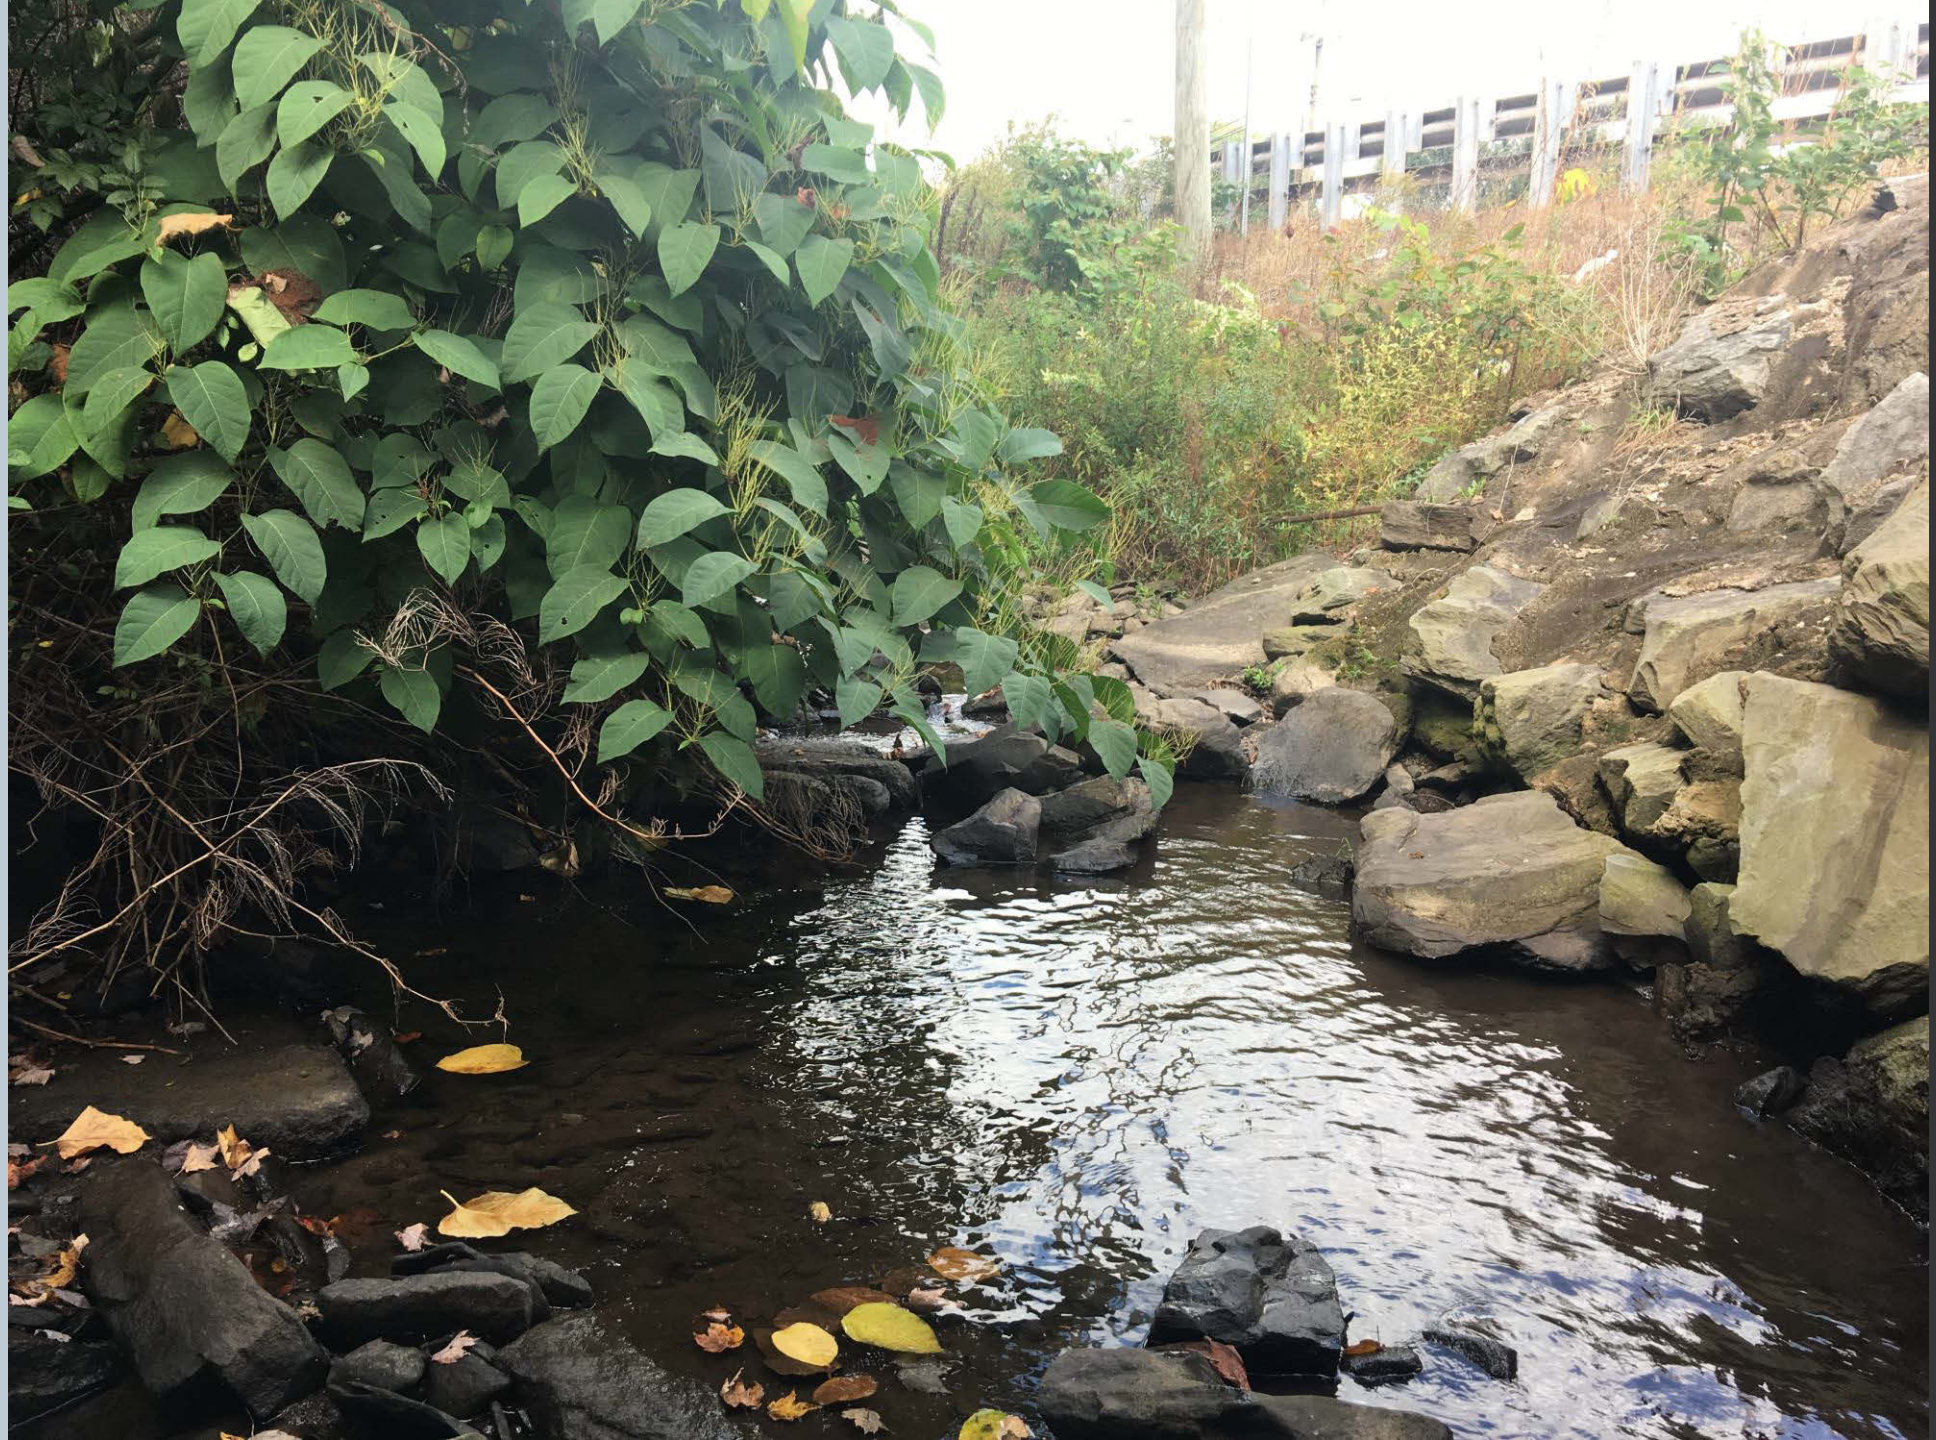
Figure 372. Looking downstream on Toby Creek from the bridge and primary access road to Walgreen's from the Dallas Memorial Highway. Minnows were present in great abundance as were sculpins and crayfish. This area was heavily sediment-laden beneath the bridge in the pool. Japanese knotweed is prevalent. Recommend an Invasives Removal Project and native riparian planting in this area.

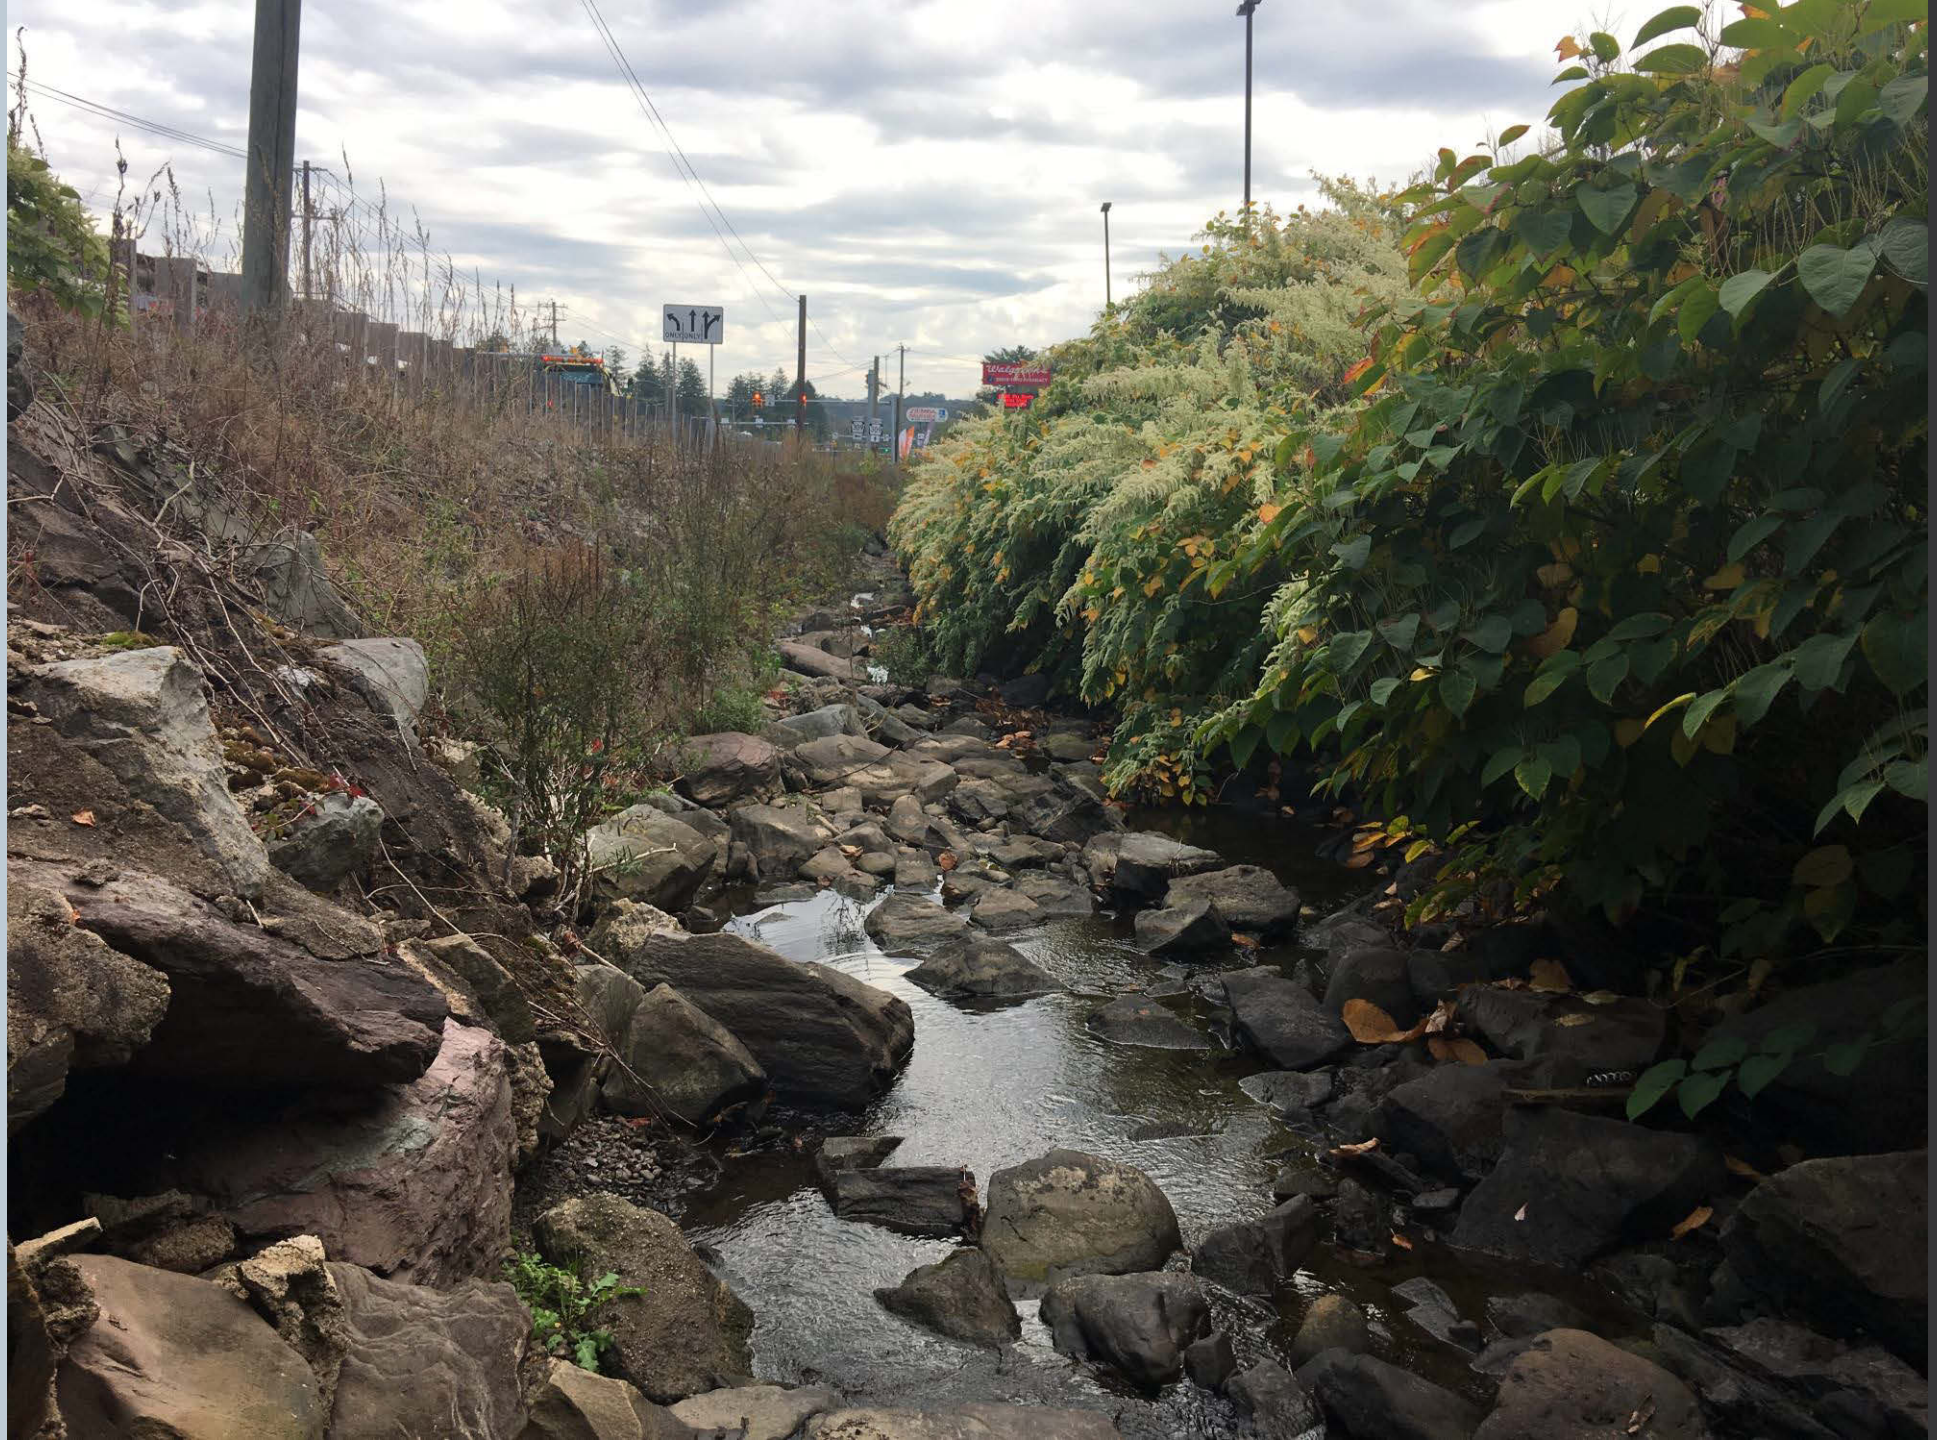
Figure 373. Two concrete storm drains enter Toby Creek that are not aligned with the stream and are well above the grade of the channel causing scour pool development below them when stormwater freefalls into the stream.

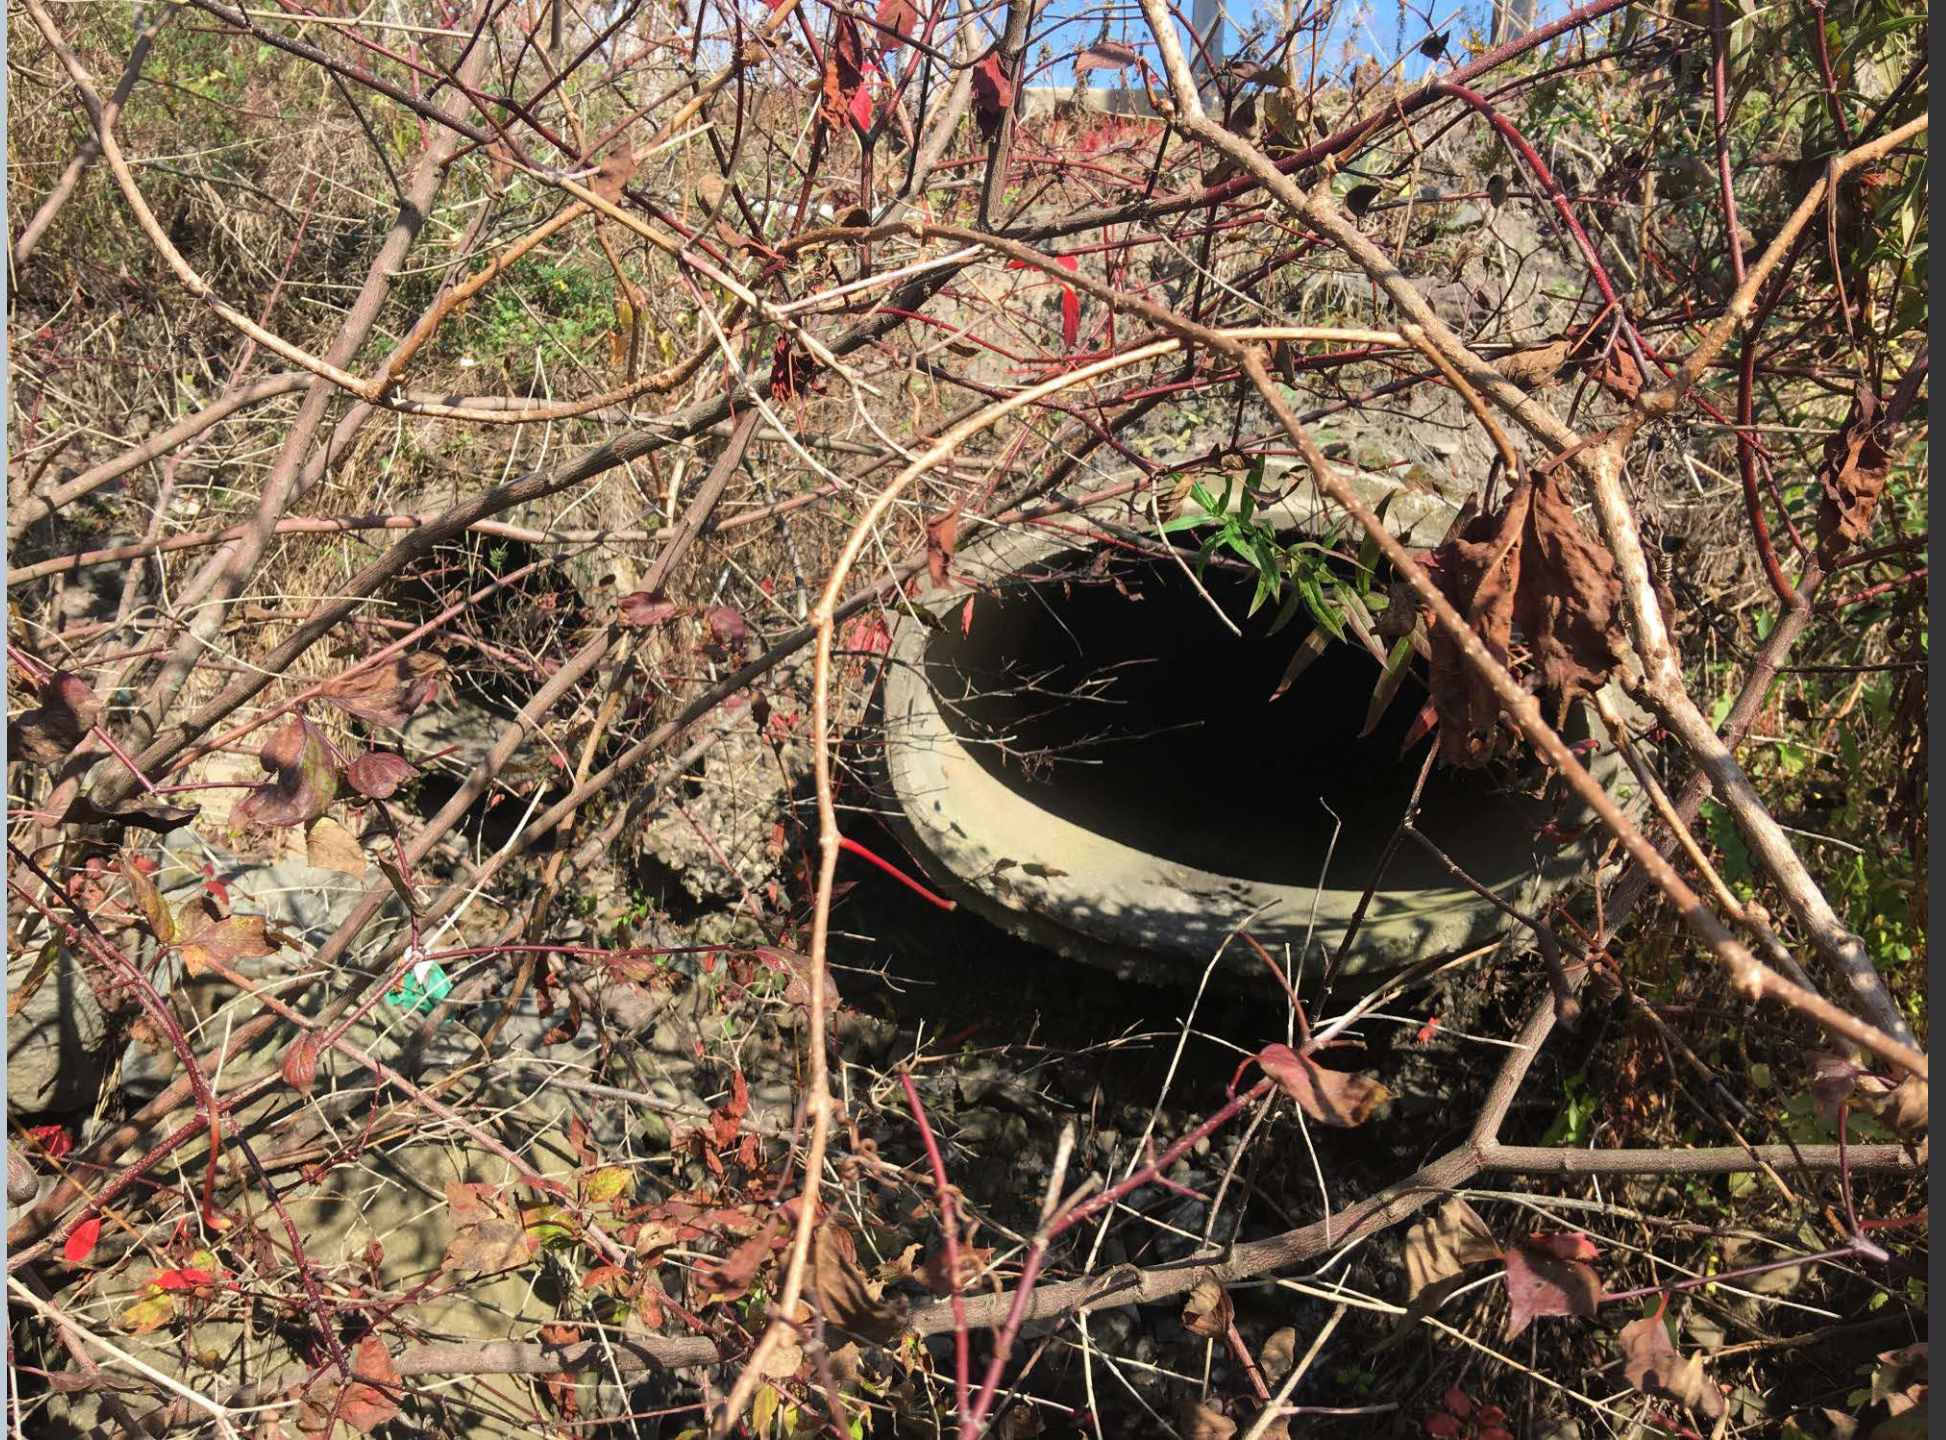
Figure 374. Looking downstream on Toby Creek that has minimal flow due to the baseflow of the stream being below the cobble and boulder gravel bar aggradation in the channel over the entire length of the bridge culvert at the entrance to Dunkin Donuts and Walgreen's. Some woody debris is at the inlet that can easily be removed by hand.

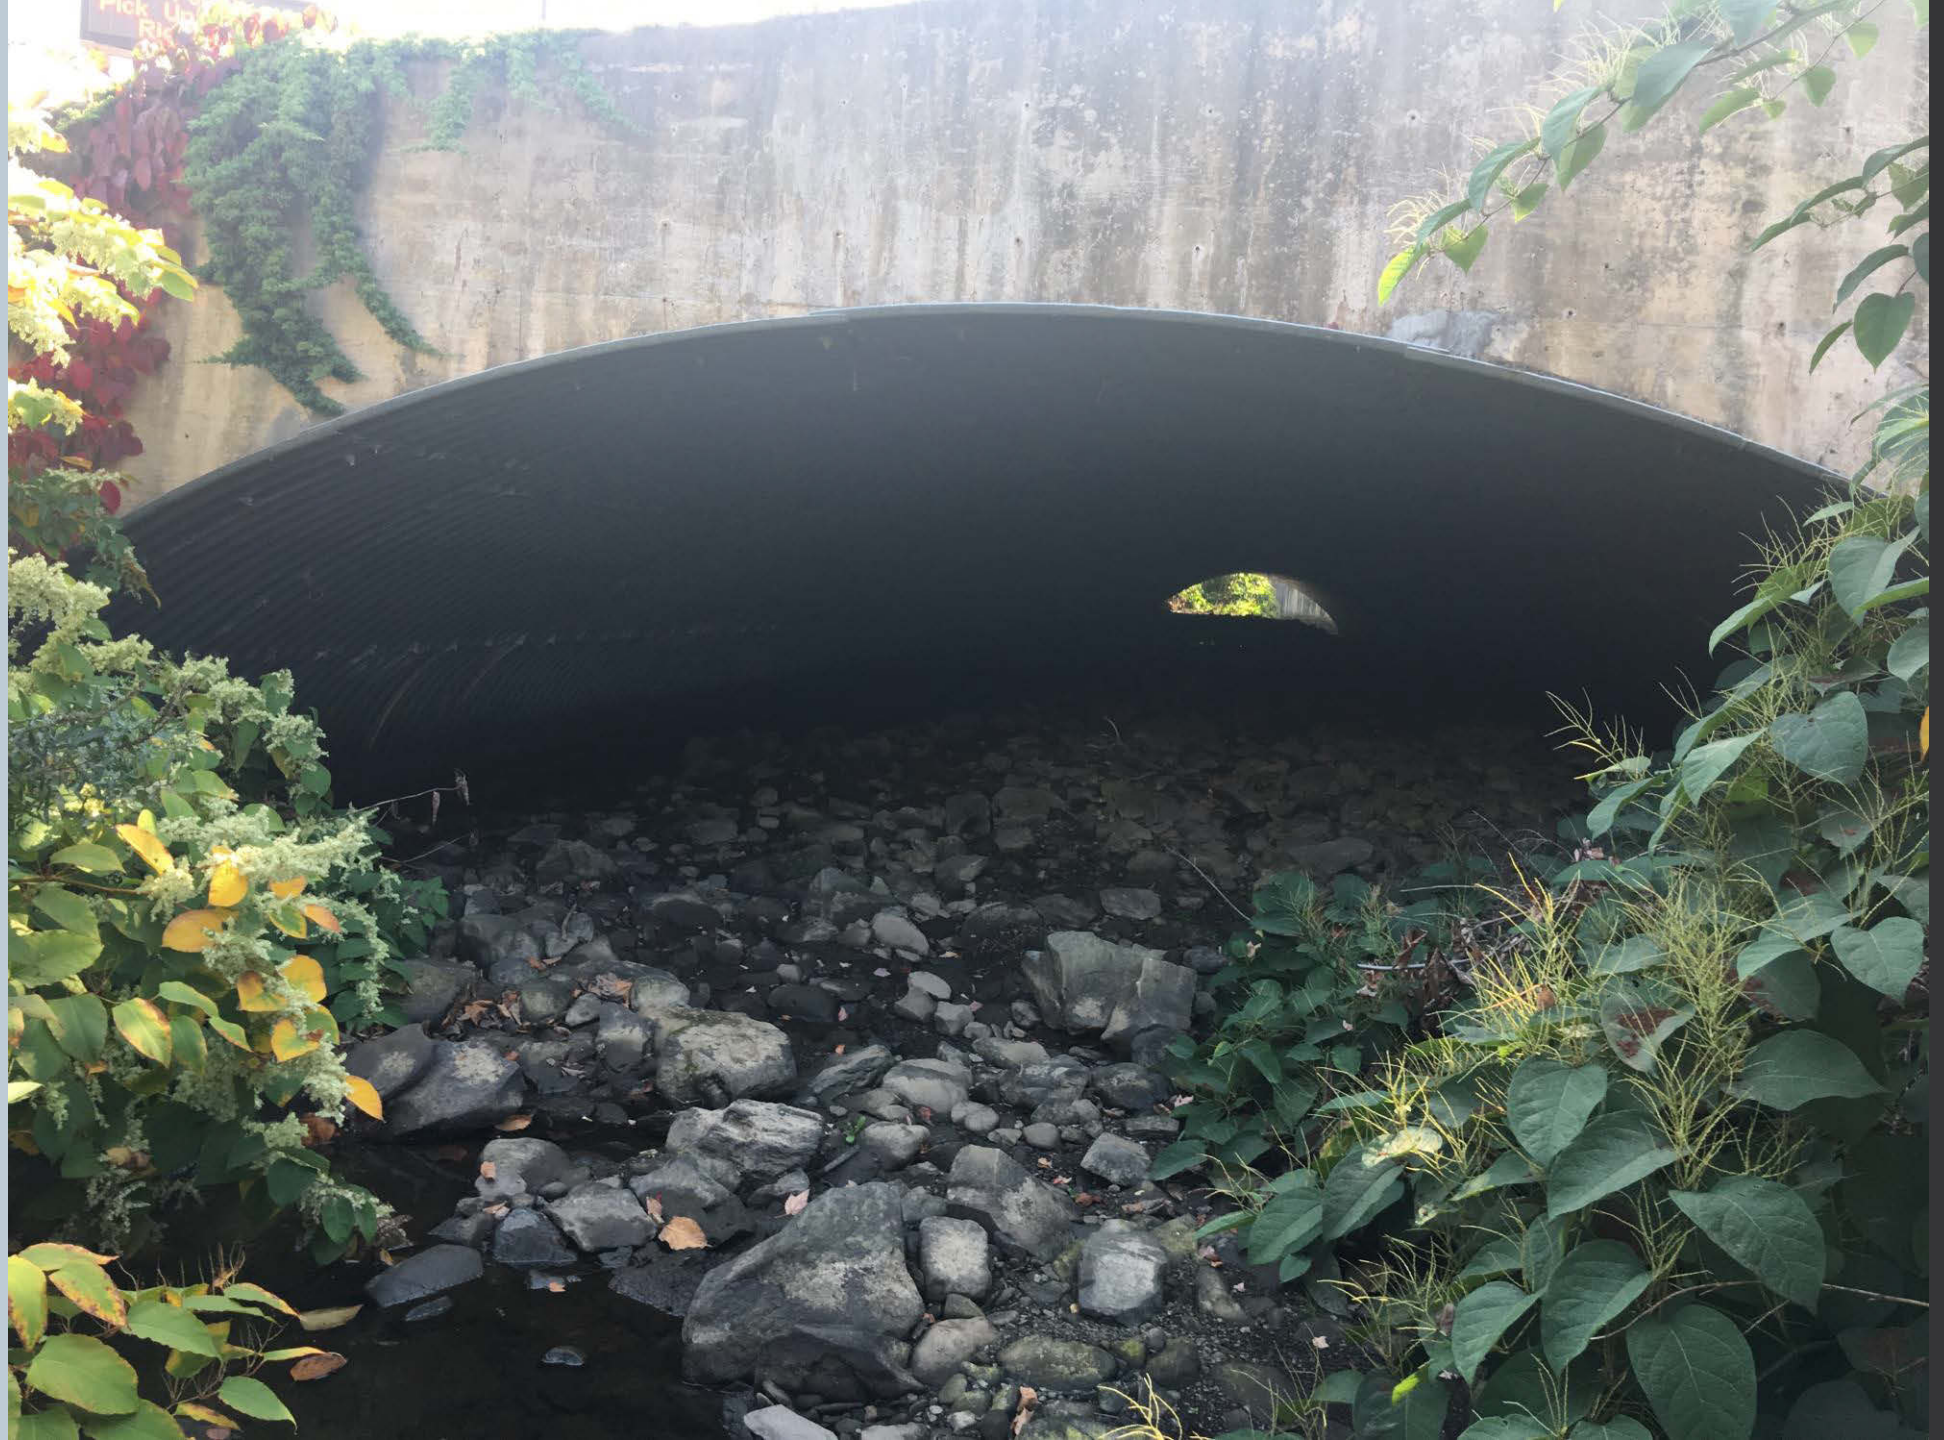
Figure 375. Looking upstream on Toby Creek that has minimal flow due to the baseflow of the stream being below the cobble and boulder gravel bar aggradation in the channel over the entire length of the bridge culvert at the entrance to Dunkin Donuts and Walgreen's. Some woody debris is at the inlet that can easily be removed by hand.
