Toby Creek Field Reconnaissance Observations

September 26, 2018

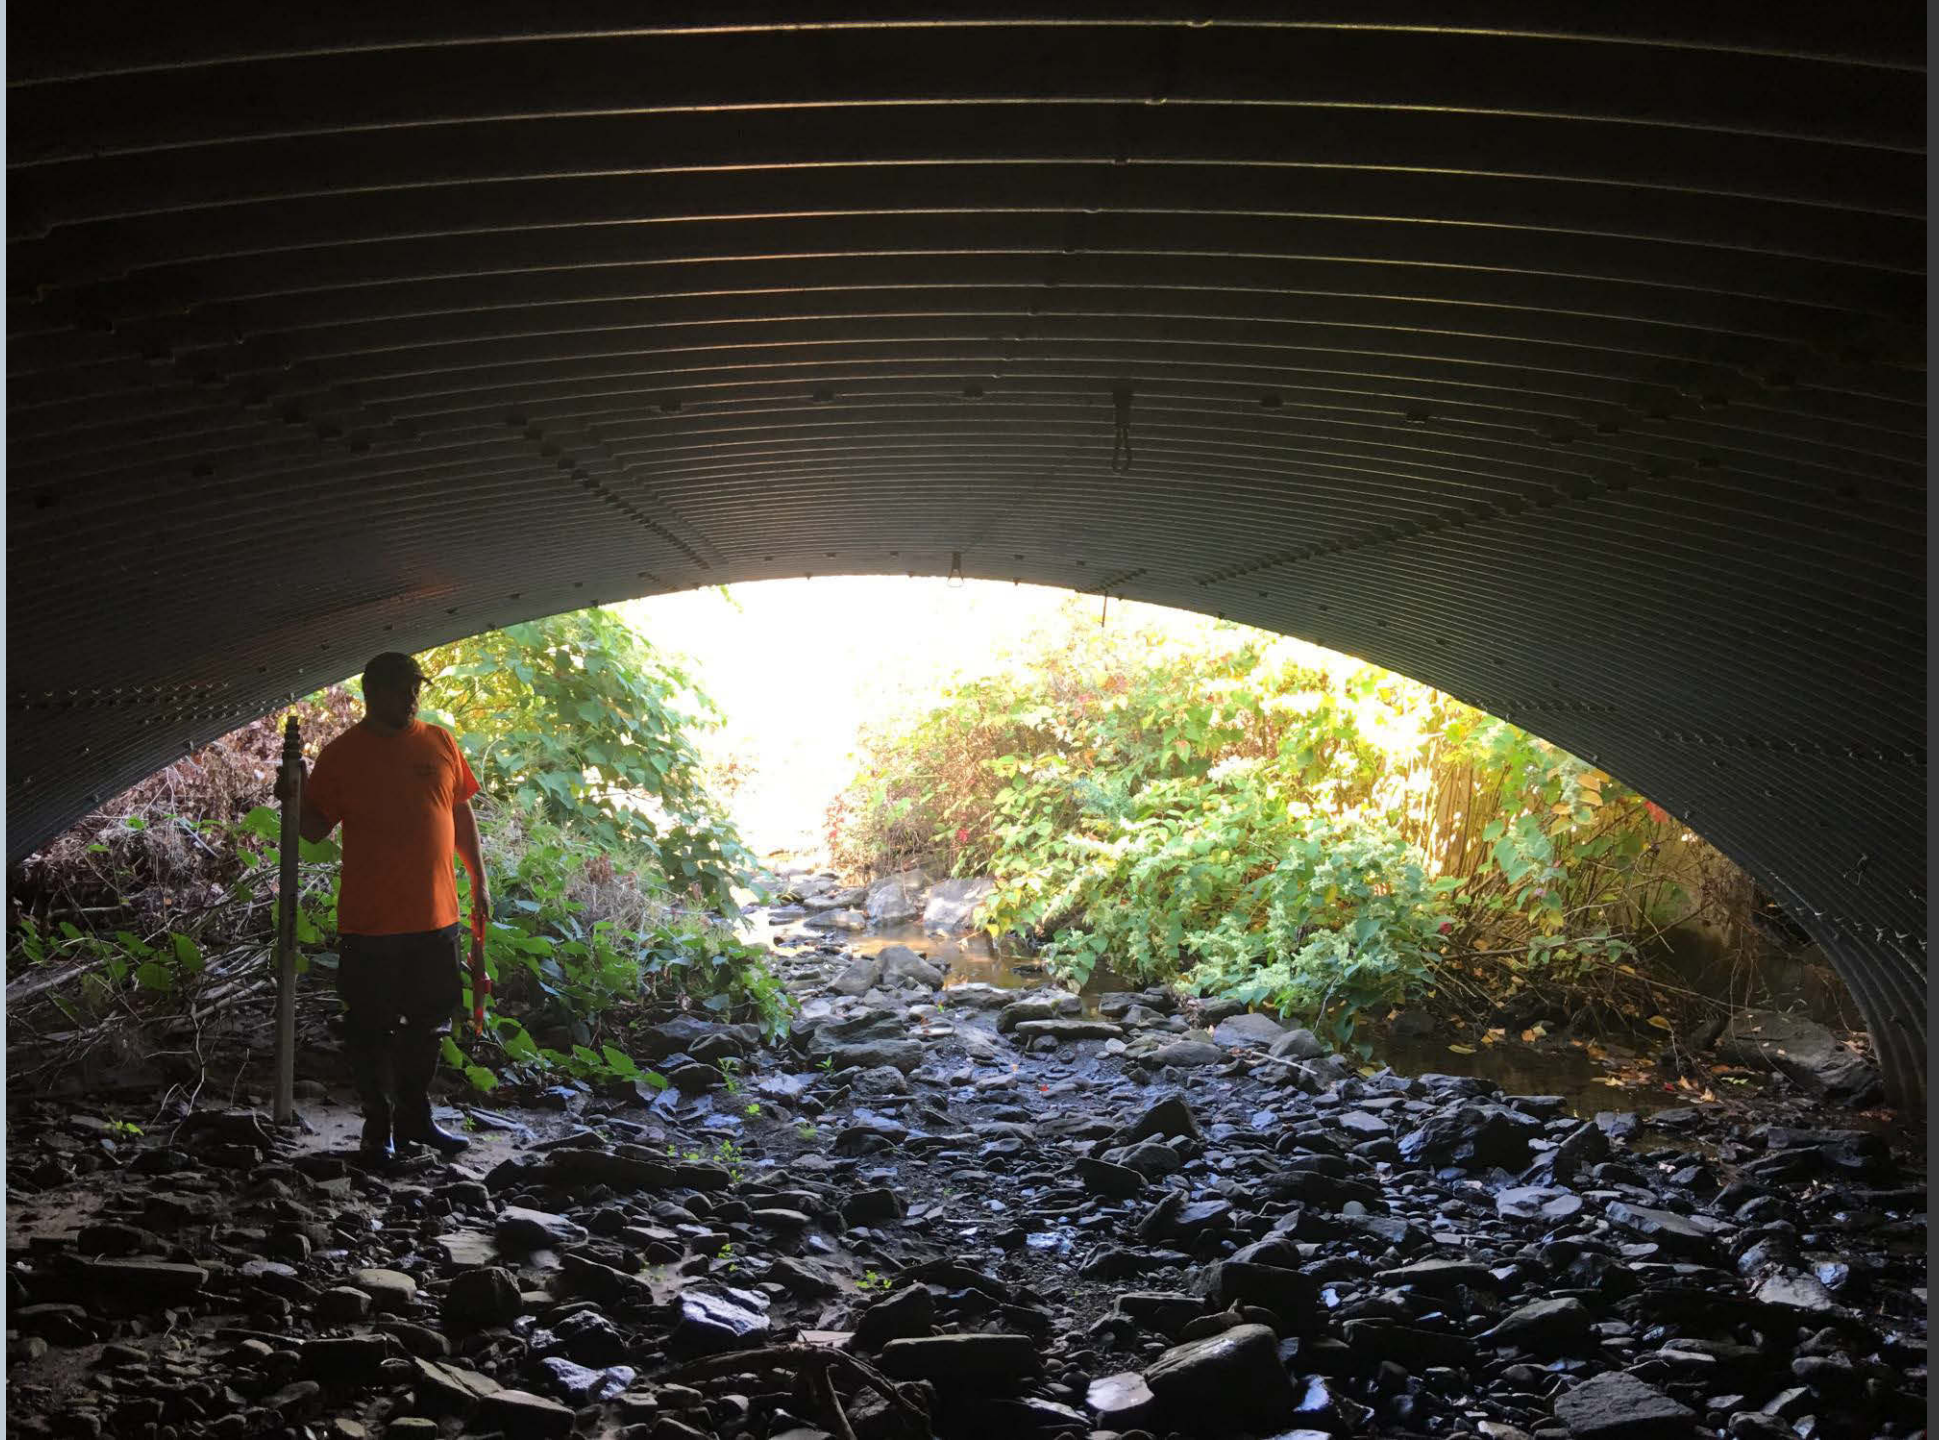
Figure 376. Looking upstream on Toby Creek that has minimal flow due to the baseflow of the stream being below the cobble and boulder gravel bar aggradation in the channel over the entire length of the bridge culvert at the entrance to Dunkin Donuts and Walgreen's. Another black HDPE storm drain is coming into Toby Creek near the stream channel along the wingwall before entering the inlet of the bridge culvert.

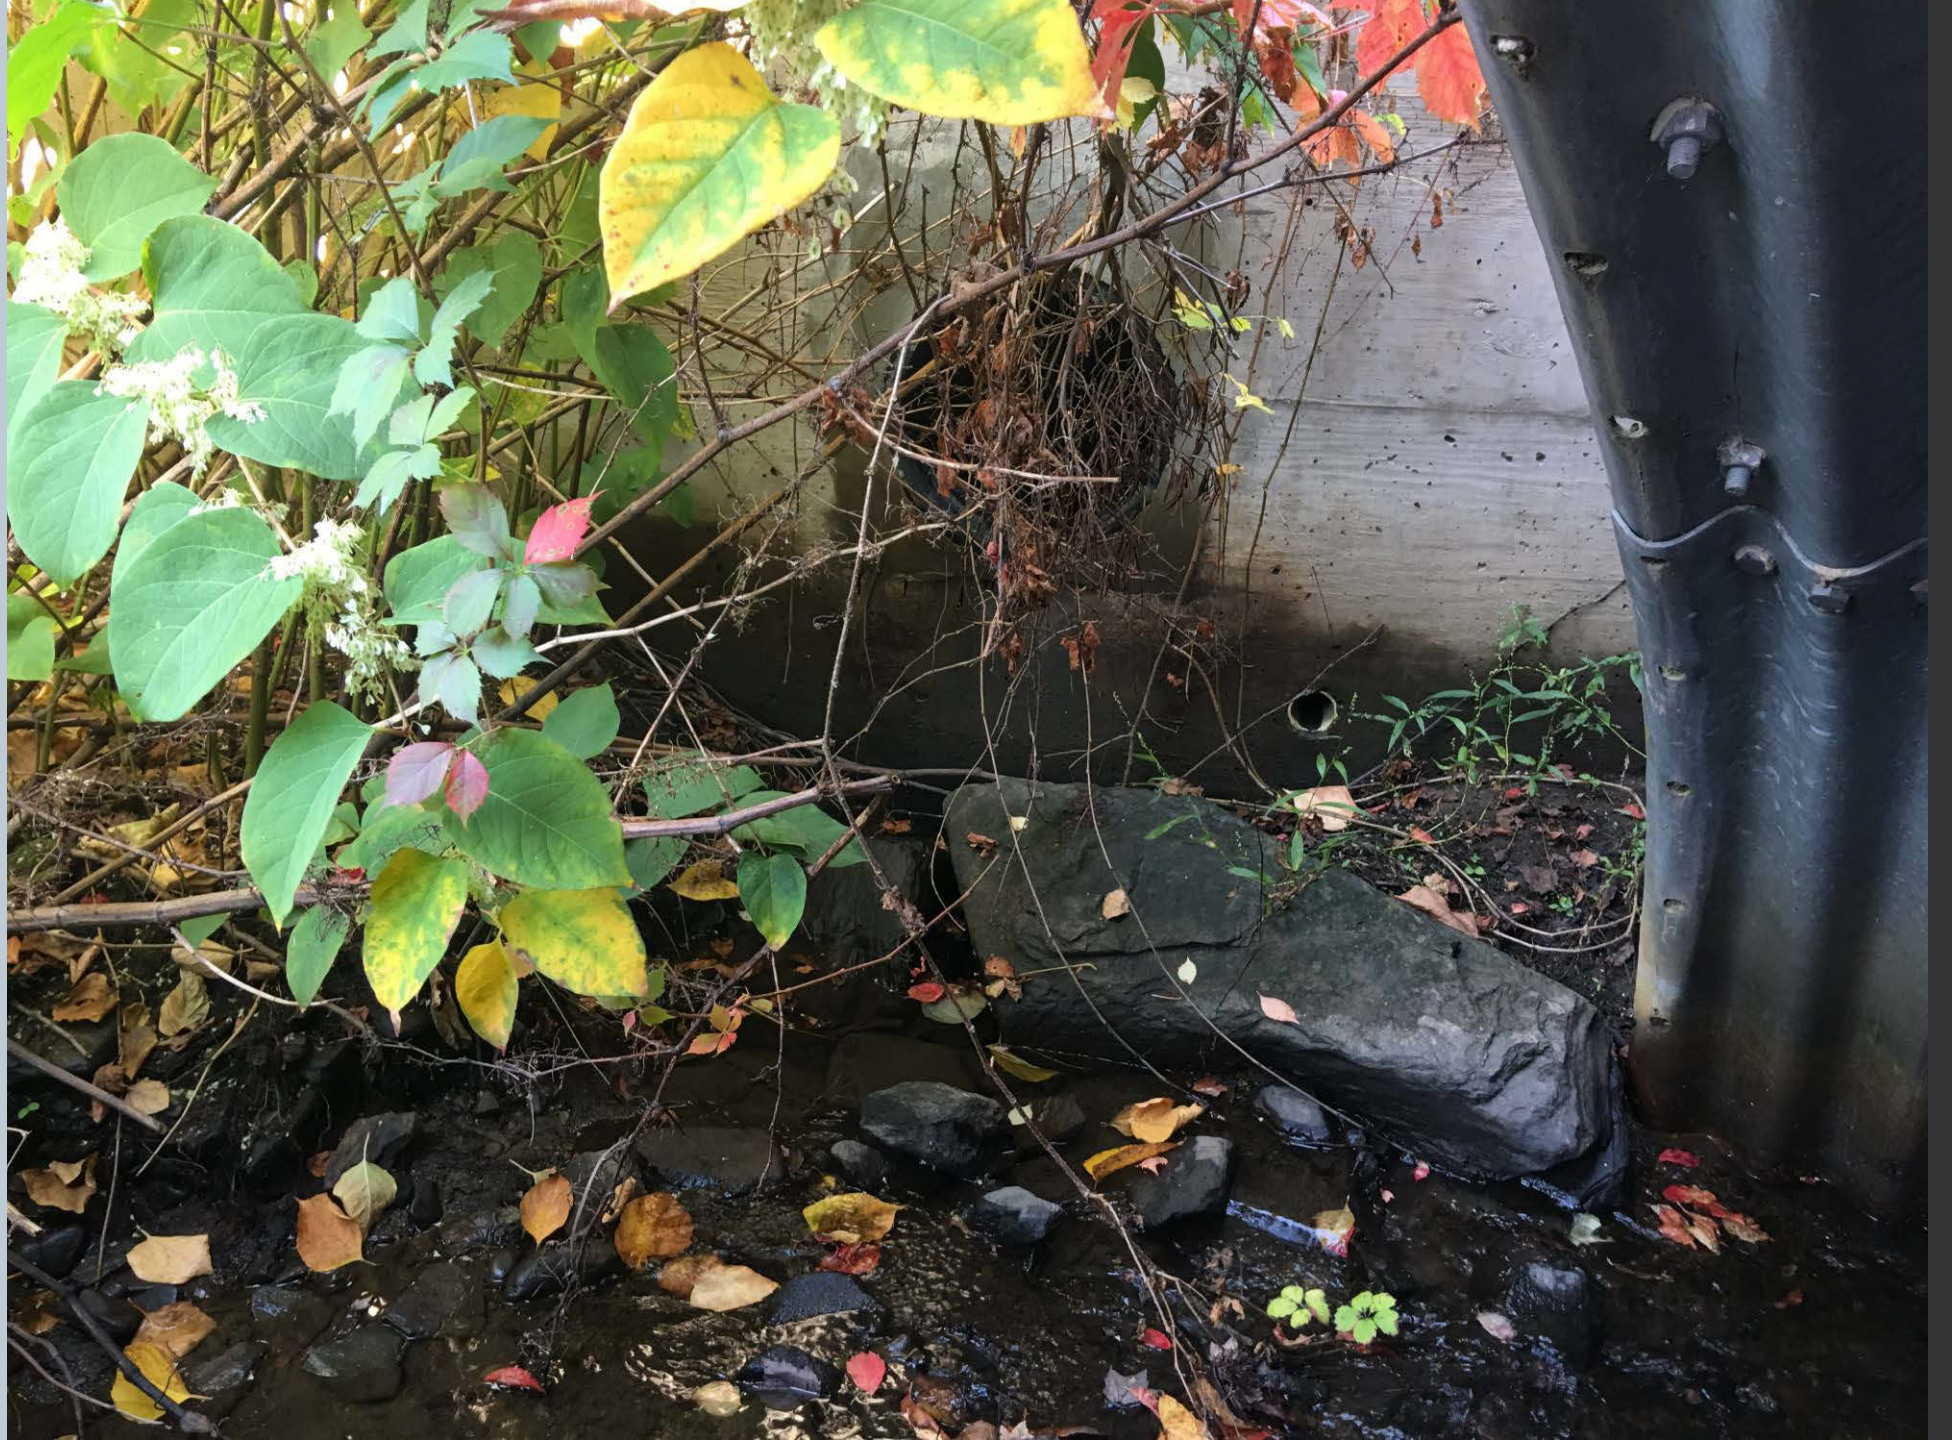
Figure 377. Looking downstream on Toby Creek that has minimal flow due to the baseflow of the stream being below the cobble and boulder gravel bar aggradation in the channel over the entire length of the bridge culvert at the entrance to Dunkin Donuts and Walgreen's. A large gravel bar has formed near the outlet of the culvert and the baseflow of Toby Creek can be seen flowing along the retaining wall and seeping from beneath the gravel bar.

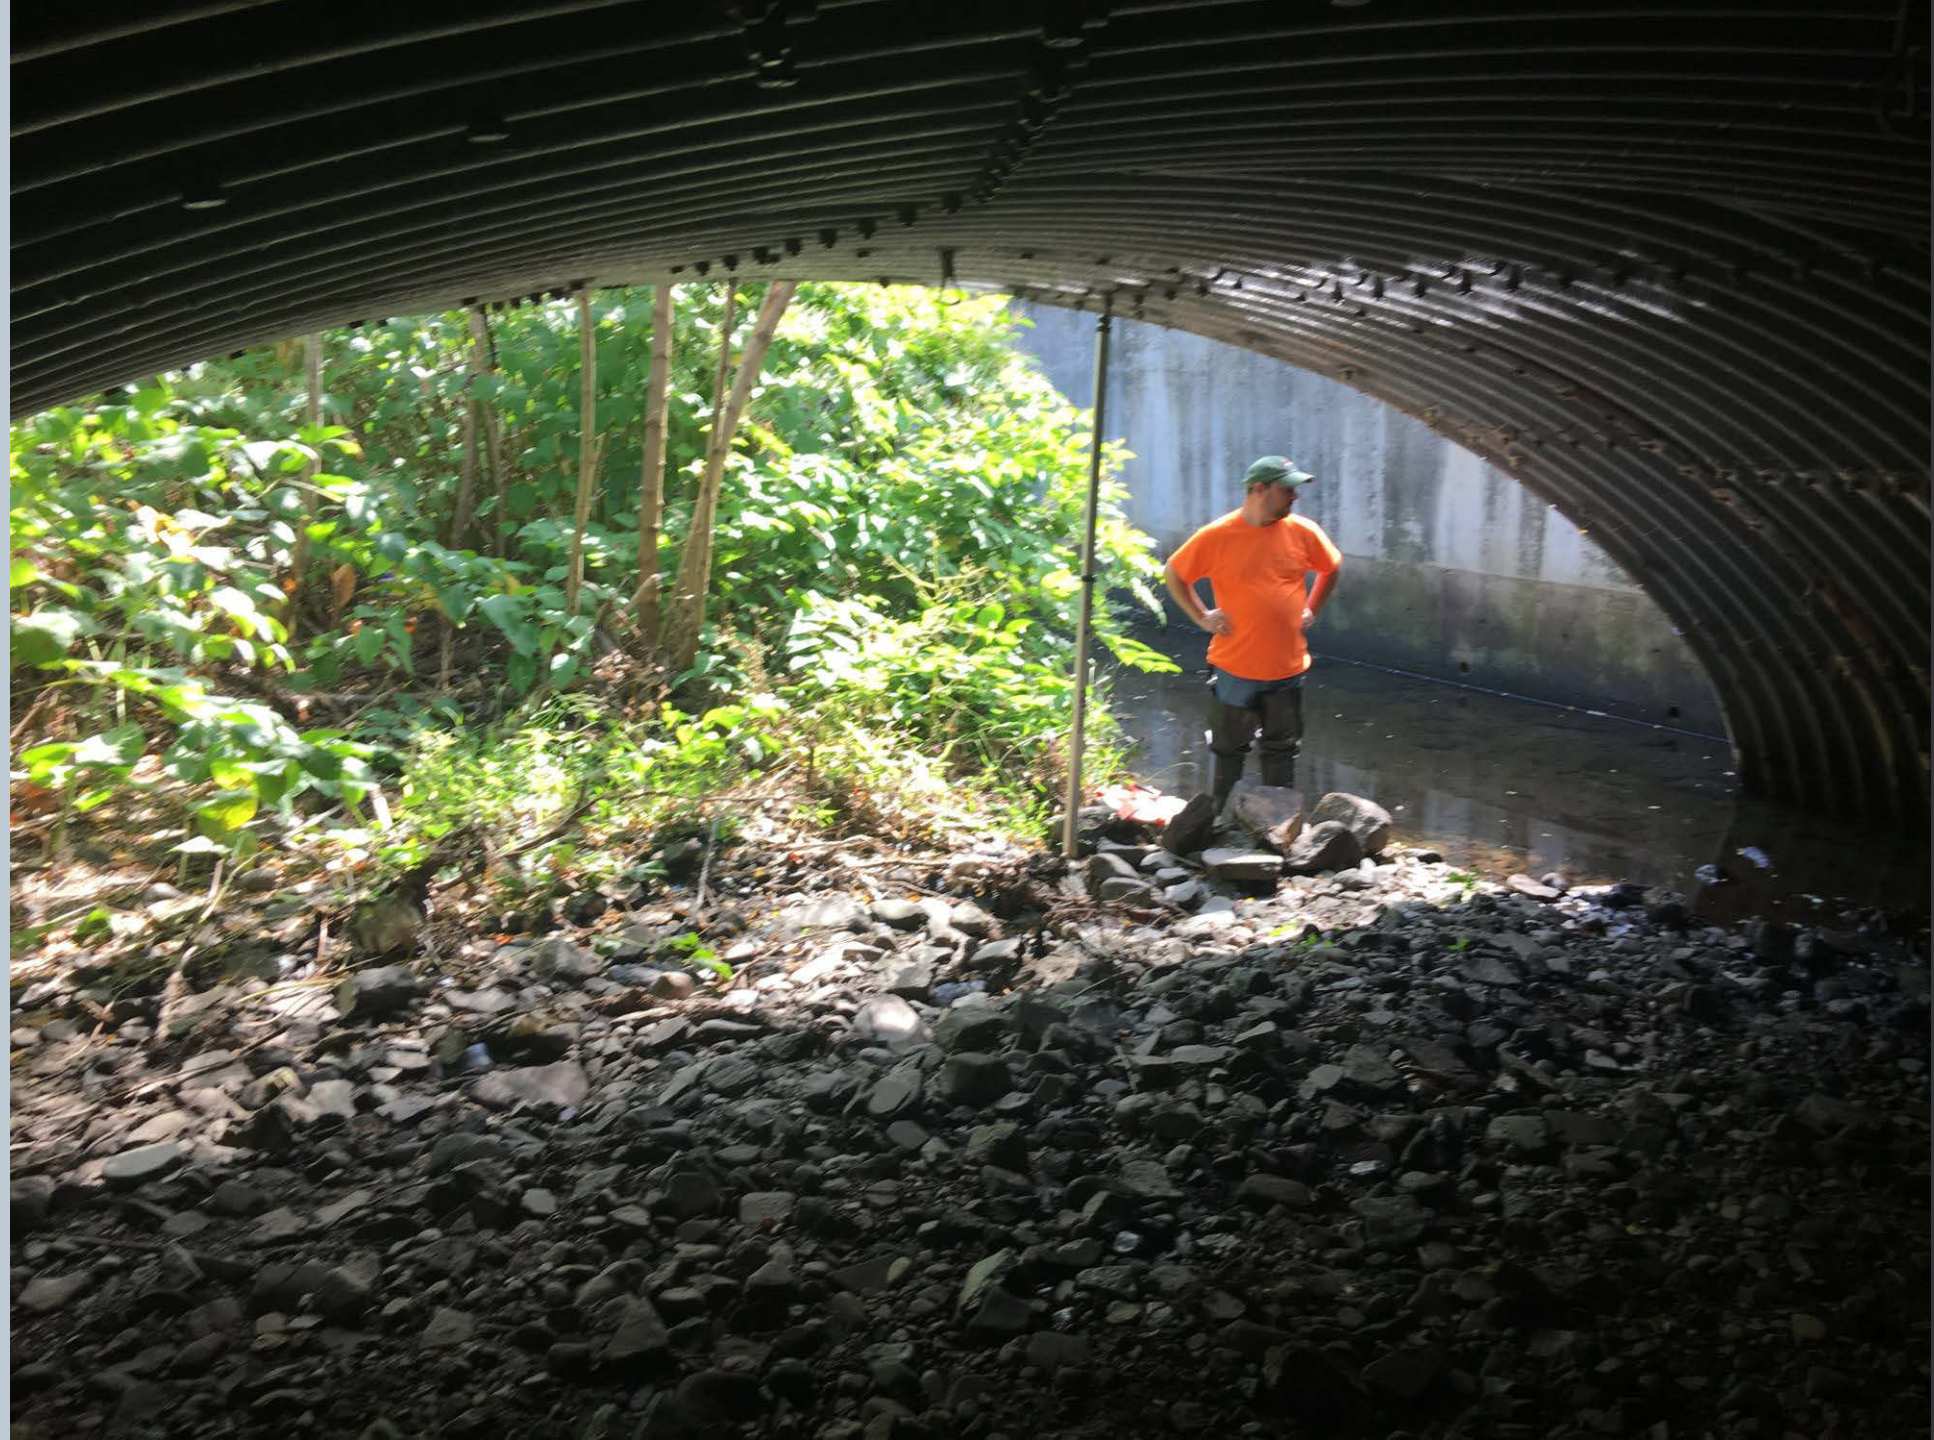
Figure 378. Looking upstream on Toby Creek that has minimal flow due to the baseflow of the stream being below the cobble and boulder gravel bar aggradation in the channel over the entire length of the bridge culvert at the entrance to Dunkin Donuts and Walgreen's. A large gravel bar has formed near the outlet of the culvert and the baseflow and deep pool in Toby Creek can be seen flowing along the retaining wall and seeping from beneath the gravel bar. Fish present.

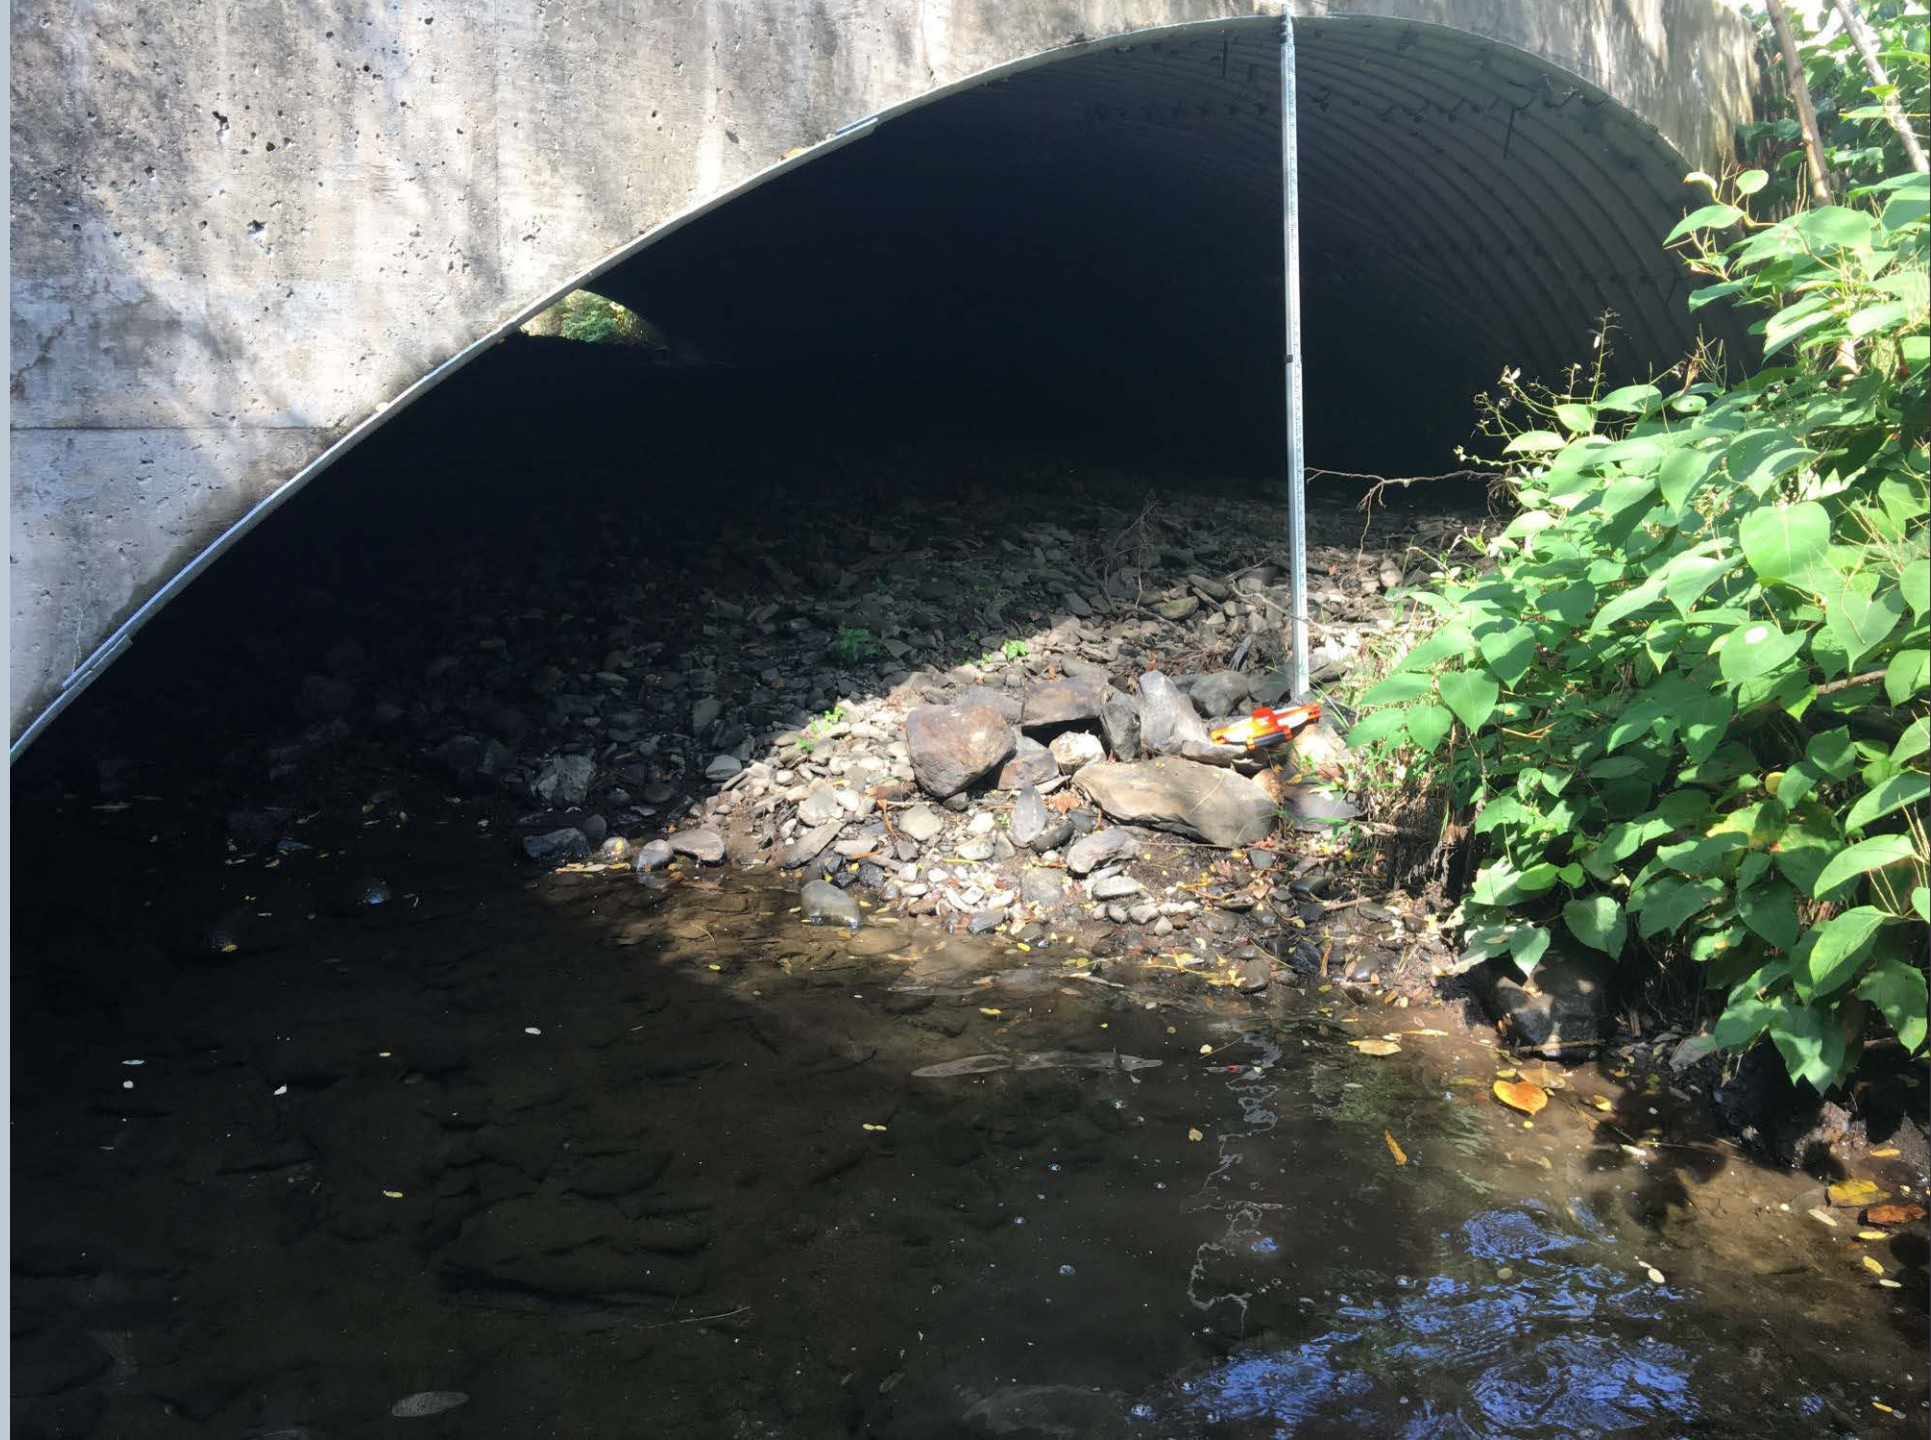
Figure 379. Looking downstream on Toby Creek that has minimal flow due to the baseflow of the stream being below the cobble and boulder gravel bar aggradation in the channel over the entire length of the bridge culvert at the entrance to Dunkin Donuts and Walgreen's. Japanese knotweed is prevalent and honey locust trees are growing on the gravel bar that has caused a major blockage at the outlet of the culvert. An Invasive Removal Project is recommended for this area and the removal of the honey locust trees. Crayfish and a number of fish species were in abundance in a deep pool just below this area.
