Initial Huntsville Creek Culvert Survey

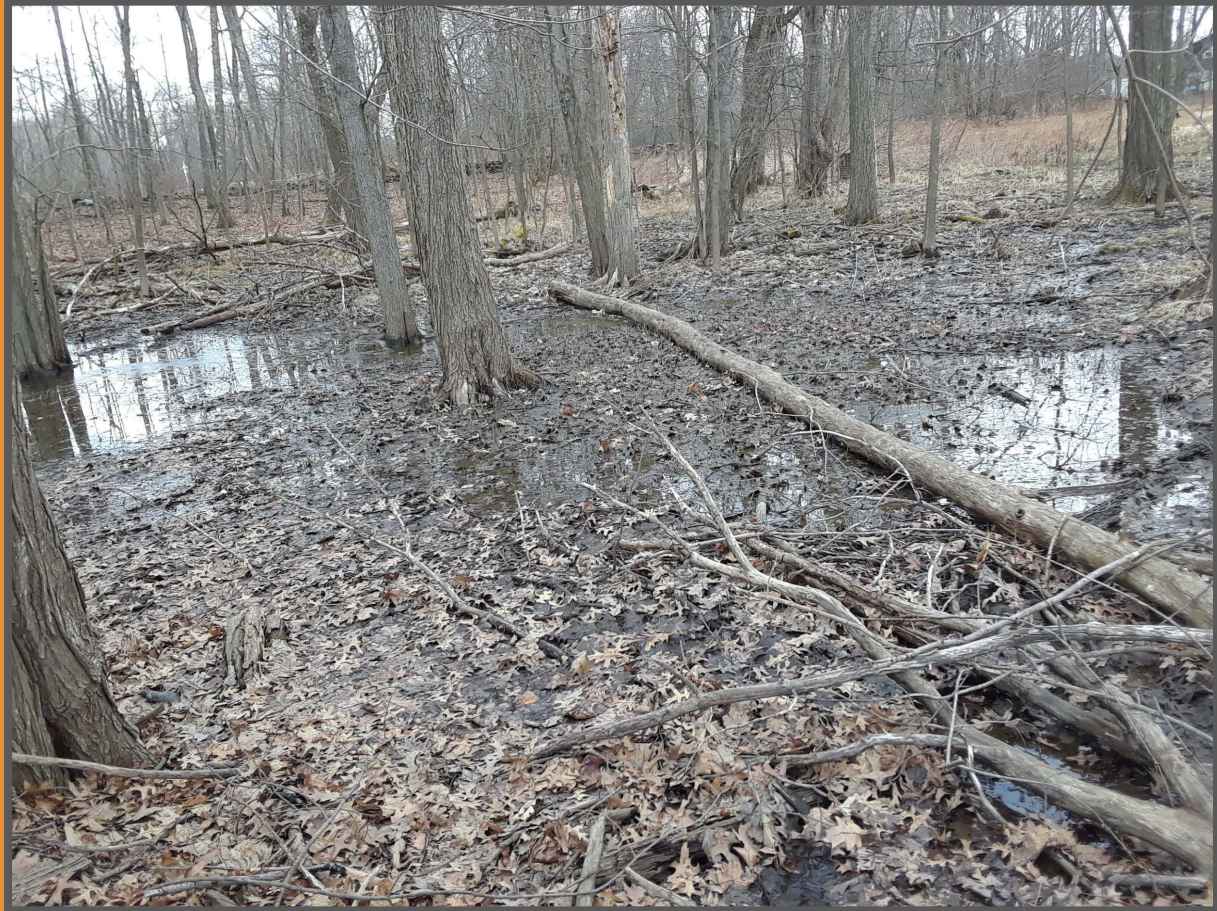
Point 1

Other view of wetlands in
Fig. 22.

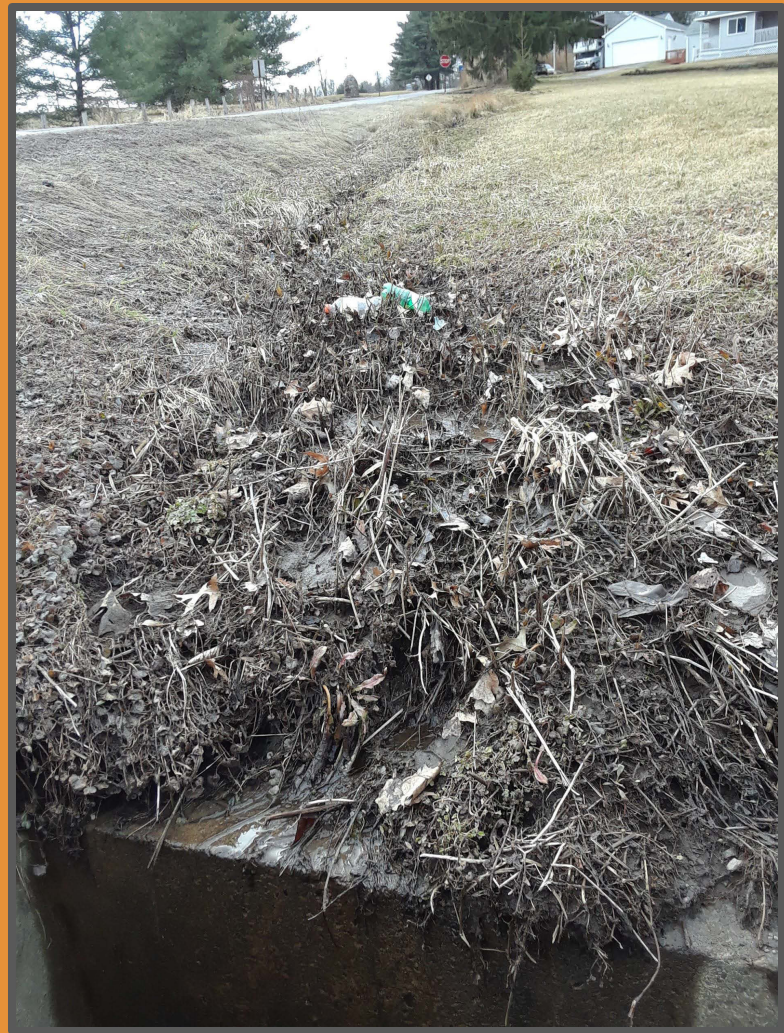
Point 3

View of square stone drop-off that holds groundwater and flow from pipe in Fig. 13. Flow drains through larger HDPE pipe to other side of small road on the golf course.

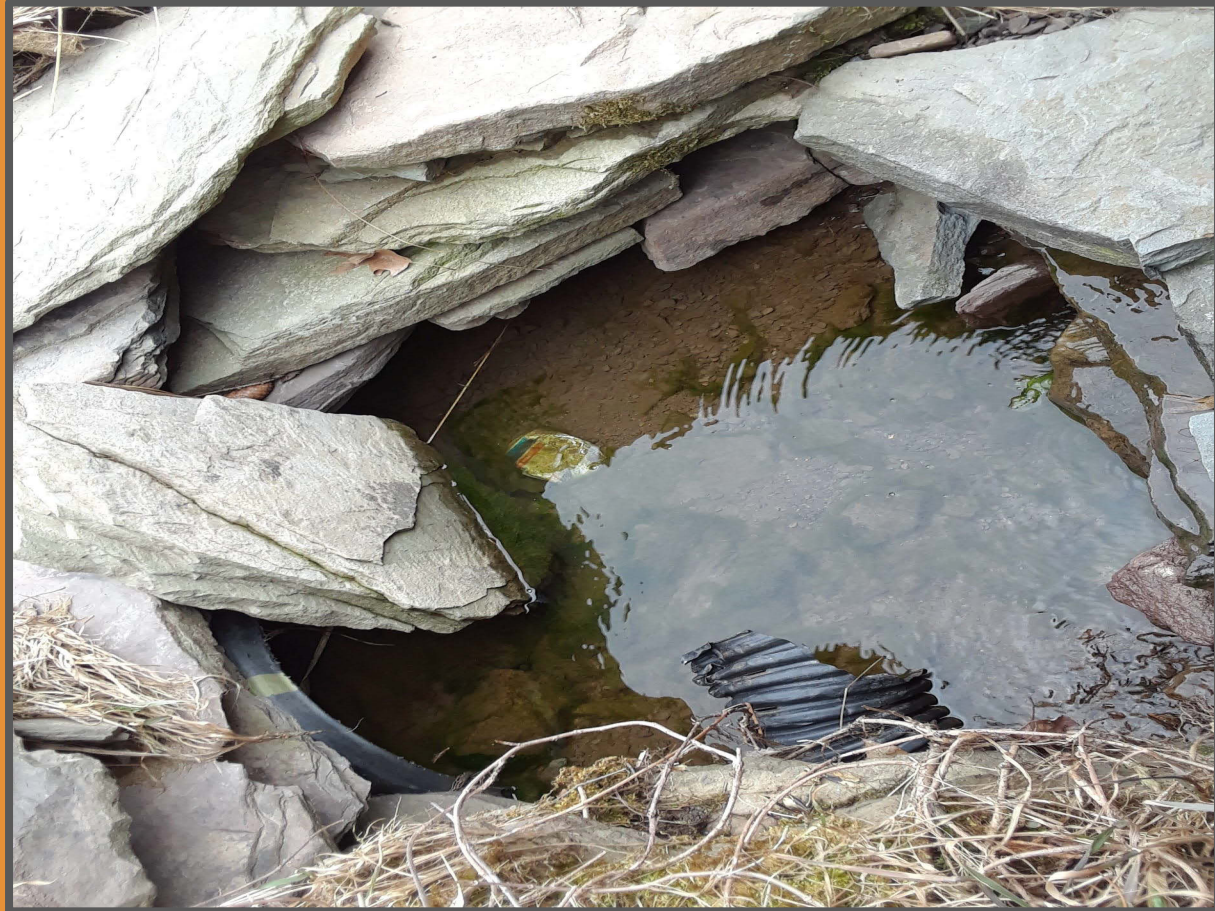
Point 3

24" HDPE pipe that carries flow from under Old Rte. 115 and Market St.

Consistent flow of groundwater under pipe that trickles down lower rocks.

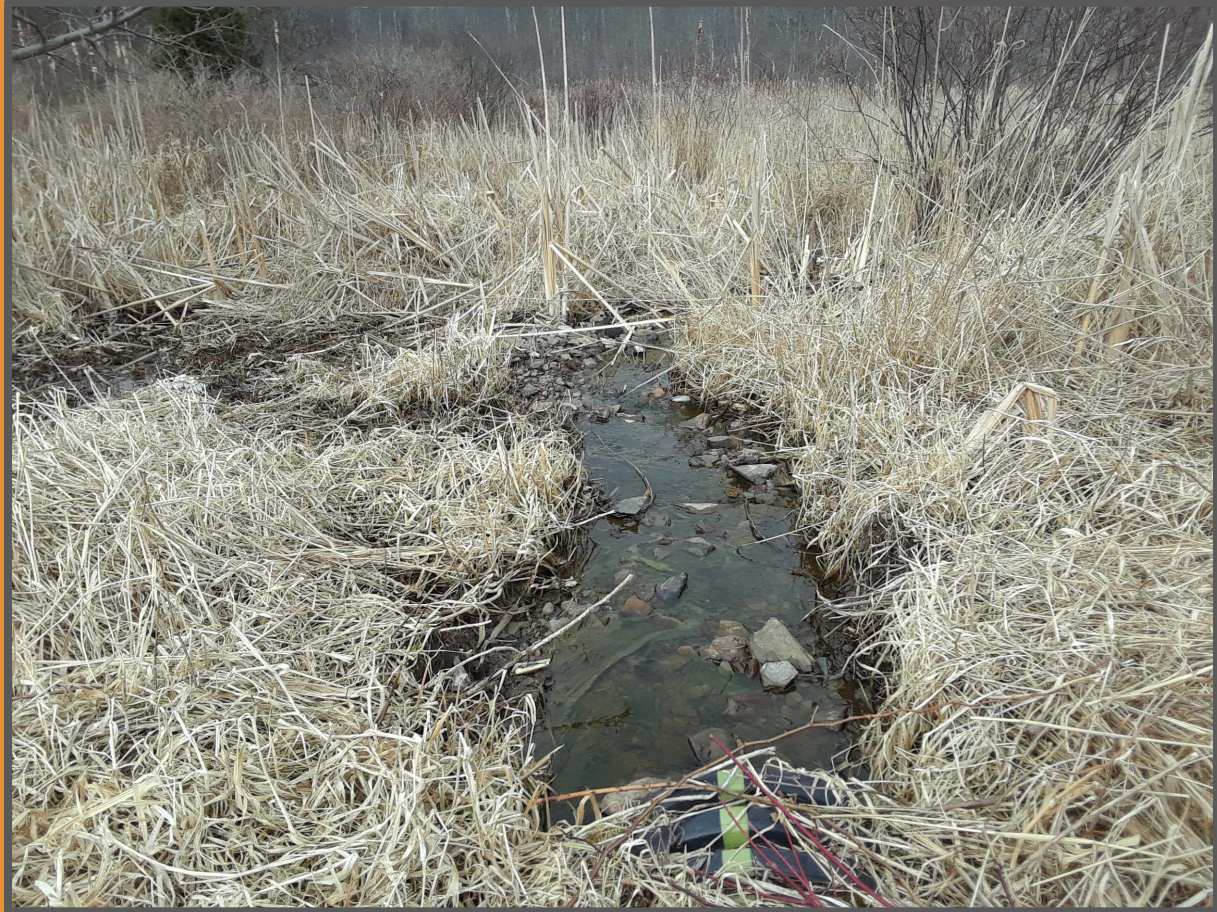
Point 3

Larger view of drainage
and wetlands from Fig. 16

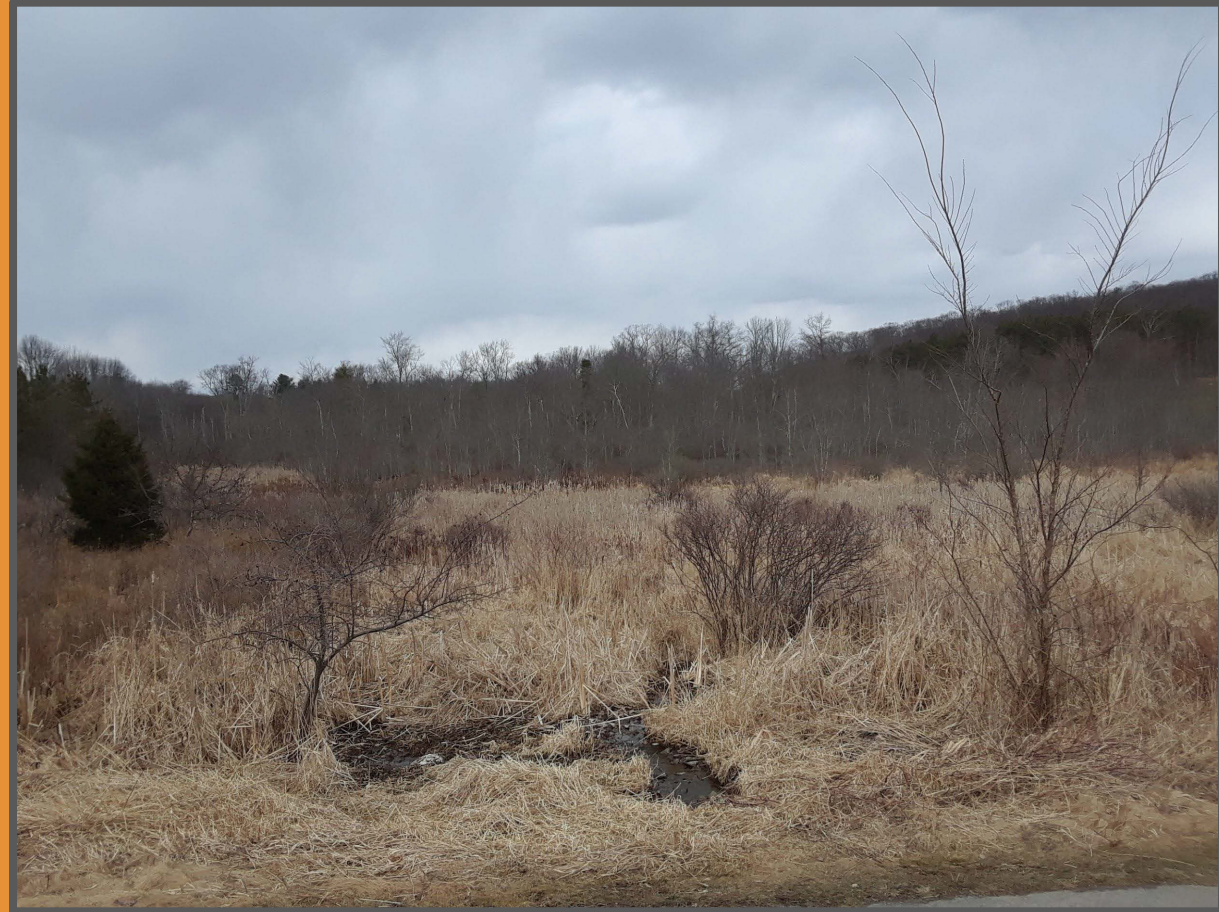
Point 3

Stormwater drainage ditch carrying flow from Old. Rte. 115 just next to Fig. 13-17.

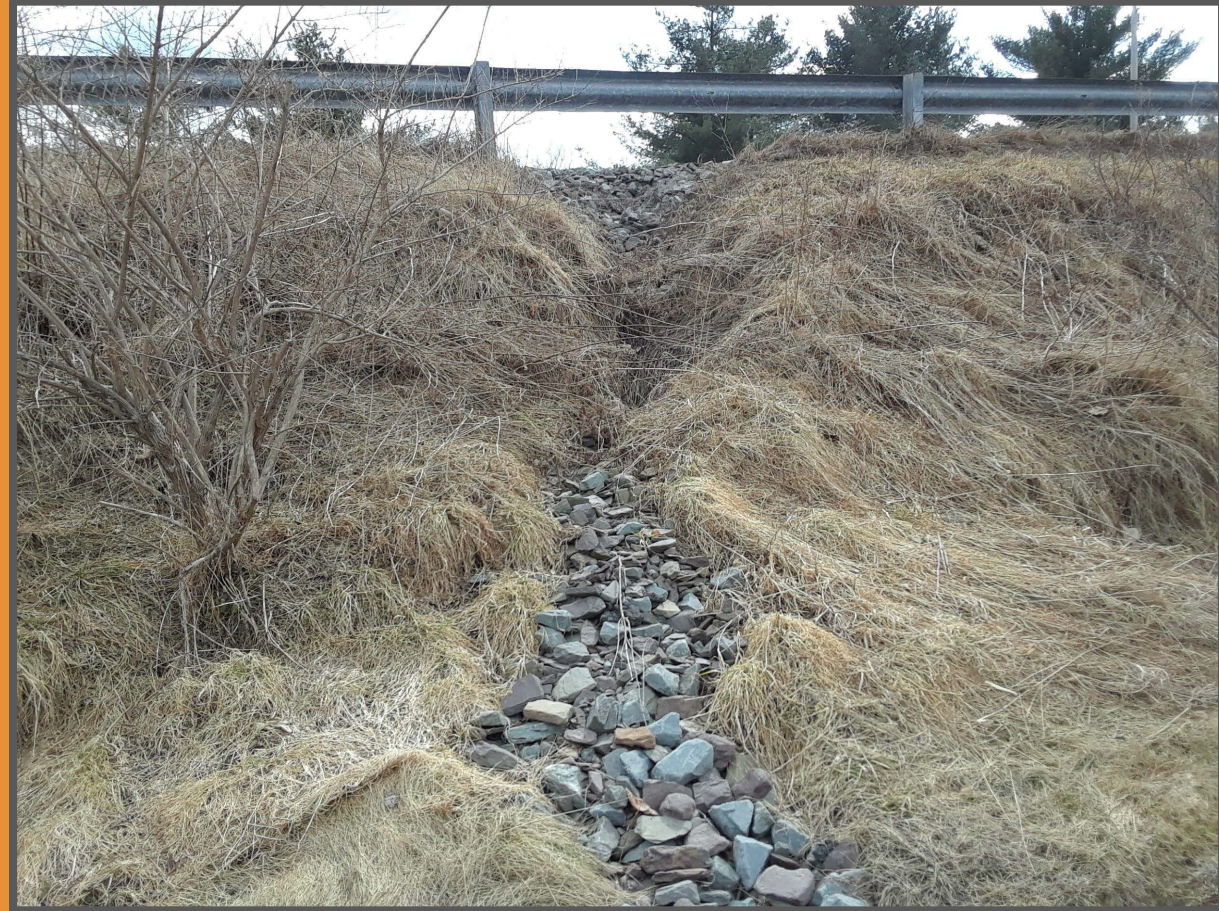
Point 4

Downstream view of Fig. 9 where flow enters another HDPE and crosses under small road in the Huntsville Golf Course.

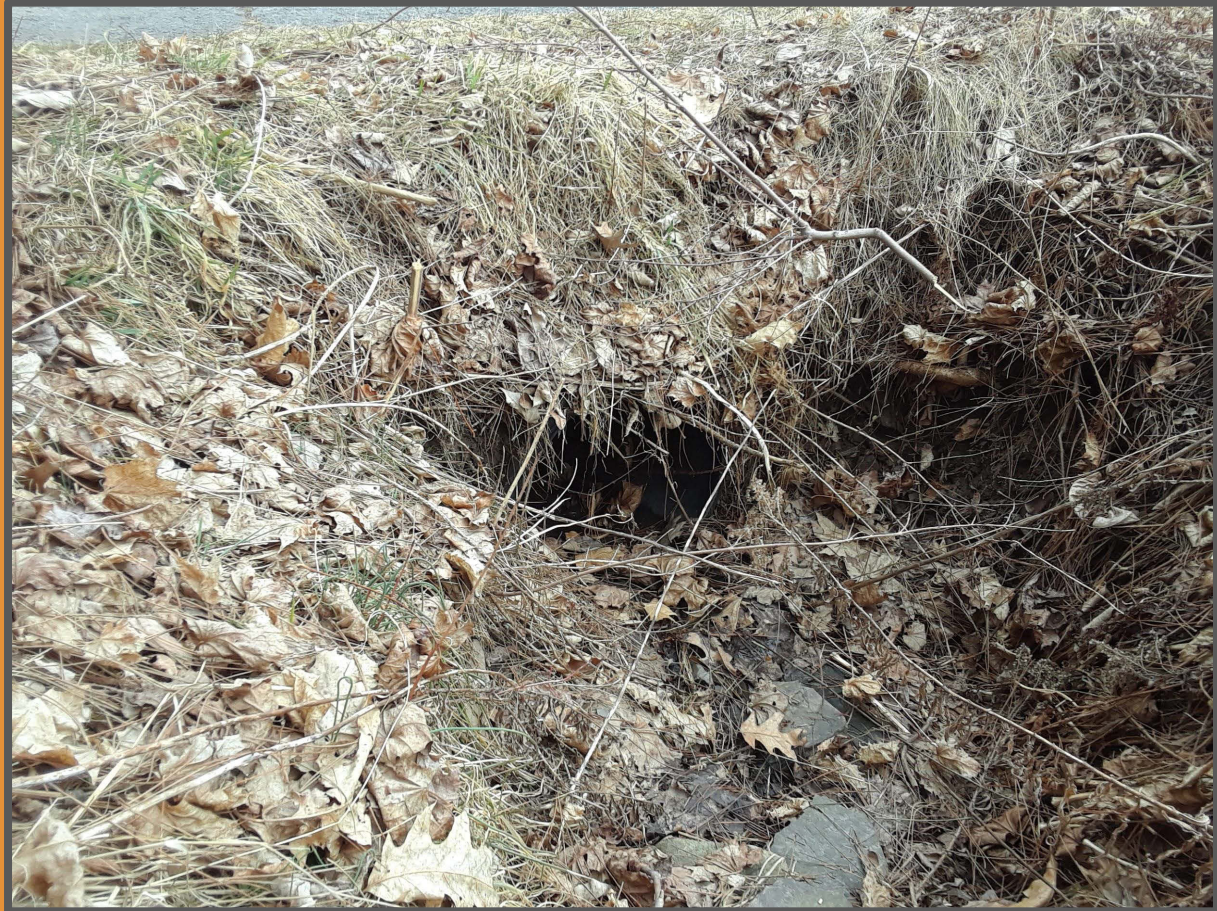
Point 4

HDPE pipe hidden by collapsed headwall across Market St in the Huntsville Golf Course.

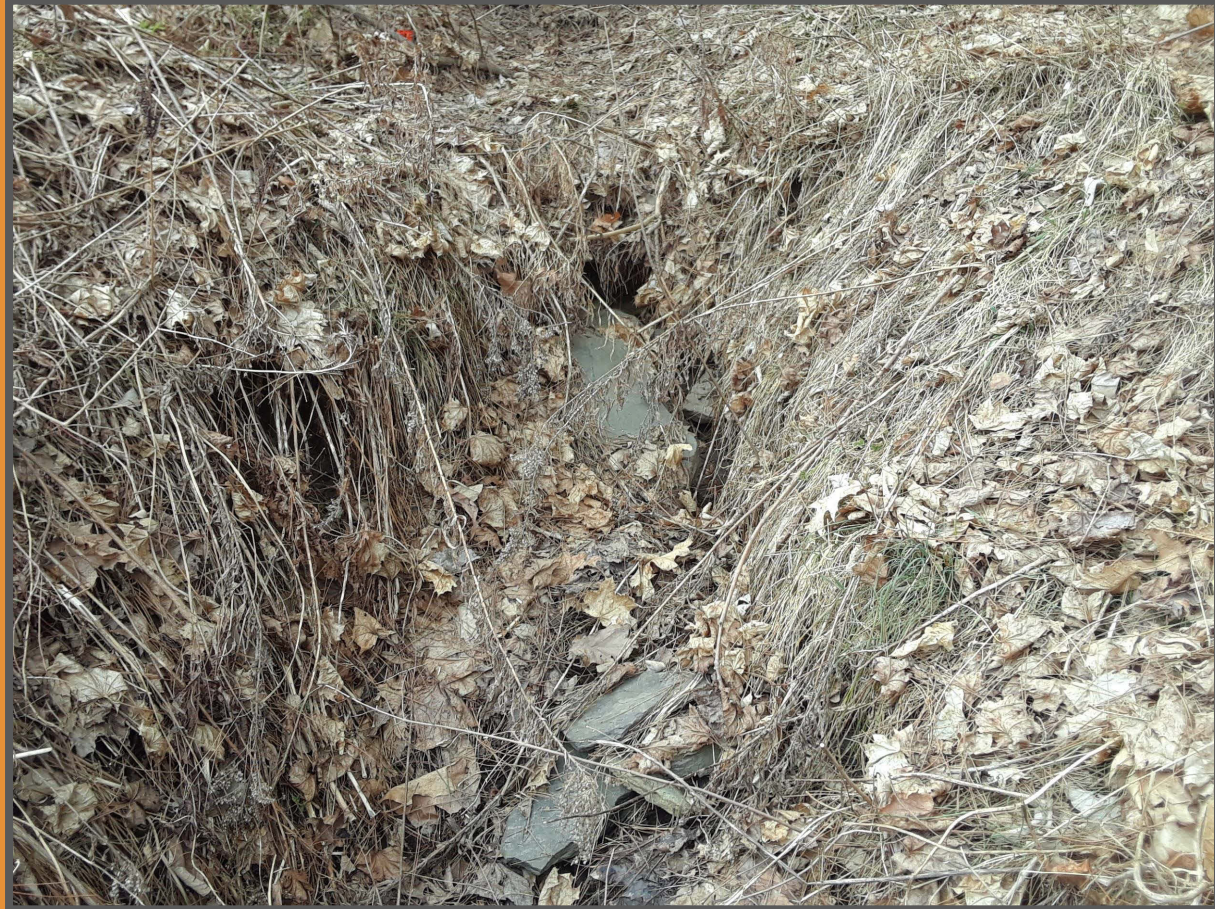
Point 4

Upstream view of same HDPE pipe in Fig. 10 on the other side of the small road in the golf course. Half full of sediment and leafy debris

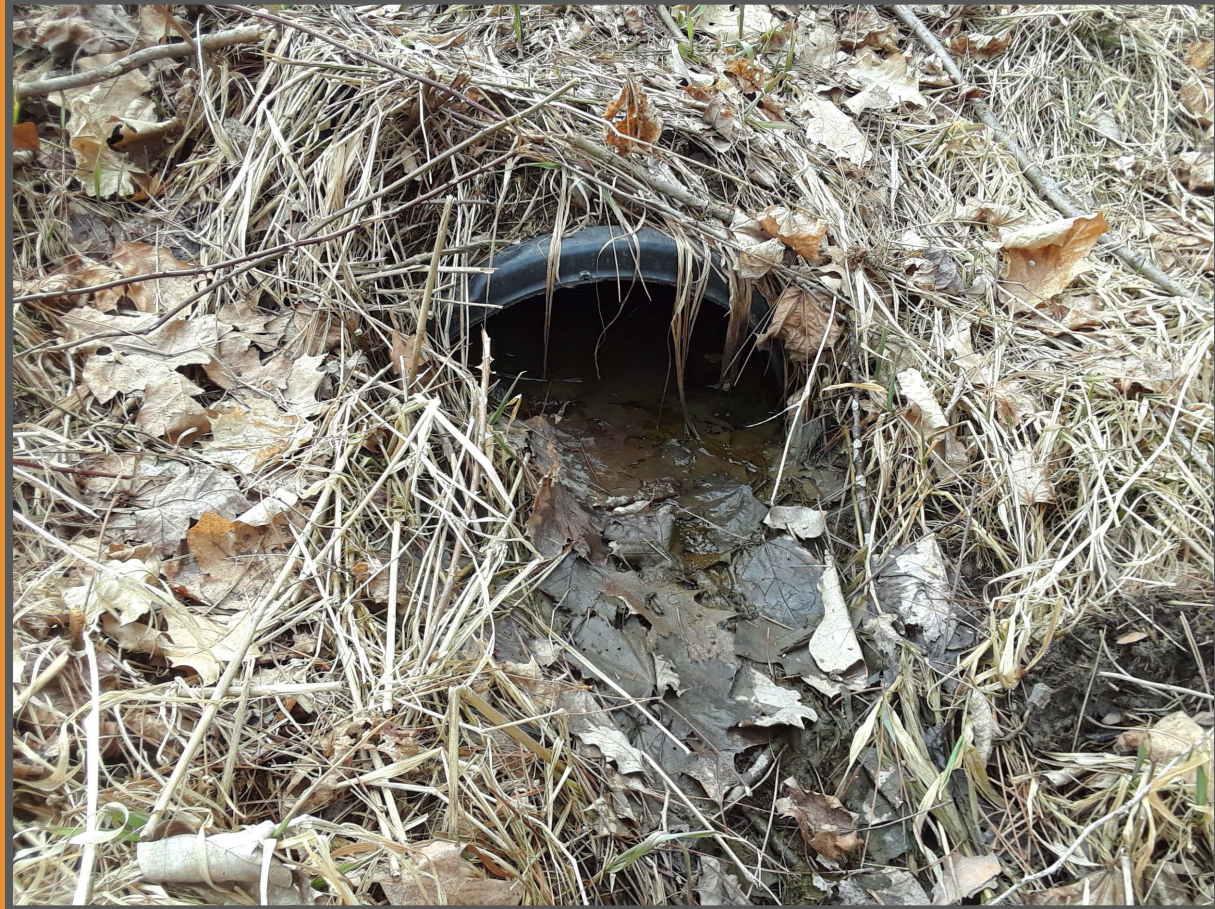
Point 4

Downstream view of Fig.
11 emptying in wetlands
at golf course

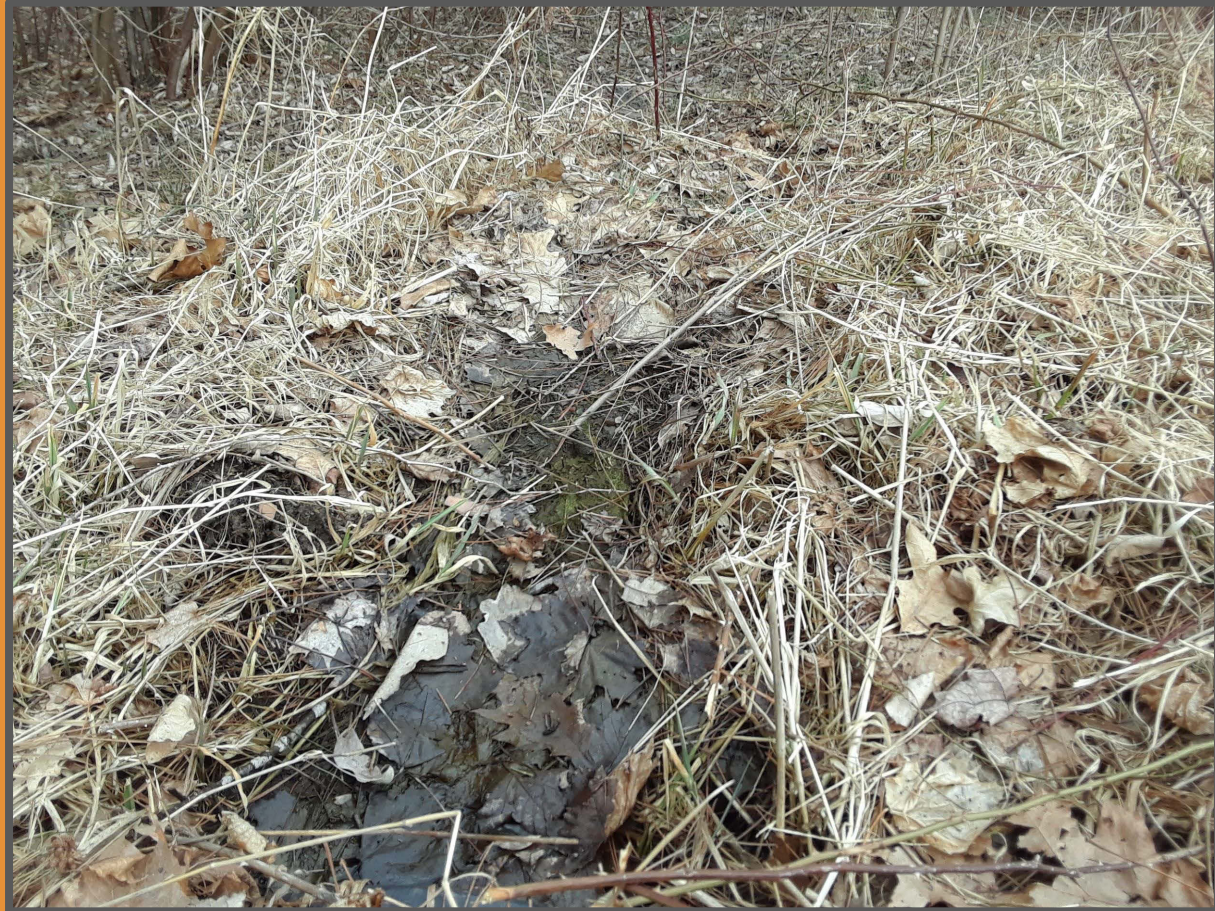
Point 5

Downstream view of Fig. 5.
Drainage spreads, then tightens,
then widens and meanders
further down along Old Rte. 115

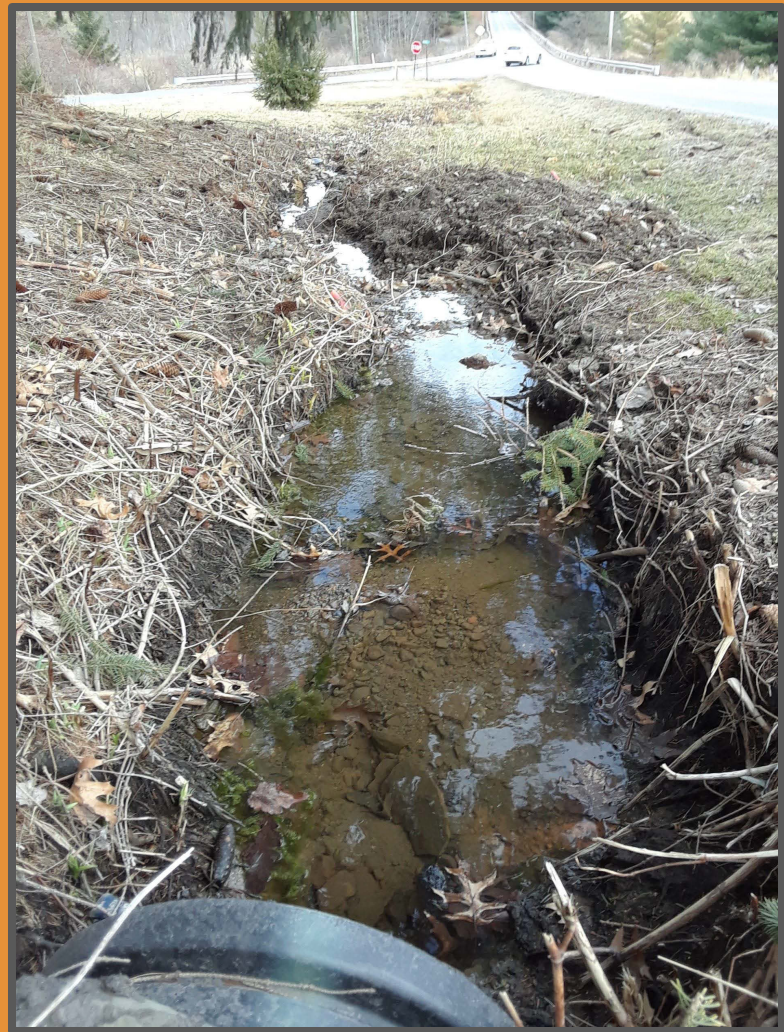
Point 5

Upstream view of opposite side of HDPE culvert passing under Hayfield Rd. Some drop off and drainage spreads from pipe

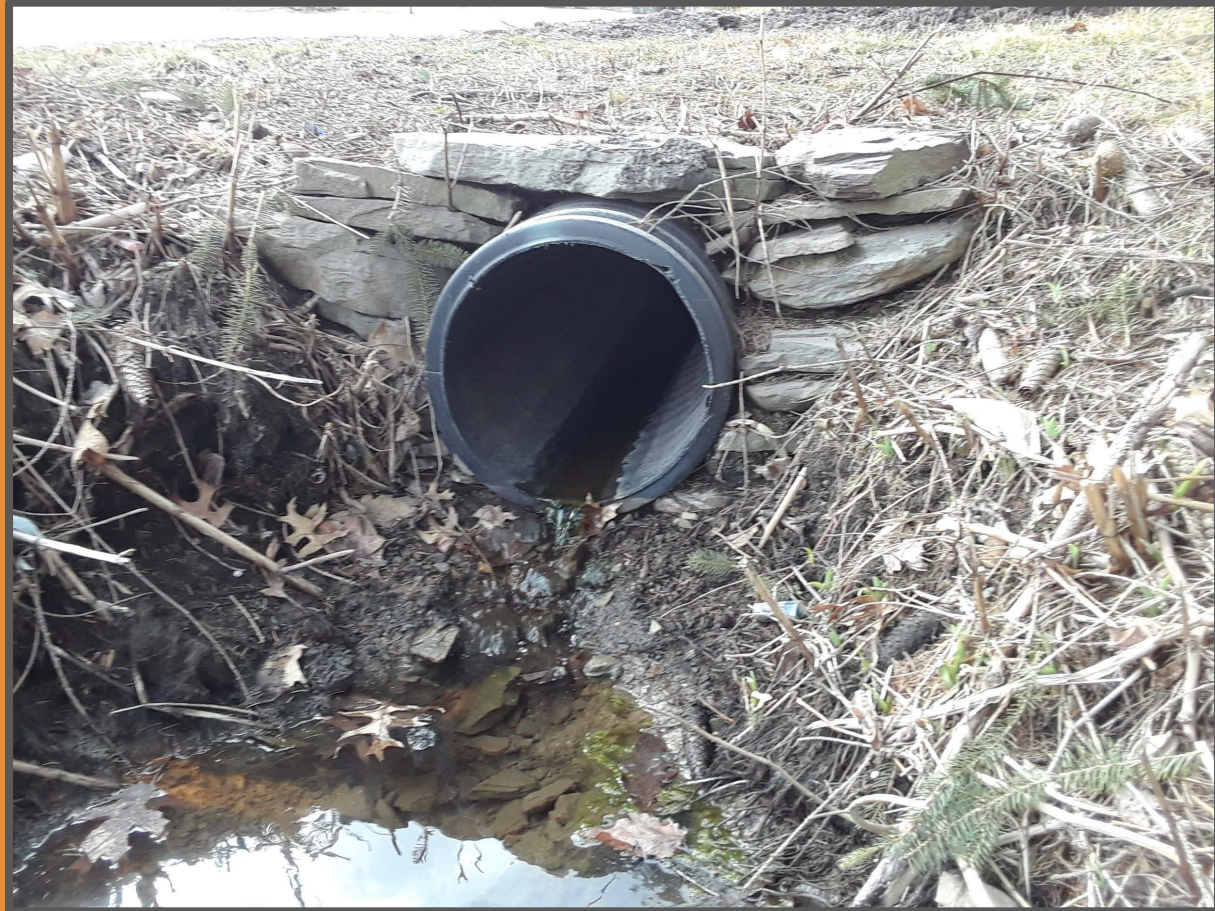
Point 6

Downstream (DS) view of
culvert from Fig.1.

18-inch with some rocks
and debris blocking
drainage

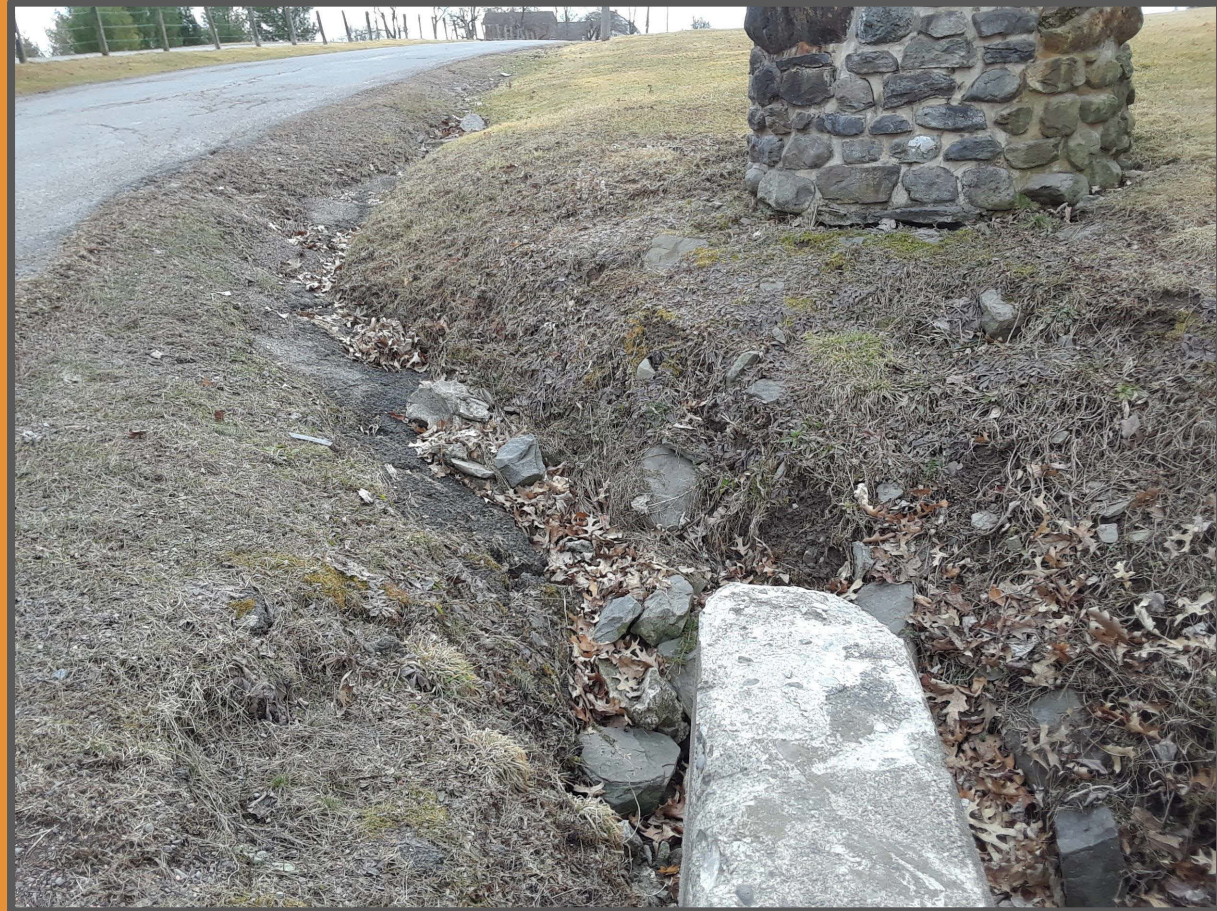
Point 8

Downstream view of Fig. 3. 18-inch HDPE culvert that passes under Hayfield Rd. - Some leaf matter, small white pipe from adjacent property

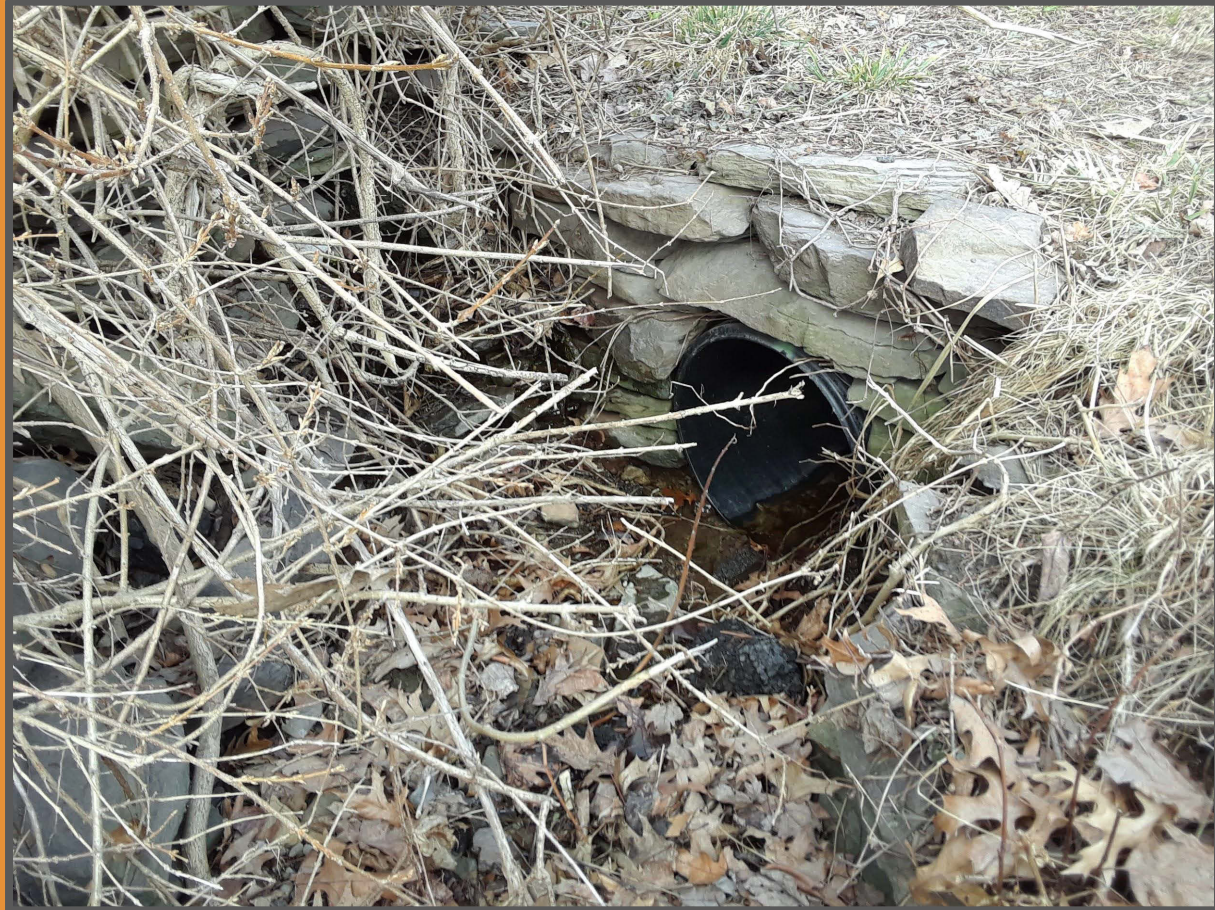
Point 8

Upstream view of
opposite side of culvert
under Old Rte. 115. -
Completely blocked with
debris and leaf litter.

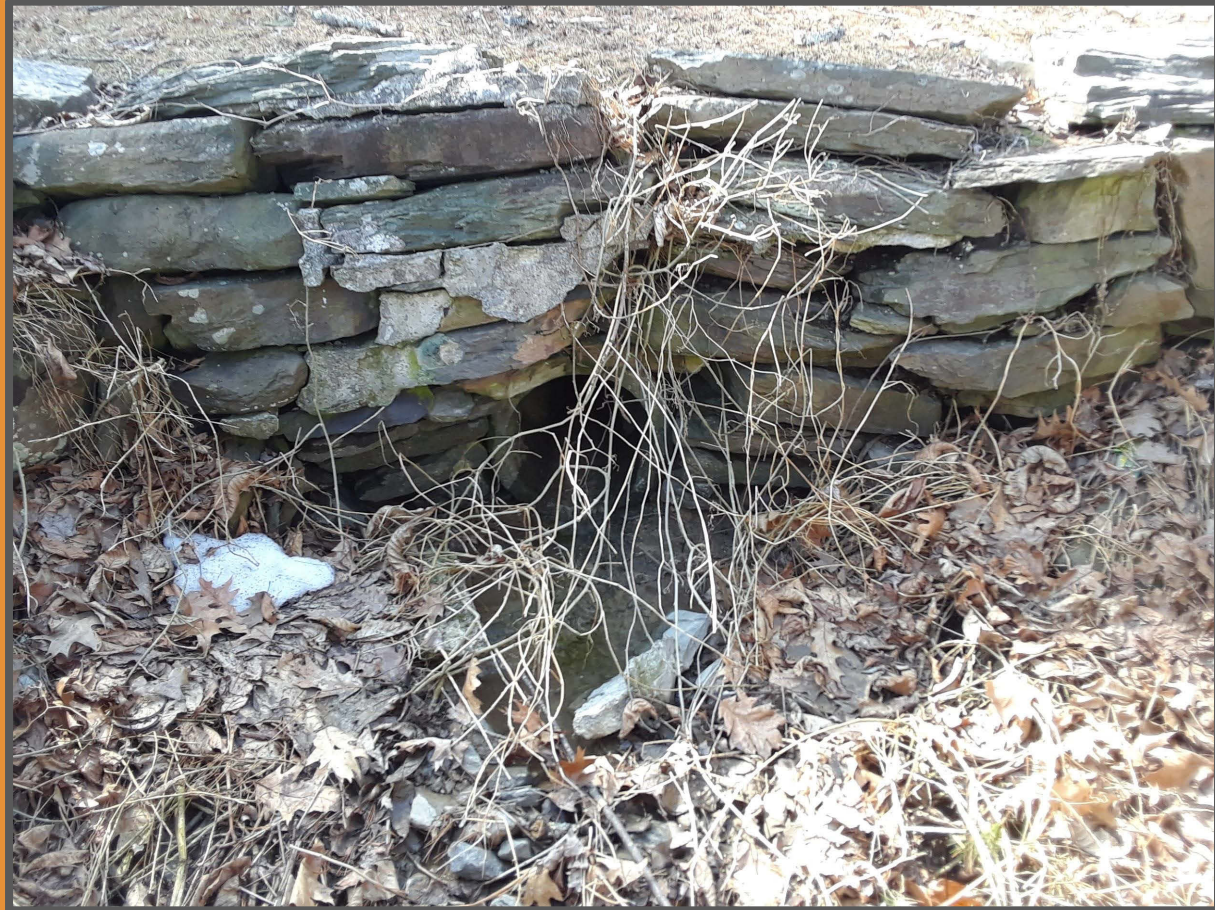
Point 10

2 12" concrete pipes in square drop-off that pass under Huntsville-Idetown Rd. - Half full of leafy debris and sediment

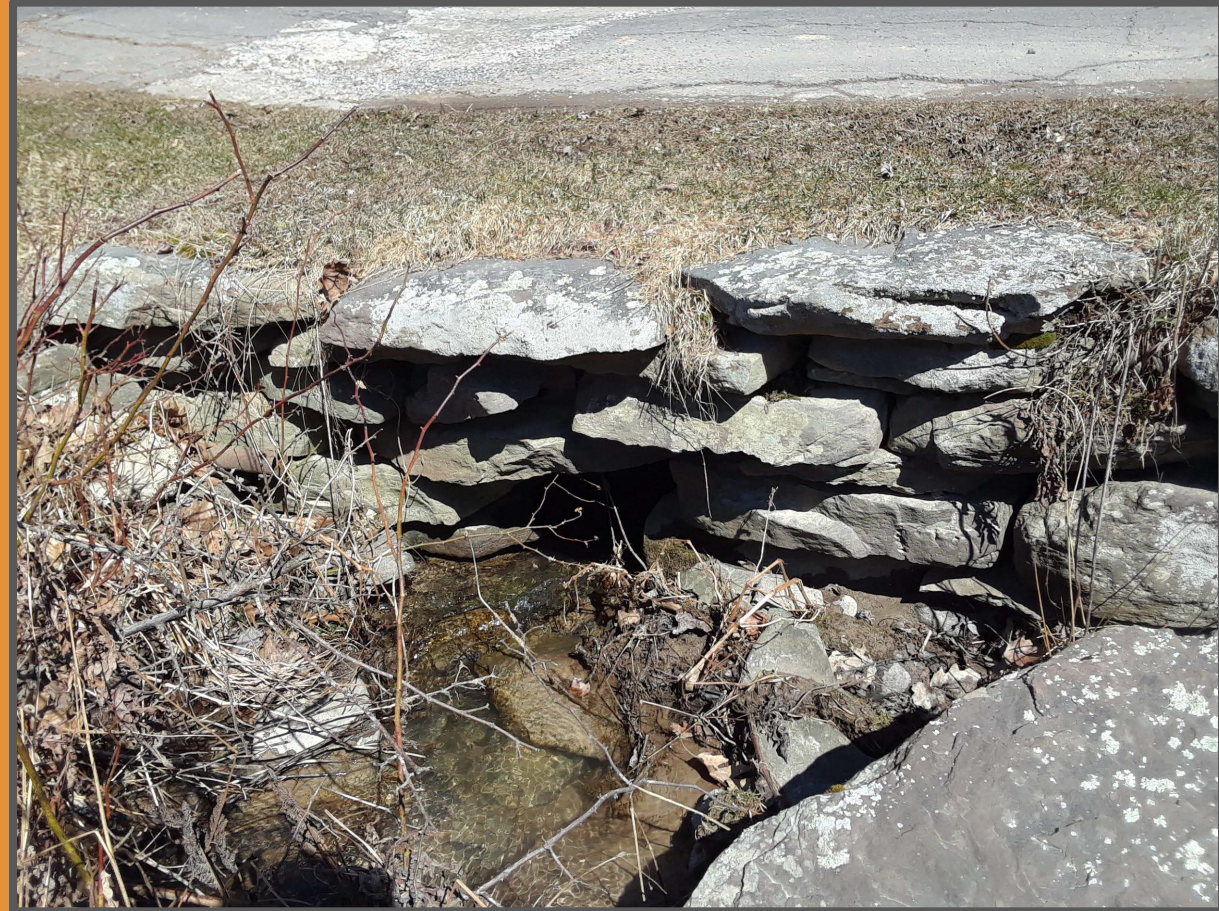
Point 11

Upstream view of drainage from opposite side of private driveway. Pipe from other side is not clearly seen and flow spreads widely

Small pipe from property at 90 degree angle

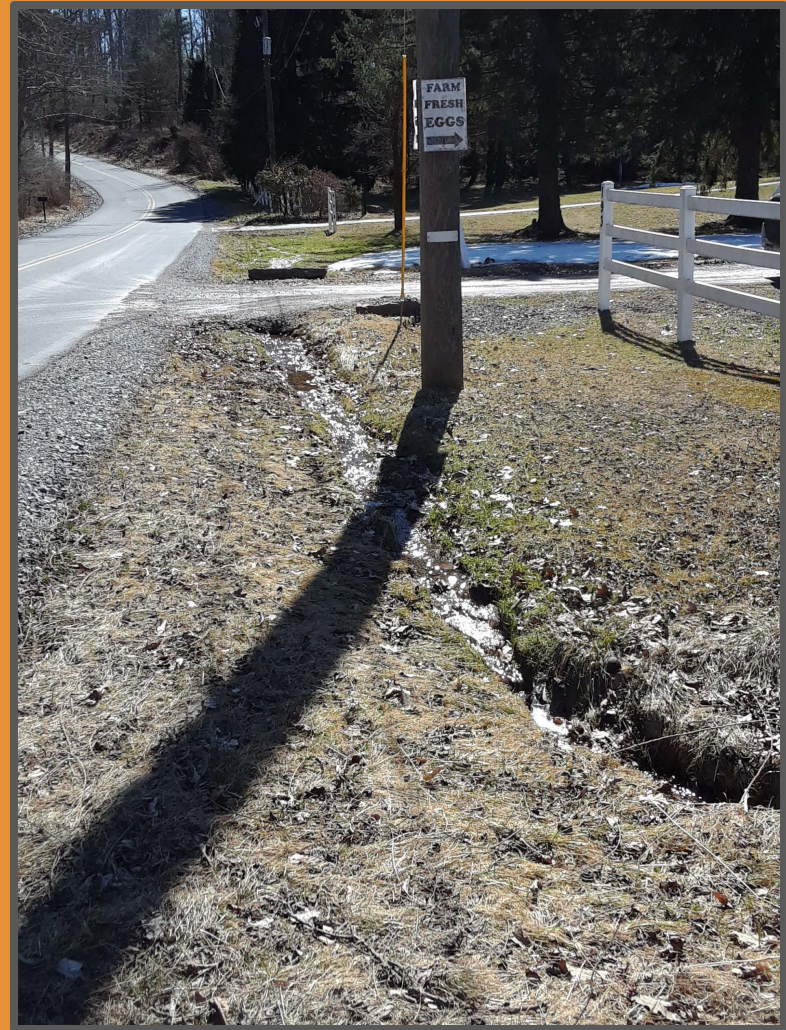
Point 12

Downstream view of UNT
in Fig. 86 flowing into 18"
concrete pipe under
stone headwall as it
crosses under
Huntsville-Idetown Rd.

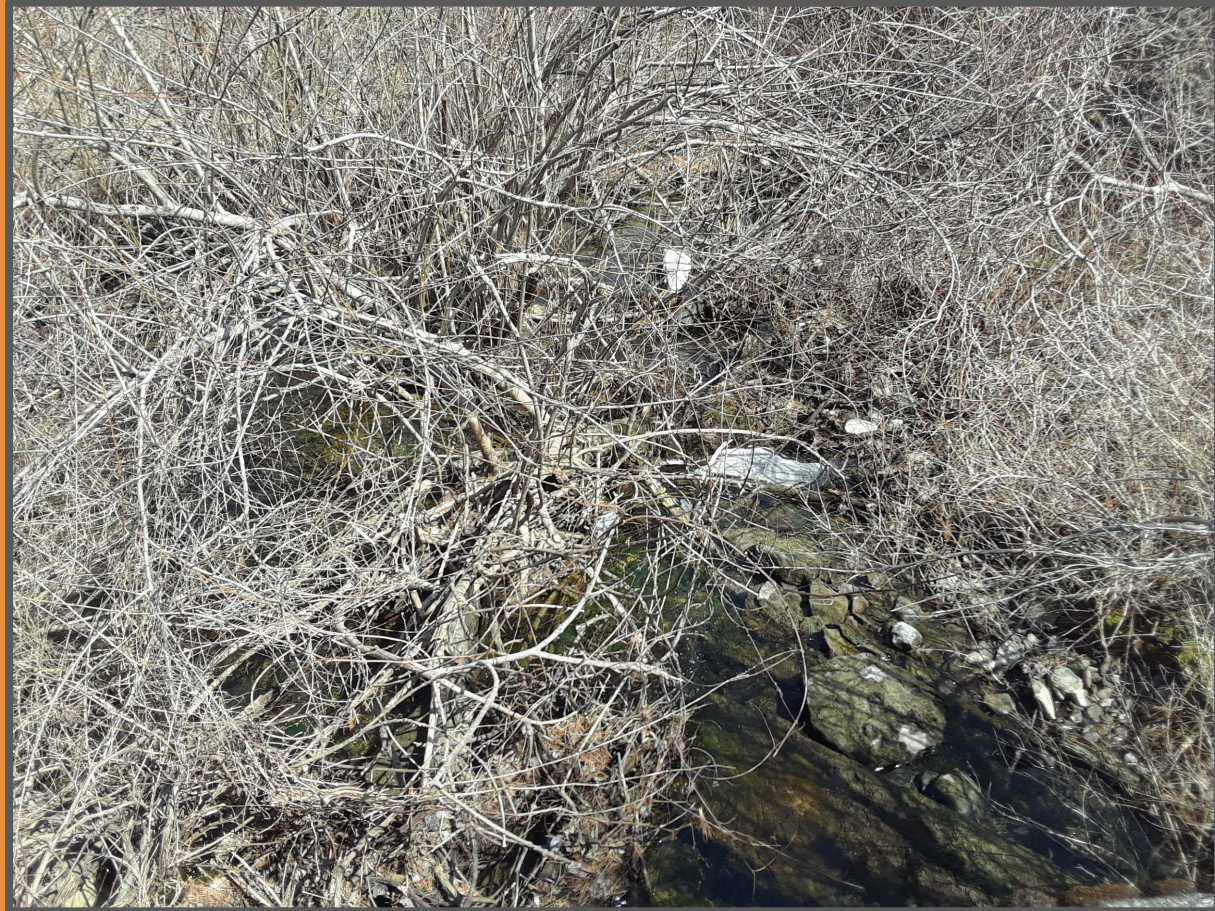
Point 14

Obstructed downstream view of Fig. 32 and the culvert. Significant organic debris in UNT just before culvert and gas pipeline passing over

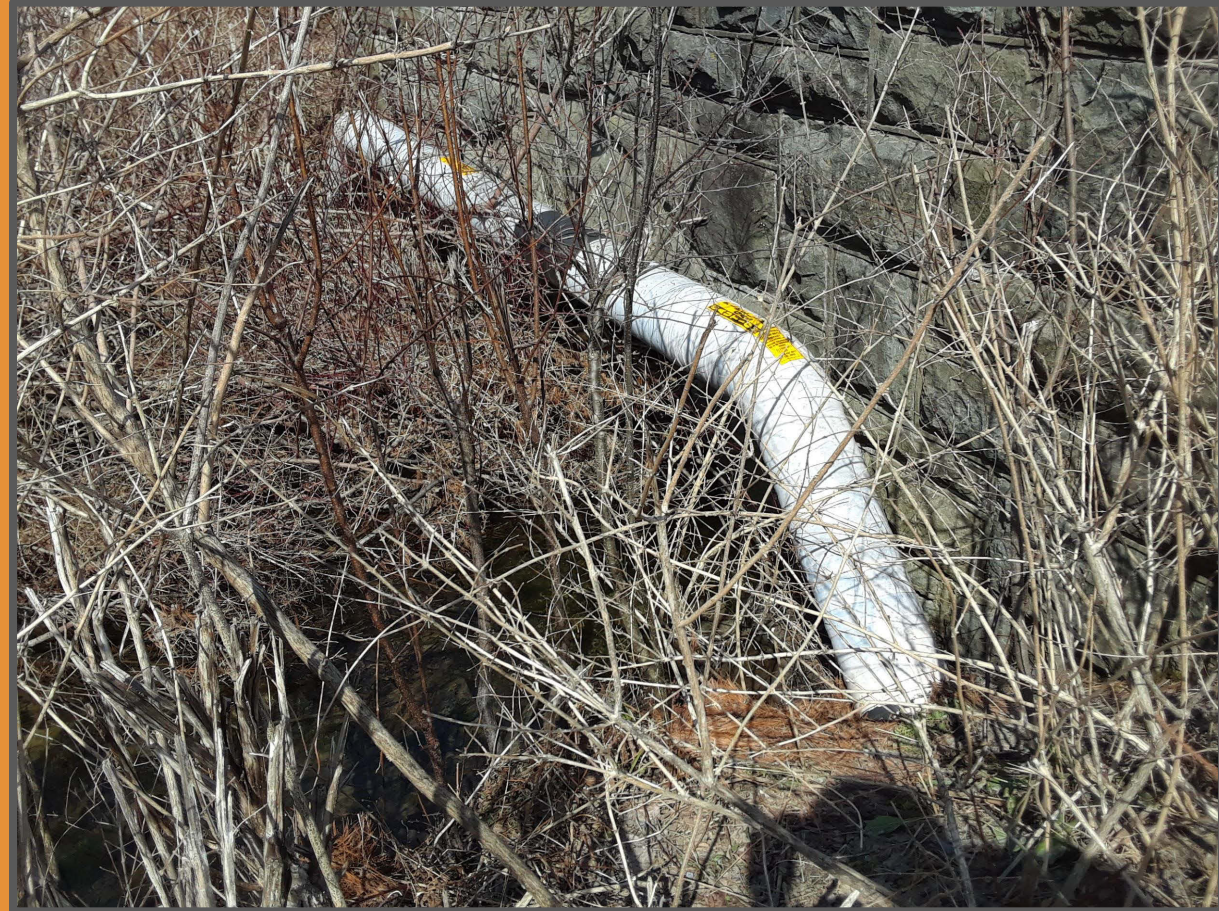
Point 14

Partial upstream view of culvert on opposite side of Huntsville-Idetown Rd. Some debris, but not as much as opposite side

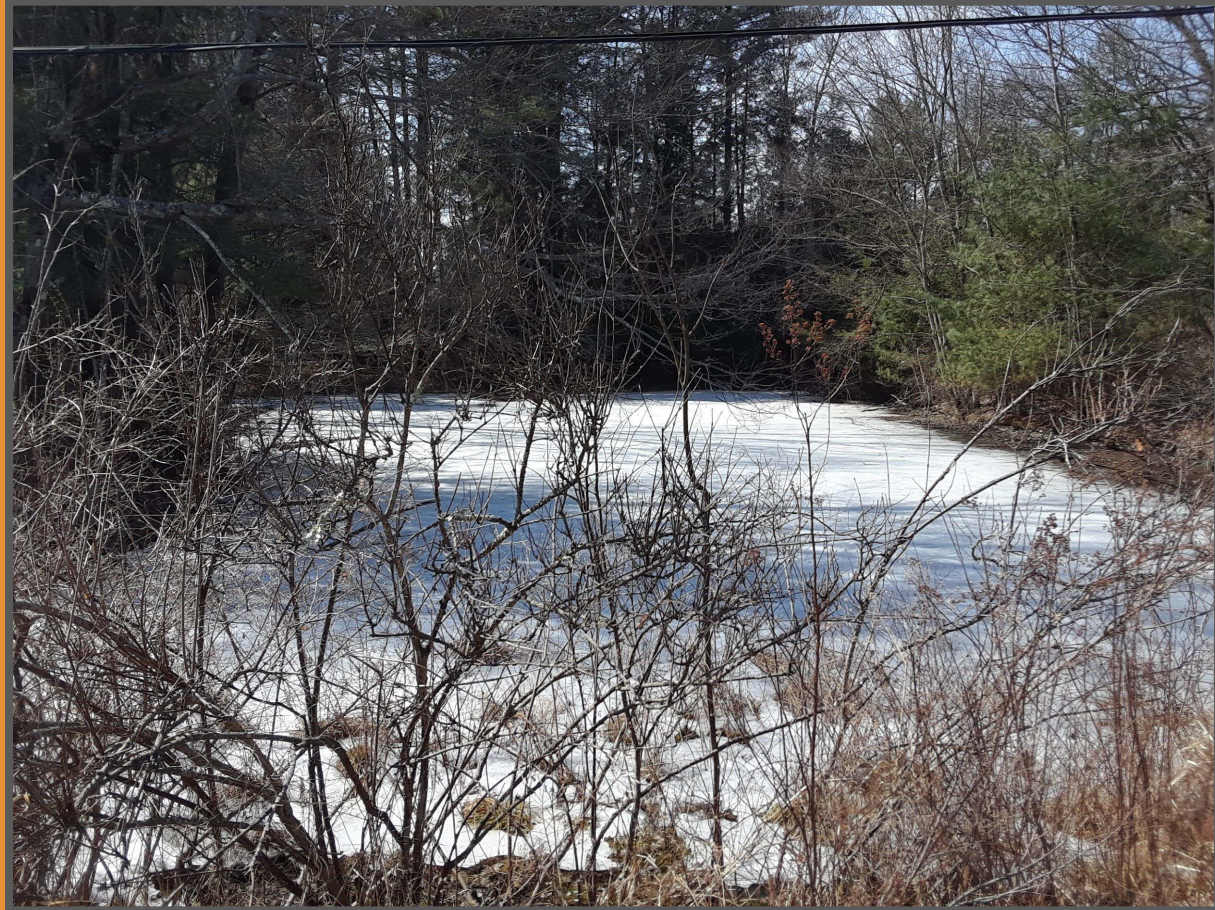
Point 15

Another downstream view
of UNT in Figs. 39-40.
Must pass through same
private property as Fig.
38 to access.

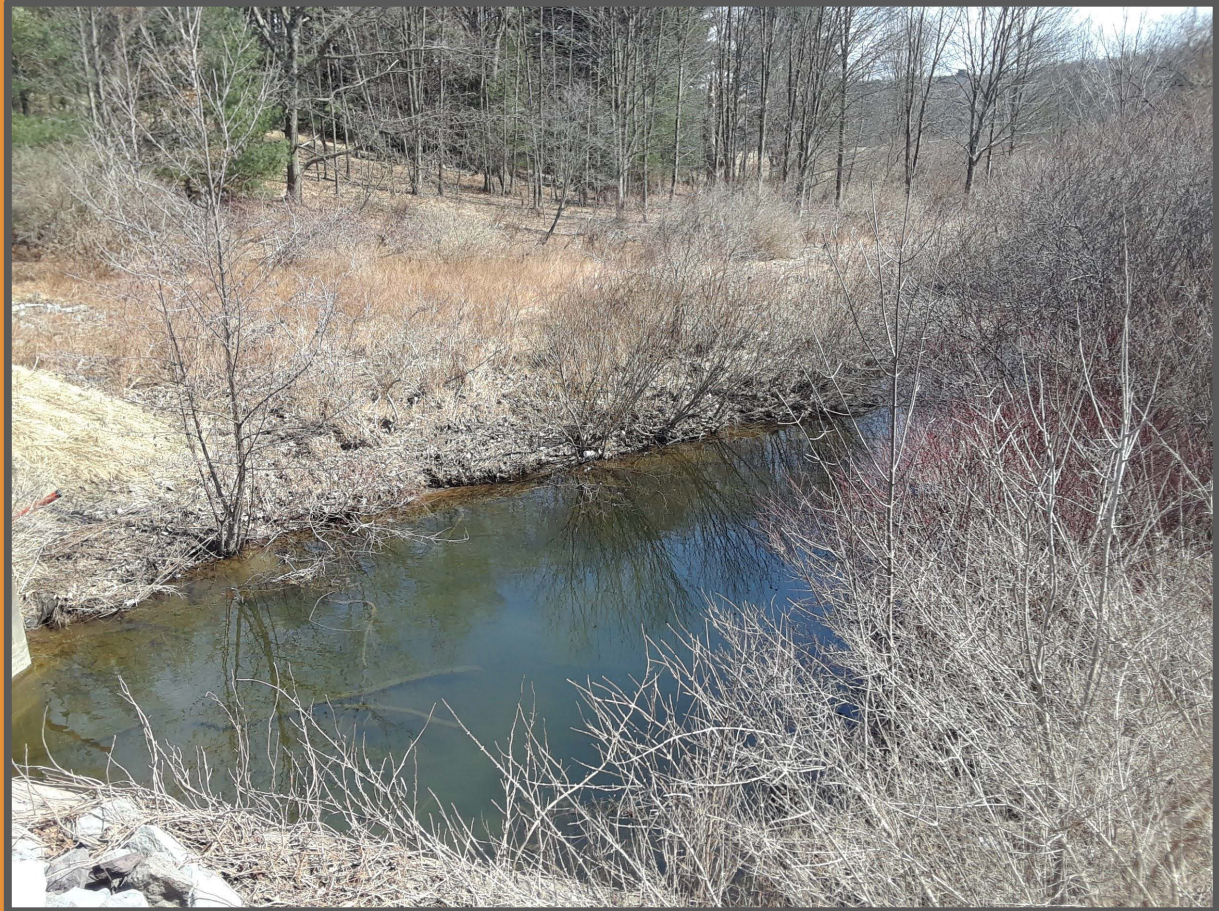
Point 15

Upstream view of UNT and very large concrete culvert that passes under Rte. 118. Meets other UNT in Figs. 32-36.
