Initial Huntsville Creek Culvert Survey

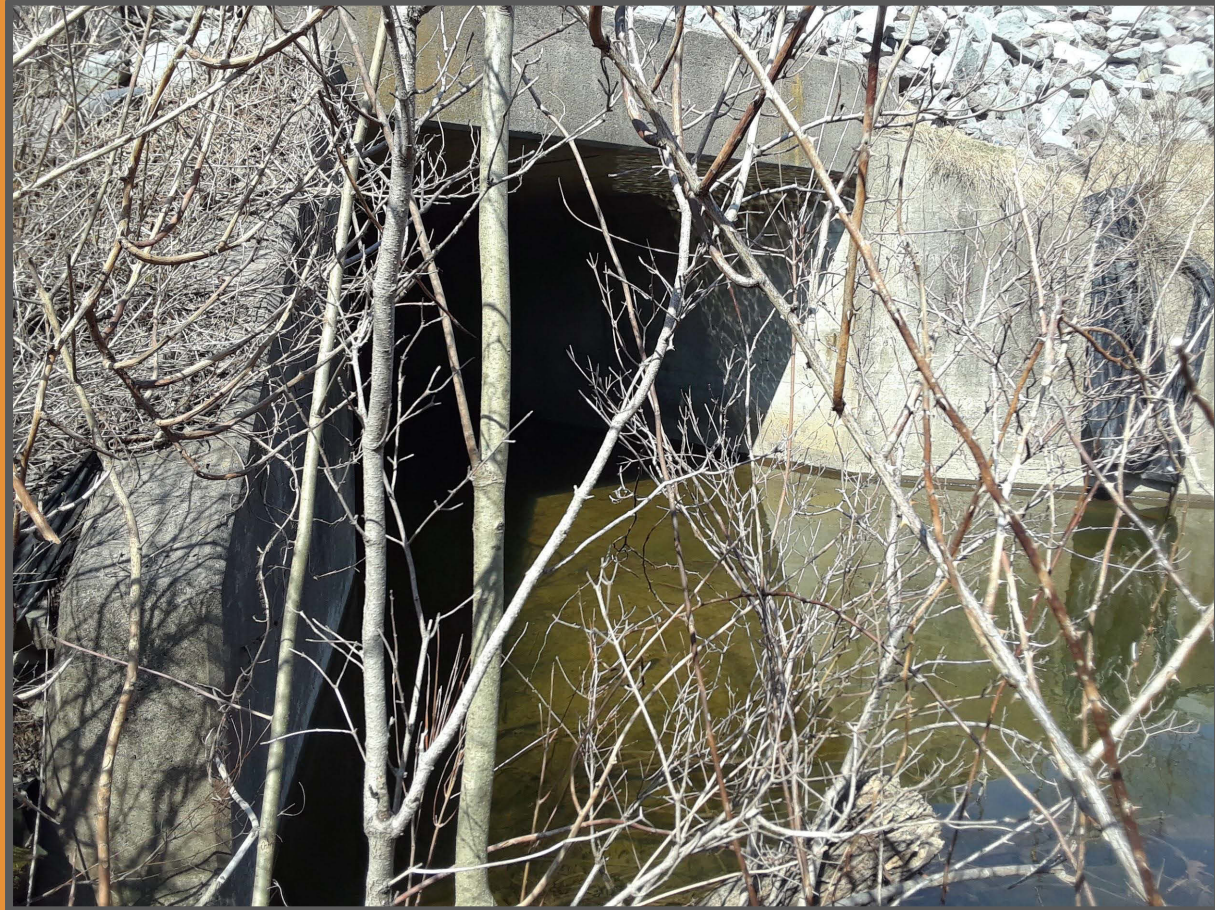
Point 15

Partial downstream view of UNT in Fig. 39. Water narrows after culvert, but is well over 2 feet deep in some areas

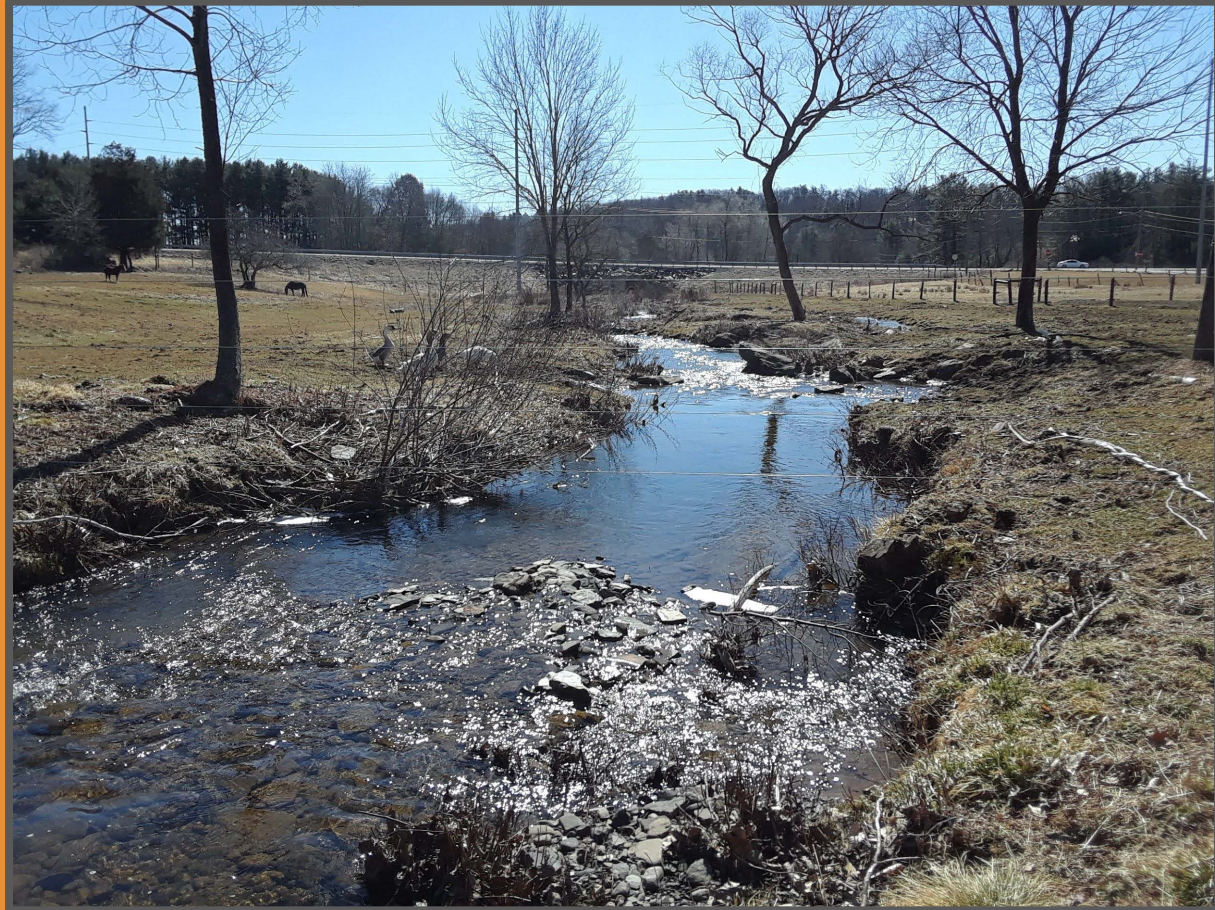
Point 16

Upstream view of UNT
that passes under Park
Rd. near Lehman Nursery

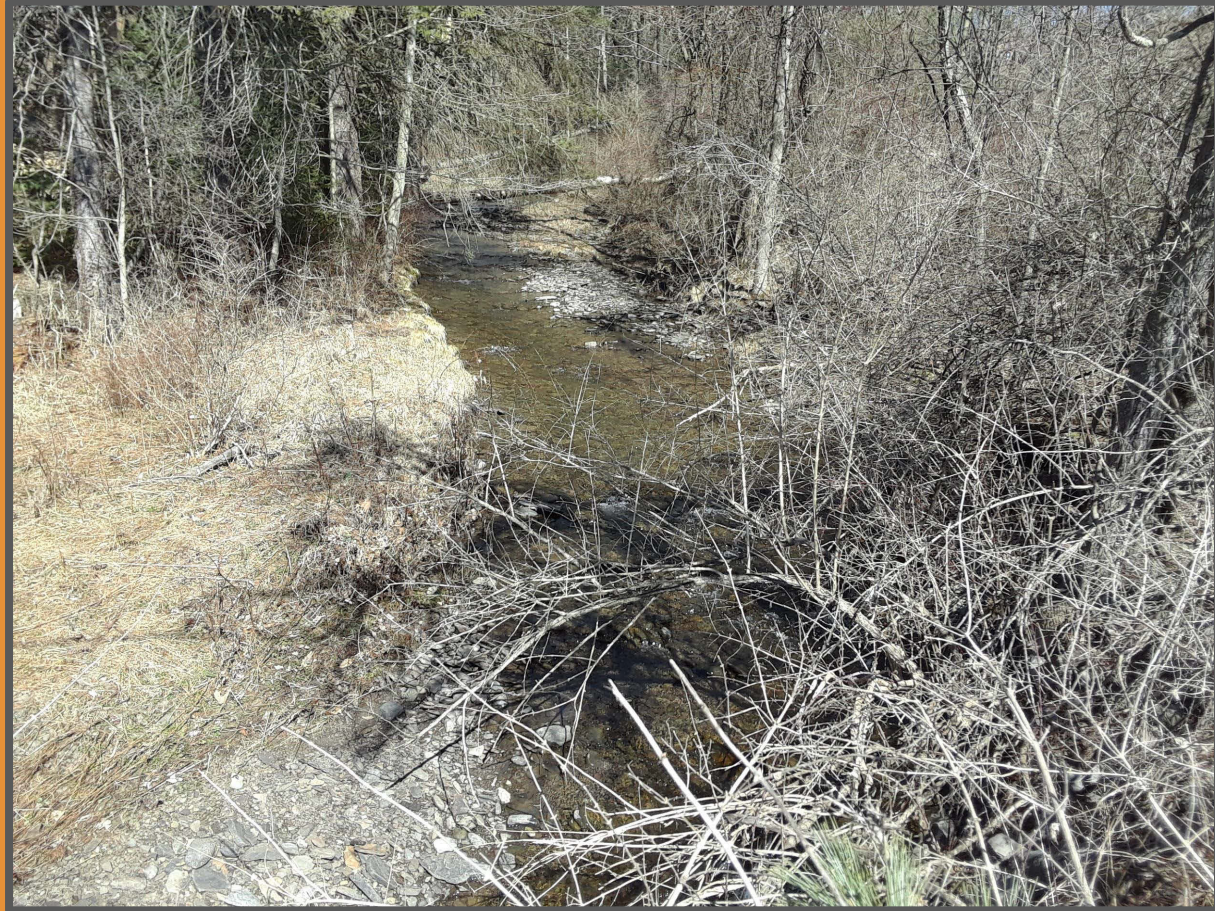
Point 16

View of UNT passing under Park Rd.

Bank repair in Fig. 74 could help direct UNT to better alignment with bridge

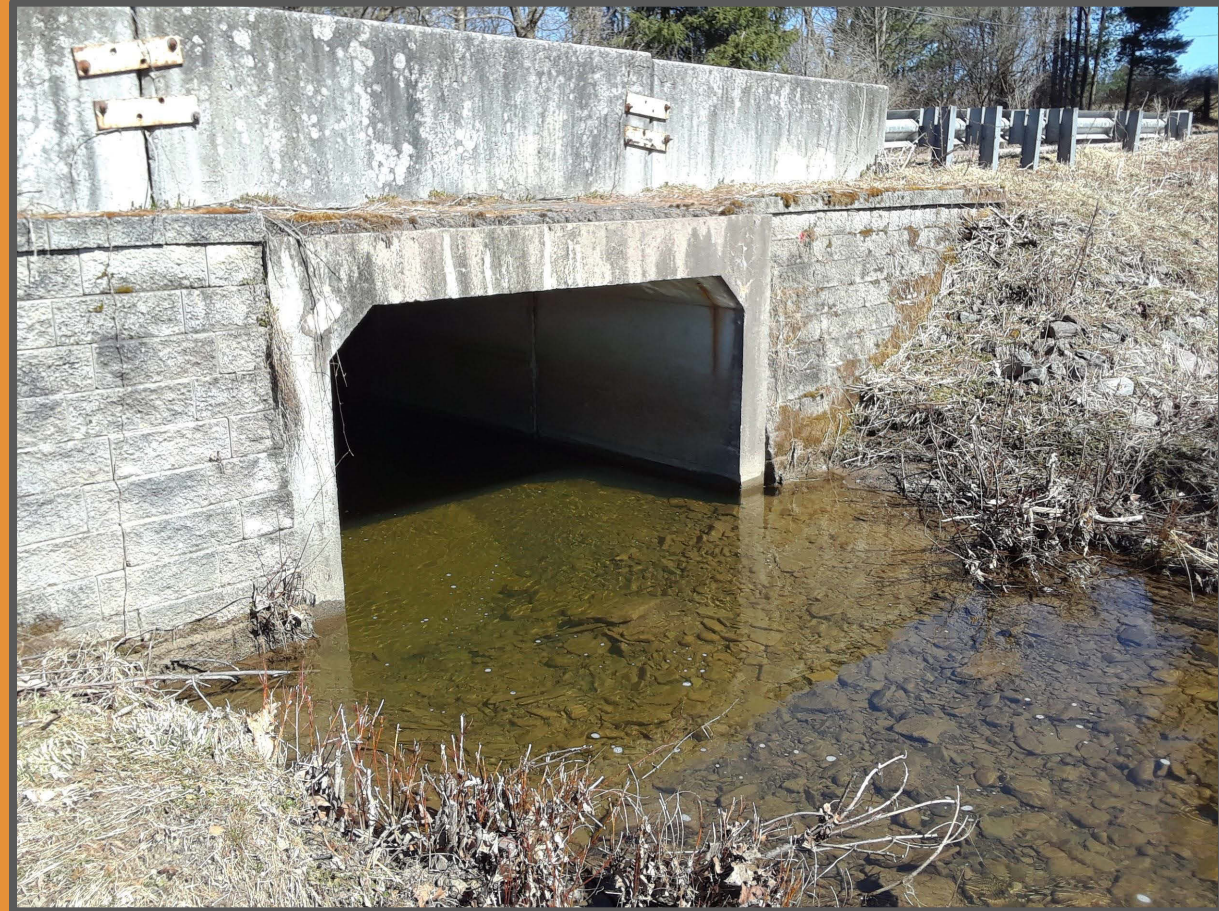
Near 16

View of bank erosion
from UNT in Fig. 73 just
before it passes under
Park Rd.

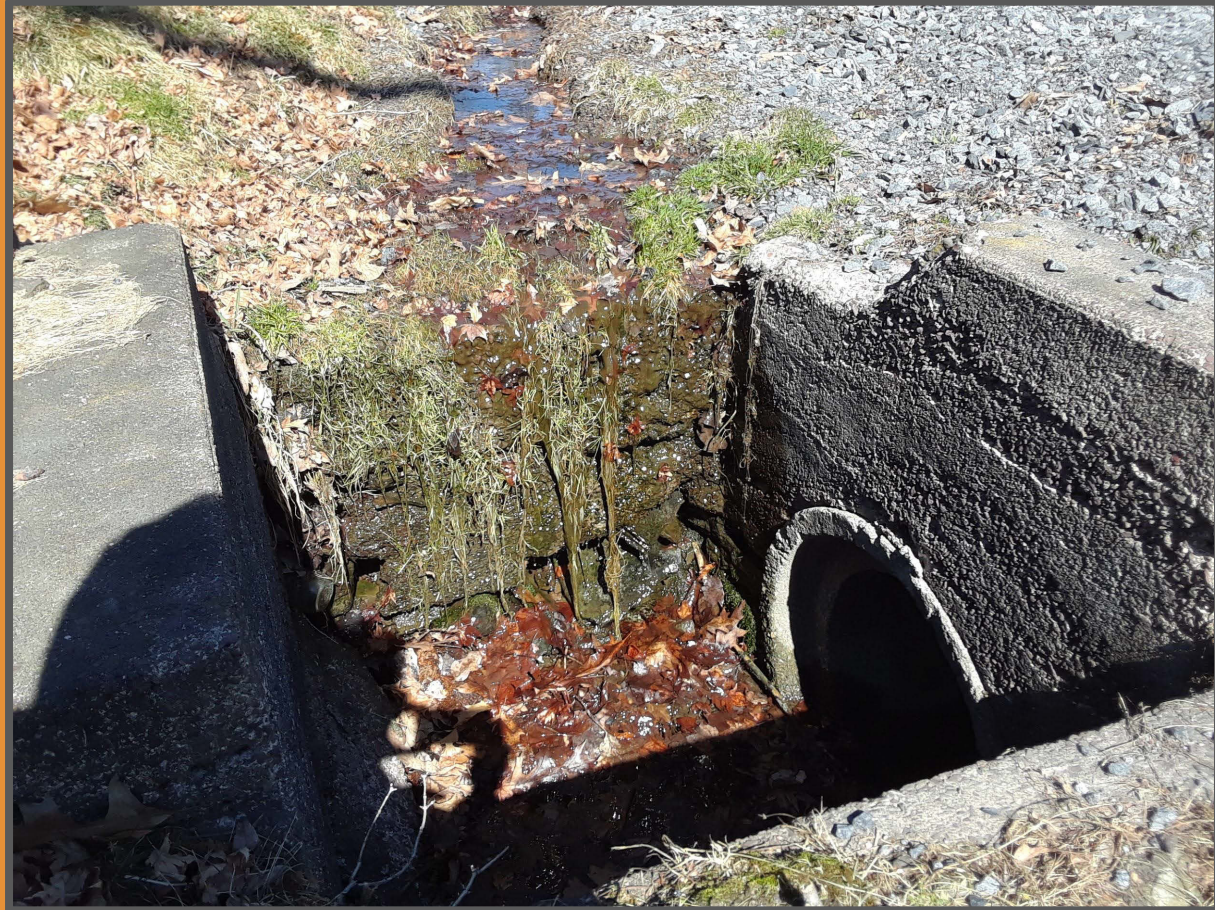
Point 17

Close-up of pipe in Fig.
69

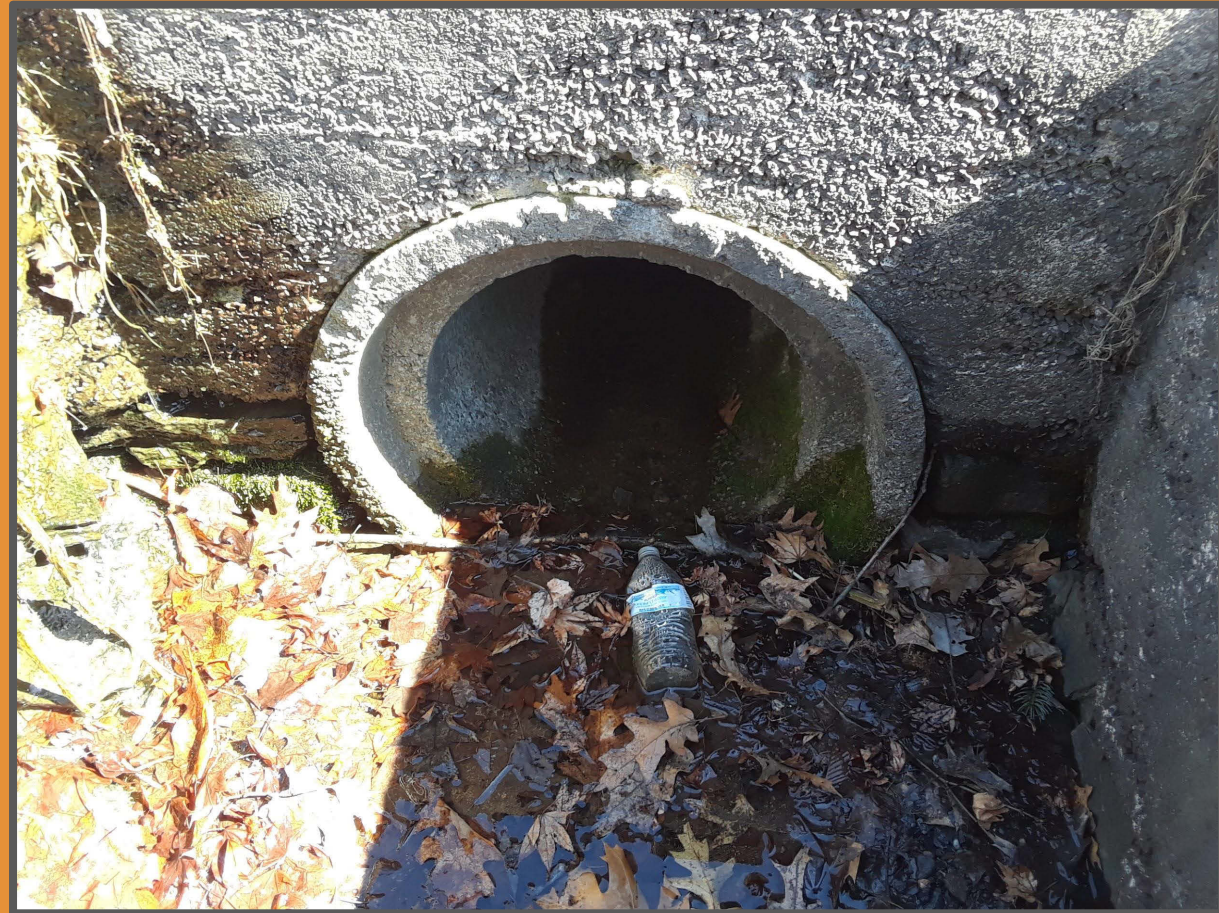
Point 17

Upstream view of concrete pipe from Fig. 70 on opposite side of Idetown Rd.

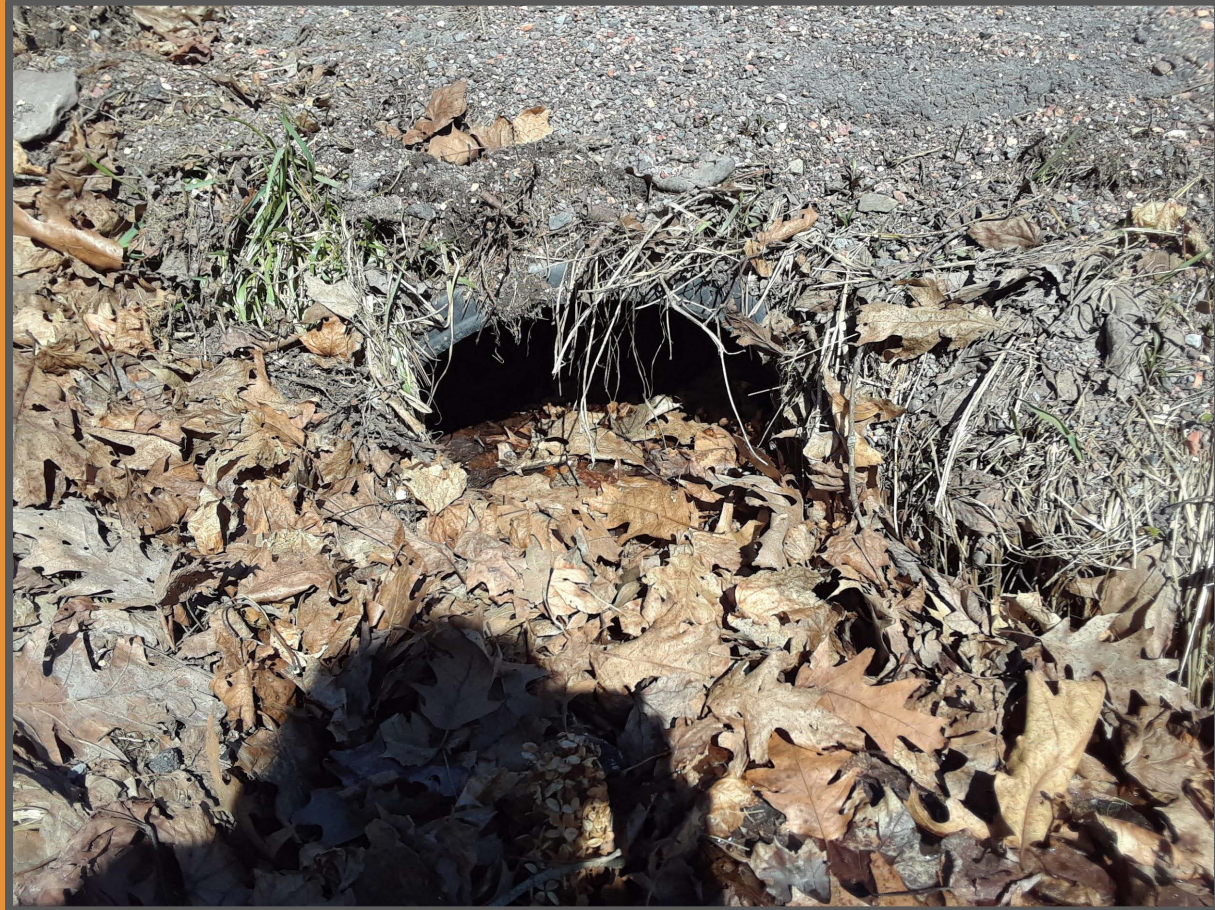
Point 22

Stormwater drains into square culvert with two 18" concrete pipes before crossing Vine St.

Leaf litter clogging the flow of water through the pipes

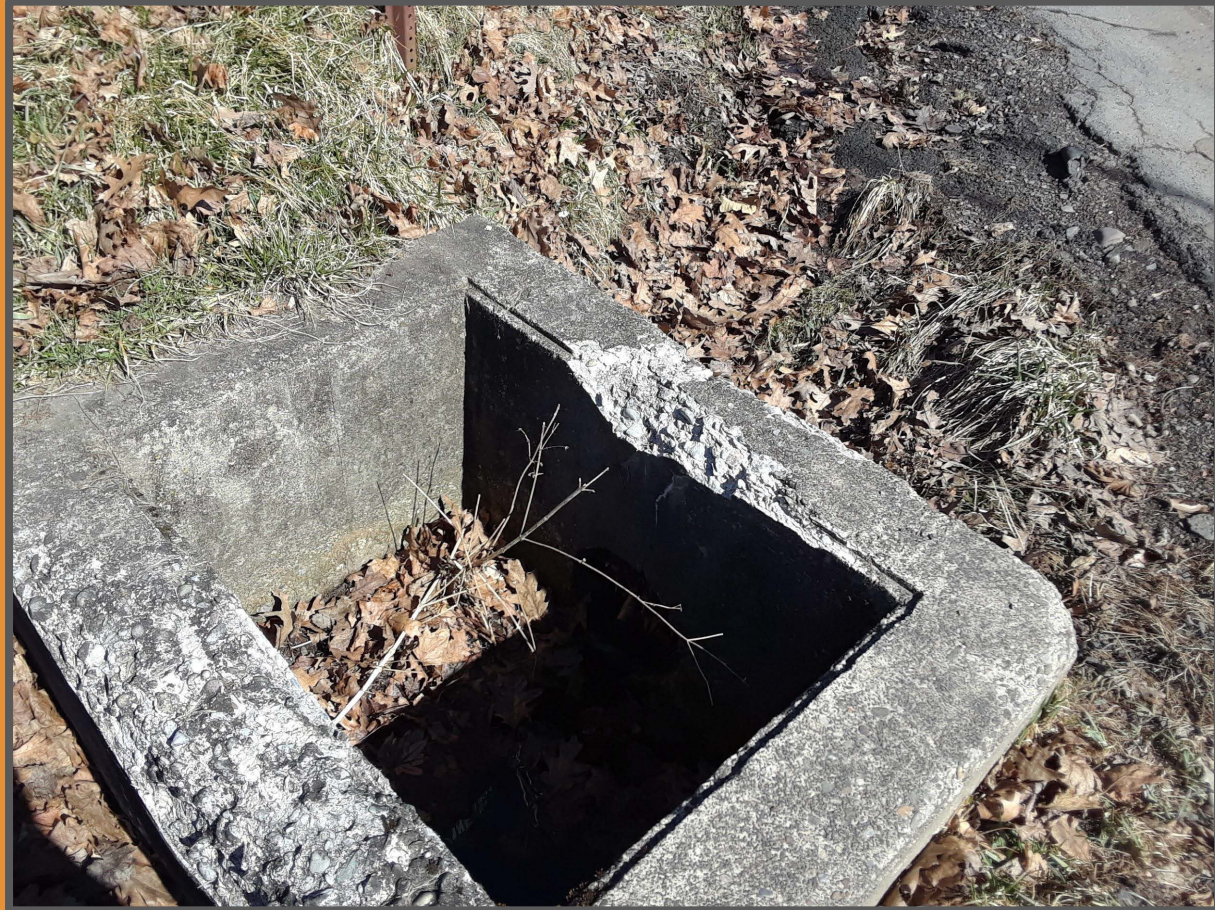
Point 22

Close-up of one pipe in Fig. 61 and leafy debris

Resident complained it regularly fills and sends flow across road.

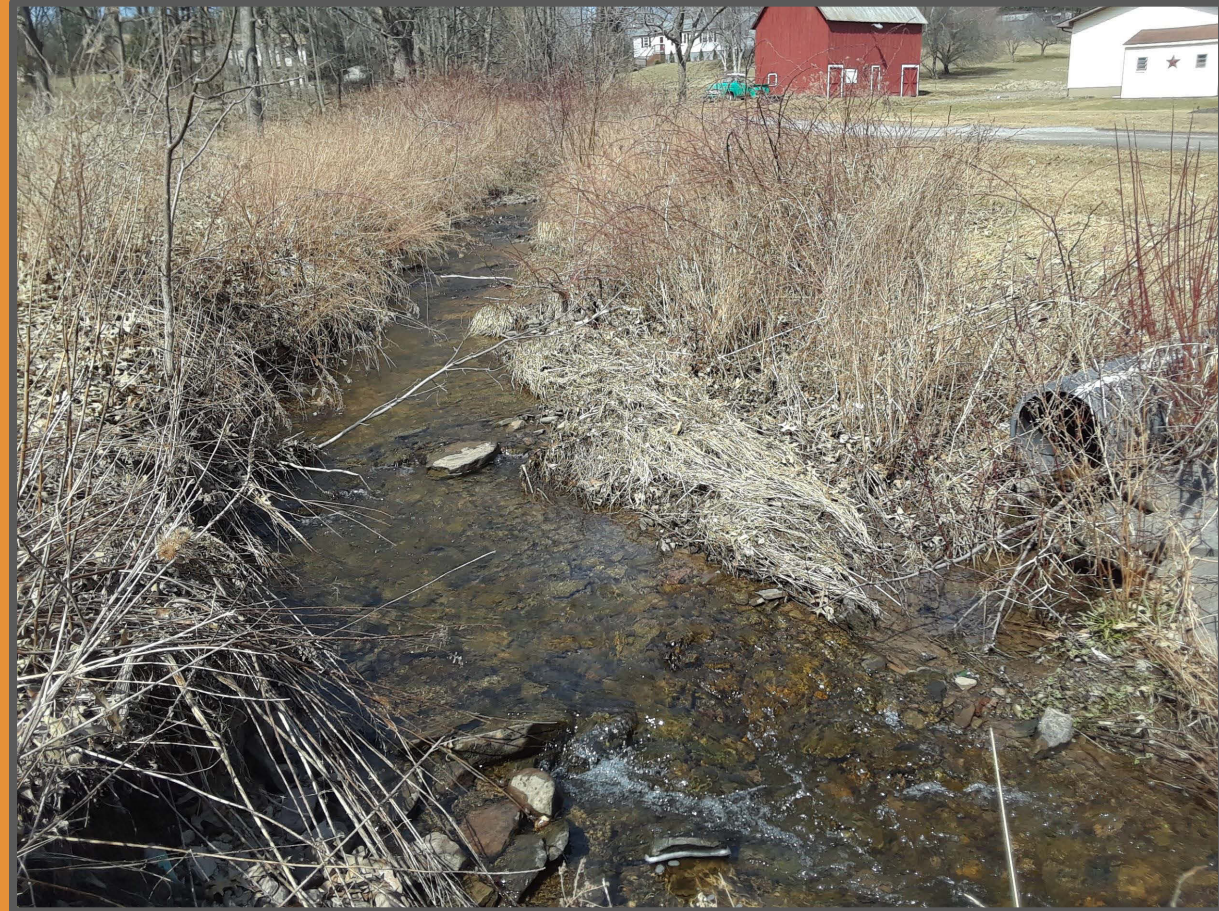
Point 21

View of 2-3' metal pipe carrying UNT under Goodman Rd. Pipe has some build up of sediment, but flow is level through the pipe relative to the UNT

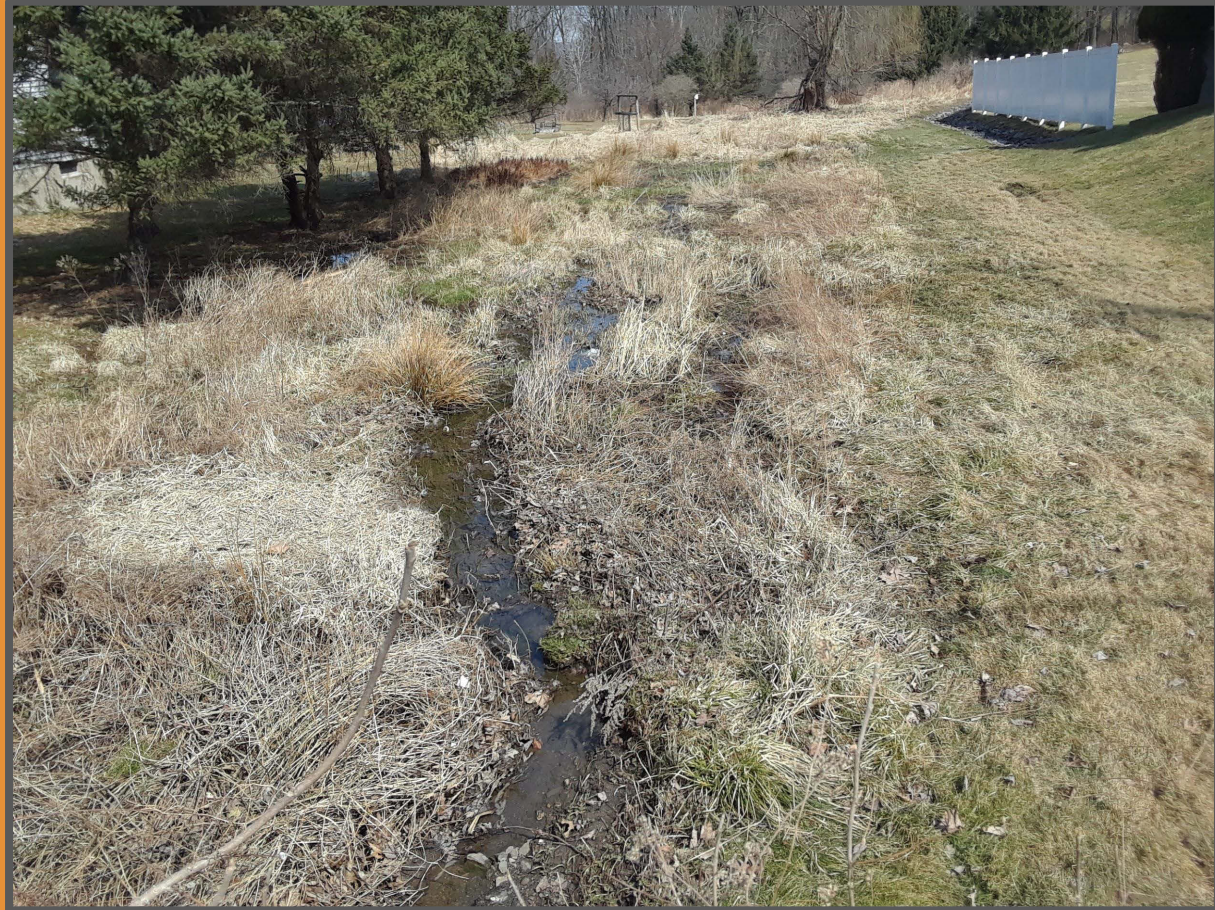
Point 9

Downstream view of Fig. 28. Drainage does not noticeably continue much further into wetland area that is part of a private yard

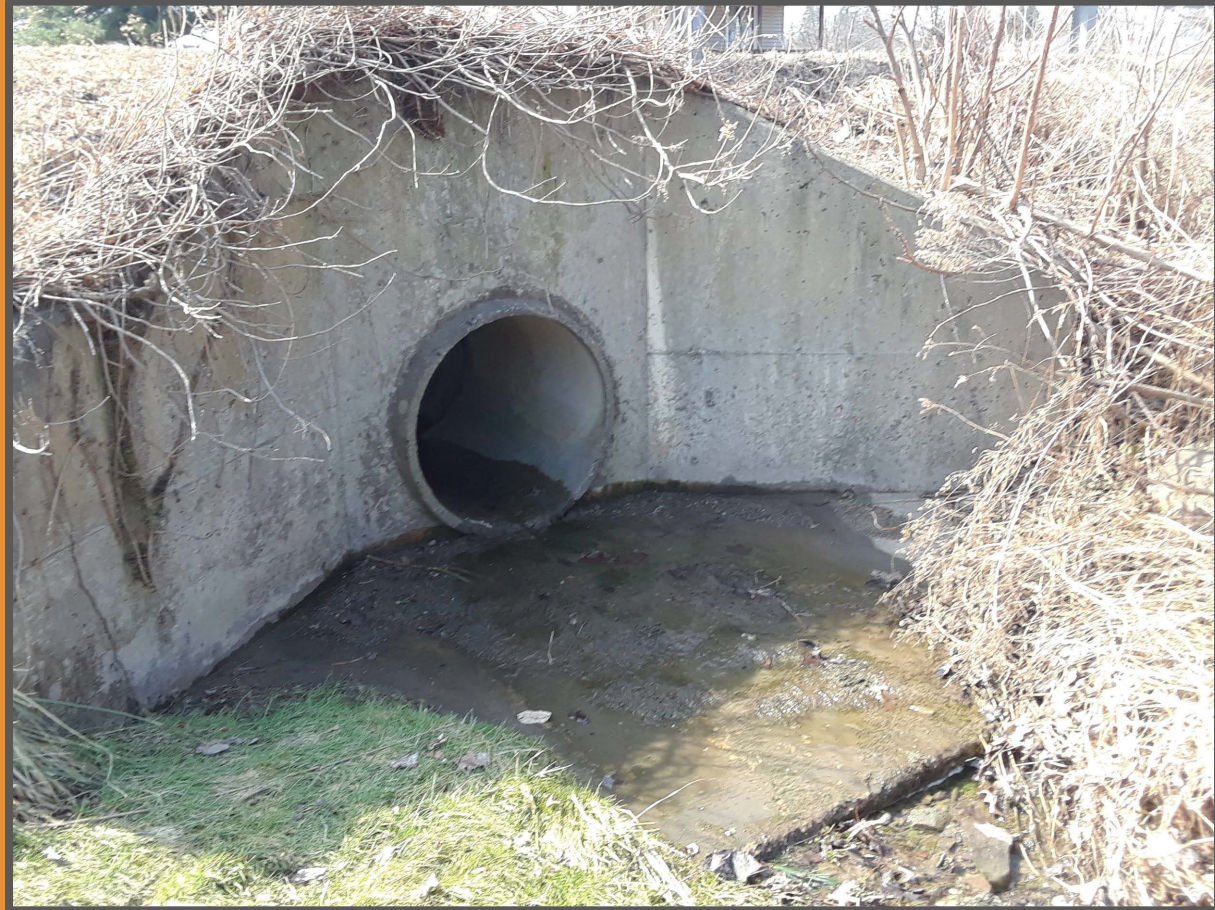
Point 9

Upstream view of culvert that passes under Market St. Drainage spreads widely into the wetlands

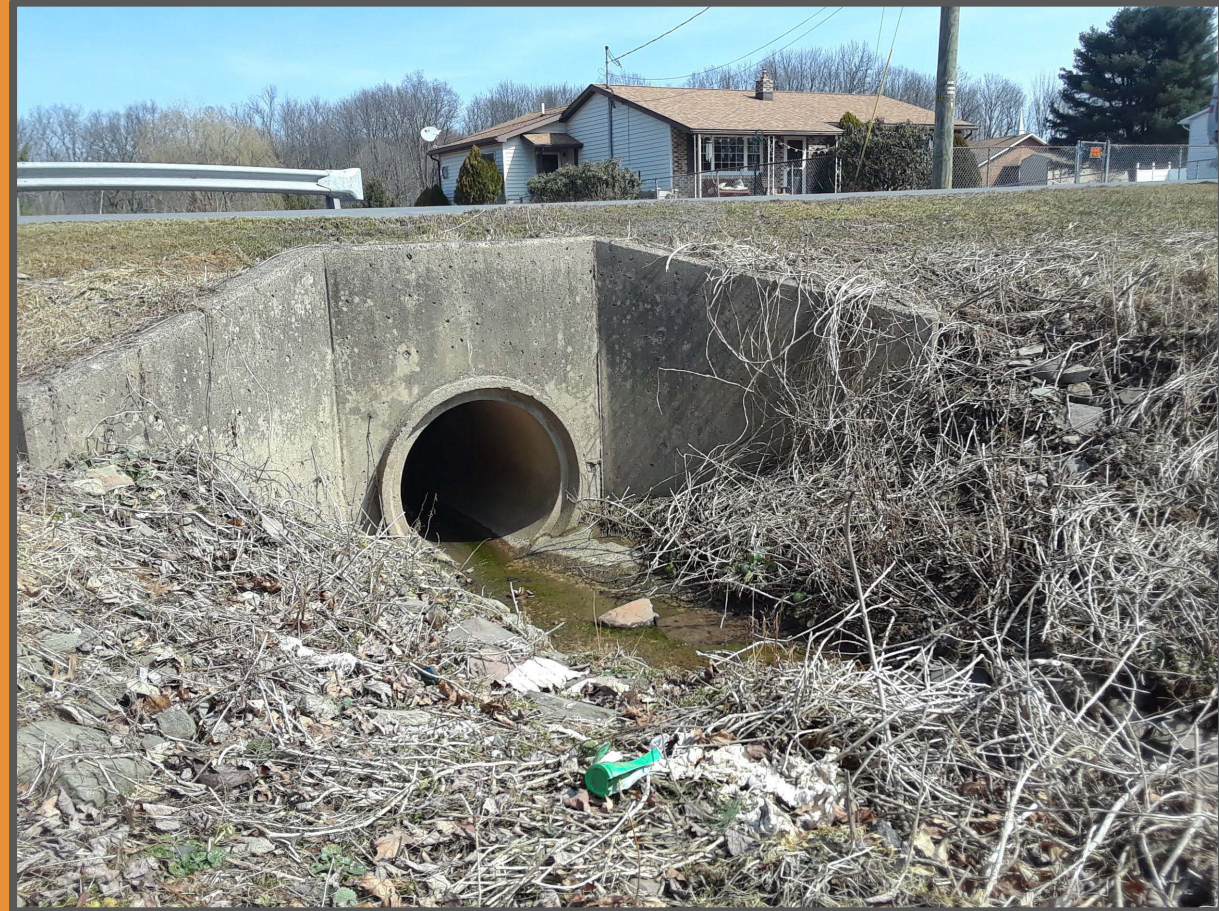
Near 9

Downstream view of Fig. 26. 30-inch concrete culvert passing under Market St.

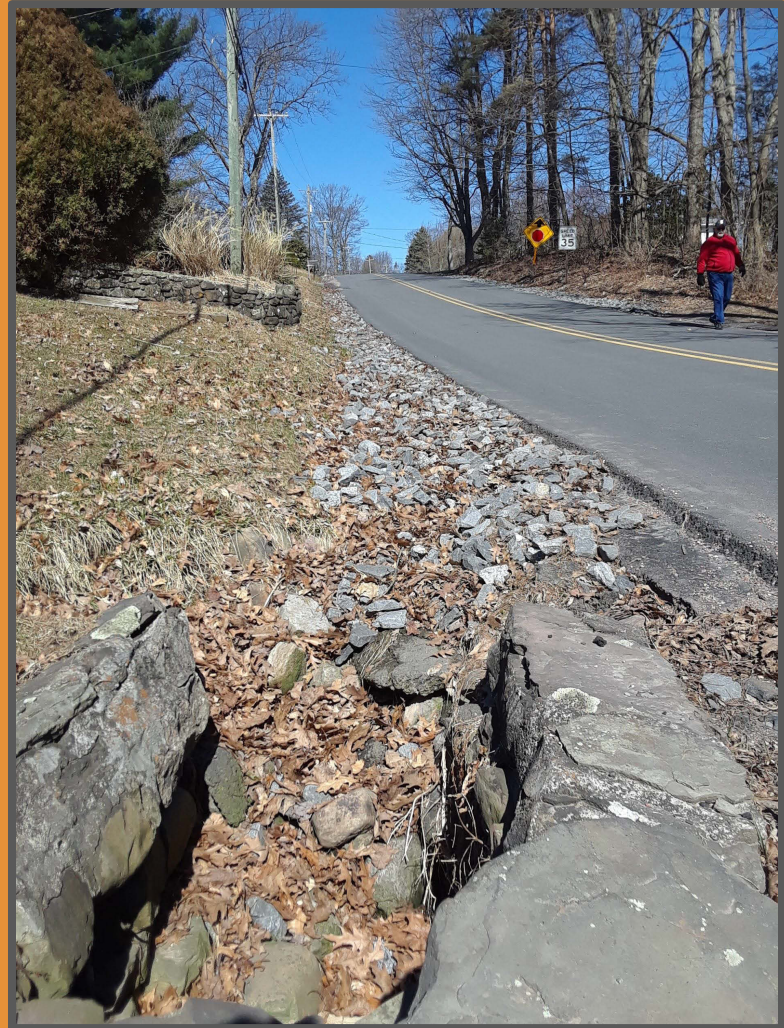
Figure 64

SW drainage off Idetown
Rd. with some blockage

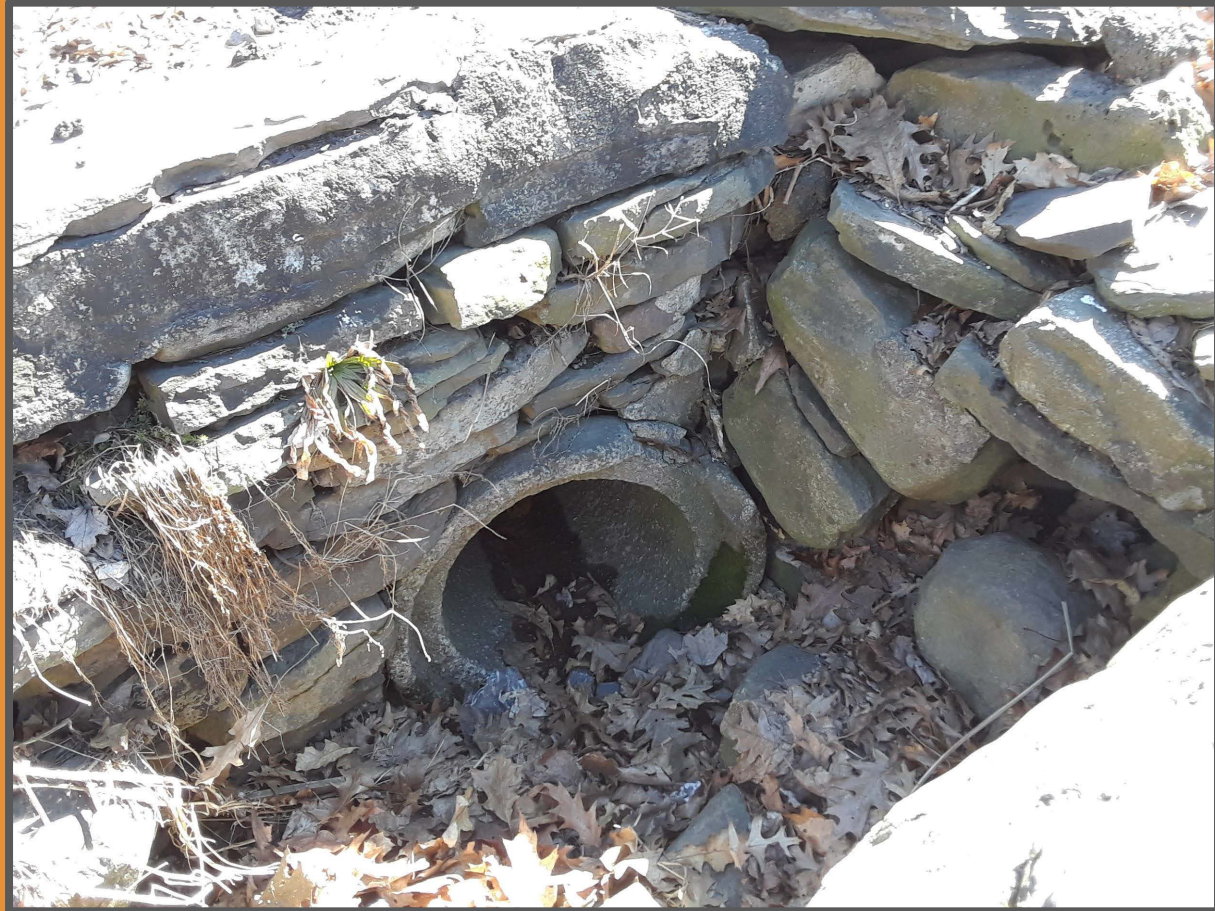
Figure 65

Square stone culvert with
18" concrete pipe

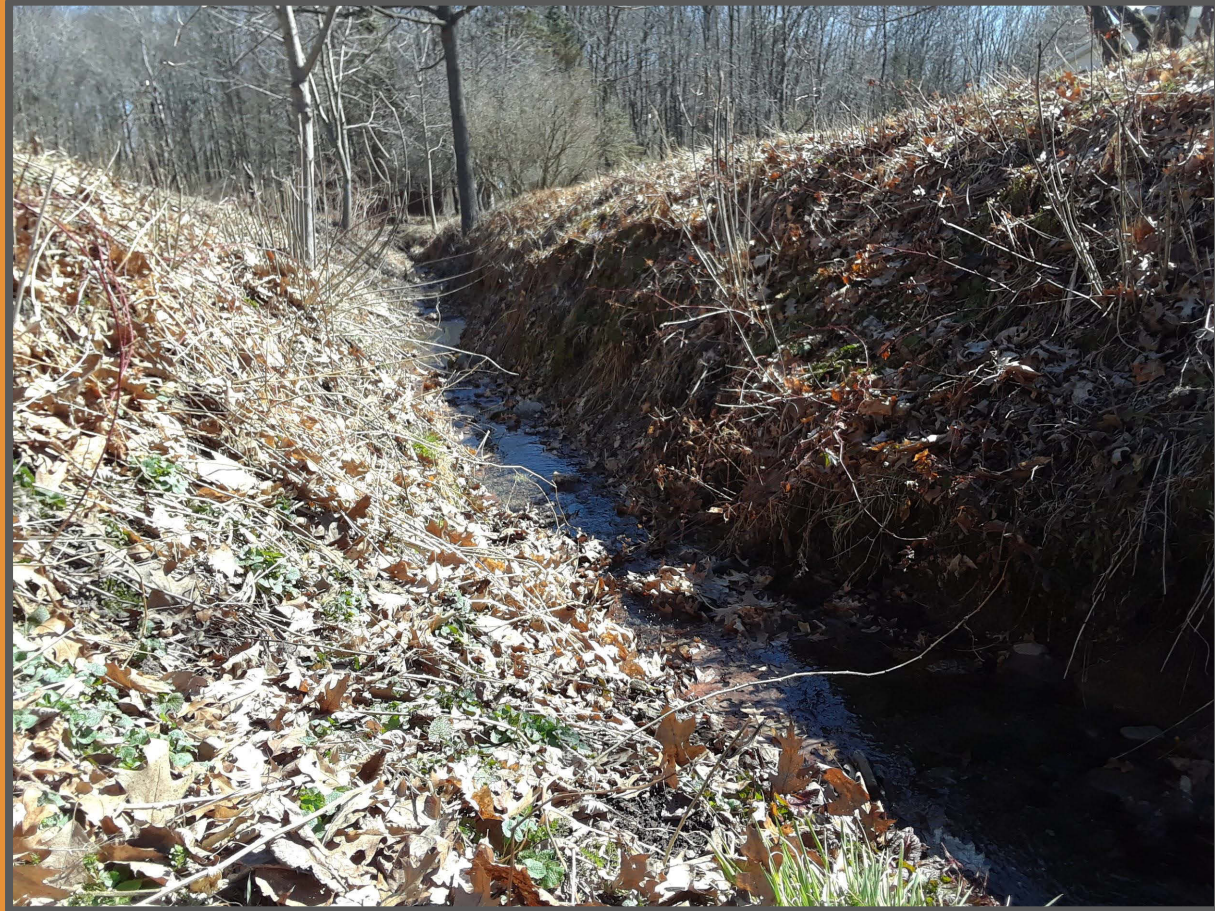
Figure 67

Downstream view of
drainage from Fig. 62-63.
Flow eventually meets
UNT in Fig. 56-59.

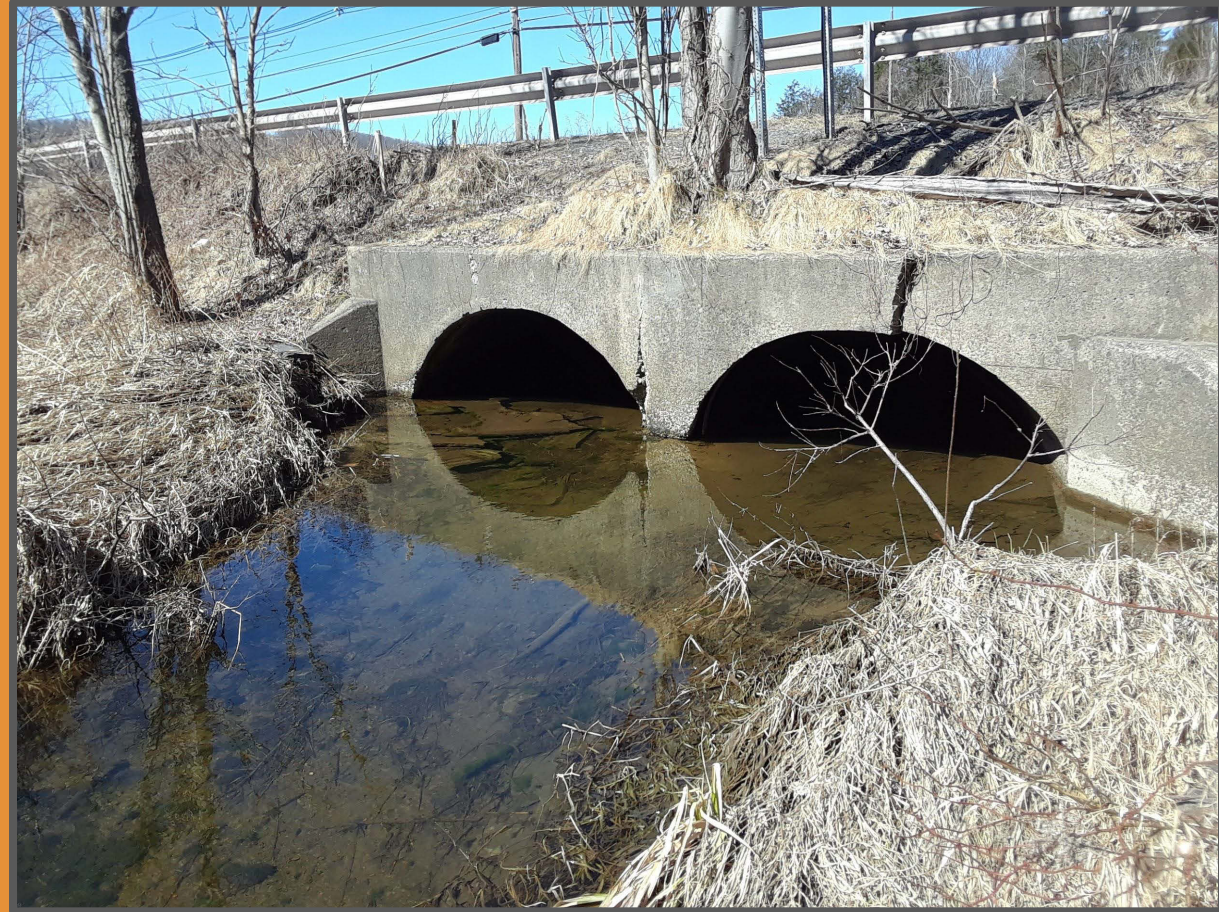
Figure 80

Upstream view of bridge carrying UNT under Rte. 118. Could not access other side

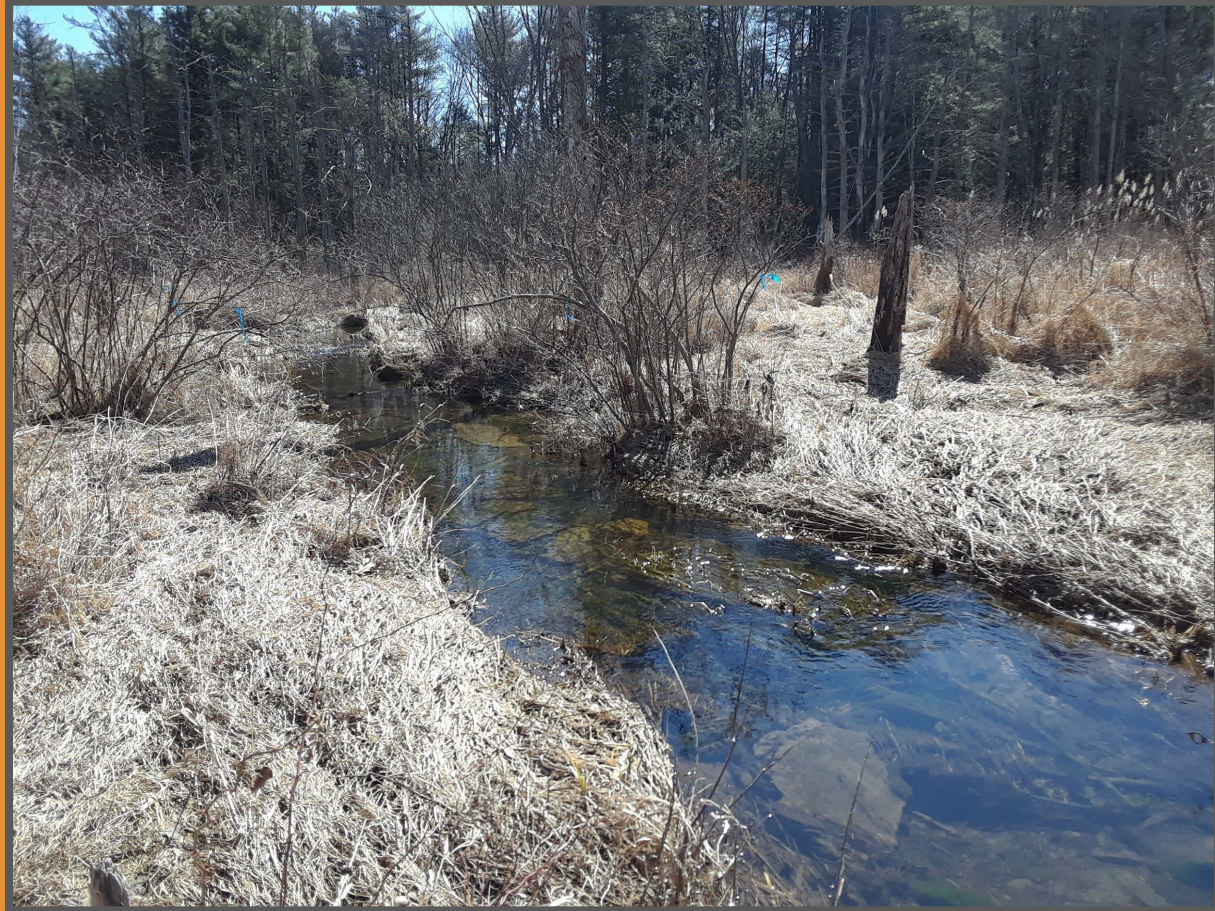
Figure 81

Downstream view of UNT
in Fig. 80. Appears as if
UNT spreads widely
during high flow events
