Sugar Notch Run sub-watershed Assessment

EPCAMR surveyed 6 stream segments in the Sugar Notch Run sub-watershed. They were labeled as **SNR 01-06** in the data tables and on the Solomon Creek Watershed Monitoring Map. The photo essay documents the entire length of the tributary and their unnamed tributaries and on occasion makes recommendations for future stream or habitat improvement projects or cleanups.

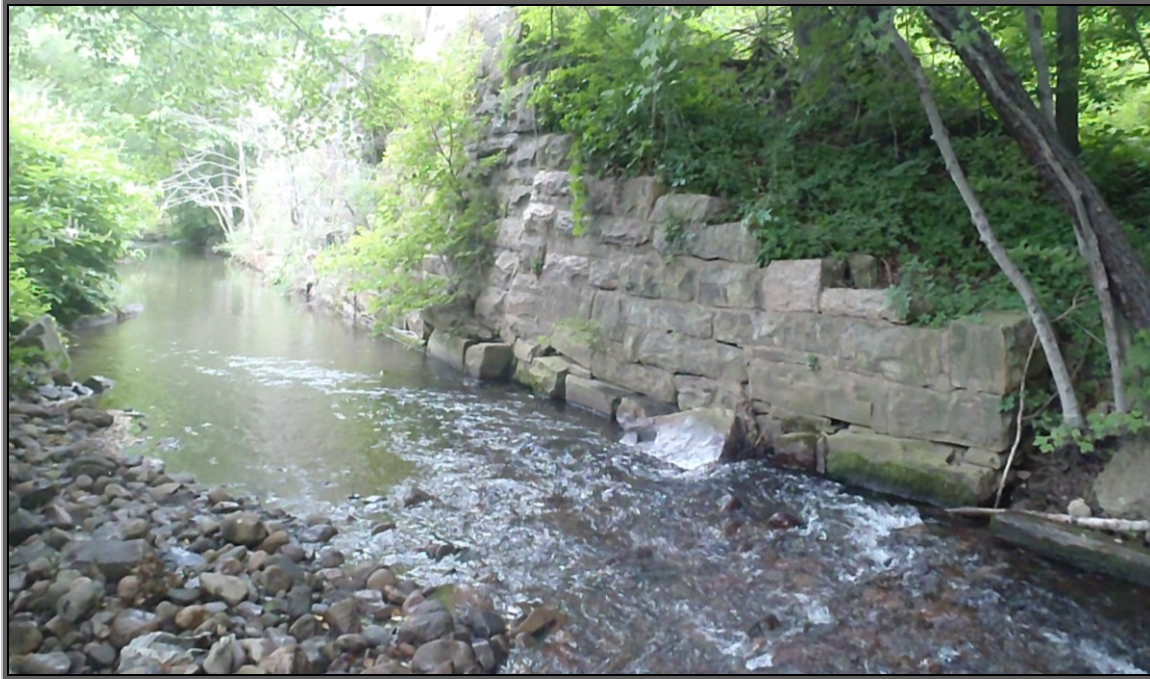
Photo : Looking downstream 200' below the confluence of Sugar Notch Run with the Solomon Creek Main Stem at one of the abandoned railroad bridges that was constructed in 1902.

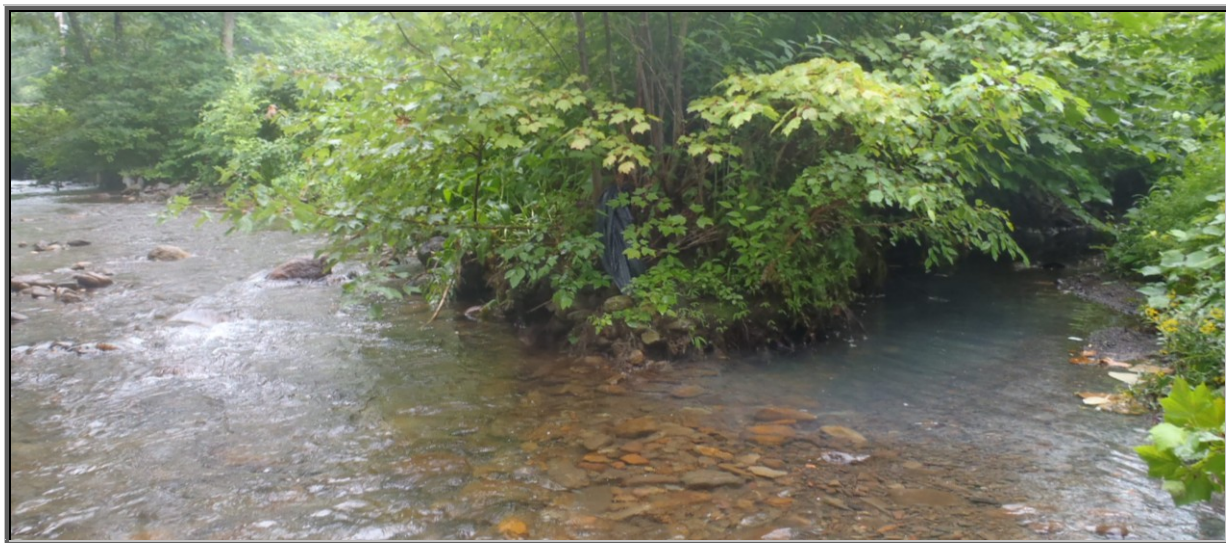
Photo : The milky white precipitate from Sugar Notch Run can be seen combining with the Solomon Creek Main Stem

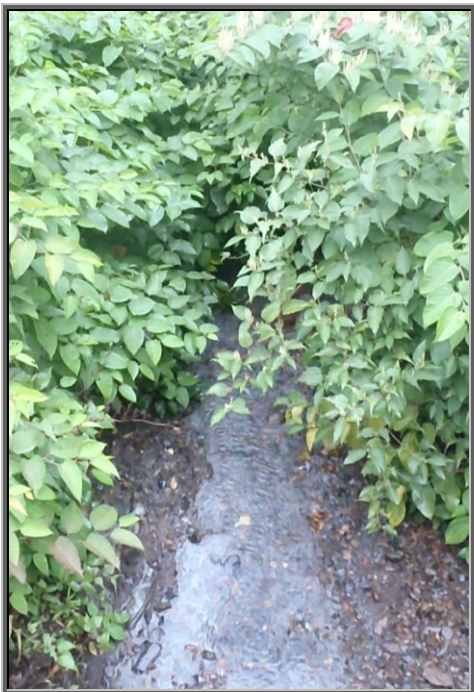
Photo : The milky white precipitate can be seen entering beneath the Ashley Street culvert before emptying into the Solomon Creek Main Stem

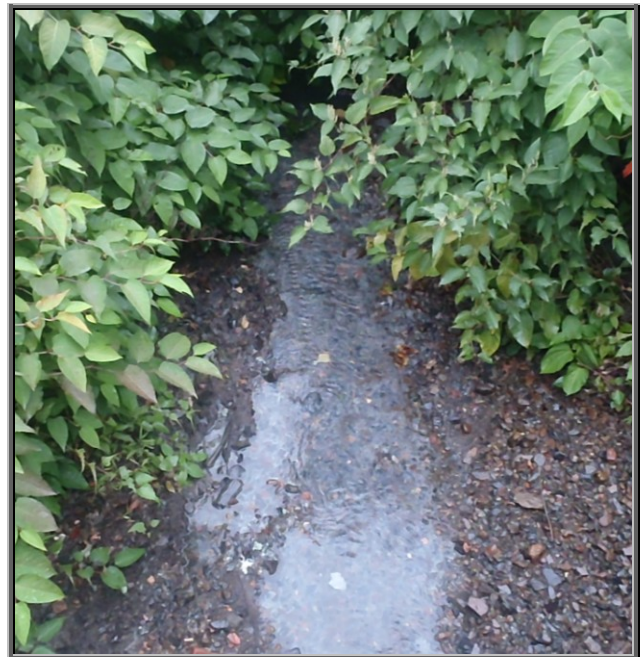
Photo : The milky white precipitate from Sugar Notch Run can be seen entering beneath the Ashley Street culvert before emptying into the Solomon Creek Main Stem

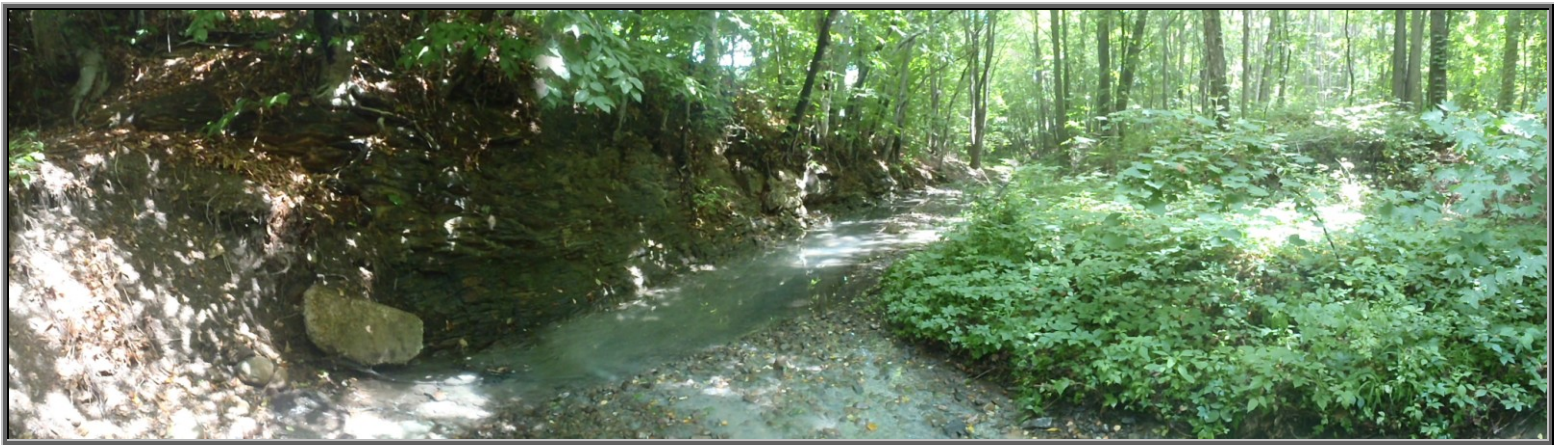
Photo : Panoramic of Sugar Notch Run below Carey's Patch as it takes a bend along a natural sandstone outcropping along the left bank with some streambank erosion evident to the east of the photo

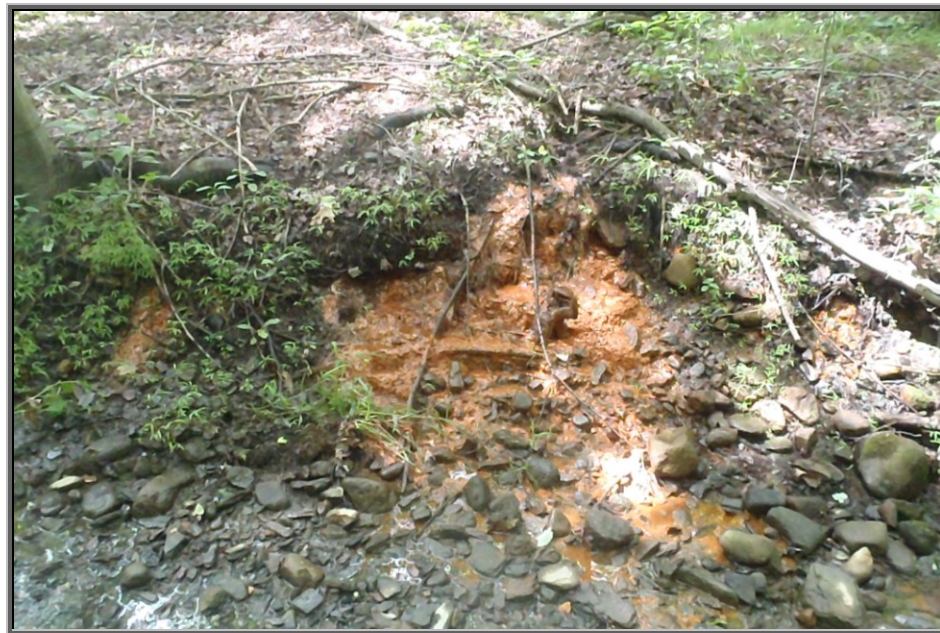
Photo : An iron seep coming into Sugar Notch Run below Carey's Patch from the left streambank that had minimal impact on the tributary

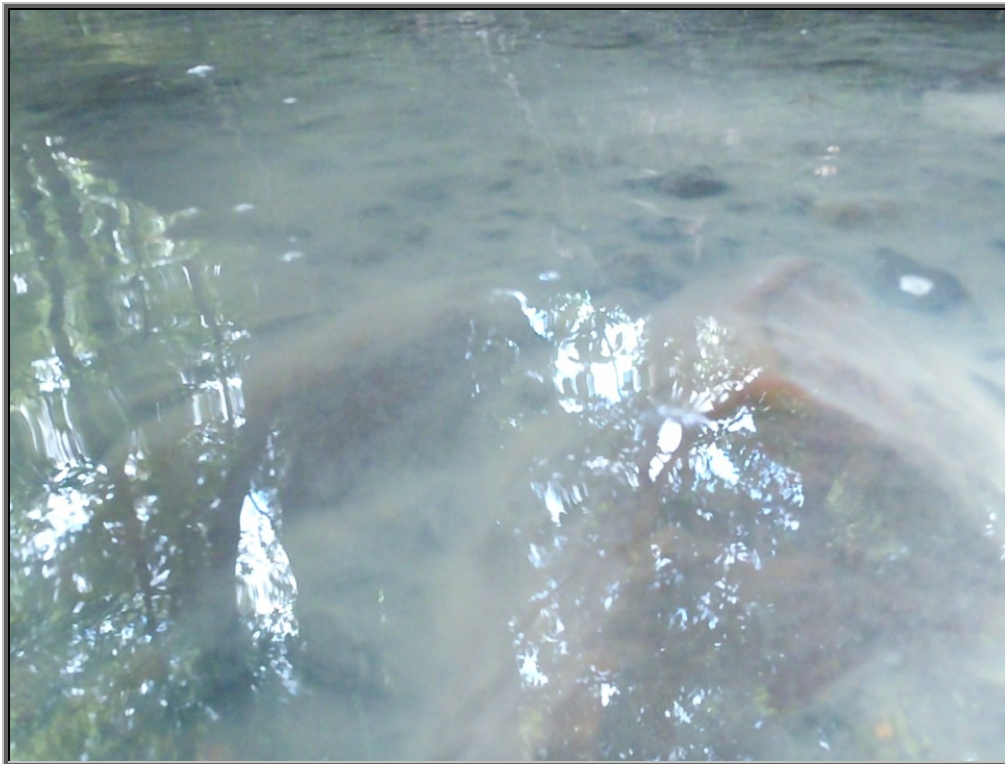
Photo : A closer look at the white precipitate and almost filamentous algal like substance that was coating the stream bottom of Sugar Notch Run below Carey's Patch

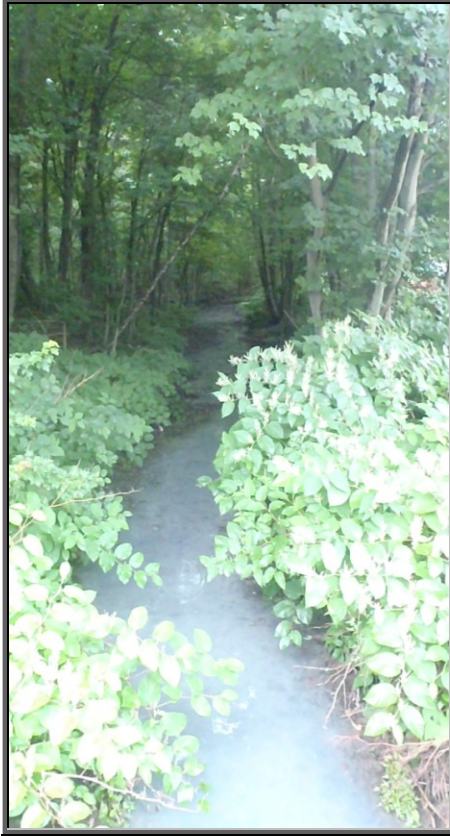
Photo : Sugar Notch Run below Carey's Patch surrounded by Japanese Knotweed and what EPCAMR believes to be an aluminum precipitate, sewage or phosphate contamination in the tributary;

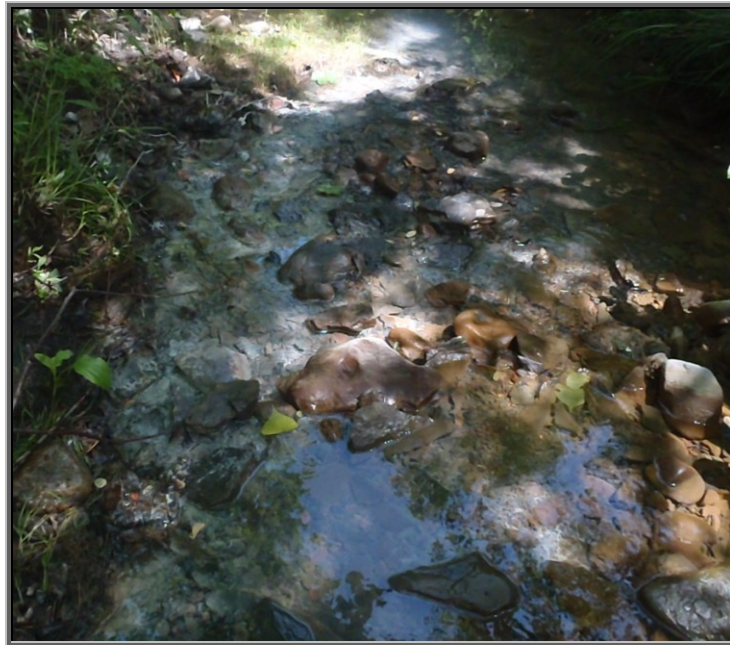
Photo : Sugar Notch Run below Carey's Patch in what seems to be the start of a transition area from a more clear iron impacted area to the white precipitate area that EPCAMR believes to be possibly aluminum hydroxide, sewage, or phosphate contamination

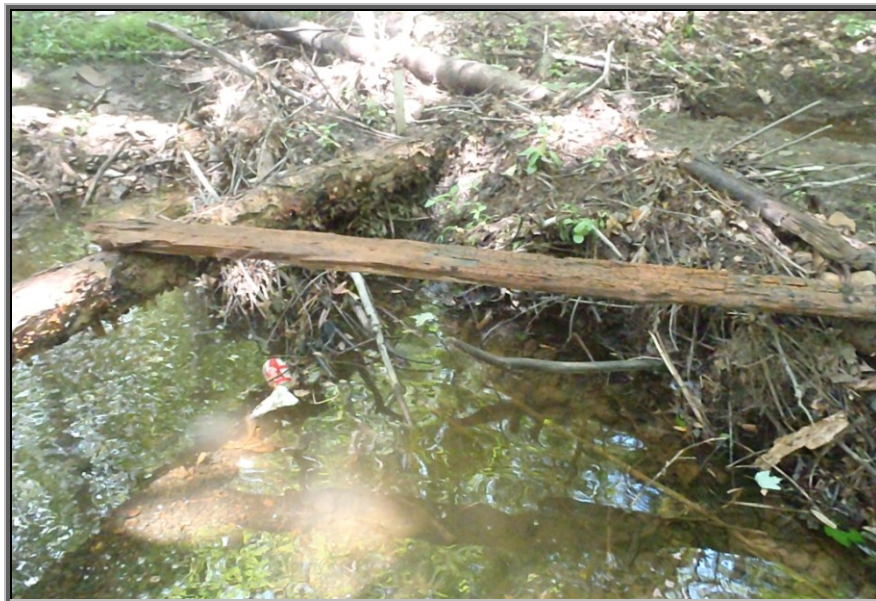
Photo : Sugar Notch Run flowing below Carey's Patch with a woody debris blockage in the stream that could easily be removed as a part of a restoration project

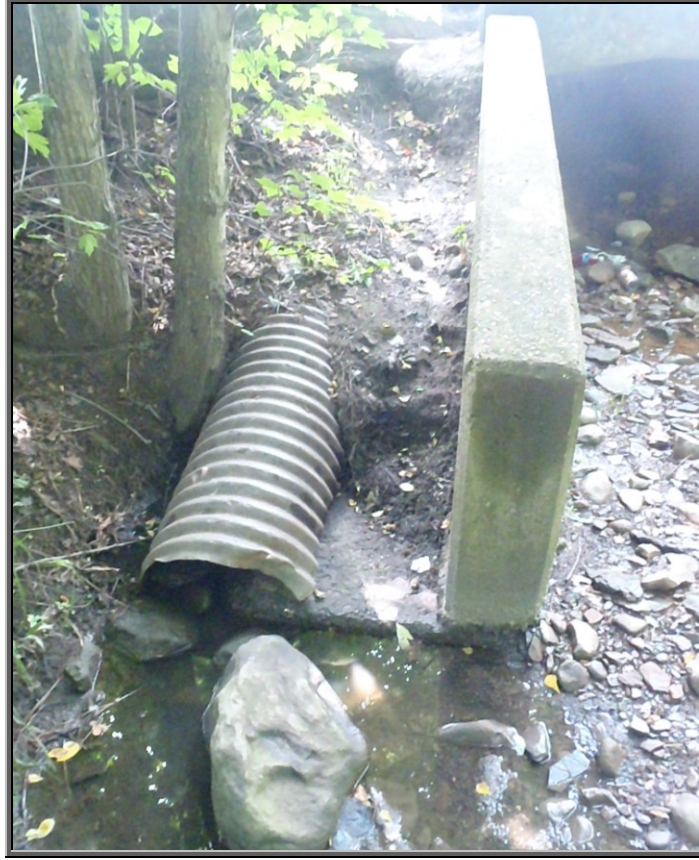
Photo : Sugar Notch Run flowing below Carey's Patch looking upstream towards Sively Street alongside the double-wide culvert where an 18" corrugated stormwater pipe enters the tributary bringing in additional flows during rain events

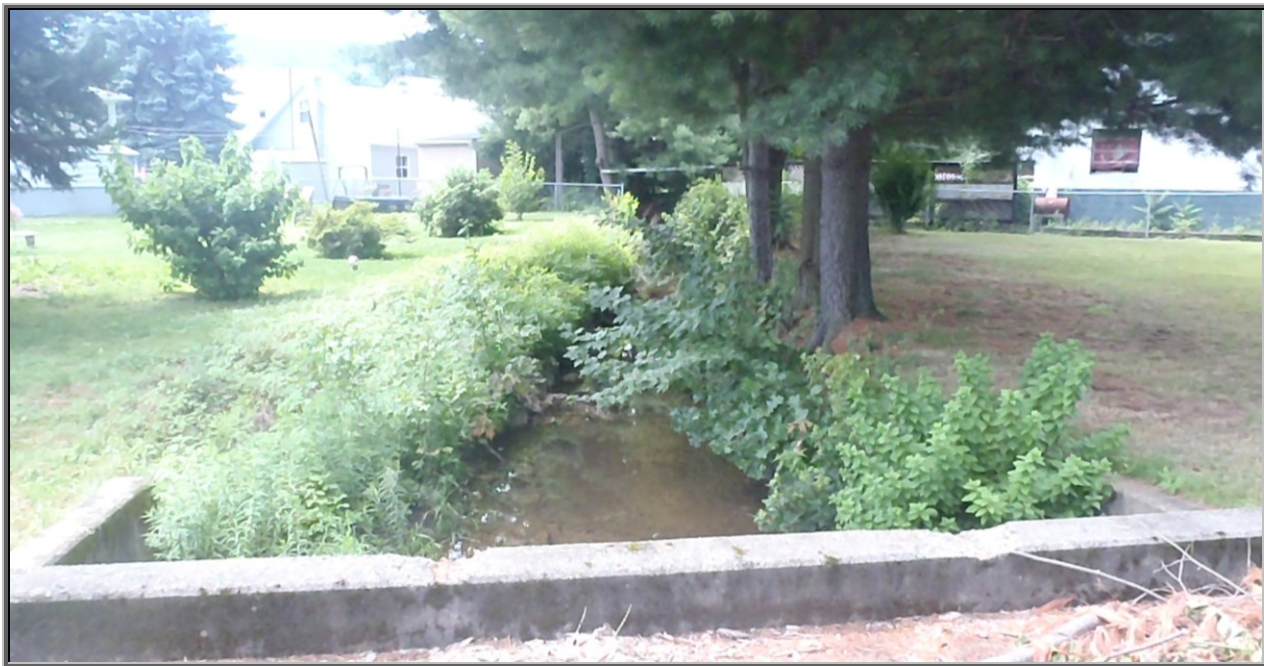
Photo : Sugar Notch Run flowing through Carey's Patch looking upstream through some private yards where the tributary has been modified and channelized heavily by residents probably to prevent further flooding incidents in their yards

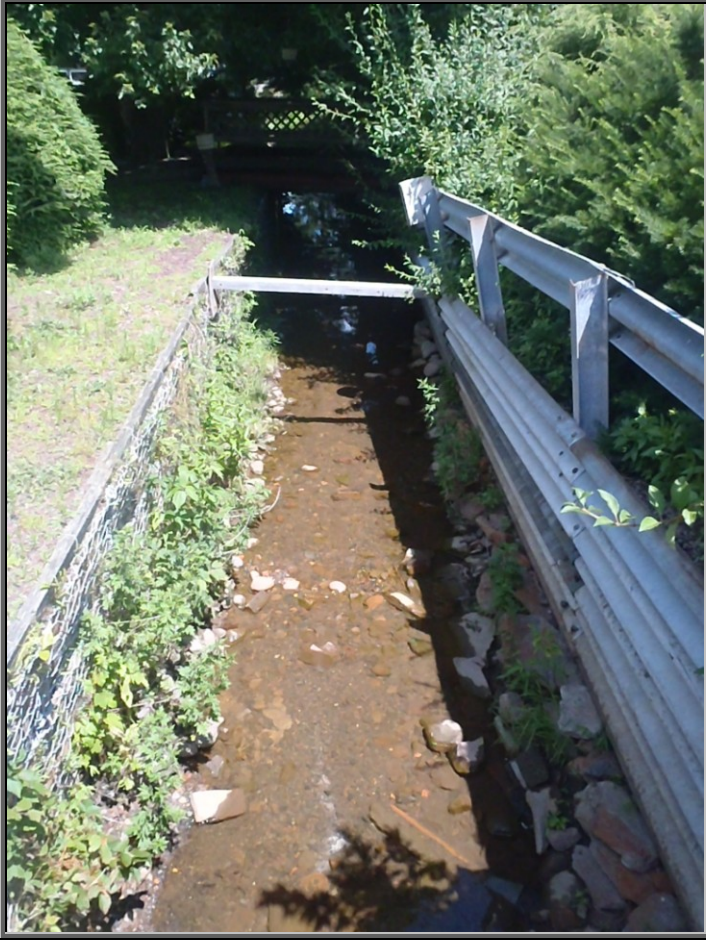
Photo : Sugar Notch Run looking downstream from the other end of Carey's Patch through some private yards where the tributary has been modified and channelized heavily by residents probably to prevent further flooding incidents in their yards using gabion baskets and guiderrails

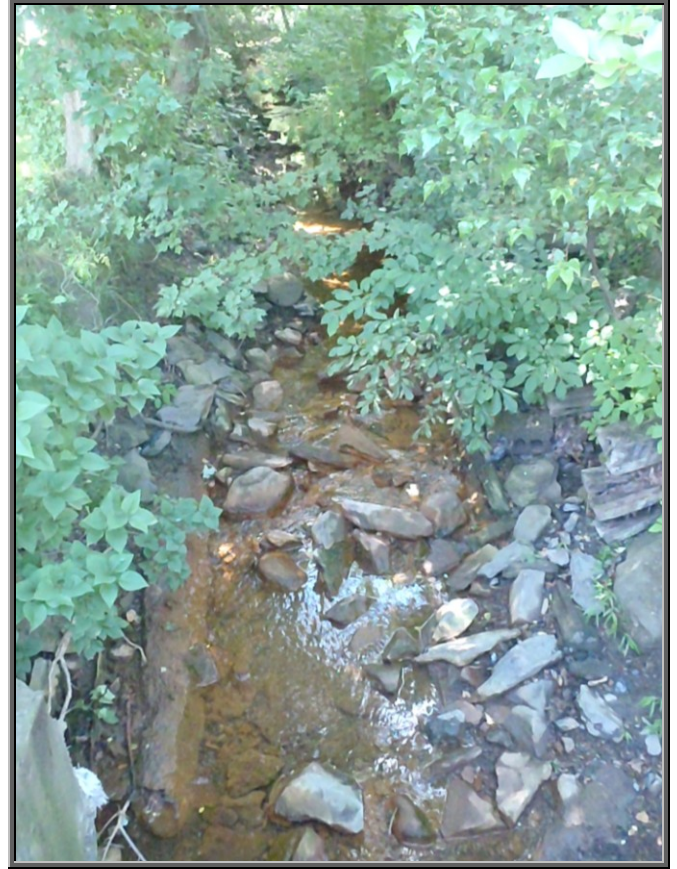
Photo : Sugar Notch Run looking upstream from the other end of Carey's Patch through some private yards where the tributary has been modified and channelized heavily by residents probably to prevent further flooding incidents in their yards using railroad ties

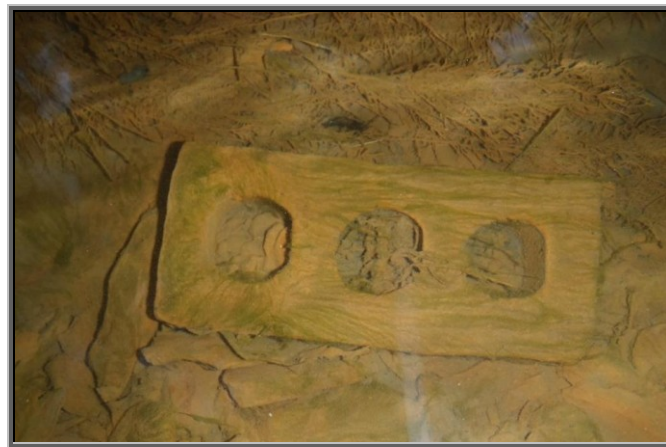
Photo : 3 holed masonry brick submerged in AMD and filamentous algae in Sugar Notch Run

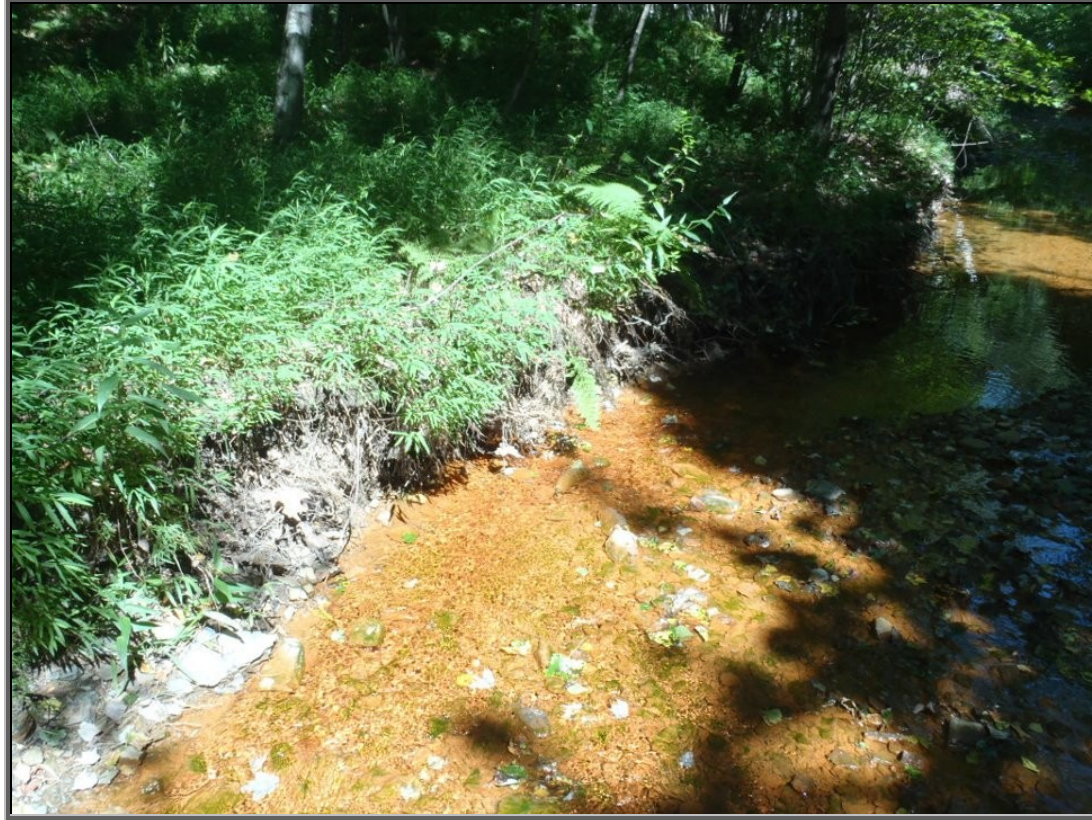
Photo : AMD in Sugar Notch Run before reaching Carey's Patch

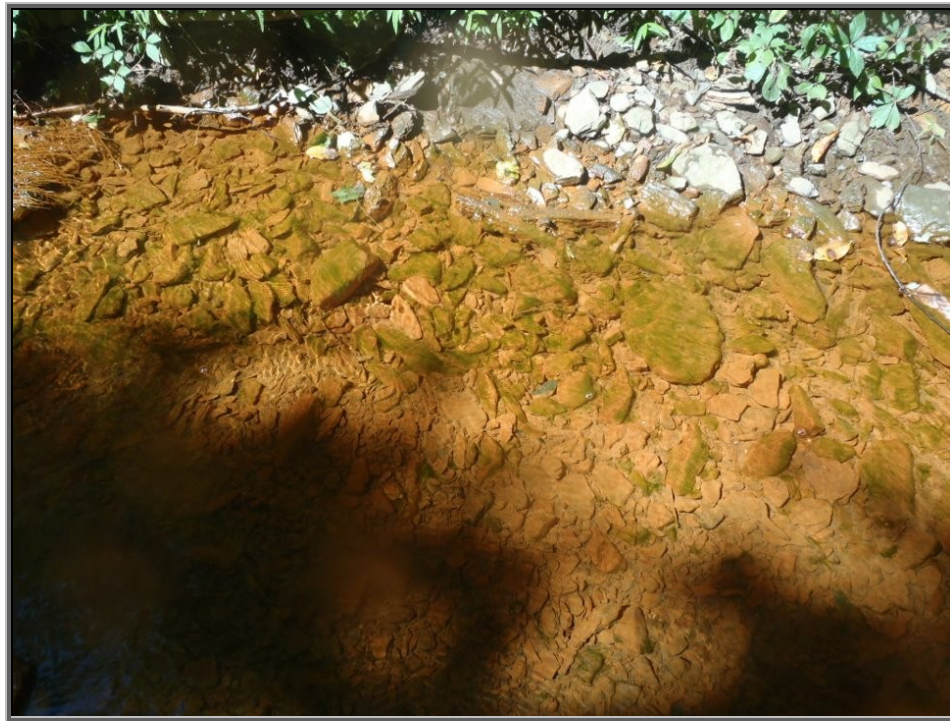
Photo : AMD, shaley rock, and filamentous algae in Sugar Notch Run before reaching Carey's Patch

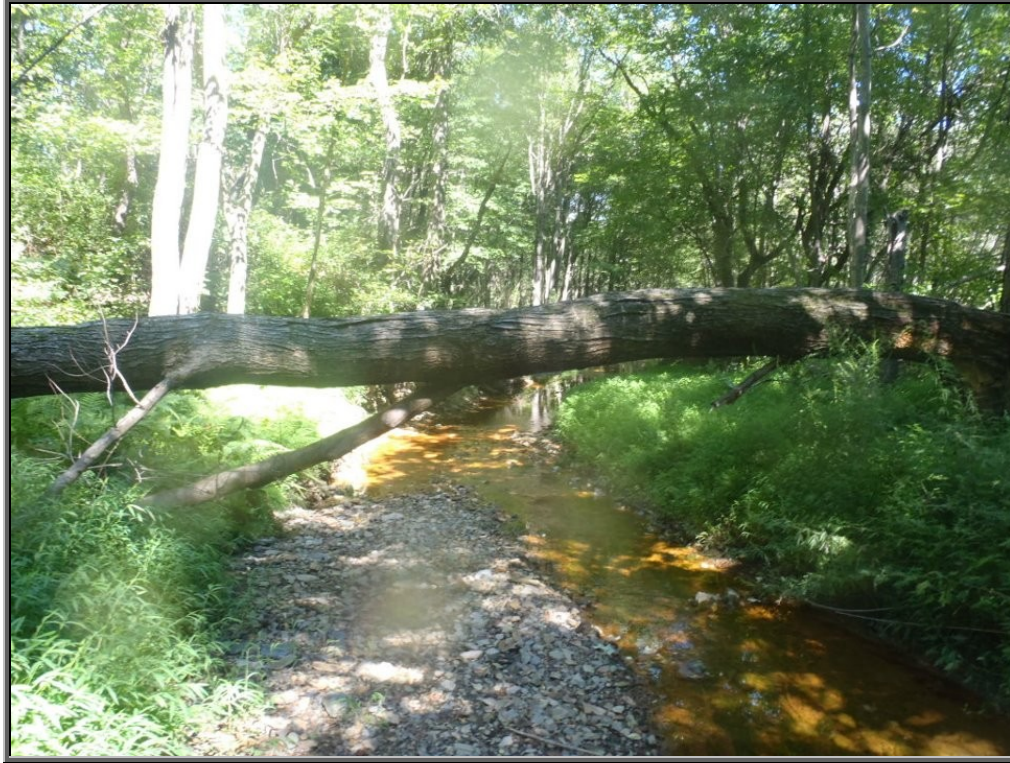
Photo : AMD, a gravel bar and fallen tree across Sugar Notch Run heading downstream towards Carey's Patch; The fallen tree could pose a future woody debris blockage and flooding concern for Carey's Patch and could easily be removed with a chainsaw as a part of a stream improvement project

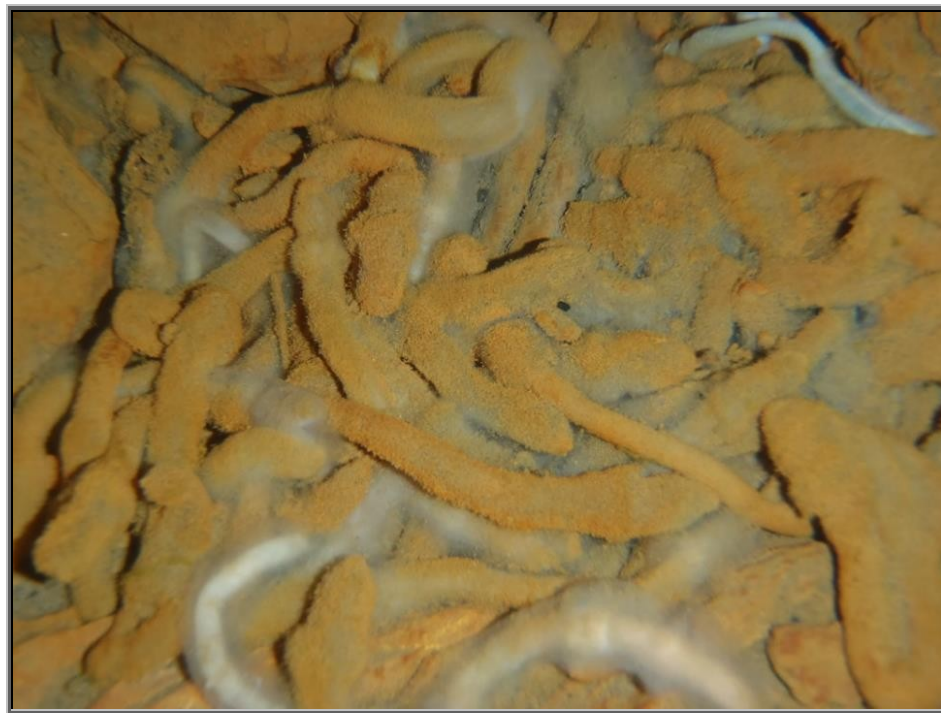
Photo : Hundreds of dead earthworms along the stream bottom of Sugar Notch Run never seen before in an AMD impacted stream

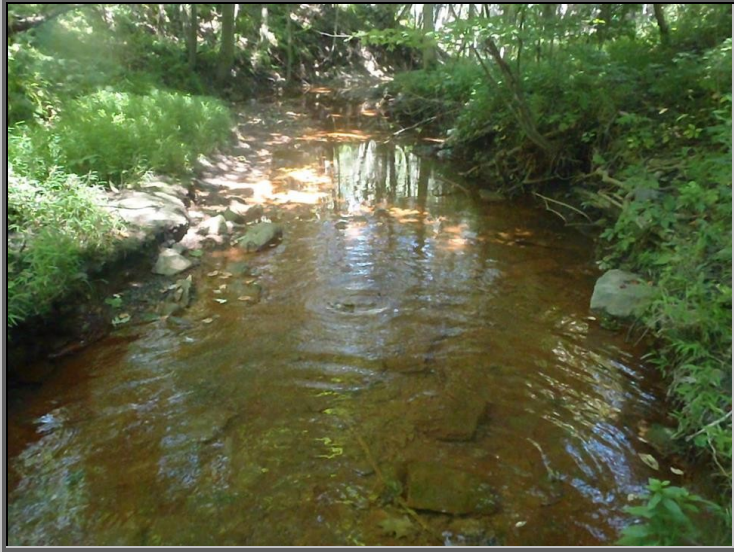
(L) Photo : Iron hydroxide precipitate even more evident and in higher concentrations within Sugar Notch Run downstream

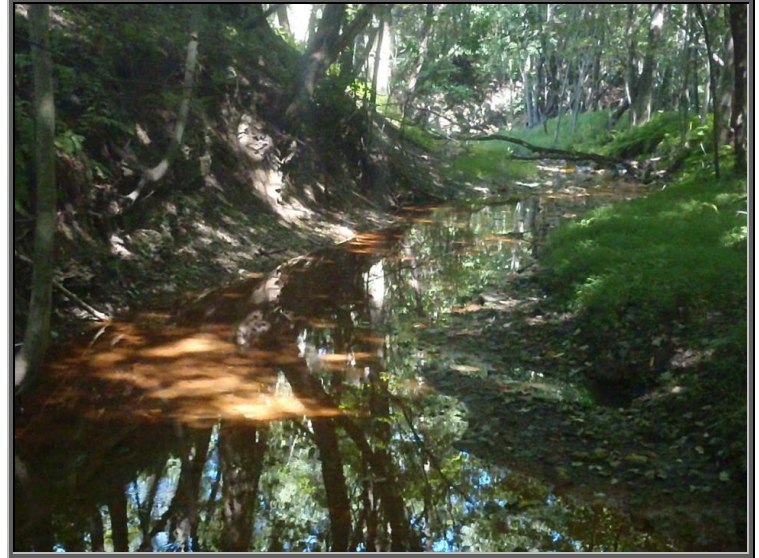
(R) Photo : Shaley outcrop on left bank and iron hydroxide present in great abundance

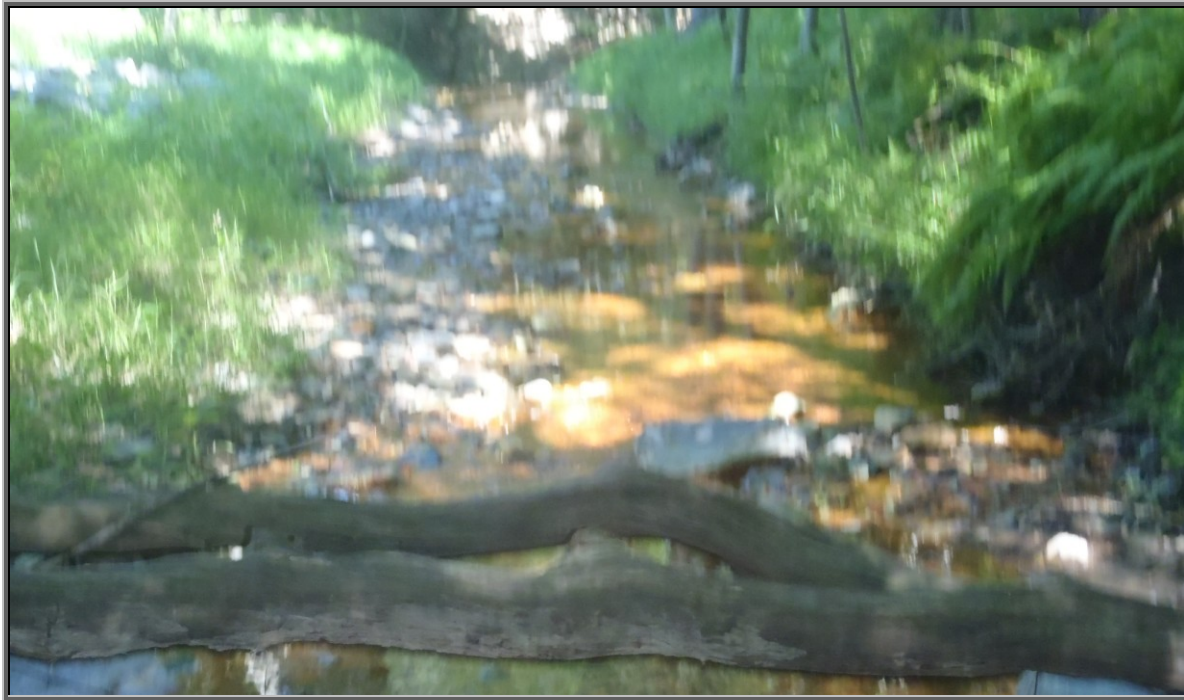
Photo : Sugar Notch Run just upstream of the Huber IV Reclamation stormwater culvert with some woody debris blockage across the channel

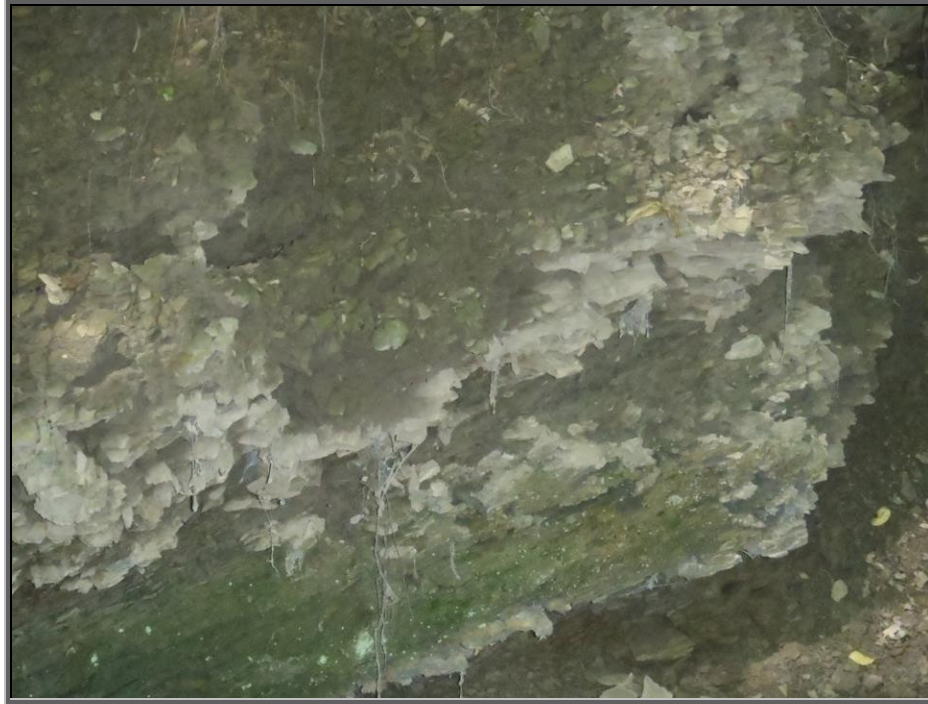
Photo : Shaley outcrop along the left streambank of Sugar Notch Run that was highly erodible and is the probable source of most of the shaley streambed further downstream before entering Carey's Patch

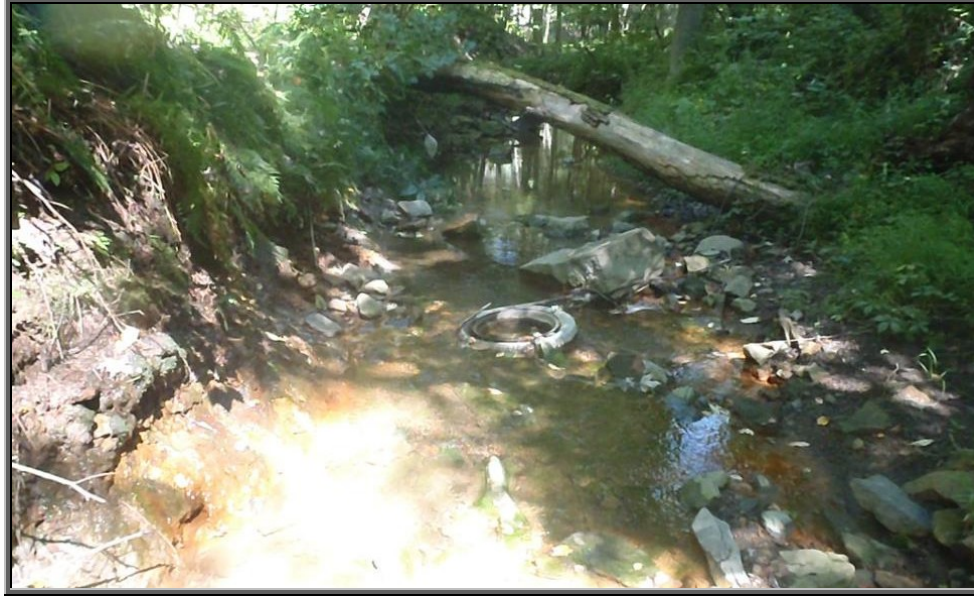
Photo : Presence of iron hydroxide becomes readily apparent within Sugar Notch Run within 100' downstream of the railroad tunnel from within the streambed itself with no apparent discharge locations in sight; Debris is littered throughout this reach

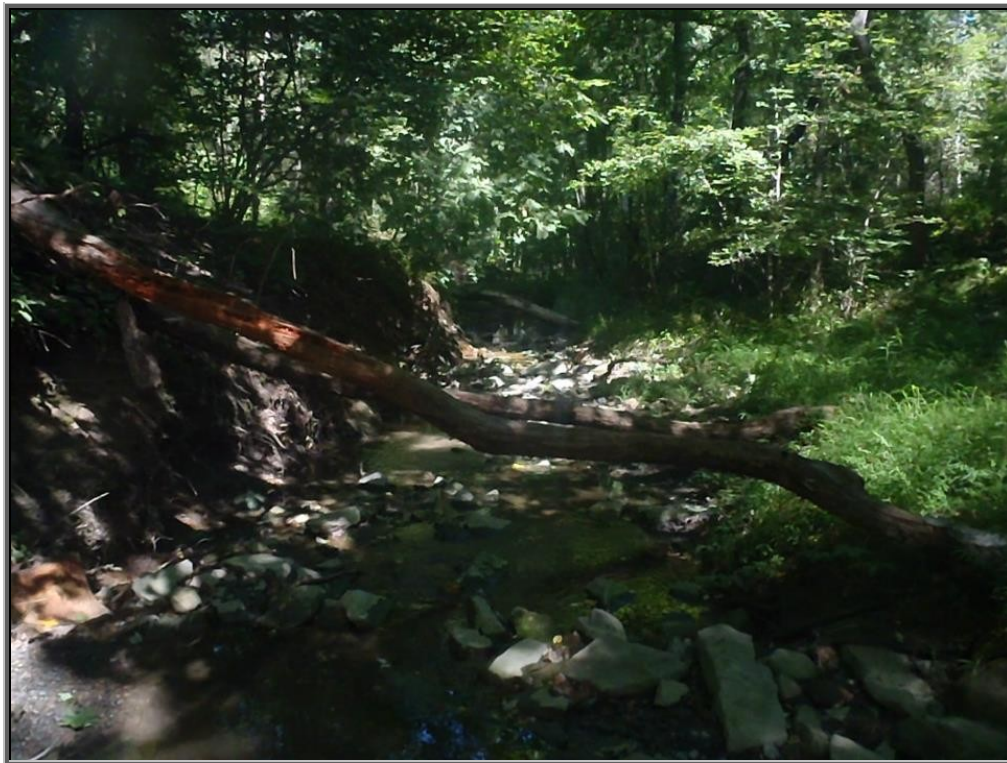
Photo : Several woody debris blockages within the stream corridor of Sugar Notch Run looking downstream; Easy removal of such blockages could occur as a part of a stream improvement project; AMD is not present in this short reach just beyond the railroad tunnel

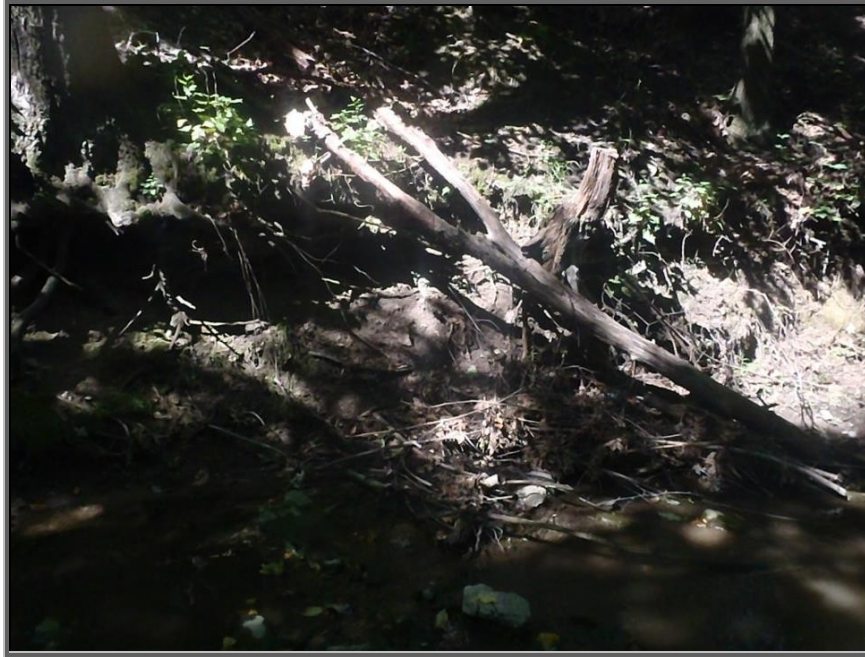
Photo : Minor undercutting of the left bank of Sugar Notch Run probably due to flashy floods on Sugar Notch Run as stormwater scours the area downstream of the railroad tunnel

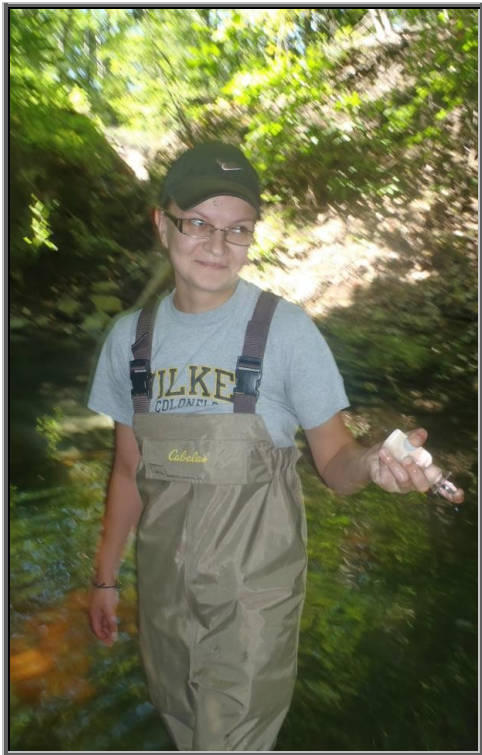
(L) Photo : Justyna Sacharzewska, EPCAMR Watershed Outreach and Education Intern samples the Dissolved Oxygen downstream of the railroad tunnel on Sugar Notch Run

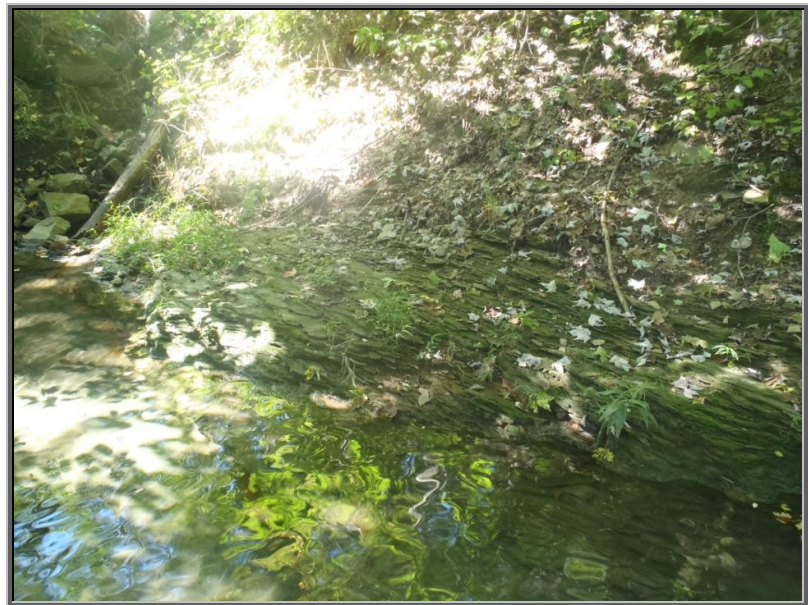
(R) Photo : Shale outcrop along the left bank of Sugar Notch Run looking downstream of the railroad tunnel

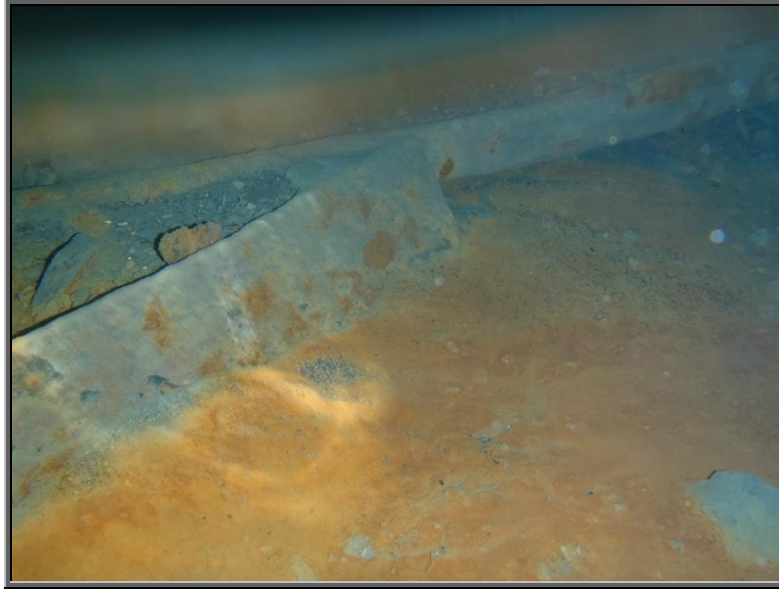
(R) Photo : Rusted rails at the bottom of a 4' deep pool with some iron precipitation on Sugar Notch Run just outside of the railroad tunnel

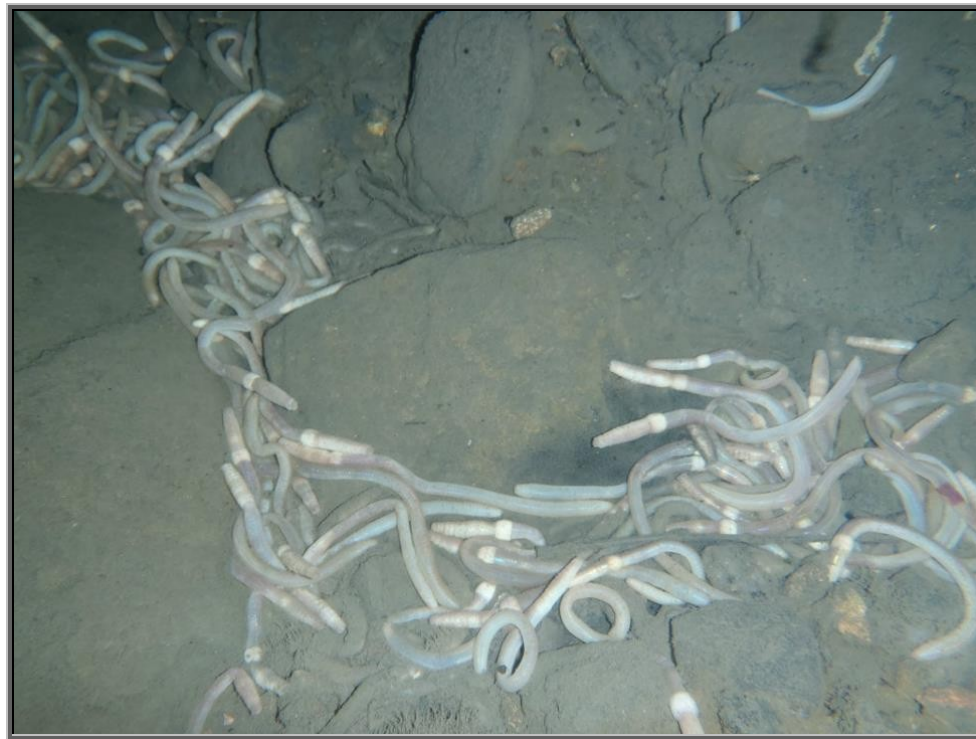
Photo : Hundreds of dead earthworms along the bottom of a 4' pool in Sugar Notch Run just outside of the railroad tunnel

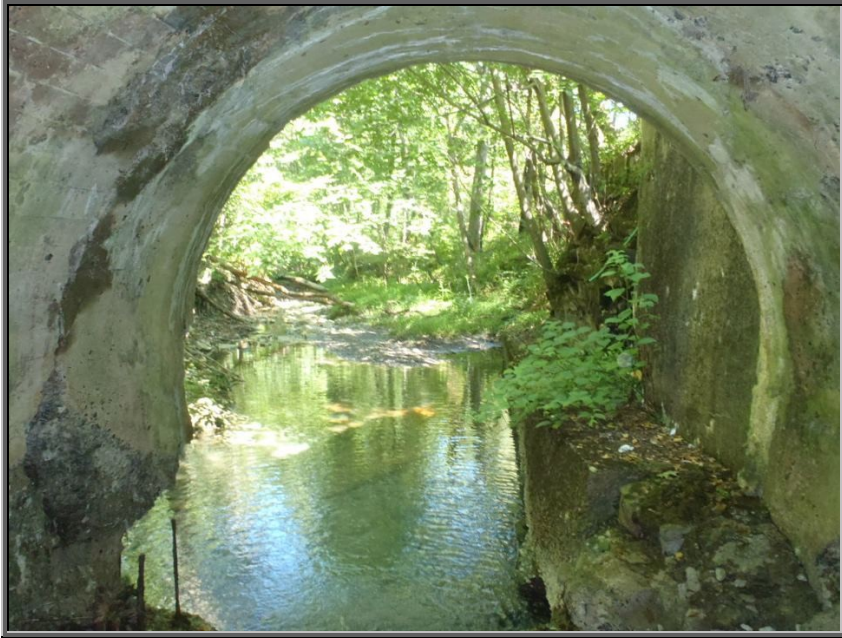
(L) Photo : Looking downstream on Sugar Notch Run at the outlet of the railroad tunnel and the pool below it; At this point, Sugar Notch Run is minimally impacted by AMD

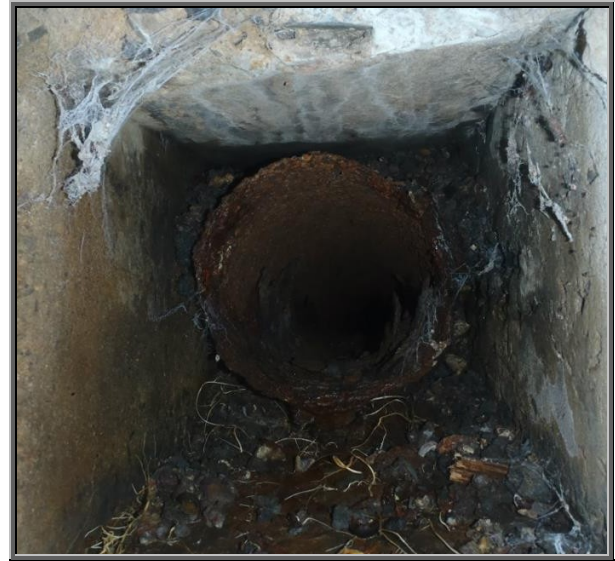
(R) Photo : A look into a rusted drainage pipe built within the railroad tunnel sidewall

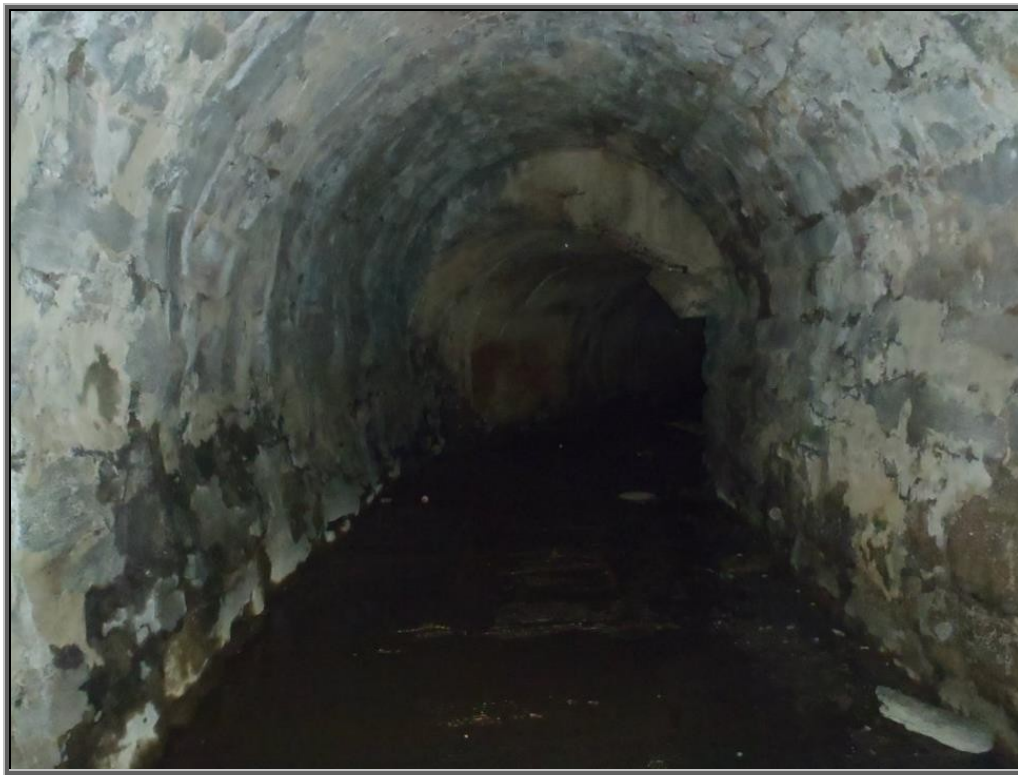
Photo: Old masonry meets new masonry work at the bend in the tunnel; Sugar Notch Run flows over wooden timbers on the left hand-side of the channel within the tunnel

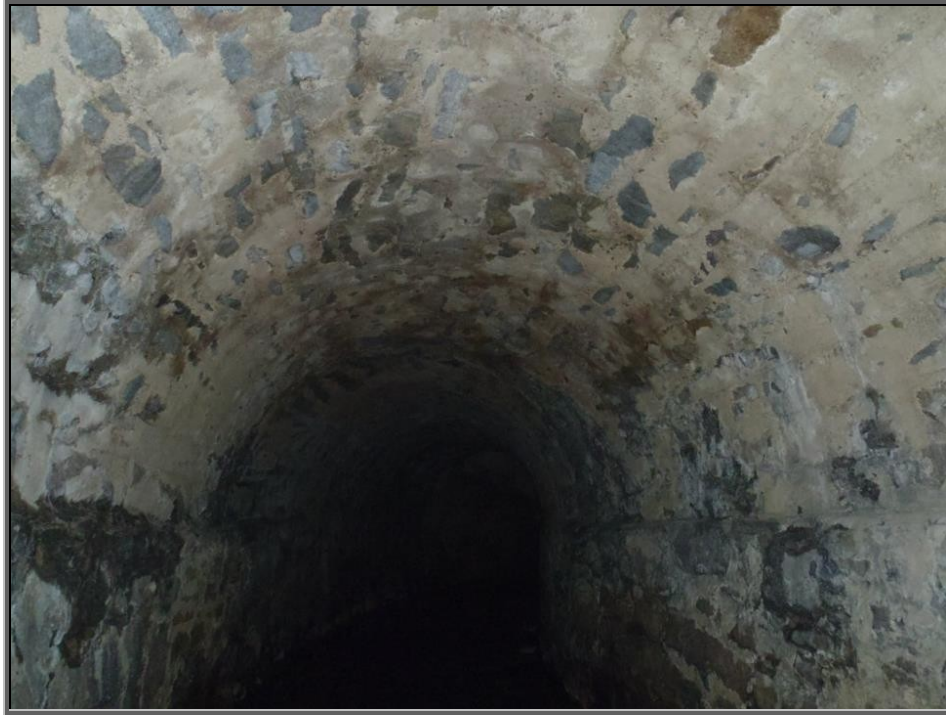
Photo: Grout work touch ups at a bend in the railroad tunnel; Walking into the darkness

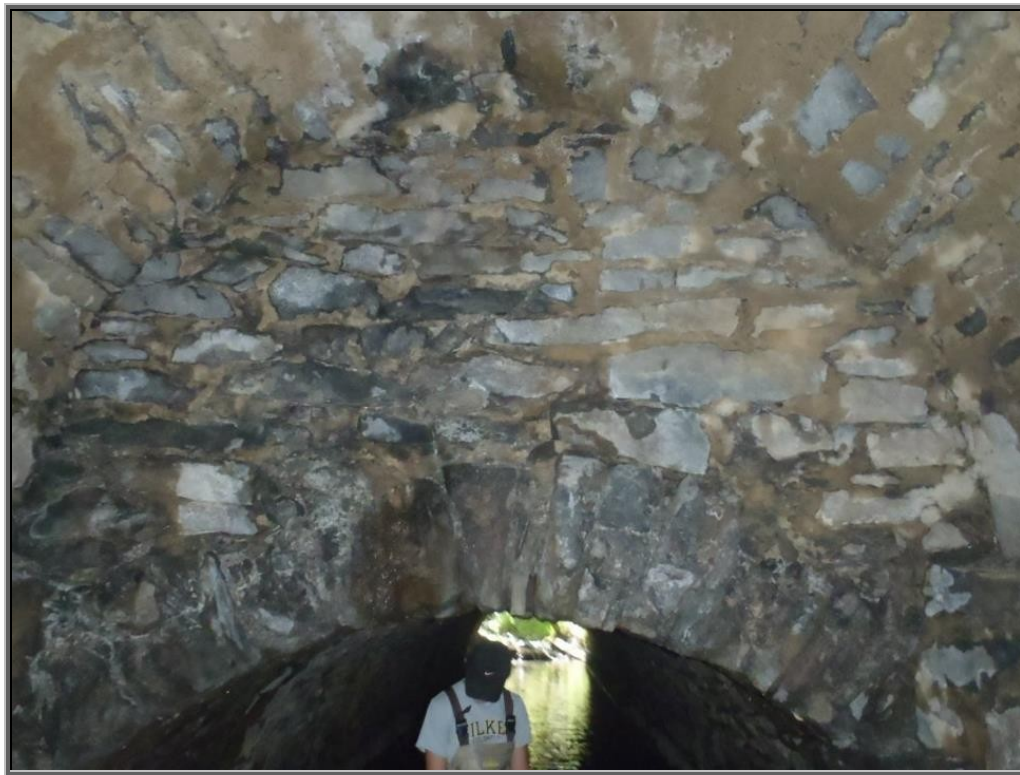
Photo: A second grouting of the original section of the railroad tunnel; Interesting mason work and keystone work on the arch; Justyna making her way through Sugar Notch Run and the tunnel looking upstream back towards the Preston section of Ashley Borough
