Sugar Notch Run sub-watershed Assessment

EPCAMR surveyed 6 stream segments in the Sugar Notch Run sub-watershed. They were labeled as **SNR 01-06** in the data tables and on the Solomon Creek Watershed Monitoring Map. The photo essay documents the entire length of the tributary and their unnamed tributaries and on occasion makes recommendations for future stream or habitat improvement projects or cleanups.

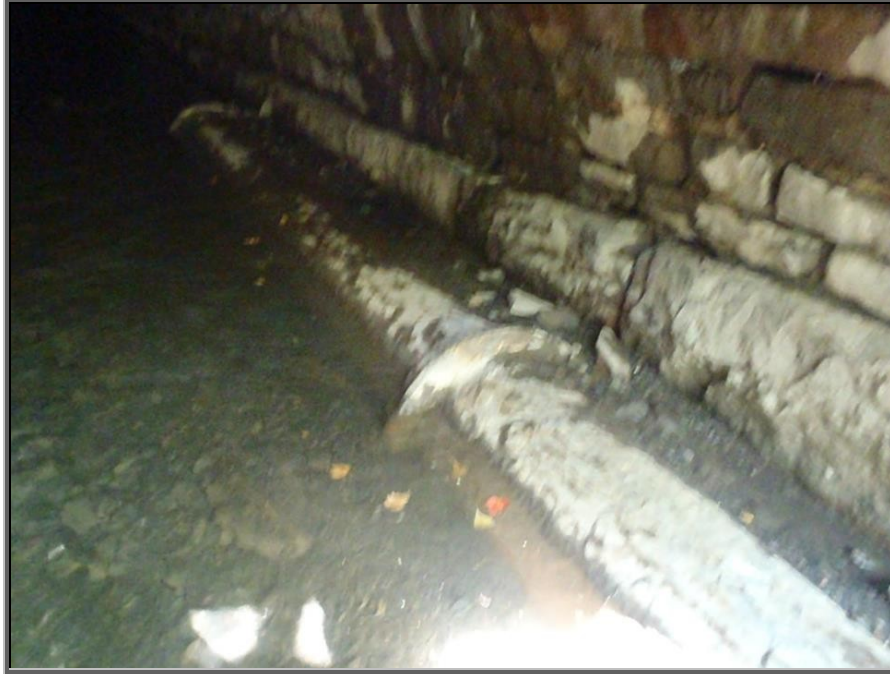
Photo: Partially submerged sanitary sewer line running underneath the railroad tunnel inside the Sugar Notch Run streambed

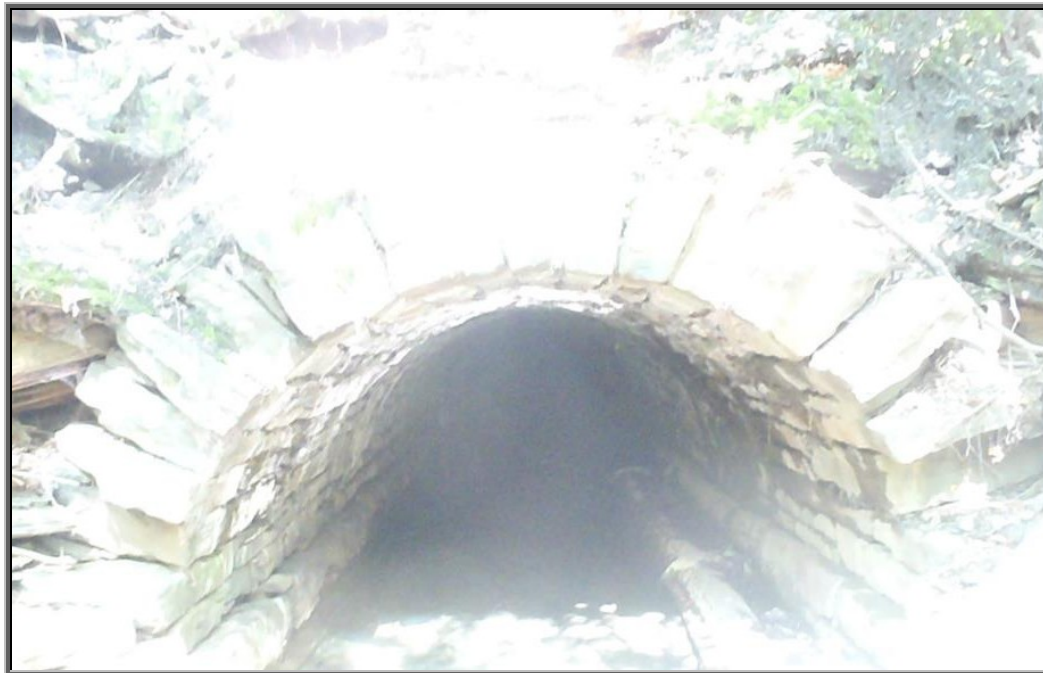
Photo: Looking into the stone arch railroad tunnel crossing and one of the submerged Ashley sanitary sewer mains or WVSA main along with Sugar Notch Run flowing downstream behind the Preston section of Ashley Borough

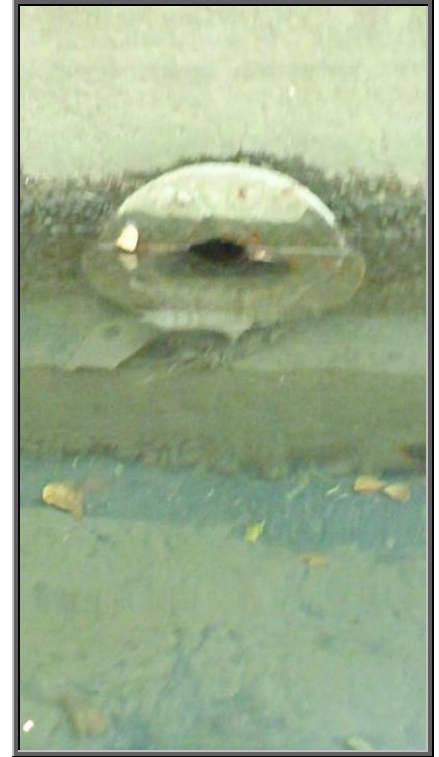
(R) Photo : One of the intake pipes along the foundation wall of the abandoned Huber Breaker Colliery Pump House along Sugar Notch Run partially submerged

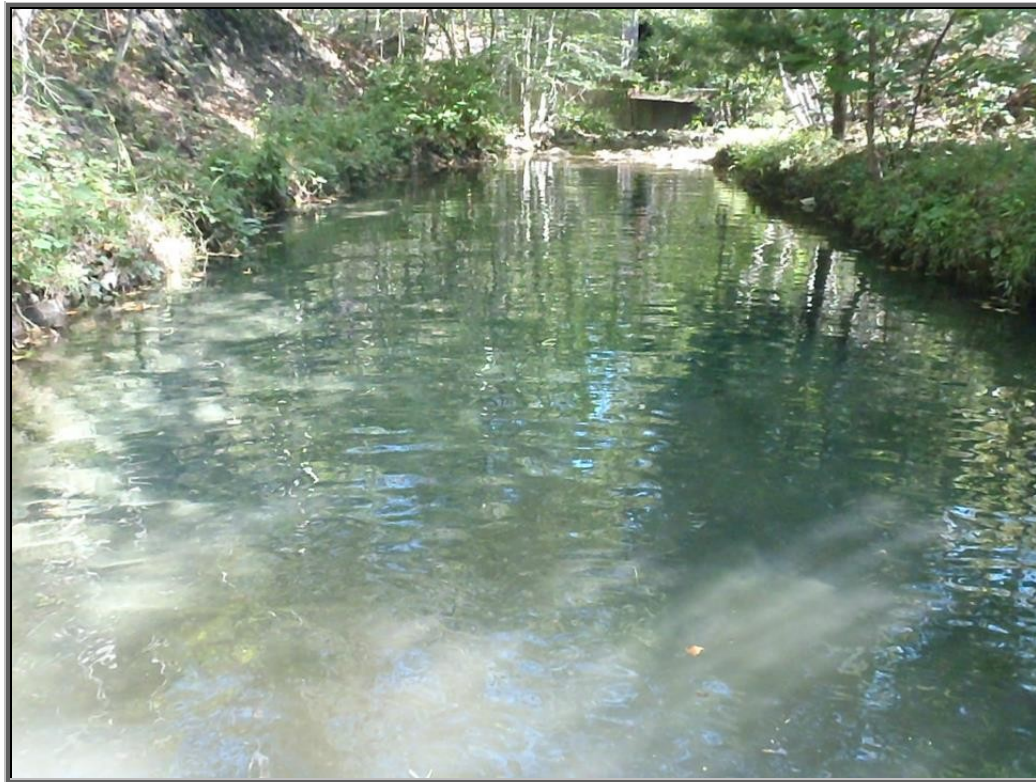
Photo : Looking downstream into a 5' scour pool at the end of the pipe on Sugar Notch Run behind the Preston section of Ashley Borough

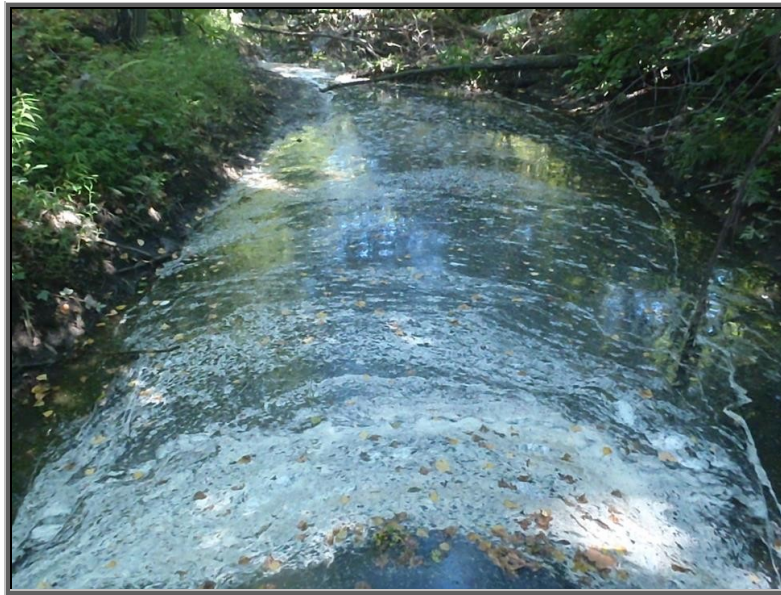
Photo : Possible phosphate foam and froth at the surface of Sugar Notch Run looking downstream

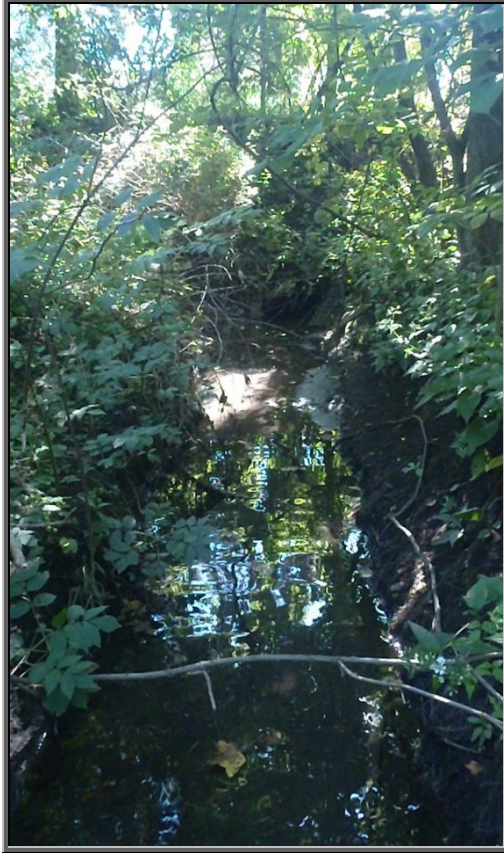
(L) Photo : Ashley storm drain diversion ditch off S. Main Street entering Sugar Notch Run through a 30' incised channel

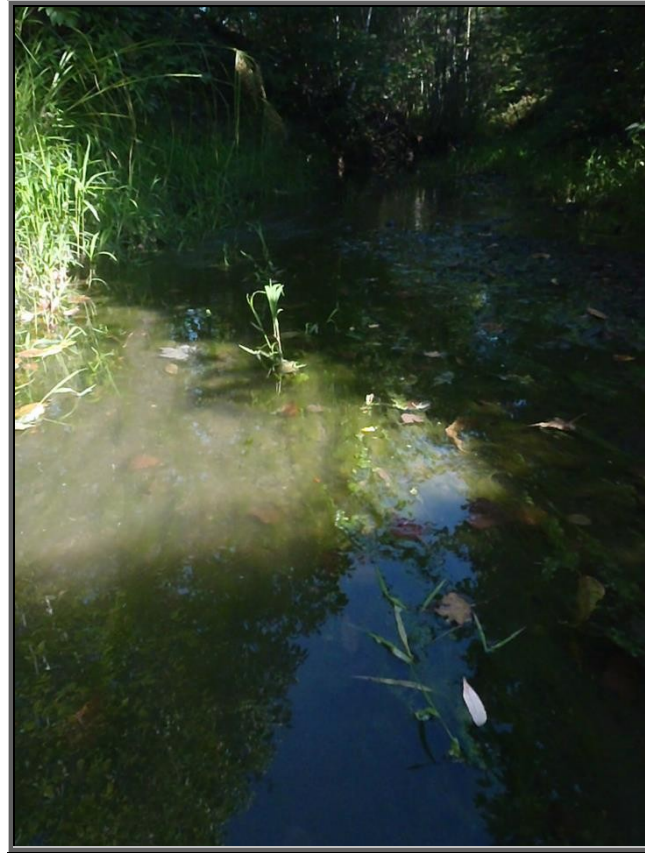
(R) Photo : Close up of the algae and grasses looking downstream on Sugar Notch Run behind the Preston Hose Company in Ashley Borough; Sugar Notch Run is full of coal fines, cinders, and sediment at this location

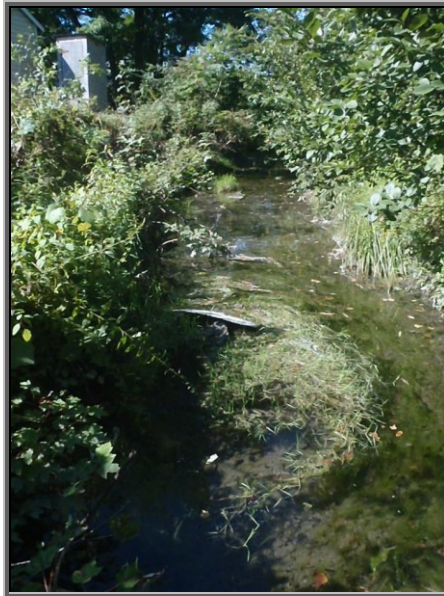
Photo : Sugar Notch Run loaded with green filamentous algae and grasses just behind the Preston Hose Company in Ashley Borough

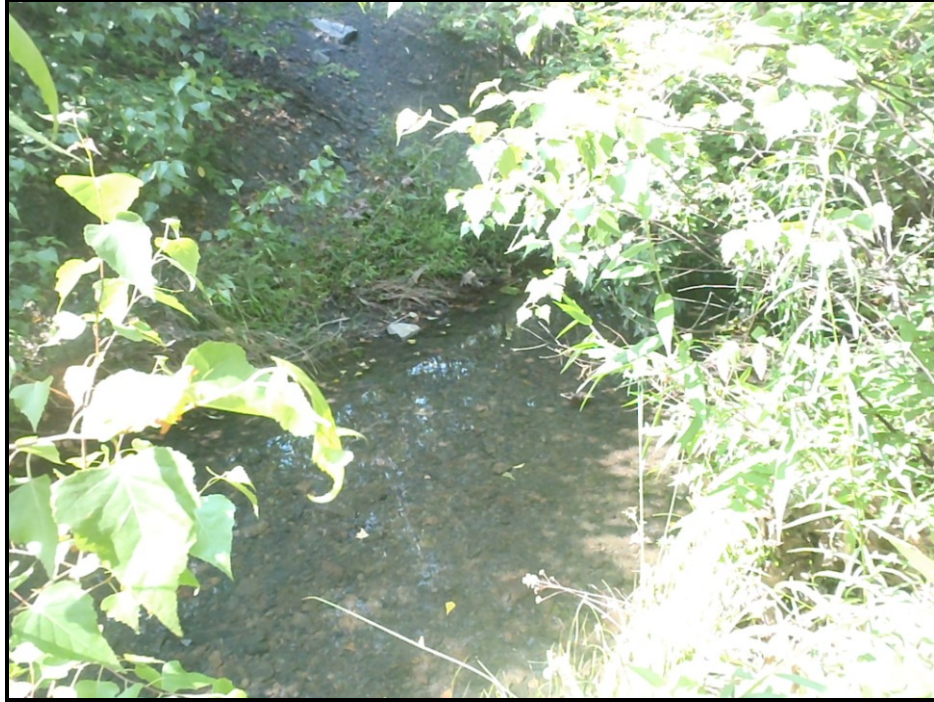
Photo : Storm water drainage from S. Main Street flowing into Sugar Notch Run

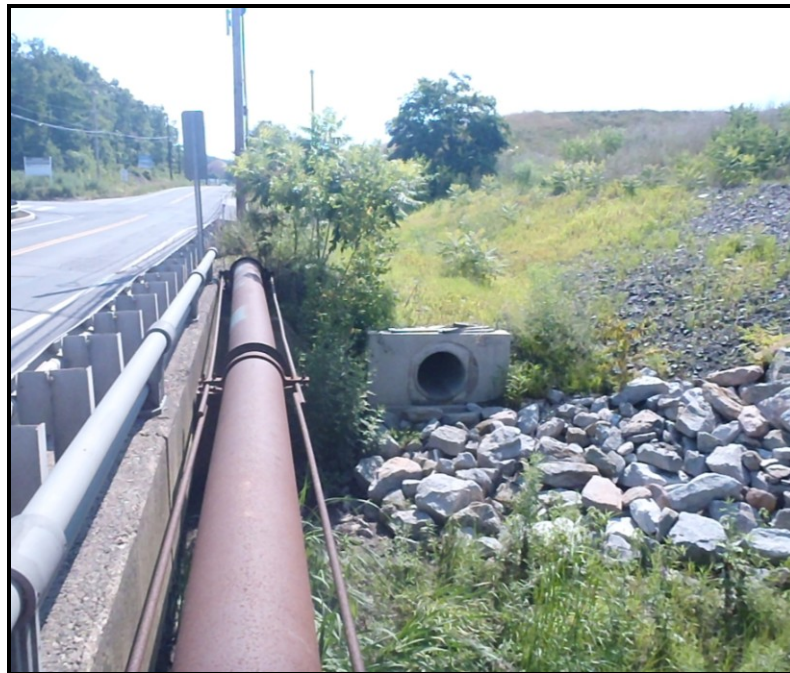
Photo : Storm water drainage outlet with rock apron into Sugar Notch Run along S. Main Street looking south

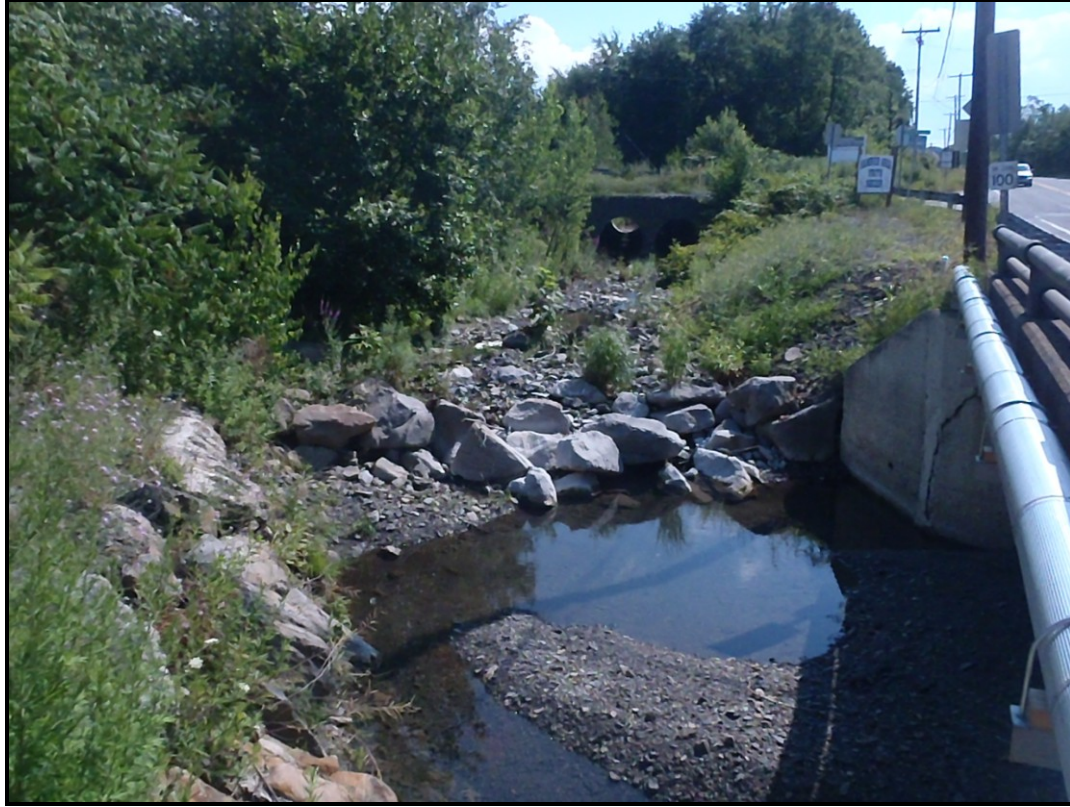
Photo : Gravel bar deposition, point bars, and a check dam of sorts along the upstream side of the bridge over S. Main Street as Sugar Notch Run continue up upstream towards Preston Road; Removal of the gravel and point bars are recommended to prevent future flooding situations from occurring along S. Main Street

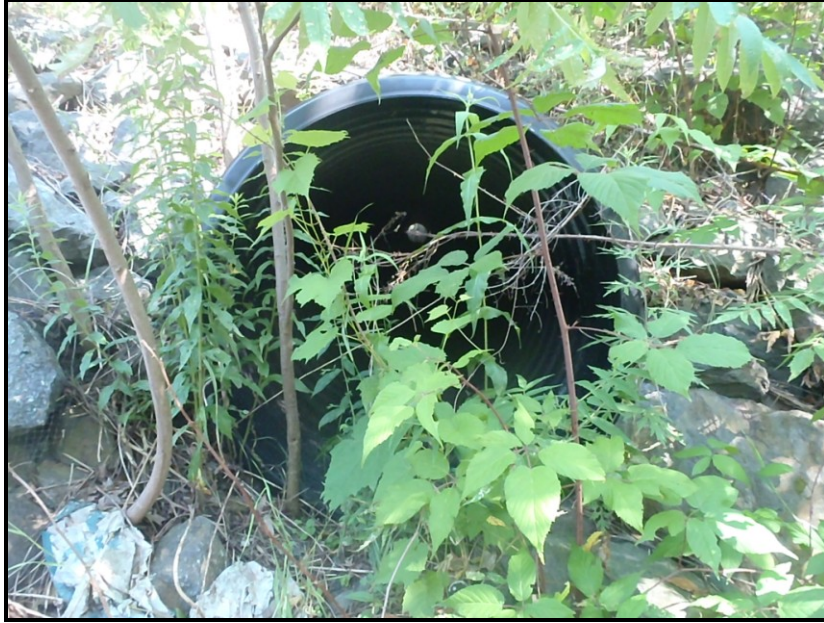
Photo: A stormwater pipe entering the left bank of Sugar Notch Run just upstream of the culvert drainage system beneath Preston Road

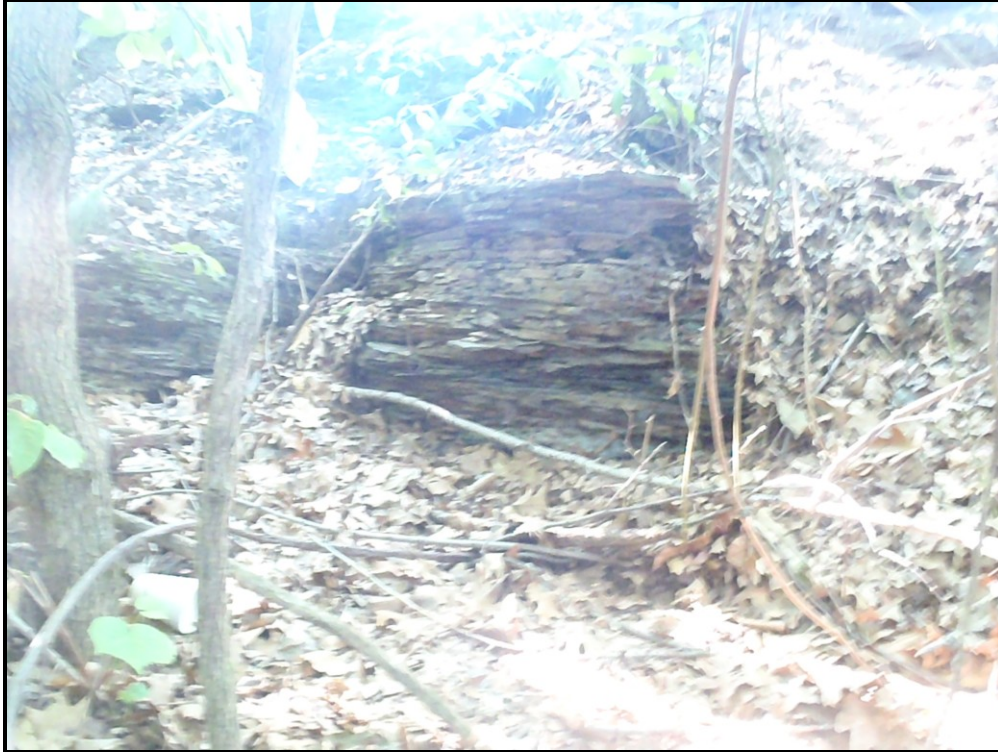
Photo: A shaley outcrop along the right bank looking upstream on Sugar Notch Run that has eroded to the point where stormwater from South Main Street has entered this section and cut down into the fracture shale and caused it to break up into the channel

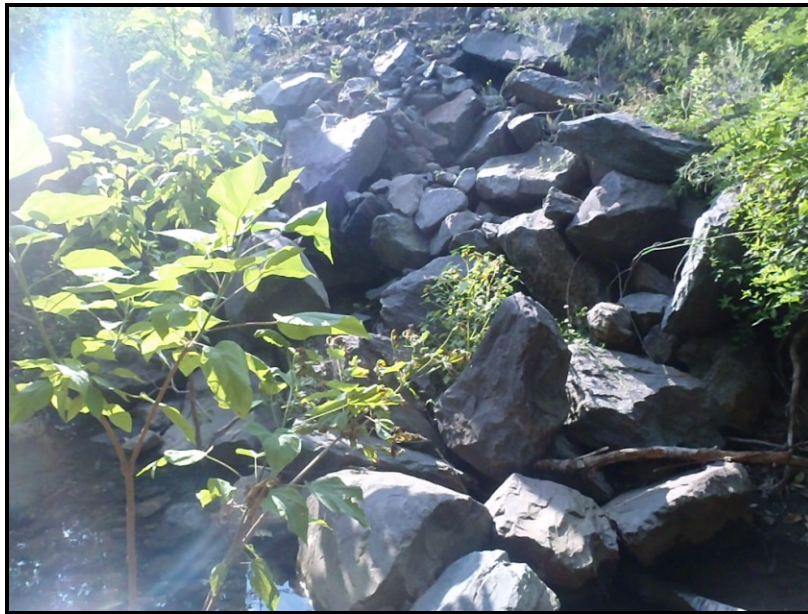
Photo: A rock-filled stormwater drainage area backfilled at some point to prevent further erosion of the channel along the right bank of Sugar Notch Run

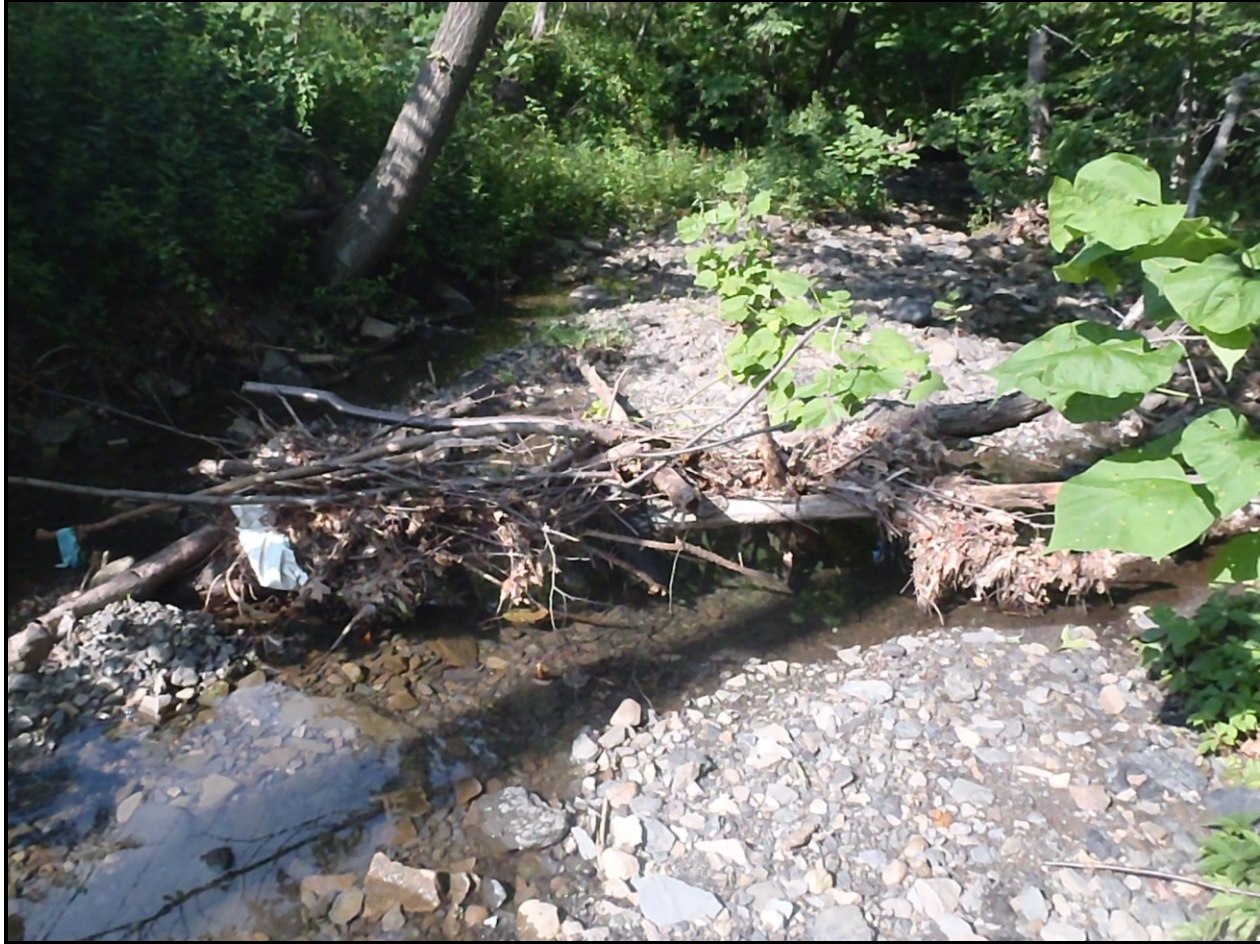
Photo: Looking downstream on Sugar Notch Run at a woody debris dam and gravel deposition from the previously filled erosion stormwater channel that entered the tributary from S. Main Street

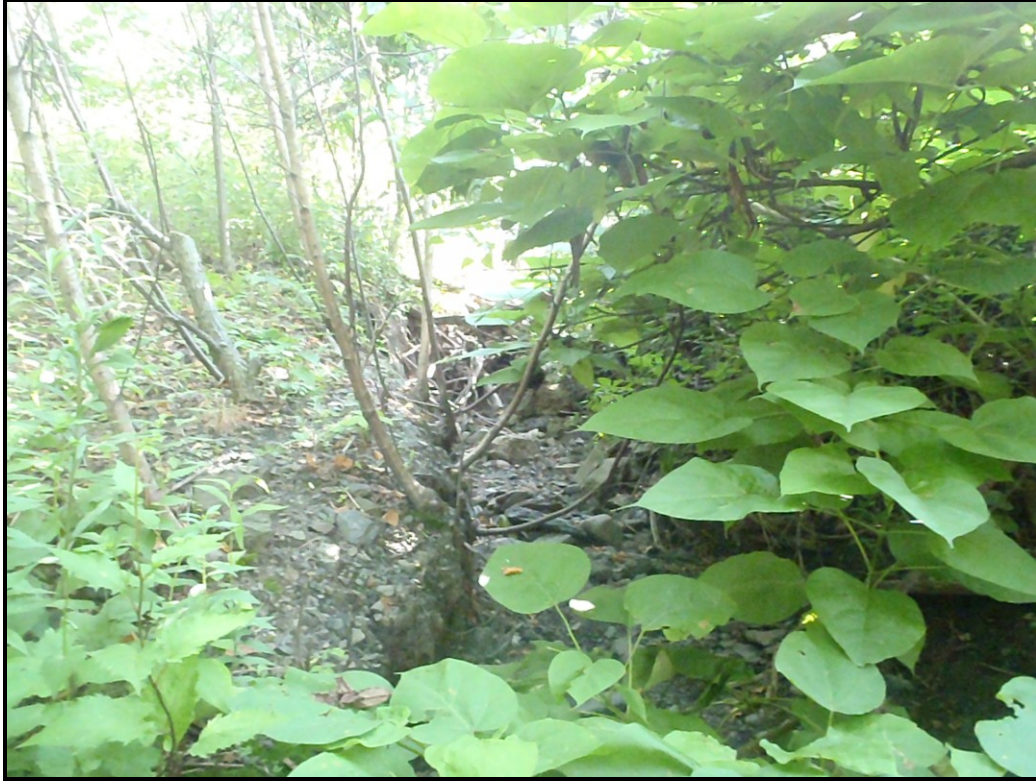
Photo: Another stormwater channel cutting into the right stream bank further upstream seen through the Japanese knotweed

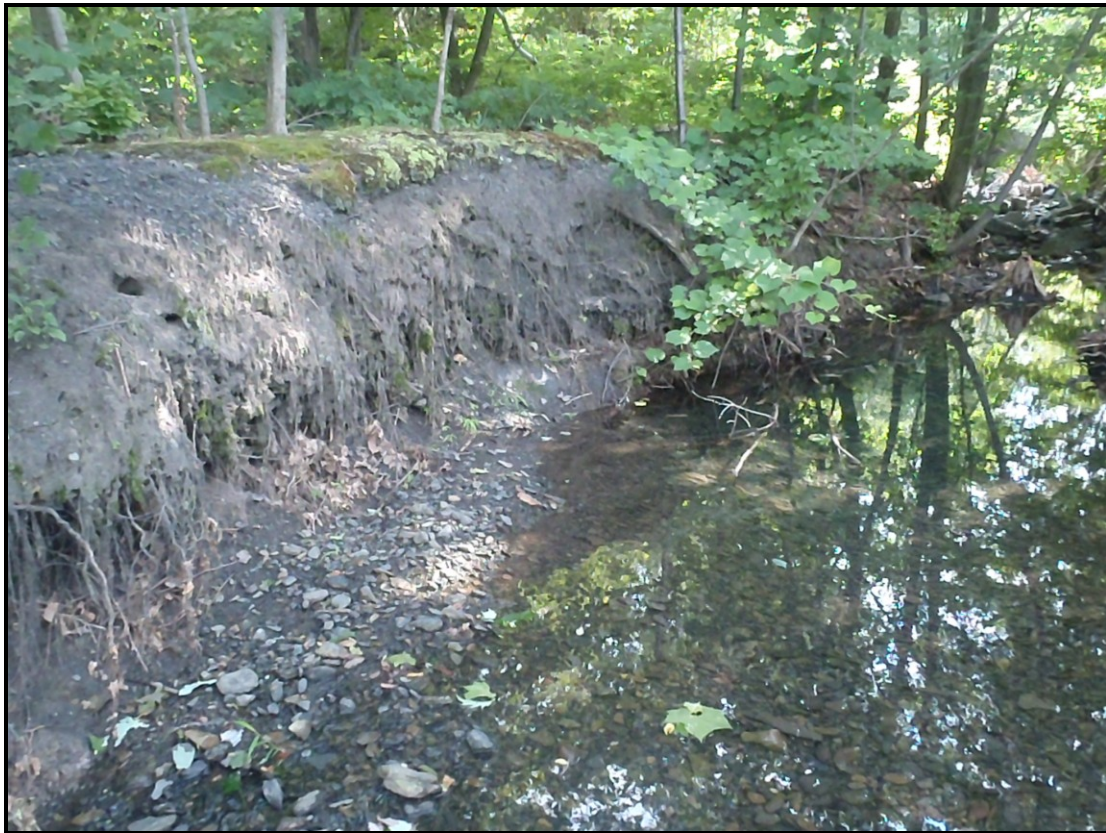
Photo : Streambank erosion along the left bank of Sugar Notch Run just downstream of an area where additional stormwater enters the tributary from several drainage pipes and upstream culverts

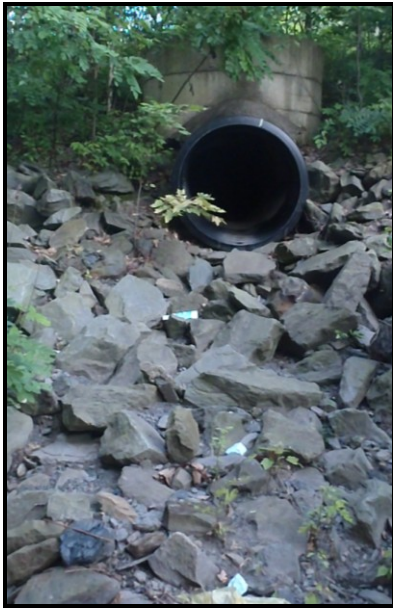
Photo : (L) Stormwater collection chamber along the left bank that empties runoff into the rock apron before entering Sugar Notch Run just upstream of the undercut eroded bank

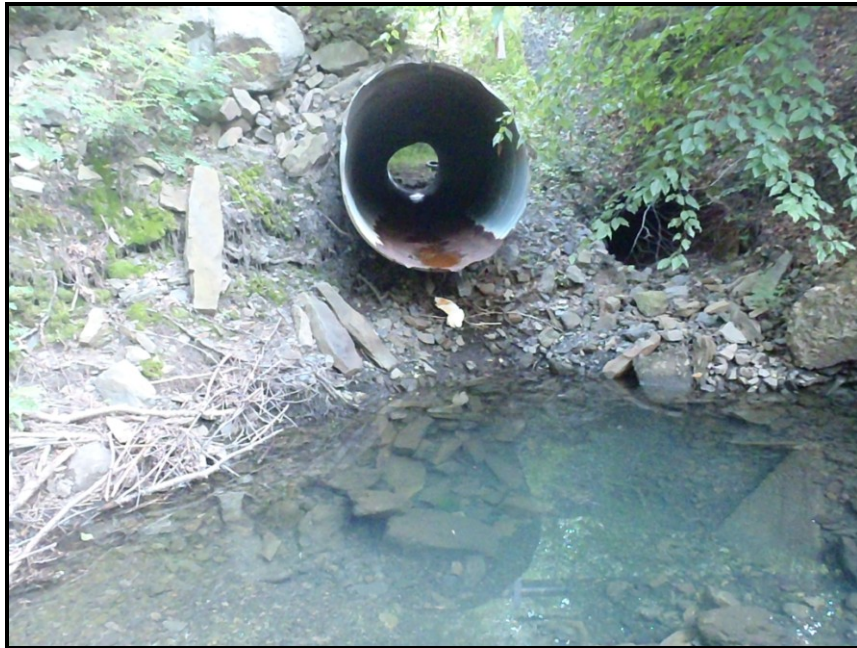
Photo : (R) Sugar Notch Run looking upstream of the stormwater collection chamber would normally flow through both of these drainage pipes, however the pipe to the right is severely blocked and the pipe to the left has created a scour pool and eroded the bank beneath it during previous high flow rain events; A stream improvement project could be designed here to place additional large rock beneath the pipe to prevent further erosion on both sides of the stream bank and would remove the scour pool

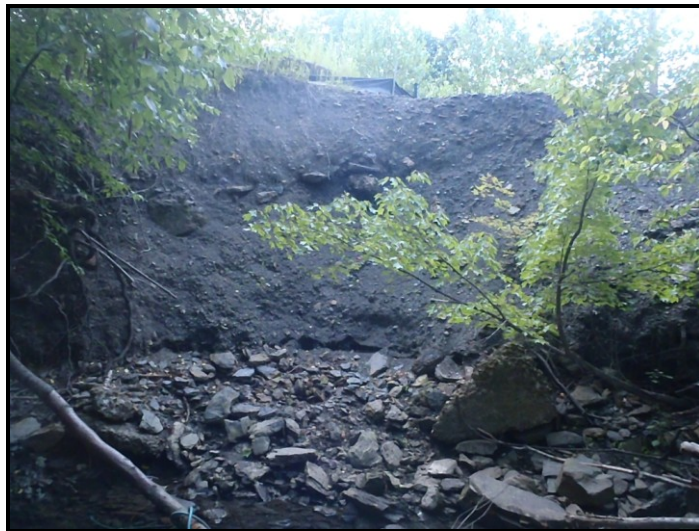
Photo : A large thick layer of coal silt probably from a remnant silt basin nearly 10' thick along the right bank that is severely eroding away and allowing coal silt to enter Sugar Notch Run in this section just downstream of the large corrugated culvert above the scour pool; A possible streambank stabilization project could be looked at for this location

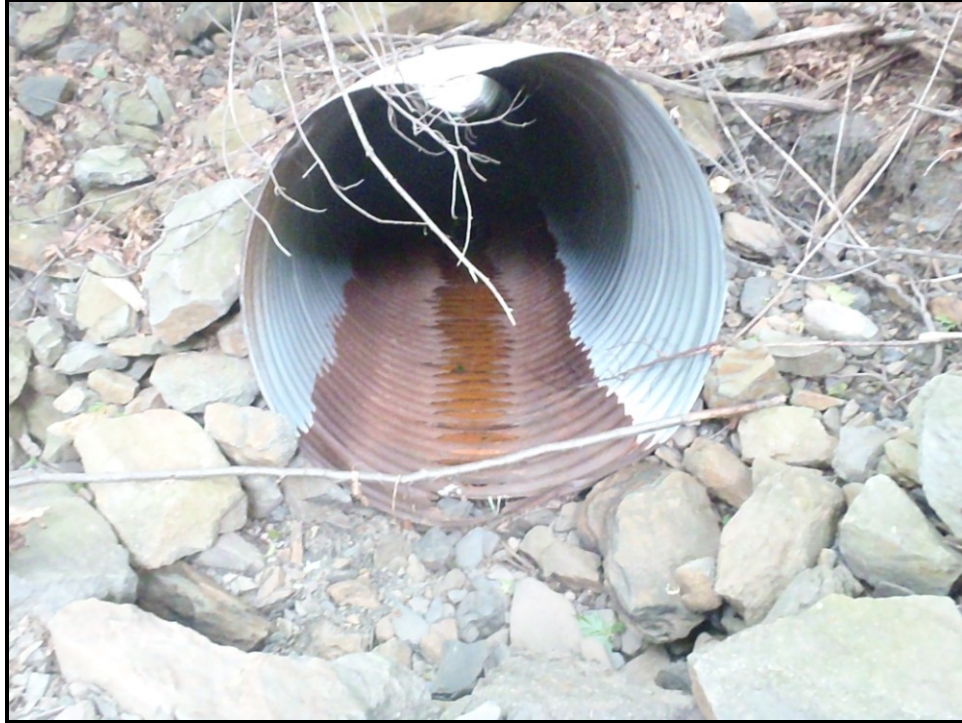
Photo : Looking downstream on what would be Sugar Notch Run, if it were flowing into the drainage pipe; In this location it is a losing reach through the porous culm, rock, and shale in the area

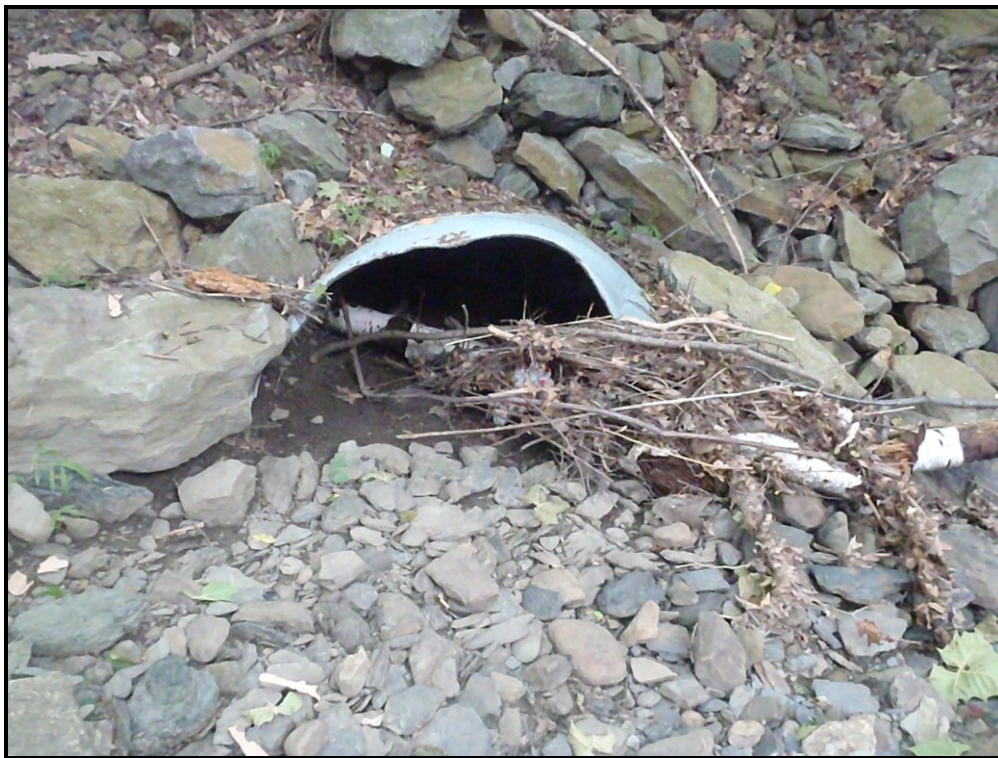
Photo : The left drainage pipe is entirely blocked on the upstream side of Sugar Notch Run which is dry and has already experienced high water and storm events that have deposited all of the smaller rock material in a gravel bar deposition just above both pipes

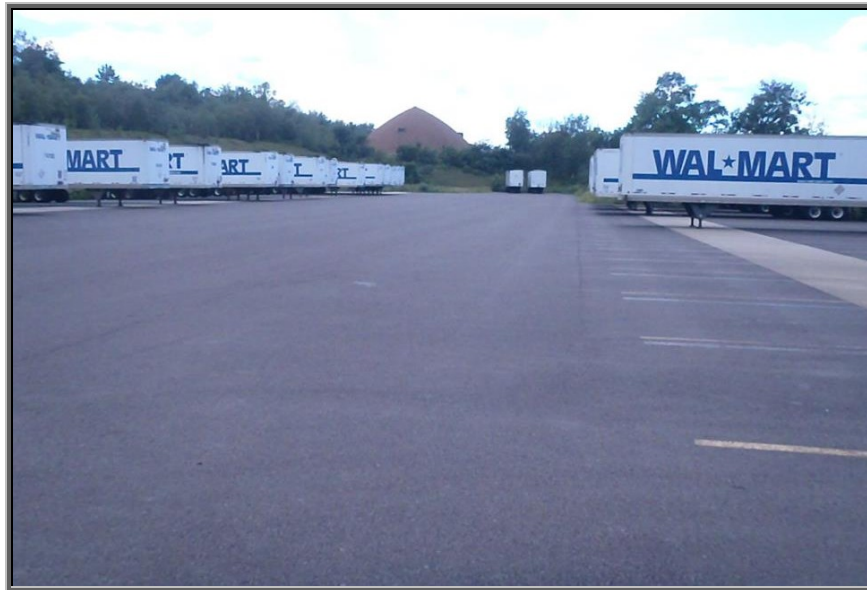
Photo: WALMART Trailer Drop Storage Lot along Preston Drive with the PA DOT Maintenance Dome in the background along S. Main St.

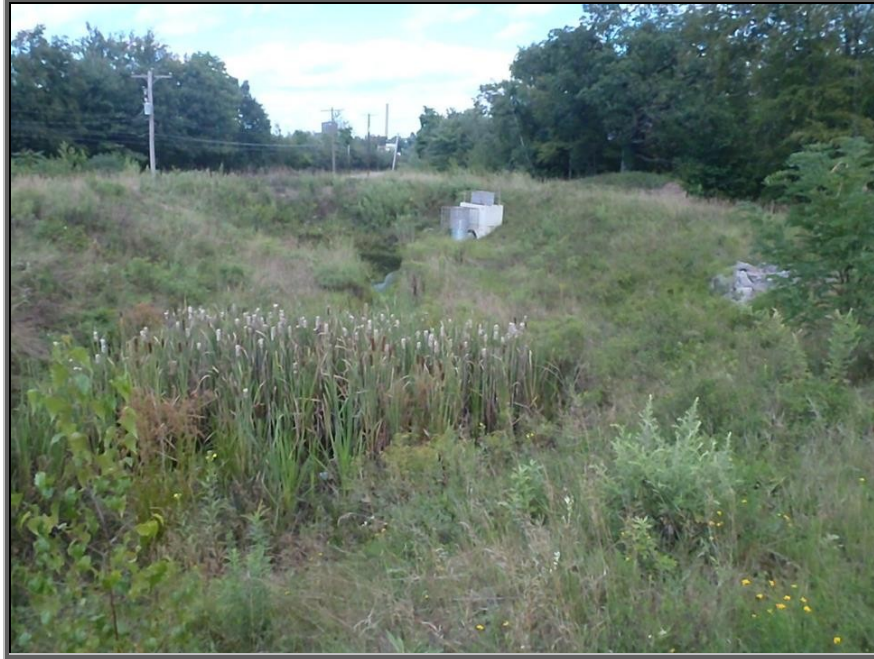
Photo: WALMART Lot Stormwater Detention/Wetlands Basin with a drop inlet structure that empties into Sugar Notch Run to the east of the riser pipe

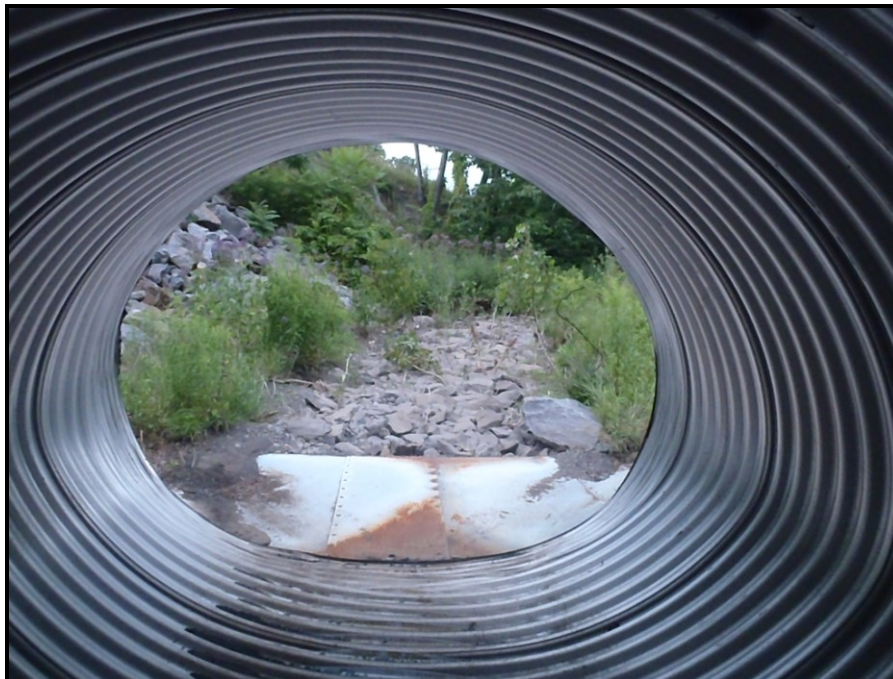
Photo : Looking downstream from inside of a corrugated squash pipe drainage culvert into Sugar Notch Run; WAL-MART stormwater enters from the left side of the bank looking downstream

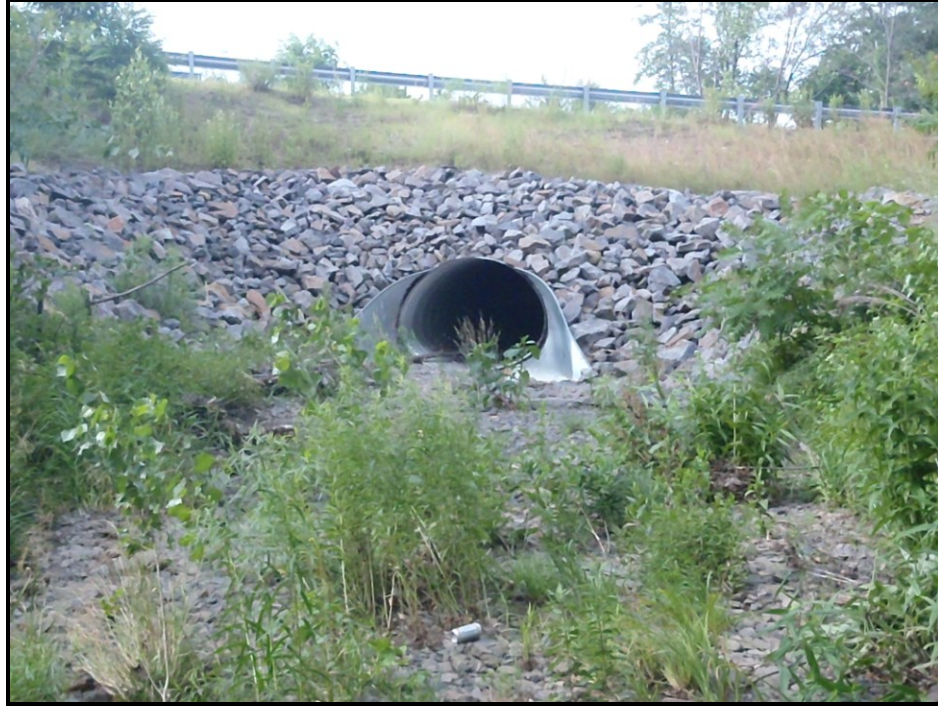
Photo : The upstream side of the squash pipe where Sugar Notch Run is more confined to a stormwater basin as opposed to a stream channel; The guard rail above and road takes you to the WAL-MART Trailer Storage Drop Lot

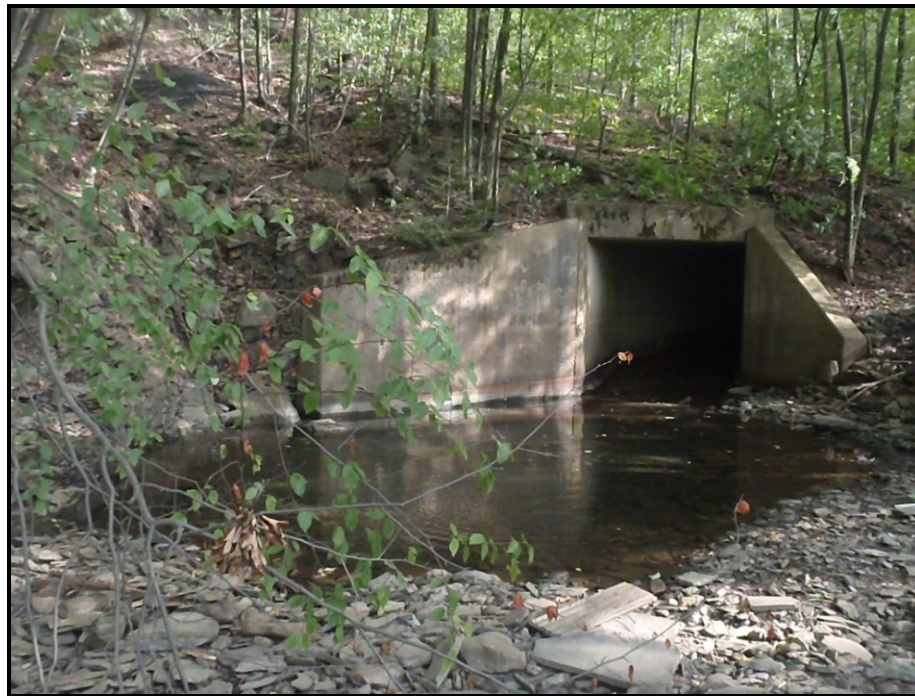
Photo : Sugar Notch Run is pooled at this point upstream in a 3' pool at the outlet of the State Route 29 underpass, however it doesn't flow downstream in the channel at this point and is more than likely lost to the local mine pool in this vicinity

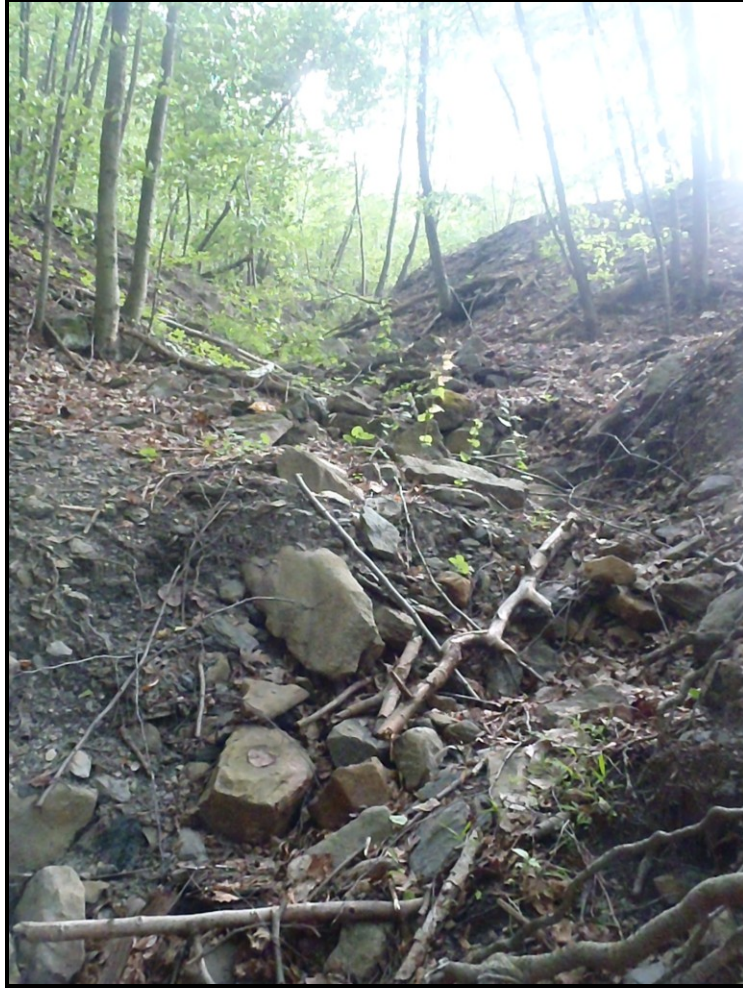
Photo : A stormwater overflow channel that is very steep that drains runoff from the off ramp of State Route 29 onto S. Main Street at the light; The PA DOT Maintenance Facility Shed is located upstream and adjacent to this draw to the right of this area

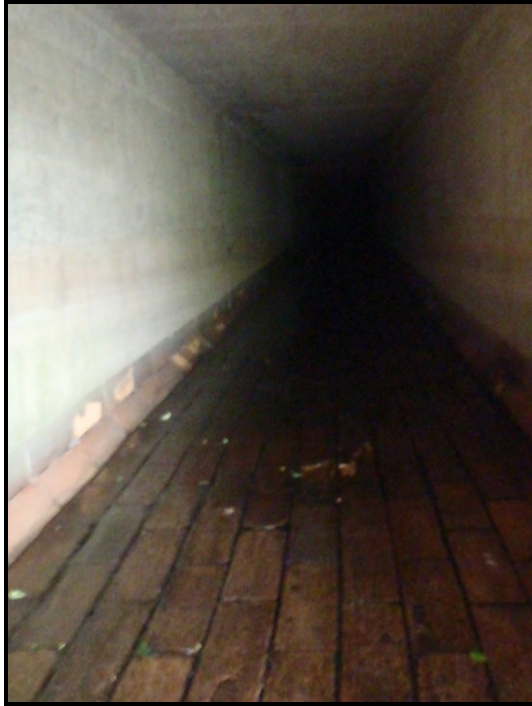
Photo: Entering the terra cotta lined State Route 29 underpass tunnel that carries Sugar Notch Run looking upstream into the several hundred foot tunnel; Sugar Notch Run was flowing through the underpass across the entire length of the terra cotta floor to a depth of 1”

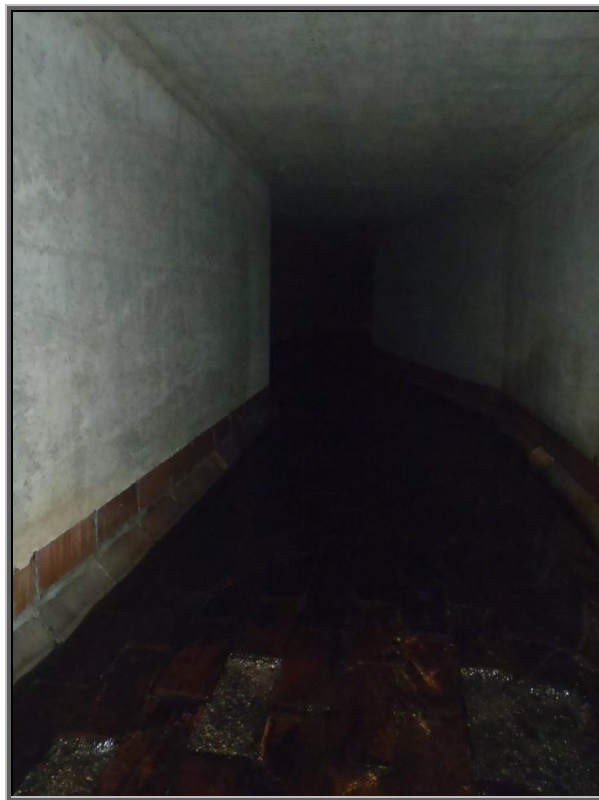
Photo: A few missing tiles here are probably the ones that were found below the pool downstream in Sugar Notch Run

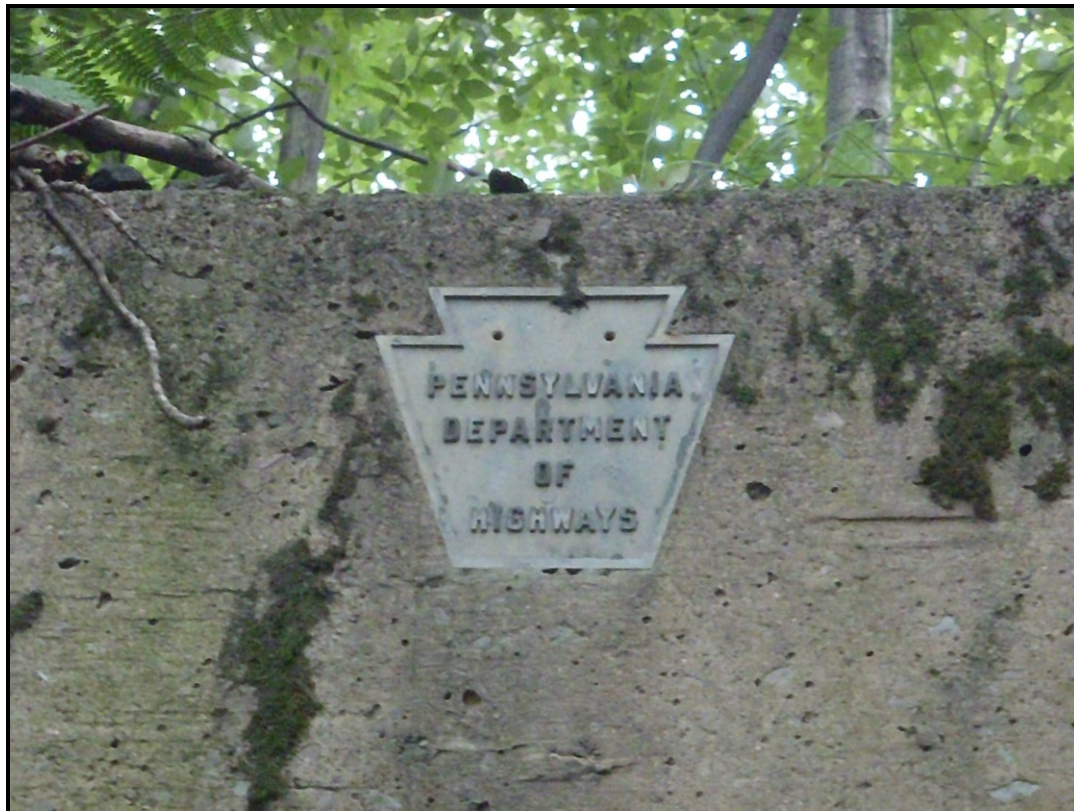
Photo: A closeup of one of the brass PA Department of Highways Keystone plates cemented into the underpass; Seems as if the year of construction name plate might have been stolen from above the plate

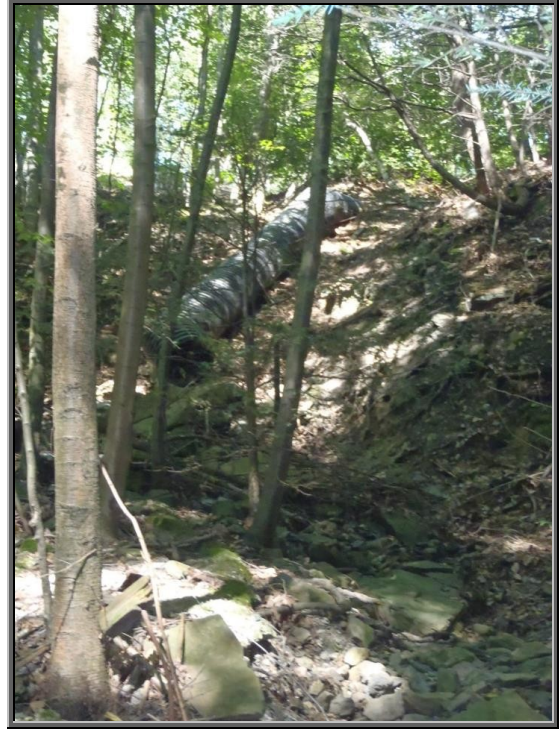
(R) Photo: Stormwater drainage pipe from State Route 29 coming down the left bank of Sugar Notch Run looking upstream

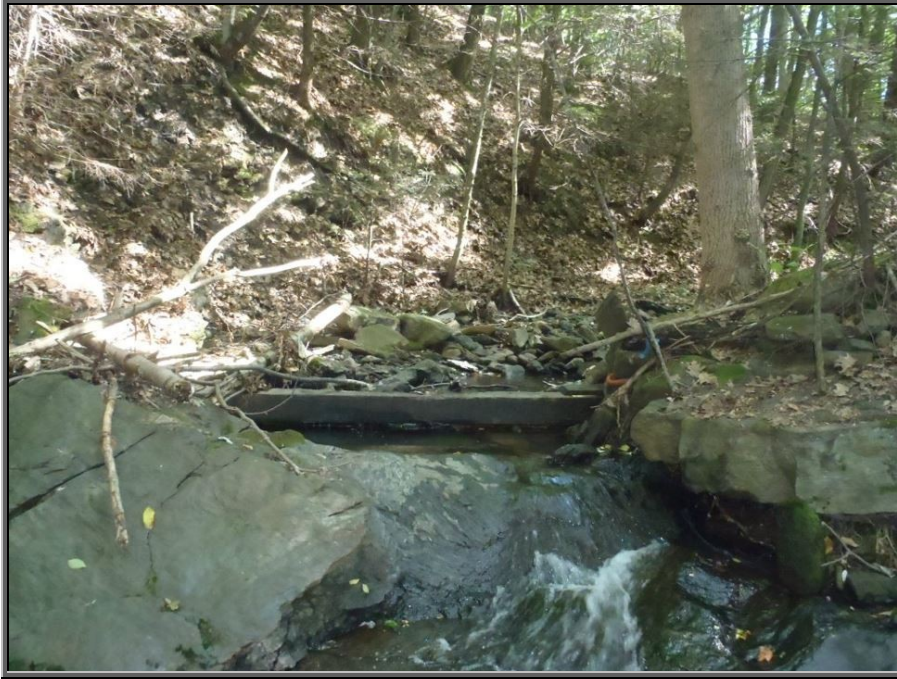
(L) Photo: Small woody debris blockage at the top of one of the sets of many falls along this section of Sugar Notch Run between State Route 29 and I-81; This area could easily be a stream improvement and habitat restoration project

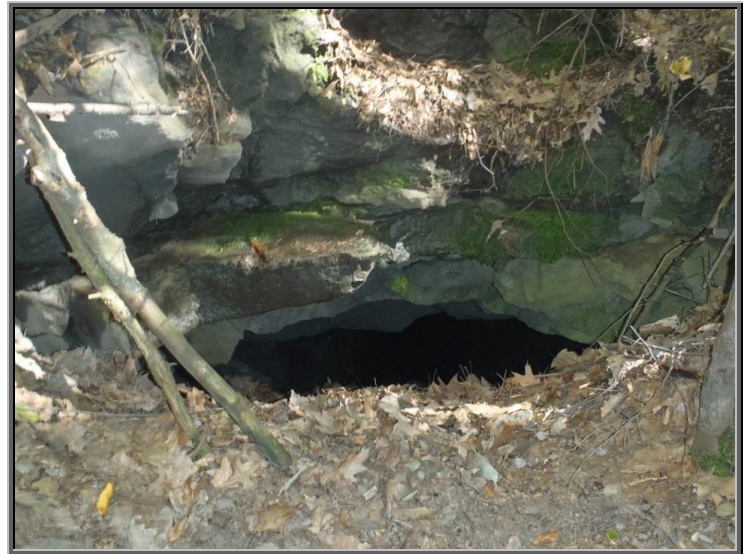
(R) Photo: Mine opening or cropfall along the left bank of Sugar Notch Run between SR 29 and I-81

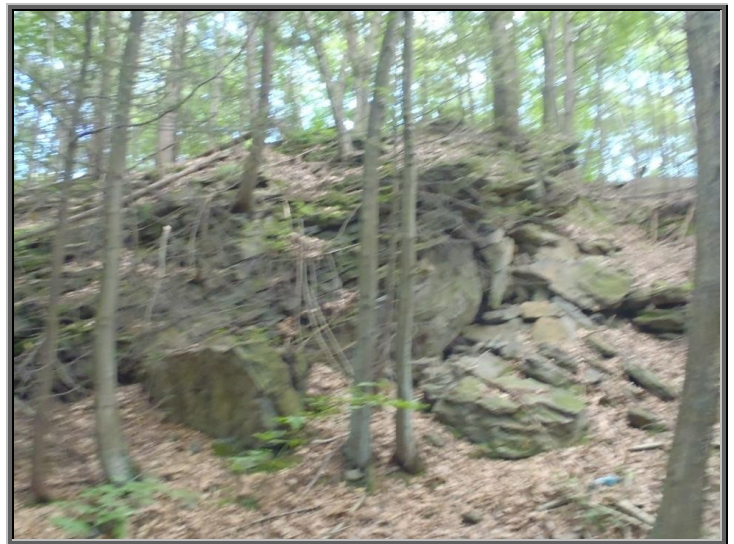
(R) Photo: A fold in the glacial outcrop causing a rock fall (right of center) along the left bank of Sugar Notch Run
