Sugar Notch Run sub-watershed Assessment

EPCAMR surveyed 6 stream segments in the Sugar Notch Run sub-watershed. They were labeled as **SNR 01-06** in the data tables and on the Solomon Creek Watershed Monitoring Map. The photo essay documents the entire length of the tributary and their unnamed tributaries and on occasion makes recommendations for future stream or habitat improvement projects or cleanups.

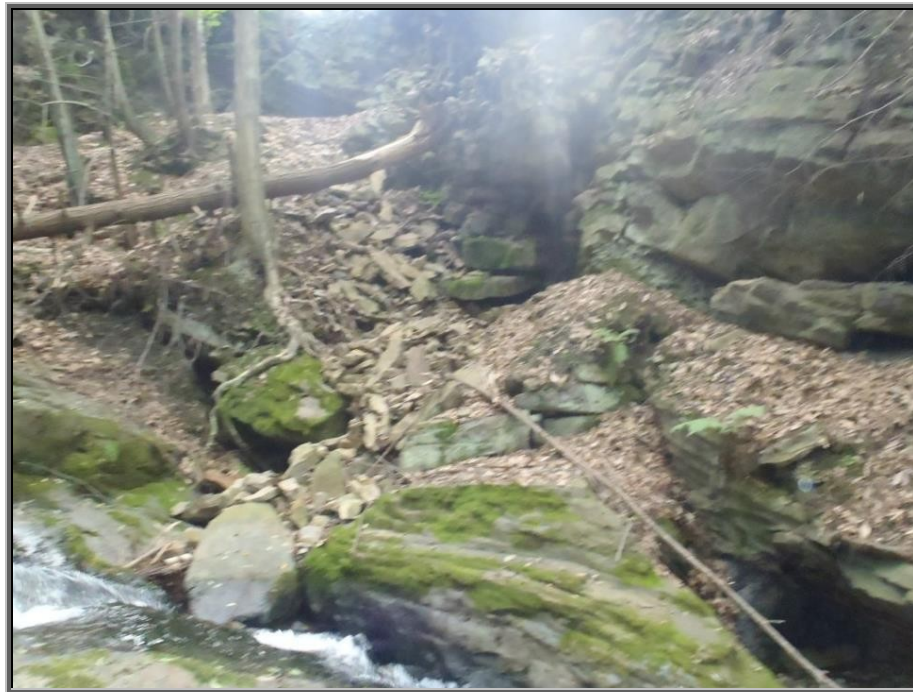
Photo: Another rock fall along the right hand bank of Sugar Notch Run looking upstream

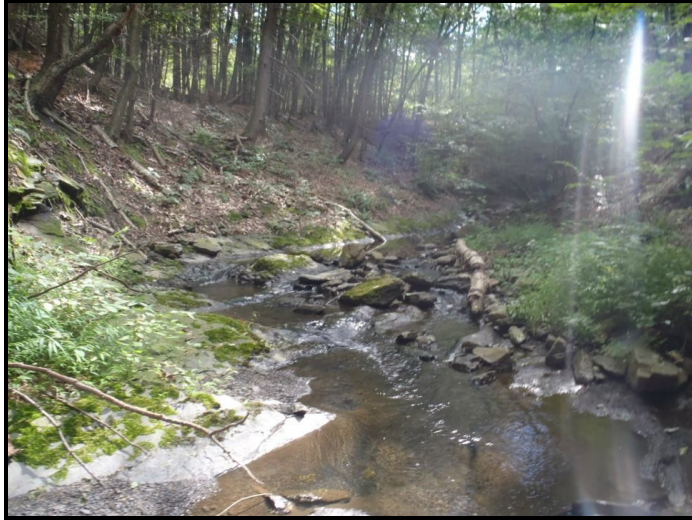
(L) Photo: Sugar Notch Run further upstream leveling out for some distance

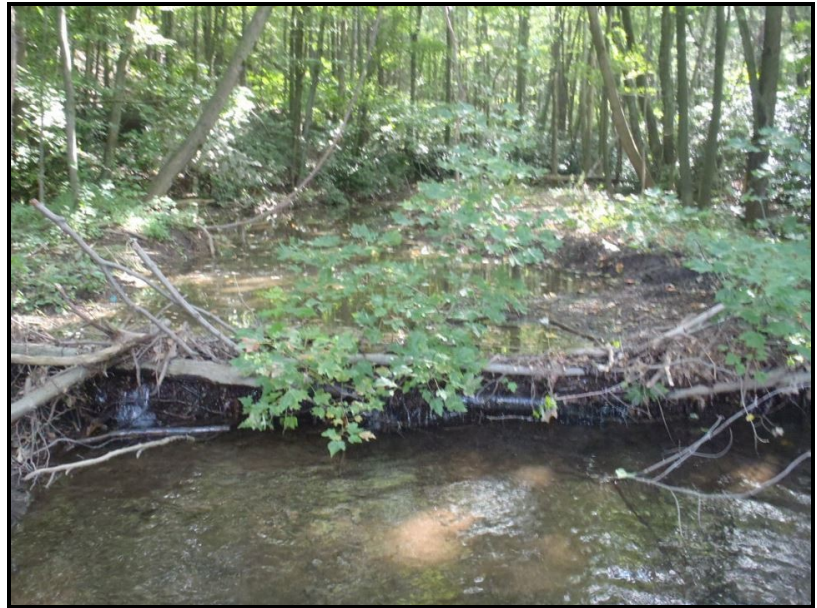
(L) Photo: Corrugated Steel double pipe culverts looking downstream on Sugar Notch on the other side of the entrance road to the Hanover Mini-Hawks Football practice area; Culverts are blocked up and could be cleared of debris with minimal effort

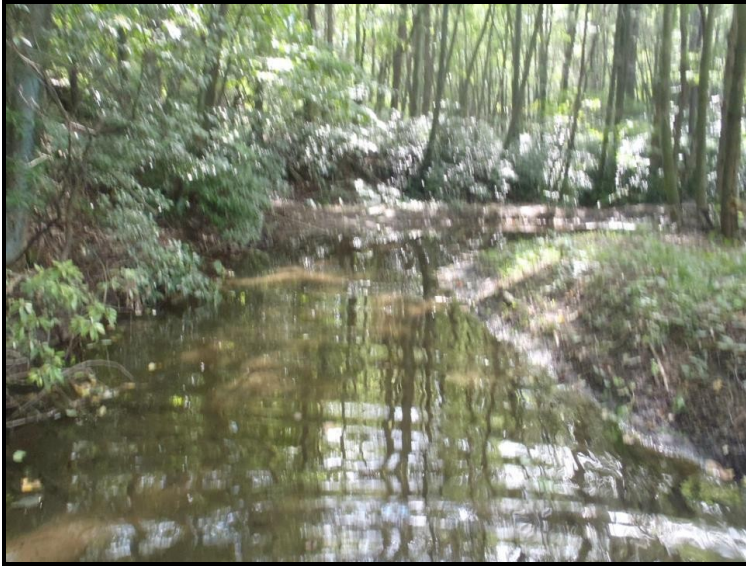
(R) Photo: Woody debris and leaf pack dam on Sugar Notch Run; This area could easily become a stream and habitat improvement project

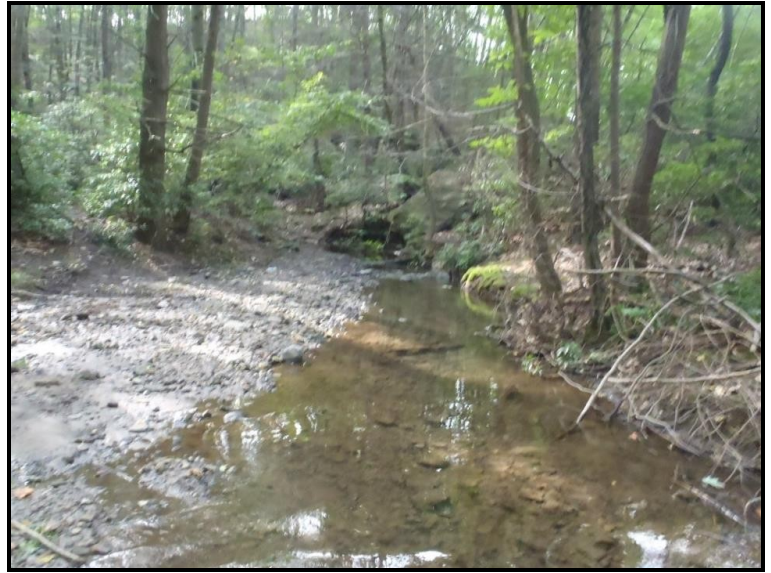
(L) Photo: Sediment laden section of Sugar Notch Run looking upstream

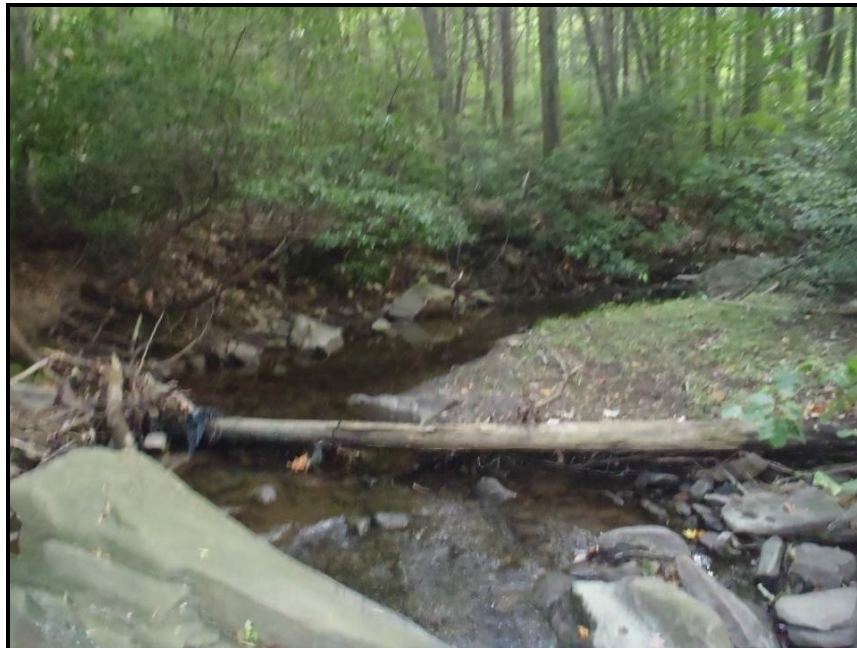
(R) Photo: Gravel bar deposition on left bank of Sugar Notch Run looking upstream

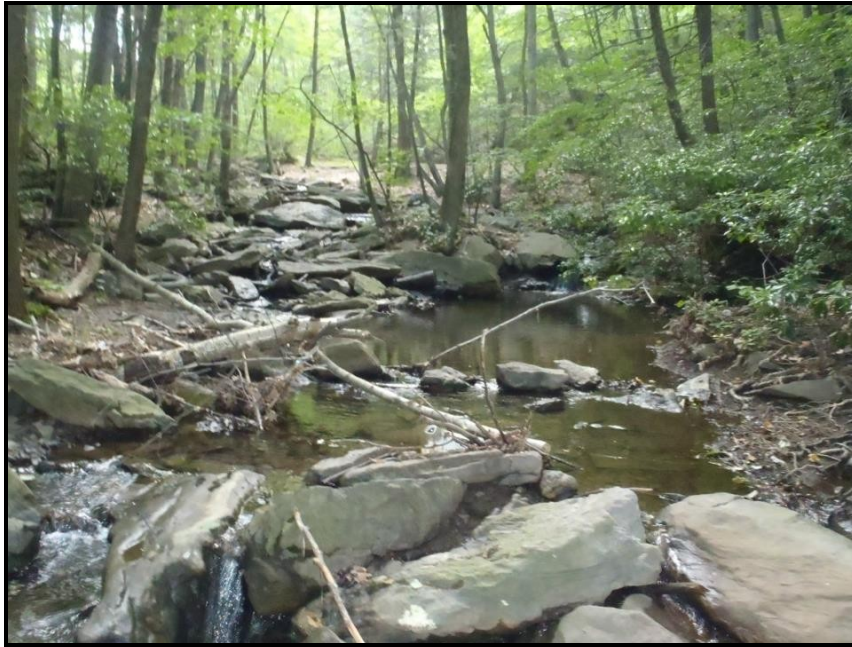
(L) Photo: Woody debris in Sugar Notch Run at meander looking upstream; This area could be a small stream improvement and habitat restoration project

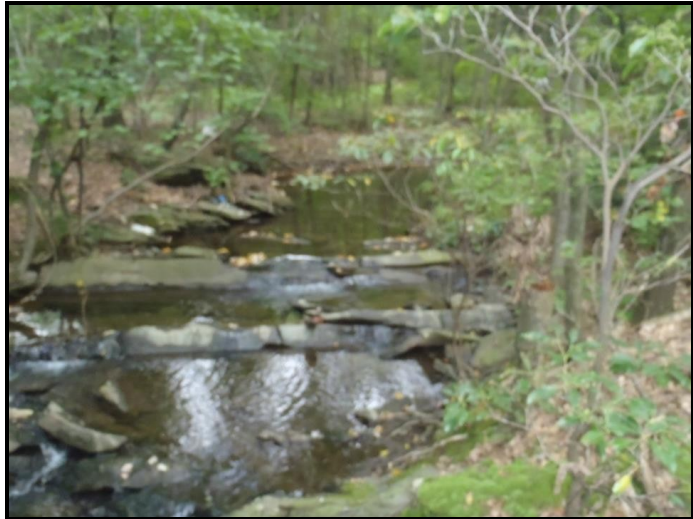
(L)Photo: Subsidence area just outside the right stream bank along Sugar Notch Run

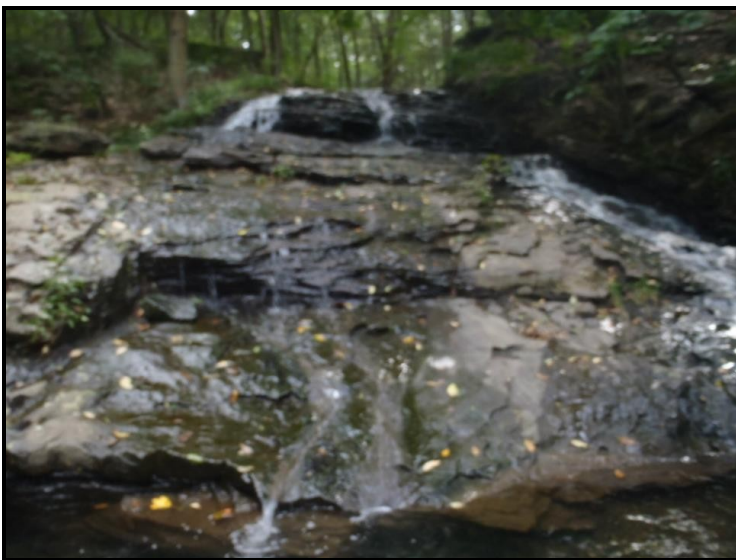
(R) Photo: Dam on Sugar Notch Run built by kids no doubt to swim in this 3' pool just below the 50' steeply sloping rock slide and waterfall

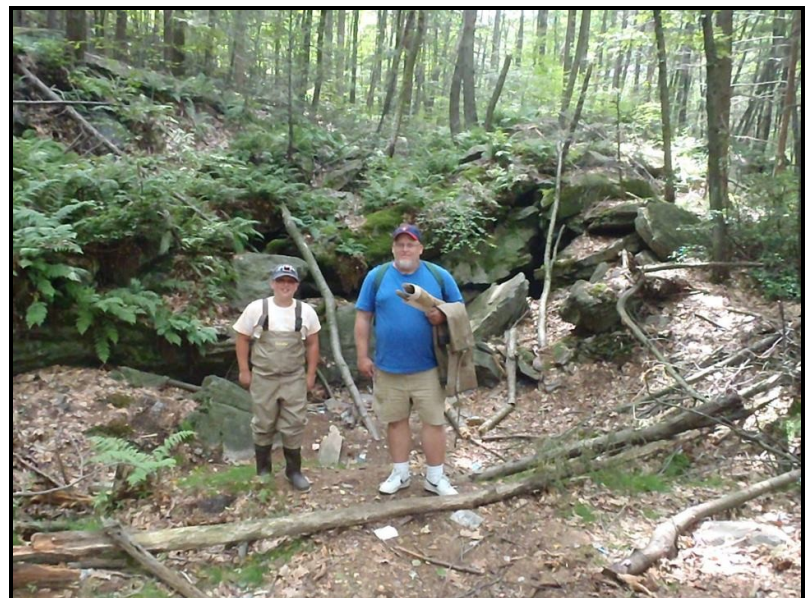
(L) Photo: Mine entrance and collapse along Sugar Notch Run just above the Sugar Notch Trail on lands owned by the Earth Conservancy; Well ventilated, cool air flows all year round out of this chasm

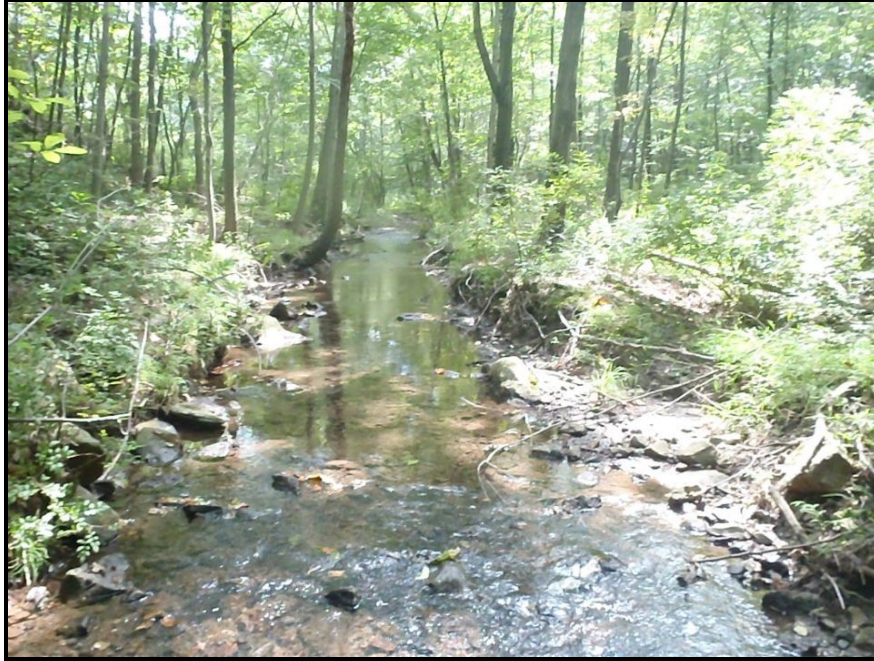
Photo: Sugar Notch Run looking upstream of the dam; Schools of fish and native brook trout darting everywhere as EPCAMR Staff walked up the stream corridor with I-81 Southbound lane to the left of the tributary

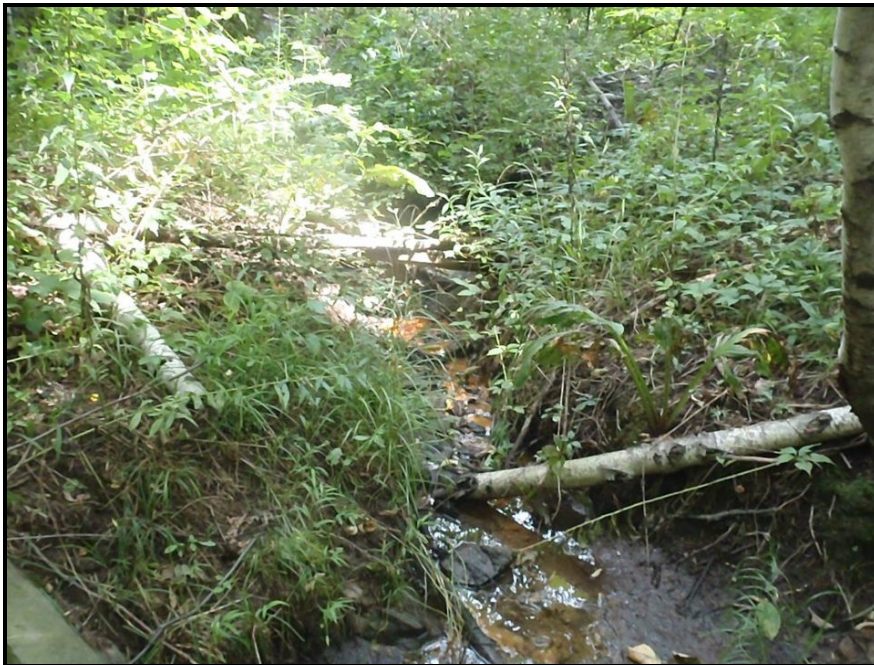
Photo: Small seep of iron from rock fill material coming from I-81 into Sugar Notch Run's left bank looking upstream; The seep had no impact on Sugar Notch Run

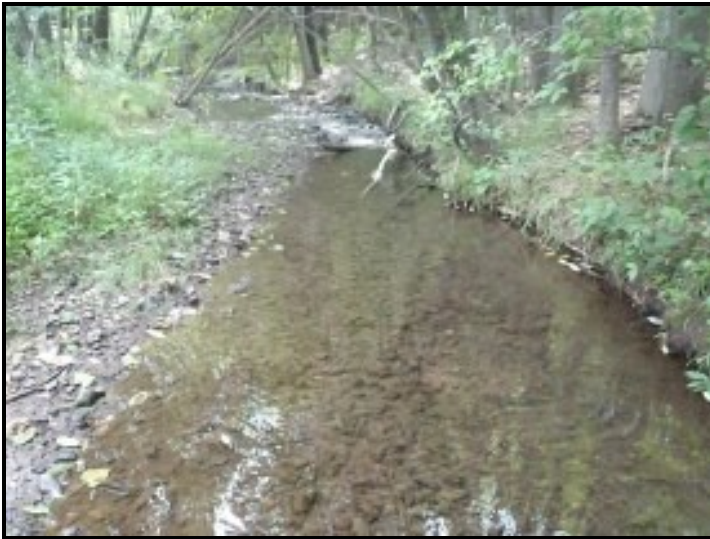
Photo: Another feeder stream entering Sugar Notch Run possibly from I-81 runoff into Sugar Notch Run's left bank looking upstream

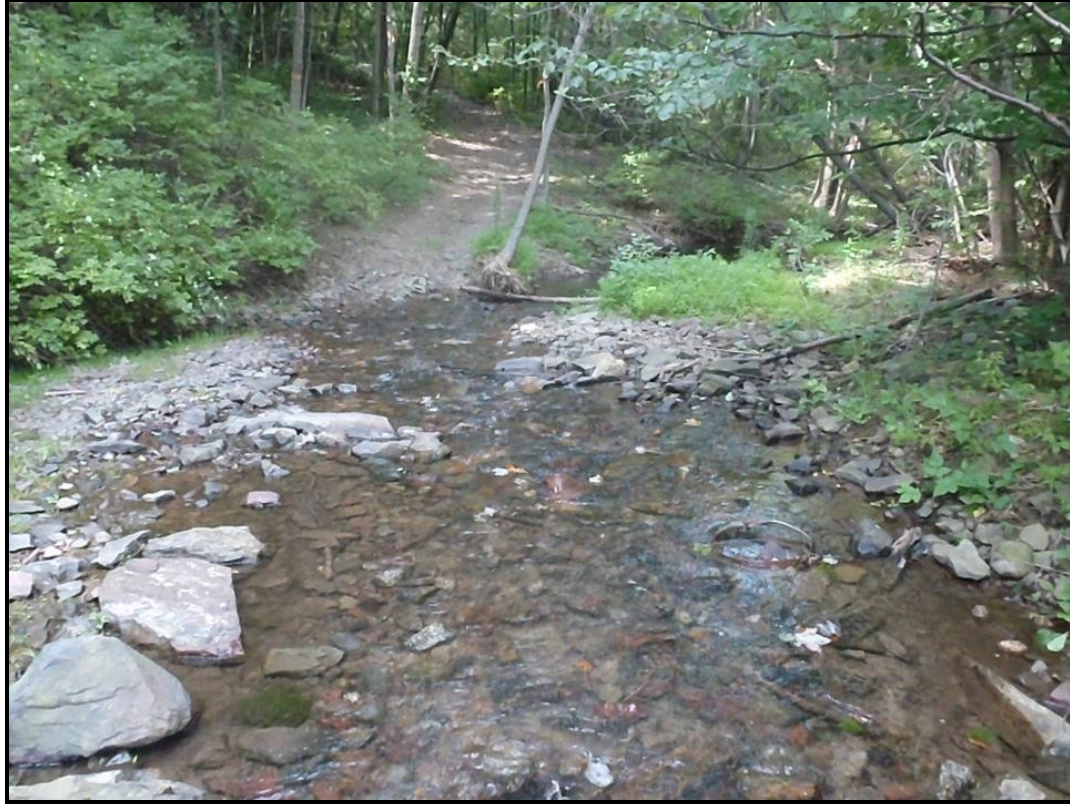
(R) Photo: Finally, the I-81 culvert that carries Sugar Notch Run downstream; several hundred feet long and 6' high

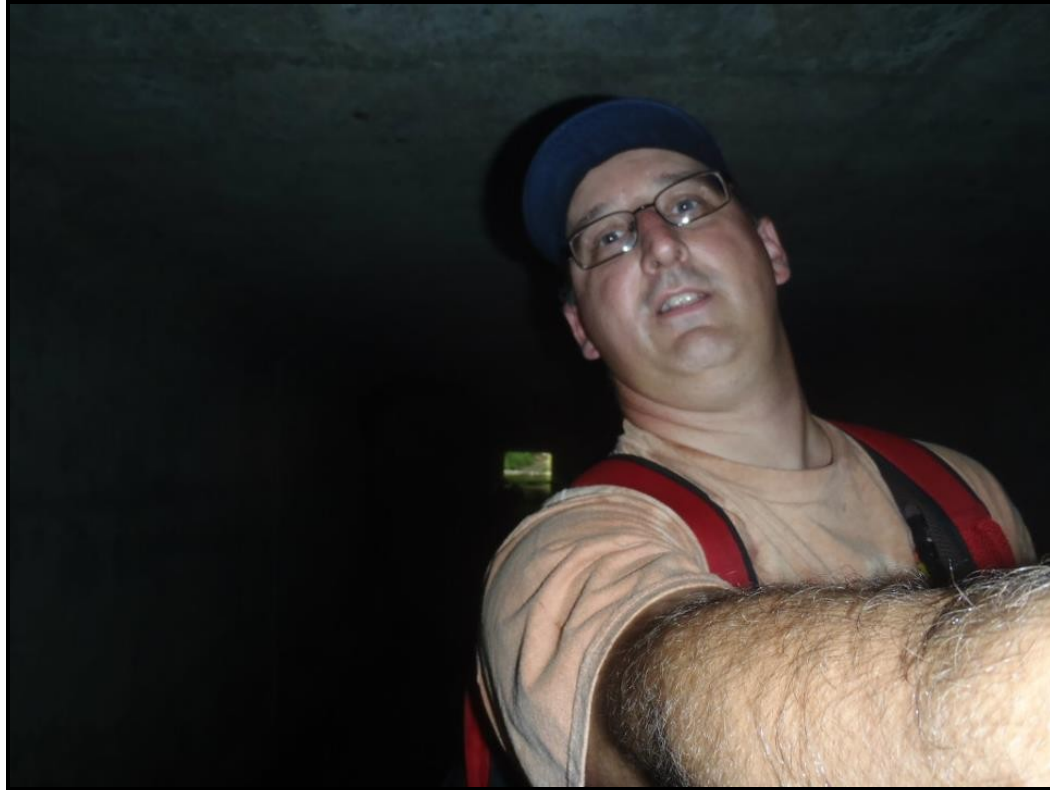
(R) Photo: Sugar Notch Run only flows to about the elevation of 4-6" through the culvert downstream

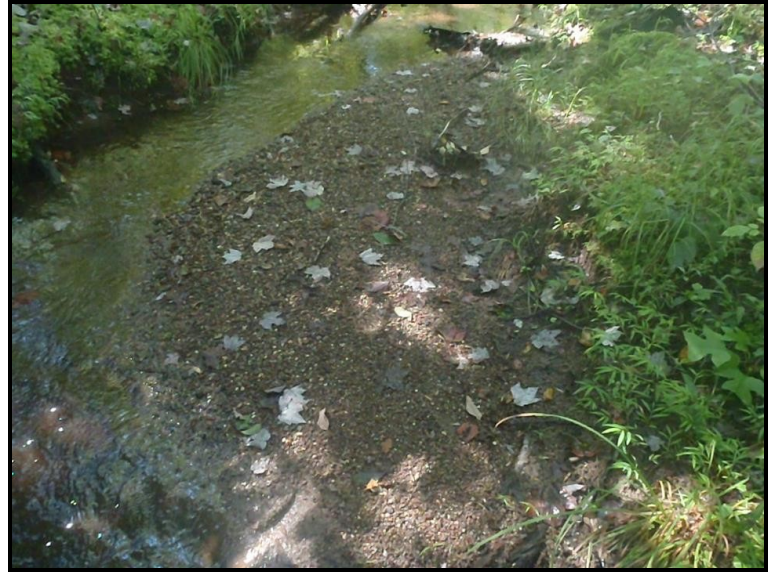
(L) Photo: Woody debris and leaf pack blockage on UNT 1 to Sugar Notch Run

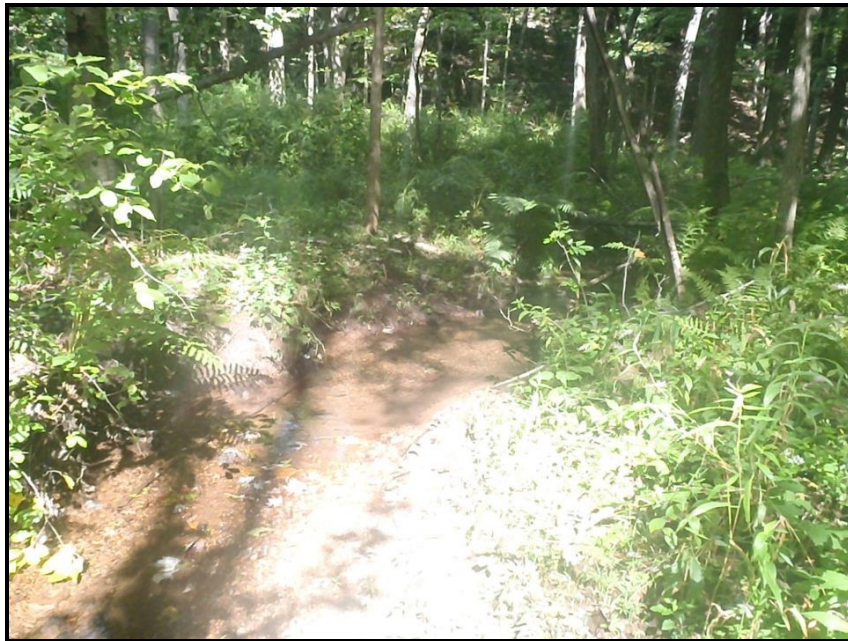
(R) Photo: Sandy gravel bar on outside bend of UNT1 to Sugar Notch Run

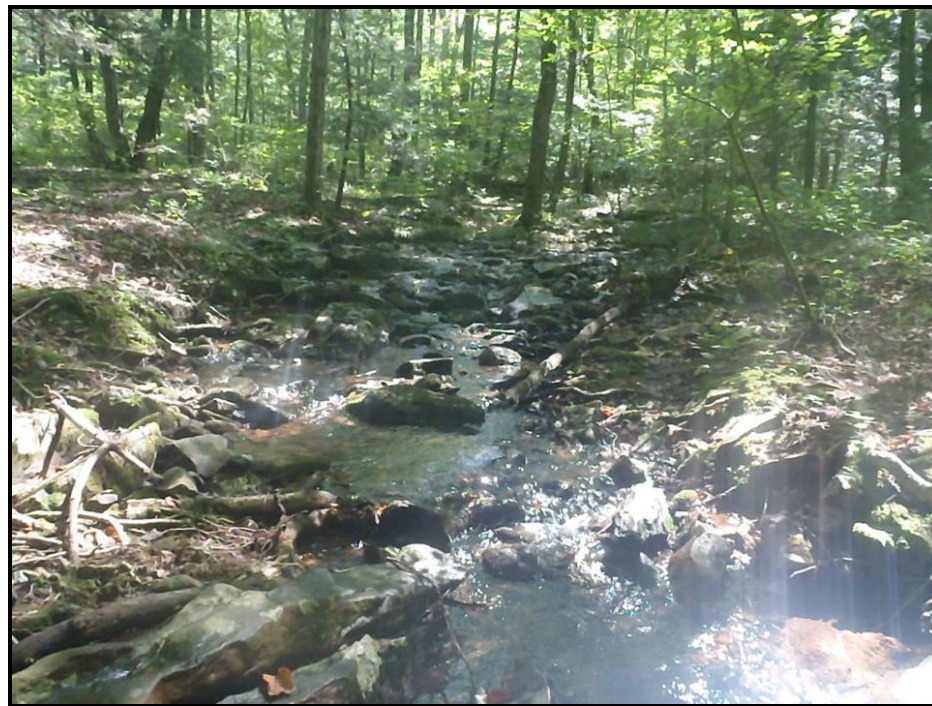
Photo (R): Upper most reach of the UNT1 to Sugar Notch Run; dry channel

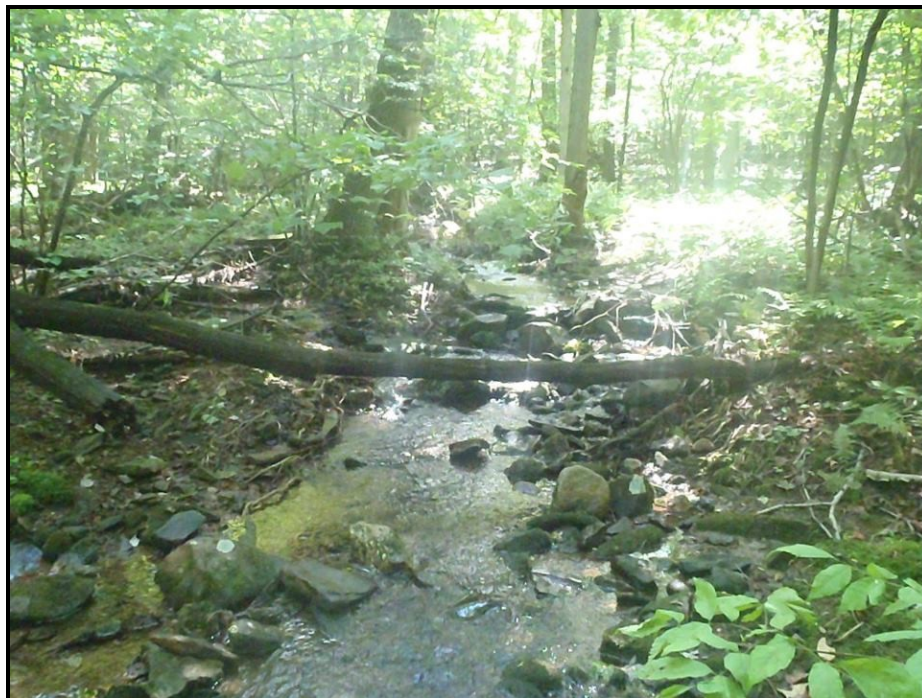
Photo : Large woody debris blockage in Sugar Notch Run; This fallen tree could easily be removed during a stream improvement project

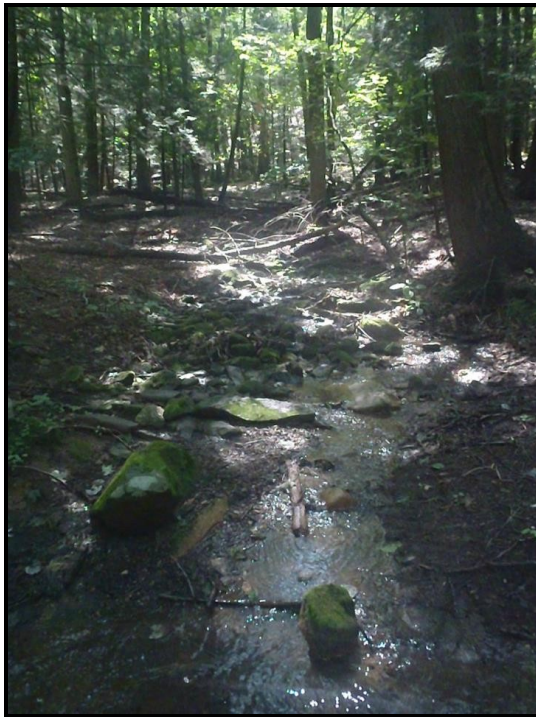
Photo: Leaf blockage and woody debris on Sugar Notch Run

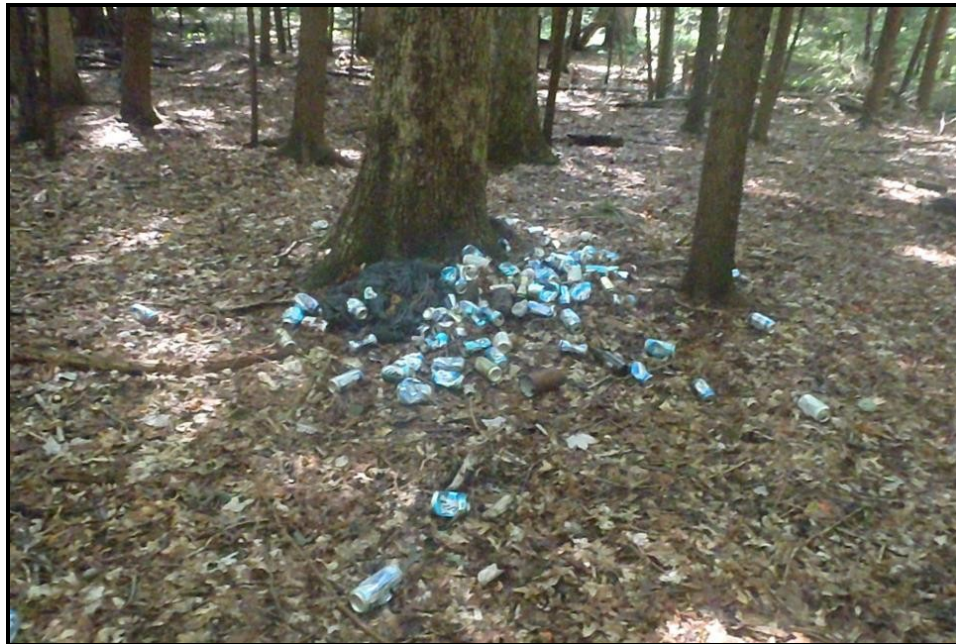
Photo : Litter on SGL 207 near Sugar Notch Run; This site can easily be a litter cleanup project coordinated by EPCAMR and the PA Game Commission

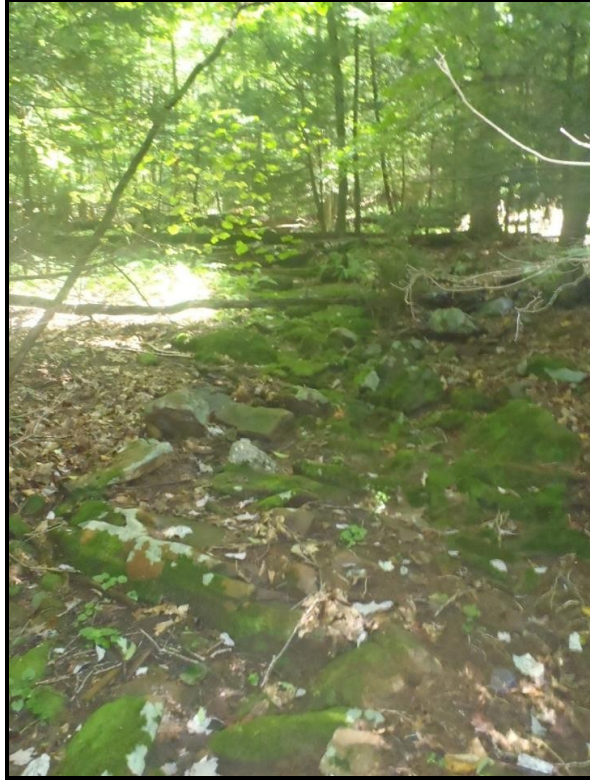
Photo : Upper most reach of Sugar Notch Run headwaters; dry with mossy growth in streambed and along channel
